Accessibility Survey

City of Downey

Borsen Street - Adenmoor Avenue to Cul-de-sac

Date of Inspection
12/10/2016

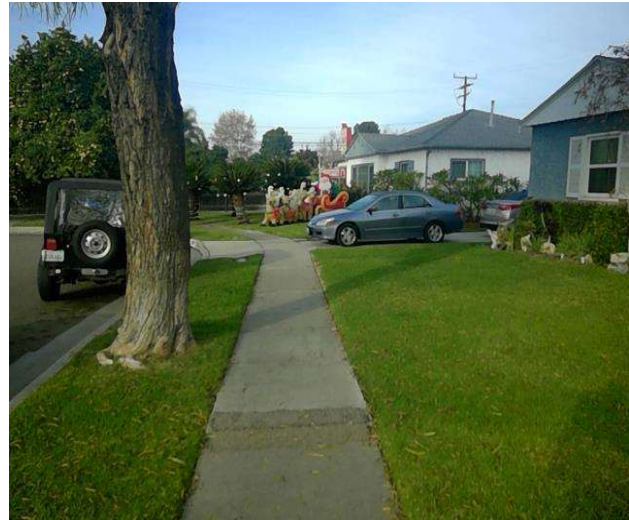
Change In Level East Of Cul-de-sac @ 33.915009249930, -118.124975860119

There is a change in elevation greater than recommended value.

On-Site Finding 2.25 inches

Ensure that the change in elevation is within the recommended value.

Recommendation Up to 0.25 inches

Remove tripping hazards \$198

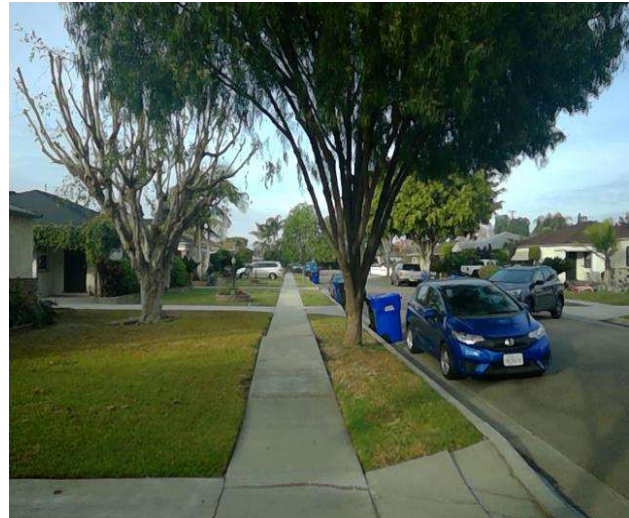
Change In Level West Of Adenmoor Avenue @ 33.914902407889, - 118.124047815800

There is a change in elevation greater than recommended value.

On-Site Finding 0.62 inches

Ensure that the change in elevation is within the recommended value.

Recommendation Up to 0.25 inches

Remove tripping hazards \$198

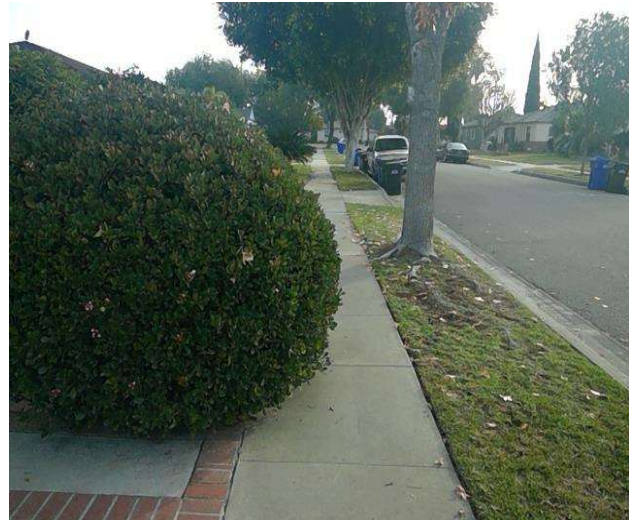
Bush East Of Cul-de-sac @ 33.915009249930, -118.124605715275

Sidewalk width at the obstruction is not compliant.

On-Site Finding 24.00 inches

Sidewalk width at the obstruction shall have the recommended value.

Recommendation At least 48.00 inches

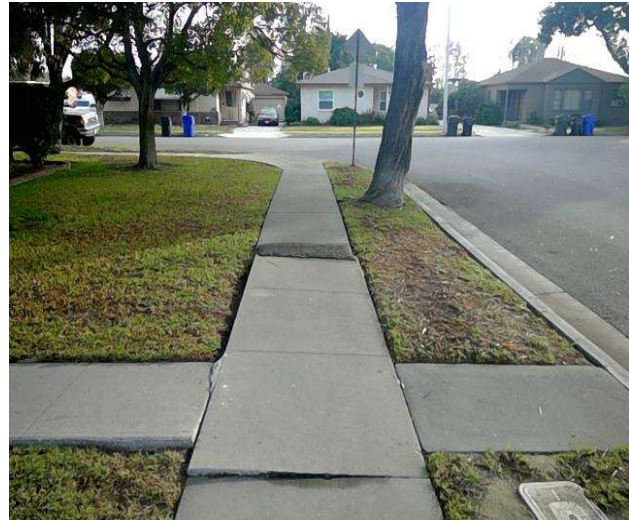
Sidewalk East Of Cul-de-sac @ 33.915004798181, -118.123902976513

Sidewalk cross slope is not compliant.

On-Site Finding 5.90 percent for 15.00 feet

Repave the sidewalk surface with the recommended cross slope.

Recommendation Up to 2.08 percent

Repave surface \$1,092

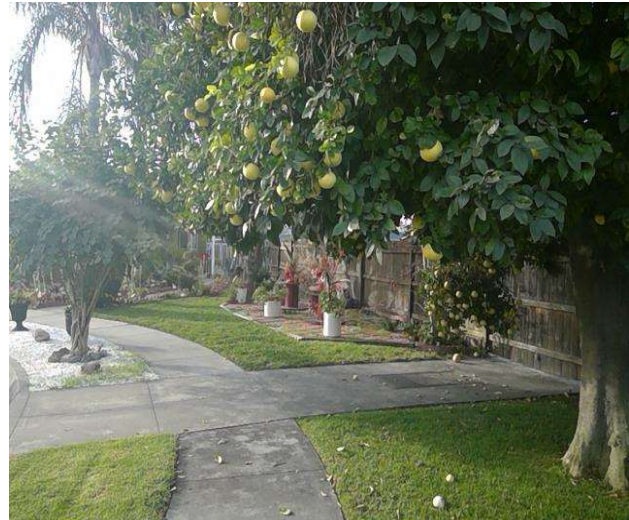
Tree East Of Cul-de-sac @ 33.914935796041, -118.125179708004

Overhead obstruction height is not compliant.

On-Site Finding 73.00 inches

Provide a compliant vertical clearance height.

Recommendation At least 80.00 inches

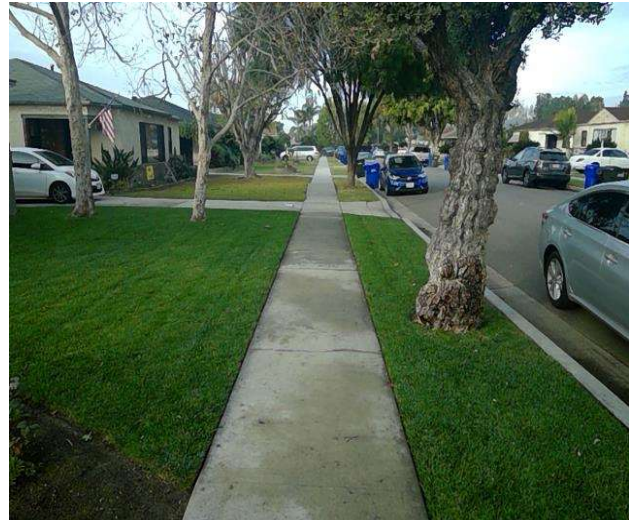
Sidewalk South Of Adenmoor Avenue @ 33.914873471480, -118.123747408390

Sidewalk cross slope is not compliant.

On-Site Finding 3.50 percent for 70.00 feet

Repave the sidewalk surface with the recommended cross slope.

Recommendation Up to 2.08 percent

Repave surface \$1,092

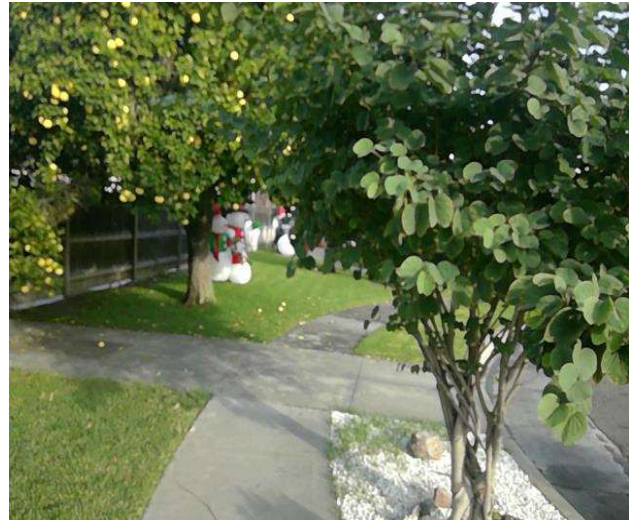
Tree West Of Adenmoor Avenue @ 33.914891278502, -118.125112652779

Overhead obstruction height is not compliant.

On-Site Finding 50.00 inches

Provide a compliant vertical clearance height.

Recommendation At least 80.00 inches

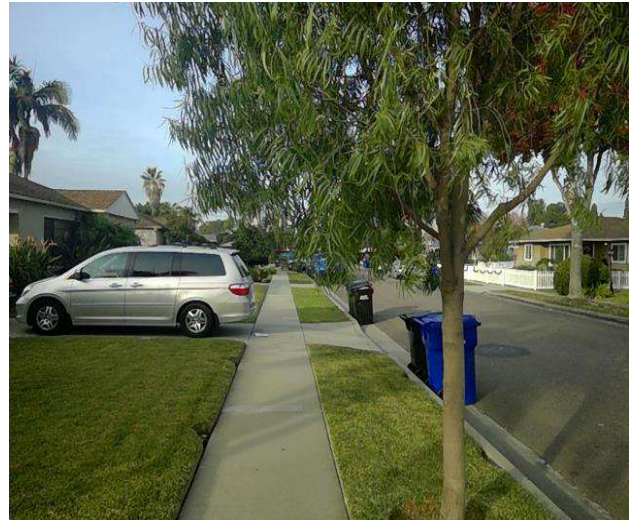
Tree West Of Adenmoor Avenue @ 33.914893504379, -118.124399185181

Sidewalks , Hazards & Gratings : Overhead Obstruction Height

Recommendation At least 80.00 inches

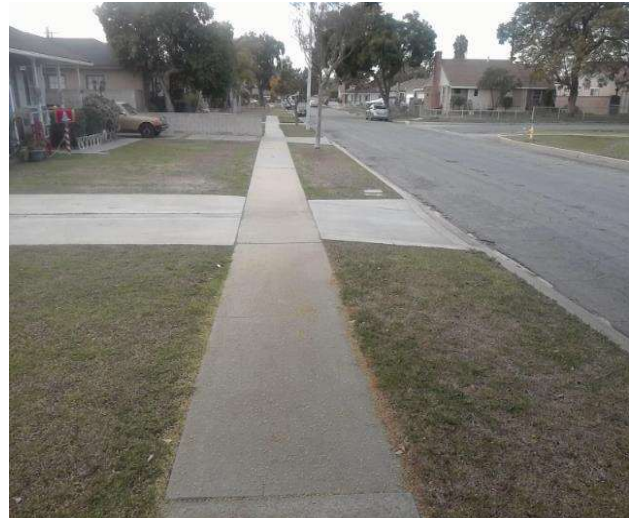
There is a change in elevation greater than recommended value.

Ensure that the change in elevation is within the recommended value.

Recommendation Up to 0.25 inches

Remove tripping hazards \$198

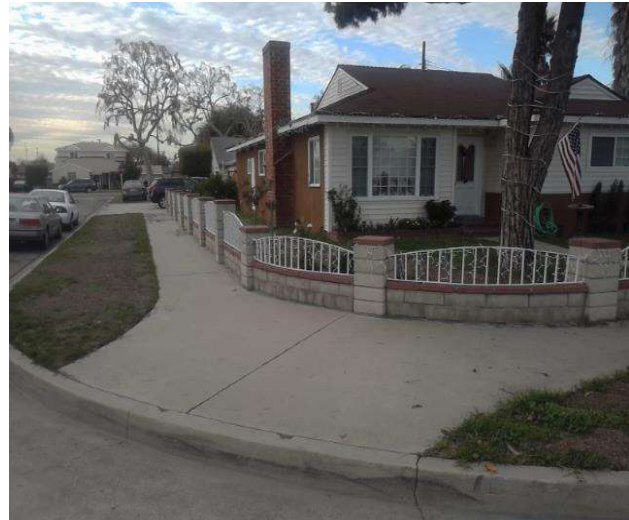
Sidewalks , Hazards & Gratings : Curb is on Path of Travel

Install curb ramp \$2,500

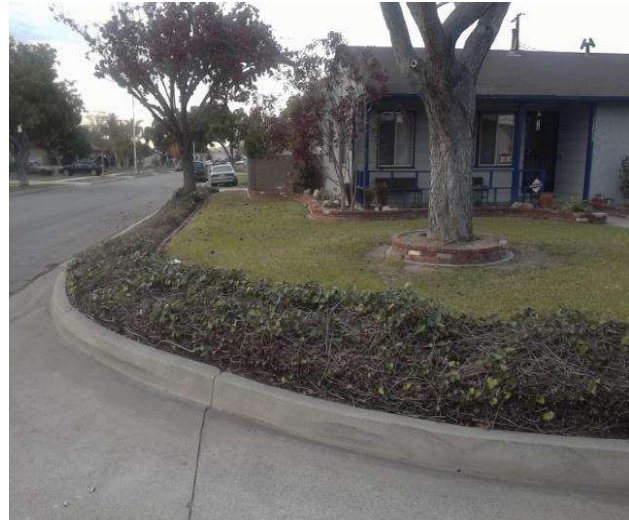
Sidewalks , Hazards & Gratings : Curb is on Path of Travel

Install curb ramp \$2,500

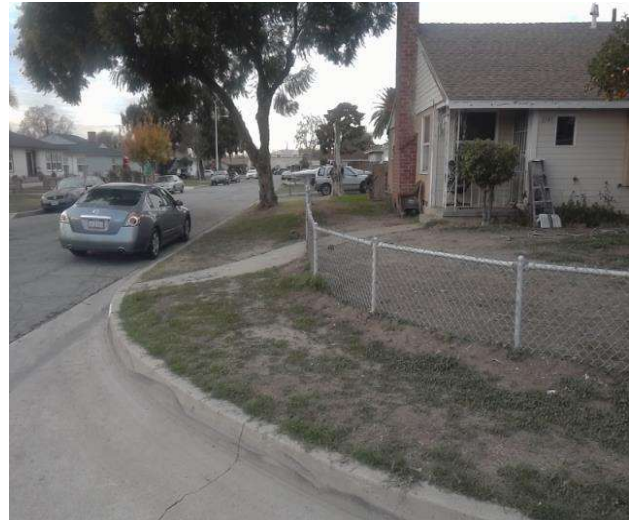
Sidewalks , Hazards & Gratings : Curb is on Path of Travel

Install curb ramp \$2,500

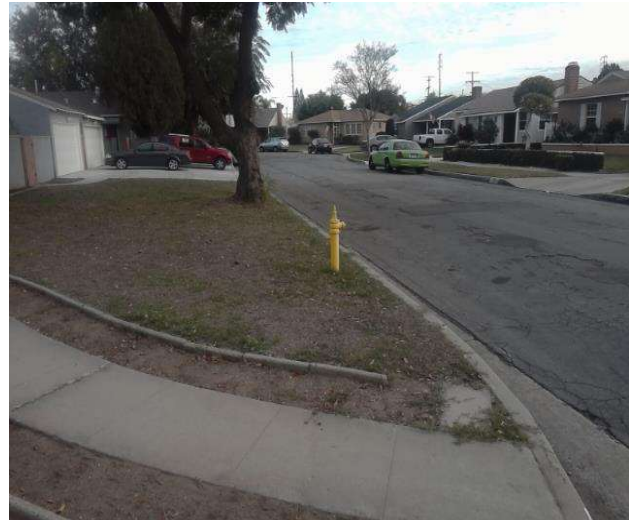
Section of sidewalk is missing and consists of dirt, grass or gravel.

Provide a compliant sidewalk for the missing section.

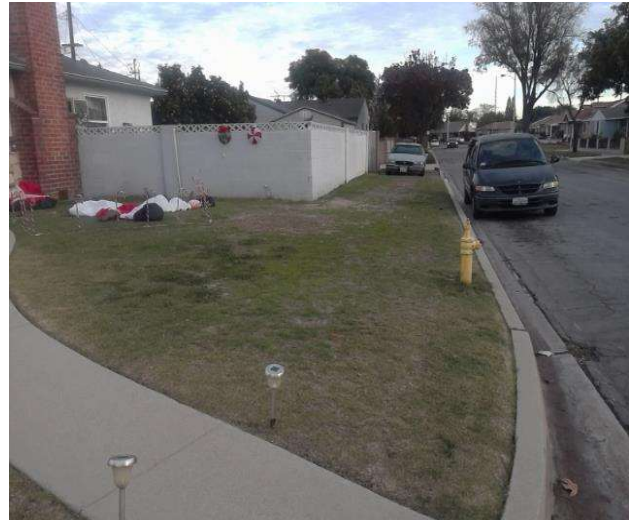
Section of sidewalk is missing and consists of dirt, grass or gravel.

Provide a compliant sidewalk for the missing section.

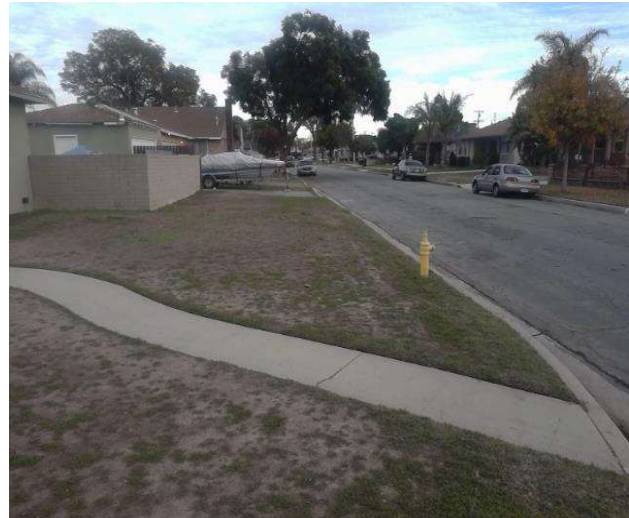
Section of sidewalk is missing and consists of dirt, grass or gravel.

Provide a compliant sidewalk for the missing section.

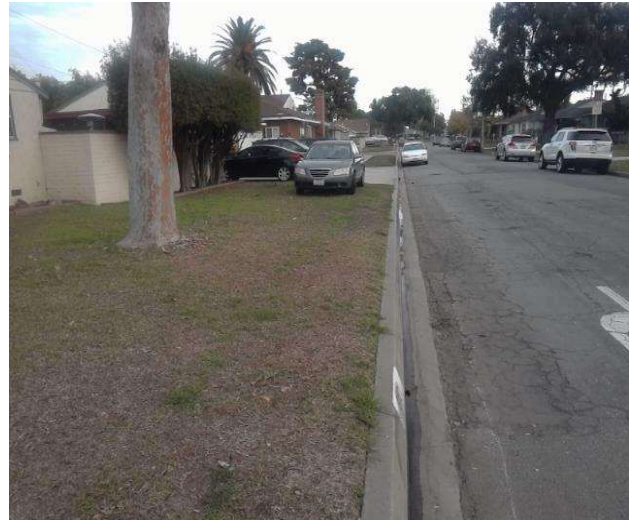
Section of sidewalk is missing and consists of dirt, grass or gravel.

Provide a compliant sidewalk for the missing section.

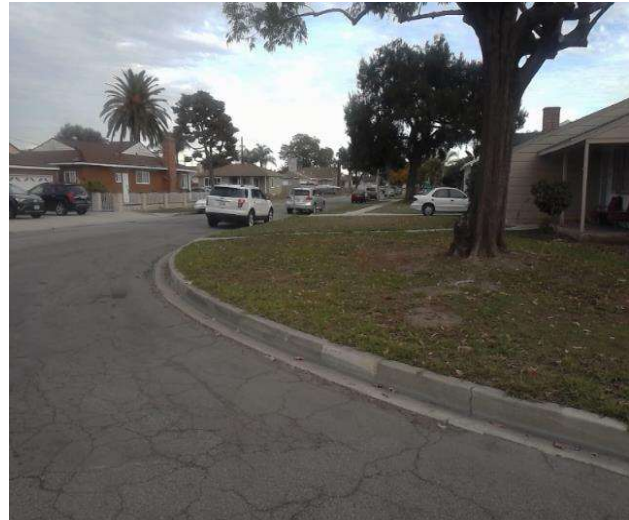
Sidewalks , Hazards & Gratings : Curb is on Path of Travel

Install curb ramp \$2,500

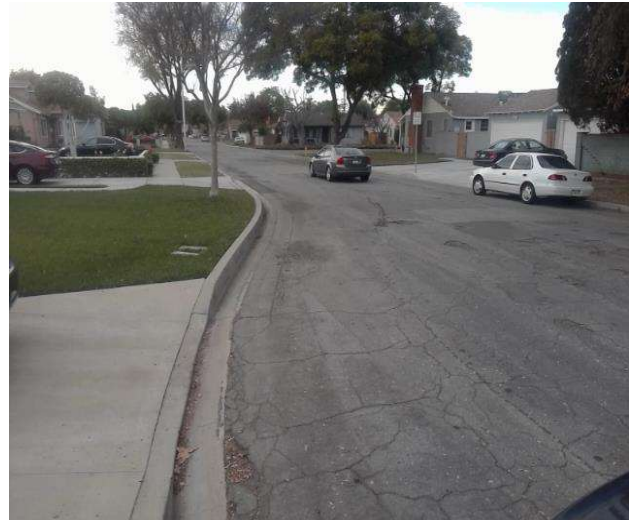
Section of sidewalk is missing and consists of dirt, grass or gravel.

Provide a compliant sidewalk for the missing section.

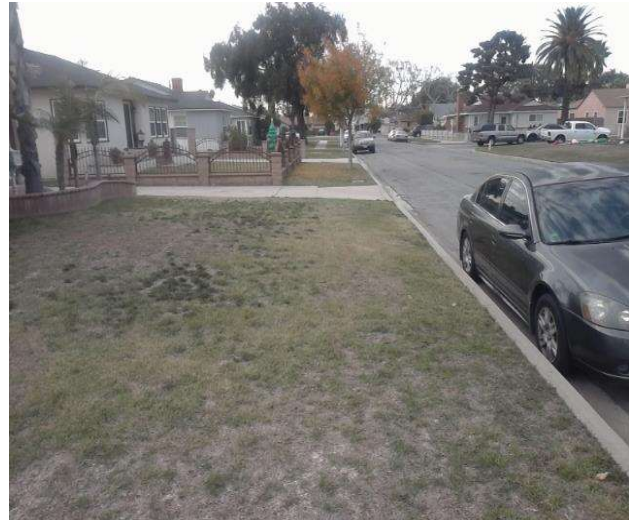
Section of sidewalk is missing and consists of dirt, grass or gravel.

Provide a compliant sidewalk for the missing section.

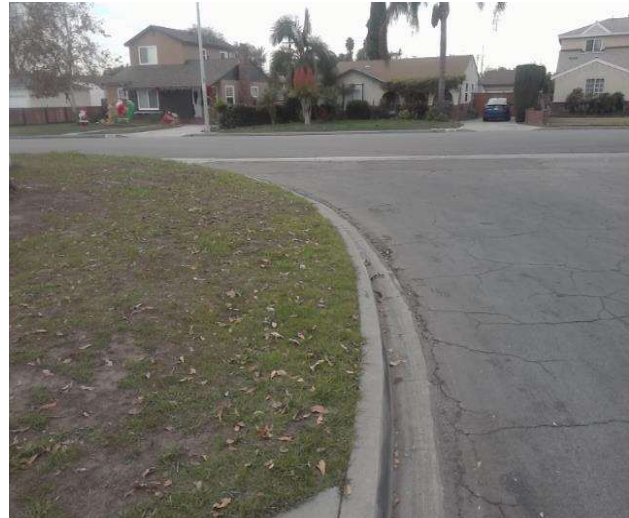
Section of sidewalk is missing and consists of dirt, grass or gravel.

Provide a compliant sidewalk for the missing section.

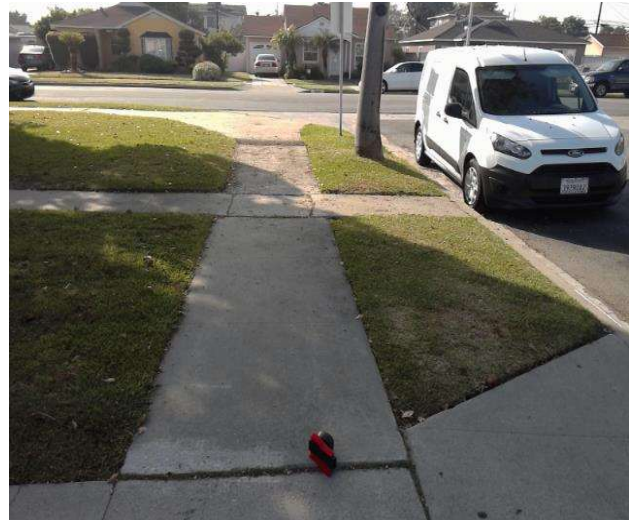
There is a change in elevation greater than recommended value.

Ensure that the change in elevation is within the recommended value.

Recommendation Up to 0.25 inches

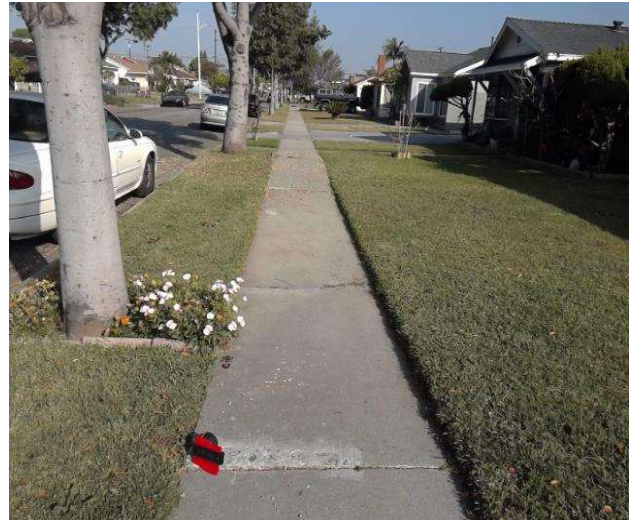
There is a change in elevation greater than recommended value.

Ensure that the change in elevation is within the recommended value.

Recommendation Up to 0.25 inches

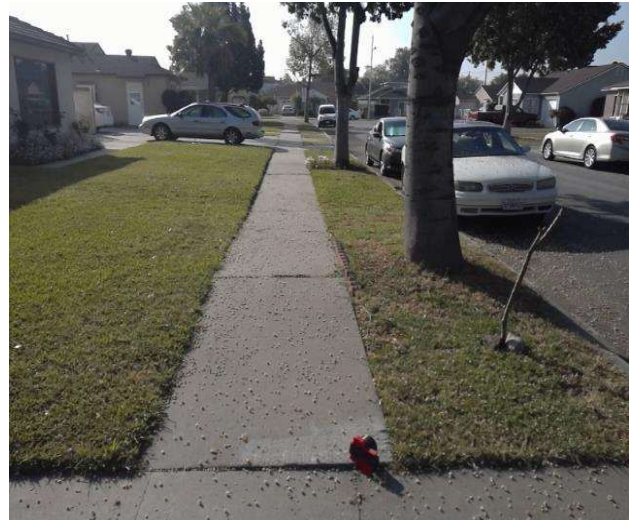
There is a change in elevation greater than recommended value.

Ensure that the change in elevation is within the recommended value.

Recommendation Up to 0.25 inches

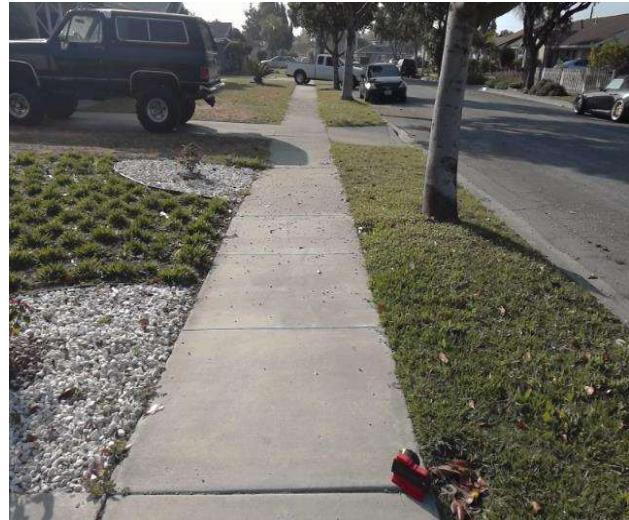
There is a change in elevation greater than recommended value.

Ensure that the change in elevation is within the recommended value.

Recommendation Up to 0.25 inches

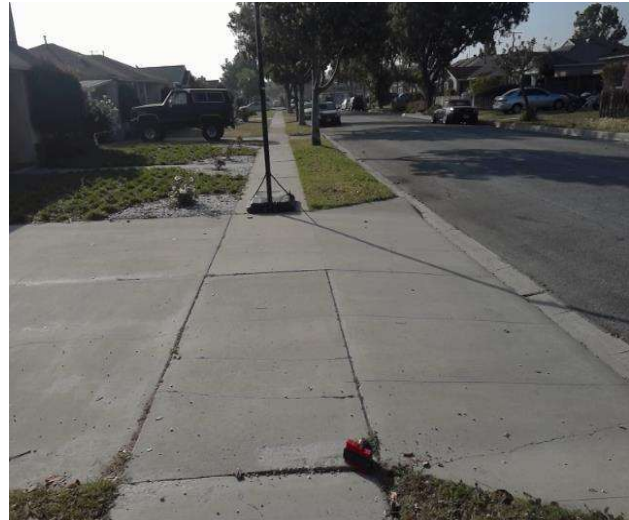
There is a change in elevation greater than recommended value.

Ensure that the change in elevation is within the recommended value.

Recommendation Up to 0.25 inches

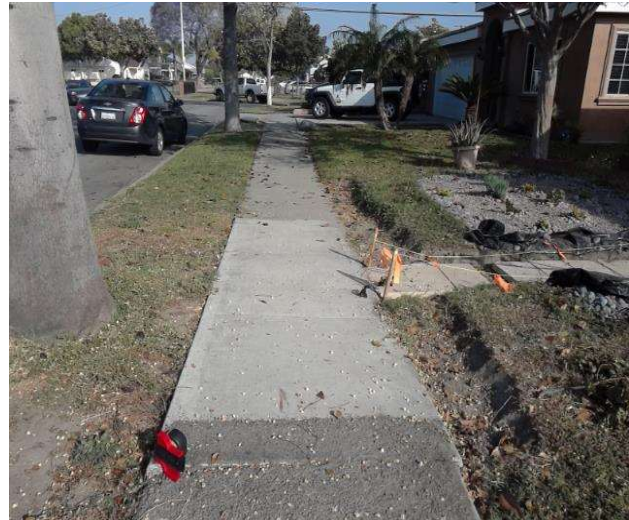
There is a change in elevation greater than recommended value.

Ensure that the change in elevation is within the recommended value.

Recommendation Up to 0.25 inches

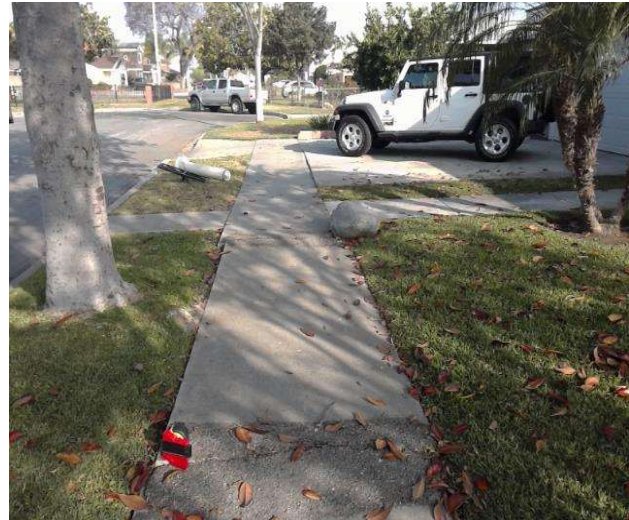
There is a change in elevation greater than recommended value.

Ensure that the change in elevation is within the recommended value.

Recommendation Up to 0.25 inches

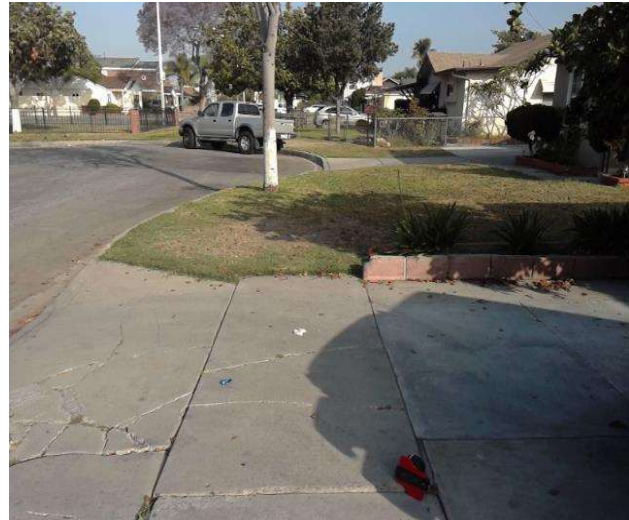
There is a change in elevation greater than recommended value.

Ensure that the change in elevation is within the recommended value.

Recommendation Up to 0.25 inches

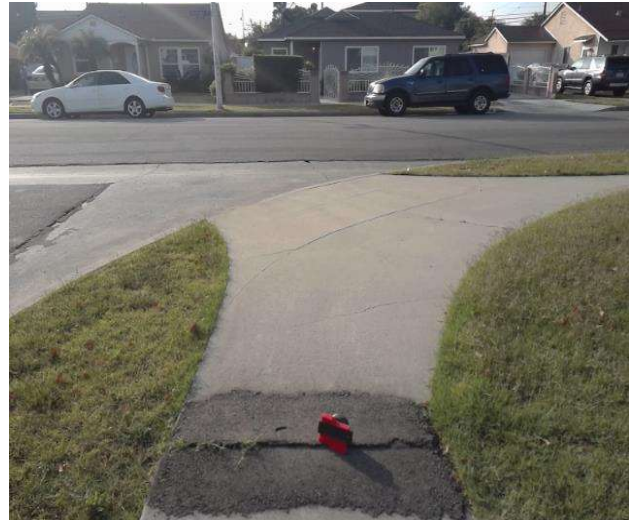
There is a change in elevation greater than recommended value.

Ensure that the change in elevation is within the recommended value.

Recommendation Up to 0.25 inches

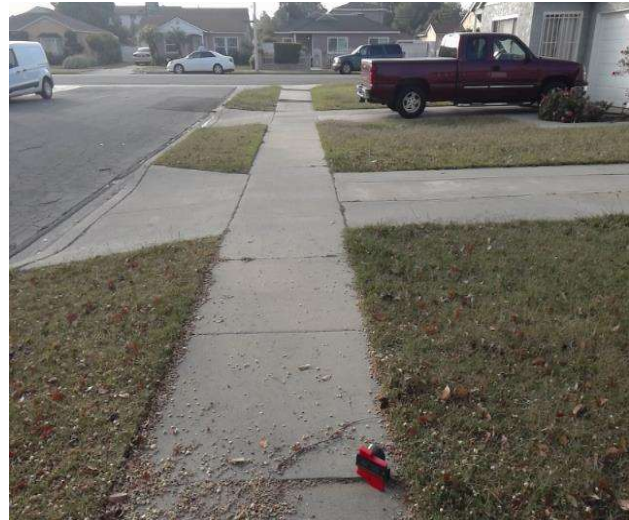
There is a change in elevation greater than recommended value.

Ensure that the change in elevation is within the recommended value.

Recommendation Up to 0.25 inches

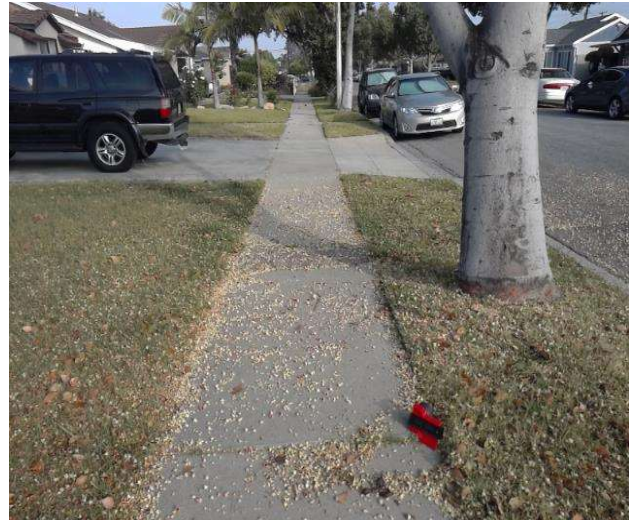
There is a change in elevation greater than recommended value.

Ensure that the change in elevation is within the recommended value.

Recommendation Up to 0.25 inches

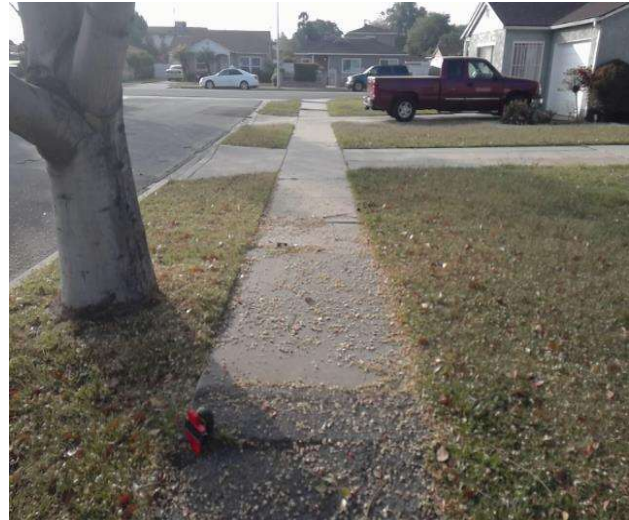
There is a change in elevation greater than recommended value.

Ensure that the change in elevation is within the recommended value.

Recommendation Up to 0.25 inches

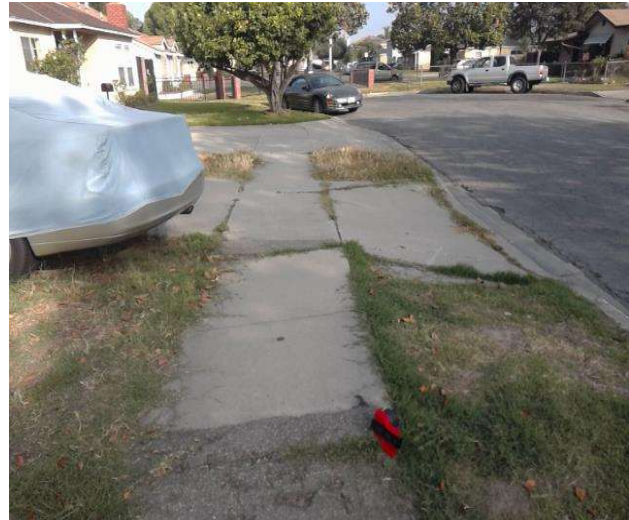
There is a change in elevation greater than recommended value.

Ensure that the change in elevation is within the recommended value.

Recommendation Up to 0.25 inches

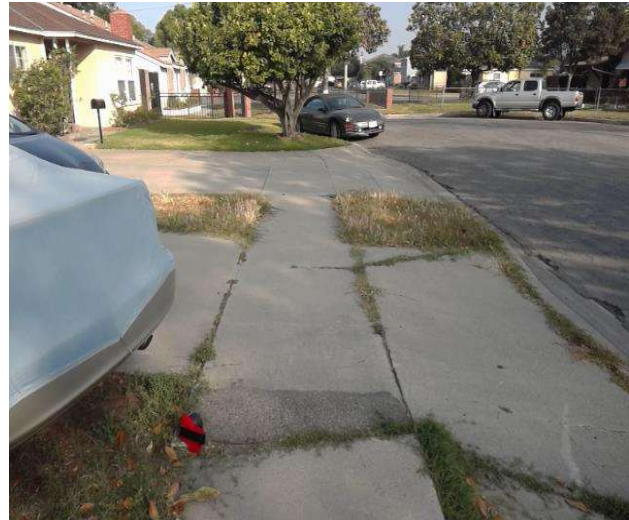
There is a change in elevation greater than recommended value.

Ensure that the change in elevation is within the recommended value.

Recommendation Up to 0.25 inches

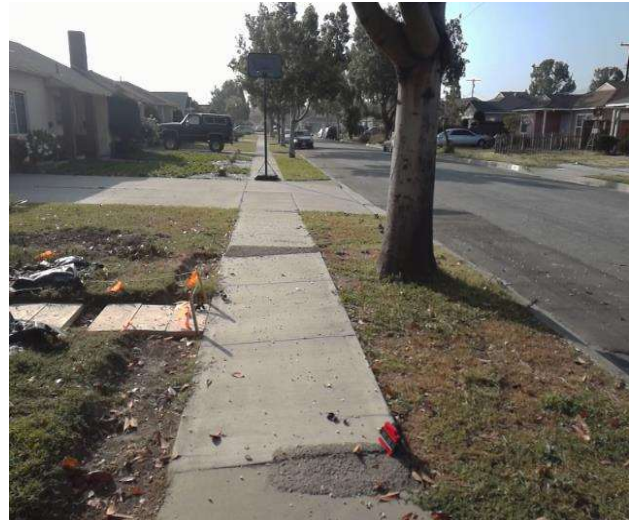
There is a change in elevation greater than recommended value.

Ensure that the change in elevation is within the recommended value.

Recommendation Up to 0.25 inches

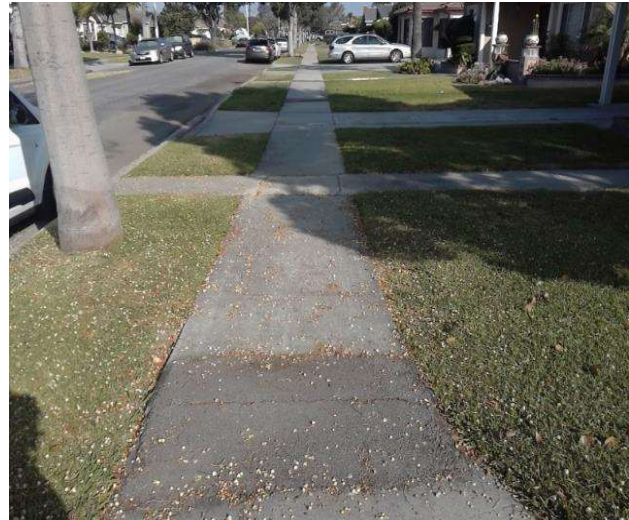
Notes : Surface is rough and uneven.

Repave the sidewalk surface with the recommended running slope.

Recommendation Up to 5.00 percent

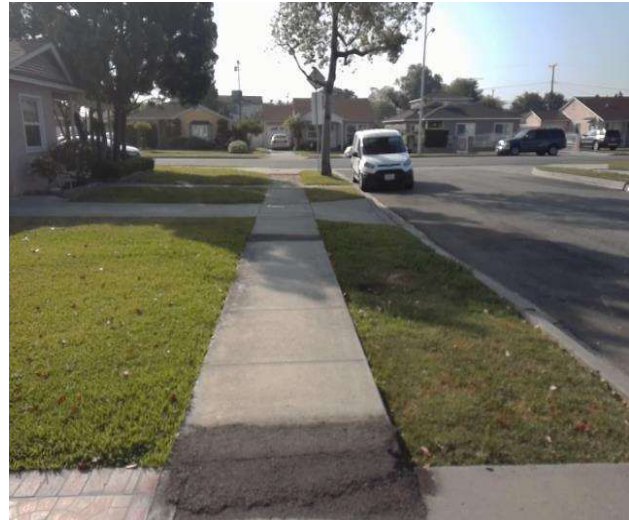
Notes : Surface is rough and uneven.

Repave the sidewalk surface with the recommended running slope.

Recommendation Up to 5.00 percent

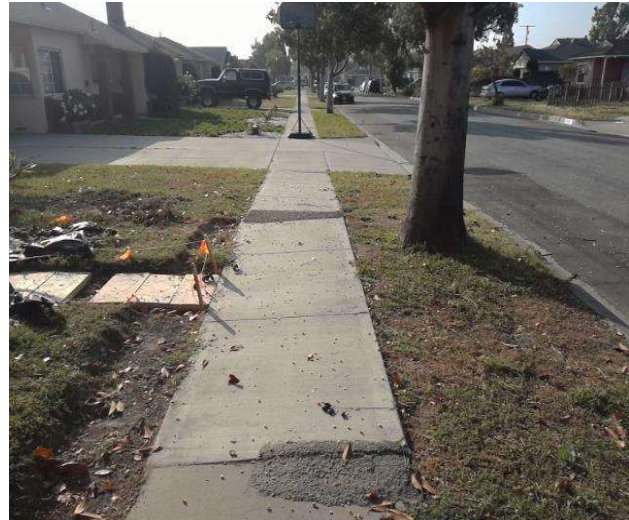
Notes : Surface is rough and uneven.

Repave the sidewalk surface with the recommended cross slope.

Recommendation Up to 2.08 percent

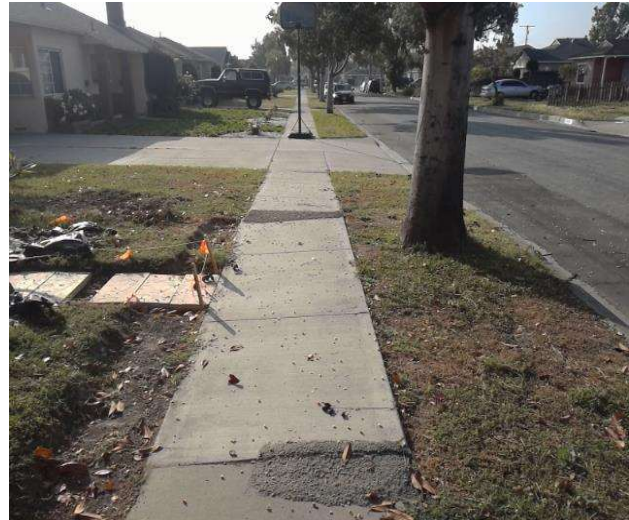
Notes : Surface is rough and uneven.

Repave the sidewalk surface with the recommended running slope.

Recommendation Up to 5.00 percent

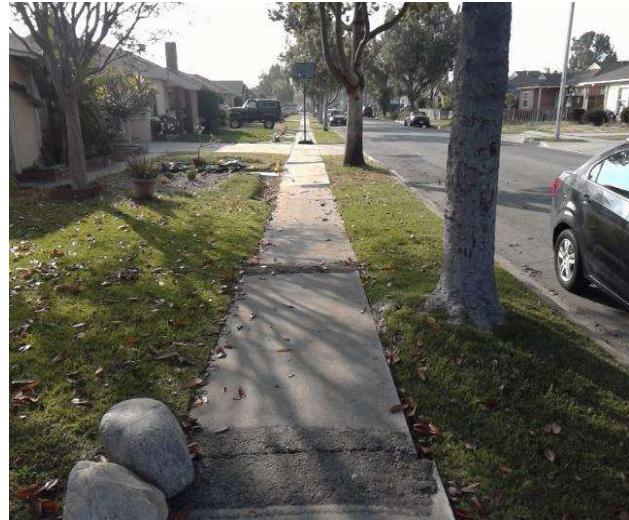
Notes : Surface is rough and uneven.

Repave the sidewalk surface with the recommended running slope.

Recommendation Up to 5.00 percent

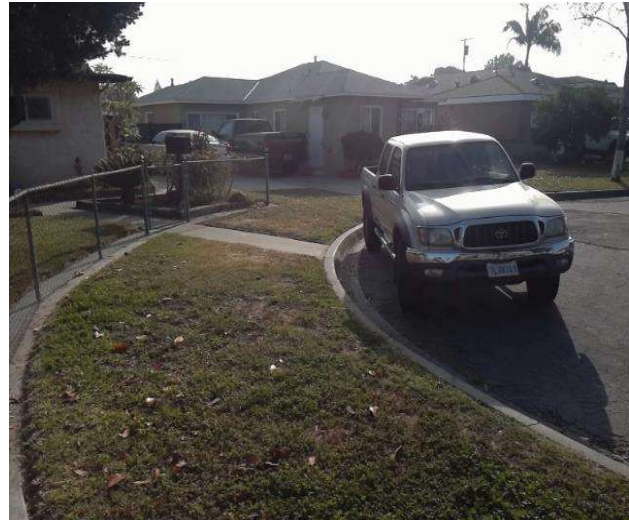
Section of sidewalk is missing and consists of dirt, grass or gravel.

Provide a compliant sidewalk for the missing section.

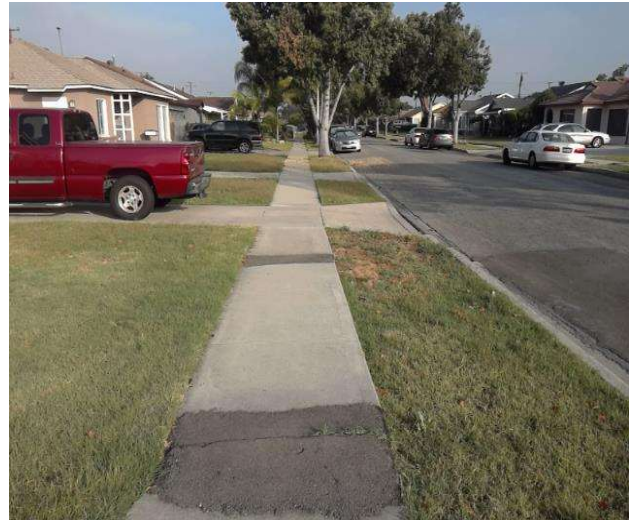
Notes : Surface is rough and uneven.

Repave the sidewalk surface with the recommended cross slope.

Recommendation Up to 2.08 percent

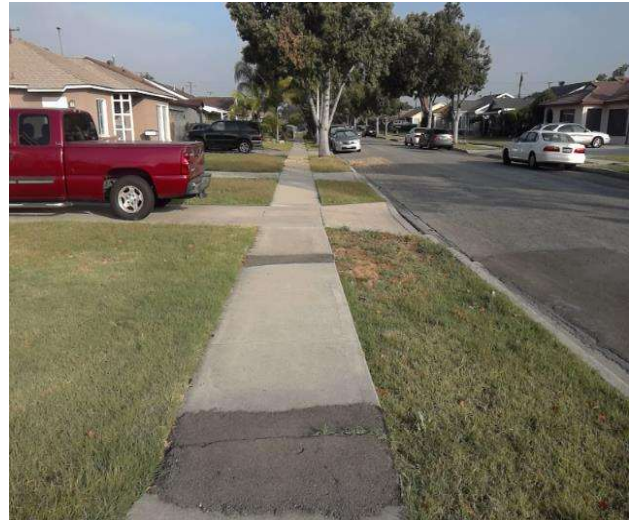
Notes : Surface is rough and uneven.

Repave the sidewalk surface with the recommended running slope.

Recommendation Up to 5.00 percent

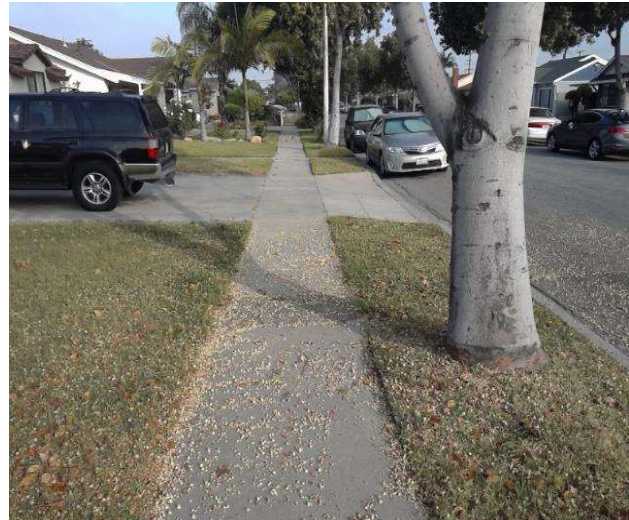
Notes : Surface is rough and uneven.

Repave the sidewalk surface with the recommended cross slope.

Recommendation Up to 2.08 percent

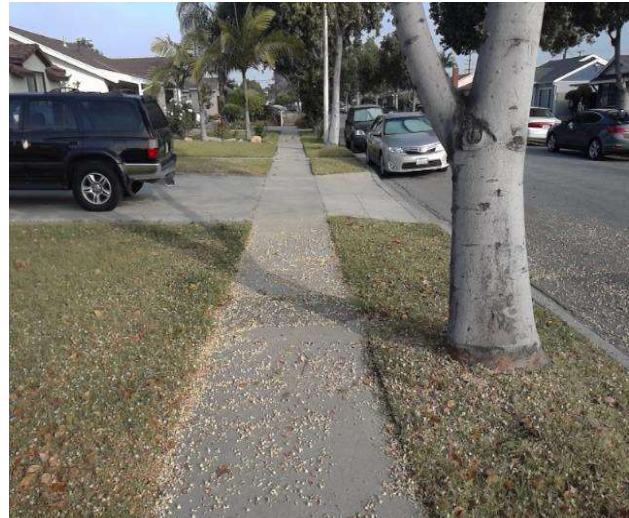
Notes : Surface is rough and uneven.

Repave the sidewalk surface with the recommended running slope.

Recommendation Up to 5.00 percent

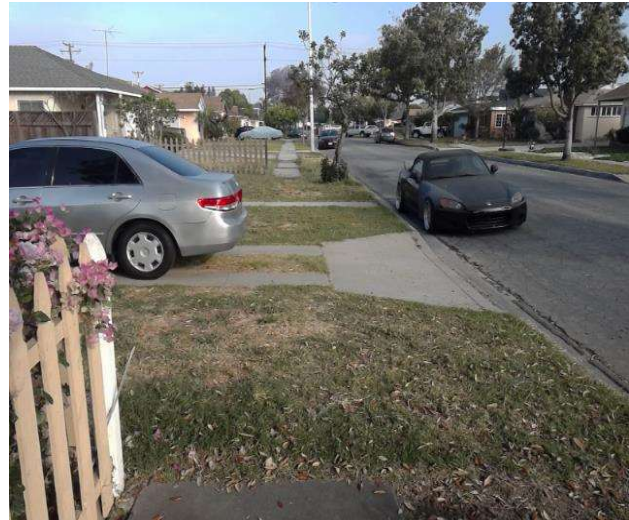
Section of sidewalk is missing and consists of dirt, grass or gravel.

Provide a compliant sidewalk for the missing section.

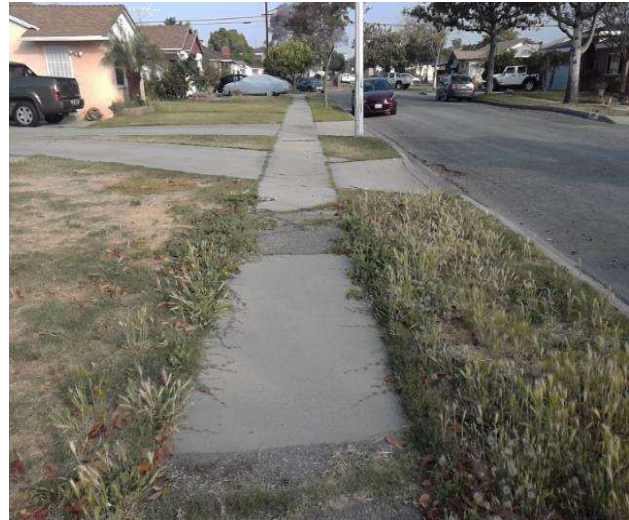
Notes : Surface is rough and uneven.

Repave the sidewalk surface with the recommended cross slope.

Recommendation Up to 2.08 percent

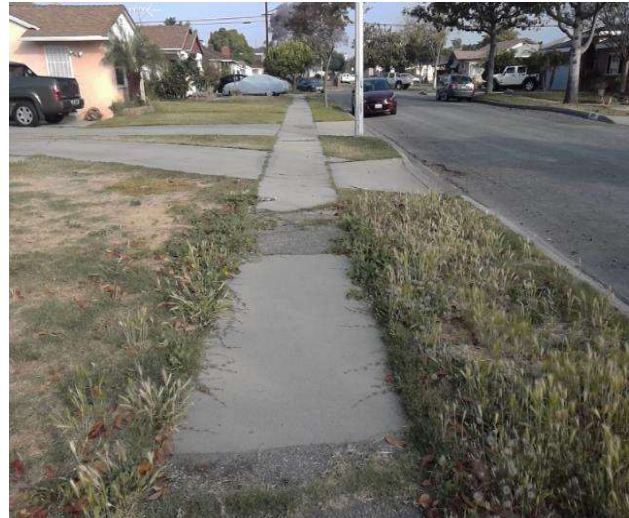
Notes : Surface is rough and uneven.

Repave the sidewalk surface with the recommended running slope.

Recommendation Up to 5.00 percent

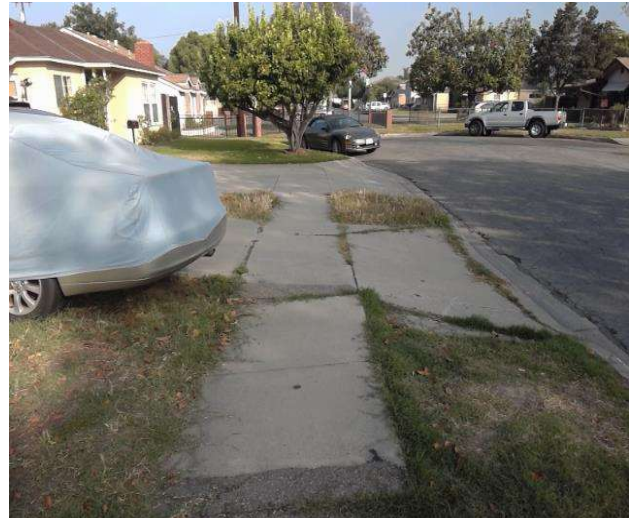
Notes : Surface is rough and uneven.

Repave the sidewalk surface with the recommended cross slope.

Recommendation Up to 2.08 percent

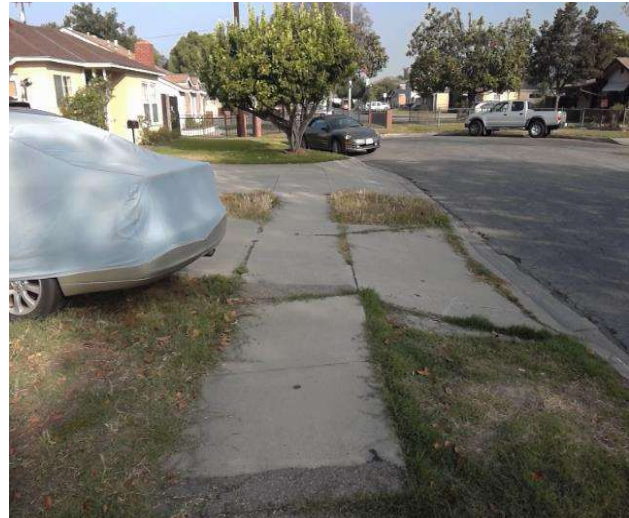
Notes : Surface is rough and uneven.

Repave the sidewalk surface with the recommended running slope.

Recommendation Up to 5.00 percent

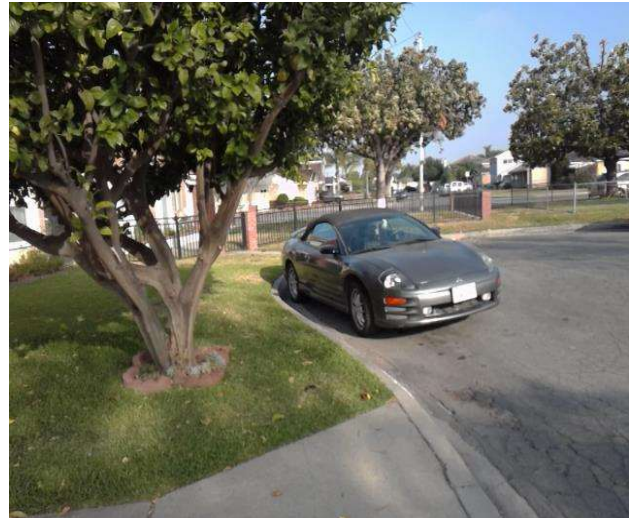
Section of sidewalk is missing and consists of dirt, grass or gravel.

Provide a compliant sidewalk for the missing section.
