Accessibility Survey

City of Downey Nada Street - Horley Avenue to Richeon Avenue

Date of Inspection
8/9/2017

Prepared By
Disability Access Consultants
(800) 743-7067

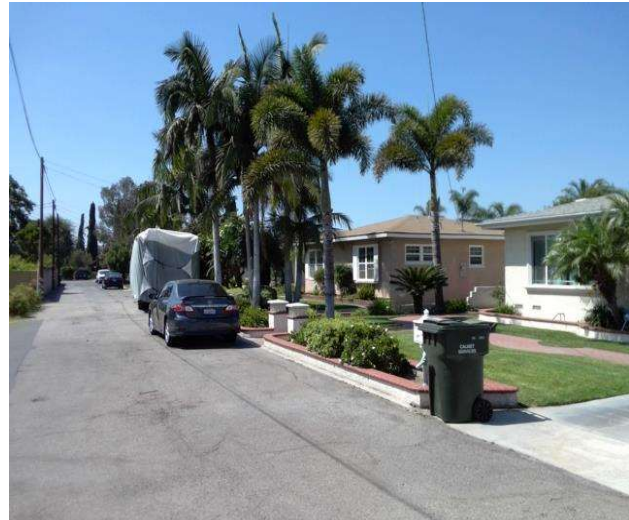
North Side @ 33.936613073948, -118.149622678757

Sidewalks : No Sidewalk

No sidewalk exists at the location.

On-Site Finding Not Found

No action necessary until a sidewalk is provided.

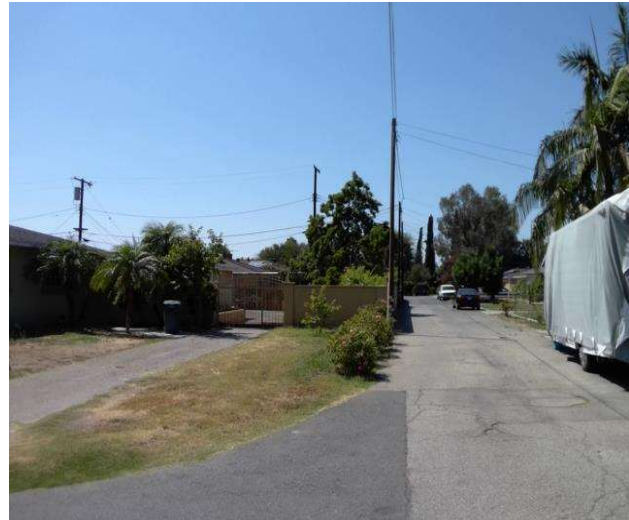
South Side @ 33.936575243669, -118.149723261595

Sidewalks : No Sidewalk

No sidewalk exists at the location.

On-Site Finding Not Found

No action necessary until a sidewalk is provided.

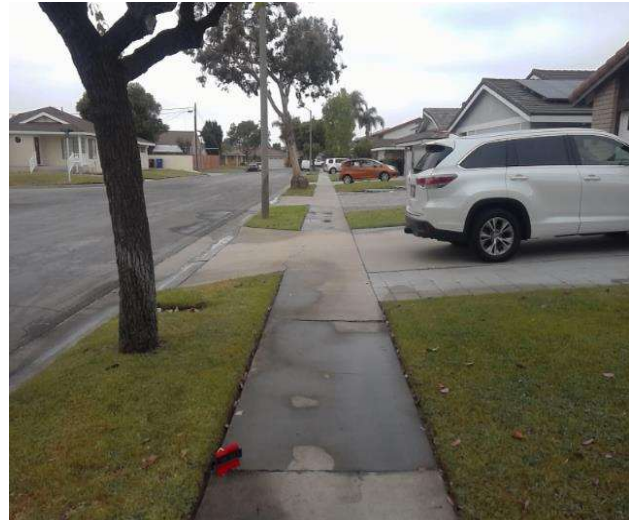
Change In Level East Of Julius Avenue @ 33.937489841580, -118.151132762432

Sidewalks , Change in Level : Change in Level Non Beveled

There is a change in elevation greater than recommended value.

On-Site Finding 0.50 inches

Ensure that the change in elevation is within the recommended value.

Recommendation Up to 0.25 inches

Remove tripping hazards \$198

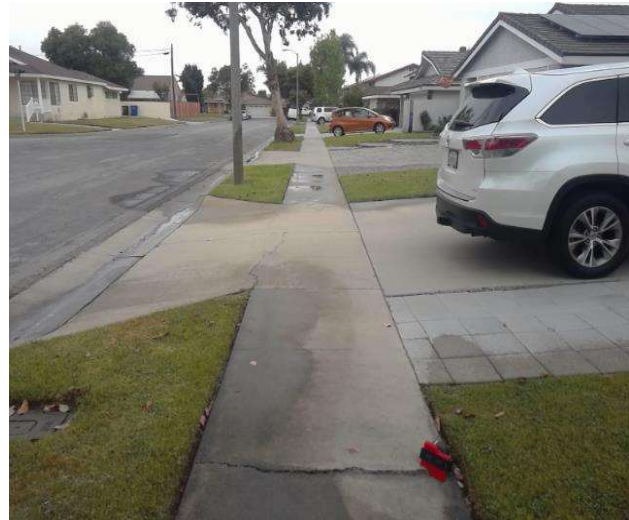
Change In Level East Of Julius Avenue @ 33.937497630084, -118.151147514582

Sidewalks , Change in Level : Change in Level Non Beveled

There is a change in elevation greater than recommended value.

On-Site Finding 0.75 inches

Ensure that the change in elevation is within the recommended value.

Recommendation Up to 0.25 inches

Remove tripping hazards \$198

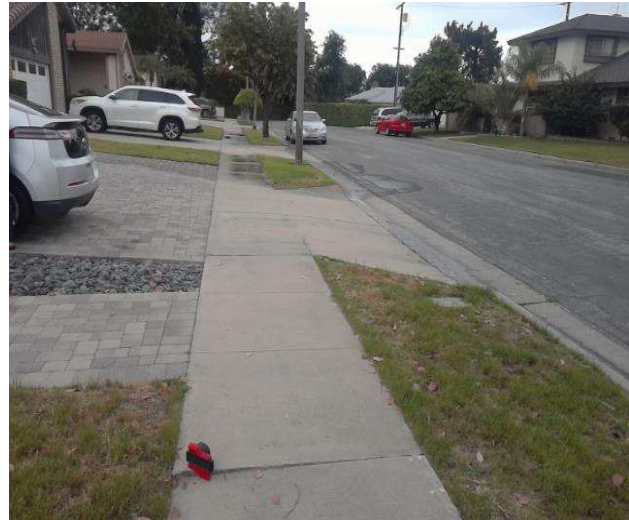
Sidewalks , Change in Level : Change in Level Non Beveled

There is a change in elevation greater than recommended value.

Ensure that the change in elevation is within the recommended value.

Recommendation Up to 0.25 inches

Remove tripping hazards \$198

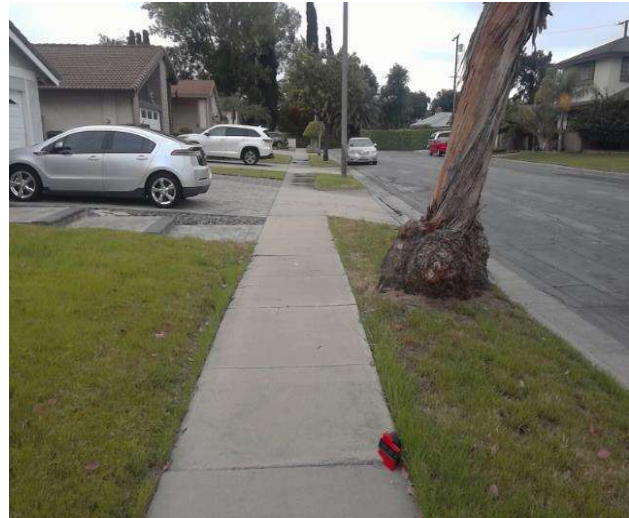
There is a change in elevation greater than recommended value.

Ensure that the change in elevation is within the recommended value.

Recommendation Up to 0.25 inches

Remove tripping hazards \$198

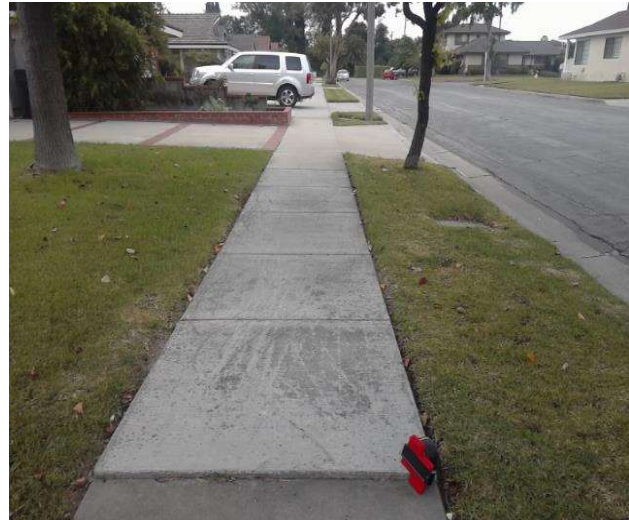
There is a change in elevation greater than recommended value.

Ensure that the change in elevation is within the recommended value.

Recommendation Up to 0.25 inches

Remove tripping hazards \$198

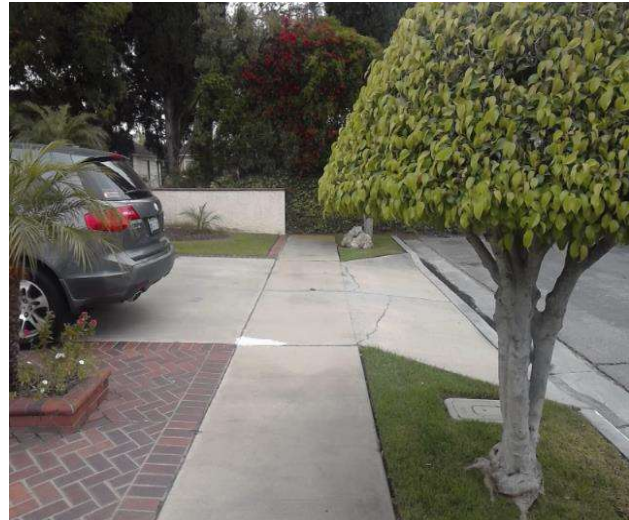
Sidewalks , Hazards & Gratings : Overhead Obstruction Height

Recommendation At least 80.00 inches

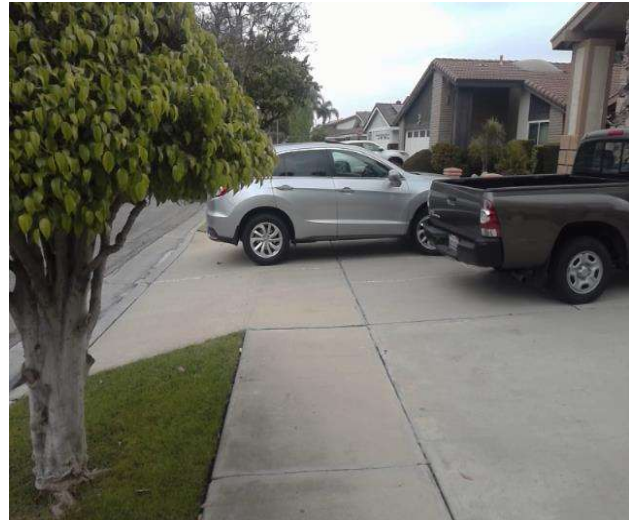
Sidewalks , Hazards & Gratings : Overhead Obstruction Height

Recommendation At least 80.00 inches

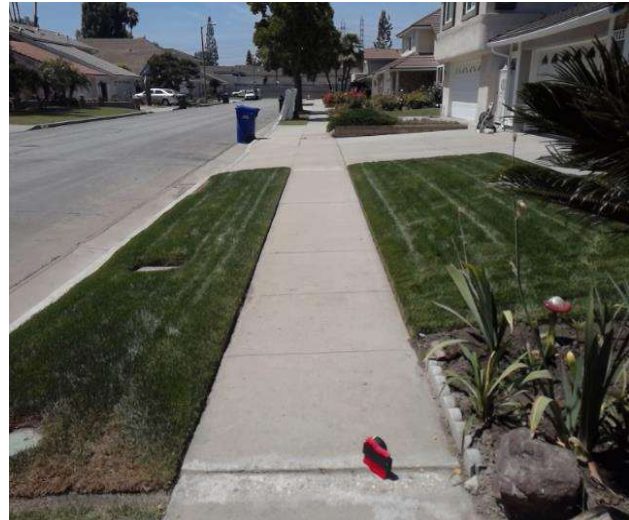
There is a change in elevation greater than recommended value.

Ensure that the change in elevation is within the recommended value.

Recommendation Up to 0.25 inches

Remove tripping hazards \$198

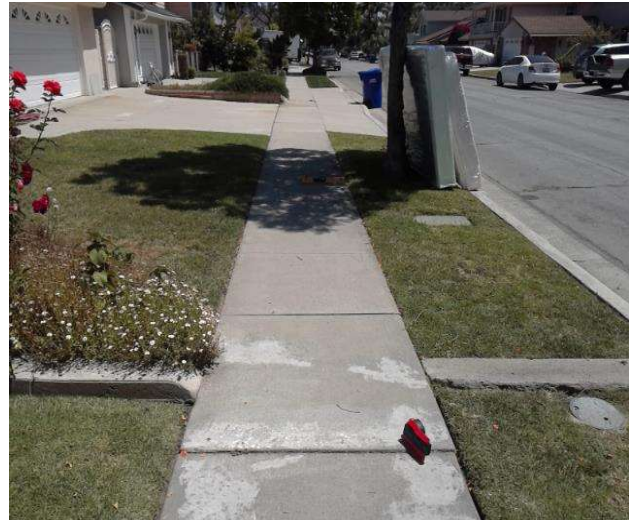
There is a change in elevation greater than recommended value.

Ensure that the change in elevation is within the recommended value.

Recommendation Up to 0.25 inches

Remove tripping hazards \$198

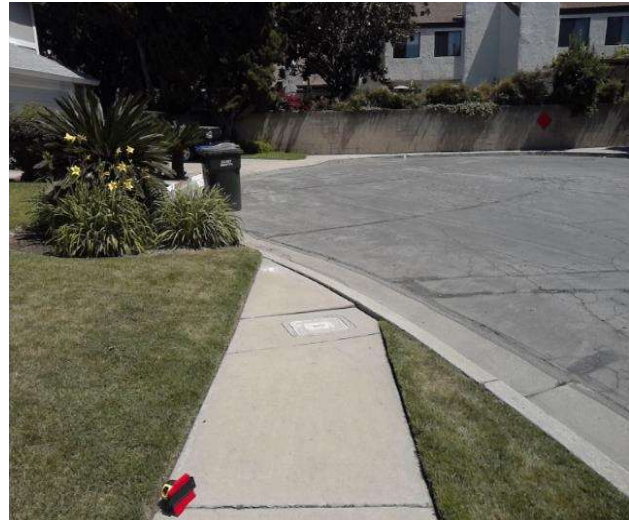
There is a change in elevation greater than recommended value.

Ensure that the change in elevation is within the recommended value.

Recommendation Up to 0.25 inches

Remove tripping hazards \$198

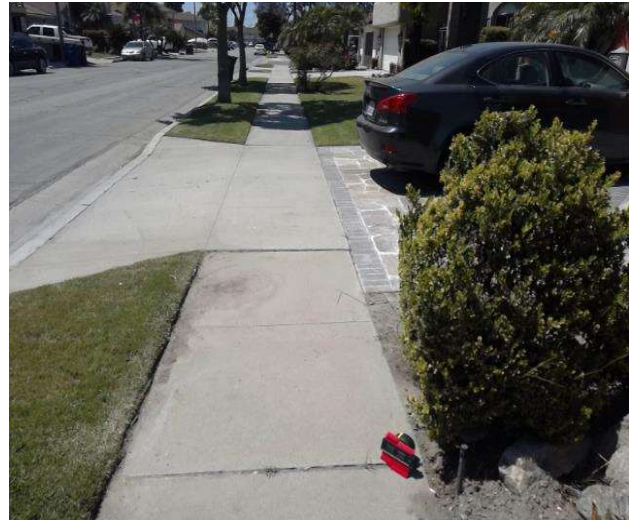
There is a change in elevation greater than recommended value.

Ensure that the change in elevation is within the recommended value.

Recommendation Up to 0.25 inches

Remove tripping hazards \$198

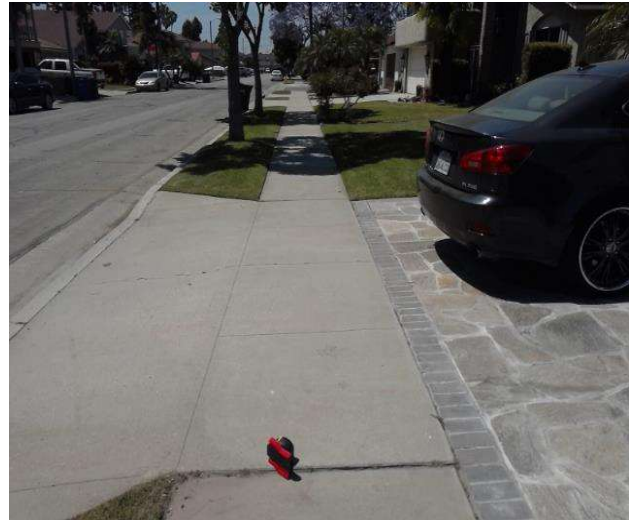
There is a change in elevation greater than recommended value.

Ensure that the change in elevation is within the recommended value.

Recommendation Up to 0.25 inches

Remove tripping hazards \$198

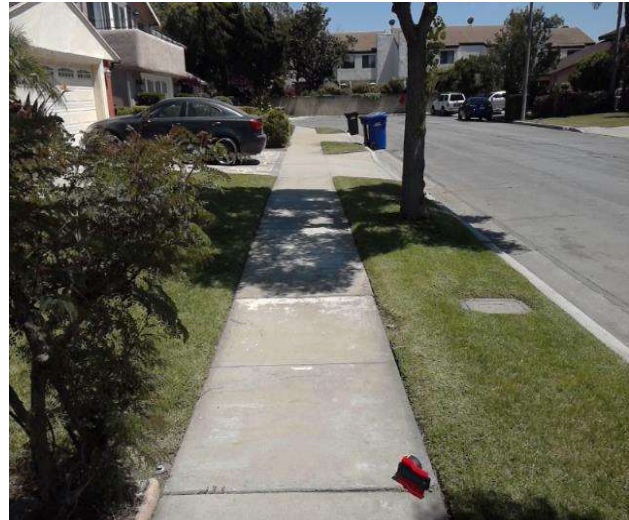
There is a change in elevation greater than recommended value.

Ensure that the change in elevation is within the recommended value.

Recommendation Up to 0.25 inches

Remove tripping hazards \$198

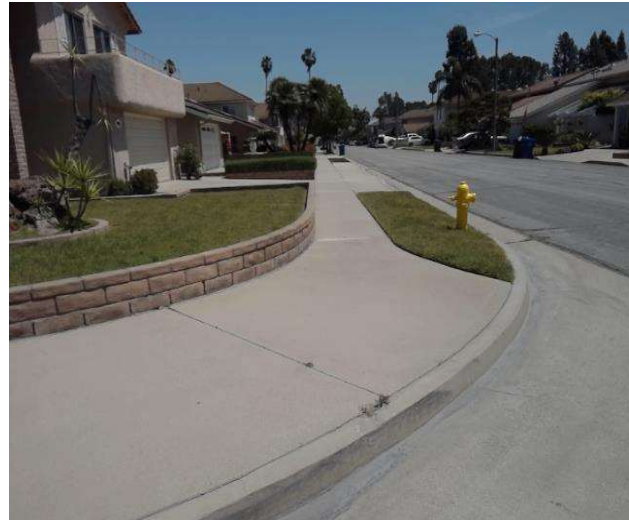
Sidewalks , Hazards & Gratings : Curb is on Path of Travel

Install curb ramp \$2,500

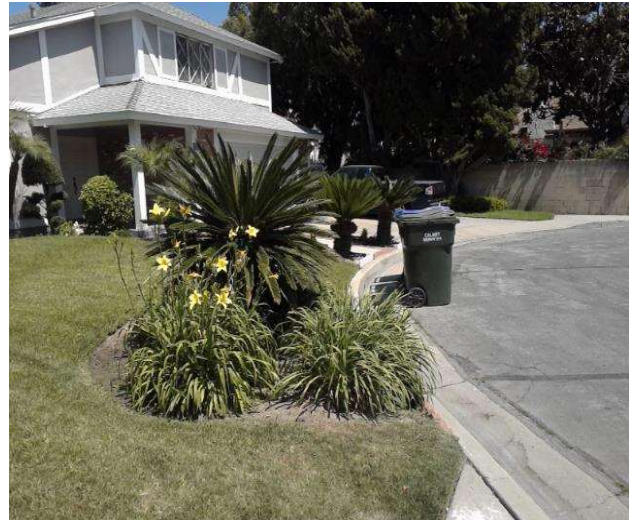
Sidewalks : Missing Sidewalk

Section of sidewalk is missing and consists of dirt, grass or gravel.

Provide a compliant sidewalk for the missing section.

\$1,260

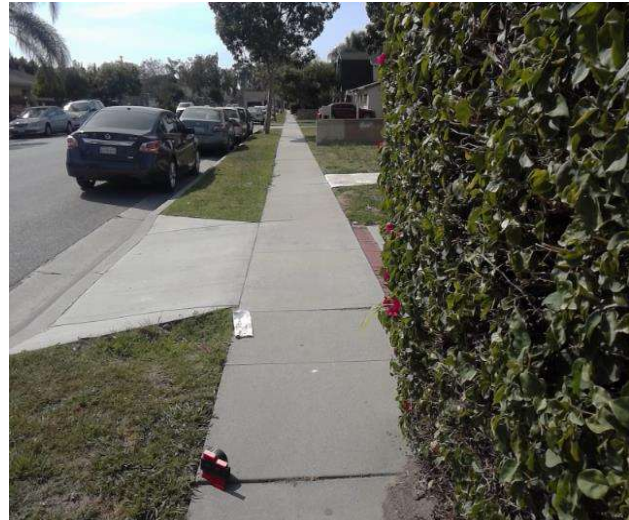
There is a change in elevation greater than recommended value.

Ensure that the change in elevation is within the recommended value.

Recommendation Up to 0.25 inches

Remove tripping hazards \$198

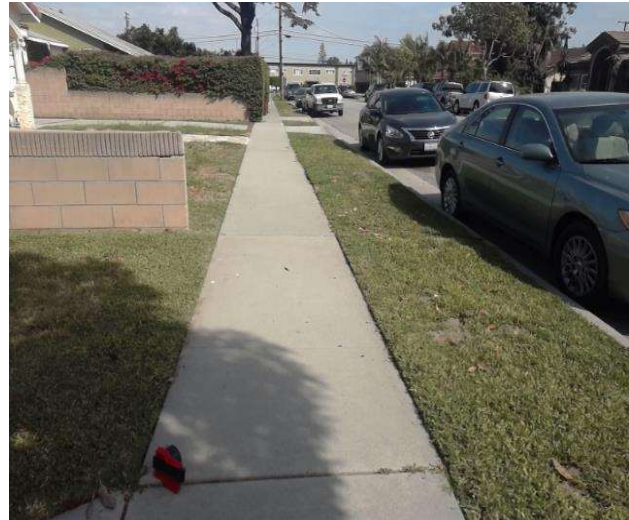
There is a change in elevation greater than recommended value.

Ensure that the change in elevation is within the recommended value.

Recommendation Up to 0.25 inches

Remove tripping hazards \$198

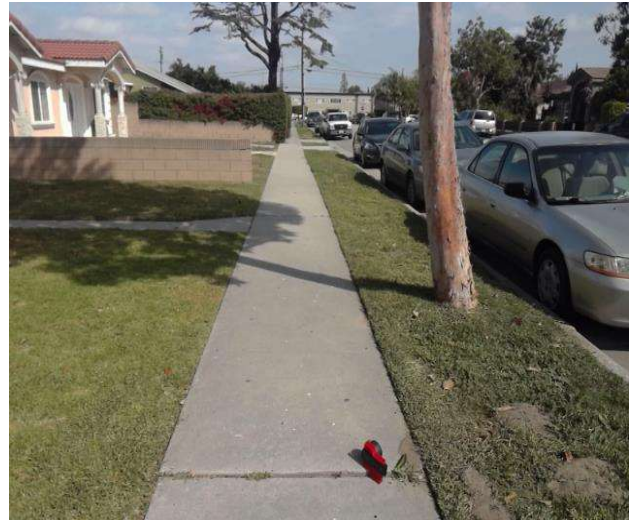
There is a change in elevation greater than recommended value.

Ensure that the change in elevation is within the recommended value.

Recommendation Up to 0.25 inches

Remove tripping hazards \$198

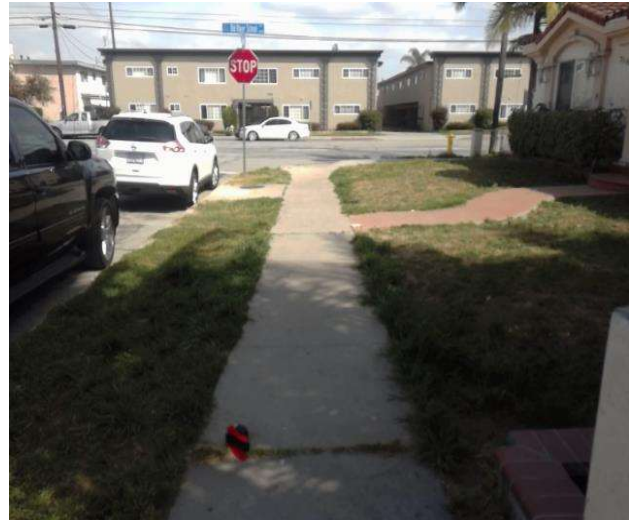
There is a change in elevation greater than recommended value.

Ensure that the change in elevation is within the recommended value.

Recommendation Up to 0.25 inches

Remove tripping hazards \$198

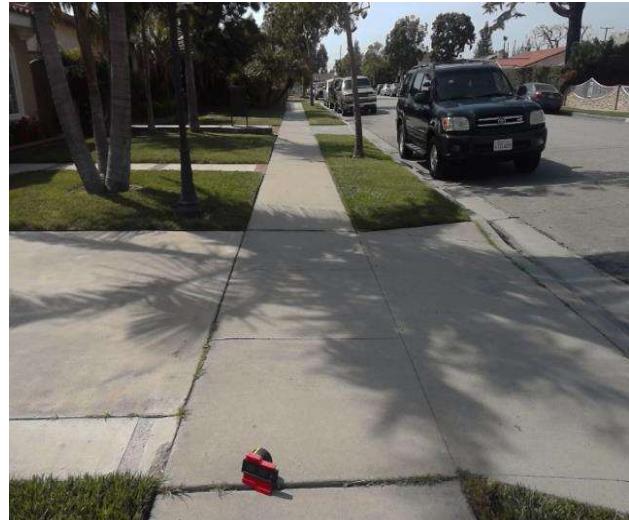
There is a change in elevation greater than recommended value.

Ensure that the change in elevation is within the recommended value.

Recommendation Up to 0.25 inches

Remove tripping hazards \$198

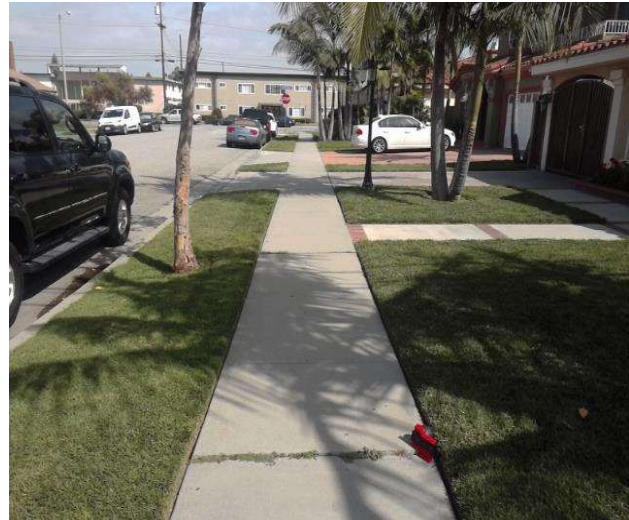
There is a change in elevation greater than recommended value.

Ensure that the change in elevation is within the recommended value.

Recommendation Up to 0.25 inches

Remove tripping hazards \$198

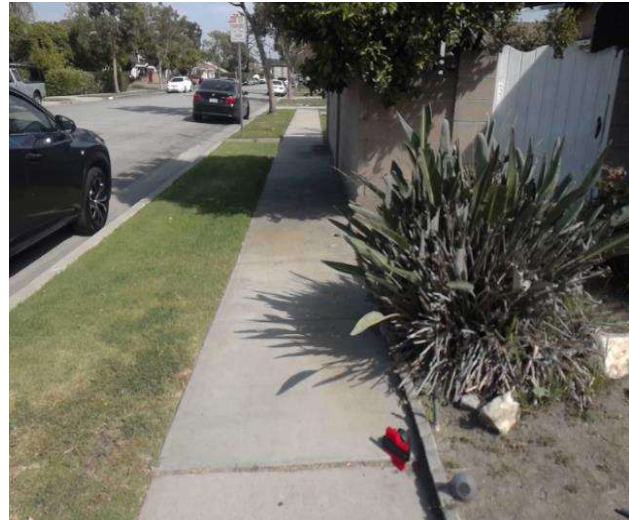
There is a change in elevation greater than recommended value.

Ensure that the change in elevation is within the recommended value.

Recommendation Up to 0.25 inches

Remove tripping hazards \$198

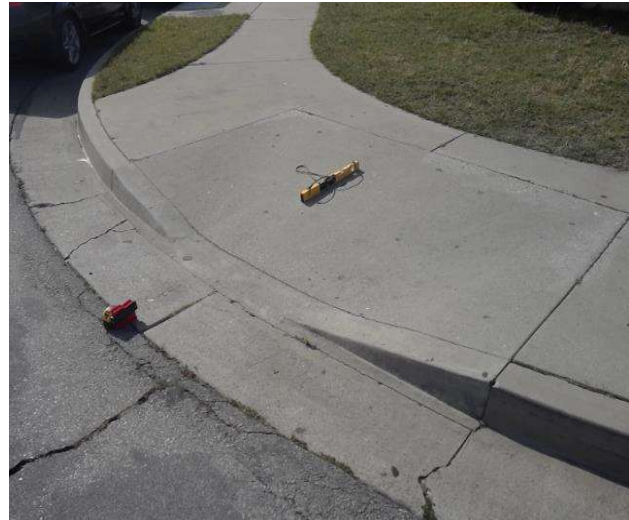
On-Site Finding Not Found

Provide detectable warning to surface \$248

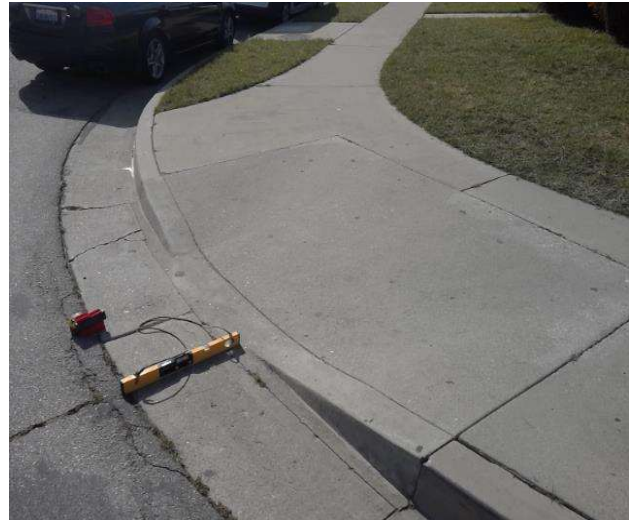
The overlayment causes a noncompliant change in level.

Ensure the change in elevation is within the recommended height.

Recommendation Up to 0.50 inches

Provide smooth surface \$150

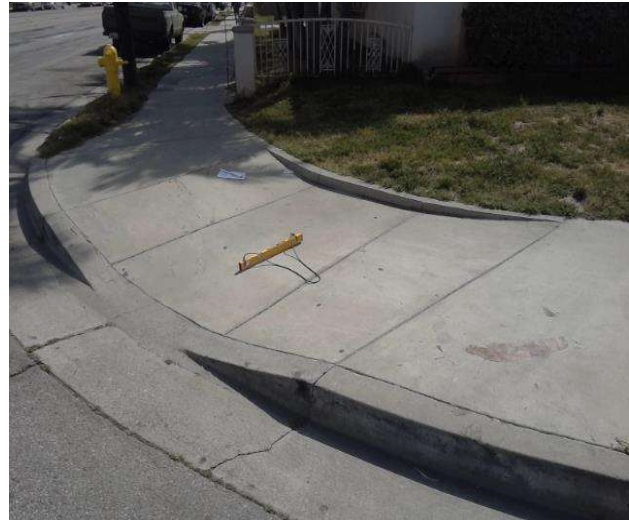
On-Site Finding Not Found

Provide detectable warning to surface \$248

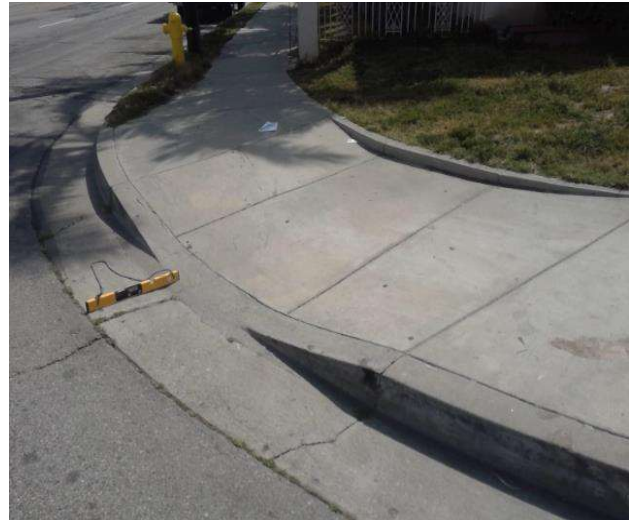
The overlayment causes a noncompliant change in level.

Ensure the change in elevation is within the recommended height.

Recommendation Up to 0.50 inches

Provide smooth surface \$150

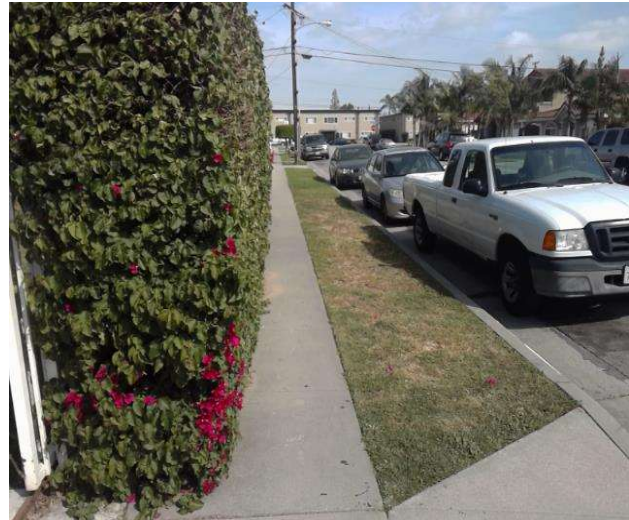
Sidewalks , Hazards & Gratings : Sidewalk Width at Obstruction

Sidewalk width at the obstruction shall have the recommended value.

Recommendation At least 48.00 inches

\$1,260

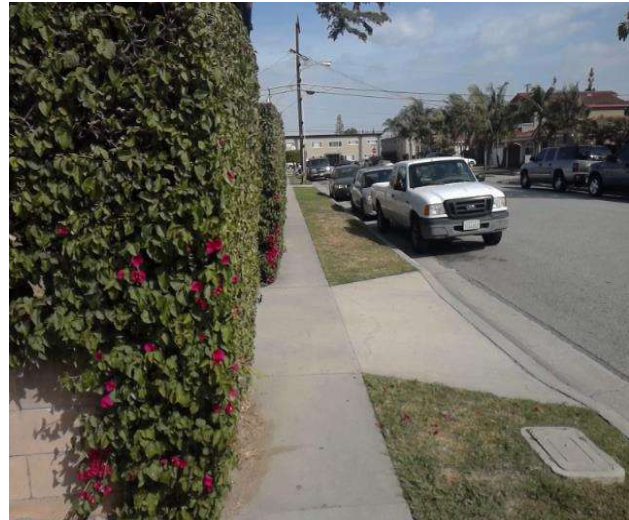
Sidewalks , Hazards & Gratings : Sidewalk Width at Obstruction

Sidewalk width at the obstruction shall have the recommended value.

Recommendation At least 48.00 inches

\$1,260

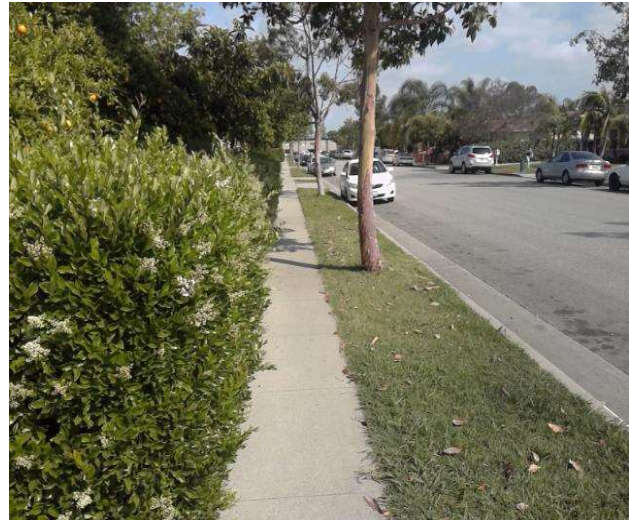
Sidewalks , Hazards & Gratings : Sidewalk Width at Obstruction

Sidewalk width at the obstruction shall have the recommended value.

Recommendation At least 48.00 inches

\$1,260

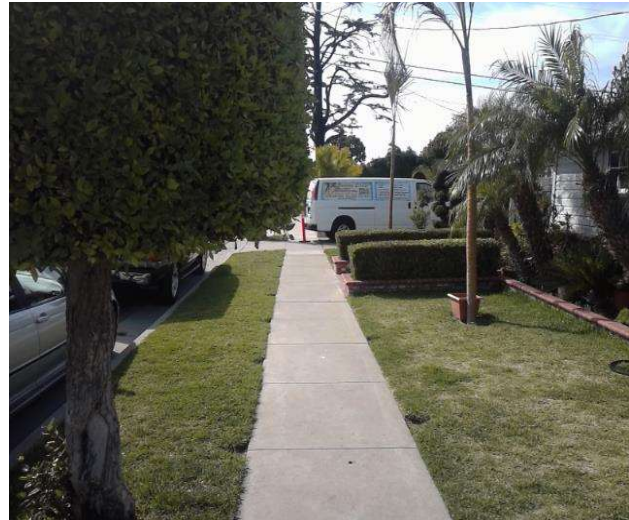
Sidewalks , Hazards & Gratings : Overhead Obstruction Height

Recommendation At least 80.00 inches

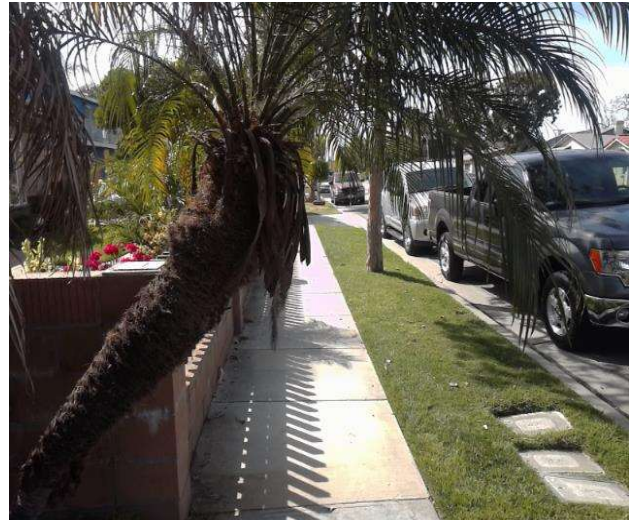
Sidewalks , Hazards & Gratings : Protruding Object Height

Recommendation Up to 4.00 inches

Install wing walls or relocate object \$640

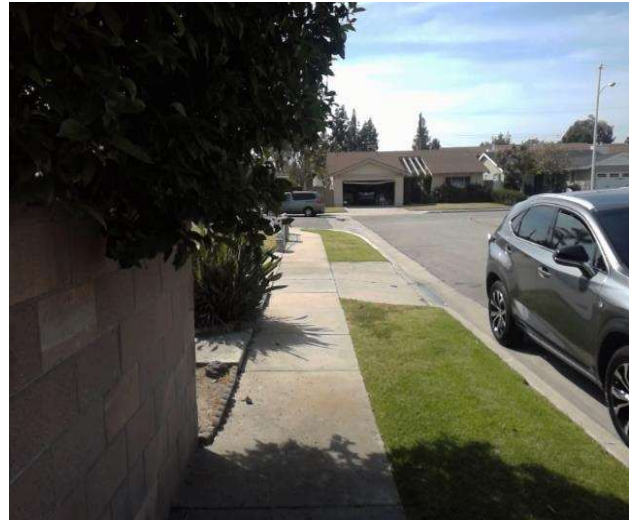
Sidewalks , Hazards & Gratings : Overhead Obstruction Height

Recommendation At least 80.00 inches

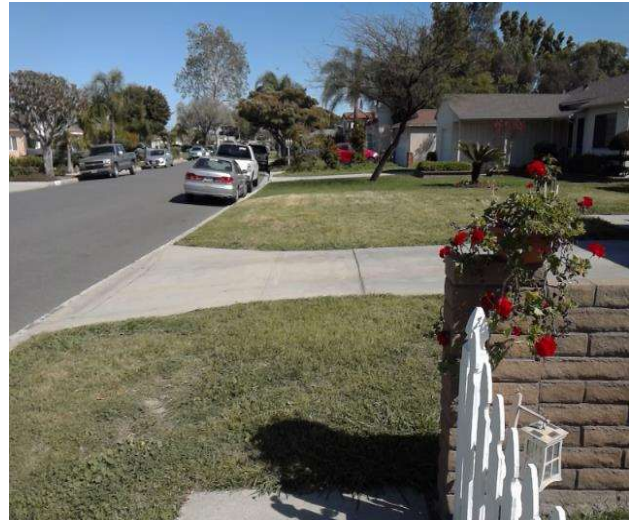
Sidewalks : Missing Sidewalk

Section of sidewalk is missing and consists of dirt, grass or gravel.

Provide a compliant sidewalk for the missing section.

\$1,260
