Accessibility Survey

City of Downey Orizaba Avenue - Borson Street To Imperial Highway

Date of Inspection
2/14/2017

Disability Access Consultants

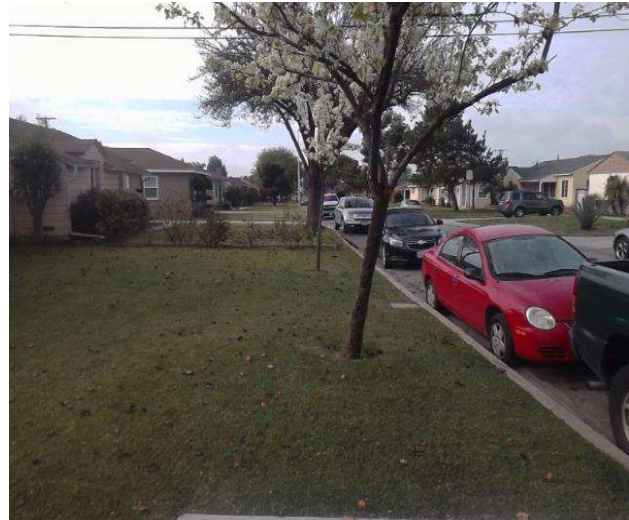
Sidewalk South Of Imperial Highway @ 33.922677042451, -118.149821162224

Sidewalks : Missing Sidewalk

Section of sidewalk is missing and consists of dirt, grass or gravel.

On-Site Finding 776.00 feet

Provide a compliant sidewalk for the missing section.

Code Reference ADA 206, 302,CA 11B-302,CA 11B-206

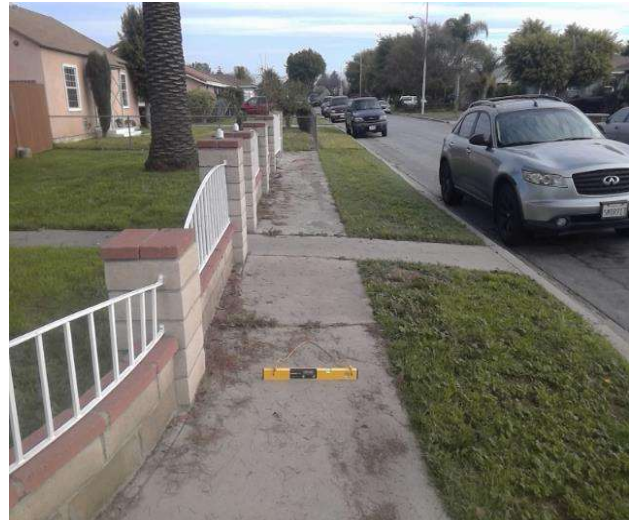
Sidewalk North Of Borson Street @ 33.920972158984, -118.151291012764

Sidewalks , Surface : Cross Slope

Sidewalk cross slope is not compliant.

On-Site Finding 3.40 percent for 4.00 feet

Repave the sidewalk surface with the recommended cross slope.

Recommendation Up to 2.08 percent

Code Reference ADA 206, 302, CA 11B-403.3

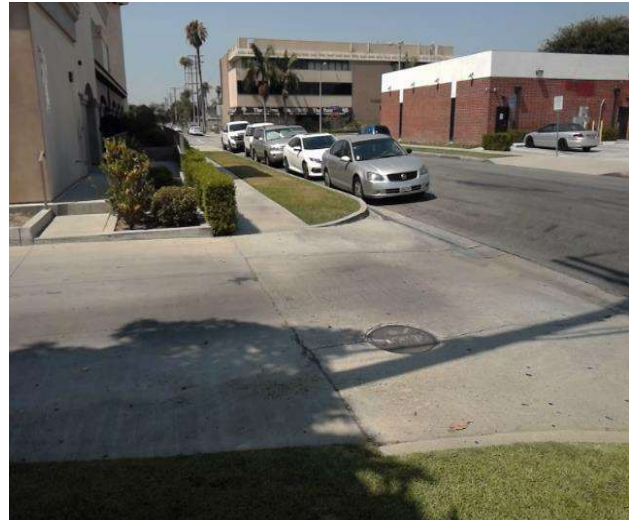
On-Site Finding Not Found

Install compliant detectable warnings \$190

Code Reference ADA 705,CA 11B-705.1.2.5,CA 11B-247.1.2.5

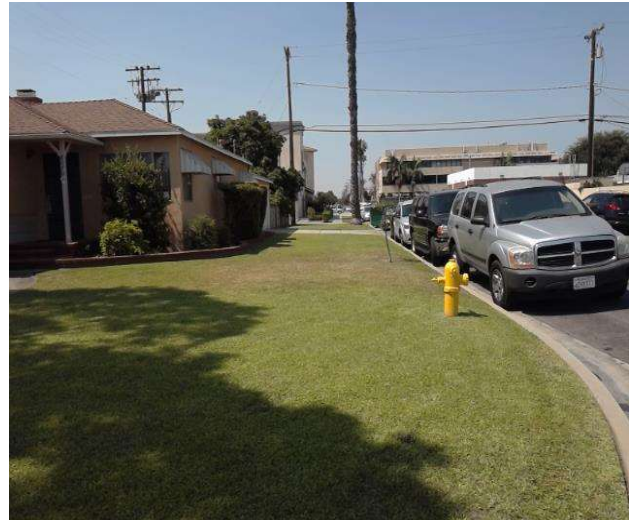
Sidewalks : Missing Sidewalk

Section of sidewalk is missing and consists of dirt, grass or gravel.

Provide a compliant sidewalk for the missing section.

Code Reference ADA 206, 302,CA 11B-302,CA 11B-206

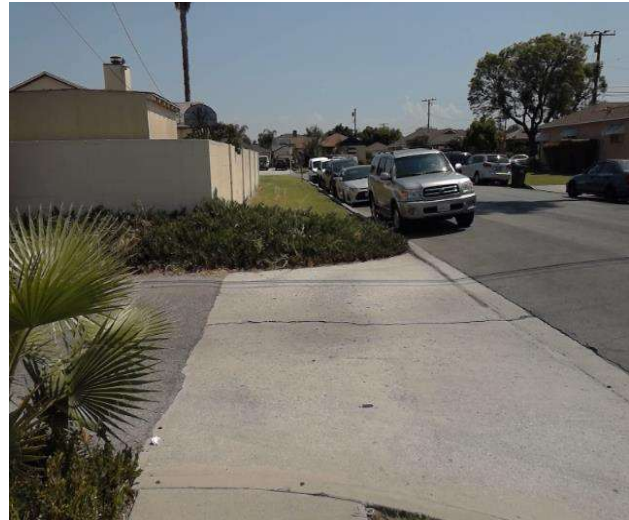
On-Site Finding Not Found

Install compliant detectable warnings \$190

Code Reference ADA 705,CA 11B-705.1.2.5,CA 11B-247.1.2.5

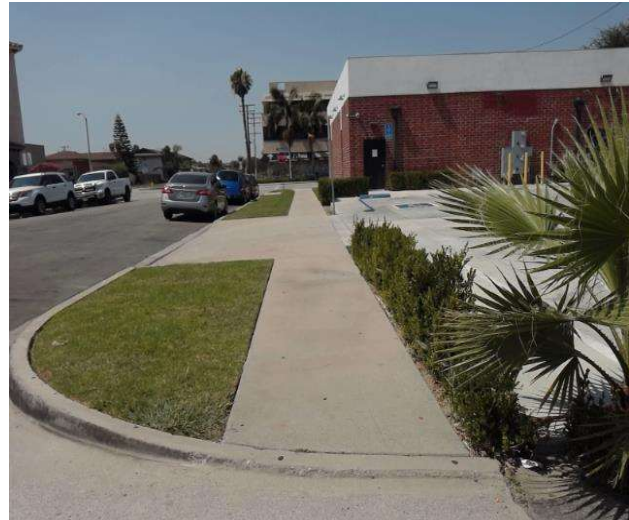
Sidewalks , Hazards & Gratings : Curb is on Path of Travel

Install curb ramp \$2,500

Code Reference ADA 402, 303, 406, 403.4, 303.4

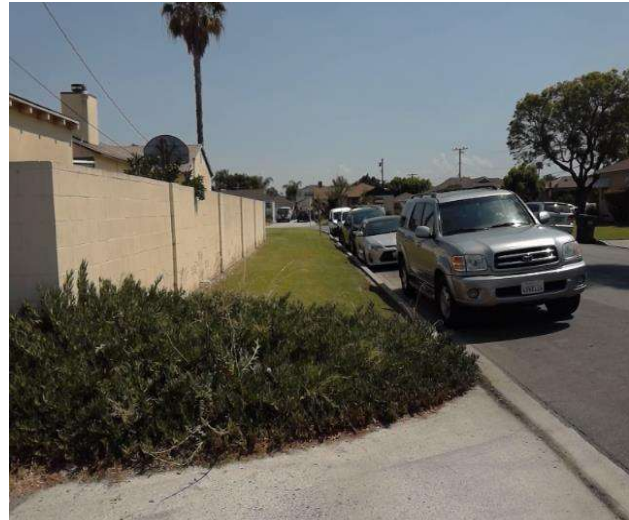
Sidewalks : Missing Sidewalk

Section of sidewalk is missing and consists of dirt, grass or gravel.

Provide a compliant sidewalk for the missing section.

Code Reference ADA 206, 302,CA 11B-302,CA 11B-206

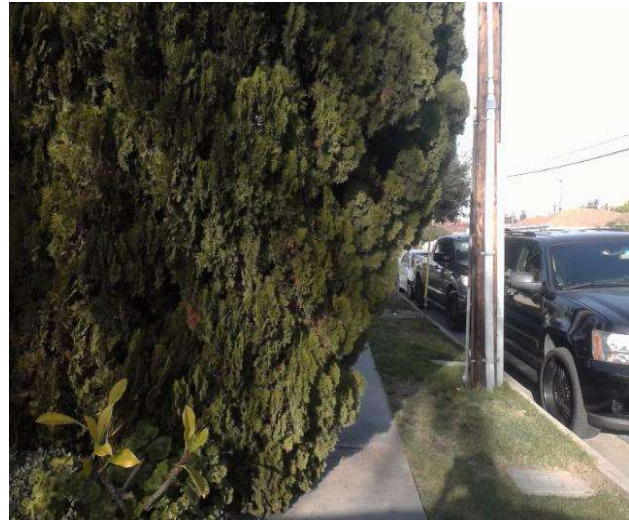
Sidewalks , Hazards & Gratings : Sidewalk Width at Obstruction

Sidewalk width at the obstruction shall have the recommended value.

Recommendation At least 48.00 inches

Code Reference ADA 206, 302, 403.5.1,CA 11B-403.5

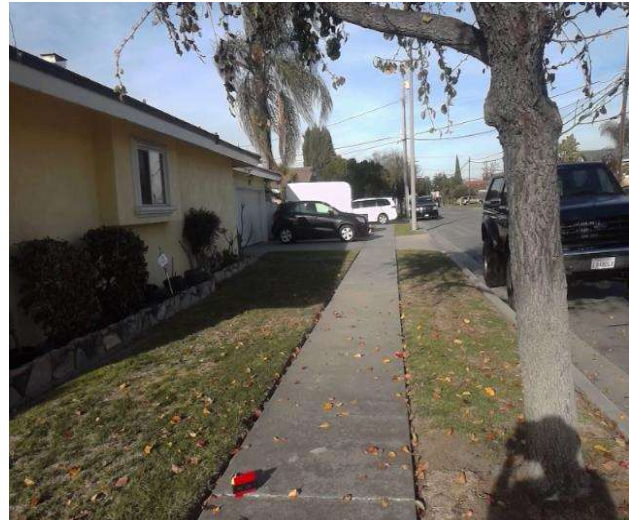
There is a change in elevation greater than recommended value.

Ensure that the change in elevation is within the recommended value.

Recommendation Up to 0.25 inches

Remove tripping hazards \$198

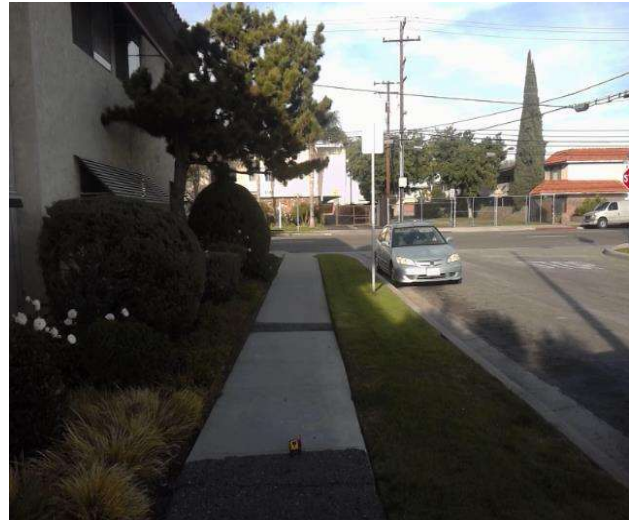
There is a change in elevation greater than recommended value.

Recommendation Up to 0.50 inches

Remove tripping hazards \$198

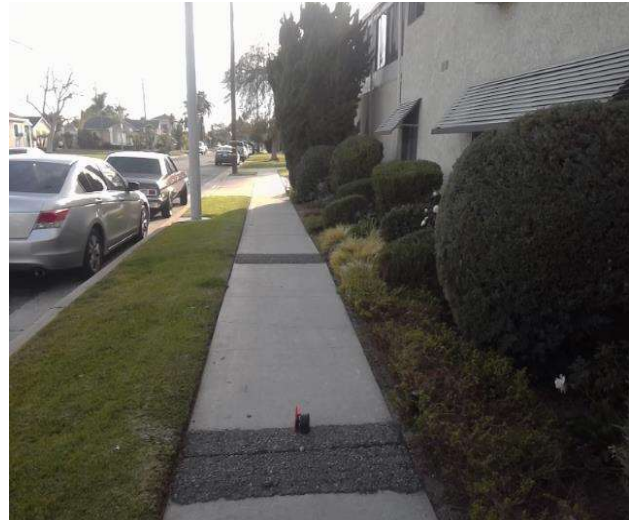
There is a change in elevation greater than recommended value.

Recommendation Up to 0.50 inches

Remove tripping hazards \$198

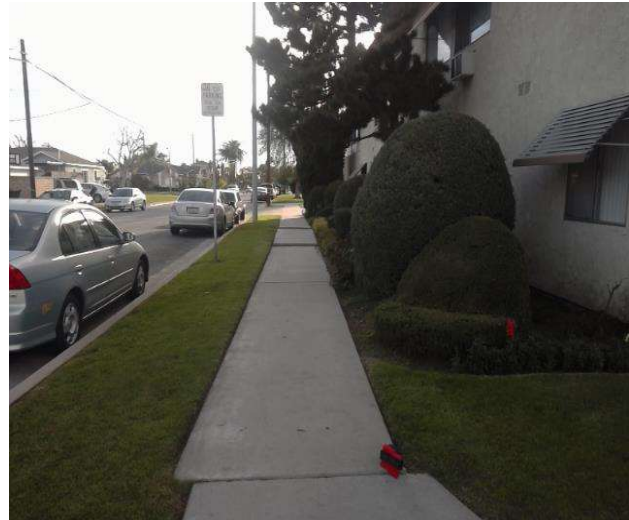
There is a change in elevation greater than recommended value.

Ensure that the change in elevation is within the recommended value.

Recommendation Up to 0.25 inches

Remove tripping hazards \$198

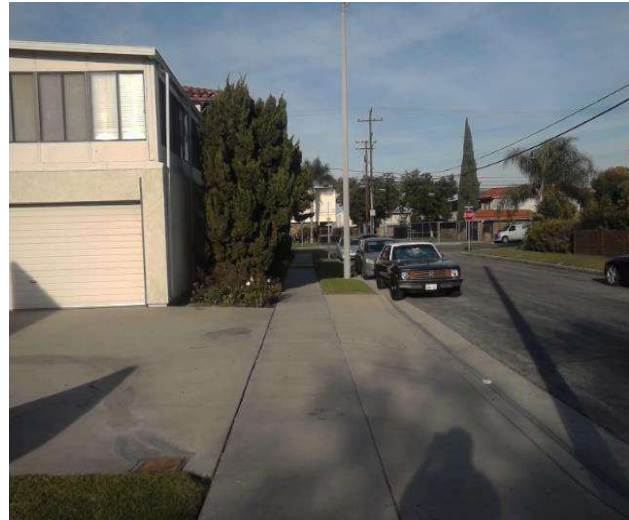
On-Site Finding Not Found

Install compliant detectable warnings \$190

Code Reference ADA 705,CA 11B-705.1.2.5,CA 11B-247.1.2.5

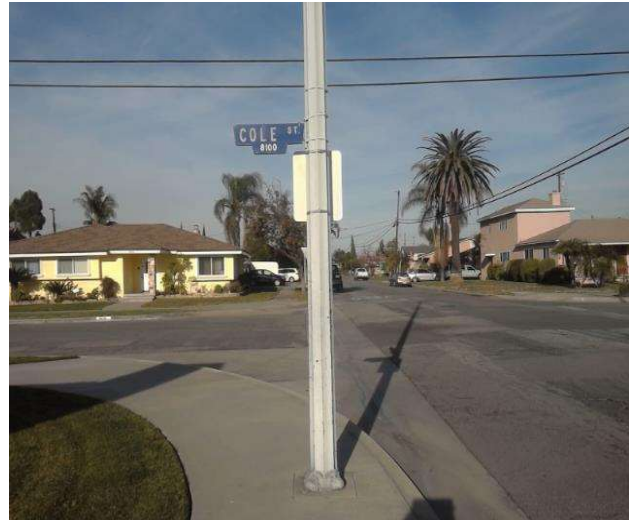
Sidewalks , Hazards & Gratings : Sidewalk Width at Obstruction

Sidewalk width at the obstruction shall have the recommended value.

Recommendation At least 48.00 inches

Code Reference ADA 206, 302, 403.5.1, CA 11B-403.5

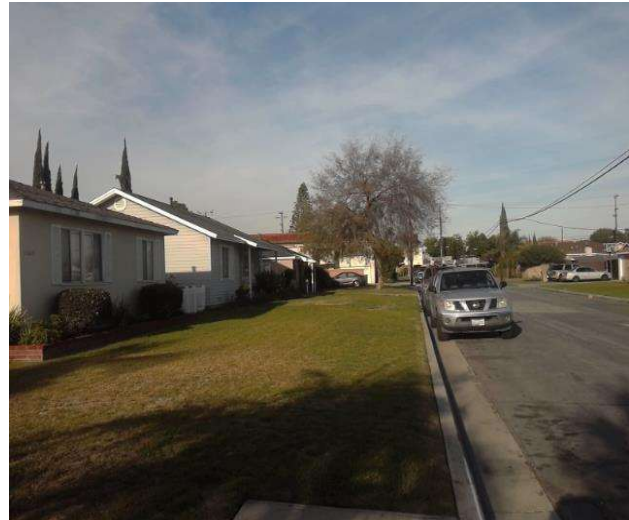
Sidewalks : Missing Sidewalk

Section of sidewalk is missing and consists of dirt, grass or gravel.

Provide a compliant sidewalk for the missing section.

Code Reference ADA 206, 302,CA 11B-302,CA 11B-206

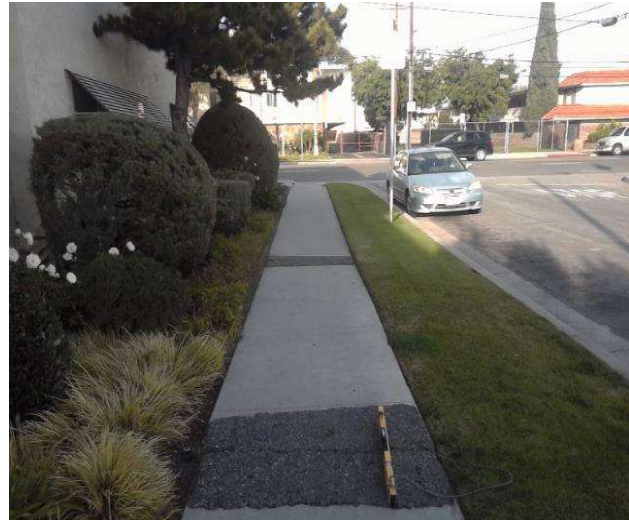
Notes : Surface is rough and uneven for 2.5 feet.

Repave the sidewalk surface with the recommended cross slope.

Recommendation Up to 2.08 percent

Code Reference ADA 206, 302,CA 11B-403.3

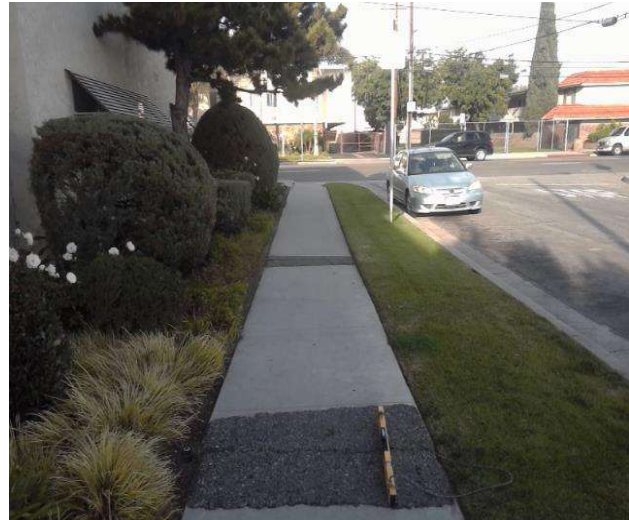
Notes : Surface is rough and uneven for 2.5 feet.

Repave the sidewalk surface with the recommended running slope.

Recommendation Up to 5.00 percent

Code Reference ADA 206, 302

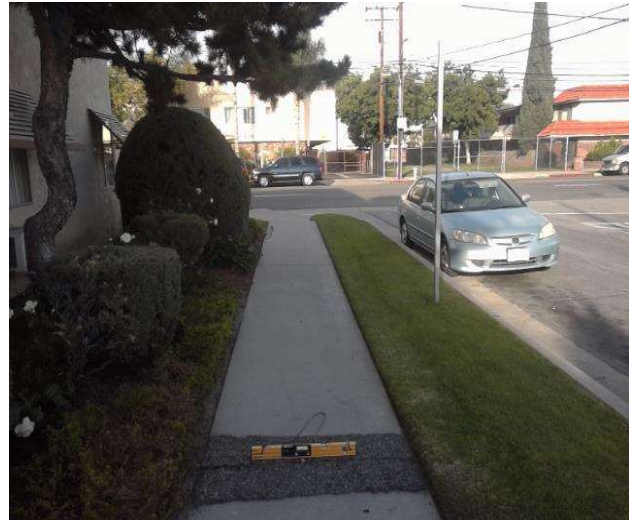
Notes : Surface is rough and uneven for 2 feet.

Repave the sidewalk surface with the recommended cross slope.

Recommendation Up to 2.08 percent

Code Reference ADA 206, 302,CA 11B-403.3

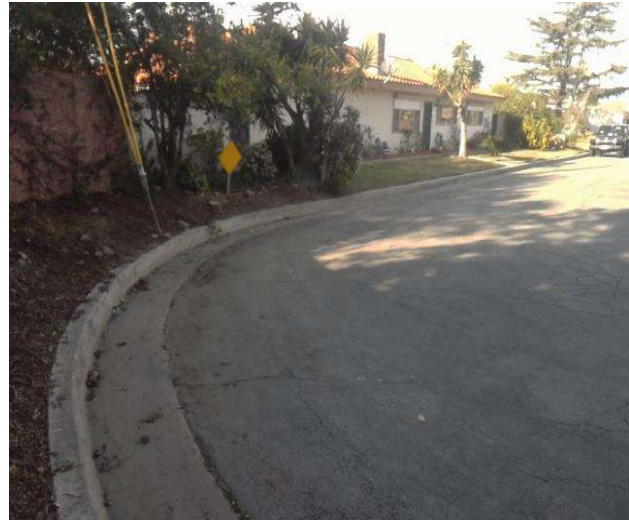
Sidewalks : Missing Sidewalk

Section of sidewalk is missing and consists of dirt, grass or gravel.

Provide a compliant sidewalk for the missing section.

Code Reference ADA 206, 302,CA 11B-302,CA 11B-206

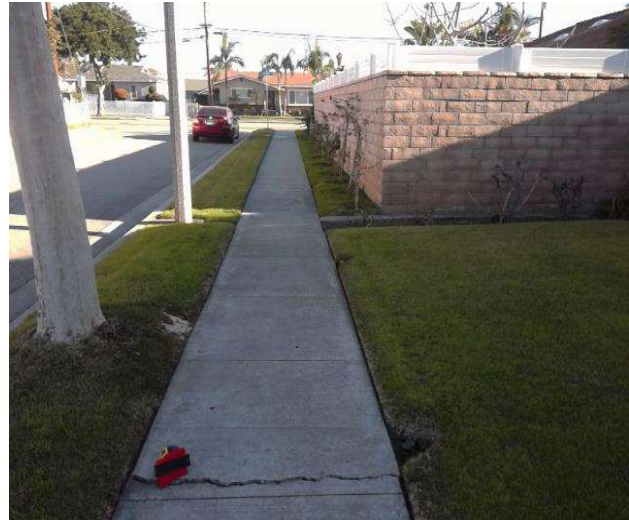
There is a change in elevation greater than recommended value.

Ensure that the change in elevation is within the recommended value.

Recommendation Up to 0.25 inches

Code Reference ADA 206, 302

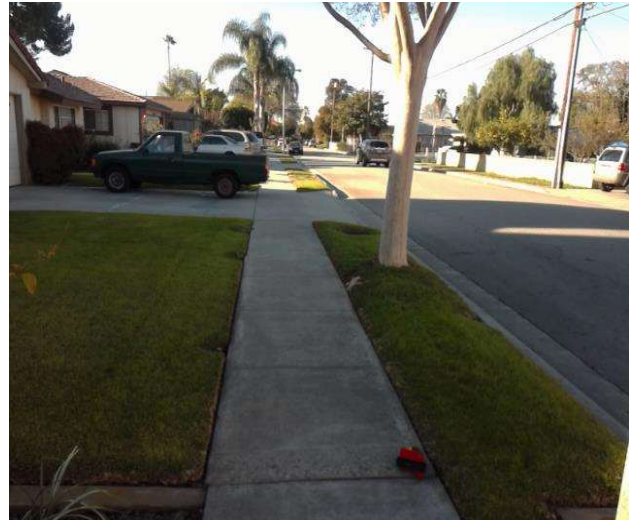
There is a change in elevation greater than recommended value.

Ensure that the change in elevation is within the recommended value.

Recommendation Up to 0.25 inches

Code Reference ADA 206, 302

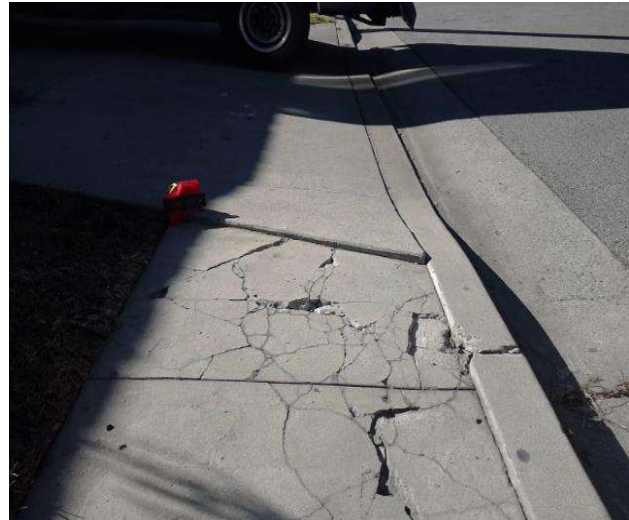
There is a change in elevation greater than recommended value.

Ensure that the change in elevation is within the recommended value.

Recommendation Up to 0.25 inches

Code Reference ADA 206, 302

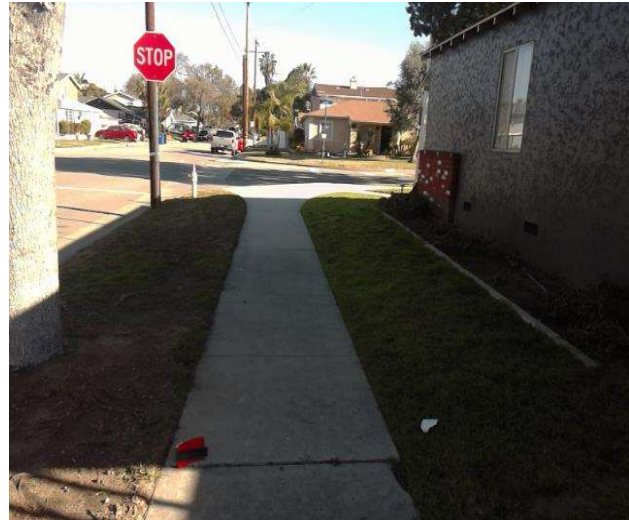
There is a change in elevation greater than recommended value.

Ensure that the change in elevation is within the recommended value.

Recommendation Up to 0.25 inches

Code Reference ADA 206, 302

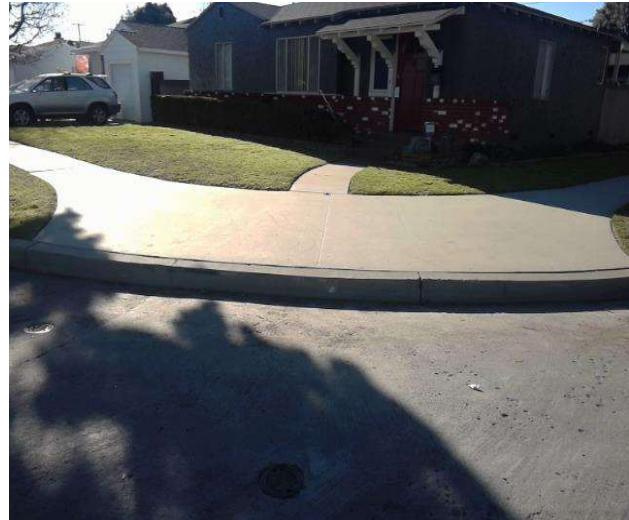
Sidewalks , Hazards & Gratings : Curb is on Path of Travel

Install curb ramp \$2,500

Code Reference ADA 402, 303, 406, 403.4, 303.4

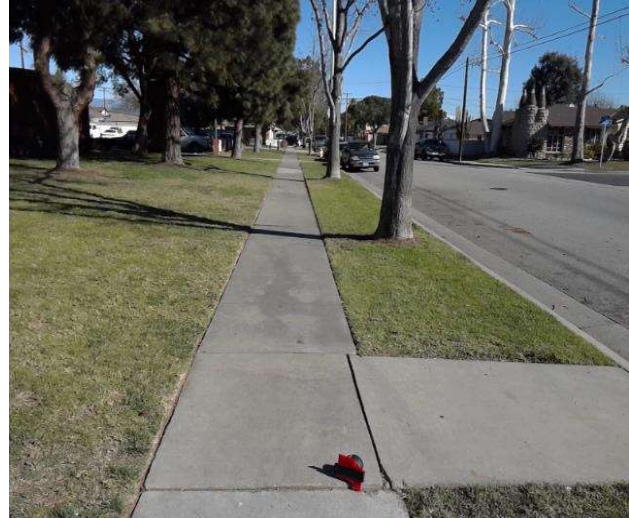
There is a change in elevation greater than recommended value.

Ensure that the change in elevation is within the recommended value.

Recommendation Up to 0.25 inches

Code Reference ADA 206, 302

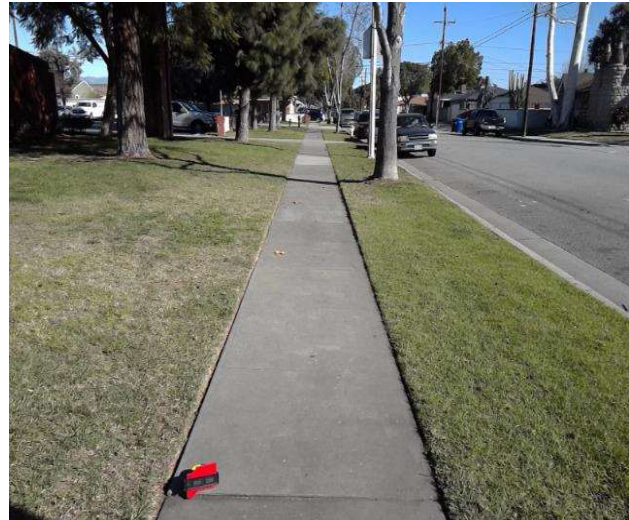
There is a change in elevation greater than recommended value.

Ensure that the change in elevation is within the recommended value.

Recommendation Up to 0.25 inches

Code Reference ADA 206, 302

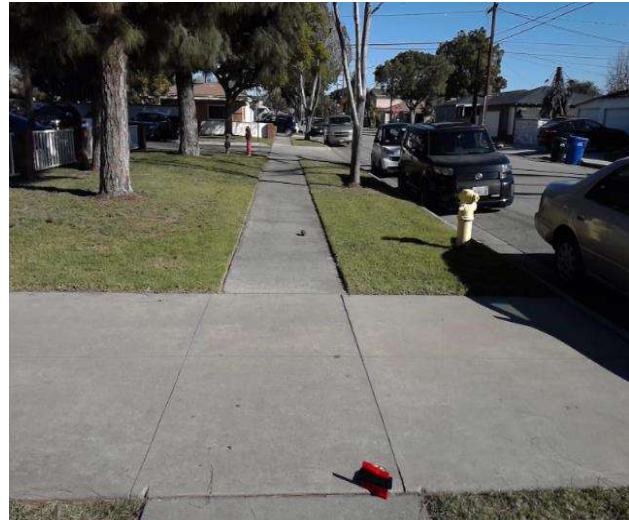
There is a change in elevation greater than recommended value.

Ensure that the change in elevation is within the recommended value.

Recommendation Up to 0.25 inches

Code Reference ADA 206, 302

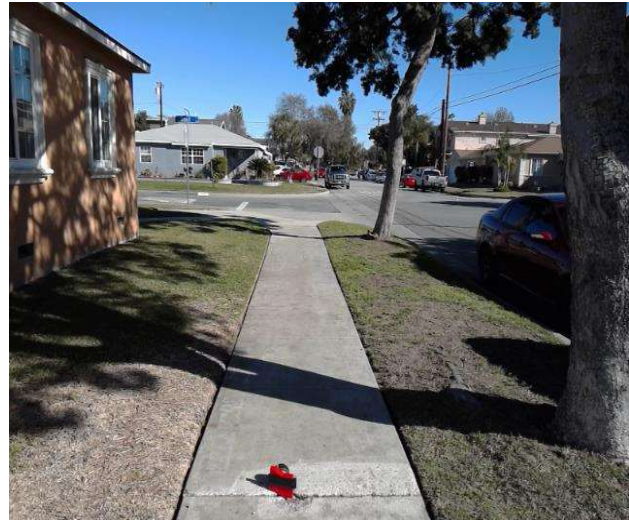
There is a change in elevation greater than recommended value.

Ensure that the change in elevation is within the recommended value.

Recommendation Up to 0.25 inches

Code Reference ADA 206, 302
