# Accessibility Survey

## City of Downey Quinn Street - Bellman Avenue to Cul-De-Sac

Date of Inspection  
7/26/2017

Prepared By  
**Disability Access Consultants**  
(800) 743-7067

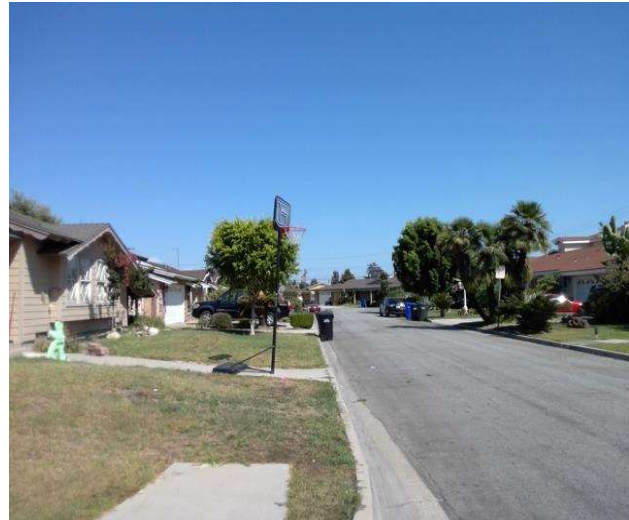
**North Side @ 33.943722642595, -118.122274875641**

Sidewalks : No Sidewalk

No sidewalk exists at the location.

No action necessary until a sidewalk is provided.

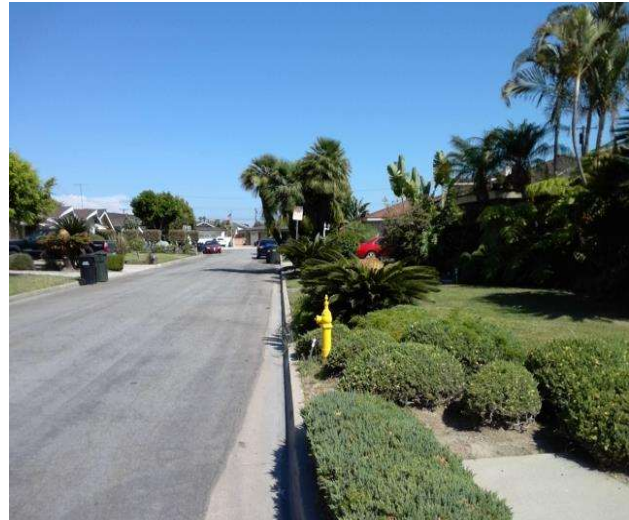
**South Side @ 33.943643650649, -118.122337907553**

Sidewalks : No Sidewalk

No sidewalk exists at the location.

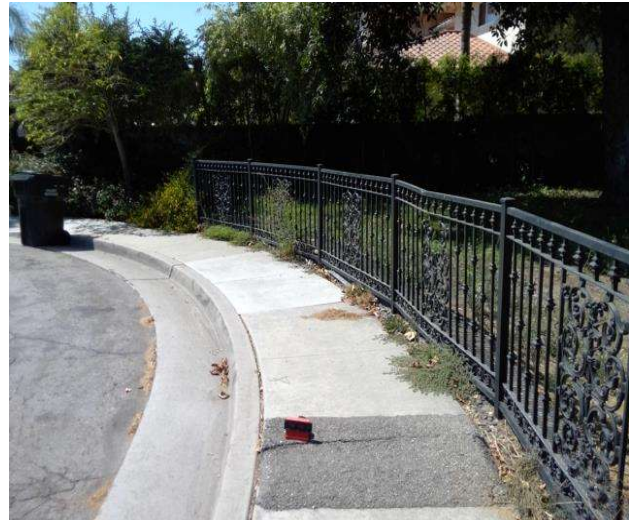
There is a change in elevation greater than recommended value.

Notes : Surface is Rough And Uneven

Ensure that the change in elevation is within the recommended value.

Recommendation Up to 0.25 inches

Remove tripping hazards \$198

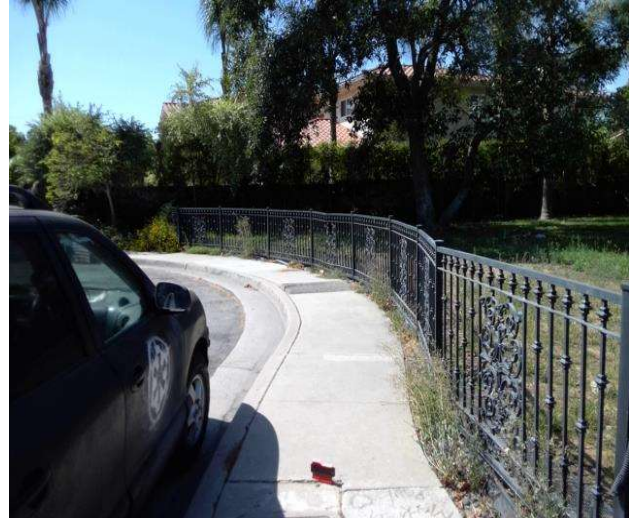
There is a change in elevation greater than recommended value.

Ensure that the change in elevation is within the recommended value.

Recommendation Up to 0.25 inches

Remove tripping hazards \$198

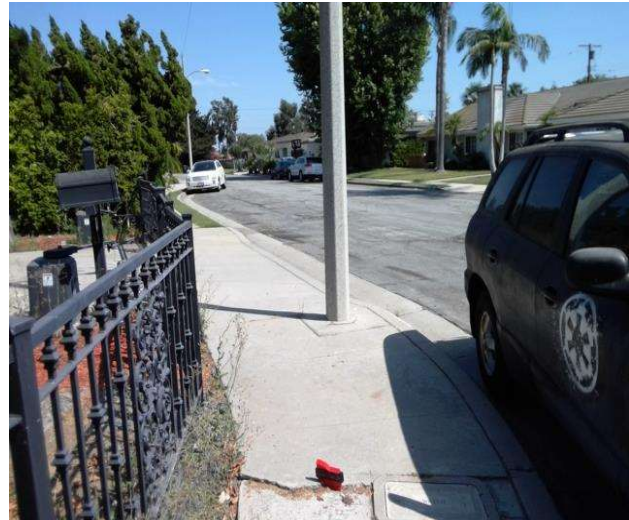
There is a change in elevation greater than recommended value.

Ensure that the change in elevation is within the recommended value.

Recommendation Up to 0.25 inches

Remove tripping hazards \$198

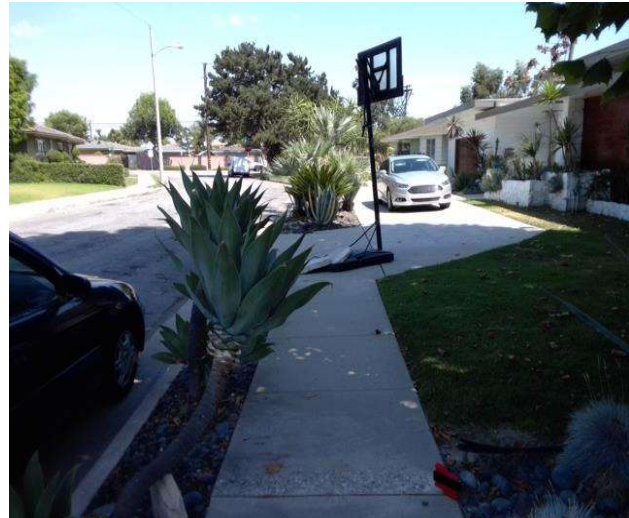
There is a change in elevation greater than recommended value.

Ensure that the change in elevation is within the recommended value.

Recommendation Up to 0.25 inches

Remove tripping hazards \$198

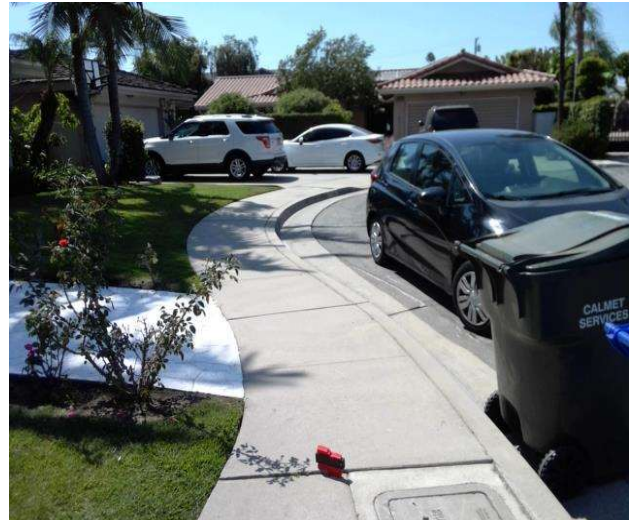
There is a change in elevation greater than recommended value.

Ensure that the change in elevation is within the recommended value.

Recommendation Up to 0.25 inches

Remove tripping hazards \$198

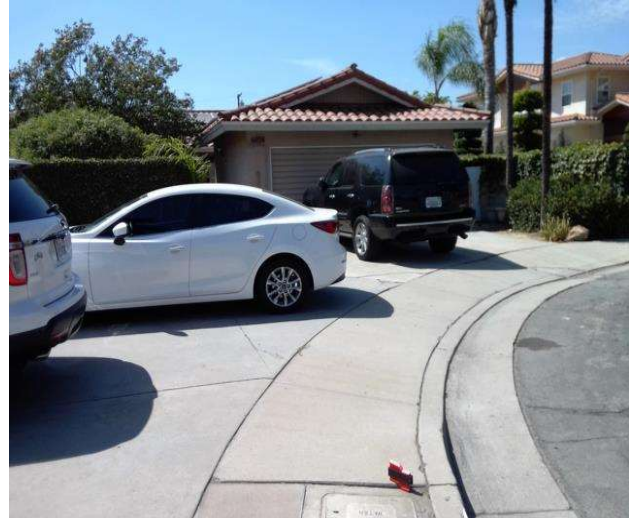
There is a change in elevation greater than recommended value.

Ensure that the change in elevation is within the recommended value.

Recommendation Up to 0.25 inches

Remove tripping hazards \$198

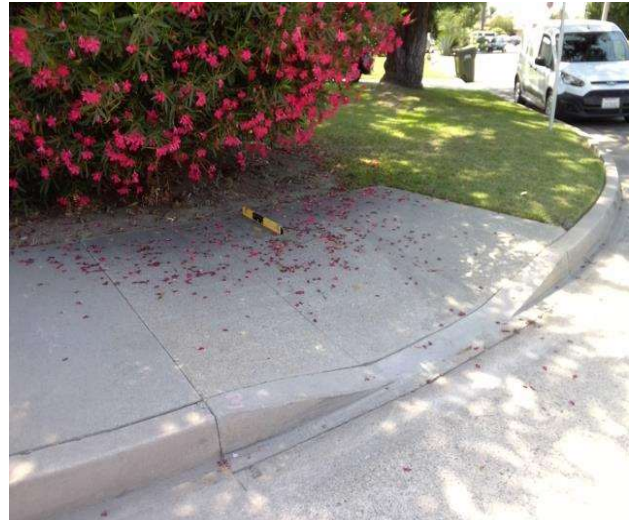
Notes : Top Landing Obstructed By Bush

Recommendation Up to 2.08 percent

Provide compliant landing \$1,260

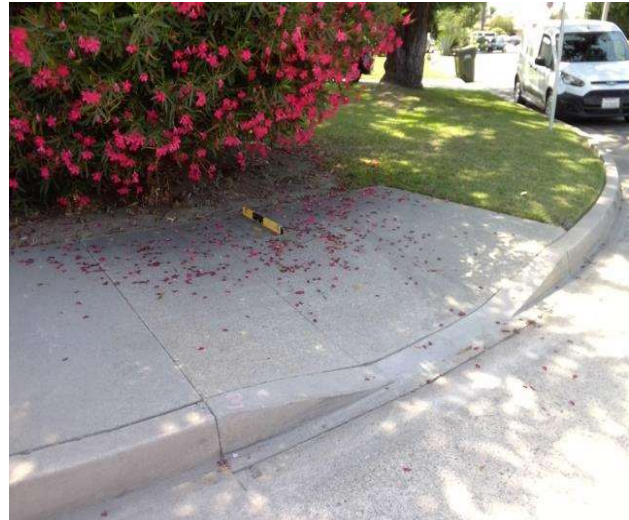
Notes : Top Landing Obstructed By Bush

Recommendation At least 48.00 inches

Provide compliant landing \$240

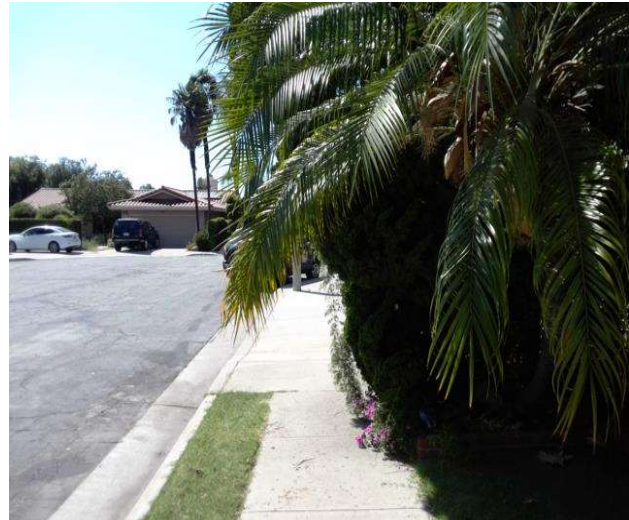
Sidewalks , Hazards & Gratings : Overhead Obstruction Height

Recommendation At least 80.00 inches

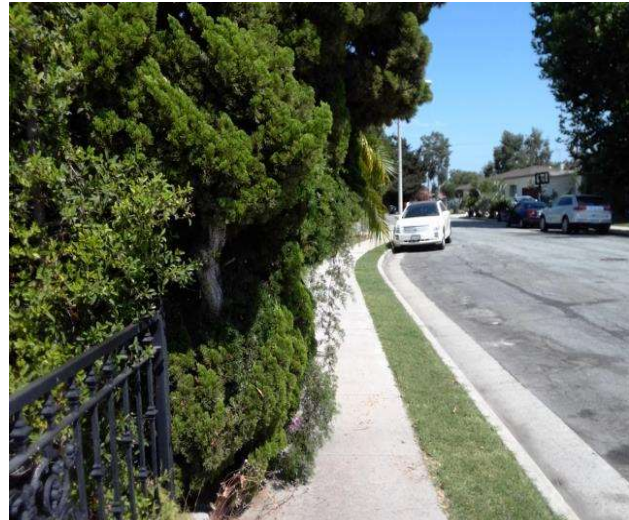
Sidewalks , Hazards & Gratings : Sidewalk Width at Obstruction

Sidewalk width at the obstruction shall have the recommended value.

Recommendation At least 48.00 inches

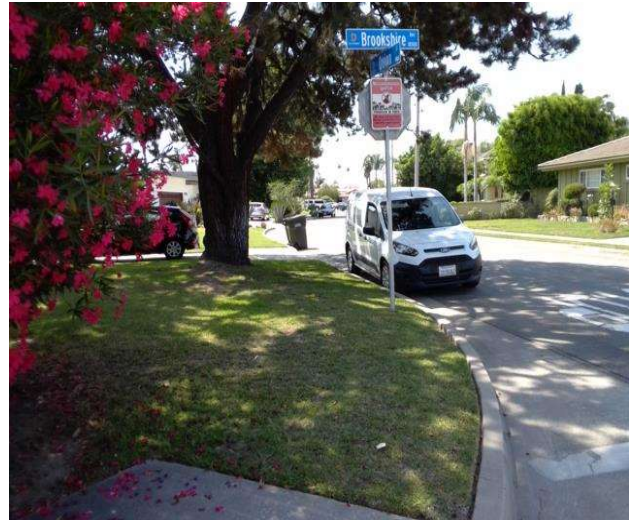
Sidewalks : Missing Sidewalk

Section of sidewalk is missing and consists of dirt, grass or gravel.

Provide a compliant sidewalk for the missing section.

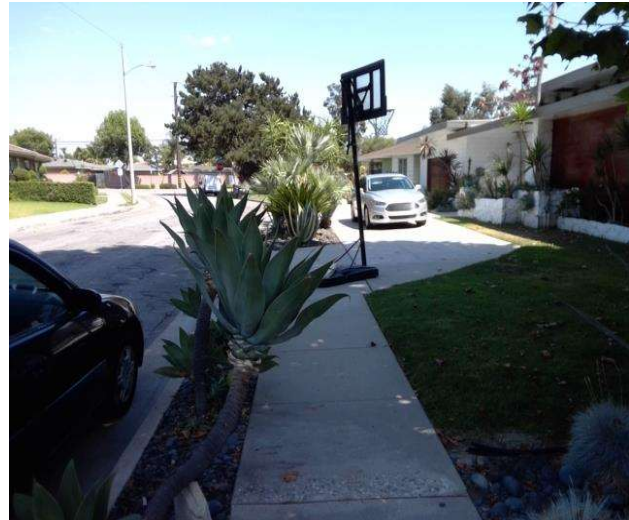
Sidewalks , Hazards & Gratings : Sidewalk Width at Obstruction

Sidewalk width at the obstruction shall have the recommended value.

Recommendation At least 48.00 inches

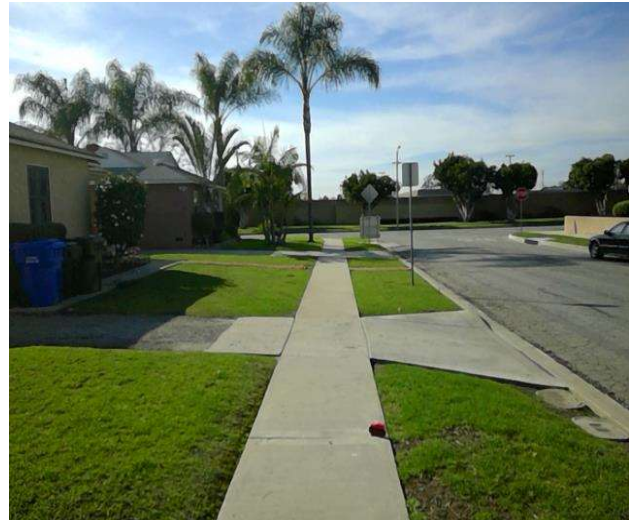
There is a change in elevation greater than recommended value.

Ensure that the change in elevation is within the recommended value.

Recommendation Up to 0.25 inches

Remove tripping hazards \$198

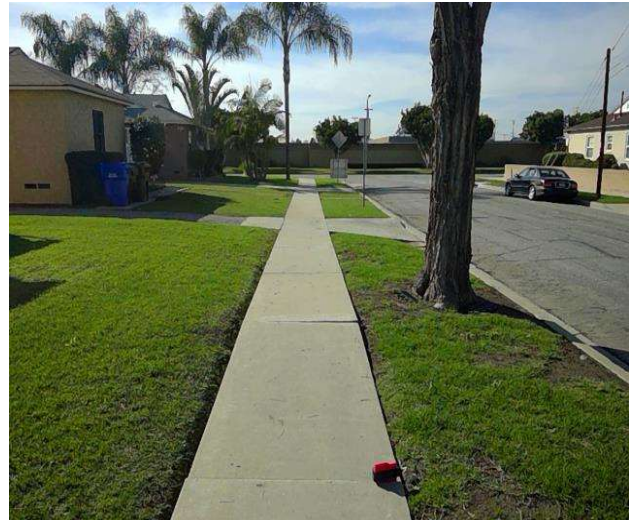
There is a change in elevation greater than recommended value.

Ensure that the change in elevation is within the recommended value.

Recommendation Up to 0.25 inches

Remove tripping hazards \$198

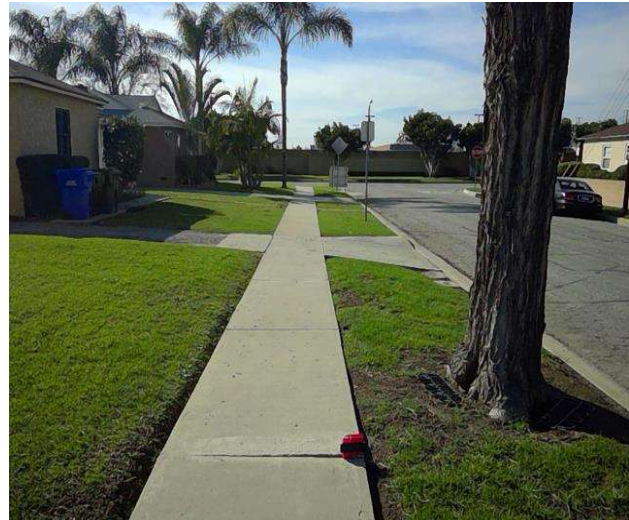
There is a change in elevation greater than recommended value.

Ensure that the change in elevation is within the recommended value.

Recommendation Up to 0.25 inches

Remove tripping hazards \$198

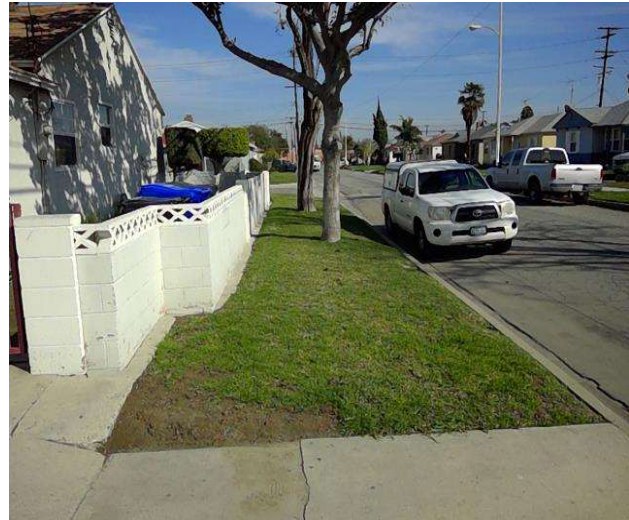
Sidewalks : Missing Sidewalk

Section of sidewalk is missing and consists of dirt, grass or gravel.

Provide a compliant sidewalk for the missing section.

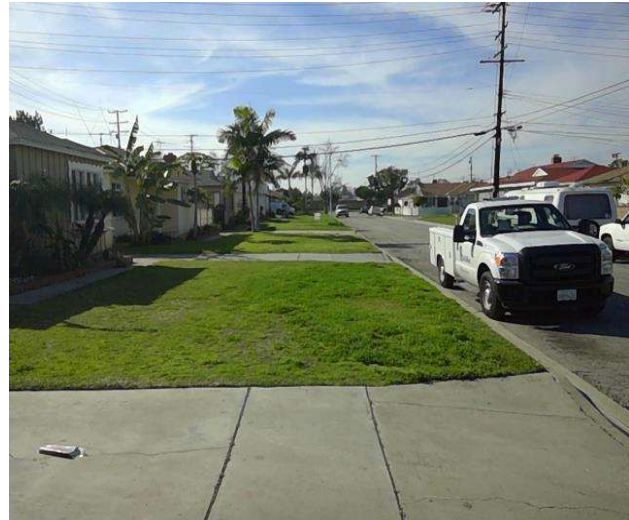
Sidewalks : Missing Sidewalk

Section of sidewalk is missing and consists of dirt, grass or gravel.

Provide a compliant sidewalk for the missing section.

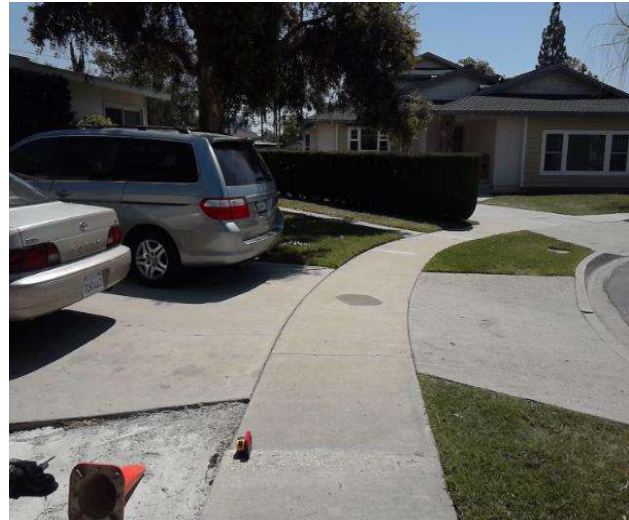
There is a change in elevation greater than recommended value.

Ensure that the change in elevation is within the recommended value.

Recommendation Up to 0.25 inches

Remove tripping hazards \$198

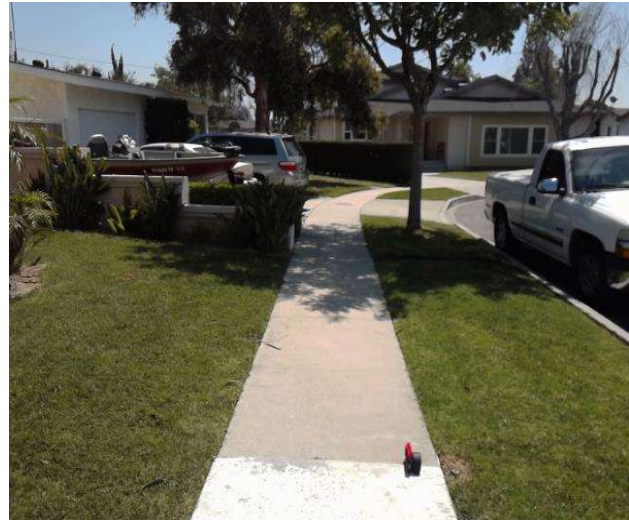
There is a change in elevation greater than recommended value.

Ensure that the change in elevation is within the recommended value.

Recommendation Up to 0.25 inches

Remove tripping hazards \$198

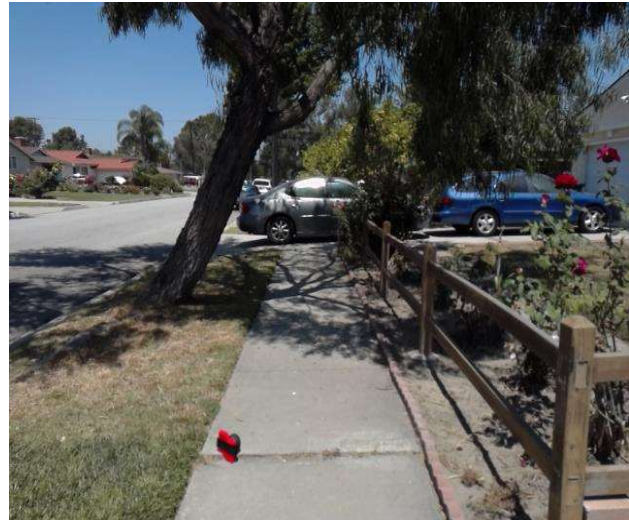
There is a change in elevation greater than recommended value.

Ensure that the change in elevation is within the recommended value.

Recommendation Up to 0.25 inches

Remove tripping hazards \$198

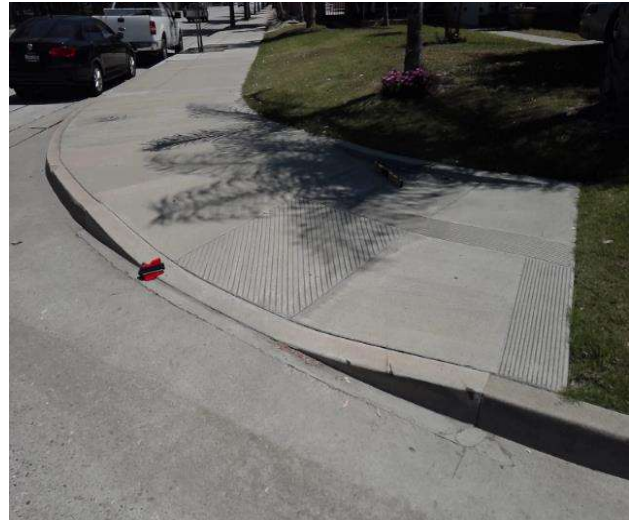
Curb Ramp , Landings And Transitions : Bottom Landing Change in Level

Recommendation Up to 0.50 inches

Patch lip at curb ramp \$255

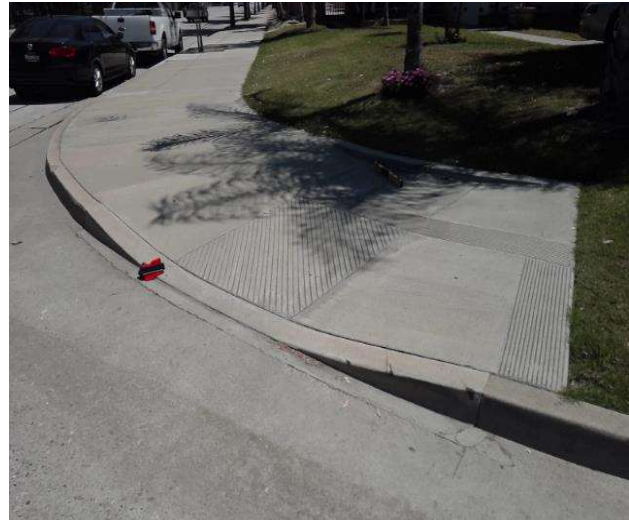
Curb Ramp , Landings and Transitions : Top Landing Clear Length - Landings

Recommendation At least 48.00 inches

Provide compliant landing \$240

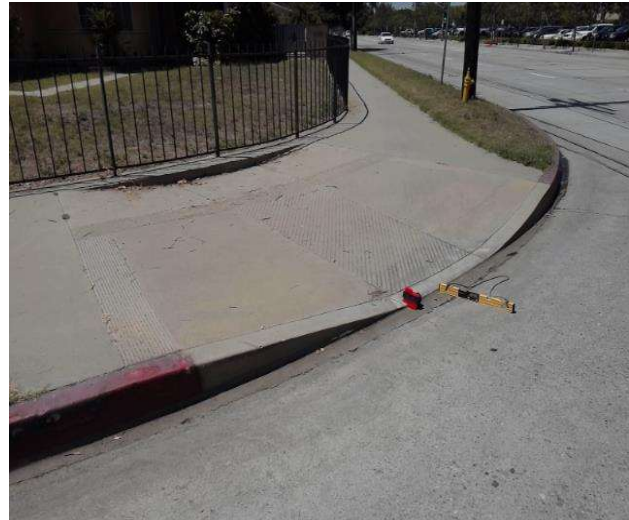
Curb Ramp , Landings And Transitions : Bottom Landing Change in Level

Recommendation Up to 0.50 inches

Patch lip at curb ramp \$255

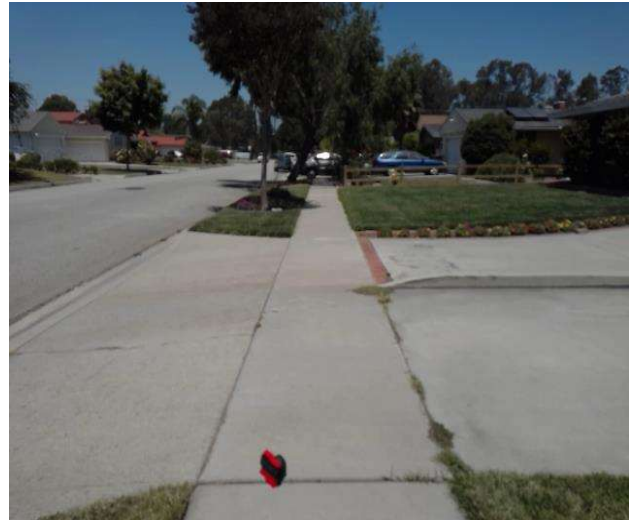
There is a change in elevation greater than recommended value.

Ensure that the change in elevation is within the recommended value.

Recommendation Up to 0.25 inches

Remove tripping hazards \$198

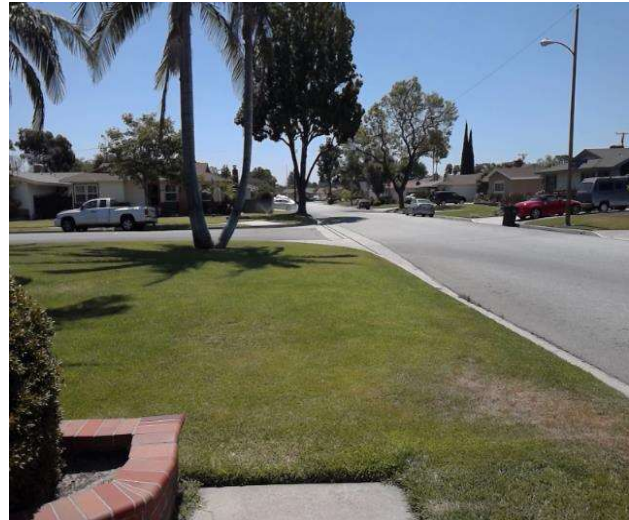
Sidewalks : Missing Sidewalk

Section of sidewalk is missing and consists of dirt, grass or gravel.

Provide a compliant sidewalk for the missing section.

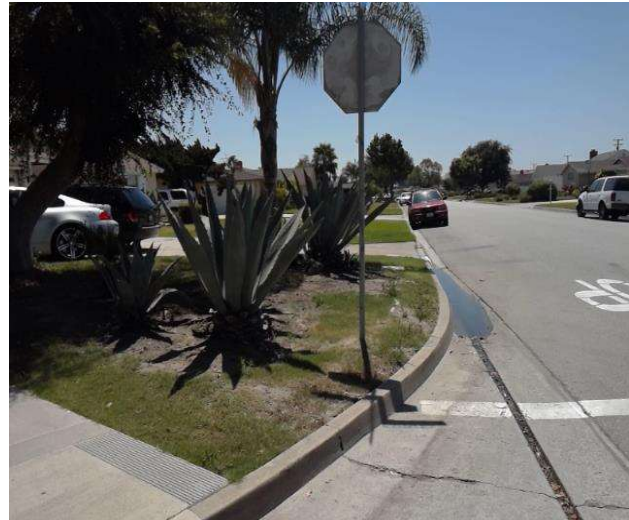
Sidewalks : Missing Sidewalk

Section of sidewalk is missing and consists of dirt, grass or gravel.

Provide a compliant sidewalk for the missing section.

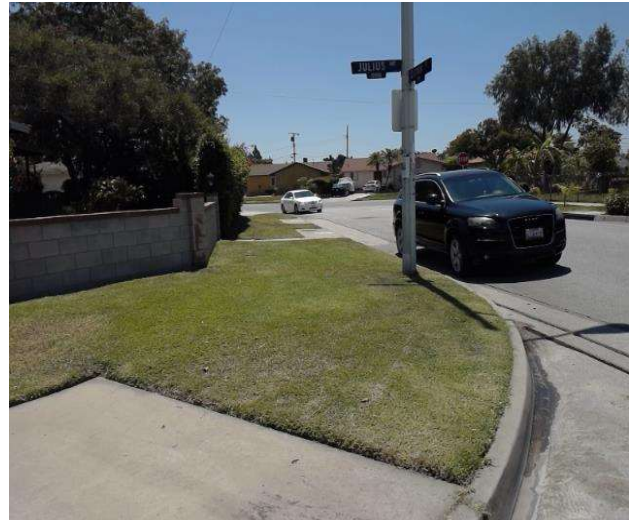
Sidewalks : Missing Sidewalk

Section of sidewalk is missing and consists of dirt, grass or gravel.

Provide a compliant sidewalk for the missing section.

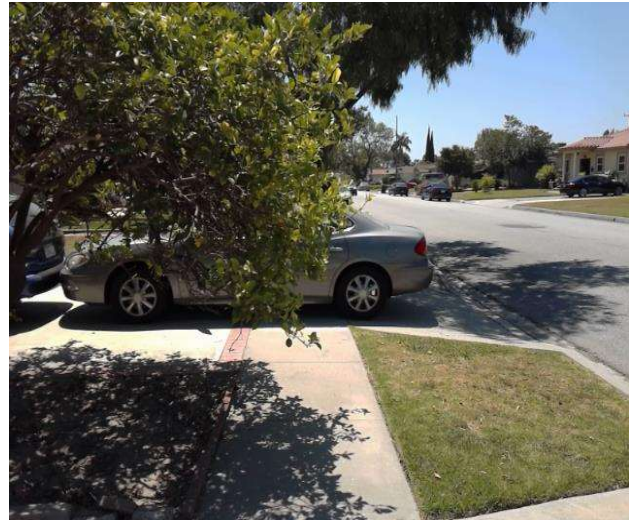
Sidewalks , Hazards & Gratings : Protruding Object Height

Recommendation Up to 4.00 inches

Install wing walls or relocate object \$640

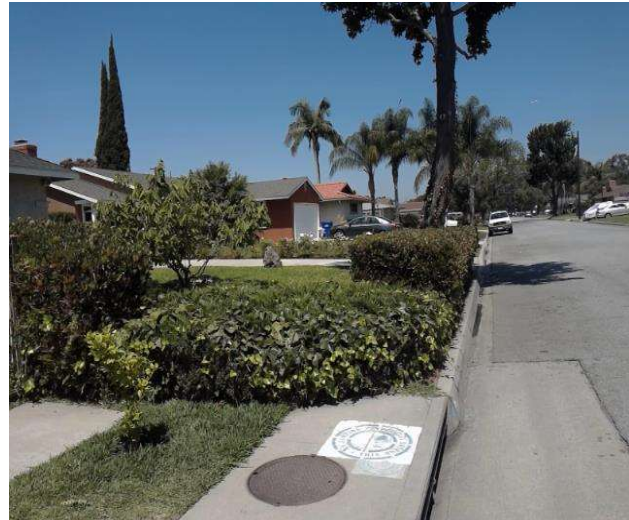
Sidewalks : Missing Sidewalk

Section of sidewalk is missing and consists of dirt, grass or gravel.

Provide a compliant sidewalk for the missing section.
