Accessibility Survey

City of Downey Richeon Avenue - Adwen Street To Arnett Street

Date of Inspection
4/11/2017

Prepared By
Disability Access Consultants
(800) 743-7067

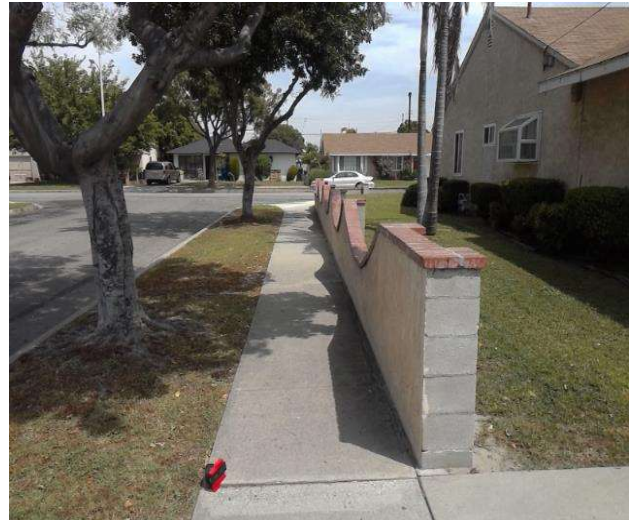
Change In Level South Of Arnett Street @ 33.942974997583, -118.145889043808

Sidewalks , Change in Level : Change in Level Non Beveled

There is a change in elevation greater than recommended value.

On-Site Finding 0.62 inches

Code Reference ADA 206, 302

Ensure that the change in elevation is within the recommended value.

Recommendation Up to 0.25 inches

Remove tripping hazards \$198

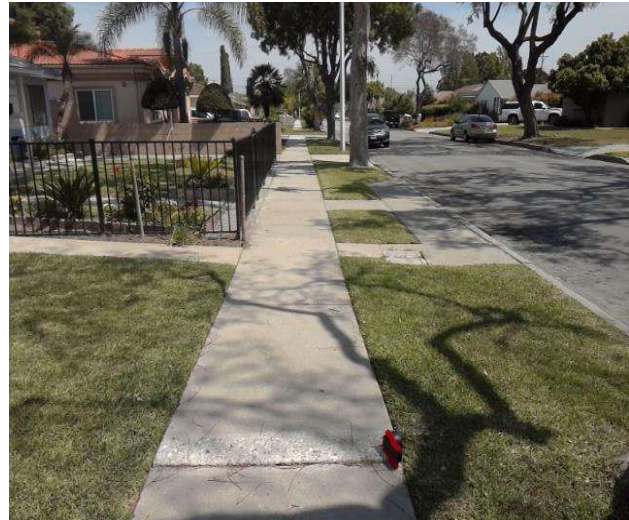
Change In Level North Of Adwen Street @ 33.942128326183, -118.146703094244

Sidewalks , Change in Level : Change in Level Non Beveled

There is a change in elevation greater than recommended value.

On-Site Finding 0.62 inches

Code Reference ADA 206, 302

Ensure that the change in elevation is within the recommended value.

Recommendation Up to 0.25 inches

Remove tripping hazards \$198

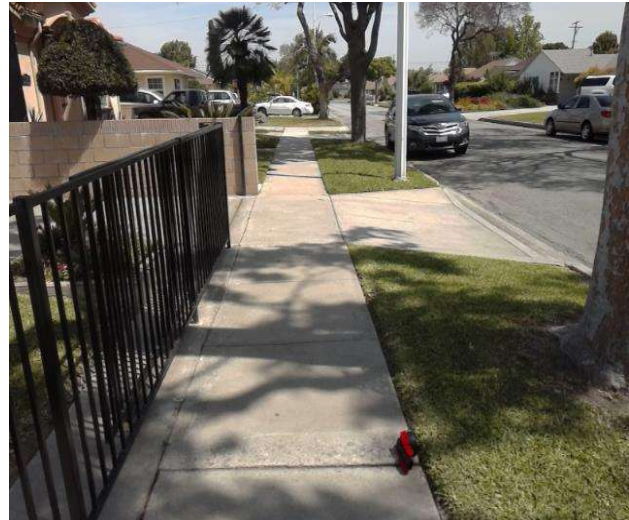
Change In Level North Of Adwen Street @ 33.942245147310, -118.146625310183

Sidewalks , Change in Level : Change in Level Non Beveled

There is a change in elevation greater than recommended value.

On-Site Finding 0.75 inches

Code Reference ADA 206, 302

Ensure that the change in elevation is within the recommended value.

Recommendation Up to 0.25 inches

Remove tripping hazards \$198

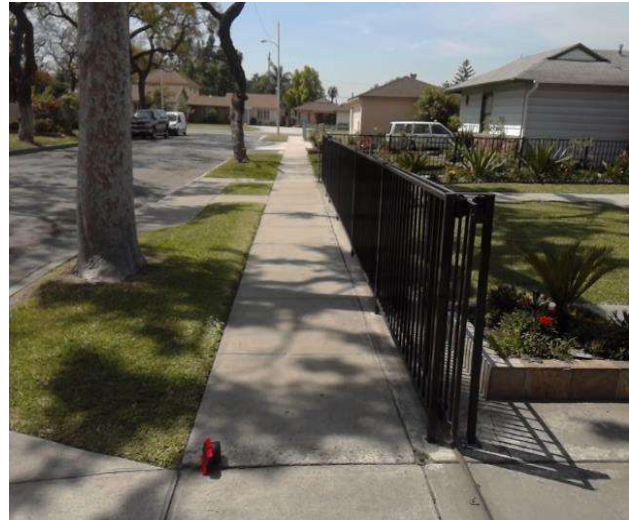
Change In Level North Of Adwen Street @ 33.942254047961, -118.146613240242

Sidewalks , Change in Level : Change in Level Non Beveled

There is a change in elevation greater than recommended value.

On-Site Finding 0.50 inches

Code Reference ADA 206, 302

Ensure that the change in elevation is within the recommended value.

Recommendation Up to 0.25 inches

Remove tripping hazards \$198

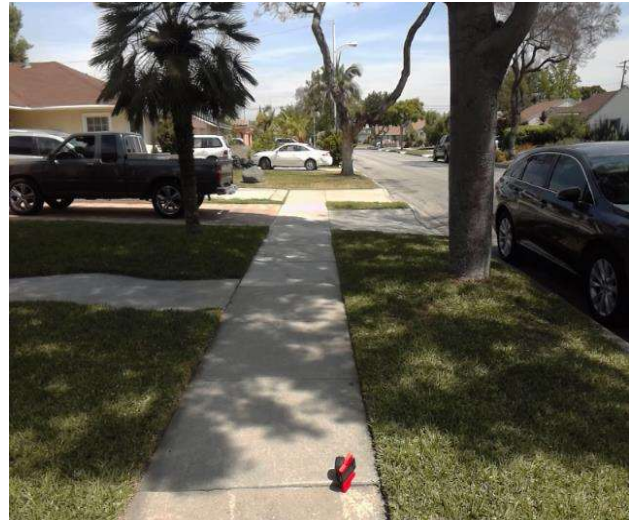
Change In Level North Of Adwen Street @ 33.942323027973, -118.146574348211

Sidewalks , Change in Level : Change in Level Non Beveled

There is a change in elevation greater than recommended value.

On-Site Finding 0.50 inches

Code Reference ADA 206, 302

Ensure that the change in elevation is within the recommended value.

Recommendation Up to 0.25 inches

Remove tripping hazards \$198

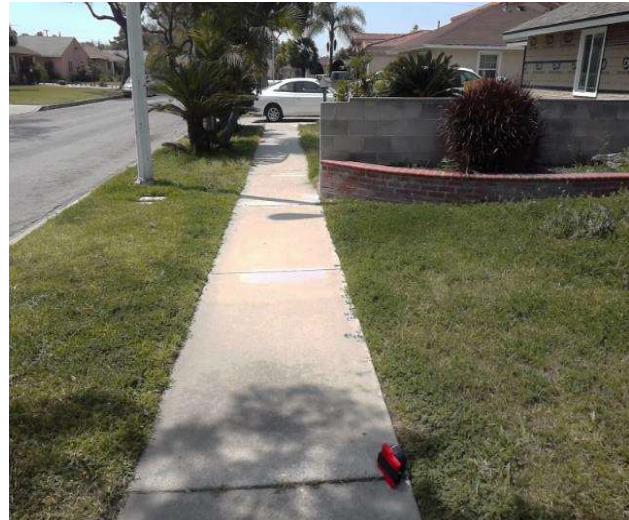
Change In Level North Of Adwen Street @ 33.942654576283, -118.146314173937

Sidewalks , Change in Level : Change in Level Non Beveled

There is a change in elevation greater than recommended value.

On-Site Finding 0.50 inches

Code Reference ADA 206, 302

Ensure that the change in elevation is within the recommended value.

Recommendation Up to 0.25 inches

Remove tripping hazards \$198

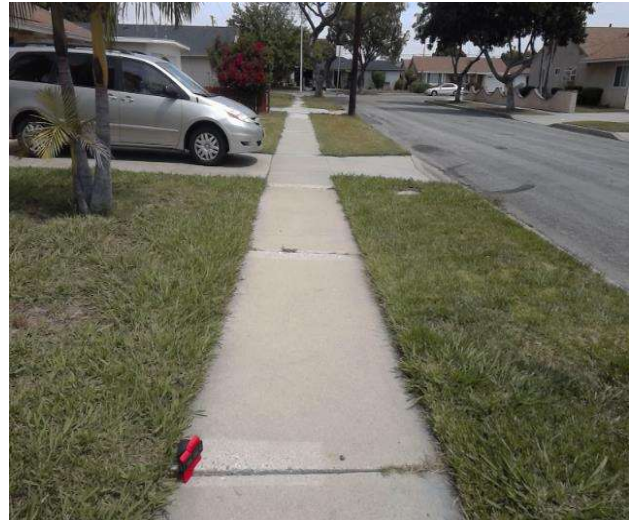
There is a change in elevation greater than recommended value.

Code Reference ADA 206, 302

Ensure that the change in elevation is within the recommended value.

Recommendation Up to 0.25 inches

Remove tripping hazards \$198

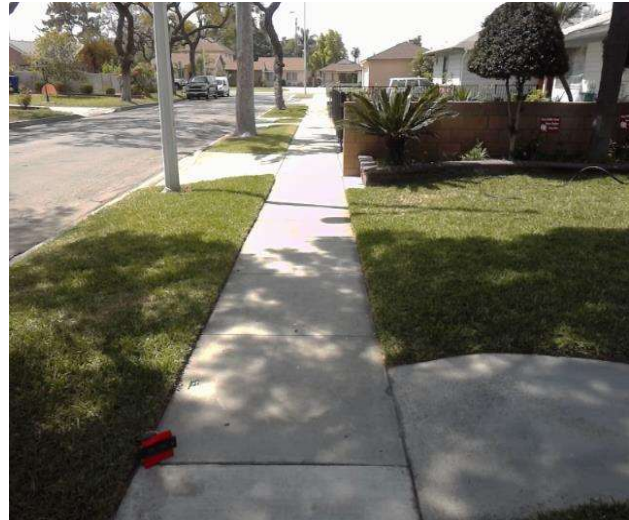
There is a change in elevation greater than recommended value.

Code Reference ADA 206, 302

Ensure that the change in elevation is within the recommended value.

Recommendation Up to 0.25 inches

Remove tripping hazards \$198

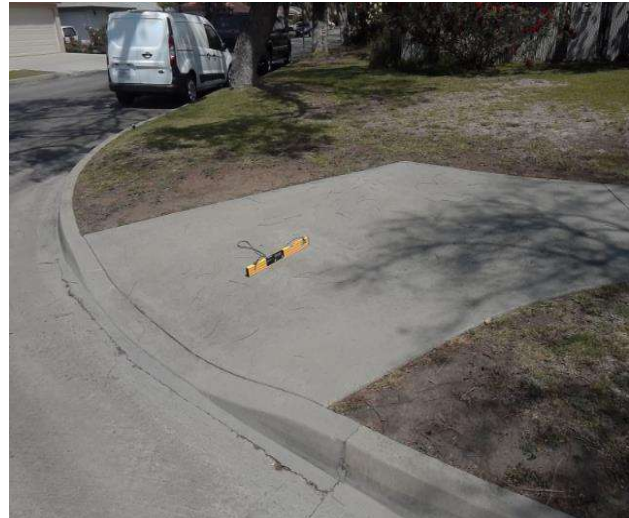
On-Site Finding Not Found

Code Reference CA 11B-406.5.12

Provide detectable warning to surface \$248

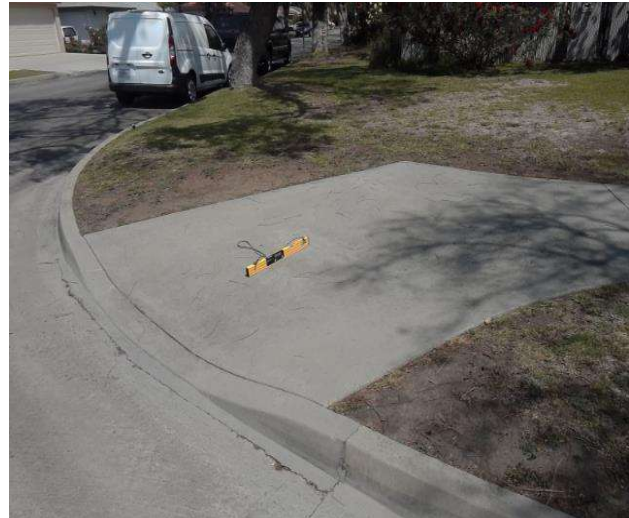
Code Reference ADA 406, 406.1, 405.2, CA 11B-406

Recommendation Up to 8.33 percent

Install curb ramp \$1,300

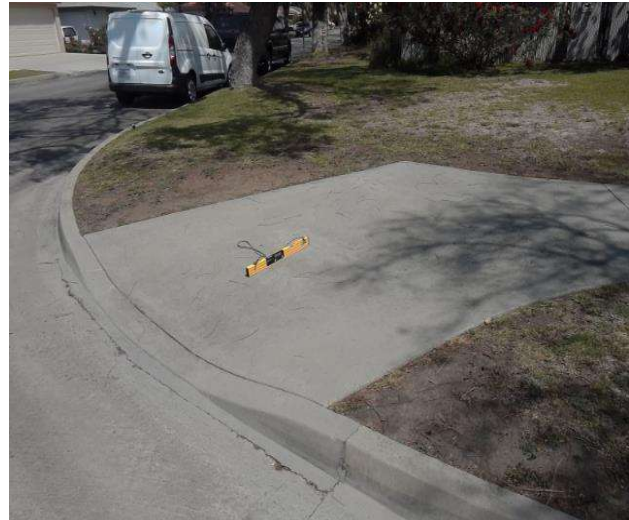
Code Reference ADA 406, 406.3,CA 11B-406.2.2

Recommendation Up to 10.00 percent

Install flared sides \$1,300

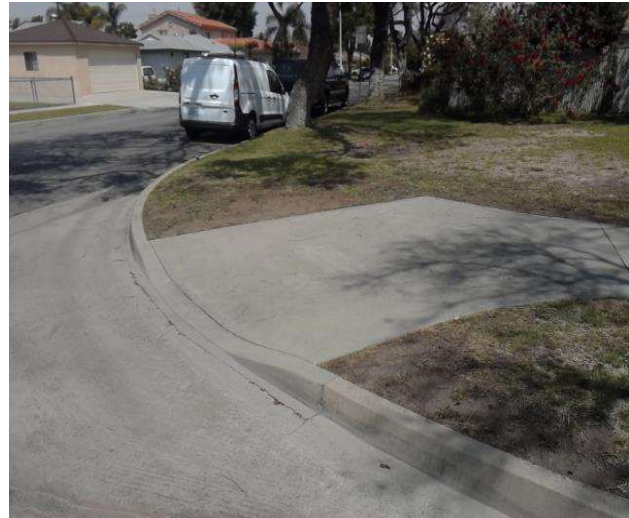
Code Reference ADA 406, 406.4,CA 11B-406.5.3

Recommendation At least 48.00 inches

Provide compliant landing \$240

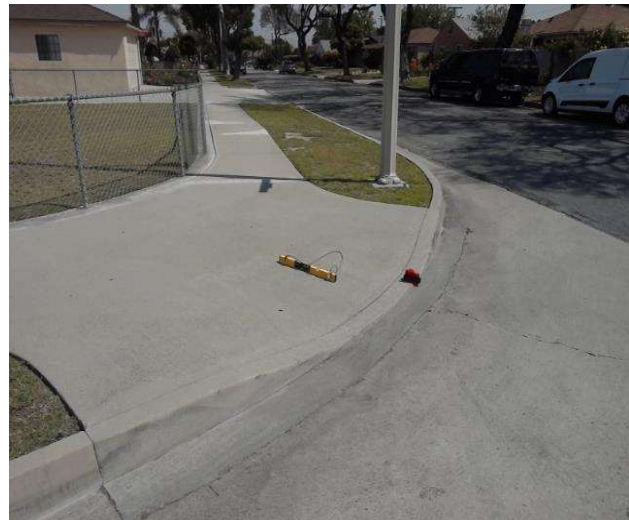
On-Site Finding Not Found

Code Reference CA 11B-406.5.12

Provide detectable warning to surface \$248

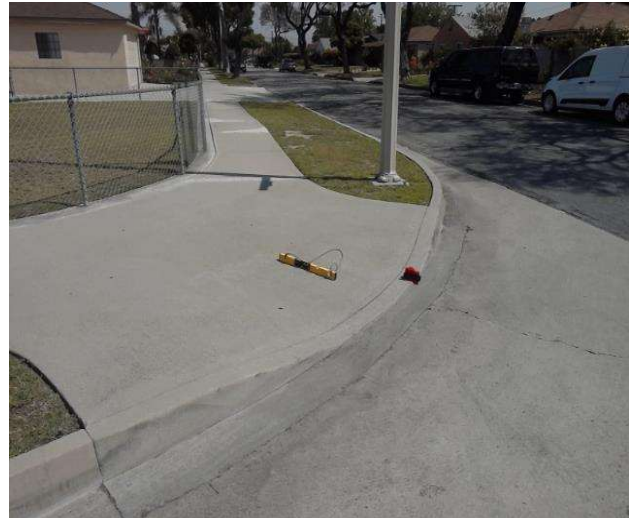
Code Reference ADA 406, 406.1, 405.2, CA 11B-406

Recommendation Up to 8.33 percent

Install curb ramp \$1,300

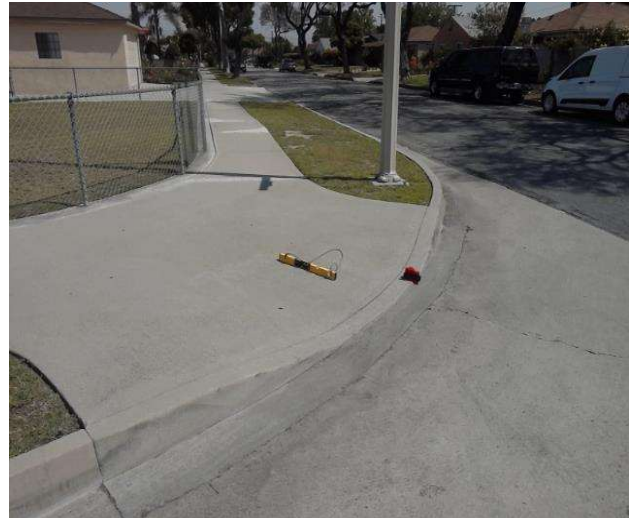
Code Reference ADA 406, 406.3,CA 11B-406.2.2

Recommendation Up to 10.00 percent

Install flared sides \$1,300

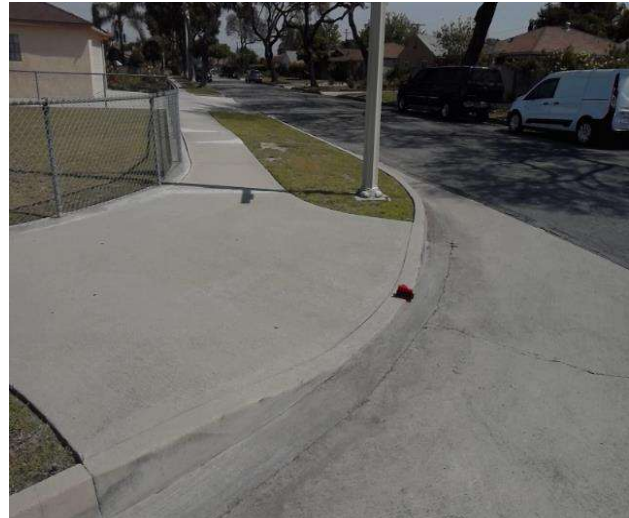
Curb Ramp , Landings and Transitions : Bottom Landing Change in Level - Curb Ramps

Code Reference ADA 302, 406.2

Patch lip at curb ramp \$255

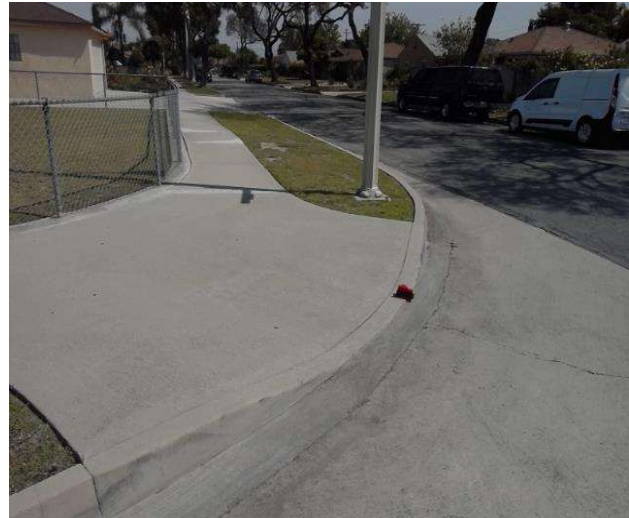
Code Reference ADA 402, 406.4, 403.3, 406.1, CA 11B-406.5.3

Recommendation Up to 2.08 percent

Provide compliant landing \$1,260

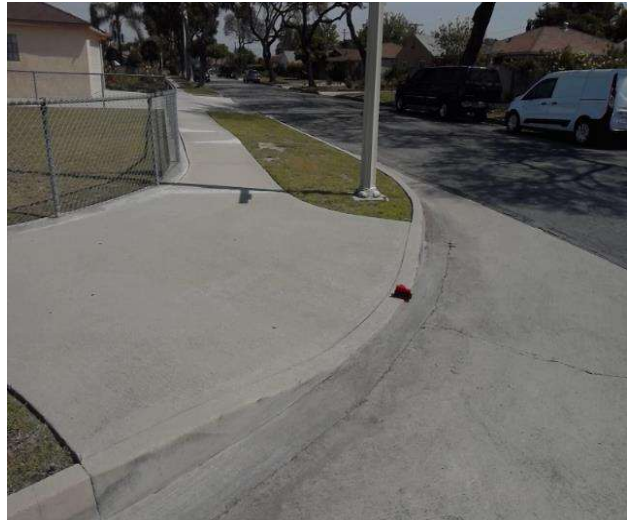
Curb Ramp , Landings and Transitions : Top Landing Clear Length - Landings

Code Reference ADA 406, 406.4,CA 11B-406.5.3

Recommendation At least 48.00 inches

Provide compliant landing \$240

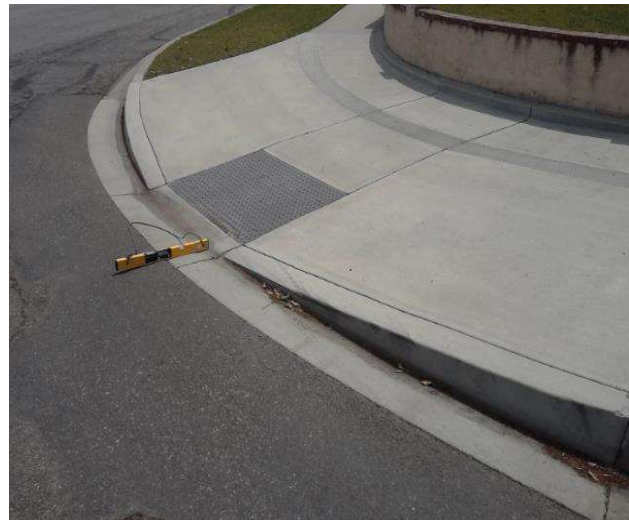
Code Reference ADA 406, 406.2, CA 11B-406.5.8

Recommendation Up to 5.00 percent

Repave landing \$1,260

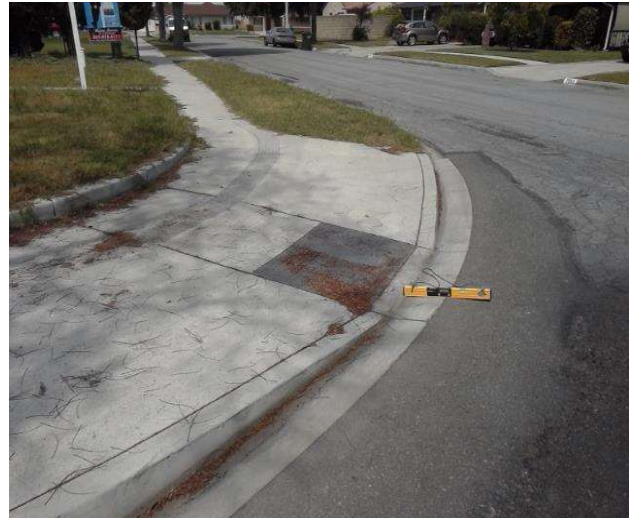
Code Reference ADA 406, 406.2, CA 11B-406.5.8

Recommendation Up to 5.00 percent

Repave landing \$1,260

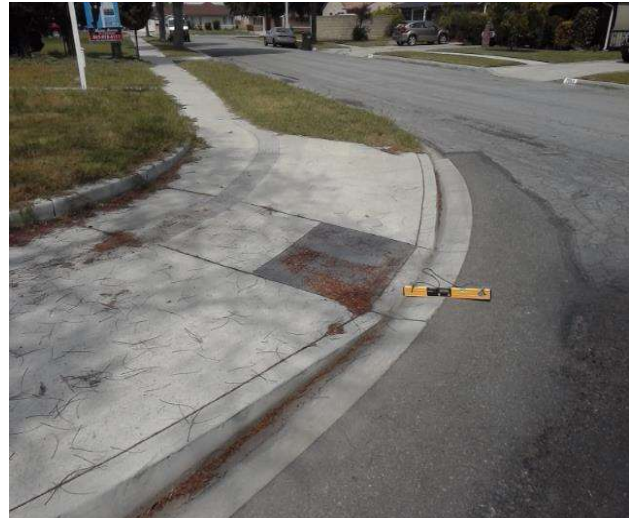
Code Reference ADA 406, 406.4,CA 11B-406.5.3

Recommendation At least 48.00 inches

Provide compliant landing \$240

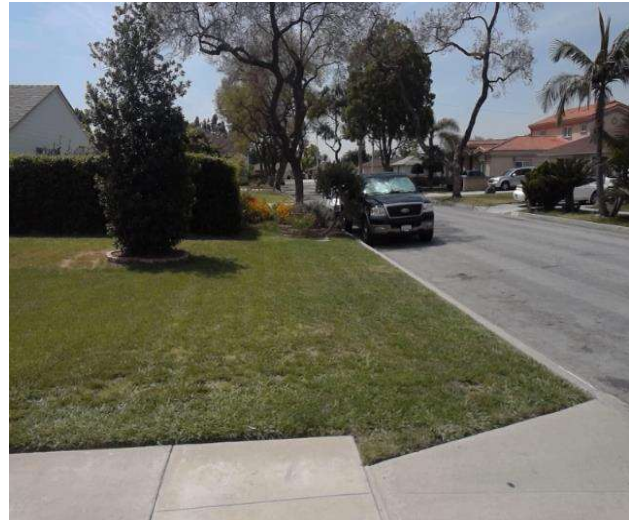
Sidewalks : Missing Sidewalk

Section of sidewalk is missing and consists of dirt, grass or gravel.

Code Reference ADA 206, 302,CA 11B-302,CA 11B-206

Provide a compliant sidewalk for the missing section.

\$1,260

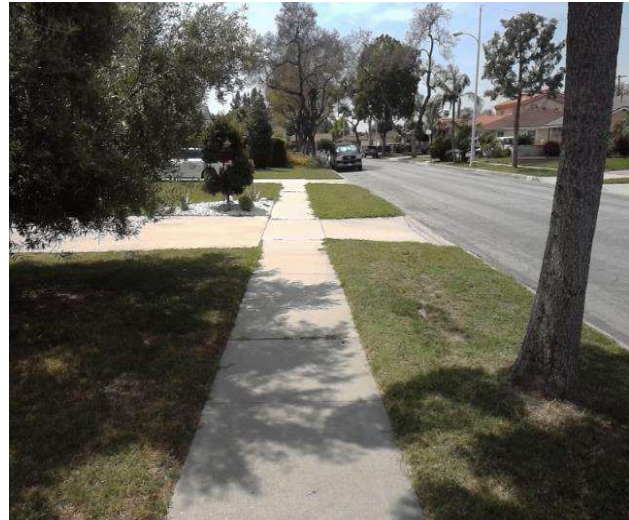
Code Reference ADA 206, 302, CA 11B-403.3

Repave the sidewalk surface with the recommended cross slope.

Recommendation Up to 2.08 percent

Repave surface \$1,092

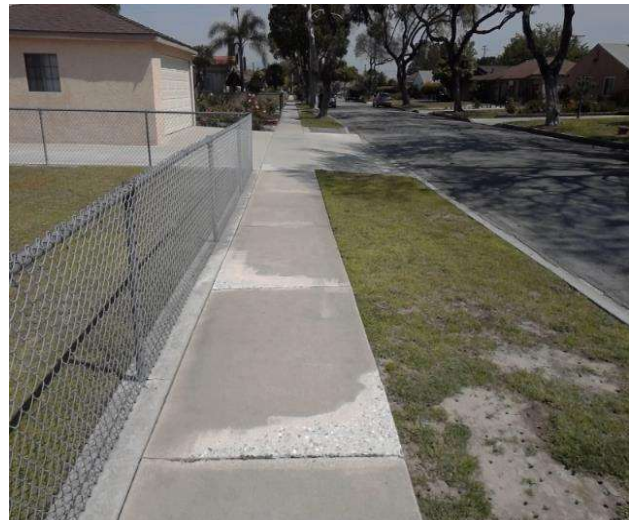
Code Reference ADA 206, 302

Repave the sidewalk surface with the recommended running slope.

Recommendation Up to 5.00 percent

Repave surface \$1,184

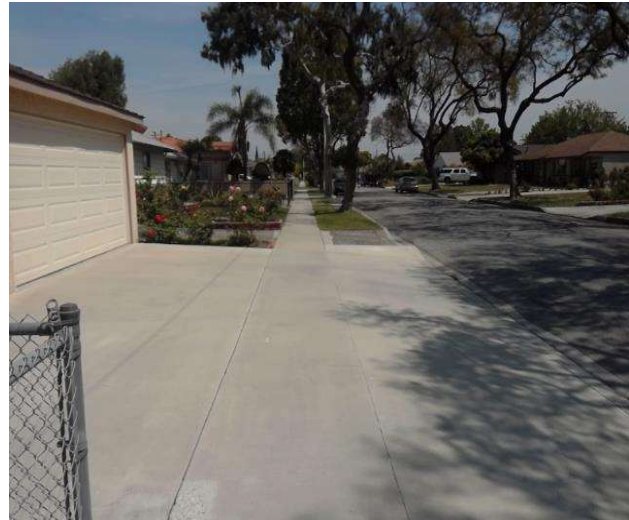
Code Reference ADA 206, 302, CA 11B-403.3

Repave the sidewalk surface with the recommended cross slope.

Recommendation Up to 2.08 percent

Repave surface \$1,092

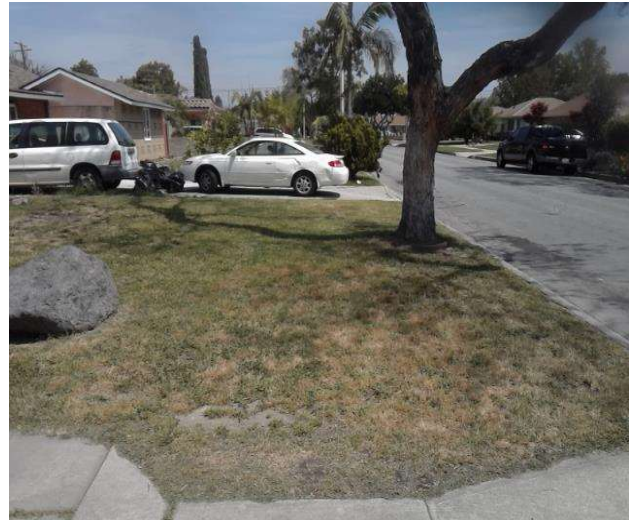
Sidewalks : Missing Sidewalk

Section of sidewalk is missing and consists of dirt, grass or gravel.

Code Reference ADA 206, 302,CA 11B-302,CA 11B-206

Provide a compliant sidewalk for the missing section.

\$1,260

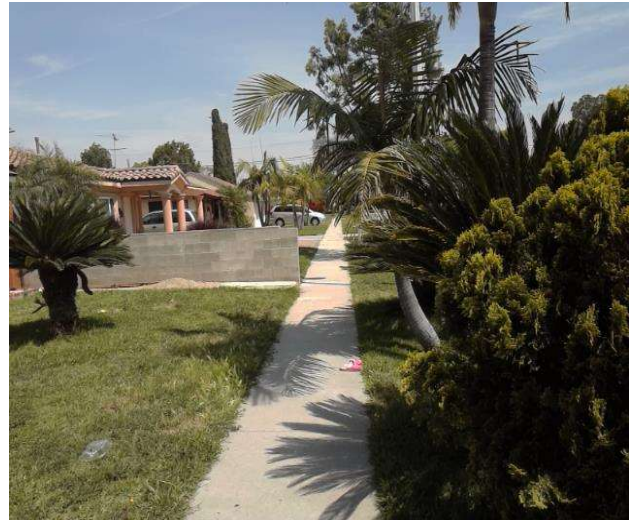
Code Reference ADA 206, 302, CA 11B-403.3

Repave the sidewalk surface with the recommended cross slope.

Recommendation Up to 2.08 percent

Repave surface \$1,092

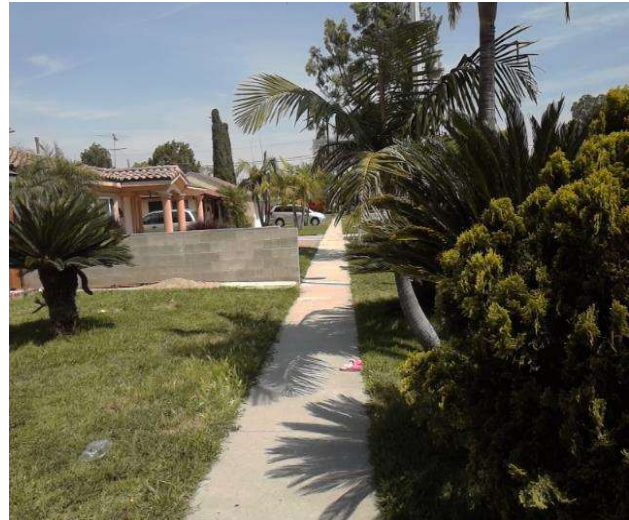
Code Reference ADA 206, 302

Repave the sidewalk surface with the recommended running slope.

Recommendation Up to 5.00 percent

Repave surface \$1,184

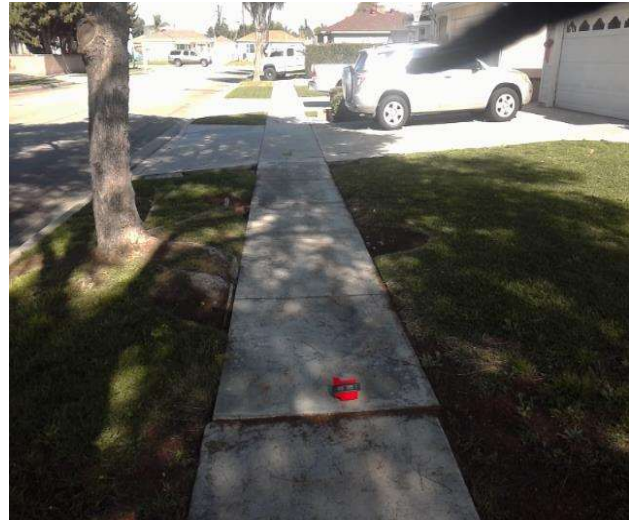
There is a change in elevation greater than recommended value.

Code Reference ADA 206, 302

Recommendation Up to 0.50 inches

Remove tripping hazards \$198

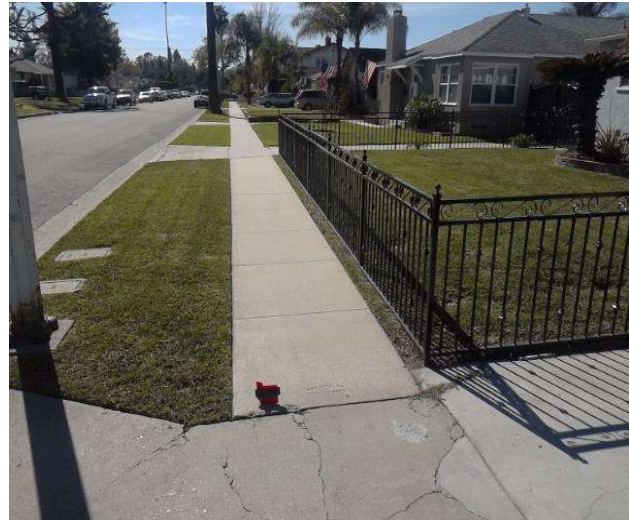
There is a change in elevation greater than recommended value.

Code Reference ADA 206, 302

Recommendation Up to 0.50 inches

Remove tripping hazards \$198

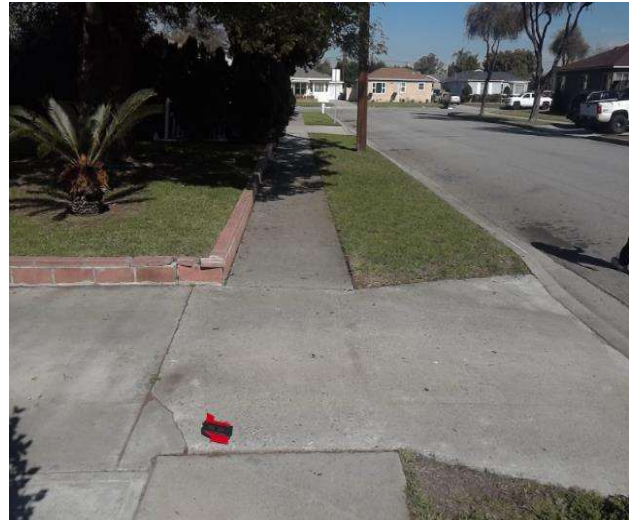
There is a change in elevation greater than recommended value.

Code Reference ADA 206, 302

Recommendation Up to 0.50 inches

Remove tripping hazards \$198

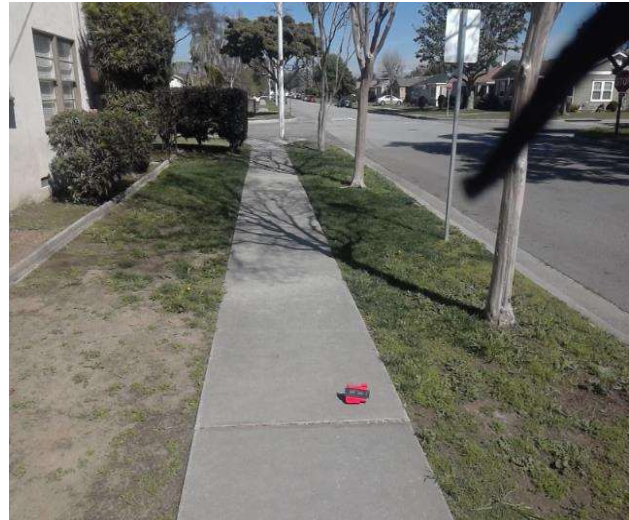
There is a change in elevation greater than recommended value.

Code Reference ADA 206, 302

Recommendation Up to 0.50 inches

Remove tripping hazards \$198

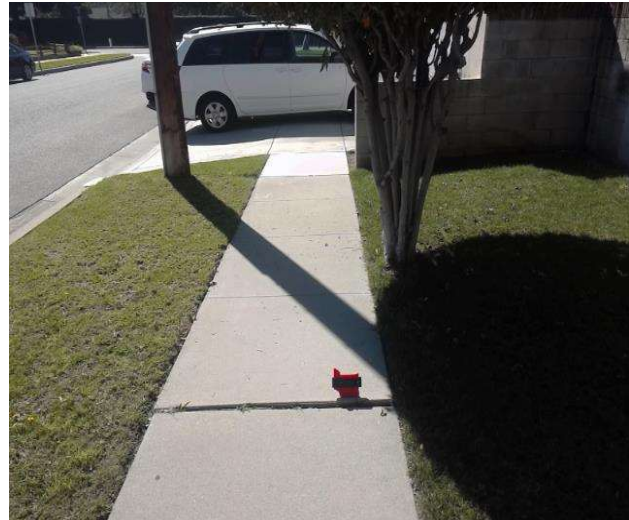
There is a change in elevation greater than recommended value.

Code Reference ADA 206, 302

Recommendation Up to 0.50 inches

Remove tripping hazards \$198

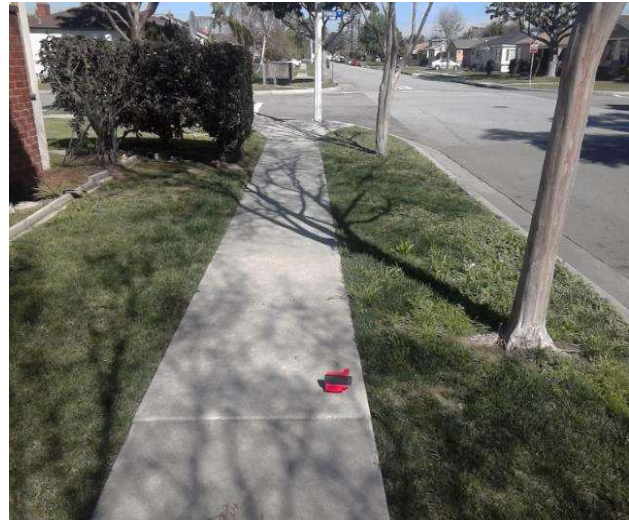
There is a change in elevation greater than recommended value.

Code Reference ADA 206, 302

Recommendation Up to 0.50 inches

Remove tripping hazards \$198

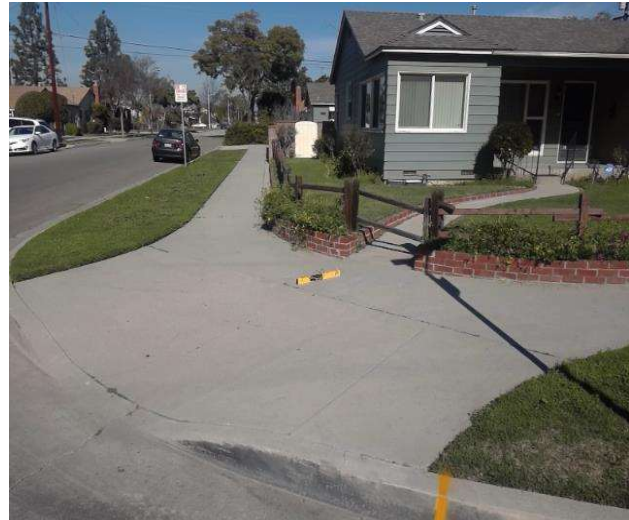
On-Site Finding Not Found

Code Reference CA 11B-406.5.12

Provide detectable warning to surface \$248

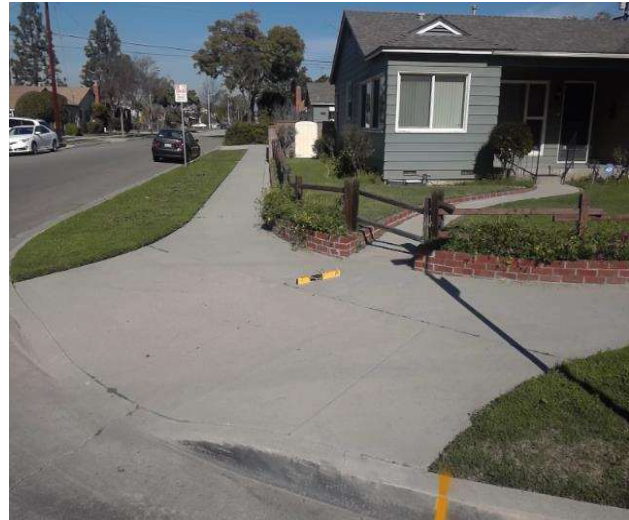
Code Reference ADA 406, 406.3, CA 11B-406.2.2

Recommendation Up to 10.00 percent

Install flared sides \$1,300

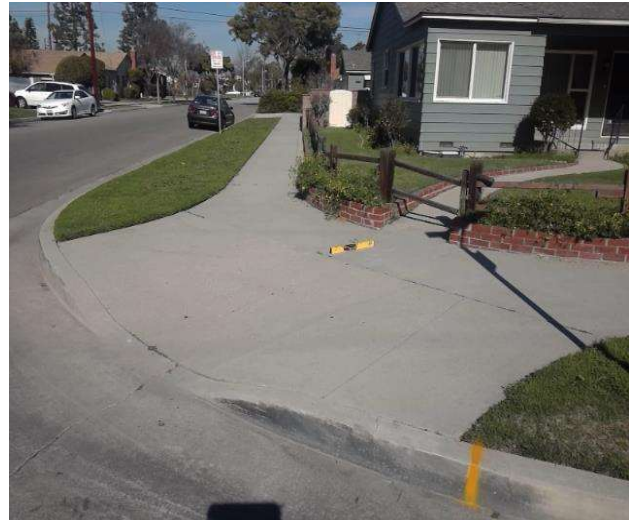
Code Reference ADA 402, 406.4, 403.3, 406.1, CA 11B-406.5.3

Recommendation Up to 2.08 percent

Provide compliant landing \$1,260

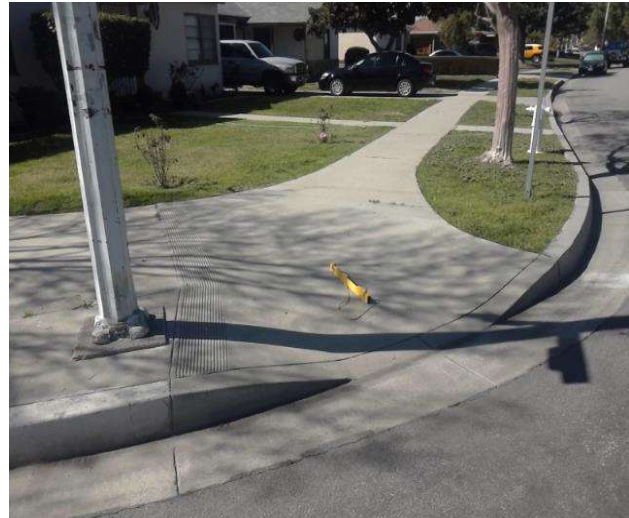
On-Site Finding Not Found

Code Reference CA 11B-406.5.12

Provide detectable warning to surface \$248

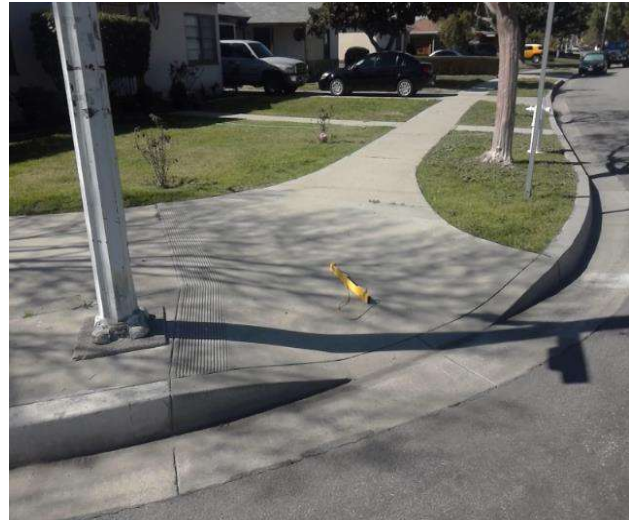
Code Reference ADA 406, 406.1, 405.2, CA 11B-406

Recommendation Up to 8.33 percent

Install curb ramp \$1,300

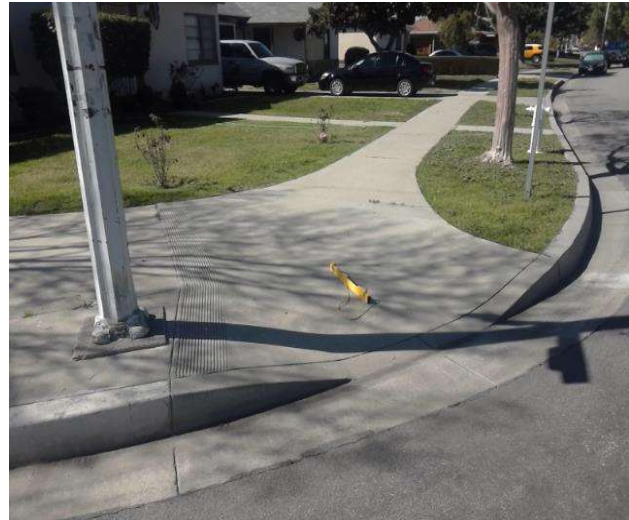
Code Reference ADA 406, 406.3,CA 11B-406.2.2

Recommendation Up to 10.00 percent

Install flared sides \$1,300

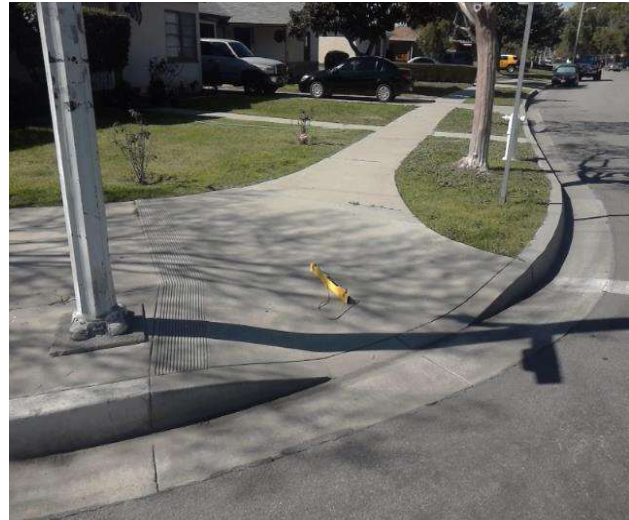
Code Reference ADA 406, 406.4,CA 11B-406.5.3

Recommendation At least 48.00 inches

Provide compliant landing \$240

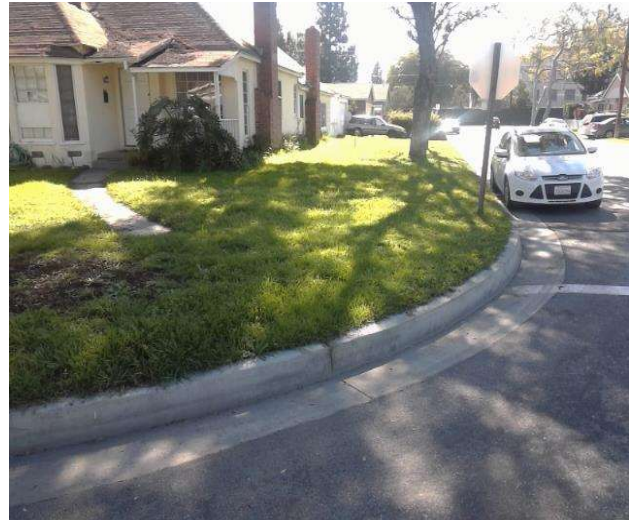
Sidewalks , Hazards & Gratings : Curb is on Path of Travel

Code Reference ADA 402, 303, 406, 403.4, 303.4

Install curb ramp \$2,500

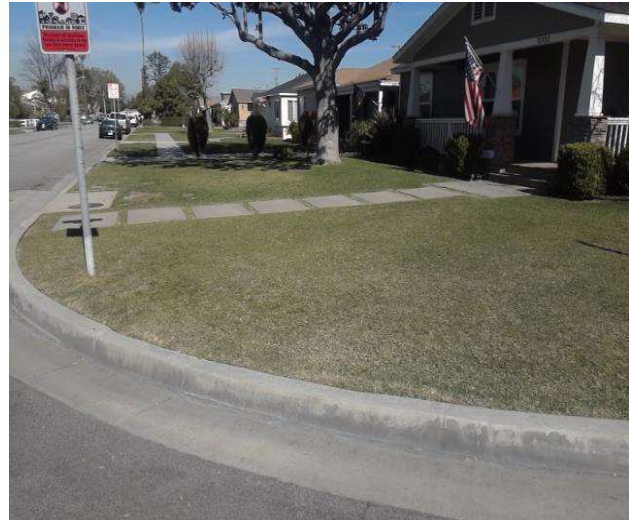
Sidewalks , Hazards & Gratings : Curb is on Path of Travel

Code Reference ADA 402, 303, 406, 403.4, 303.4

Install curb ramp \$2,500

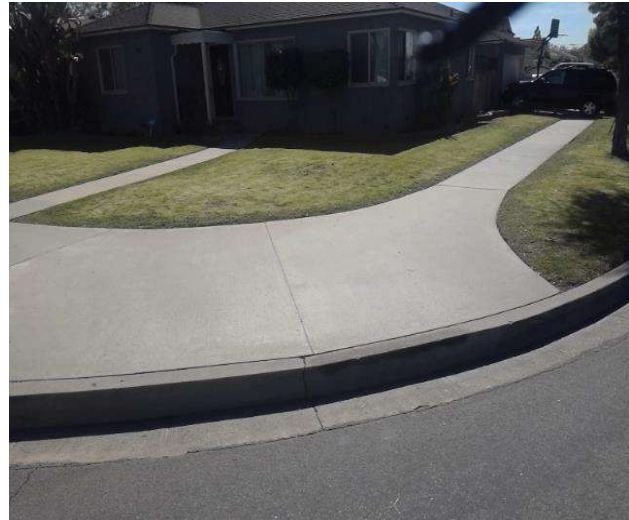
Sidewalks , Hazards & Gratings : Curb is on Path of Travel

Code Reference ADA 402, 303, 406, 403.4, 303.4

Install curb ramp \$2,500

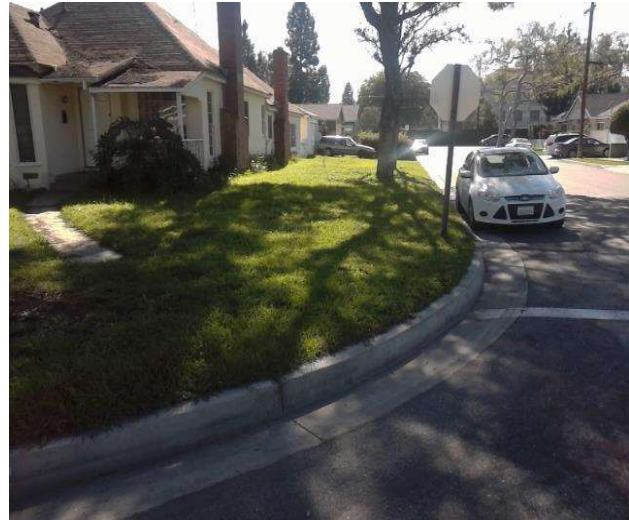
Sidewalks : Missing Sidewalk

Section of sidewalk is missing and consists of dirt, grass or gravel.

Code Reference ADA 206, 302,CA 11B-302,CA 11B-206

Provide a compliant sidewalk for the missing section.

\$1,260

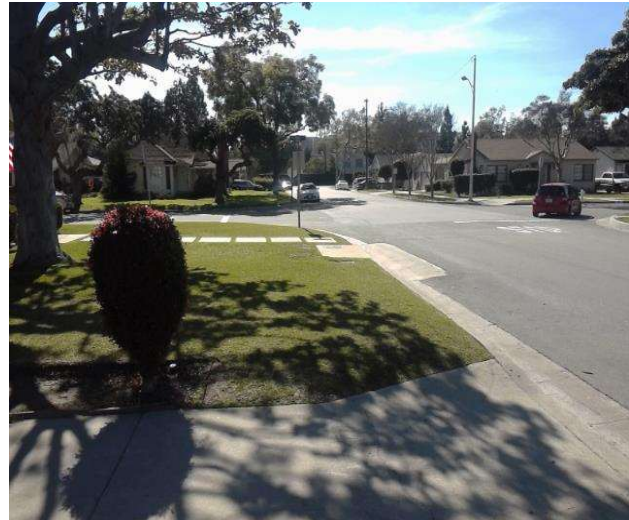
Sidewalks : Missing Sidewalk

Section of sidewalk is missing and consists of dirt, grass or gravel.

Code Reference ADA 206, 302,CA 11B-302,CA 11B-206

Provide a compliant sidewalk for the missing section.

\$1,260

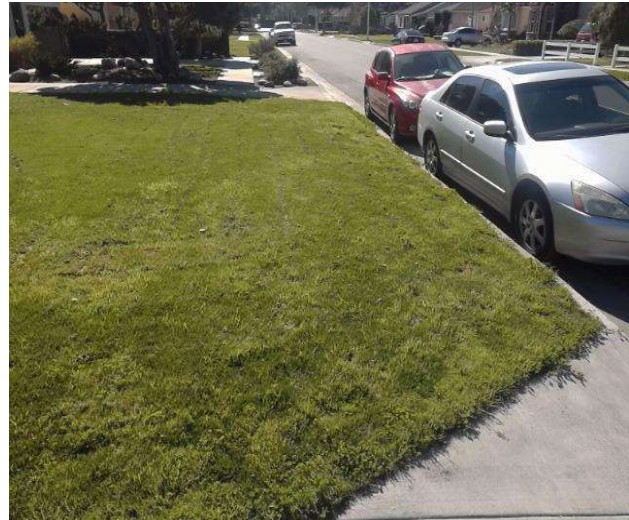
Sidewalks : Missing Sidewalk

Section of sidewalk is missing and consists of dirt, grass or gravel.

Code Reference ADA 206, 302,CA 11B-302,CA 11B-206

Provide a compliant sidewalk for the missing section.

\$1,260

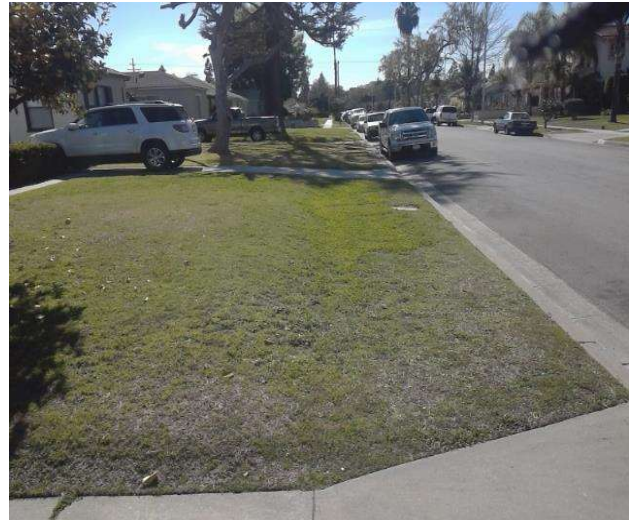
Sidewalks : Missing Sidewalk

Section of sidewalk is missing and consists of dirt, grass or gravel.

Code Reference ADA 206, 302,CA 11B-302,CA 11B-206

Provide a compliant sidewalk for the missing section.

\$1,260

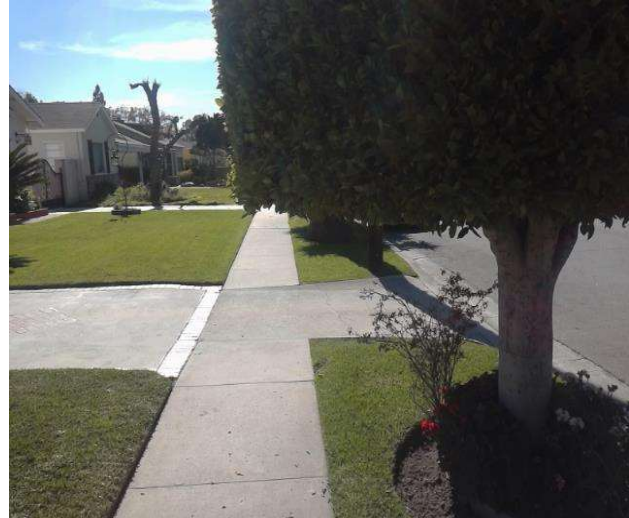
Sidewalks , Hazards & Gratings : Overhead Obstruction Height

Code Reference ADA 206, 307.4,CA 11B-307.4

Recommendation At least 80.00 inches

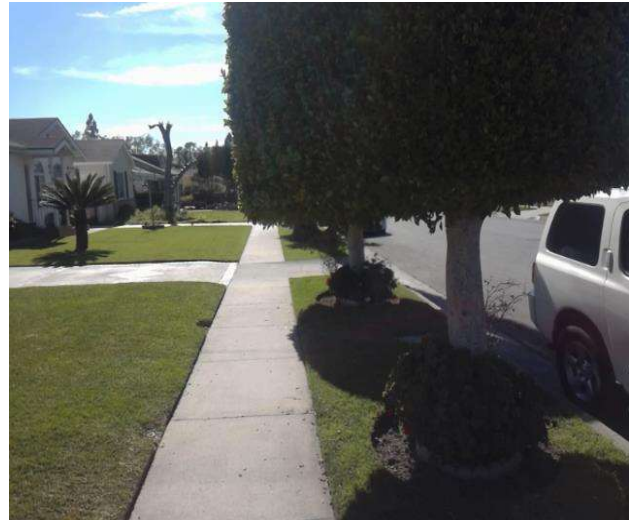
Sidewalks , Hazards & Gratings : Overhead Obstruction Height

Code Reference ADA 206, 307.4,CA 11B-307.4

Recommendation At least 80.00 inches

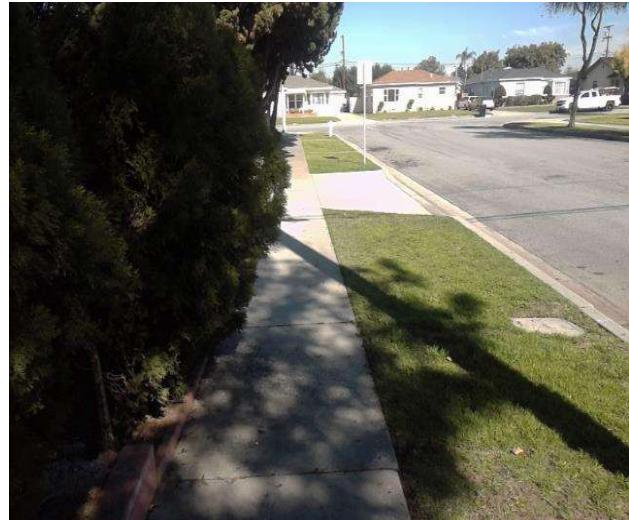
Sidewalks , Hazards & Gratings : Sidewalk Width at Obstruction

Code Reference ADA 206, 302, 403.5.1, CA 11B-403.5

Sidewalk width at the obstruction shall have the recommended value.

Recommendation At least 48.00 inches

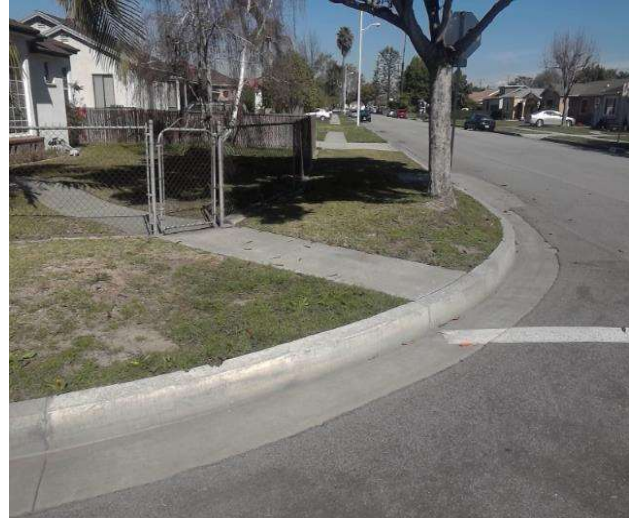
Sidewalks , Hazards & Gratings : Curb is on Path of Travel

Code Reference ADA 402, 303, 406, 403.4, 303.4

Install curb ramp \$2,500

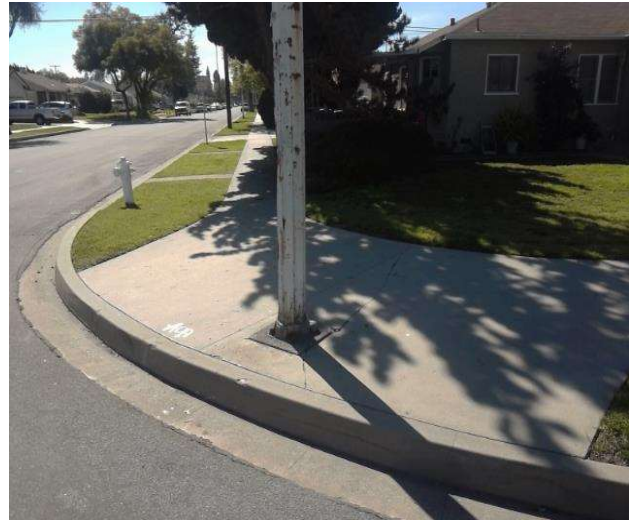
Sidewalks , Hazards & Gratings : Curb is on Path of Travel

Code Reference ADA 402, 303, 406, 403.4, 303.4

Install curb ramp \$2,500

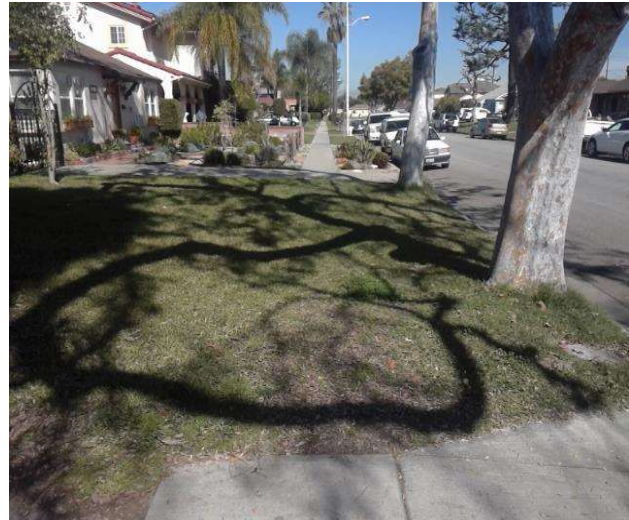
Sidewalks : Missing Sidewalk

Section of sidewalk is missing and consists of dirt, grass or gravel.

Code Reference ADA 206, 302,CA 11B-302,CA 11B-206

Provide a compliant sidewalk for the missing section.

\$1,260

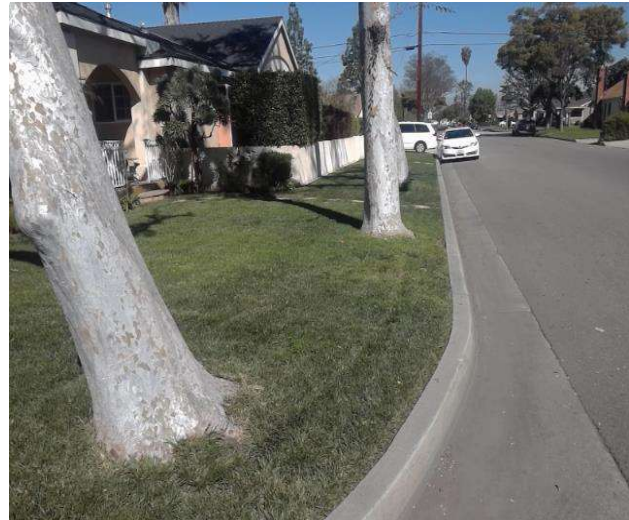
Sidewalks : Missing Sidewalk

Section of sidewalk is missing and consists of dirt, grass or gravel.

Code Reference ADA 206, 302,CA 11B-302,CA 11B-206

Provide a compliant sidewalk for the missing section.

\$1,260
