Accessibility Survey

City of Downey Dalewood Avenue - Brookpark Road to Cul-De-Sac

Date of Inspection
6/17/2017

Disability Access Consultants

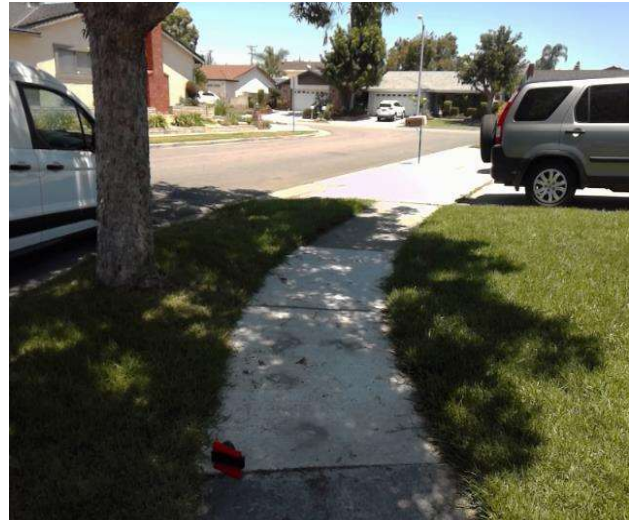
Change in Level South of Brookpark Road @ 33.946876697699, -118.099573999643

Sidewalks , Change in Level : Change in Level Non Beveled

There is a change in elevation greater than recommended value.

On-Site Finding 0.50 inches

Ensure that the change in elevation is within the recommended value.

Recommendation Up to 0.25 inches

Remove tripping hazards \$198

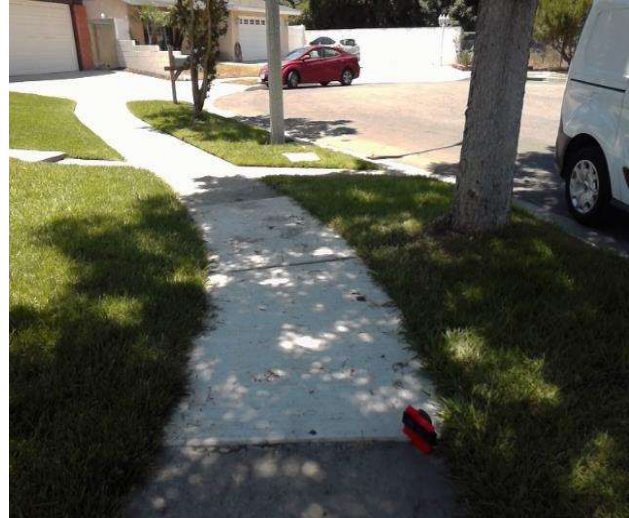
Change in Level South of Brookpark Road @ 33.946893385510, -118.099567294121

Sidewalks , Change in Level : Change in Level Non Beveled

There is a change in elevation greater than recommended value.

On-Site Finding 0.50 inches

Ensure that the change in elevation is within the recommended value.

Recommendation Up to 0.25 inches

Remove tripping hazards \$198

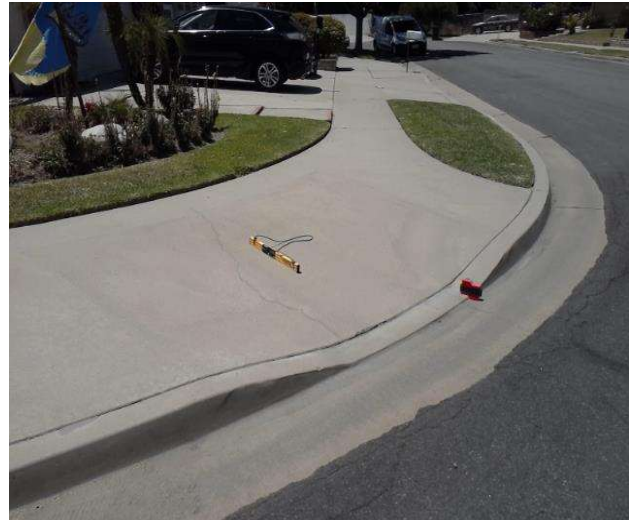
Southeast Corner of Brookpark Road @ 33.947089188920, - 118.099405020475

Curb Ramp : No Detectable Warnings

The curb ramp does not provide a detectable warning surface which includes truncated domes.

On-Site Finding Not Found

Provide compliant detectable warnings to surface.

Provide detectable warning to surface \$248

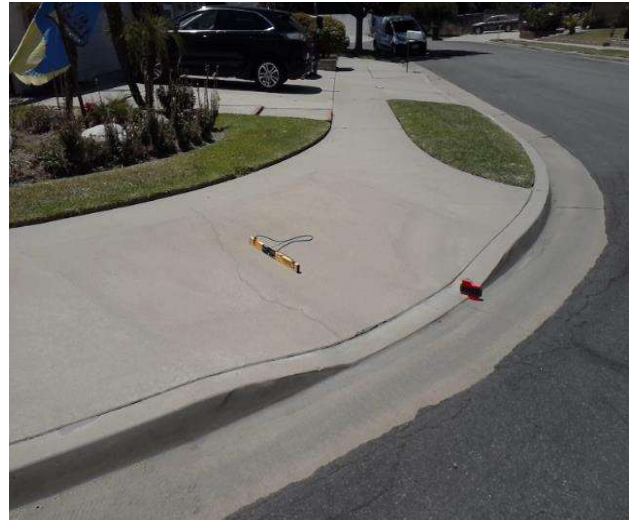
Southeast Corner of Brookpark Road @ 33.947089188920, - 118.099405020475

Curb Ramp : Curb Ramp Slope

The running slope is greater than allowed.

On-Site Finding 8.90 percent

Provide a compliant curb ramp.

Recommendation Up to 8.33 percent

Install curb ramp \$1,300

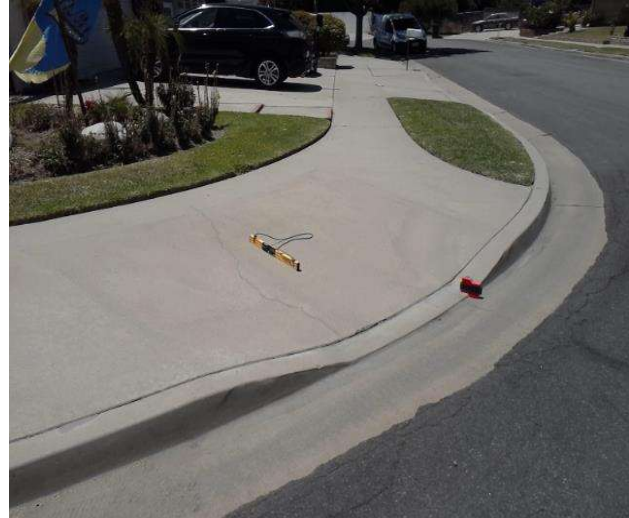
Southeast Corner of Brookpark Road @ 33.947089188920, - 118.099405020475

Curb Ramp : Side Flare Slope

The slope of the curb ramp side flare is greater than allowed.

On-Site Finding 16.40 percent

Provide curb ramp side flares with a compliant slope.

Recommendation Up to 10.00 percent

Install flared sides \$1,300

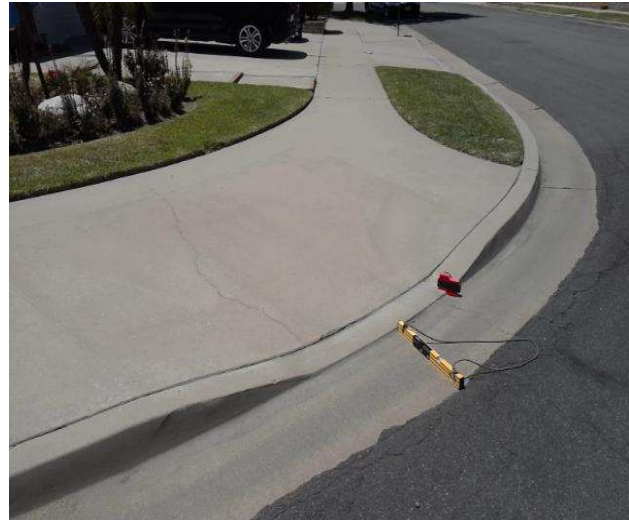
Southeast Corner of Brookpark Road @ 33.947089188920, - 118.099405020475

Curb Ramp : Bottom Landing Slope

The bottom landing of the curb ramp is on the street, and the slope of the bottom landing is not compliant.

On-Site Finding 8.50 percent

Ensure the bottom landing slope is compliant and provides a smooth transition.

Recommendation Up to 5.00 percent

Repave landing \$1,260

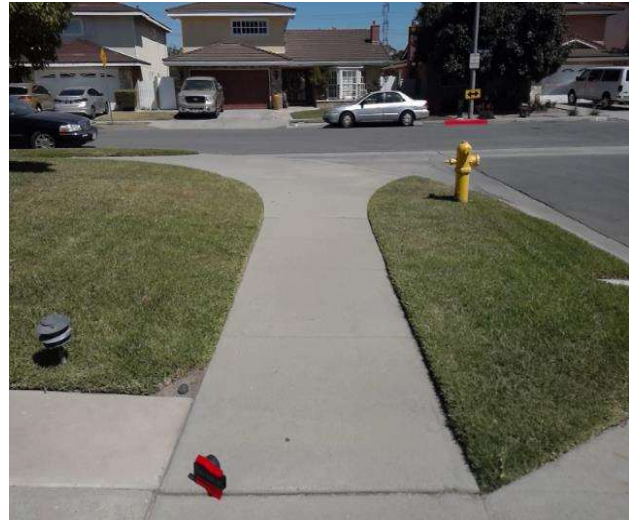
There is a change in elevation greater than recommended value.

Ensure that the change in elevation is within the recommended value.

Recommendation Up to 0.25 inches

Remove tripping hazards \$198

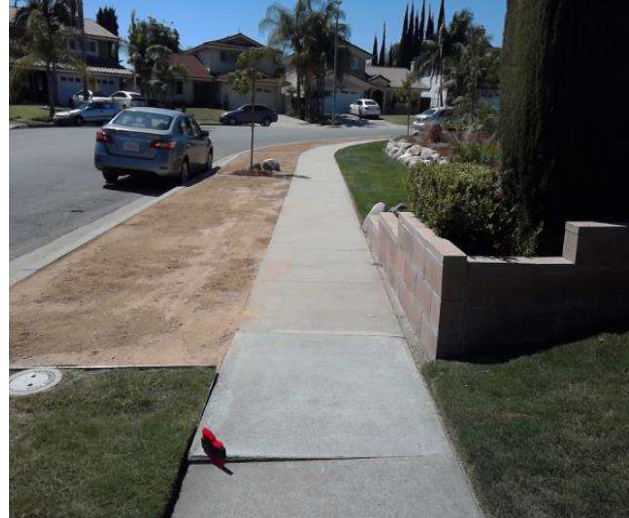
There is a change in elevation greater than recommended value.

Ensure that the change in elevation is within the recommended value.

Recommendation Up to 0.25 inches

Remove tripping hazards \$198

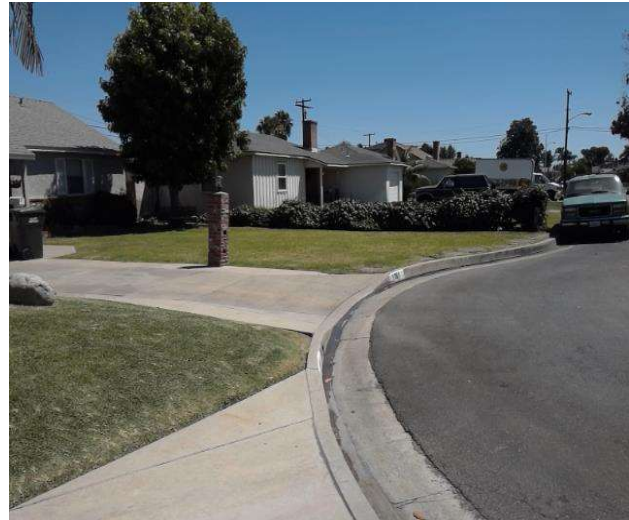
Sidewalks : Missing Sidewalk

Section of sidewalk is missing and consists of dirt, grass or gravel.

Provide a compliant sidewalk for the missing section.

\$1,260

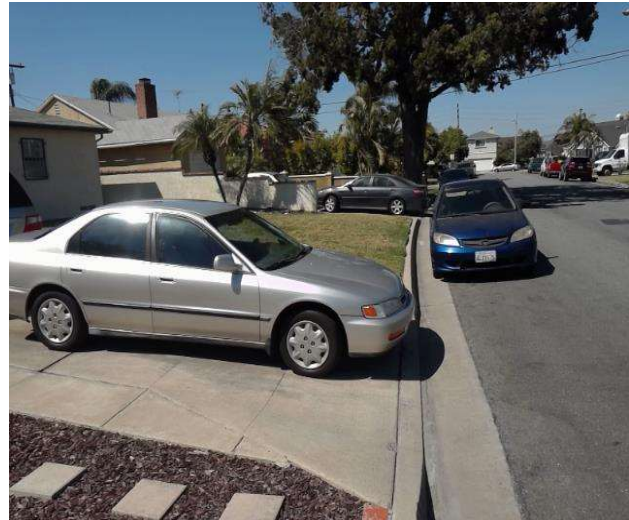
Sidewalks : Missing Sidewalk

Section of sidewalk is missing and consists of dirt, grass or gravel.

Provide a compliant sidewalk for the missing section.

\$1,260

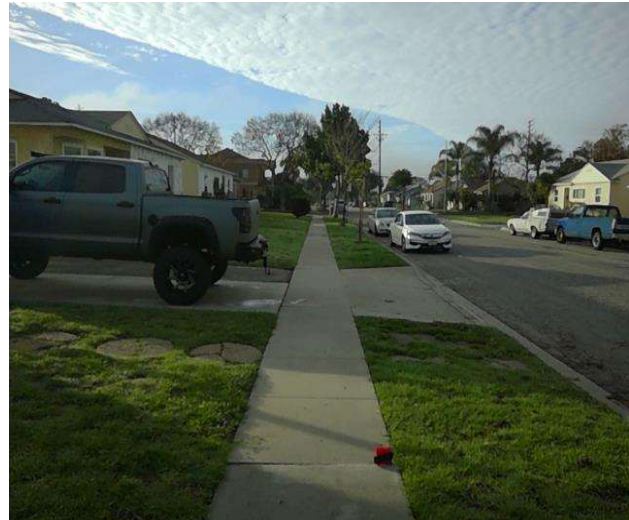
There is a change in elevation greater than recommended value.

Ensure that the change in elevation is within the recommended value.

Recommendation Up to 0.25 inches

Remove tripping hazards \$198
