Accessibility Survey

City of Downey Hall Road - Lakewood Boulevard To Woodruff Avenue

Lakewood Boulevard To Woodruff Avenue
Downey, CA 90241

Date of Inspection
12/8/2016

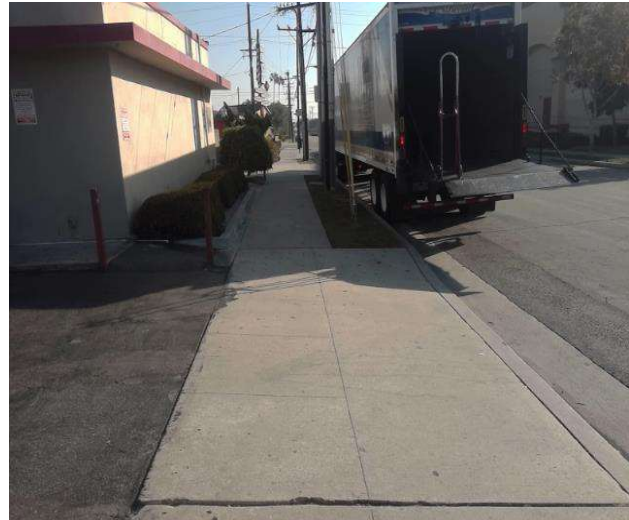
Change In Level East Of Lakewood Boulevard @ 33.931659389771, - 118.126351833344

Sidewalks , Change in Level : Change in Level Non Beveled

There is a change in elevation greater than recommended value.

On-Site Finding 0.50 inches

Code Reference ADA 206, 302

Ensure that the change in elevation is within the recommended value.

Recommendation Up to 0.25 inches

Remove tripping hazards \$198

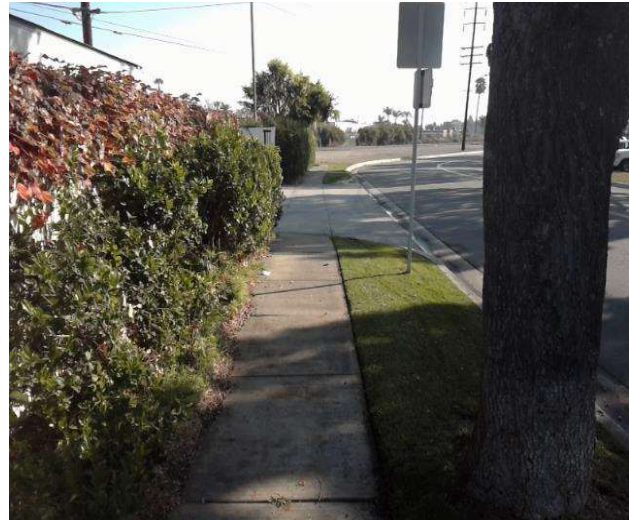
Change In Level North Of Adenmoor Avenue @ 33.931650488013, - 118.120874762535

Sidewalks , Change in Level : Change in Level Non Beveled

There is a change in elevation greater than recommended value.

On-Site Finding 0.50 inches

Code Reference ADA 206, 302

Ensure that the change in elevation is within the recommended value.

Recommendation Up to 0.25 inches

Remove tripping hazards \$198

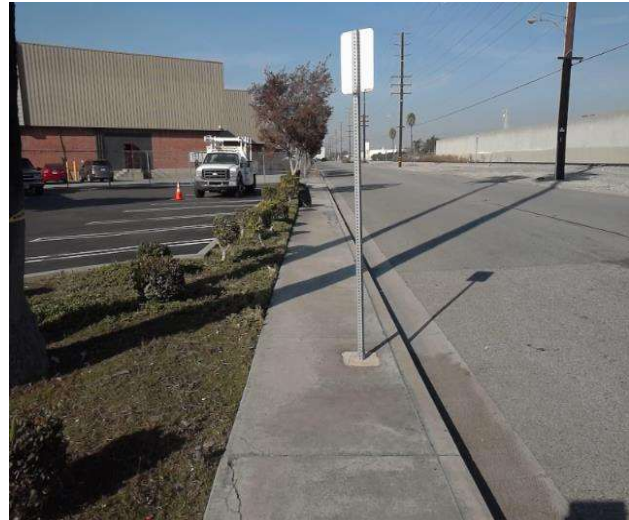
Change In Level West Of Woodruff Avenue @ 33.929758843259, -118.117119669914

Sidewalks , Change in Level : Change in Level Non Beveled

There is a change in elevation greater than recommended value.

On-Site Finding 0.50 inches

Code Reference ADA 206, 302

Ensure that the change in elevation is within the recommended value.

Recommendation Up to 0.25 inches

Remove tripping hazards \$198

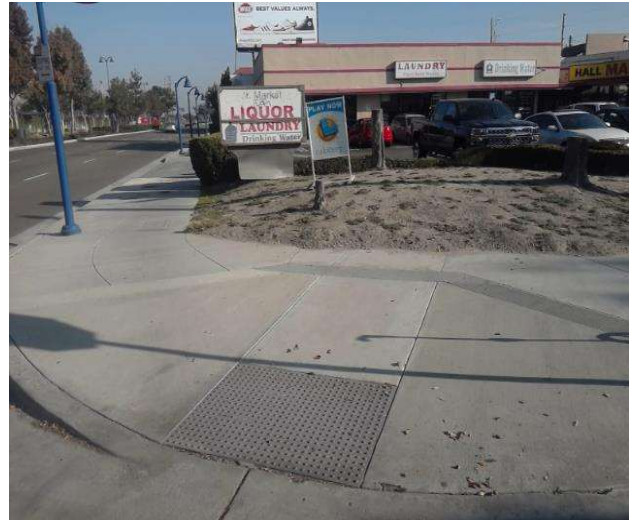
Northeast Corner Of Lakewood Boulevard @ 33.931686095041, - 118.126673698425

Curb Ramp , Landings and Transitions : Top Landing Slope

The slope at the top landing is greater than allowed.

On-Site Finding 2.50 percent

Code Reference ADA 402, 406.4, 403.3, 406.1, CA 11B-406.5.3

Provide a top landing surface that does not exceed the maximum slope and cross slope. Provide a sufficient maneuvering clearance that does not accumulate water.

Recommendation Up to 2.08 percent

Provide compliant landing \$1,260

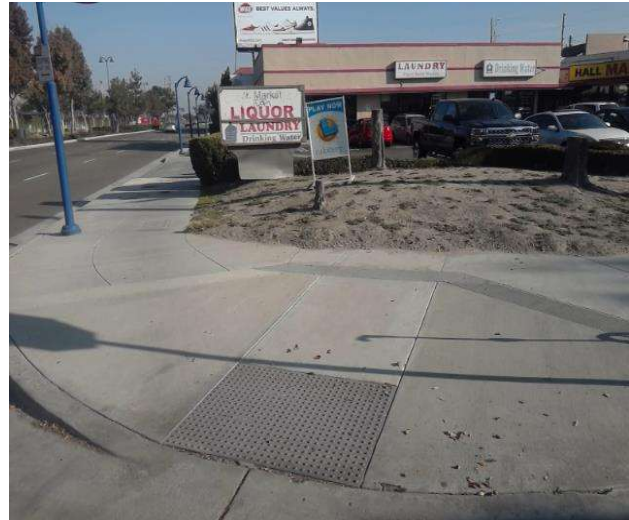
Northeast Corner Of Lakewood Boulevard @ 33.931686095041, - 118.126673698425

Curb Ramp , Landings and Transitions : Top Landing Clear Length - Landings

There is not enough top landing clear length.

On-Site Finding 44.00 inches

Code Reference ADA 406, 406.4, CA 11B-406.5.3

Provide a level top landing with enough clear length.

Recommendation At least 48.00 inches

Provide compliant landing \$240

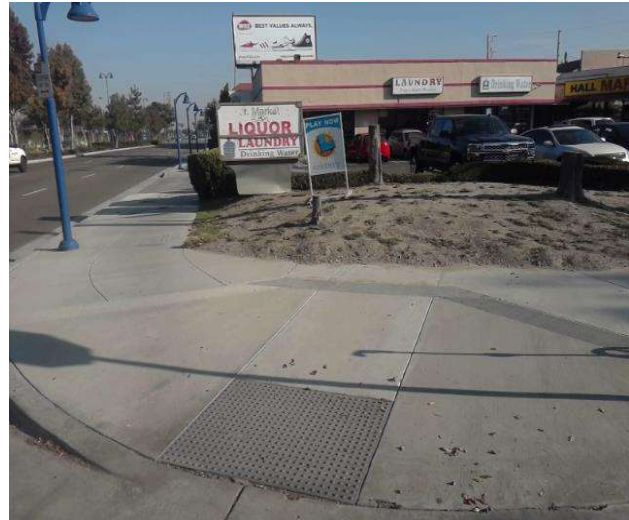
Northeast Corner Of Lakewood Boulevard @ 33.931686095041, - 118.126673698425

Curb Ramp : Appurtenances

Utilities, gratings or other appurtenances are located on the curb ramp.

On-Site Finding Not Compliant

Code Reference ADA 303.3,CA 11B-303.3

Provide a compliant curb ramp free of appurtenances.

Install curb ramp \$1,440

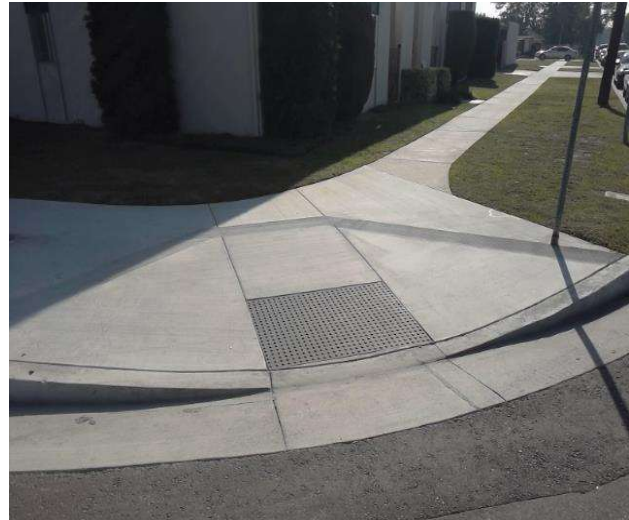
Southeast Corner Of Adenmoor Avenue @ 33.931490256204, - 118.123953938484

Curb Ramp : Bottom Landing Slope

The bottom landing of the curb ramp is on the street, and the slope of the bottom landing is not compliant.

On-Site Finding 6.90 percent

Code Reference ADA 406, 406.2, CA 11B-406.5.8

Ensure the bottom landing slope is compliant and provides a smooth transition.

Recommendation Up to 5.00 percent

Repave landing \$1,260

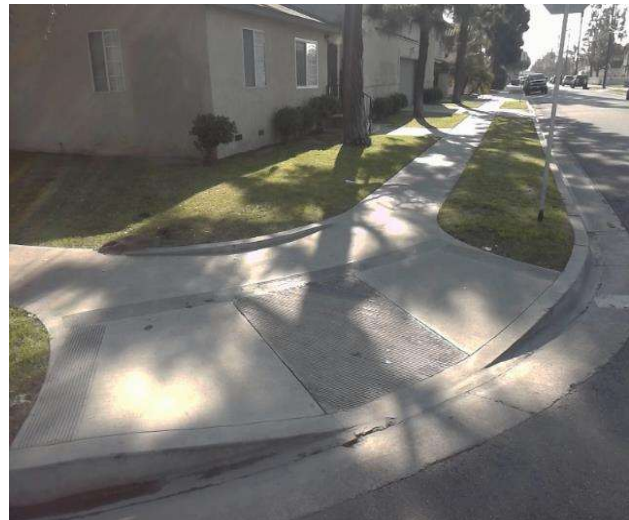
Code Reference ADA 406, 406.2, CA 11B-406.5.8

Recommendation Up to 5.00 percent

Repave landing \$1,260

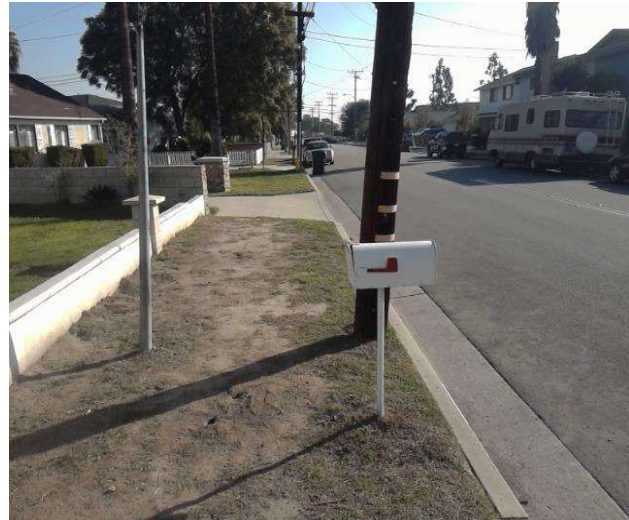
Sidewalks : Missing Sidewalk

Section of sidewalk is missing and consists of dirt, grass or gravel.

Code Reference ADA 206, 302,CA 11B-302,CA 11B-206

Provide a compliant sidewalk for the missing section.

\$1,260

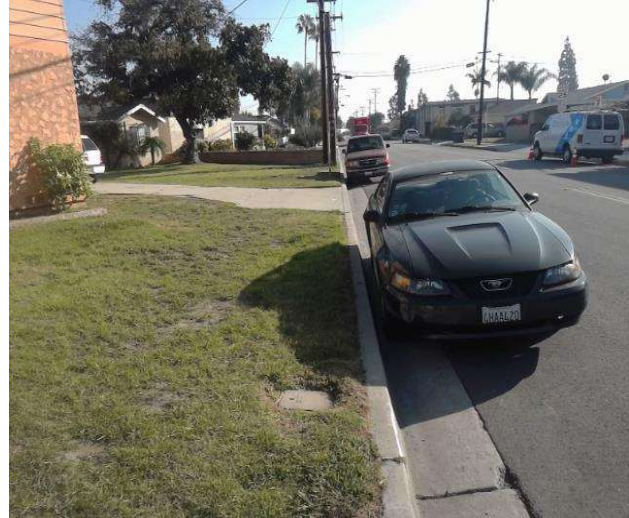
Sidewalks : Missing Sidewalk

Section of sidewalk is missing and consists of dirt, grass or gravel.

Code Reference ADA 206, 302,CA 11B-302,CA 11B-206

Provide a compliant sidewalk for the missing section.

\$1,260

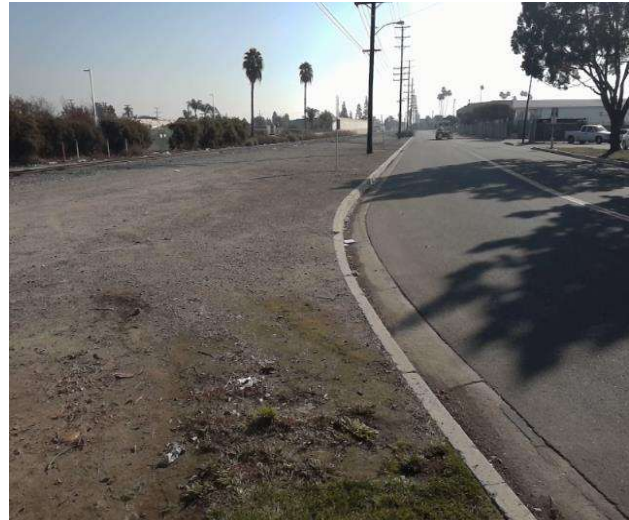
Sidewalks : Missing Sidewalk

Section of sidewalk is missing and consists of dirt, grass or gravel.

Code Reference ADA 206, 302,CA 11B-302,CA 11B-206

Provide a compliant sidewalk for the missing section.

\$1,260

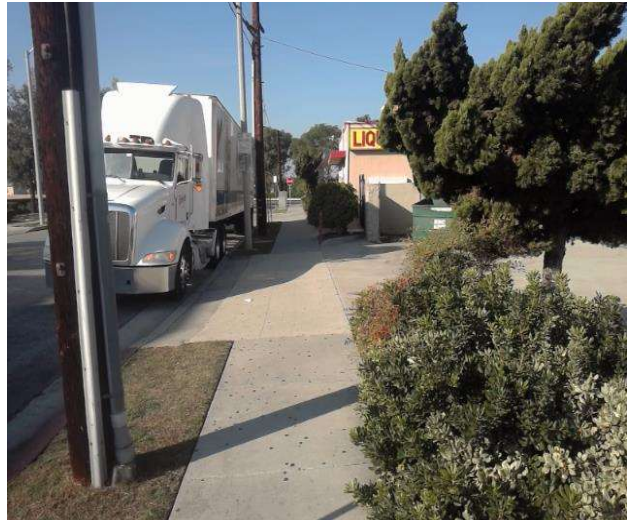
Code Reference ADA 206, 302,CA 11B-403.3

Repave the sidewalk surface with the recommended cross slope.

Recommendation Up to 2.08 percent

Repave surface \$1,092

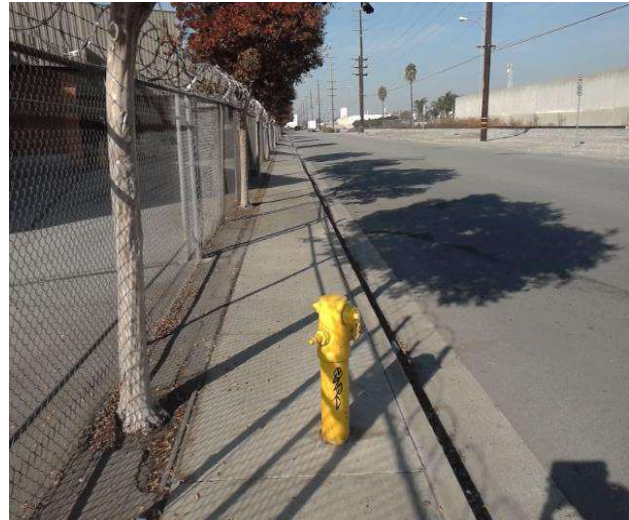
Sidewalks , Hazards & Gratings : Sidewalk Width at Obstruction

Code Reference ADA 206, 302, 403.5.1, CA 11B-403.5

Sidewalk width at the obstruction shall have the recommended value.

Recommendation At least 48.00 inches

\$1,260

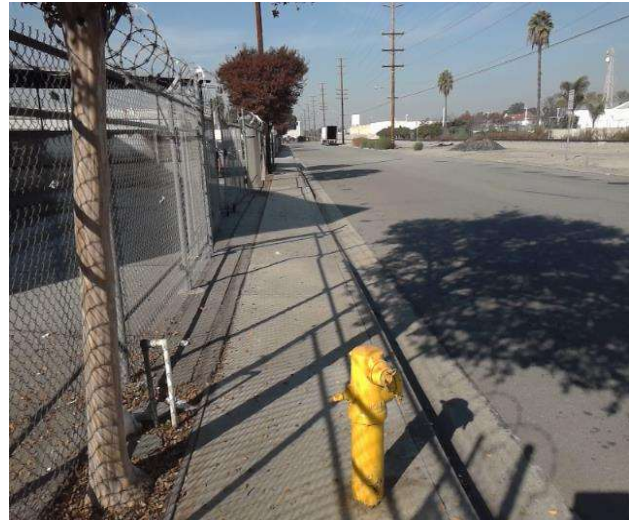
Sidewalks , Hazards & Gratings : Sidewalk Width at Obstruction

Code Reference ADA 206, 302, 403.5.1, CA 11B-403.5

Sidewalk width at the obstruction shall have the recommended value.

Recommendation At least 48.00 inches

\$1,260

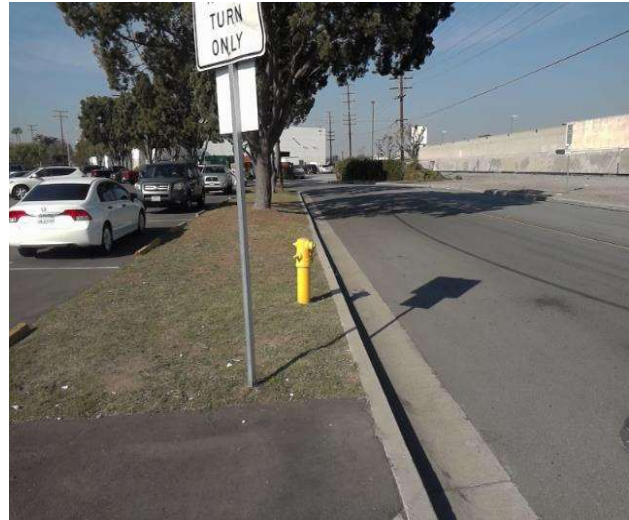
Sidewalks : Missing Sidewalk

Section of sidewalk is missing and consists of dirt, grass or gravel.

Code Reference ADA 206, 302,CA 11B-302,CA 11B-206

Provide a compliant sidewalk for the missing section.

\$1,260

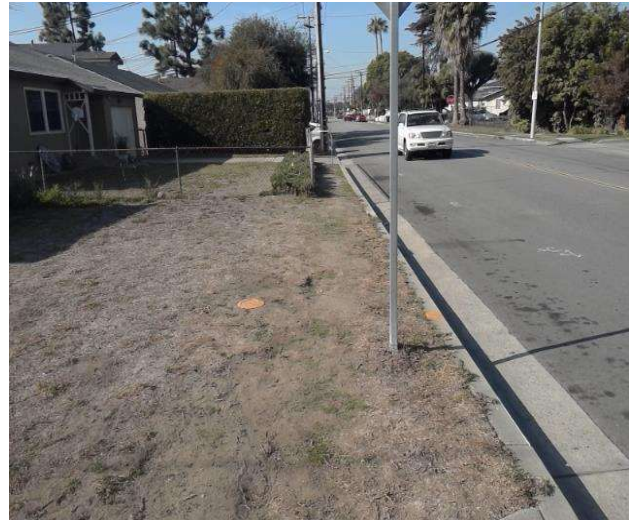
Sidewalks : Missing Sidewalk

Section of sidewalk is missing and consists of dirt, grass or gravel.

Code Reference ADA 206, 302,CA 11B-302,CA 11B-206

Provide a compliant sidewalk for the missing section.

\$1,260

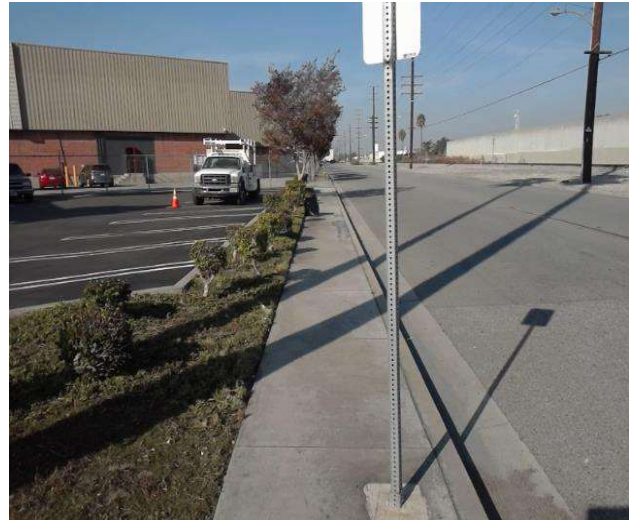
Sidewalks , Hazards & Gratings : Sidewalk Width at Obstruction

Code Reference ADA 206, 302, 403.5.1, CA 11B-403.5

Sidewalk width at the obstruction shall have the recommended value.

Recommendation At least 48.00 inches

\$1,260
