Accessibility Survey

City of Downey Horton Avenue - Pivot Street To Adwen Street

Date of Inspection
4/26/2017

Prepared By
Disability Access Consultants
(800) 743-7067

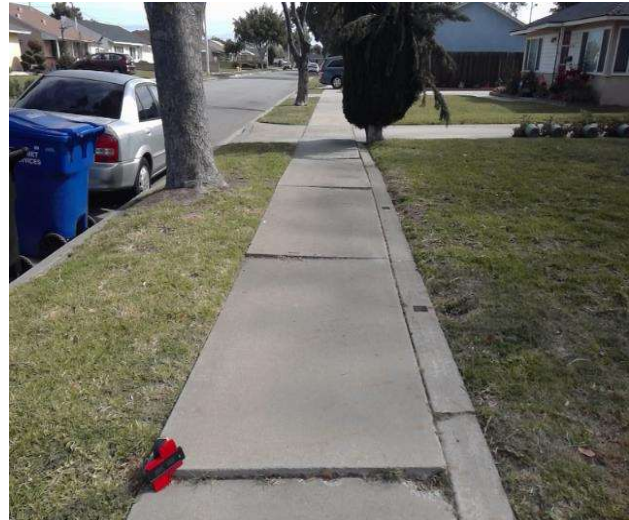
Change In Level South Of Arnett Street @ 33.943104055822, -118.146892189980

Sidewalks , Change in Level : Change in Level Non Beveled

There is a change in elevation greater than recommended value.

On-Site Finding 1.75 inches

Code Reference ADA 206, 302

Ensure that the change in elevation is within the recommended value.

Recommendation Up to 0.25 inches

Remove tripping hazards \$198

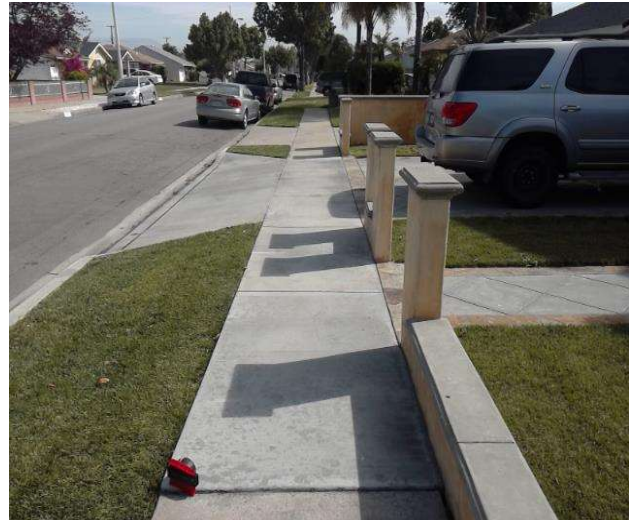
Change In Level South Of Arnett Street @ 33.942539980872, -118.147309273481

Sidewalks , Change in Level : Change in Level Non Beveled

There is a change in elevation greater than recommended value.

On-Site Finding 0.50 inches

Code Reference ADA 206, 302

Ensure that the change in elevation is within the recommended value.

Recommendation Up to 0.25 inches

Remove tripping hazards \$198

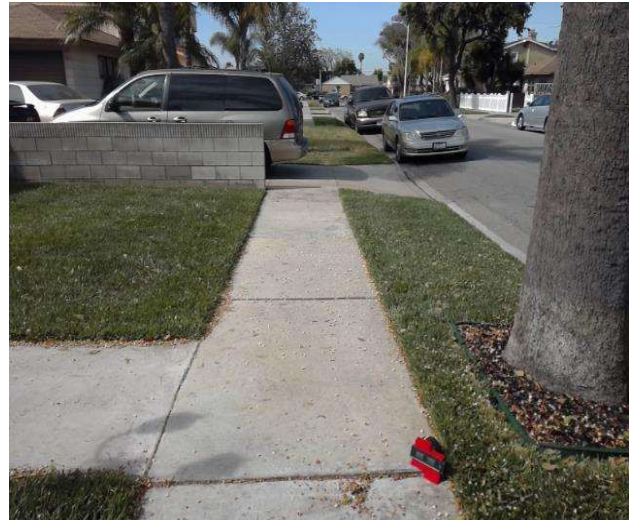
Change In Level South Of Arnett Street @ 33.942919368972, -118.147037029266

Sidewalks , Change in Level : Change in Level Non Beveled

There is a change in elevation greater than recommended value.

On-Site Finding 0.87 inches

Code Reference ADA 206, 302

Ensure that the change in elevation is within the recommended value.

Recommendation Up to 0.25 inches

Remove tripping hazards \$198

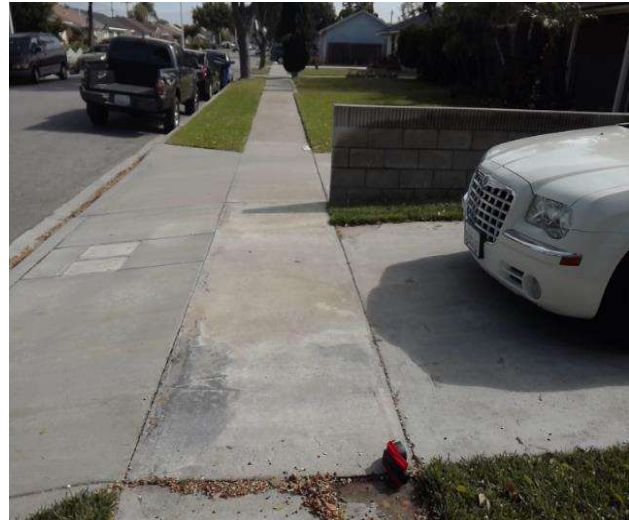
Change In Level South Of Arnett Street @ 33.942944958138, -118.147016912699

Sidewalks , Change in Level : Change in Level - Beveled

There is a change in elevation greater than recommended value.

On-Site Finding 0.75 inches

Code Reference ADA 206, 302

Ensure that the change in elevation not exceed a .5 beveled inch.

Recommendation Up to 0.50 inches

Remove tripping hazards \$198

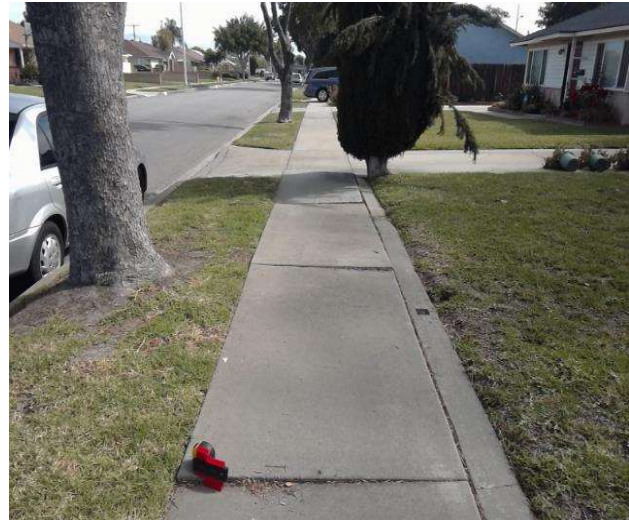
Change In Level South Of Arnett Street @ 33.943121856943, -118.146876096725

Sidewalks , Change in Level : Change in Level Non Beveled

There is a change in elevation greater than recommended value.

On-Site Finding 1.25 inches

Code Reference ADA 206, 302

Ensure that the change in elevation is within the recommended value.

Recommendation Up to 0.25 inches

Remove tripping hazards \$198

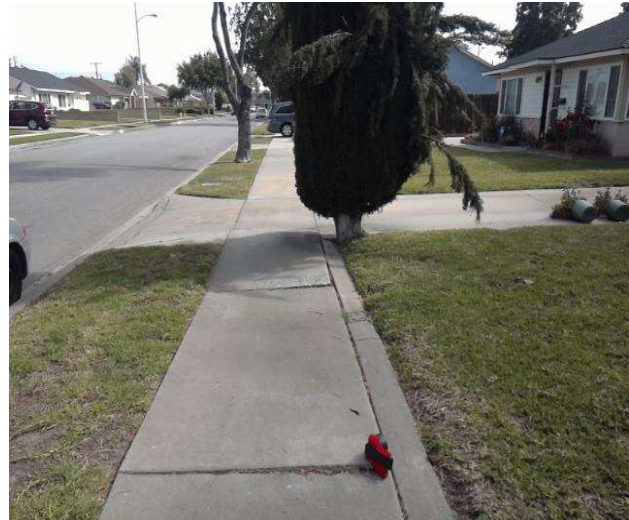
Change In Level South Of Arnett Street @ 33.943144108339, -118.146863471

Sidewalks , Change in Level : Change in Level Non Beveled

There is a change in elevation greater than recommended value.

On-Site Finding 1.12 inches

Code Reference ADA 206, 302

Ensure that the change in elevation is within the recommended value.

Recommendation Up to 0.25 inches

Remove tripping hazards \$198

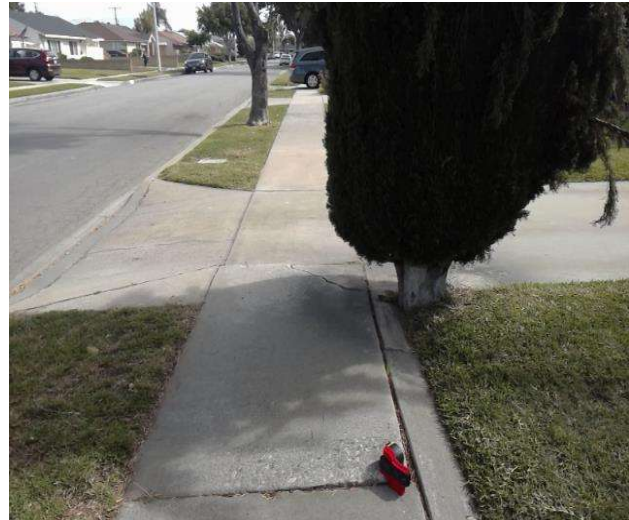
Change In Level South Of Arnett Street @ 33.943153008896, -118.146849274635

Sidewalks , Change in Level : Change in Level Non Beveled

There is a change in elevation greater than recommended value.

On-Site Finding 1.00 inches

Code Reference ADA 206, 302

Ensure that the change in elevation is within the recommended value.

Recommendation Up to 0.25 inches

Remove tripping hazards \$198

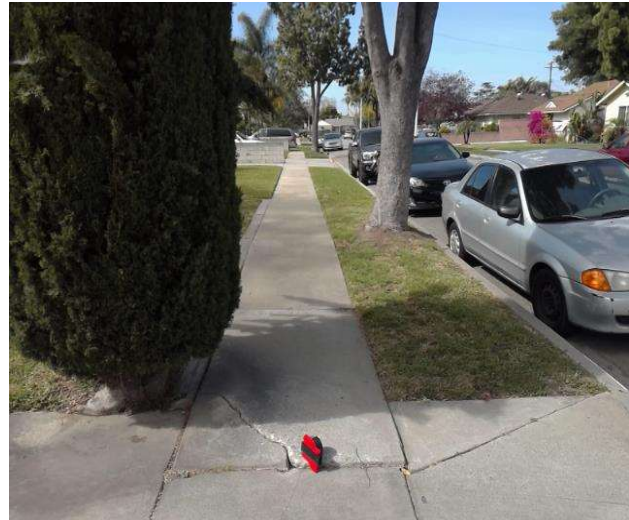
Change In Level South Of Arnett Street @ 33.943168584868, -118.146846592426

Sidewalks , Change in Level : Change in Level Non Beveled

There is a change in elevation greater than recommended value.

On-Site Finding 0.75 inches

Code Reference ADA 206, 302

Ensure that the change in elevation is within the recommended value.

Recommendation Up to 0.25 inches

Remove tripping hazards \$198

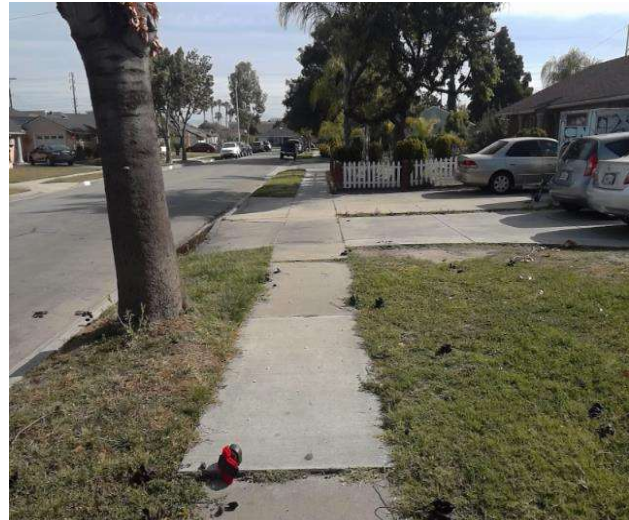
Change In Level South Of Phlox Street @ 33.943910665381, -118.146296739578

Sidewalks , Change in Level : Change in Level Non Beveled

There is a change in elevation greater than recommended value.

On-Site Finding 1.25 inches

Code Reference ADA 206, 302

Ensure that the change in elevation is within the recommended value.

Recommendation Up to 0.25 inches

Remove tripping hazards \$198

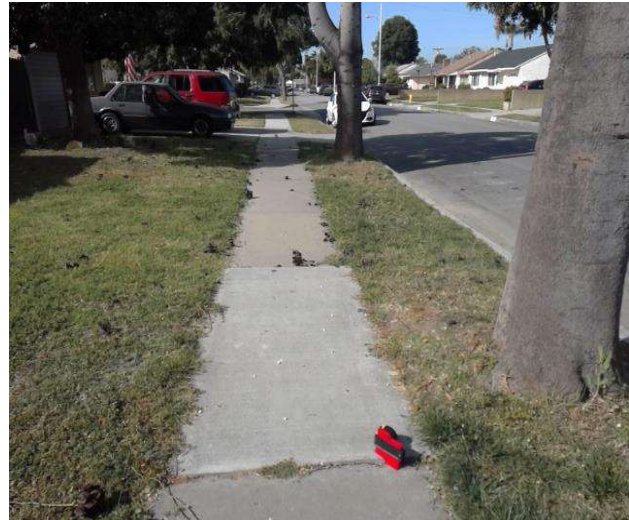
Change In Level South Of Phlox Street @ 33.943960730550, -118.146273940802

Sidewalks , Change in Level : Change in Level Non Beveled

There is a change in elevation greater than recommended value.

On-Site Finding 0.50 inches

Code Reference ADA 206, 302

Ensure that the change in elevation is within the recommended value.

Recommendation Up to 0.25 inches

Remove tripping hazards \$198

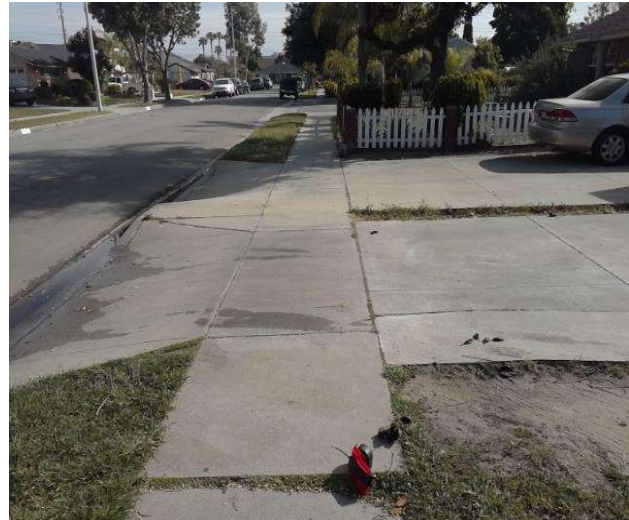
Change In Level South Of Phlox Street @ 33.943978531492, -118.146263211966

Sidewalks , Change in Level : Change in Level Non Beveled

There is a change in elevation greater than recommended value.

On-Site Finding 1.25 inches

Code Reference ADA 206, 302

Ensure that the change in elevation is within the recommended value.

Recommendation Up to 0.25 inches

Remove tripping hazards \$198

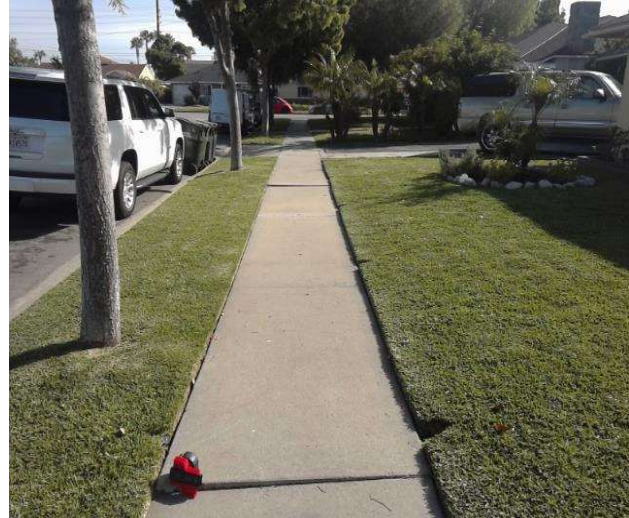
Change In Level South Of Pivot Street @ 33.944482519114, -118.145870268345

Sidewalks , Change in Level : Change in Level Non Beveled

There is a change in elevation greater than recommended value.

On-Site Finding 1.12 inches

Code Reference ADA 206, 302

Ensure that the change in elevation is within the recommended value.

Recommendation Up to 0.25 inches

Remove tripping hazards \$198

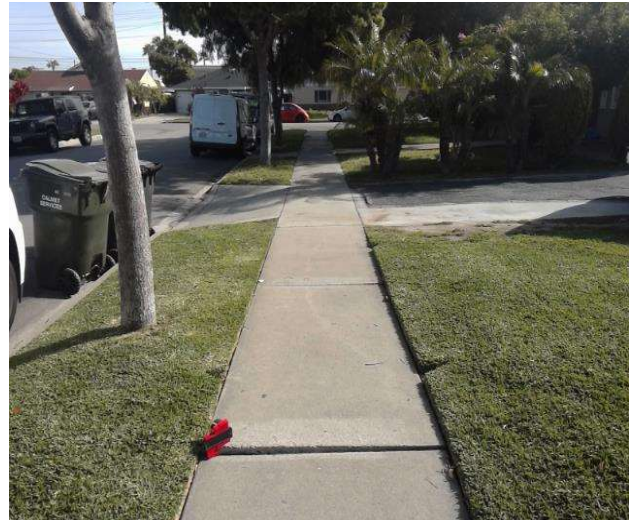
There is a change in elevation greater than recommended value.

On-Site Finding 1.25 inches

Code Reference ADA 206, 302

Ensure that the change in elevation is within the recommended value.

Recommendation Up to 0.25 inches

Remove tripping hazards \$198

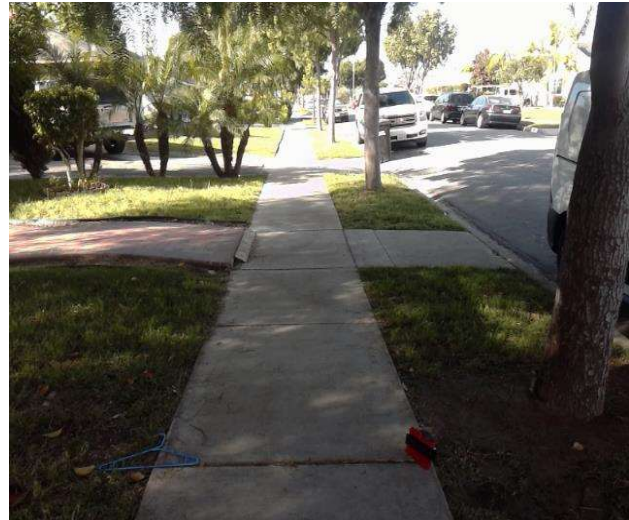
There is a change in elevation greater than recommended value.

Code Reference ADA 206, 302

Ensure that the change in elevation is within the recommended value.

Recommendation Up to 0.25 inches

Remove tripping hazards \$198

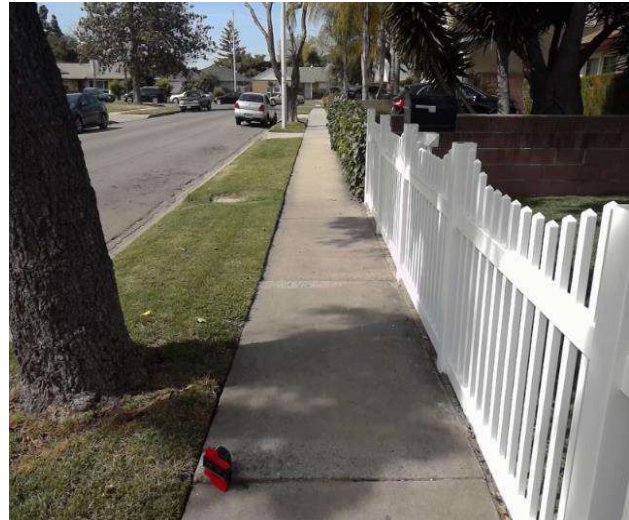
There is a change in elevation greater than recommended value.

Code Reference ADA 206, 302

Ensure that the change in elevation is within the recommended value.

Recommendation Up to 0.25 inches

Remove tripping hazards \$198

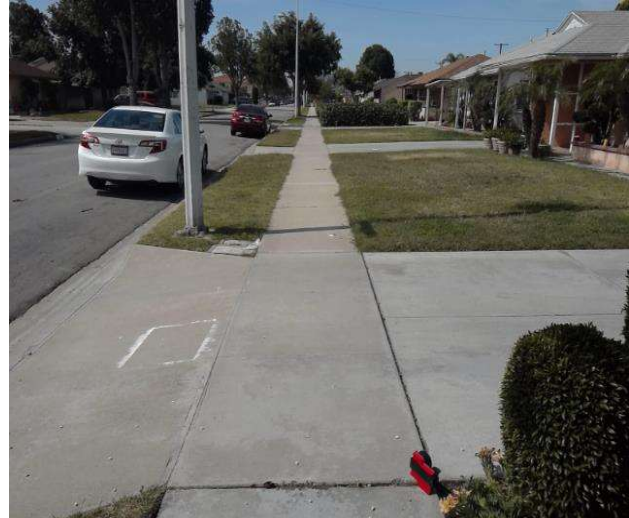
There is a change in elevation greater than recommended value.

Code Reference ADA 206, 302

Ensure that the change in elevation is within the recommended value.

Recommendation Up to 0.25 inches

Remove tripping hazards \$198

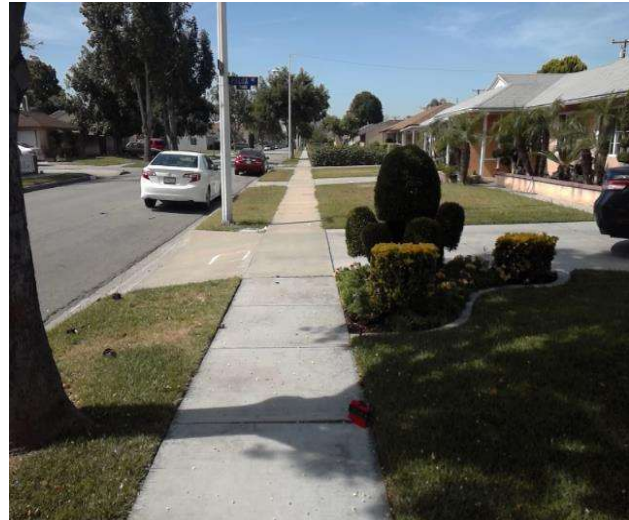
There is a change in elevation greater than recommended value.

Code Reference ADA 206, 302

Ensure that the change in elevation is within the recommended value.

Recommendation Up to 0.25 inches

Remove tripping hazards \$198

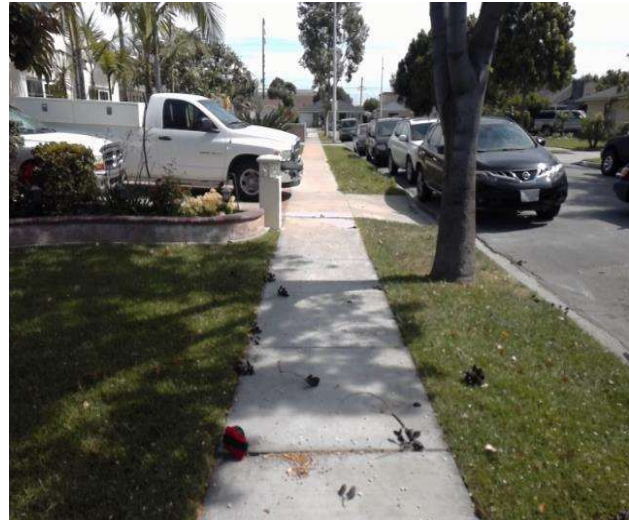
There is a change in elevation greater than recommended value.

Code Reference ADA 206, 302

Ensure that the change in elevation is within the recommended value.

Recommendation Up to 0.25 inches

Remove tripping hazards \$198

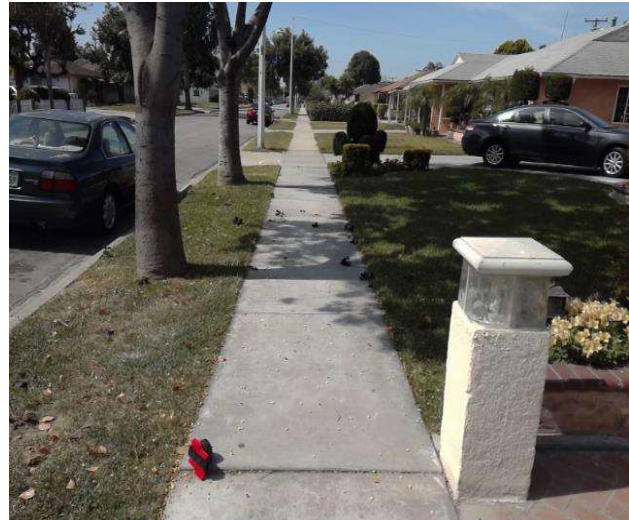
There is a change in elevation greater than recommended value.

Code Reference ADA 206, 302

Ensure that the change in elevation is within the recommended value.

Recommendation Up to 0.25 inches

Remove tripping hazards \$198

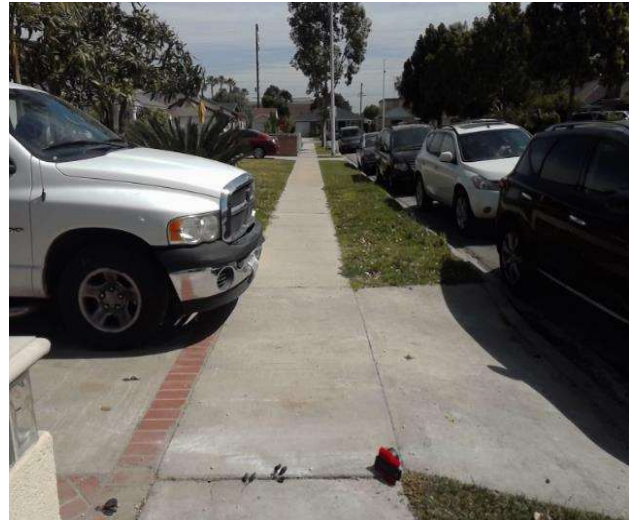
There is a change in elevation greater than recommended value.

Code Reference ADA 206, 302

Ensure that the change in elevation is within the recommended value.

Recommendation Up to 0.25 inches

Remove tripping hazards \$198

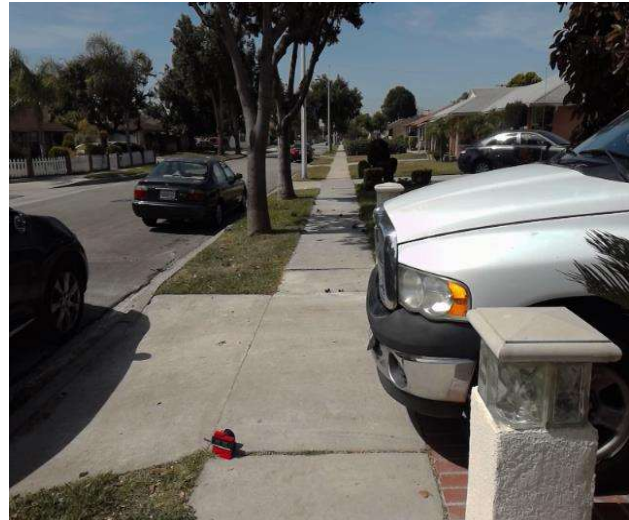
There is a change in elevation greater than recommended value.

Code Reference ADA 206, 302

Ensure that the change in elevation is within the recommended value.

Recommendation Up to 0.25 inches

Remove tripping hazards \$198

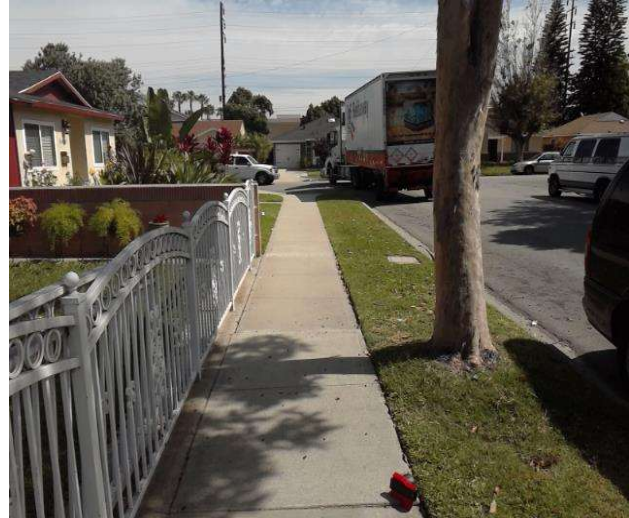
There is a change in elevation greater than recommended value.

Code Reference ADA 206, 302

Ensure that the change in elevation is within the recommended value.

Recommendation Up to 0.25 inches

Remove tripping hazards \$198

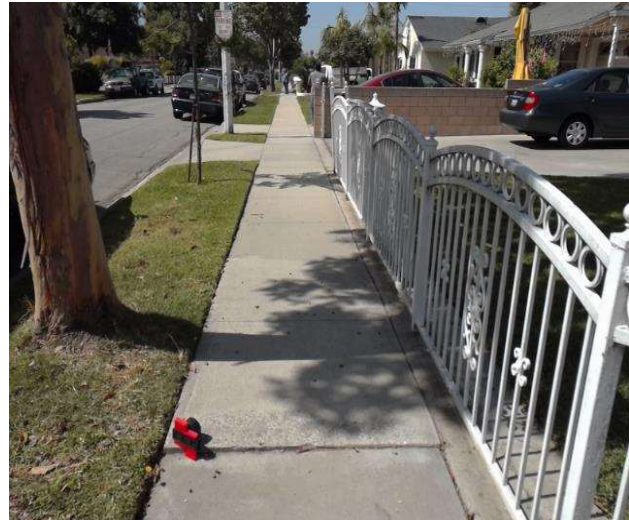
There is a change in elevation greater than recommended value.

Code Reference ADA 206, 302

Ensure that the change in elevation is within the recommended value.

Recommendation Up to 0.25 inches

Remove tripping hazards \$198

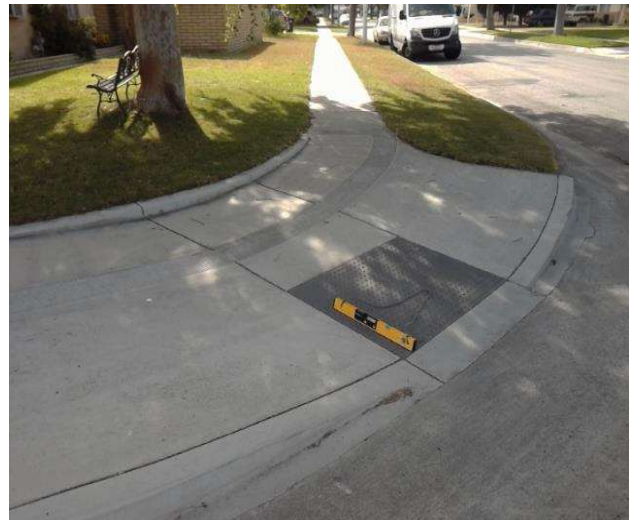
On-Site Finding Not Found

Code Reference CA 11B-406.5.12

Provide detectable warning to surface \$248

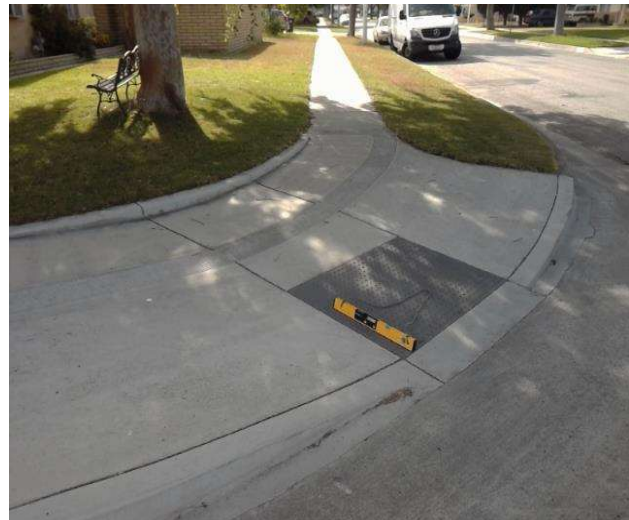
Code Reference ADA 406, 406.1, 405.2, CA 11B-406

Recommendation Up to 8.33 percent

Install curb ramp \$1,300

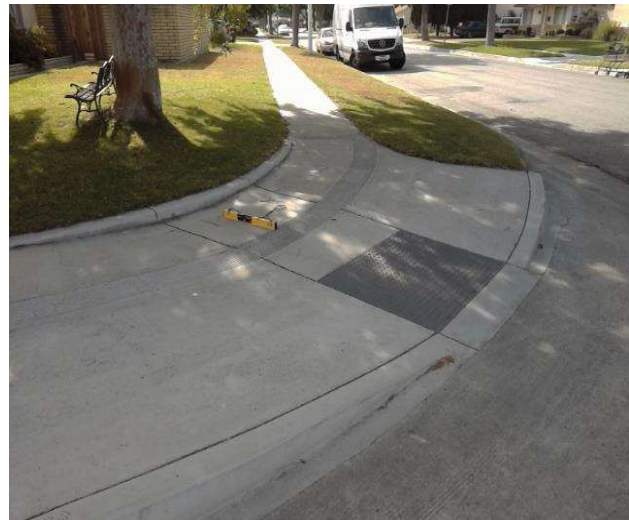
Code Reference ADA 402, 406.4, 403.3, 406.1, CA 11B-406.5.3

Recommendation Up to 2.08 percent

Provide compliant landing \$1,260

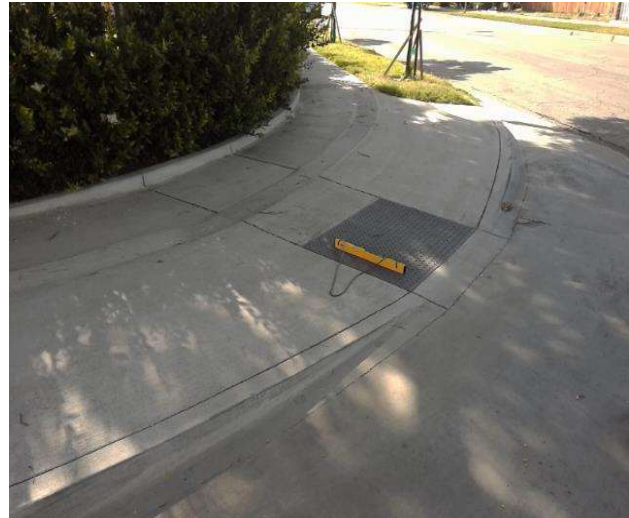
Code Reference ADA 406, 406.1, 405.2, CA 11B-406

Recommendation Up to 8.33 percent

Install curb ramp \$1,300

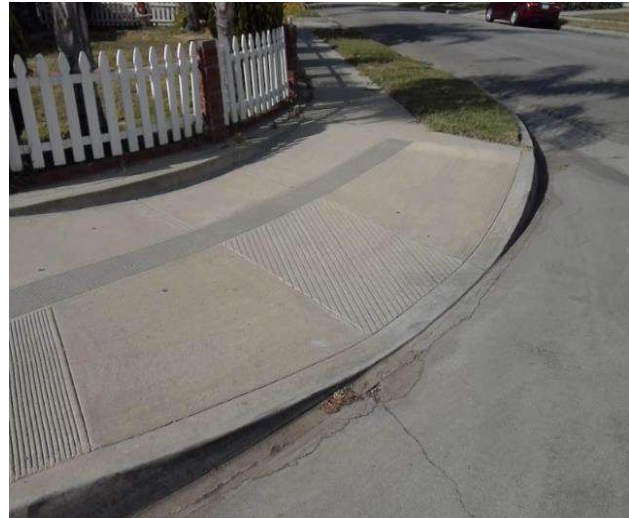
On-Site Finding Not Found

Code Reference CA 11B-406.5.12

Provide detectable warning to surface \$248

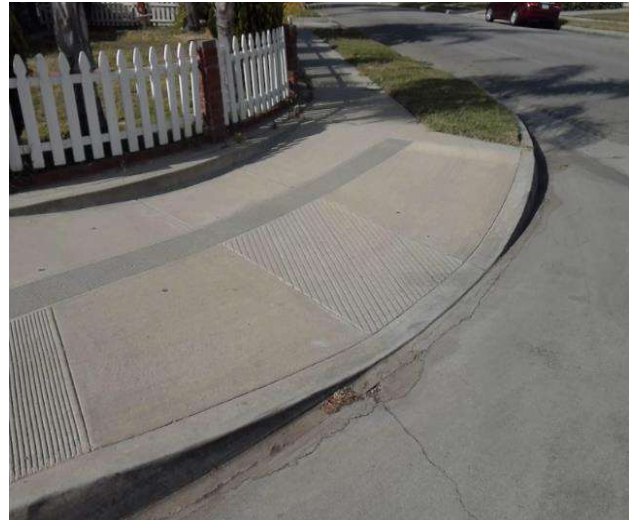
Code Reference ADA 406, 406.3,CA 11B-406.2.2

Recommendation Up to 10.00 percent

Install flared sides \$1,300

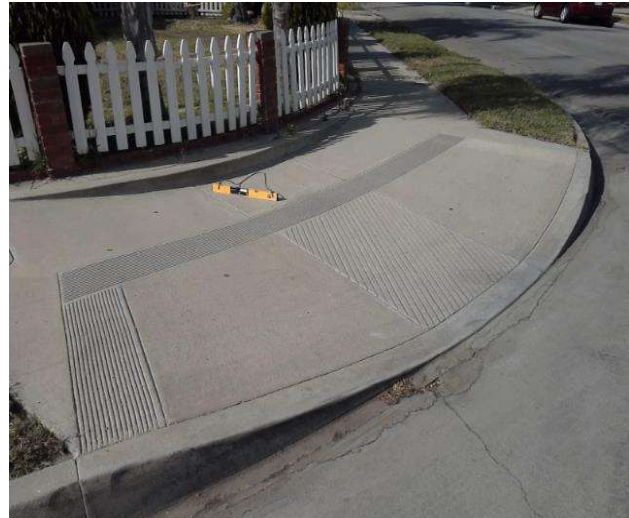
Curb Ramp , Landings and Transitions : Bottom Landing Change in Level - Curb Ramps

Code Reference ADA 302, 406.2

Patch lip at curb ramp \$255

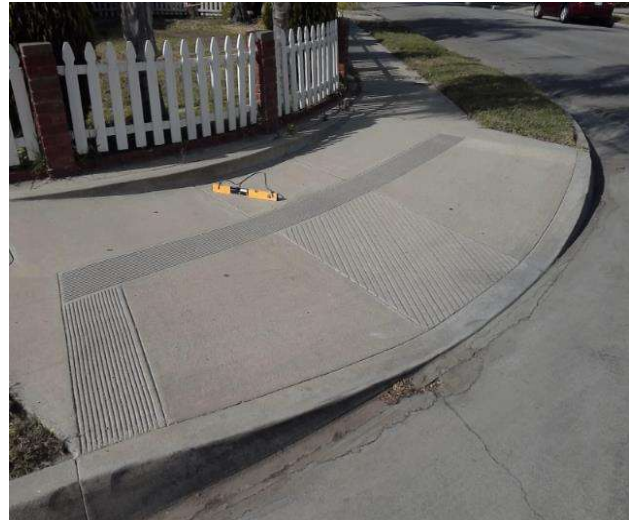
Code Reference ADA 402, 406.4, 403.3, 406.1, CA 11B-406.5.3

Recommendation Up to 2.08 percent

Provide compliant landing \$1,260

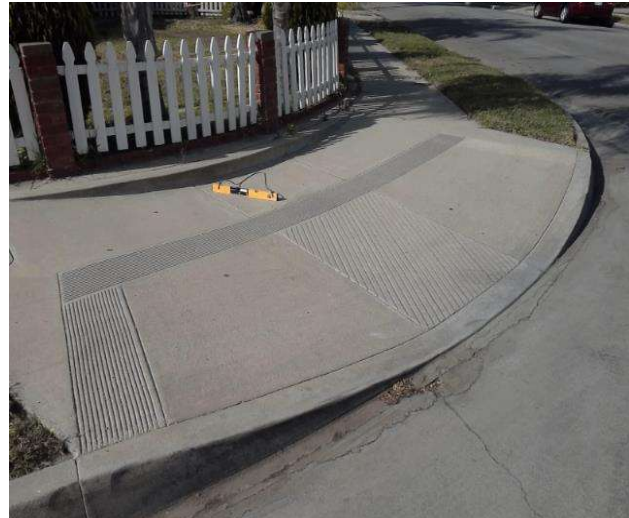
Curb Ramp , Landings and Transitions : Top Landing Clear Length - Landings

Code Reference ADA 406, 406.4,CA 11B-406.5.3

Recommendation At least 48.00 inches

Provide compliant landing \$240

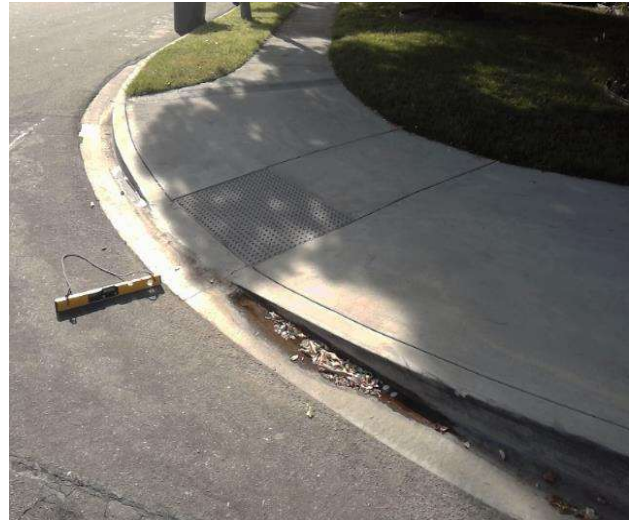
Code Reference ADA 406, 406.2, CA 11B-406.5.8

Recommendation Up to 5.00 percent

Repave landing \$1,260

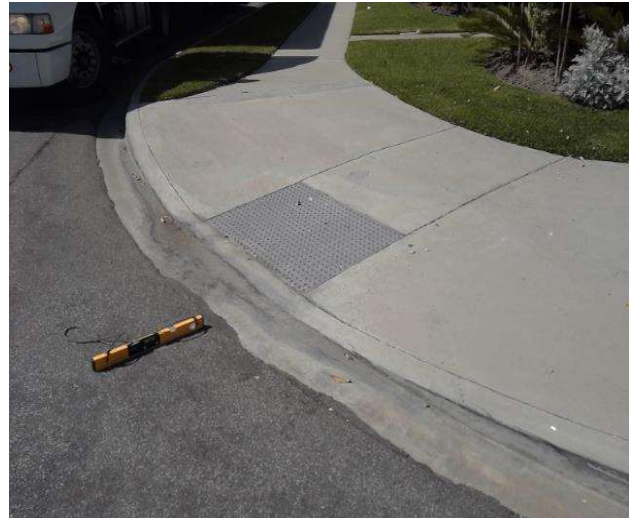
Code Reference ADA 406, 406.2, CA 11B-406.5.8

Recommendation Up to 5.00 percent

Repave landing \$1,260

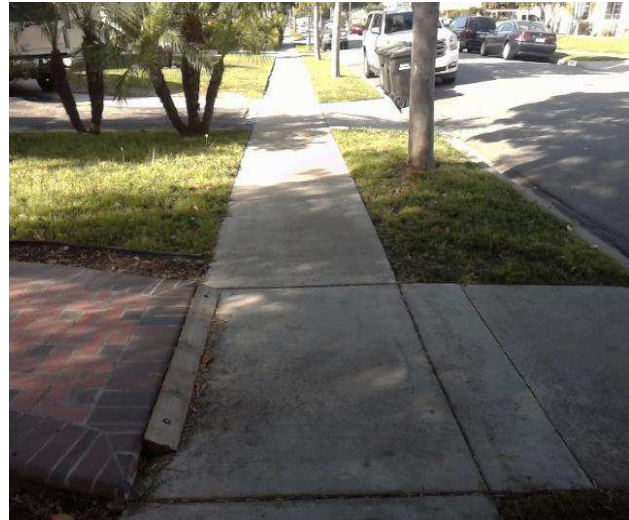
Sidewalks , Hazards & Gratings : Sidewalk Width at Obstruction

Code Reference ADA 206, 302, 403.5.1, CA 11B-403.5

Sidewalk width at the obstruction shall have the recommended value.

Recommendation At least 48.00 inches

\$1,260

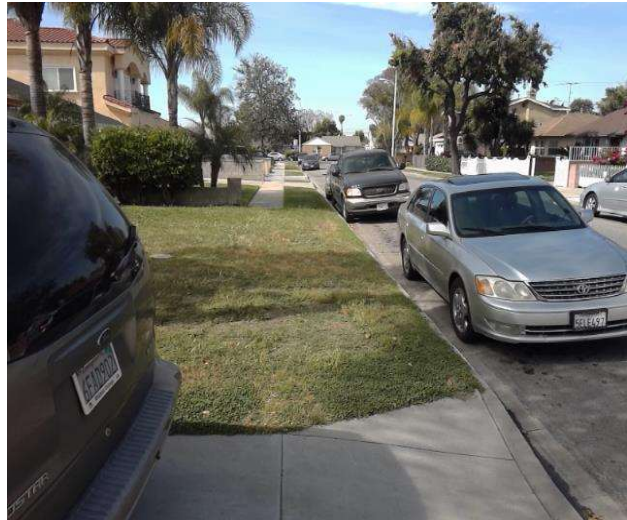
Sidewalks : Missing Sidewalk

Section of sidewalk is missing and consists of dirt, grass or gravel.

Code Reference ADA 206, 302,CA 11B-302,CA 11B-206

Provide a compliant sidewalk for the missing section.

\$1,260

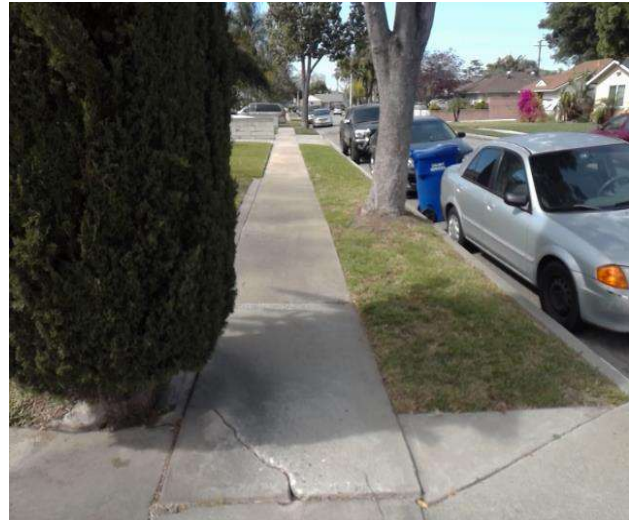
Code Reference ADA 206, 302, CA 11B-403.3

Repave the sidewalk surface with the recommended cross slope.

Recommendation Up to 2.08 percent

Repave surface \$1,092

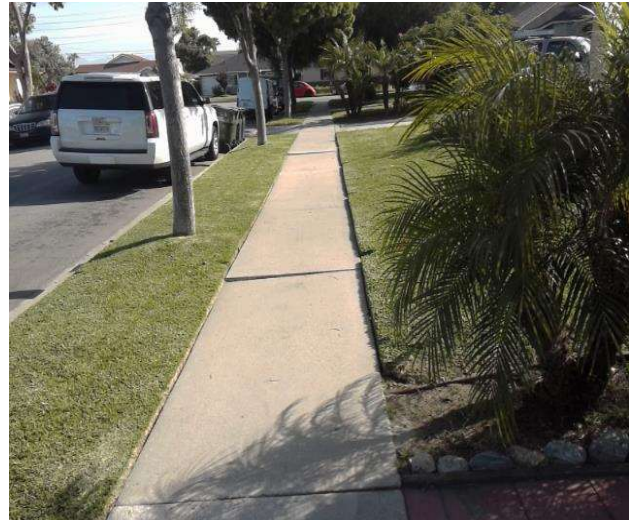
Code Reference ADA 206, 302, CA 11B-403.3

Repave the sidewalk surface with the recommended cross slope.

Recommendation Up to 2.08 percent

Repave surface \$1,092

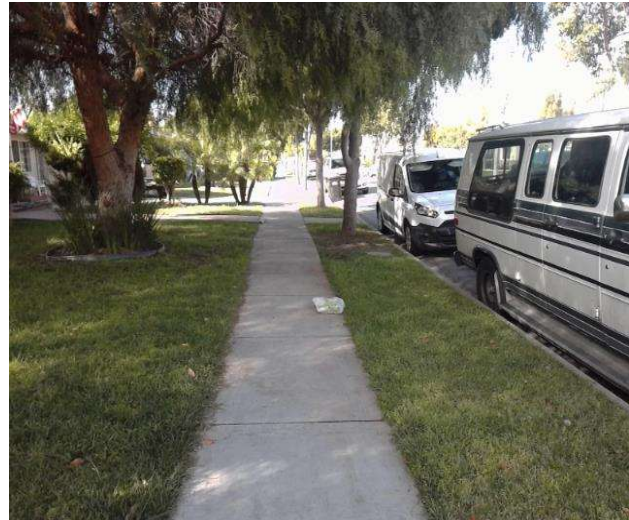
Code Reference ADA 206, 302, CA 11B-403.3

Repave the sidewalk surface with the recommended cross slope.

Recommendation Up to 2.08 percent

Repave surface \$1,092

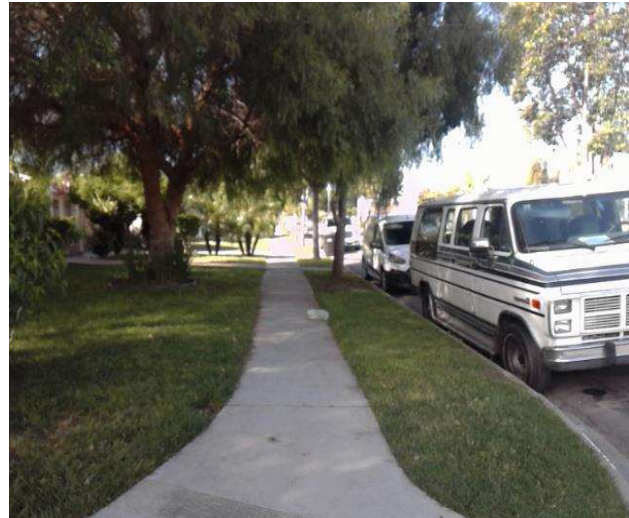
On-Site Finding Not Found

Code Reference ADA 206, 302

\$2,400

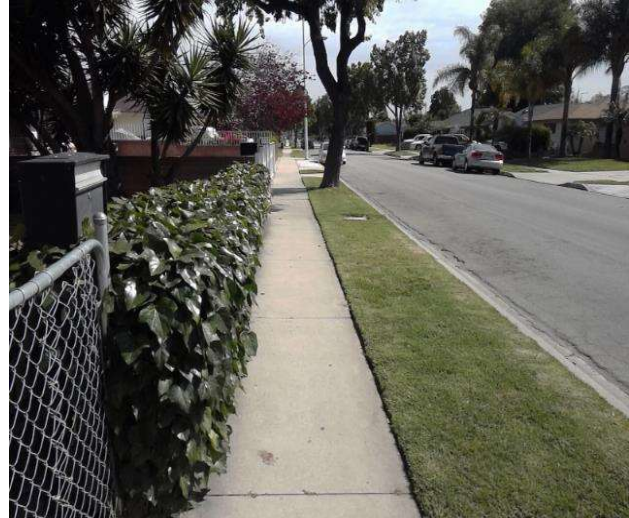
Sidewalks , Hazards & Gratings : Sidewalk Width at Obstruction

Code Reference ADA 206, 302, 403.5.1, CA 11B-403.5

Sidewalk width at the obstruction shall have the recommended value.

Recommendation At least 48.00 inches

\$1,260

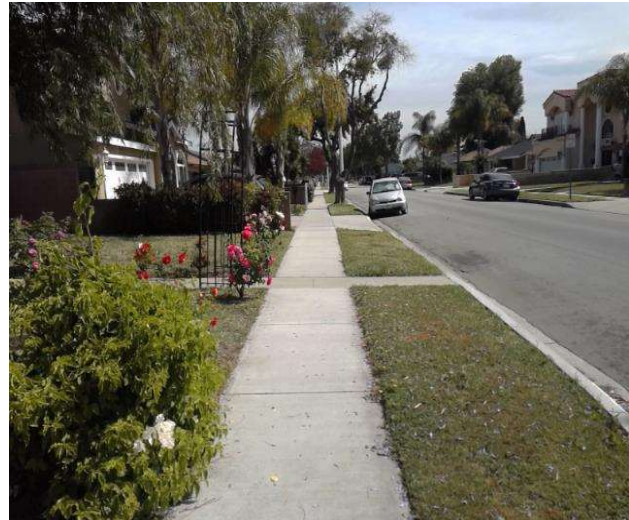
Code Reference ADA 206, 302,CA 11B-403.3

Repave the sidewalk surface with the recommended cross slope.

Recommendation Up to 2.08 percent

Repave surface \$1,092

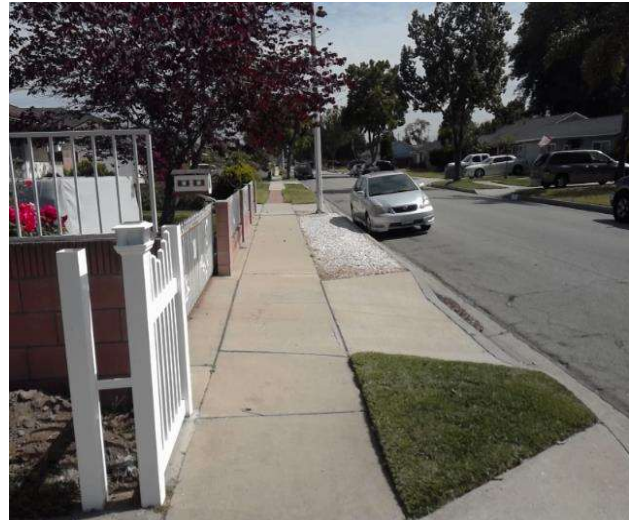
Code Reference ADA 206, 302,CA 11B-403.3

Repave the sidewalk surface with the recommended cross slope.

Recommendation Up to 2.08 percent

Repave surface \$1,092

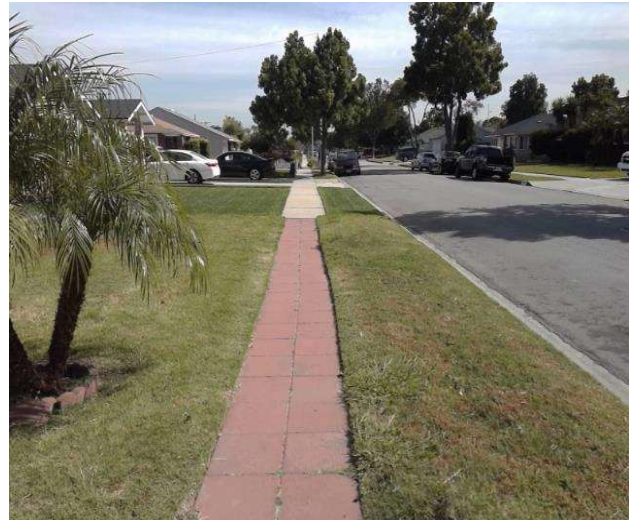
Sidewalks : Missing Sidewalk

Section of sidewalk is missing and consists of dirt, grass or gravel.

Code Reference ADA 206, 302,CA 11B-302,CA 11B-206

Provide a compliant sidewalk for the missing section.

\$1,260

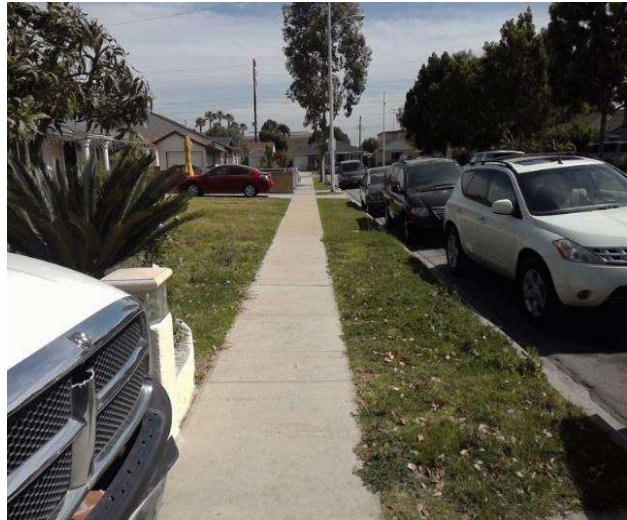
Code Reference ADA 206, 302, CA 11B-403.3

Repave the sidewalk surface with the recommended cross slope.

Recommendation Up to 2.08 percent

Repave surface \$1,092

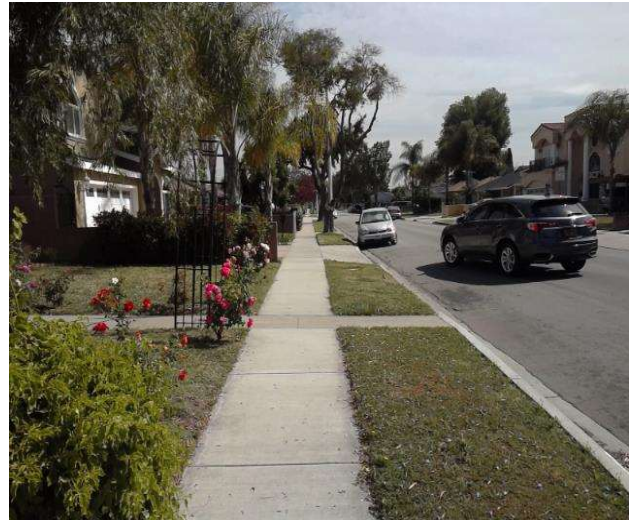
On-Site Finding Not Found

Code Reference ADA 206, 302

\$2,400

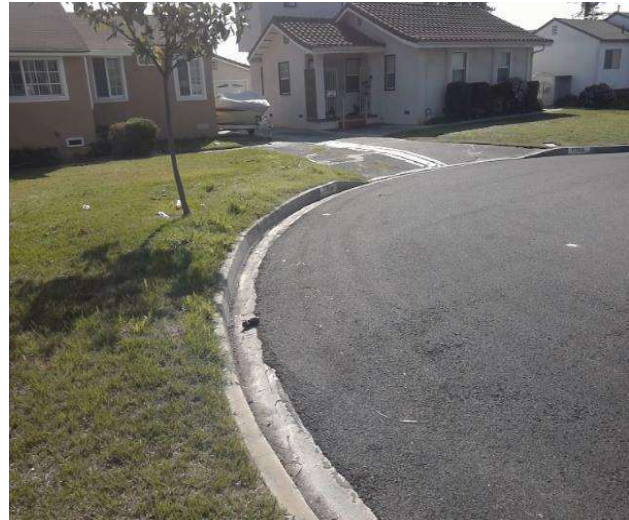
Sidewalks : Missing Sidewalk

Section of sidewalk is missing and consists of dirt, grass or gravel.

Code Reference ADA 206, 302,CA 11B-302,CA 11B-206

Provide a compliant sidewalk for the missing section.

\$1,260

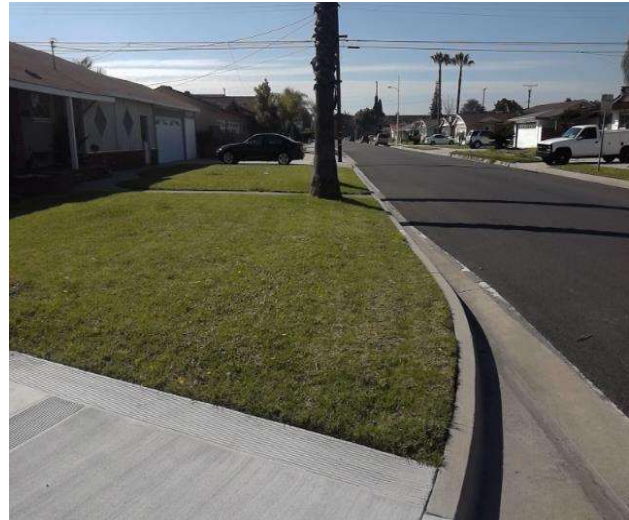
Sidewalks : Missing Sidewalk

Section of sidewalk is missing and consists of dirt, grass or gravel.

Code Reference ADA 206, 302,CA 11B-302,CA 11B-206

Provide a compliant sidewalk for the missing section.

\$1,260

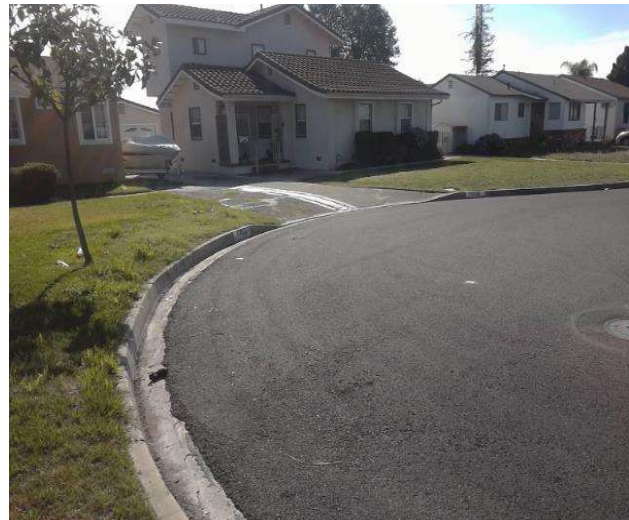
On-Site Finding Not Found

Code Reference ADA 206, 302

\$2,400

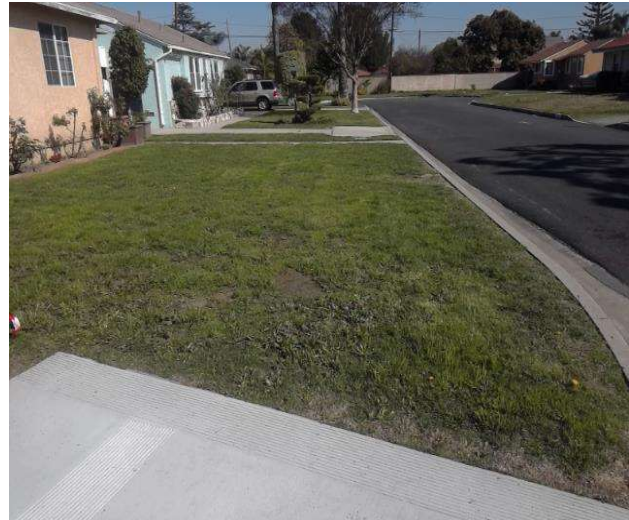
Sidewalks : Missing Sidewalk

Section of sidewalk is missing and consists of dirt, grass or gravel.

Code Reference ADA 206, 302,CA 11B-302,CA 11B-206

Provide a compliant sidewalk for the missing section.

\$1,260

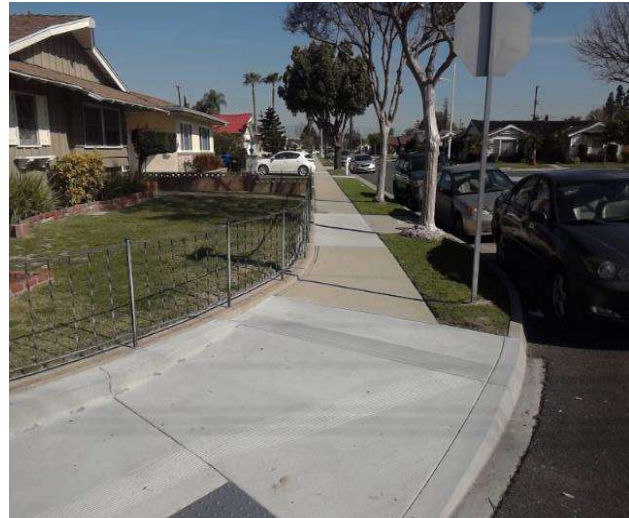
Code Reference ADA 206, 302

\$1,260
