Accessibility Survey

City of Downey Stamps Avenue - Downey Avenue to Gallatin Road

Date of Inspection
7/12/2017

Disability Access Consultants

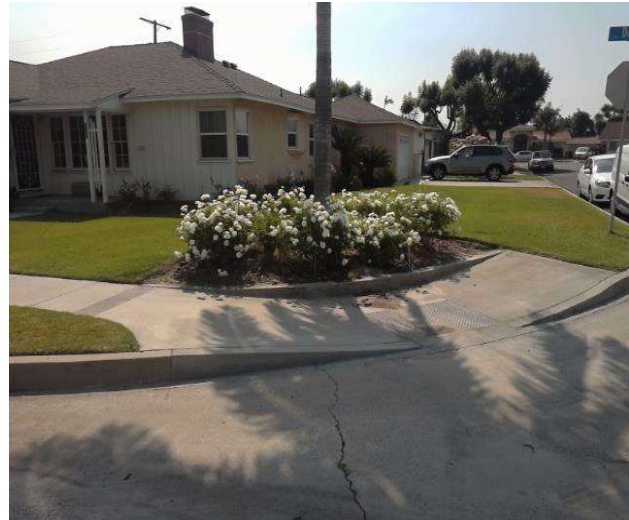
Curb Ramp : Parallel Curb Ramp Left Side Slope

The running slope is greater than allowed.

On-Site Finding 9.40 percent

Code Reference ADA 406.1, 405.2, CA 11B-406

Provide a compliant curb ramp.

Recommendation Up to 8.33 percent

Install curb ramp \$1,300

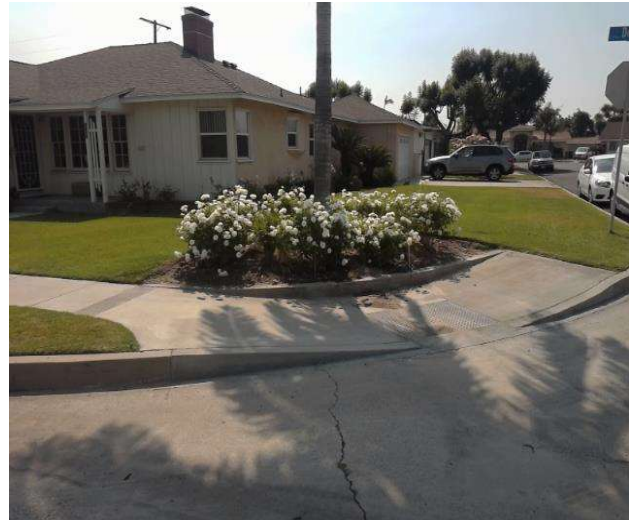
Curb Ramp : Parallel Curb Ramp Right Side Slope

The running slope is greater than allowed.

On-Site Finding 8.40 percent

Code Reference ADA 406.1, 405.2, CA 11B-406

Provide a compliant curb ramp.

Recommendation Up to 8.33 percent

Install curb ramp \$1,300

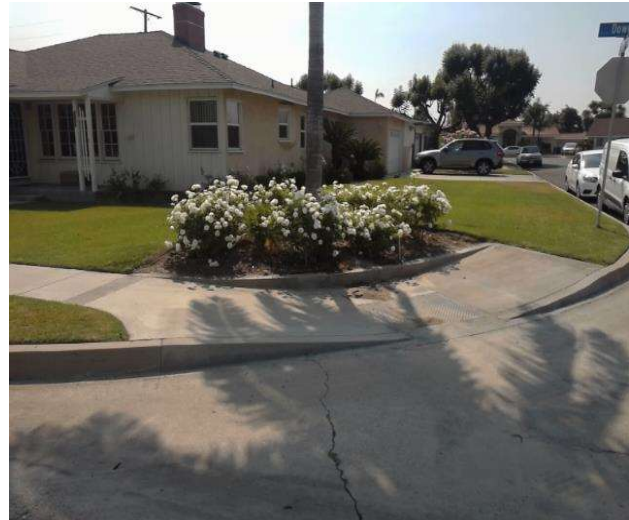
Curb Ramp , Landings and Transitions : Top Landing Right Side Clear Length - Parallel Curb Ramp

There is not enough top landing clear length.

On-Site Finding 0.00 inches

Code Reference ADA 406.4,CA 11B-406.5.3

Provide a level top landing with enough clear length.

Recommendation At least 48.00 inches

Provide compliant landing \$240

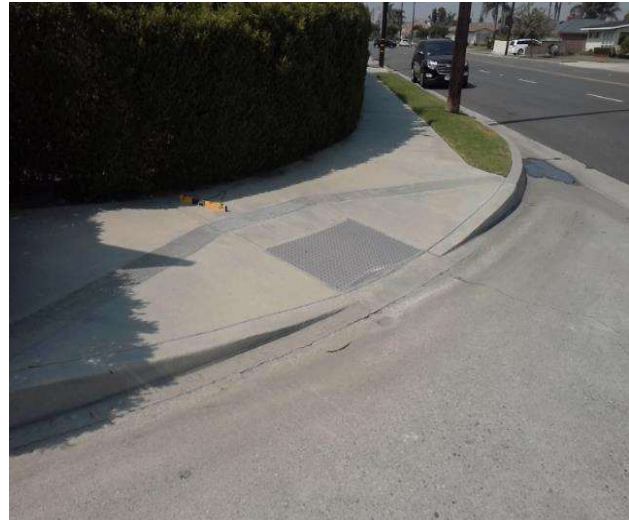
Curb Ramp , Landings and Transitions : Top Landing Slope

The slope at the top landing is greater than allowed.

On-Site Finding 2.80 percent

Code Reference ADA 402, 406.4, 403.3, 406.1, CA 11B-406.5.3

Provide a top landing surface that does not exceed the maximum slope and cross slope. Provide a sufficient maneuvering clearance that does not accumulate water.

Recommendation Up to 2.08 percent

Provide compliant landing \$1,260

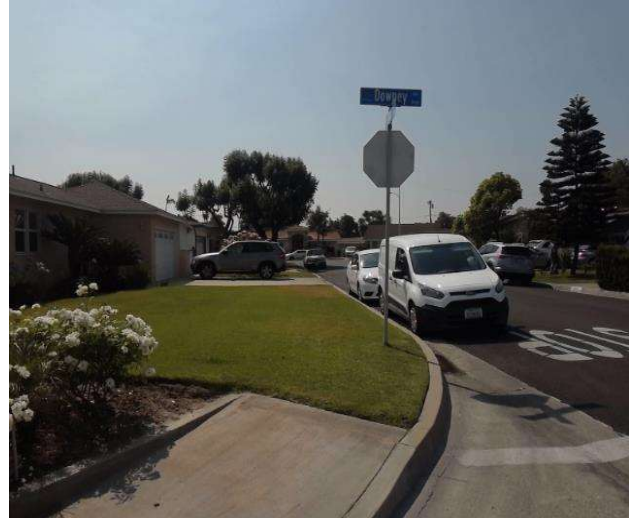
Sidewalks : No Sidewalk

No sidewalk exists at the location.

No action necessary until a sidewalk is provided.

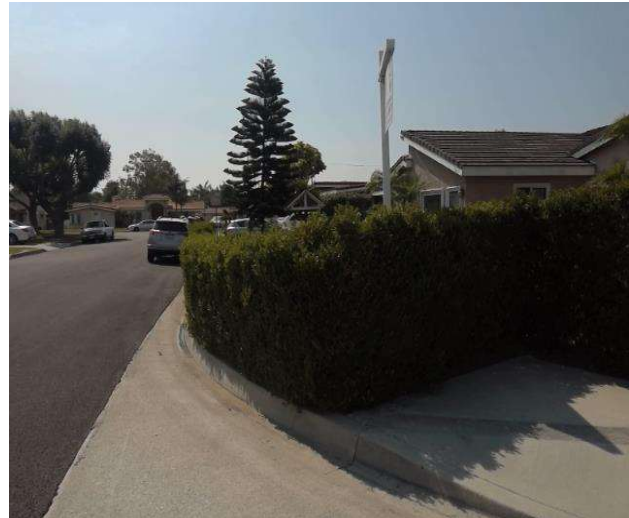
Sidewalks : No Sidewalk

No sidewalk exists at the location.

No action necessary until a sidewalk is provided.

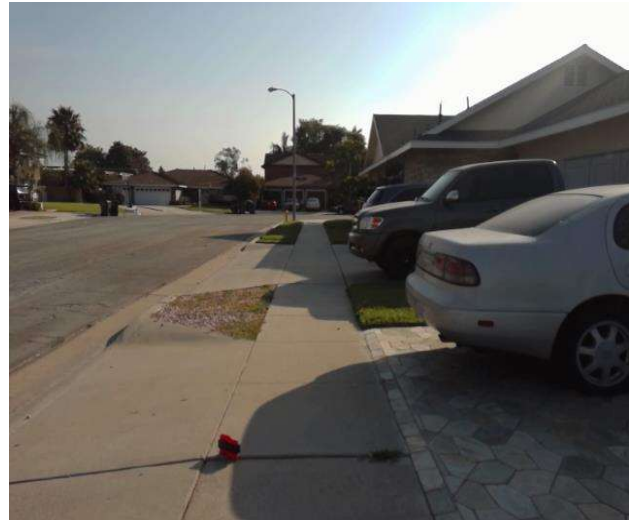
Sidewalks , Change in Level : Change in Level Non Beveled

There is a change in elevation greater than recommended value.

On-Site Finding 0.62 inches

Code Reference ADA 206, 302

Ensure that the change in elevation is within the recommended value.

Recommendation Up to 0.25 inches

Remove tripping hazards \$198

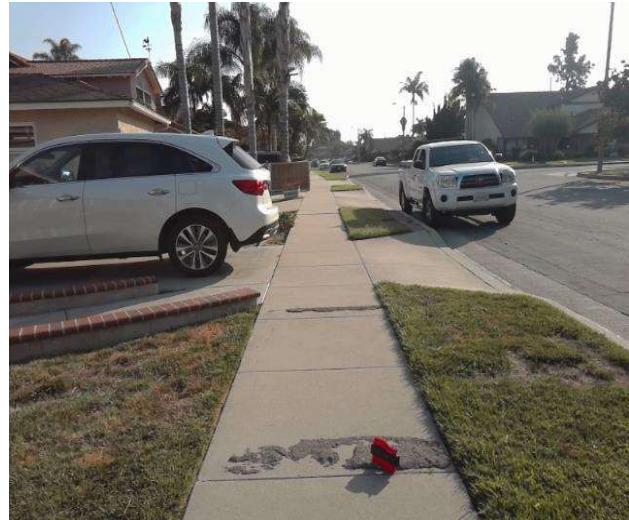
Sidewalks , Change in Level : Change in Level Non Beveled

There is a change in elevation greater than recommended value.

On-Site Finding 0.50 inches

Code Reference ADA 206, 302

Ensure that the change in elevation is within the recommended value.

Recommendation Up to 0.25 inches

Remove tripping hazards \$198

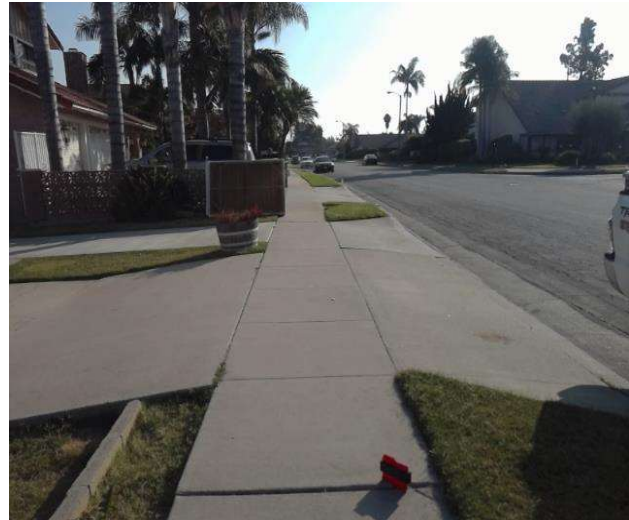
Sidewalks , Change in Level : Change in Level Non Beveled

There is a change in elevation greater than recommended value.

On-Site Finding 0.37 inches

Code Reference ADA 206, 302

Ensure that the change in elevation is within the recommended value.

Recommendation Up to 0.25 inches

Remove tripping hazards \$198

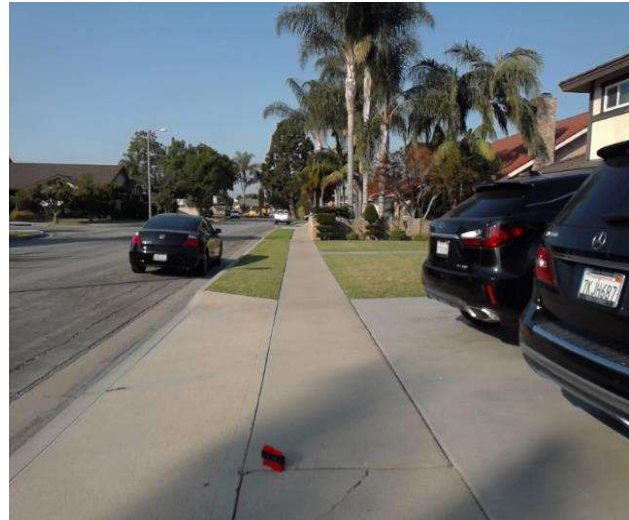
There is a change in elevation greater than recommended value.

Ensure that the change in elevation is within the recommended value.

Recommendation Up to 0.25 inches

Remove tripping hazards \$198

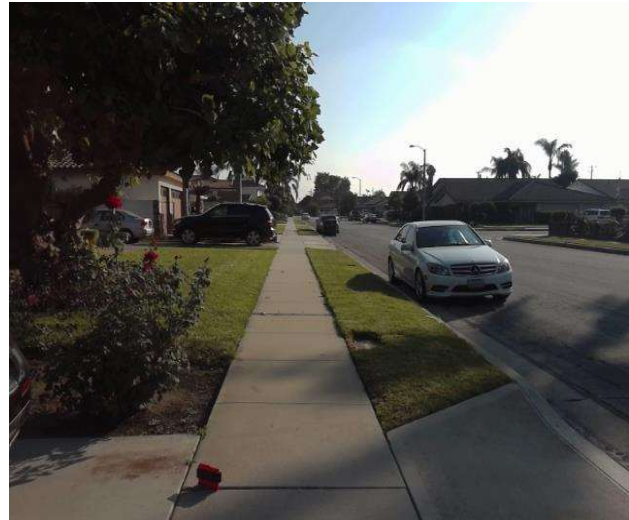
There is a change in elevation greater than recommended value.

Ensure that the change in elevation is within the recommended value.

Recommendation Up to 0.25 inches

Remove tripping hazards \$198

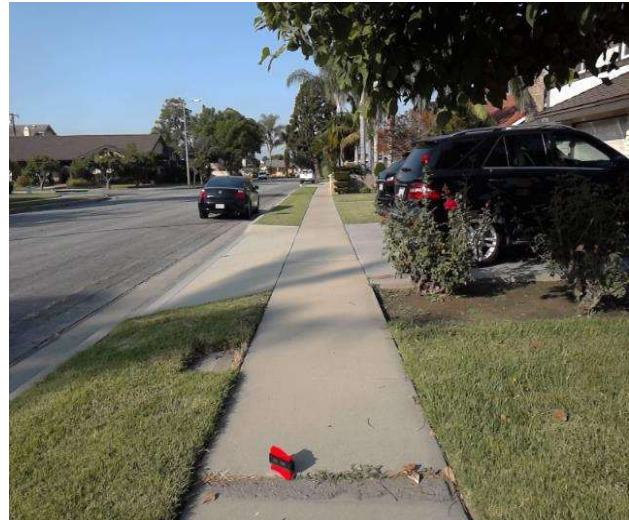
There is a change in elevation greater than recommended value.

Ensure that the change in elevation is within the recommended value.

Recommendation Up to 0.25 inches

Remove tripping hazards \$198

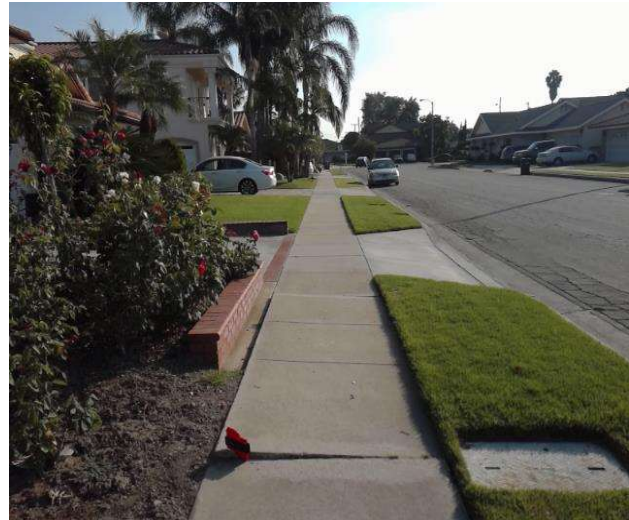
There is a change in elevation greater than recommended value.

Ensure that the change in elevation is within the recommended value.

Recommendation Up to 0.25 inches

Remove tripping hazards \$198

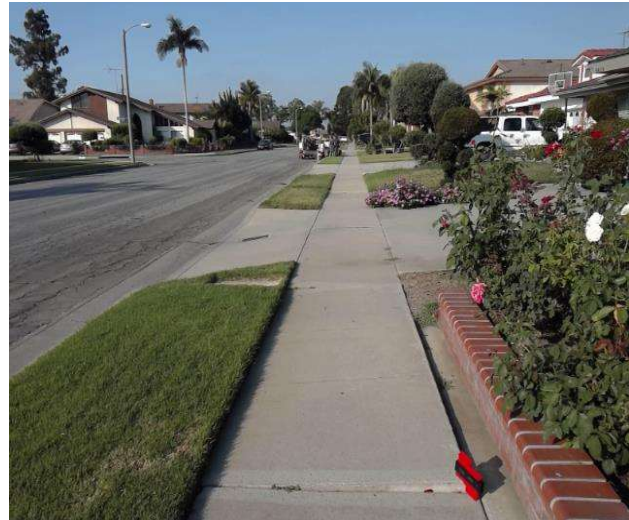
There is a change in elevation greater than recommended value.

Ensure that the change in elevation is within the recommended value.

Recommendation Up to 0.25 inches

Remove tripping hazards \$198

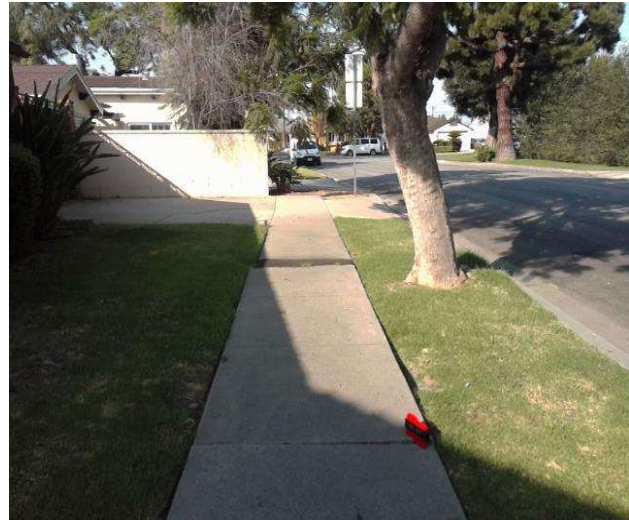
There is a change in elevation greater than recommended value.

Ensure that the change in elevation is within the recommended value.

Recommendation Up to 0.25 inches

Remove tripping hazards \$198

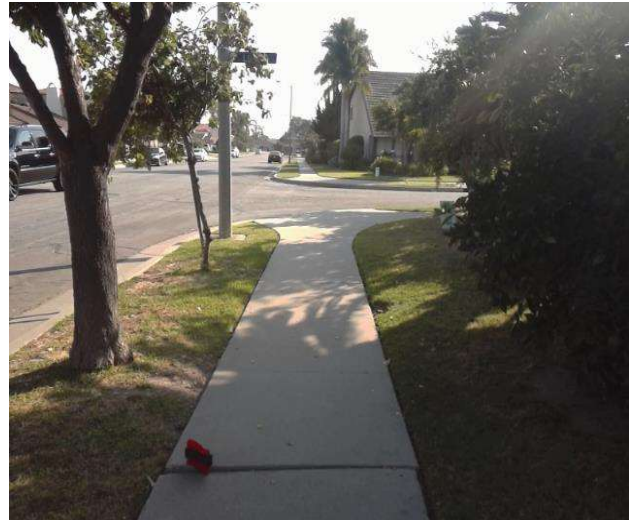
There is a change in elevation greater than recommended value.

Ensure that the change in elevation is within the recommended value.

Recommendation Up to 0.25 inches

Remove tripping hazards \$198

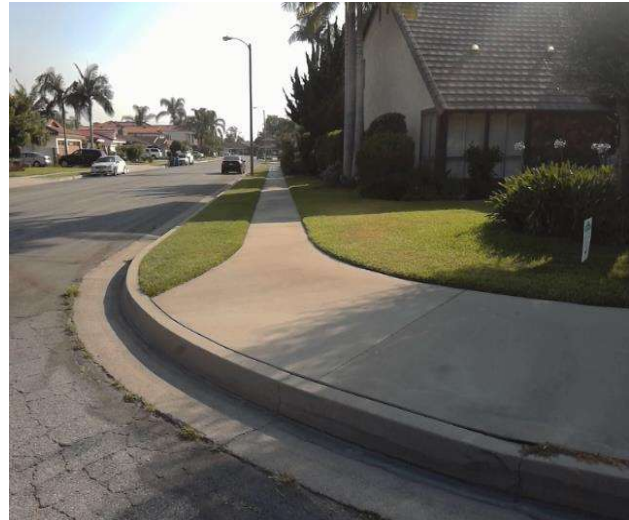
Sidewalks , Hazards & Gratings : Curb is on Path of Travel

Install curb ramp \$2,500

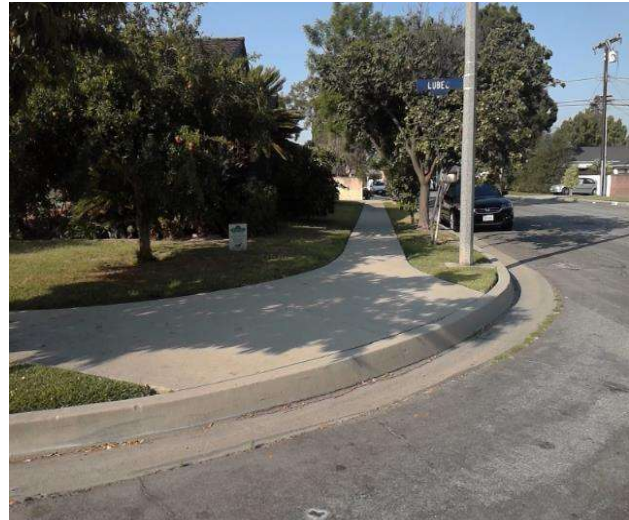
Sidewalks , Hazards & Gratings : Curb is on Path of Travel

Install curb ramp \$2,500

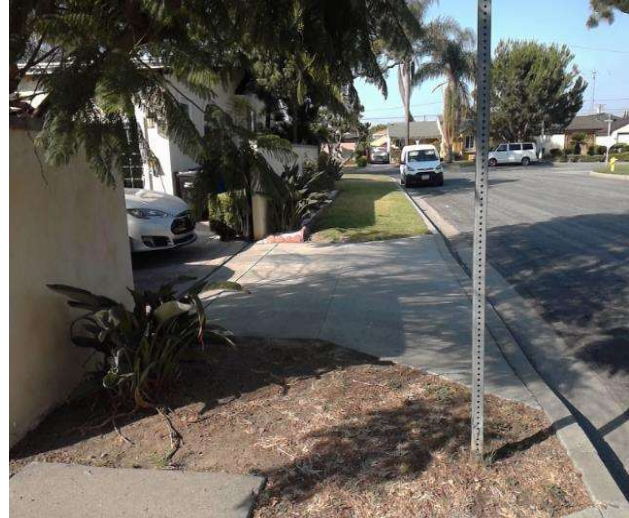
Sidewalks : Missing Sidewalk

Section of sidewalk is missing and consists of dirt, grass or gravel.

Provide a compliant sidewalk for the missing section.

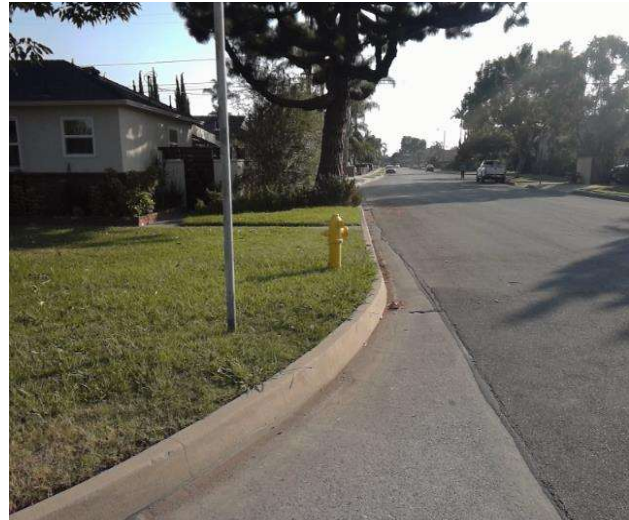
Sidewalks : Missing Sidewalk

Section of sidewalk is missing and consists of dirt, grass or gravel.

Provide a compliant sidewalk for the missing section.

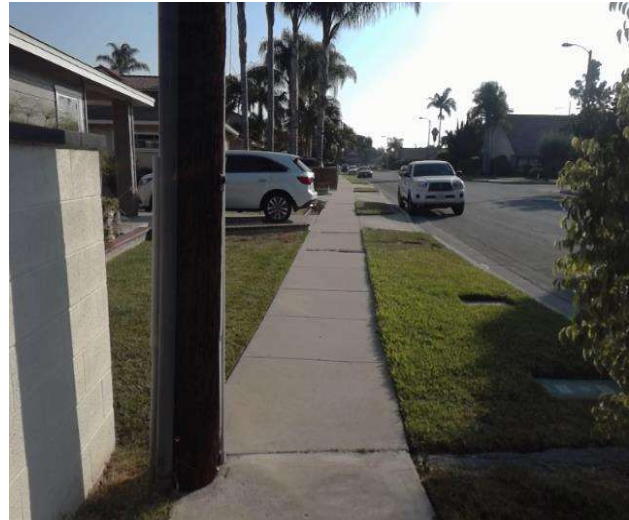
Sidewalks , Hazards & Gratings : Sidewalk Width at Obstruction

Sidewalk width at the obstruction shall have the recommended value.

Recommendation At least 48.00 inches

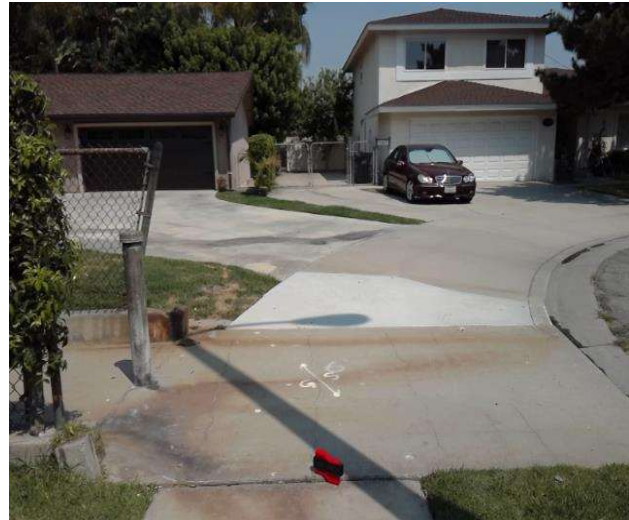
There is a change in elevation greater than recommended value.

Ensure that the change in elevation is within the recommended value.

Recommendation Up to 0.25 inches

Remove tripping hazards \$198

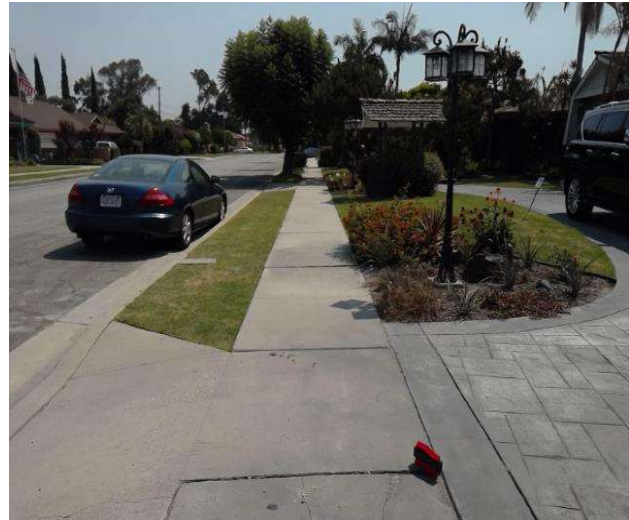
There is a change in elevation greater than recommended value.

Ensure that the change in elevation is within the recommended value.

Recommendation Up to 0.25 inches

Remove tripping hazards \$198

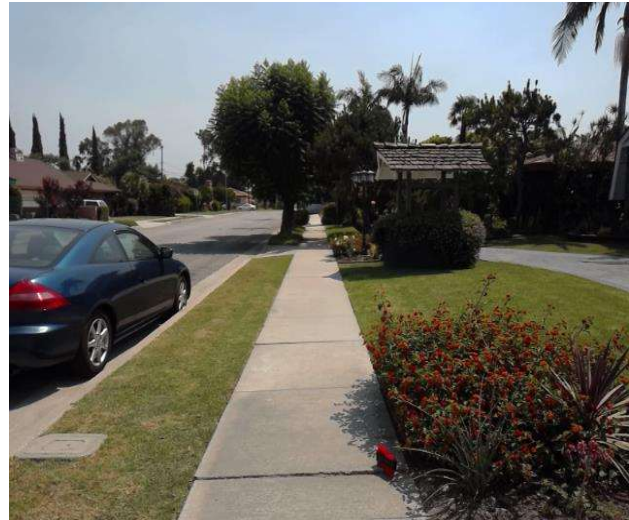
There is a change in elevation greater than recommended value.

Ensure that the change in elevation is within the recommended value.

Recommendation Up to 0.25 inches

Remove tripping hazards \$198

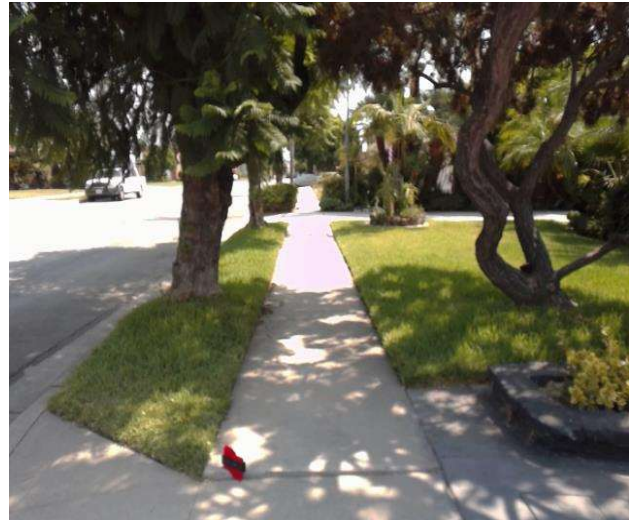
There is a change in elevation greater than recommended value.

Ensure that the change in elevation is within the recommended value.

Recommendation Up to 0.25 inches

Remove tripping hazards \$198

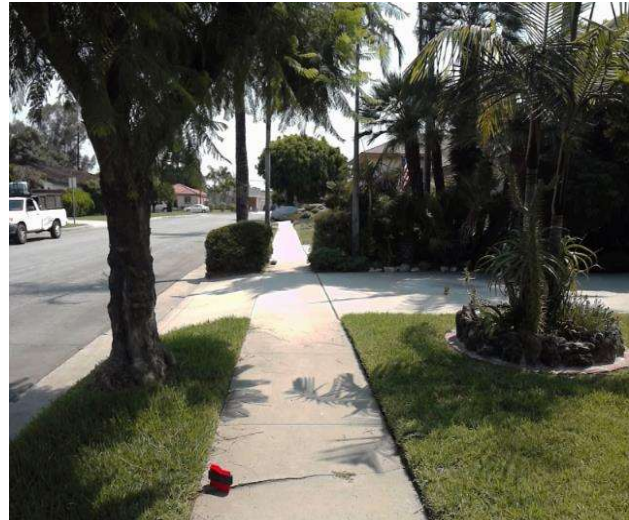
There is a change in elevation greater than recommended value.

Ensure that the change in elevation is within the recommended value.

Recommendation Up to 0.25 inches

Remove tripping hazards \$198

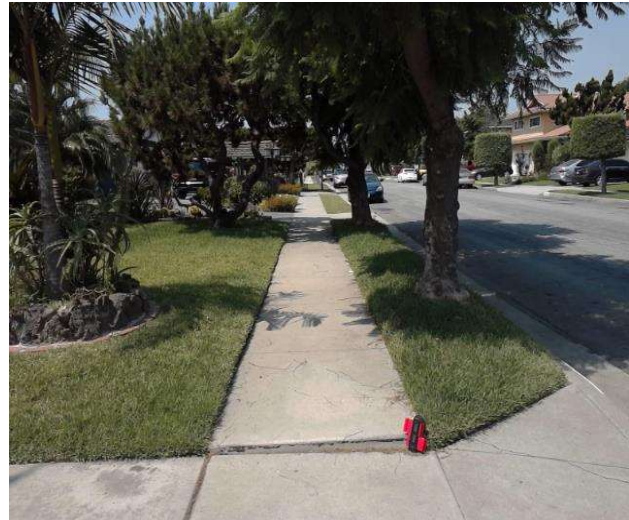
There is a change in elevation greater than recommended value.

Ensure that the change in elevation is within the recommended value.

Recommendation Up to 0.25 inches

Remove tripping hazards \$198

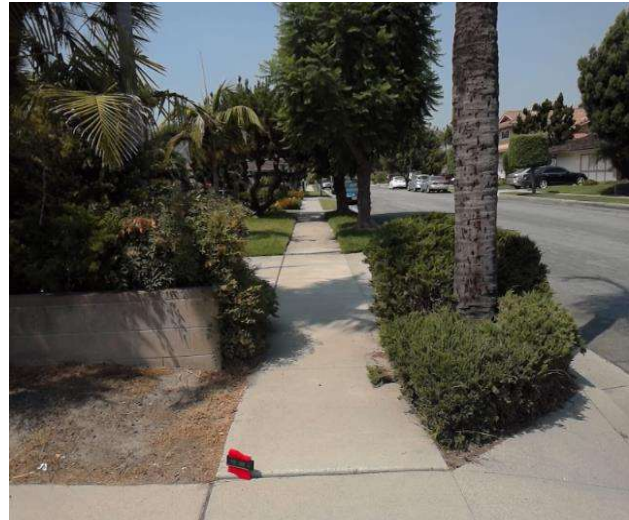
There is a change in elevation greater than recommended value.

Ensure that the change in elevation is within the recommended value.

Recommendation Up to 0.25 inches

Remove tripping hazards \$198

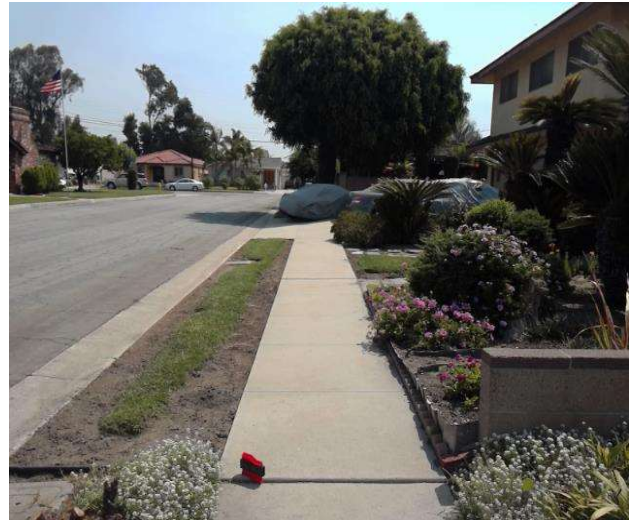
There is a change in elevation greater than recommended value.

Ensure that the change in elevation is within the recommended value.

Recommendation Up to 0.25 inches

Remove tripping hazards \$198

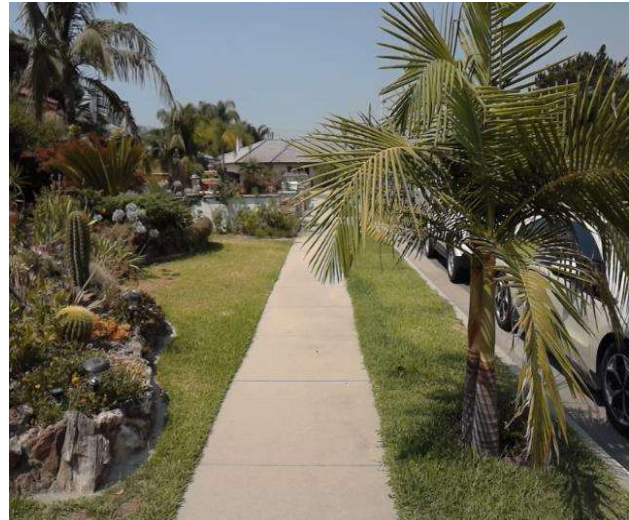
Sidewalks , Hazards & Gratings : Overhead Obstruction Height

Recommendation At least 80.00 inches

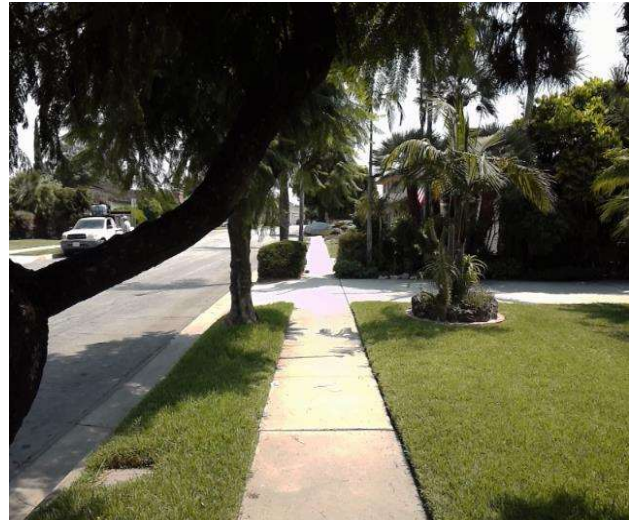
Sidewalks , Hazards & Gratings : Overhead Obstruction Height

Recommendation At least 80.00 inches

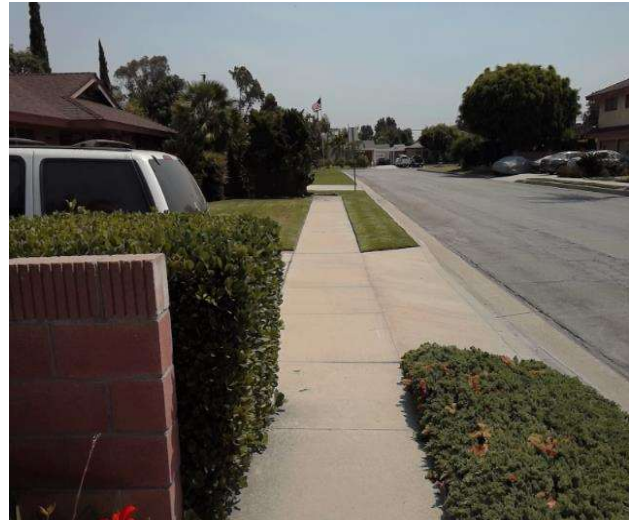
Sidewalks , Hazards & Gratings : Sidewalk Width at Obstruction

Sidewalk width at the obstruction shall have the recommended value.

Recommendation At least 48.00 inches

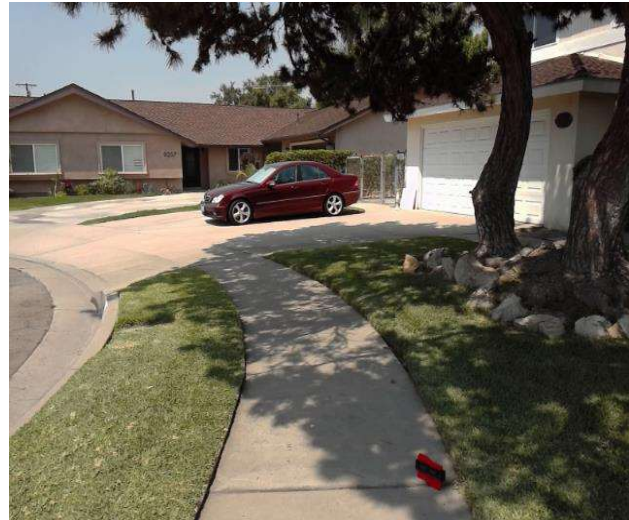
There is a change in elevation greater than recommended value.

Ensure that the change in elevation is within the recommended value.

Recommendation Up to 0.25 inches

Remove tripping hazards \$198

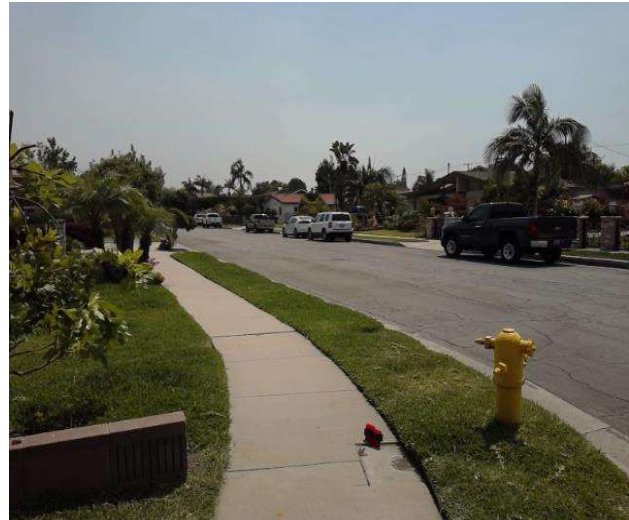
There is a change in elevation greater than recommended value.

Ensure that the change in elevation is within the recommended value.

Recommendation Up to 0.25 inches

Remove tripping hazards \$198

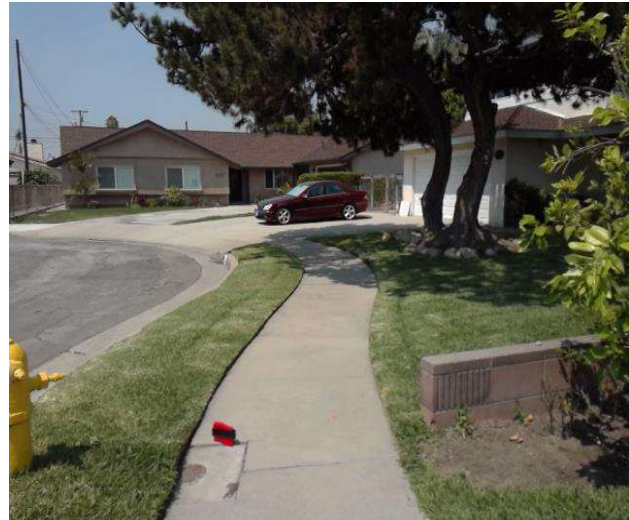
There is a change in elevation greater than recommended value.

Ensure that the change in elevation is within the recommended value.

Recommendation Up to 0.25 inches

Remove tripping hazards \$198

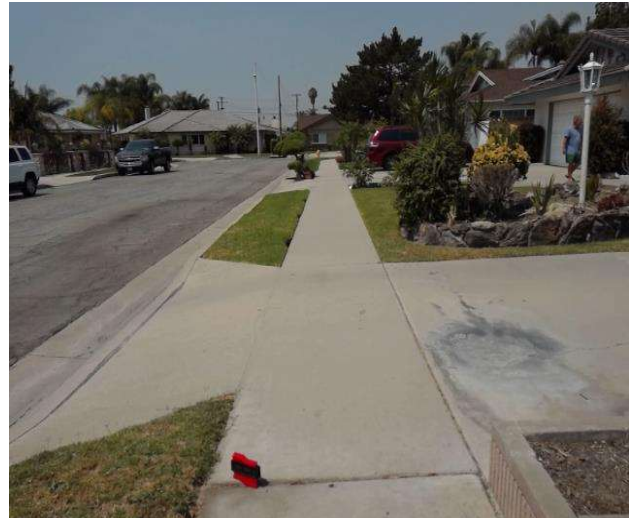
There is a change in elevation greater than recommended value.

Ensure that the change in elevation is within the recommended value.

Recommendation Up to 0.25 inches

Remove tripping hazards \$198

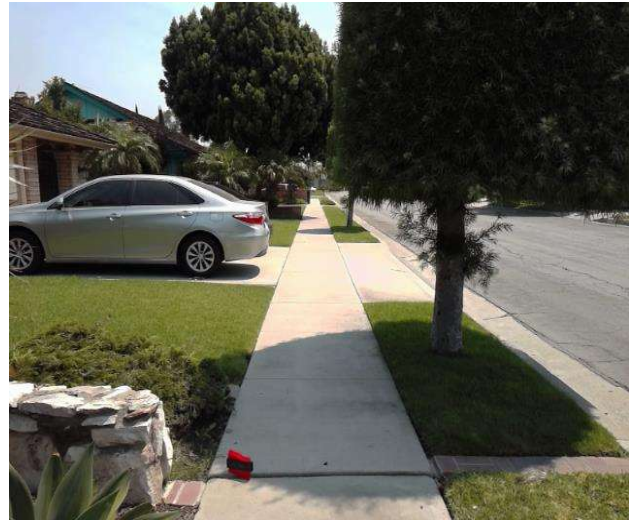
There is a change in elevation greater than recommended value.

Ensure that the change in elevation is within the recommended value.

Recommendation Up to 0.25 inches

Remove tripping hazards \$198

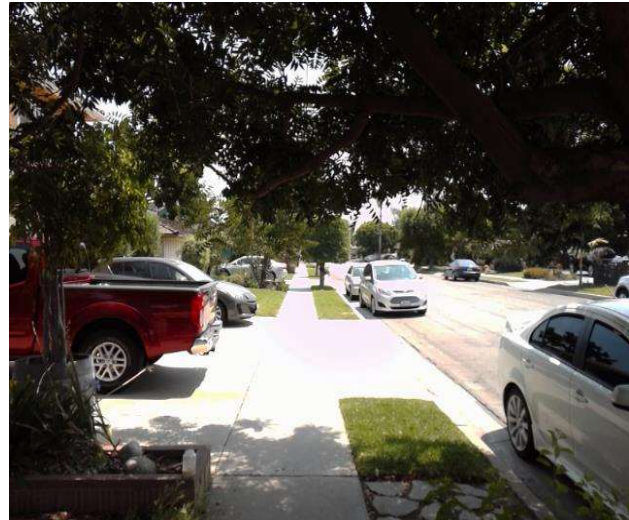
Sidewalks , Hazards & Gratings : Overhead Obstruction Height

Recommendation At least 80.00 inches

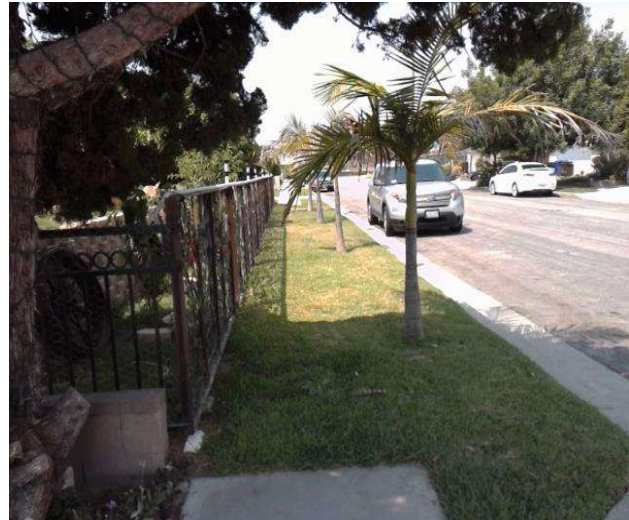
Sidewalks : Missing Sidewalk

Section of sidewalk is missing and consists of dirt, grass or gravel.

Provide a compliant sidewalk for the missing section.

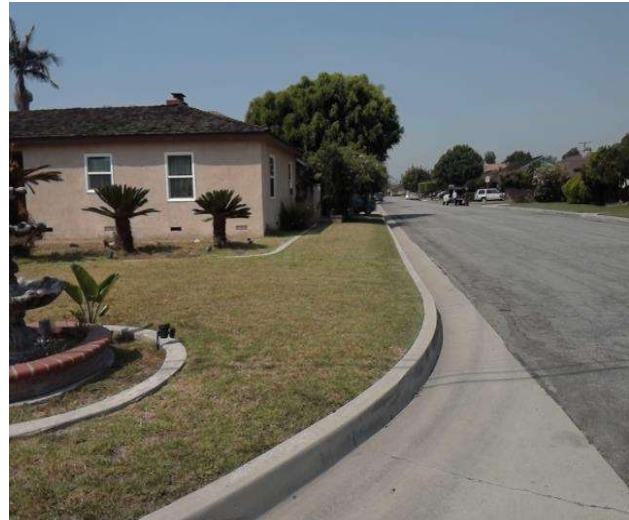
Sidewalks : Missing Sidewalk

Section of sidewalk is missing and consists of dirt, grass or gravel.

Provide a compliant sidewalk for the missing section.

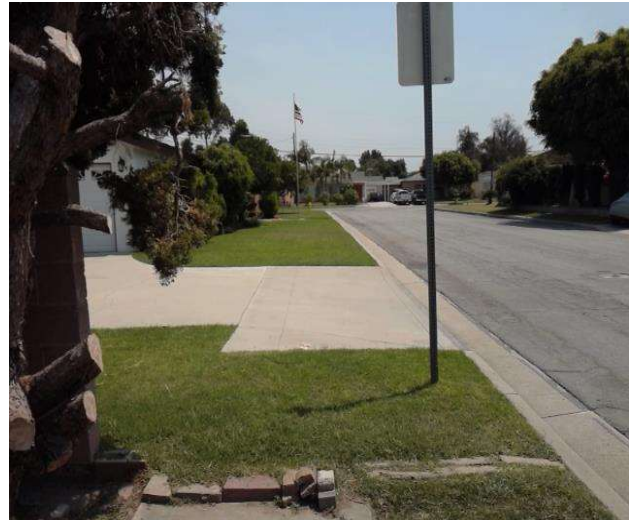
Sidewalks : Missing Sidewalk

Section of sidewalk is missing and consists of dirt, grass or gravel.

Provide a compliant sidewalk for the missing section.
