## Accessibility Survey

## City of Downey Verdura Avenue - Devenir Street To Imperial Highway

Date of Inspection  
3/17/2017

**Disability Access Consultants**

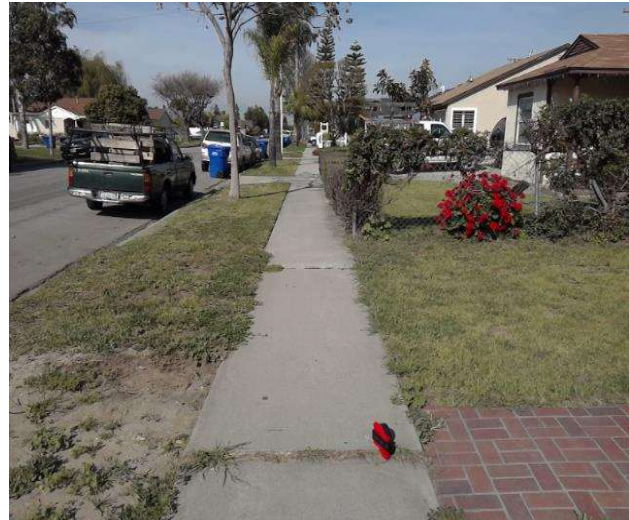
#### Change In Level South Of Imperial Highway @ 33.915315307120, - 118.144585490227

Sidewalks , Change in Level : Change in Level Non Beveled

There is a change in elevation greater than recommended value.

**On-Site Finding** 1.25 inches

Ensure that the change in elevation is within the recommended value.

Recommendation Up to 0.25 inches

Remove tripping hazards \$198

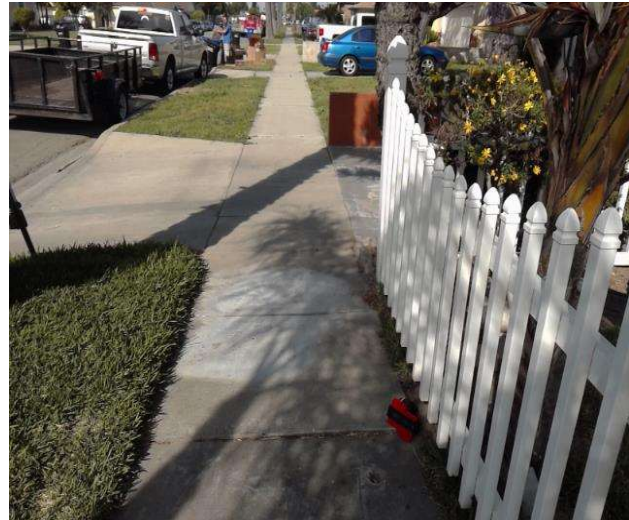
#### Change In Level South Of Imperial Highway @ 33.915788302432, - 118.144239485264

Sidewalks , Change in Level : Change in Level Non Beveled

There is a change in elevation greater than recommended value.

**On-Site Finding** 0.87 inches

Ensure that the change in elevation is within the recommended value.

Recommendation Up to 0.25 inches

Remove tripping hazards \$198

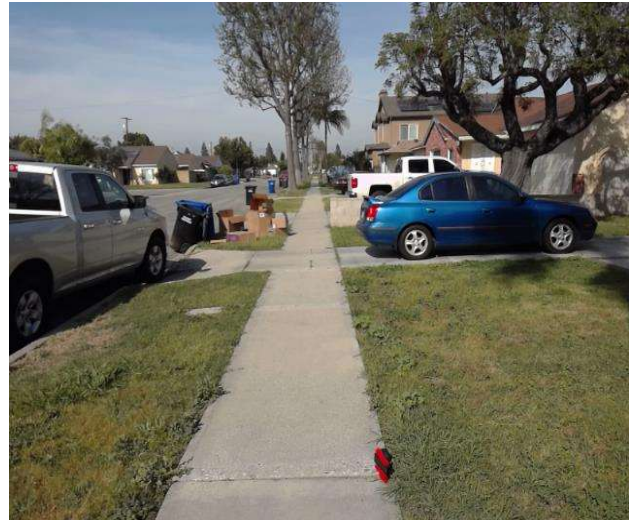
There is a change in elevation greater than recommended value.

Ensure that the change in elevation is within the recommended value.

Recommendation Up to 0.25 inches

Remove tripping hazards \$198

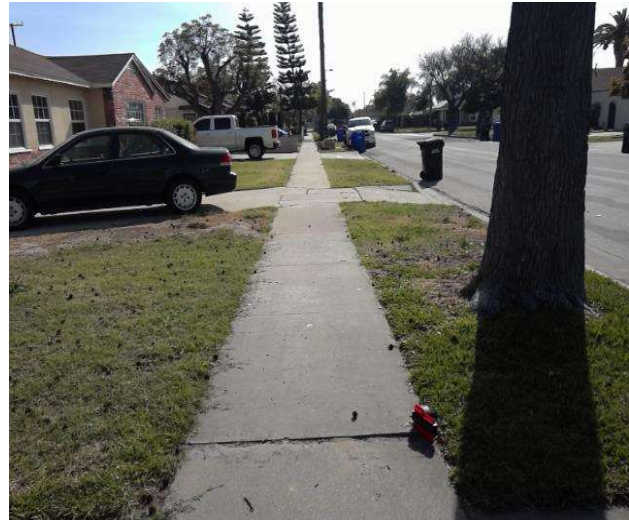
There is a change in elevation greater than recommended value.

Ensure that the change in elevation is within the recommended value.

Recommendation Up to 0.25 inches

Remove tripping hazards \$198

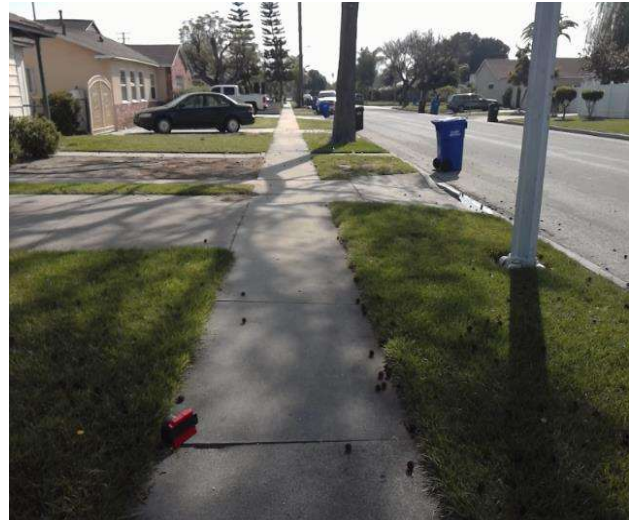
There is a change in elevation greater than recommended value.

Ensure that the change in elevation is within the recommended value.

Recommendation Up to 0.25 inches

Remove tripping hazards \$198

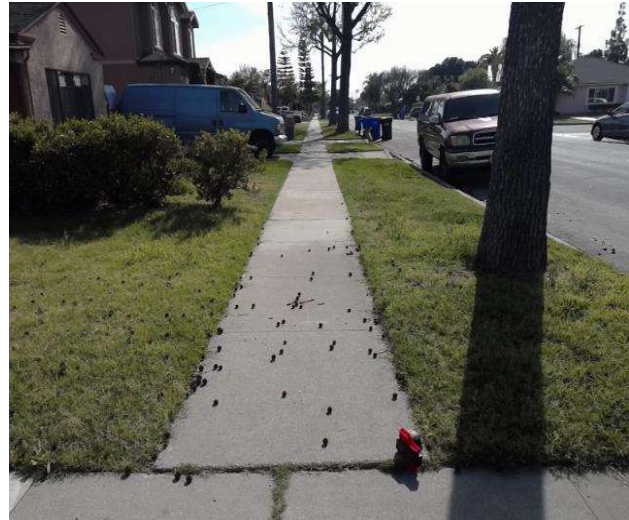
There is a change in elevation greater than recommended value.

Ensure that the change in elevation is within the recommended value.

Recommendation Up to 0.25 inches

Remove tripping hazards \$198

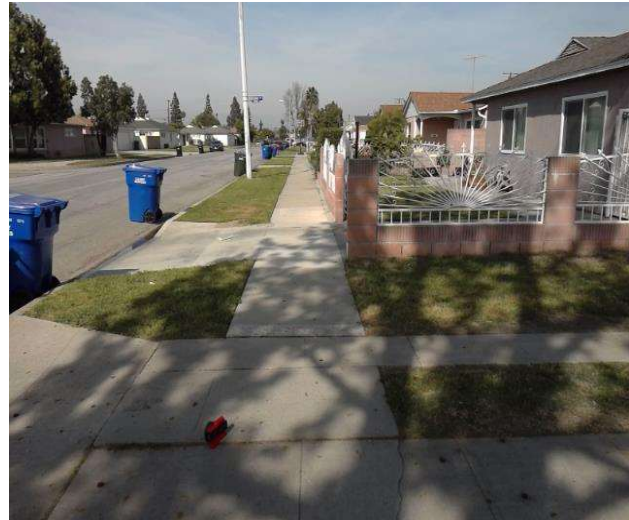
There is a change in elevation greater than recommended value.

Ensure that the change in elevation is within the recommended value.

Recommendation Up to 0.25 inches

Remove tripping hazards \$198

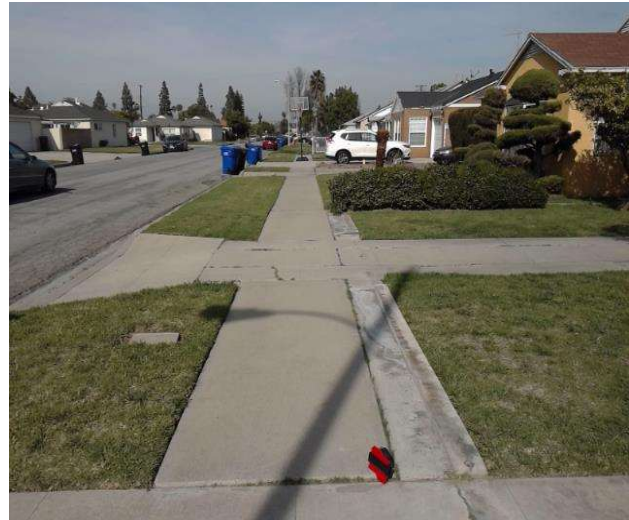
There is a change in elevation greater than recommended value.

Ensure that the change in elevation is within the recommended value.

Recommendation Up to 0.25 inches

Remove tripping hazards \$198

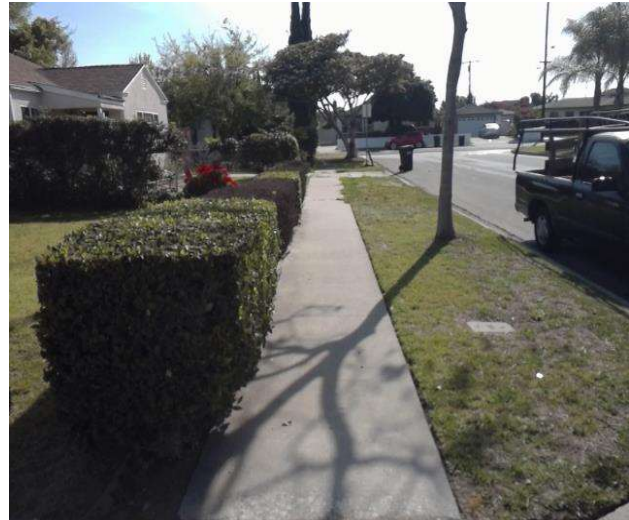
Sidewalks , Hazards & Gratings : Sidewalk Width at Obstruction

Sidewalk width at the obstruction shall have the recommended value.

Recommendation At least 48.00 inches

\$1,260

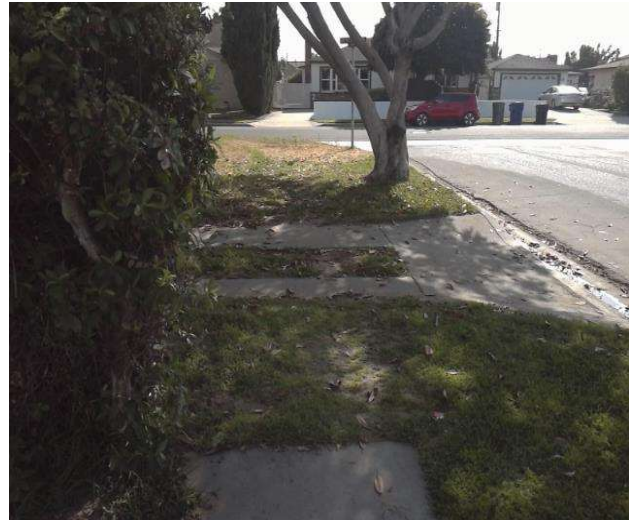
Sidewalks : Missing Sidewalk

Section of sidewalk is missing and consists of dirt, grass or gravel.

Provide a compliant sidewalk for the missing section.

\$1,260

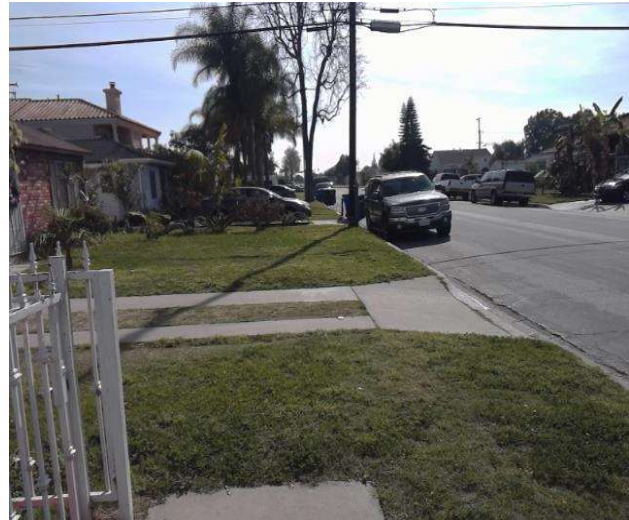
Sidewalks : Missing Sidewalk

Section of sidewalk is missing and consists of dirt, grass or gravel.

Provide a compliant sidewalk for the missing section.

\$1,260

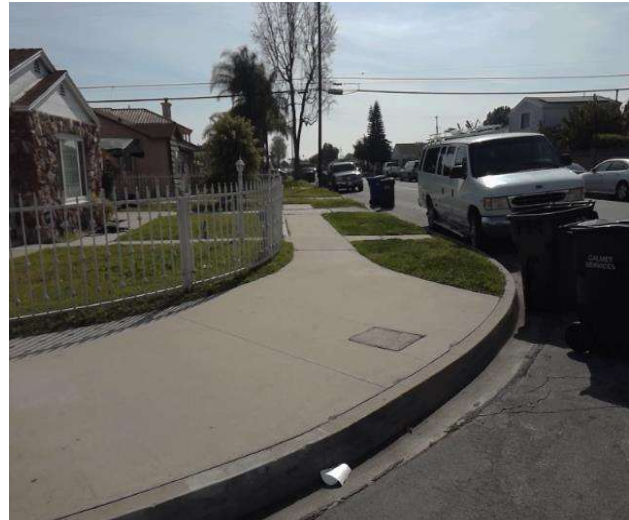
Sidewalks , Hazards & Gratings : Curb is on Path of Travel

Install curb ramp \$2,500

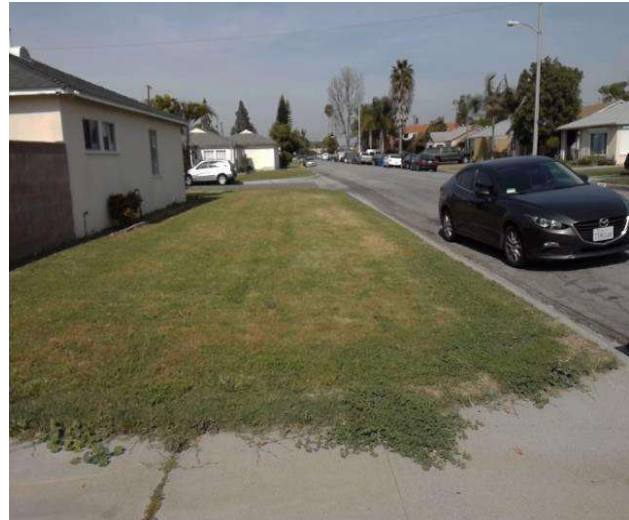
Sidewalks : Missing Sidewalk

Section of sidewalk is missing and consists of dirt, grass or gravel.

Provide a compliant sidewalk for the missing section.

\$1,260

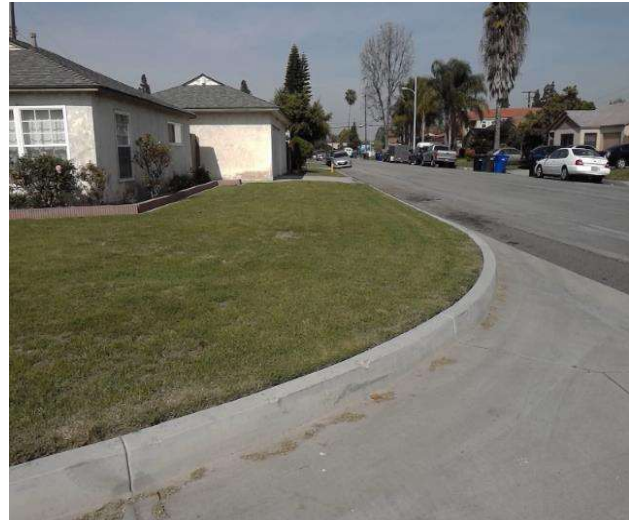
Sidewalks : Missing Sidewalk

Section of sidewalk is missing and consists of dirt, grass or gravel.

Provide a compliant sidewalk for the missing section.

\$1,260

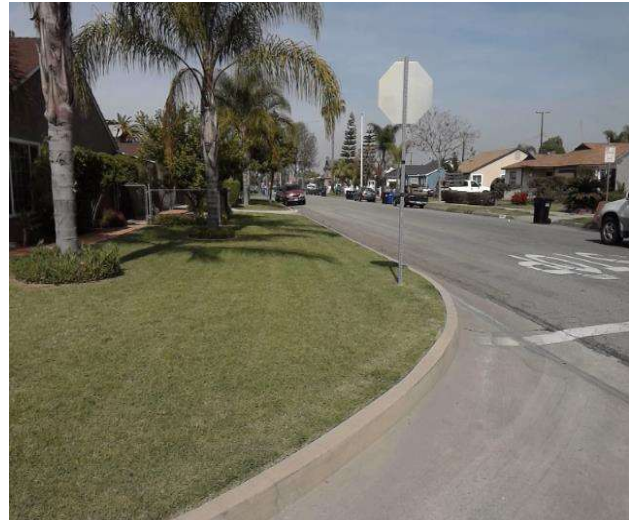
Sidewalks : Missing Sidewalk

Section of sidewalk is missing and consists of dirt, grass or gravel.

Provide a compliant sidewalk for the missing section.

\$1,260

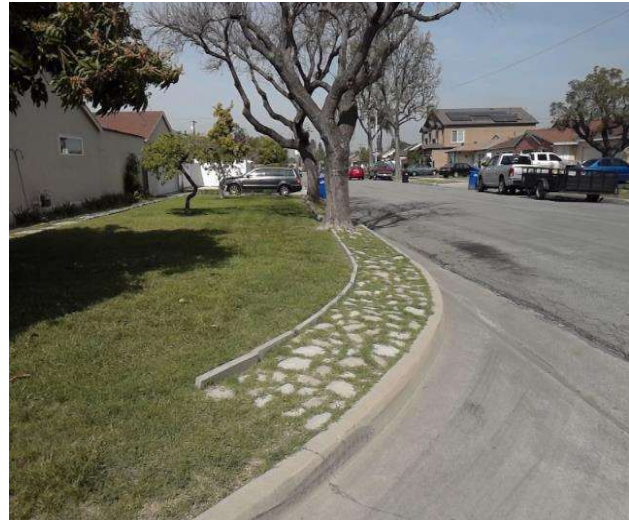
Sidewalks : Missing Sidewalk

Section of sidewalk is missing and consists of dirt, grass or gravel.

Provide a compliant sidewalk for the missing section.

\$1,260

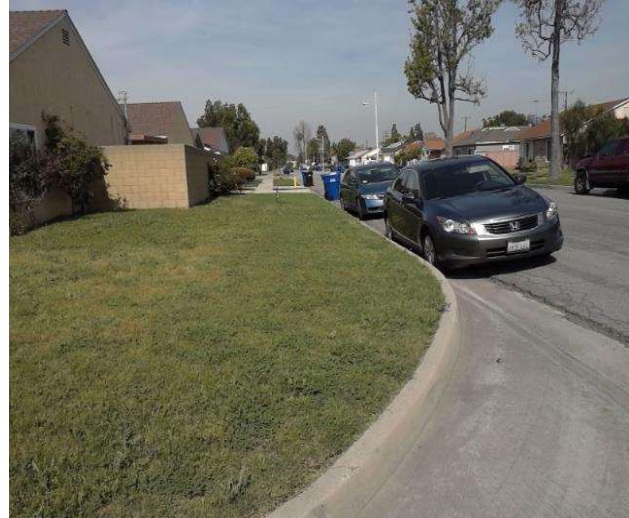
Sidewalks : Missing Sidewalk

Section of sidewalk is missing and consists of dirt, grass or gravel.

Provide a compliant sidewalk for the missing section.

\$1,260

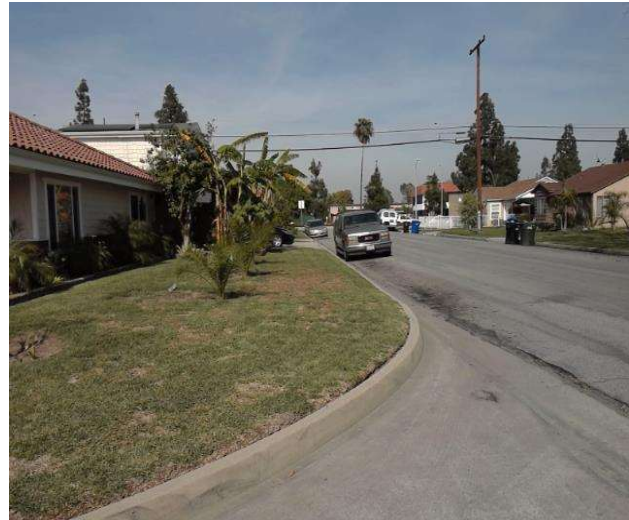
Sidewalks : Missing Sidewalk

Section of sidewalk is missing and consists of dirt, grass or gravel.

Provide a compliant sidewalk for the missing section.

\$1,260

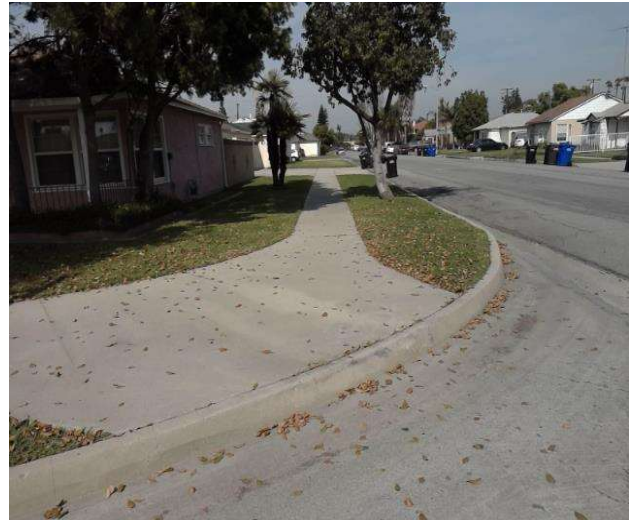
Sidewalks , Hazards & Gratings : Curb is on Path of Travel

Install curb ramp \$2,500

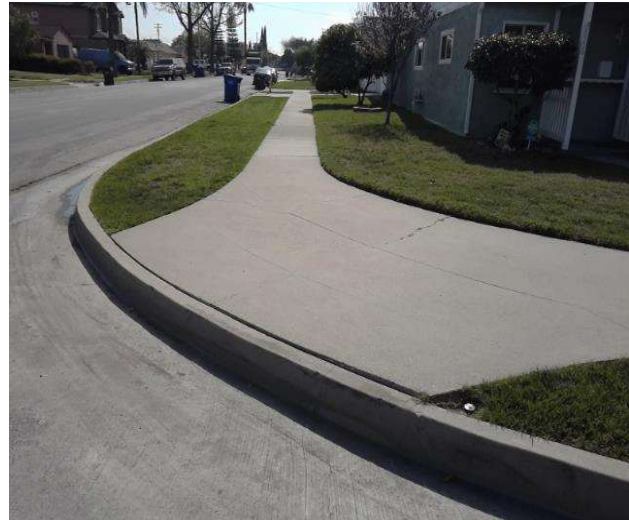
Sidewalks , Hazards & Gratings : Curb is on Path of Travel

Install curb ramp \$2,500

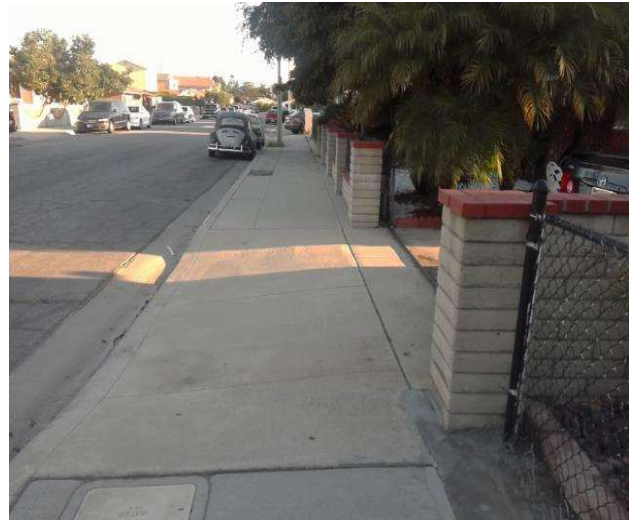
There is a change in elevation greater than recommended value.

Ensure that the change in elevation is within the recommended value.

Recommendation Up to 0.25 inches

Remove tripping hazards \$198

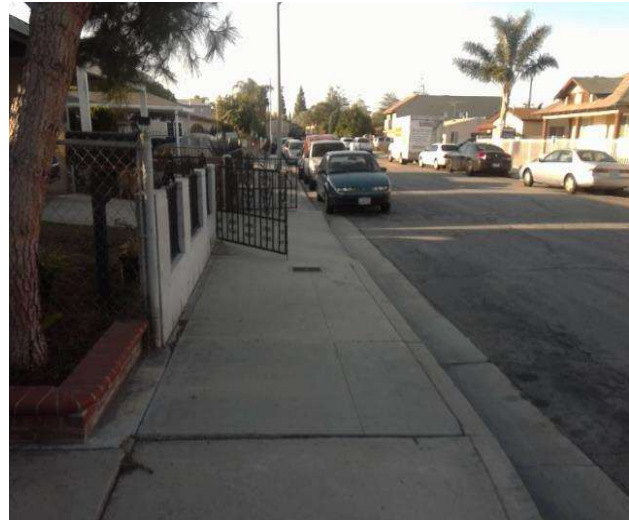
There is a change in elevation greater than recommended value.

Ensure that the change in elevation is within the recommended value.

Recommendation Up to 0.25 inches

Remove tripping hazards \$198

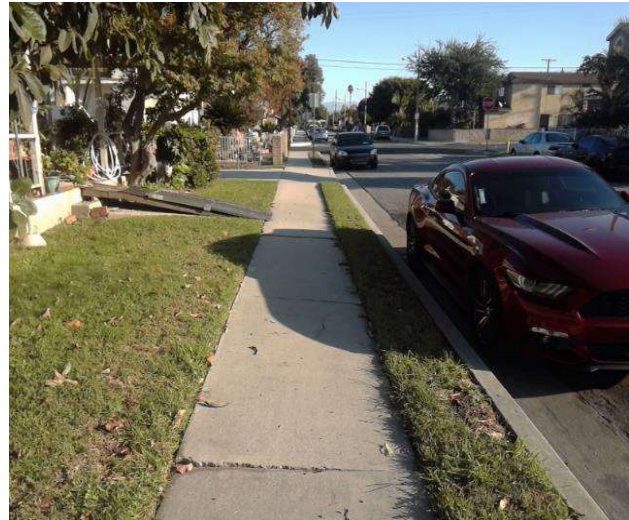
There is a change in elevation greater than recommended value.

Ensure that the change in elevation is within the recommended value.

Recommendation Up to 0.25 inches

Remove tripping hazards \$198

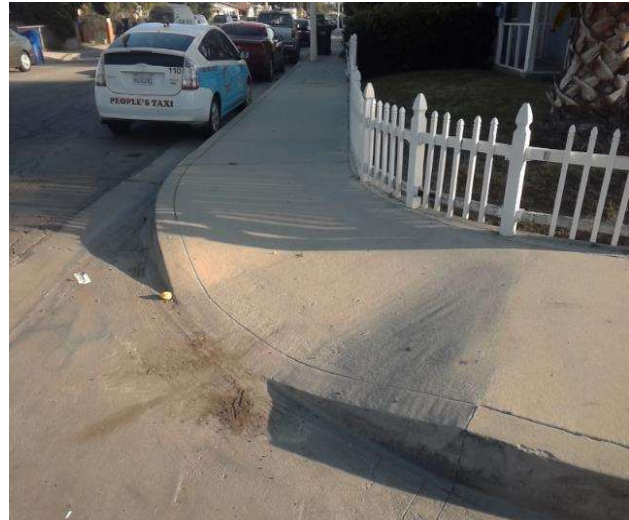
Curb Ramp , Landings and Transitions : Top Landing Clear Length - Landings

Recommendation At least 48.00 inches

Provide compliant landing \$240

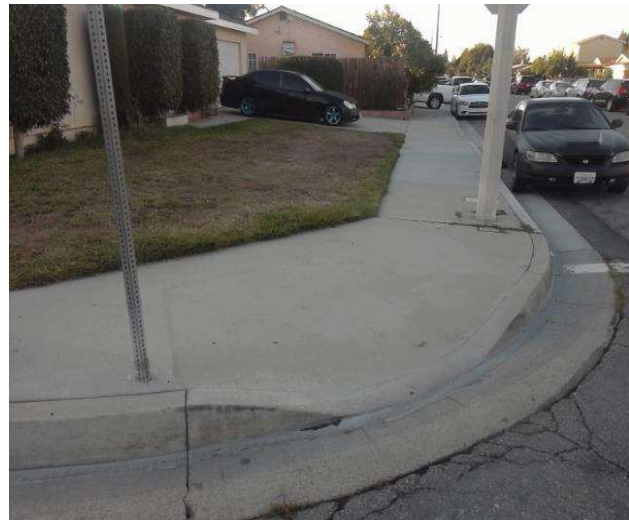
Curb Ramp , Landings and Transitions : Top Landing Clear Length - Landings

Recommendation At least 48.00 inches

Provide compliant landing \$240

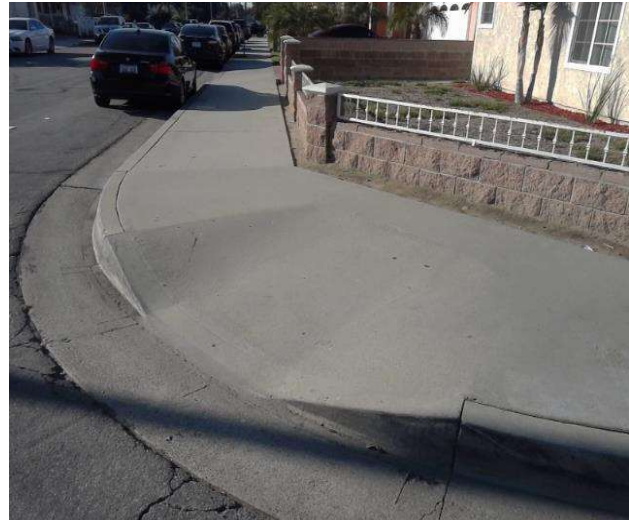
Curb Ramp , Landings and Transitions : Top Landing Clear Length - Landings

Recommendation At least 48.00 inches

Provide compliant landing \$240

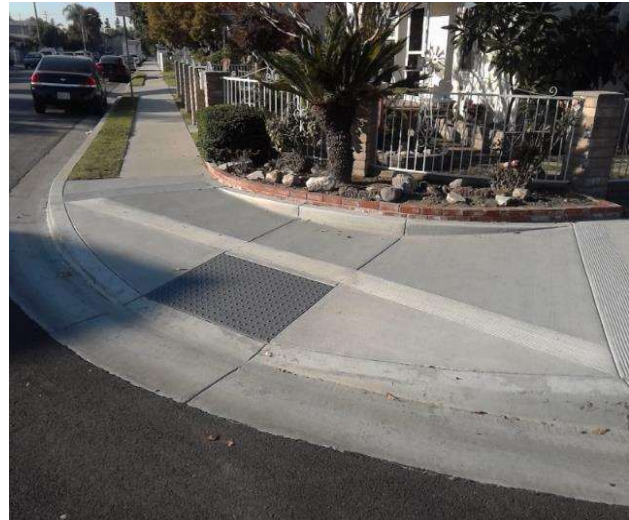
Curb Ramp , Landings and Transitions : Top Landing Clear Length - Landings

Recommendation At least 48.00 inches

Provide compliant landing \$240

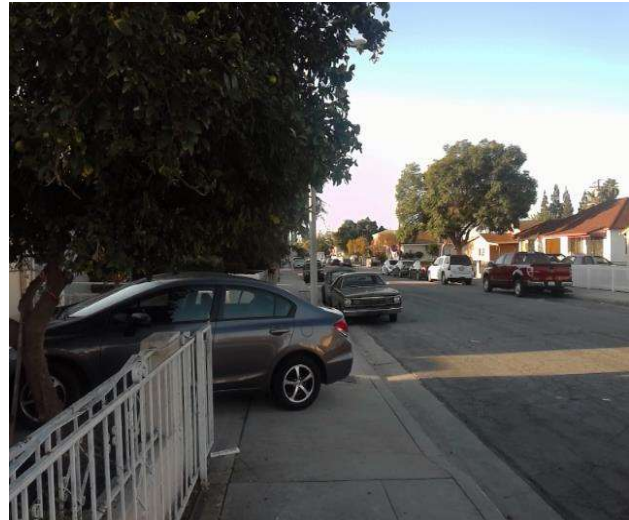
Sidewalks , Hazards & Gratings : Overhead Obstruction Height

Recommendation At least 80.00 inches

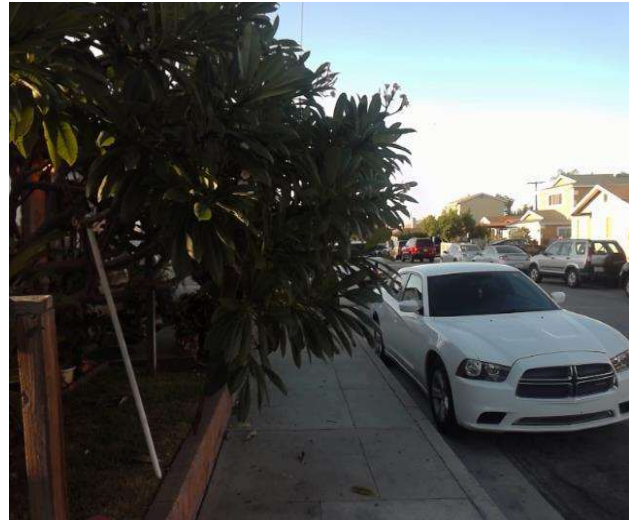
Sidewalks , Hazards & Gratings : Overhead Obstruction Height

Recommendation At least 80.00 inches

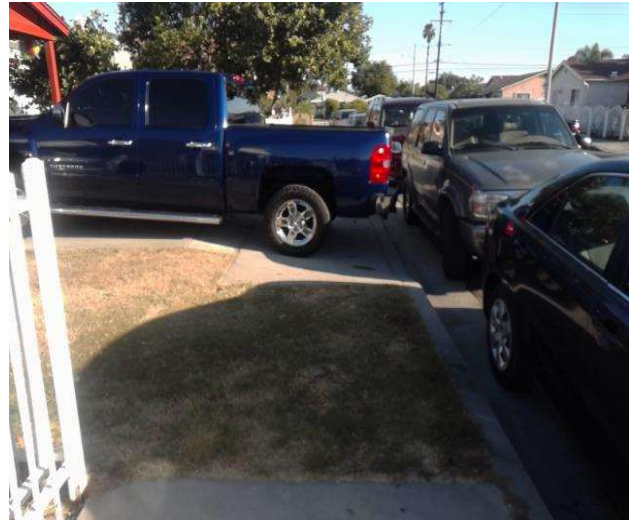
Sidewalks : Missing Sidewalk

Section of sidewalk is missing and consists of dirt, grass or gravel.

Provide a compliant sidewalk for the missing section.

\$1,260

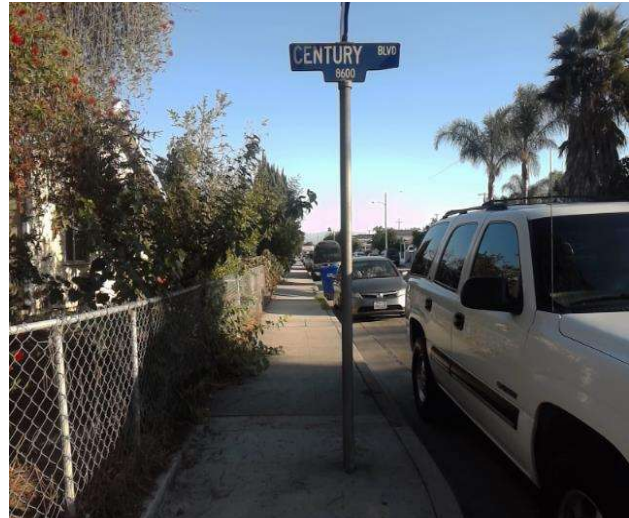
Sidewalks , Hazards & Gratings : Sidewalk Width at Obstruction

Sidewalk width at the obstruction shall have the recommended value.

Recommendation At least 48.00 inches

\$1,260

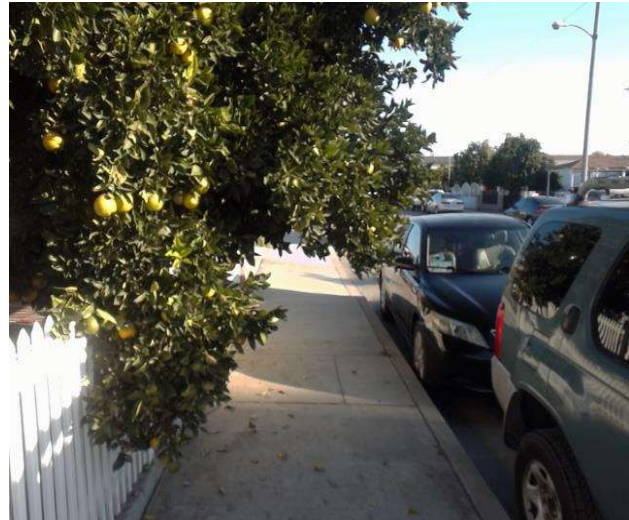
Sidewalks , Hazards & Gratings : Overhead Obstruction Height

Recommendation At least 80.00 inches

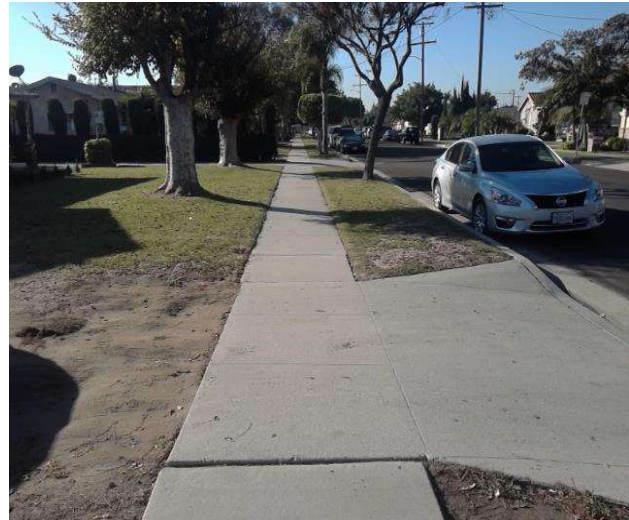
There is a change in elevation greater than recommended value.

Ensure that the change in elevation is within the recommended value.

Recommendation Up to 0.25 inches

Remove tripping hazards \$198

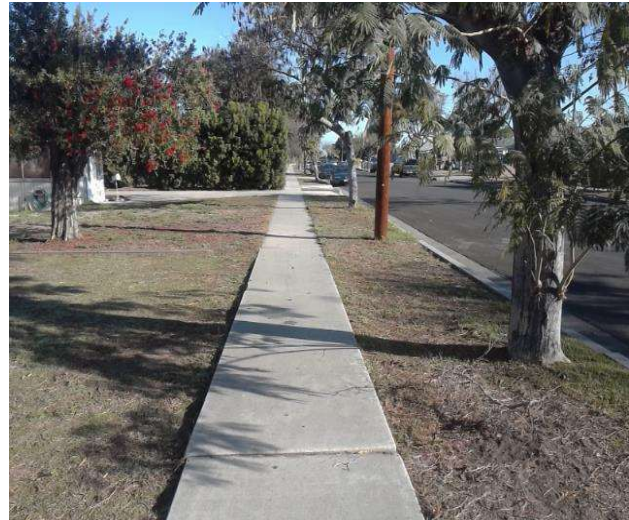
There is a change in elevation greater than recommended value.

Ensure that the change in elevation is within the recommended value.

Recommendation Up to 0.25 inches

Remove tripping hazards \$198

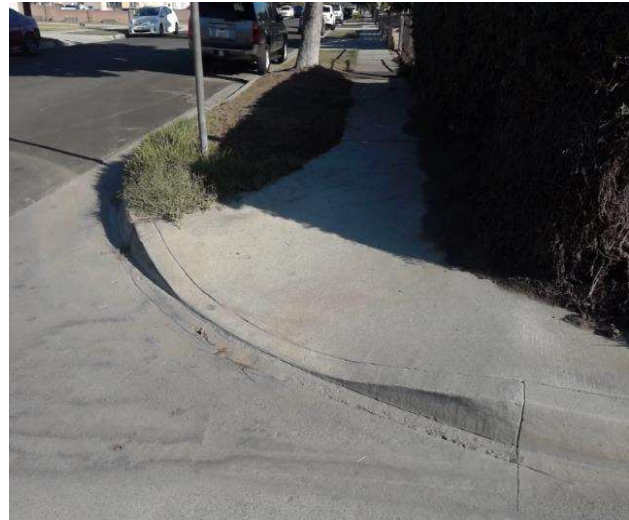
Curb Ramp , Landings And Transitions : Bottom Landing Change in Level

Recommendation Up to 0.50 inches

Patch lip at curb ramp \$255

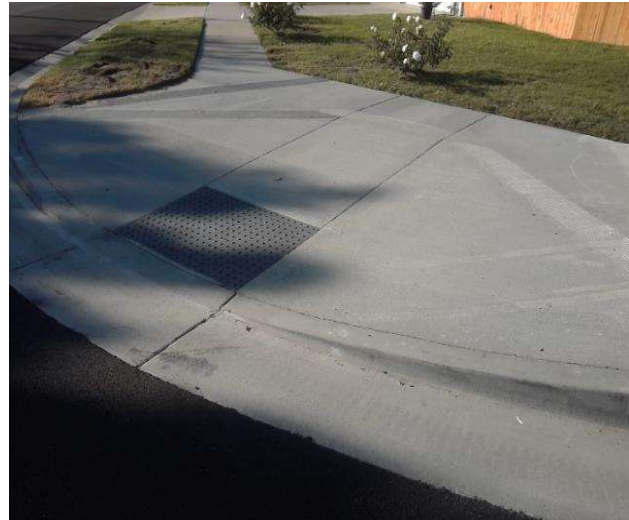
Curb Ramp , Landings and Transitions : Top Landing Clear Length - Landings

Recommendation At least 48.00 inches

Provide compliant landing \$240
