Accessibility Survey

City of Downey Blodgett Avenue - Cheyenne Street To Adoree Street

Date of Inspection
4/7/2017

Disability Access Consultants

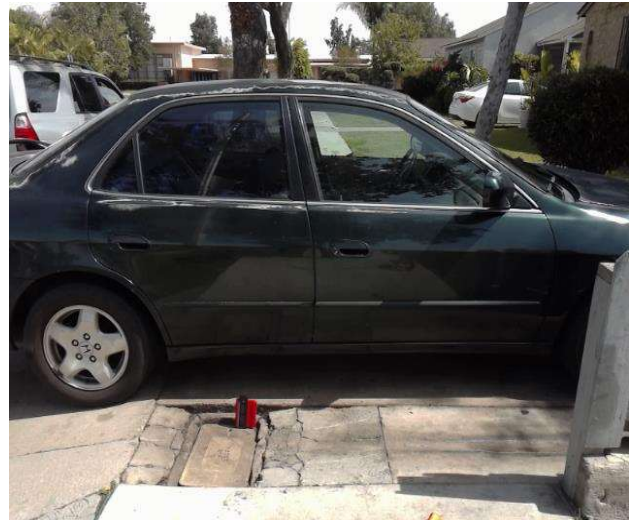
Change In Level North Of Cheyenne Street @ 33.914056570333, -118.141612261534

Sidewalks , Change in Level : Change in Level Non Beveled

There is a change in elevation greater than recommended value.

On-Site Finding 4.00 inches

Ensure that the change in elevation is within the recommended value.

Recommendation Up to 0.25 inches

Remove tripping hazards \$198

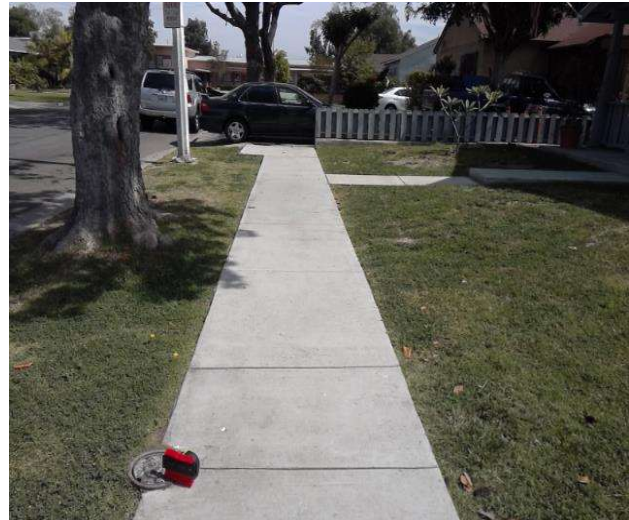
Change In Level North Of Cheyenne Street @ 33.913940823488, -118.141688704491

Sidewalks , Change in Level : Change in Level Non Beveled

There is a change in elevation greater than recommended value.

On-Site Finding 0.37 inches

Ensure that the change in elevation is within the recommended value.

Recommendation Up to 0.25 inches

Remove tripping hazards \$198

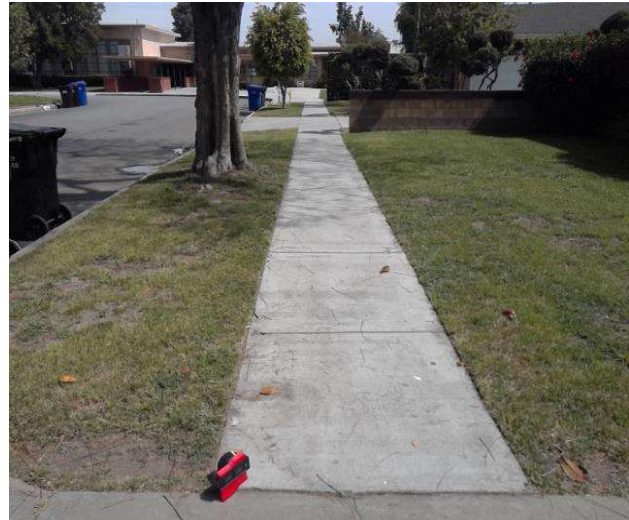
Change In Level North Of Cheyenne Street @ 33.914189011242, -118.141513019800

Sidewalks , Change in Level : Change in Level Non Beveled

There is a change in elevation greater than recommended value.

On-Site Finding 0.37 inches

Ensure that the change in elevation is within the recommended value.

Recommendation Up to 0.25 inches

Remove tripping hazards \$198

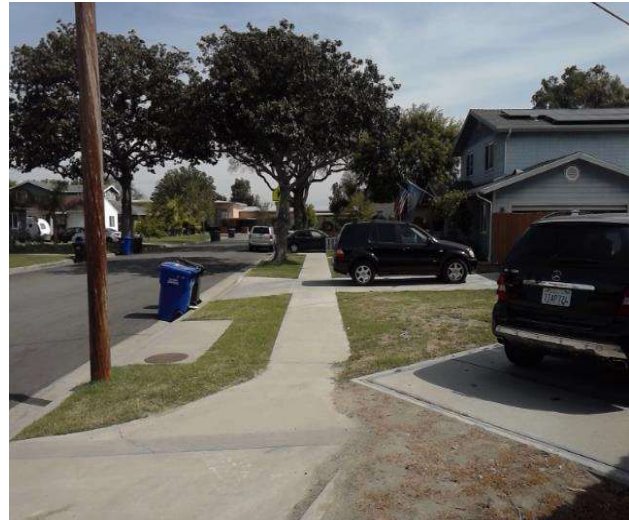
East Side @ 33.913840657823, -118.141762465239

Sidewalks : 60X60 Turn Area

There is no 60X60 turn area at every 200 feet.

On-Site Finding Not Found

Provide a 60X60 turn every 200 feet on the sidewalk.

\$2,400

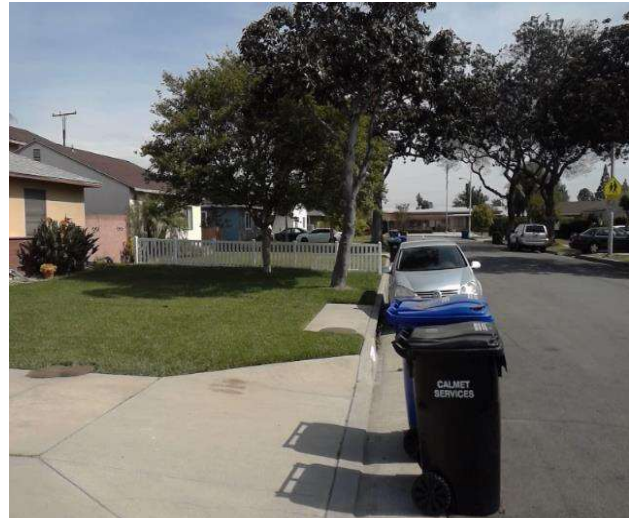
West Side @ 33.913915225607, -118.141901940107

Sidewalks : No Sidewalk

No sidewalk exists at the location.

No action necessary until a sidewalk is provided.

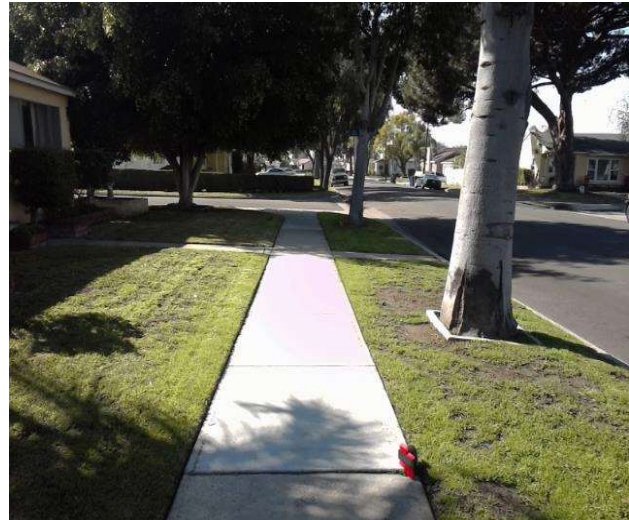
Change In Level South Of Alameda Street @ 33.924150426006, -118.135164231062

Sidewalks , Change in Level : Change in Level Non Beveled

There is a change in elevation greater than recommended value.

On-Site Finding 0.75 inches

Ensure that the change in elevation is within the recommended value.

Recommendation Up to 0.25 inches

Remove tripping hazards \$198

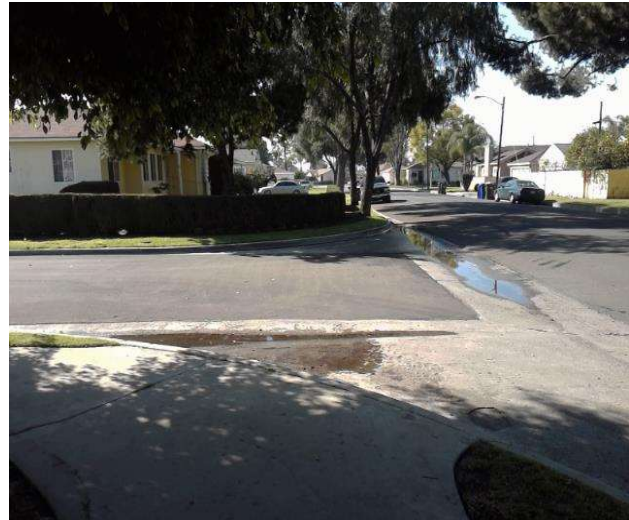
Melva Street East Crossing @ 33.923935651893, -118.135325163603

Sidewalks : Vehicular Traffic Slope

Slope at vehicular traffic is not compliant.

On-Site Finding 9.20 percent

Repave the surface to provide a compliant slope.

Recommendation Up to 5.00 percent

Repave surface \$1,092

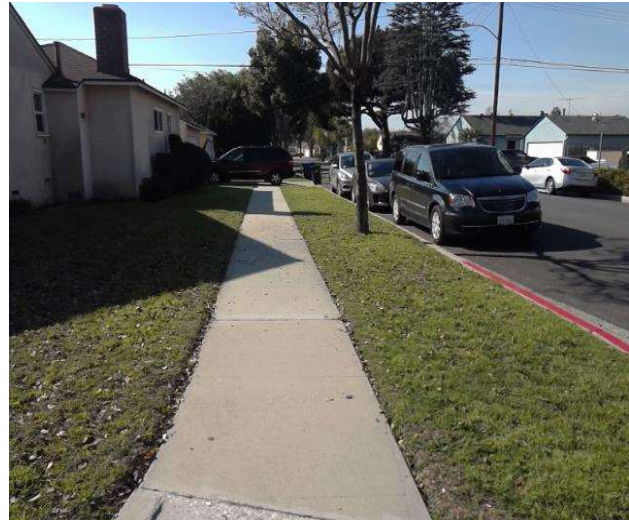
Sidewalk South Of Alameda Street @ 33.924478706635, -118.134913444519

Sidewalks : Width

Sidewalk does not have enough width.

On-Site Finding 47.00 inches for 80.00 feet

Widen the sidewalk to the recommended value.

Recommendation At least 48.00 inches

\$1,260

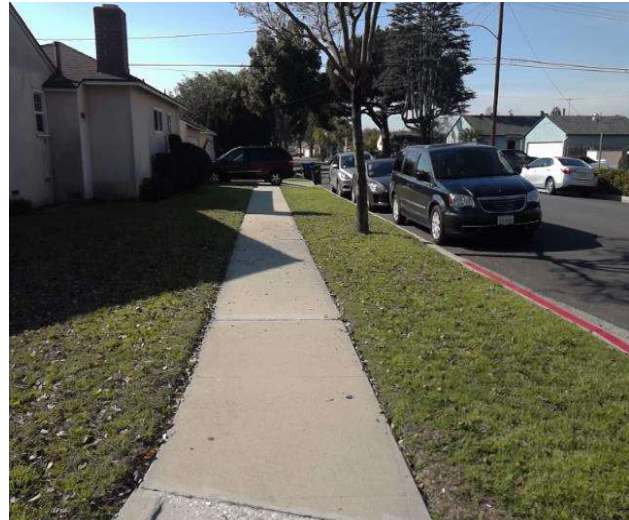
Sidewalk South Of Alameda Street @ 33.924478706635, -118.134913444519

Sidewalks , Surface : Cross Slope

Sidewalk cross slope is not compliant.

On-Site Finding 3.60 percent for 23.00 feet

Repave the sidewalk surface with the recommended cross slope.

Recommendation Up to 2.08 percent

Repave surface \$1,092

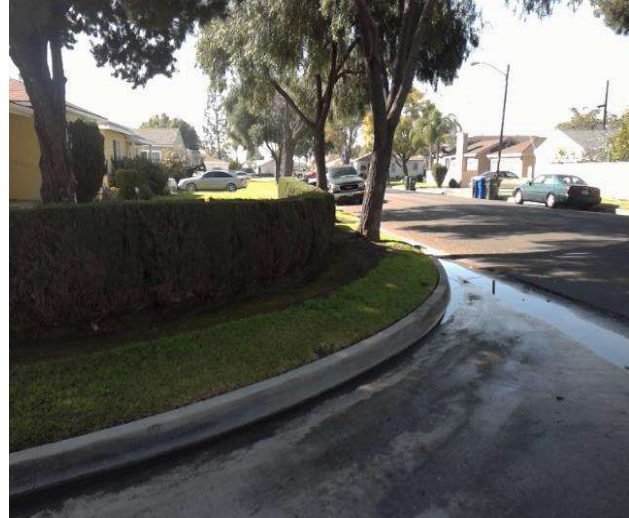
Sidewalk South Of Melva Street @ 33.923876672379, -118.135366737843

Sidewalks : Missing Sidewalk

Section of sidewalk is missing and consists of dirt, grass or gravel.

On-Site Finding 390.00 feet

Provide a compliant sidewalk for the missing section.

\$1,260

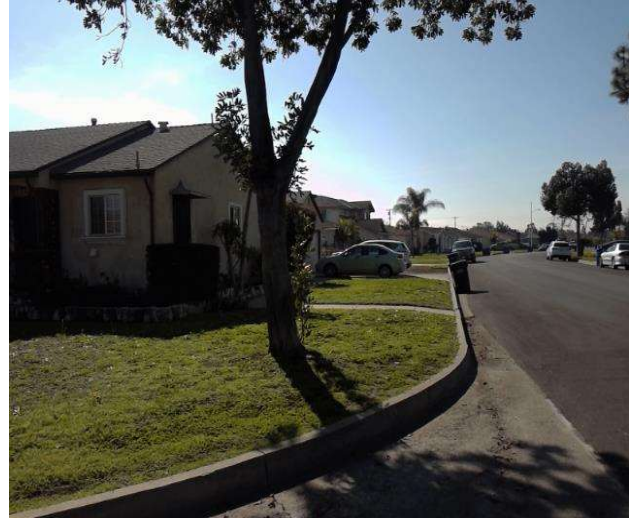
Sidewalks : Missing Sidewalk

Section of sidewalk is missing and consists of dirt, grass or gravel.

Provide a compliant sidewalk for the missing section.

\$1,260

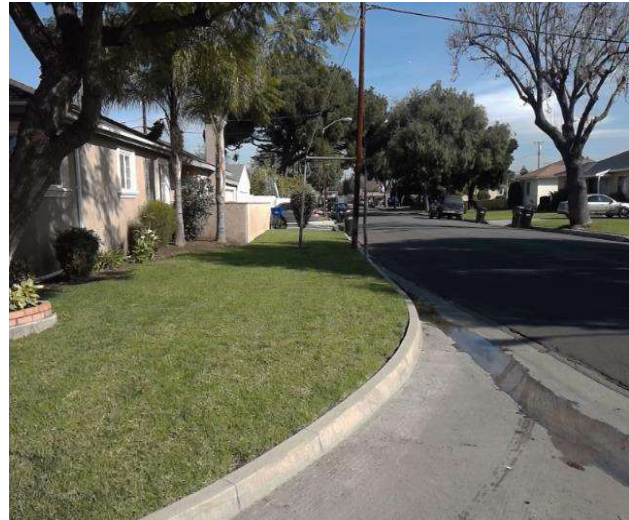
Sidewalks : Missing Sidewalk

Section of sidewalk is missing and consists of dirt, grass or gravel.

Provide a compliant sidewalk for the missing section.

\$1,260

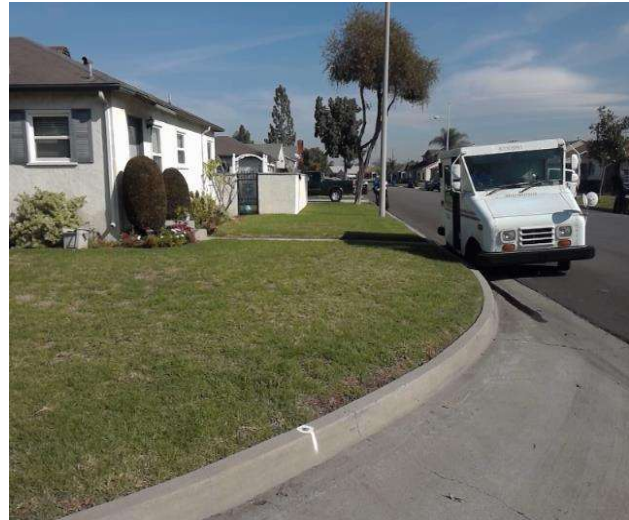
Sidewalks : Missing Sidewalk

Section of sidewalk is missing and consists of dirt, grass or gravel.

Provide a compliant sidewalk for the missing section.

\$1,260

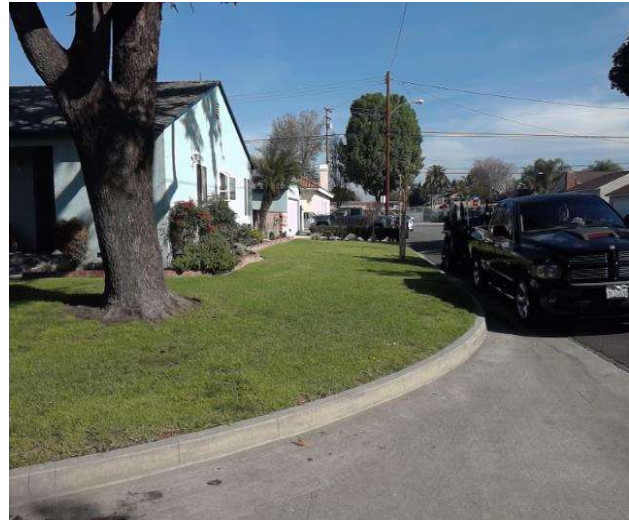
Sidewalks : Missing Sidewalk

Section of sidewalk is missing and consists of dirt, grass or gravel.

Provide a compliant sidewalk for the missing section.

\$1,260

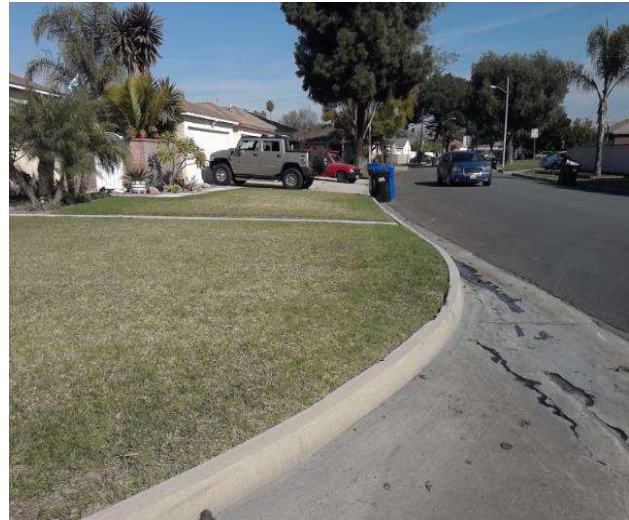
Sidewalks : Missing Sidewalk

Section of sidewalk is missing and consists of dirt, grass or gravel.

Provide a compliant sidewalk for the missing section.

\$1,260

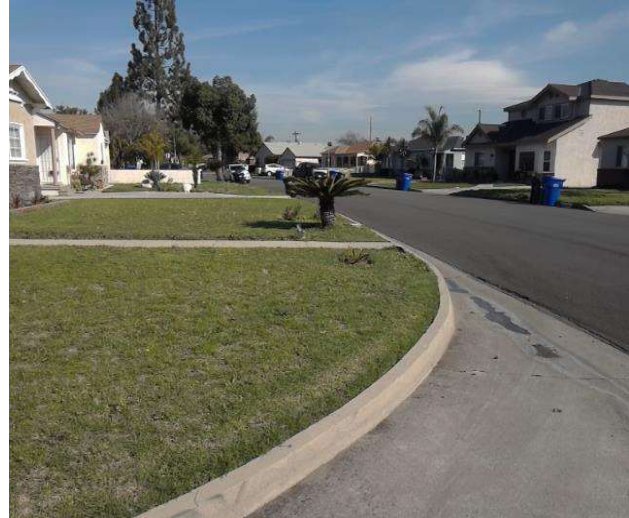
Sidewalks : Missing Sidewalk

Section of sidewalk is missing and consists of dirt, grass or gravel.

Provide a compliant sidewalk for the missing section.

\$1,260

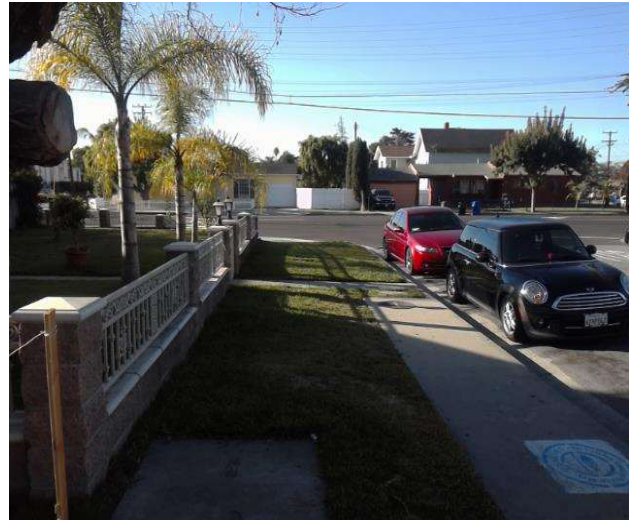
Sidewalks : Missing Sidewalk

Section of sidewalk is missing and consists of dirt, grass or gravel.

Provide a compliant sidewalk for the missing section.

\$1,260

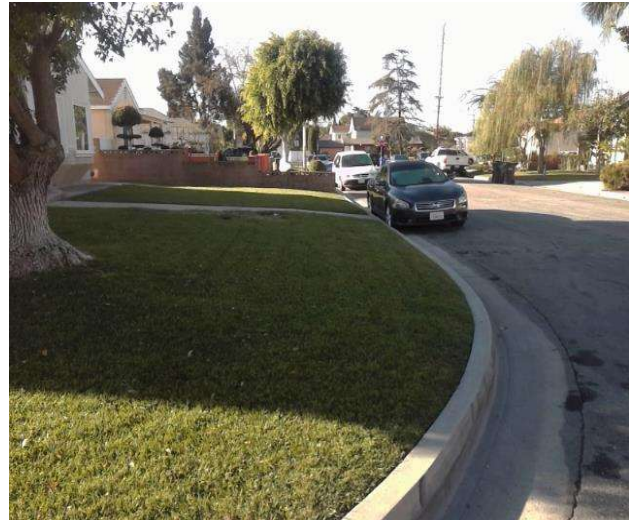
Sidewalks : Missing Sidewalk

Section of sidewalk is missing and consists of dirt, grass or gravel.

Provide a compliant sidewalk for the missing section.

\$1,260

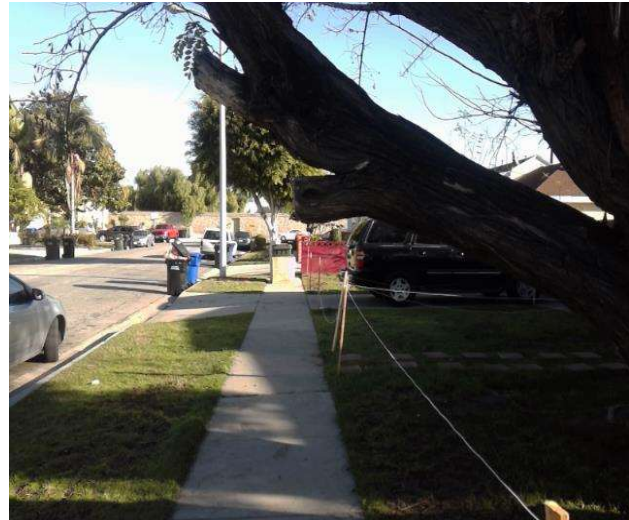
Sidewalks , Hazards & Gratings : Overhead Obstruction Height

Recommendation At least 80.00 inches

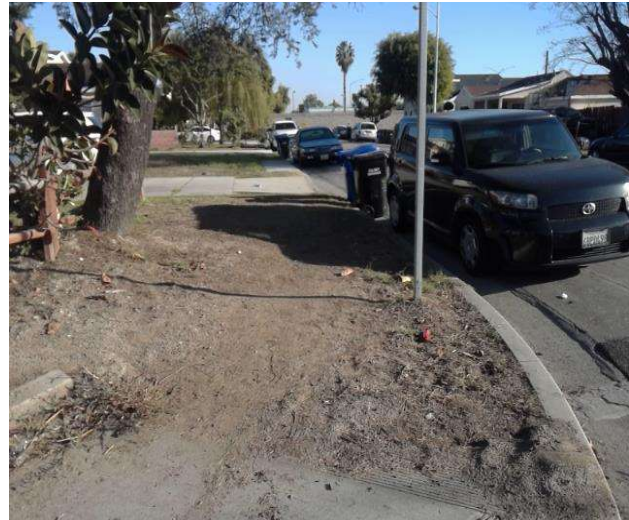
Sidewalks : Missing Sidewalk

Section of sidewalk is missing and consists of dirt, grass or gravel.

Provide a compliant sidewalk for the missing section.

\$1,260

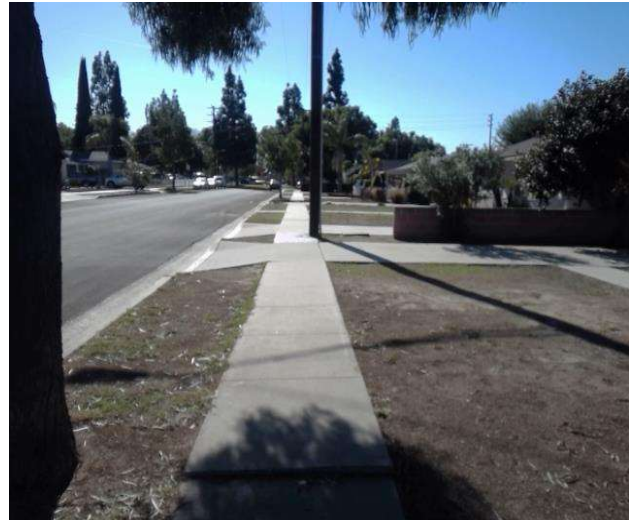
There is a change in elevation greater than recommended value.

Ensure that the change in elevation is within the recommended value.

Recommendation Up to 0.25 inches

Remove tripping hazards \$198

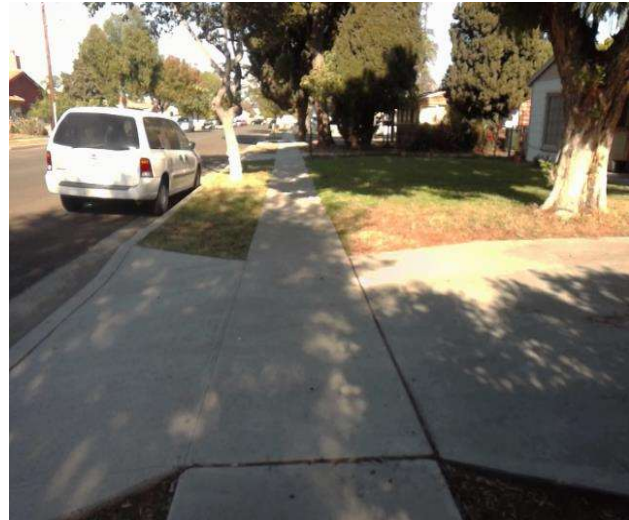
There is a change in elevation greater than recommended value.

Ensure that the change in elevation is within the recommended value.

Recommendation Up to 0.25 inches

Remove tripping hazards \$198

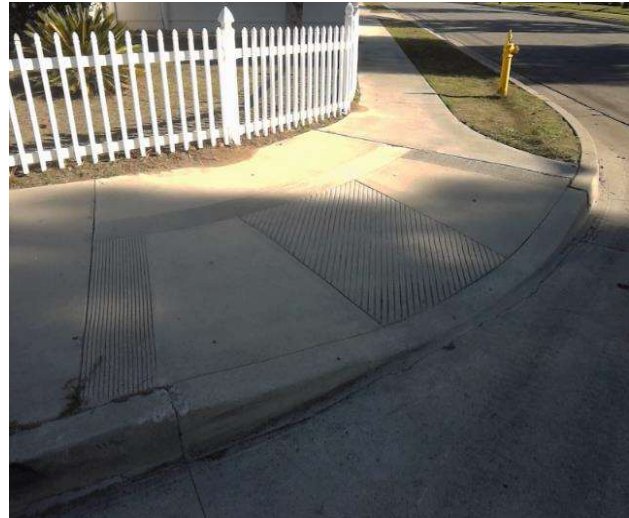
On-Site Finding Not Found

Provide detectable warning to surface \$248

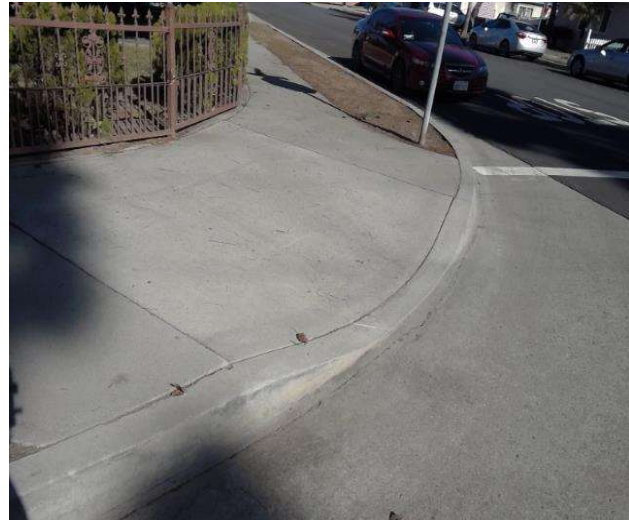
On-Site Finding Not Found

Provide detectable warning to surface \$248

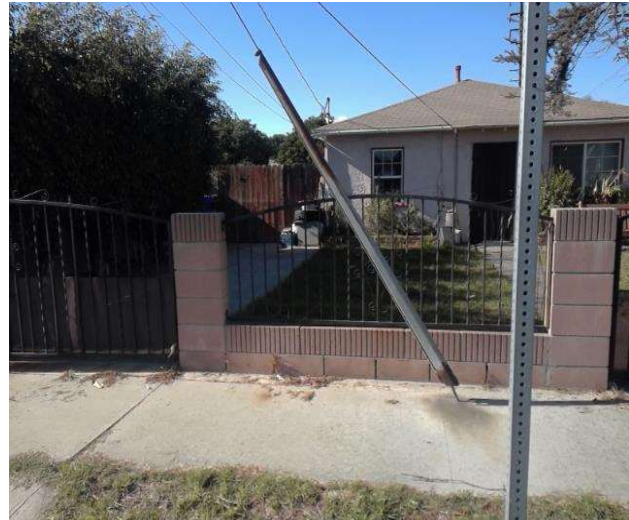
Sidewalks , Hazards & Gratings : Overhead Obstruction Height

Recommendation At least 80.00 inches

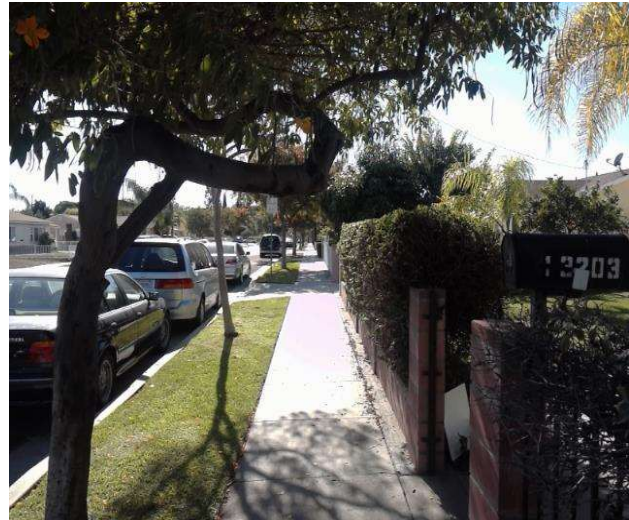
Sidewalks , Hazards & Gratings : Overhead Obstruction Height

Recommendation At least 80.00 inches

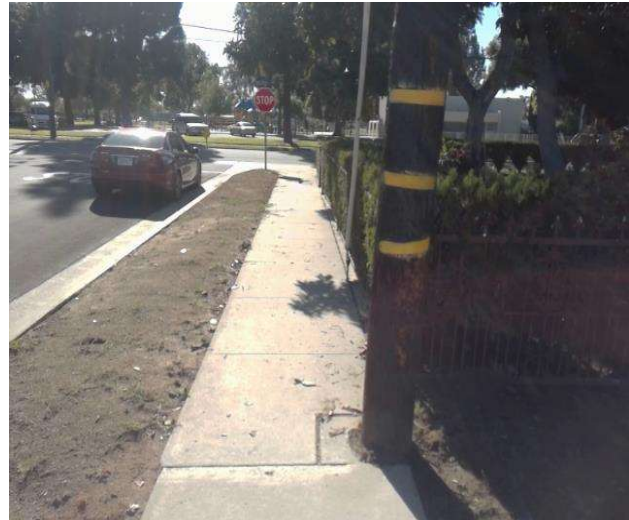
Sidewalks , Hazards & Gratings : Sidewalk Width at Obstruction

Sidewalk width at the obstruction shall have the recommended value.

Recommendation At least 48.00 inches

\$1,260

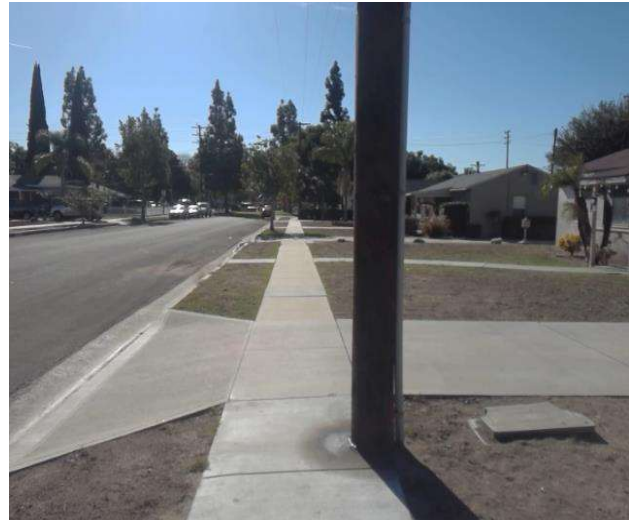
Sidewalks , Hazards & Gratings : Sidewalk Width at Obstruction

Sidewalk width at the obstruction shall have the recommended value.

Recommendation At least 48.00 inches

\$1,260

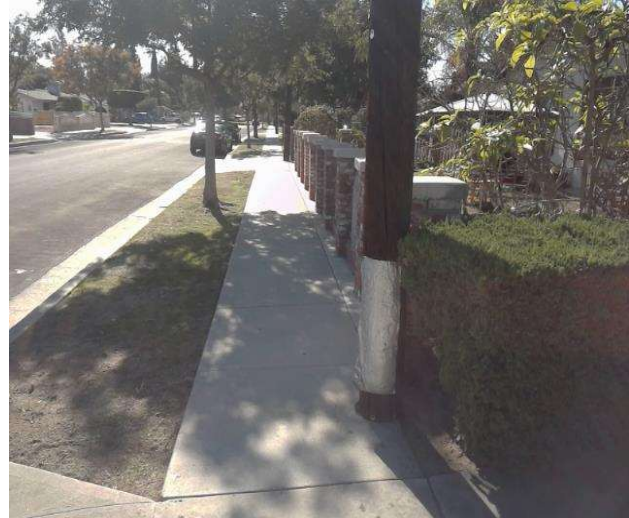
Sidewalks , Hazards & Gratings : Sidewalk Width at Obstruction

Sidewalk width at the obstruction shall have the recommended value.

Recommendation At least 48.00 inches

\$1,260

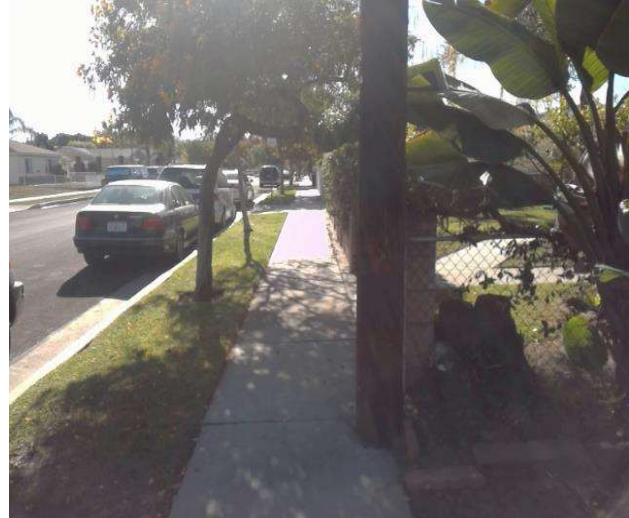
Sidewalks , Hazards & Gratings : Sidewalk Width at Obstruction

Sidewalk width at the obstruction shall have the recommended value.

Recommendation At least 48.00 inches

\$1,260

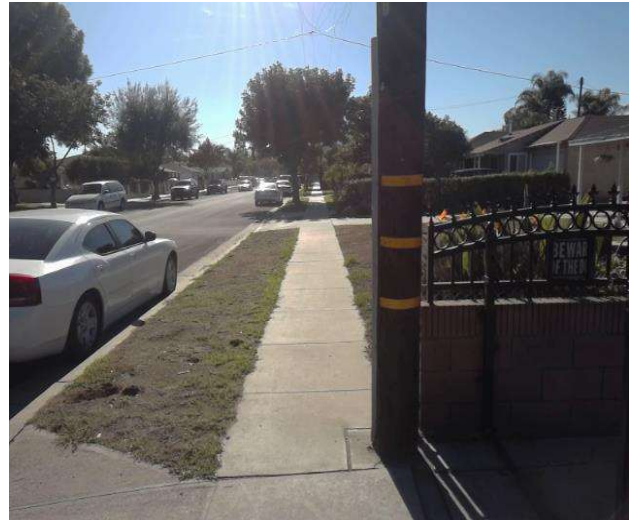
Sidewalks , Hazards & Gratings : Sidewalk Width at Obstruction

Sidewalk width at the obstruction shall have the recommended value.

Recommendation At least 48.00 inches

\$1,260

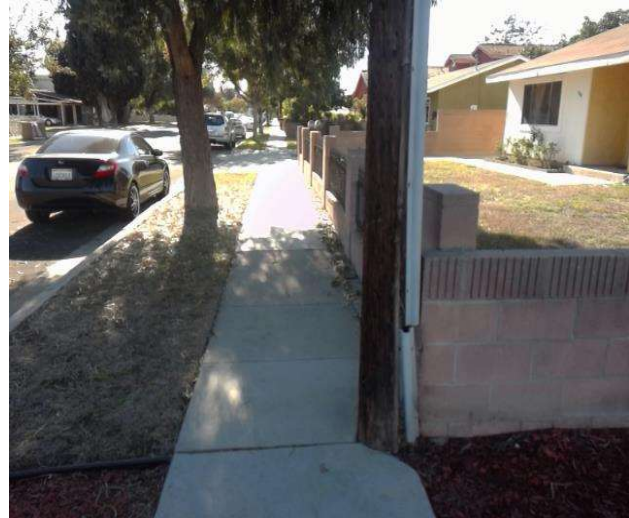
Sidewalks , Hazards & Gratings : Sidewalk Width at Obstruction

Sidewalk width at the obstruction shall have the recommended value.

Recommendation At least 48.00 inches

\$1,260

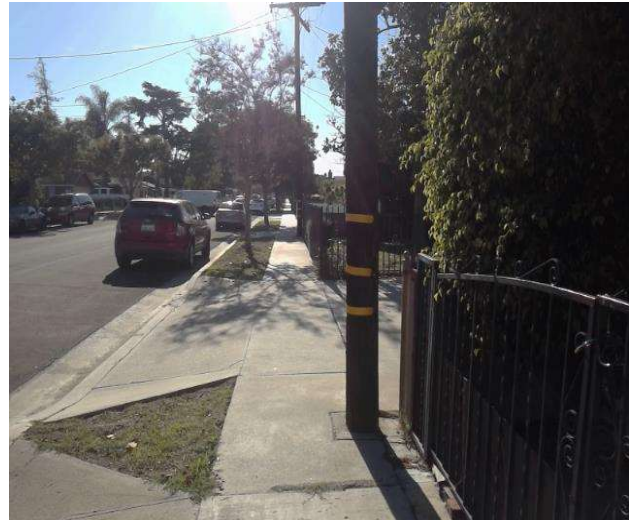
Sidewalks , Hazards & Gratings : Sidewalk Width at Obstruction

Sidewalk width at the obstruction shall have the recommended value.

Recommendation At least 48.00 inches

\$1,260
