Accessibility Survey

City of Downey Devenir Avenue - Paramount Boulevard To Downey Avenue

Date of Inspection
12/29/2016

Disability Access Consultants

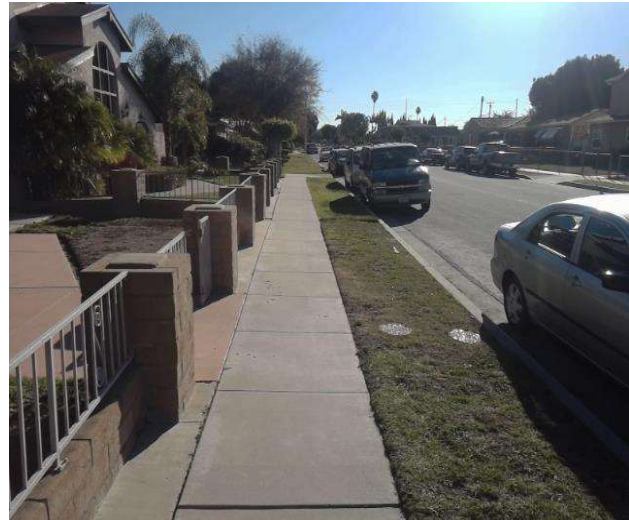
Change In Level East Of Brock Avenue @ 33.918995697851, -118.152809143066

Sidewalks , Change in Level : Change in Level Non Beveled

There is a change in elevation greater than recommended value.

On-Site Finding 0.50 inches

Code Reference ADA 206, 302

Ensure that the change in elevation is within the recommended value.

Recommendation Up to 0.25 inches

Remove tripping hazards \$198

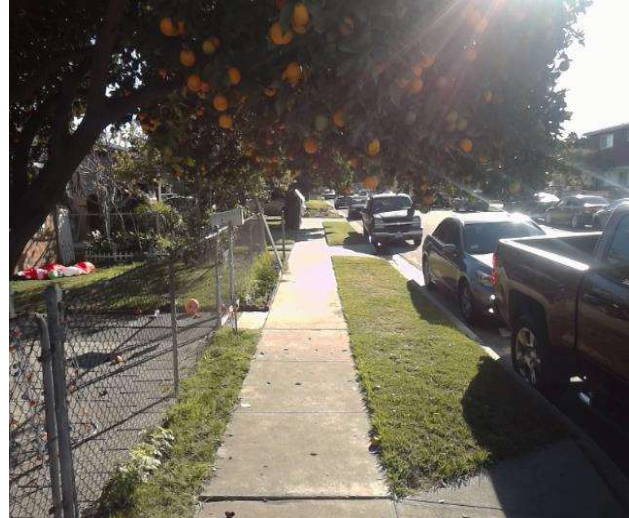
Change In Level East Of Gneiss Avenue @ 33.918230029415, -118.151312470436

Sidewalks , Change in Level : Change in Level Non Beveled

There is a change in elevation greater than recommended value.

On-Site Finding 0.50 inches

Code Reference ADA 206, 302

Ensure that the change in elevation is within the recommended value.

Recommendation Up to 0.25 inches

Remove tripping hazards \$198

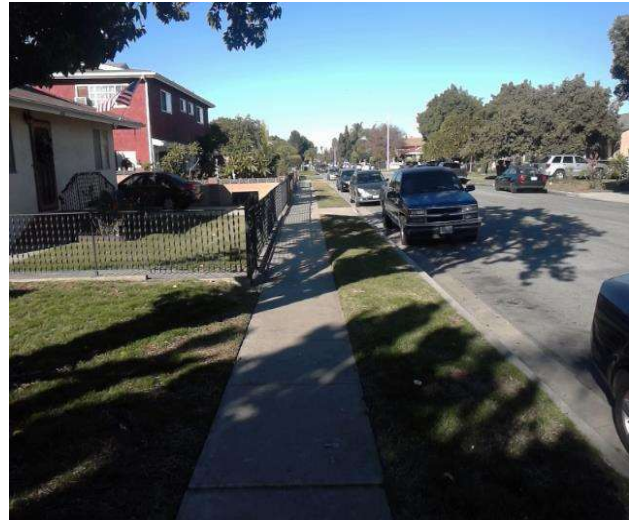
Change In Level West Of Downey Avenue @ 33.917967385751, -118.151167631149

Sidewalks , Change in Level : Change in Level Non Beveled

There is a change in elevation greater than recommended value.

On-Site Finding 0.75 inches

Code Reference ADA 206, 302

Ensure that the change in elevation is within the recommended value.

Recommendation Up to 0.25 inches

Remove tripping hazards \$198

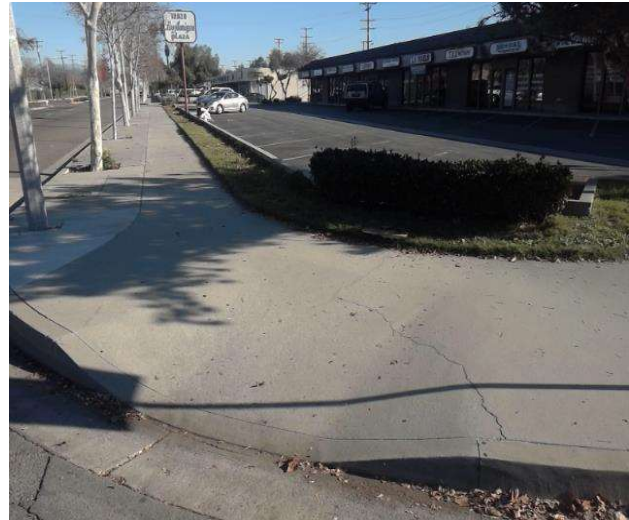
Northeast Corner Of Paramount Boulevard @ 33.919997288614, - 118.154820799828

Curb Ramp : No Detectable Warnings

The curb ramp does not provide a detectable warning surface which includes truncated domes.

On-Site Finding Not Found

Code Reference CA 11B-406.5.12

Provide compliant detectable warnings to surface.

Provide detectable warning to surface \$248

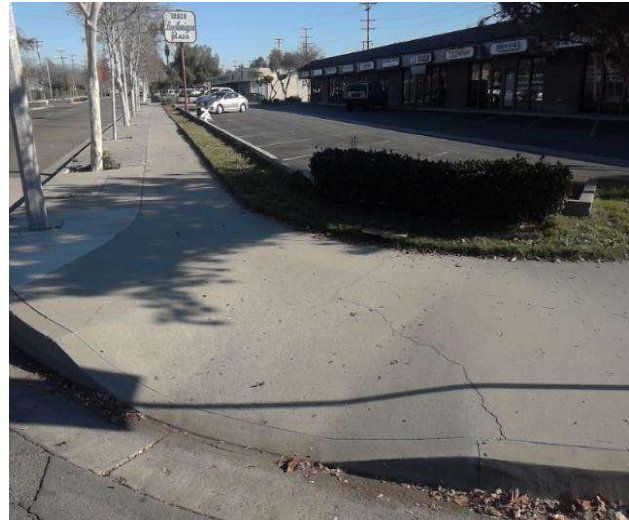
Northeast Corner Of Paramount Boulevard @ 33.919997288614, - 118.154820799828

Curb Ramp : Curb Ramp Slope

The running slope is greater than allowed.

On-Site Finding 9.50 percent

Code Reference ADA 406, 406.1, 405.2, CA 11B-406

Provide a compliant curb ramp.

Recommendation Up to 8.33 percent

Install curb ramp \$1,300

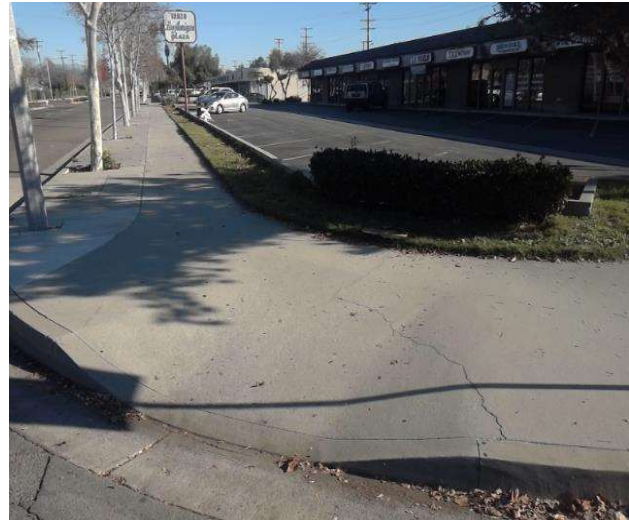
Northeast Corner Of Paramount Boulevard @ 33.919997288614, - 118.154820799828

Curb Ramp : Side Flare Slope

The slope of the curb ramp side flare is greater than allowed.

On-Site Finding 16.00 percent

Code Reference ADA 406, 406.3,CA 11B-406.2.2

Provide curb ramp side flares with a compliant slope.

Recommendation Up to 10.00 percent

Install flared sides \$1,300

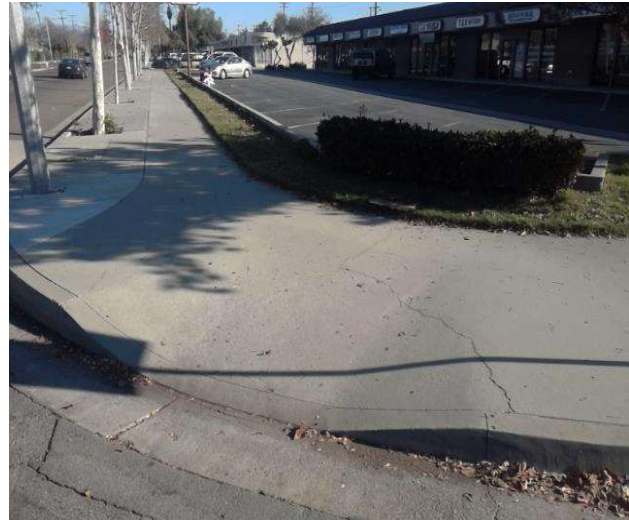
Northeast Corner Of Paramount Boulevard @ 33.919997288614, - 118.154820799828

Curb Ramp , Landings and Transitions : Bottom Landing Slope

The slope at the bottom landing is greater than allowed.

On-Site Finding 10.70 percent

Code Reference ADA 402, 406.4, 406.2, 403.3, 406.1, CA 11B-406.5.3

Provide a compliant bottom landing that does not exceed the maximum slope requirements.

Recommendation Up to 2.08 percent

Provide compliant landing \$240

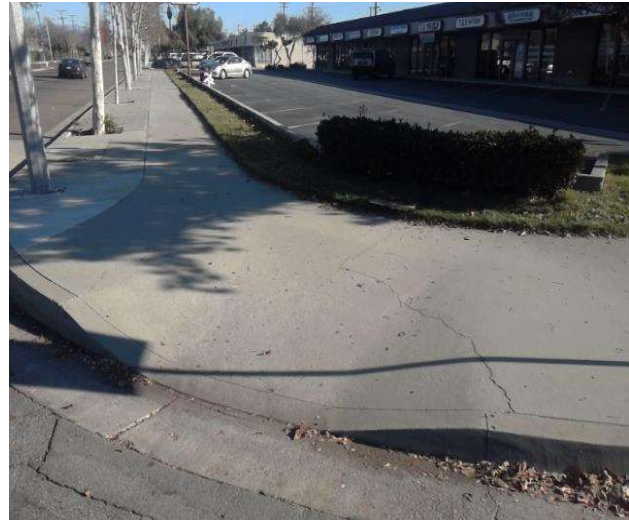
Northeast Corner Of Paramount Boulevard @ 33.919997288614, - 118.154820799828

Curb Ramp , Landings and Transitions : Top Landing Slope

The slope at the top landing is greater than allowed.

On-Site Finding 3.00 percent

Code Reference ADA 402, 406.4, 403.3, 406.1, CA 11B-406.5.3

Provide a top landing surface that does not exceed the maximum slope and cross slope. Provide a sufficient maneuvering clearance that does not accumulate water.

Recommendation Up to 2.08 percent

Provide compliant landing \$1,260

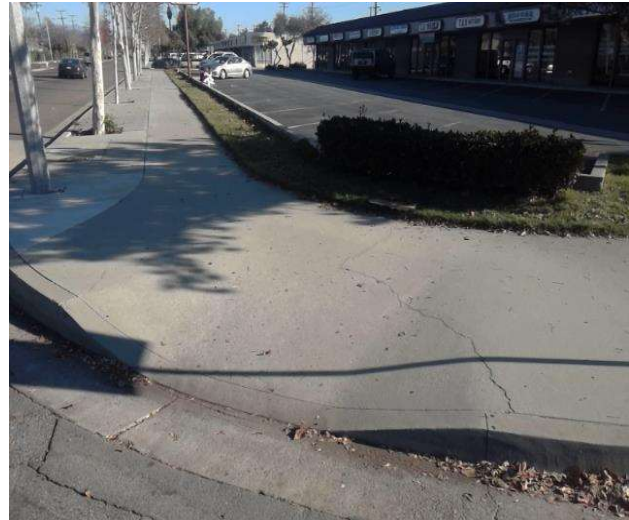
Northeast Corner Of Paramount Boulevard @ 33.919997288614, - 118.154820799828

There is not enough top landing clear length.

On-Site Finding 36.00 inches

Curb Ramp , Landings and Transitions : Top Landing Clear Length - Landings

Code Reference ADA 406, 406.4,CA 11B-406.5.3

Provide a level top landing with enough clear length.

Recommendation At least 48.00 inches

Provide compliant landing \$240

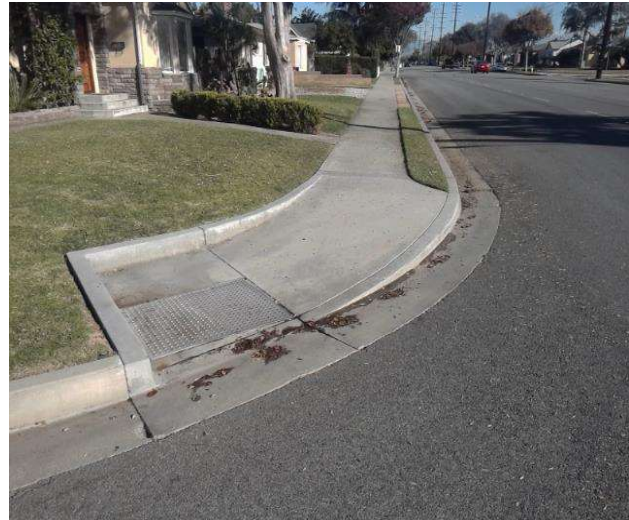
Northwest Corner Of Downey Avenue @ 33.917526676766, - 118.149912357330

Curb Ramp , Landings and Transitions : Bottom Landing Slope

The slope at the bottom landing is greater than allowed.

Code Reference ADA 402, 406.4, 406.2, 403.3, 406.1, CA 11B-406.5.3

Recommendation Up to 2.08 percent

Provide compliant landing \$240

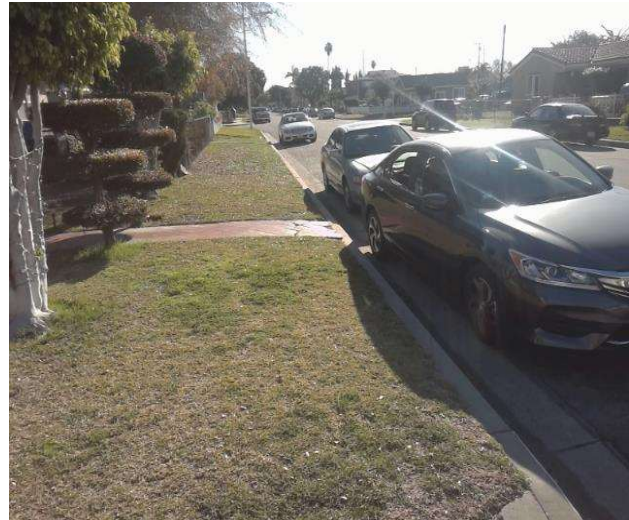
Sidewalks : Missing Sidewalk

Section of sidewalk is missing and consists of dirt, grass or gravel.

Provide a compliant sidewalk for the missing section.

\$1,260

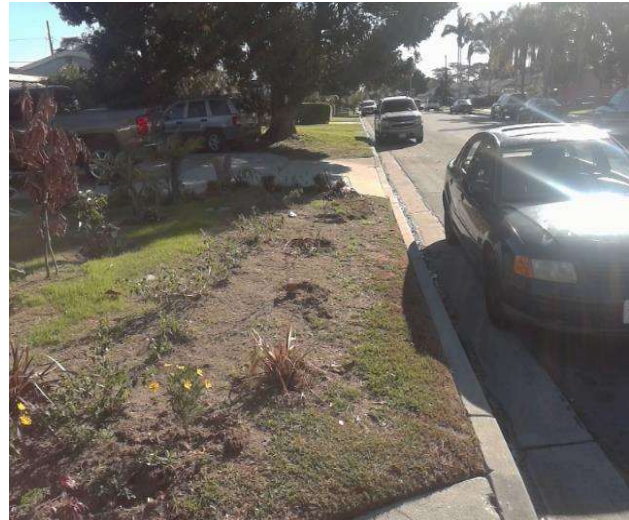
Sidewalks : Missing Sidewalk

Section of sidewalk is missing and consists of dirt, grass or gravel.

Provide a compliant sidewalk for the missing section.

\$1,260

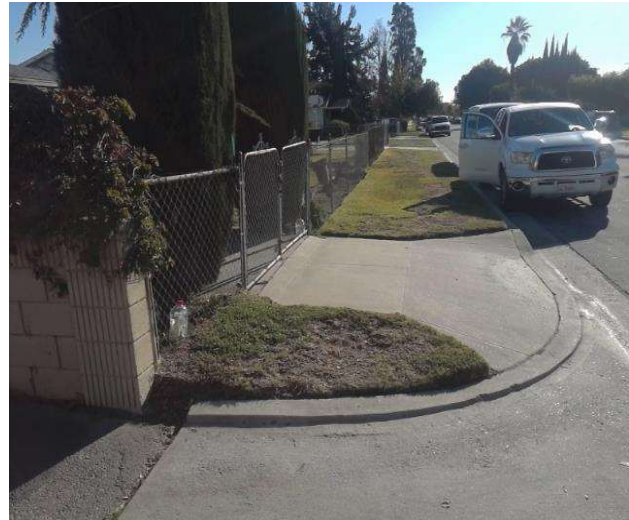
Sidewalks : Missing Sidewalk

Section of sidewalk is missing and consists of dirt, grass or gravel.

Provide a compliant sidewalk for the missing section.

\$1,260

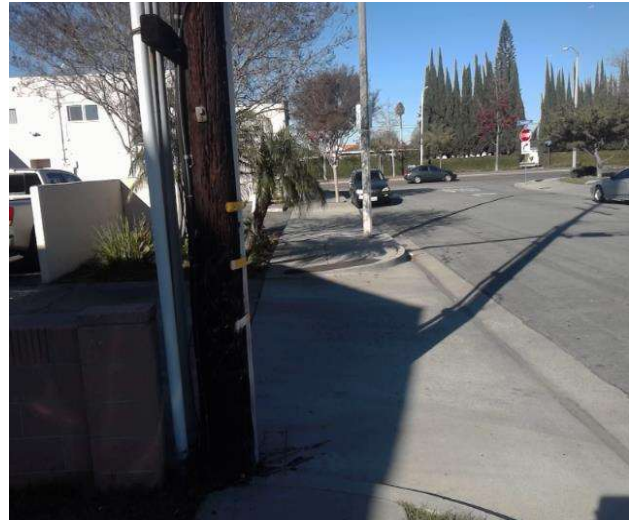
Sidewalks , Hazards & Gratings : Sidewalk Width at Obstruction

Code Reference ADA 206, 302, 403.5.1, CA 11B-403.5

Sidewalk width at the obstruction shall have the recommended value.

Recommendation At least 48.00 inches

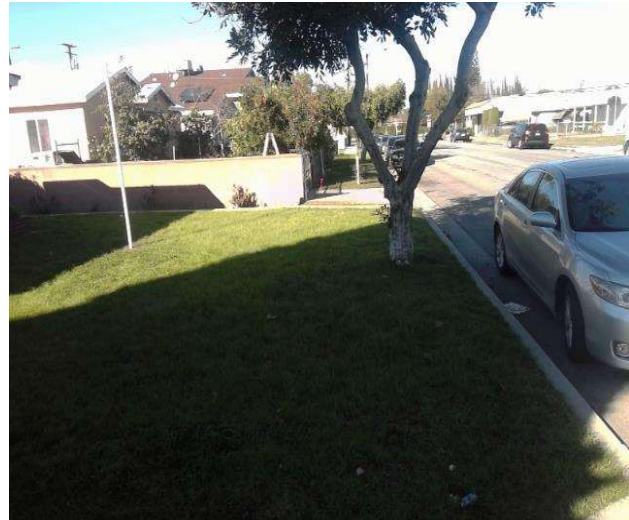
Sidewalks : Missing Sidewalk

Section of sidewalk is missing and consists of dirt, grass or gravel.

Provide a compliant sidewalk for the missing section.

\$1,260

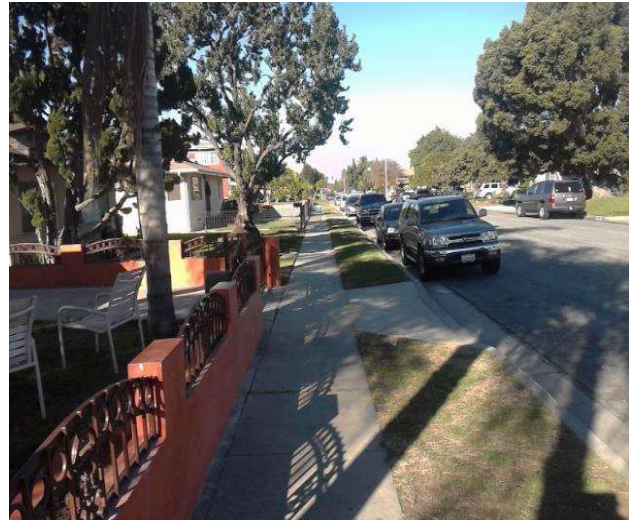
Code Reference ADA 206, 302,CA 11B-403.3

Repave the sidewalk surface with the recommended cross slope.

Recommendation Up to 2.08 percent

Repave surface \$1,092

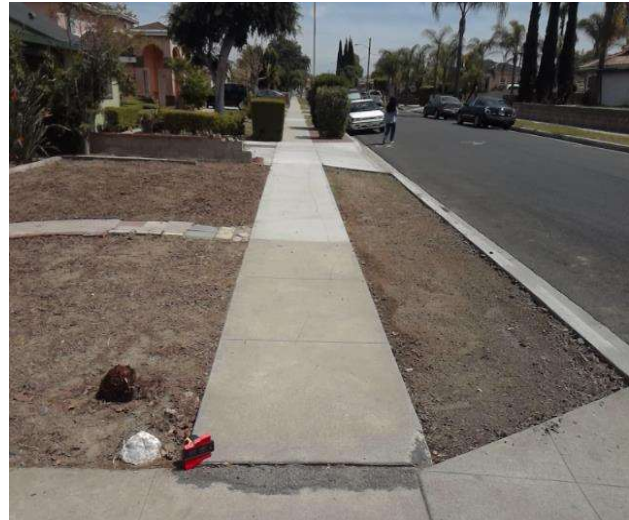
There is a change in elevation greater than recommended value.

Ensure that the change in elevation is within the recommended value.

Recommendation Up to 0.25 inches

Remove tripping hazards \$198

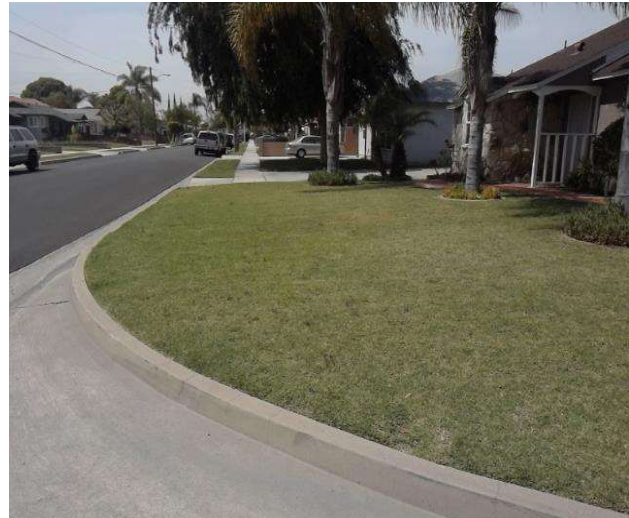
Sidewalks : Missing Sidewalk

Section of sidewalk is missing and consists of dirt, grass or gravel.

Provide a compliant sidewalk for the missing section.

\$1,260

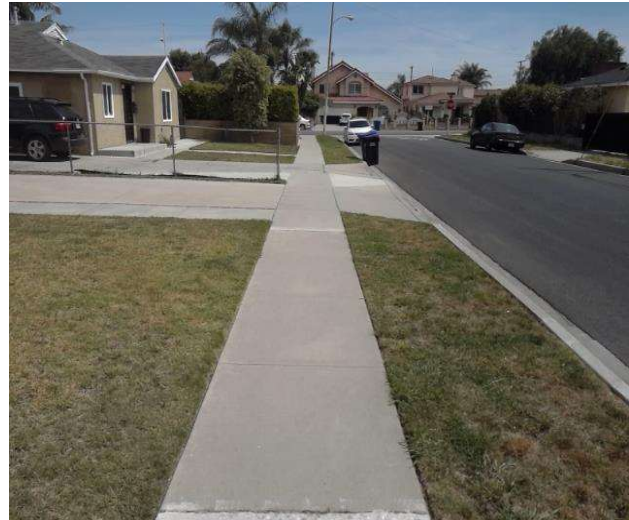
Code Reference ADA 206, 302, CA 11B-403.5.1

Widen the sidewalk to the recommended value.

Recommendation At least 48.00 inches

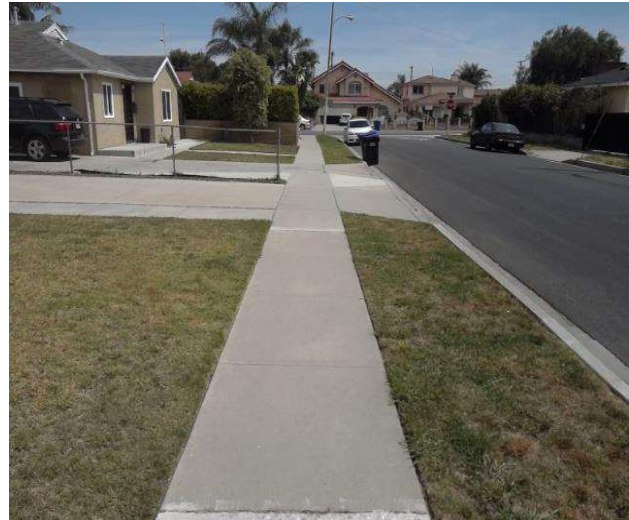
Code Reference ADA 206, 302, CA 11B-403.3

Repave the sidewalk surface with the recommended cross slope.

Recommendation Up to 2.08 percent

Repave surface \$1,092

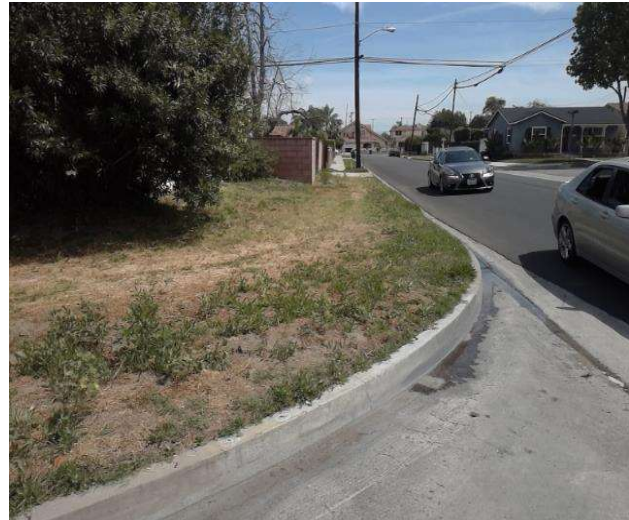
Sidewalks : Missing Sidewalk

Section of sidewalk is missing and consists of dirt, grass or gravel.

Provide a compliant sidewalk for the missing section.

\$1,260

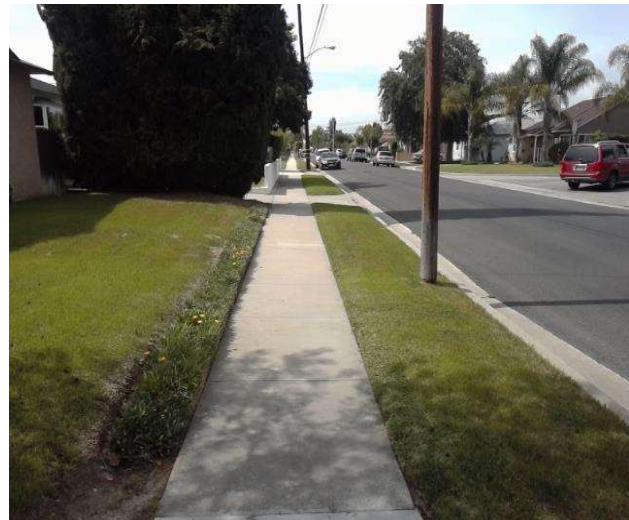
Code Reference ADA 206, 302,CA 11B-403.3

Repave the sidewalk surface with the recommended cross slope.

Recommendation Up to 2.08 percent

Repave surface \$1,092

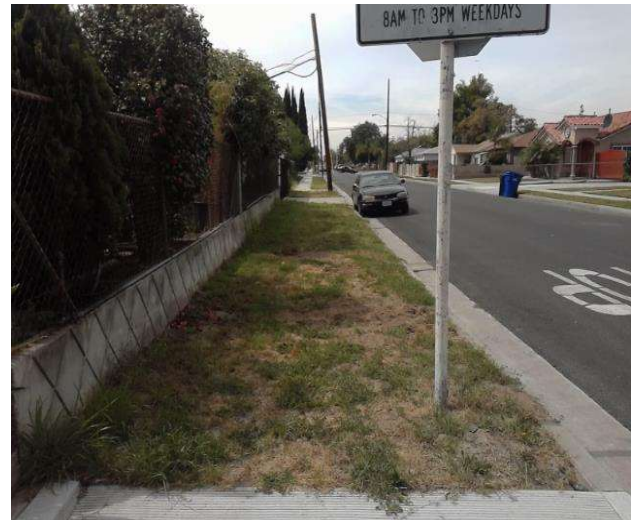
Sidewalks : Missing Sidewalk

Section of sidewalk is missing and consists of dirt, grass or gravel.

Provide a compliant sidewalk for the missing section.

\$1,260
