Accessibility Survey

City of Downey La Villa Street - Downey Avenue to Cul-De-Sac

Date of Inspection
7/26/2017

Prepared By
Disability Access Consultants
(800) 743-7067

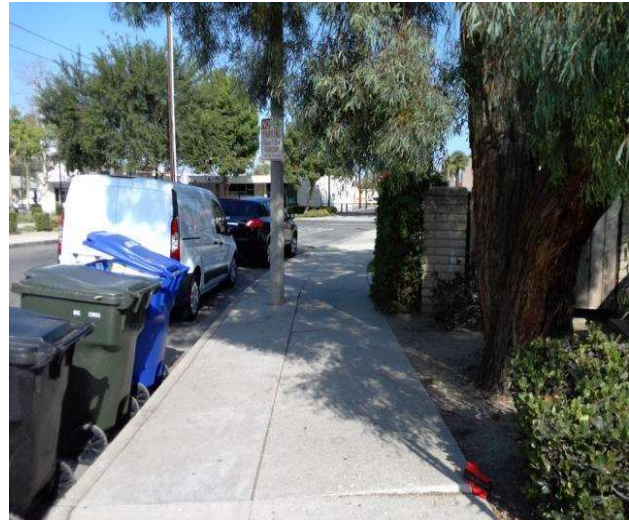
Change in Level East of Downey Avenue @ 33.943028401016, -118.130363076925

Sidewalks , Change in Level : Change in Level Non Beveled

There is a change in elevation greater than recommended value.

On-Site Finding 1.50 inches

Ensure that the change in elevation is within the recommended value.

Recommendation Up to 0.25 inches

Remove tripping hazards \$198

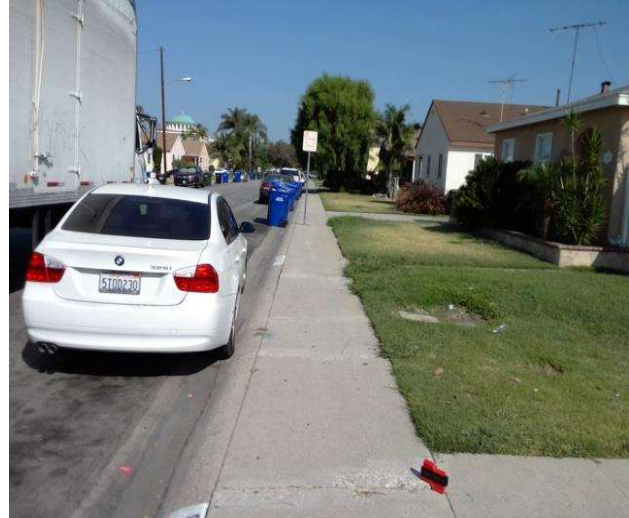
Change in Level East of Downey Avenue @ 33.942199531460, -118.128551244736

Sidewalks , Change in Level : Change in Level Non Beveled

There is a change in elevation greater than recommended value.

On-Site Finding 1.00 inches

Ensure that the change in elevation is within the recommended value.

Recommendation Up to 0.25 inches

Remove tripping hazards \$198

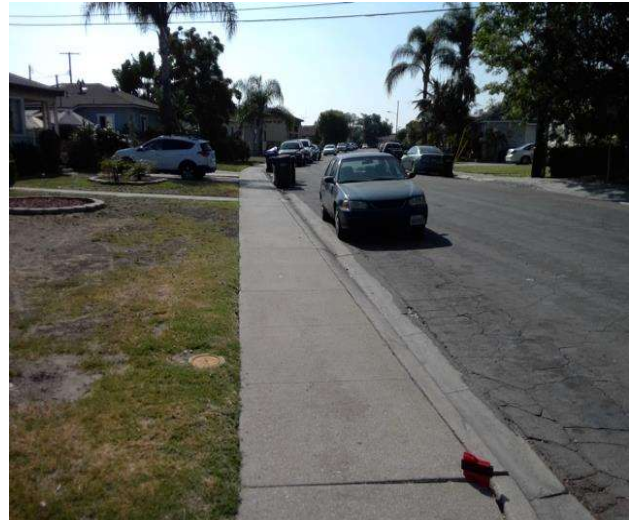
Change in Level East of Downey Avenue @ 33.942987235873, -118.130250424147

Sidewalks , Change in Level : Change in Level Non Beveled

There is a change in elevation greater than recommended value.

On-Site Finding 0.62 inches

Ensure that the change in elevation is within the recommended value.

Recommendation Up to 0.25 inches

Remove tripping hazards \$198

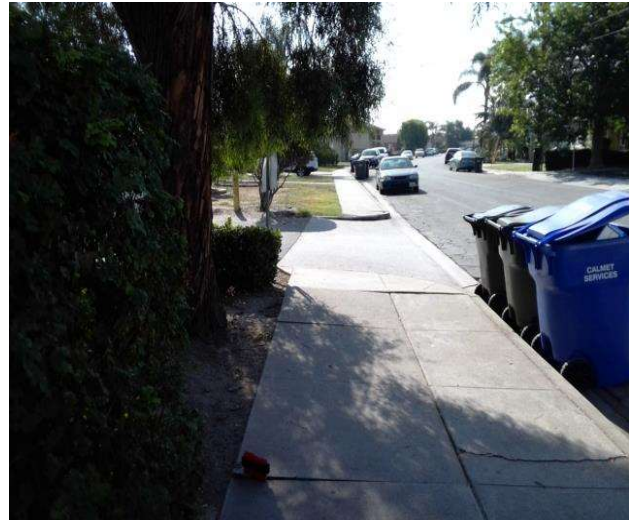
Change in Level East of Downey Avenue @ 33.943035076443, -118.130388557911

Sidewalks , Change in Level : Change in Level Non Beveled

There is a change in elevation greater than recommended value.

On-Site Finding 0.50 inches

Ensure that the change in elevation is within the recommended value.

Recommendation Up to 0.25 inches

Remove tripping hazards \$198

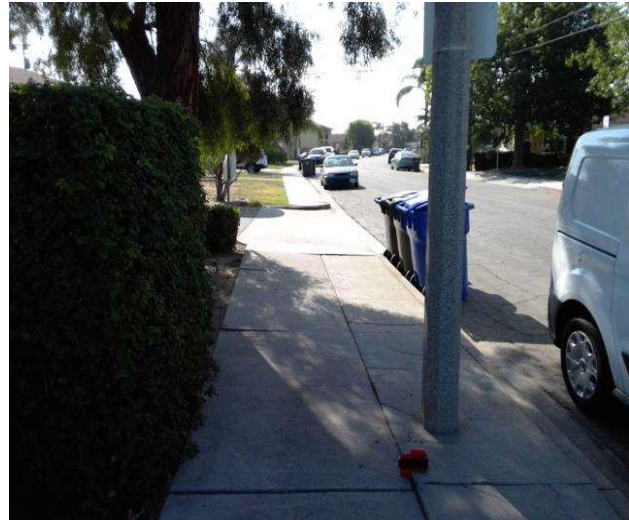
Change in Level East of Downey Avenue @ 33.943041751869, -118.130407333374

Sidewalks , Change in Level : Change in Level Non Beveled

There is a change in elevation greater than recommended value.

On-Site Finding 1.12 inches

Ensure that the change in elevation is within the recommended value.

Recommendation Up to 0.25 inches

Remove tripping hazards \$198

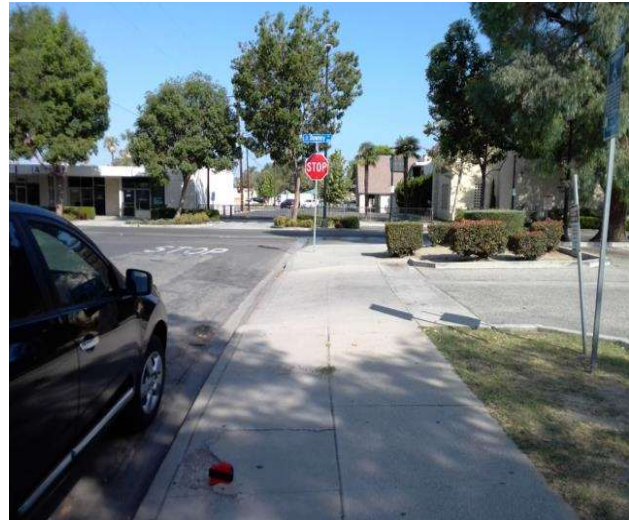
Change in Level East of Downey Avenue @ 33.943058440433, -118.130485117435

Sidewalks , Change in Level : Change in Level Non Beveled

There is a change in elevation greater than recommended value.

On-Site Finding 1.00 inches

Ensure that the change in elevation is within the recommended value.

Recommendation Up to 0.25 inches

Remove tripping hazards \$198

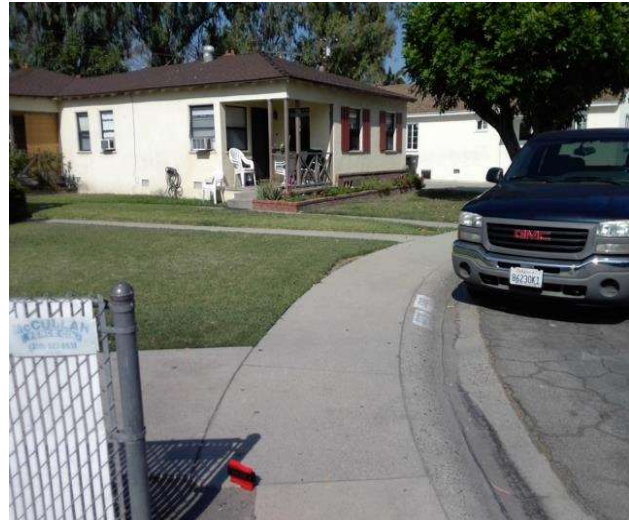
Change in Level West of Cul-De-Sac @ 33.941992590957, -118.128407746553

Sidewalks , Change in Level : Change in Level Non Beveled

There is a change in elevation greater than recommended value.

On-Site Finding 0.62 inches

Ensure that the change in elevation is within the recommended value.

Recommendation Up to 0.25 inches

Remove tripping hazards \$198

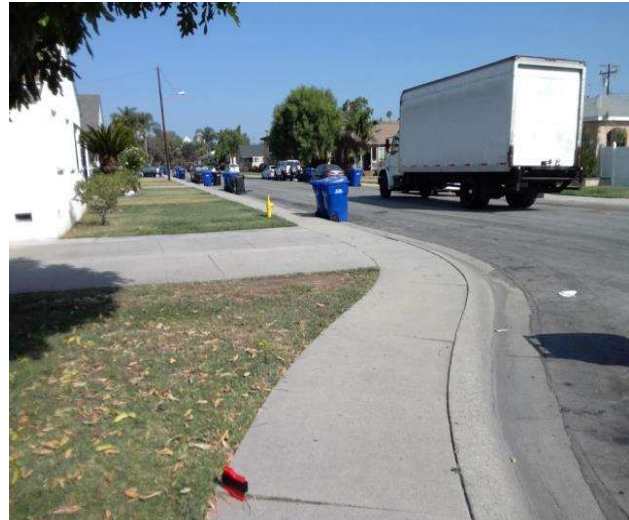
Change in Level West of Cul-De-Sac @ 33.942024855907, -118.128533810377

Sidewalks , Change in Level : Change in Level Non Beveled

There is a change in elevation greater than recommended value.

On-Site Finding 0.75 inches

Ensure that the change in elevation is within the recommended value.

Recommendation Up to 0.25 inches

Remove tripping hazards \$198

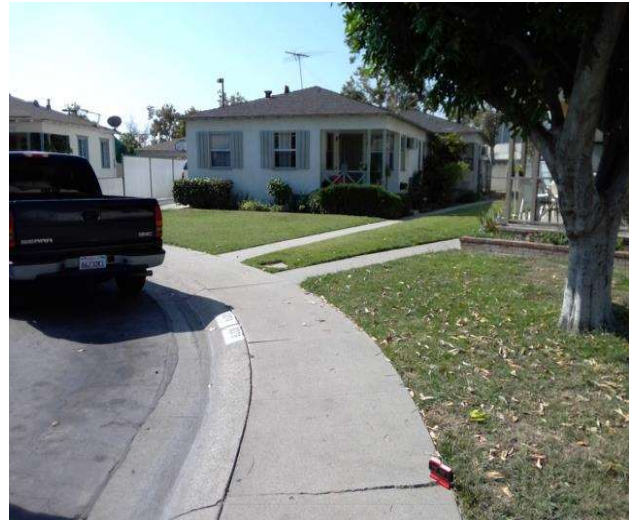
Change in Level West of Cul-De-Sac @ 33.942057120845, -118.128557950258

Sidewalks , Change in Level : Change in Level Non Beveled

There is a change in elevation greater than recommended value.

On-Site Finding 0.50 inches

Ensure that the change in elevation is within the recommended value.

Recommendation Up to 0.25 inches

Remove tripping hazards \$198

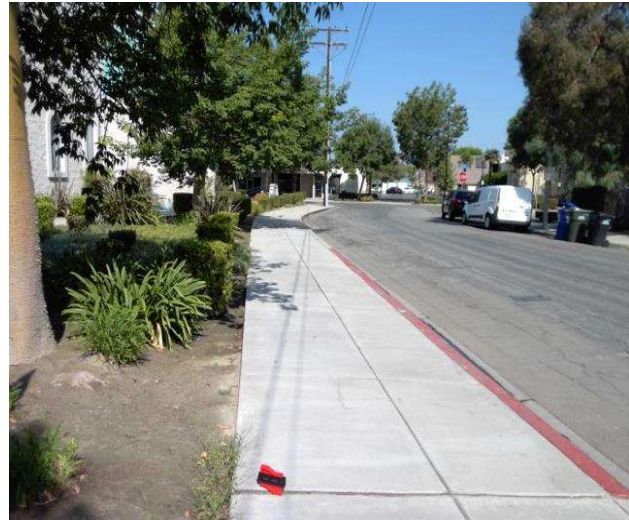
Change in Level West of Cul-De-Sac @ 33.942863740324, -118.130215555429

Sidewalks , Change in Level : Change in Level Non Beveled

There is a change in elevation greater than recommended value.

On-Site Finding 0.87 inches

Ensure that the change in elevation is within the recommended value.

Recommendation Up to 0.25 inches

Remove tripping hazards \$198

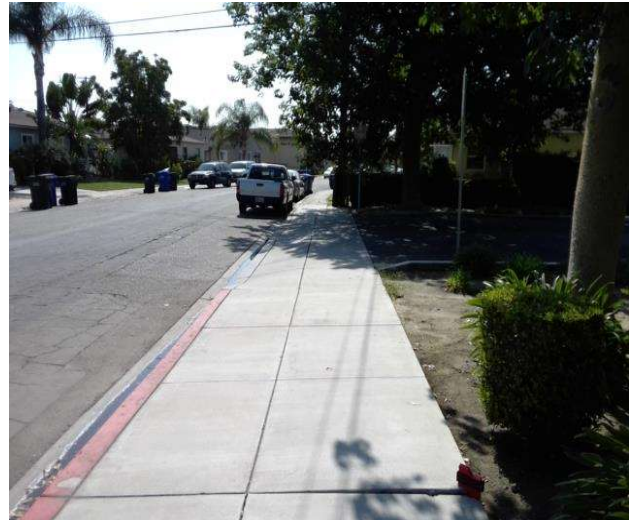
Change in Level West of Cul-De-Sac @ 33.942881541495, -118.130283951759

Sidewalks , Change in Level : Change in Level Non Beveled

There is a change in elevation greater than recommended value.

On-Site Finding 1.00 inches

Ensure that the change in elevation is within the recommended value.

Recommendation Up to 0.25 inches

Remove tripping hazards \$198

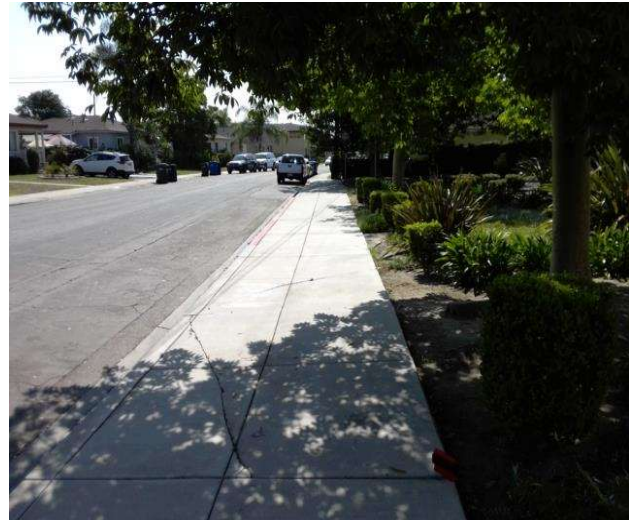
Change in Level West of Cul-De-Sac @ 33.942910468391, -118.130431473255

Sidewalks , Change in Level : Change in Level Non Beveled

There is a change in elevation greater than recommended value.

On-Site Finding 0.50 inches

Ensure that the change in elevation is within the recommended value.

Recommendation Up to 0.25 inches

Remove tripping hazards \$198

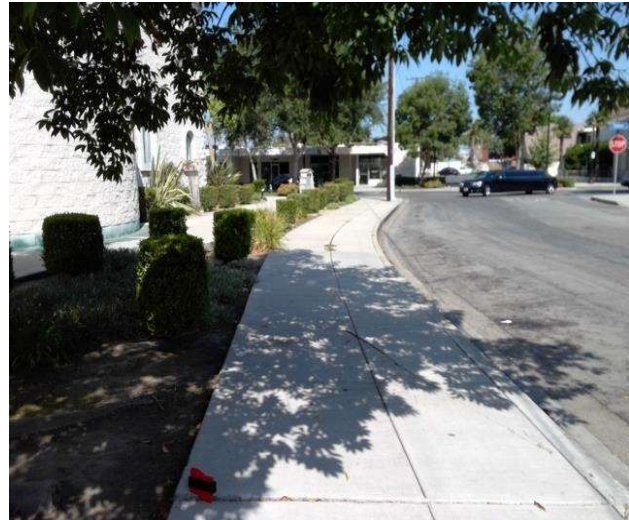
Change in Level West of Cul-De-Sac @ 33.942914918681, -118.130408674479

Sidewalks , Change in Level : Change in Level Non Beveled

There is a change in elevation greater than recommended value.

On-Site Finding 0.87 inches

Ensure that the change in elevation is within the recommended value.

Recommendation Up to 0.25 inches

Remove tripping hazards \$198

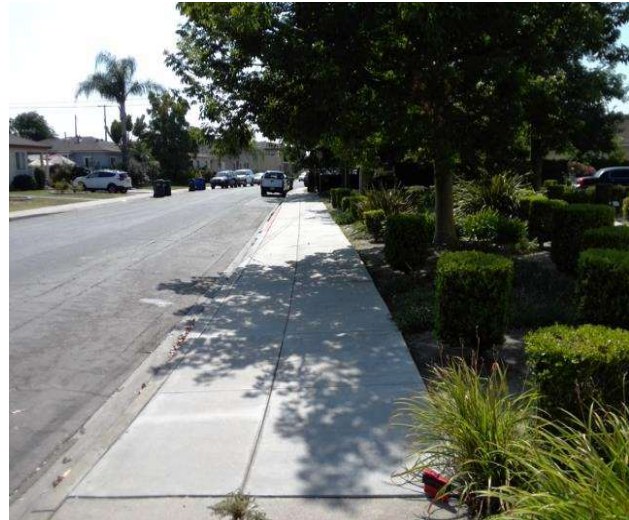
Change in Level West of Cul-De-Sac @ 33.942948295854, -118.130518645048

Sidewalks , Change in Level : Change in Level Non Beveled

There is a change in elevation greater than recommended value.

On-Site Finding 0.50 inches

Ensure that the change in elevation is within the recommended value.

Recommendation Up to 0.25 inches

Remove tripping hazards \$198

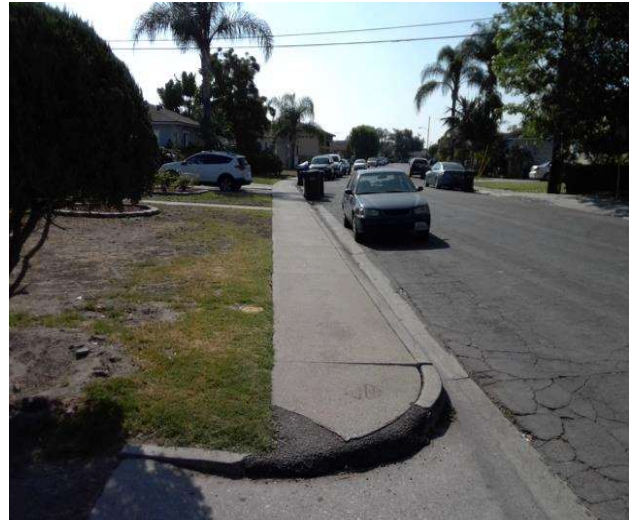
Curb East of Downey Avenue @ 33.942998361589, -118.130259811878

Sidewalks , Hazards & Gratings : Curb is on Path of Travel

There is a curb on the designated path of travel.

On-Site Finding Not Compliant

Provide a compliant curb ramp.

Install curb ramp \$2,500

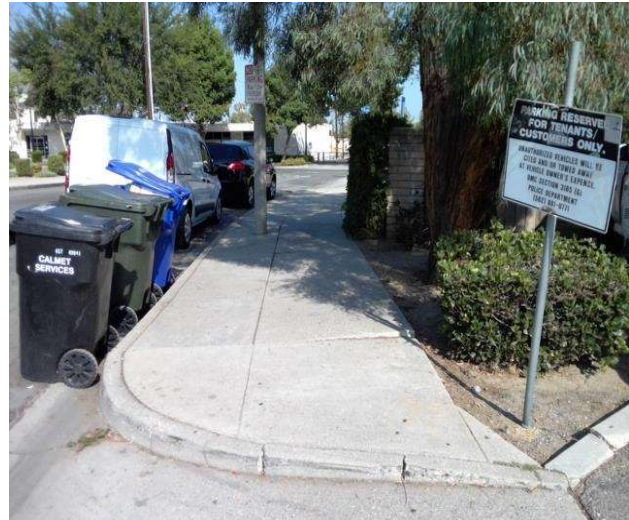
Curb East of Downey Avenue @ 33.943028401016, -118.130356371403

Sidewalks , Hazards & Gratings : Curb is on Path of Travel

There is a curb on the designated path of travel.

On-Site Finding Not Compliant

Provide a compliant curb ramp.

Install curb ramp \$2,500

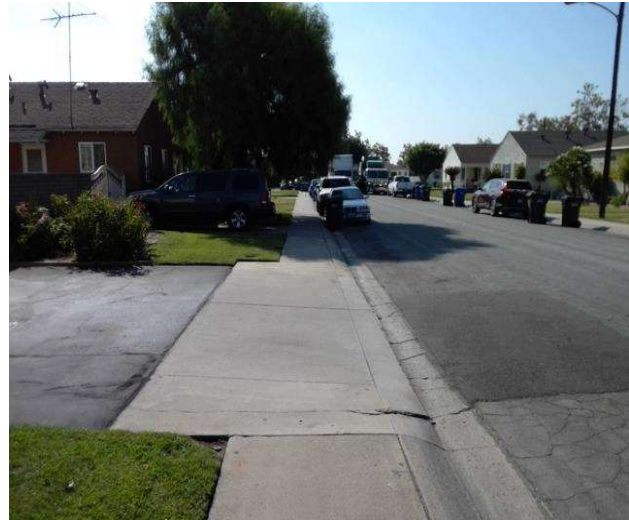
Driveway East of Downey Avenue @ 33.942505490961, -118.129125237465

Sidewalks , Vehicular Traffic : Cross Walks and Detectable Warnings

There are no detectable warnings where the pedestrian route crosses vehicular traffic.

On-Site Finding Not Found

Provide detectable warnings.

Install compliant detectable warnings \$190

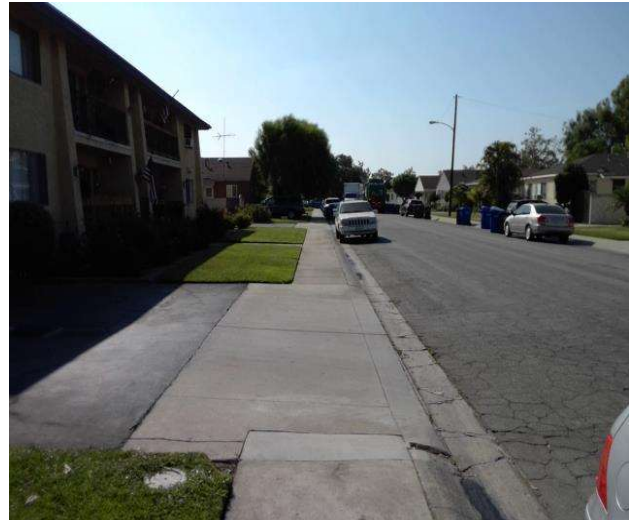
On-Site Finding Not Found

Install compliant detectable warnings \$190

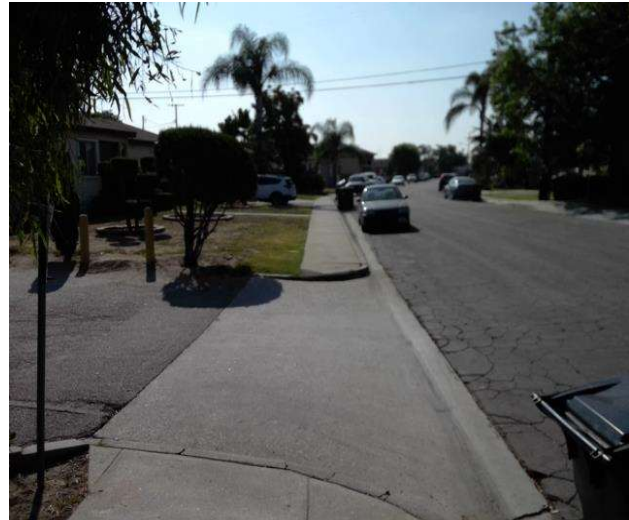
On-Site Finding Not Found

Install compliant detectable warnings \$190

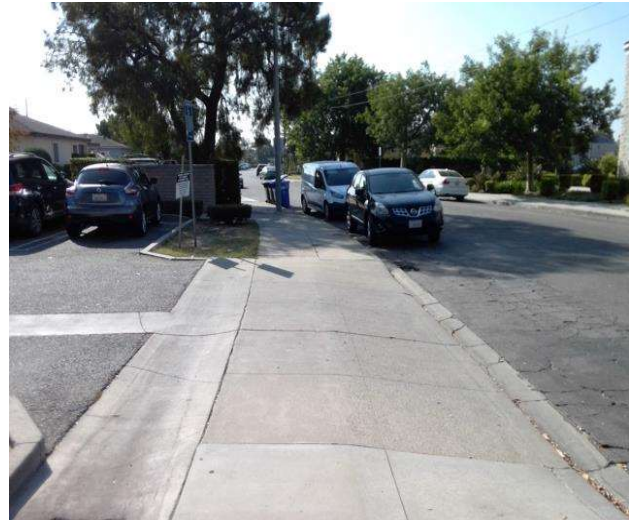
On-Site Finding Not Found

Install compliant detectable warnings \$190

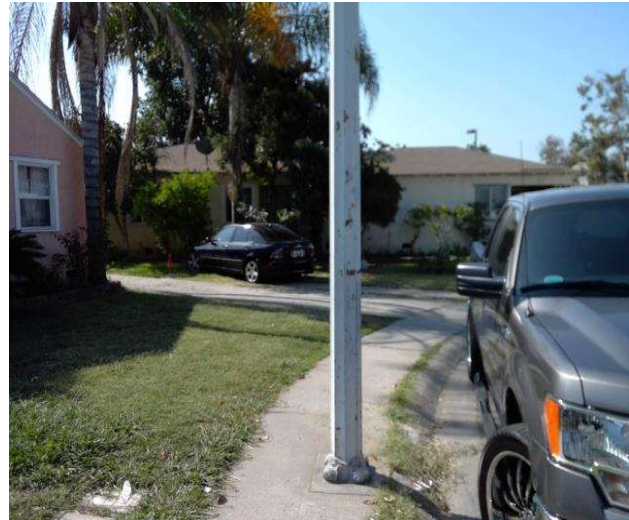
Sidewalks , Hazards & Gratings : Sidewalk Width at Obstruction

Sidewalk width at the obstruction shall have the recommended value.

Recommendation At least 48.00 inches

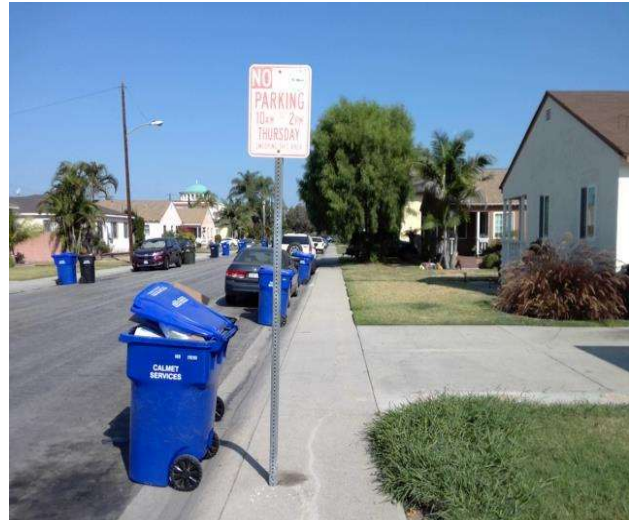
Sidewalks , Hazards & Gratings : Sidewalk Width at Obstruction

Sidewalk width at the obstruction shall have the recommended value.

Recommendation At least 48.00 inches

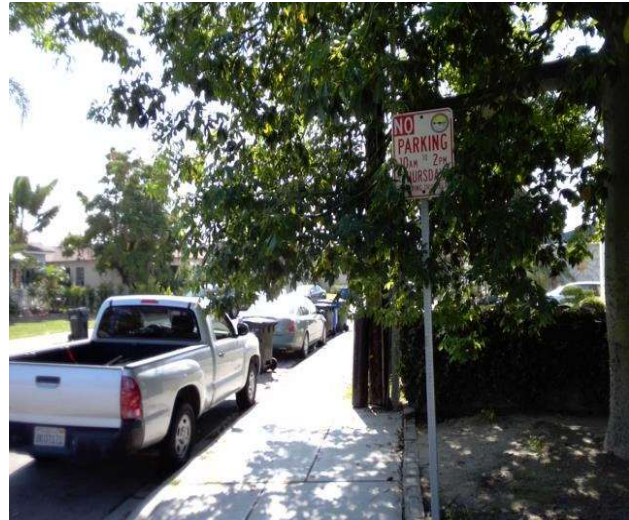
Sidewalks , Hazards & Gratings : Overhead Obstruction Height

Recommendation At least 80.00 inches

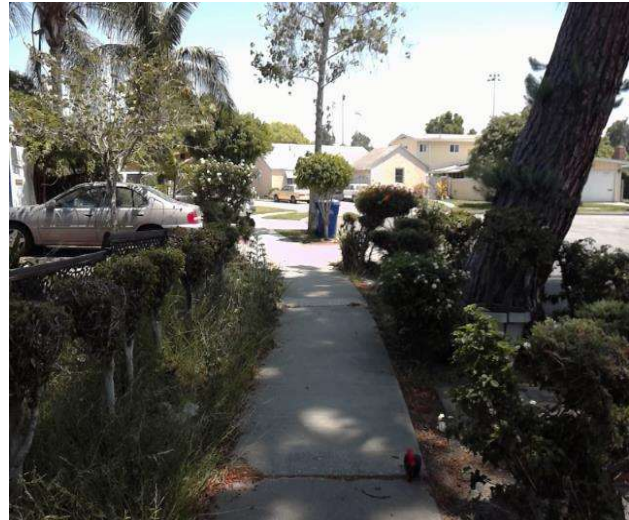
There is a change in elevation greater than recommended value.

Ensure that the change in elevation is within the recommended value.

Recommendation Up to 0.25 inches

Remove tripping hazards \$198

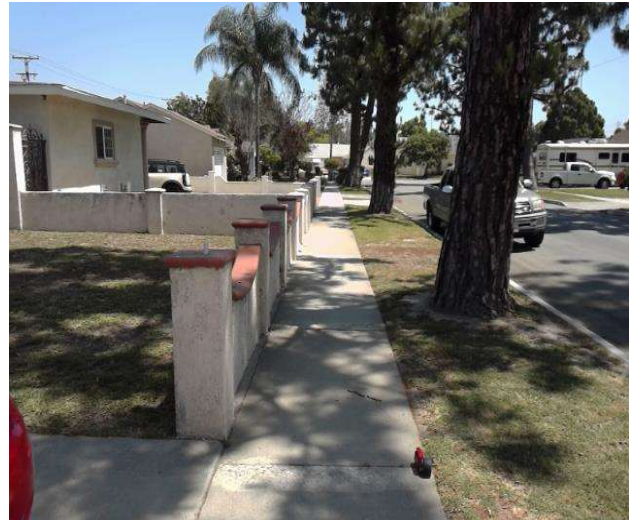
There is a change in elevation greater than recommended value.

Ensure that the change in elevation is within the recommended value.

Recommendation Up to 0.25 inches

Remove tripping hazards \$198

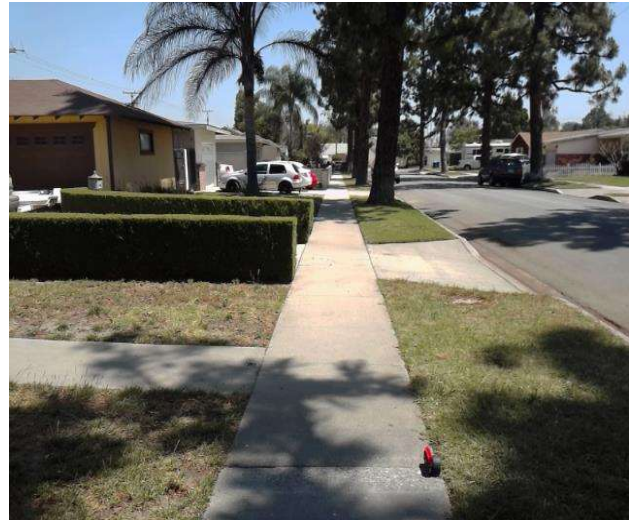
There is a change in elevation greater than recommended value.

Ensure that the change in elevation is within the recommended value.

Recommendation Up to 0.25 inches

Remove tripping hazards \$198

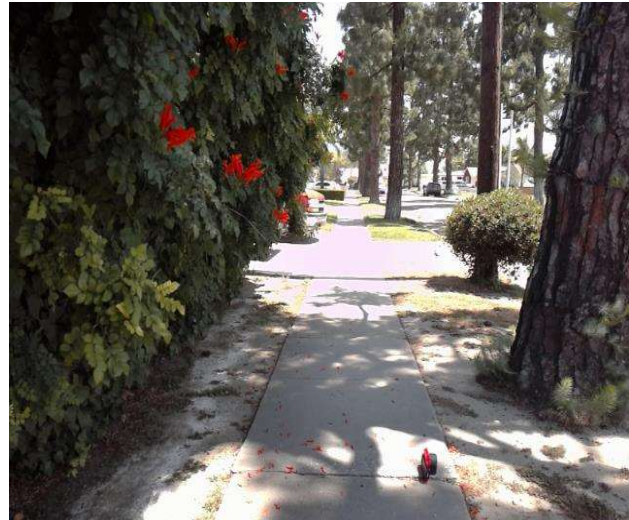
There is a change in elevation greater than recommended value.

Ensure that the change in elevation is within the recommended value.

Recommendation Up to 0.25 inches

Remove tripping hazards \$198

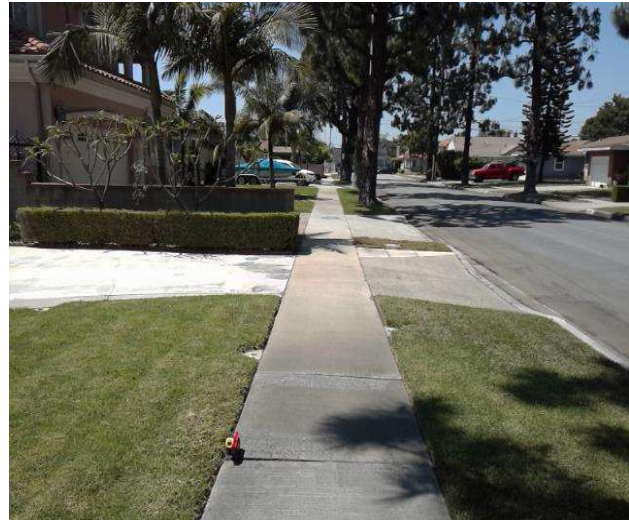
There is a change in elevation greater than recommended value.

Ensure that the change in elevation is within the recommended value.

Recommendation Up to 0.25 inches

Remove tripping hazards \$198

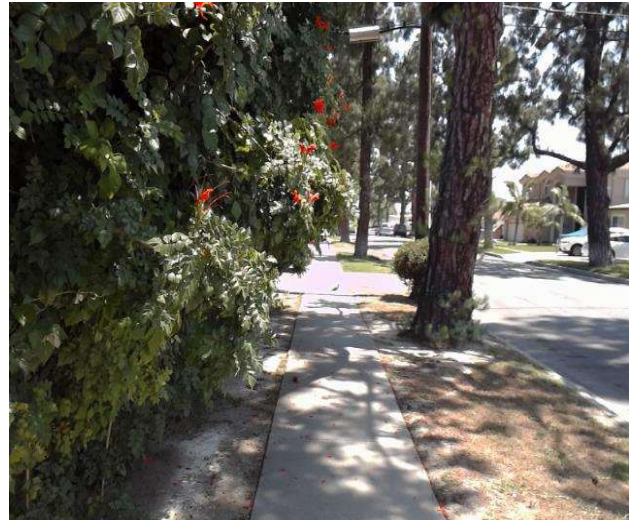
Sidewalks , Hazards & Gratings : Overhead Obstruction Height

Recommendation At least 80.00 inches
