## Accessibility Survey

### City of Downey Melva Street - Birchdale Avenue To Blodgett Avenue

Birchdale Avenue To Blodgett Avenue  
Downey, CA 90242

Date of Inspection  
2/8/2017

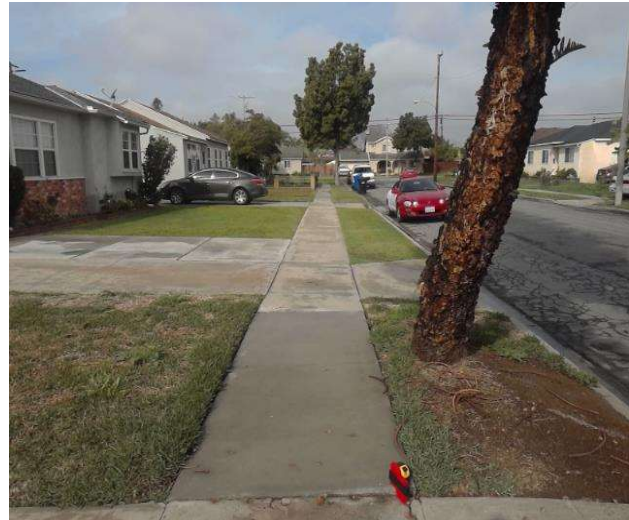
#### Change In Level West Of Blodgett Avenue @ 33.924357409872, -118.136263936758

Sidewalks , Change in Level : Change in Level Non Beveled

There is a change in elevation greater than recommended value.

**On-Site Finding** 1.50 inches

**Code Reference** ADA 206, 302

Ensure that the change in elevation is within the recommended value.

Recommendation Up to 0.25 inches

Remove tripping hazards \$198

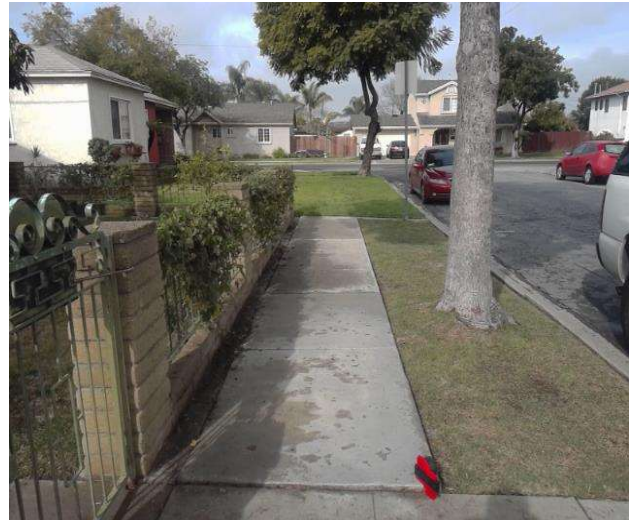
**Change In Level West Of Blodgett Avenue @ 33.924575521358, -118.136681020260**

Sidewalks , Change in Level : Change in Level Non Beveled

There is a change in elevation greater than recommended value.

**On-Site Finding** 1.37 inches

**Code Reference** ADA 206, 302

Ensure that the change in elevation is within the recommended value.

Recommendation Up to 0.25 inches

Remove tripping hazards \$198

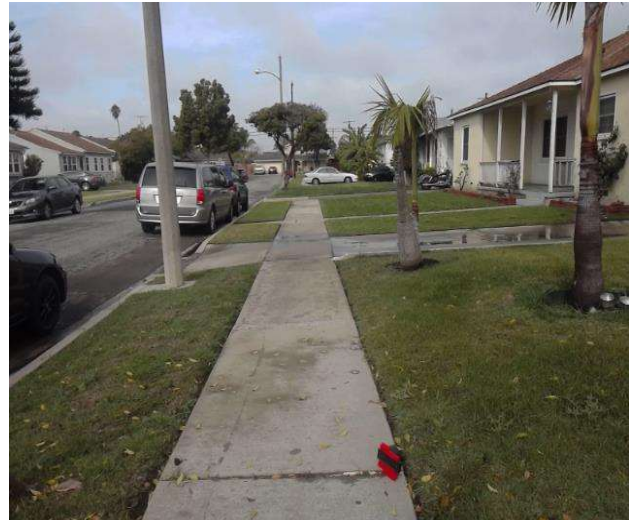
**Change In Level East Of Birchdale Avenue @ 33.924370763652, -118.135999739170**

Sidewalks , Change in Level : Change in Level Non Beveled

There is a change in elevation greater than recommended value.

**On-Site Finding** 0.50 inches

**Code Reference** ADA 206, 302

Ensure that the change in elevation is within the recommended value.

Recommendation Up to 0.25 inches

Remove tripping hazards \$198

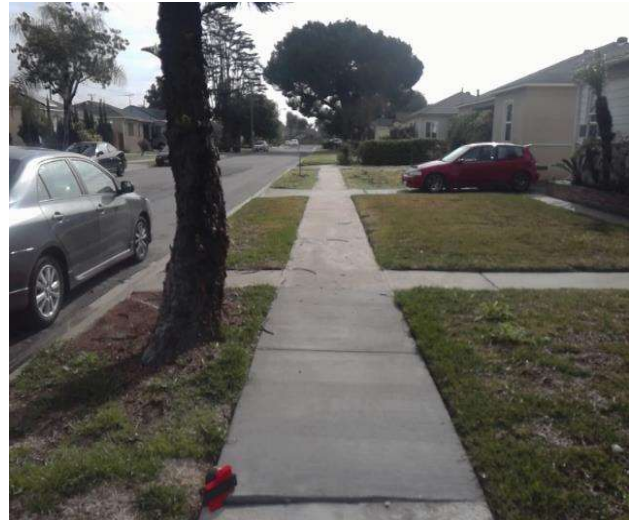
**Change In Level West Of Blodgett Avenue @ 33.924370763652, -118.136280030012**

There is a change in elevation greater than recommended value.

**Code Reference** ADA 206, 302

Ensure that the change in elevation is within the recommended value.

Recommendation Up to 0.25 inches

Remove tripping hazards \$198

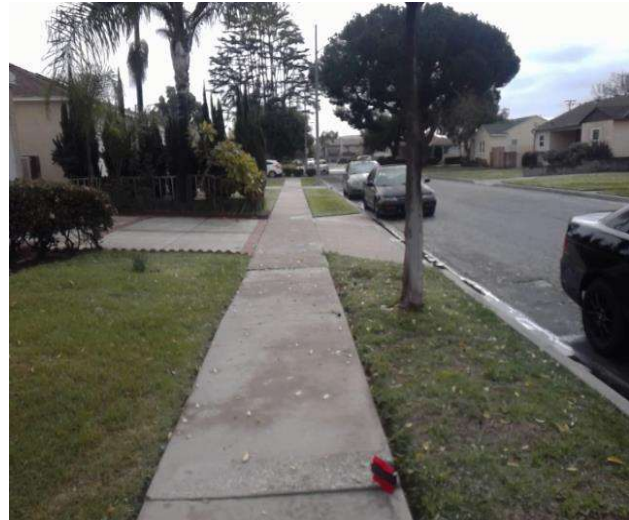
There is a change in elevation greater than recommended value.

**Code Reference** ADA 206, 302

Ensure that the change in elevation is within the recommended value.

Recommendation Up to 0.25 inches

Remove tripping hazards \$198

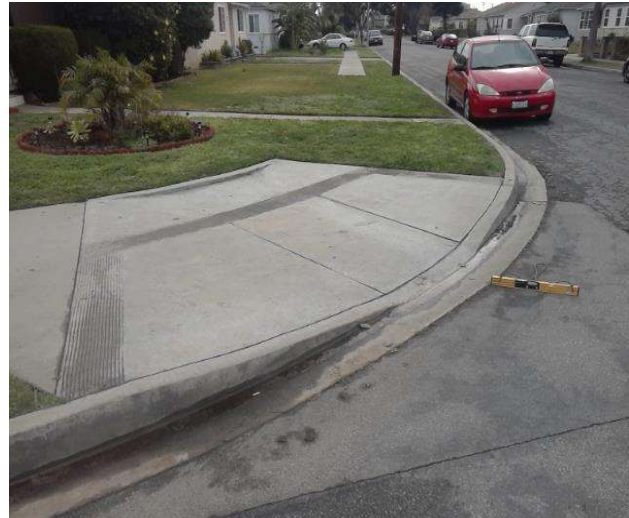
**On-Site Finding** Not Found

**Code Reference** CA 11B-406.5.12

Provide detectable warning to surface \$248

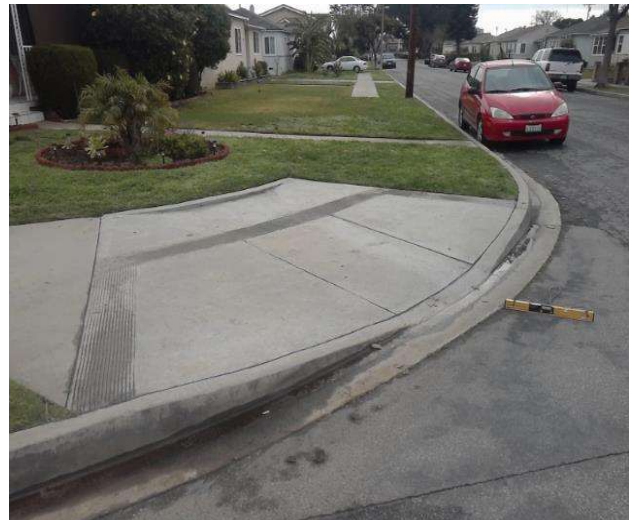
**Code Reference** ADA 402, 406.4, 403.3, 406.1, CA 11B-406.5.3

Recommendation Up to 2.08 percent

Provide compliant landing \$1,260

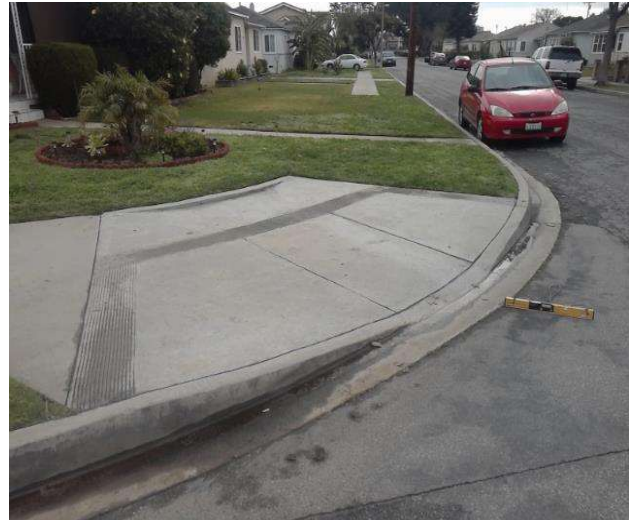
Curb Ramp , Landings and Transitions : Top Landing Clear Length - Landings

**Code Reference** ADA 406, 406.4,CA 11B-406.5.3

Recommendation At least 48.00 inches

Provide compliant landing \$240

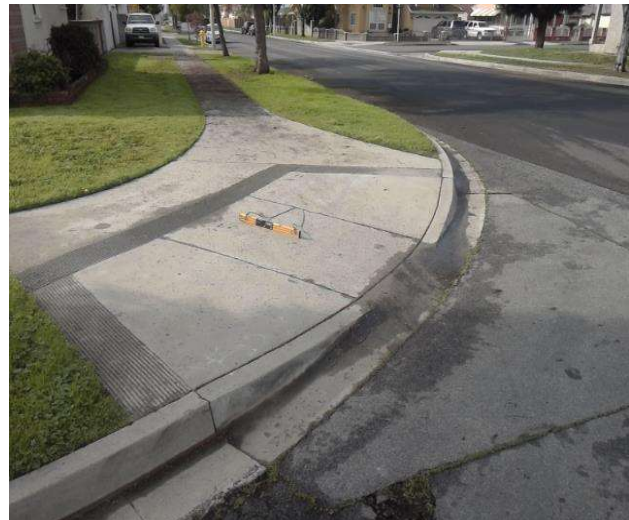
**On-Site Finding** Not Found

**Code Reference** CA 11B-406.5.12

Provide detectable warning to surface \$248

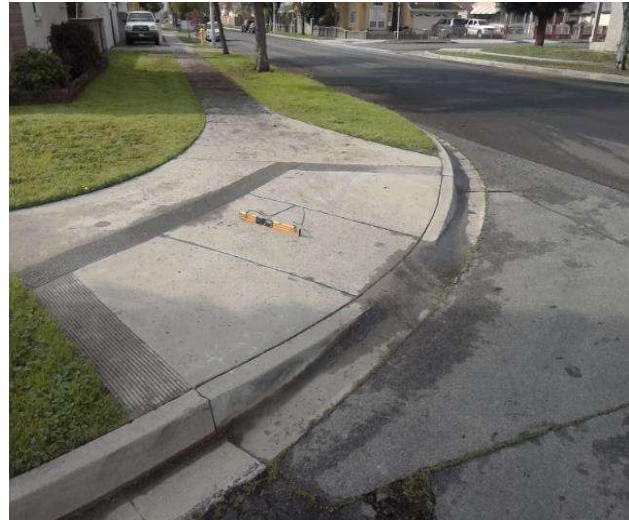
**Code Reference** ADA 406, 406.1, 405.2, CA 11B-406

Recommendation Up to 8.33 percent

Install curb ramp \$1,300

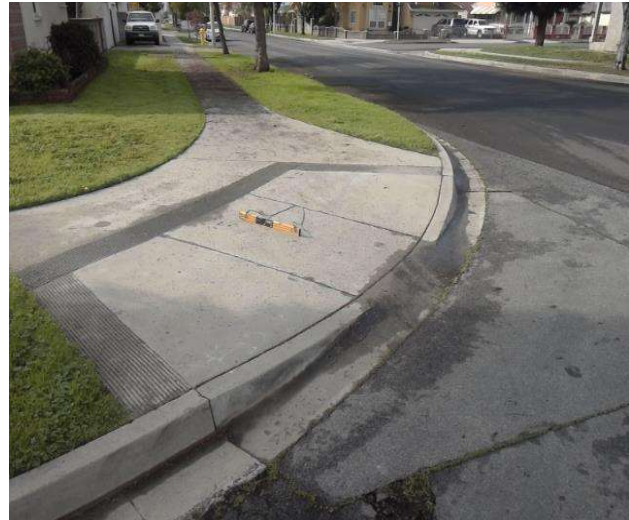
**Code Reference** ADA 406, 406.3, CA 11B-406.2.2

Recommendation Up to 10.00 percent

Install flared sides \$1,300

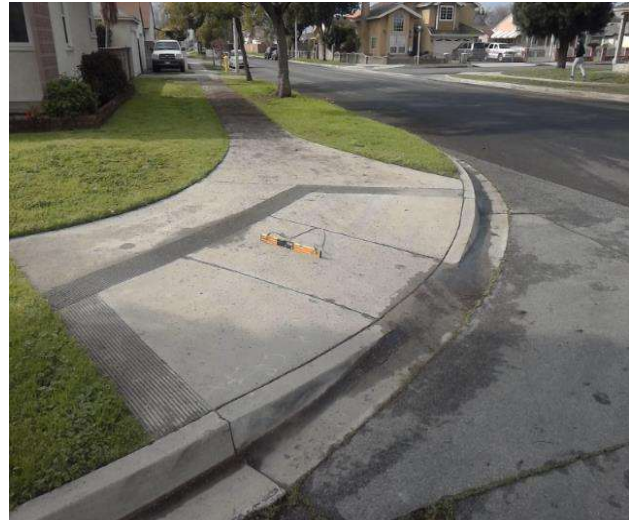
**Code Reference** ADA 406, 406.2, CA 11B-406.5.8

Recommendation Up to 5.00 percent

Repave landing \$1,260

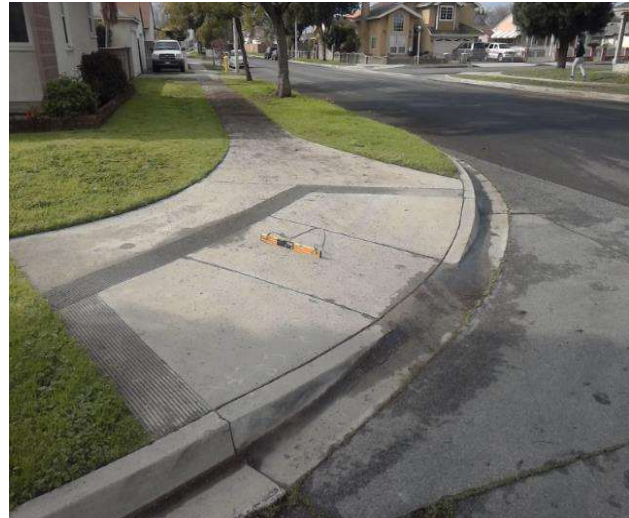
**Code Reference** ADA 402, 406.4, 403.3, 406.1,CA 11B-406.5.3

Recommendation Up to 2.08 percent

Provide compliant landing \$1,260

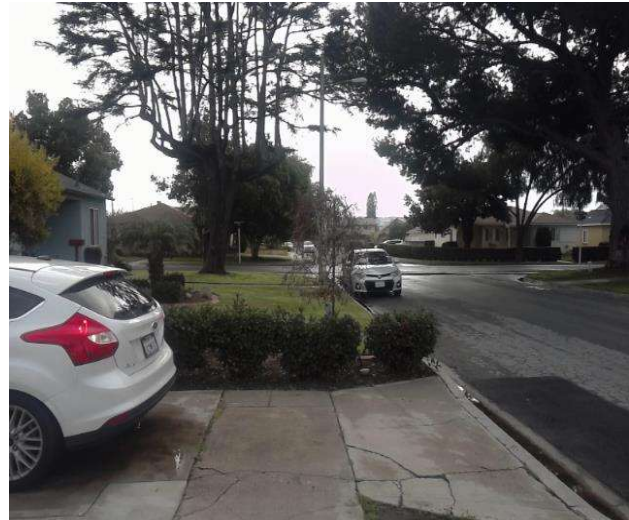
Sidewalks : Missing Sidewalk

Section of sidewalk is missing and consists of dirt, grass or gravel.

**Code Reference** ADA 206, 302,CA 11B-302,CA 11B-206

Provide a compliant sidewalk for the missing section.

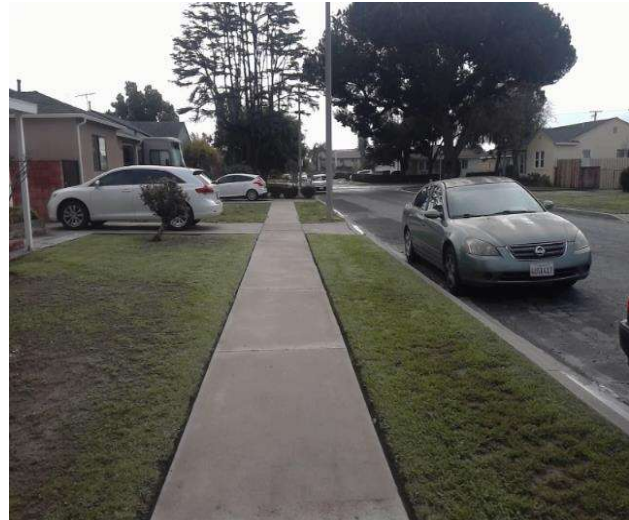
**Code Reference** ADA 206, 302,CA 11B-403.5.1

Widen the sidewalk to the recommended value.

Recommendation At least 48.00 inches

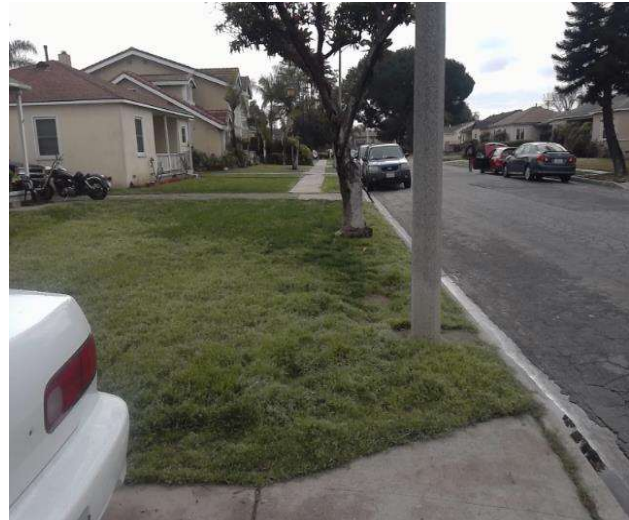
Sidewalks : Missing Sidewalk

Section of sidewalk is missing and consists of dirt, grass or gravel.

**Code Reference** ADA 206, 302,CA 11B-302,CA 11B-206

Provide a compliant sidewalk for the missing section.

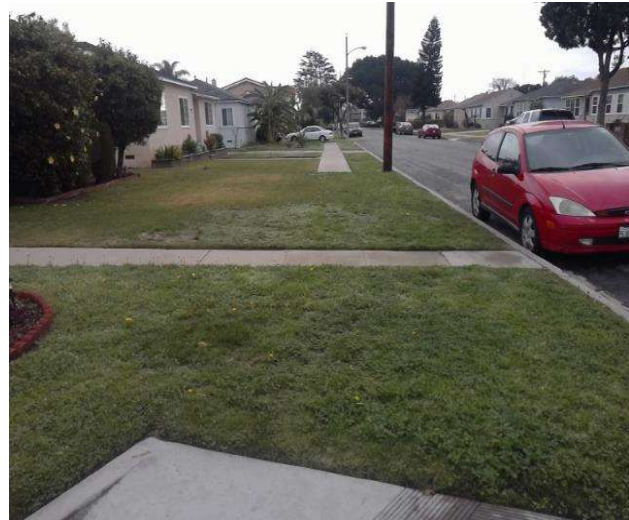
Sidewalks : Missing Sidewalk

Section of sidewalk is missing and consists of dirt, grass or gravel.

**Code Reference** ADA 206, 302,CA 11B-302,CA 11B-206

Provide a compliant sidewalk for the missing section.

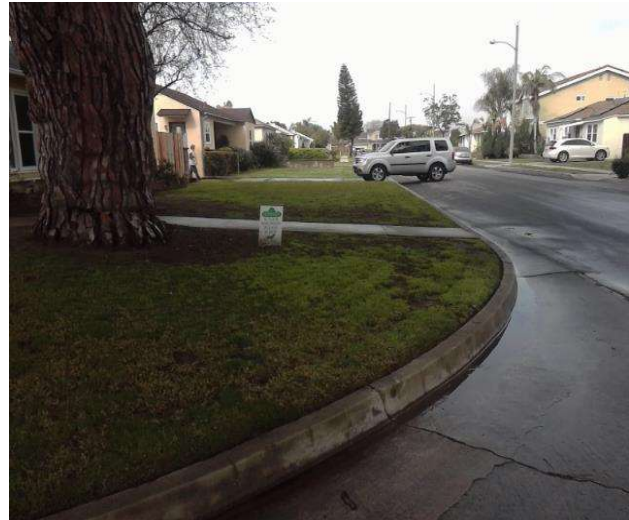
Sidewalks : Missing Sidewalk

Section of sidewalk is missing and consists of dirt, grass or gravel.

**Code Reference** ADA 206, 302,CA 11B-302,CA 11B-206

Provide a compliant sidewalk for the missing section.

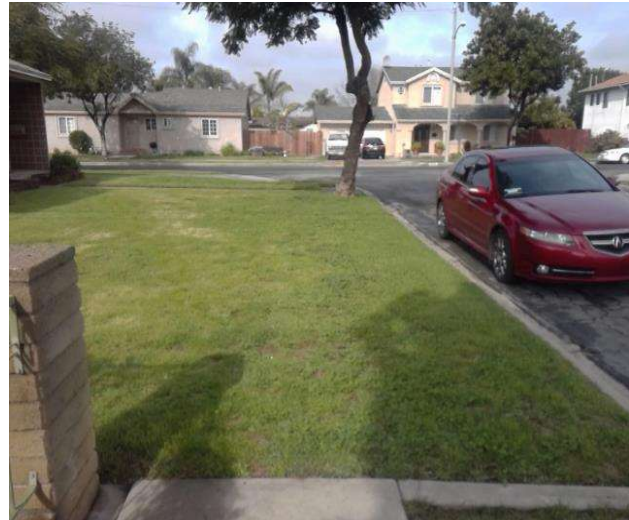
Sidewalks : Missing Sidewalk

Section of sidewalk is missing and consists of dirt, grass or gravel.

**Code Reference** ADA 206, 302,CA 11B-302,CA 11B-206

Provide a compliant sidewalk for the missing section.

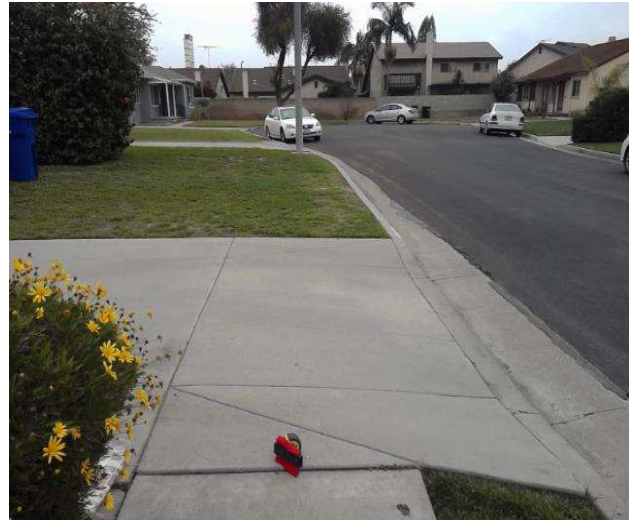
There is a change in elevation greater than recommended value.

**Code Reference** ADA 206, 302

Ensure that the change in elevation is within the recommended value.

Recommendation Up to 0.25 inches

Remove tripping hazards \$198

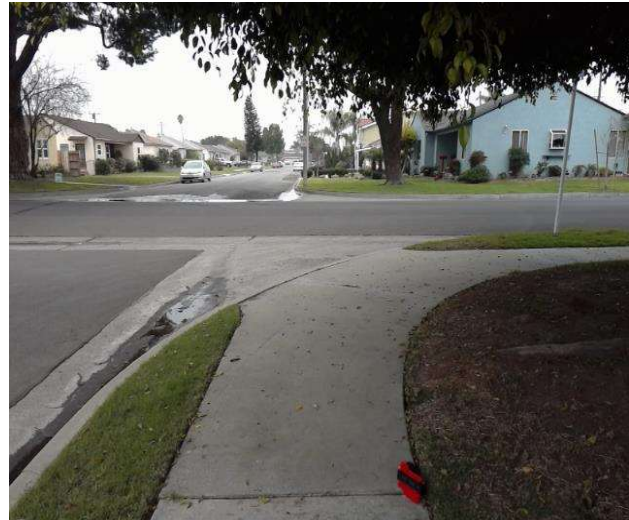
There is a change in elevation greater than recommended value.

**Code Reference** ADA 206, 302

Ensure that the change in elevation is within the recommended value.

Recommendation Up to 0.25 inches

Remove tripping hazards \$198

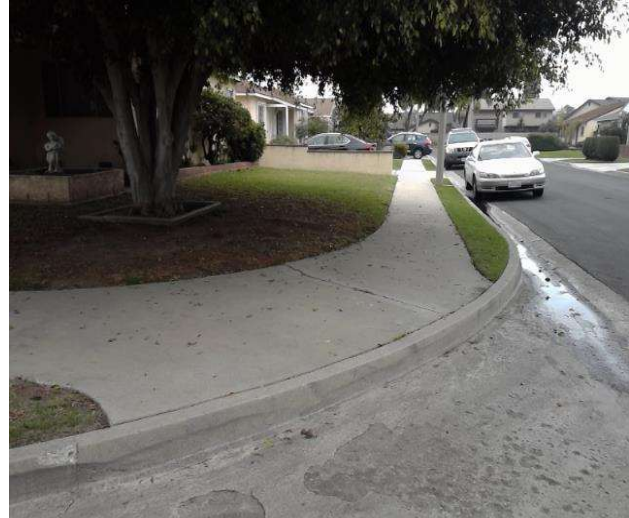
Sidewalks , Hazards & Gratings : Curb is on Path of Travel

**Code Reference** ADA 402, 303, 406, 403.4, 303.4

Install curb ramp \$2,500

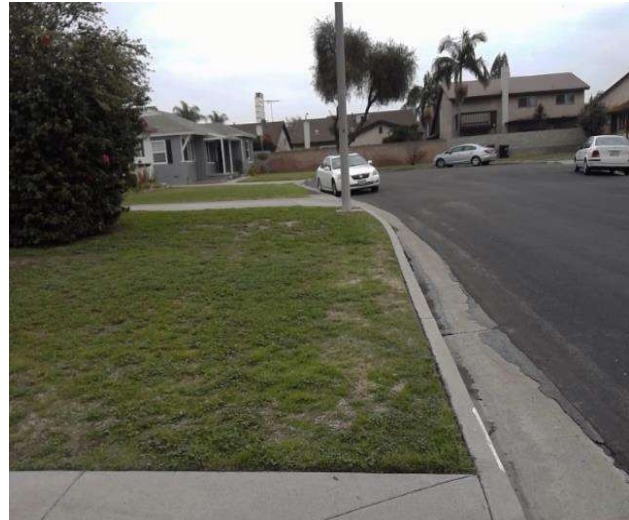
Sidewalks : Missing Sidewalk

Section of sidewalk is missing and consists of dirt, grass or gravel.

**Code Reference** ADA 206, 302,CA 11B-302,CA 11B-206

Provide a compliant sidewalk for the missing section.

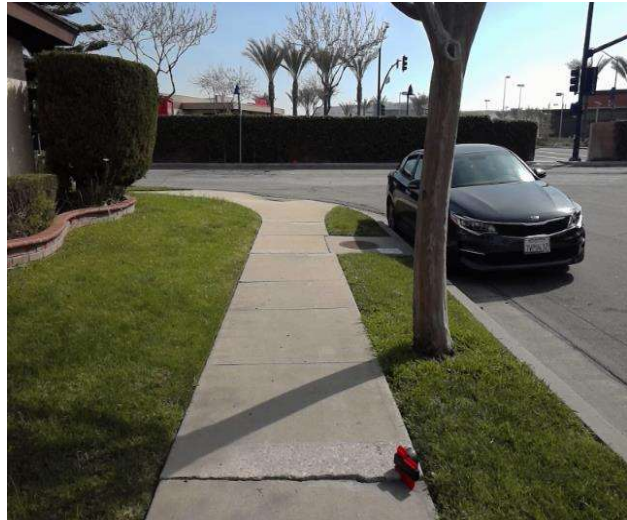
There is a change in elevation greater than recommended value.

**Code Reference** ADA 206, 302

Ensure that the change in elevation is within the recommended value.

Recommendation Up to 0.25 inches

Remove tripping hazards \$198

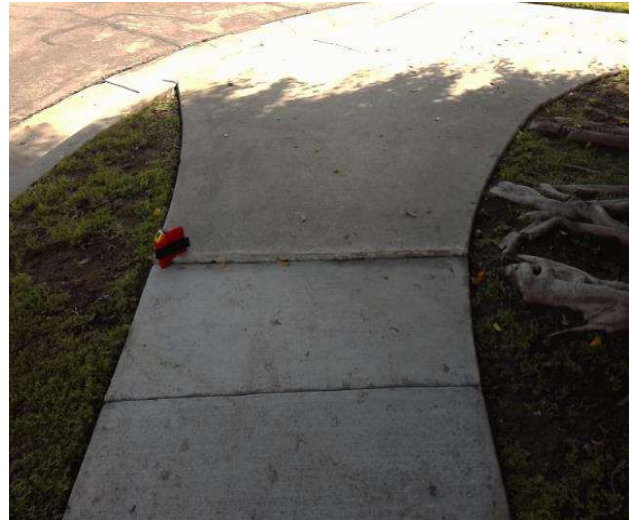
There is a change in elevation greater than recommended value.

**Code Reference** ADA 206, 302

Ensure that the change in elevation is within the recommended value.

Recommendation Up to 0.25 inches

Remove tripping hazards \$198

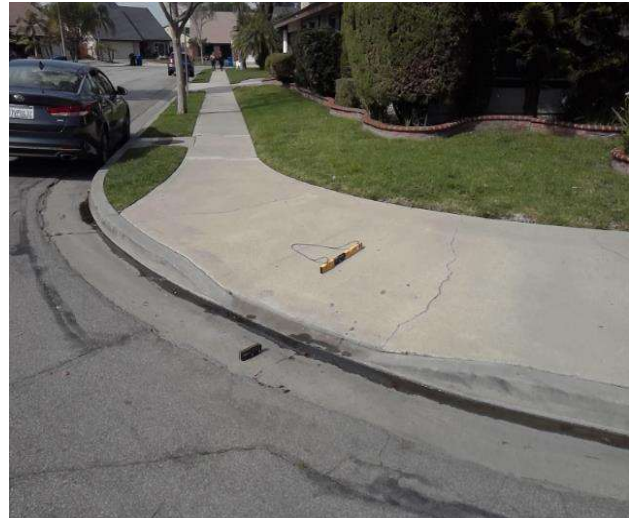
Curb Ramp , Landings and Transitions : Landing Accumulates Water - Wet Conditions

**Code Reference** ADA 405, 406.1, 405.10

Provide compliant landing \$255

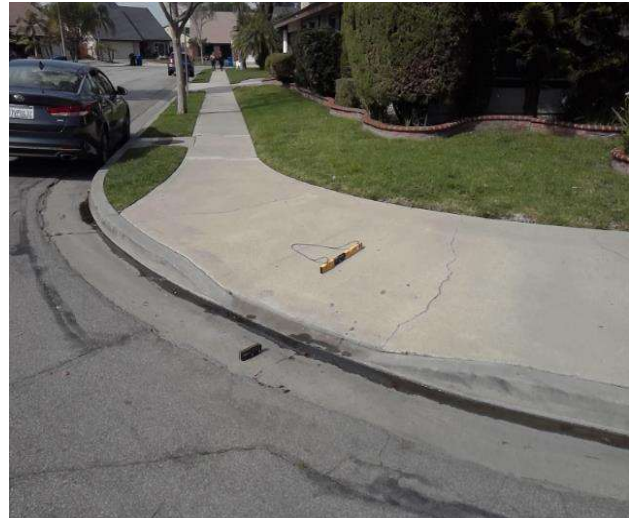
Curb Ramp , Landings and Transitions : Bottom Landing Change in Level - Curb Ramps

**Code Reference** ADA 302, 406.2

Patch lip at curb ramp \$255

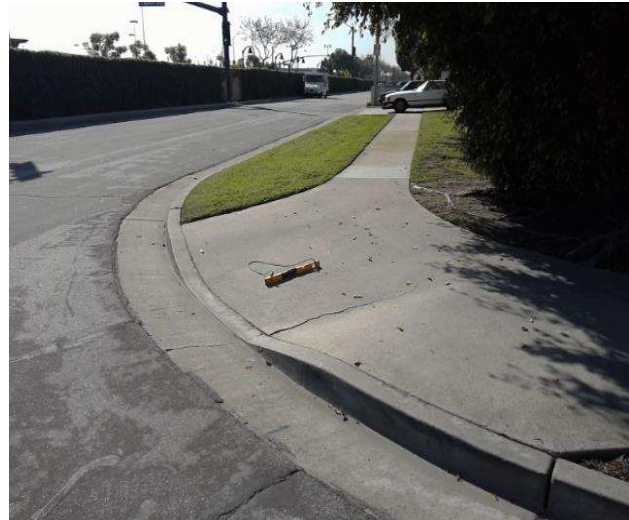
Curb Ramp : Bottom Landing Slope

**Code Reference** ADA 406, 406.2, CA 11B-406.5.8

Recommendation Up to 5.00 percent

Repave landing \$1,260

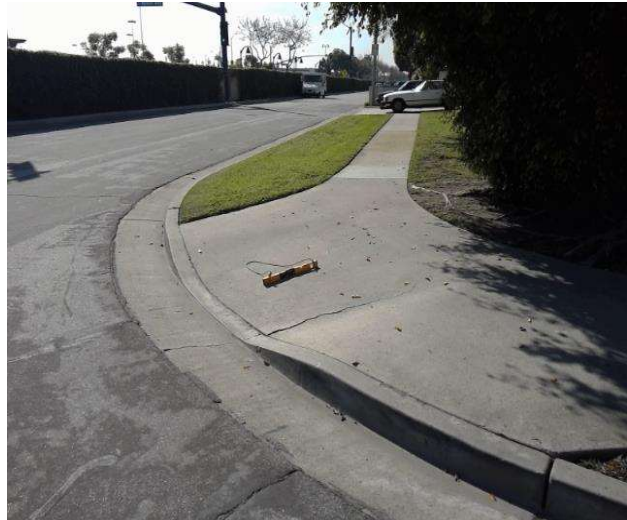
Curb Ramp , Landings And Transitions : Bottom Landing Change in Level

**Code Reference** ADA 302, 303, 406.2, 303.1

Recommendation Up to 0.50 inches

Patch lip at curb ramp \$255

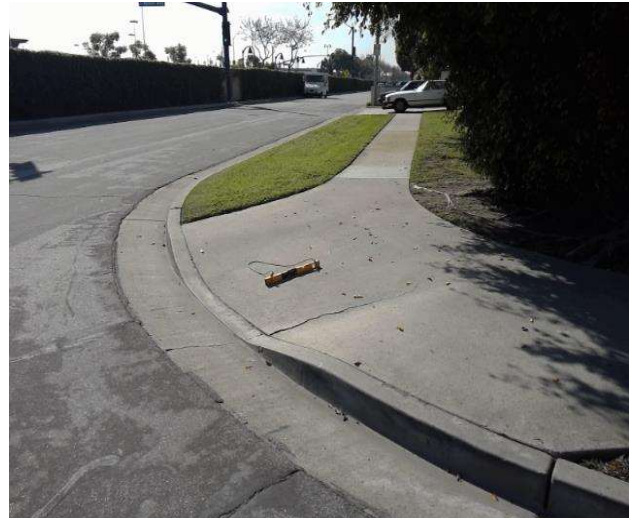
The overlayment causes a noncompliant change in level.

**Code Reference** ADA 303.2, 303.3,CA 11B-303.3,CA 11B-303.2

Ensure the change in elevation is within the recommended height.

Recommendation Up to 0.50 inches

Provide smooth surface \$150

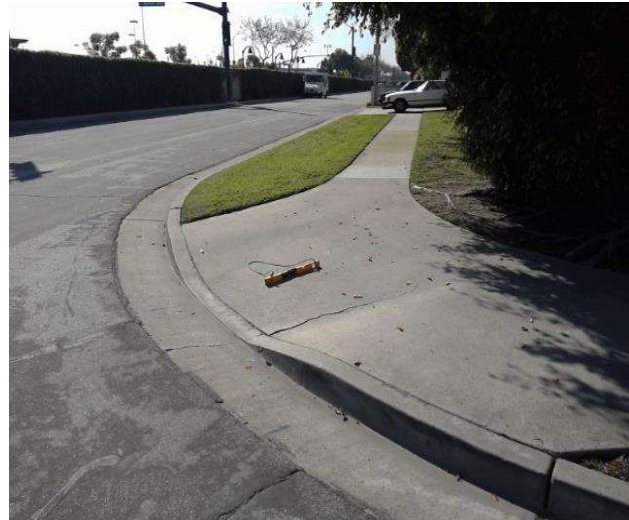
Curb Ramp , Landings and Transitions : Top Landing Slope

**Code Reference** ADA 402, 406.4, 403.3, 406.1, CA 11B-406.5.3

Recommendation Up to 2.08 percent

Provide compliant landing \$1,260

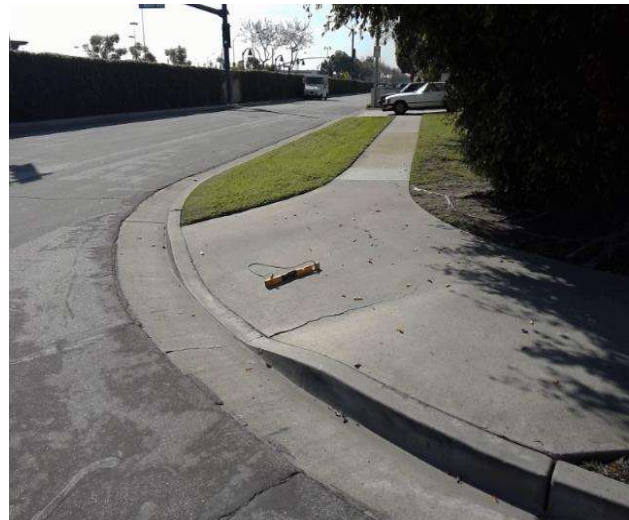
Curb Ramp , Landings and Transitions : Top Landing Clear Length - Landings

**Code Reference** ADA 406, 406.4,CA 11B-406.5.3

Recommendation At least 48.00 inches

Provide compliant landing \$240

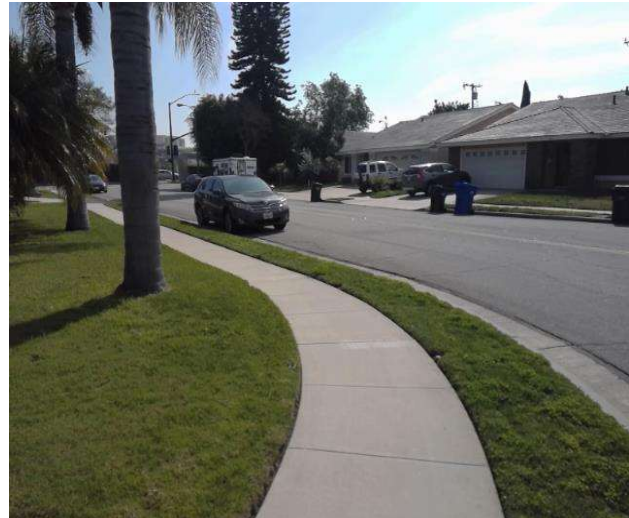
**Code Reference** ADA 206, 302,CA 11B-403.3

Notes : Has 4 Openings For 154 Feet

Repave the sidewalk surface with the recommended cross slope.

Repave surface \$1,092

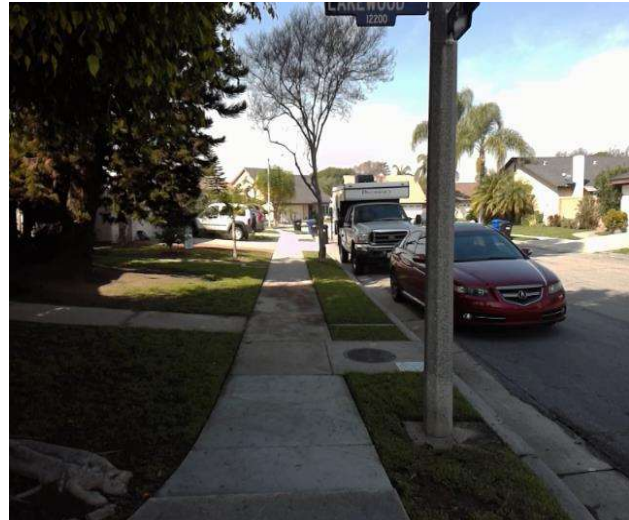
**Code Reference** ADA 206, 302,CA 11B-403.3

Repave the sidewalk surface with the recommended cross slope.

Repave surface \$1,092

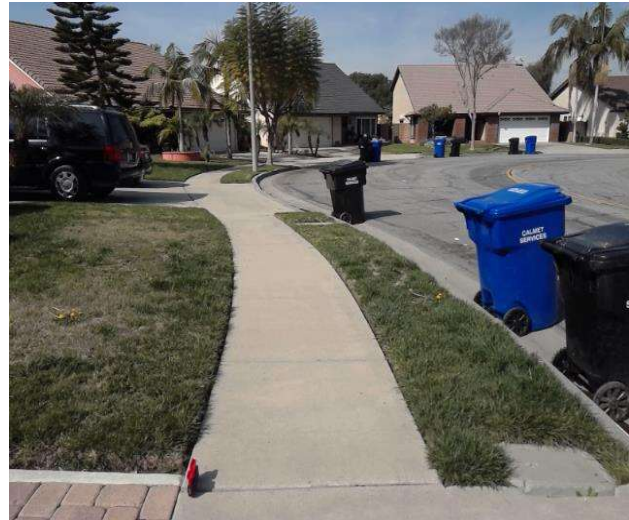
**Code Reference** ADA 206, 302, CA 11B-403.3

Notes : Has 4 Openings

Repave the sidewalk surface with the recommended cross slope.

Repave surface \$1,092

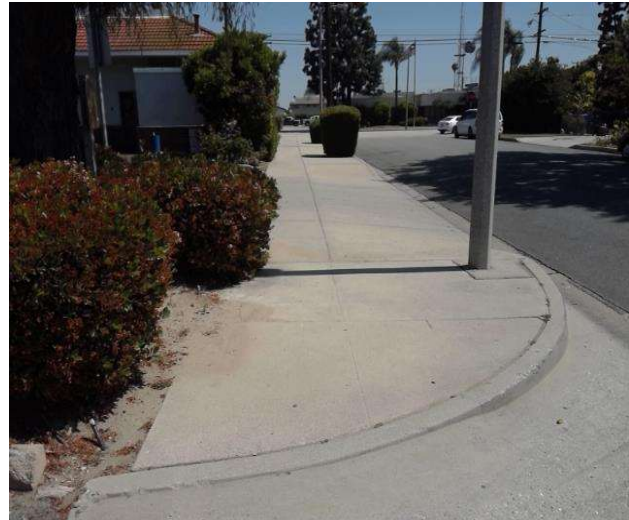
Sidewalks , Hazards & Gratings : Curb is on Path of Travel

**Code Reference** ADA 402, 303, 406, 403.4, 303.4

Install curb ramp \$2,500

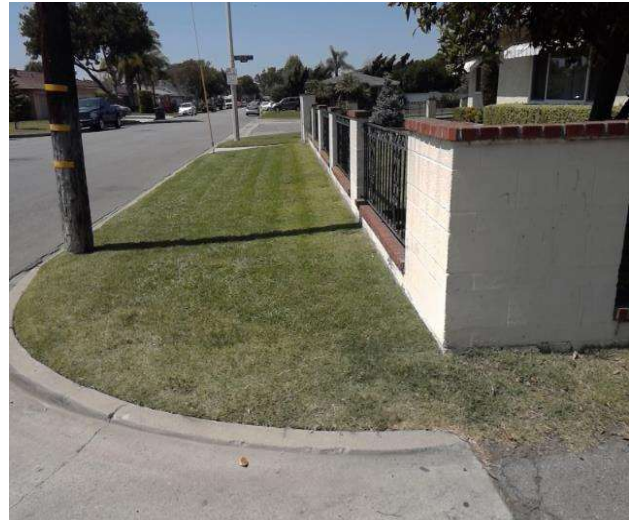
Sidewalks , Hazards & Gratings : Curb is on Path of Travel

**Code Reference** ADA 402, 303, 406, 403.4, 303.4

Install curb ramp \$2,500

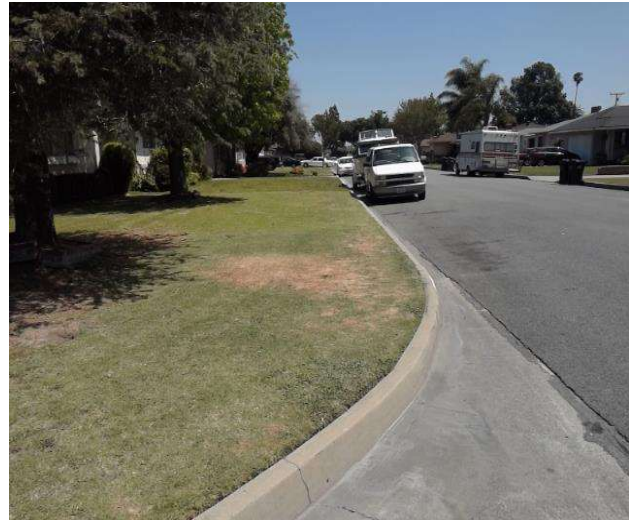
Sidewalks : Missing Sidewalk

Section of sidewalk is missing and consists of dirt, grass or gravel.

ADA 206, 302,CA 11B-302,CA 11B-206

Provide a compliant sidewalk for the missing section.

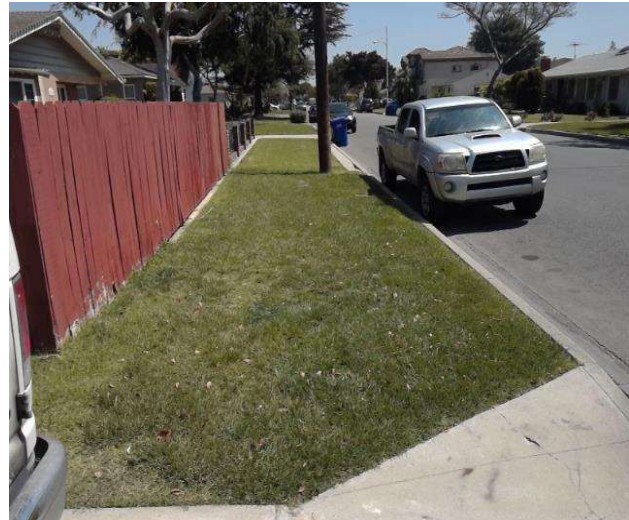
Sidewalks : Missing Sidewalk

Section of sidewalk is missing and consists of dirt, grass or gravel.

**Code Reference** ADA 206, 302,CA 11B-302,CA 11B-206

Provide a compliant sidewalk for the missing section.

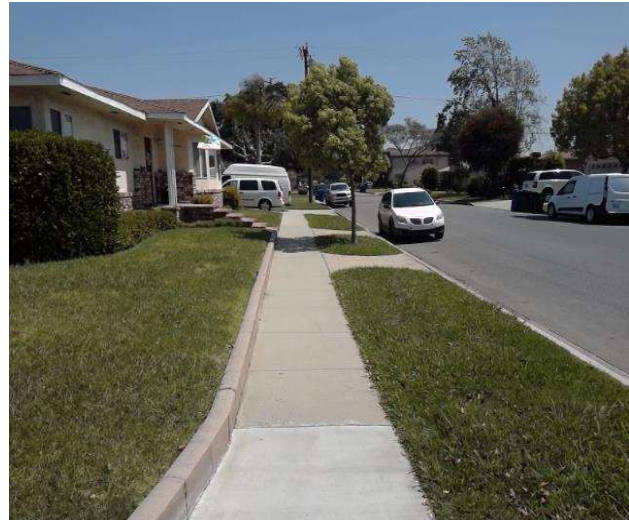
**Code Reference** ADA 206, 302,CA 11B-403.3

Repave the sidewalk surface with the recommended cross slope.

Repave surface \$1,092

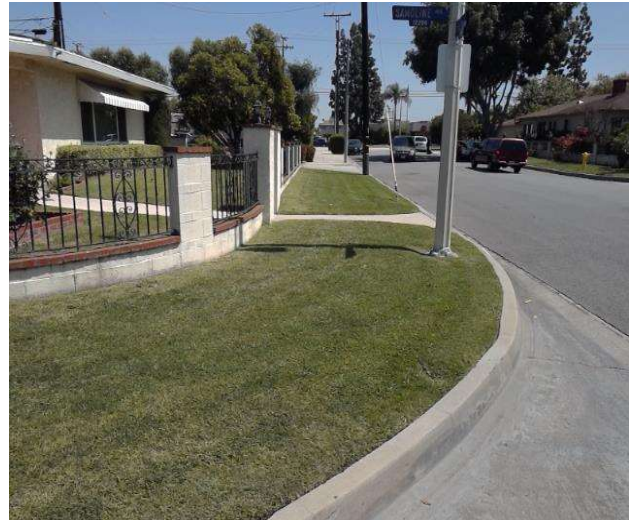
Sidewalks : Missing Sidewalk

Section of sidewalk is missing and consists of dirt, grass or gravel.

**Code Reference** ADA 206, 302,CA 11B-302,CA 11B-206

Provide a compliant sidewalk for the missing section.

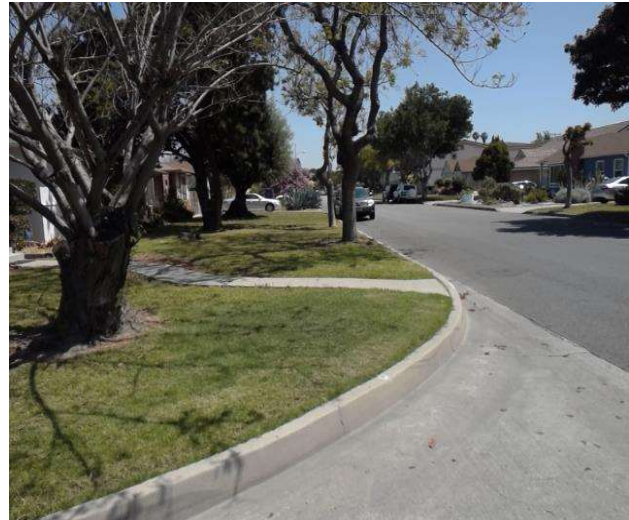
Sidewalks : Missing Sidewalk

Section of sidewalk is missing and consists of dirt, grass or gravel.

**Code Reference** ADA 206, 302,CA 11B-302,CA 11B-206

Provide a compliant sidewalk for the missing section.
