Accessibility Survey

City of Downey Nance Avenue - Woodruff Avenue to Pangborn Avenue

Date of Inspection
8/8/2017

Disability Access Consultants

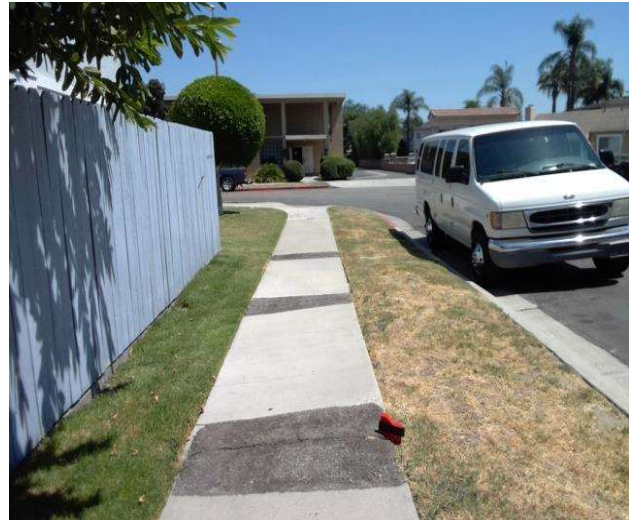
Change in Level East of Woodruff Avenue @ 33.929818931444, -118.115039616823

Sidewalks , Change in Level : Change in Level Non Beveled

There is a change in elevation greater than recommended value.

On-Site Finding 2.00 inches

Ensure that the change in elevation is within the recommended value.

Recommendation Up to 0.25 inches

Remove tripping hazards \$198

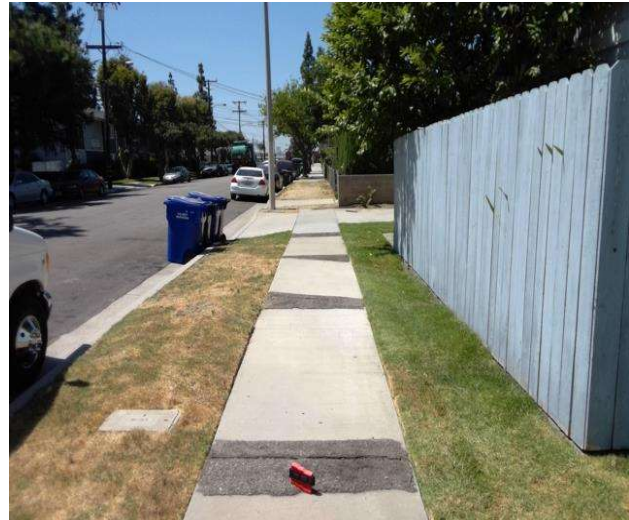
Change in Level East of Woodruff Avenue @ 33.929781098147, -118.114981949329

Sidewalks , Change in Level : Change in Level Non Beveled

There is a change in elevation greater than recommended value.

On-Site Finding 0.75 inches

Ensure that the change in elevation is within the recommended value.

Recommendation Up to 0.25 inches

Remove tripping hazards \$198

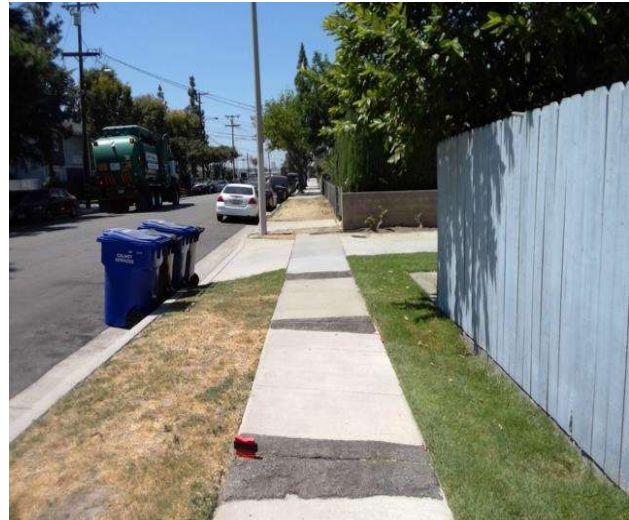
Change in Level East of Woodruff Avenue @ 33.929797789310, -118.115011453629

Sidewalks , Change in Level : Change in Level Non Beveled

There is a change in elevation greater than recommended value.

On-Site Finding 1.00 inches

Ensure that the change in elevation is within the recommended value.

Recommendation Up to 0.25 inches

Remove tripping hazards \$198

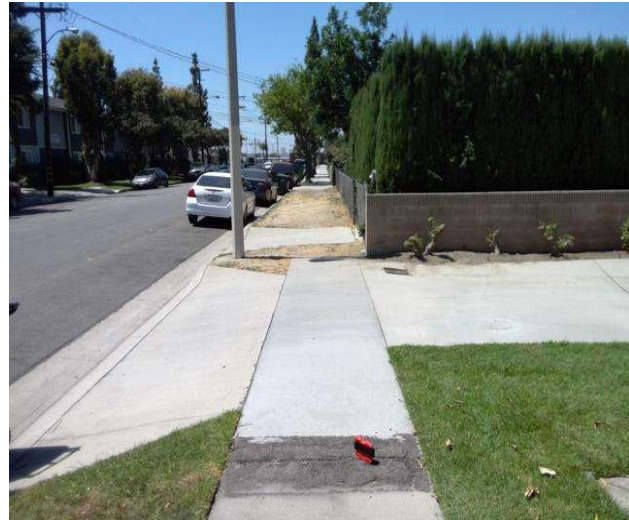
Change in Level East of Woodruff Avenue @ 33.929828946137, -118.115073144436

Sidewalks , Change in Level : Change in Level Non Beveled

There is a change in elevation greater than recommended value.

On-Site Finding 0.75 inches

Ensure that the change in elevation is within the recommended value.

Recommendation Up to 0.25 inches

Remove tripping hazards \$198

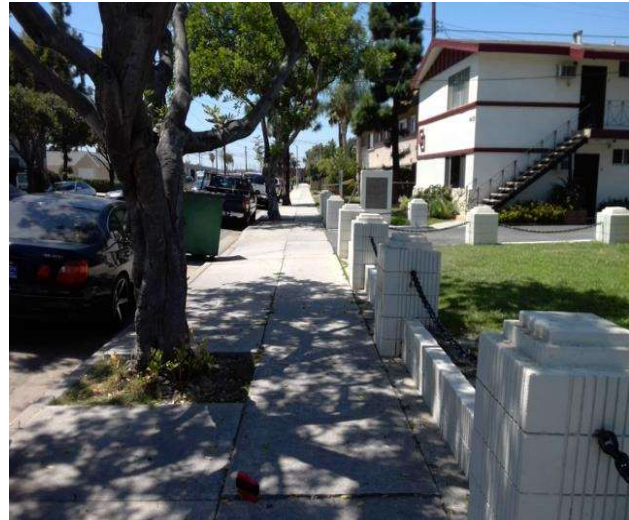
Change in Level East of Woodruff Avenue @ 33.930030352500, -118.115449994802

Sidewalks , Change in Level : Change in Level Non Beveled

There is a change in elevation greater than recommended value.

On-Site Finding 0.75 inches

Ensure that the change in elevation is within the recommended value.

Recommendation Up to 0.25 inches

Remove tripping hazards \$198

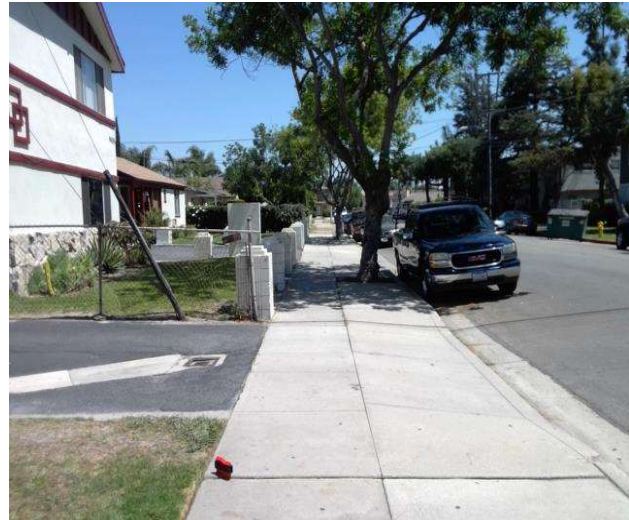
Change in Level East of Woodruff Avenue @ 33.930198376228, -118.115777224302

Sidewalks , Change in Level : Change in Level Non Beveled

There is a change in elevation greater than recommended value.

On-Site Finding 0.50 inches

Ensure that the change in elevation is within the recommended value.

Recommendation Up to 0.25 inches

Remove tripping hazards \$198

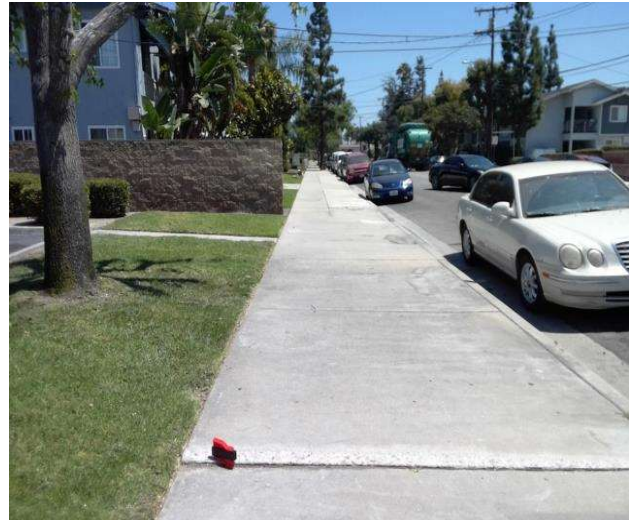
Change in Level East of Woodruff Avenue @ 33.930507717059, -118.116360604763

Sidewalks , Change in Level : Change in Level Non Beveled

There is a change in elevation greater than recommended value.

On-Site Finding 1.00 inches

Ensure that the change in elevation is within the recommended value.

Recommendation Up to 0.25 inches

Remove tripping hazards \$198

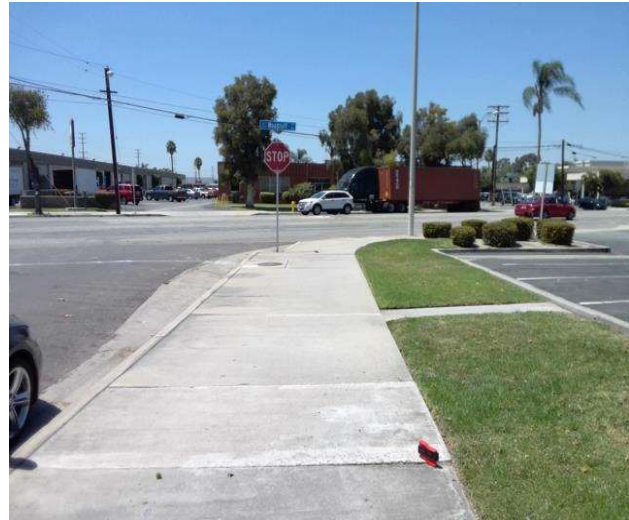
Change in Level East of Woodruff Avenue @ 33.930550970, -118.116416931152

Sidewalks , Change in Level : Change in Level Non Beveled

There is a change in elevation greater than recommended value.

On-Site Finding 0.75 inches

Ensure that the change in elevation is within the recommended value.

Recommendation Up to 0.25 inches

Remove tripping hazards \$198

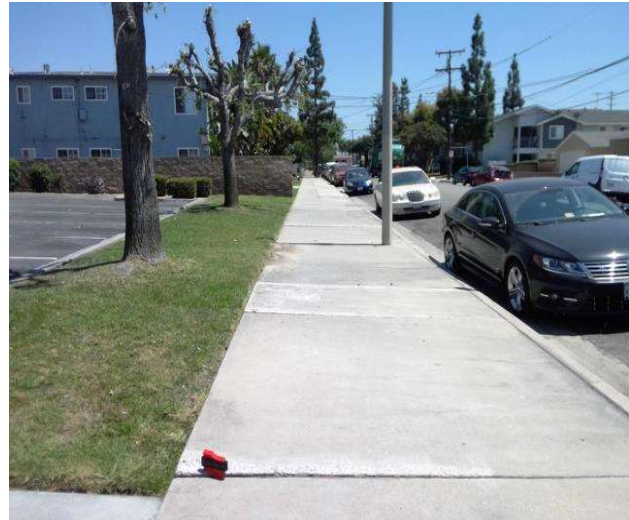
Change in Level East of Woodruff Avenue @ 33.930577819322, -118.116466552019

Sidewalks , Change in Level : Change in Level Non Beveled

There is a change in elevation greater than recommended value.

On-Site Finding 0.75 inches

Ensure that the change in elevation is within the recommended value.

Recommendation Up to 0.25 inches

Remove tripping hazards \$198

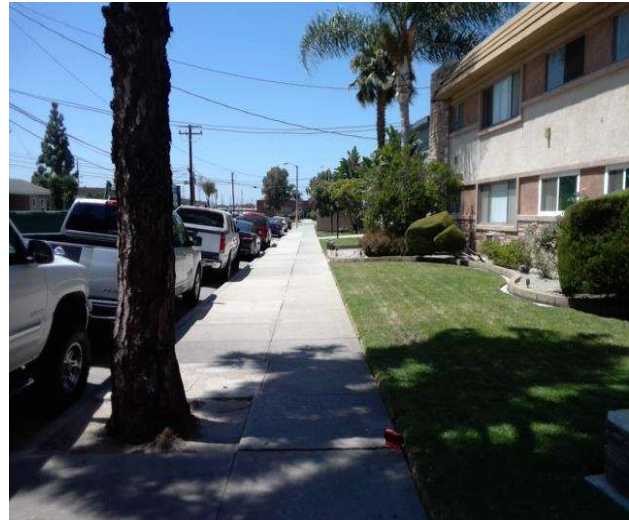
Change in Level East of Woodruff Avenue @ 33.930198376228, -118.115777224302

Sidewalks , Change in Level : Change in Level Non Beveled

There is a change in elevation greater than recommended value.

On-Site Finding 0.37 inches

Ensure that the change in elevation is within the recommended value.

Recommendation Up to 0.25 inches

Remove tripping hazards \$198

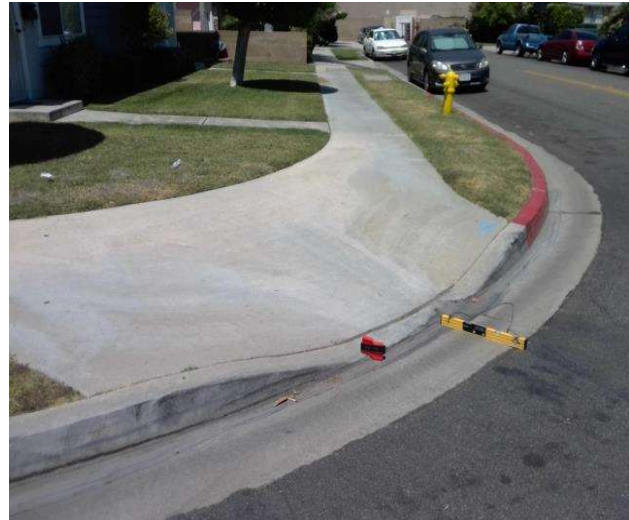
Northwest Corner of Woodruff Avenue @ 33.929726573660, - 118.114865273237

Bottom Landing

Recommendation Up to 5.00 percent

Repave landing \$1,260

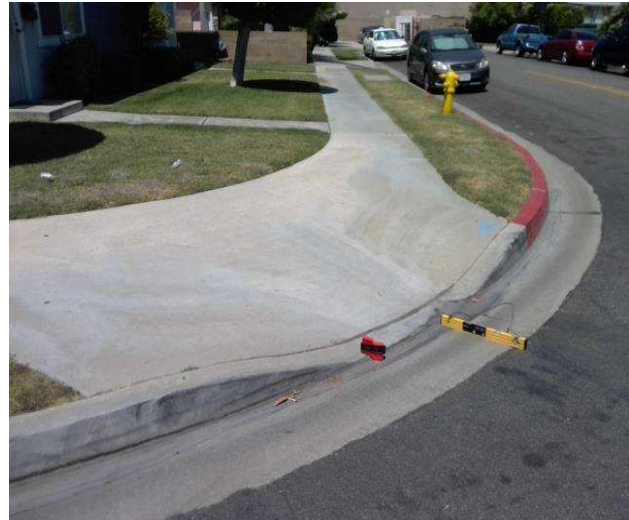
Curb Ramp , Landings And Transitions : Bottom Landing Change in Level

Recommendation Up to 0.50 inches

Patch lip at curb ramp \$255

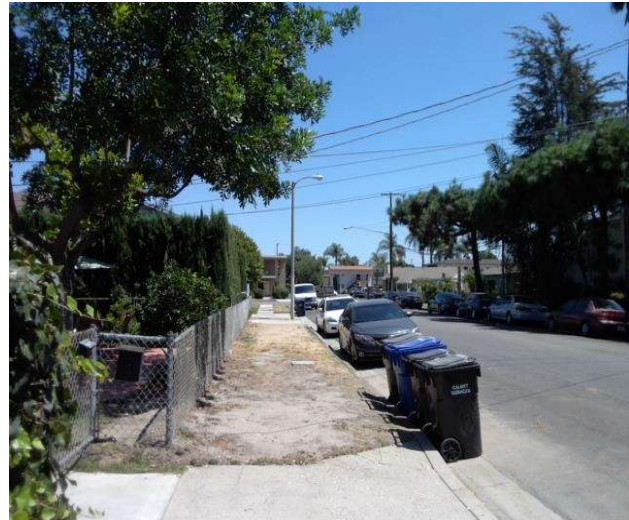
Sidewalks : Missing Sidewalk

Section of sidewalk is missing and consists of dirt, grass or gravel.

Provide a compliant sidewalk for the missing section.

\$1,260

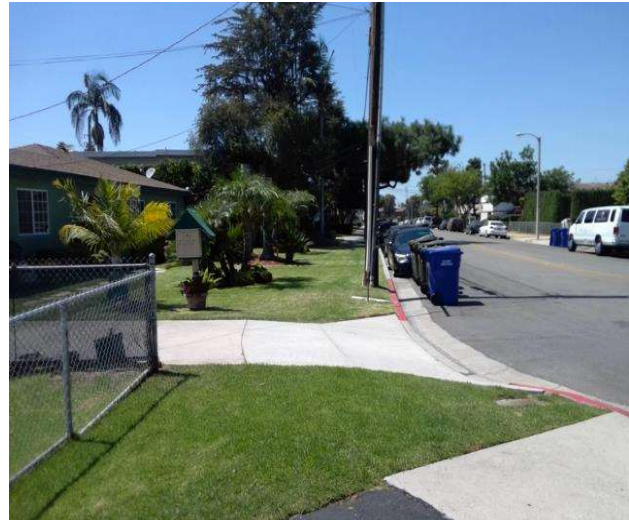
Sidewalks : Missing Sidewalk

Section of sidewalk is missing and consists of dirt, grass or gravel.

Provide a compliant sidewalk for the missing section.

\$1,260

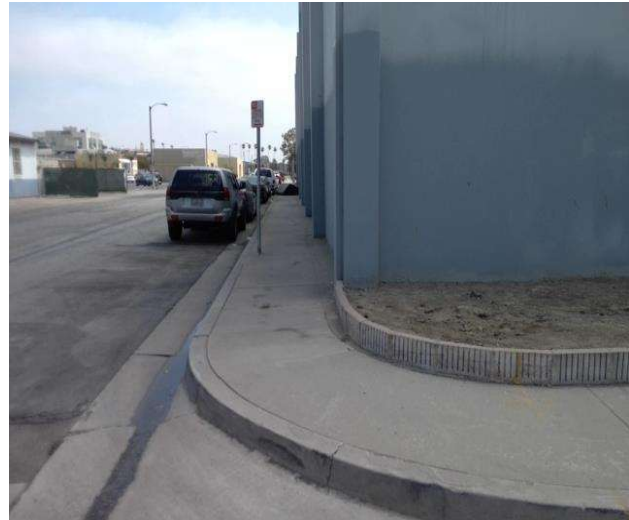
Sidewalks , Hazards & Gratings : Curb is on Path of Travel

Install curb ramp \$2,500

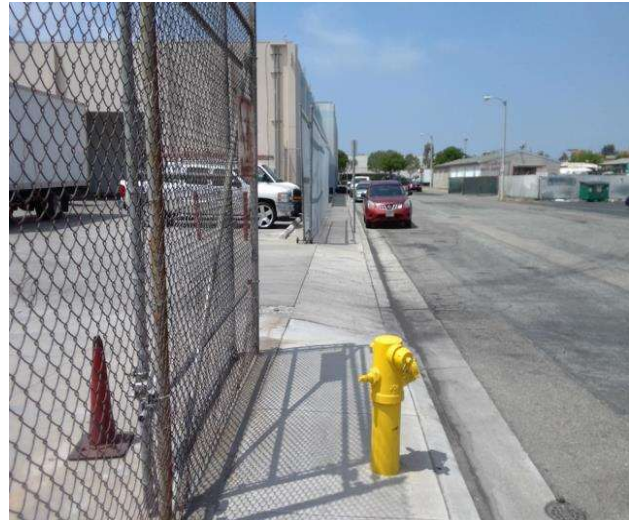
Sidewalks , Hazards & Gratings : Sidewalk Width at Obstruction

Sidewalk width at the obstruction shall have the recommended value.

Recommendation At least 48.00 inches

\$1,260

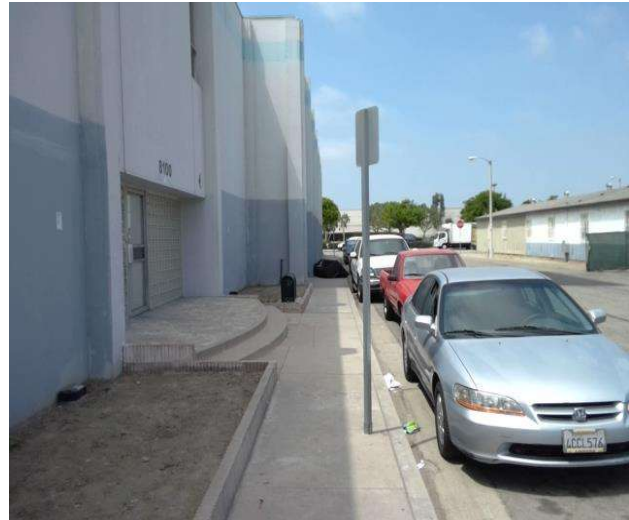
Sidewalks , Hazards & Gratings : Sidewalk Width at Obstruction

Sidewalk width at the obstruction shall have the recommended value.

Recommendation At least 48.00 inches

\$1,260

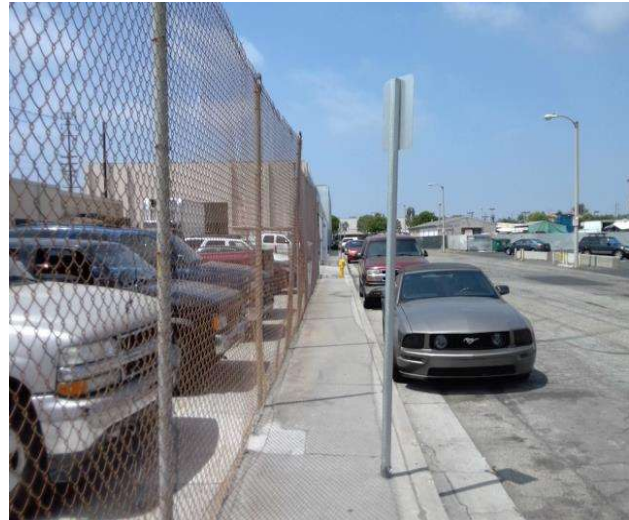
Sidewalks , Hazards & Gratings : Sidewalk Width at Obstruction

Sidewalk width at the obstruction shall have the recommended value.

Recommendation At least 48.00 inches

\$1,260

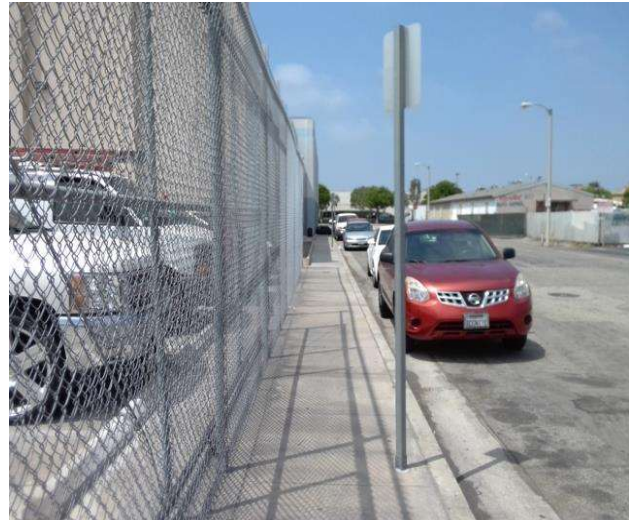
Sidewalks , Hazards & Gratings : Sidewalk Width at Obstruction

Sidewalk width at the obstruction shall have the recommended value.

Recommendation At least 48.00 inches

\$1,260
