Accessibility Survey

City of Downey Chavers Avenue - Hondo Street To Rundell Street

Date of Inspection
4/12/2017

Prepared By
Disability Access Consultants
(800) 743-7067

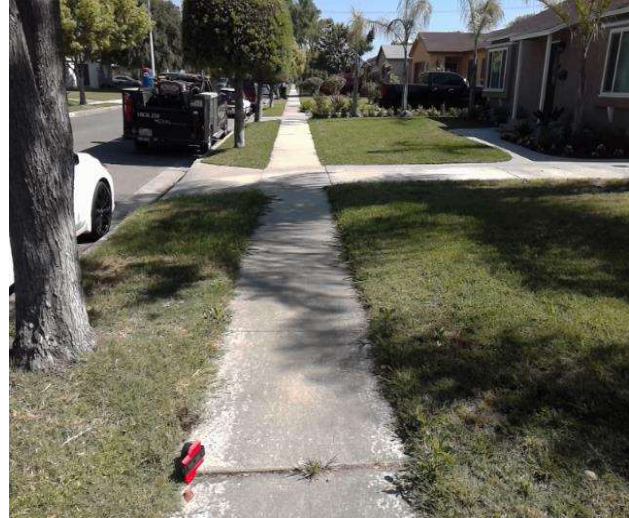
Change In Level South Of Rundell Street @ 33.931414591078, -118.155944645405

Sidewalks , Change in Level : Change in Level Non Beveled

There is a change in elevation greater than recommended value.

On-Site Finding 0.87 inches

Code Reference ADA 206, 302

Ensure that the change in elevation is within the recommended value.

Recommendation Up to 0.25 inches

Remove tripping hazards \$198

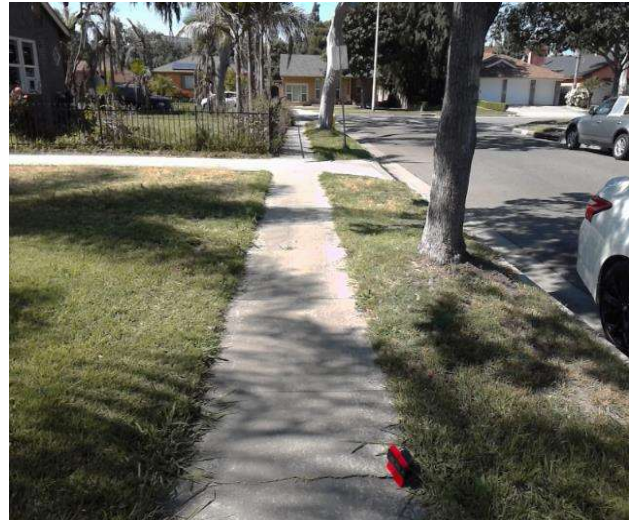
Change In Level South Of Rundell Street @ 33.931447972759, -118.155923187733

Sidewalks , Change in Level : Change in Level Non Beveled

There is a change in elevation greater than recommended value.

On-Site Finding 0.37 inches

Code Reference ADA 206, 302

Ensure that the change in elevation is within the recommended value.

Recommendation Up to 0.25 inches

Remove tripping hazards \$198

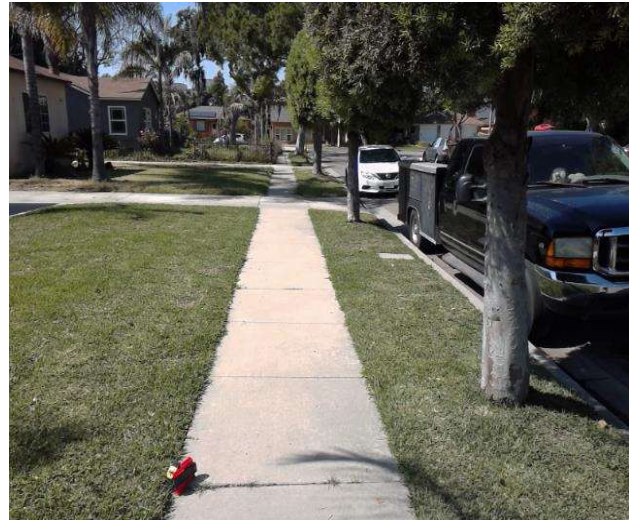
Change In Level South Of Rundell Street @ 33.931560357657, -118.155836015940

Sidewalks , Change in Level : Change in Level Non Beveled

There is a change in elevation greater than recommended value.

On-Site Finding 0.75 inches

Code Reference ADA 206, 302

Ensure that the change in elevation is within the recommended value.

Recommendation Up to 0.25 inches

Remove tripping hazards \$198

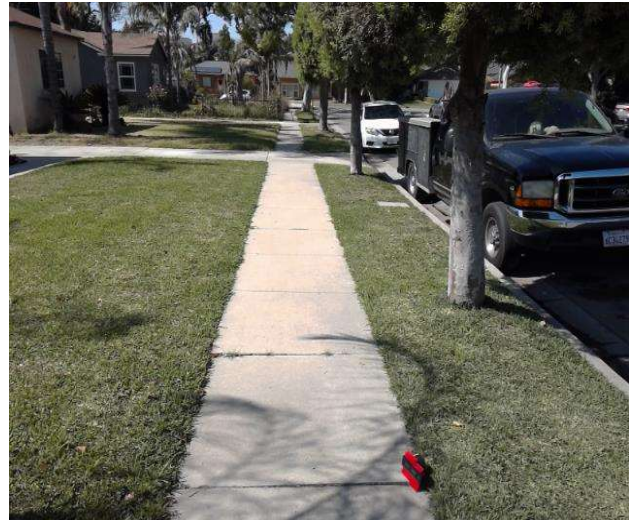
Change In Level South Of Rundell Street @ 33.931582612075, -118.155819922686

Sidewalks , Change in Level : Change in Level Non Beveled

There is a change in elevation greater than recommended value.

On-Site Finding 0.50 inches

Code Reference ADA 206, 302

Ensure that the change in elevation is within the recommended value.

Recommendation Up to 0.25 inches

Remove tripping hazards \$198

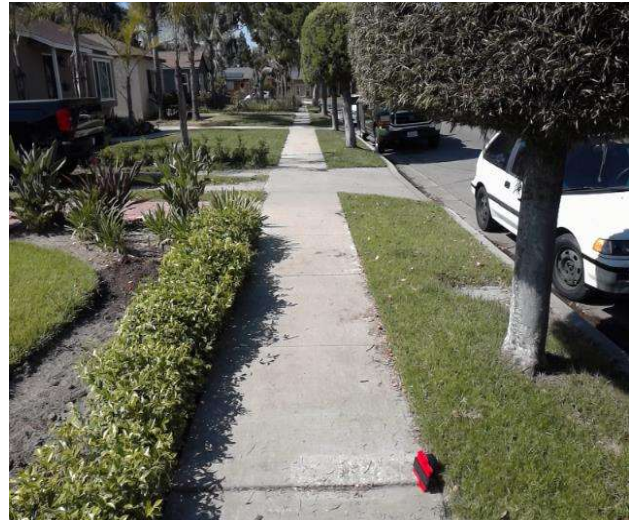
Change In Level South Of Rundell Street @ 33.931656051612, -118.155762255192

Sidewalks , Change in Level : Change in Level Non Beveled

There is a change in elevation greater than recommended value.

On-Site Finding 0.50 inches

Code Reference ADA 206, 302

Ensure that the change in elevation is within the recommended value.

Recommendation Up to 0.25 inches

Remove tripping hazards \$198

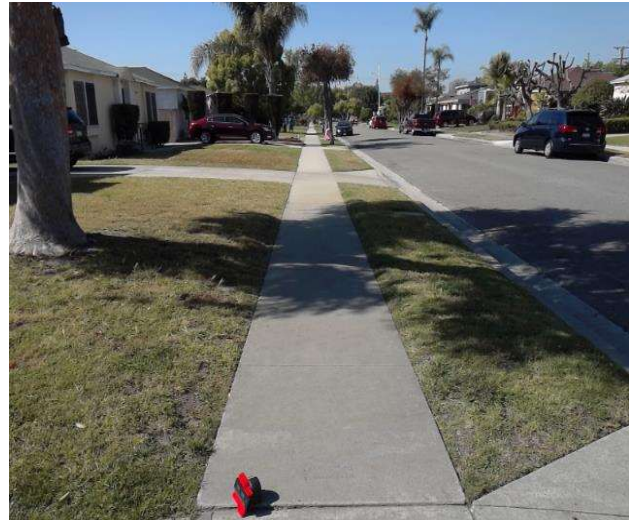
Change In Level South Of Rundell Street @ 33.933085884524, -118.154673278332

Sidewalks , Change in Level : Change in Level Non Beveled

There is a change in elevation greater than recommended value.

On-Site Finding 0.62 inches

Code Reference ADA 206, 302

Ensure that the change in elevation is within the recommended value.

Recommendation Up to 0.25 inches

Remove tripping hazards \$198

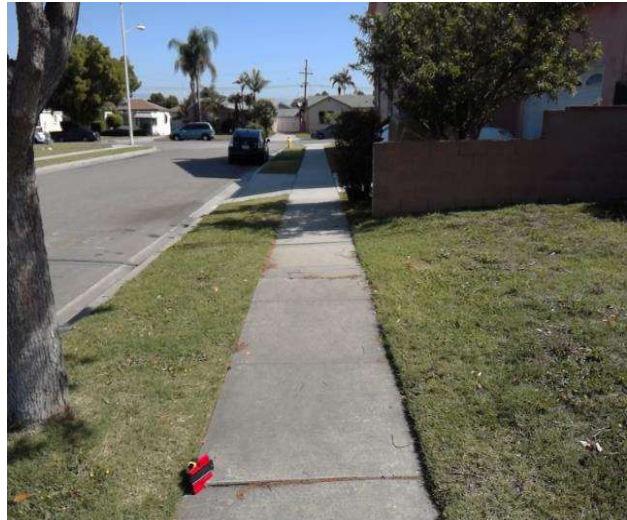
Change In Level South Of Rundell Street @ 33.933280606993, -118.154519051313

Sidewalks , Change in Level : Change in Level Non Beveled

There is a change in elevation greater than recommended value.

On-Site Finding 0.75 inches

Code Reference ADA 206, 302

Ensure that the change in elevation is within the recommended value.

Recommendation Up to 0.25 inches

Remove tripping hazards \$198

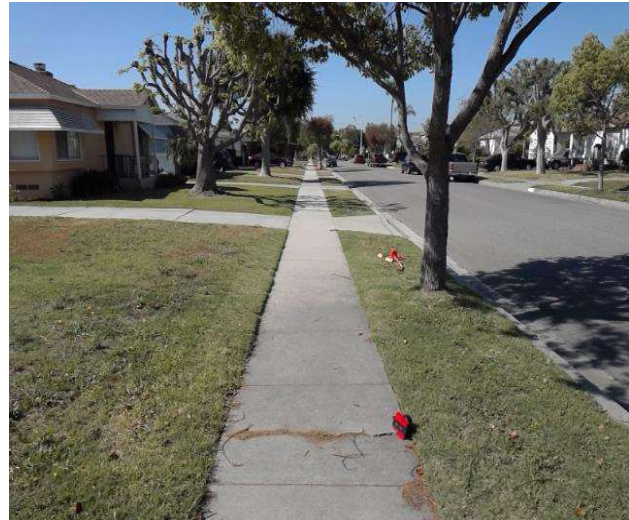
Change In Level South Of Rundell Street @ 33.933289508581, -118.154508322477

Sidewalks , Change in Level : Change in Level Non Beveled

There is a change in elevation greater than recommended value.

On-Site Finding 0.50 inches

Code Reference ADA 206, 302

Ensure that the change in elevation is within the recommended value.

Recommendation Up to 0.25 inches

Remove tripping hazards \$198

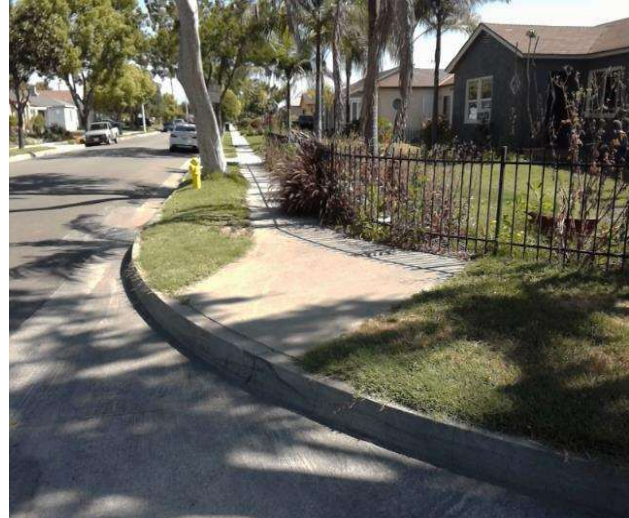
Northeast Corner Of Hondo Street @ 33.931216526166, -118.156066685915

Sidewalks , Hazards & Gratings : Curb is on Path of Travel

There is a curb on the designated path of travel.

On-Site Finding Not Compliant

Code Reference ADA 402, 303, 406, 403.4, 303.4

Provide a compliant curb ramp.

Install curb ramp \$2,500

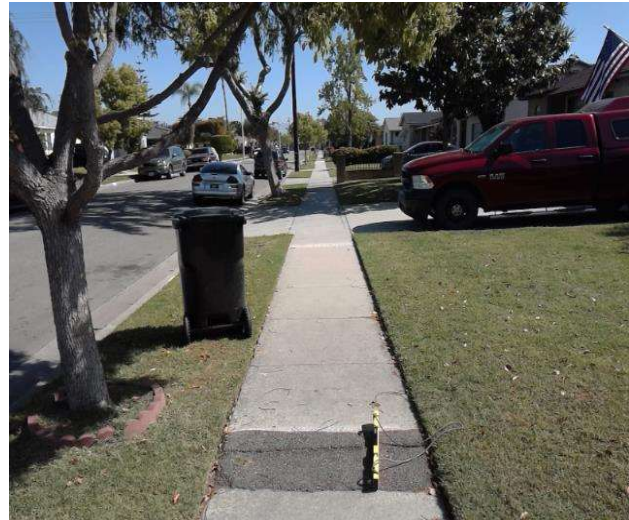
Sidewalk South Of Rundell Street @ 33.931767323517, -118.155668377876

Sidewalks , Surface : Running Slope

Sidewalk running slope is not compliant.

On-Site Finding 9.40 percent for 2.00 feet

Code Reference ADA 206, 302

Notes : Surface is rough and uneven.

Repave the sidewalk surface with the recommended running slope.

Recommendation Up to 5.00 percent

Repave surface \$1,184

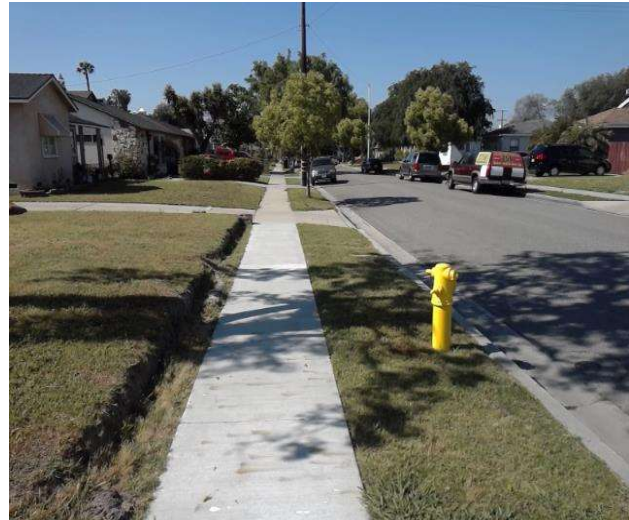
Sidewalk South Of Rundell Street @ 33.932280285120, -118.155287504196

Sidewalks : Width

Sidewalk does not have enough width.

On-Site Finding 44.50 inches for 40.00 feet

Code Reference ADA 206, 302,CA 11B-403.5.1

Widen the sidewalk to the recommended value.

Recommendation At least 48.00 inches

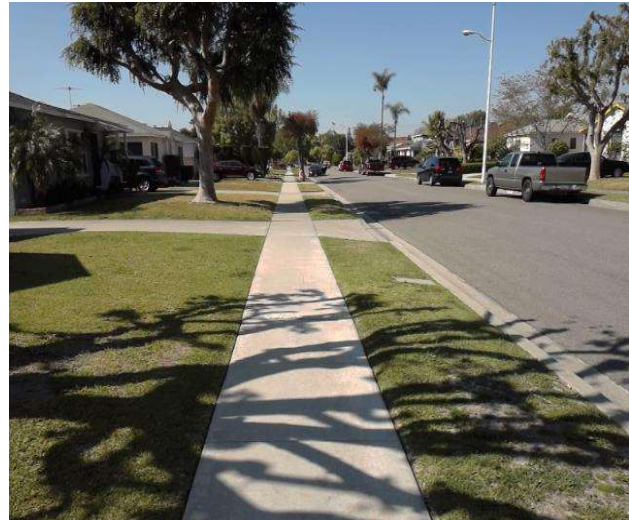
Sidewalk South Of Rundell Street @ 33.933084771823, -118.154671937227

Sidewalks , Surface : Cross Slope

Sidewalk cross slope is not compliant.

On-Site Finding 5.40 percent for 43.00 feet

Code Reference ADA 206, 302,CA 11B-403.3

Repave the sidewalk surface with the recommended cross slope.

Recommendation Up to 2.08 percent

Repave surface \$1,092

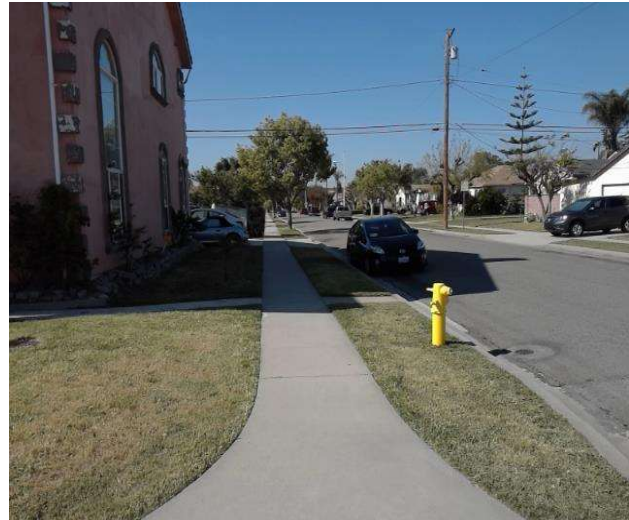
Sidewalk South Of Rundell Street @ 33.933579922378, -118.154299110174

Sidewalks , Surface : Cross Slope

Sidewalk cross slope is not compliant.

On-Site Finding 3.80 percent for 133.00 feet

Code Reference ADA 206, 302,CA 11B-403.3

Repave the sidewalk surface with the recommended cross slope.

Recommendation Up to 2.08 percent

Repave surface \$1,092

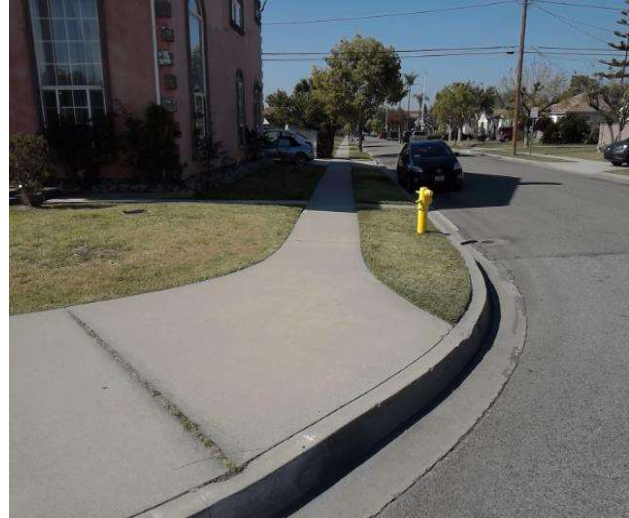
Southeast Corner Of Rundell Street @ 33.933579922378, -118.154299110174

Sidewalks , Hazards & Gratings : Curb is on Path of Travel

There is a curb on the designated path of travel.

On-Site Finding Not Compliant

Code Reference ADA 402, 303, 406, 403.4, 303.4

Provide a compliant curb ramp.

Install curb ramp \$2,500

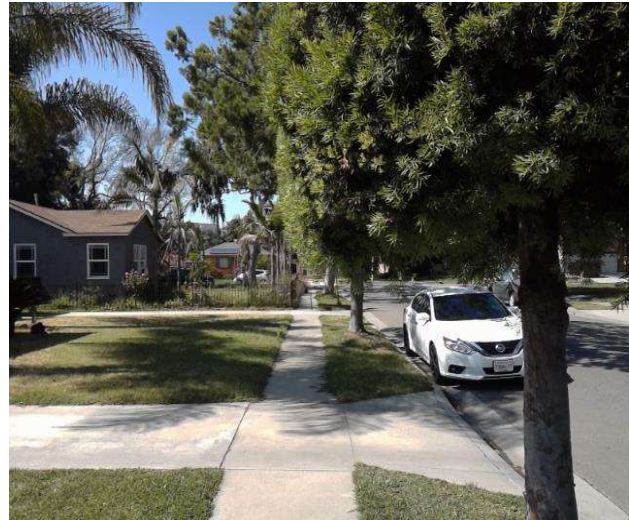
Tree South Of Rundell Street @ 33.931539215955, -118.155852109194

Sidewalks , Hazards & Gratings : Overhead Obstruction Height

Overhead obstruction height is not compliant.

On-Site Finding 70.00 inches

Code Reference ADA 206, 307.4, CA 11B-307.4

Provide a compliant vertical clearance height.

Recommendation At least 80.00 inches

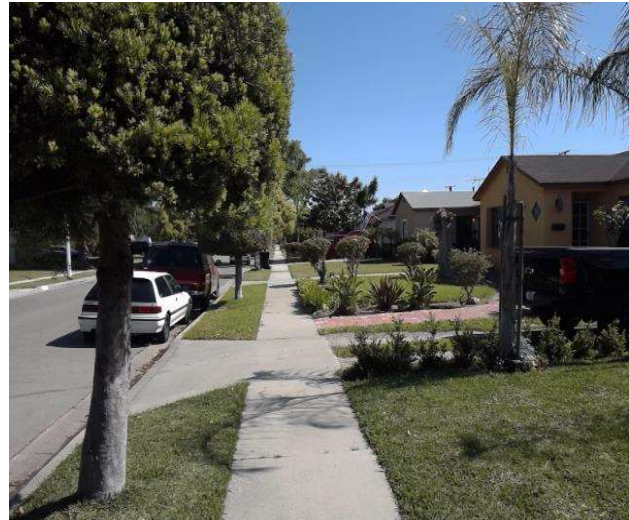
Tree South Of Rundell Street @ 33.931560357657, -118.155836015940

Sidewalks , Hazards & Gratings : Overhead Obstruction Height

Overhead obstruction height is not compliant.

On-Site Finding 70.00 inches

Code Reference ADA 206, 307.4, CA 11B-307.4

Provide a compliant vertical clearance height.

Recommendation At least 80.00 inches

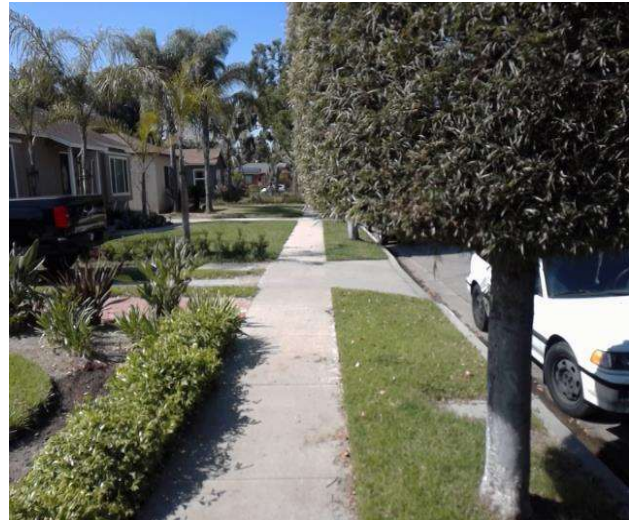
Tree South Of Rundell Street @ 33.931656051612, -118.155762255192

Sidewalks , Hazards & Gratings : Overhead Obstruction Height

Overhead obstruction height is not compliant.

On-Site Finding 59.00 inches

Code Reference ADA 206, 307.4, CA 11B-307.4

Provide a compliant vertical clearance height.

Recommendation At least 80.00 inches

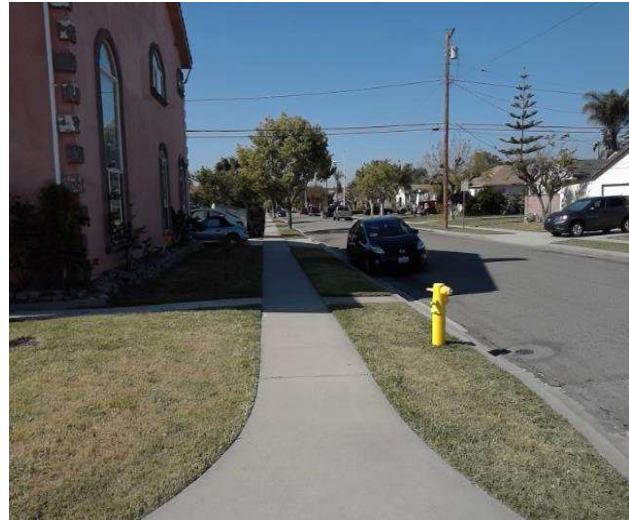
East Side @ 33.933579922378, -118.154299110174

Sidewalks : 60X60 Turn Area

There is no 60X60 turn area at every 200 feet.

On-Site Finding Not Found

Code Reference ADA 206, 302

Provide a 60X60 turn every 200 feet on the sidewalk.

\$2,400

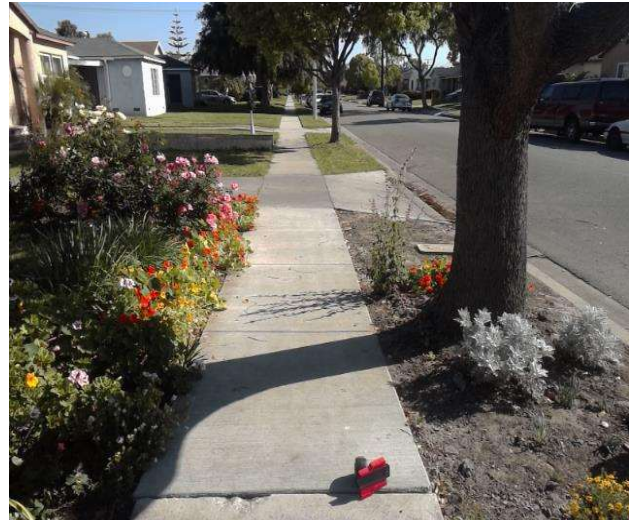
Change In Level North Of Hondo Street @ 33.931590401120, -118.155988901854

Sidewalks , Change in Level : Change in Level Non Beveled

There is a change in elevation greater than recommended value.

On-Site Finding 0.50 inches

Code Reference ADA 206, 302

Ensure that the change in elevation is within the recommended value.

Recommendation Up to 0.25 inches

Remove tripping hazards \$198

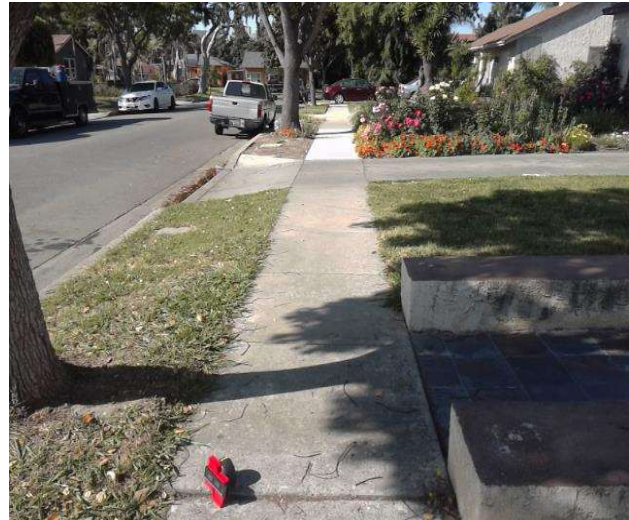
Change In Level North Of Hondo Street @ 33.931713913021, -118.155901730061

Sidewalks , Change in Level : Change in Level Non Beveled

There is a change in elevation greater than recommended value.

On-Site Finding 1.12 inches

Code Reference ADA 206, 302

Ensure that the change in elevation is within the recommended value.

Recommendation Up to 0.25 inches

Remove tripping hazards \$198

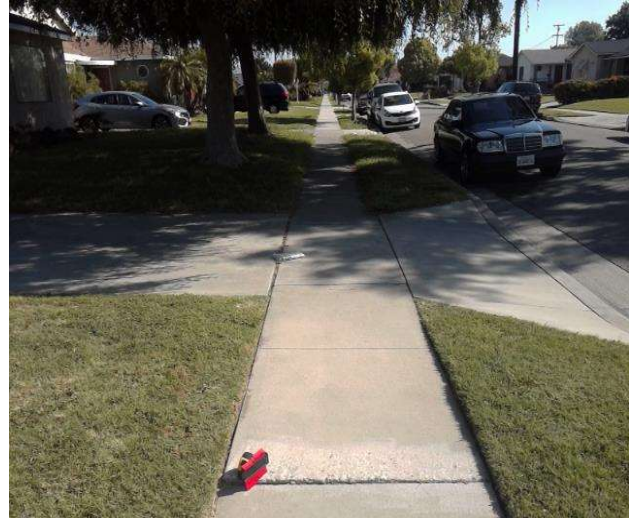
Change In Level North Of Hondo Street @ 33.931865242674, -118.155781030655

Sidewalks , Change in Level : Change in Level Non Beveled

There is a change in elevation greater than recommended value.

On-Site Finding 0.37 inches

Code Reference ADA 206, 302

Ensure that the change in elevation is within the recommended value.

Recommendation Up to 0.25 inches

Remove tripping hazards \$198

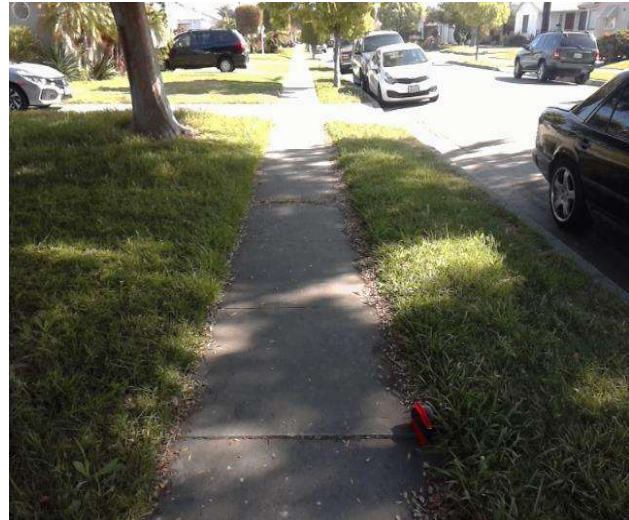
There is a change in elevation greater than recommended value.

On-Site Finding 0.50 inches

Code Reference ADA 206, 302

Ensure that the change in elevation is within the recommended value.

Recommendation Up to 0.25 inches

Remove tripping hazards \$198

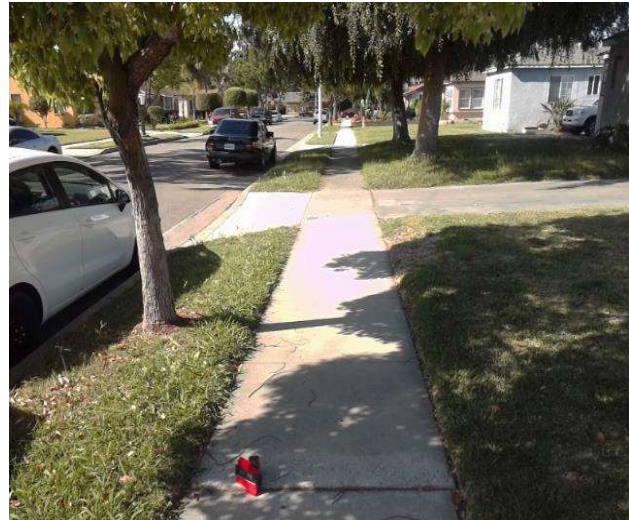
There is a change in elevation greater than recommended value.

Code Reference ADA 206, 302

Ensure that the change in elevation is within the recommended value.

Recommendation Up to 0.25 inches

Remove tripping hazards \$198

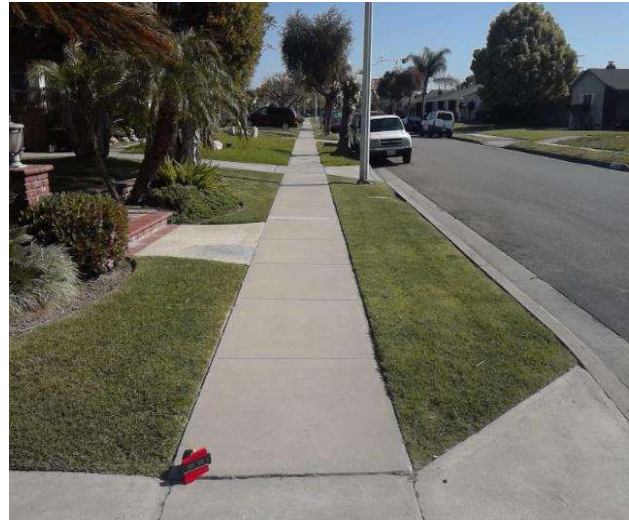
There is a change in elevation greater than recommended value.

Code Reference ADA 206, 302

Ensure that the change in elevation is within the recommended value.

Recommendation Up to 0.25 inches

Remove tripping hazards \$198

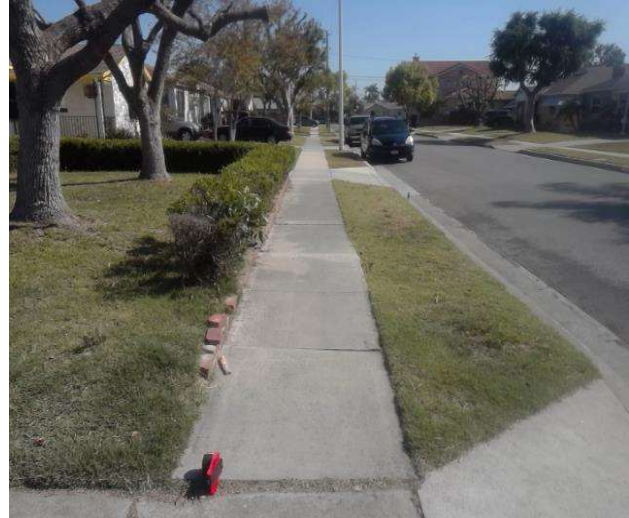
There is a change in elevation greater than recommended value.

Code Reference ADA 206, 302

Ensure that the change in elevation is within the recommended value.

Recommendation Up to 0.25 inches

Remove tripping hazards \$198

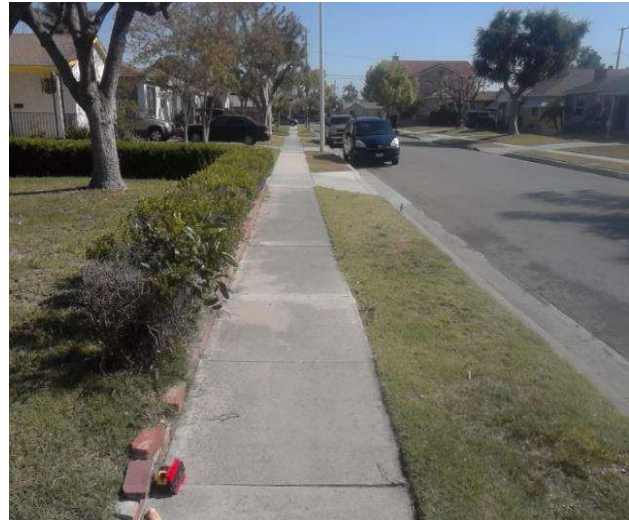
There is a change in elevation greater than recommended value.

Code Reference ADA 206, 302

Ensure that the change in elevation is within the recommended value.

Recommendation Up to 0.25 inches

Remove tripping hazards \$198

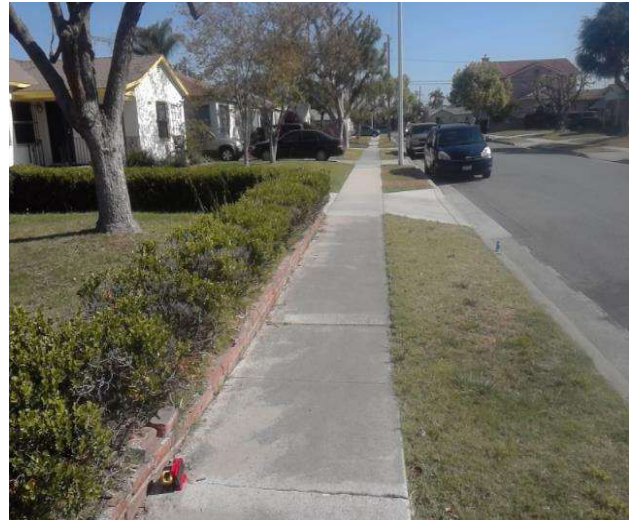
There is a change in elevation greater than recommended value.

Code Reference ADA 206, 302

Ensure that the change in elevation is within the recommended value.

Recommendation Up to 0.25 inches

Remove tripping hazards \$198

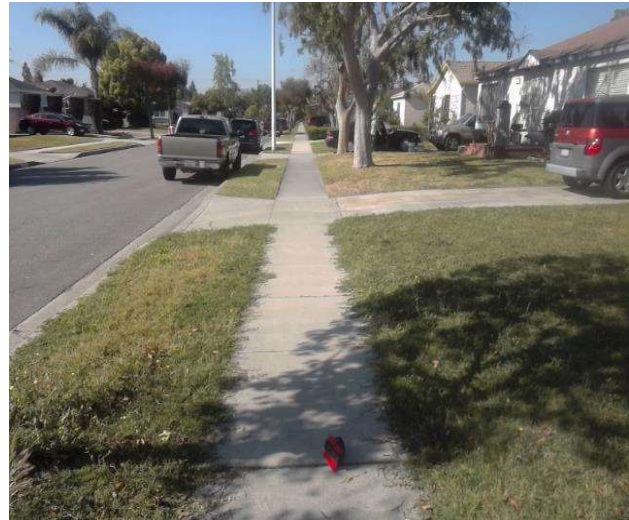
There is a change in elevation greater than recommended value.

Code Reference ADA 206, 302

Ensure that the change in elevation is within the recommended value.

Recommendation Up to 0.25 inches

Remove tripping hazards \$198

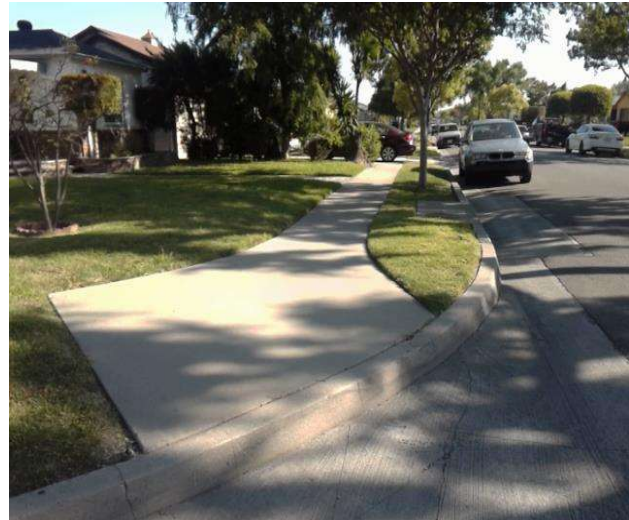
Sidewalks , Hazards & Gratings : Curb is on Path of Travel

Code Reference ADA 402, 303, 406, 403.4, 303.4

Install curb ramp \$2,500

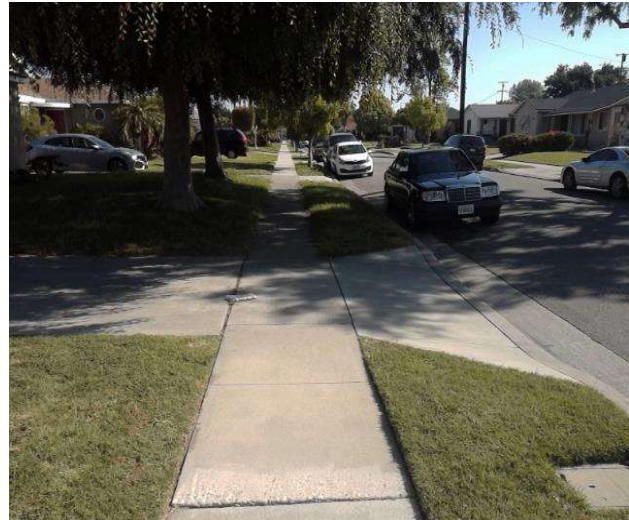
Code Reference ADA 206, 302,CA 11B-403.3

Repave the sidewalk surface with the recommended cross slope.

Recommendation Up to 2.08 percent

Repave surface \$1,092

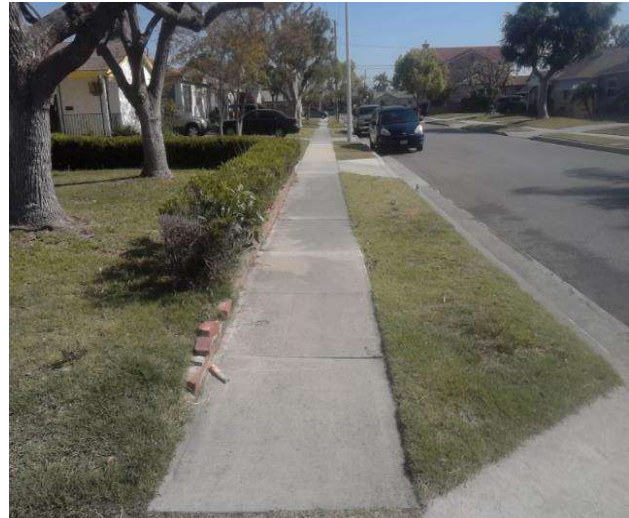
Code Reference ADA 206, 302,CA 11B-403.3

Repave the sidewalk surface with the recommended cross slope.

Recommendation Up to 2.08 percent

Repave surface \$1,092

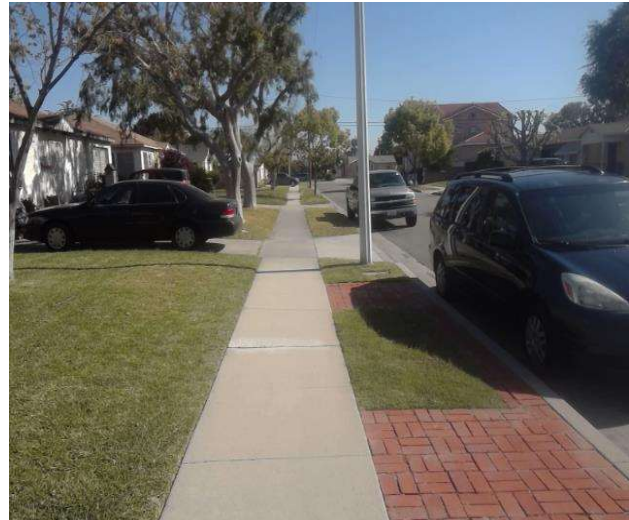
Code Reference ADA 206, 302, CA 11B-403.3

Repave the sidewalk surface with the recommended cross slope.

Recommendation Up to 2.08 percent

Repave surface \$1,092

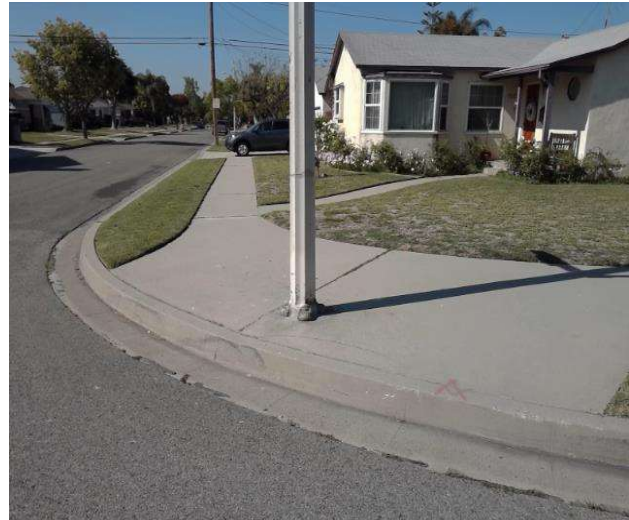
Sidewalks , Hazards & Gratings : Curb is on Path of Travel

Code Reference ADA 402, 303, 406, 403.4, 303.4

Install curb ramp \$2,500

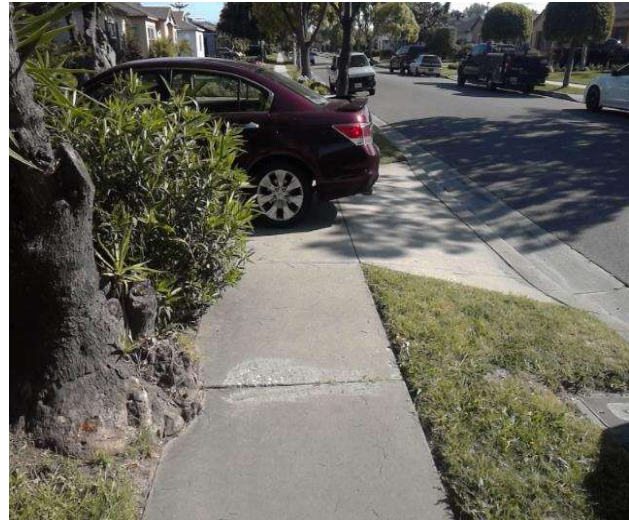
Sidewalks , Hazards & Gratings : Sidewalk Width at Obstruction

Code Reference ADA 206, 302, 403.5.1, CA 11B-403.5

Sidewalk width at the obstruction shall have the recommended value.

Recommendation At least 48.00 inches

\$1,260

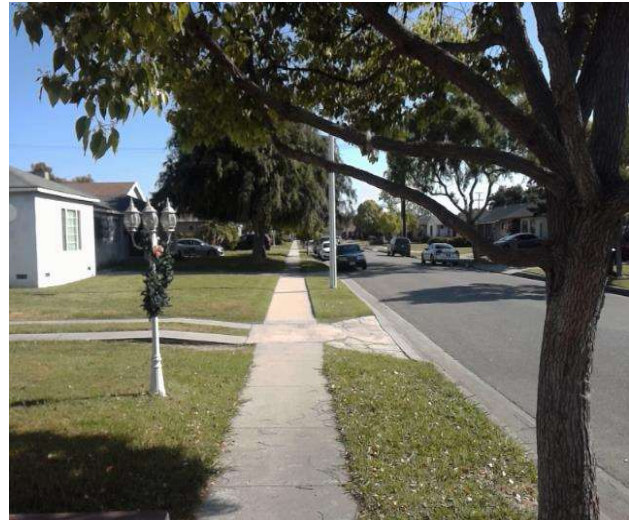
Sidewalks , Hazards & Gratings : Overhead Obstruction Height

Code Reference ADA 206, 307.4,CA 11B-307.4

Recommendation At least 80.00 inches

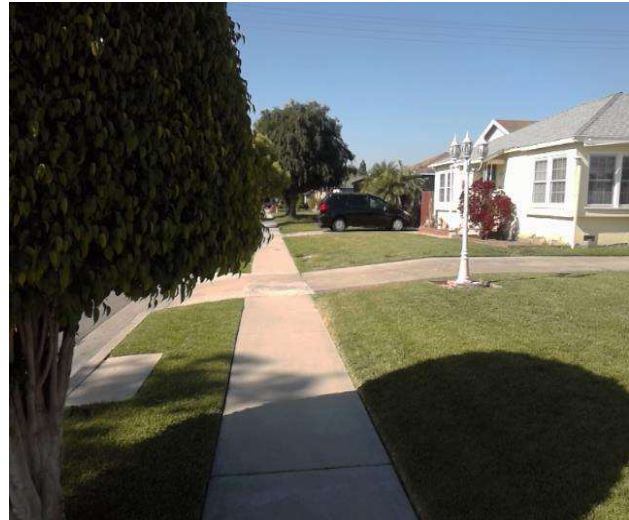
Sidewalks , Hazards & Gratings : Overhead Obstruction Height

Code Reference ADA 206, 307.4,CA 11B-307.4

Recommendation At least 80.00 inches

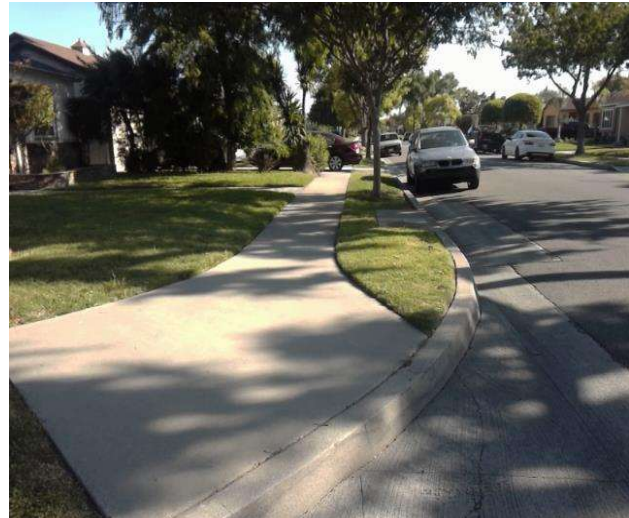
On-Site Finding Not Found

Code Reference ADA 206, 302

\$2,400
