Accessibility Survey

City of Downey Cleta Street - Lakewood Boulevard To Downey Avenue

Date of Inspection
12/9/2016

Disability Access Consultants

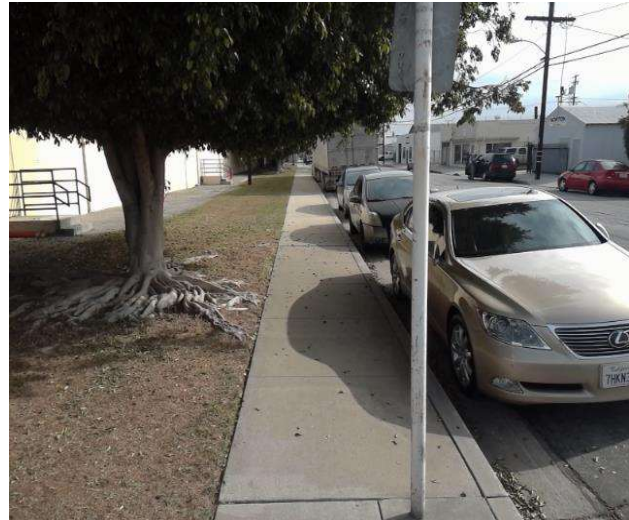
Change In Level East Of Patton Road @ 33.932384879948, -118.130525350571

Sidewalks , Change in Level : Change in Level Non Beveled

There is a change in elevation greater than recommended value.

On-Site Finding 0.50 inches

Code Reference ADA 206, 302

Ensure that the change in elevation is within the recommended value.

Recommendation Up to 0.25 inches

Remove tripping hazards \$198

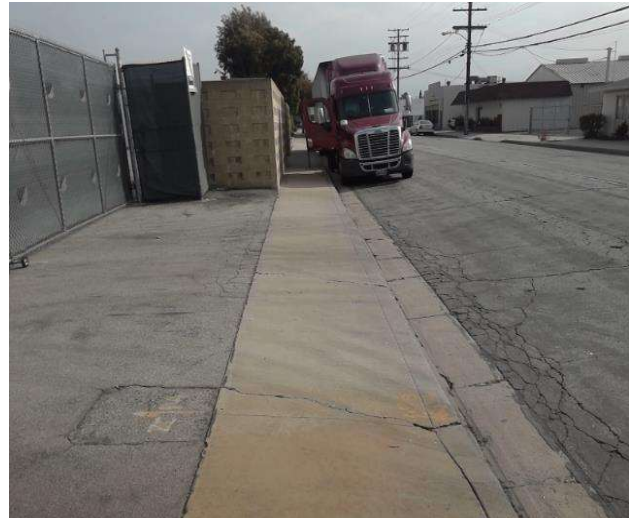
Driveway East Of Patton Road @ 33.931619331852, -118.128905296326

Sidewalks , Vehicular Traffic : Cross Walks and Detectable Warnings

There are no detectable warnings where the pedestrian route crosses vehicular traffic.

On-Site Finding Not Found

Code Reference ADA 705,CA 11B-705.1.2.5,CA 11B-247.1.2.5

Provide detectable warnings.

Install compliant detectable warnings \$190

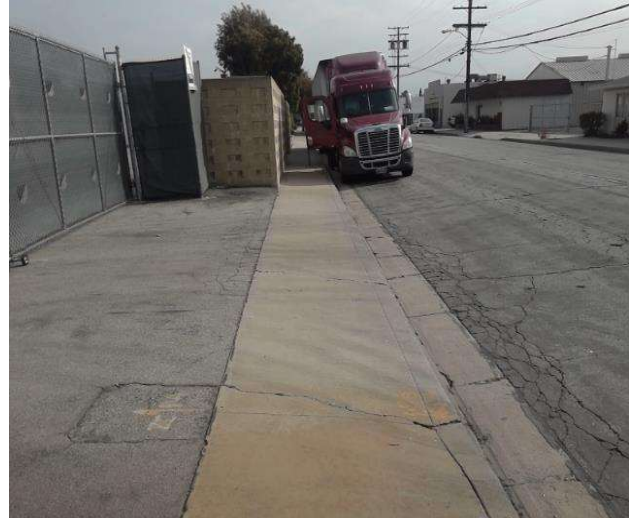
Driveway East Of Patton Road @ 33.931619331852, -118.128905296326

Sidewalks : Vehicular Traffic Cross Slope

Cross slope at vehicular traffic is not compliant.

On-Site Finding 9.80 percent

Code Reference ADA 206, 302, CA 11B-403.3

Repave the surface to provide a compliant cross slope.

Recommendation Up to 2.08 percent

Repave surface \$1,092

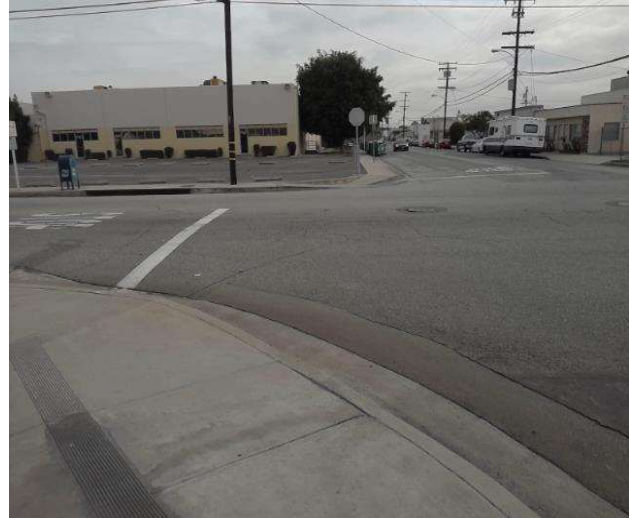
North Crossing @ 33.932687536600, -118.131083250046

Sidewalks : Vehicular Traffic Slope

Slope at vehicular traffic is not compliant.

On-Site Finding 7.20 percent

Repave the surface to provide a compliant slope.

Recommendation Up to 5.00 percent

Repave surface \$1,092

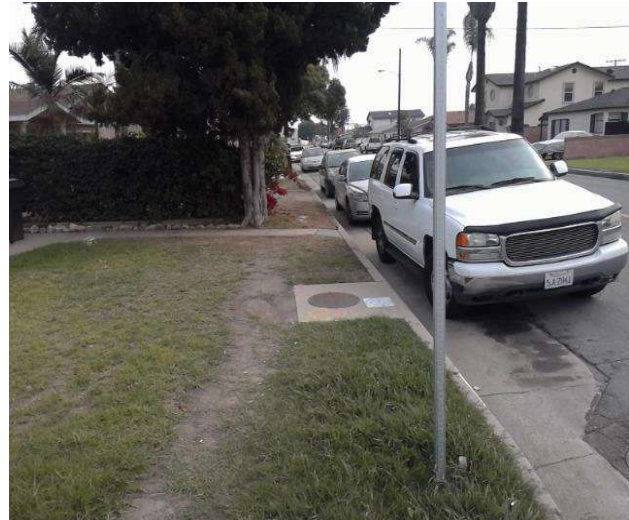
Sidewalk East Of Brookshire Avenue @ 33.933399665655, -118.133100271225

Sidewalks : Missing Sidewalk

Section of sidewalk is missing and consists of dirt, grass or gravel.

On-Site Finding 552.00 feet

Code Reference ADA 206, 302,CA 11B-302,CA 11B-206

Provide a compliant sidewalk for the missing section.

\$1,260

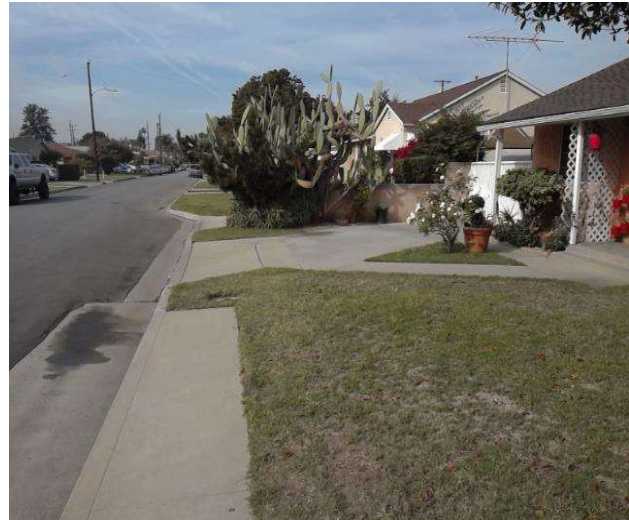
Sidewalk East Of Downey Avenue @ 33.934850610177, -118.136361837387

Sidewalks : Missing Sidewalk

Section of sidewalk is missing and consists of dirt, grass or gravel.

On-Site Finding 1034.00 feet

Code Reference ADA 206, 302,CA 11B-302,CA 11B-206

Provide a compliant sidewalk for the missing section.

\$1,260

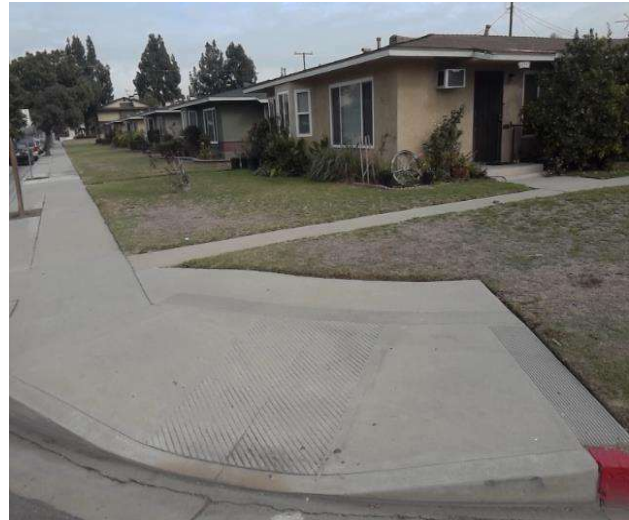
Northeast Corner Of Downey Avenue @ 33.934912920124, - 118.136458396912

Curb Ramp : No Detectable Warnings

The curb ramp does not provide a detectable warning surface which includes truncated domes.

On-Site Finding Not Found

Code Reference CA 11B-406.5.12

Provide compliant detectable warnings to surface.

Provide detectable warning to surface \$248

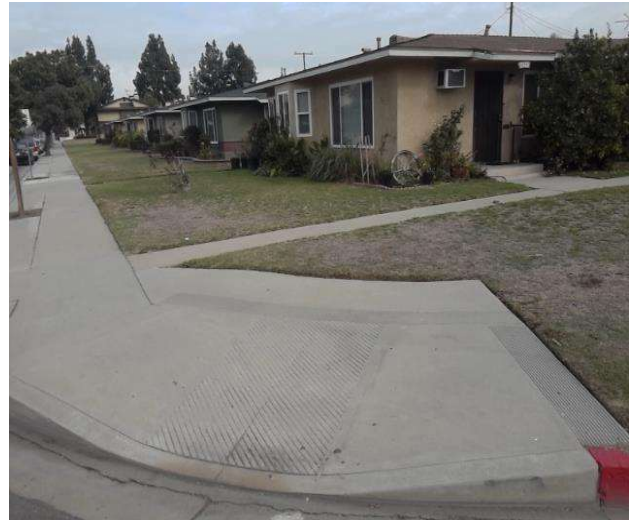
Northeast Corner Of Downey Avenue @ 33.934912920124, - 118.136458396912

Curb Ramp : Curb Ramp Slope

The running slope is greater than allowed.

On-Site Finding 8.90 percent

Code Reference ADA 406, 406.1, 405.2, CA 11B-406

Provide a compliant curb ramp.

Recommendation Up to 8.33 percent

Install curb ramp \$1,300

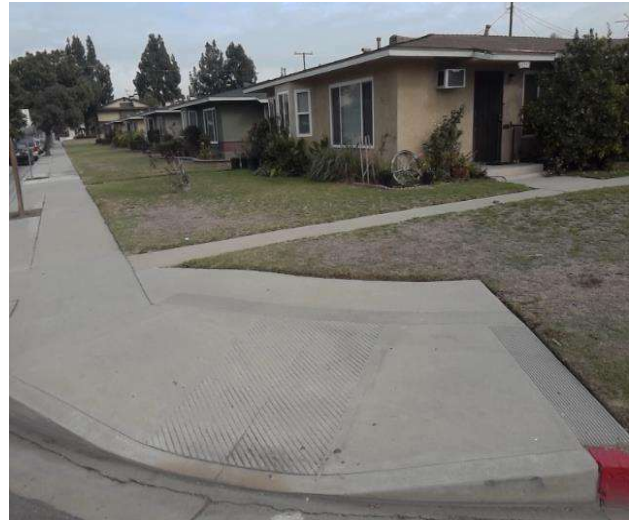
Curb Ramp : Side Flare Slope

Code Reference ADA 406, 406.3, CA 11B-406.2.2

Recommendation Up to 10.00 percent

Install flared sides \$1,300

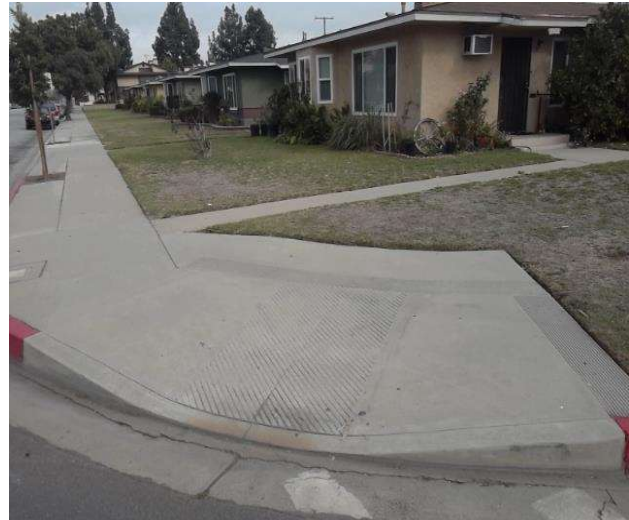
Bottom Landing

Code Reference ADA 406, 406.2, CA 11B-406.5.8

Recommendation Up to 5.00 percent

Repave landing \$1,260

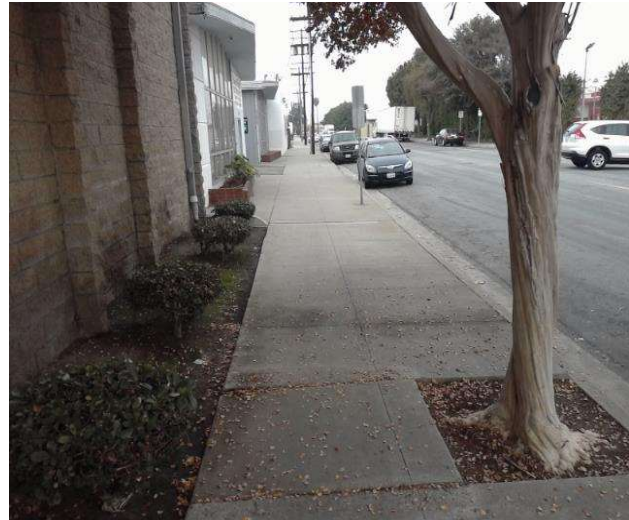
There is a change in elevation greater than recommended value.

Code Reference ADA 206, 302

Ensure that the change in elevation is within the recommended value.

Recommendation Up to 0.25 inches

Remove tripping hazards \$198

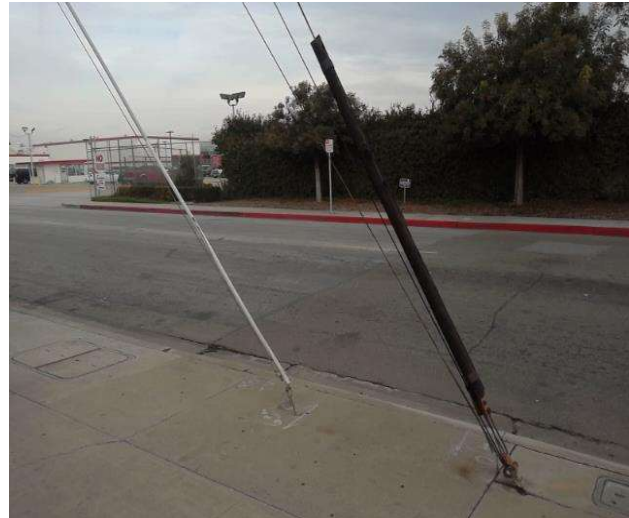
Sidewalks , Hazards & Gratings : Overhead Obstruction Height

Code Reference ADA 206, 307.4, CA 11B-307.4

Recommendation At least 80.00 inches

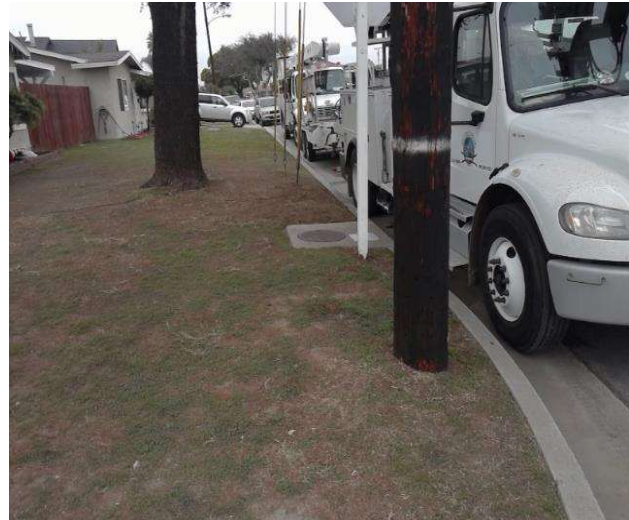
Sidewalks : Missing Sidewalk

Section of sidewalk is missing and consists of dirt, grass or gravel.

Code Reference ADA 206, 302,CA 11B-302,CA 11B-206

Provide a compliant sidewalk for the missing section.

\$1,260

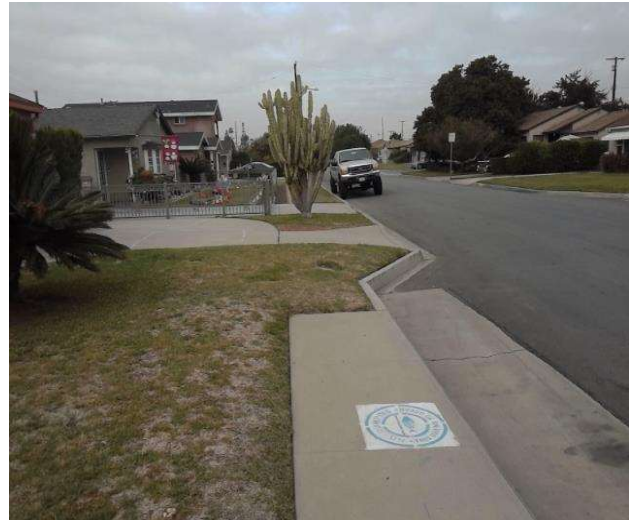
Sidewalks : Missing Sidewalk

Section of sidewalk is missing and consists of dirt, grass or gravel.

Code Reference ADA 206, 302,CA 11B-302,CA 11B-206

Provide a compliant sidewalk for the missing section.

\$1,260

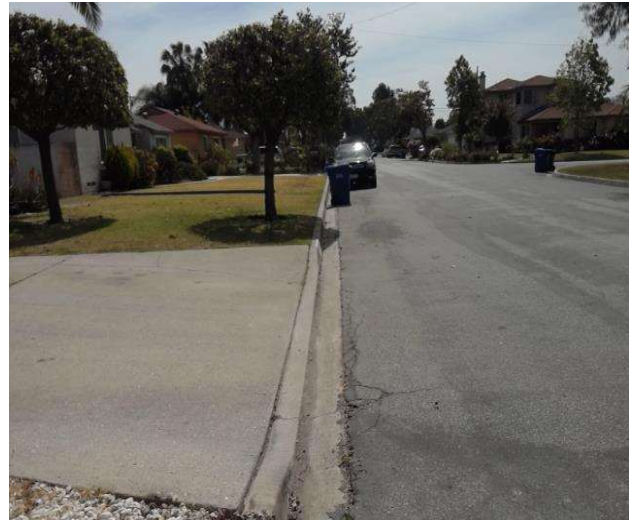
Sidewalks : Missing Sidewalk

Section of sidewalk is missing and consists of dirt, grass or gravel.

Code Reference ADA 206, 302,CA 11B-302,CA 11B-206

Provide a compliant sidewalk for the missing section.

\$1,260

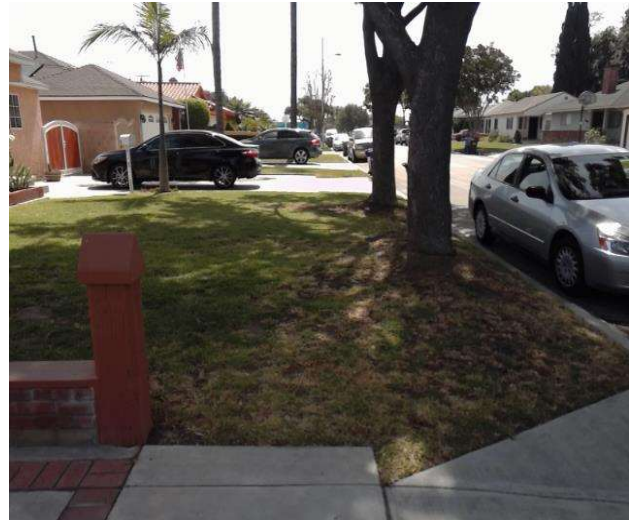
Sidewalks : Missing Sidewalk

Section of sidewalk is missing and consists of dirt, grass or gravel.

Code Reference ADA 206, 302,CA 11B-302,CA 11B-206

Provide a compliant sidewalk for the missing section.

\$1,260

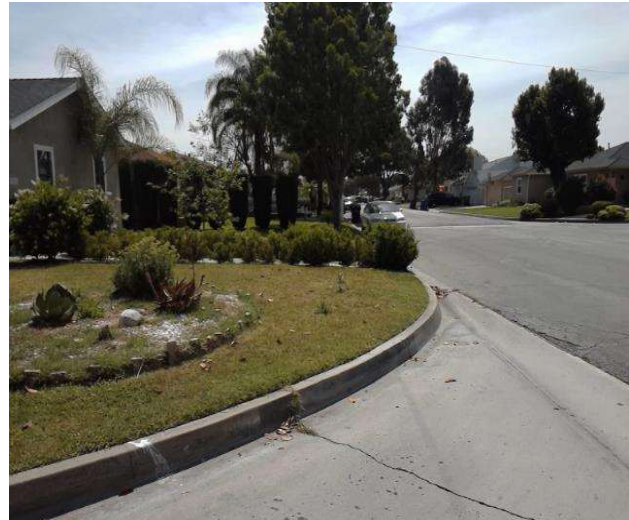
Sidewalks : Missing Sidewalk

Section of sidewalk is missing and consists of dirt, grass or gravel.

Code Reference ADA 206, 302,CA 11B-302,CA 11B-206

Provide a compliant sidewalk for the missing section.

\$1,260

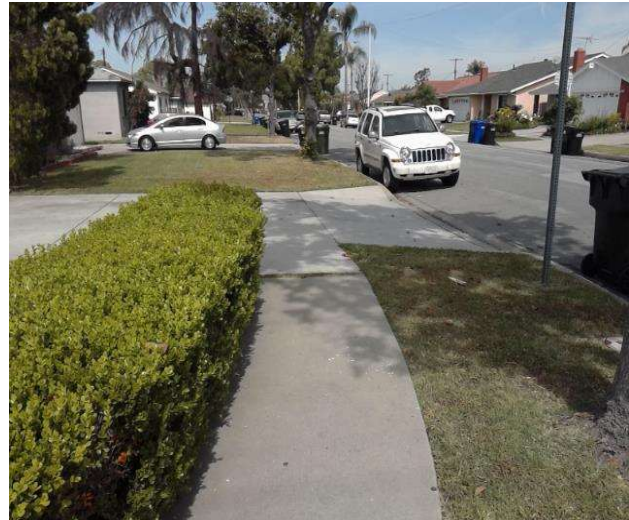
Sidewalks , Hazards & Gratings : Sidewalk Width at Obstruction

Code Reference ADA 206, 302, 403.5.1, CA 11B-403.5

Sidewalk width at the obstruction shall have the recommended value.

Recommendation At least 48.00 inches

\$1,260

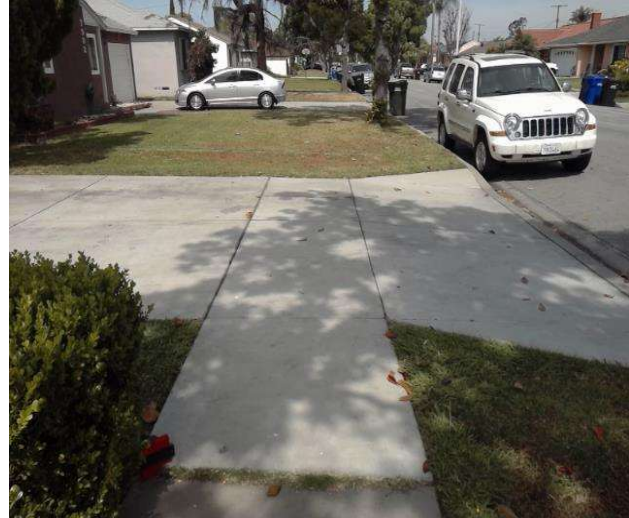
There is a change in elevation greater than recommended value.

Code Reference ADA 206, 302

Ensure that the change in elevation is within the recommended value.

Recommendation Up to 0.25 inches

Remove tripping hazards \$198

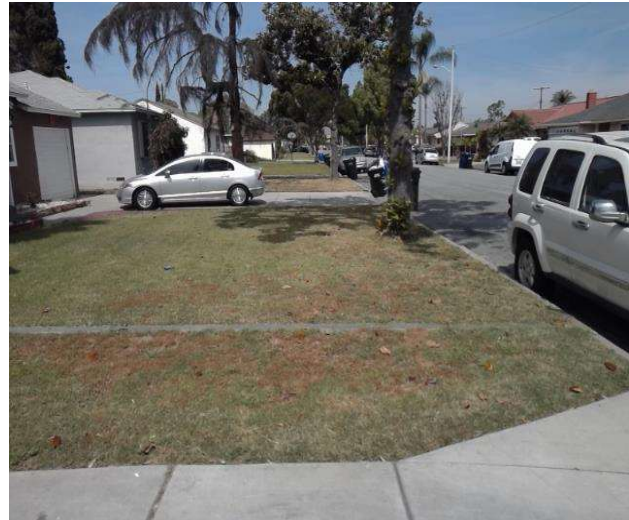
Sidewalks : Missing Sidewalk

Section of sidewalk is missing and consists of dirt, grass or gravel.

Code Reference ADA 206, 302,CA 11B-302,CA 11B-206

Provide a compliant sidewalk for the missing section.

\$1,260

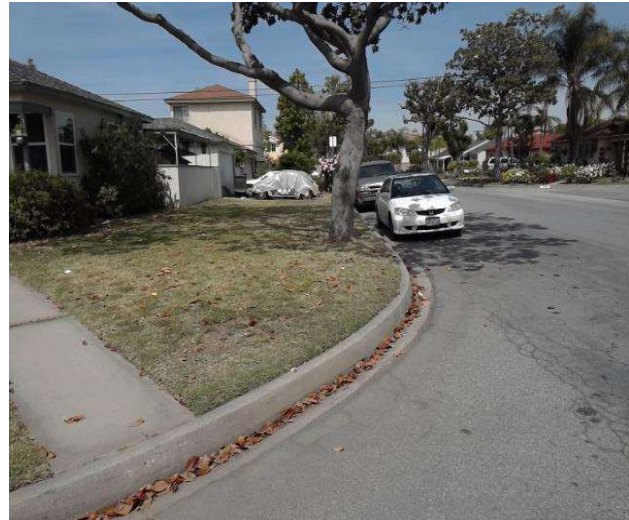
Sidewalks : Missing Sidewalk

Section of sidewalk is missing and consists of dirt, grass or gravel.

Code Reference ADA 206, 302,CA 11B-302,CA 11B-206

Provide a compliant sidewalk for the missing section.

\$1,260

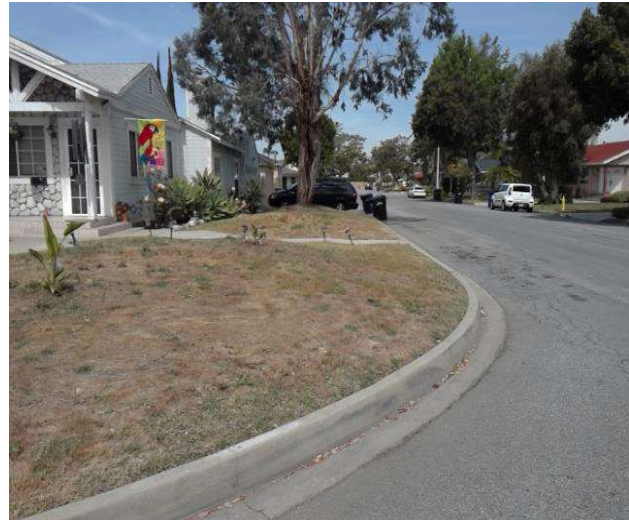
Sidewalks : Missing Sidewalk

Section of sidewalk is missing and consists of dirt, grass or gravel.

Code Reference ADA 206, 302,CA 11B-302,CA 11B-206

Provide a compliant sidewalk for the missing section.

\$1,260
