Accessibility Survey

City of Downey Flores Street - Erickson Avenue to End

Date of Inspection
7/7/2017

Prepared By
Disability Access Consultants
(800) 743-7067

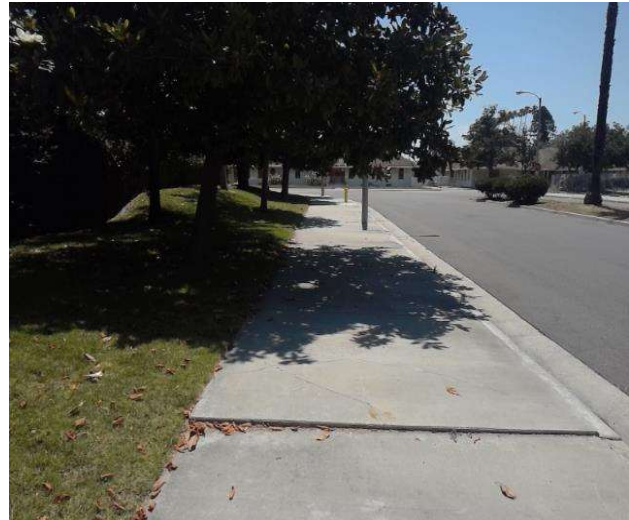
Change in Level East of End @ 33.924648966937, -118.162137866020

Sidewalks , Change in Level : Change in Level Non Beveled

There is a change in elevation greater than recommended value.

On-Site Finding 2.00 inches

Code Reference ADA 206, 302

Ensure that the change in elevation is within the recommended value.

Recommendation Up to 0.25 inches

Remove tripping hazards \$198

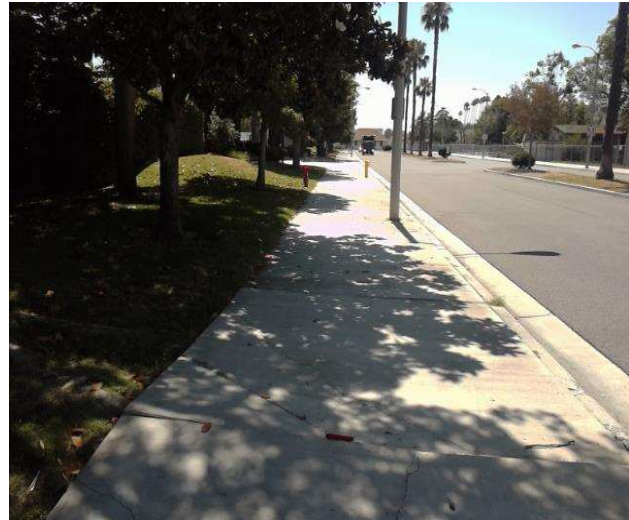
Change in Level East of End @ 33.925120797631, -118.163076639175

Sidewalks , Change in Level : Change in Level Non Beveled

There is a change in elevation greater than recommended value.

On-Site Finding 2.00 inches

Code Reference ADA 206, 302

Ensure that the change in elevation is within the recommended value.

Recommendation Up to 0.25 inches

Remove tripping hazards \$198

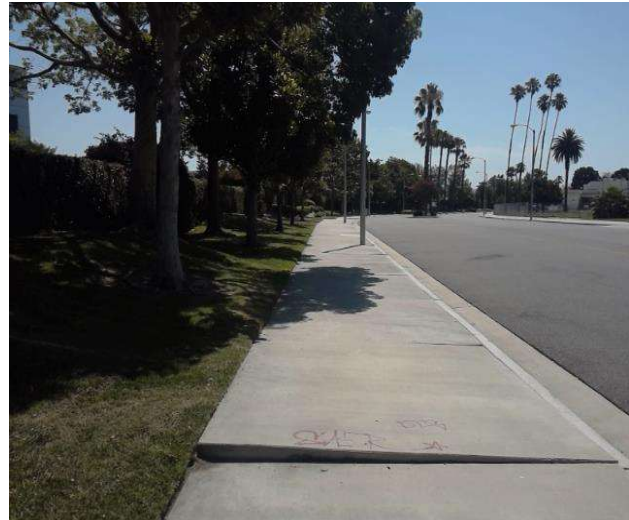
Change in Level East of End @ 33.925654942433, -118.165571093559

Sidewalks , Change in Level : Change in Level Non Beveled

There is a change in elevation greater than recommended value.

On-Site Finding 4.00 inches

Code Reference ADA 206, 302

Ensure that the change in elevation is within the recommended value.

Recommendation Up to 0.25 inches

Remove tripping hazards \$198

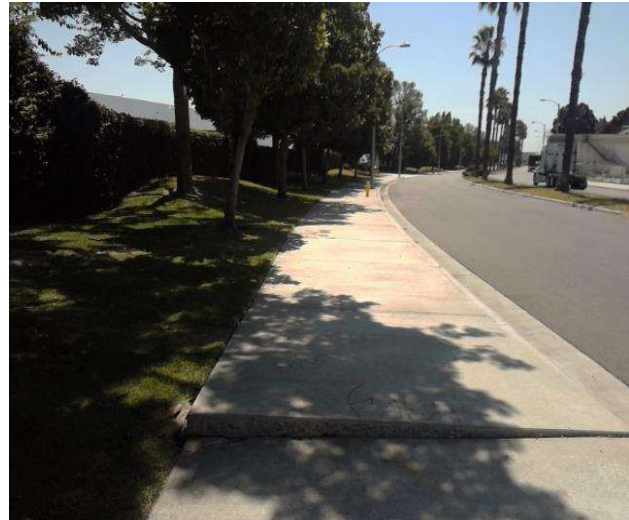
Change in Level East of End @ 33.925672747202, -118.164621591568

Sidewalks , Change in Level : Change in Level Non Beveled

There is a change in elevation greater than recommended value.

On-Site Finding 5.50 inches

Code Reference ADA 206, 302

Ensure that the change in elevation is within the recommended value.

Recommendation Up to 0.25 inches

Remove tripping hazards \$198

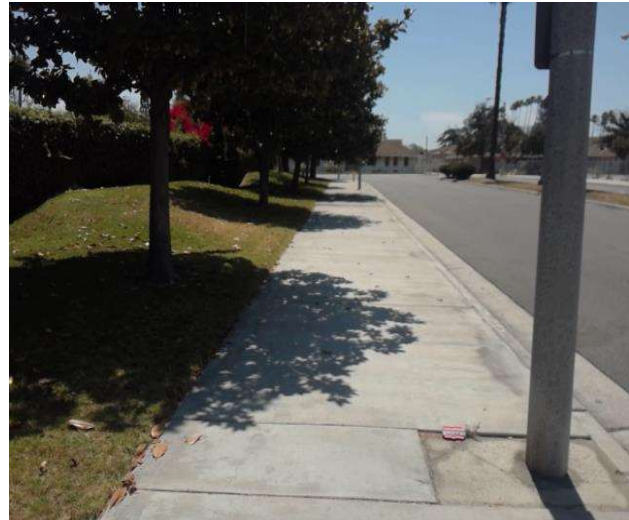
Change in Level East of End @ 33.924680125649, -118.162223696709

Sidewalks , Change in Level : Change in Level Non Beveled

There is a change in elevation greater than recommended value.

On-Site Finding 0.62 inches

Code Reference ADA 206, 302

Ensure that the change in elevation is within the recommended value.

Recommendation Up to 0.25 inches

Remove tripping hazards \$198

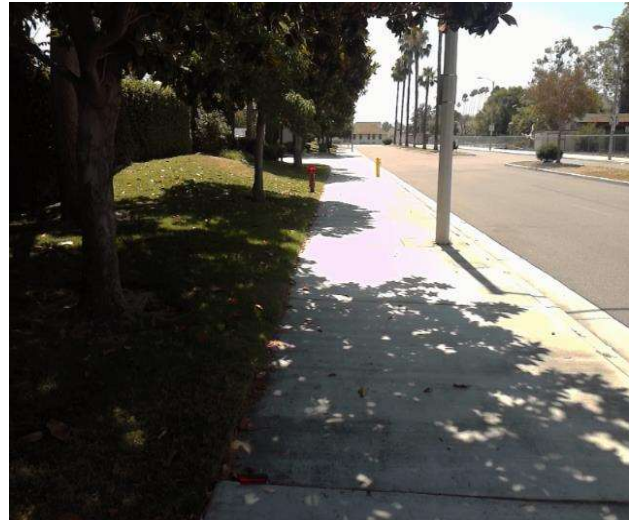
Change in Level East of End @ 33.925120797631, -118.163049817085

Sidewalks , Change in Level : Change in Level Non Beveled

There is a change in elevation greater than recommended value.

On-Site Finding 1.00 inches

Code Reference ADA 206, 302

Ensure that the change in elevation is within the recommended value.

Recommendation Up to 0.25 inches

Remove tripping hazards \$198

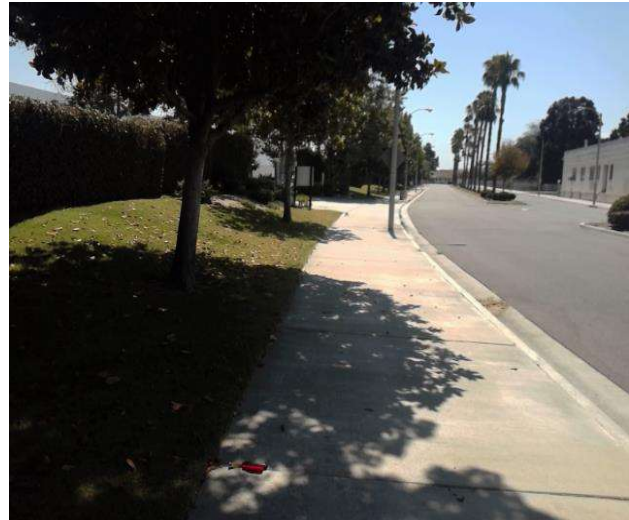
Change in Level East of End @ 33.925525857746, -118.163924217224

Sidewalks , Change in Level : Change in Level Non Beveled

There is a change in elevation greater than recommended value.

On-Site Finding 0.62 inches

Code Reference ADA 206, 302

Ensure that the change in elevation is within the recommended value.

Recommendation Up to 0.25 inches

Remove tripping hazards \$198

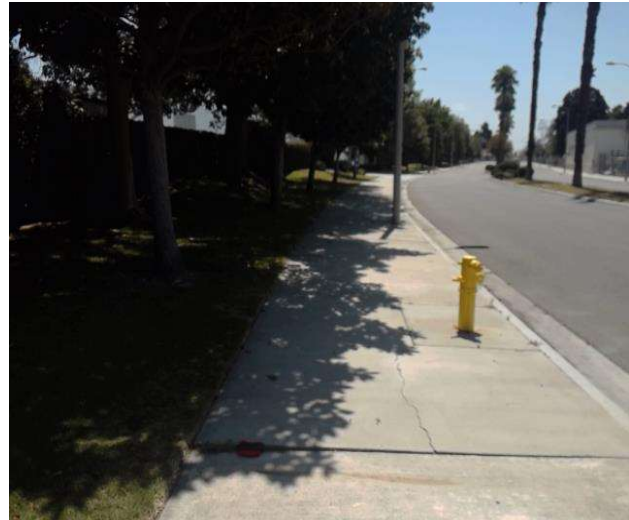
Change in Level East of End @ 33.925619332883, -118.164251446724

Sidewalks , Change in Level : Change in Level Non Beveled

There is a change in elevation greater than recommended value.

On-Site Finding 0.75 inches

Code Reference ADA 206, 302

Ensure that the change in elevation is within the recommended value.

Recommendation Up to 0.25 inches

Remove tripping hazards \$198

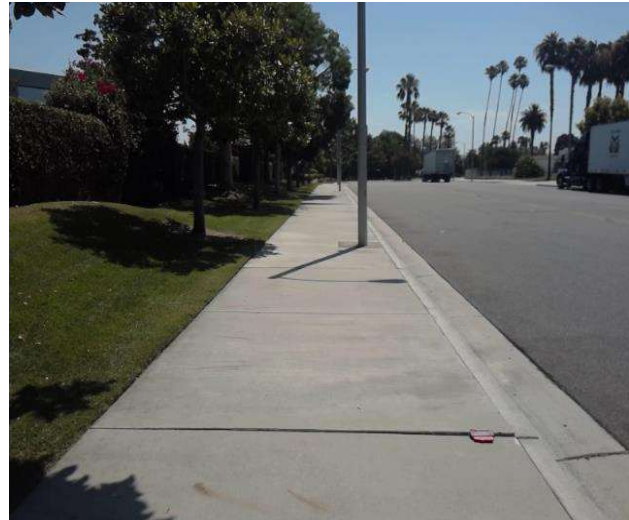
Change in Level East of End @ 33.925632686466, -118.165850043297

Sidewalks , Change in Level : Change in Level Non Beveled

There is a change in elevation greater than recommended value.

On-Site Finding 0.75 inches

Code Reference ADA 206, 302

Ensure that the change in elevation is within the recommended value.

Recommendation Up to 0.25 inches

Remove tripping hazards \$198

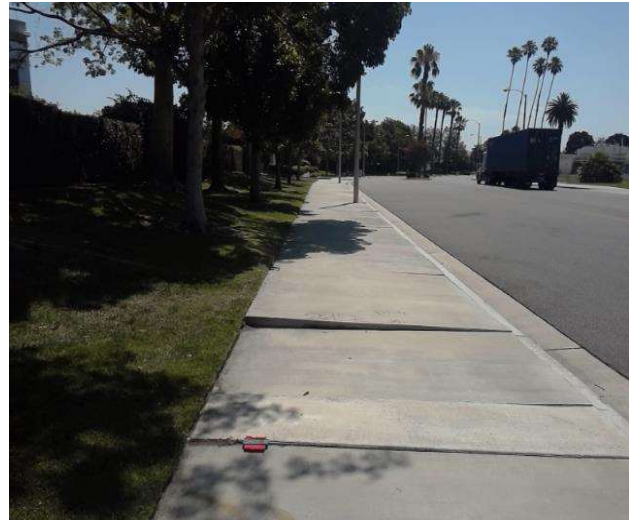
Change in Level East of End @ 33.925646040047, -118.165630102158

Sidewalks , Change in Level : Change in Level Non Beveled

There is a change in elevation greater than recommended value.

On-Site Finding 0.62 inches

Code Reference ADA 206, 302

Ensure that the change in elevation is within the recommended value.

Recommendation Up to 0.25 inches

Remove tripping hazards \$198

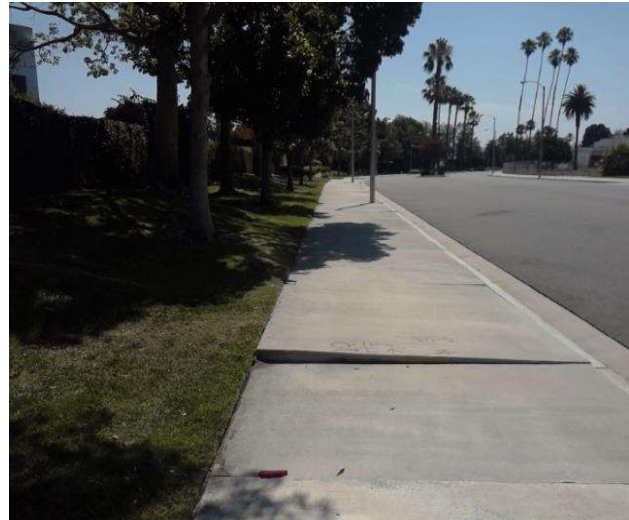
There is a change in elevation greater than recommended value.

Code Reference ADA 206, 302

Ensure that the change in elevation is within the recommended value.

Recommendation Up to 0.25 inches

Remove tripping hazards \$198

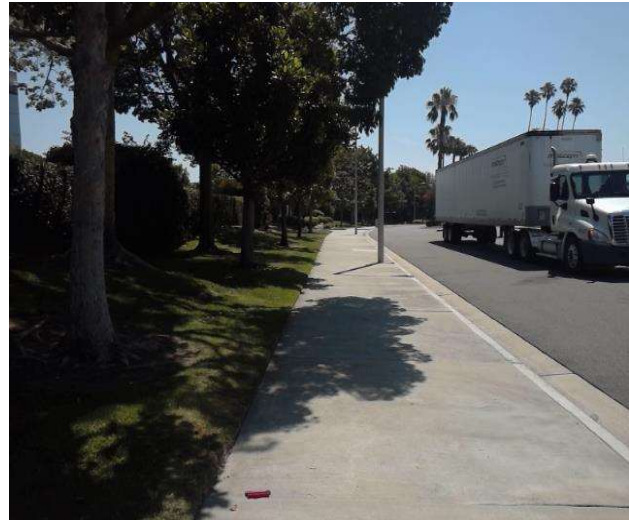
There is a change in elevation greater than recommended value.

Code Reference ADA 206, 302

Ensure that the change in elevation is within the recommended value.

Recommendation Up to 0.25 inches

Remove tripping hazards \$198

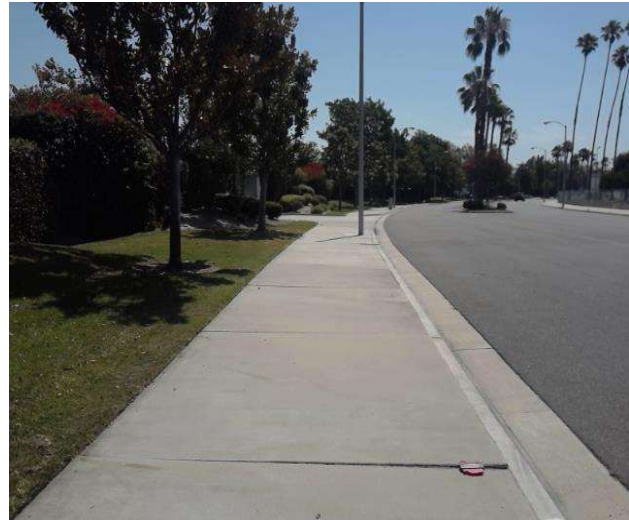
There is a change in elevation greater than recommended value.

Code Reference ADA 206, 302

Ensure that the change in elevation is within the recommended value.

Recommendation Up to 0.25 inches

Remove tripping hazards \$198

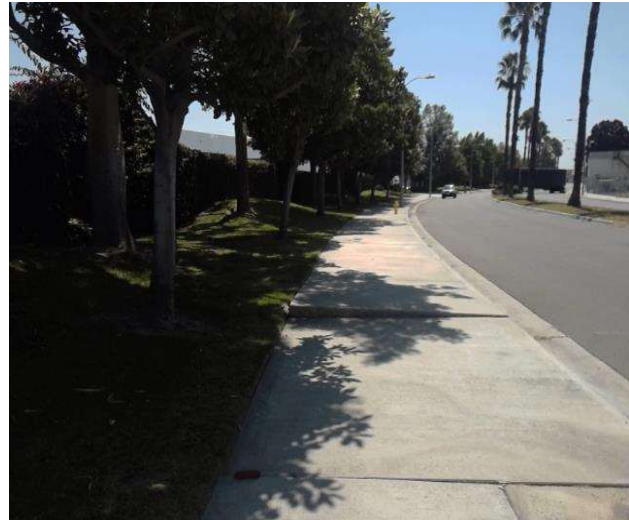
There is a change in elevation greater than recommended value.

Code Reference ADA 206, 302

Ensure that the change in elevation is within the recommended value.

Recommendation Up to 0.25 inches

Remove tripping hazards \$198

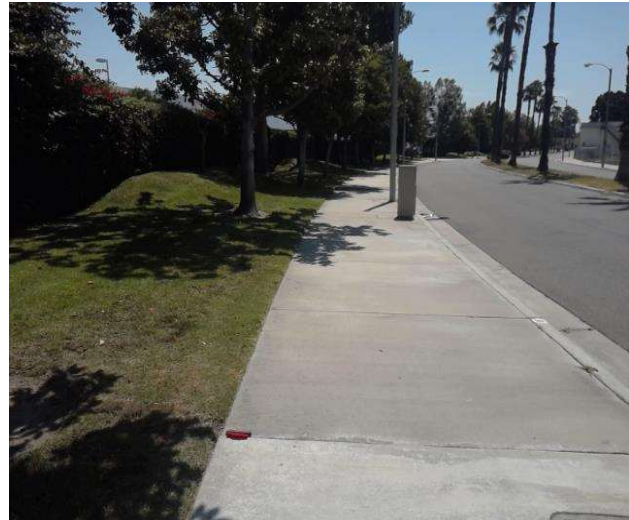
There is a change in elevation greater than recommended value.

Code Reference ADA 206, 302

Ensure that the change in elevation is within the recommended value.

Recommendation Up to 0.25 inches

Remove tripping hazards \$198

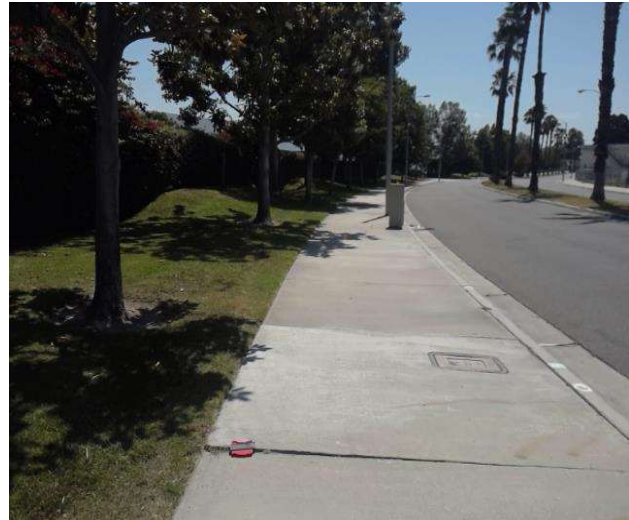
There is a change in elevation greater than recommended value.

Code Reference ADA 206, 302

Ensure that the change in elevation is within the recommended value.

Recommendation Up to 0.25 inches

Remove tripping hazards \$198

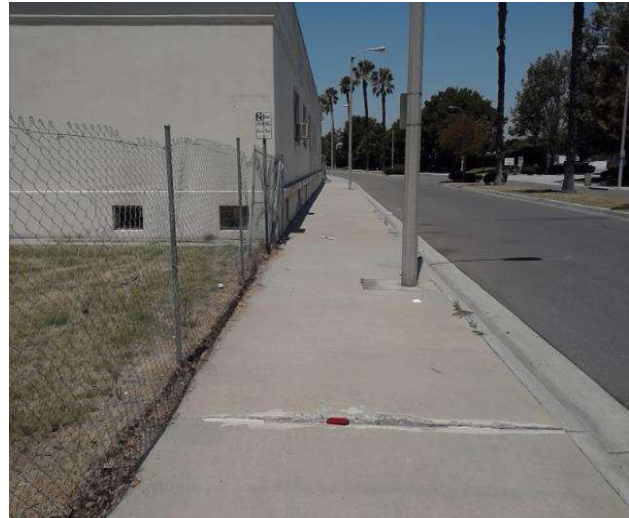
There is a change in elevation greater than recommended value.

Code Reference ADA 206, 302

Ensure that the change in elevation is within the recommended value.

Recommendation Up to 0.25 inches

Remove tripping hazards \$198

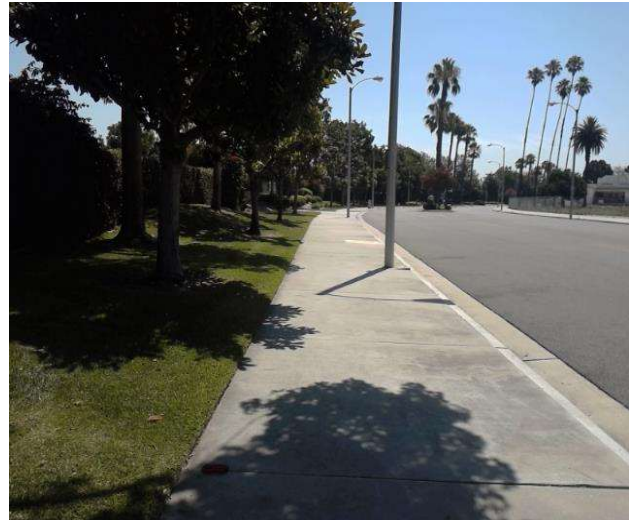
There is a change in elevation greater than recommended value.

Code Reference ADA 206, 302

Ensure that the change in elevation is within the recommended value.

Recommendation Up to 0.25 inches

Remove tripping hazards \$198

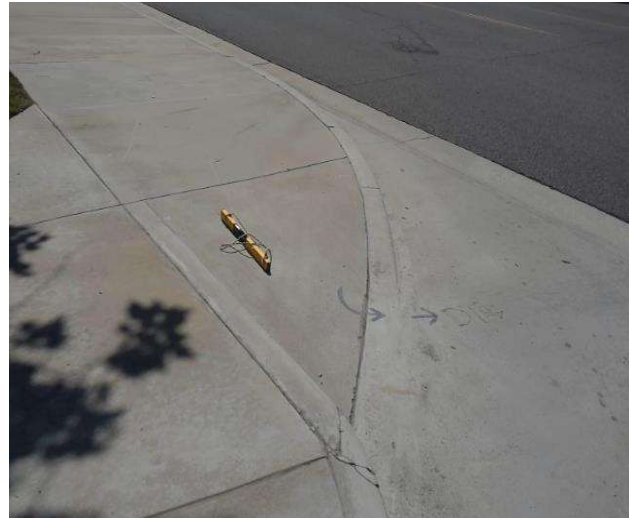
On-Site Finding Not Found

Code Reference CA 11B-406.5.12

Provide detectable warning to surface \$248

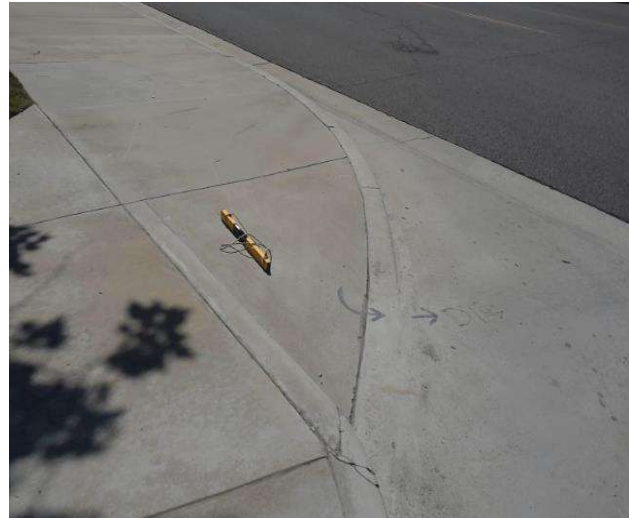
Code Reference ADA 406, 406.1, 405.2, CA 11B-406

Recommendation Up to 8.33 percent

Install curb ramp \$1,300

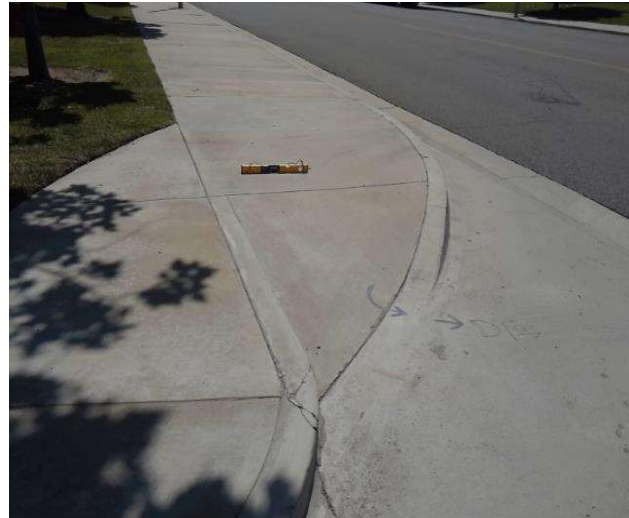
Code Reference ADA 402, 406.4, 403.3, 406.1, CA 11B-406.5.3

Recommendation Up to 2.08 percent

Provide compliant landing \$1,260

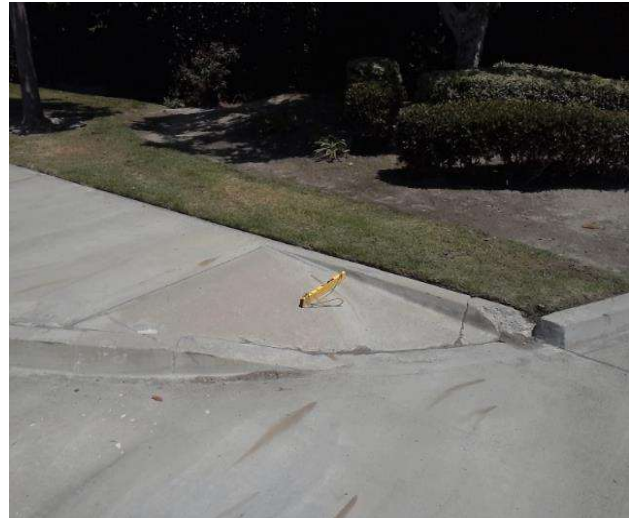
On-Site Finding Not Found

Code Reference CA 11B-406.5.12

Provide detectable warning to surface \$248

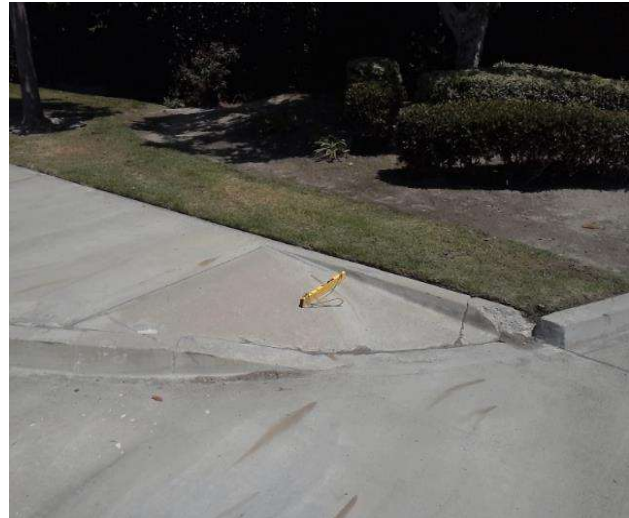
Code Reference ADA 406, 406.1, 405.2, CA 11B-406

Recommendation Up to 8.33 percent

Install curb ramp \$1,300

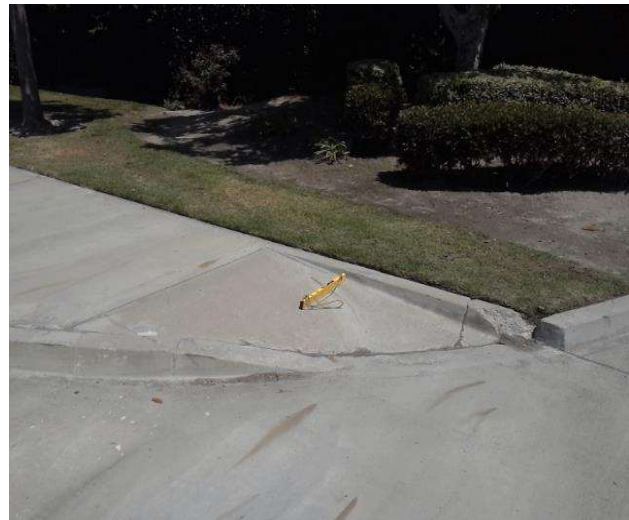
Code Reference ADA 402, 406.1, 405.3, CA 11B-406.5.7

Recommendation Up to 2.08 percent

Install curb ramp \$1,300

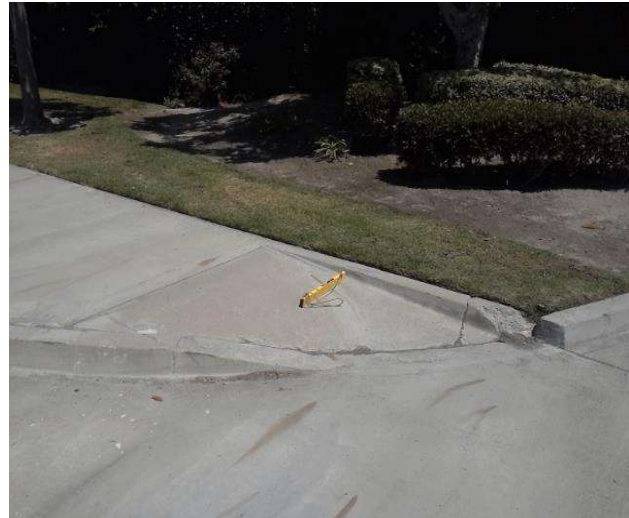
Code Reference ADA 406, 406.3, CA 11B-406.2.2

Recommendation Up to 10.00 percent

Install flared sides \$1,300

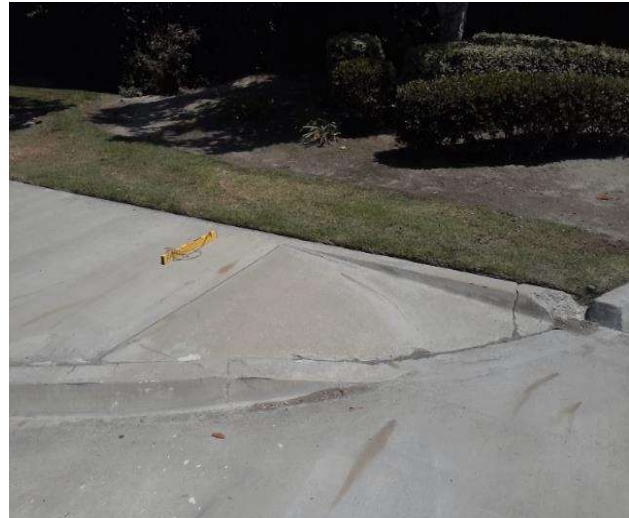
Code Reference ADA 402, 406.4, 403.3, 406.1,CA 11B-406.5.3

Recommendation Up to 2.08 percent

Provide compliant landing \$1,260

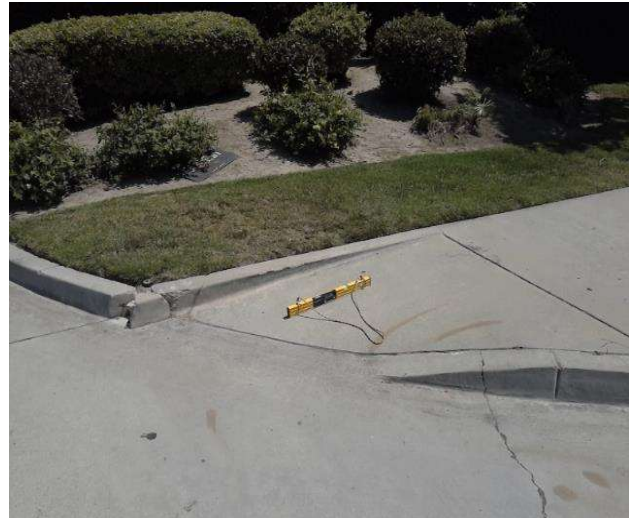
On-Site Finding Not Found

Code Reference CA 11B-406.5.12

Provide detectable warning to surface \$248

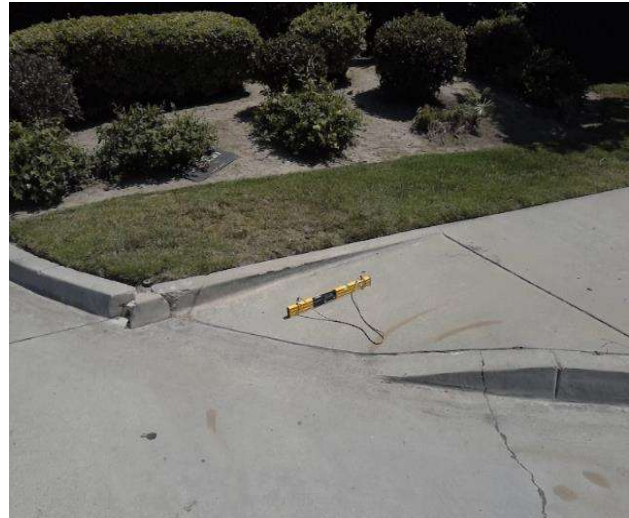
ADA 406, 406.1, 405.2, CA 11B-406

Recommendation Up to 8.33 percent

Install curb ramp \$1,300

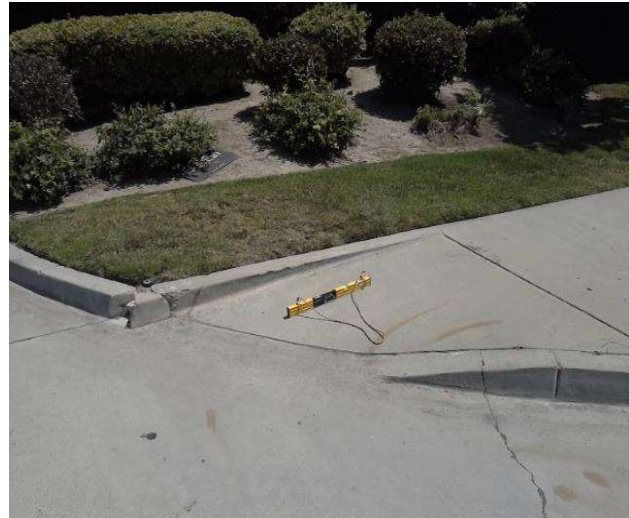
Code Reference ADA 402, 406.1, 405.3, CA 11B-406.5.7

Recommendation Up to 2.08 percent

Install curb ramp \$1,300

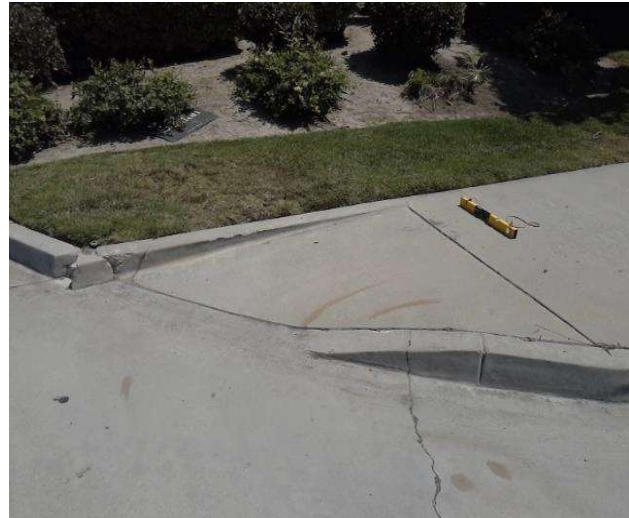
Code Reference ADA 402, 406.4, 403.3, 406.1, CA 11B-406.5.3

Recommendation Up to 2.08 percent

Provide compliant landing \$1,260

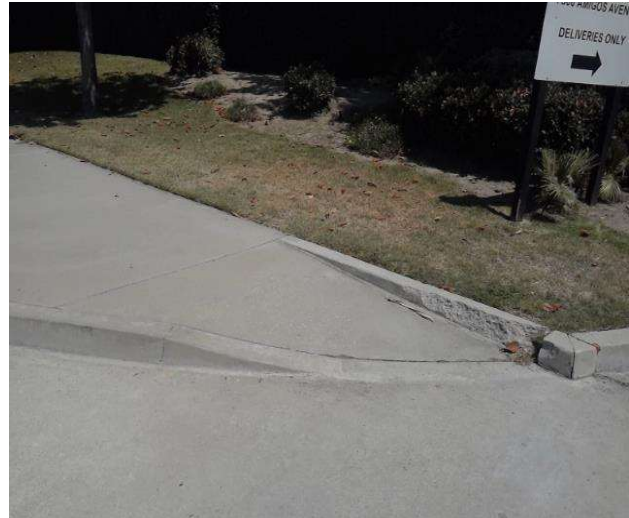
On-Site Finding Not Found

Code Reference CA 11B-406.5.12

Provide detectable warning to surface \$248

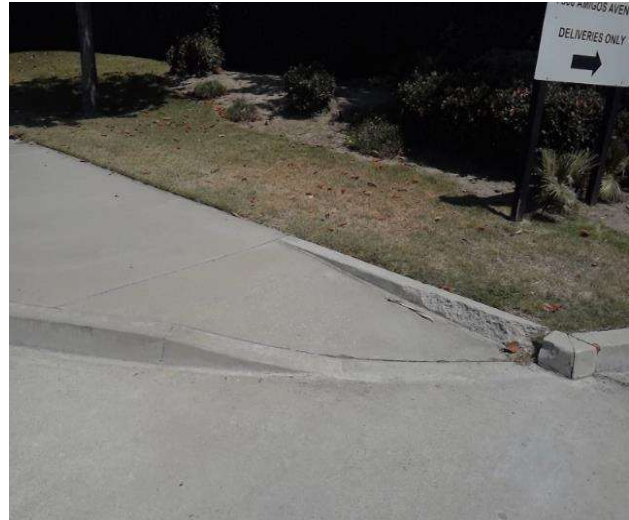
Code Reference ADA 406, 406.3, CA 11B-406.2.2

Recommendation Up to 10.00 percent

Install flared sides \$1,300

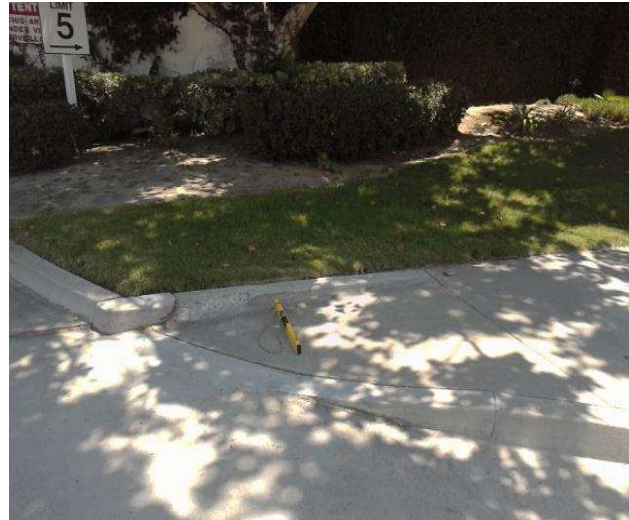
On-Site Finding Not Found

Code Reference CA 11B-406.5.12

Provide detectable warning to surface \$248

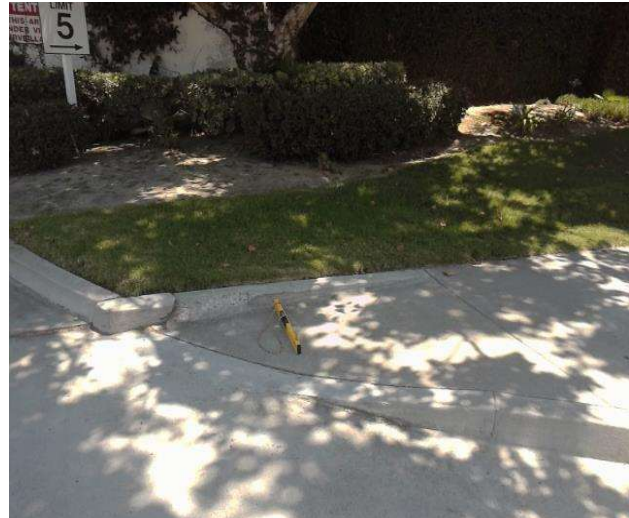
Code Reference ADA 402, 406.1, 405.3, CA 11B-406.5.7

Recommendation Up to 2.08 percent

Install curb ramp \$1,300

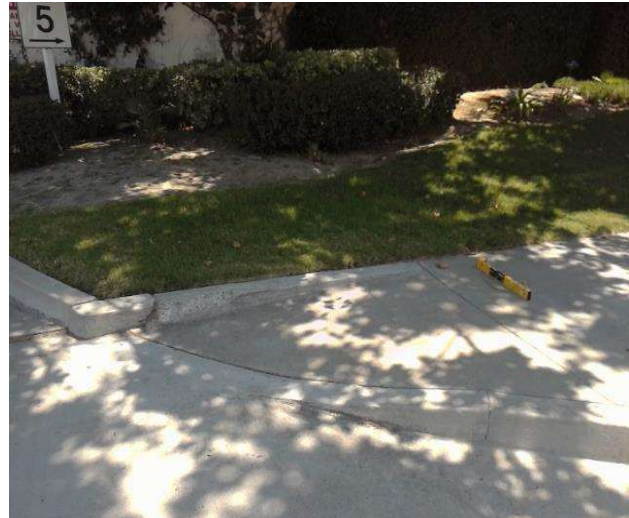
Code Reference ADA 402, 406.4, 403.3, 406.1, CA 11B-406.5.3

Recommendation Up to 2.08 percent

Provide compliant landing \$1,260

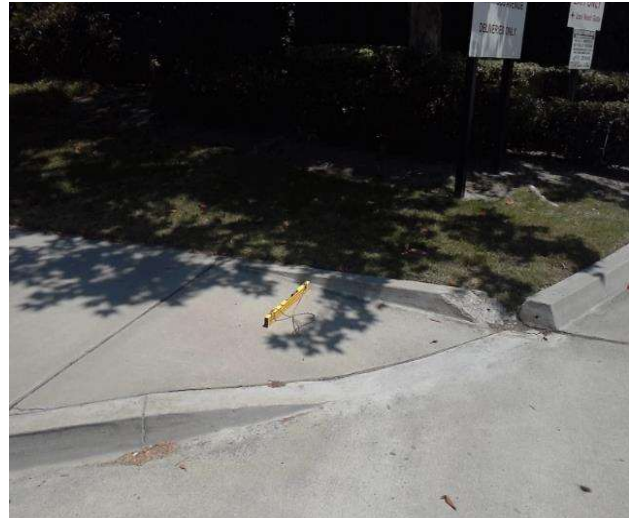
On-Site Finding Not Found

Code Reference CA 11B-406.5.12

Provide detectable warning to surface \$248

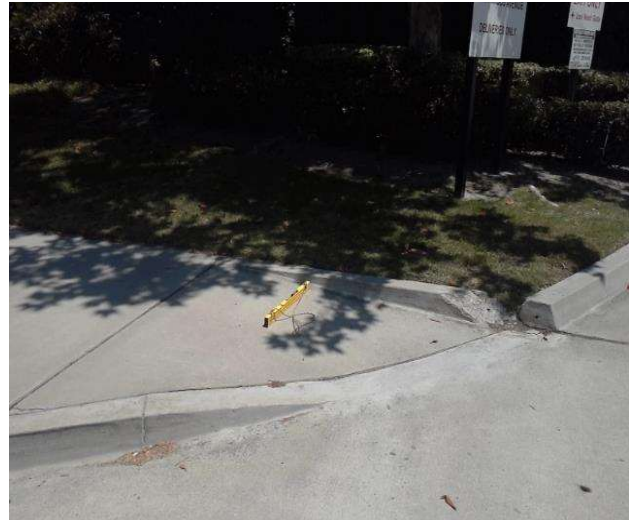
Code Reference ADA 402, 406.1, 405.3, CA 11B-406.5.7

Recommendation Up to 2.08 percent

Install curb ramp \$1,300

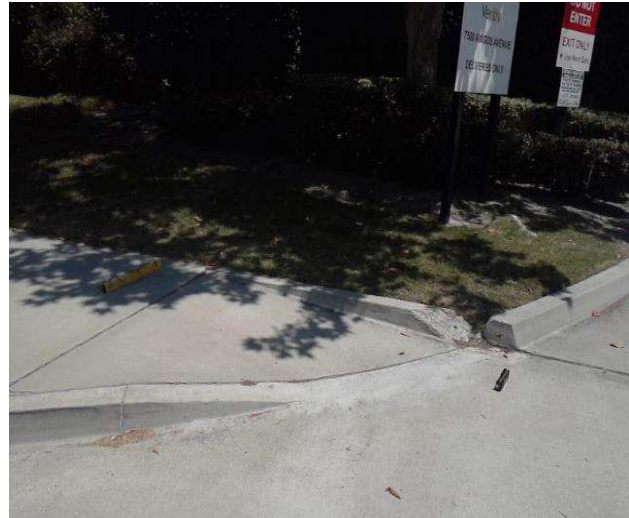
Code Reference ADA 406, 406.2, CA 11B-406.5.8

Recommendation Up to 5.00 percent

Repave landing \$1,260

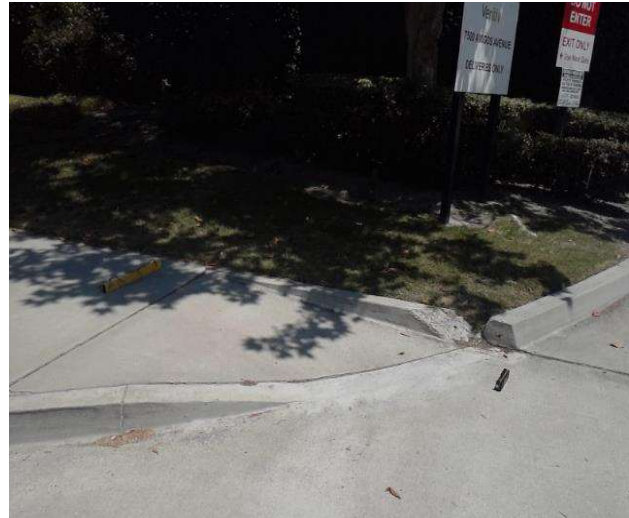
Code Reference ADA 402, 406.4, 403.3, 406.1, CA 11B-406.5.3

Recommendation Up to 2.08 percent

Provide compliant landing \$1,260

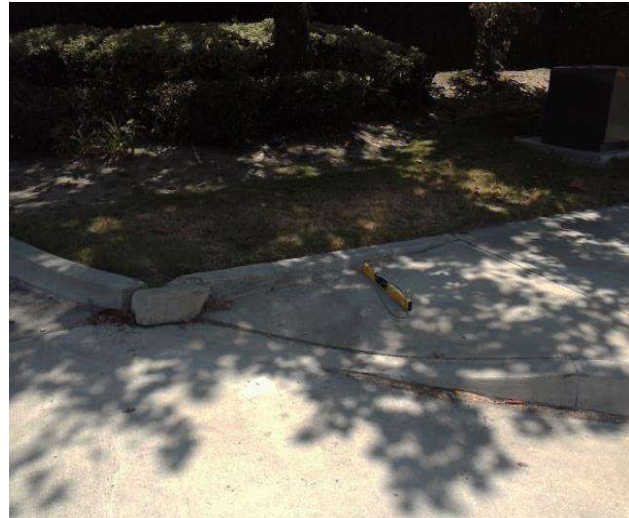
On-Site Finding Not Found

Code Reference CA 11B-406.5.12

Provide detectable warning to surface \$248

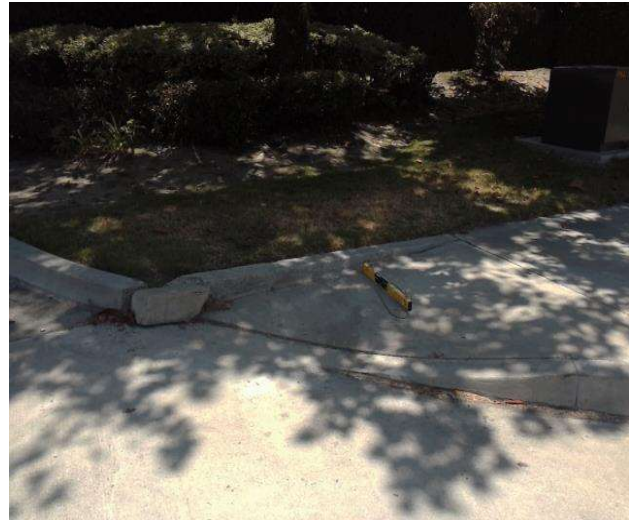
Code Reference ADA 402, 406.1, 405.3, CA 11B-406.5.7

Recommendation Up to 2.08 percent

Install curb ramp \$1,300

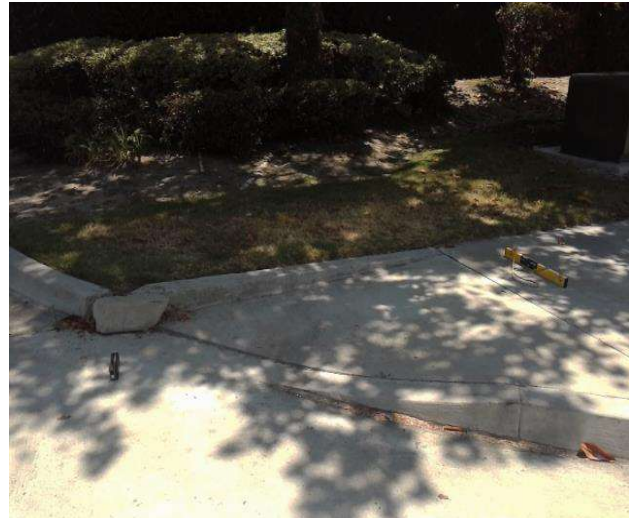
Code Reference ADA 406, 406.2,CA 11B-406.5.8

Recommendation Up to 5.00 percent

Repave landing \$1,260

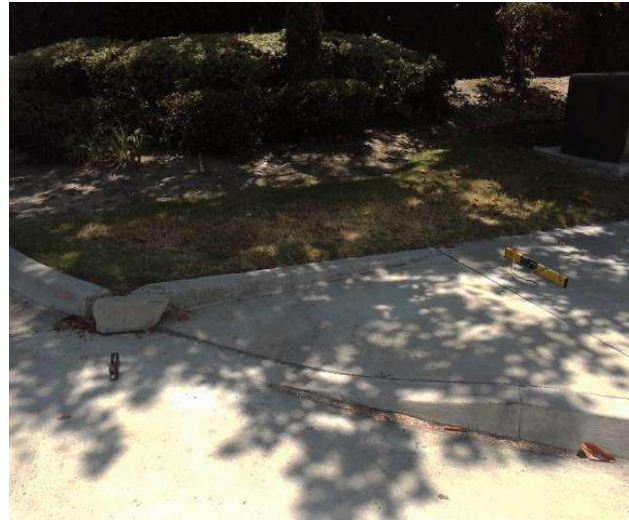
Code Reference ADA 402, 406.4, 403.3, 406.1, CA 11B-406.5.3

Recommendation Up to 2.08 percent

Provide compliant landing \$1,260

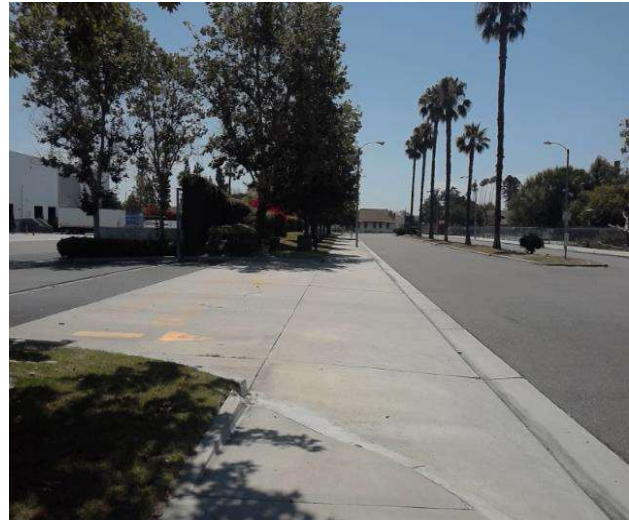
On-Site Finding Not Found

Code Reference ADA 705,CA 11B-705.1.2.5,CA 11B-247.1.2.5

Install compliant detectable warnings \$190

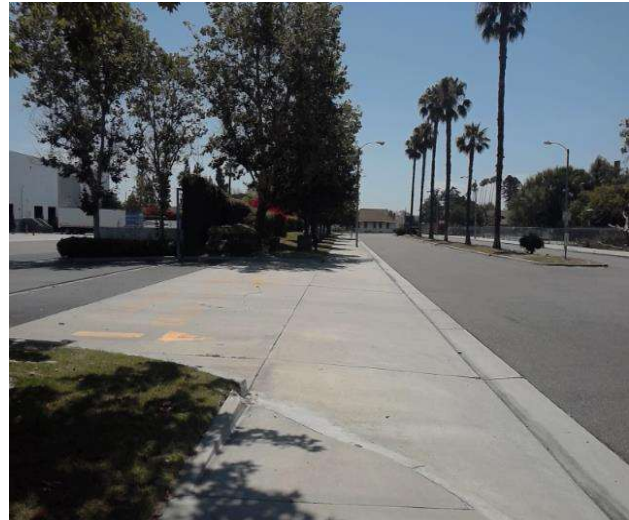
Code Reference ADA 206, 302, CA 11B-403.3

Recommendation Up to 2.08 percent

Repave surface \$1,092

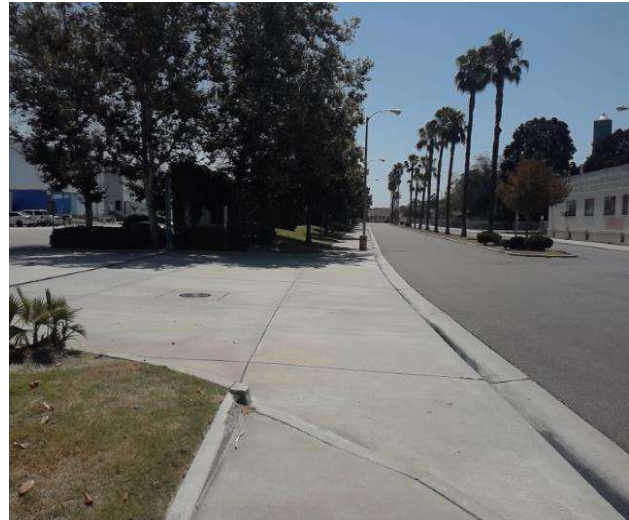
On-Site Finding Not Found

Code Reference ADA 705,CA 11B-705.1.2.5,CA 11B-247.1.2.5

Install compliant detectable warnings \$190

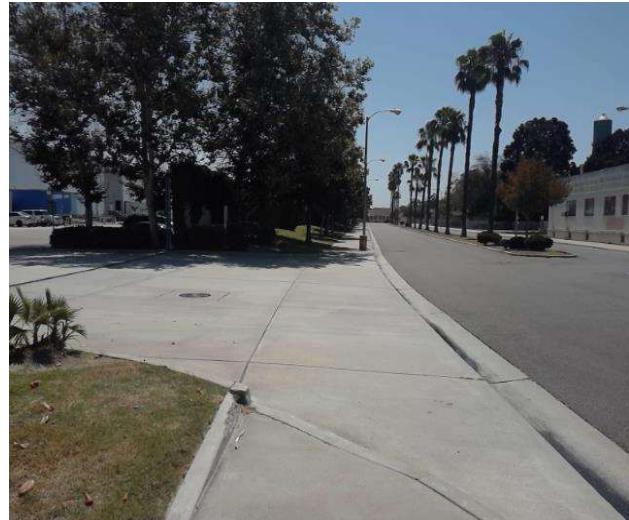
Code Reference ADA 206, 302, CA 11B-403.3

Recommendation Up to 2.08 percent

Repave surface \$1,092

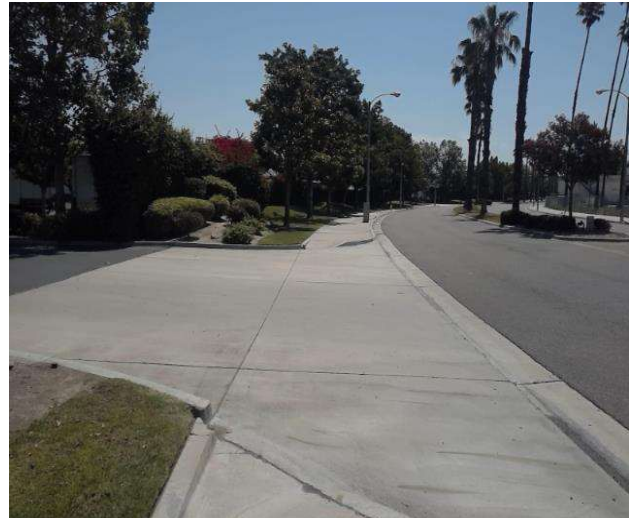
On-Site Finding Not Found

Code Reference ADA 705,CA 11B-705.1.2.5,CA 11B-247.1.2.5

Install compliant detectable warnings \$190

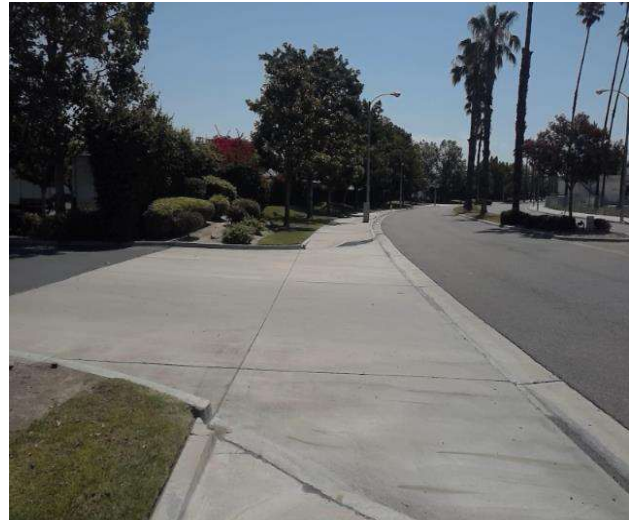
Code Reference ADA 206, 302, CA 11B-403.3

Recommendation Up to 2.08 percent

Repave surface \$1,092

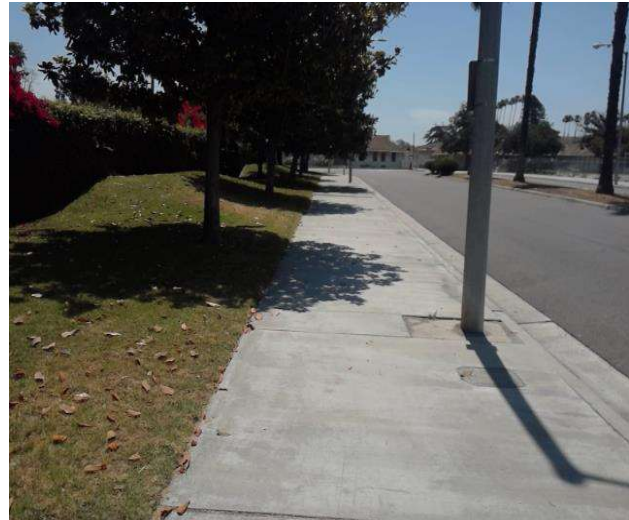
Code Reference ADA 206, 302, CA 11B-403.3

Repave the sidewalk surface with the recommended cross slope.

Recommendation Up to 2.08 percent

Repave surface \$1,092

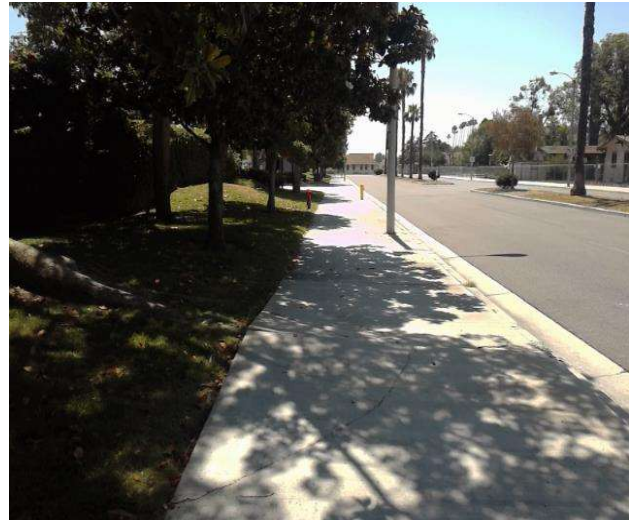
Code Reference ADA 206, 302, CA 11B-403.3

Repave the sidewalk surface with the recommended cross slope.

Recommendation Up to 2.08 percent

Repave surface \$1,092

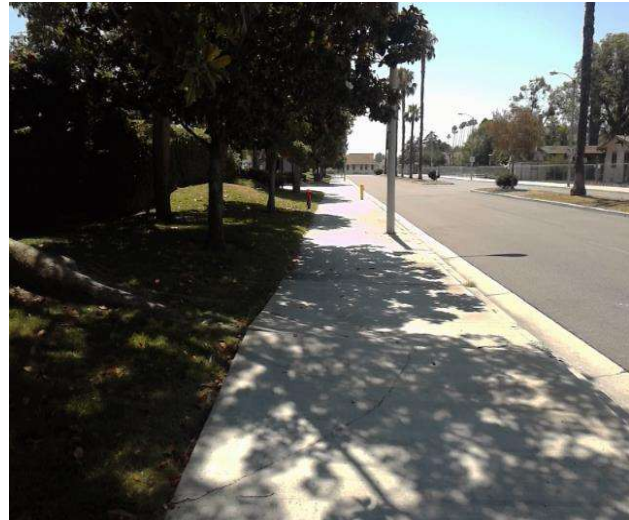
Code Reference ADA 206, 302

Repave the sidewalk surface with the recommended running slope.

Recommendation Up to 5.00 percent

Repave surface \$1,184

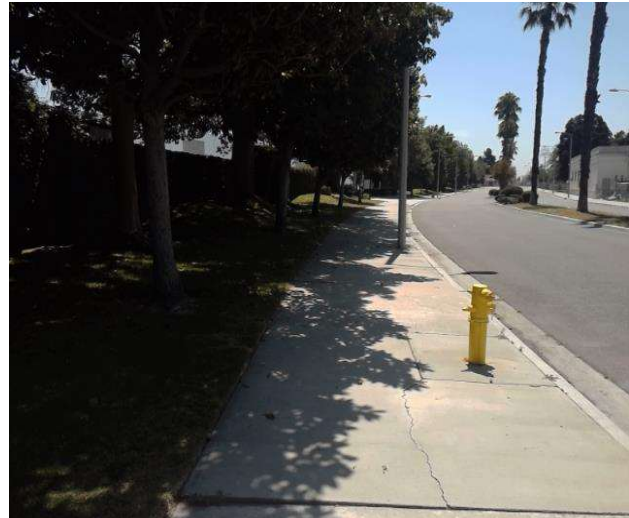
Code Reference ADA 206, 302, CA 11B-403.3

Repave the sidewalk surface with the recommended cross slope.

Recommendation Up to 2.08 percent

Repave surface \$1,092

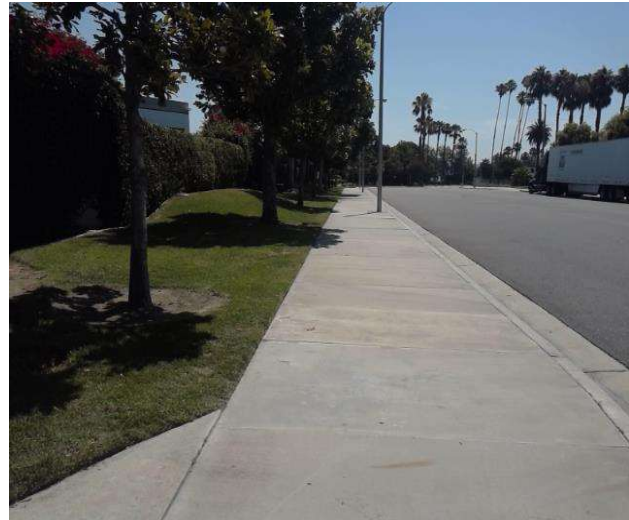
Code Reference ADA 206, 302,CA 11B-403.3

Repave the sidewalk surface with the recommended cross slope.

Recommendation Up to 2.08 percent

Repave surface \$1,092

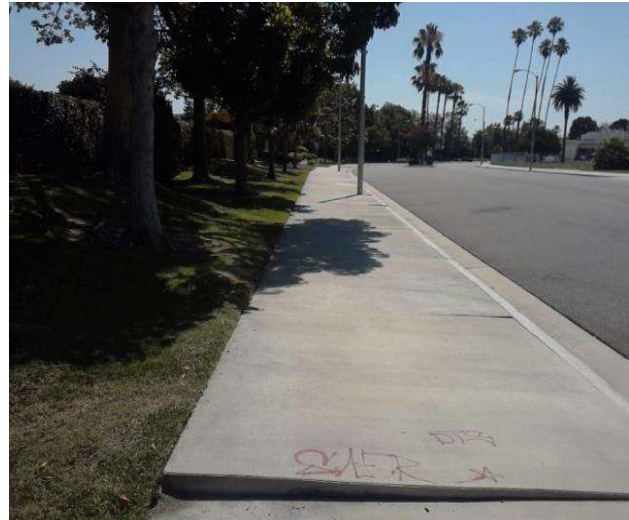
Code Reference ADA 206, 302, CA 11B-403.3

Repave the sidewalk surface with the recommended cross slope.

Recommendation Up to 2.08 percent

Repave surface \$1,092

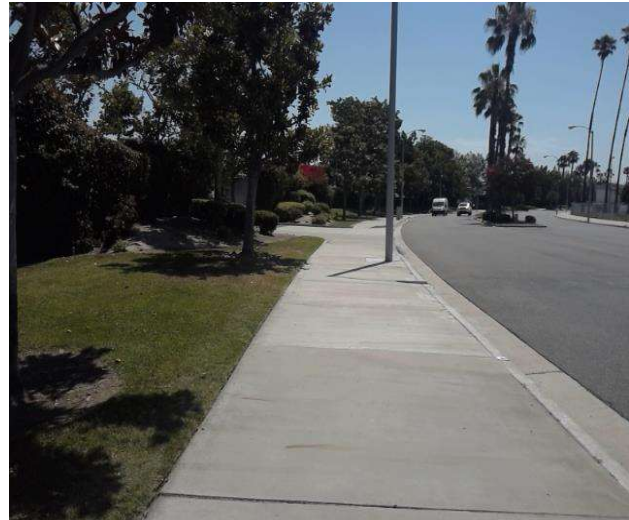
Code Reference ADA 206, 302, CA 11B-403.3

Repave the sidewalk surface with the recommended cross slope.

Recommendation Up to 2.08 percent

Repave surface \$1,092

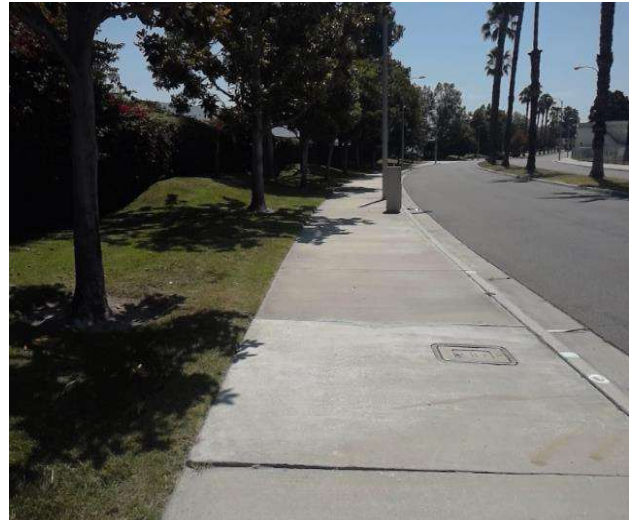
Code Reference ADA 206, 302, CA 11B-403.3

Repave the sidewalk surface with the recommended cross slope.

Recommendation Up to 2.08 percent

Repave surface \$1,092

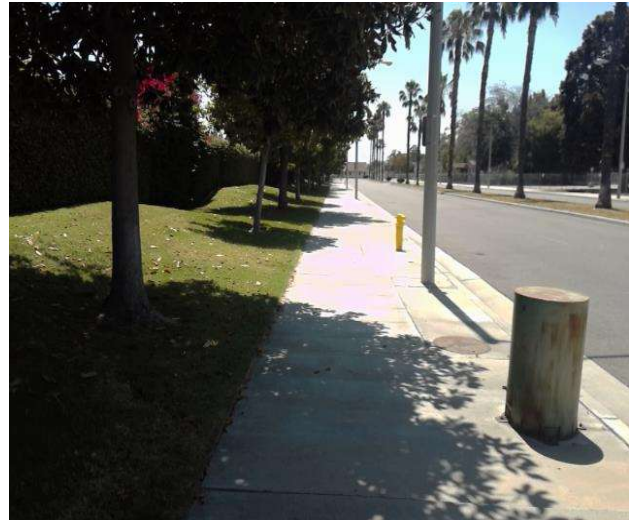
Code Reference ADA 206, 302, CA 11B-403.3

Repave the sidewalk surface with the recommended cross slope.

Recommendation Up to 2.08 percent

Repave surface \$1,092

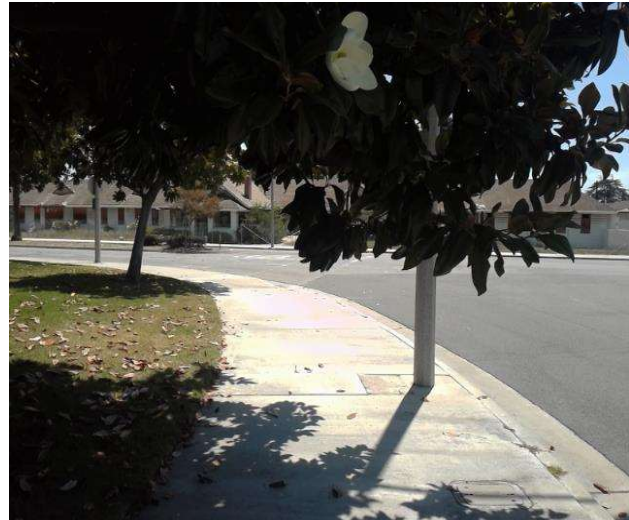
Sidewalks , Hazards & Gratings : Overhead Obstruction Height

Code Reference ADA 206, 307.4, CA 11B-307.4

Recommendation At least 80.00 inches

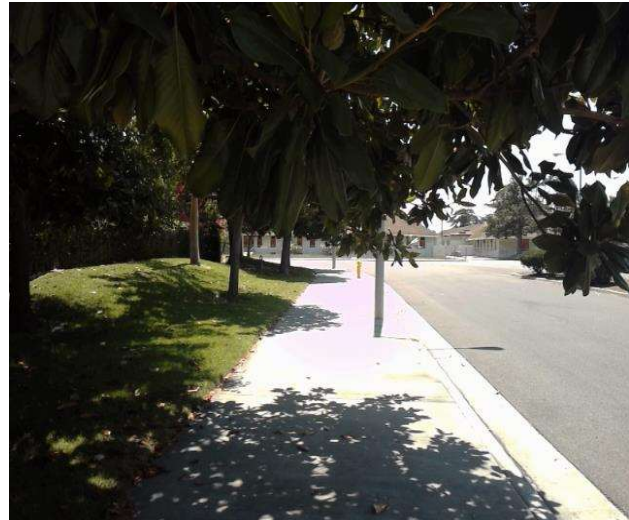
Sidewalks , Hazards & Gratings : Overhead Obstruction Height

Code Reference ADA 206, 307.4,CA 11B-307.4

Recommendation At least 80.00 inches

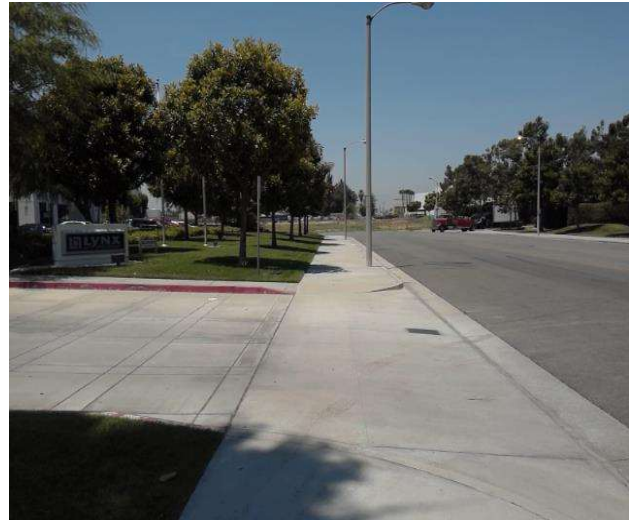
On-Site Finding Not Found

Code Reference ADA 705,CA 11B-705.1.2.5,CA 11B-247.1.2.5

Install compliant detectable warnings \$190
