Accessibility Survey

City of Downey Flores Street - Erickson Avenue to End

Date of Inspection
7/7/2017

Prepared By
Disability Access Consultants
(800) 743-7067

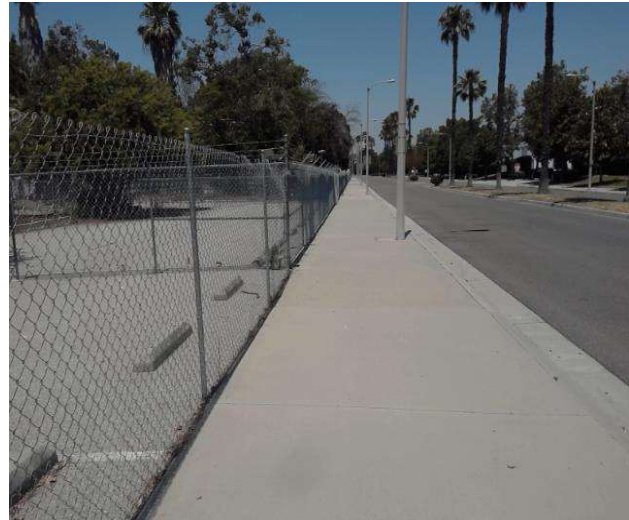
Code Reference ADA 206, 302, CA 11B-403.3

Repave the sidewalk surface with the recommended cross slope.

Recommendation Up to 2.08 percent

Repave surface \$1,092

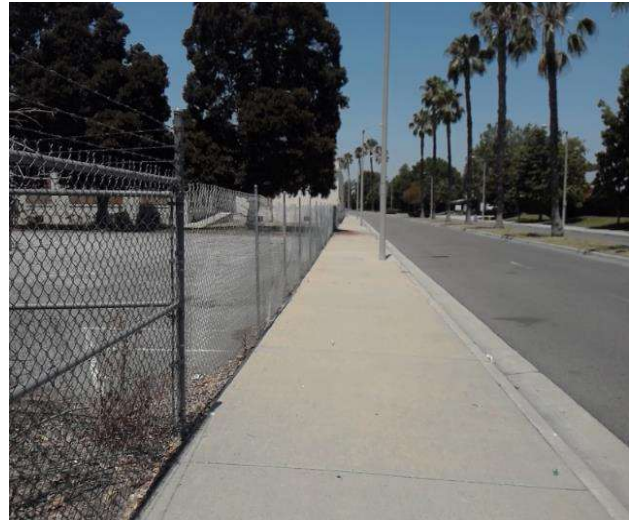
Code Reference ADA 206, 302, CA 11B-403.3

Repave the sidewalk surface with the recommended cross slope.

Recommendation Up to 2.08 percent

Repave surface \$1,092

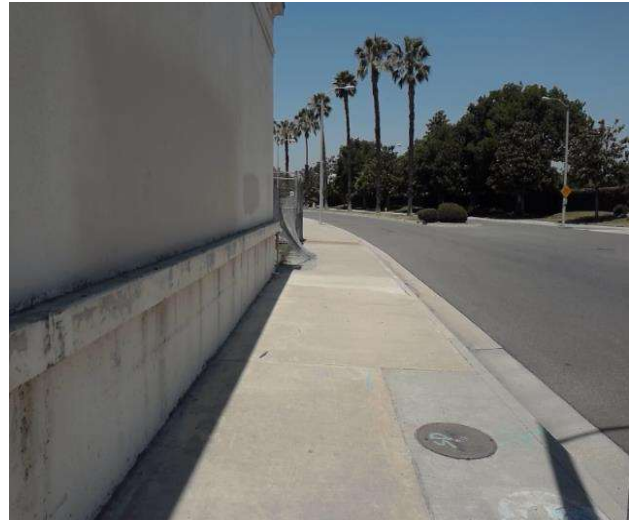
Code Reference ADA 206, 302, CA 11B-403.3

Repave the sidewalk surface with the recommended cross slope.

Recommendation Up to 2.08 percent

Repave surface \$1,092

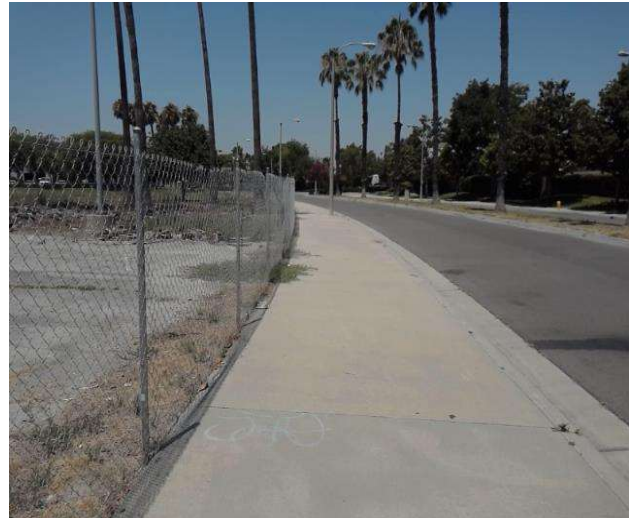
Code Reference ADA 206, 302,CA 11B-403.3

Repave the sidewalk surface with the recommended cross slope.

Recommendation Up to 2.08 percent

Repave surface \$1,092

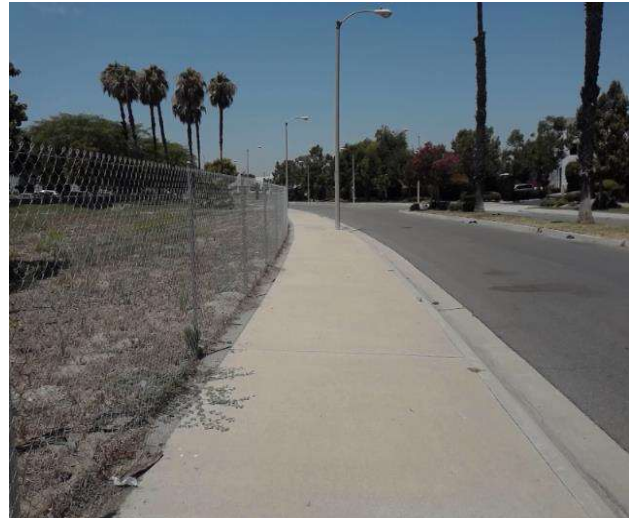
Code Reference ADA 206, 302, CA 11B-403.3

Repave the sidewalk surface with the recommended cross slope.

Recommendation Up to 2.08 percent

Repave surface \$1,092
