Accessibility Survey

City of Downey Heritage Circle - Stewart & Gray Road To Heritage Circle

Stewart & Gray Road To Heritage Circle
Downey, CA 90242

Date of Inspection
5/3/2017

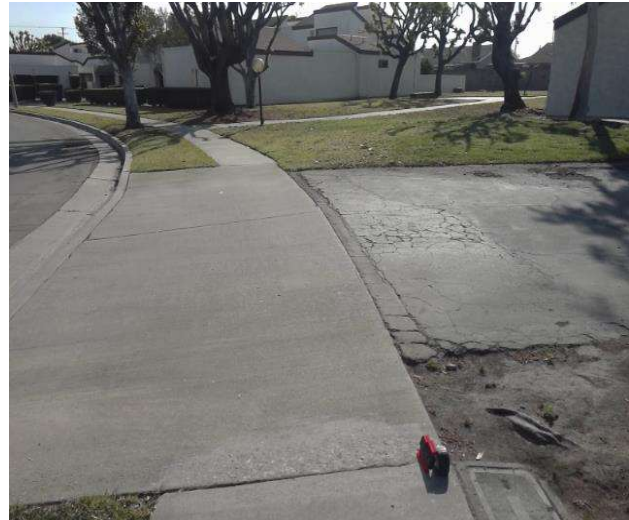
Change In Level South Of Stewart & Gray Road @ 33.940706433321, - 118.158138692379

Sidewalks , Change in Level : Change in Level Non Beveled

There is a change in elevation greater than recommended value.

On-Site Finding 0.62 inches

Code Reference ADA 206, 302

Ensure that the change in elevation is within the recommended value.

Recommendation Up to 0.25 inches

Remove tripping hazards \$198

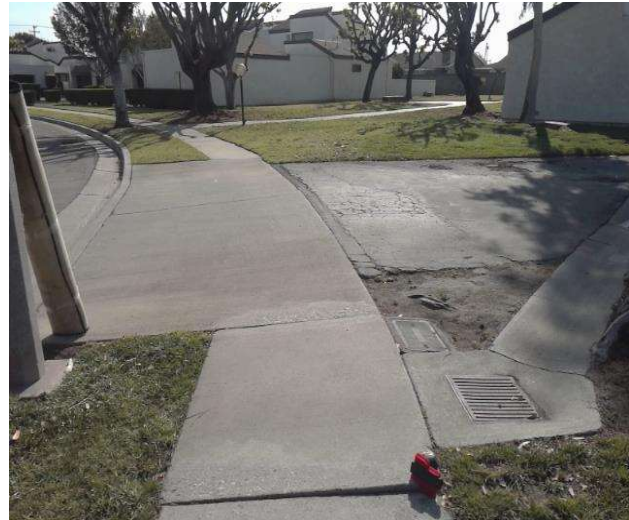
Change In Level South Of Stewart & Gray Road @ 33.940707545922, - 118.158145397902

Sidewalks , Change in Level : Change in Level Non Beveled

There is a change in elevation greater than recommended value.

On-Site Finding 1.00 inches

Code Reference ADA 206, 302

Ensure that the change in elevation is within the recommended value.

Recommendation Up to 0.25 inches

Remove tripping hazards \$198

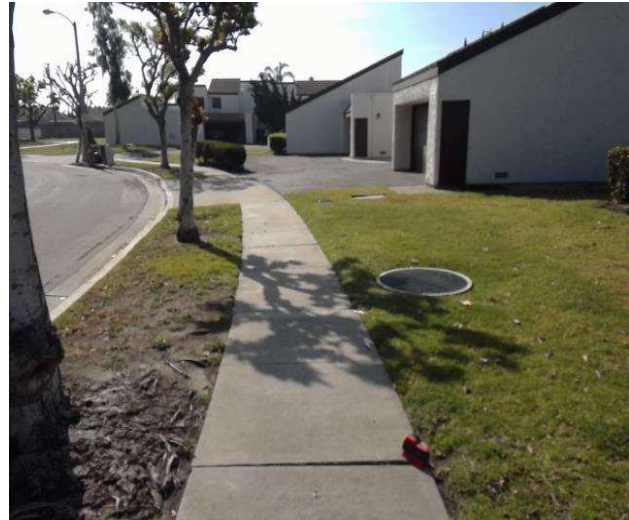
Change In Level South Of Stewart & Gray Road @ 33.940769851584, - 118.158504813910

Sidewalks , Change in Level : Change in Level Non Beveled

There is a change in elevation greater than recommended value.

On-Site Finding 0.62 inches

Code Reference ADA 206, 302

Ensure that the change in elevation is within the recommended value.

Recommendation Up to 0.25 inches

Remove tripping hazards \$198

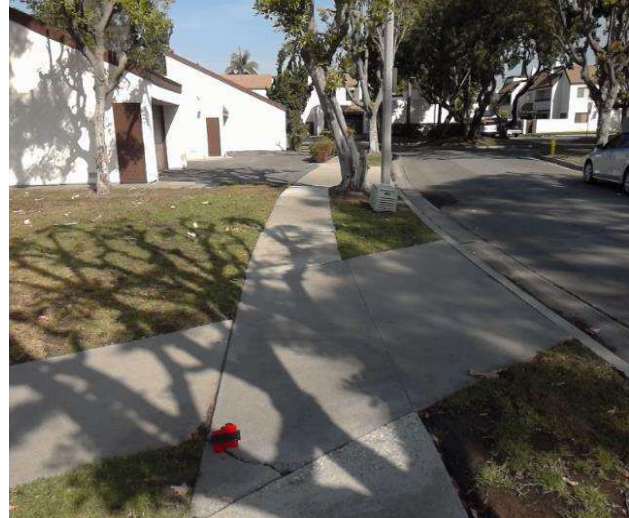
Change In Level South Of Stewart & Gray Road @ 33.940784315391, - 118.158526271582

Sidewalks , Change in Level : Change in Level Non Beveled

There is a change in elevation greater than recommended value.

On-Site Finding 0.62 inches

Code Reference ADA 206, 302

Ensure that the change in elevation is within the recommended value.

Recommendation Up to 0.25 inches

Remove tripping hazards \$198

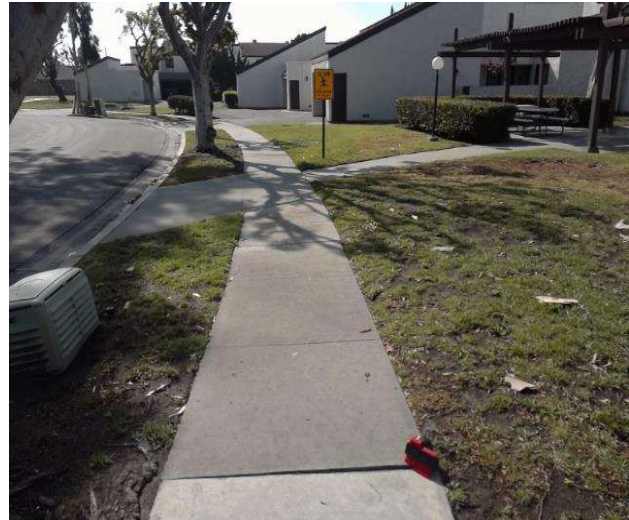
Change In Level South Of Stewart & Gray Road @ 33.940852183995, - 118.158655017614

Sidewalks , Change in Level : Change in Level Non Beveled

There is a change in elevation greater than recommended value.

On-Site Finding 0.62 inches

Code Reference ADA 206, 302

Ensure that the change in elevation is within the recommended value.

Recommendation Up to 0.25 inches

Remove tripping hazards \$198

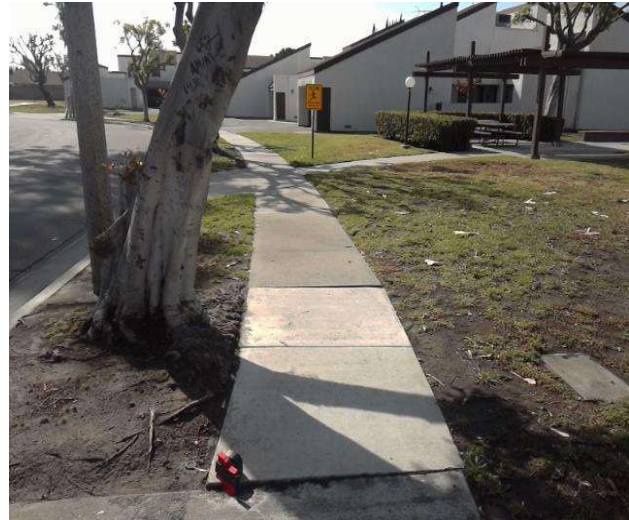
Change In Level South Of Stewart & Gray Road @ 33.940866647788, - 118.158669769764

Sidewalks , Change in Level : Change in Level Non Beveled

There is a change in elevation greater than recommended value.

On-Site Finding 1.25 inches

Code Reference ADA 206, 302

Ensure that the change in elevation is within the recommended value.

Recommendation Up to 0.25 inches

Remove tripping hazards \$198

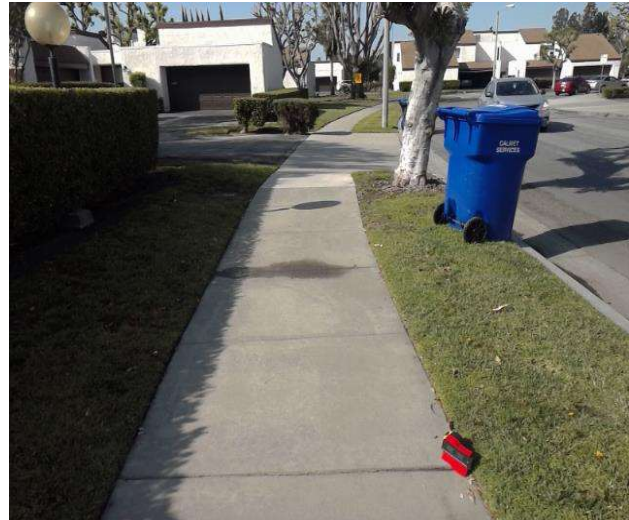
Change In Level South Of Stewart & Gray Road @ 33.941130333443, - 118.157676011324

Sidewalks , Change in Level : Change in Level Non Beveled

There is a change in elevation greater than recommended value.

On-Site Finding 0.50 inches

Code Reference ADA 206, 302

Ensure that the change in elevation is within the recommended value.

Recommendation Up to 0.25 inches

Remove tripping hazards \$198

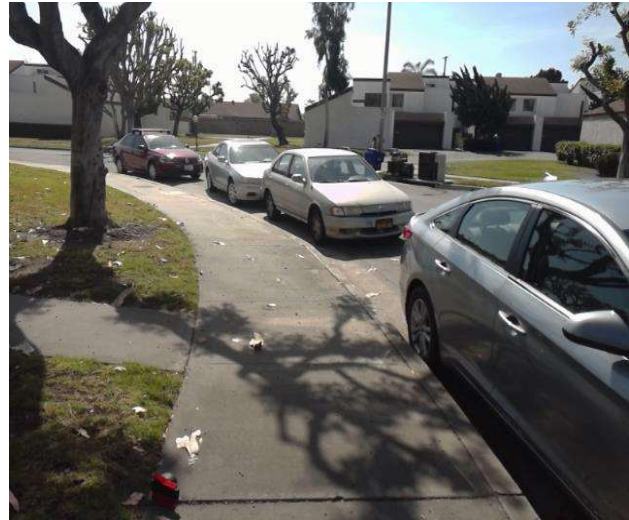
Change In Level South Of Heritage Circle @ 33.940833269799, -118.158296942711

Sidewalks , Change in Level : Change in Level Non Beveled

There is a change in elevation greater than recommended value.

On-Site Finding 0.50 inches

Code Reference ADA 206, 302

Ensure that the change in elevation is within the recommended value.

Recommendation Up to 0.25 inches

Remove tripping hazards \$198

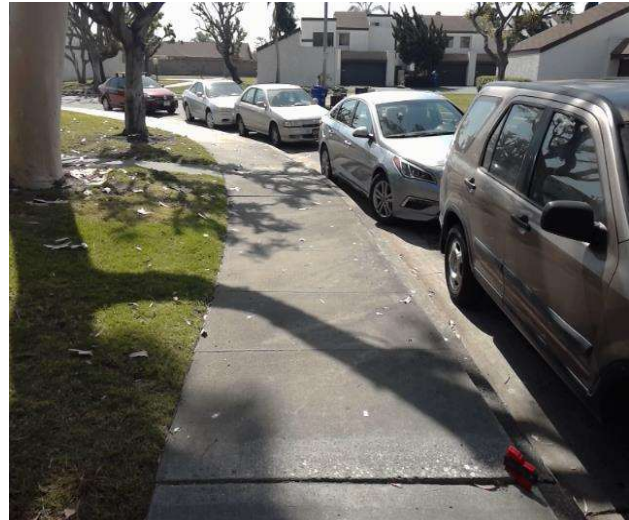
Change In Level South Of Heritage Circle @ 33.940868872987, -118.158368021250

Sidewalks , Change in Level : Change in Level Non Beveled

There is a change in elevation greater than recommended value.

On-Site Finding 1.12 inches

Code Reference ADA 206, 302

Ensure that the change in elevation is within the recommended value.

Recommendation Up to 0.25 inches

Remove tripping hazards \$198

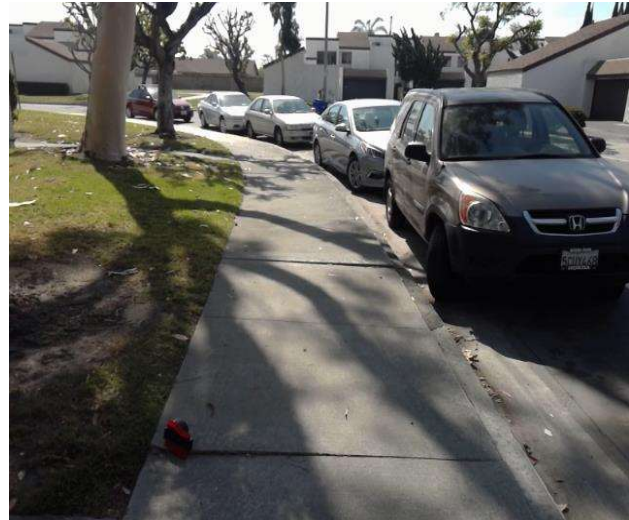
Change In Level South Of Heritage Circle @ 33.940878886381, -118.158408254385

Sidewalks , Change in Level : Change in Level Non Beveled

There is a change in elevation greater than recommended value.

On-Site Finding 0.75 inches

Code Reference ADA 206, 302

Ensure that the change in elevation is within the recommended value.

Recommendation Up to 0.25 inches

Remove tripping hazards \$198

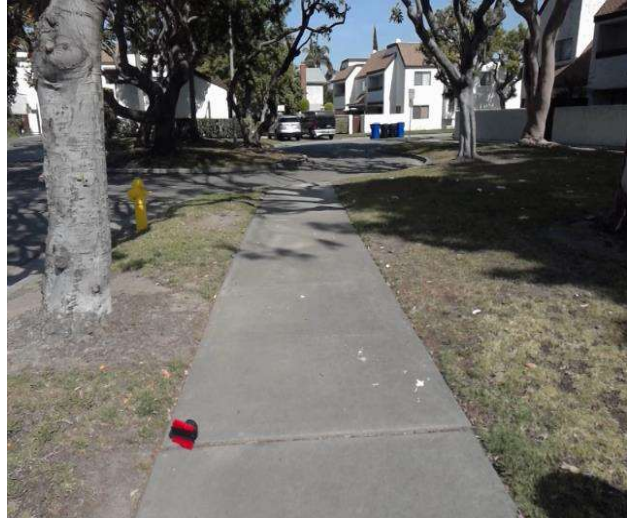
Change In Level South Of Heritage Circle @ 33.941005722602, -118.158632330

Sidewalks , Change in Level : Change in Level Non Beveled

There is a change in elevation greater than recommended value.

On-Site Finding 0.62 inches

Code Reference ADA 206, 302

Ensure that the change in elevation is within the recommended value.

Recommendation Up to 0.25 inches

Remove tripping hazards \$198

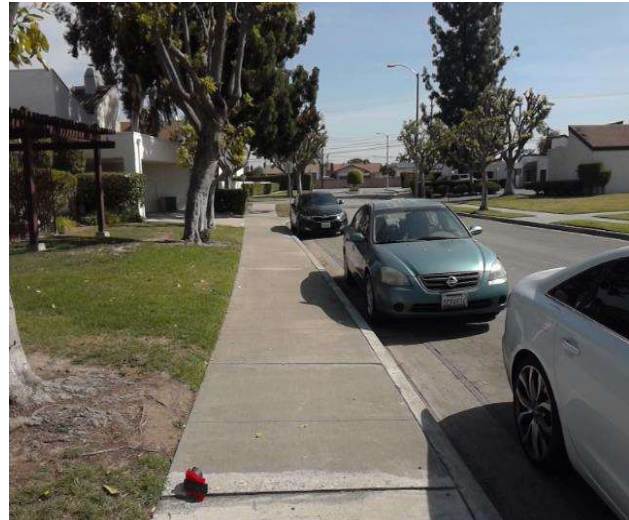
Change In Level South Of Heritage Circle @ 33.941116982290, -118.157842308283

Sidewalks , Change in Level : Change in Level Non Beveled

There is a change in elevation greater than recommended value.

On-Site Finding 0.87 inches

Code Reference ADA 206, 302

Ensure that the change in elevation is within the recommended value.

Recommendation Up to 0.25 inches

Remove tripping hazards \$198

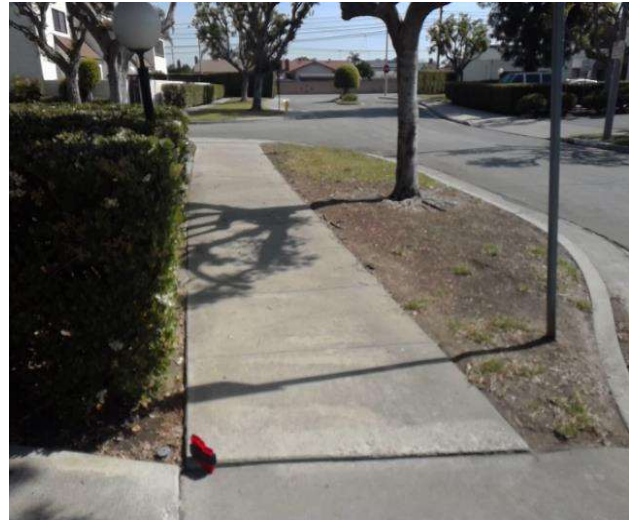
Change In Level South Of Heritage Circle @ 33.941326150109, -118.157749772072

Sidewalks , Change in Level : Change in Level Non Beveled

There is a change in elevation greater than recommended value.

On-Site Finding 1.25 inches

Code Reference ADA 206, 302

Ensure that the change in elevation is within the recommended value.

Recommendation Up to 0.25 inches

Remove tripping hazards \$198

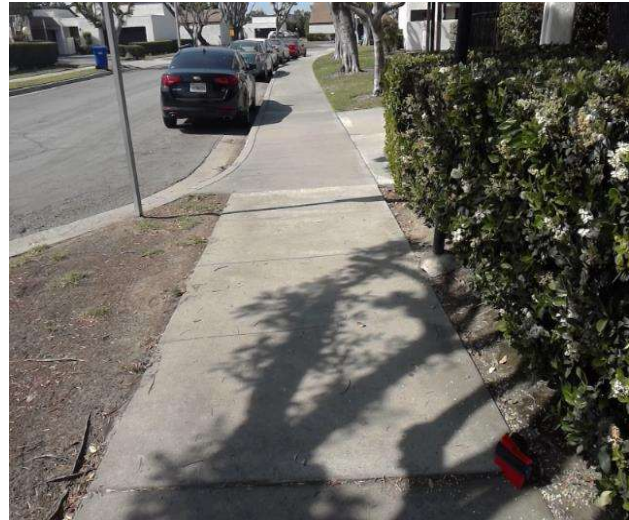
Change In Level South Of Heritage Circle @ 33.941380667169, -118.157701492310

There is a change in elevation greater than recommended value.

Code Reference ADA 206, 302

Ensure that the change in elevation is within the recommended value.

Recommendation Up to 0.25 inches

Remove tripping hazards \$198

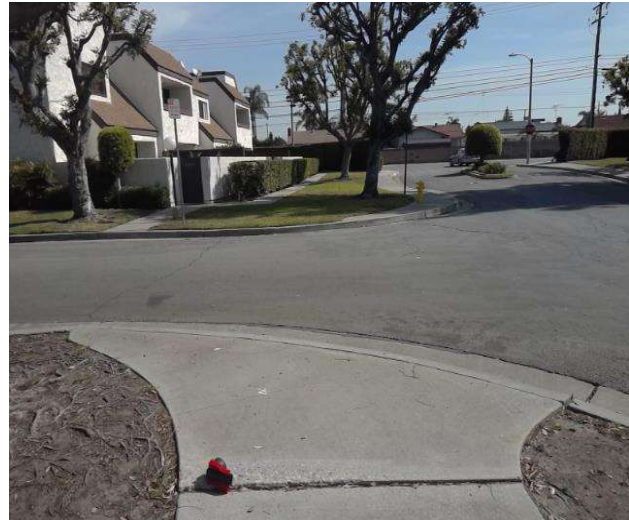
There is a change in elevation greater than recommended value.

Code Reference ADA 206, 302

Ensure that the change in elevation is within the recommended value.

Recommendation Up to 0.25 inches

Remove tripping hazards \$198

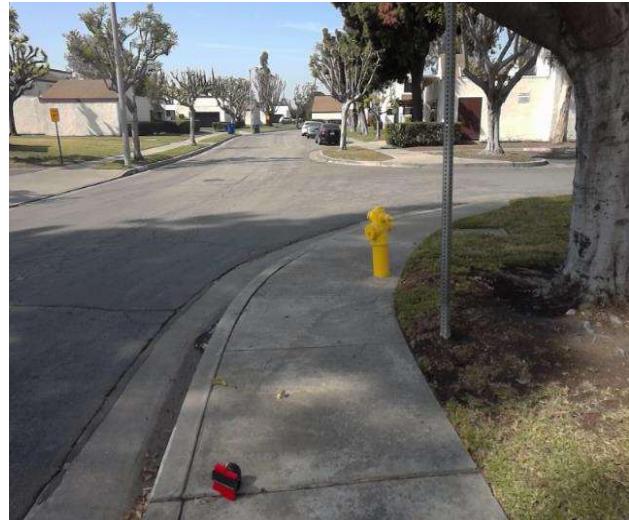
There is a change in elevation greater than recommended value.

Code Reference ADA 206, 302

Ensure that the change in elevation is within the recommended value.

Recommendation Up to 0.25 inches

Remove tripping hazards \$198

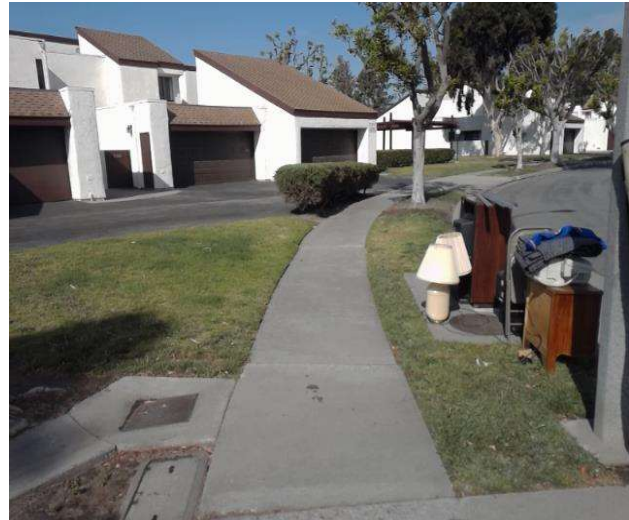
Code Reference ADA 206, 302,CA 11B-403.3

Repave the sidewalk surface with the recommended cross slope.

Recommendation Up to 2.08 percent

Repave surface \$1,092

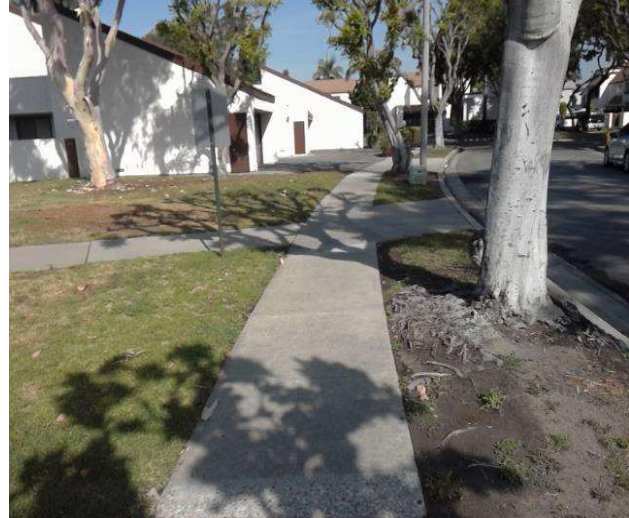
Code Reference ADA 206, 302,CA 11B-403.3

Repave the sidewalk surface with the recommended cross slope.

Recommendation Up to 2.08 percent

Repave surface \$1,092

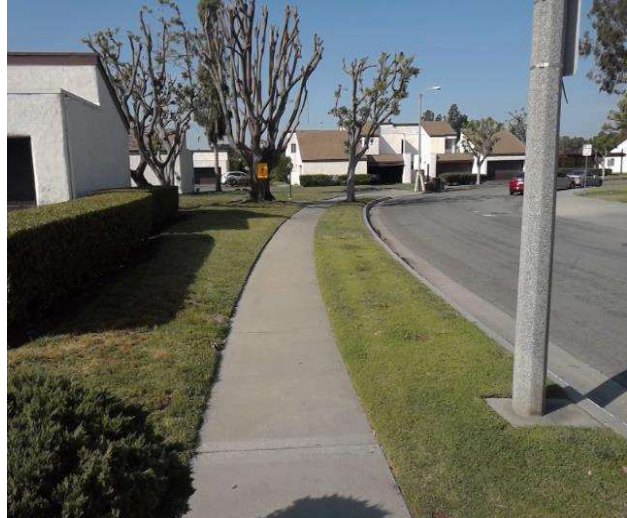
Code Reference ADA 206, 302,CA 11B-403.3

Repave the sidewalk surface with the recommended cross slope.

Recommendation Up to 2.08 percent

Repave surface \$1,092

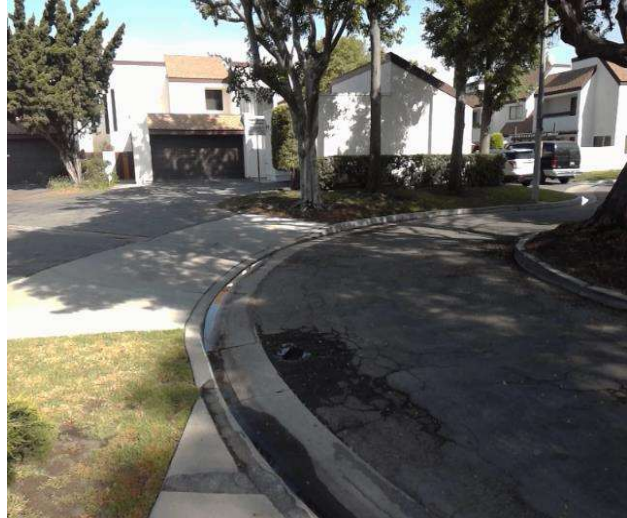
Sidewalks : Missing Sidewalk

Section of sidewalk is missing and consists of dirt, grass or gravel.

Code Reference ADA 206, 302,CA 11B-302,CA 11B-206

Provide a compliant sidewalk for the missing section.

\$1,260

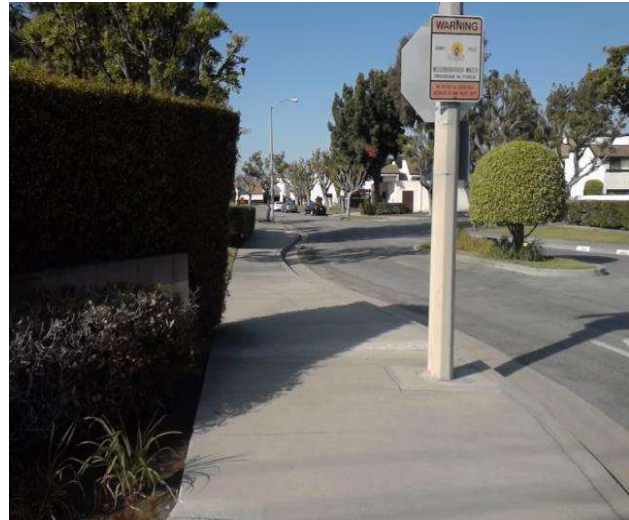
Code Reference ADA 206, 302,CA 11B-403.3

Repave the sidewalk surface with the recommended cross slope.

Recommendation Up to 2.08 percent

Repave surface \$1,092

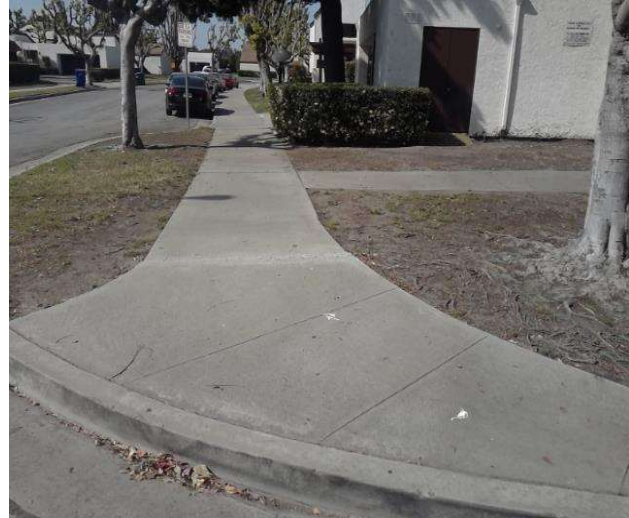
Sidewalks , Hazards & Gratings : Curb is on Path of Travel

Code Reference ADA 402, 303, 406, 403.4, 303.4

Install curb ramp \$2,500

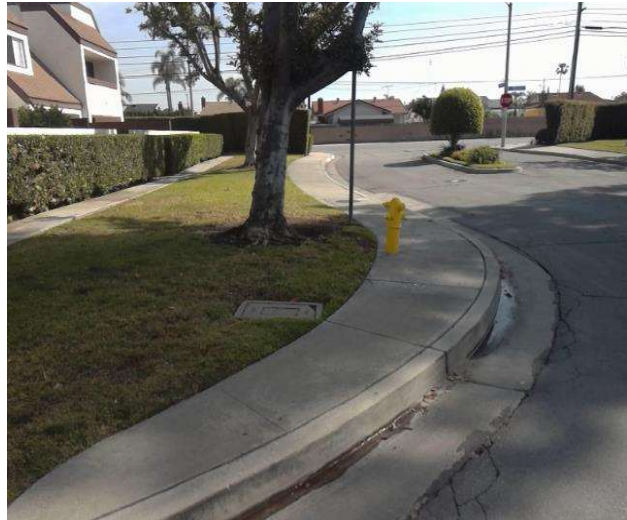
Sidewalks , Hazards & Gratings : Curb is on Path of Travel

Code Reference ADA 402, 303, 406, 403.4, 303.4

Install curb ramp \$2,500

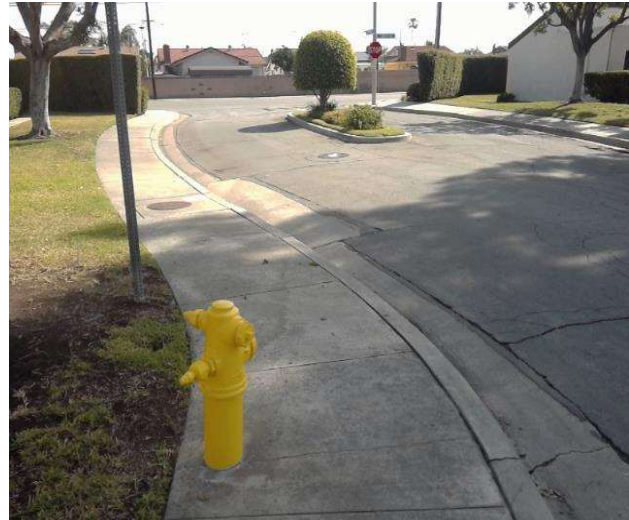
Sidewalks , Hazards & Gratings : Sidewalk Width at Obstruction

Code Reference ADA 206, 302, 403.5.1, CA 11B-403.5

Sidewalk width at the obstruction shall have the recommended value.

Recommendation At least 48.00 inches

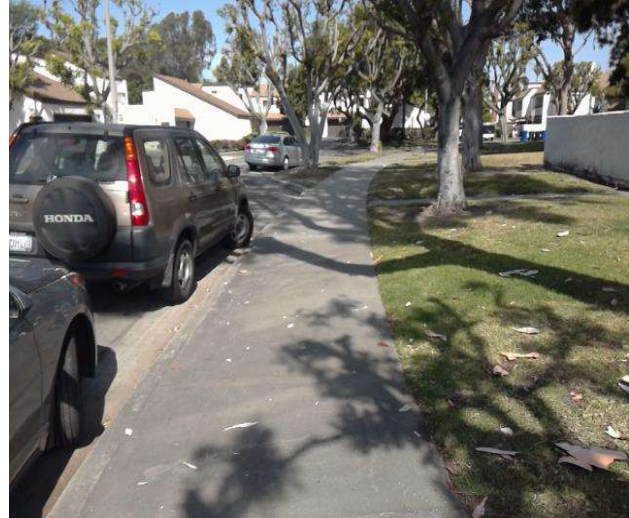
Code Reference ADA 206, 302,CA 11B-403.3

Repave the sidewalk surface with the recommended cross slope.

Recommendation Up to 2.08 percent

Repave surface \$1,092

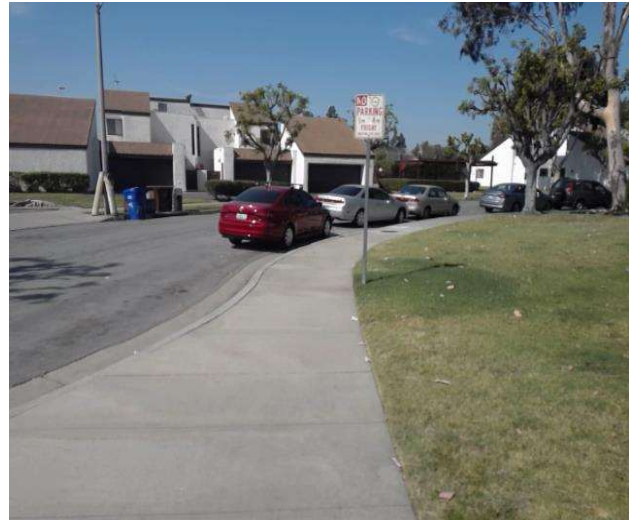
Code Reference ADA 206, 302, CA 11B-403.3

Repave the sidewalk surface with the recommended cross slope.

Recommendation Up to 2.08 percent

Repave surface \$1,092

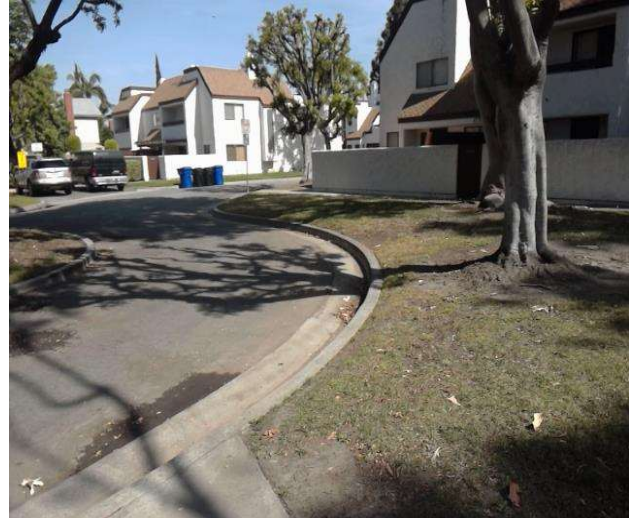
Sidewalks : Missing Sidewalk

Section of sidewalk is missing and consists of dirt, grass or gravel.

Code Reference ADA 206, 302,CA 11B-302,CA 11B-206

Provide a compliant sidewalk for the missing section.

\$1,260

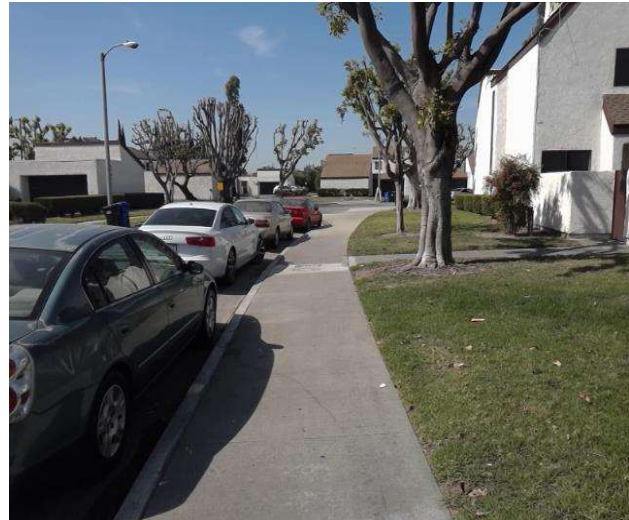
Code Reference ADA 206, 302,CA 11B-403.3

Repave the sidewalk surface with the recommended cross slope.

Recommendation Up to 2.08 percent

Repave surface \$1,092

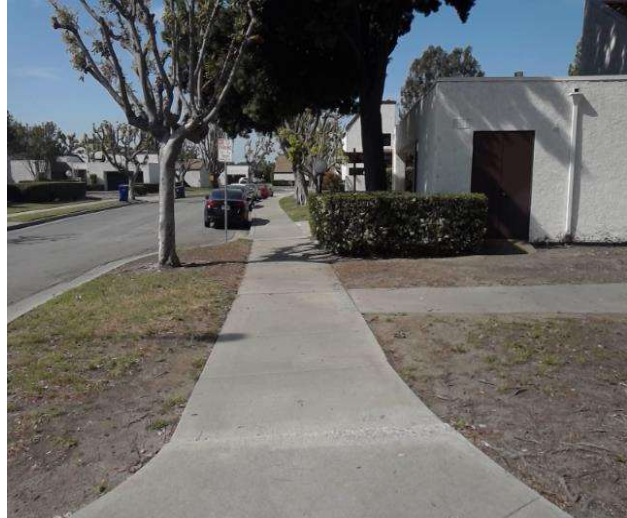
Code Reference ADA 206, 302, CA 11B-403.3

Repave the sidewalk surface with the recommended cross slope.

Recommendation Up to 2.08 percent

Repave surface \$1,092

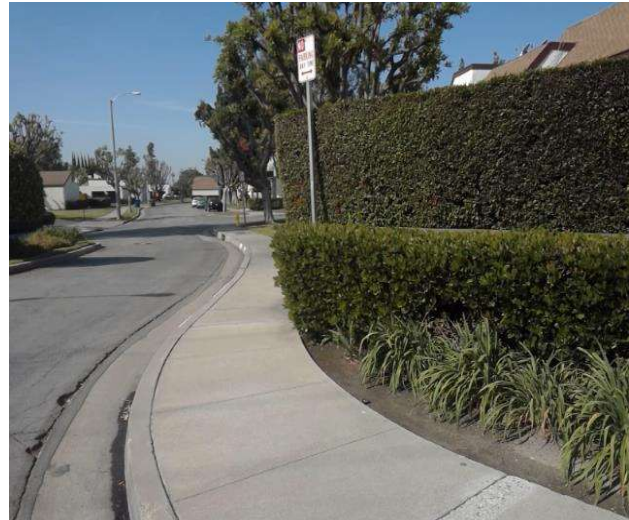
Code Reference ADA 206, 302,CA 11B-403.3

Repave the sidewalk surface with the recommended cross slope.

Recommendation Up to 2.08 percent

Repave surface \$1,092
