## Accessibility Survey

### City of Downey Hondo Street - Rives Avenue To Old River School Road

Date of Inspection  
4/13/2017

**Disability Access Consultants**

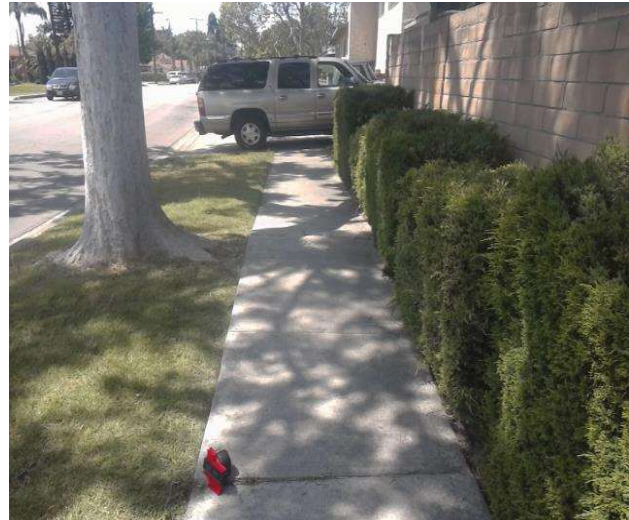
**Change In Level East Of Pomeroy Road @ 33.931918653075, -118.157468140125**

Sidewalks , Change in Level : Change in Level Non Beveled

There is a change in elevation greater than recommended value.

**On-Site Finding** 1.12 inches

Ensure that the change in elevation is within the recommended value.

Recommendation Up to 0.25 inches

Remove tripping hazards \$198

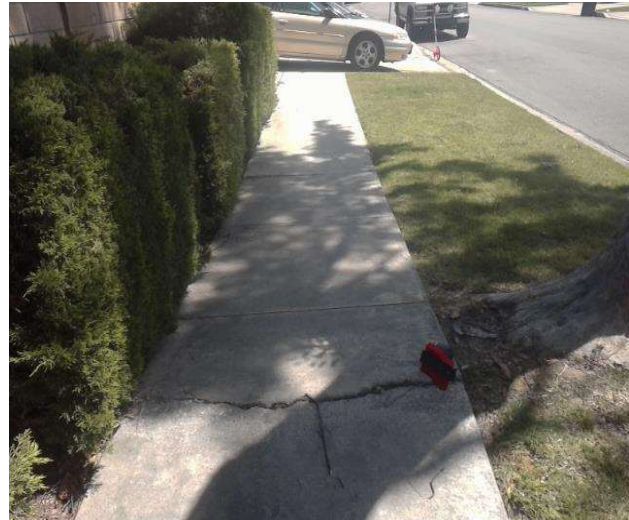
**Change In Level East Of Pomeroy Road @ 33.931937569251, -118.157497644424**

Sidewalks , Change in Level : Change in Level Non Beveled

There is a change in elevation greater than recommended value.

**On-Site Finding** 0.75 inches

Ensure that the change in elevation is within the recommended value.

Recommendation Up to 0.25 inches

Remove tripping hazards \$198

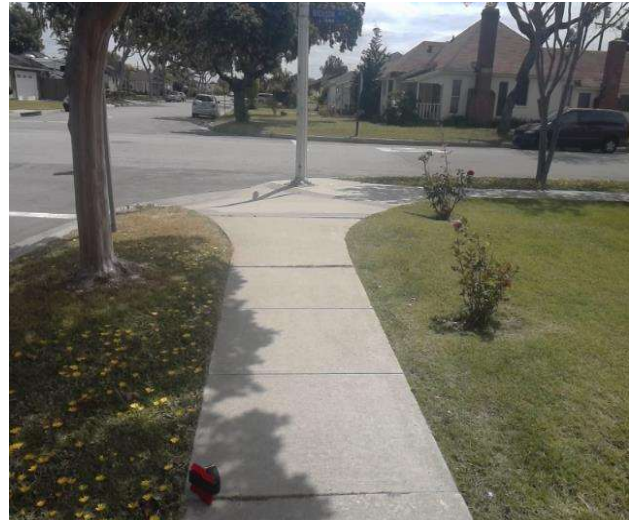
**Change In Level West Of Richeon Avenue @ 33.930639019662, -118.155583888292**

Sidewalks , Change in Level : Change in Level Non Beveled

There is a change in elevation greater than recommended value.

**On-Site Finding** 0.50 inches

Ensure that the change in elevation is within the recommended value.

Recommendation Up to 0.25 inches

Remove tripping hazards \$198

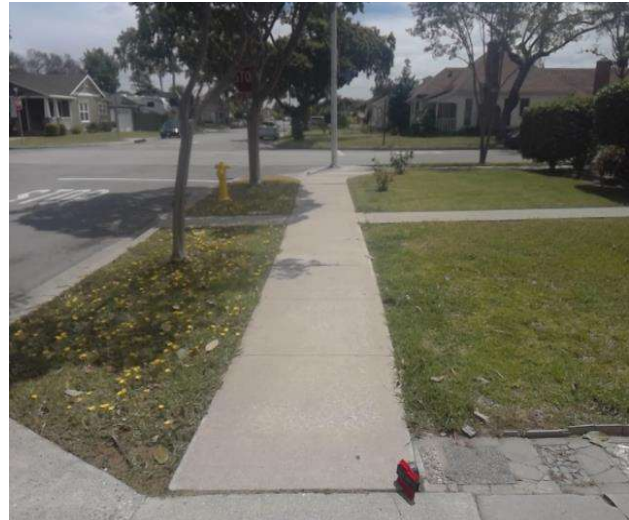
**Change In Level West Of Richeon Avenue @ 33.930689092635, -118.155665695667**

Sidewalks , Change in Level : Change in Level Non Beveled

There is a change in elevation greater than recommended value.

**On-Site Finding** 0.50 inches

Ensure that the change in elevation is within the recommended value.

Recommendation Up to 0.25 inches

Remove tripping hazards \$198

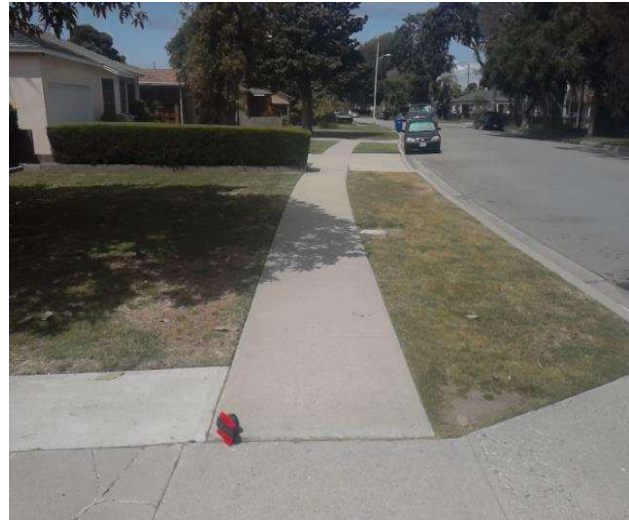
**Change In Level West Of Richeon Avenue @ 33.930706896352, -118.155699223280**

Sidewalks , Change in Level : Change in Level Non Beveled

There is a change in elevation greater than recommended value.

**On-Site Finding** 0.50 inches

Ensure that the change in elevation is within the recommended value.

Recommendation Up to 0.25 inches

Remove tripping hazards \$198

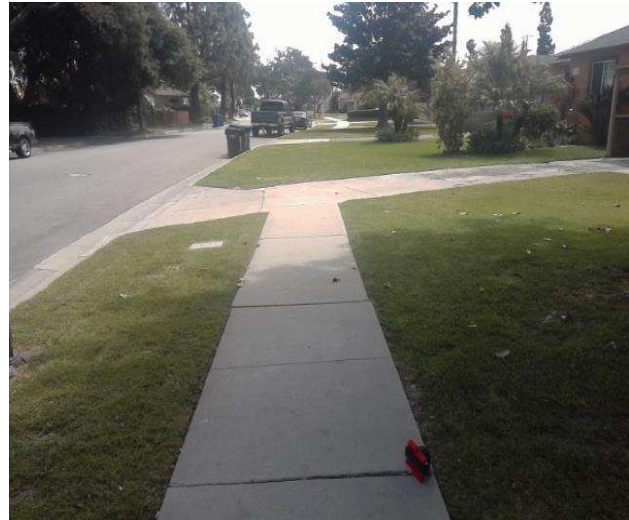
**Change In Level West Of Richeon Avenue @ 33.931138635343, -118.156269192696**

Sidewalks , Change in Level : Change in Level Non Beveled

There is a change in elevation greater than recommended value.

**On-Site Finding** 0.62 inches

Ensure that the change in elevation is within the recommended value.

Recommendation Up to 0.25 inches

Remove tripping hazards \$198

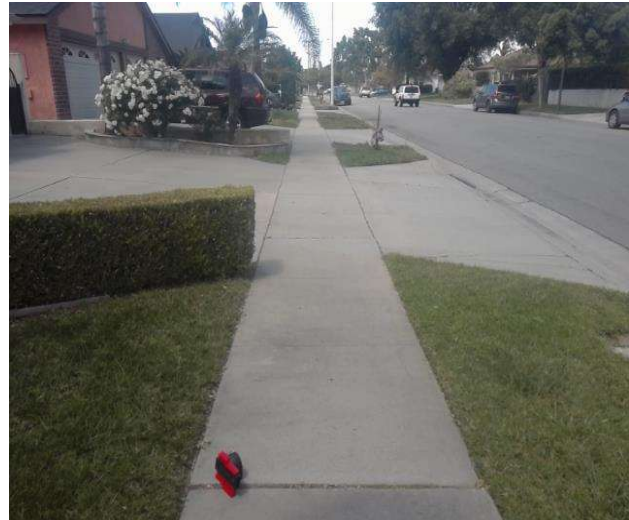
**Change In Level West Of Richeon Avenue @ 33.931174242585, -118.156328201294**

Sidewalks , Change in Level : Change in Level Non Beveled

There is a change in elevation greater than recommended value.

**On-Site Finding** 0.50 inches

Ensure that the change in elevation is within the recommended value.

Recommendation Up to 0.25 inches

Remove tripping hazards \$198

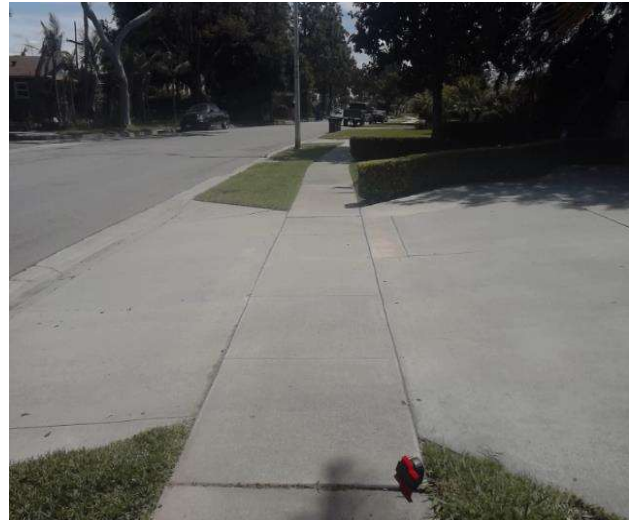
There is a change in elevation greater than recommended value.

Ensure that the change in elevation is within the recommended value.

Recommendation Up to 0.25 inches

Remove tripping hazards \$198

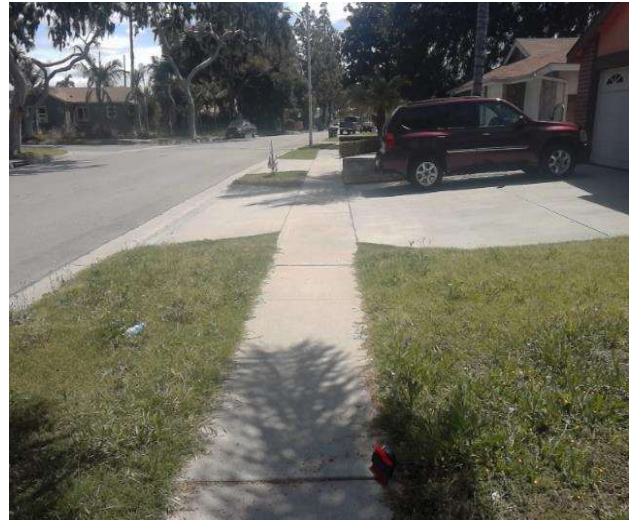
There is a change in elevation greater than recommended value.

Ensure that the change in elevation is within the recommended value.

Recommendation Up to 0.25 inches

Remove tripping hazards \$198

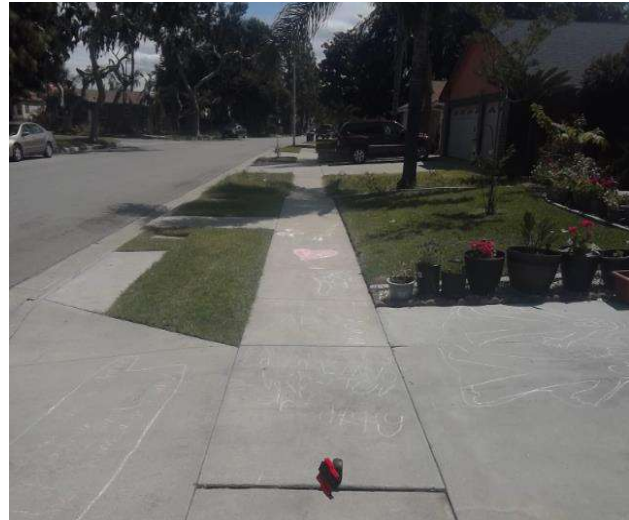
There is a change in elevation greater than recommended value.

Ensure that the change in elevation is within the recommended value.

Recommendation Up to 0.25 inches

Remove tripping hazards \$198

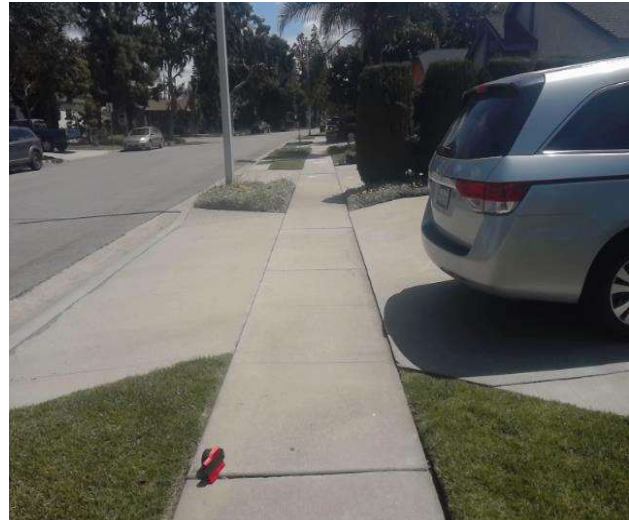
There is a change in elevation greater than recommended value.

Ensure that the change in elevation is within the recommended value.

Recommendation Up to 0.25 inches

Remove tripping hazards \$198

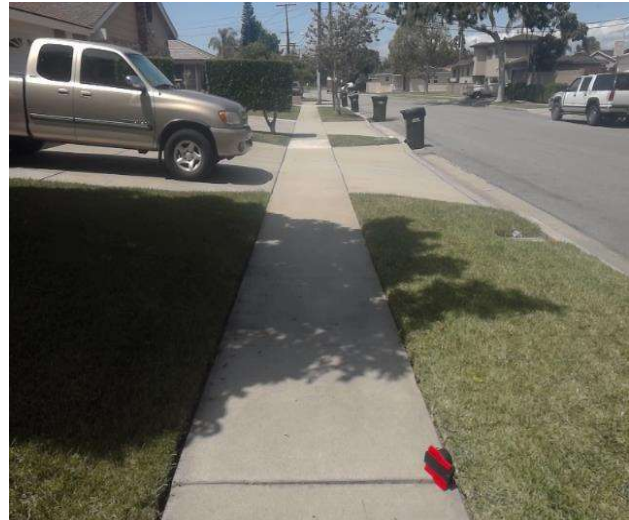
There is a change in elevation greater than recommended value.

Ensure that the change in elevation is within the recommended value.

Recommendation Up to 0.25 inches

Remove tripping hazards \$198

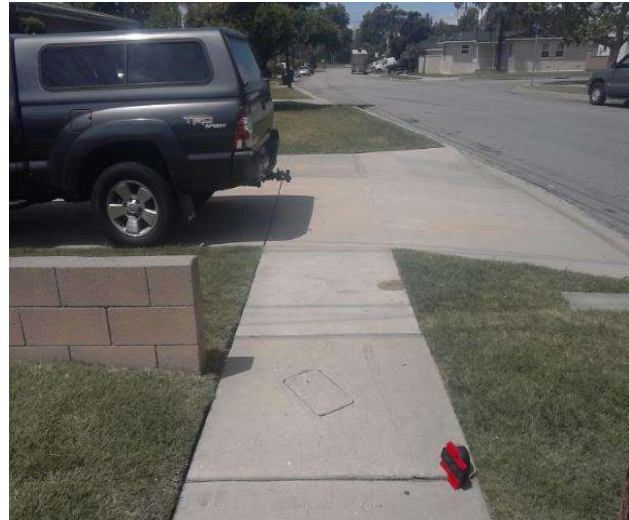
There is a change in elevation greater than recommended value.

Ensure that the change in elevation is within the recommended value.

Recommendation Up to 0.25 inches

Remove tripping hazards \$198

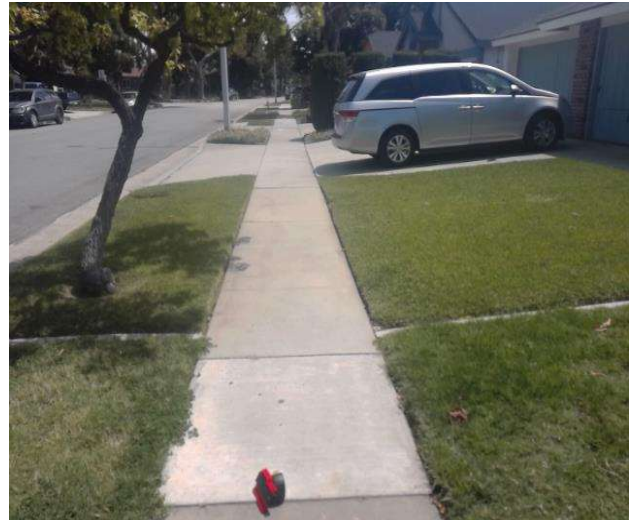
There is a change in elevation greater than recommended value.

Ensure that the change in elevation is within the recommended value.

Recommendation Up to 0.25 inches

Remove tripping hazards \$198

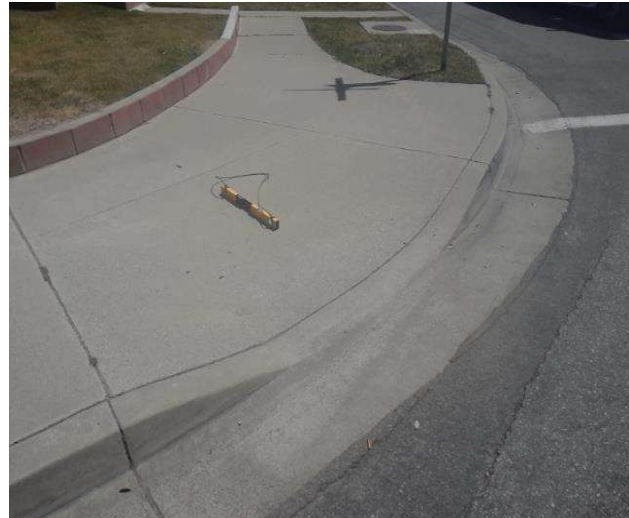
**On-Site Finding** Not Found

Provide detectable warning to surface \$248

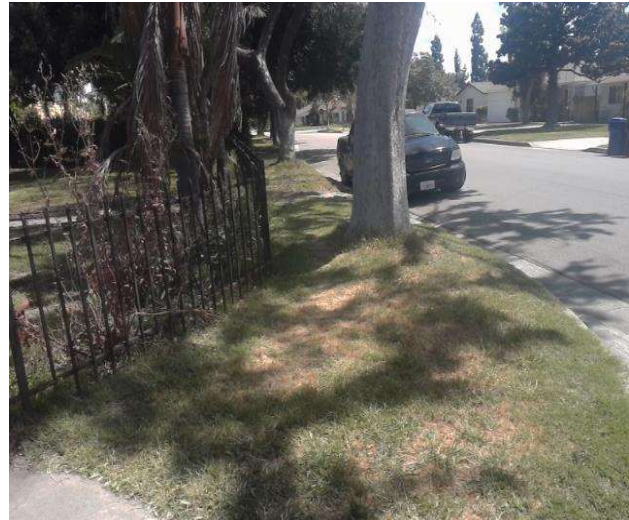
Sidewalks : Missing Sidewalk

Section of sidewalk is missing and consists of dirt, grass or gravel.

Provide a compliant sidewalk for the missing section.

\$1,260

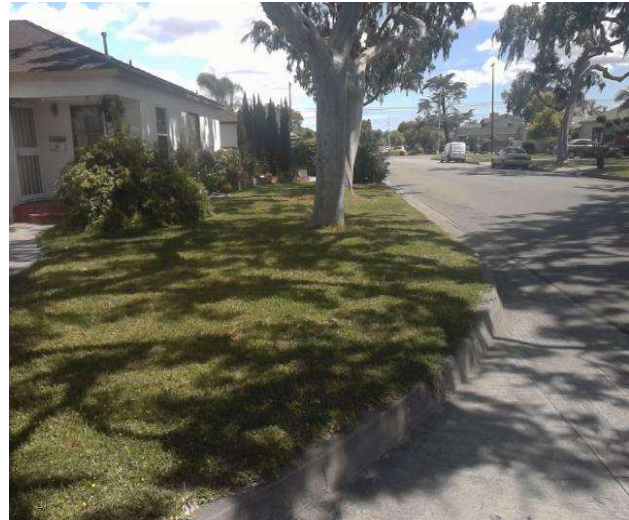
Sidewalks : Missing Sidewalk

Section of sidewalk is missing and consists of dirt, grass or gravel.

Provide a compliant sidewalk for the missing section.

\$1,260

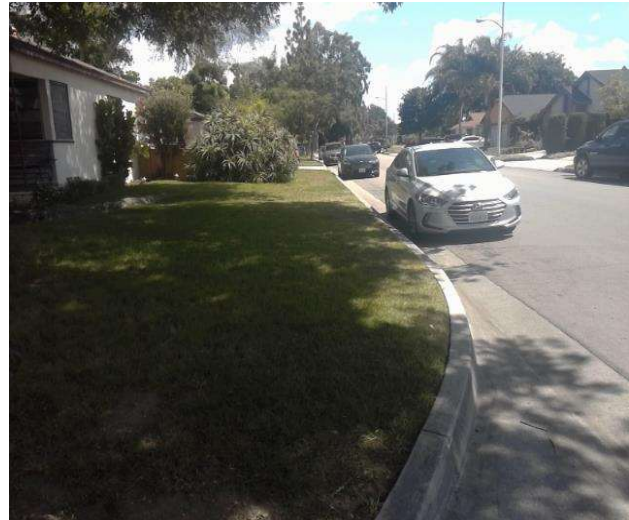
Sidewalks : Missing Sidewalk

Section of sidewalk is missing and consists of dirt, grass or gravel.

Provide a compliant sidewalk for the missing section.

\$1,260

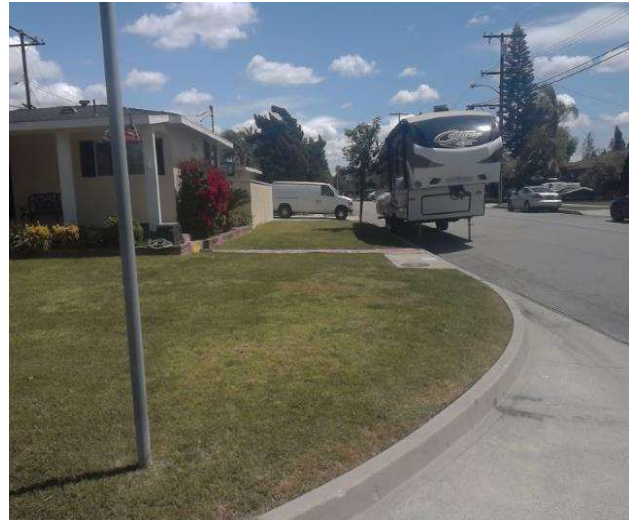
Sidewalks : Missing Sidewalk

Section of sidewalk is missing and consists of dirt, grass or gravel.

Provide a compliant sidewalk for the missing section.

\$1,260

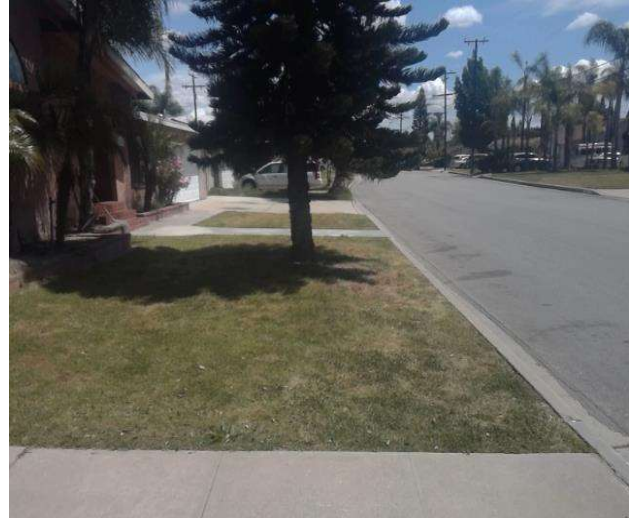
Sidewalks : Missing Sidewalk

Section of sidewalk is missing and consists of dirt, grass or gravel.

Provide a compliant sidewalk for the missing section.

\$1,260

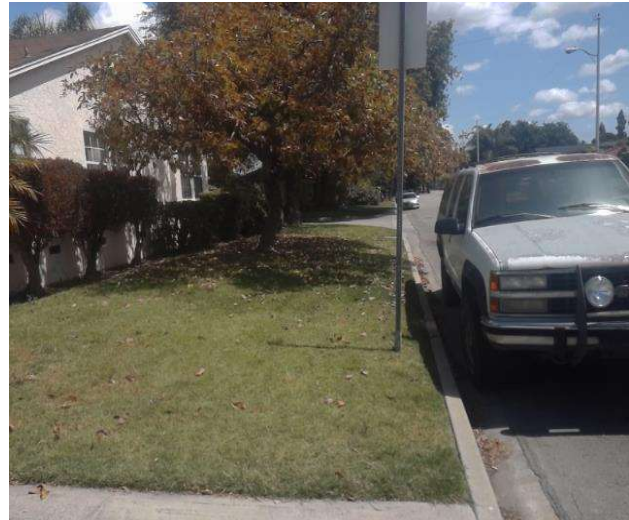
Sidewalks : Missing Sidewalk

Section of sidewalk is missing and consists of dirt, grass or gravel.

Provide a compliant sidewalk for the missing section.

\$1,260

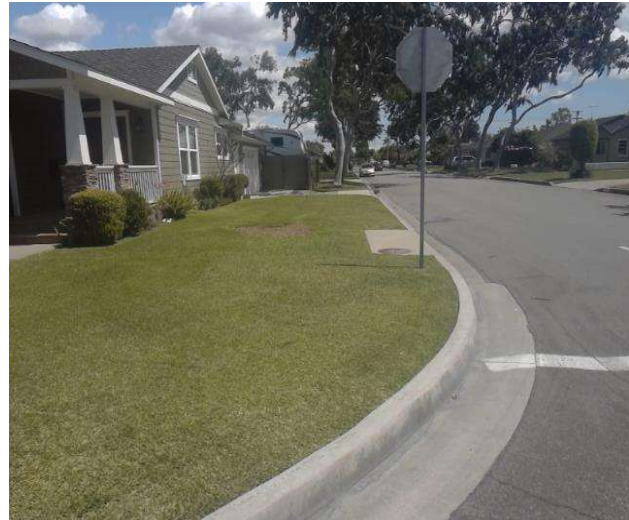
Sidewalks : Missing Sidewalk

Section of sidewalk is missing and consists of dirt, grass or gravel.

Provide a compliant sidewalk for the missing section.

\$1,260

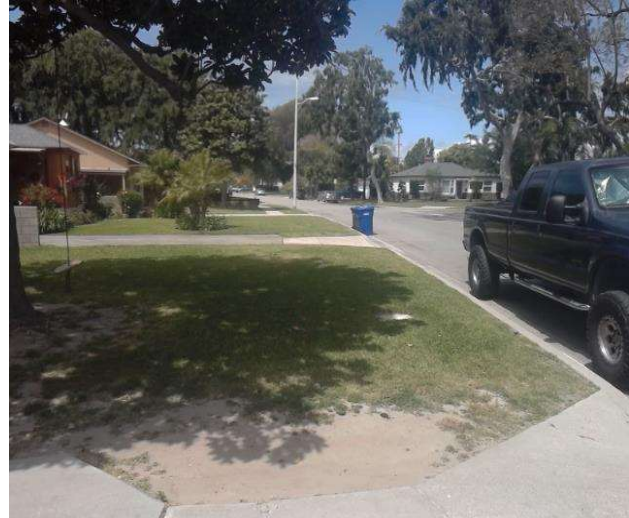
Sidewalks : Missing Sidewalk

Section of sidewalk is missing and consists of dirt, grass or gravel.

Provide a compliant sidewalk for the missing section.

\$1,260

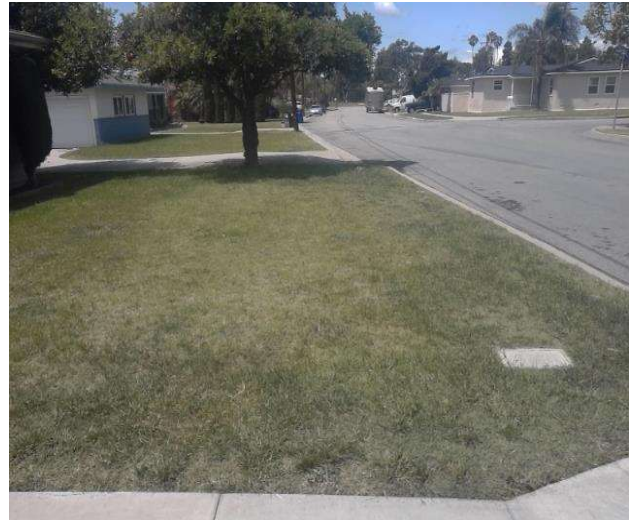
Sidewalks : Missing Sidewalk

Section of sidewalk is missing and consists of dirt, grass or gravel.

Provide a compliant sidewalk for the missing section.

\$1,260

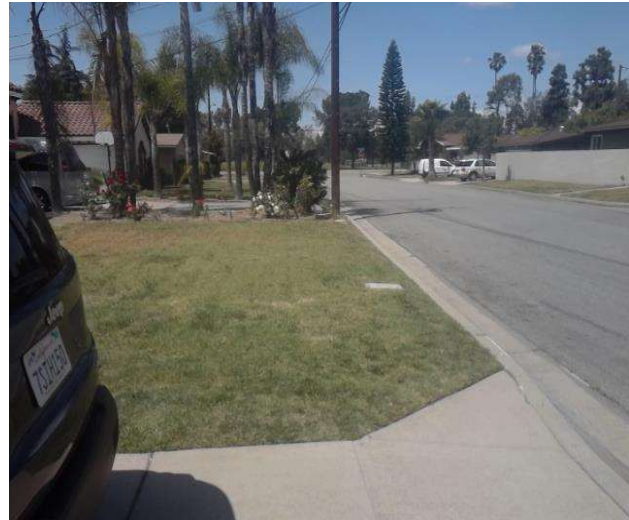
Sidewalks : Missing Sidewalk

Section of sidewalk is missing and consists of dirt, grass or gravel.

Provide a compliant sidewalk for the missing section.

\$1,260

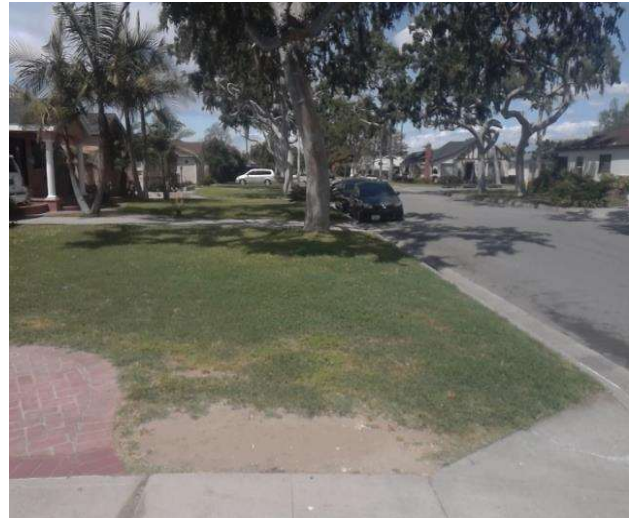
Sidewalks : Missing Sidewalk

Section of sidewalk is missing and consists of dirt, grass or gravel.

Provide a compliant sidewalk for the missing section.

\$1,260

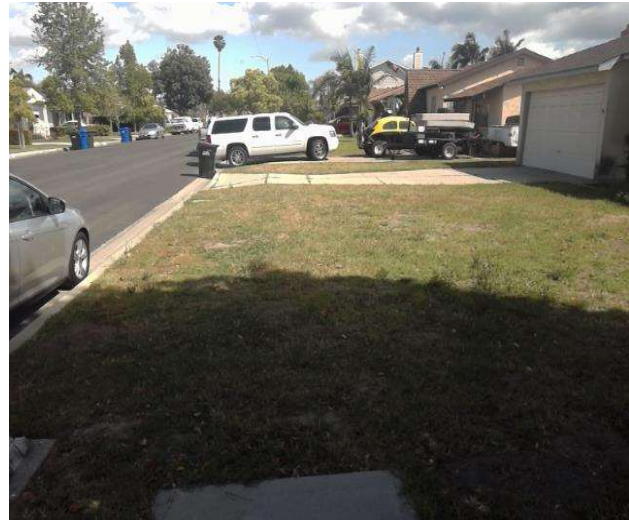
Sidewalks : Missing Sidewalk

Section of sidewalk is missing and consists of dirt, grass or gravel.

Provide a compliant sidewalk for the missing section.

\$1,260
