Accessibility Survey

City of Downey Norlain Avenue - Arnett Street To Neo Street

Date of Inspection
4/25/2017

Prepared By
Disability Access Consultants
(800) 743-7067

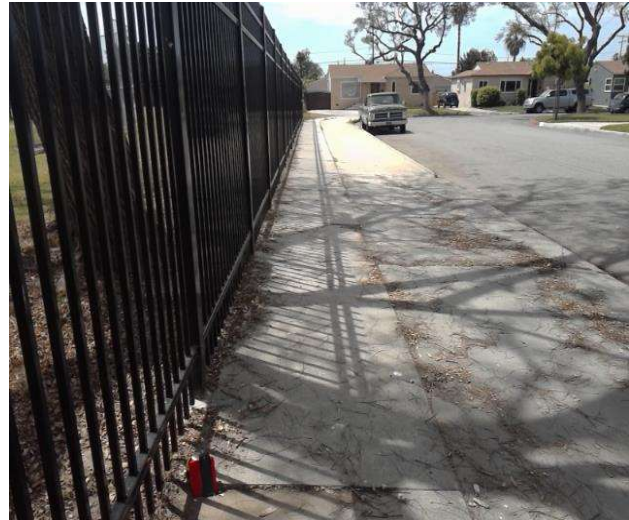
Change In Level South Of Arnett Street @ 33.944598224460, -118.149746060371

Sidewalks , Change in Level : Change in Level Non Beveled

There is a change in elevation greater than recommended value.

On-Site Finding 1.50 inches

Ensure that the change in elevation is within the recommended value.

Recommendation Up to 0.25 inches

Remove tripping hazards \$198

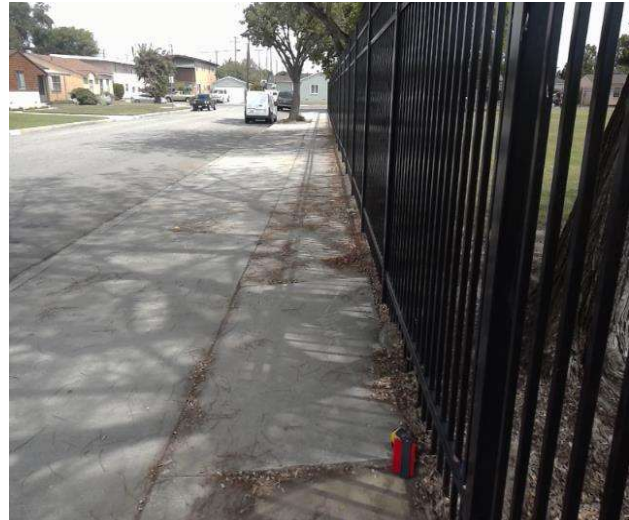
Change In Level South Of Arnett Street @ 33.944648289225, -118.149693757296

Sidewalks , Change in Level : Change in Level Non Beveled

There is a change in elevation greater than recommended value.

On-Site Finding 2.25 inches

Ensure that the change in elevation is within the recommended value.

Recommendation Up to 0.25 inches

Remove tripping hazards \$198

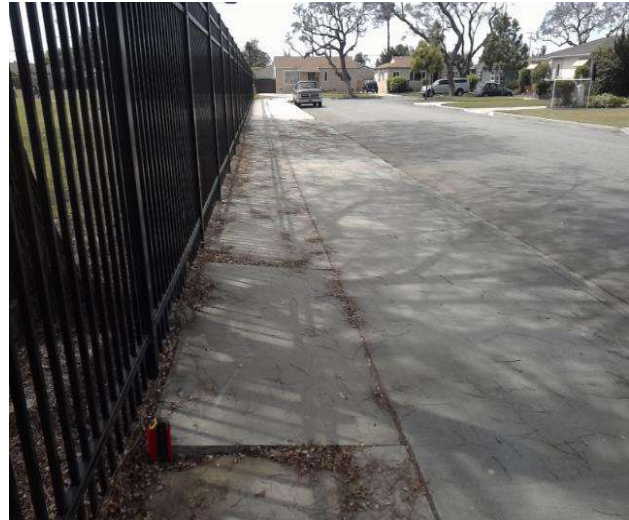
Change In Level South Of Arnett Street @ 33.944672765321, -118.149681687355

Sidewalks , Change in Level : Change in Level Non Beveled

There is a change in elevation greater than recommended value.

On-Site Finding 2.50 inches

Ensure that the change in elevation is within the recommended value.

Recommendation Up to 0.25 inches

Remove tripping hazards \$198

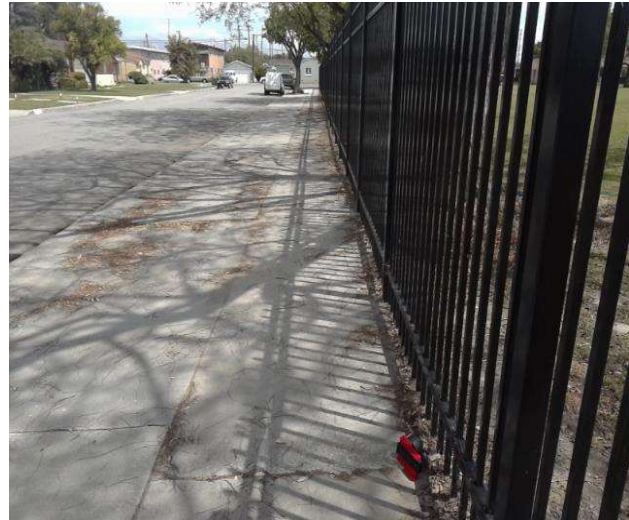
Change In Level South Of Arnett Street @ 33.944515895672, -118.149810433388

Sidewalks , Change in Level : Change in Level Non Beveled

There is a change in elevation greater than recommended value.

On-Site Finding 0.87 inches

Ensure that the change in elevation is within the recommended value.

Recommendation Up to 0.25 inches

Remove tripping hazards \$198

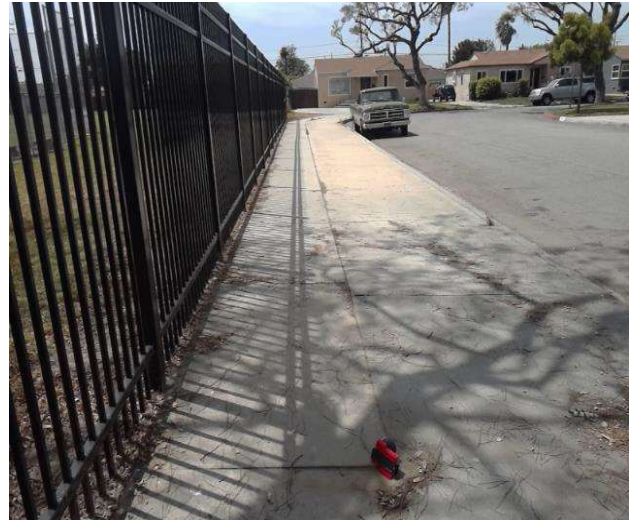
Change In Level South Of Arnett Street @ 33.944543709461, -118.149798363447

Sidewalks , Change in Level : Change in Level Non Beveled

There is a change in elevation greater than recommended value.

On-Site Finding 0.62 inches

Ensure that the change in elevation is within the recommended value.

Recommendation Up to 0.25 inches

Remove tripping hazards \$198

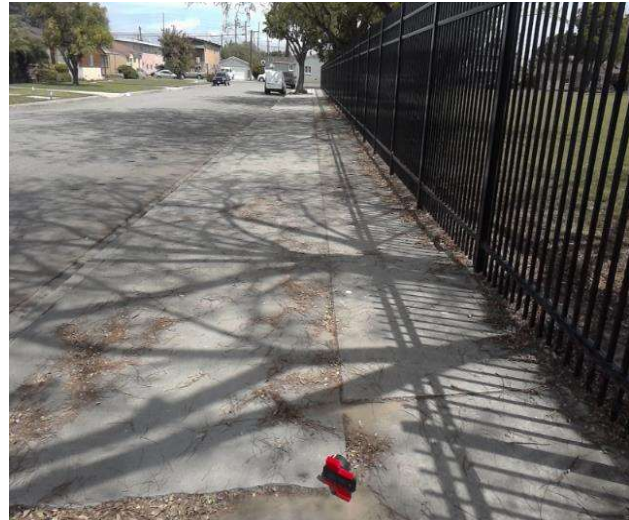
Change In Level South Of Arnett Street @ 33.944560397730, -118.149779587984

Sidewalks , Change in Level : Change in Level Non Beveled

There is a change in elevation greater than recommended value.

On-Site Finding 1.00 inches

Ensure that the change in elevation is within the recommended value.

Recommendation Up to 0.25 inches

Remove tripping hazards \$198

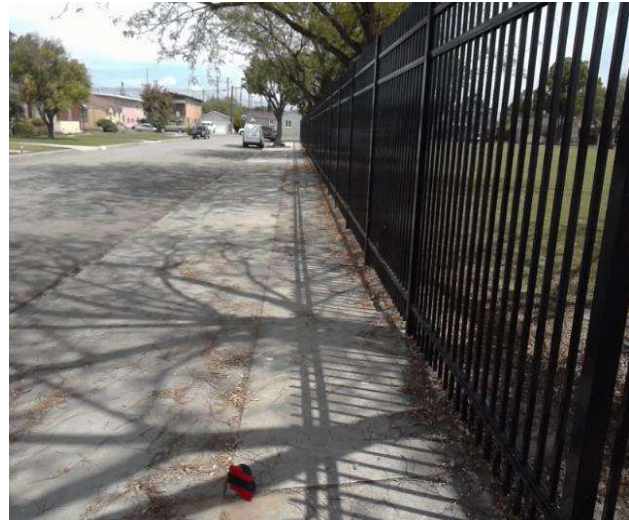
Change In Level South Of Arnett Street @ 33.944575973444, -118.149771541357

Sidewalks , Change in Level : Change in Level Non Beveled

There is a change in elevation greater than recommended value.

On-Site Finding 0.87 inches

Ensure that the change in elevation is within the recommended value.

Recommendation Up to 0.25 inches

Remove tripping hazards \$198

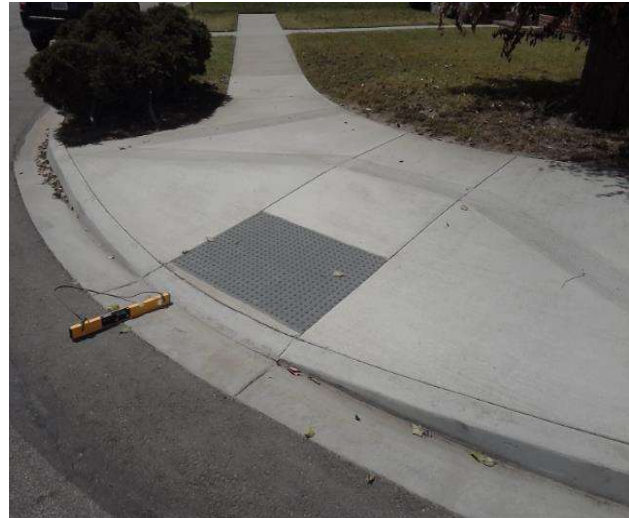
Southwest Corner Of Arnett Street @ 33.945272427485, - 118.149465769529

Curb Ramp : Bottom Landing Slope

The bottom landing of the curb ramp is on the street, and the slope of the bottom landing is not compliant.

On-Site Finding 9.70 percent

Ensure the bottom landing slope is compliant and provides a smooth transition.

Recommendation Up to 5.00 percent

Repave landing \$1,260

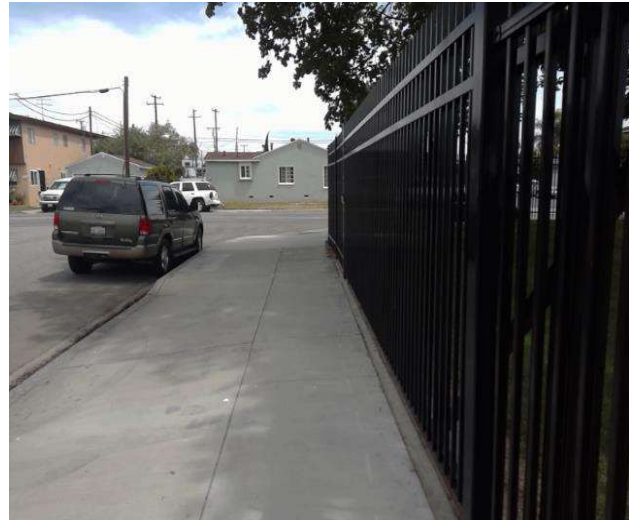
Driveway South Of Arnett Street @ 33.945095533149, -118.149371892214

Sidewalks , Vehicular Traffic : Cross Walks and Detectable Warnings

There are no detectable warnings where the pedestrian route crosses vehicular traffic.

On-Site Finding Not Found

Provide detectable warnings.

Install compliant detectable warnings \$190

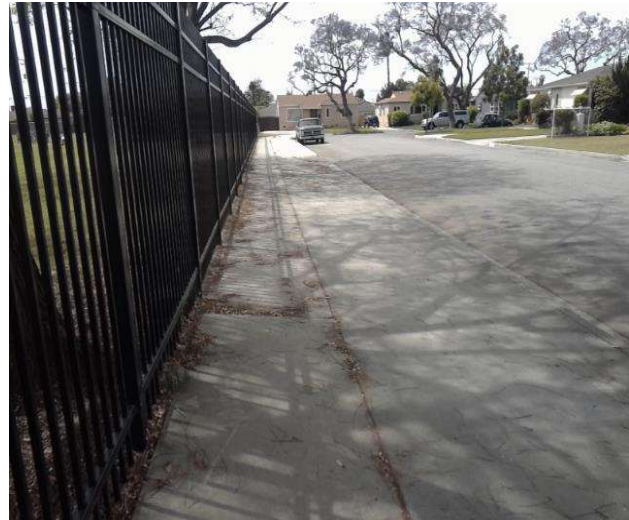
Sidewalk South Of Arnett Street @ 33.944672765321, -118.149681687355

Sidewalks , Surface : Cross Slope

Sidewalk cross slope is not compliant.

On-Site Finding 10.90 percent for 100.00 feet

Repave the sidewalk surface with the recommended cross slope.

Recommendation Up to 2.08 percent

Repave surface \$1,092

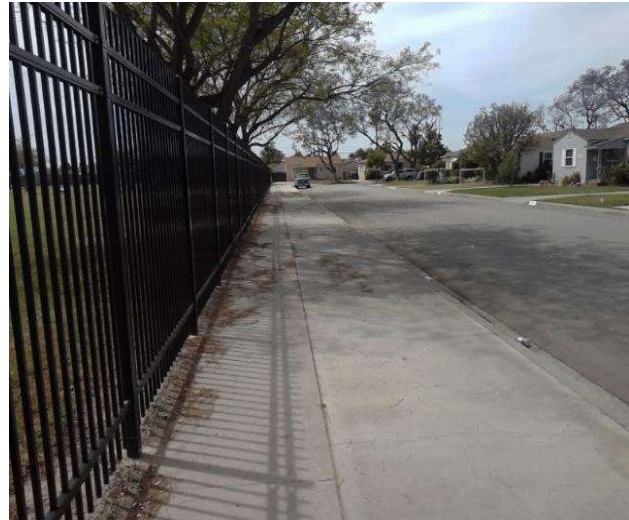
Sidewalk South Of Arnett Street @ 33.944870798933, -118.149547576904

Sidewalks , Surface : Cross Slope

Sidewalk cross slope is not compliant.

On-Site Finding 4.60 percent for 60.00 feet

Repave the sidewalk surface with the recommended cross slope.

Recommendation Up to 2.08 percent

Repave surface \$1,092

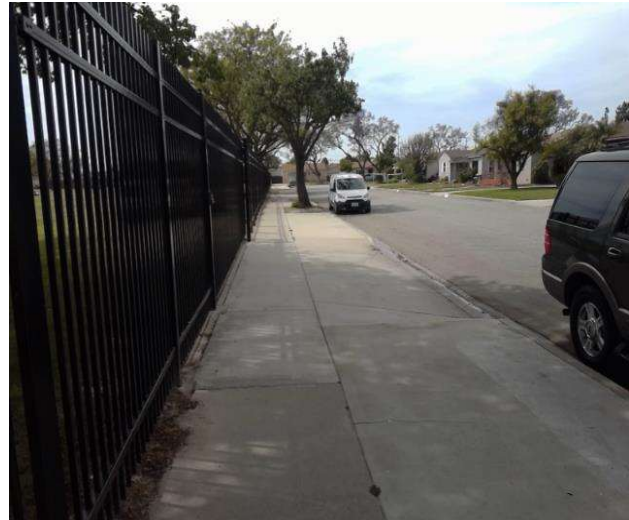
Sidewalk South Of Arnett Street @ 33.945160060685, -118.149341046810

Sidewalks , Surface : Cross Slope

Sidewalk cross slope is not compliant.

On-Site Finding 3.50 percent for 100.00 feet

Repave the sidewalk surface with the recommended cross slope.

Recommendation Up to 2.08 percent

Repave surface \$1,092

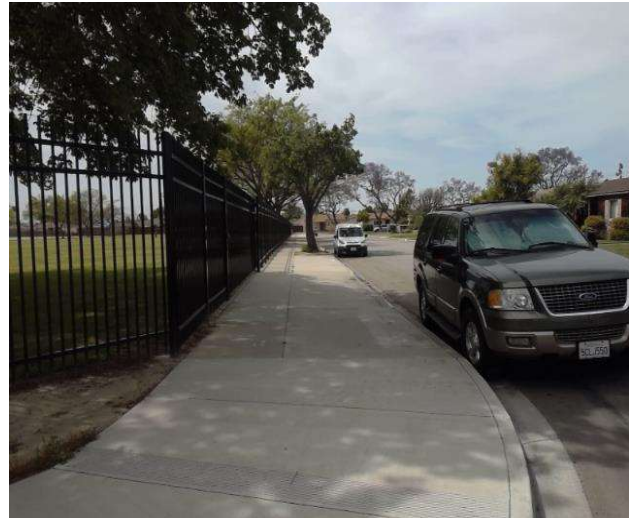
East Side @ 33.945161173228, -118.149331659079

Sidewalks : Turn Area

Turn area is not level.

On-Site Finding Not Level

Make sure that the turn area is level.

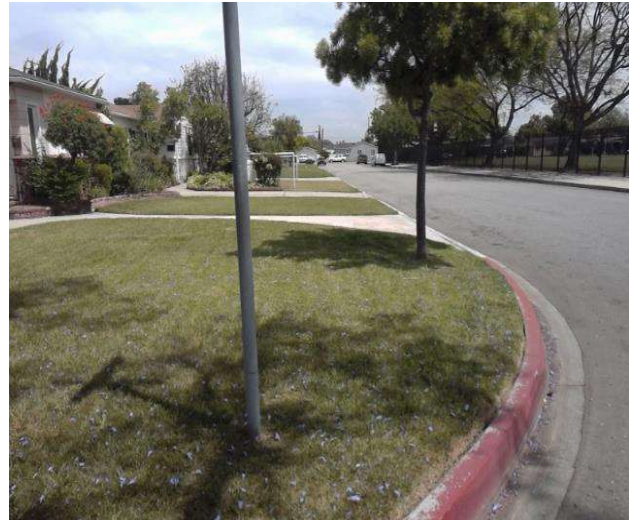
Sidewalk North Of Neo Street @ 33.944382389360, -118.150100111961

Sidewalks : Missing Sidewalk

Section of sidewalk is missing and consists of dirt, grass or gravel.

On-Site Finding 325.00 feet

Provide a compliant sidewalk for the missing section.

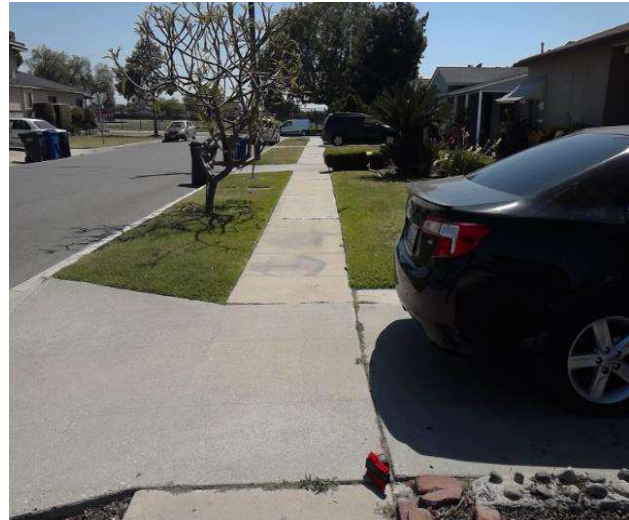
Change In Level North Of Arnett Street To Pivot Street @ 33.945646240722, - 118.148828744888

Sidewalks , Change in Level : Change in Level Non Beveled

There is a change in elevation greater than recommended value.

On-Site Finding 0.62 inches

Ensure that the change in elevation is within the recommended value.

Recommendation Up to 0.25 inches

Remove tripping hazards \$198

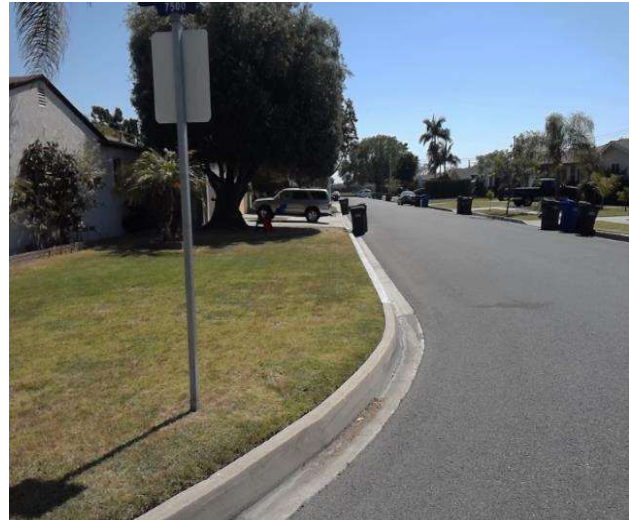
East Side @ 33.946204732440, -118.148241341114

Sidewalks : No Sidewalk

No sidewalk exists at the location.

On-Site Finding Not Found

No action necessary until a sidewalk is provided.

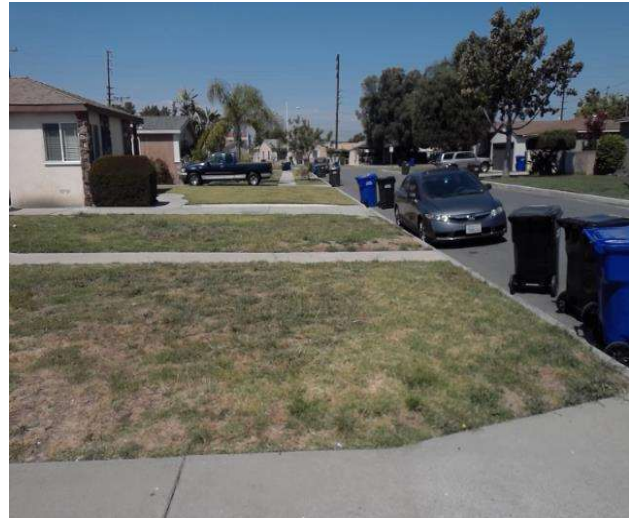
Sidewalk North Of Arnett Street To Pivot Street @ 33.945764169557, - 118.148746937513

Sidewalks : Missing Sidewalk

Section of sidewalk is missing and consists of dirt, grass or gravel.

On-Site Finding 93.00 feet

Provide a compliant sidewalk for the missing section.

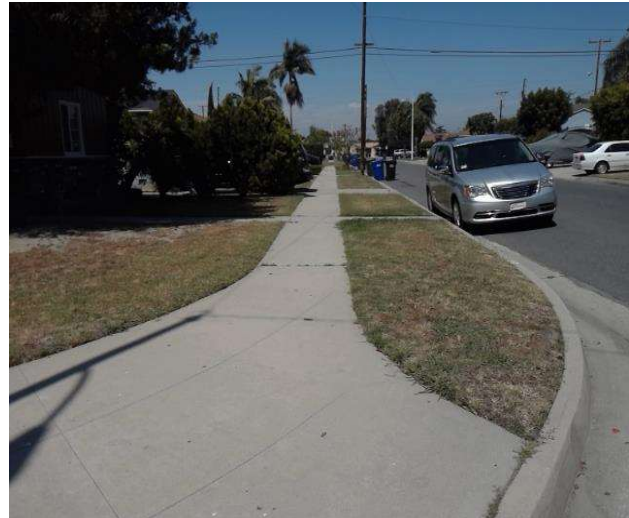
Sidewalks : 60X60 Turn Area

On-Site Finding Not Found

\$2,400

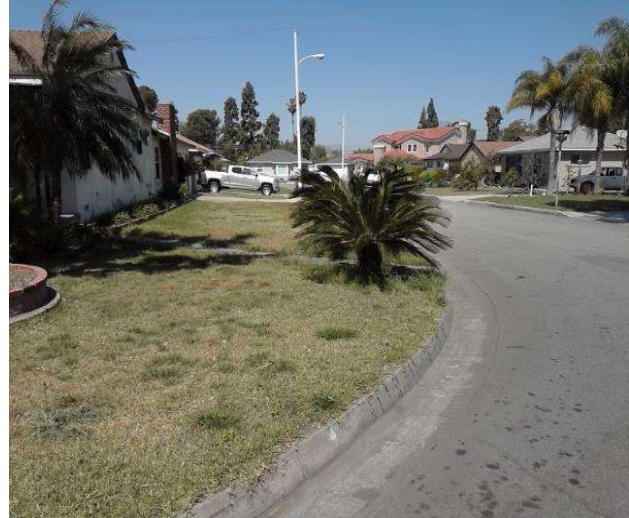
Sidewalks : Missing Sidewalk

Section of sidewalk is missing and consists of dirt, grass or gravel.

Provide a compliant sidewalk for the missing section.

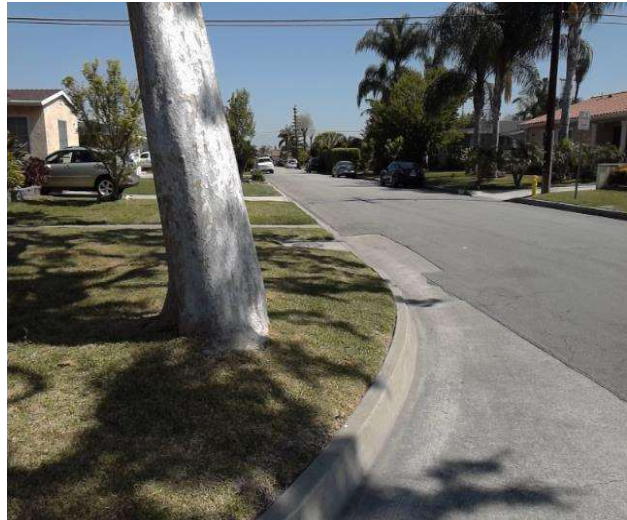
Sidewalks : Missing Sidewalk

Section of sidewalk is missing and consists of dirt, grass or gravel.

Provide a compliant sidewalk for the missing section.

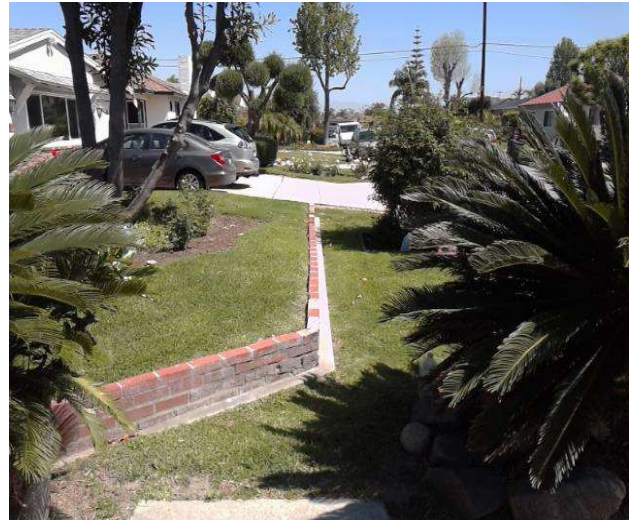
Sidewalks : Missing Sidewalk

Section of sidewalk is missing and consists of dirt, grass or gravel.

Provide a compliant sidewalk for the missing section.

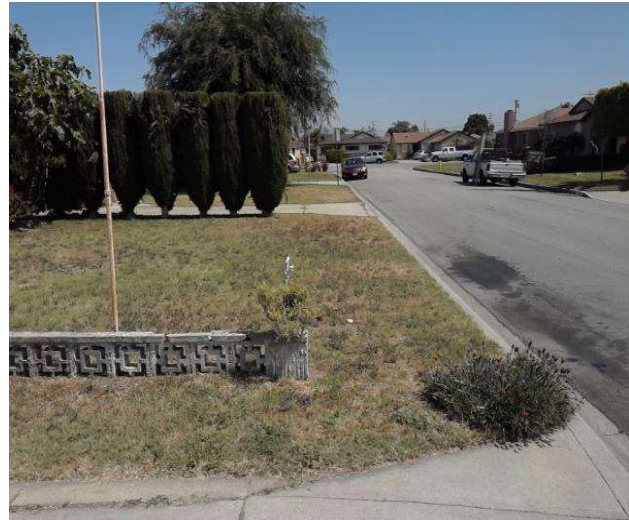
Sidewalks : Missing Sidewalk

Section of sidewalk is missing and consists of dirt, grass or gravel.

Provide a compliant sidewalk for the missing section.

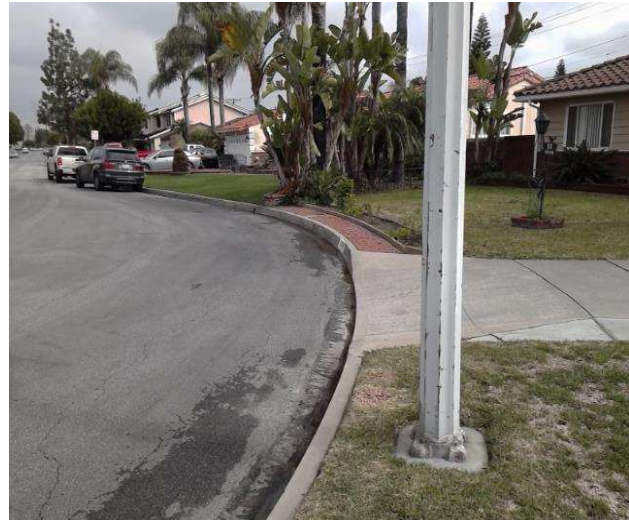
Sidewalks : Missing Sidewalk

Section of sidewalk is missing and consists of dirt, grass or gravel.

Provide a compliant sidewalk for the missing section.

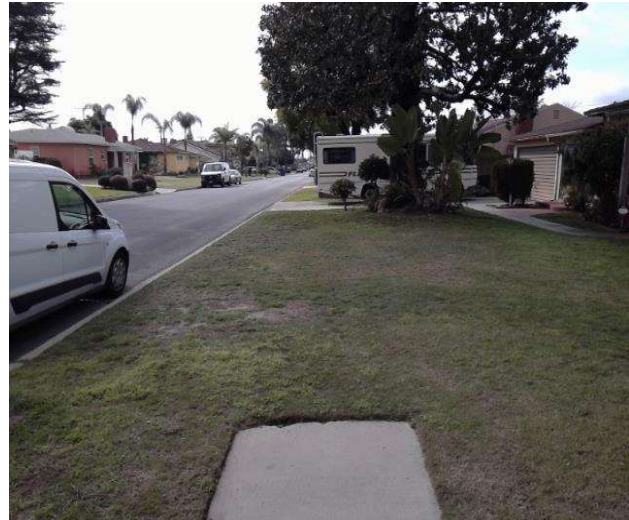
Sidewalks : Missing Sidewalk

Section of sidewalk is missing and consists of dirt, grass or gravel.

Provide a compliant sidewalk for the missing section.

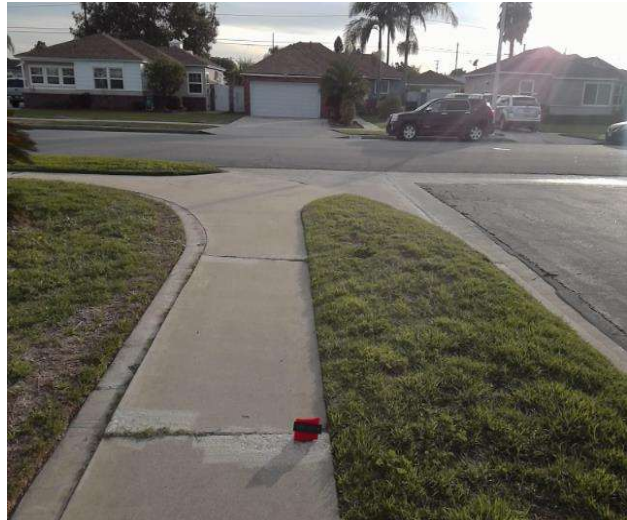
There is a change in elevation greater than recommended value.

Recommendation Up to 0.50 inches

Remove tripping hazards \$198

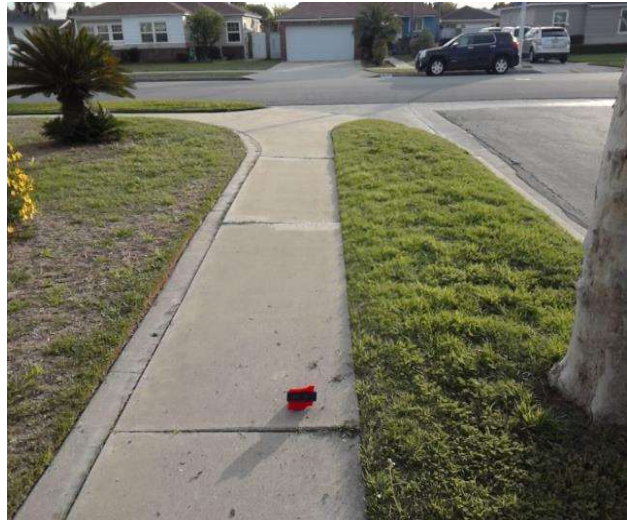
There is a change in elevation greater than recommended value.

Recommendation Up to 0.50 inches

Remove tripping hazards \$198
