Accessibility Survey

City of Downey Ryerson Avenue - De Palma Street To Adwen Street

Date of Inspection
4/20/2017

Disability Access Consultants

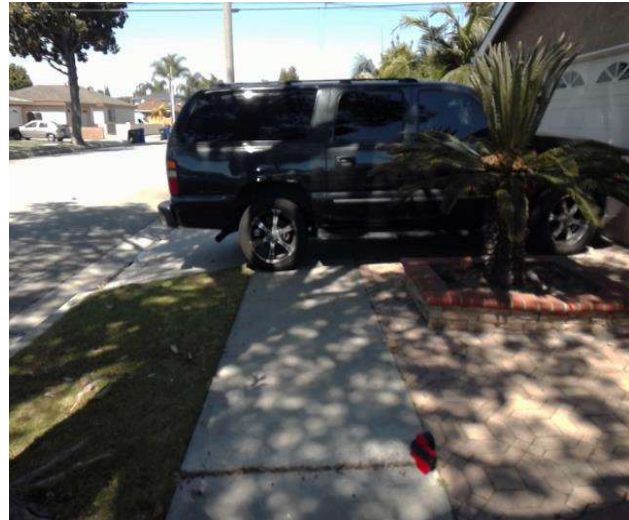
Change In Level South Of Benares Street @ 33.944306735691, -118.156147152185

Sidewalks , Change in Level : Change in Level Non Beveled

There is a change in elevation greater than recommended value.

On-Site Finding 0.87 inches

Code Reference ADA 206, 302

Ensure that the change in elevation is within the recommended value.

Recommendation Up to 0.25 inches

Remove tripping hazards \$198

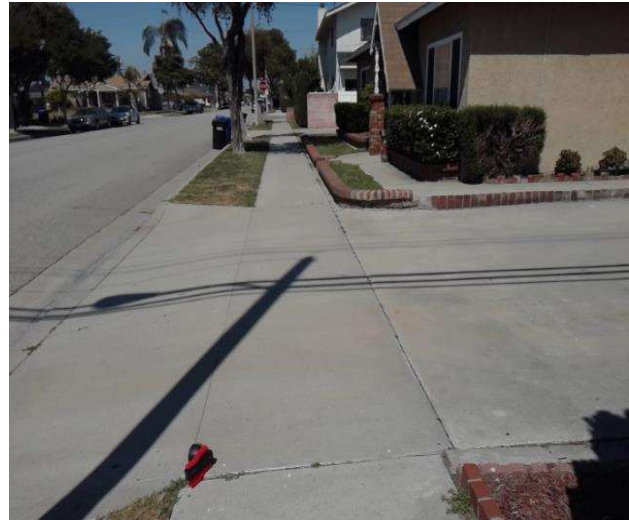
Change In Level South Of Luxor Street @ 33.943507917839, -118.156730532646

Sidewalks , Change in Level : Change in Level Non Beveled

There is a change in elevation greater than recommended value.

On-Site Finding 1.12 inches

Code Reference ADA 206, 302

Ensure that the change in elevation is within the recommended value.

Recommendation Up to 0.25 inches

Remove tripping hazards \$198

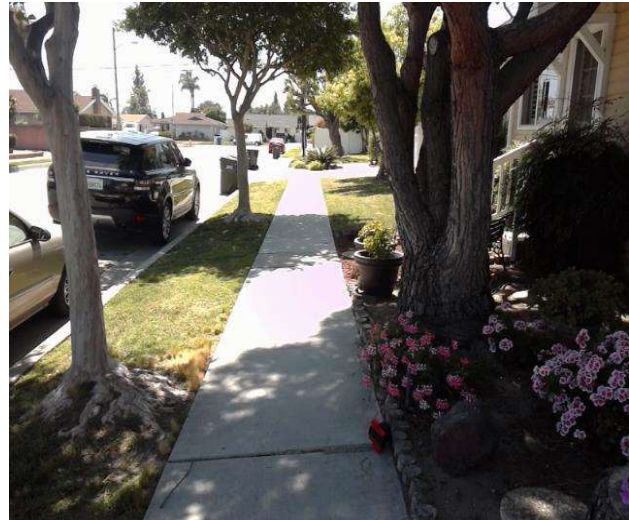
Change In Level North Of De Palma Street @ 33.943889526745, -118.156663477421

Sidewalks , Change in Level : Change in Level Non Beveled

There is a change in elevation greater than recommended value.

On-Site Finding 0.75 inches

Code Reference ADA 206, 302

Ensure that the change in elevation is within the recommended value.

Recommendation Up to 0.25 inches

Remove tripping hazards \$198

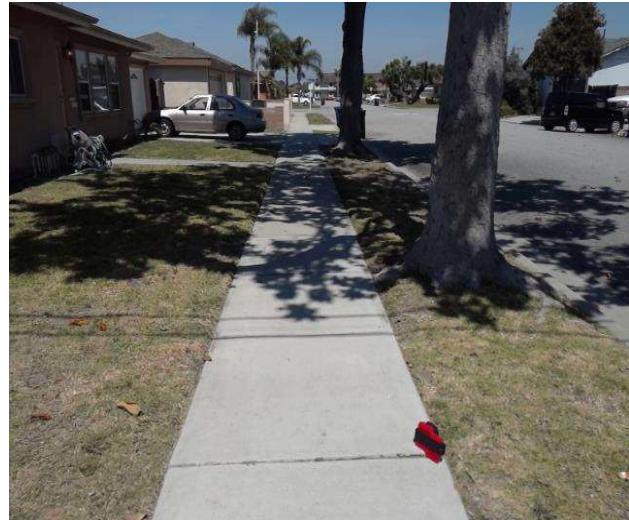
Change In Level North Of Luxor Street @ 33.944568185587, -118.156172633171

Sidewalks , Change in Level : Change in Level Non Beveled

There is a change in elevation greater than recommended value.

On-Site Finding 0.75 inches

Code Reference ADA 206, 302

Ensure that the change in elevation is within the recommended value.

Recommendation Up to 0.25 inches

Remove tripping hazards \$198

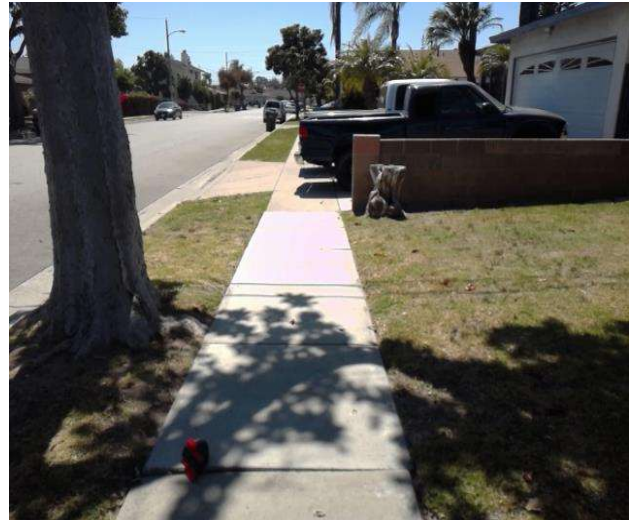
Change In Level North Of Luxor Street @ 33.944595999359, -118.156156539917

Sidewalks , Change in Level : Change in Level Non Beveled

There is a change in elevation greater than recommended value.

On-Site Finding 0.87 inches

Code Reference ADA 206, 302

Ensure that the change in elevation is within the recommended value.

Recommendation Up to 0.25 inches

Remove tripping hazards \$198

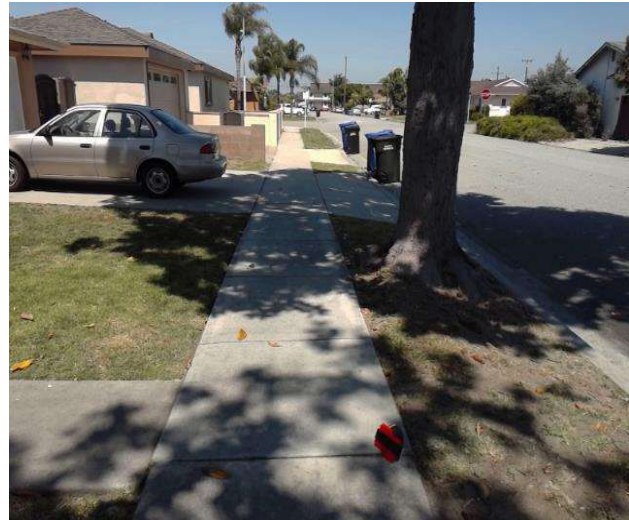
Change In Level North Of Luxor Street @ 33.944638276274, -118.156133741140

Sidewalks , Change in Level : Change in Level Non Beveled

There is a change in elevation greater than recommended value.

On-Site Finding 0.75 inches

Code Reference ADA 206, 302

Ensure that the change in elevation is within the recommended value.

Recommendation Up to 0.25 inches

Remove tripping hazards \$198

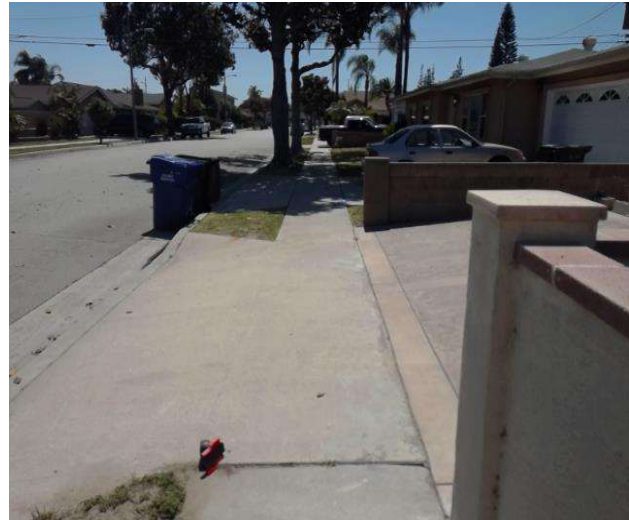
Change In Level North Of Luxor Street @ 33.944796258246, -118.156003654003

Sidewalks , Change in Level : Change in Level Non Beveled

There is a change in elevation greater than recommended value.

On-Site Finding 0.75 inches

Code Reference ADA 206, 302

Ensure that the change in elevation is within the recommended value.

Recommendation Up to 0.25 inches

Remove tripping hazards \$198

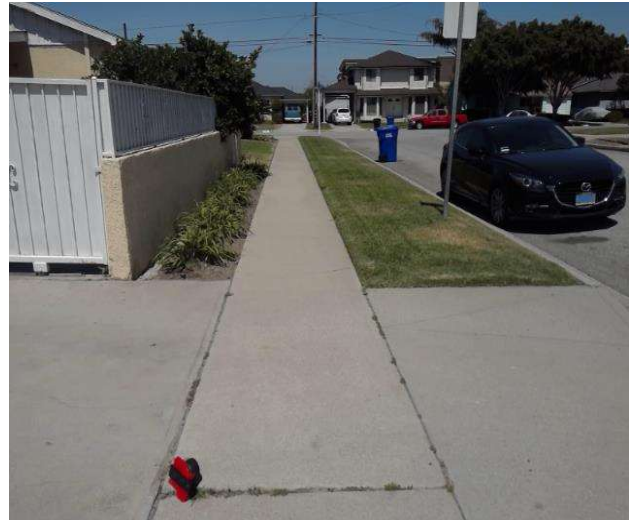
Change In Level North Of Luxor Street @ 33.945729680953, -118.155358582735

Sidewalks , Change in Level : Change in Level Non Beveled

There is a change in elevation greater than recommended value.

On-Site Finding 0.87 inches

Code Reference ADA 206, 302

Ensure that the change in elevation is within the recommended value.

Recommendation Up to 0.25 inches

Remove tripping hazards \$198

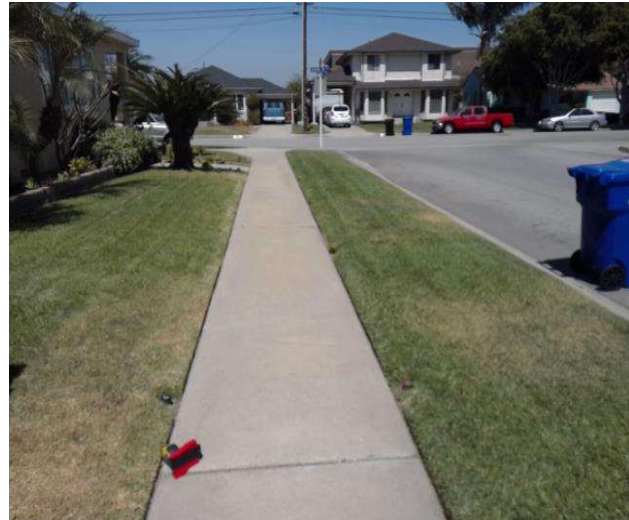
Change In Level North Of Luxor Street @ 33.945849834741, -118.155266046524

Sidewalks , Change in Level : Change in Level Non Beveled

There is a change in elevation greater than recommended value.

On-Site Finding 0.62 inches

Code Reference ADA 206, 302

Ensure that the change in elevation is within the recommended value.

Recommendation Up to 0.25 inches

Remove tripping hazards \$198

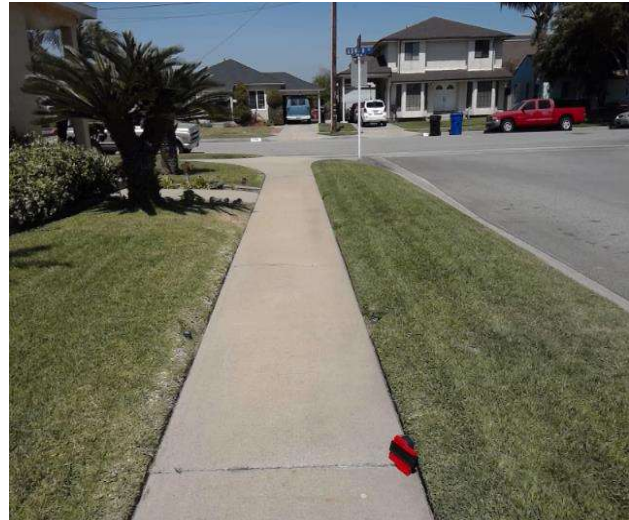
Change In Level North Of Luxor Street @ 33.945906573971, -118.155219107866

Sidewalks , Change in Level : Change in Level Non Beveled

There is a change in elevation greater than recommended value.

On-Site Finding 0.50 inches

Code Reference ADA 206, 302

Ensure that the change in elevation is within the recommended value.

Recommendation Up to 0.25 inches

Remove tripping hazards \$198

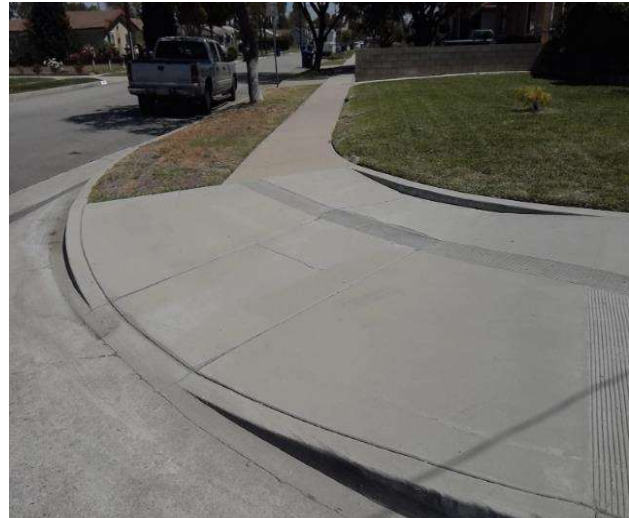
**Southeast Corner Of Adwen Street @ 33.945921036906, -
118.154999166727**

Curb Ramp : No Detectable Warnings

The curb ramp does not provide a detectable warning surface which includes truncated domes.

On-Site Finding Not Found

Code Reference CA 11B-406.5.12

Provide compliant detectable warnings to surface.

Provide detectable warning to surface \$248

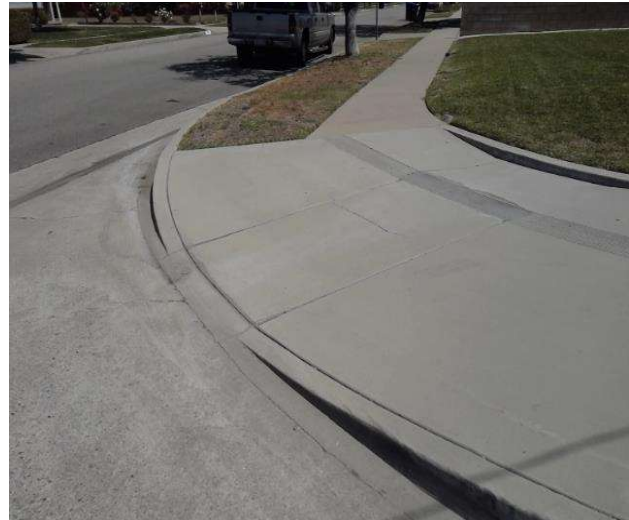
**Southeast Corner Of Adwen Street @ 33.945921036906, -
118.154999166727**

There is not enough top landing clear length.

On-Site Finding 47.00 inches

Curb Ramp , Landings and Transitions : Top Landing Clear Length - Landings

Code Reference ADA 406, 406.4,CA 11B-406.5.3

Provide a level top landing with enough clear length.

Recommendation At least 48.00 inches

Provide compliant landing \$240

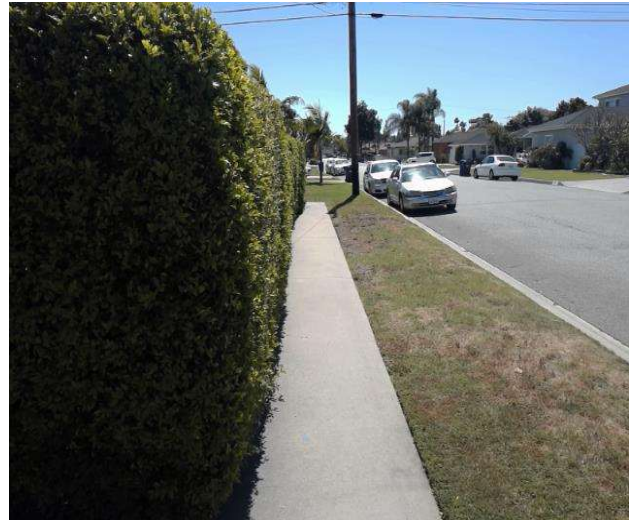
Bush South Of Adwen Street @ 33.945771957305, -118.155106455088

Sidewalks , Hazards & Gratings : Sidewalk Width at Obstruction

Sidewalk width at the obstruction is not compliant.

On-Site Finding 38.00 inches

Code Reference ADA 206, 302, 403.5.1, CA 11B-403.5

Sidewalk width at the obstruction shall have the recommended value.

Recommendation At least 48.00 inches

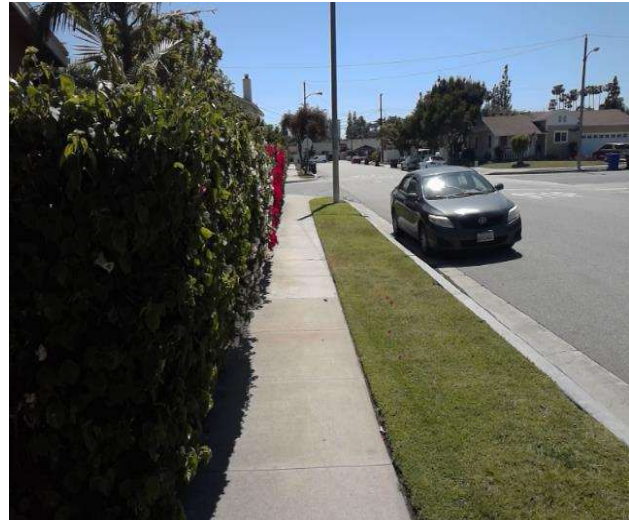
Bush South Of Benares Street @ 33.944255558170, -118.156192749739

Sidewalks , Hazards & Gratings : Sidewalk Width at Obstruction

Sidewalk width at the obstruction is not compliant.

On-Site Finding 32.00 inches

Code Reference ADA 206, 302, 403.5.1,CA 11B-403.5

Sidewalk width at the obstruction shall have the recommended value.

Recommendation At least 48.00 inches

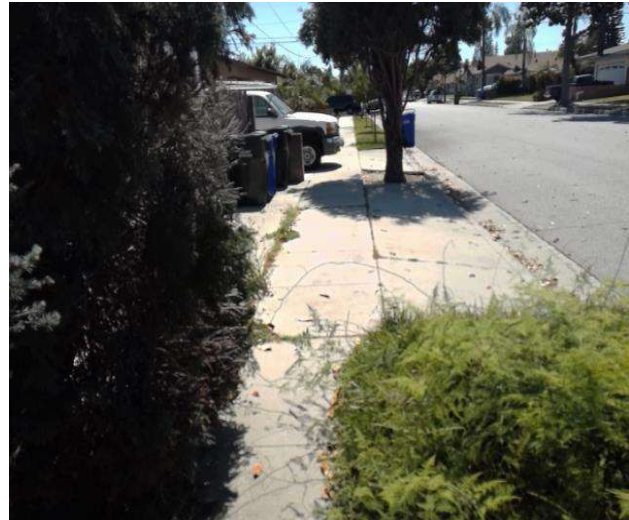
Bush South Of Benares Street @ 33.944782907668, -118.155798465014

Sidewalks , Hazards & Gratings : Sidewalk Width at Obstruction

Code Reference ADA 206, 302, 403.5.1,CA 11B-403.5

Sidewalk width at the obstruction shall have the recommended value.

Recommendation At least 48.00 inches

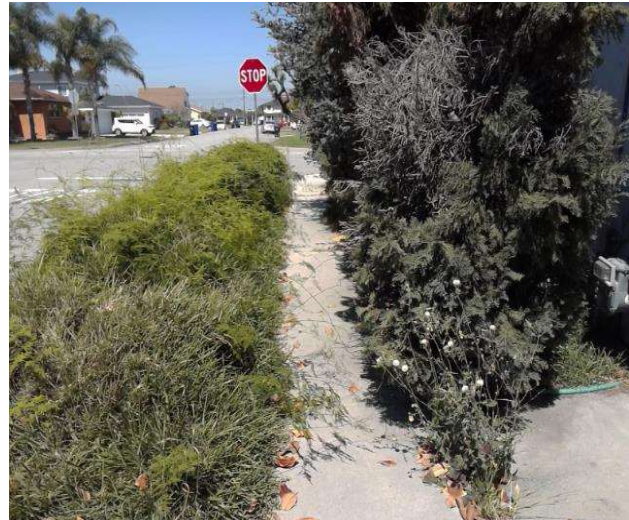
Sidewalks , Hazards & Gratings : Sidewalk Width at Obstruction

Code Reference ADA 206, 302, 403.5.1, CA 11B-403.5

Sidewalk width at the obstruction shall have the recommended value.

Recommendation At least 48.00 inches

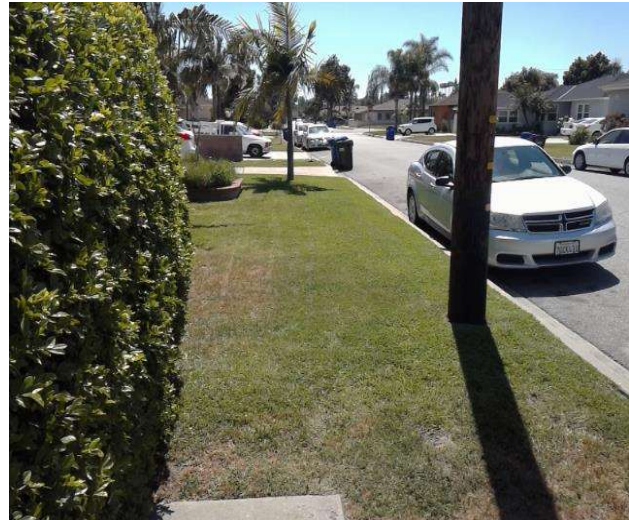
Sidewalks : Missing Sidewalk

Section of sidewalk is missing and consists of dirt, grass or gravel.

Code Reference ADA 206, 302,CA 11B-302,CA 11B-206

Provide a compliant sidewalk for the missing section.

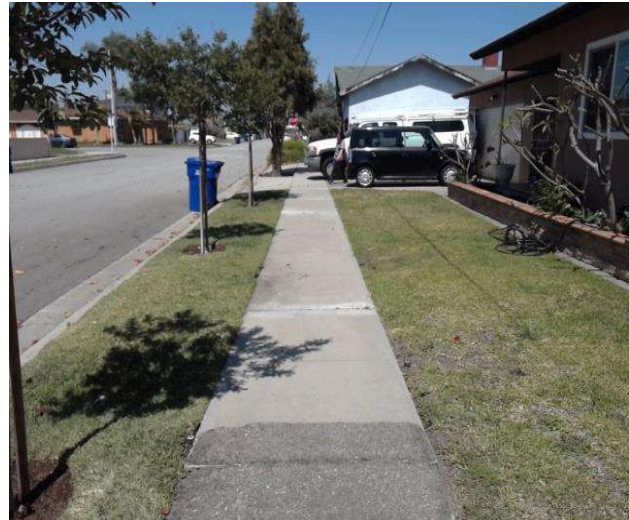
Code Reference ADA 206, 302

Notes : Surface is rough and uneven.

Recommendation See Recommendation

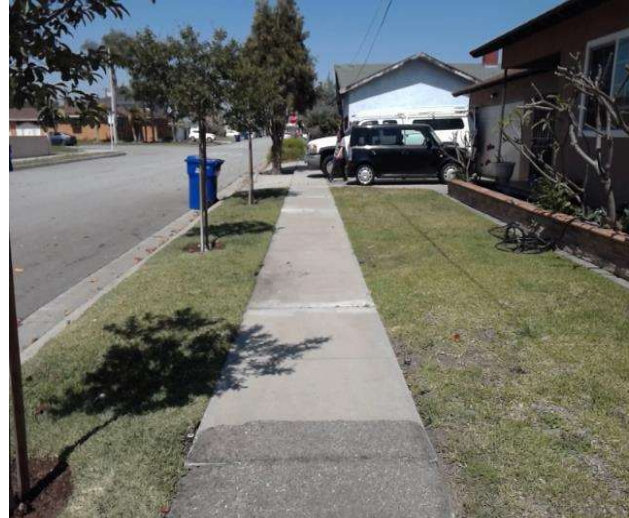
Code Reference ADA 206, 302

Notes : Surface is rough and uneven.

Repave the sidewalk surface with the recommended running slope.

Recommendation Up to 5.00 percent

Repave surface \$1,184

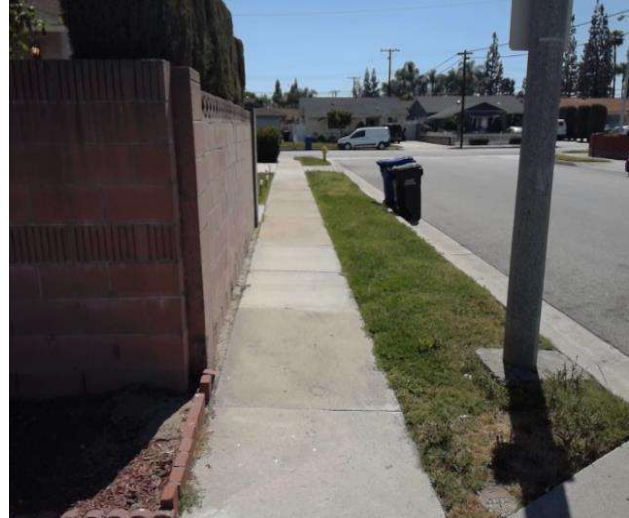
Code Reference ADA 206, 302,CA 11B-403.3

Repave the sidewalk surface with the recommended cross slope.

Recommendation Up to 2.08 percent

Repave surface \$1,092

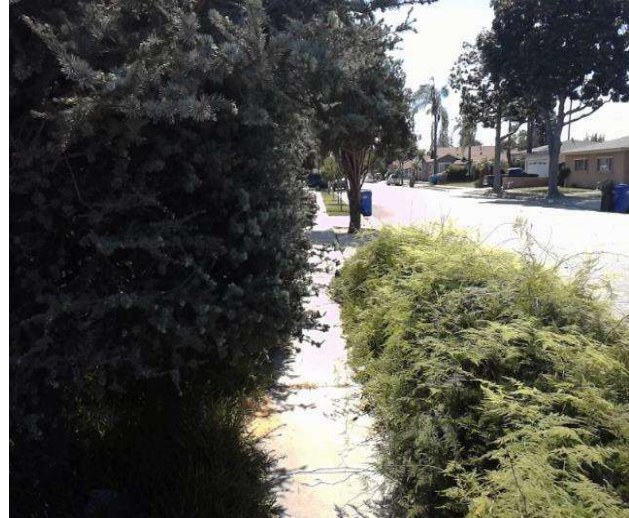
Sidewalks , Hazards & Gratings : Protruding Object Height

Code Reference ADA 307.2, CA 11B-307.2

Recommendation Up to 4.00 inches

Install wing walls or relocate object \$640

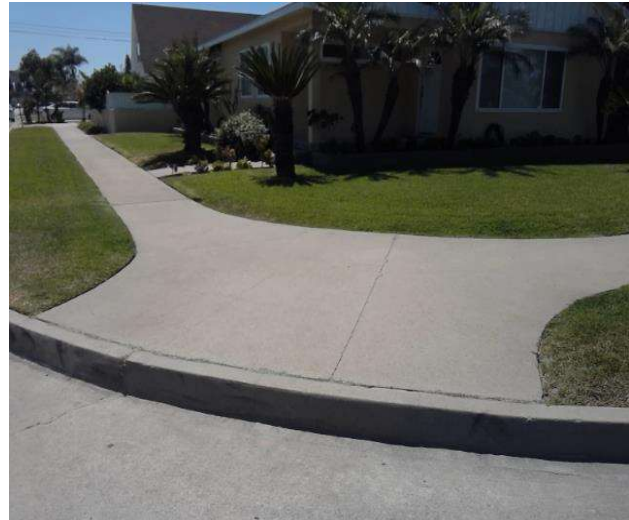
Sidewalks , Hazards & Gratings : Curb is on Path of Travel

Code Reference ADA 402, 303, 406, 403.4, 303.4

Install curb ramp \$2,500

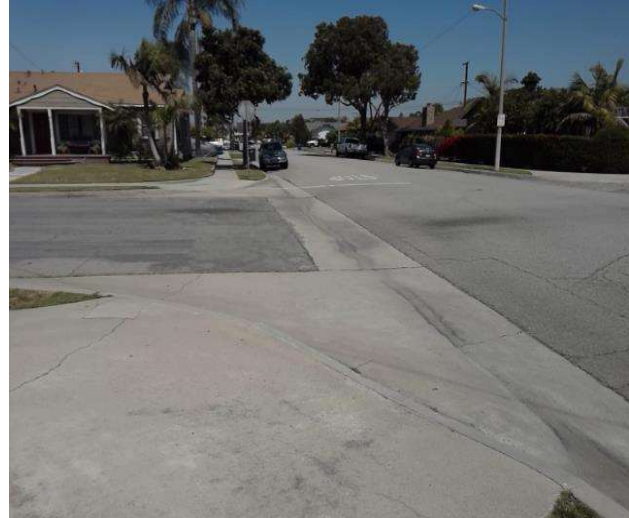
Code Reference ADA 206, 302, CA 11B-403.3

Recommendation Up to 2.08 percent

Repave surface \$1,092

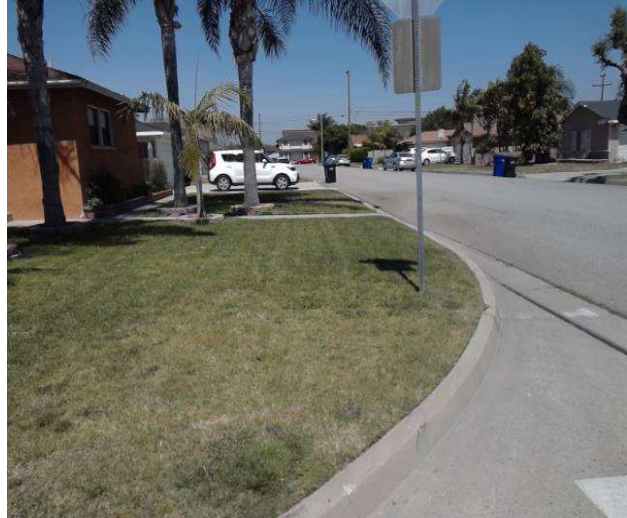
Sidewalks : Missing Sidewalk

Section of sidewalk is missing and consists of dirt, grass or gravel.

Code Reference ADA 206, 302,CA 11B-302,CA 11B-206

Provide a compliant sidewalk for the missing section.

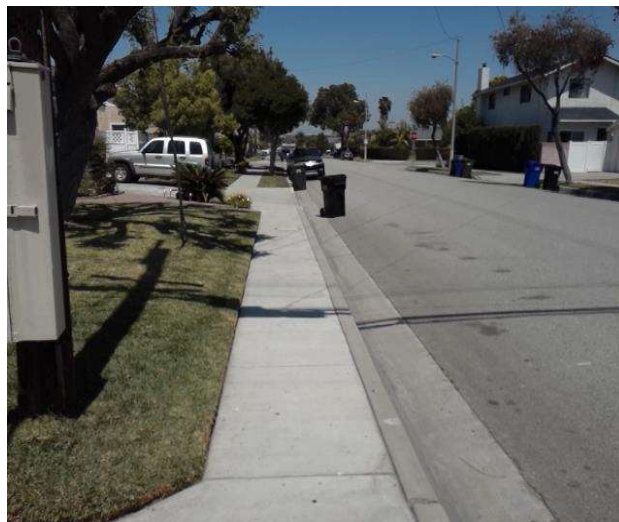
Code Reference ADA 206, 302,CA 11B-403.5.1

Widen the sidewalk to the recommended value.

Recommendation At least 48.00 inches

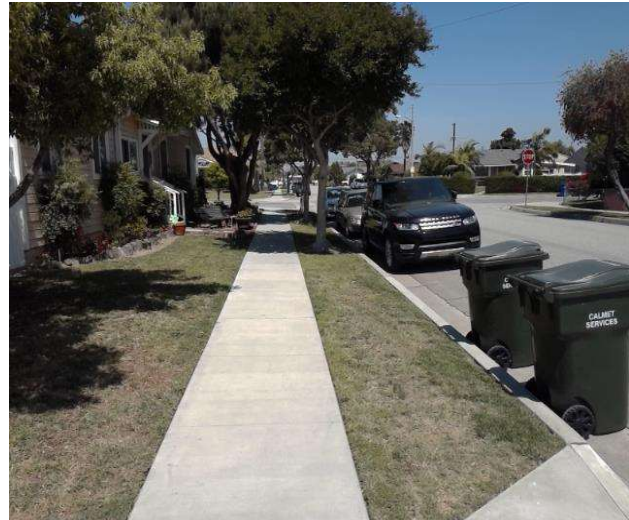
Code Reference ADA 206, 302, CA 11B-403.3

Repave the sidewalk surface with the recommended cross slope.

Recommendation Up to 2.08 percent

Repave surface \$1,092

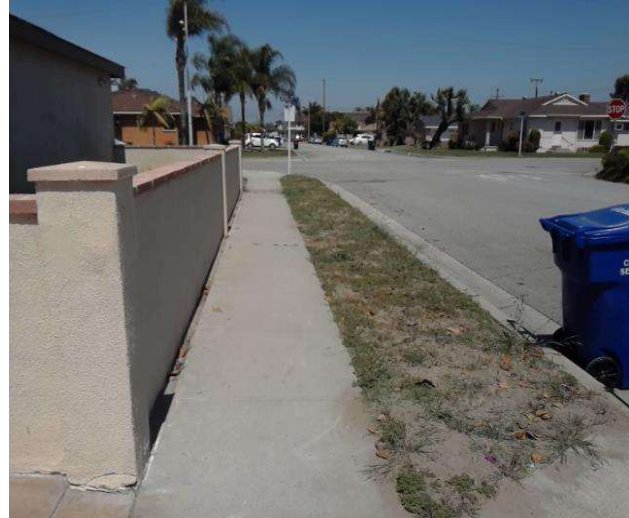
Code Reference ADA 206, 302,CA 11B-403.3

Repave the sidewalk surface with the recommended cross slope.

Recommendation Up to 2.08 percent

Repave surface \$1,092

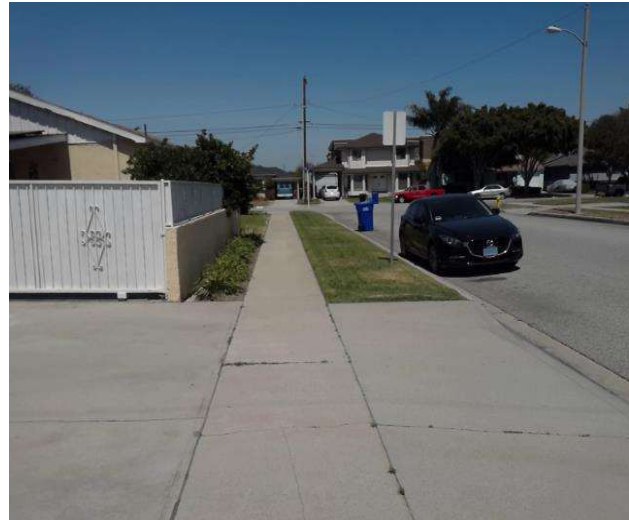
Code Reference ADA 206, 302, CA 11B-403.3

Repave the sidewalk surface with the recommended cross slope.

Recommendation Up to 2.08 percent

Repave surface \$1,092

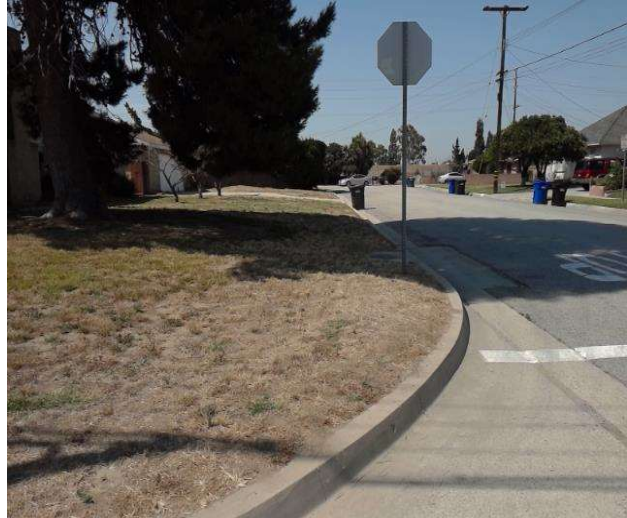
Sidewalks : Missing Sidewalk

Section of sidewalk is missing and consists of dirt, grass or gravel.

Code Reference ADA 206, 302,CA 11B-302,CA 11B-206

Provide a compliant sidewalk for the missing section.

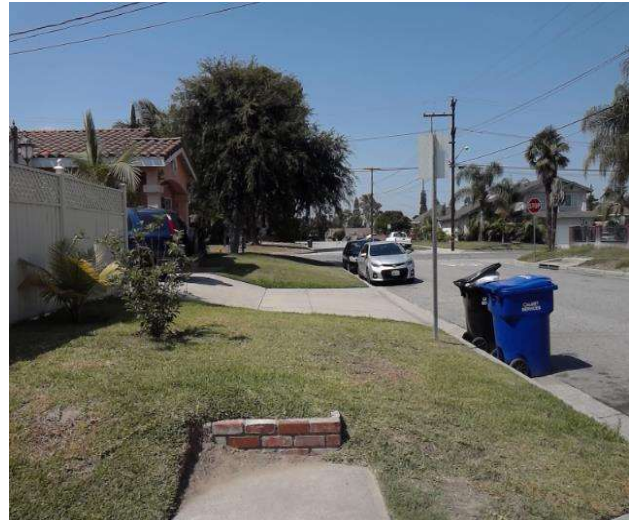
Sidewalks : Missing Sidewalk

Section of sidewalk is missing and consists of dirt, grass or gravel.

Code Reference ADA 206, 302,CA 11B-302,CA 11B-206

Provide a compliant sidewalk for the missing section.

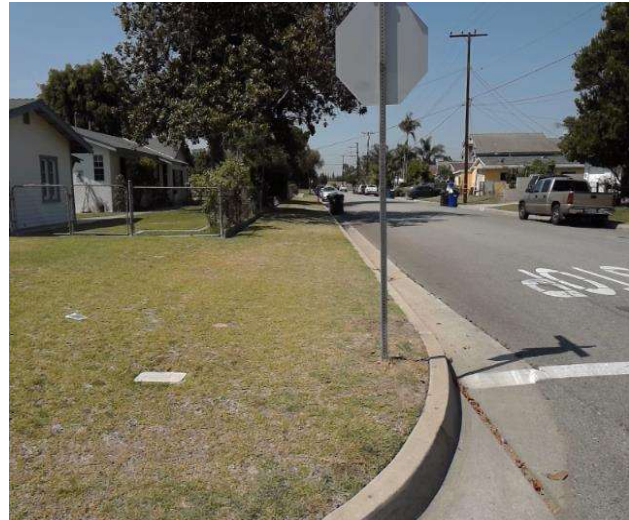
Sidewalks : Missing Sidewalk

Section of sidewalk is missing and consists of dirt, grass or gravel.

Code Reference ADA 206, 302,CA 11B-302,CA 11B-206

Provide a compliant sidewalk for the missing section.

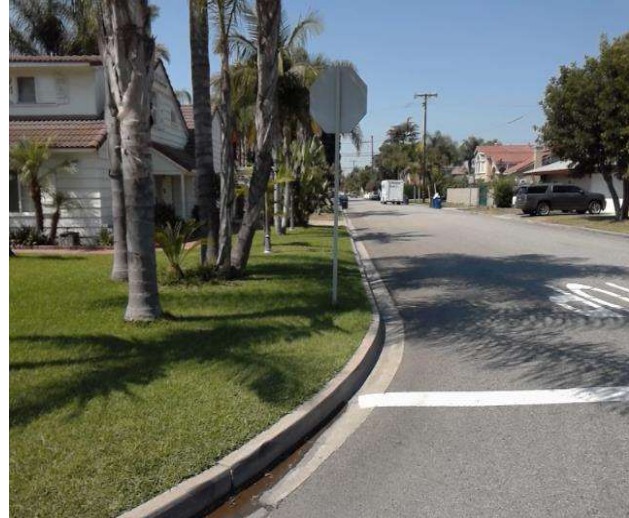
Sidewalks : Missing Sidewalk

Section of sidewalk is missing and consists of dirt, grass or gravel.

Code Reference ADA 206, 302,CA 11B-302,CA 11B-206

Provide a compliant sidewalk for the missing section.

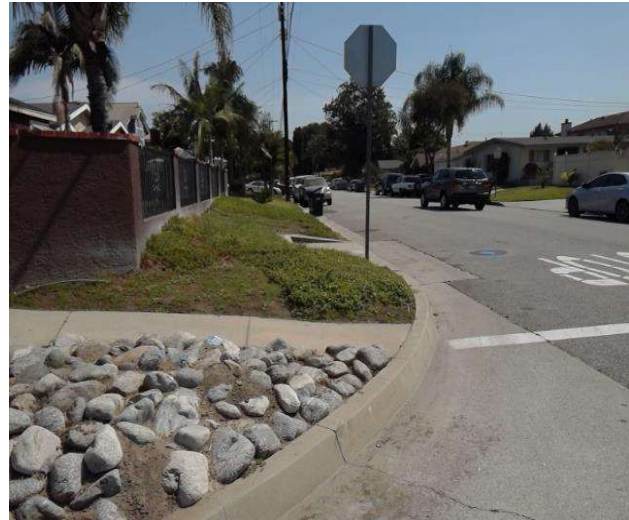
Sidewalks : Missing Sidewalk

Section of sidewalk is missing and consists of dirt, grass or gravel.

Code Reference ADA 206, 302,CA 11B-302,CA 11B-206

Provide a compliant sidewalk for the missing section.

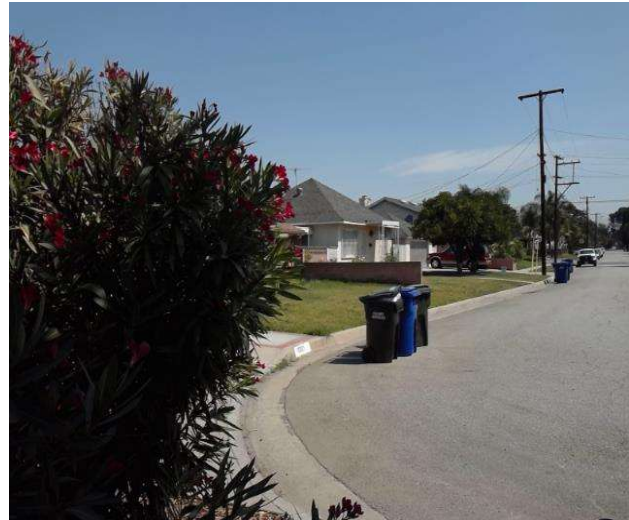
Sidewalks : Missing Sidewalk

Section of sidewalk is missing and consists of dirt, grass or gravel.

Code Reference ADA 206, 302,CA 11B-302,CA 11B-206

Provide a compliant sidewalk for the missing section.

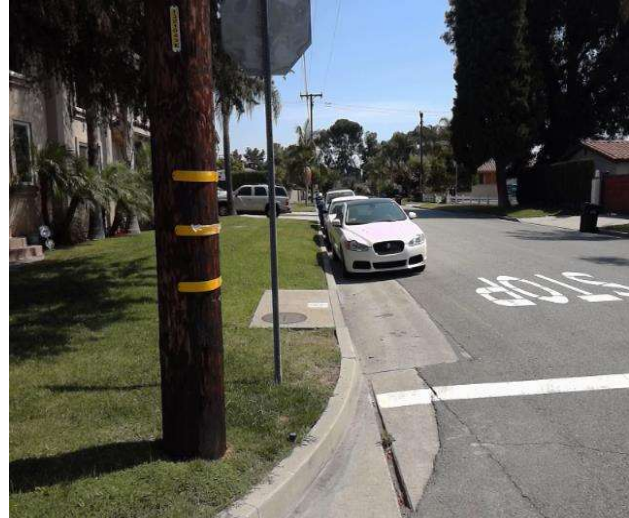
Sidewalks : Missing Sidewalk

Section of sidewalk is missing and consists of dirt, grass or gravel.

Code Reference ADA 206, 302,CA 11B-302,CA 11B-206

Provide a compliant sidewalk for the missing section.

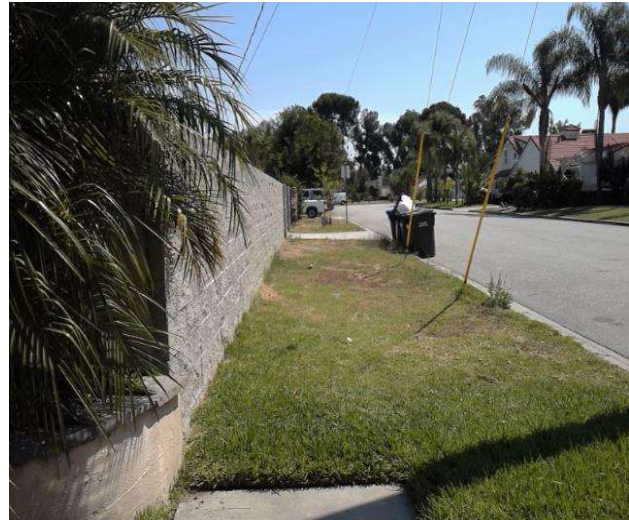
Sidewalks : Missing Sidewalk

Section of sidewalk is missing and consists of dirt, grass or gravel.

Code Reference ADA 206, 302,CA 11B-302,CA 11B-206

Provide a compliant sidewalk for the missing section.

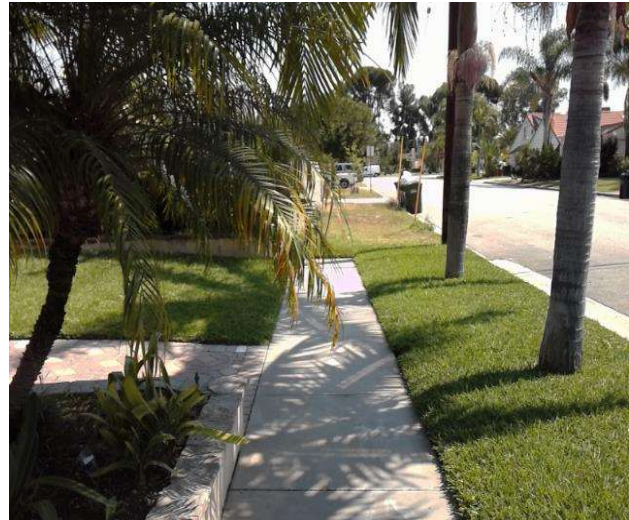
Sidewalks , Hazards & Gratings : Overhead Obstruction Height

Code Reference ADA 206, 307.4,CA 11B-307.4

Recommendation At least 80.00 inches
