Accessibility Survey

City of Downey Baysinger Street - Birchdale Avenue to Tristan Drive

Date of Inspection
7/14/2017

Disability Access Consultants

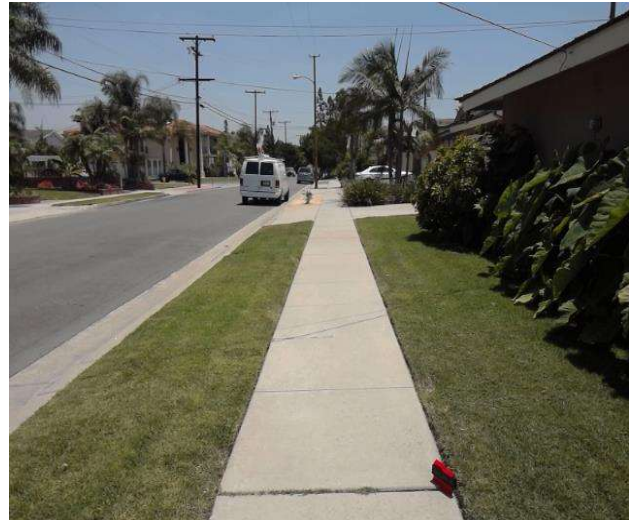
Change in Level East of Birchdale Avenue @ 33.947676596446, -118.120892196894

Sidewalks , Change in Level : Change in Level Non Beveled

There is a change in elevation greater than recommended value.

On-Site Finding 0.50 inches

Recommendation Up to 0.25 inches

Code Reference ADA 206, 302

Ensure that the change in elevation is within the recommended value.

Remove tripping hazards \$198

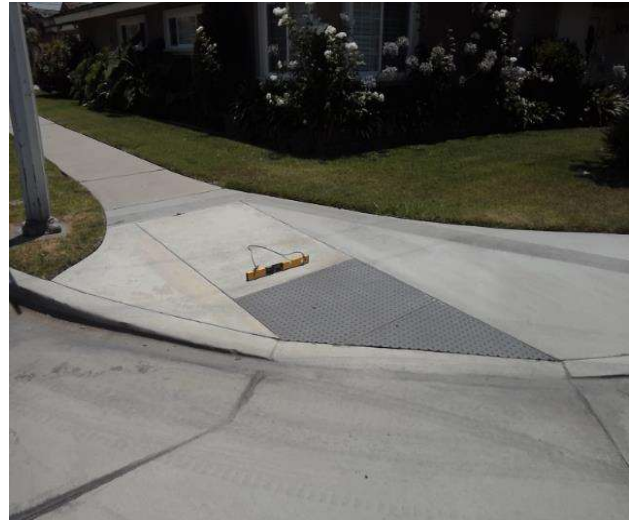
Southeast Corner of Birchdale Avenue @ 33.947729996929, - 118.120990097523

Curb Ramp : Curb Ramp - Cross Slope

The cross slope is greater than allowed.

On-Site Finding 3.80 percent

Recommendation Up to 2.08 percent

Code Reference ADA 402, 406.1, 405.3, CA 11B-406.5.7

Provide a compliant curb ramp.

Install curb ramp \$1,300

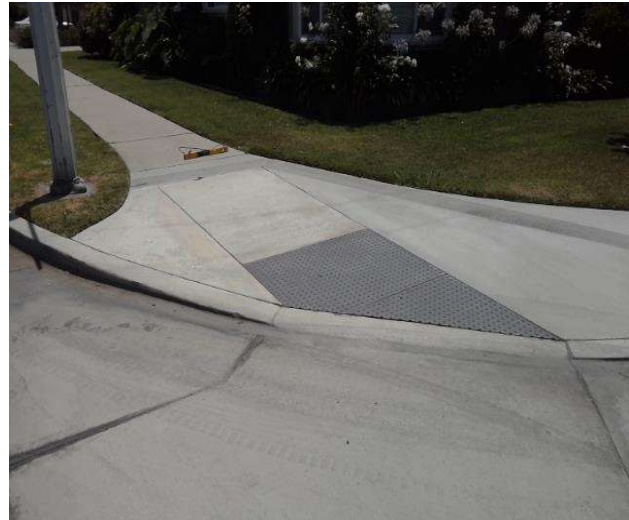
Southeast Corner of Birchdale Avenue @ 33.947729996929, - 118.120990097523

Curb Ramp , Landings and Transitions : Top Landing Slope

The slope at the top landing is greater than allowed.

On-Site Finding 3.50 percent

Recommendation Up to 2.08 percent

Code Reference ADA 402, 406.4, 403.3, 406.1,CA 11B-406.5.3

Provide a top landing surface that does not exceed the maximum slope and cross slope. Provide a sufficient maneuvering clearance that does not accumulate water.

Provide compliant landing \$1,260

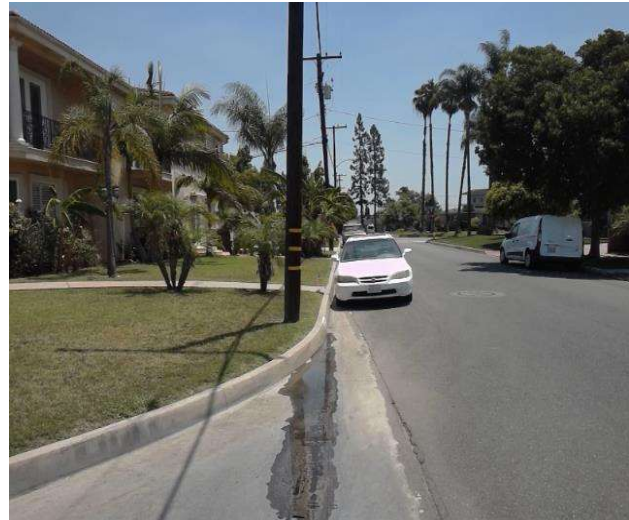
North Side @ 33.947442968938, -118.120129108429

Sidewalks : No Sidewalk

No sidewalk exists at the location.

On-Site Finding Not Found

No action necessary until a sidewalk is provided.

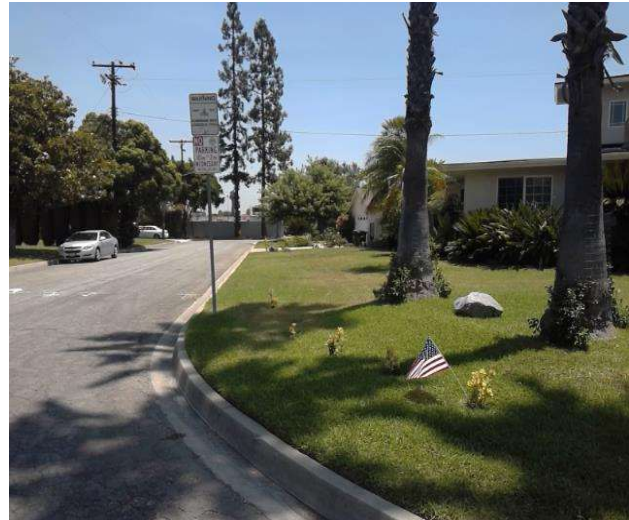
Sidewalk East of Bellman Avenue @ 33.946984612155, -118.119529634714

Sidewalks : Missing Sidewalk

Section of sidewalk is missing and consists of dirt, grass or gravel.

On-Site Finding 200.00 feet

Code Reference ADA 206, 302,CA 11B-302,CA 11B-206

Provide a compliant sidewalk for the missing section.

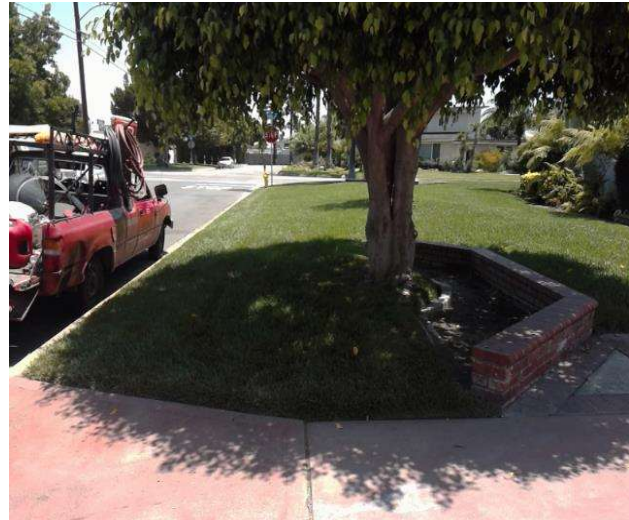
Sidewalk East of Birchdale Avenue @ 33.947201553173, -118.119968175888

Sidewalks : Missing Sidewalk

Section of sidewalk is missing and consists of dirt, grass or gravel.

On-Site Finding 97.00 feet

Code Reference ADA 206, 302,CA 11B-302,CA 11B-206

Provide a compliant sidewalk for the missing section.

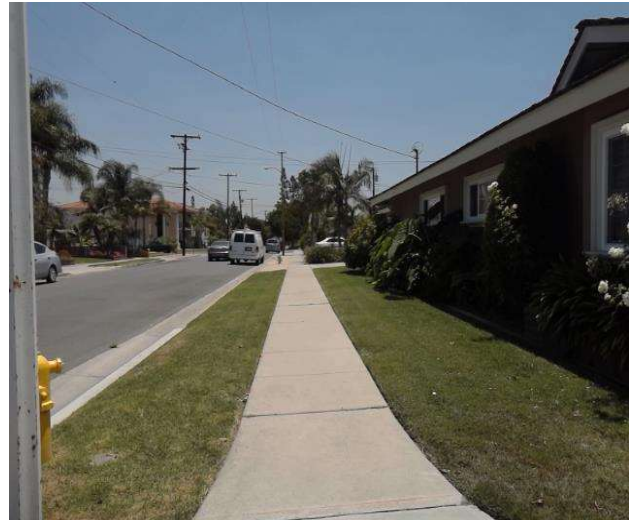
Sidewalk East of Birchdale Avenue @ 33.947716646812, -118.120969980955

Sidewalks , Surface : Cross Slope

Sidewalk cross slope is not compliant.

On-Site Finding 3.50 percent for 227.00 feet

Recommendation Up to 2.08 percent

Code Reference ADA 206, 302, CA 11B-403.3

Repave the sidewalk surface with the recommended cross slope.

Repave surface \$1,092

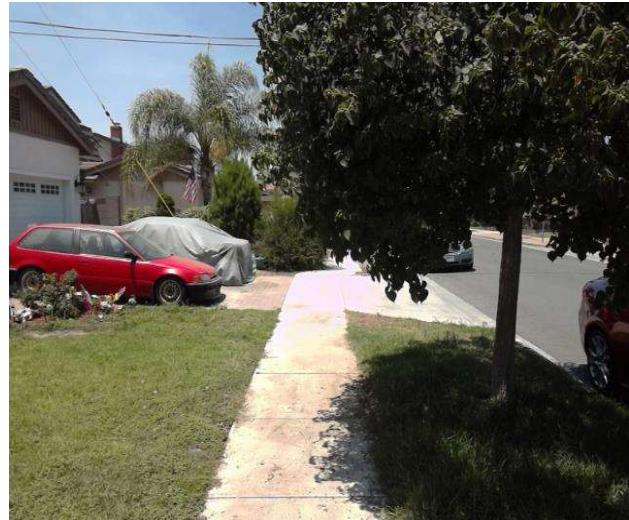
Tree East of Birchdale Avenue @ 33.947320592369, -118.120194822550

Sidewalks , Hazards & Gratings : Overhead Obstruction Height

Overhead obstruction height is not compliant.

On-Site Finding 55.00 inches

Recommendation At least 80.00 inches

Code Reference ADA 206, 307.4,CA 11B-307.4

Provide a compliant vertical clearance height.

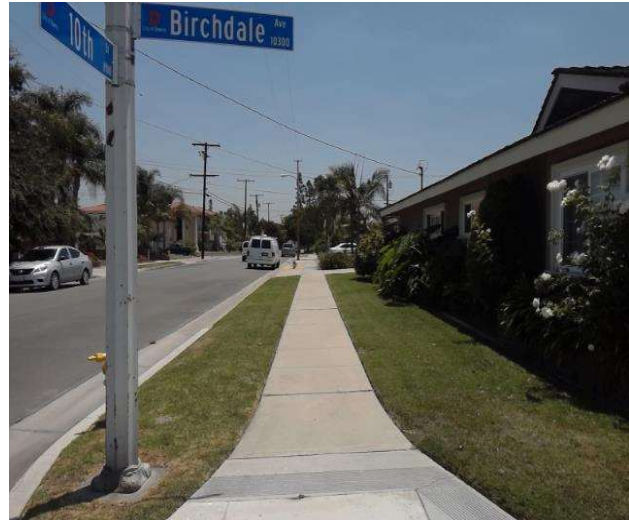
South Side @ 33.947729996929, -118.120990097523

Sidewalks : 60X60 Turn Area

There is no 60X60 turn area at every 200 feet.

On-Site Finding Not Found

Code Reference ADA 206, 302

Provide a 60X60 turn every 200 feet on the sidewalk.

\$2,400

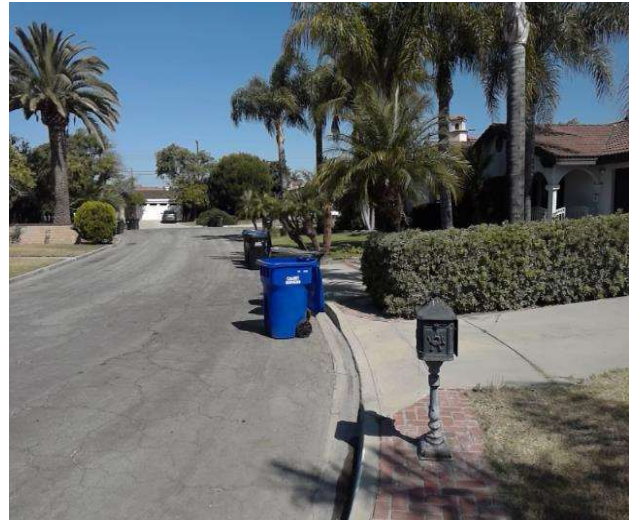
North Side @ 33.941597622470, -118.108322024345

Sidewalks : No Sidewalk

No sidewalk exists at the location.

On-Site Finding Not Found

No action necessary until a sidewalk is provided.

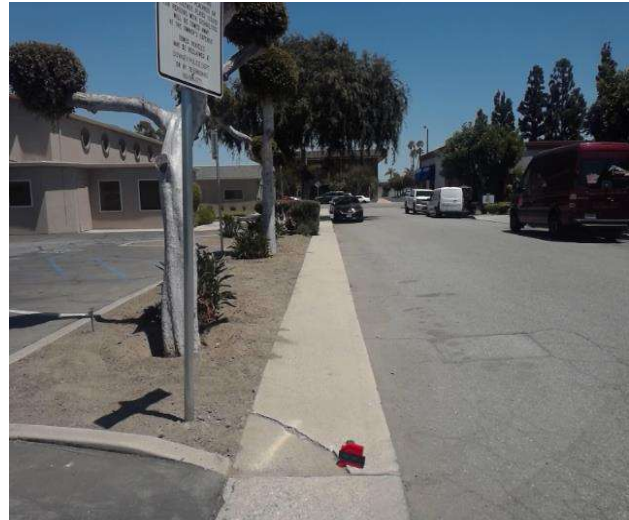
There is a change in elevation greater than recommended value.

Recommendation Up to 0.25 inches

Code Reference ADA 206, 302

Ensure that the change in elevation is within the recommended value.

Remove tripping hazards \$198

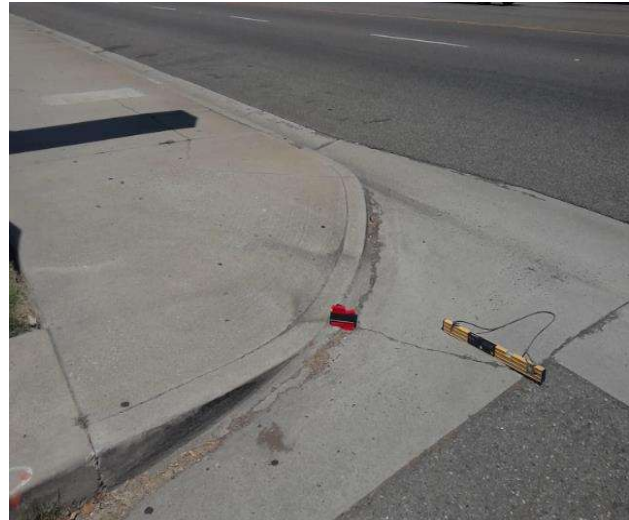
Recommendation Up to 0.50 inches

Curb Ramp , Landings And Transitions : Bottom Landing Change in Level

Code Reference ADA 302, 303, 406.2, 303.1

Patch lip at curb ramp \$255

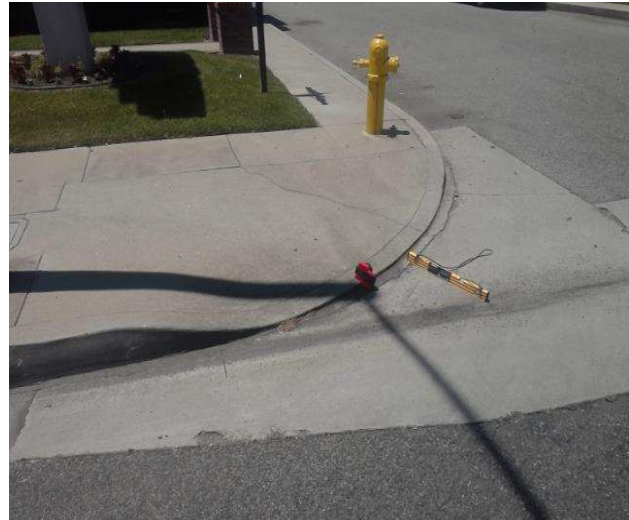
Recommendation Up to 0.50 inches

Curb Ramp , Landings And Transitions : Bottom Landing Change in Level

Code Reference ADA 302, 303, 406.2, 303.1

Patch lip at curb ramp \$255

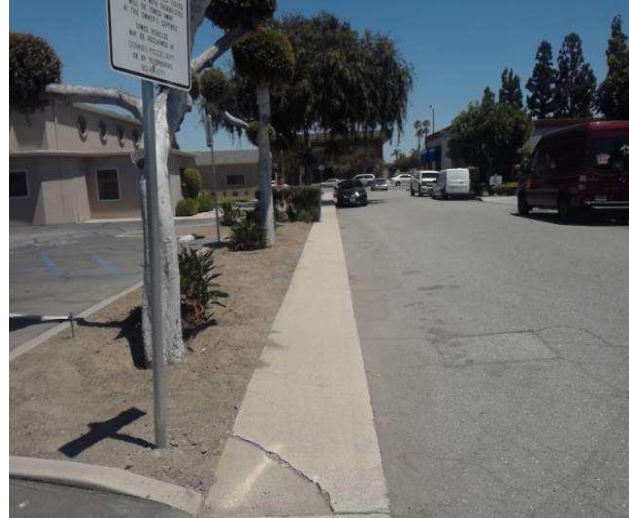
Recommendation At least 48.00 inches

Code Reference ADA 206, 302,CA 11B-403.5.1

Widen the sidewalk to the recommended value.

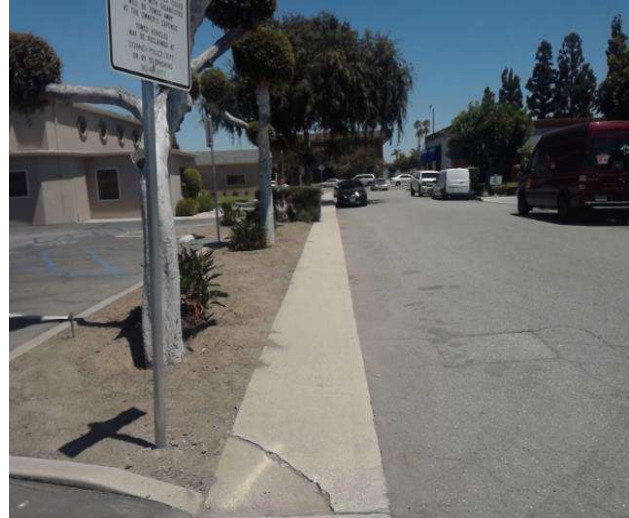
Recommendation Up to 2.08 percent

Code Reference ADA 206, 302, CA 11B-403.3

Repave the sidewalk surface with the recommended cross slope.

Repave surface \$1,092

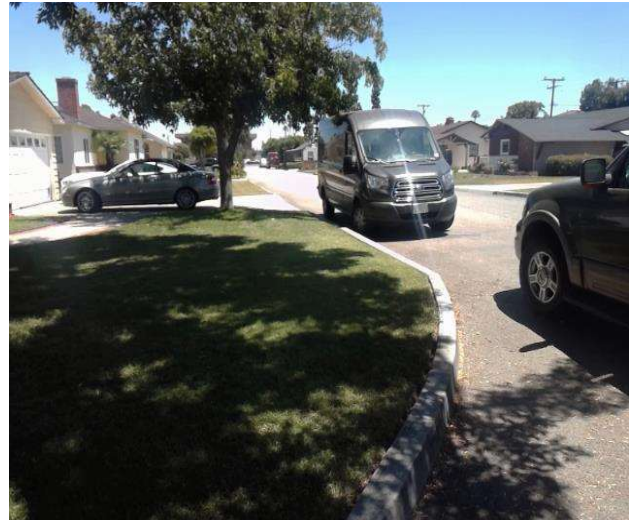
Sidewalks : Missing Sidewalk

Section of sidewalk is missing and consists of dirt, grass or gravel.

Code Reference ADA 206, 302,CA 11B-302,CA 11B-206

Provide a compliant sidewalk for the missing section.

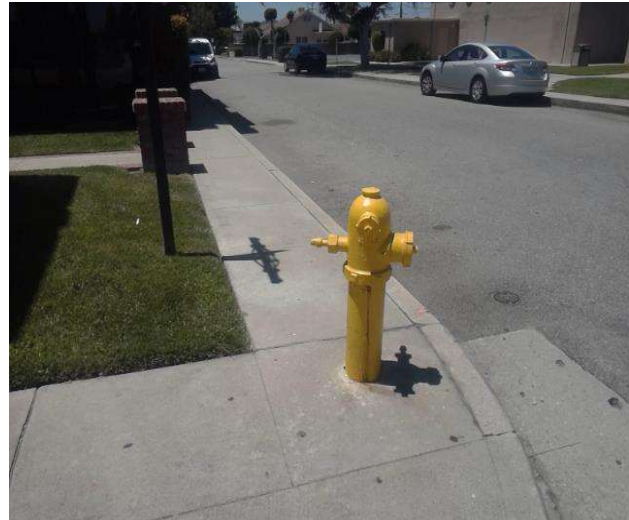
Sidewalks , Hazards & Gratings : Sidewalk Width at Obstruction

Recommendation At least 48.00 inches

Code Reference ADA 206, 302, 403.5.1, CA 11B-403.5

Sidewalk width at the obstruction shall have the recommended value.

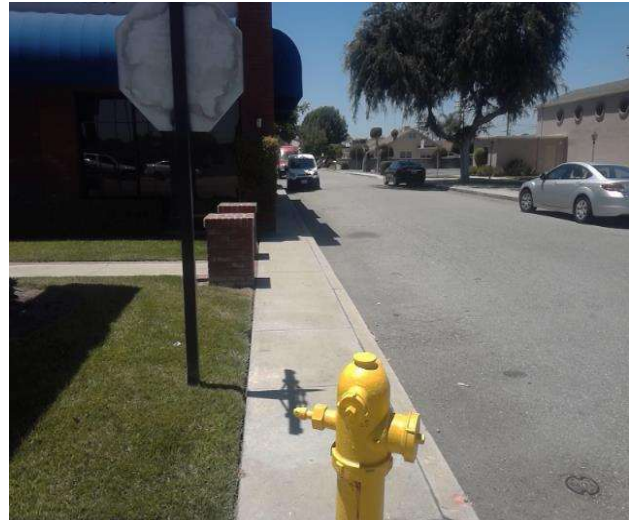
Recommendation At least 48.00 inches

Code Reference ADA 206, 302,CA 11B-403.5.1

Widen the sidewalk to the recommended value.

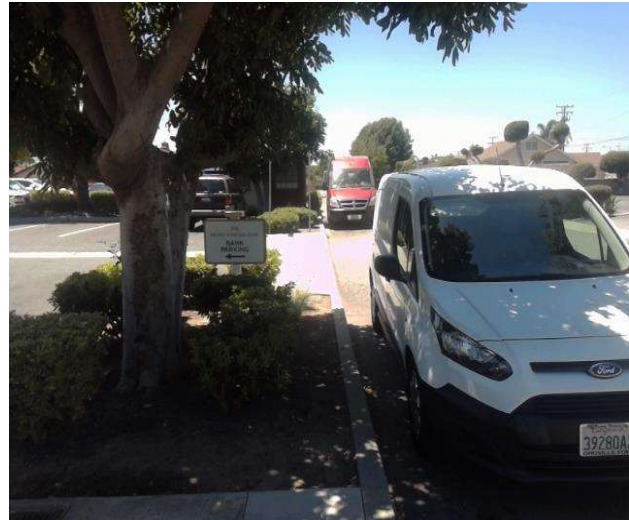
Sidewalks : Missing Sidewalk

Section of sidewalk is missing and consists of dirt, grass or gravel.

Code Reference ADA 206, 302,CA 11B-302,CA 11B-206

Provide a compliant sidewalk for the missing section.

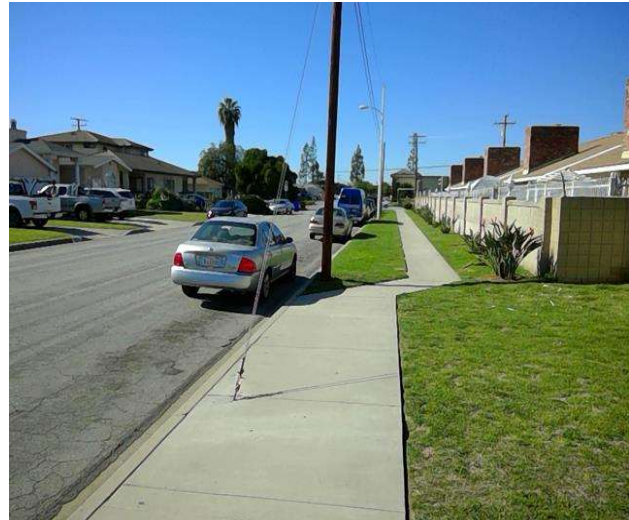
Sidewalks , Hazards & Gratings : Overhead Obstruction Height

Recommendation At least 80.00 inches

Code Reference ADA 206, 307.4, CA 11B-307.4

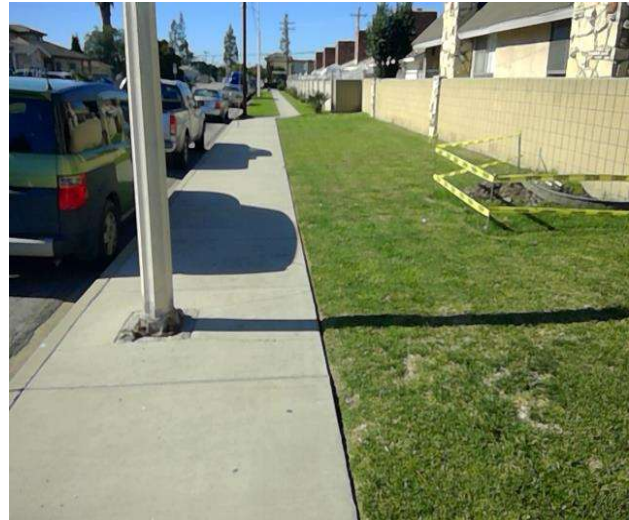
Sidewalks , Hazards & Gratings : Sidewalk Width at Obstruction

Recommendation At least 48.00 inches

Code Reference ADA 206, 302, 403.5.1, CA 11B-403.5

Sidewalk width at the obstruction shall have the recommended value.

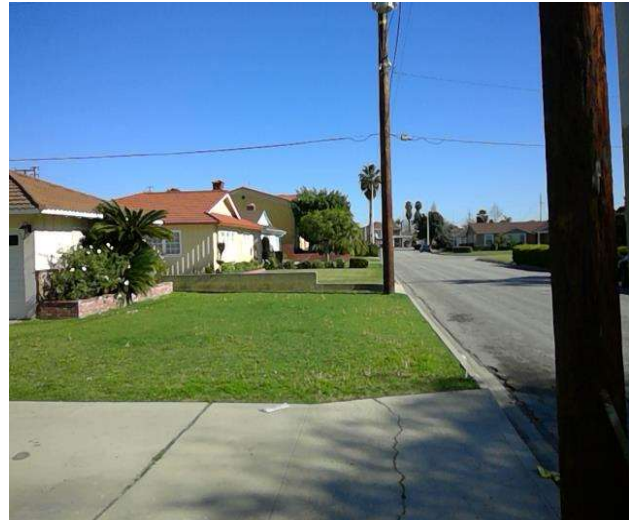
Sidewalks : Missing Sidewalk

Section of sidewalk is missing and consists of dirt, grass or gravel.

Code Reference ADA 206, 302,CA 11B-302,CA 11B-206

Provide a compliant sidewalk for the missing section.

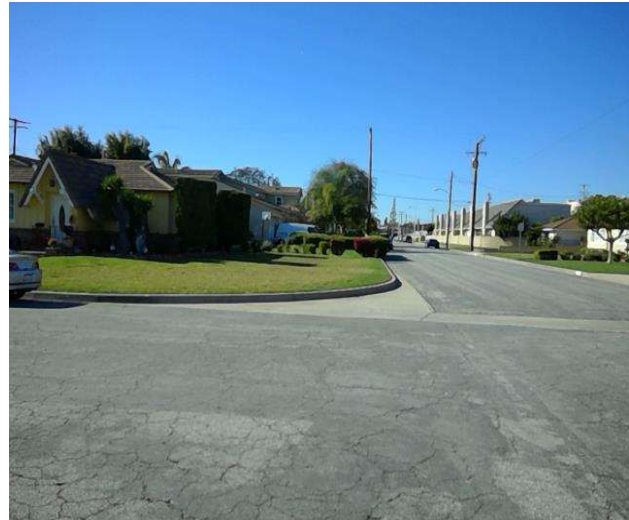
Sidewalks : Missing Sidewalk

Section of sidewalk is missing and consists of dirt, grass or gravel.

Code Reference ADA 206, 302,CA 11B-302,CA 11B-206

Provide a compliant sidewalk for the missing section.

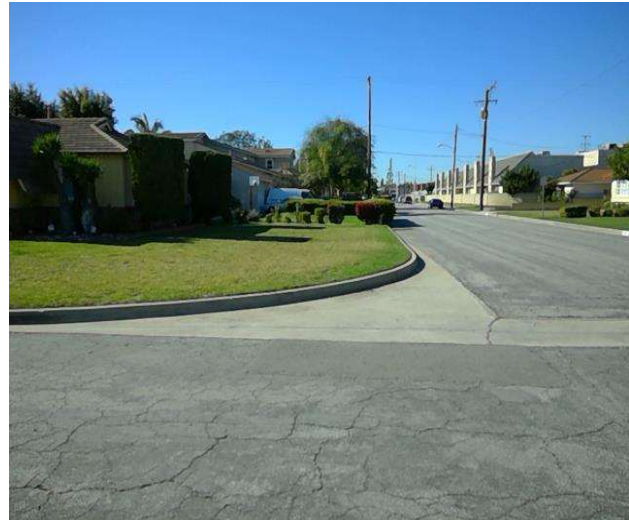
Sidewalks , Hazards & Gratings : Curb is on Path of Travel

Code Reference ADA 402, 303, 406, 403.4, 303.4

Install curb ramp \$2,500

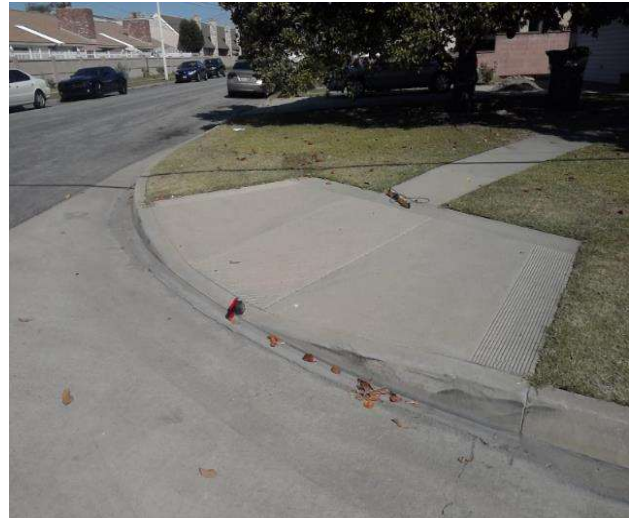
Curb Ramp , Landings and Transitions : Bottom Landing Change in Level - Curb Ramps

Code Reference ADA 302, 406.2

Patch lip at curb ramp \$255

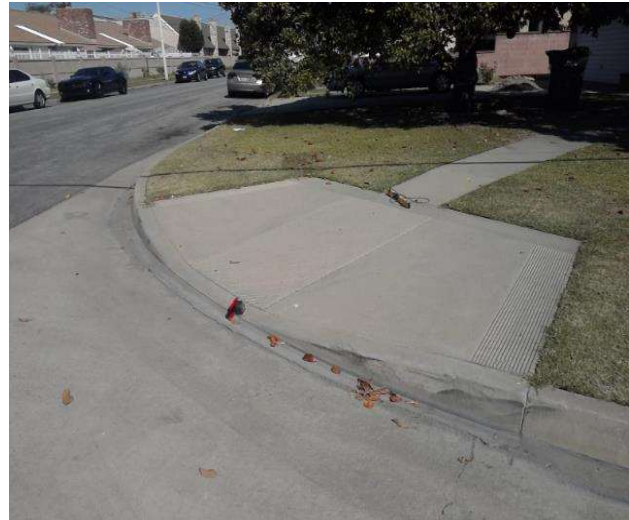
Recommendation At least 48.00 inches

Curb Ramp , Landings and Transitions : Top Landing Clear Length - Landings

Code Reference ADA 406, 406.4,CA 11B-406.5.3

Provide compliant landing \$240

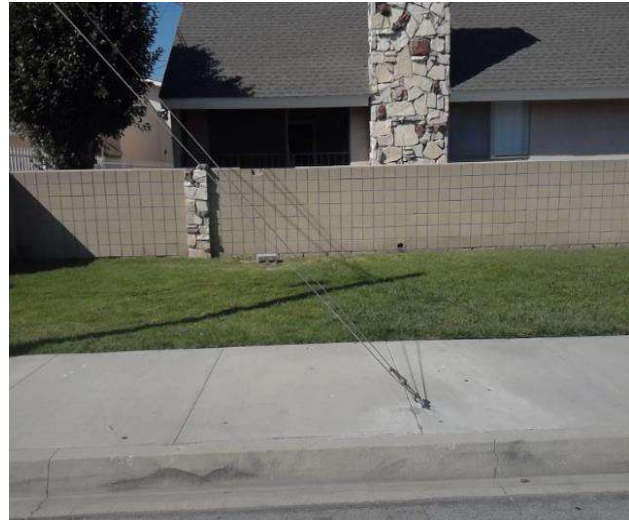
Sidewalks , Hazards & Gratings : Overhead Obstruction Height

Recommendation At least 80.00 inches

Code Reference ADA 206, 307.4,CA 11B-307.4

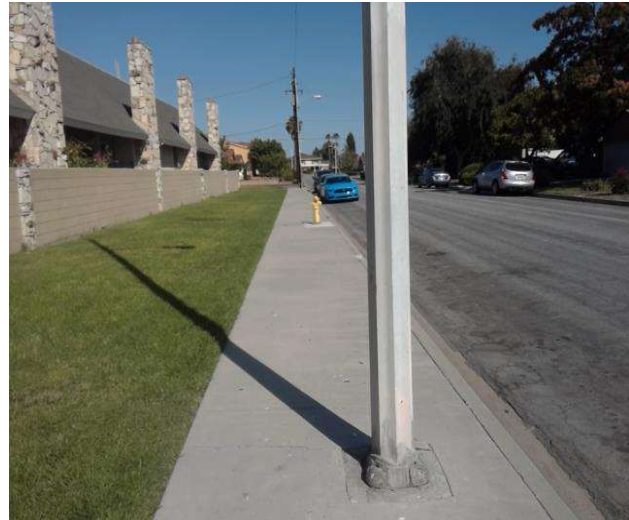
Sidewalks , Hazards & Gratings : Sidewalk Width at Obstruction

Recommendation At least 48.00 inches

Code Reference ADA 206, 302, 403.5.1, CA 11B-403.5

Sidewalk width at the obstruction shall have the recommended value.

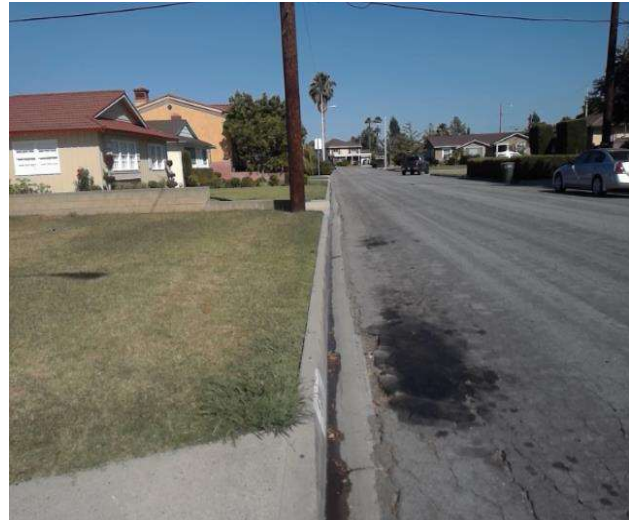
Sidewalks : Missing Sidewalk

Section of sidewalk is missing and consists of dirt, grass or gravel.

Code Reference ADA 206, 302,CA 11B-302,CA 11B-206

Provide a compliant sidewalk for the missing section.

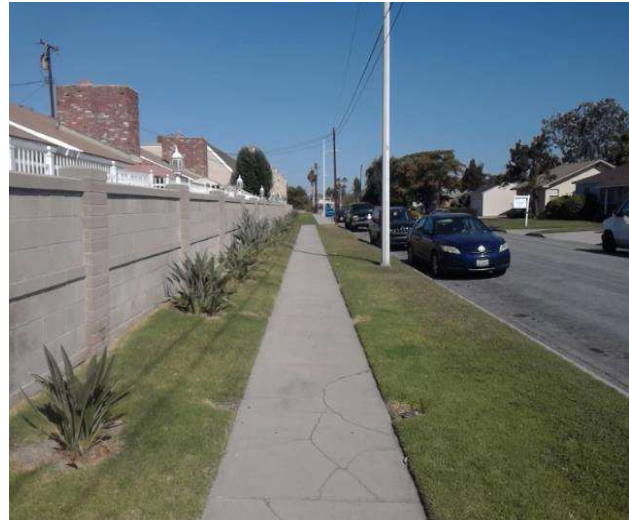
Recommendation Up to 2.08 percent

Code Reference ADA 206, 302,CA 11B-403.3

Repave the sidewalk surface with the recommended cross slope.

Repave surface \$1,092
