## Accessibility Survey

### City of Downey Brookpark Road - Lindsey Avenue to Eglise Avenue

Date of Inspection  
6/14/2017

**Disability Access Consultants**

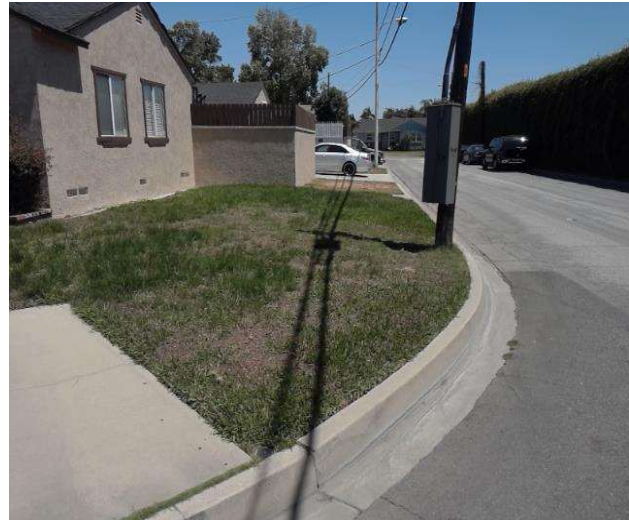
#### Sidewalk East of Buhman Avenue @ 33.952793990500, -118.104224950075

Sidewalks : Missing Sidewalk

Section of sidewalk is missing and consists of dirt, grass or gravel.

**On-Site Finding** 210.00 feet

Provide a compliant sidewalk for the missing section.

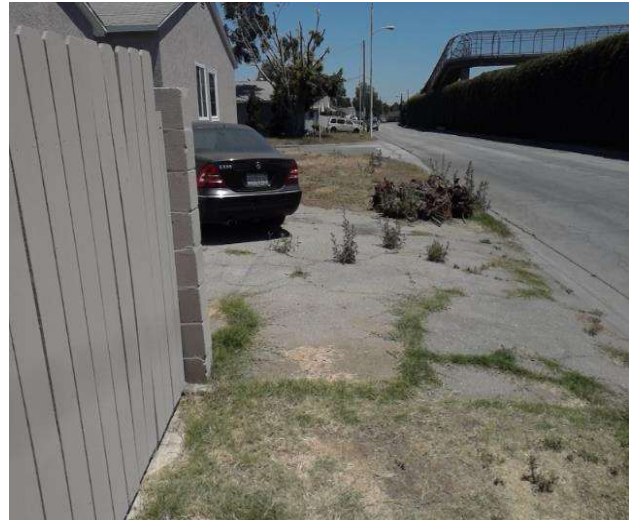
#### Sidewalk East of Chaney Avenue @ 33.954021006857, -118.105791360140

Sidewalks : Missing Sidewalk

Section of sidewalk is missing and consists of dirt, grass or gravel.

**On-Site Finding** 82.00 feet

Provide a compliant sidewalk for the missing section.

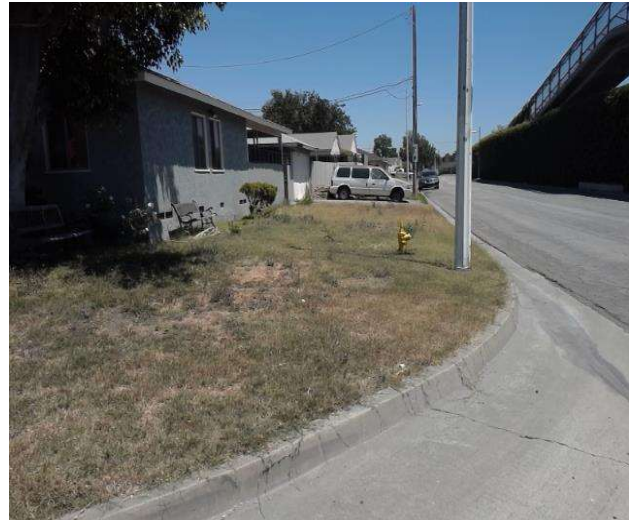
#### Sidewalk East of Lemoran Avenue @ 33.953801858361, -118.105485588312

Sidewalks : Missing Sidewalk

Section of sidewalk is missing and consists of dirt, grass or gravel.

**On-Site Finding** 212.00 feet

Provide a compliant sidewalk for the missing section.

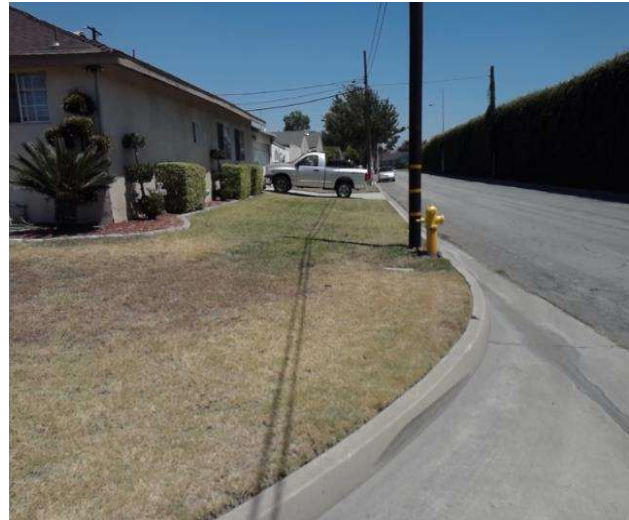
Sidewalks : Missing Sidewalk

Section of sidewalk is missing and consists of dirt, grass or gravel.

Provide a compliant sidewalk for the missing section.

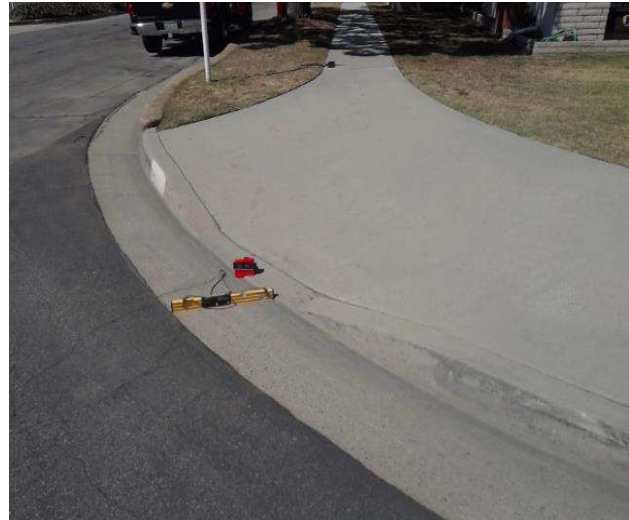
Curb Ramp , Landings and Transitions : Bottom Landing Change in Level - Curb Ramps

Patch lip at curb ramp \$255

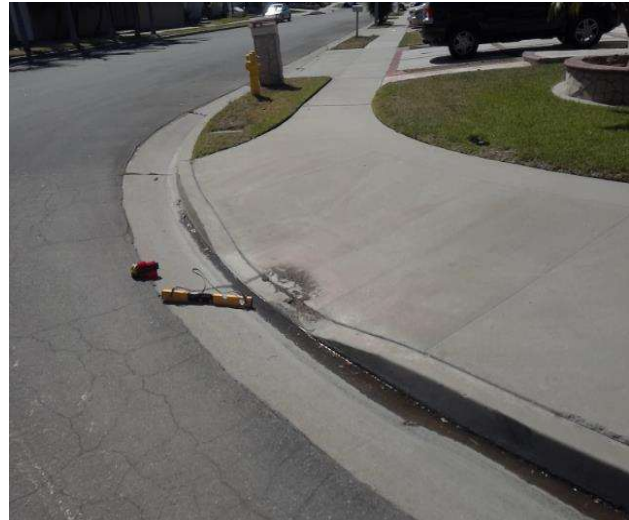
The overlayment causes a noncompliant change in level.

Ensure the change in elevation is within the recommended height.

Recommendation Up to 0.50 inches

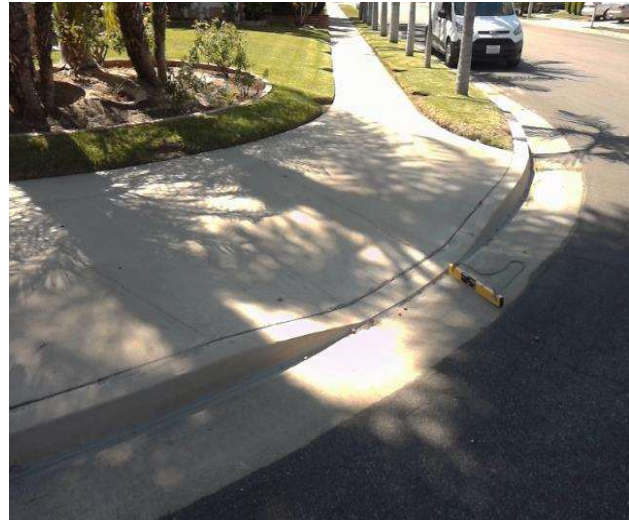
The overlayment causes a noncompliant change in level.

Ensure the change in elevation is within the recommended height.

Recommendation Up to 0.50 inches

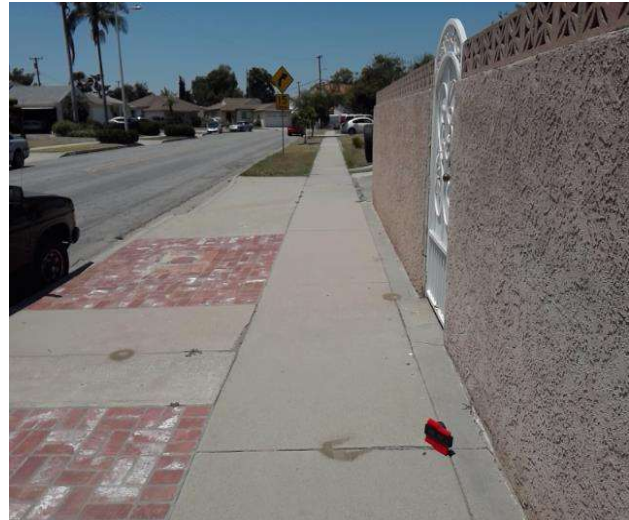
There is a change in elevation greater than recommended value.

Ensure that the change in elevation is within the recommended value.

Recommendation Up to 0.25 inches

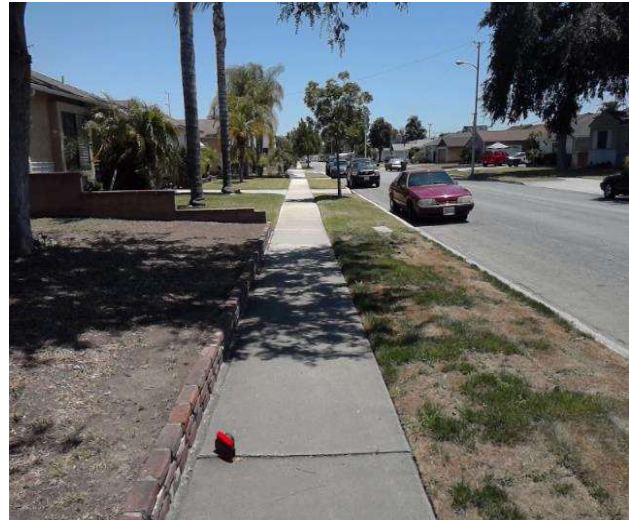
There is a change in elevation greater than recommended value.

Ensure that the change in elevation is within the recommended value.

Recommendation Up to 0.25 inches

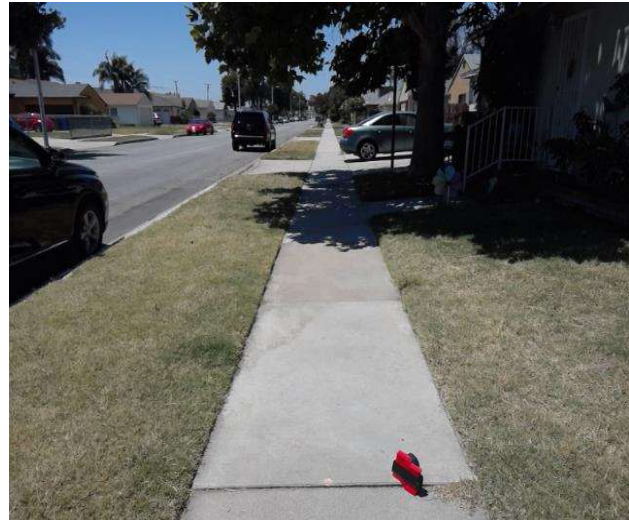
There is a change in elevation greater than recommended value.

Ensure that the change in elevation is within the recommended value.

Recommendation Up to 0.25 inches

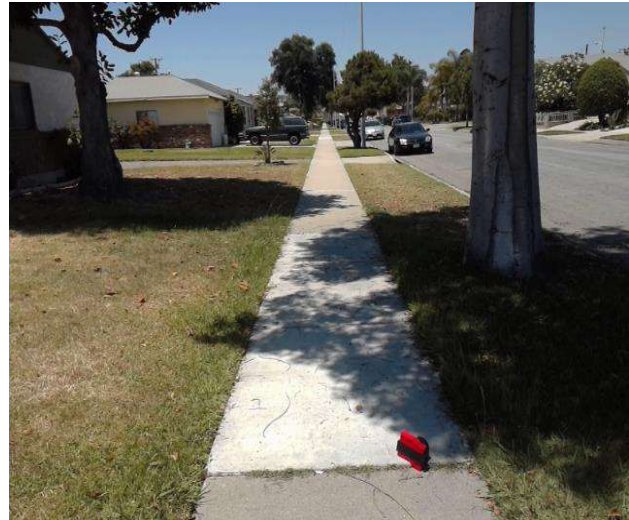
There is a change in elevation greater than recommended value.

Ensure that the change in elevation is within the recommended value.

Recommendation Up to 0.25 inches

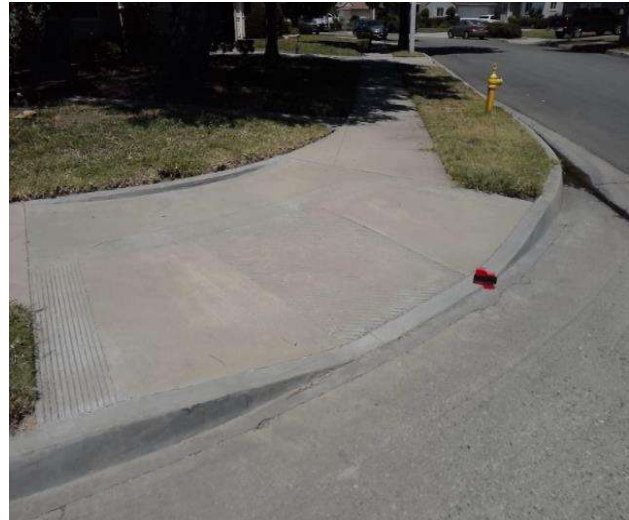
Curb Ramp , Landings And Transitions : Bottom Landing Change in Level

Recommendation Up to 0.50 inches

Patch lip at curb ramp \$255

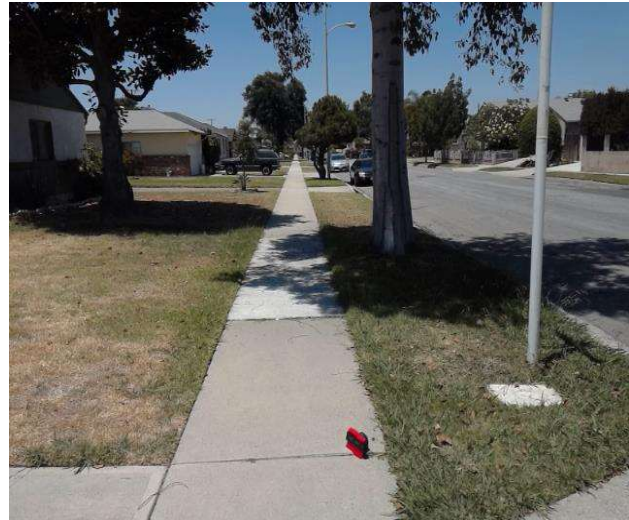
There is a change in elevation greater than recommended value.

Ensure that the change in elevation is within the recommended value.

Recommendation Up to 0.25 inches
