Accessibility Survey

City of Downey Erickson Avenue - Imperial Highway to Flores Street

Date of Inspection
7/7/2017

Disability Access Consultants

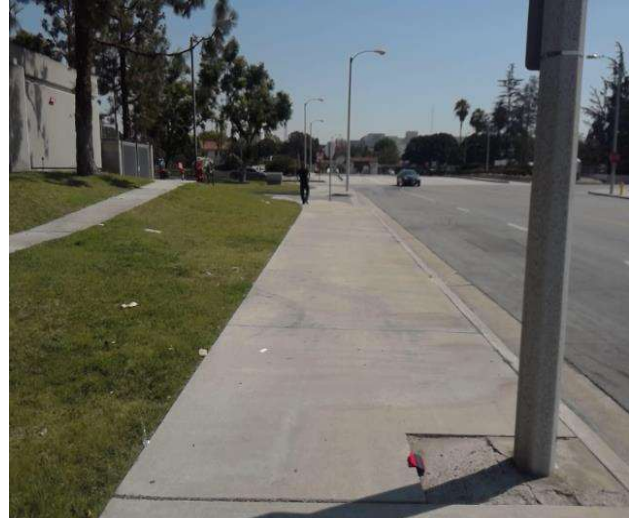
Change in Level North of Amigos Avenue @ 33.926994740906, -118.159493207932

Sidewalks , Change in Level : Change in Level Non Beveled

There is a change in elevation greater than recommended value.

On-Site Finding 1.50 inches

Ensure that the change in elevation is within the recommended value.

Recommendation Up to 0.25 inches

Remove tripping hazards \$198

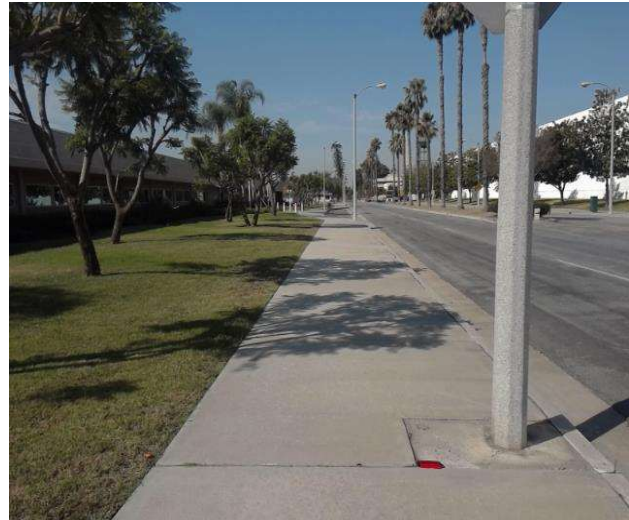
Change in Level South of Amigos Avenue @ 33.925864148234, -118.160040378571

Sidewalks , Change in Level : Change in Level Non Beveled

There is a change in elevation greater than recommended value.

On-Site Finding 0.50 inches

Ensure that the change in elevation is within the recommended value.

Recommendation Up to 0.25 inches

Remove tripping hazards \$198

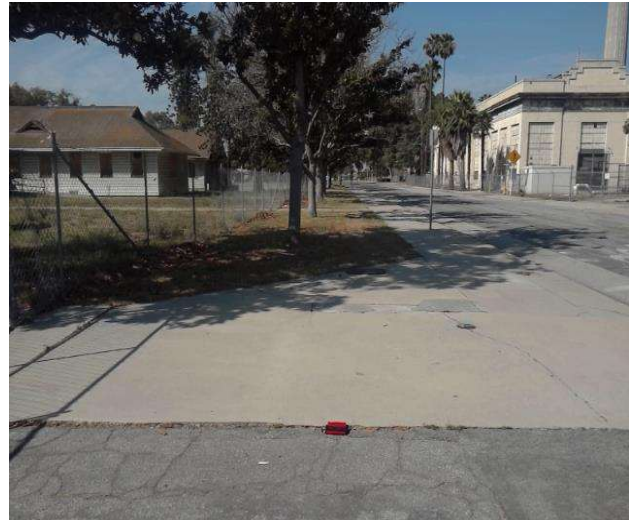
Change in Level South of Flores Street @ 33.924021339039, -118.161386847496

Sidewalks , Change in Level : Change in Level Non Beveled

There is a change in elevation greater than recommended value.

On-Site Finding 0.50 inches

Ensure that the change in elevation is within the recommended value.

Recommendation Up to 0.25 inches

Remove tripping hazards \$198

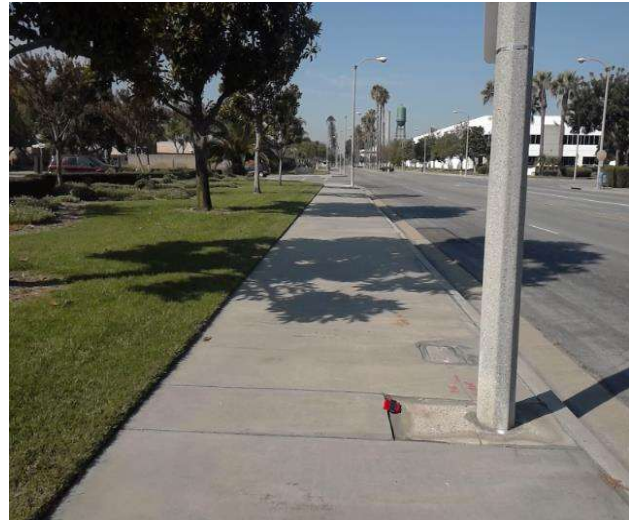
Change in Level South of Imperial Highway @ 33.926514018296, - 118.159536123276

Sidewalks , Change in Level : Change in Level Non Beveled

There is a change in elevation greater than recommended value.

On-Site Finding 0.62 inches

Ensure that the change in elevation is within the recommended value.

Recommendation Up to 0.25 inches

Remove tripping hazards \$198

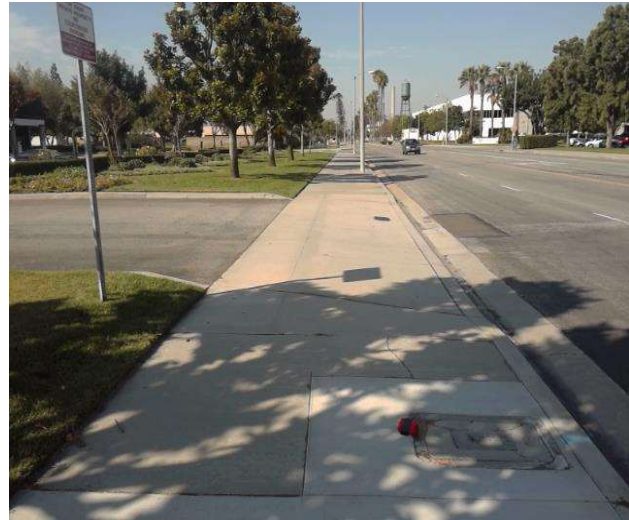
Change in Level South of Imperial Highway @ 33.926745477669, - 118.159375190735

Sidewalks , Change in Level : Change in Level Non Beveled

There is a change in elevation greater than recommended value.

On-Site Finding 0.62 inches

Ensure that the change in elevation is within the recommended value.

Recommendation Up to 0.25 inches

Remove tripping hazards \$198

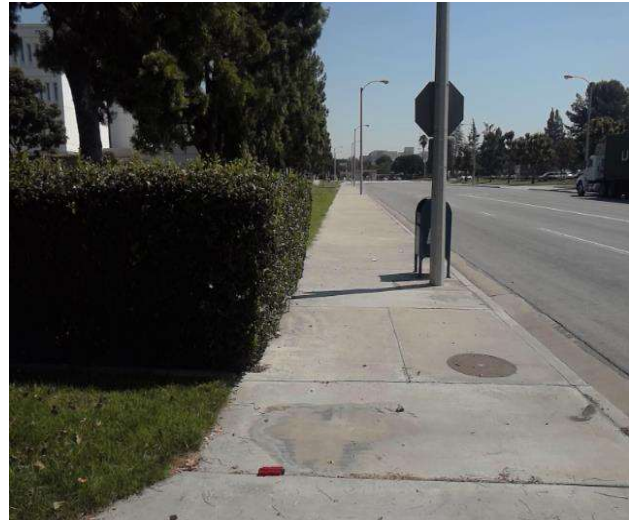
Change in Level North of Amigos Avenue @ 33.926260302492, -118.160018920898

Sidewalks , Change in Level : Change in Level Non Beveled

There is a change in elevation greater than recommended value.

On-Site Finding 0.62 inches

Ensure that the change in elevation is within the recommended value.

Recommendation Up to 0.25 inches

Remove tripping hazards \$198

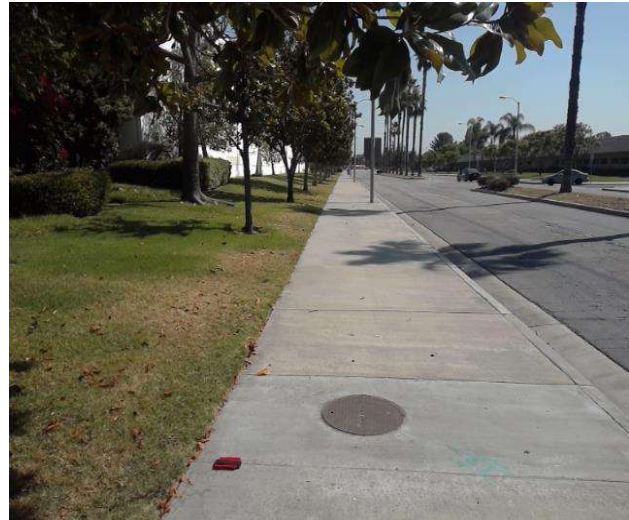
Change in Level North of Flores Street @ 33.924564393235, -118.161274194717

Sidewalks , Change in Level : Change in Level Non Beveled

There is a change in elevation greater than recommended value.

On-Site Finding 0.50 inches

Ensure that the change in elevation is within the recommended value.

Recommendation Up to 0.25 inches

Remove tripping hazards \$198

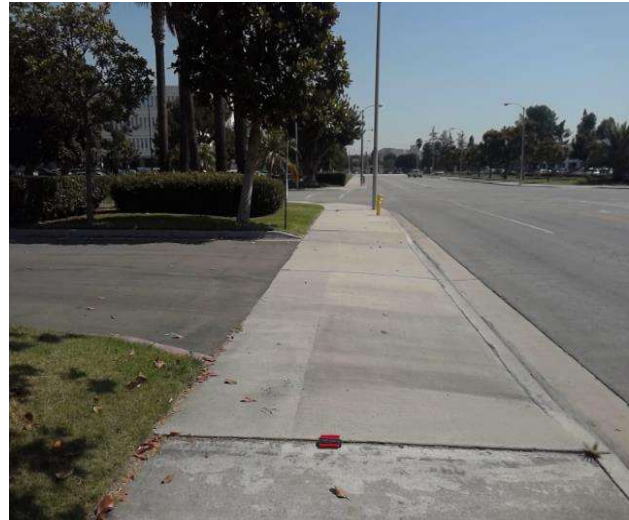
Change in Level North of Flores Street @ 33.925784026924, -118.160426616669

Sidewalks , Change in Level : Change in Level Non Beveled

There is a change in elevation greater than recommended value.

On-Site Finding 0.62 inches

Ensure that the change in elevation is within the recommended value.

Recommendation Up to 0.25 inches

Remove tripping hazards \$198

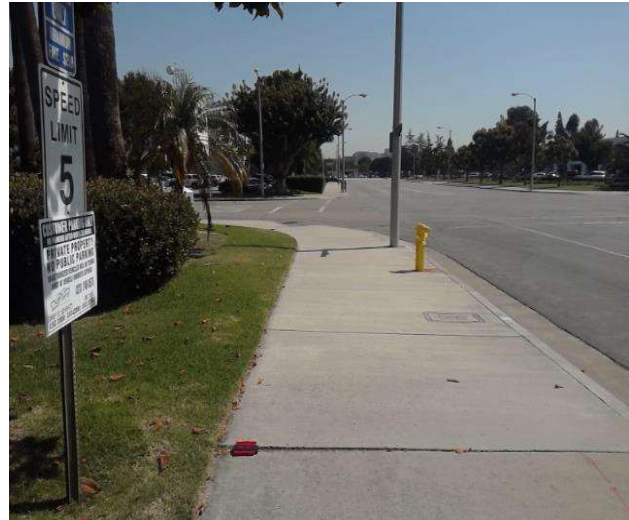
Change in Level North of Flores Street @ 33.925930915934, -118.160276412964

Sidewalks , Change in Level : Change in Level Non Beveled

There is a change in elevation greater than recommended value.

On-Site Finding 0.62 inches

Ensure that the change in elevation is within the recommended value.

Recommendation Up to 0.25 inches

Remove tripping hazards \$198

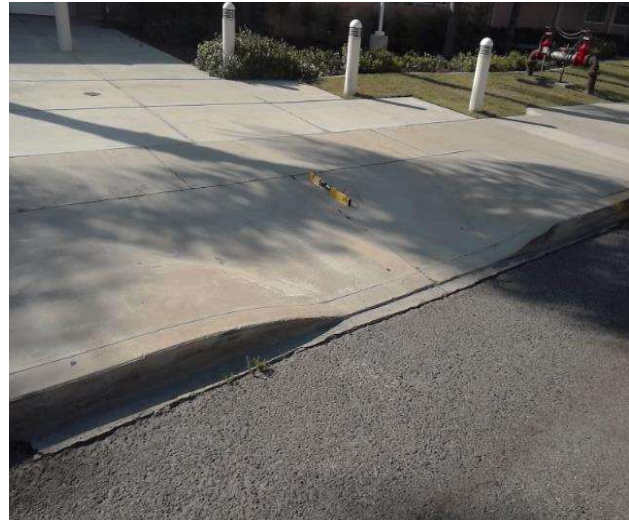
East Side South of Amigos Avenue @ 33.925272138998, - 118.160399794579

Curb Ramp : No Detectable Warnings

The curb ramp does not provide a detectable warning surface which includes truncated domes.

On-Site Finding Not Found

Provide detectable warning to surface \$248

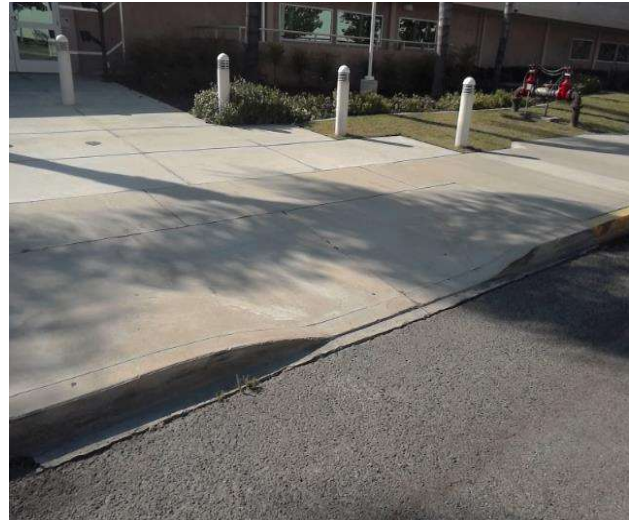
Curb Ramp , Landings and Transitions : Bottom Landing Change in Level - Curb Ramps

Patch lip at curb ramp \$255

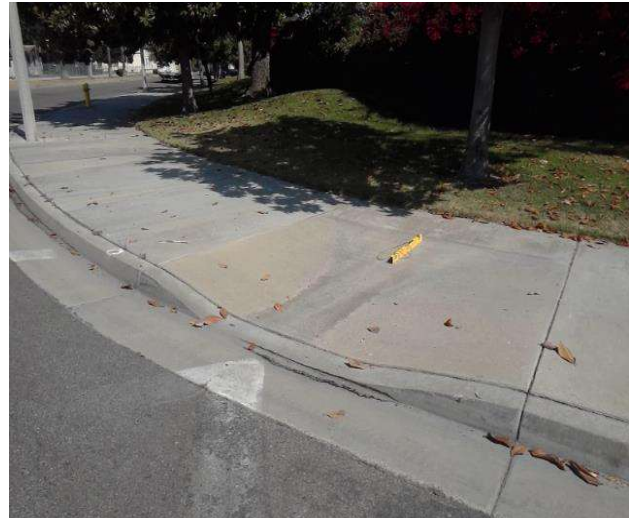
On-Site Finding Not Found

Provide detectable warning to surface \$248

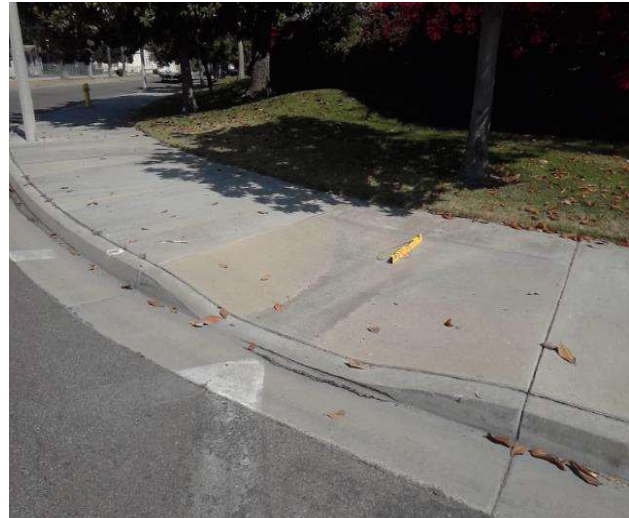
On-Site Finding Not Found

Install crosswalk \$800

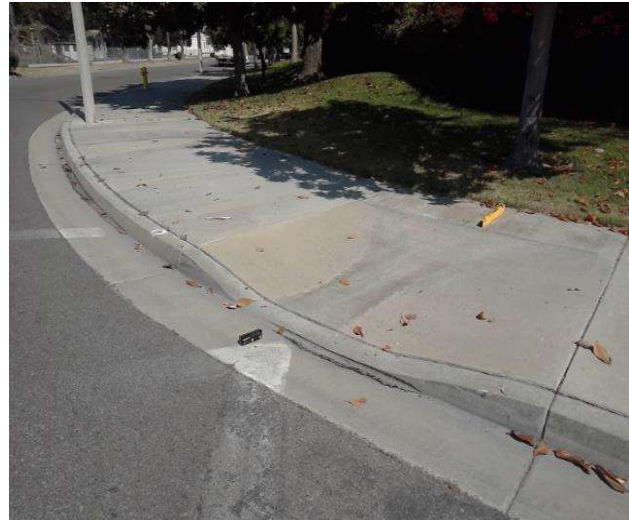
Curb Ramp , Landings and Transitions : Bottom Landing Change in Level - Curb Ramps

Patch lip at curb ramp \$255

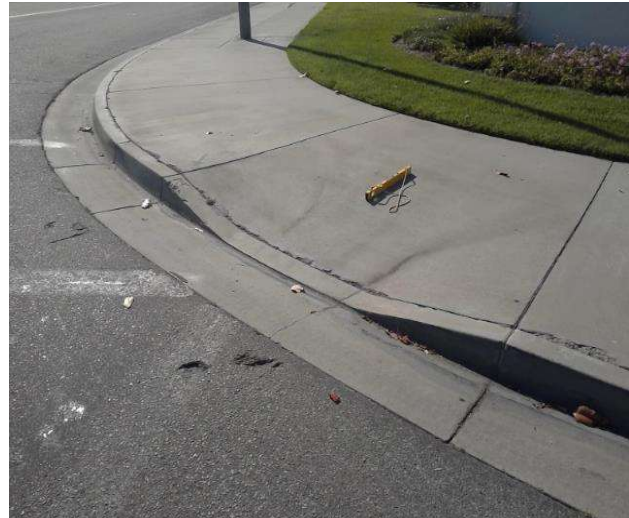
On-Site Finding Not Found

Provide detectable warning to surface \$248

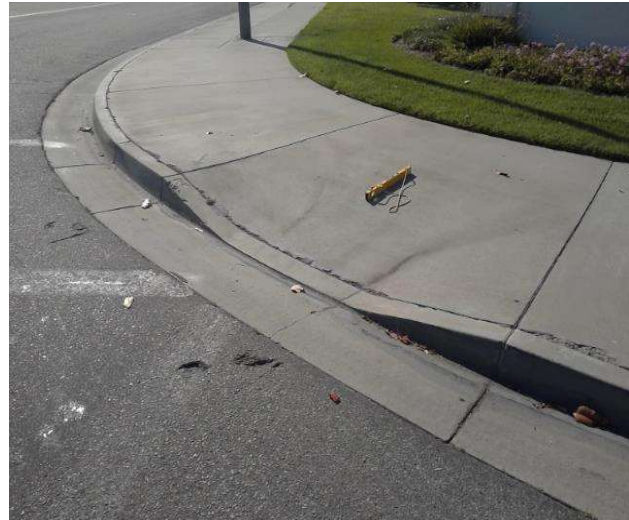
On-Site Finding Not Found

Install crosswalk \$800

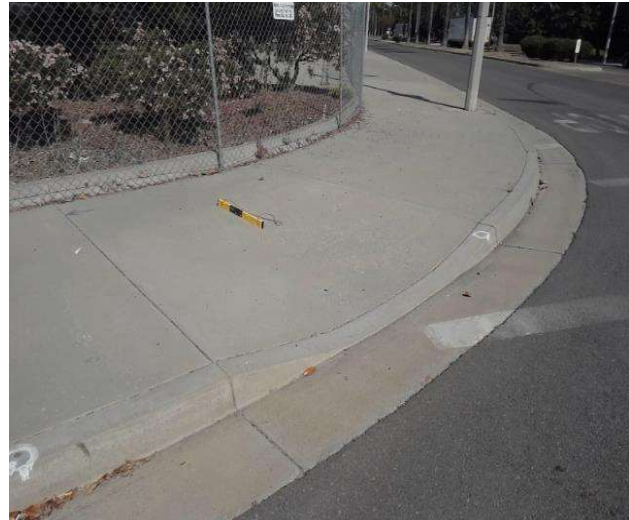
On-Site Finding Not Found

Provide detectable warning to surface \$248

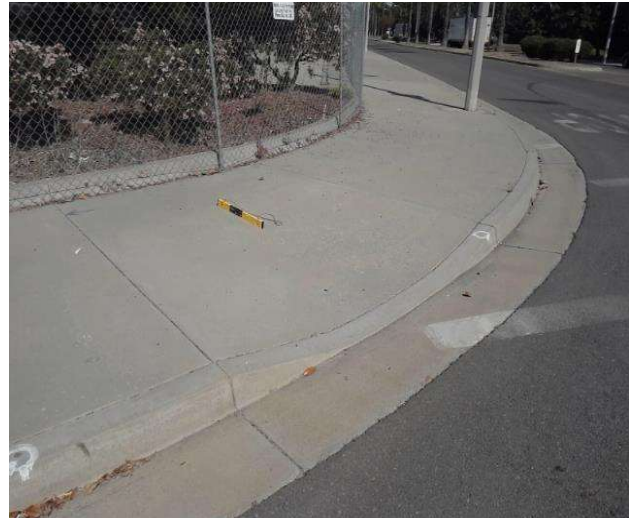
On-Site Finding Not Found

Install crosswalk \$800

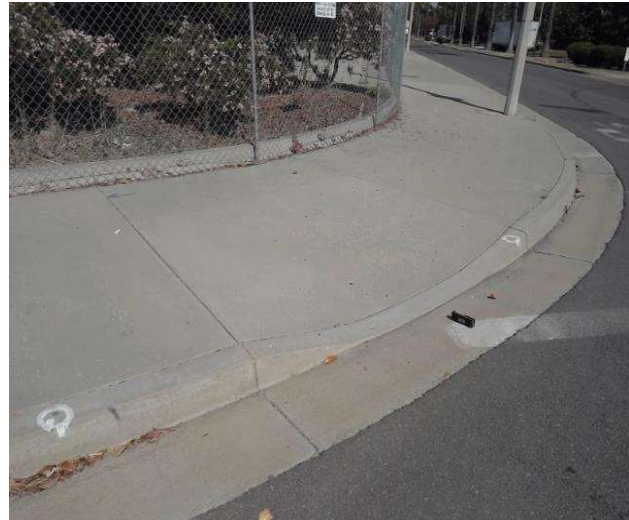
Curb Ramp , Landings and Transitions : Bottom Landing Change in Level - Curb Ramps

Patch lip at curb ramp \$255

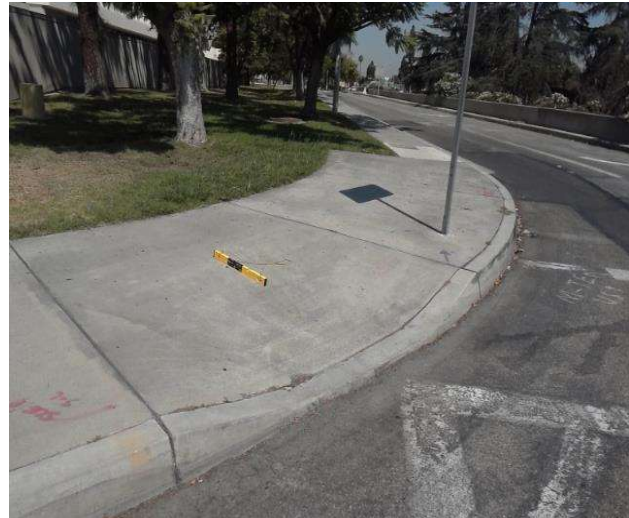
On-Site Finding Not Found

Provide detectable warning to surface \$248

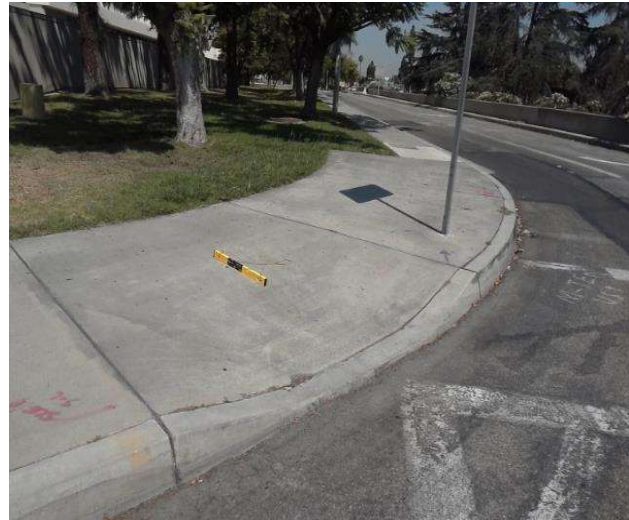
On-Site Finding Not Found

Install crosswalk \$800

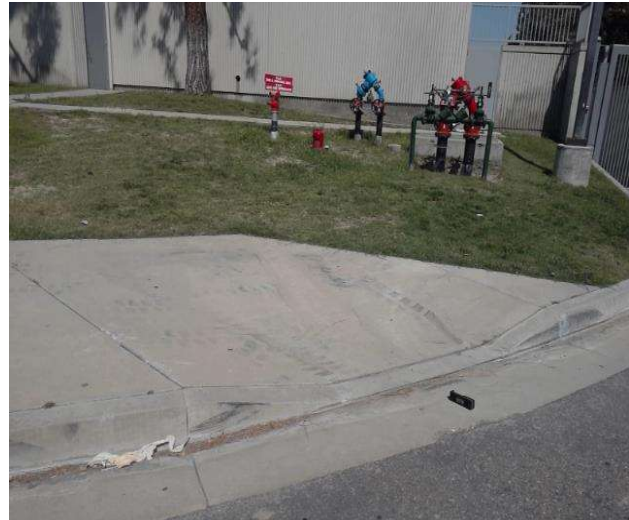
Curb Ramp , Landings and Transitions : Bottom Landing Change in Level - Curb Ramps

Patch lip at curb ramp \$255

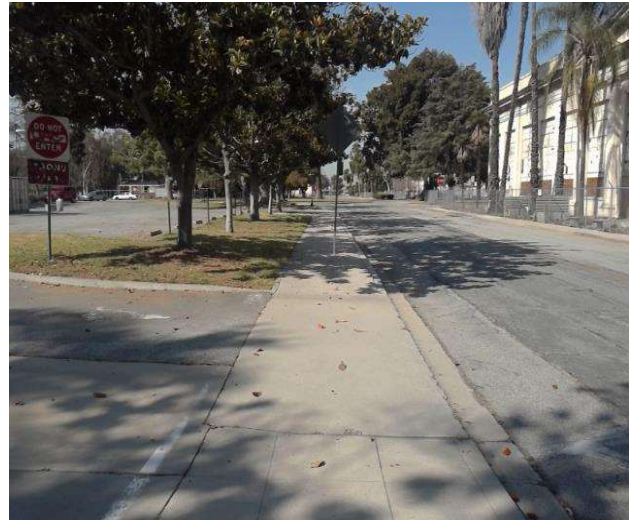
On-Site Finding Not Found

Install compliant detectable warnings \$190

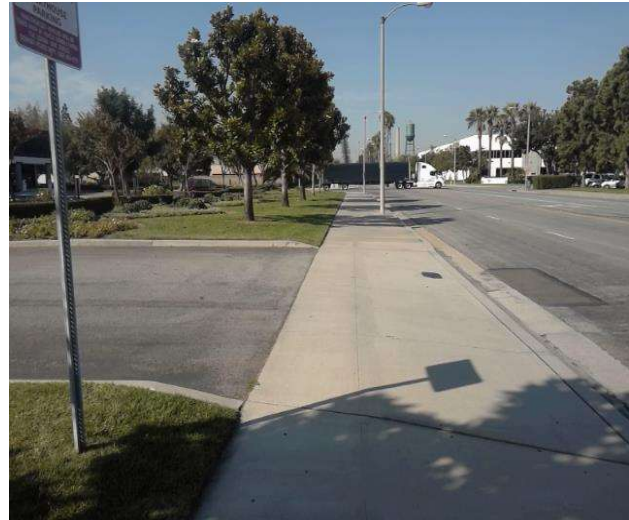
On-Site Finding Not Found

Install compliant detectable warnings \$190

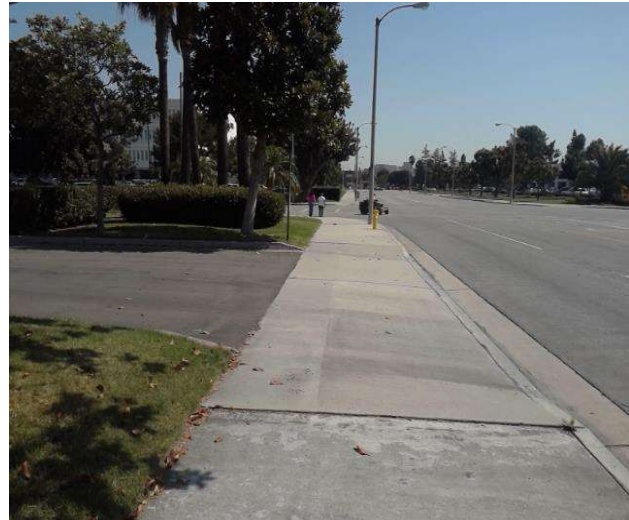
On-Site Finding Not Found

Install compliant detectable warnings \$190

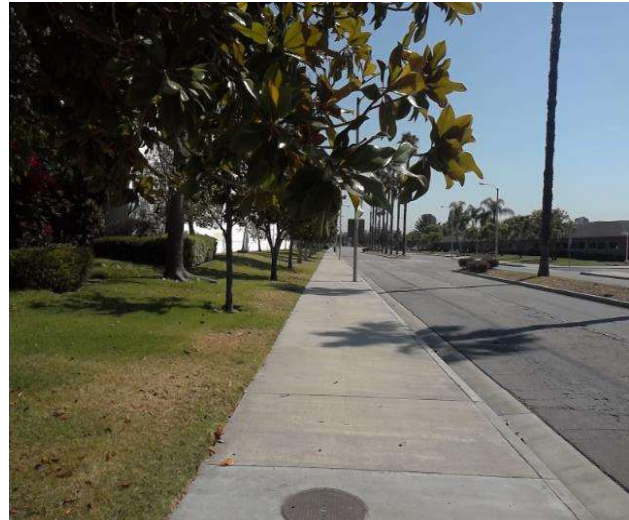
Sidewalks , Hazards & Gratings : Overhead Obstruction Height

Recommendation At least 80.00 inches
