Accessibility Survey

City of Downey Pernell Avenue - Cole Street To De Palma Street

Date of Inspection
5/3/2017

Prepared By
Disability Access Consultants
(800) 743-7067

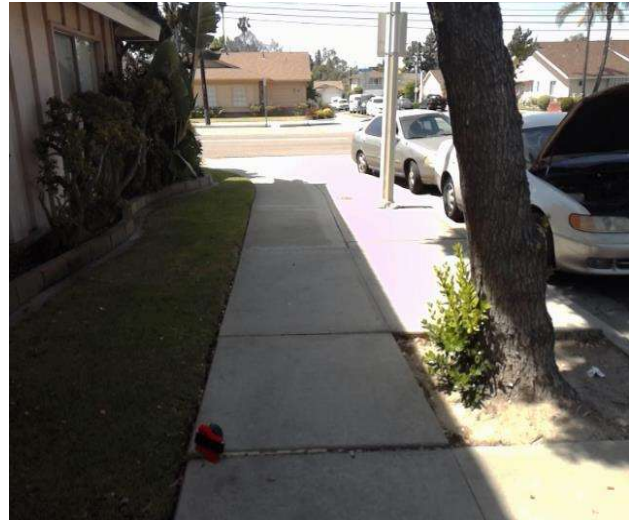
Change In Level South Of De Palma Street @ 33.943257590368, -118.159416764975

Sidewalks , Change in Level : Change in Level Non Beveled

There is a change in elevation greater than recommended value.

On-Site Finding 0.75 inches

Code Reference ADA 206, 302

Ensure that the change in elevation is within the recommended value.

Recommendation Up to 0.25 inches

Remove tripping hazards \$198

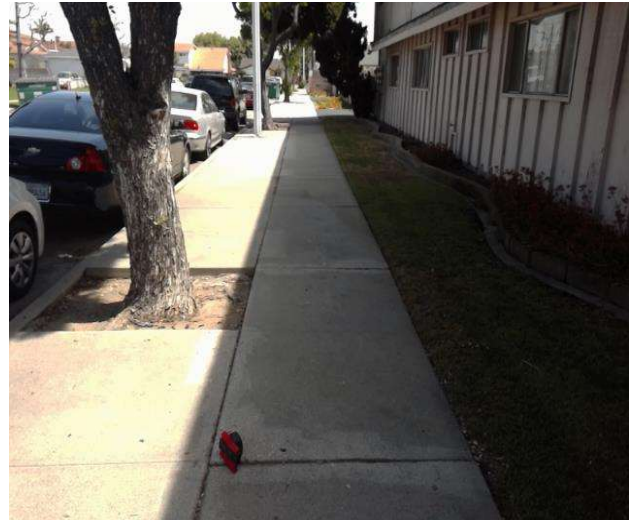
Change In Level South Of De Palma Street @ 33.943423362865, -118.159296065569

Sidewalks , Change in Level : Change in Level Non Beveled

There is a change in elevation greater than recommended value.

On-Site Finding 0.62 inches

Code Reference ADA 206, 302

Ensure that the change in elevation is within the recommended value.

Recommendation Up to 0.25 inches

Remove tripping hazards \$198

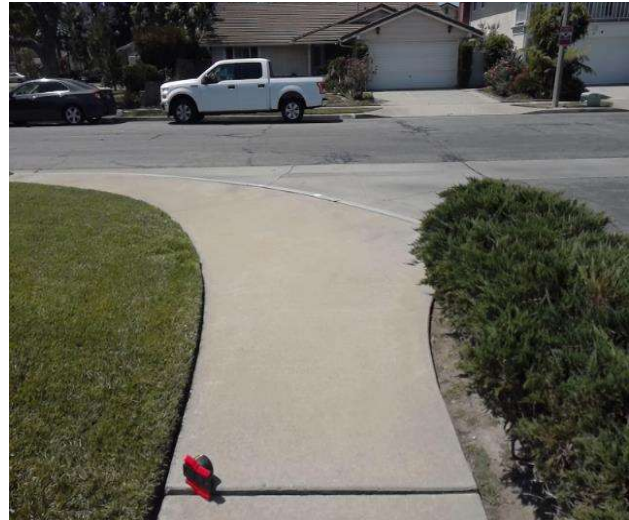
Change In Level South Of Stewart & Grey Road @ 33.942547768915, - 118.162827644

Sidewalks , Change in Level : Change in Level Non Beveled

There is a change in elevation greater than recommended value.

On-Site Finding 0.75 inches

Code Reference ADA 206, 302

Ensure that the change in elevation is within the recommended value.

Recommendation Up to 0.25 inches

Remove tripping hazards \$198

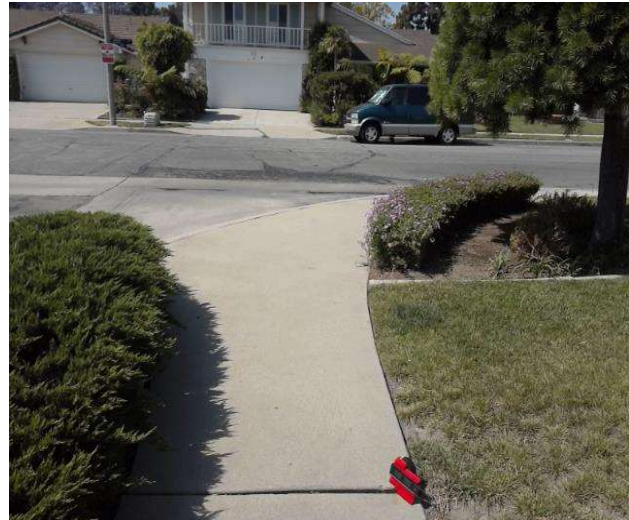
Change In Level North Of Cole Street @ 33.942622311571, -118.160149008036

Sidewalks , Change in Level : Change in Level Non Beveled

There is a change in elevation greater than recommended value.

On-Site Finding 0.75 inches

Code Reference ADA 206, 302

Ensure that the change in elevation is within the recommended value.

Recommendation Up to 0.25 inches

Remove tripping hazards \$198

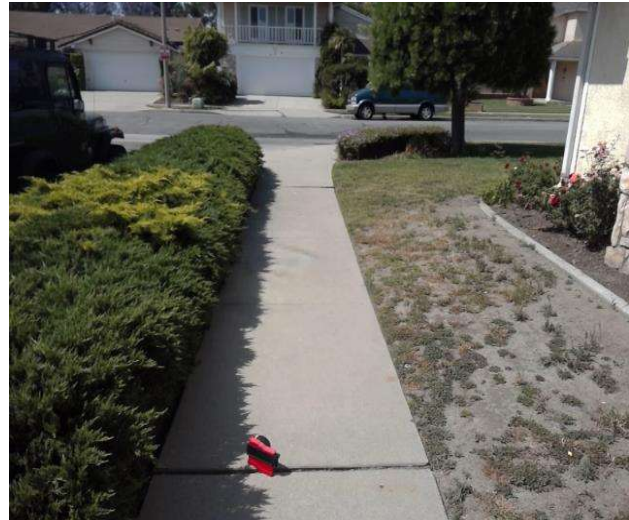
Change In Level North Of Cole Street @ 33.942672377498, -118.160110116005

Sidewalks , Change in Level : Change in Level Non Beveled

There is a change in elevation greater than recommended value.

On-Site Finding 0.37 inches

Code Reference ADA 206, 302

Ensure that the change in elevation is within the recommended value.

Recommendation Up to 0.25 inches

Remove tripping hazards \$198

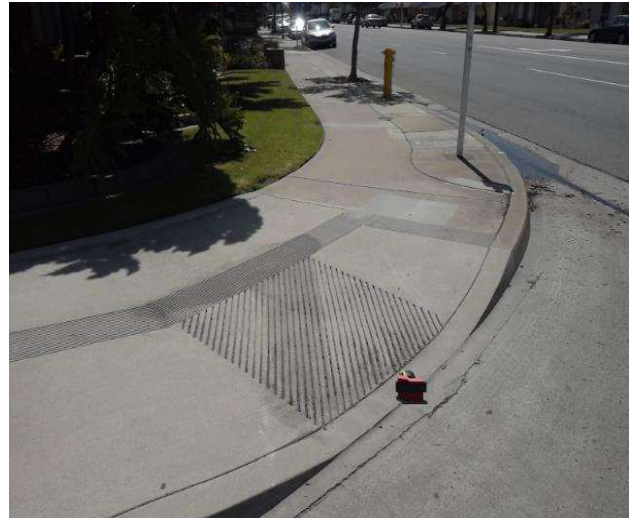
Northeast Corner Of Stewart & Grey Road @ 33.943239789276, - 118.159648776054

Curb Ramp : No Detectable Warnings

The curb ramp does not provide a detectable warning surface which includes truncated domes.

On-Site Finding Not Found

Code Reference CA 11B-406.5.12

Provide compliant detectable warnings to surface.

Provide detectable warning to surface \$248

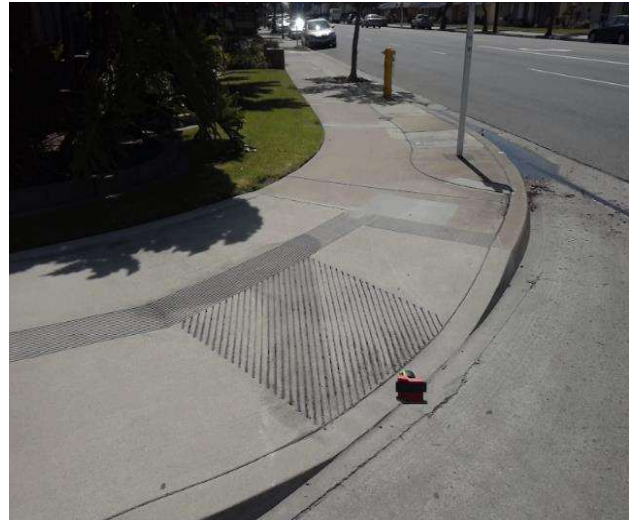
Northeast Corner Of Stewart & Grey Road @ 33.943239789276, - 118.159648776054

Curb Ramp : Side Flare Slope

The slope of the curb ramp side flare is greater than allowed.

On-Site Finding 13.10 percent

Code Reference ADA 406, 406.3, CA 11B-406.2.2

Provide curb ramp side flares with a compliant slope.

Recommendation Up to 10.00 percent

Install flared sides \$1,300

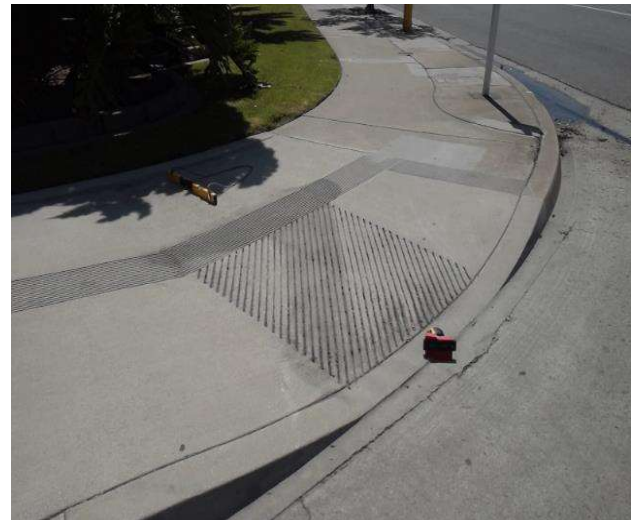
Northeast Corner Of Stewart & Grey Road @ 33.943239789276, - 118.159648776054

Curb Ramp , Landings and Transitions : Bottom Landing Change in Level - Curb Ramps

The transition from the bottom of the curb ramp to the walk, gutter, or street is abrupt.

On-Site Finding Not Beveled

Code Reference ADA 302, 406.2

Patch the transition area at the bottom of the curb ramp so that the transition is flush and free of abrupt changes.

Patch lip at curb ramp \$255

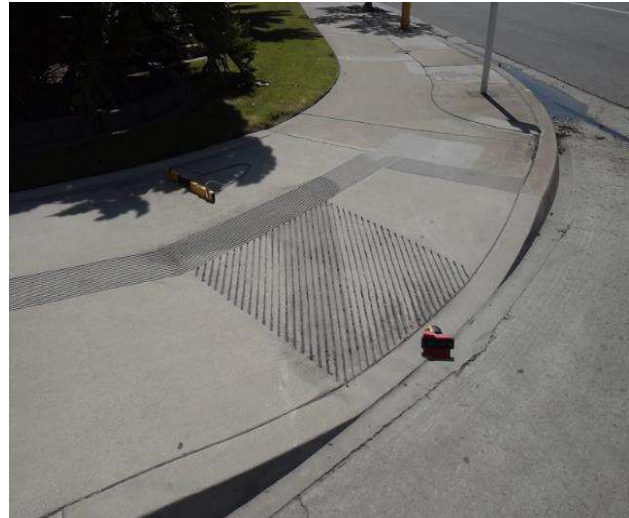
Northeast Corner Of Stewart & Grey Road @ 33.943239789276, - 118.159648776054

Curb Ramp , Landings and Transitions : Top Landing Slope

The slope at the top landing is greater than allowed.

On-Site Finding 2.80 percent

Code Reference ADA 402, 406.4, 403.3, 406.1, CA 11B-406.5.3

Provide a top landing surface that does not exceed the maximum slope and cross slope. Provide a sufficient maneuvering clearance that does not accumulate water.

Recommendation Up to 2.08 percent

Provide compliant landing \$1,260

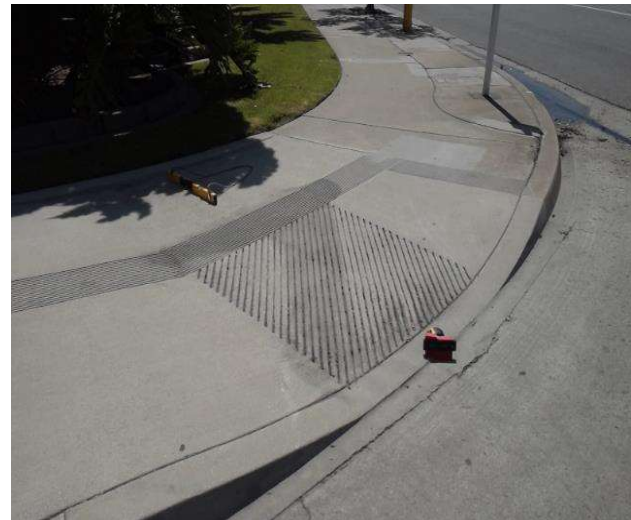
Northeast Corner Of Stewart & Grey Road @ 33.943239789276, - 118.159648776054

Curb Ramp , Landings and Transitions : Top Landing Clear Length - Landings

There is not enough top landing clear length.

On-Site Finding 47.00 inches

Code Reference ADA 406, 406.4,CA 11B-406.5.3

Provide a level top landing with enough clear length.

Recommendation At least 48.00 inches

Provide compliant landing \$240

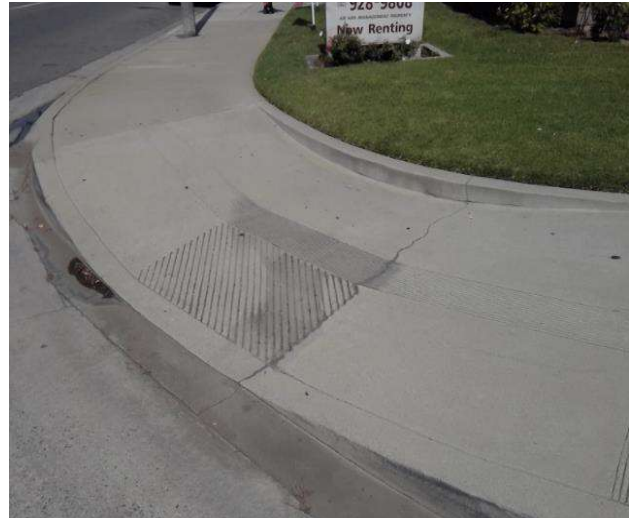
Northwest Corner Of Stewart & Grey Road @ 33.943239789276, - 118.159648776054

Curb Ramp : No Detectable Warnings

The curb ramp does not provide a detectable warning surface which includes truncated domes.

On-Site Finding Not Found

Code Reference CA 11B-406.5.12

Provide compliant detectable warnings to surface.

Provide detectable warning to surface \$248

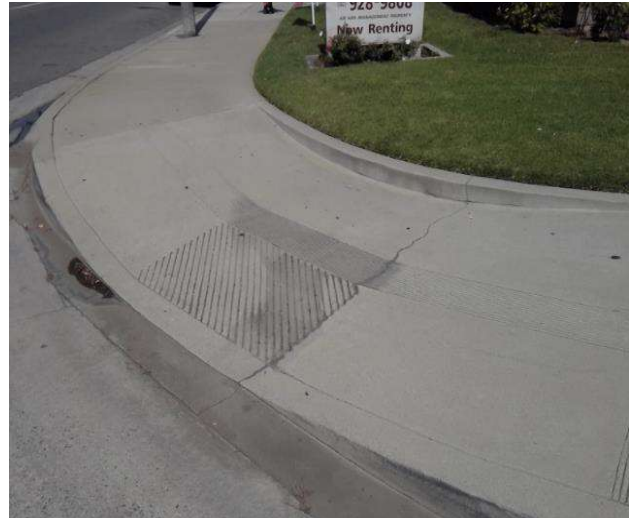
Northwest Corner Of Stewart & Grey Road @ 33.943239789276, - 118.159648776054

Curb Ramp : Side Flare Slope

Code Reference ADA 406, 406.3,CA 11B-406.2.2

Recommendation Up to 10.00 percent

Install flared sides \$1,300

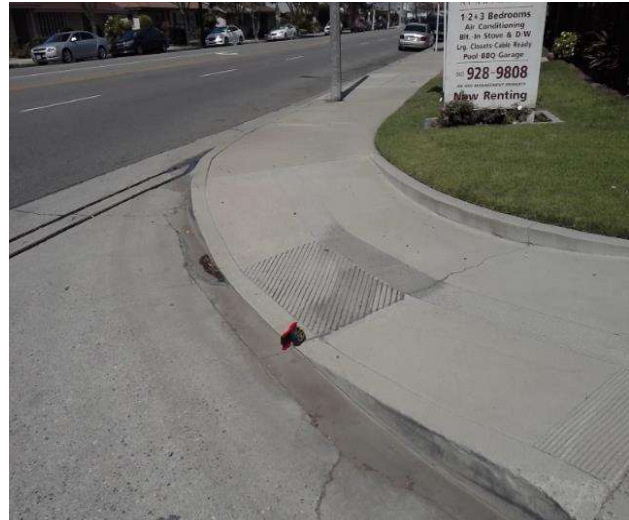
Curb Ramp , Landings And Transitions : Bottom Landing Change in Level

Code Reference ADA 302, 303, 406.2, 303.1

Recommendation Up to 0.50 inches

Patch lip at curb ramp \$255

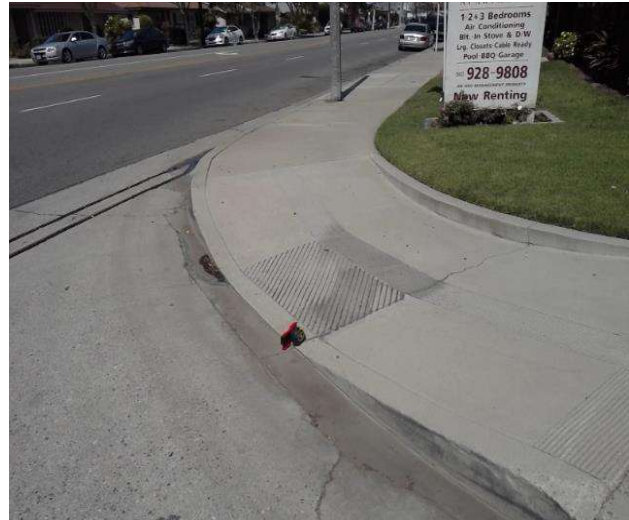
Code Reference ADA 406, 406.4,CA 11B-406.5.3

Recommendation At least 48.00 inches

Provide compliant landing \$240

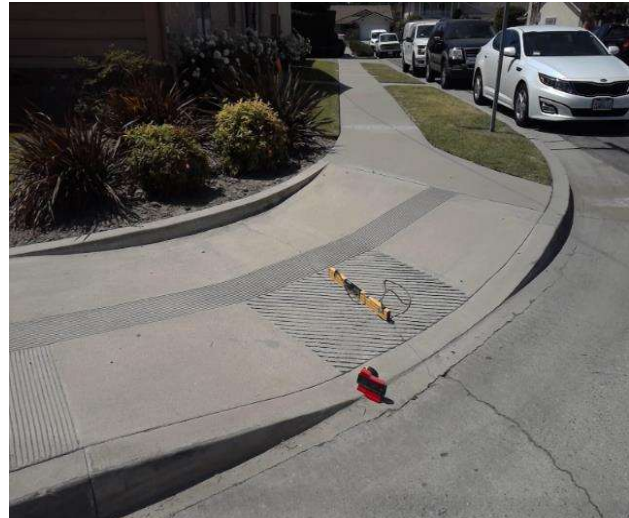
On-Site Finding Not Found

Code Reference CA 11B-406.5.12

Provide detectable warning to surface \$248

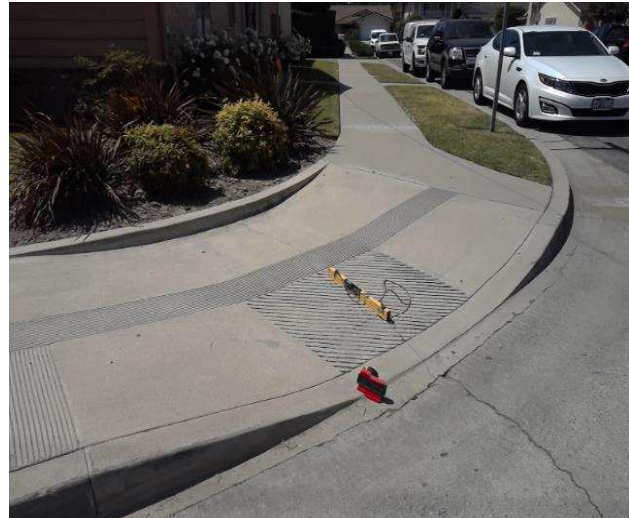
Code Reference ADA 406, 406.1, 405.2, CA 11B-406

Recommendation Up to 8.33 percent

Install curb ramp \$1,300

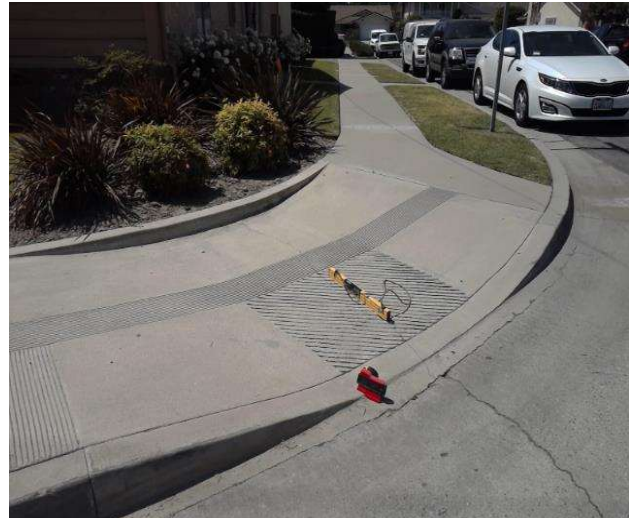
Code Reference ADA 406, 406.3, CA 11B-406.2.2

Recommendation Up to 10.00 percent

Install flared sides \$1,300

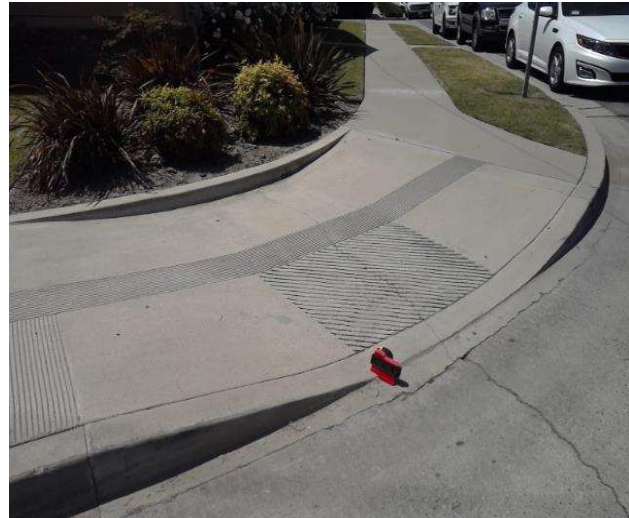
Code Reference ADA 302, 406.2

Patch lip at curb ramp \$255

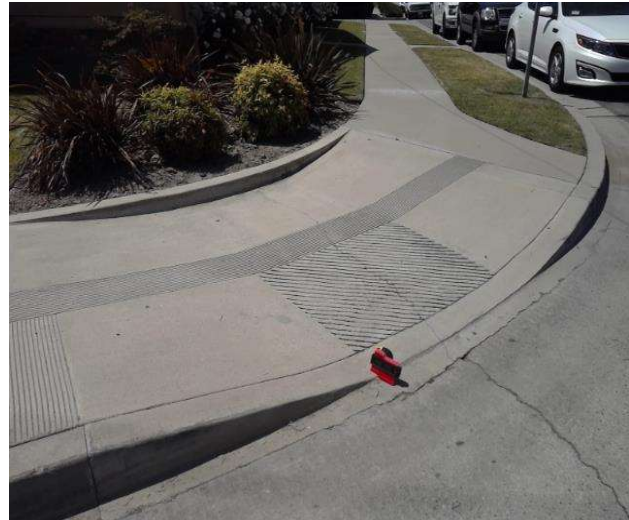
Code Reference ADA 406, 406.4,CA 11B-406.5.3

Recommendation At least 48.00 inches

Provide compliant landing \$240

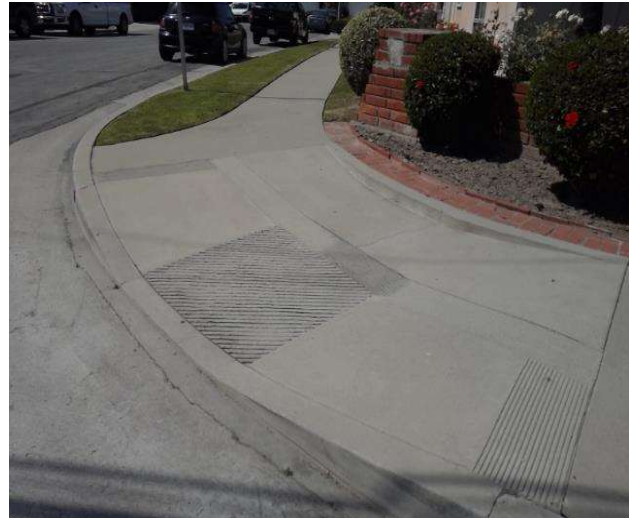
On-Site Finding Not Found

Code Reference CA 11B-406.5.12

Provide detectable warning to surface \$248

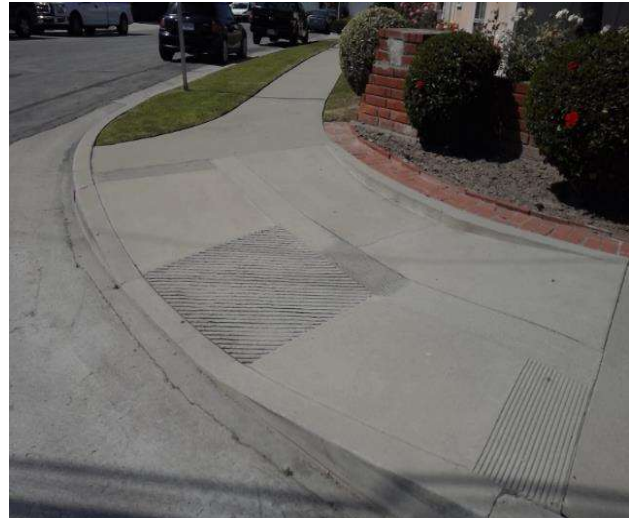
Code Reference ADA 406, 406.1, 405.5, CA 11B-406.5.2

Recommendation At least 48.00 inches

Install curb ramp \$1,300

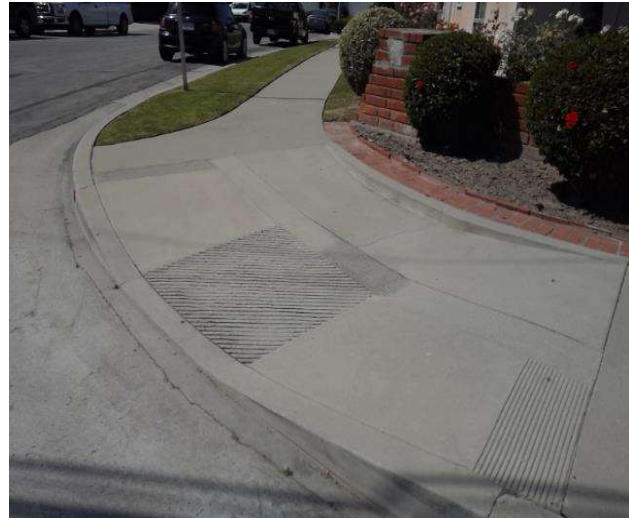
Code Reference ADA 406, 406.3, CA 11B-406.2.2

Recommendation Up to 10.00 percent

Install flared sides \$1,300

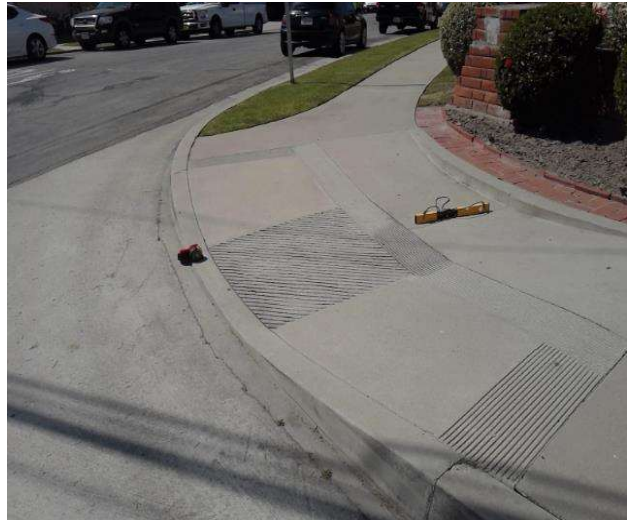
Curb Ramp , Landings And Transitions : Bottom Landing Change in Level

Code Reference ADA 302, 303, 406.2, 303.1

Recommendation Up to 0.50 inches

Patch lip at curb ramp \$255

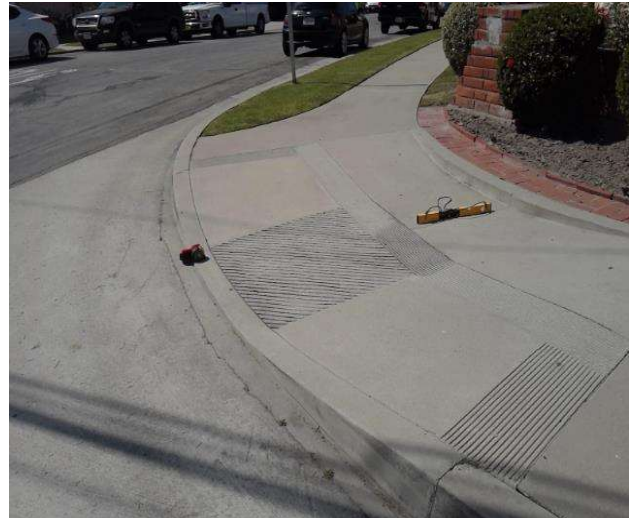
Code Reference ADA 402, 406.4, 403.3, 406.1, CA 11B-406.5.3

Recommendation Up to 2.08 percent

Provide compliant landing \$1,260

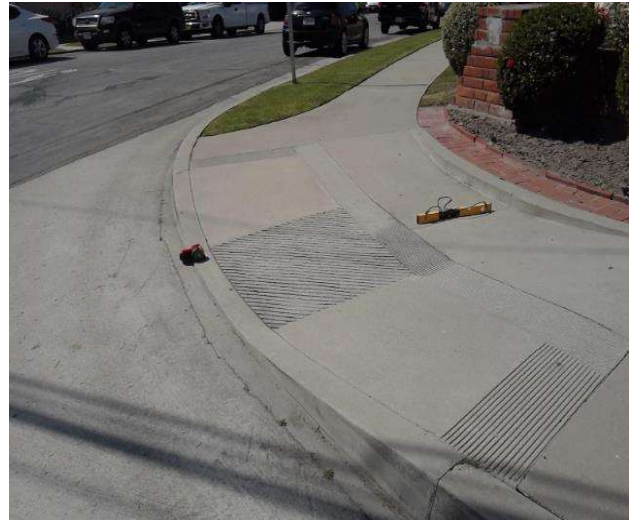
Code Reference ADA 406, 406.4,CA 11B-406.5.3

Recommendation At least 48.00 inches

Provide compliant landing \$240

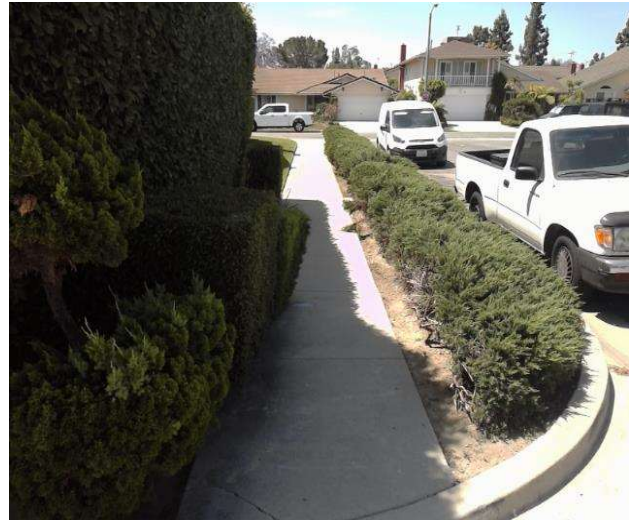
Sidewalks , Hazards & Gratings : Sidewalk Width at Obstruction

Code Reference ADA 206, 302, 403.5.1, CA 11B-403.5

Sidewalk width at the obstruction shall have the recommended value.

Recommendation At least 48.00 inches

\$1,260

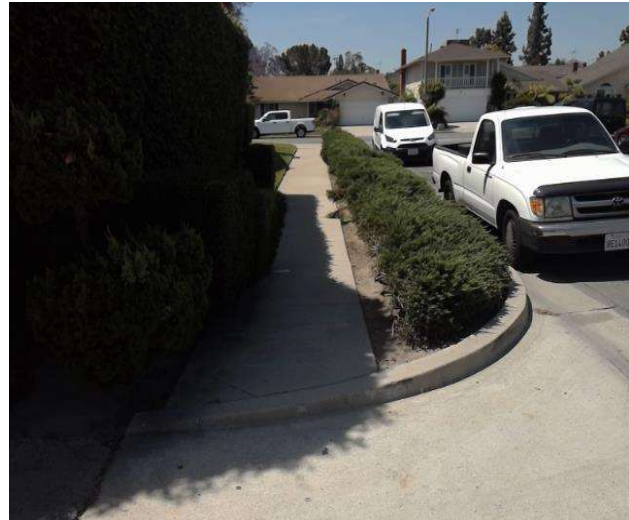
Sidewalks , Hazards & Gratings : Curb is on Path of Travel

Code Reference ADA 402, 303, 406, 403.4, 303.4

Install curb ramp \$2,500

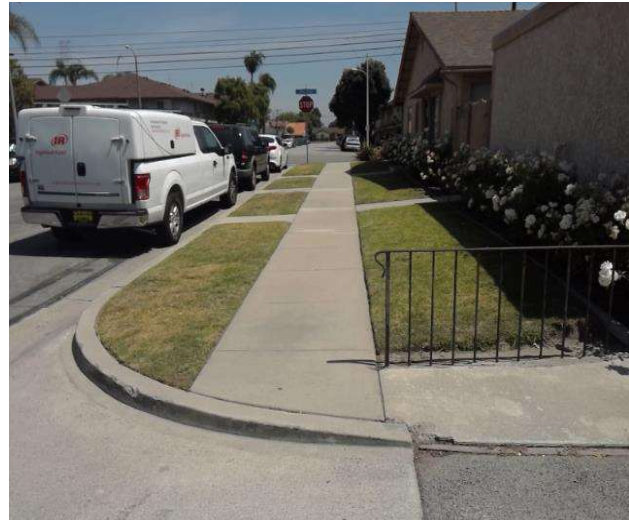
Sidewalks , Hazards & Gratings : Curb is on Path of Travel

Code Reference ADA 402, 303, 406, 403.4, 303.4

Install curb ramp \$2,500

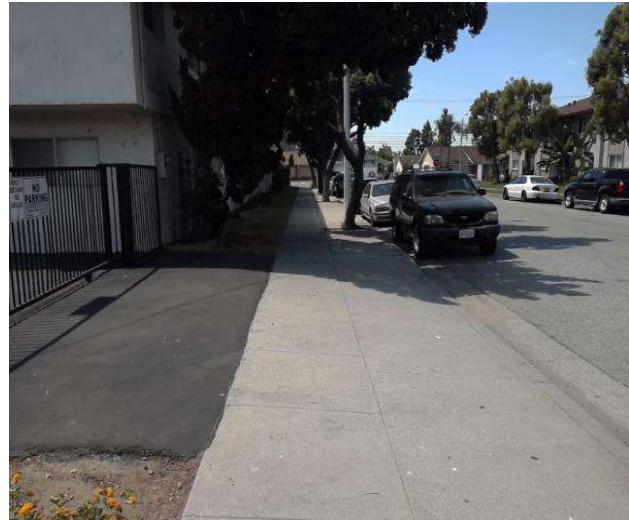
On-Site Finding Not Found

Code Reference ADA 705,CA 11B-705.1.2.5,CA 11B-247.1.2.5

Install compliant detectable warnings \$190

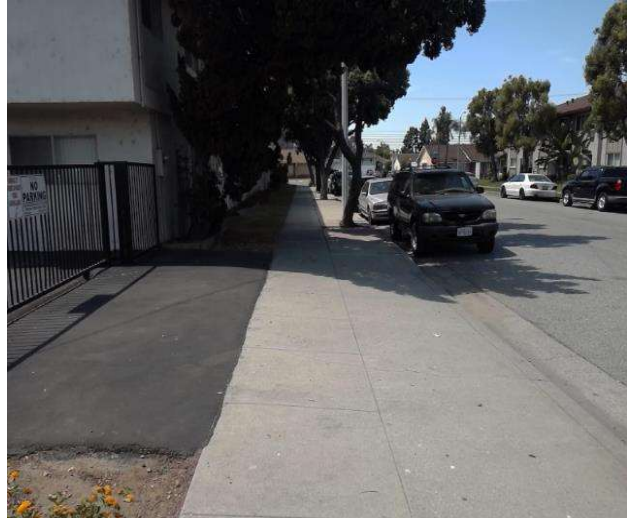
Code Reference ADA 206, 302,CA 11B-403.3

Recommendation Up to 2.08 percent

Repave surface \$1,092

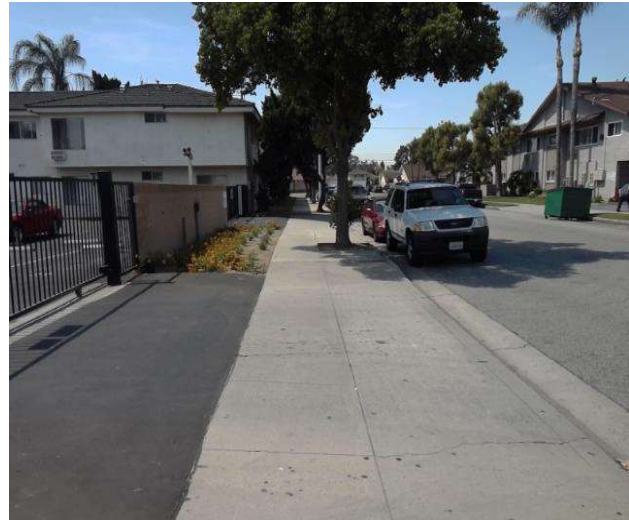
On-Site Finding Not Found

Code Reference ADA 705,CA 11B-705.1.2.5,CA 11B-247.1.2.5

Install compliant detectable warnings \$190

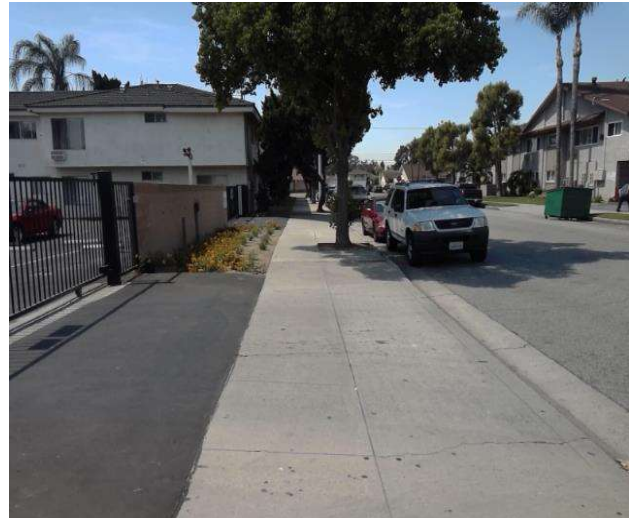
Code Reference ADA 206, 302, CA 11B-403.3

Recommendation Up to 2.08 percent

Repave surface \$1,092

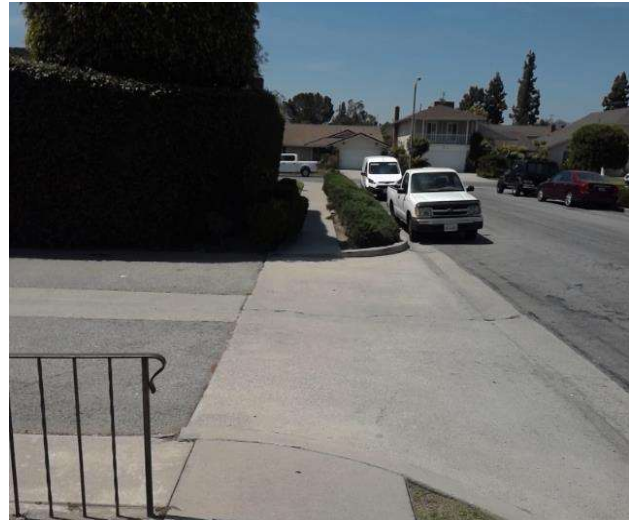
On-Site Finding Not Found

Code Reference ADA 705,CA 11B-705.1.2.5,CA 11B-247.1.2.5

Install compliant detectable warnings \$190

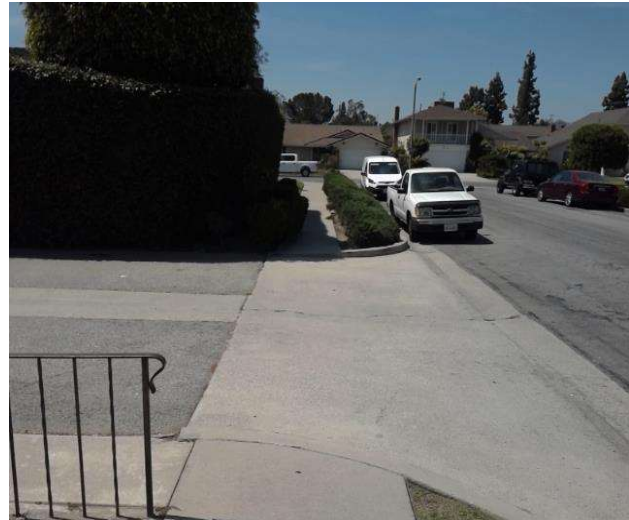
Code Reference ADA 206, 302, CA 11B-403.3

Recommendation Up to 2.08 percent

Repave surface \$1,092

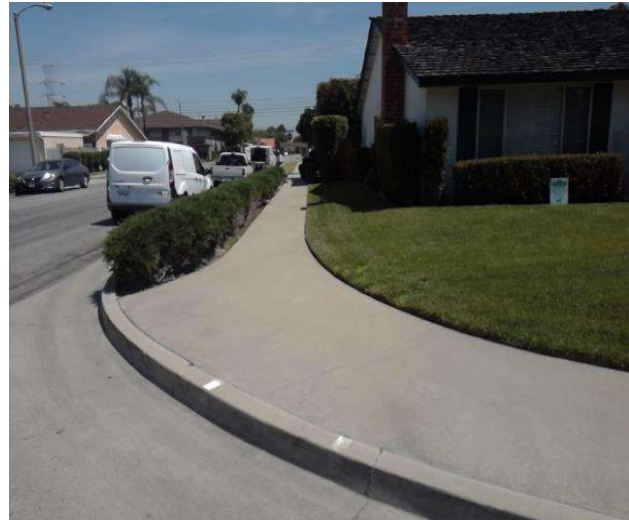
Sidewalks , Hazards & Gratings : Curb is on Path of Travel

Code Reference ADA 402, 303, 406, 403.4, 303.4

Install curb ramp \$2,500

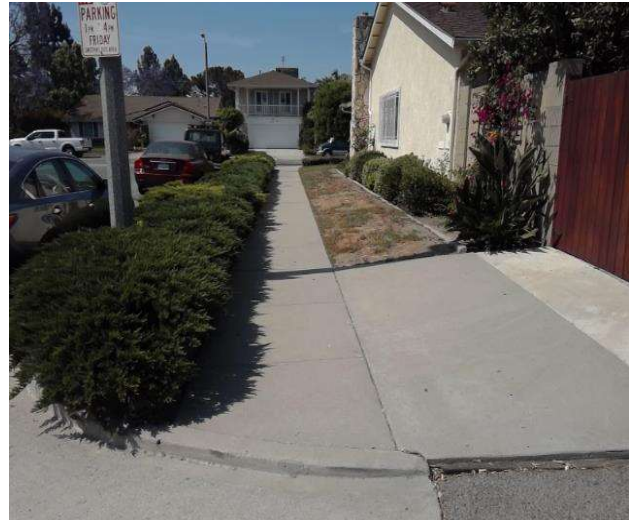
Sidewalks , Hazards & Gratings : Curb is on Path of Travel

Code Reference ADA 402, 303, 406, 403.4, 303.4

Install curb ramp \$2,500

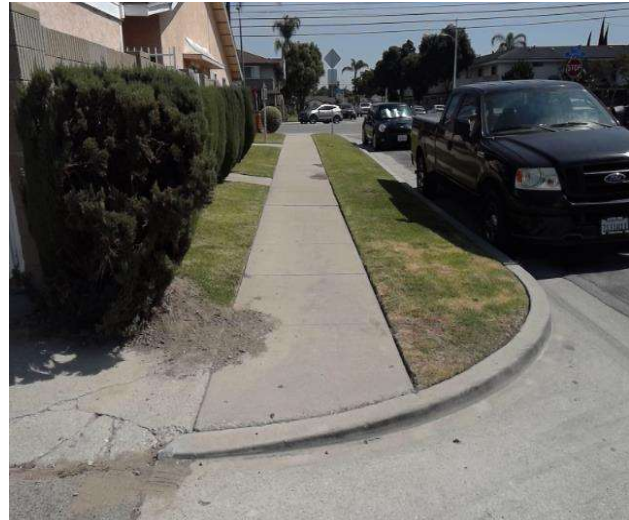
Sidewalks , Hazards & Gratings : Curb is on Path of Travel

Code Reference ADA 402, 303, 406, 403.4, 303.4

Install curb ramp \$2,500

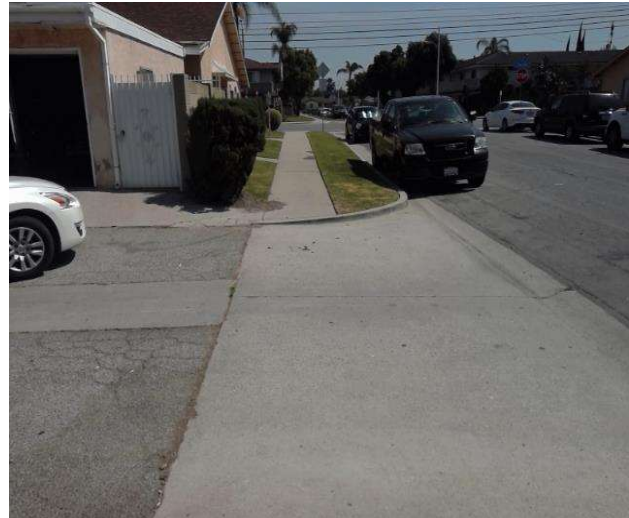
On-Site Finding Not Found

Code Reference ADA 705,CA 11B-705.1.2.5,CA 11B-247.1.2.5

Install compliant detectable warnings \$190

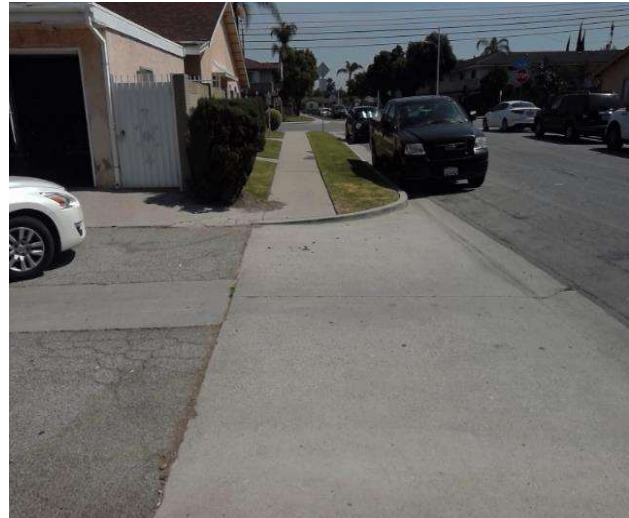
Code Reference ADA 206, 302,CA 11B-403.3

Recommendation Up to 2.08 percent

Repave surface \$1,092

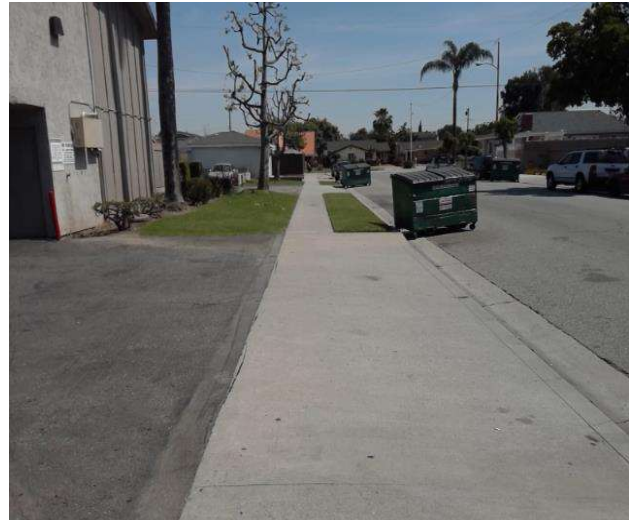
On-Site Finding Not Found

Code Reference ADA 705,CA 11B-705.1.2.5,CA 11B-247.1.2.5

Install compliant detectable warnings \$190

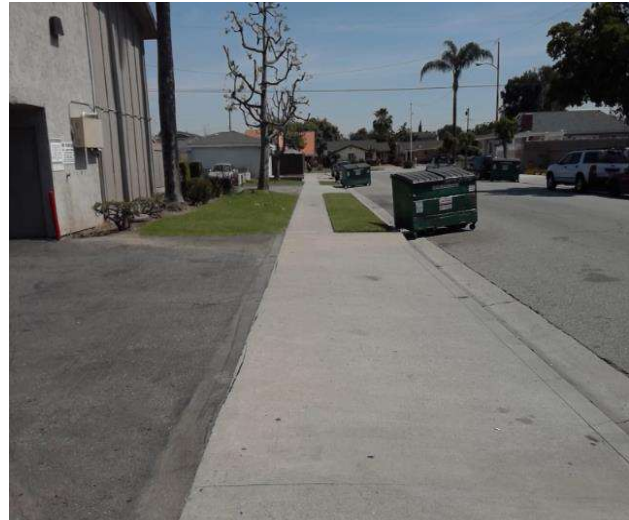
Code Reference ADA 206, 302,CA 11B-403.3

Recommendation Up to 2.08 percent

Repave surface \$1,092

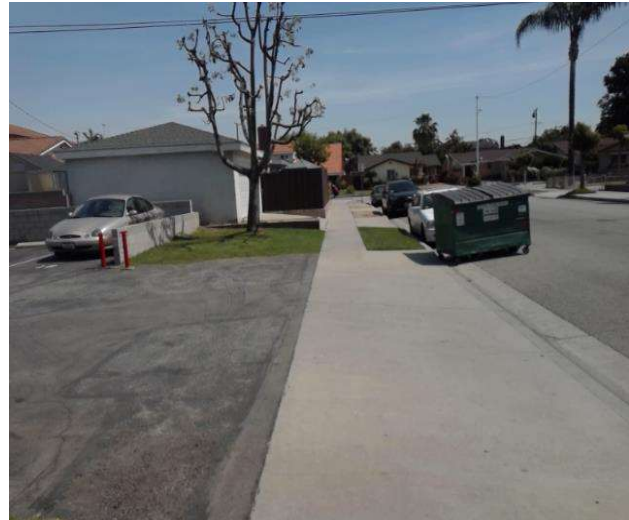
On-Site Finding Not Found

Code Reference ADA 705,CA 11B-705.1.2.5,CA 11B-247.1.2.5

Install compliant detectable warnings \$190

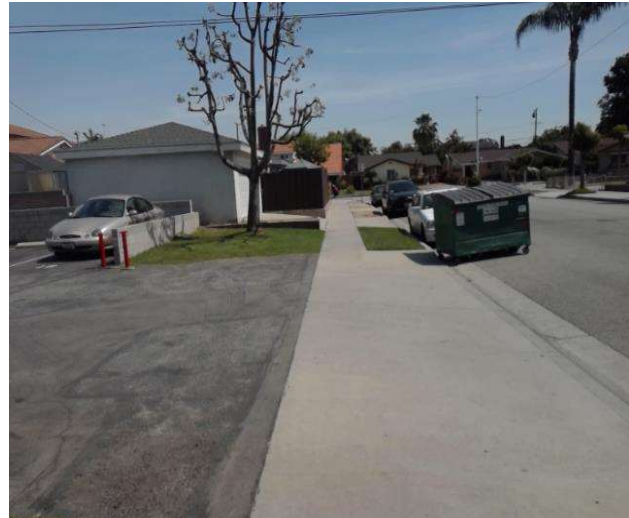
Code Reference ADA 206, 302,CA 11B-403.3

Recommendation Up to 2.08 percent

Repave surface \$1,092

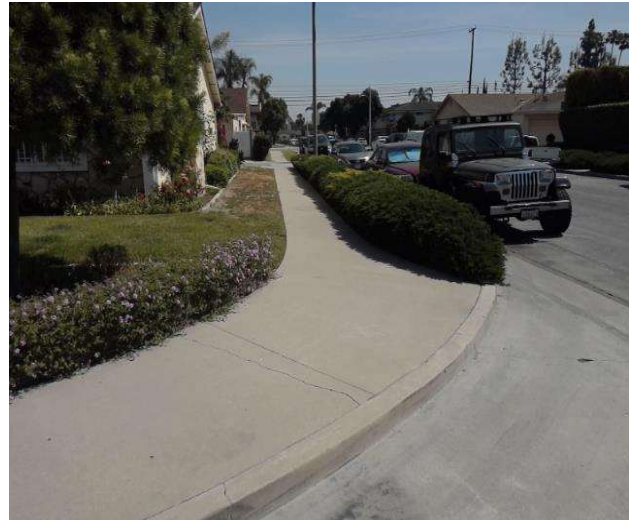
Sidewalks , Hazards & Gratings : Curb is on Path of Travel

Code Reference ADA 402, 303, 406, 403.4, 303.4

Install curb ramp \$2,500

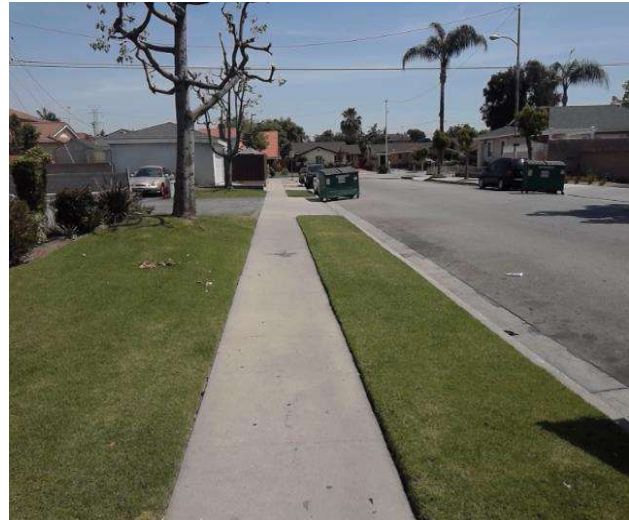
Code Reference ADA 206, 302,CA 11B-403.3

Repave the sidewalk surface with the recommended cross slope.

Recommendation Up to 2.08 percent

Repave surface \$1,092

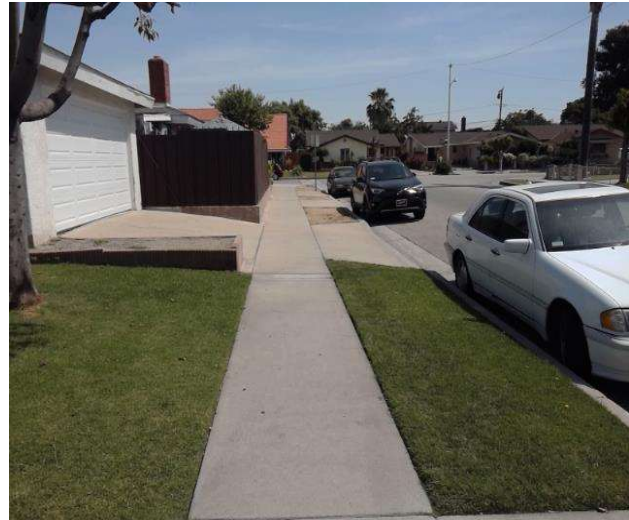
Code Reference ADA 206, 302,CA 11B-403.3

Repave the sidewalk surface with the recommended cross slope.

Recommendation Up to 2.08 percent

Repave surface \$1,092

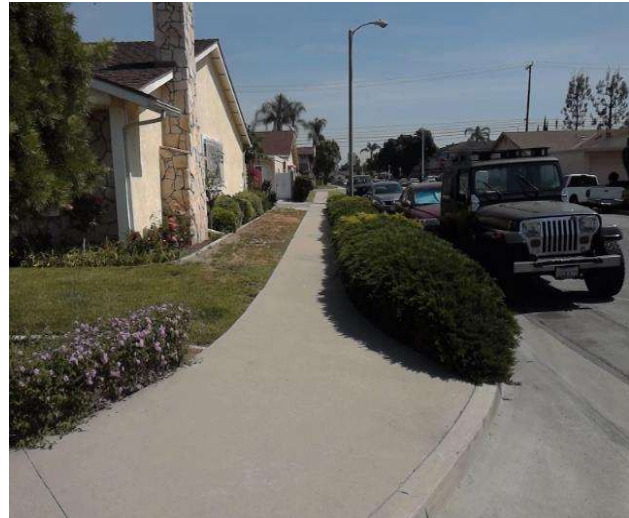
Code Reference ADA 206, 302

Recommendation See Recommendation

\$1,260

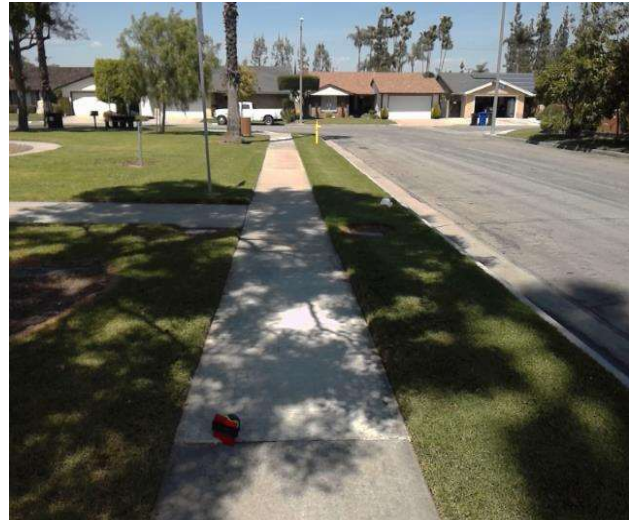
There is a change in elevation greater than recommended value.

Code Reference ADA 206, 302

Ensure that the change in elevation is within the recommended value.

Recommendation Up to 0.25 inches

Remove tripping hazards \$198

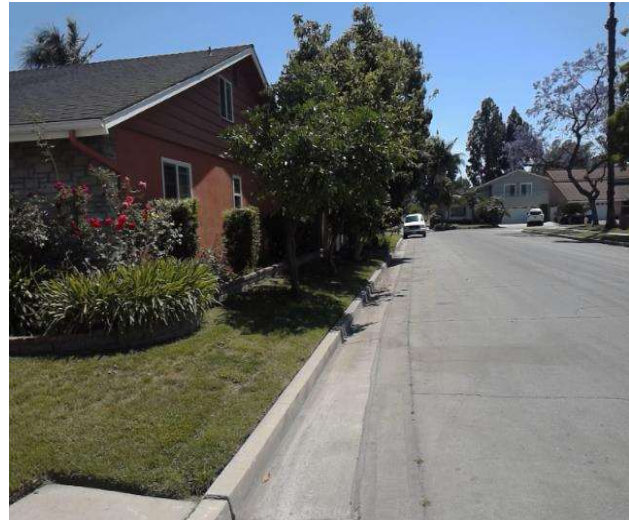
On-Site Finding Not Found

Code Reference ADA 206

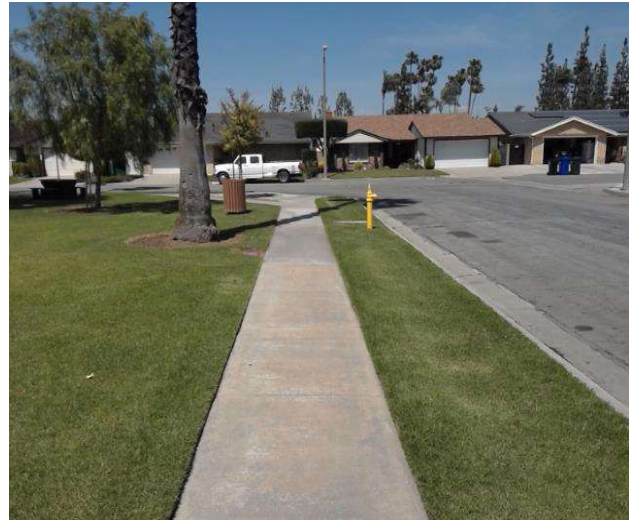
Code Reference ADA 206, 302,CA 11B-403.3

Repave the sidewalk surface with the recommended cross slope.

Recommendation Up to 2.08 percent

Repave surface \$1,092

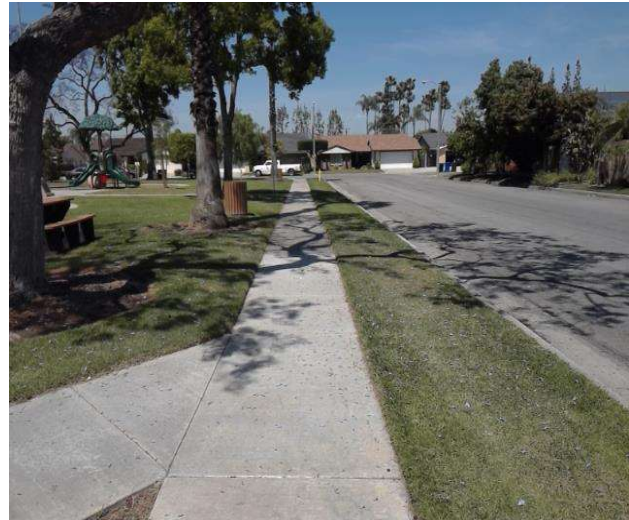
Code Reference ADA 206, 302, CA 11B-403.3

Repave the sidewalk surface with the recommended cross slope.

Recommendation Up to 2.08 percent

Repave surface \$1,092

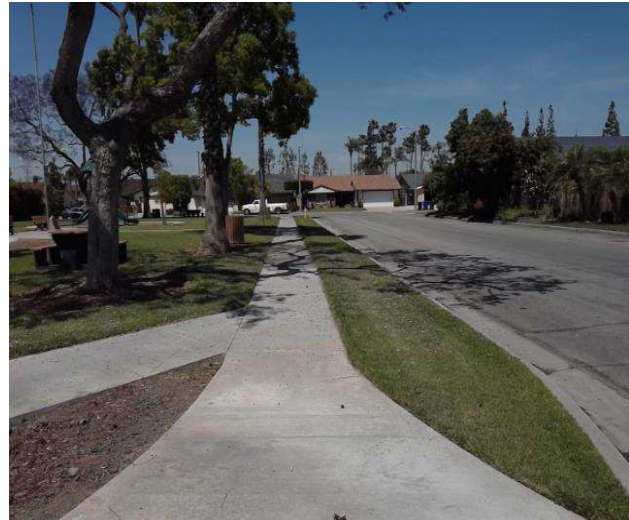
On-Site Finding Not Found

Code Reference ADA 206, 302

\$2,400

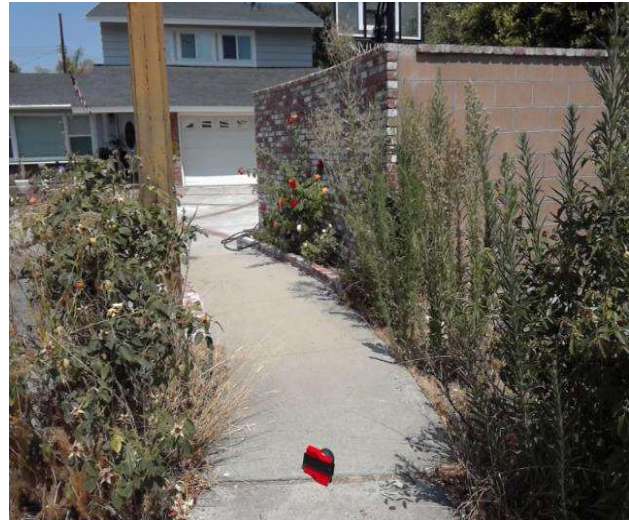
There is a change in elevation greater than recommended value.

Code Reference ADA 206, 302

Ensure that the change in elevation is within the recommended value.

Recommendation Up to 0.25 inches

Remove tripping hazards \$198

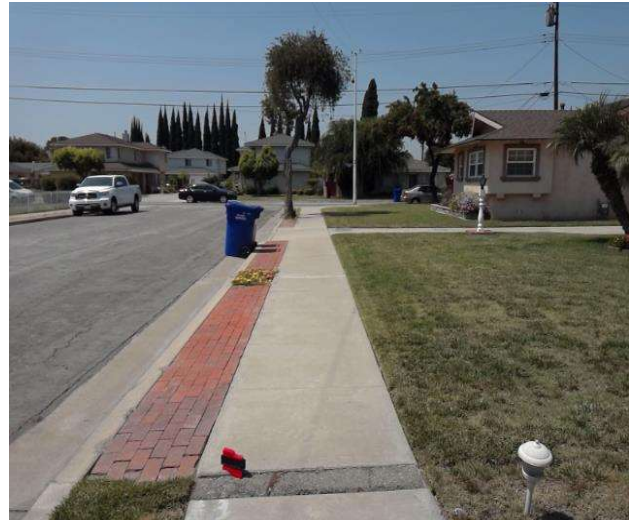
There is a change in elevation greater than recommended value.

Code Reference ADA 206, 302

Notes : Surface is Rough And Uneven.

Ensure that the change in elevation is within the recommended value.

Recommendation Up to 0.25 inches

Remove tripping hazards \$198

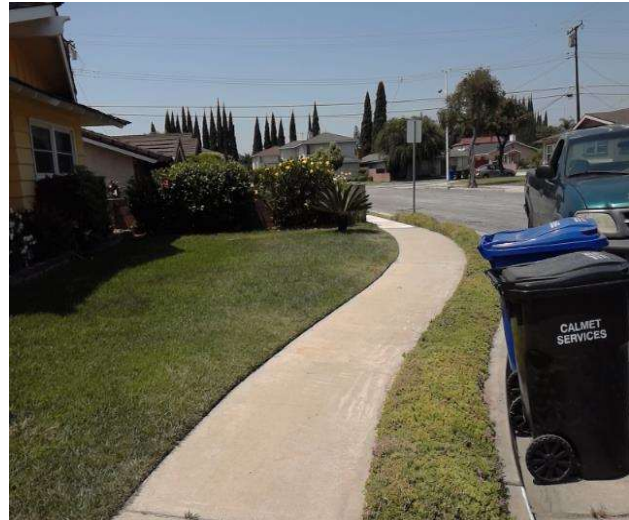
Code Reference ADA 206, 302, CA 11B-403.3

Repave the sidewalk surface with the recommended cross slope.

Recommendation Up to 2.08 percent

Repave surface \$1,092

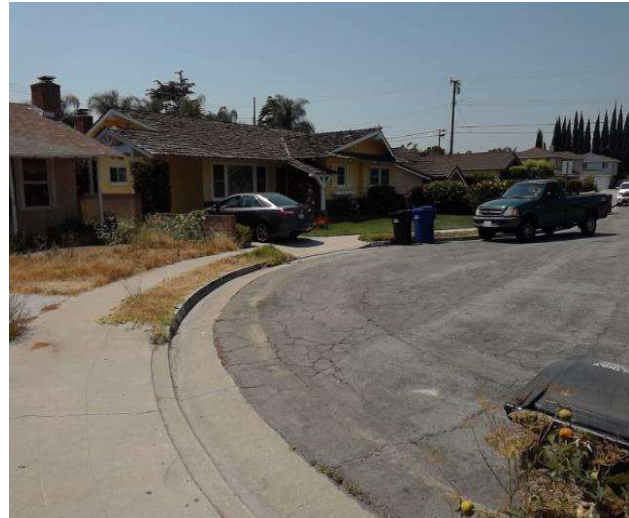
On-Site Finding Not Found

Code Reference ADA 206, 302

\$2,400

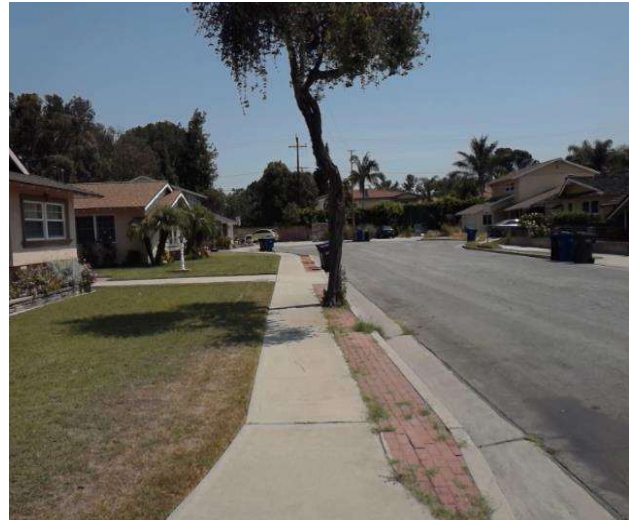
On-Site Finding Not Found

Code Reference ADA 206, 302

\$2,400
