Accessibility Survey

City of Downey Via Amorita - Bellder Drive to Bellman Avenue

Date of Inspection
7/28/2017

Prepared By
Disability Access Consultants
(800) 743-7067

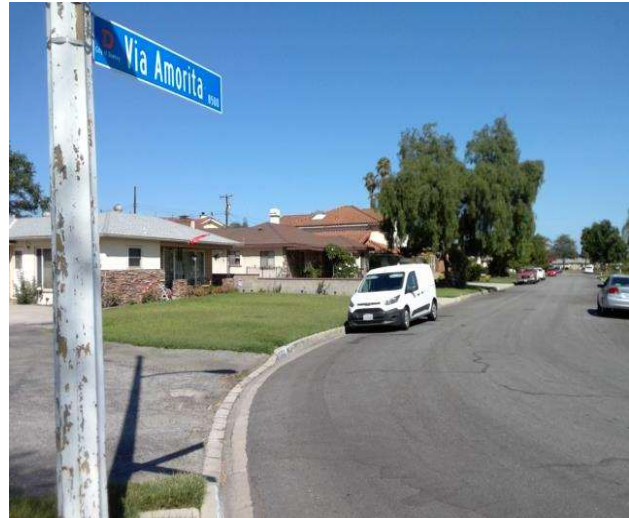
North Side @ 33.947219353437, -118.122469335794

Sidewalks : No Sidewalk

No sidewalk exists at the location.

No action necessary until a sidewalk is provided.

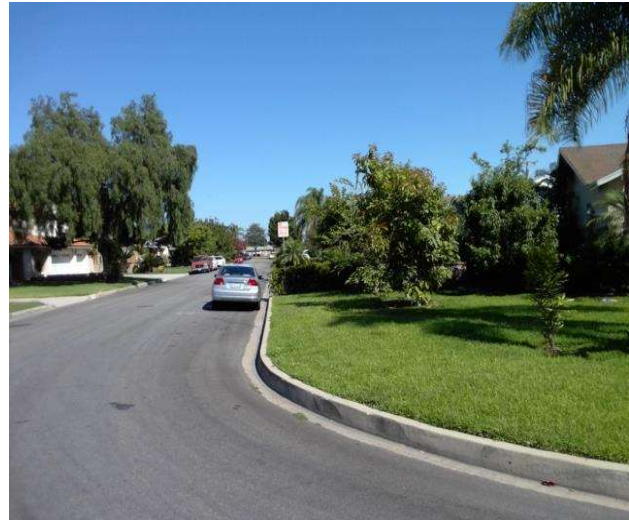
South Side @ 33.947125902009, -118.122488111258

Sidewalks : No Sidewalk

No sidewalk exists at the location.

No action necessary until a sidewalk is provided.

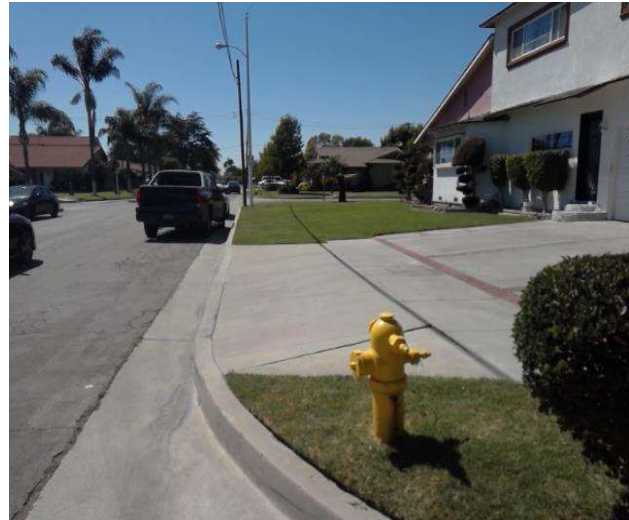
North Side @ 33.936702086302, -118.103998303413

Sidewalks : No Sidewalk

No sidewalk exists at the location.

No action necessary until a sidewalk is provided.

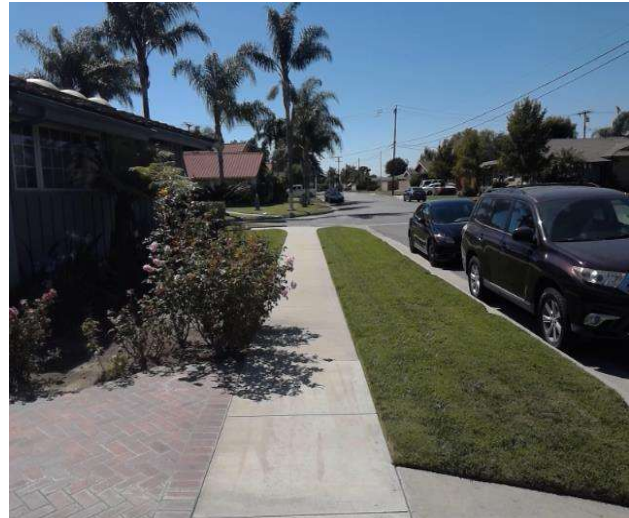
Sidewalk West of Gaybrook Avenue to Pico Vista Road @ 33.936626425807, - 118.104196786880

Sidewalks , Surface : Cross Slope

Sidewalk cross slope is not compliant.

On-Site Finding 3.30 percent for 80.00 feet

Repave the sidewalk surface with the recommended cross slope.

Recommendation Up to 2.08 percent

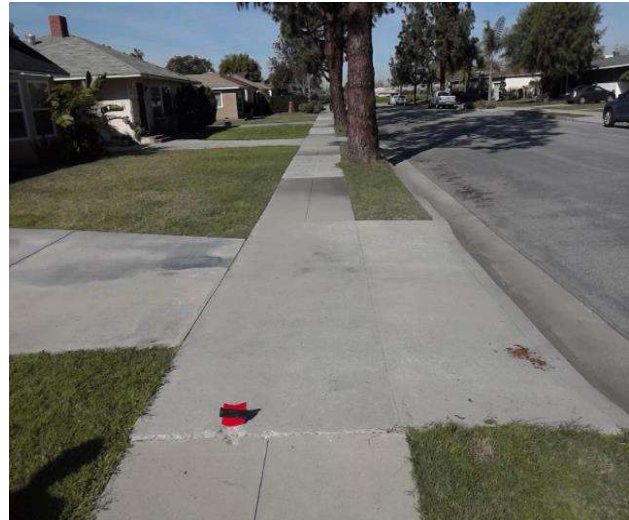
Change In Level West Of Susan Avenue @ 33.957991167907, -118.145036101341

Sidewalks , Change in Level : Change in Level - Beveled

There is a change in elevation greater than recommended value.

On-Site Finding 0.75 inches

Ensure that the change in elevation not exceed a .5 beveled inch.

Recommendation Up to 0.50 inches

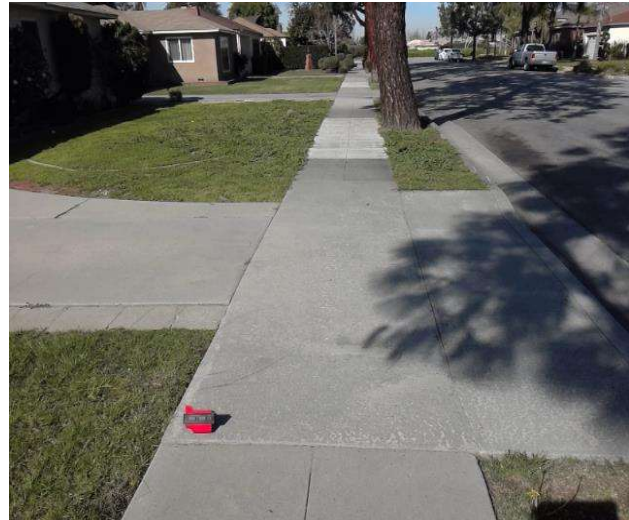
Change In Level West Of Susan Avenue @ 33.958204743749, -118.145400881767

Sidewalks , Change in Level : Change in Level - Beveled

There is a change in elevation greater than recommended value.

On-Site Finding 0.75 inches

Ensure that the change in elevation not exceed a .5 beveled inch.

Recommendation Up to 0.50 inches

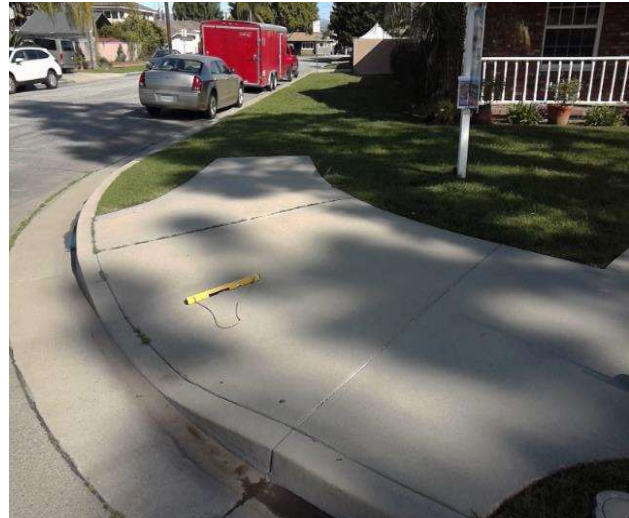
Northeast Corner Of Susan Avenue @ 33.957688601213, - 118.144113421440

Curb Ramp : No Detectable Warnings

The curb ramp does not provide a detectable warning surface which includes truncated domes.

Provide compliant detectable warnings to surface.

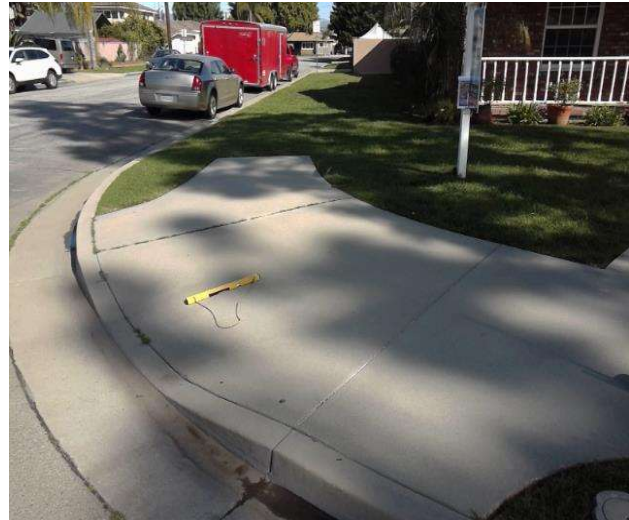
Northeast Corner Of Susan Avenue @ 33.957688601213, - 118.144113421440

Curb Ramp : Curb Ramp Slope

The running slope is greater than allowed.

On-Site Finding 15.50 percent

Provide a compliant curb ramp.

Recommendation Up to 8.33 percent

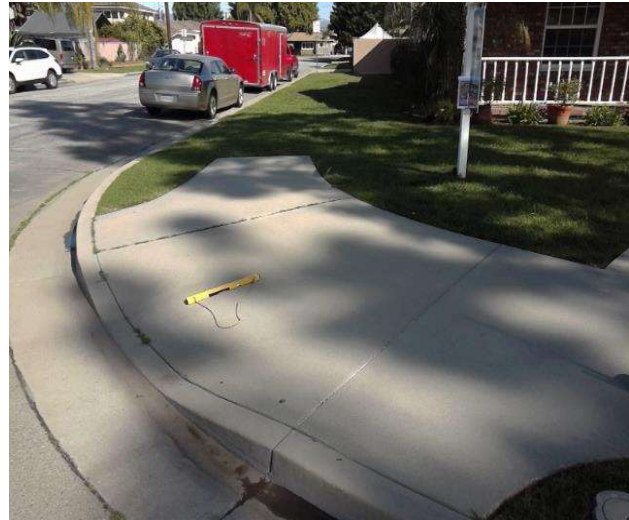
Northeast Corner Of Susan Avenue @ 33.957688601213, - 118.144113421440

Curb Ramp : Side Flare Slope

The slope of the curb ramp side flare is greater than allowed.

On-Site Finding 13.00 percent

Provide curb ramp side flares with a compliant slope.

Recommendation Up to 10.00 percent

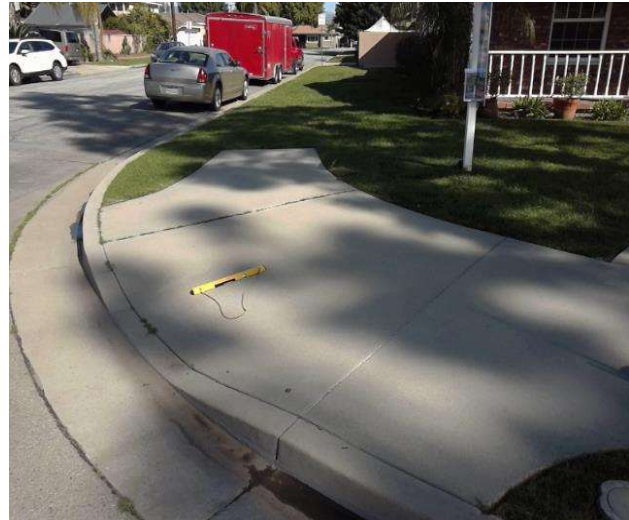
Northeast Corner Of Susan Avenue @ 33.957688601213, - 118.144113421440

Curb Ramp : Bottom Landing Slope

The bottom landing of the curb ramp is on the street, and the slope of the bottom landing is not compliant.

On-Site Finding 11.50 percent

Ensure the bottom landing slope is compliant and provides a smooth transition.

Recommendation Up to 5.00 percent

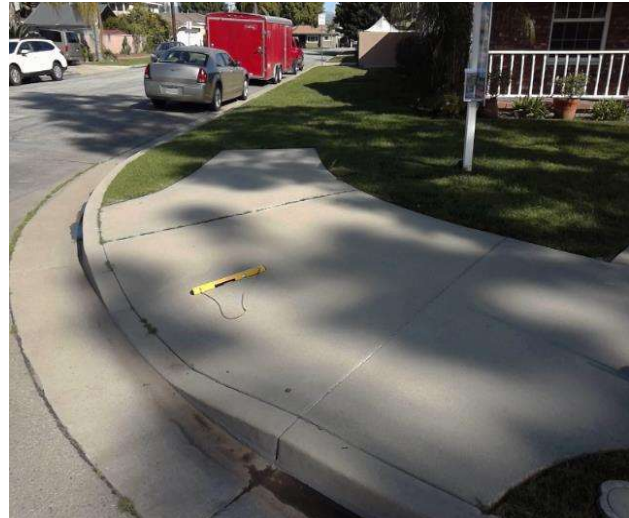
Northeast Corner Of Susan Avenue @ 33.957688601213, - 118.144113421440

Curb Ramp , Landings and Transitions : Top Landing Slope

The slope at the top landing is greater than allowed.

On-Site Finding 4.00 percent

Recommendation Up to 2.08 percent

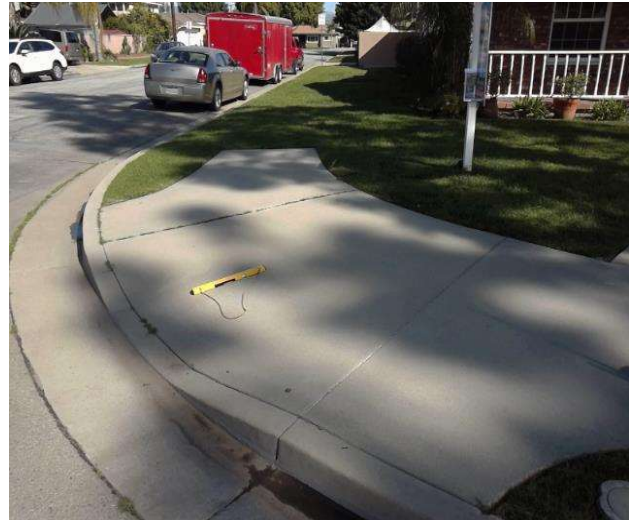
Curb Ramp , Landings and Transitions : Top Landing Clear Length - Landings

Recommendation At least 48.00 inches

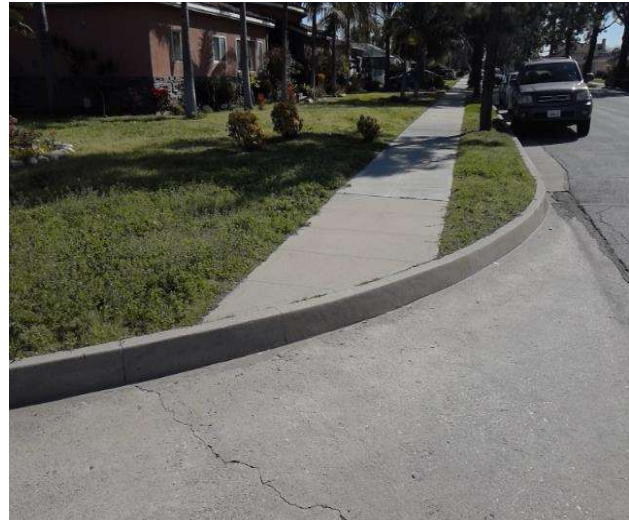
Sidewalks , Hazards & Gratings : Curb is on Path of Travel

Recommendation See Recommendation

Install curb ramp \$2,500

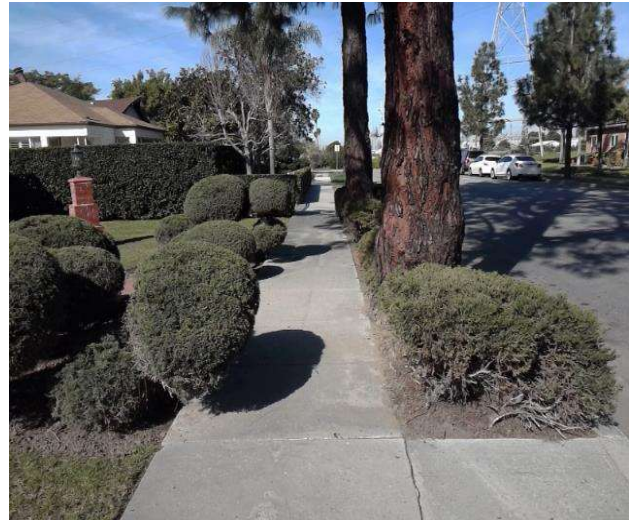
Sidewalks , Hazards & Gratings : Sidewalk Width at Obstruction

Sidewalk width at the obstruction shall have the recommended value.

Recommendation At least 48.00 inches

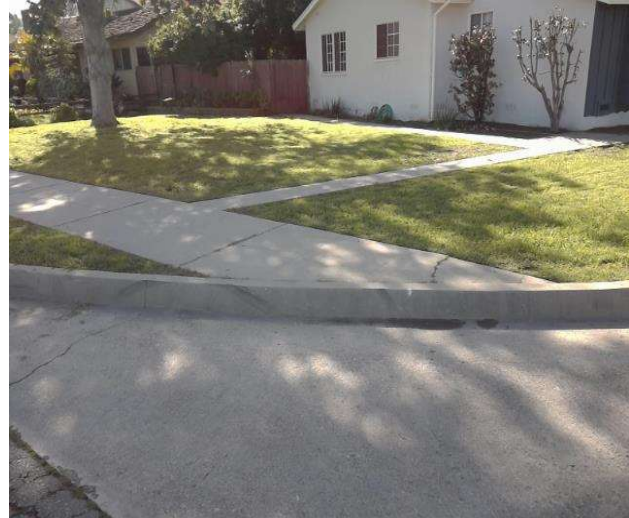
Sidewalks , Hazards & Gratings : Curb is on Path of Travel

Install curb ramp \$2,500

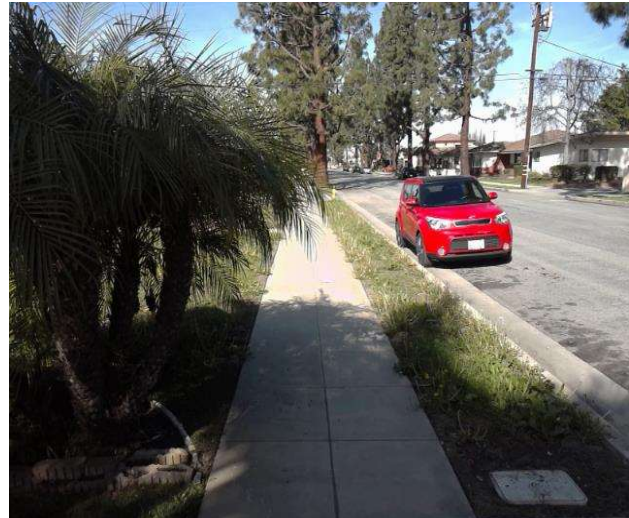
Sidewalks , Hazards & Gratings : Overhead Obstruction Height

Recommendation At least 80.00 inches
