Accessibility Survey

City of Downey Bellder Drive - Everest Street To Imperial Highway

Date of Inspection
2/4/2017

Disability Access Consultants

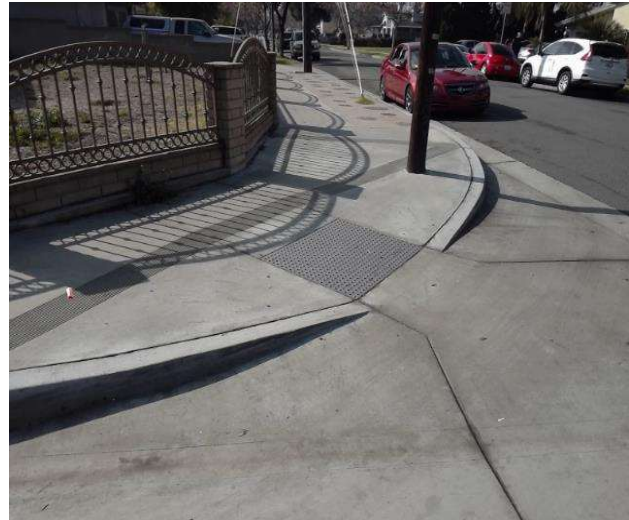
Southeast Corner Of Everest Street @ 33.921455138573, - 118.141270279884

Utilities, gratings or other appurtenances are located on the curb ramp.

On-Site Finding Not Compliant

Code Reference ADA 303.3,CA 11B-303.3

Provide a compliant curb ramp free of appurtenances.

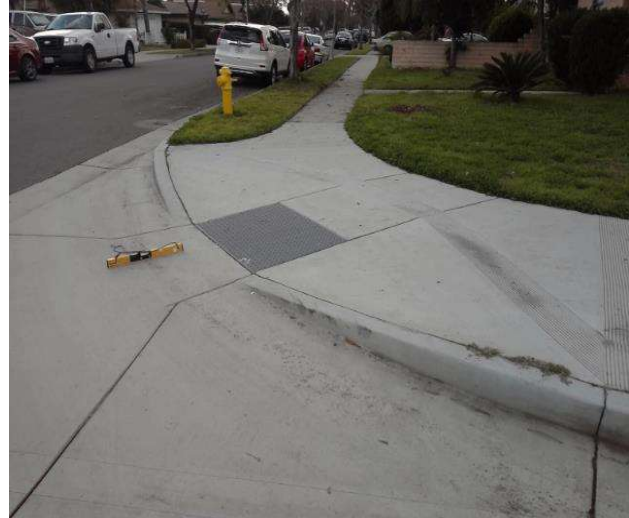
Southwest Corner Of Everest Street @ 33.921536376806, - 118.141396343708

There is not enough top landing clear length.

On-Site Finding 42.50 inches

Code Reference ADA 406, 406.4,CA 11B-406.5.3

Provide a level top landing with enough clear length.

Recommendation At least 48.00 inches

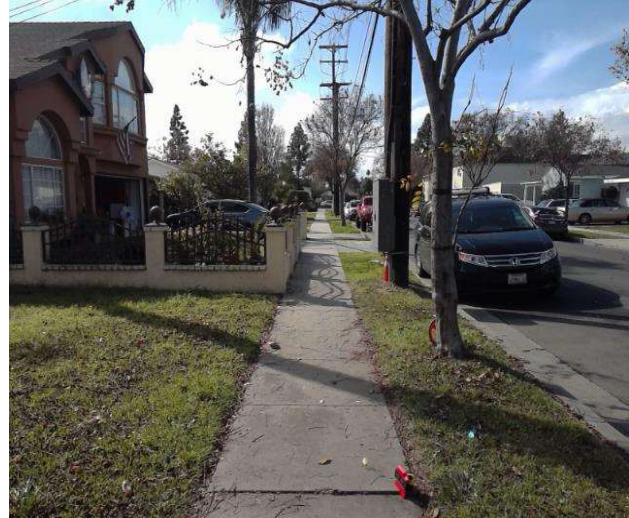
Change In Level South Of Meadow Road @ 33.920153090564, -118.142250627279

There is a change in elevation greater than recommended value.

On-Site Finding 0.62 inches

Ensure that the change in elevation is within the recommended value.

Recommendation Up to 0.25 inches

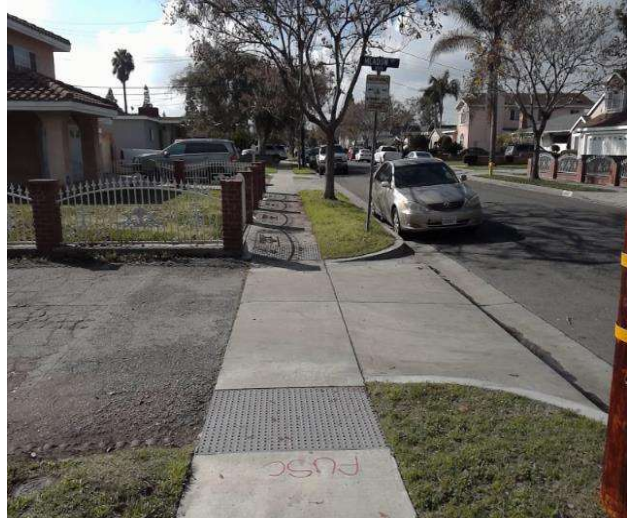
Meadow Road East Crossing @ 33.920725103849, -118.141833543777

Slope at vehicular traffic is not compliant.

On-Site Finding 8.00 percent

Repave the surface to provide a compliant slope.

Recommendation Up to 5.00 percent

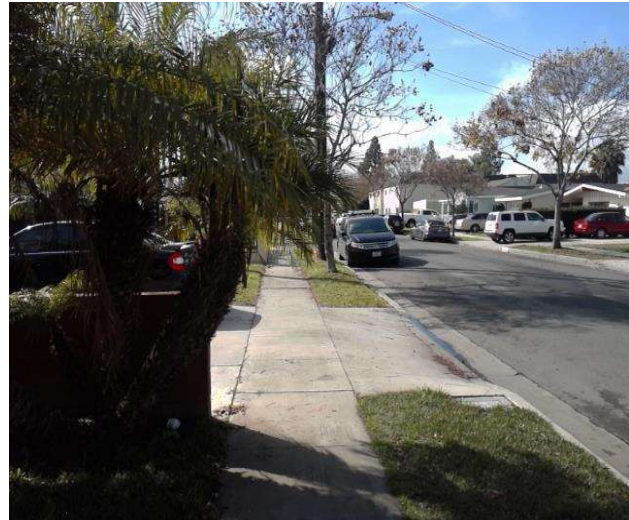
Tree South Of Meadow Road @ 33.920223201348, -118.142205029726

Overhead obstruction height is not compliant.

On-Site Finding 70.00 inches

Code Reference ADA 206, 307.4, CA 11B-307.4

Provide a compliant vertical clearance height.

Recommendation At least 80.00 inches

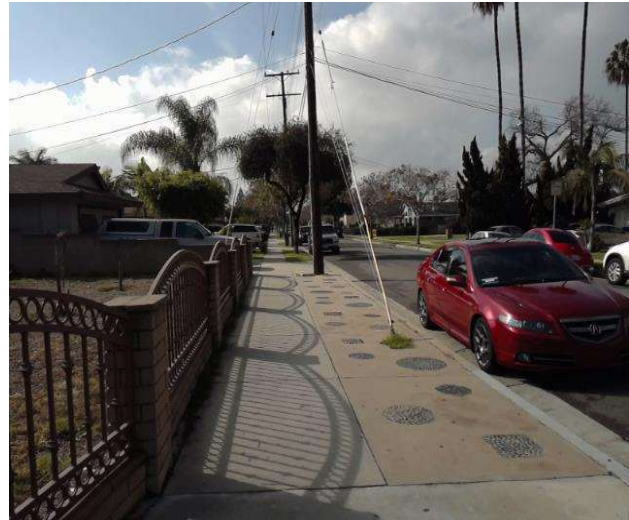
East Side @ 33.921455138573, -118.141270279884

There is no 60X60 turn area at every 200 feet.

On-Site Finding Not Found

Provide a 60X60 turn every 200 feet on the sidewalk.

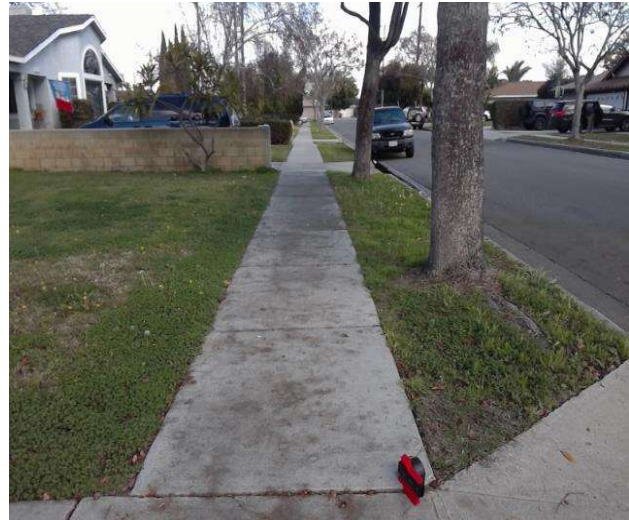
Change In Level North Of Imperial Highway @ 33.919510, -118.142001181841

There is a change in elevation greater than recommended value.

On-Site Finding 0.75 inches

Ensure that the change in elevation is within the recommended value.

Recommendation Up to 0.25 inches

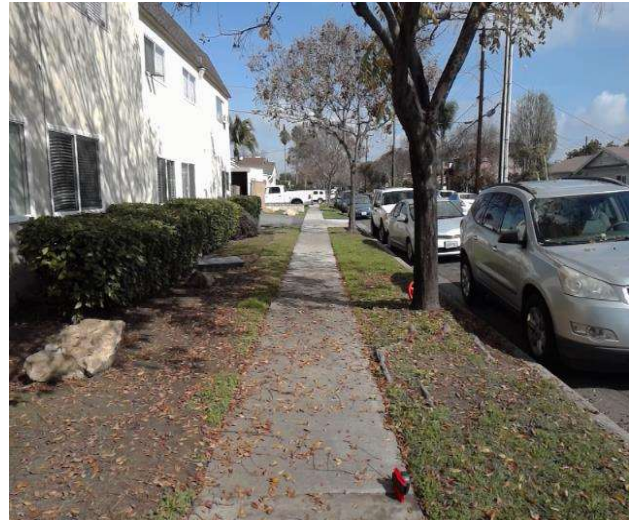
Change In Level North Of Imperial Highway @ 33.919568831784, - 118.142874240875

There is a change in elevation greater than recommended value.

On-Site Finding 0.75 inches

Ensure that the change in elevation is within the recommended value.

Recommendation Up to 0.25 inches

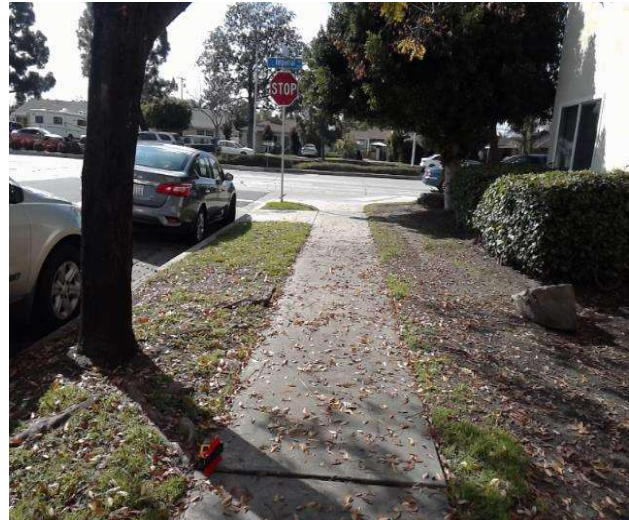
Change In Level North Of Imperial Highway @ 33.919594427967, - 118.142854124308

There is a change in elevation greater than recommended value.

On-Site Finding 0.62 inches

Ensure that the change in elevation is within the recommended value.

Recommendation Up to 0.25 inches

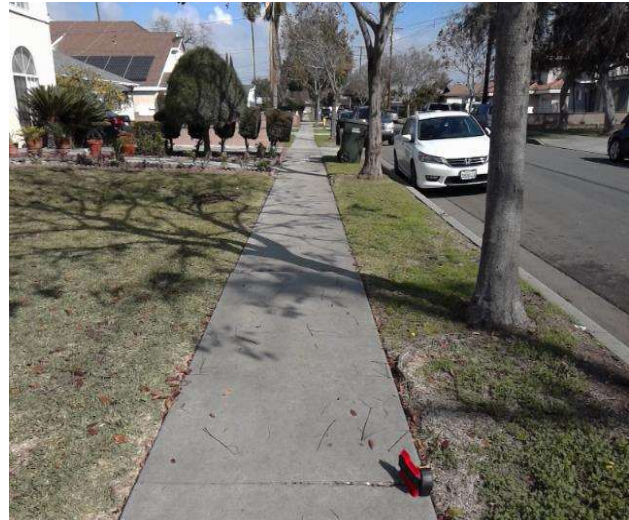
Change In Level North Of Imperial Highway @ 33.920249910203, - 118.142352551222

There is a change in elevation greater than recommended value.

On-Site Finding 0.75 inches

Ensure that the change in elevation is within the recommended value.

Recommendation Up to 0.25 inches

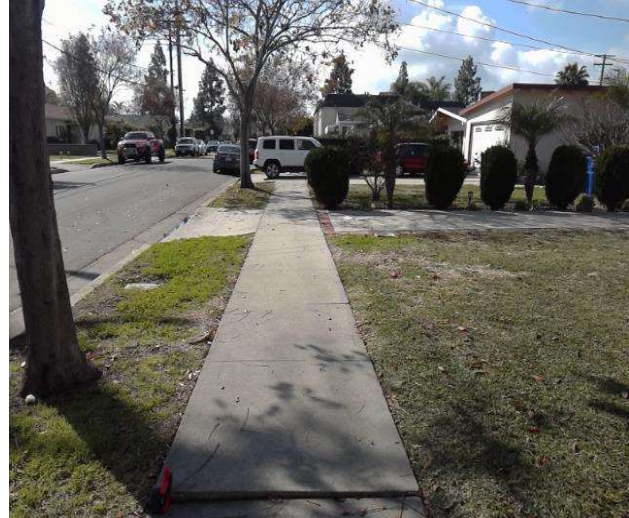
Change In Level North Of Imperial Highway @ 33.920277731918, - 118.142341822386

There is a change in elevation greater than recommended value.

On-Site Finding 1.50 inches

Ensure that the change in elevation is within the recommended value.

Recommendation Up to 0.25 inches

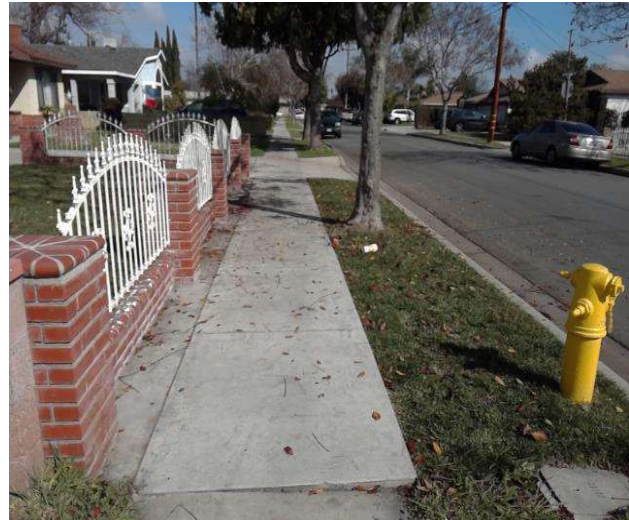
Change In Level North Of Imperial Highway @ 33.920607140334, - 118.142092376947

There is a change in elevation greater than recommended value.

On-Site Finding 1.75 inches

Ensure that the change in elevation is within the recommended value.

Recommendation Up to 0.25 inches

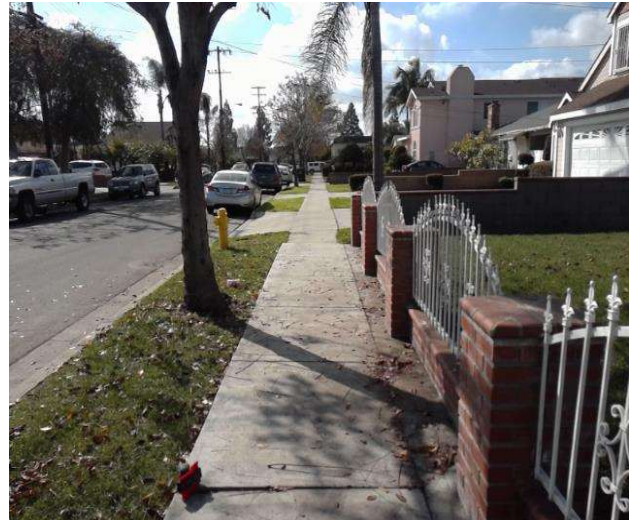
Change In Level North Of Imperial Highway @ 33.920668347839, - 118.142045438290

There is a change in elevation greater than recommended value.

On-Site Finding 0.87 inches

Ensure that the change in elevation is within the recommended value.

Recommendation Up to 0.25 inches

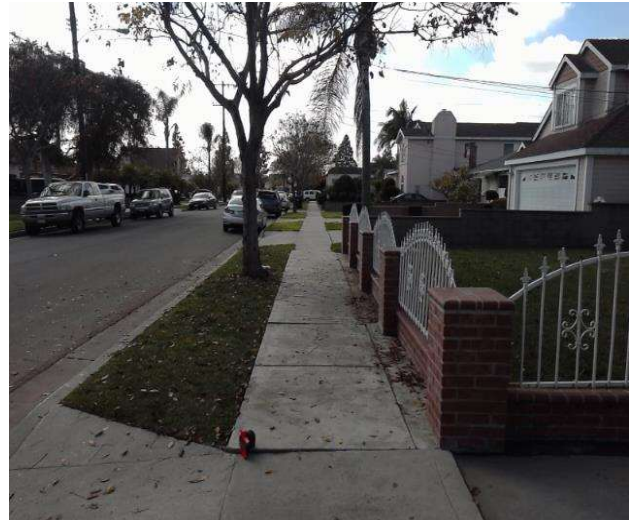
Change In Level North Of Imperial Highway @ 33.920686153650, - 118.142036050558

There is a change in elevation greater than recommended value.

On-Site Finding 1.12 inches

Ensure that the change in elevation is within the recommended value.

Recommendation Up to 0.25 inches

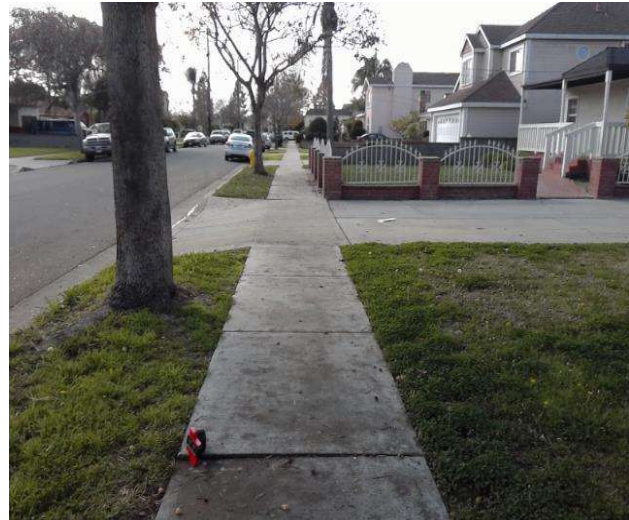
Change In Level North Of Imperial Highway @ 33.920771844065, - 118.141975700855

There is a change in elevation greater than recommended value.

On-Site Finding 0.87 inches

Ensure that the change in elevation is within the recommended value.

Recommendation Up to 0.25 inches

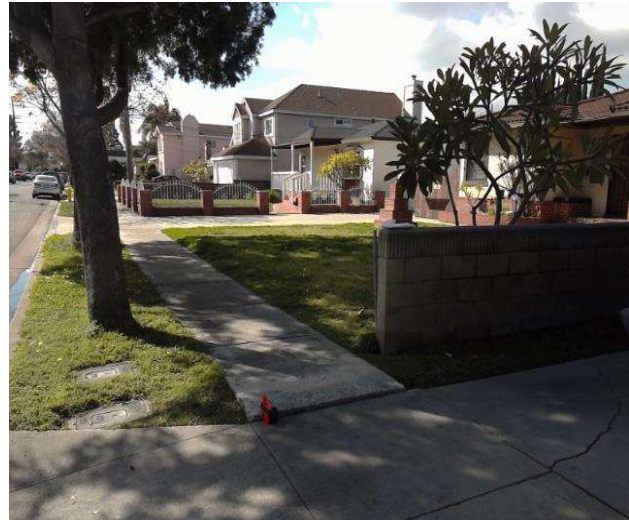
Change In Level North Of Imperial Highway @ 33.920786311269, - 118.141940832138

There is a change in elevation greater than recommended value.

On-Site Finding 1.50 inches

Ensure that the change in elevation is within the recommended value.

Recommendation Up to 0.25 inches

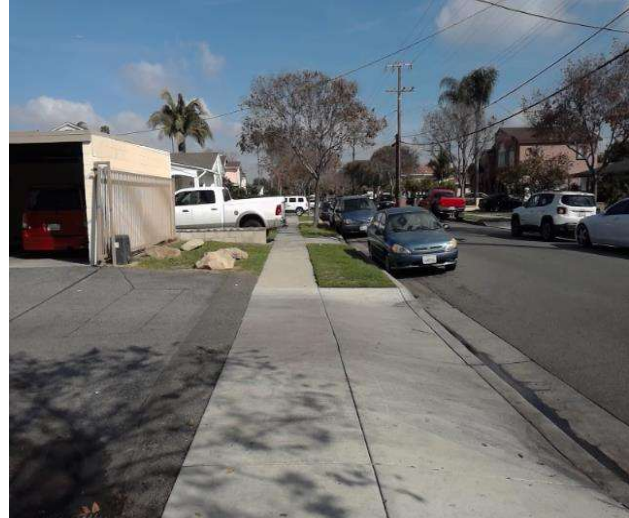
Driveway North Of Imperial Highway @ 33.919782504031, -118.142711967230

There are no detectable warnings where the pedestrian route crosses vehicular traffic.

On-Site Finding Not Found

Code Reference ADA 705,CA 11B-705.1.2.5,CA 11B-247.1.2.5

Provide detectable warnings.

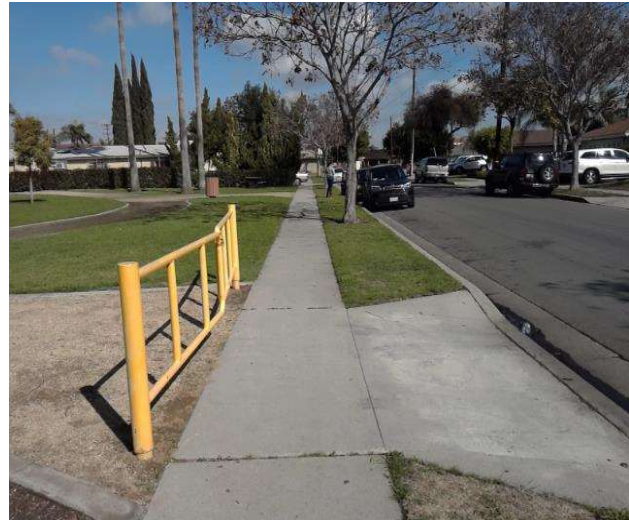
Driveway North Of Imperial Highway @ 33.920958804670, -118.141830861568

There are no detectable warnings where the pedestrian route crosses vehicular traffic.

On-Site Finding Not Found

Code Reference ADA 705,CA 11B-705.1.2.5,CA 11B-247.1.2.5

Provide detectable warnings.

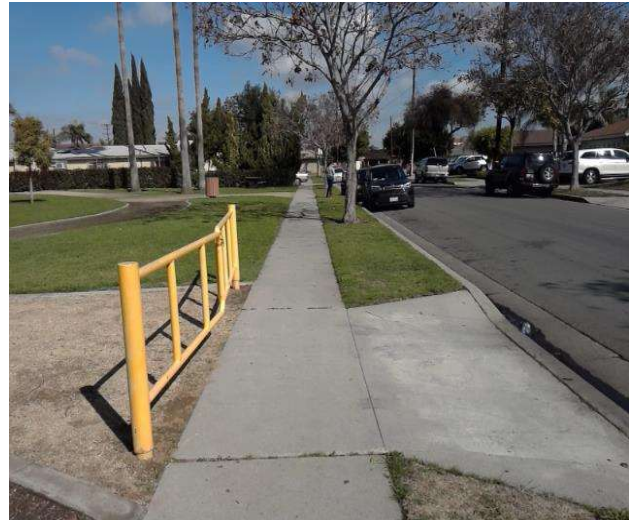
Driveway North Of Imperial Highway @ 33.920958804670, -118.141830861568

Cross slope at vehicular traffic is not compliant.

On-Site Finding 2.80 percent

Code Reference ADA 206, 302,CA 11B-403.3

Repave the surface to provide a compliant cross slope.

Recommendation Up to 2.08 percent

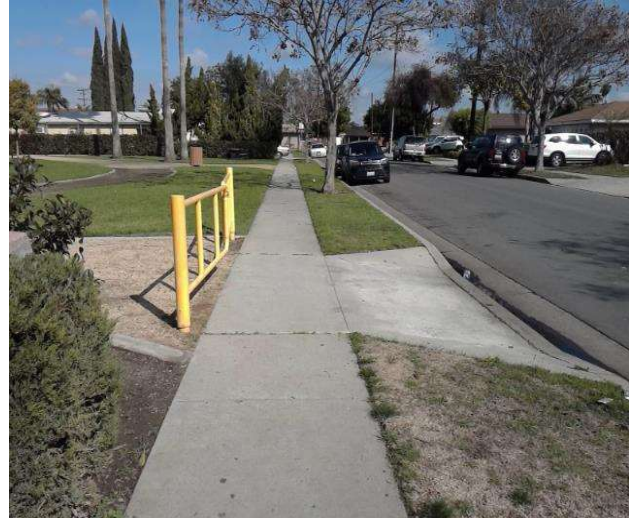
Sidewalk North Of Imperial Highway @ 33.920932096038, -118.141848295927

Sidewalk does not have enough width.

On-Site Finding 47.00 inches for 249.00 feet

Code Reference ADA 206, 302,CA 11B-403.5.1

Widen the sidewalk to the recommended value.

Recommendation At least 48.00 inches

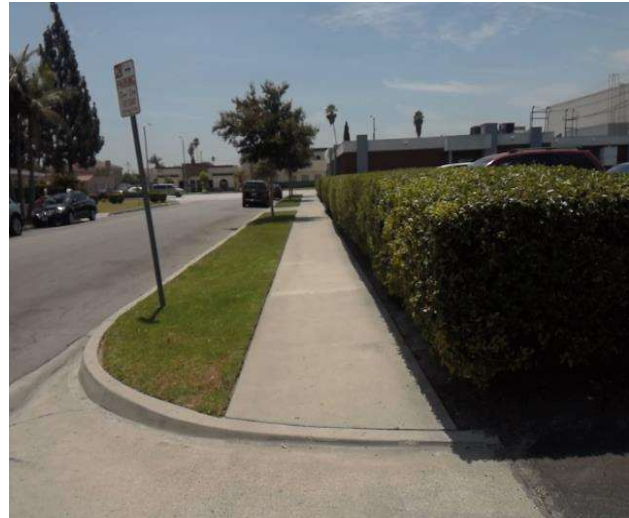
Sidewalks , Hazards & Gratings : Curb is on Path of Travel

Code Reference ADA 402, 303, 406, 403.4, 303.4

Install curb ramp \$2,500

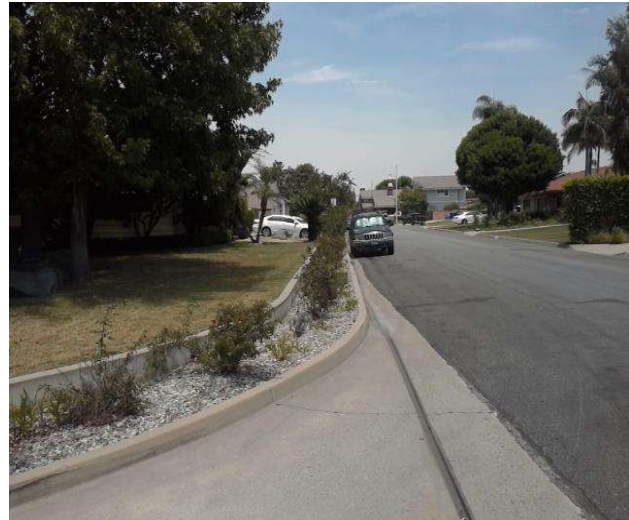
Sidewalks : Missing Sidewalk

Section of sidewalk is missing and consists of dirt, grass or gravel.

Provide a compliant sidewalk for the missing section.

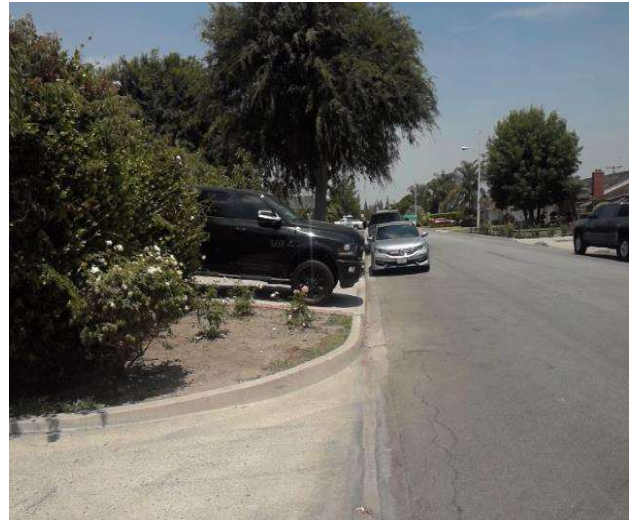
Sidewalks : Missing Sidewalk

Section of sidewalk is missing and consists of dirt, grass or gravel.

Provide a compliant sidewalk for the missing section.

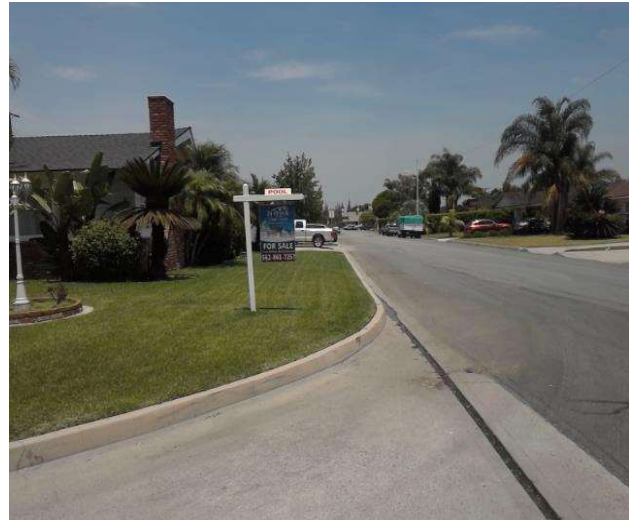
Sidewalks : Missing Sidewalk

Section of sidewalk is missing and consists of dirt, grass or gravel.

Provide a compliant sidewalk for the missing section.
