Accessibility Survey

City of Downey Century Boulevard - End To Downey Avenue

Date of Inspection
11/29/2016

Prepared By
Disability Access Consultants
(800) 743-7067

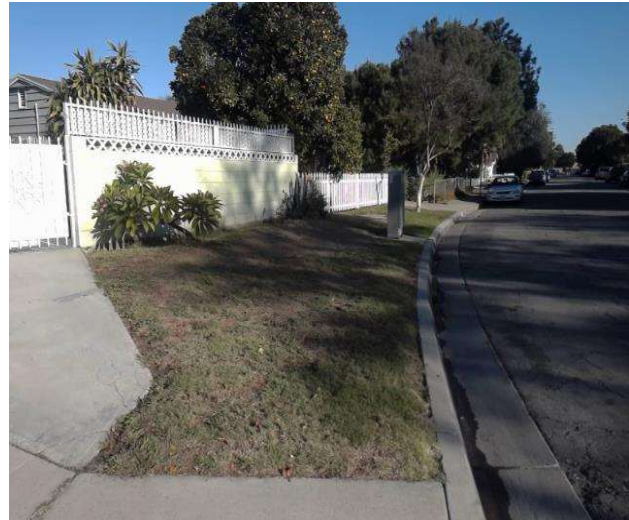
Sidewalk East Of Downey Avenue @ 33.906271131774, -118.151170313358

Section of sidewalk is missing and consists of dirt, grass or gravel.

On-Site Finding 65.00 feet

Provide a compliant sidewalk for the missing section.

\$1,260

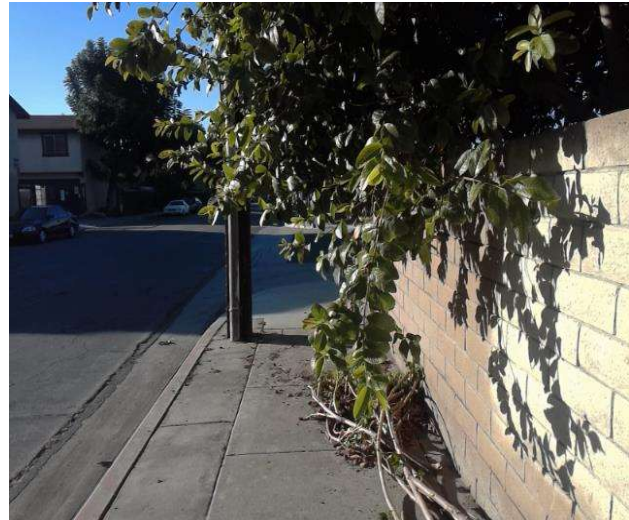
Tree East Of Earnshaw Avenue @ 33.905380686050, -118.149174749851

Overhead obstruction height is not compliant.

On-Site Finding 36.00 inches

Provide a compliant vertical clearance height.

Recommendation At least 80.00 inches

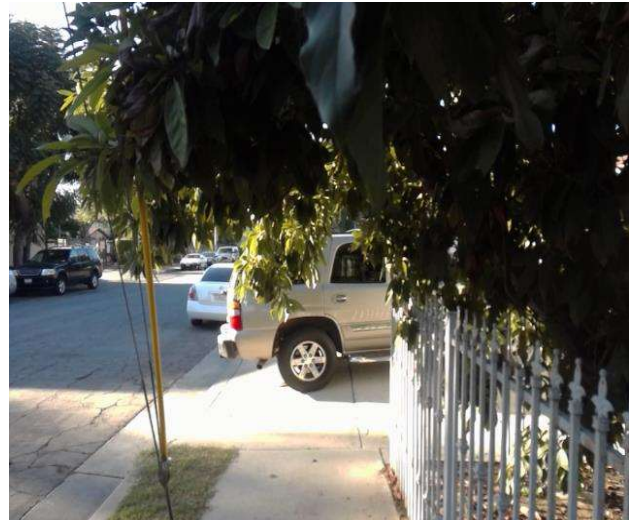
Tree East Of Earnshaw Avenue @ 33.905656725219, -118.149740695953

Overhead obstruction height is not compliant.

On-Site Finding 48.00 inches

Provide a compliant vertical clearance height.

Recommendation At least 80.00 inches

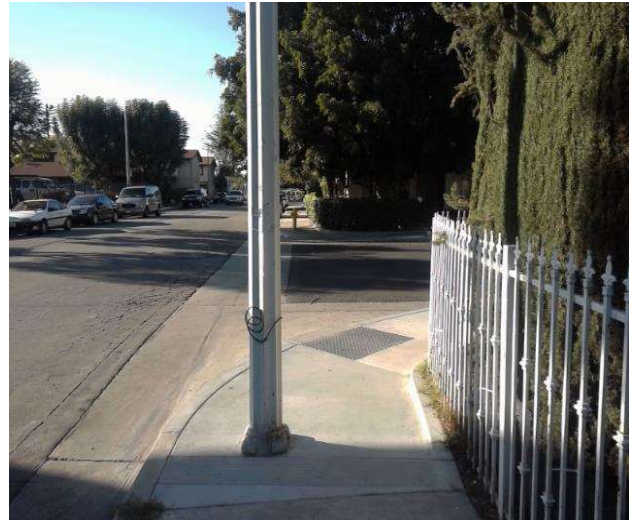
Utility Pole East Of Earnshaw Avenue @ 33.905743543805, -118.149960637093

Sidewalk width at the obstruction is not compliant.

On-Site Finding 38.00 inches

Sidewalk width at the obstruction shall have the recommended value.

Recommendation At least 48.00 inches

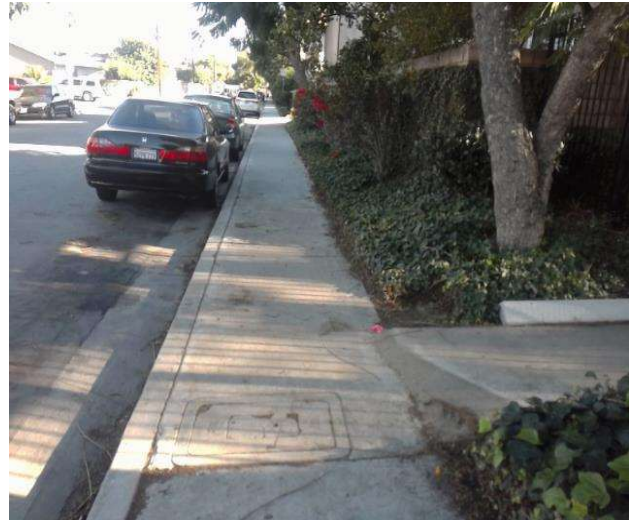
Change In Level West Of End @ 33.905515366563, -118.149772882462

There is a change in elevation greater than recommended value.

On-Site Finding 0.50 inches

Ensure that the change in elevation is within the recommended value.

Recommendation Up to 0.25 inches

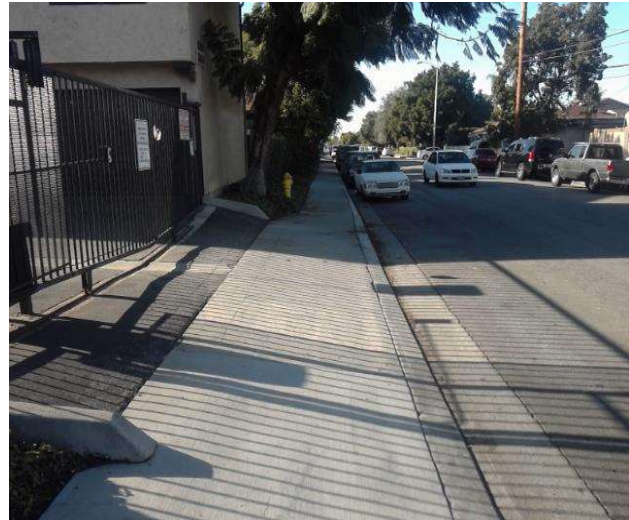
Driveway West Of End @ 33.905404060369, -118.149523437023

There are no detectable warnings where the pedestrian route crosses vehicular traffic.

On-Site Finding Not Found

Provide detectable warnings.

Install compliant detectable warnings \$190

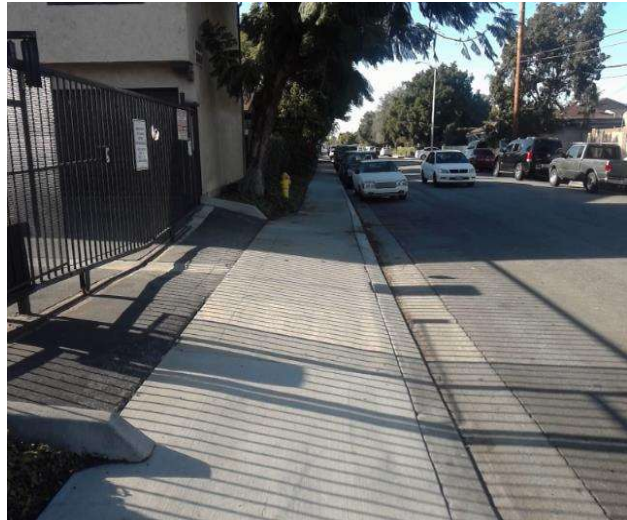
Driveway West Of End @ 33.905404060369, -118.149523437023

Slope at vehicular traffic is not compliant.

On-Site Finding 11.70 percent

Repave the surface to provide a compliant slope.

Recommendation Up to 5.00 percent

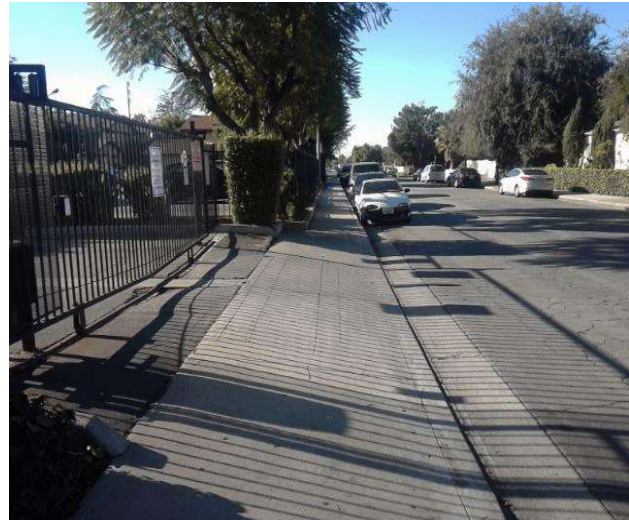
Driveway West Of End @ 33.905693456170, -118.150124251843

There are no detectable warnings where the pedestrian route crosses vehicular traffic.

On-Site Finding Not Found

Provide detectable warnings.

Install compliant detectable warnings \$190

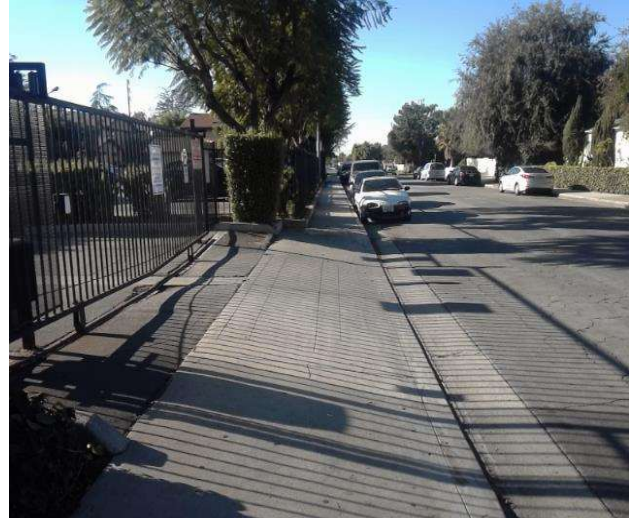
Driveway West Of End @ 33.905693456170, -118.150124251843

Cross slope at vehicular traffic is not compliant.

On-Site Finding 11.20 percent

Repave the surface to provide a compliant cross slope.

Recommendation Up to 2.08 percent

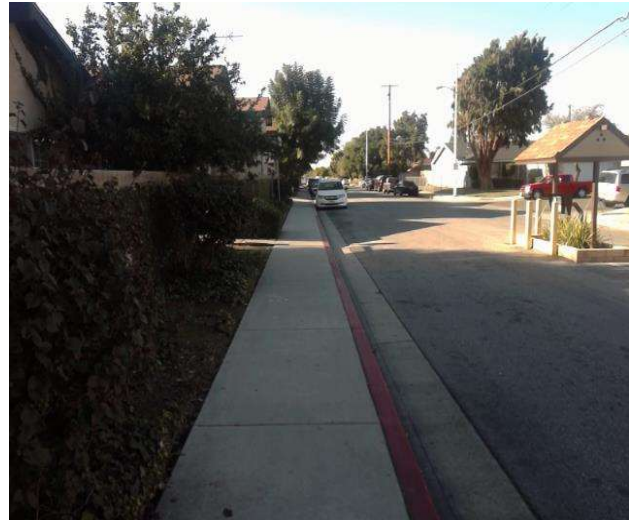
Sidewalk West Of End @ 33.905203708855, -118.149086236954

Sidewalk surface is not slip resistant.

On-Site Finding Not Compliant

Make sure that the sidewalk surface is firm, stable and slip resistant.

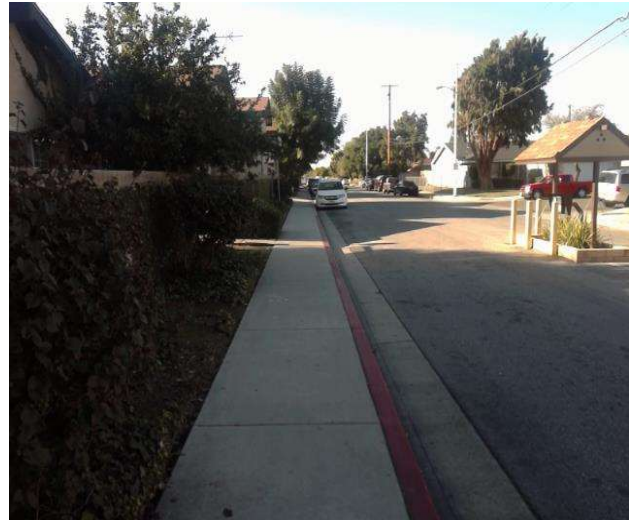
Sidewalk West Of End @ 33.905203708855, -118.149086236954

Sidewalk cross slope is not compliant.

On-Site Finding 6.30 percent for 782.00 feet

Repave the sidewalk surface with the recommended cross slope.

Recommendation Up to 2.08 percent

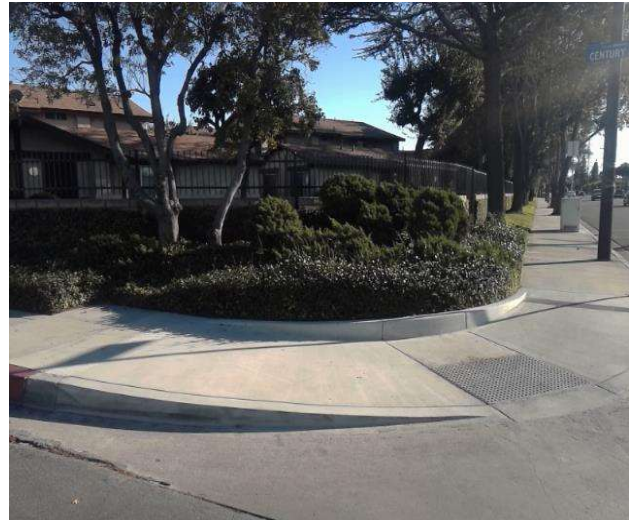
Southeast Corner Of Downey Avenue @ 33.906155374356, - 118.151370137930

The slope at the top landing is greater than allowed.

On-Site Finding 3.10 percent

Provide a top landing surface that does not exceed the maximum slope and cross slope. Provide a sufficient maneuvering clearance that does not accumulate water.

Recommendation Up to 2.08 percent

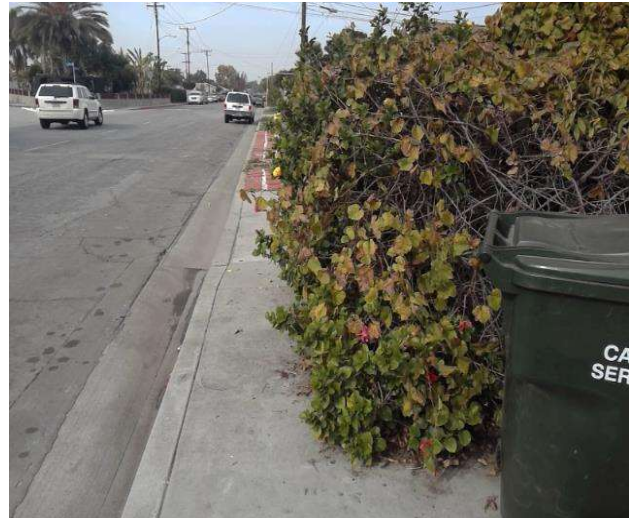
Bush East Of Bixler Avenue @ 33.906669603222, -118.151902556419

Sidewalk width at the obstruction is not compliant.

On-Site Finding 22.00 inches

Sidewalk width at the obstruction shall have the recommended value.

Recommendation At least 48.00 inches

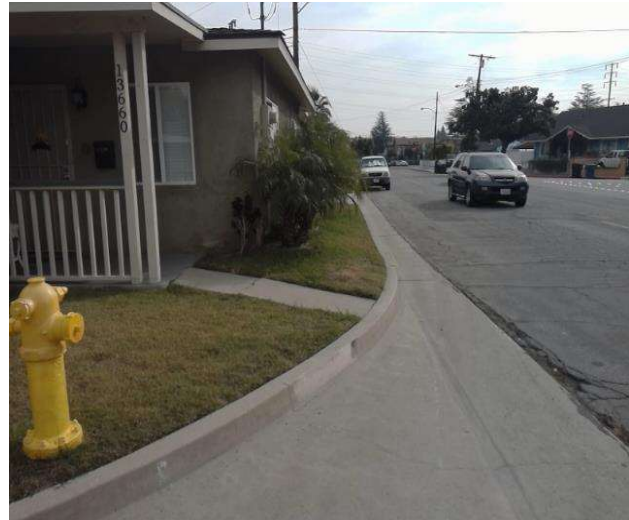
Sidewalk East Of Bixler Avenue @ 33.906948977345, -118.152469843626

Section of sidewalk is missing and consists of dirt, grass or gravel.

On-Site Finding 195.00 feet

Provide a compliant sidewalk for the missing section.

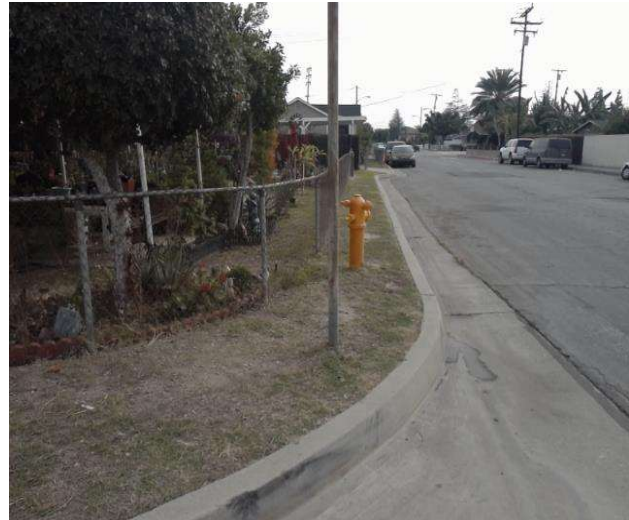
Sidewalk East Of Klondike Avenue @ 33.907250611326, -118.153104186058

Section of sidewalk is missing and consists of dirt, grass or gravel.

On-Site Finding 162.00 feet

Provide a compliant sidewalk for the missing section.

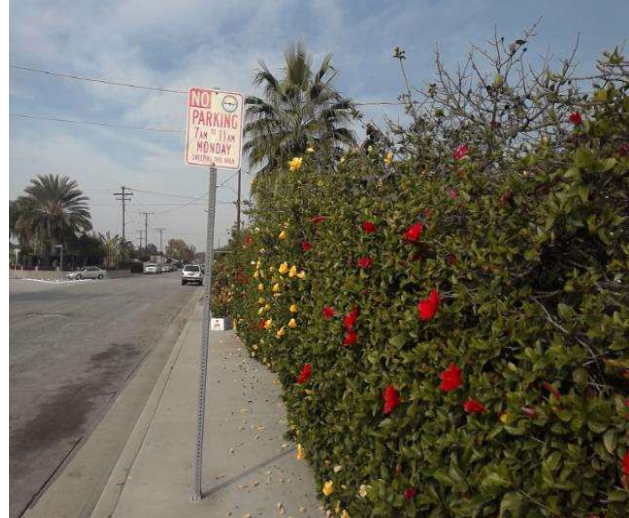
Sign East Of Bixler Avenue @ 33.906608385663, -118.151781857014

Sidewalk width at the obstruction is not compliant.

On-Site Finding 29.00 inches

Sidewalk width at the obstruction shall have the recommended value.

Recommendation At least 48.00 inches

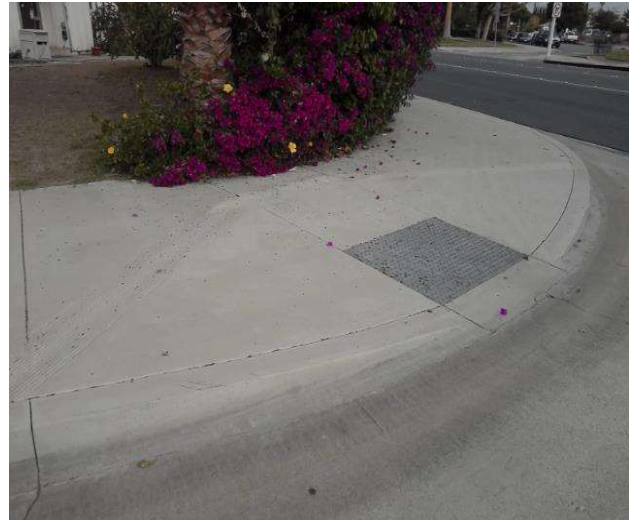
Northwest Corner Of Downey Avenue @ 33.906577220343, - 118.151651769876

The slope at the top landing is greater than allowed.

On-Site Finding 2.80 percent

Provide a top landing surface that does not exceed the maximum slope and cross slope. Provide a sufficient maneuvering clearance that does not accumulate water.

Recommendation Up to 2.08 percent

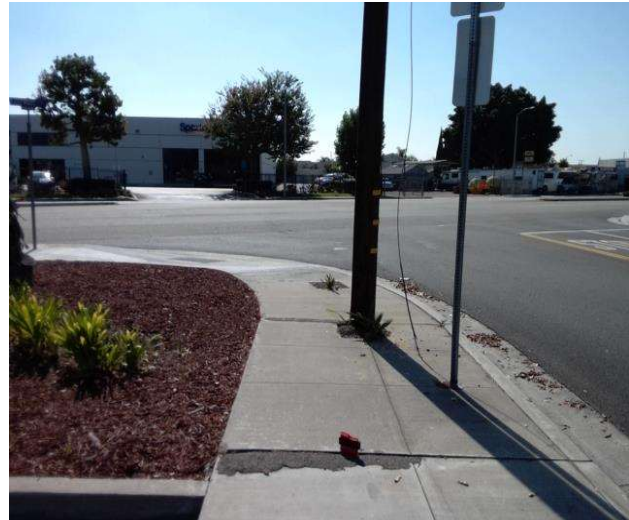
There is a change in elevation greater than recommended value.

Ensure that the change in elevation is within the recommended value.

Recommendation Up to 0.25 inches

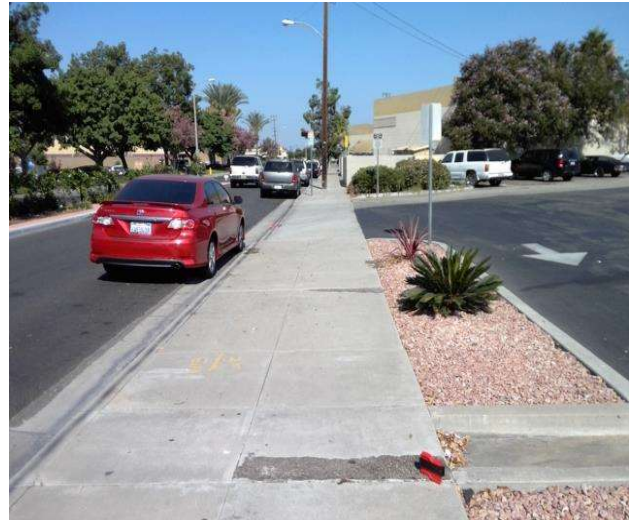
There is a change in elevation greater than recommended value.

Ensure that the change in elevation is within the recommended value.

Recommendation Up to 0.25 inches

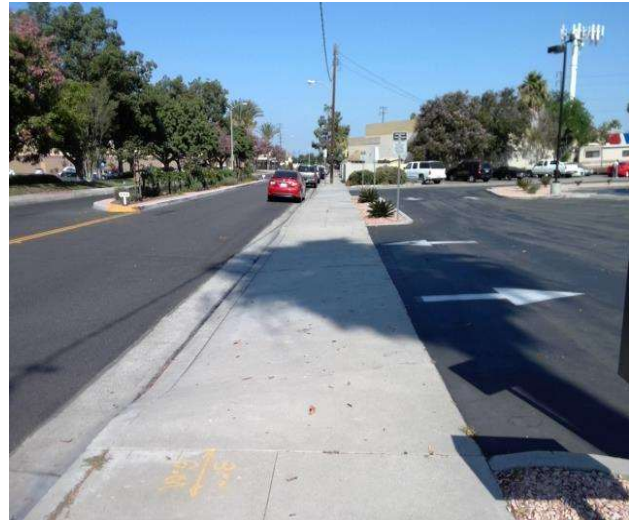
On-Site Finding Not Found

Install compliant detectable warnings \$190

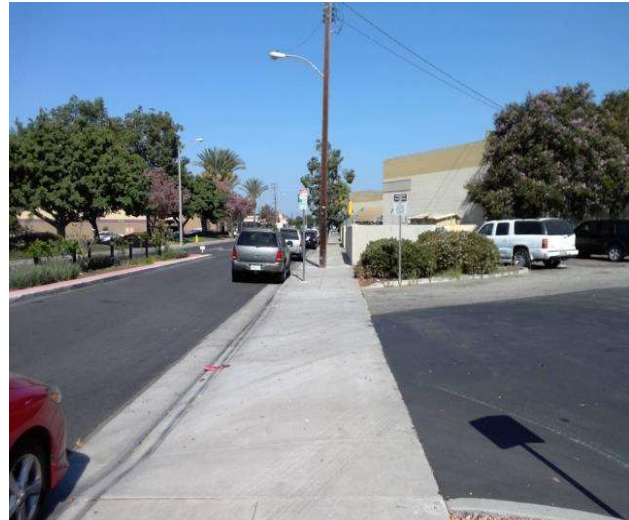
On-Site Finding Not Found

Install compliant detectable warnings \$190

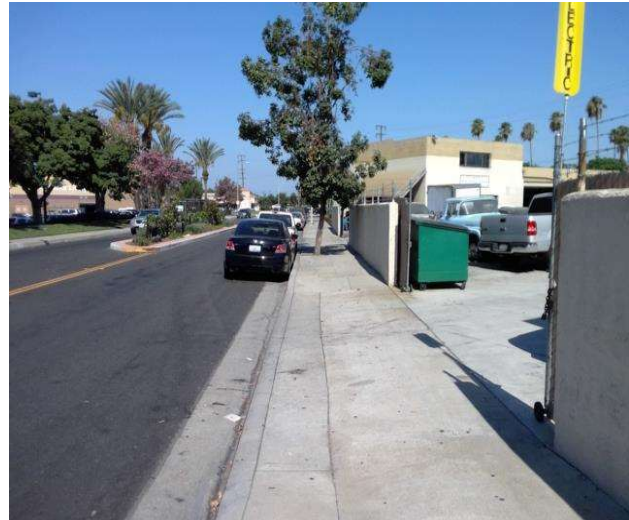
On-Site Finding Not Found

Install compliant detectable warnings \$190

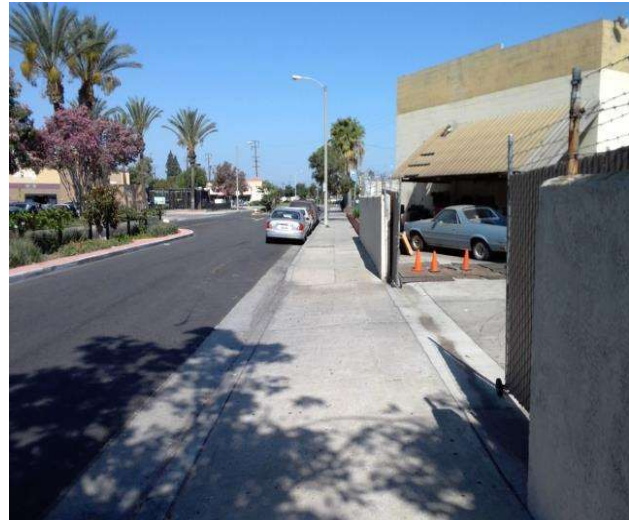
On-Site Finding Not Found

Install compliant detectable warnings \$190

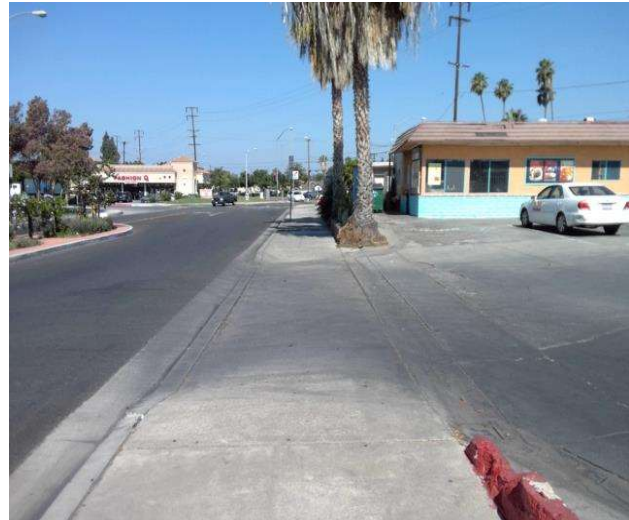
On-Site Finding Not Found

Install compliant detectable warnings \$190

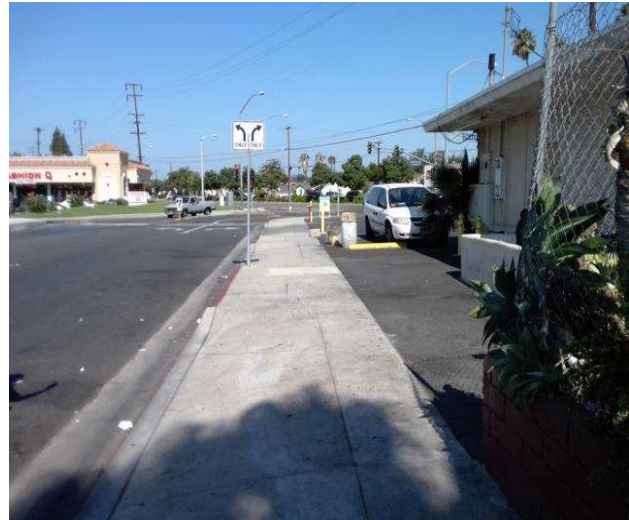
On-Site Finding Not Found

Install compliant detectable warnings \$190

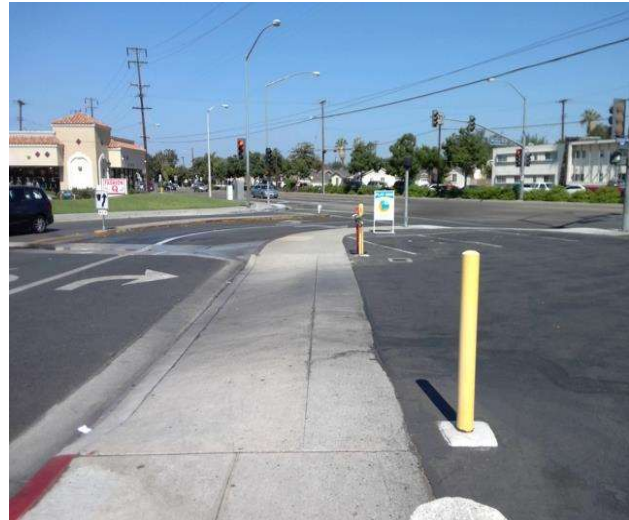
On-Site Finding Not Found

Install compliant detectable warnings \$190

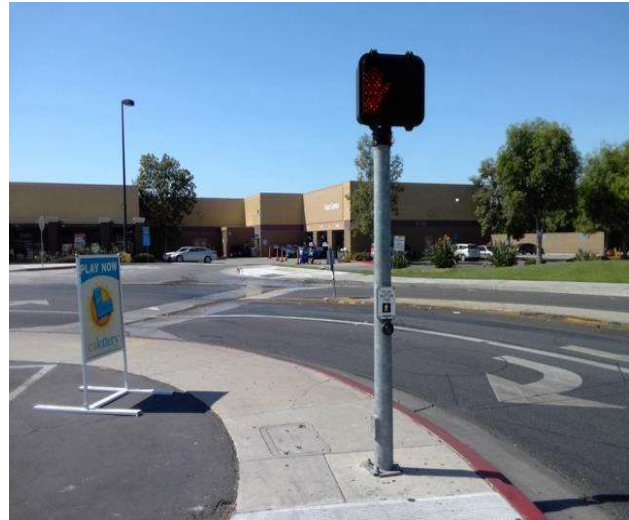
Sidewalks , Hazards & Gratings : Sidewalk Width at Obstruction

Sidewalk width at the obstruction shall have the recommended value.

Recommendation At least 48.00 inches

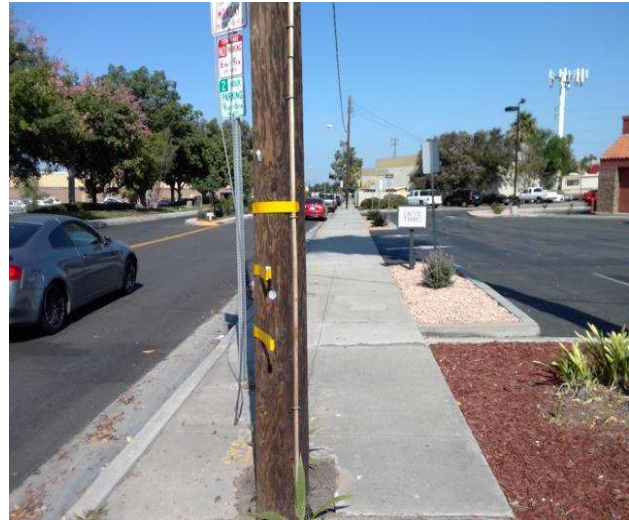
Sidewalks , Hazards & Gratings : Sidewalk Width at Obstruction

Sidewalk width at the obstruction shall have the recommended value.

Recommendation At least 48.00 inches

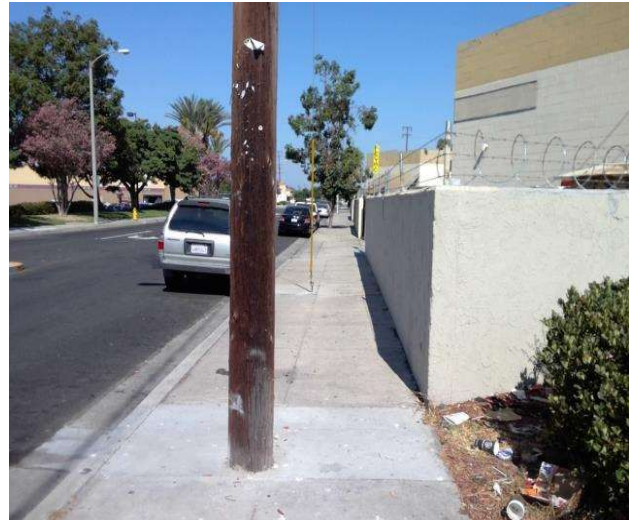
Sidewalks , Hazards & Gratings : Sidewalk Width at Obstruction

Sidewalk width at the obstruction shall have the recommended value.

Recommendation At least 48.00 inches
