Accessibility Survey

City of Downey Fairford Avenue - Florance Avenue to Cecilia Street

Date of Inspection
2/9/2017

Disability Access Consultants

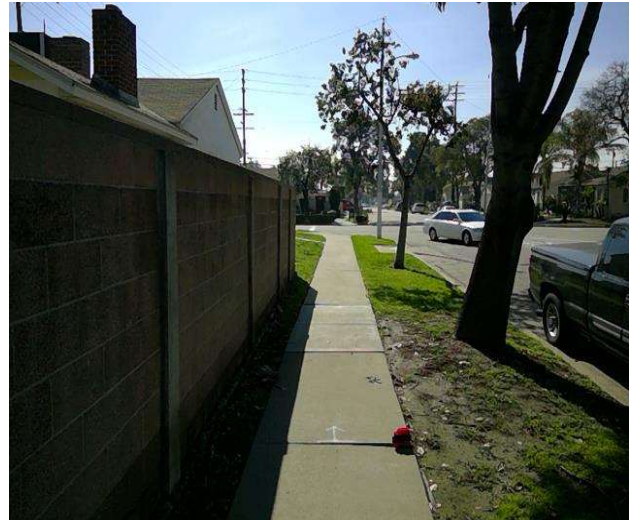
Change In Level South of Buell Street @ 33.932264707156, -118.094815760851

Sidewalks , Change in Level : Change in Level Non Beveled

There is a change in elevation greater than recommended value.

On-Site Finding 0.87 inches

Code Reference ADA 206, 302

Ensure that the change in elevation is within the recommended value.

Recommendation Up to 0.25 inches

Remove tripping hazards \$198

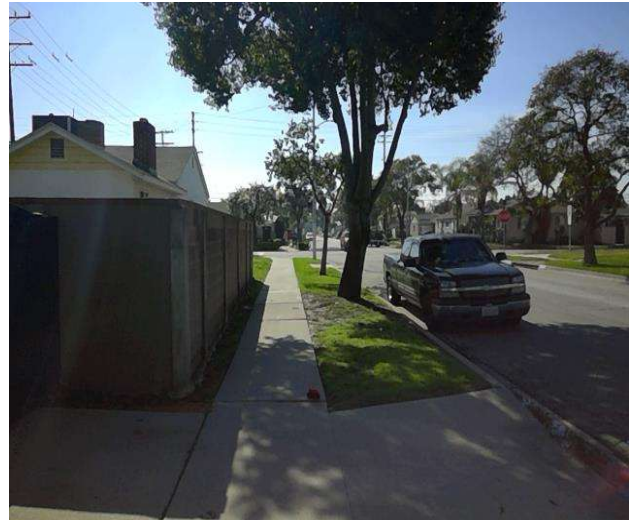
Change In Level South of Buell Street @ 33.932510616114, -118.094815760851

Sidewalks , Change in Level : Change in Level Non Beveled

There is a change in elevation greater than recommended value.

On-Site Finding 0.87 inches

Code Reference ADA 206, 302

Ensure that the change in elevation is within the recommended value.

Recommendation Up to 0.25 inches

Remove tripping hazards \$198

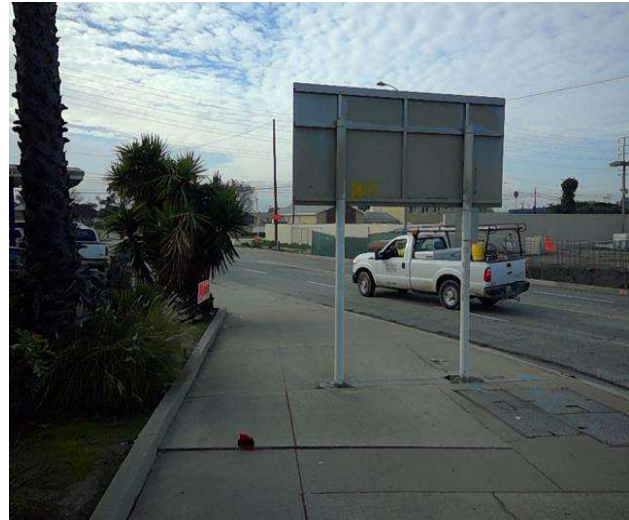
Change In Level South of Fairford Avenue @ 33.935829761220, -118.094739317894

Sidewalks , Change in Level : Change in Level Non Beveled

There is a change in elevation greater than recommended value.

On-Site Finding 0.75 inches

Code Reference ADA 206, 302

Ensure that the change in elevation is within the recommended value.

Recommendation Up to 0.25 inches

Remove tripping hazards \$198

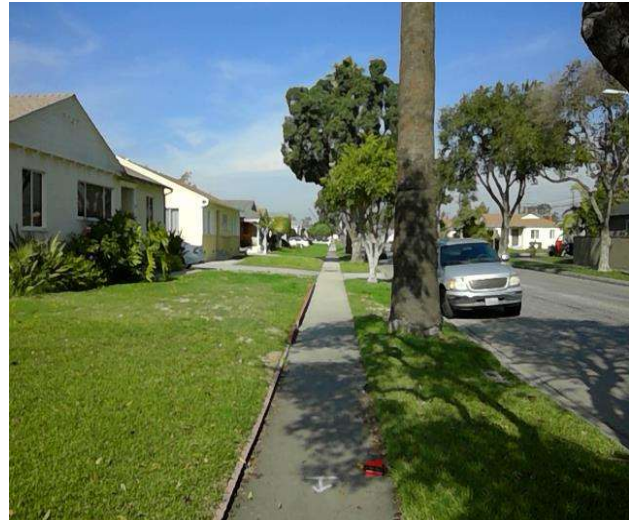
Change In Level North of Cecilia Street @ 33.932259143596, -118.094980716705

Sidewalks , Change in Level : Change in Level Non Beveled

There is a change in elevation greater than recommended value.

On-Site Finding 1.00 inches

Code Reference ADA 206, 302

Ensure that the change in elevation is within the recommended value.

Recommendation Up to 0.25 inches

Remove tripping hazards \$198

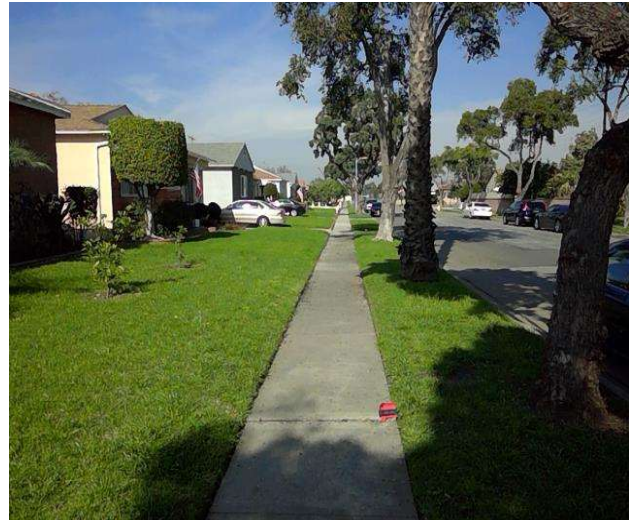
Change In Level North of Cecilia Street @ 33.932643028336, -118.094979375601

Sidewalks , Change in Level : Change in Level Non Beveled

There is a change in elevation greater than recommended value.

On-Site Finding 0.87 inches

Code Reference ADA 206, 302

Ensure that the change in elevation is within the recommended value.

Recommendation Up to 0.25 inches

Remove tripping hazards \$198

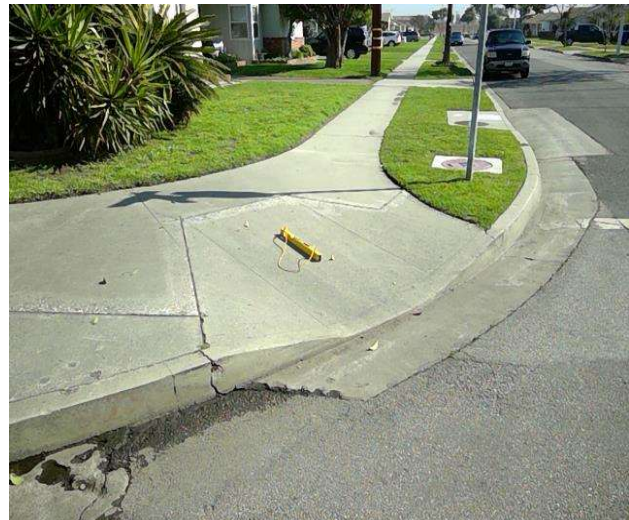
Northeast Corner of Buell Street @ 33.932794356338, - 118.094817101955

Curb Ramp : No Detectable Warnings

The curb ramp does not provide a detectable warning surface which includes truncated domes.

On-Site Finding Not Found

Code Reference CA 11B-406.5.12

Provide compliant detectable warnings to surface.

Provide detectable warning to surface \$248

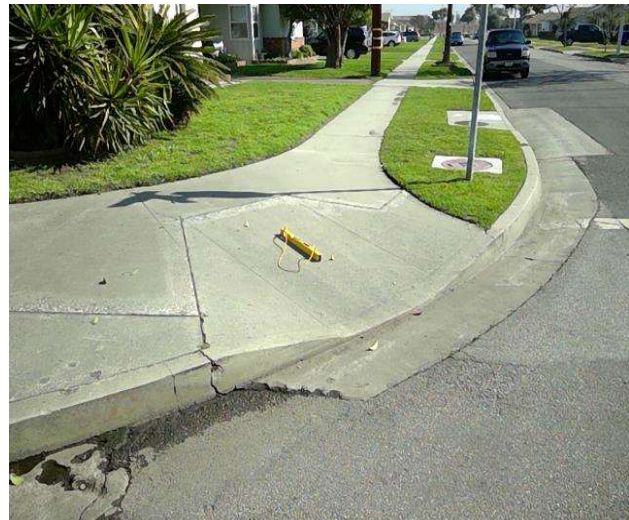
Northeast Corner of Buell Street @ 33.932794356338, - 118.094817101955

Curb Ramp : Curb Ramp Width

The width of the curb ramp is less than required.

On-Site Finding 46.00 inches

Code Reference ADA 406, 406.1, 405.5, CA 11B-406.5.2

Provide a compliant curb ramp.

Recommendation At least 48.00 inches

Install curb ramp \$1,300

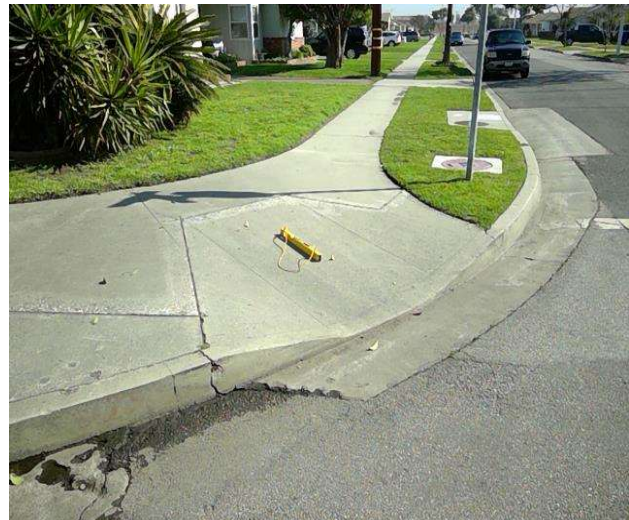
Northeast Corner of Buell Street @ 33.932794356338, - 118.094817101955

Curb Ramp : Curb Ramp Slope

The running slope is greater than allowed.

On-Site Finding 12.00 percent

Code Reference ADA 406, 406.1, 405.2, CA 11B-406

Provide a compliant curb ramp.

Recommendation Up to 8.33 percent

Install curb ramp \$1,300

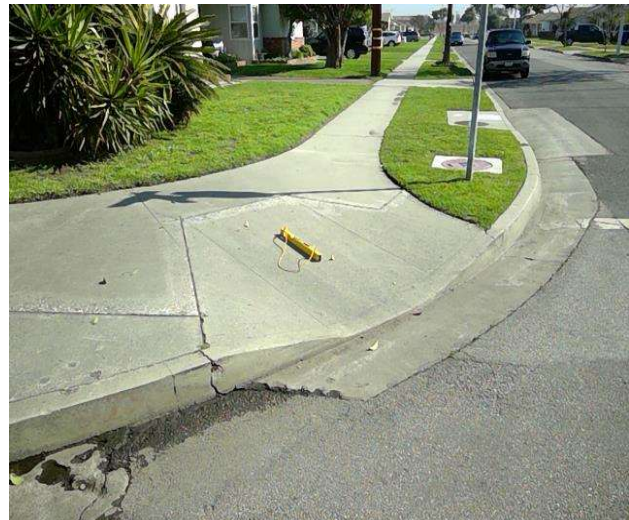
Northeast Corner of Buell Street @ 33.932794356338, - 118.094817101955

Curb Ramp : Side Flare Slope

The slope of the curb ramp side flare is greater than allowed.

On-Site Finding 18.50 percent

Code Reference ADA 406, 406.3, CA 11B-406.2.2

Provide curb ramp side flares with a compliant slope.

Recommendation Up to 10.00 percent

Install flared sides \$1,300

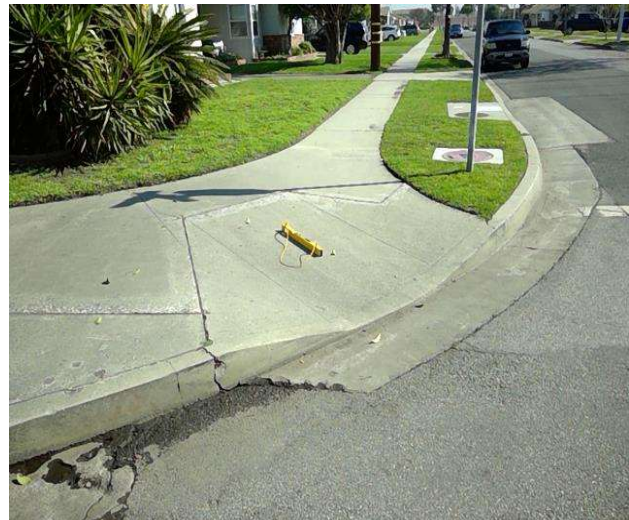
Northeast Corner of Buell Street @ 33.932794356338, - 118.094817101955

Curb Ramp : Bottom Landing Slope

The bottom landing of the curb ramp is on the street, and the slope of the bottom landing is not compliant.

On-Site Finding 8.90 percent

Code Reference ADA 406, 406.2, CA 11B-406.5.8

Ensure the bottom landing slope is compliant and provides a smooth transition.

Recommendation Up to 5.00 percent

Repave landing \$1,260

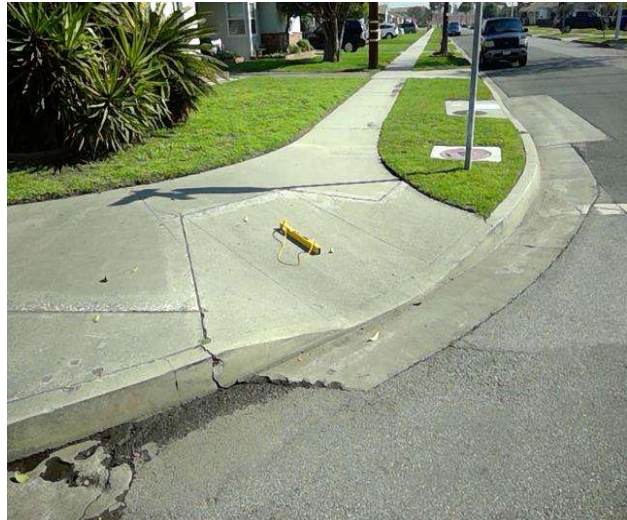
Northeast Corner of Buell Street @ 33.932794356338, - 118.094817101955

The transition from the bottom of the curb ramp to the walk, gutter, or street is abrupt.

On-Site Finding 1.75 inches

Curb Ramp , Landings And Transitions : Bottom Landing Change in Level

Code Reference ADA 302, 303, 406.2, 303.1

Patch the transition area at the bottom of the curb ramp so that the transition is flush and free of abrupt changes.

Recommendation Up to 0.50 inches

Patch lip at curb ramp \$255

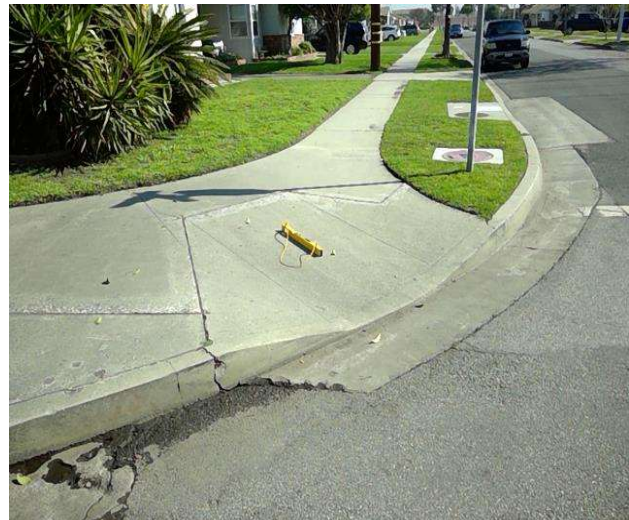
Northeast Corner of Buell Street @ 33.932794356338, - 118.094817101955

Curb Ramp , Landings and Transitions : Top Landing Slope

The slope at the top landing is greater than allowed.

On-Site Finding 3.00 percent

Code Reference ADA 402, 406.4, 403.3, 406.1, CA 11B-406.5.3

Provide a top landing surface that does not exceed the maximum slope and cross slope. Provide a sufficient maneuvering clearance that does not accumulate water.

Recommendation Up to 2.08 percent

Provide compliant landing \$1,260

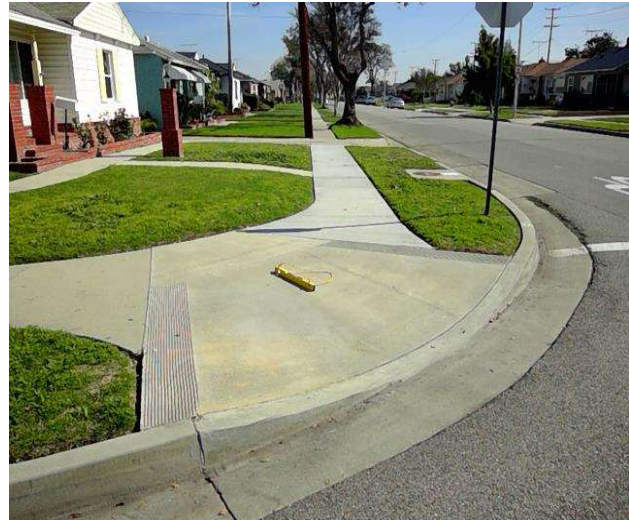
On-Site Finding Not Found

Code Reference CA 11B-406.5.12

Provide detectable warning to surface \$248

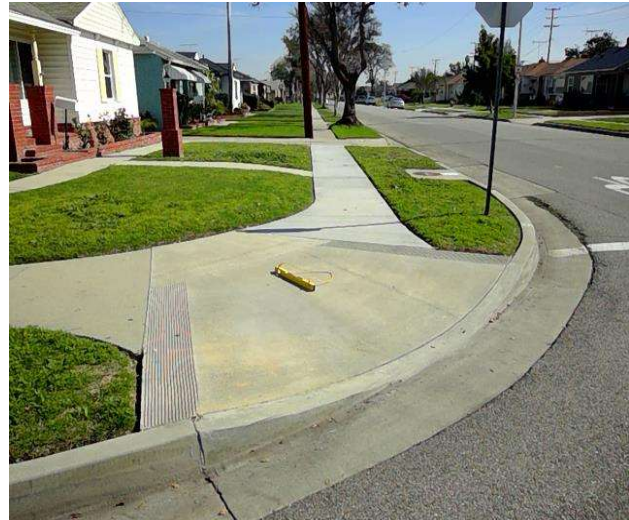
Code Reference ADA 406, 406.1, 405.2, CA 11B-406

Recommendation Up to 8.33 percent

Install curb ramp \$1,300

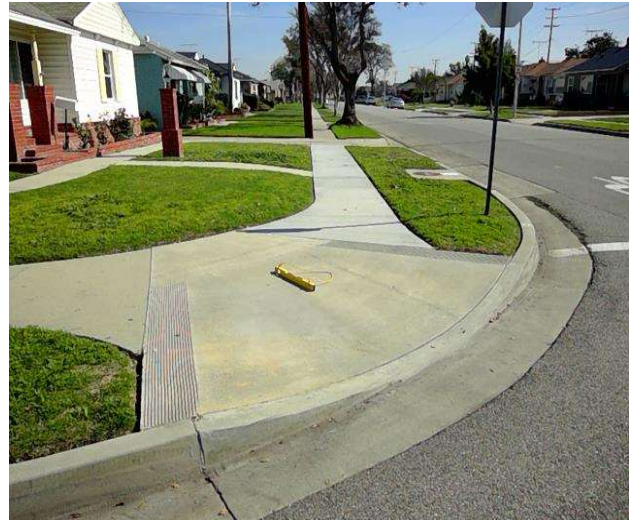
Code Reference ADA 406, 406.3, CA 11B-406.2.2

Recommendation Up to 10.00 percent

Install flared sides \$1,300

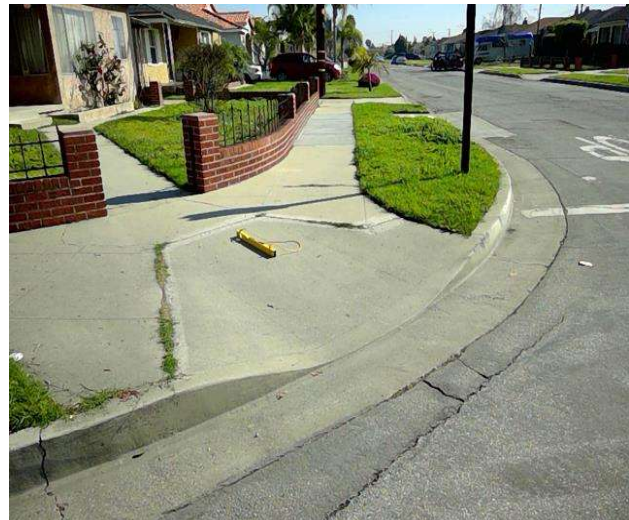
On-Site Finding Not Found

Code Reference CA 11B-406.5.12

Provide detectable warning to surface \$248

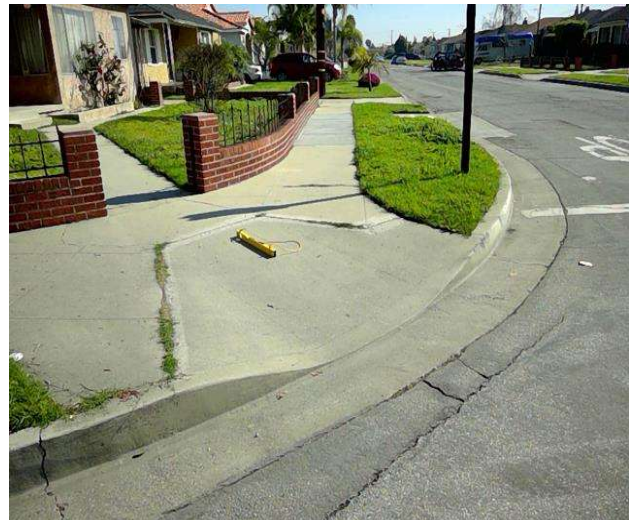
Code Reference ADA 406, 406.1, 405.2, CA 11B-406

Recommendation Up to 8.33 percent

Install curb ramp \$1,300

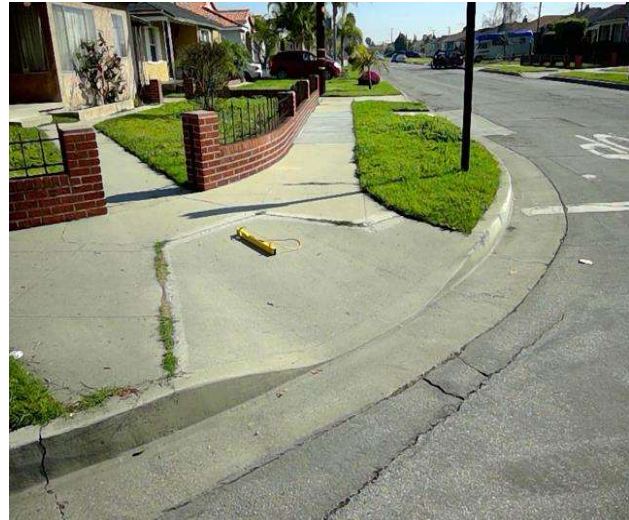
Code Reference ADA 406, 406.3, CA 11B-406.2.2

Recommendation Up to 10.00 percent

Install flared sides \$1,300

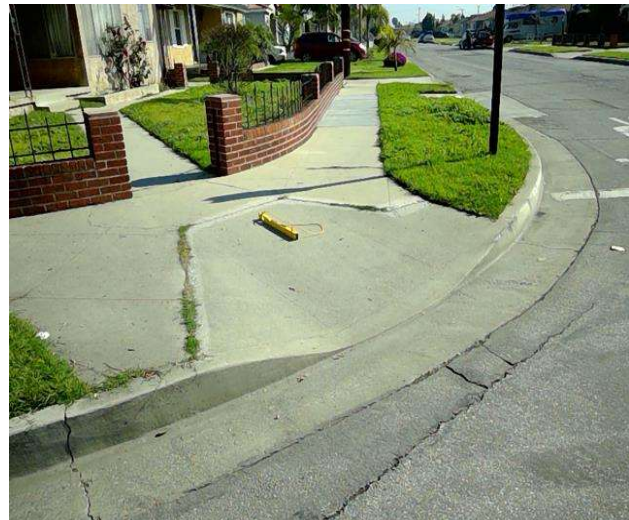
Curb Ramp , Landings and Transitions : Bottom Landing Change in Level - Curb Ramps

Code Reference ADA 302, 406.2

Patch lip at curb ramp \$255

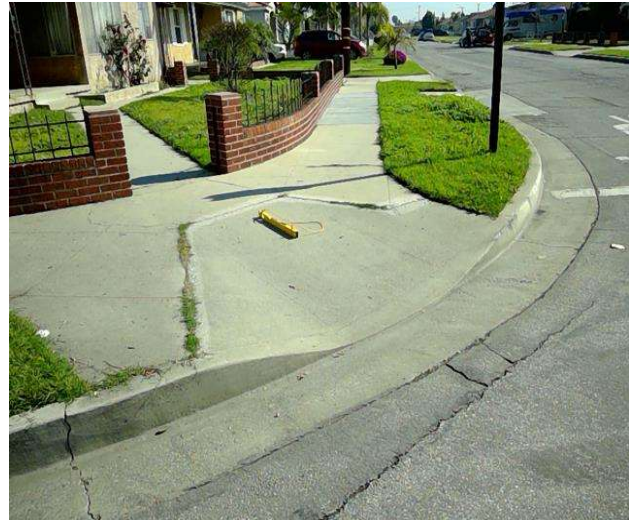
Code Reference ADA 402, 406.4, 403.3, 406.1, CA 11B-406.5.3

Recommendation Up to 2.08 percent

Provide compliant landing \$1,260

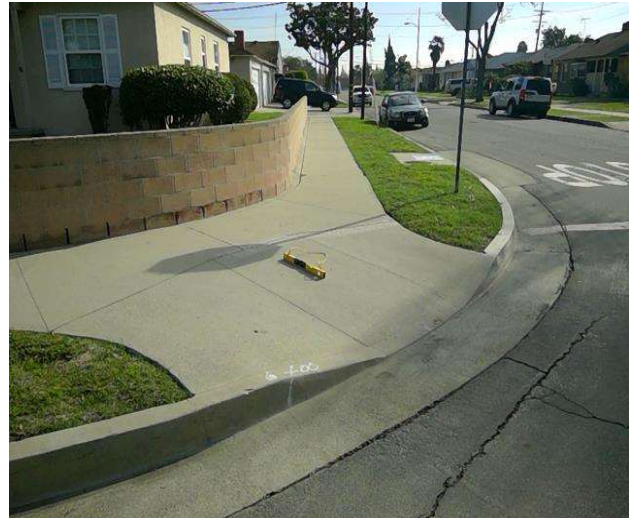
On-Site Finding Not Found

Code Reference CA 11B-406.5.12

Provide detectable warning to surface \$248

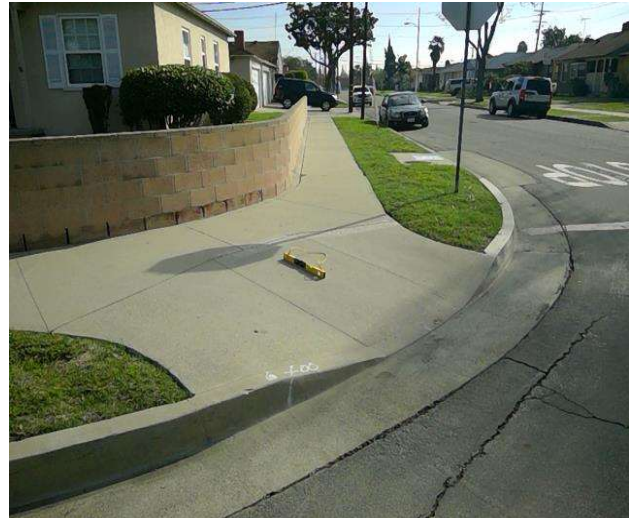
Code Reference ADA 406, 406.1, 405.2, CA 11B-406

Recommendation Up to 8.33 percent

Install curb ramp \$1,300

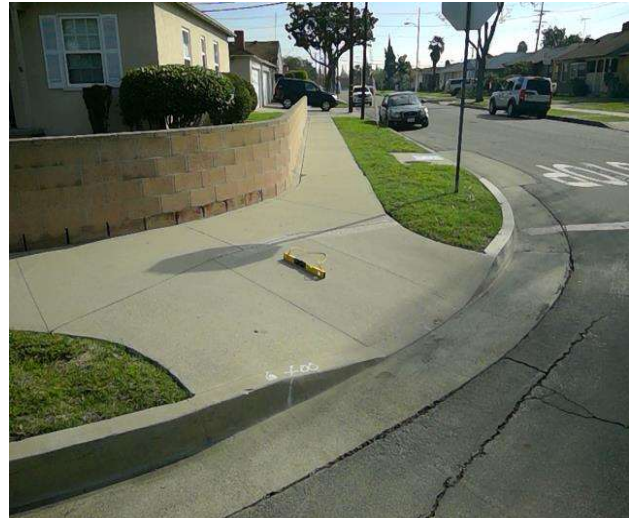
Code Reference ADA 406, 406.3, CA 11B-406.2.2

Recommendation Up to 10.00 percent

Install flared sides \$1,300

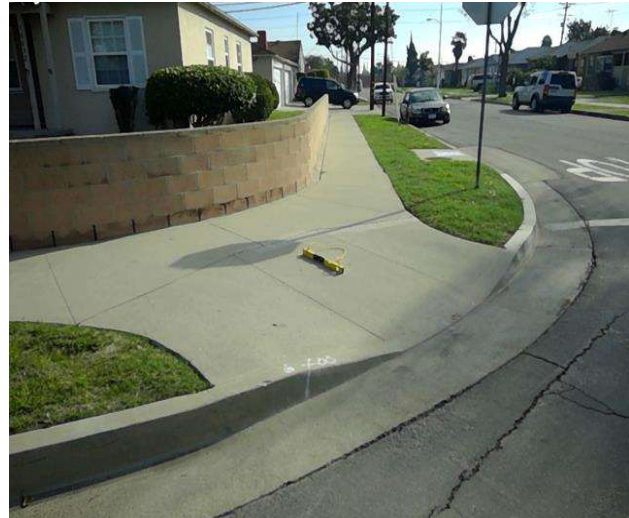
Curb Ramp , Landings And Transitions : Bottom Landing Change in Level

Code Reference ADA 302, 303, 406.2, 303.1

Recommendation Up to 0.50 inches

Patch lip at curb ramp \$255

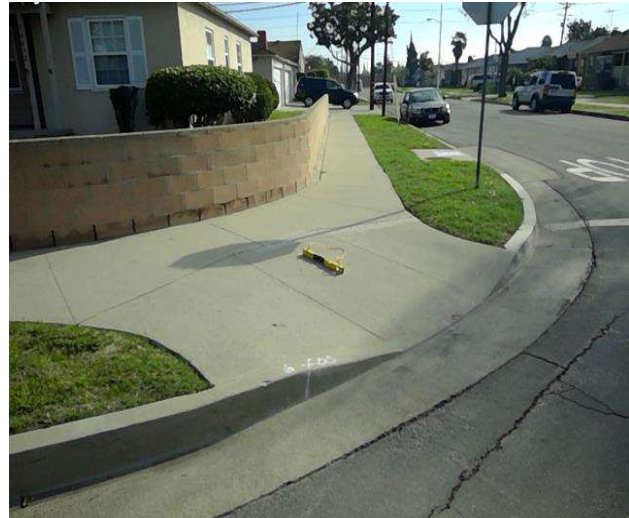
Code Reference ADA 402, 406.4, 403.3, 406.1, CA 11B-406.5.3

Recommendation Up to 2.08 percent

Provide compliant landing \$1,260

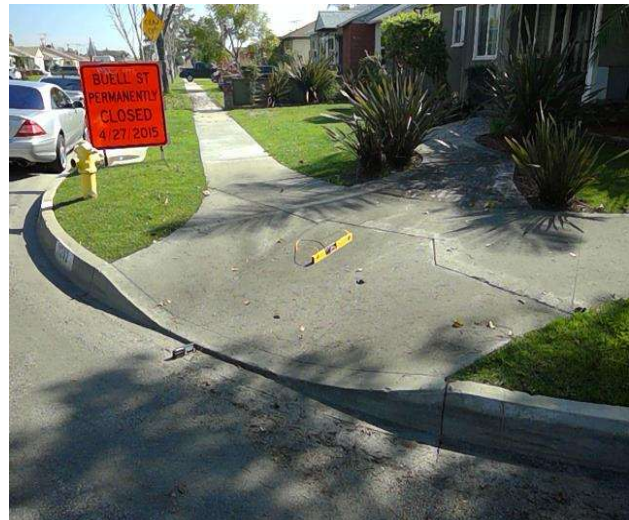
On-Site Finding Not Found

Code Reference CA 11B-406.5.12

Provide detectable warning to surface \$248

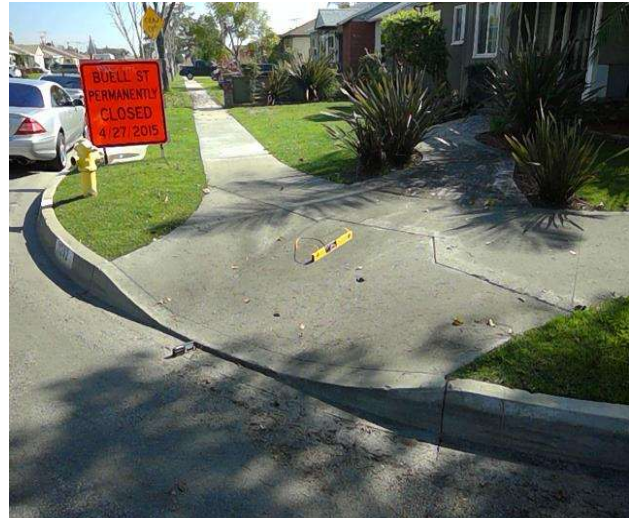
Code Reference ADA 406, 406.1, 405.5, CA 11B-406.5.2

Recommendation At least 48.00 inches

Install curb ramp \$1,300

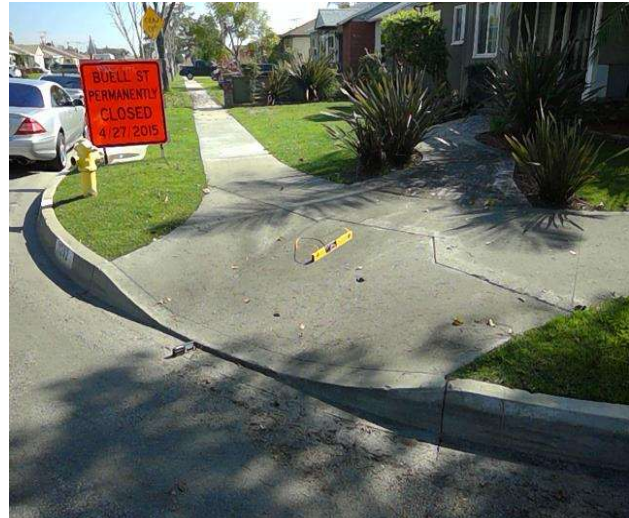
Code Reference ADA 406, 406.1, 405.2, CA 11B-406

Recommendation Up to 8.33 percent

Install curb ramp \$1,300

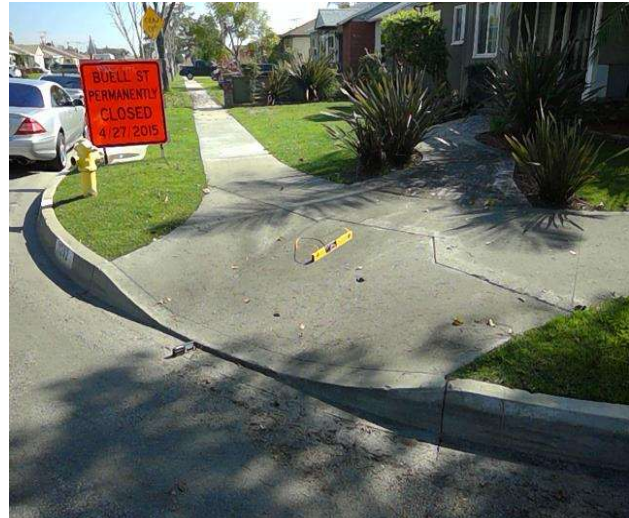
Code Reference ADA 406, 406.3, CA 11B-406.2.2

Recommendation Up to 10.00 percent

Install flared sides \$1,300

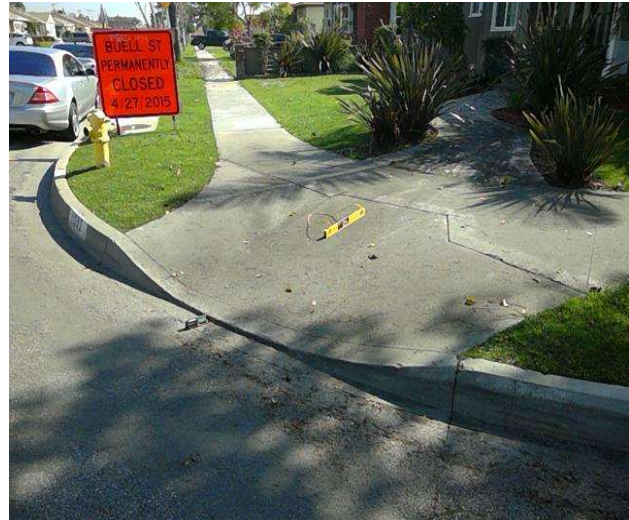
Code Reference ADA 402, 406.4, 406.2, 403.3, 406.1, CA 11B-406.5.3

Recommendation Up to 2.08 percent

Provide compliant landing \$240

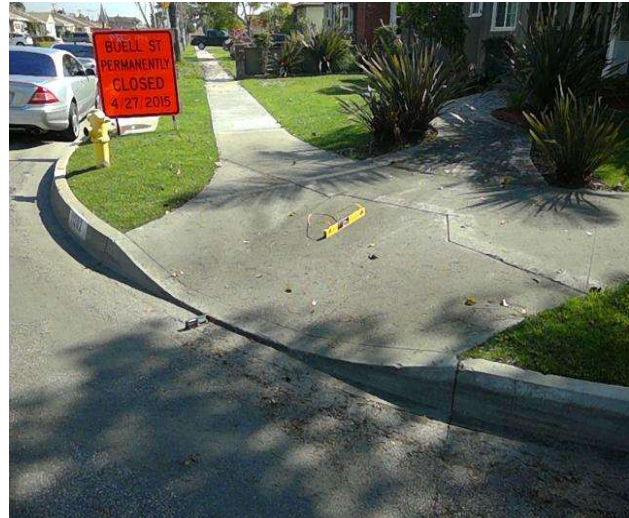
Curb Ramp , Landings And Transitions : Bottom Landing Change in Level

Code Reference ADA 302, 303, 406.2, 303.1

Recommendation Up to 0.50 inches

Patch lip at curb ramp \$255

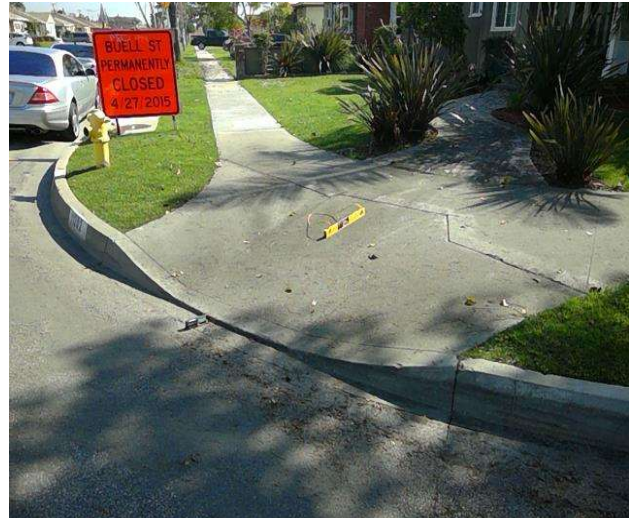
The overlayment causes a noncompliant change in level.

Code Reference ADA 303.2, 303.3,CA 11B-303.3,CA 11B-303.2

Ensure the change in elevation is within the recommended height.

Recommendation Up to 0.50 inches

Provide smooth surface \$150

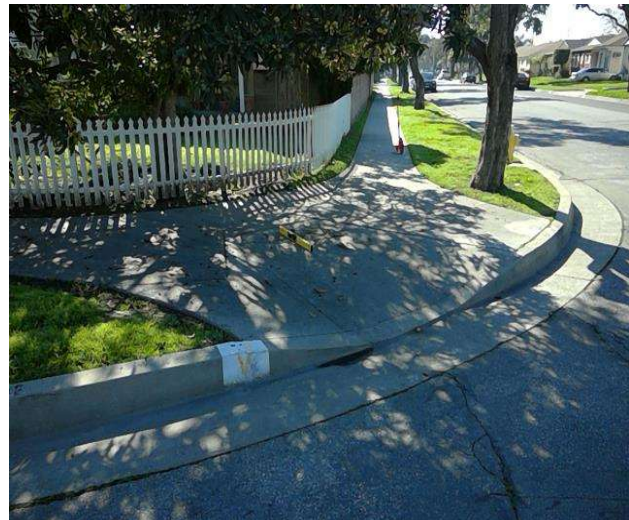
On-Site Finding Not Found

Code Reference CA 11B-406.5.12

Provide detectable warning to surface \$248

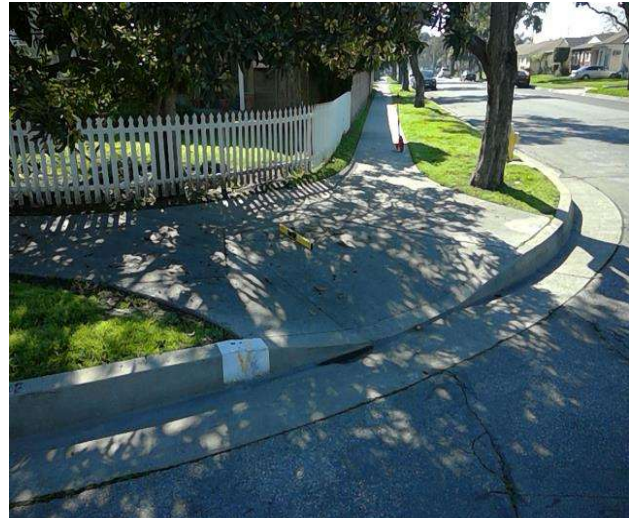
Code Reference ADA 406, 406.1, 405.5, CA 11B-406.5.2

Recommendation At least 48.00 inches

Install curb ramp \$1,300

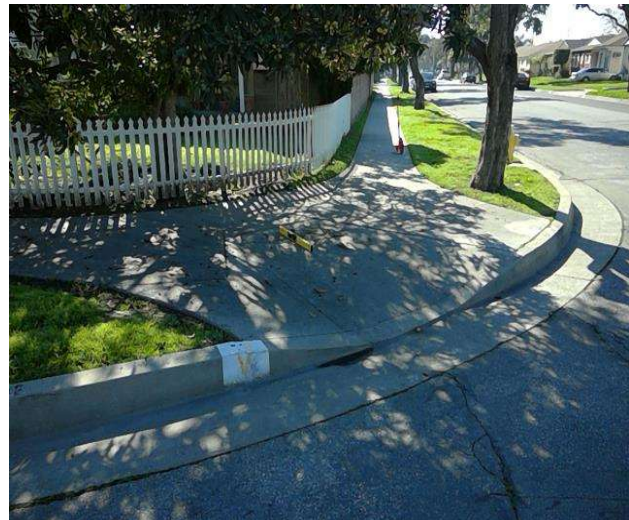
Code Reference ADA 406, 406.1, 405.2, CA 11B-406

Recommendation Up to 8.33 percent

Install curb ramp \$1,300

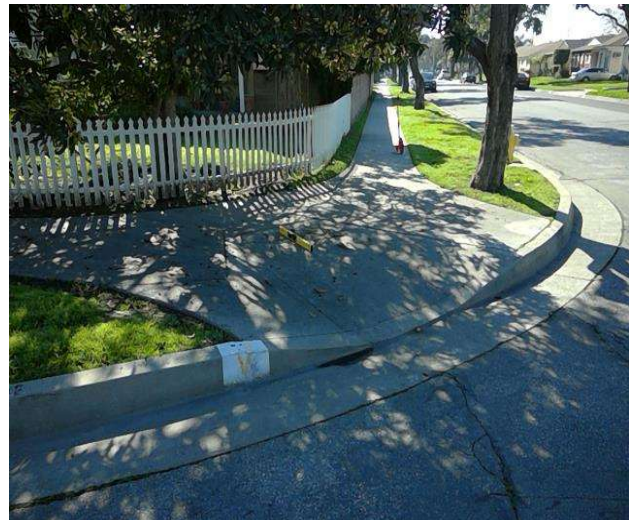
Code Reference ADA 406, 406.3, CA 11B-406.2.2

Recommendation Up to 10.00 percent

Install flared sides \$1,300

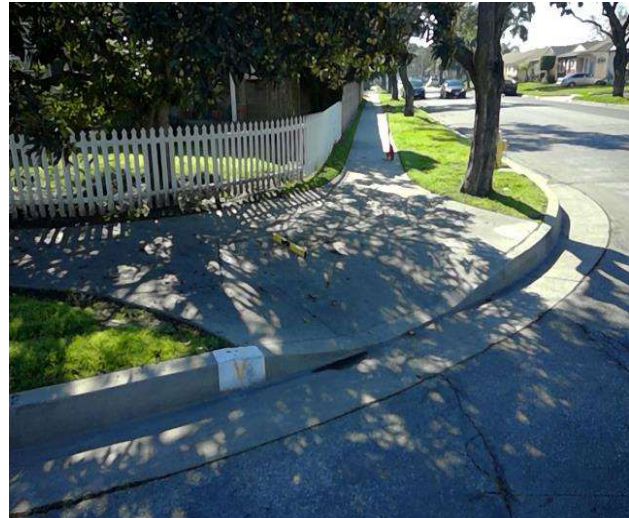
Code Reference ADA 406, 406.2, CA 11B-406.5.8

Recommendation Up to 5.00 percent

Repave landing \$1,260

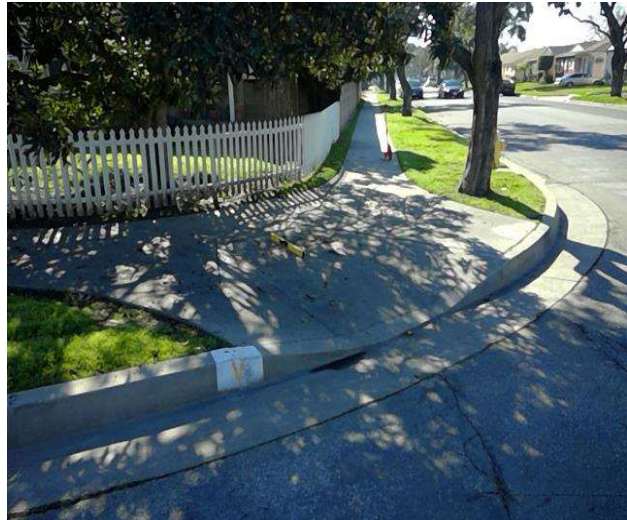
Curb Ramp , Landings And Transitions : Bottom Landing Change in Level

Code Reference ADA 302, 303, 406.2, 303.1

Recommendation Up to 0.50 inches

Patch lip at curb ramp \$255

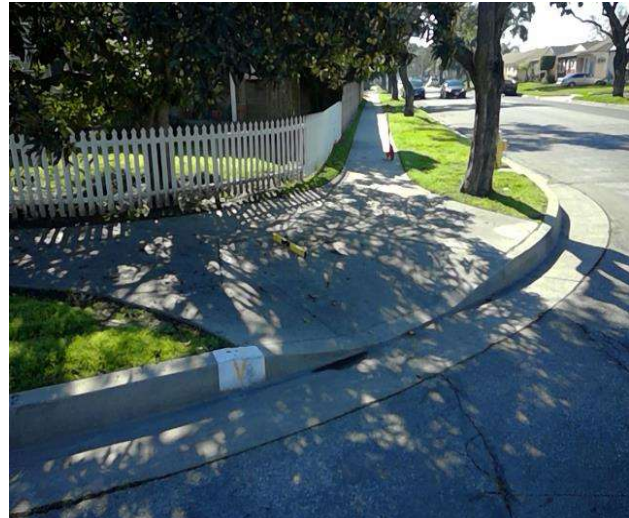
Code Reference ADA 402, 406.4, 403.3, 406.1, CA 11B-406.5.3

Recommendation Up to 2.08 percent

Provide compliant landing \$1,260

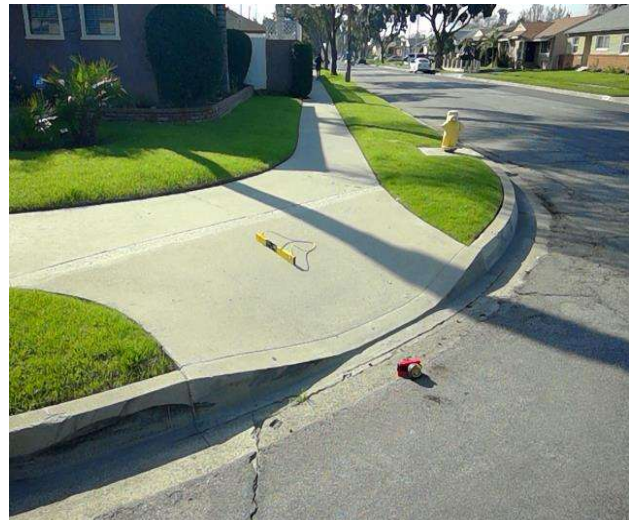
On-Site Finding Not Found

Code Reference CA 11B-406.5.12

Provide detectable warning to surface \$248

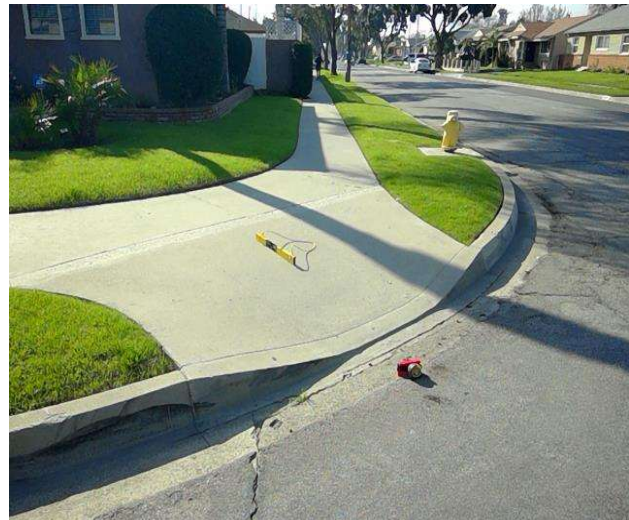
Code Reference ADA 406, 406.1, 405.2, CA 11B-406

Recommendation Up to 8.33 percent

Install curb ramp \$1,300

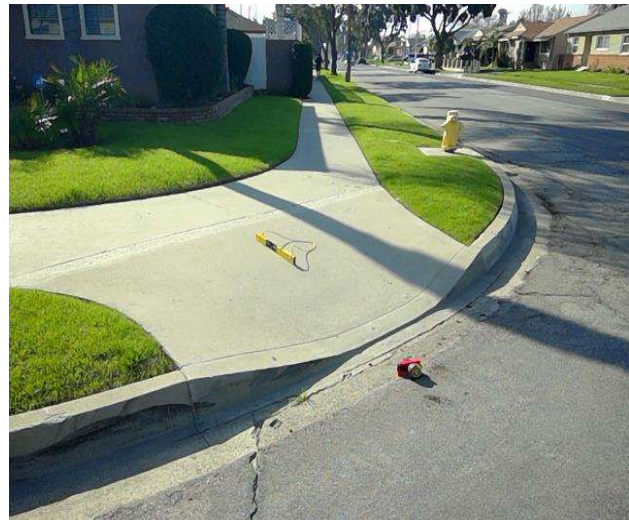
Code Reference ADA 402, 406.1, 405.3, CA 11B-406.5.7

Recommendation Up to 2.08 percent

Install curb ramp \$1,300

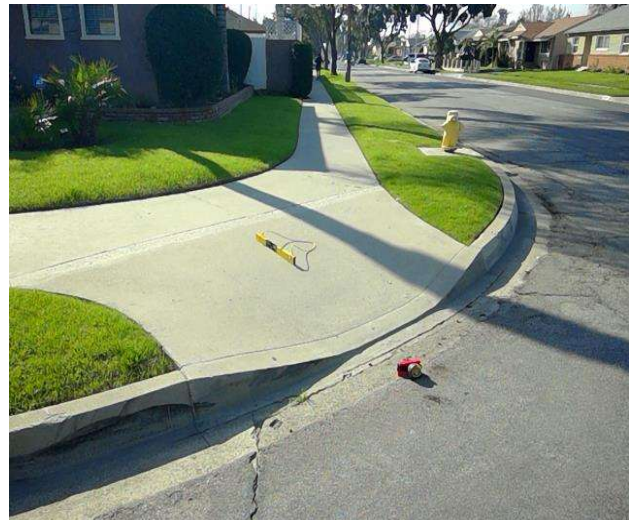
Code Reference ADA 406, 406.3, CA 11B-406.2.2

Recommendation Up to 10.00 percent

Install flared sides \$1,300

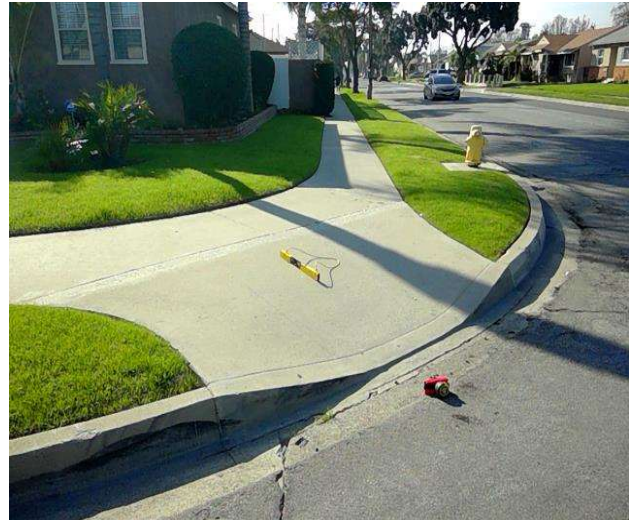
Curb Ramp , Landings And Transitions : Bottom Landing Change in Level

Code Reference ADA 302, 303, 406.2, 303.1

Recommendation Up to 0.50 inches

Patch lip at curb ramp \$255

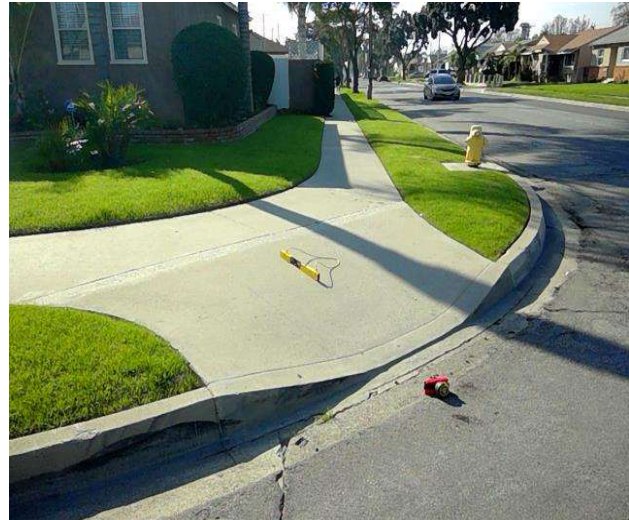
The overlayment causes a noncompliant change in level.

Code Reference ADA 303.2, 303.3,CA 11B-303.3,CA 11B-303.2

Ensure the change in elevation is within the recommended height.

Recommendation Up to 0.50 inches

Provide smooth surface \$150

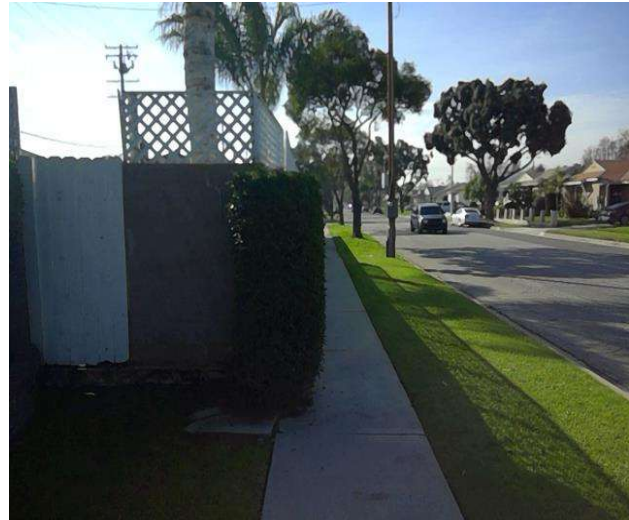
Sidewalks , Hazards & Gratings : Sidewalk Width at Obstruction

Code Reference ADA 206, 302, 403.5.1, CA 11B-403.5

Sidewalk width at the obstruction shall have the recommended value.

Recommendation At least 48.00 inches

\$1,260

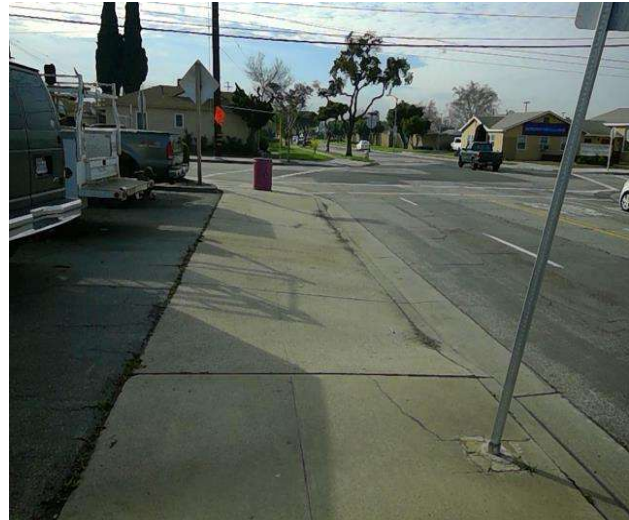
On-Site Finding Not Found

Code Reference ADA 705,CA 11B-705.1.2.5,CA 11B-247.1.2.5

Install compliant detectable warnings \$190

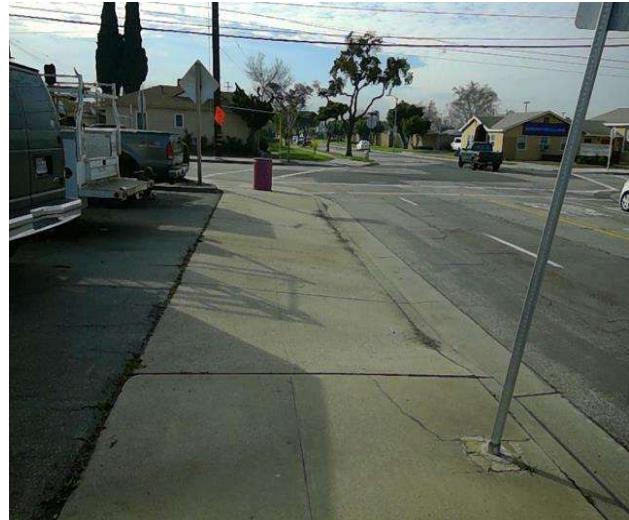
Code Reference ADA 206, 302, CA 11B-403.3

Recommendation Up to 2.08 percent

Repave surface \$1,092

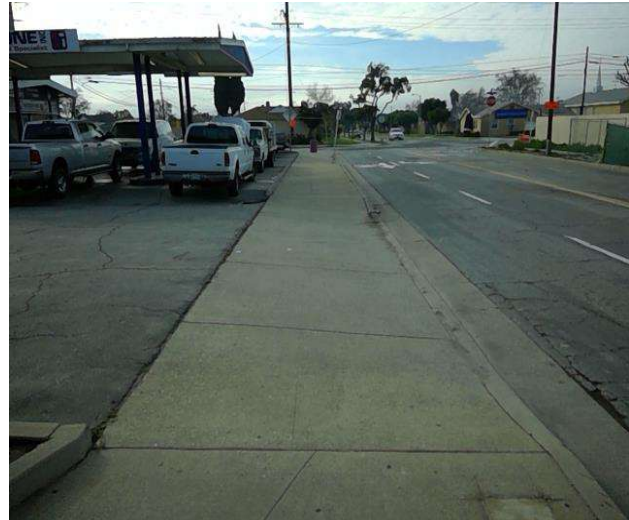
On-Site Finding Not Found

Code Reference ADA 705,CA 11B-705.1.2.5,CA 11B-247.1.2.5

Install compliant detectable warnings \$190

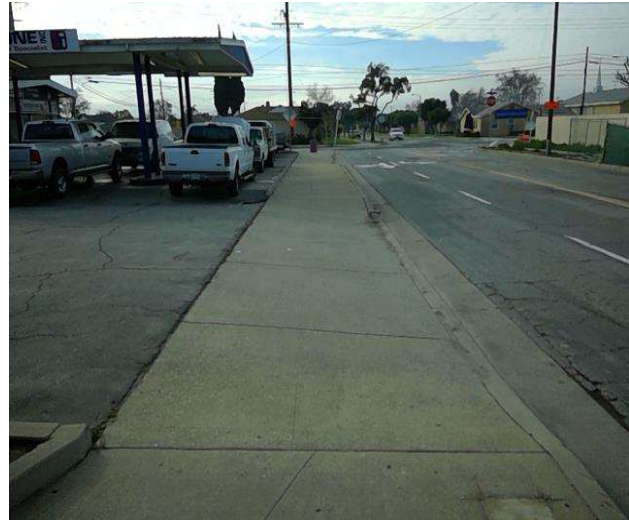
Code Reference ADA 206, 302, CA 11B-403.3

Recommendation Up to 2.08 percent

Repave surface \$1,092

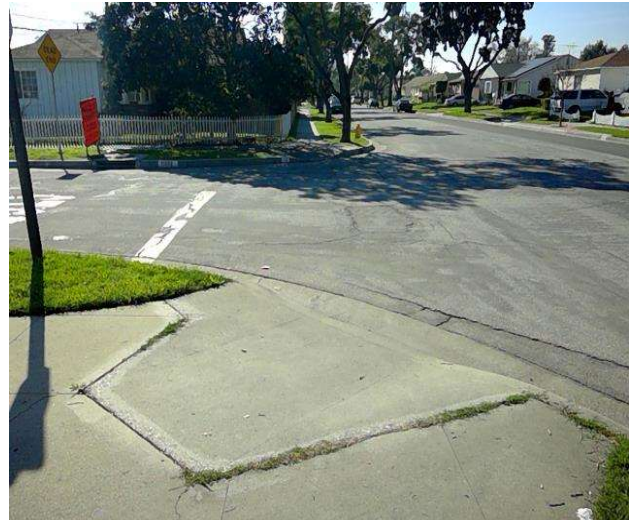
On-Site Finding Not Found

Code Reference ADA 705,CA 11B-705.1.2.5,CA 11B-247.1.2.5

Install compliant detectable warnings \$190

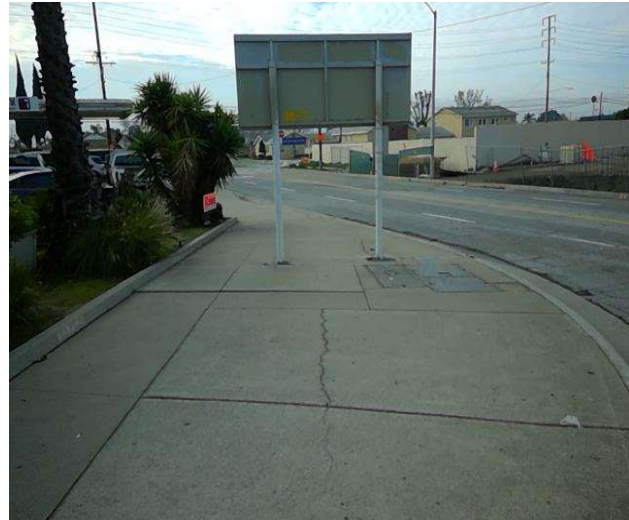
Code Reference ADA 206, 302,CA 11B-403.3

Repave the sidewalk surface with the recommended cross slope.

Recommendation Up to 2.08 percent

Repave surface \$1,092

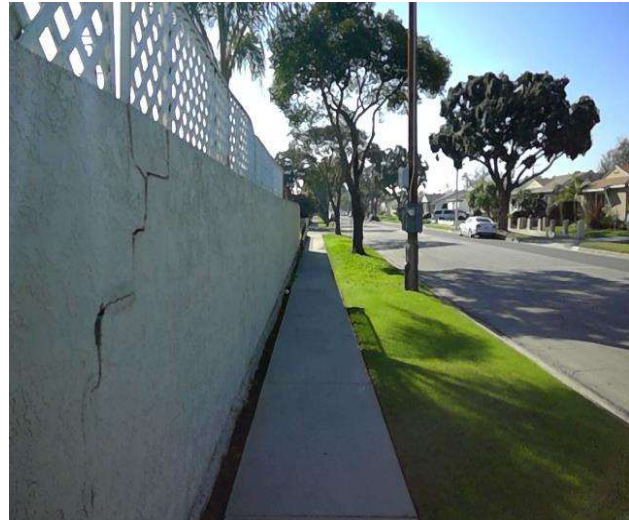
Code Reference ADA 206, 302, CA 11B-403.3

Repave the sidewalk surface with the recommended cross slope.

Recommendation Up to 2.08 percent

Repave surface \$1,092

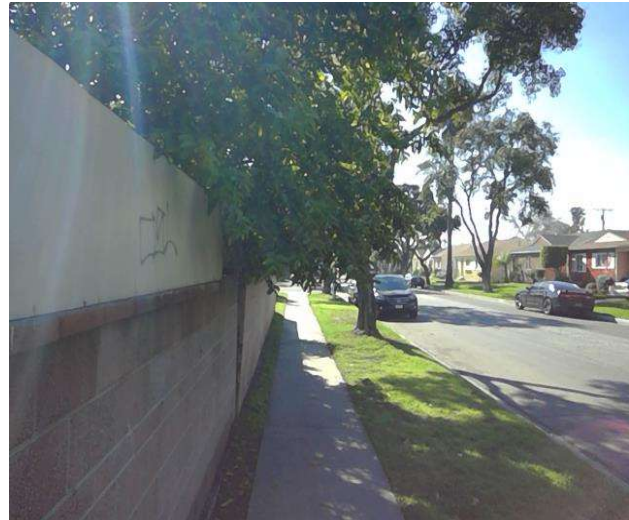
Sidewalks , Hazards & Gratings : Overhead Obstruction Height

Code Reference ADA 206, 307.4, CA 11B-307.4

Recommendation At least 80.00 inches

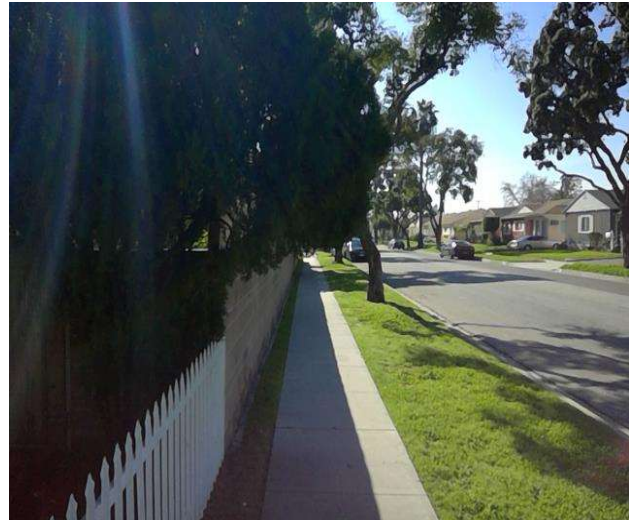
Sidewalks , Hazards & Gratings : Overhead Obstruction Height

Code Reference ADA 206, 307.4, CA 11B-307.4

Recommendation At least 80.00 inches

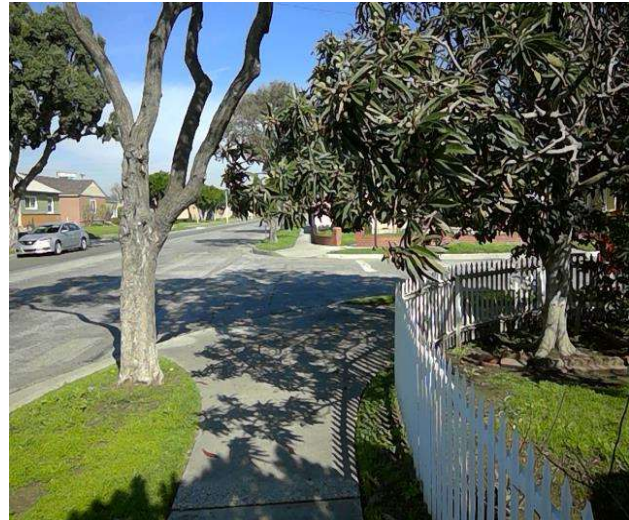
Sidewalks , Hazards & Gratings : Overhead Obstruction Height

Code Reference ADA 206, 307.4, CA 11B-307.4

Recommendation At least 80.00 inches

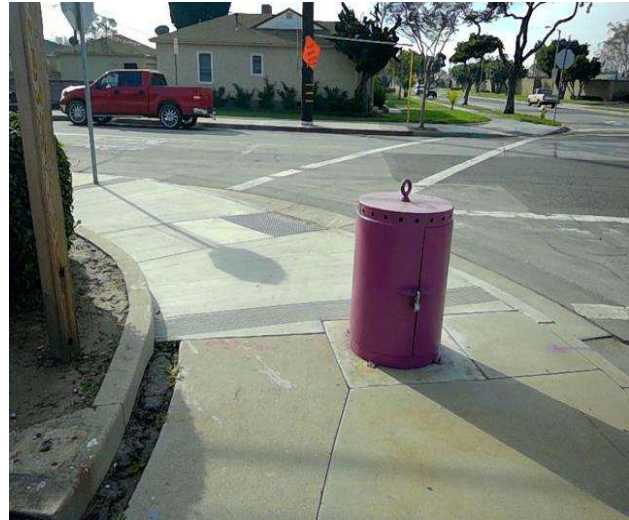
Sidewalks , Hazards & Gratings : Sidewalk Width at Obstruction

Code Reference ADA 206, 302, 403.5.1, CA 11B-403.5

Sidewalk width at the obstruction shall have the recommended value.

Recommendation At least 48.00 inches

\$1,260

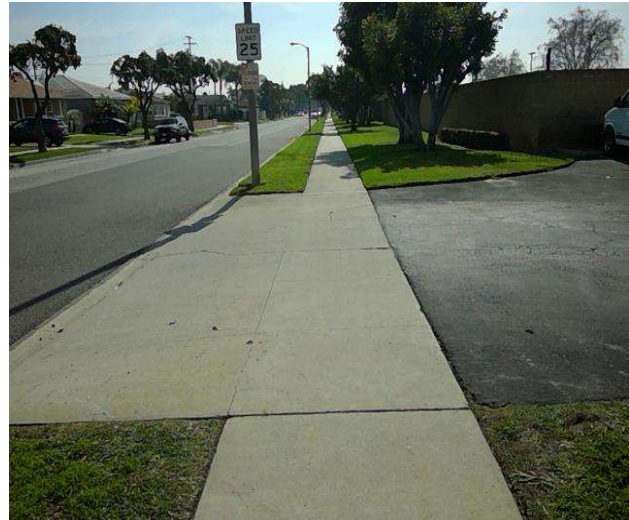
On-Site Finding Not Found

Code Reference ADA 705,CA 11B-705.1.2.5,CA 11B-247.1.2.5

Install compliant detectable warnings \$190

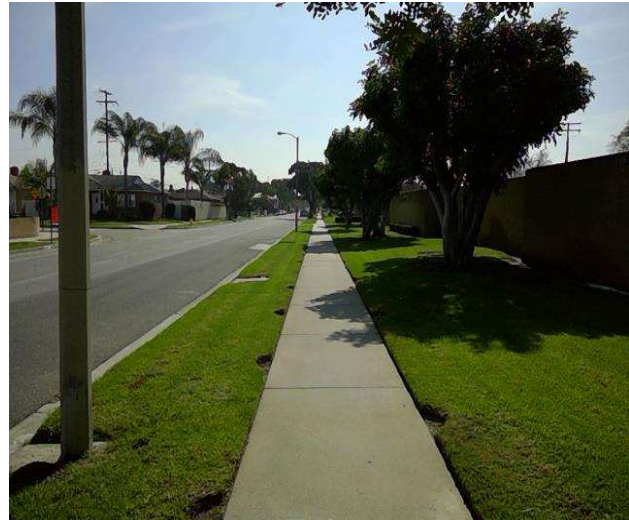
Code Reference ADA 206, 302,CA 11B-403.3

Repave the sidewalk surface with the recommended cross slope.

Recommendation Up to 2.08 percent

Repave surface \$1,092

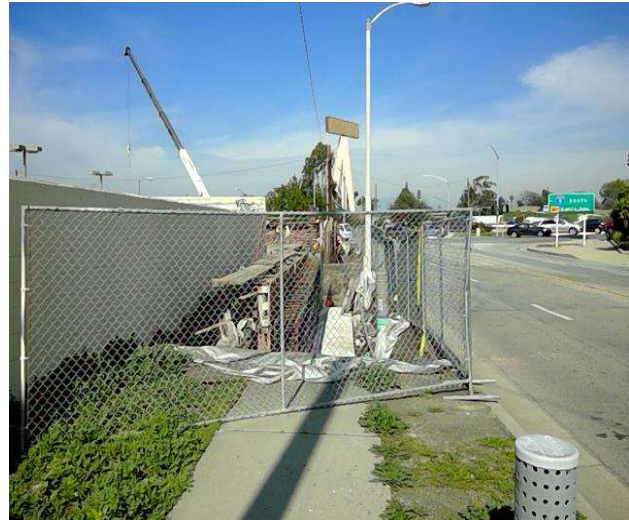
Sidewalks : Missing Sidewalk

Section of sidewalk is missing and consists of dirt, grass or gravel.

Code Reference ADA 206, 302,CA 11B-302,CA 11B-206

Notes : Sidewalk Under Construction at Time of inspection.

Provide a compliant sidewalk for the missing section.

\$1,260
