Accessibility Survey

City of Downey Fairford Avenue - Florance Avenue to Cecilia Street

Date of Inspection
2/9/2017

Disability Access Consultants

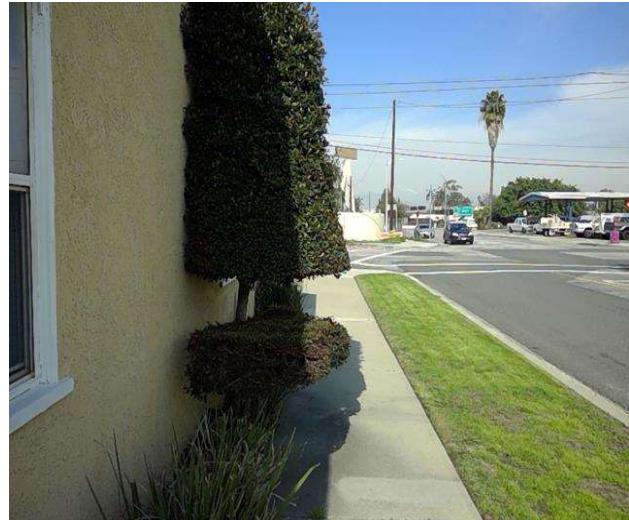
Sidewalks , Hazards & Gratings : Overhead Obstruction Height

Code Reference ADA 206, 307.4,CA 11B-307.4

Recommendation At least 80.00 inches
