# Accessibility Survey

## City of Downey Mitla Avenue - De Palma Street To End

Date of Inspection  
4/21/2017

Prepared By  
**Disability Access Consultants**  
(800) 743-7067

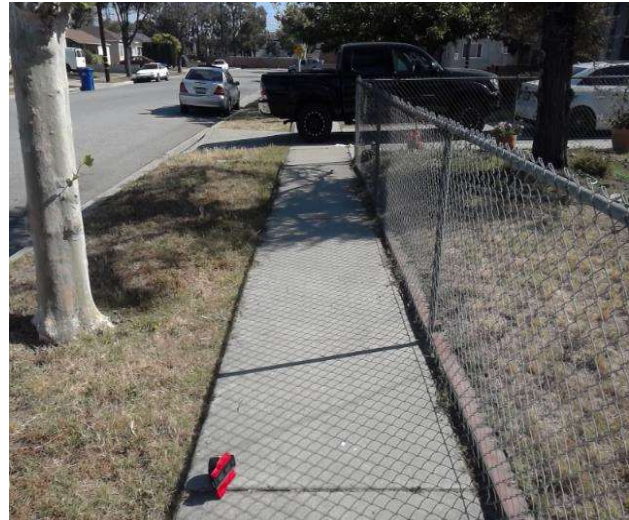
#### Change In Level South Of Adwen Street @ 33.947169290185, -118.158019334078

Sidewalks , Change in Level : Change in Level Non Beveled

There is a change in elevation greater than recommended value.

**On-Site Finding** 0.50 inches

Ensure that the change in elevation is within the recommended value.

Recommendation Up to 0.25 inches

Remove tripping hazards \$198

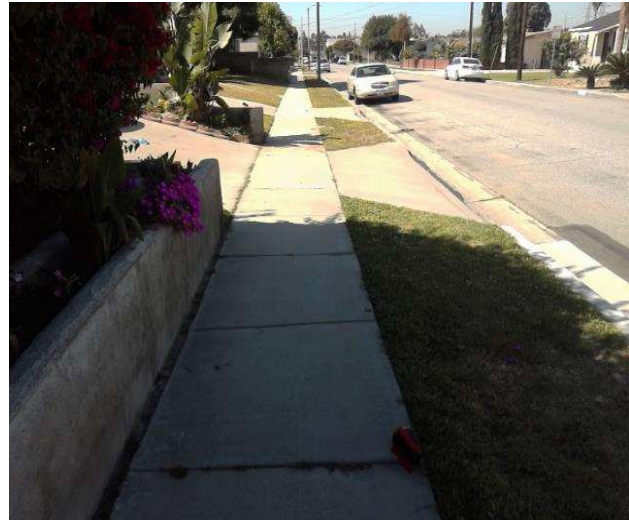
**Change In Level South Of Benares Street @ 33.946274821780, -118.158657699823**

Sidewalks , Change in Level : Change in Level Non Beveled

There is a change in elevation greater than recommended value.

**On-Site Finding** 0.75 inches

Ensure that the change in elevation is within the recommended value.

Recommendation Up to 0.25 inches

Remove tripping hazards \$198

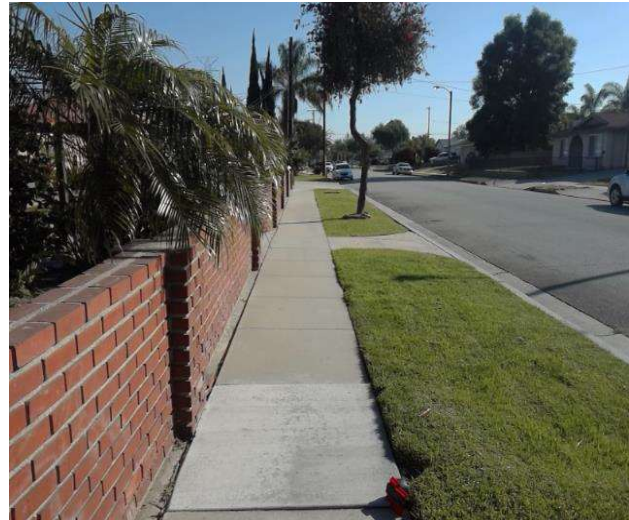
#### Change In Level North Of Luxor Street @ 33.945670716532, -118.159293383360

Sidewalks , Change in Level : Change in Level Non Beveled

There is a change in elevation greater than recommended value.

**On-Site Finding** 0.75 inches

Ensure that the change in elevation is within the recommended value.

Recommendation Up to 0.25 inches

Remove tripping hazards \$198

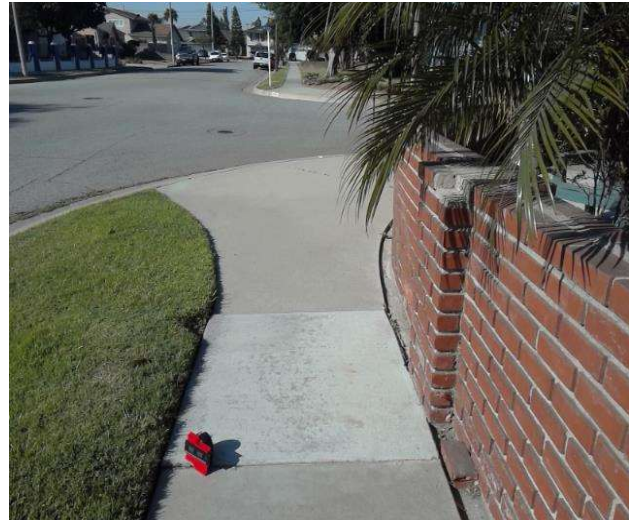
**Change In Level North Of Luxor Street @ 33.945685179507, -118.159288018942**

Sidewalks , Change in Level : Change in Level Non Beveled

There is a change in elevation greater than recommended value.

**On-Site Finding** 0.75 inches

Ensure that the change in elevation is within the recommended value.

Recommendation Up to 0.25 inches

Remove tripping hazards \$198

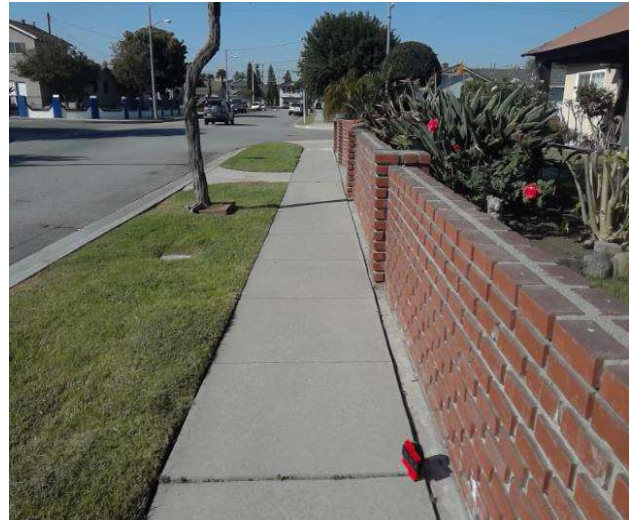
**Change In Level North Of Luxor Street @ 33.945781970122, -118.159215599298**

Sidewalks , Change in Level : Change in Level Non Beveled

There is a change in elevation greater than recommended value.

**On-Site Finding** 0.62 inches

Ensure that the change in elevation is within the recommended value.

Recommendation Up to 0.25 inches

Remove tripping hazards \$198

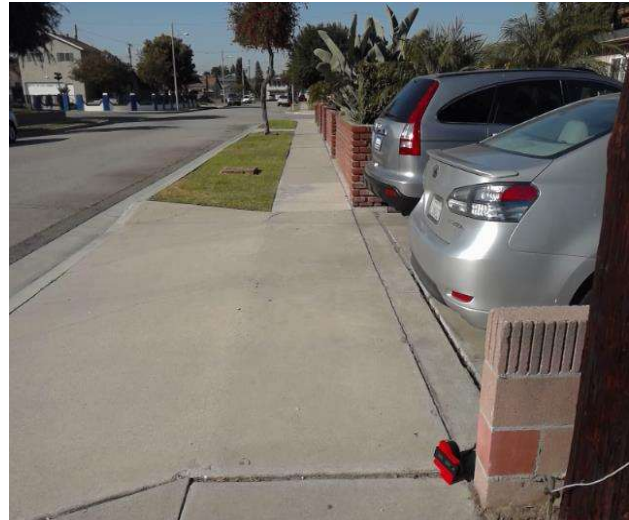
**Change In Level North Of Luxor Street @ 33.945943287570, -118.159112334251**

Sidewalks , Change in Level : Change in Level Non Beveled

There is a change in elevation greater than recommended value.

**On-Site Finding** 0.87 inches

Ensure that the change in elevation is within the recommended value.

Recommendation Up to 0.25 inches

Remove tripping hazards \$198

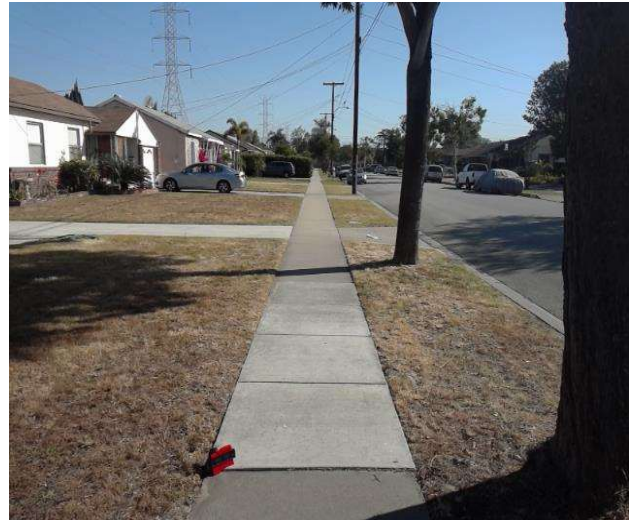
**Change In Level North Of Luxor Street @ 33.946578541583, -118.158641606569**

Sidewalks , Change in Level : Change in Level Non Beveled

There is a change in elevation greater than recommended value.

**On-Site Finding** 0.62 inches

Ensure that the change in elevation is within the recommended value.

Recommendation Up to 0.25 inches

Remove tripping hazards \$198

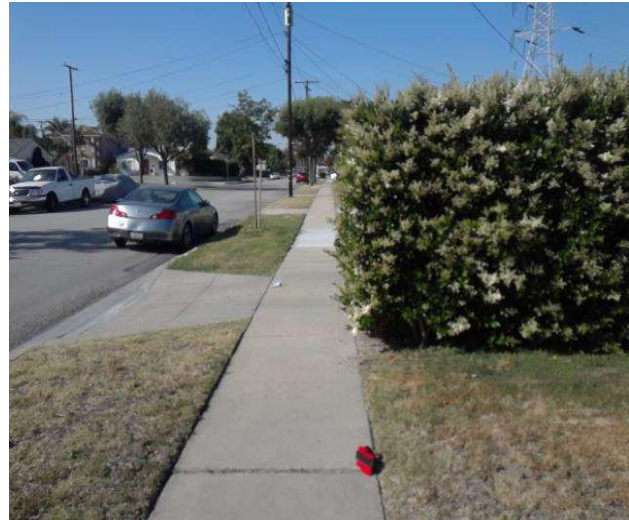
**Change In Level North Of Luxor Street @ 33.947045800703, -118.158317059278**

Sidewalks , Change in Level : Change in Level Non Beveled

There is a change in elevation greater than recommended value.

**On-Site Finding** 0.50 inches

Ensure that the change in elevation is within the recommended value.

Recommendation Up to 0.25 inches

Remove tripping hazards \$198

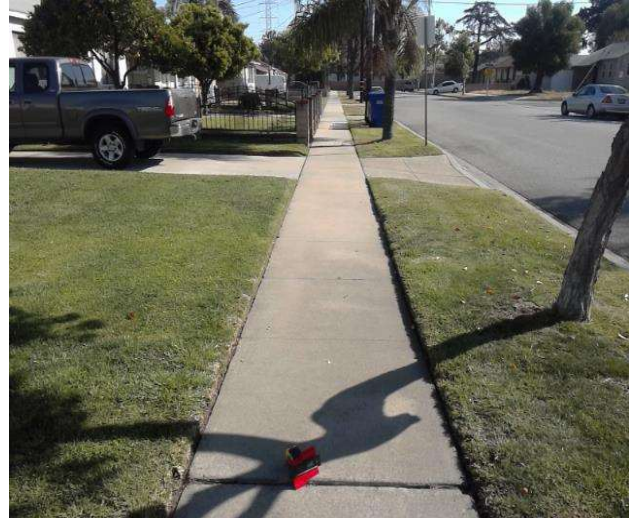
#### Change In Level North Of Luxor Street @ 33.947173740253, -118.158221840858

Sidewalks , Change in Level : Change in Level Non Beveled

There is a change in elevation greater than recommended value.

**On-Site Finding** 0.62 inches

Ensure that the change in elevation is within the recommended value.

Recommendation Up to 0.25 inches

Remove tripping hazards \$198

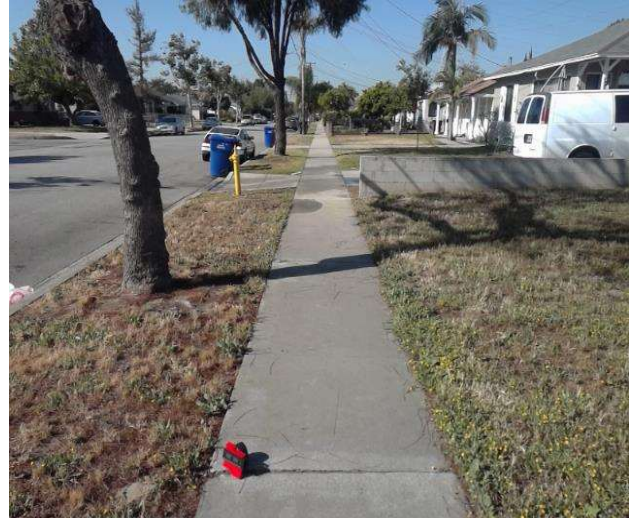
#### Change In Level North Of Luxor Street @ 33.947717759321, -118.157854378223

Sidewalks , Change in Level : Change in Level Non Beveled

There is a change in elevation greater than recommended value.

**On-Site Finding** 0.62 inches

Ensure that the change in elevation is within the recommended value.

Recommendation Up to 0.25 inches

Remove tripping hazards \$198

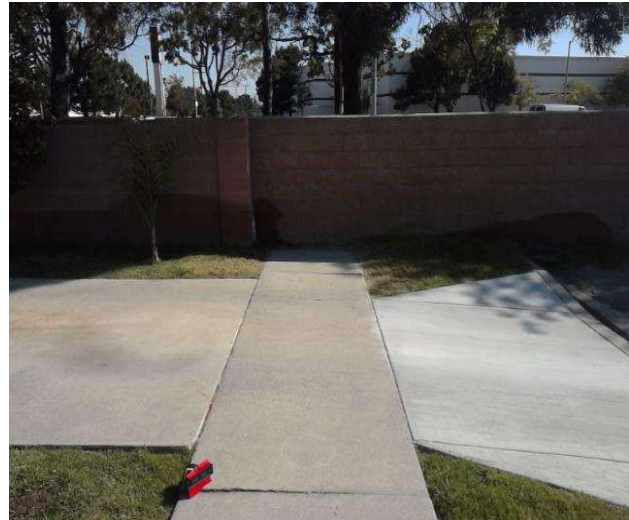
#### Change In Level North Of Luxor Street @ 33.947978086235, -118.157665282488

Sidewalks , Change in Level : Change in Level Non Beveled

There is a change in elevation greater than recommended value.

**On-Site Finding** 0.50 inches

Ensure that the change in elevation is within the recommended value.

Recommendation Up to 0.25 inches

Remove tripping hazards \$198

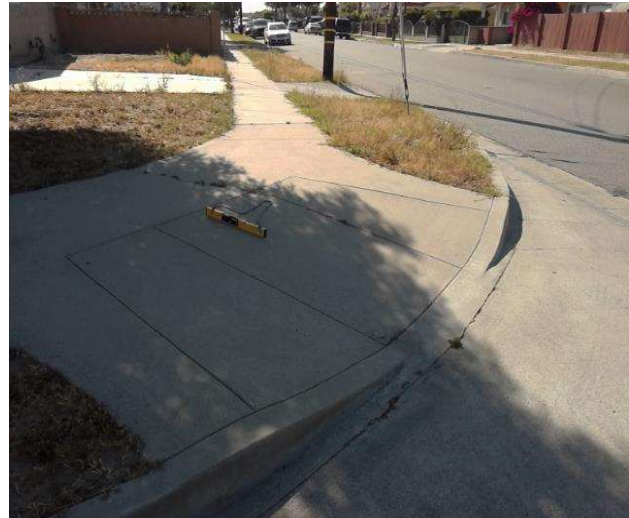
**Northeast Corner Of Adwen Street @ 33.947494144542, - 118.157787322998**

Curb Ramp : No Detectable Warnings

The curb ramp does not provide a detectable warning surface which includes truncated domes.

**On-Site Finding** Not Found

Provide compliant detectable warnings to surface.

Provide detectable warning to surface \$248

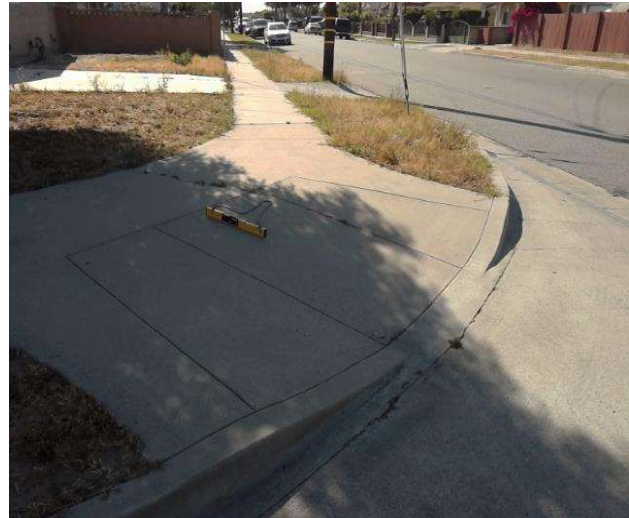
**Northeast Corner Of Adwen Street @ 33.947494144542, - 118.157787322998**

Curb Ramp : Curb Ramp Slope

The running slope is greater than allowed.

**On-Site Finding** 12.70 percent

Provide a compliant curb ramp.

Recommendation Up to 8.33 percent

Install curb ramp \$1,300

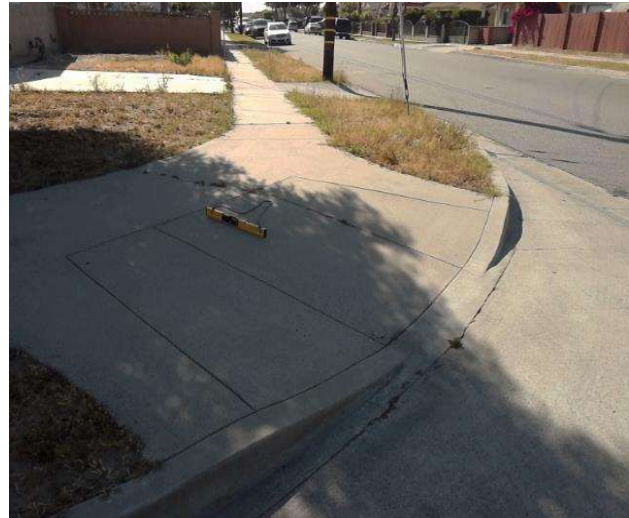
**Northeast Corner Of Adwen Street @ 33.947494144542, - 118.157787322998**

Curb Ramp : Curb Ramp - Cross Slope

The cross slope is greater than allowed.

**On-Site Finding** 2.70 percent

Provide a compliant curb ramp.

Recommendation Up to 2.08 percent

Install curb ramp \$1,300

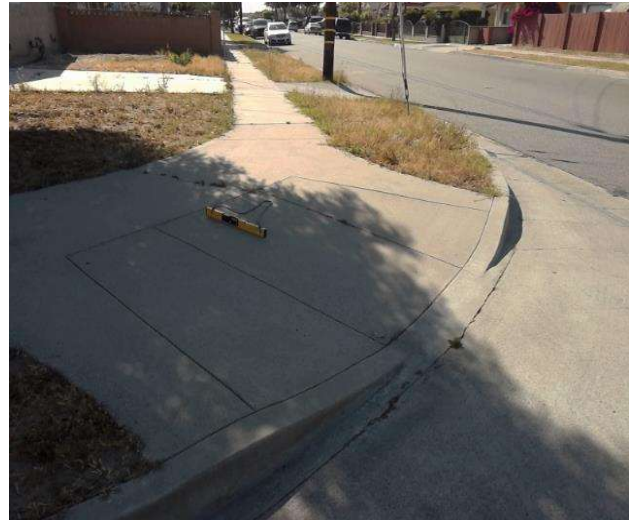
**Northeast Corner Of Adwen Street @ 33.947494144542, - 118.157787322998**

Curb Ramp : Side Flare Slope

The slope of the curb ramp side flare is greater than allowed.

**On-Site Finding** 14.40 percent

Provide curb ramp side flares with a compliant slope.

Recommendation Up to 10.00 percent

Install flared sides \$1,300

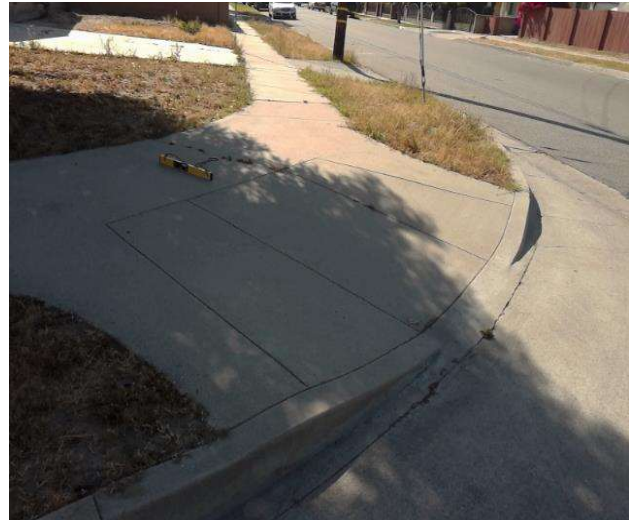
**Northeast Corner Of Adwen Street @ 33.947494144542, - 118.157787322998**

Curb Ramp , Landings and Transitions : Top Landing Slope

The slope at the top landing is greater than allowed.

**On-Site Finding** 3.30 percent

Provide a top landing surface that does not exceed the maximum slope and cross slope. Provide a sufficient maneuvering clearance that does not accumulate water.

Recommendation Up to 2.08 percent

Provide compliant landing \$1,260

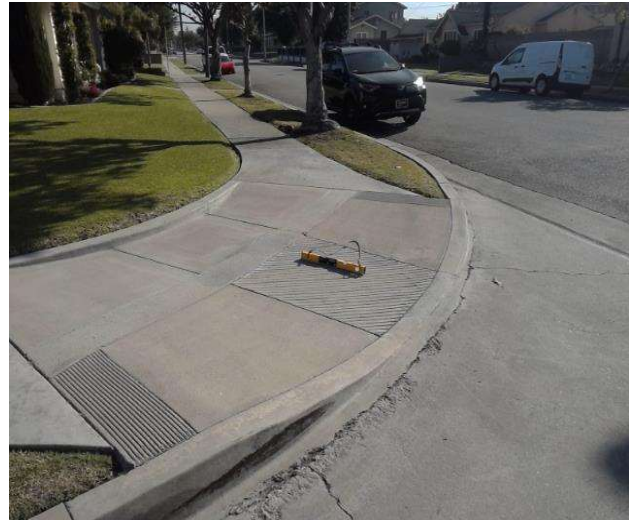
#### Northwest Corner Of De Palma Street @ 33.944841872704, - 118.159903585911

Curb Ramp : No Detectable Warnings

The curb ramp does not provide a detectable warning surface which includes truncated domes.

**On-Site Finding** Not Found

Provide compliant detectable warnings to surface.

Provide detectable warning to surface \$248

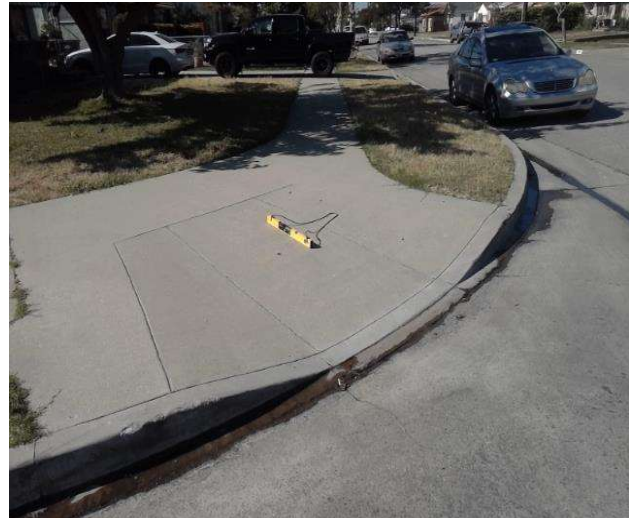
**On-Site Finding** Not Found

Provide detectable warning to surface \$248

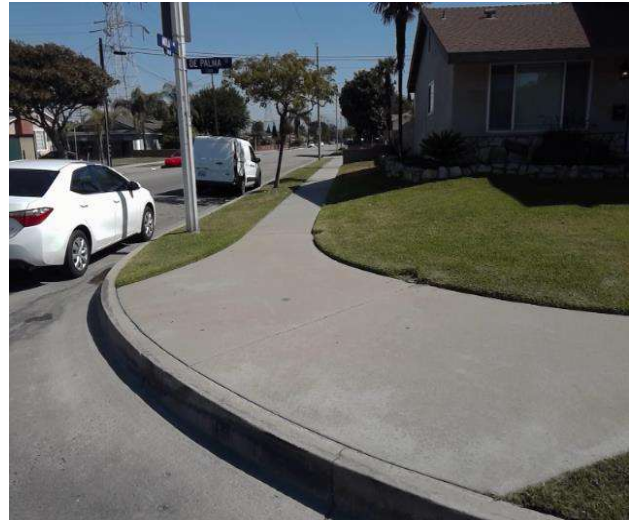
Sidewalks , Hazards & Gratings : Curb is on Path of Travel

Install curb ramp \$2,500

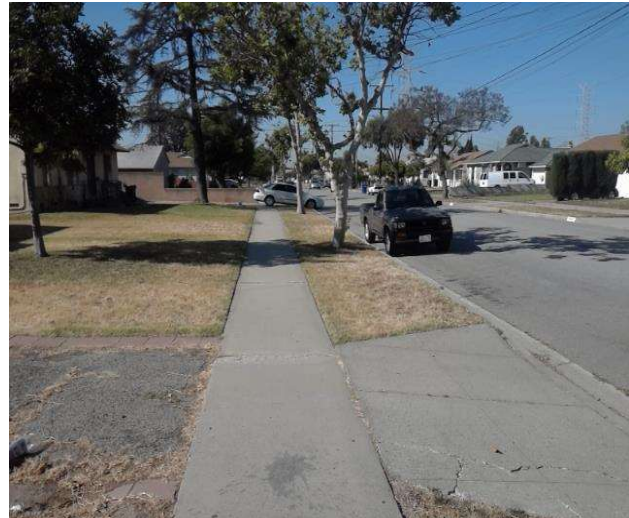
**On-Site Finding** Not Found

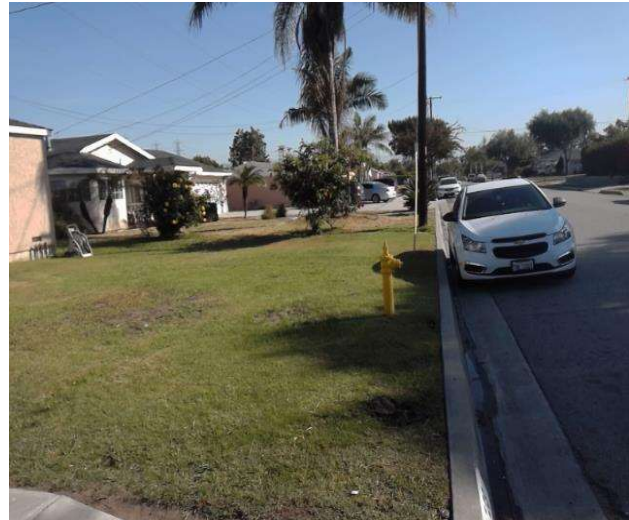
Sidewalks : Missing Sidewalk

Section of sidewalk is missing and consists of dirt, grass or gravel.

Provide a compliant sidewalk for the missing section.

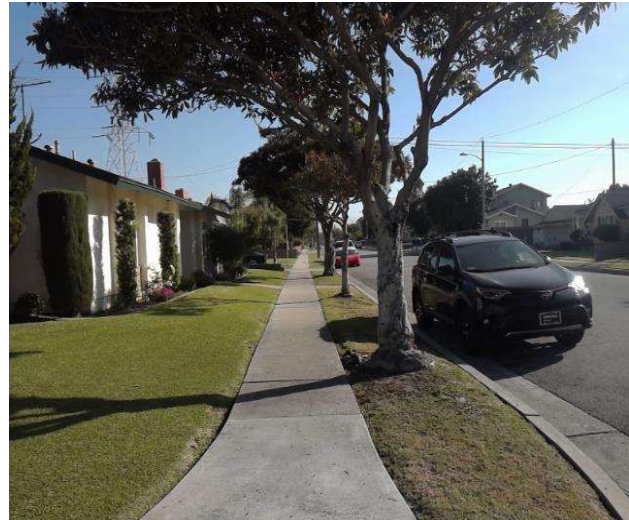
**On-Site Finding** Not Found

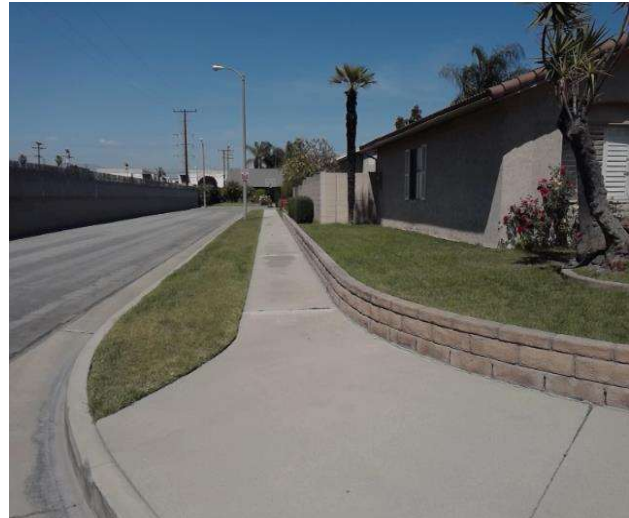
**On-Site Finding** Not Found

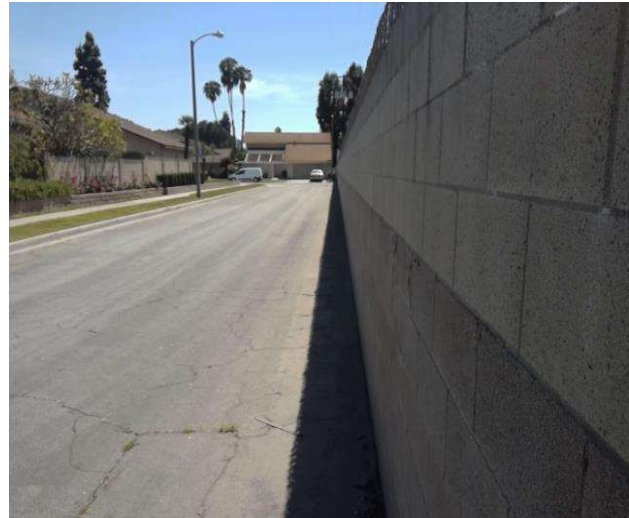
**On-Site Finding** Not Found
