# Accessibility Survey

## City of Downey Bangle Road - Tweedy Lane to End

Tweedy Lane to End  
Downey, CA 90242

Date of Inspection  
6/26/2017

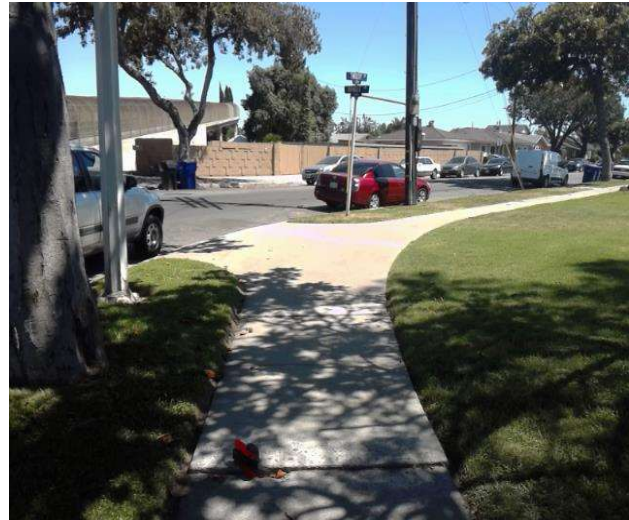
#### Change in Level West of Tweedy Lane @ 33.967723897395, -118.122159540653

Sidewalks , Change in Level : Change in Level Non Beveled

There is a change in elevation greater than recommended value.

**On-Site Finding** 1.00 inches

**Code Reference** ADA 206, 302

Ensure that the change in elevation is within the recommended value.

Recommendation Up to 0.25 inches

Remove tripping hazards \$198

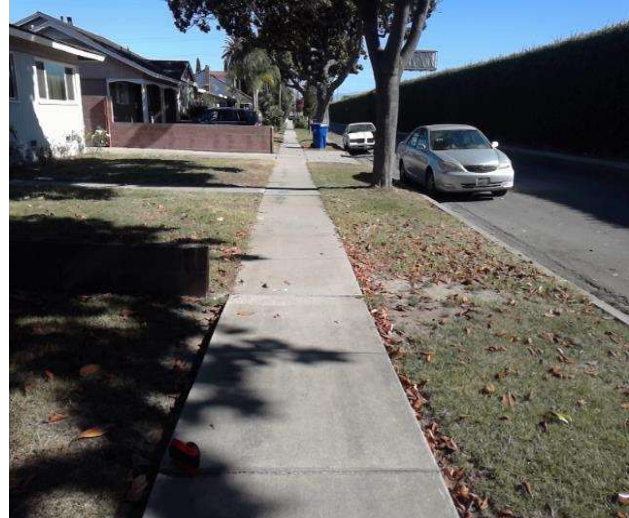
#### Change in Level West of Tweedy Lane @ 33.968084265083, -118.122253417969

Sidewalks , Change in Level : Change in Level Non Beveled

There is a change in elevation greater than recommended value.

**On-Site Finding** 0.50 inches

**Code Reference** ADA 206, 302

Ensure that the change in elevation is within the recommended value.

Recommendation Up to 0.25 inches

Remove tripping hazards \$198

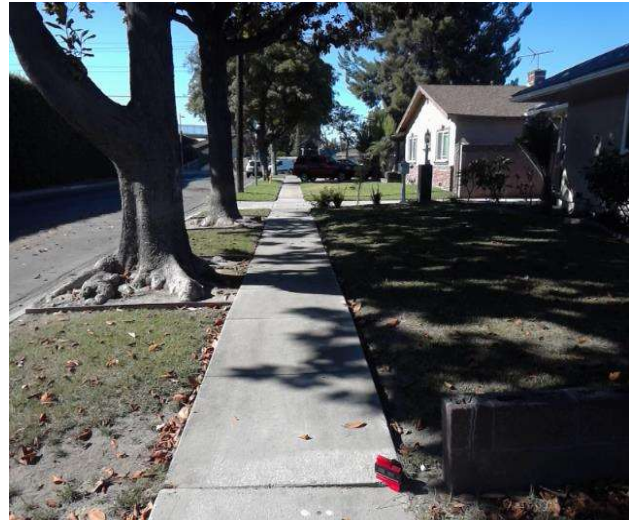
#### Change in Level West of Tweedy Lane @ 33.968158785371, -118.122282922268

Sidewalks , Change in Level : Change in Level Non Beveled

There is a change in elevation greater than recommended value.

**On-Site Finding** 0.87 inches

**Code Reference** ADA 206, 302

Ensure that the change in elevation is within the recommended value.

Recommendation Up to 0.25 inches

Remove tripping hazards \$198

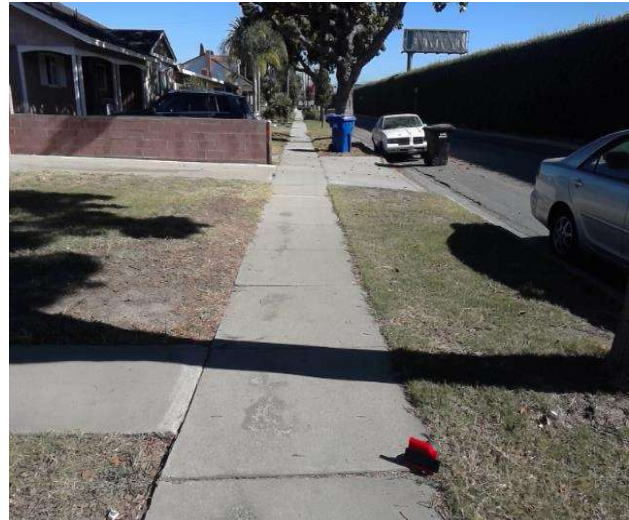
#### Change in Level West of Tweedy Lane @ 33.968215509726, -118.122315108776

Sidewalks , Change in Level : Change in Level Non Beveled

There is a change in elevation greater than recommended value.

**On-Site Finding** 0.50 inches

**Code Reference** ADA 206, 302

Ensure that the change in elevation is within the recommended value.

Recommendation Up to 0.25 inches

Remove tripping hazards \$198

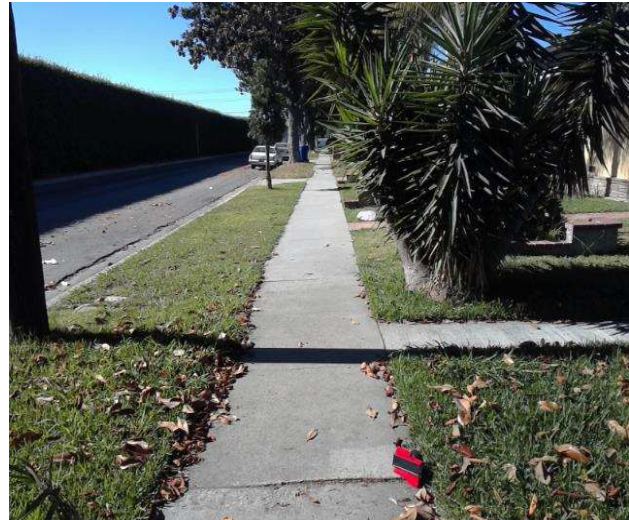
#### Change in Level West of Tweedy Lane @ 33.968669303201, -118.122455924749

Sidewalks , Change in Level : Change in Level Non Beveled

There is a change in elevation greater than recommended value.

**On-Site Finding** 0.75 inches

**Code Reference** ADA 206, 302

Ensure that the change in elevation is within the recommended value.

Recommendation Up to 0.25 inches

Remove tripping hazards \$198

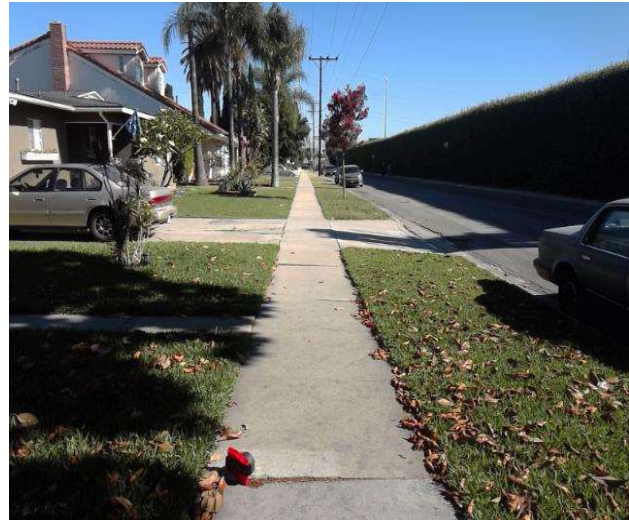
#### Change in Level West of Tweedy Lane @ 33.968718241568, -118.122454583645

Sidewalks , Change in Level : Change in Level Non Beveled

There is a change in elevation greater than recommended value.

**On-Site Finding** 1.00 inches

**Code Reference** ADA 206, 302

Ensure that the change in elevation is within the recommended value.

Recommendation Up to 0.25 inches

Remove tripping hazards \$198

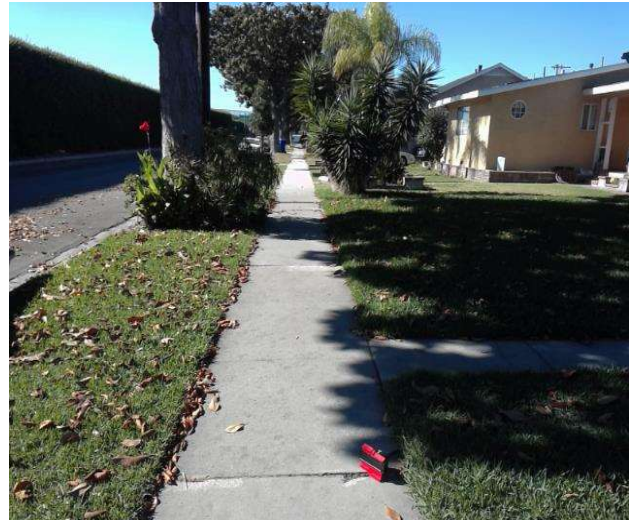
#### Change in Level West of Tweedy Lane @ 33.968742710741, -118.122469335794

Sidewalks , Change in Level : Change in Level Non Beveled

There is a change in elevation greater than recommended value.

**On-Site Finding** 0.50 inches

**Code Reference** ADA 206, 302

Ensure that the change in elevation is within the recommended value.

Recommendation Up to 0.25 inches

Remove tripping hazards \$198

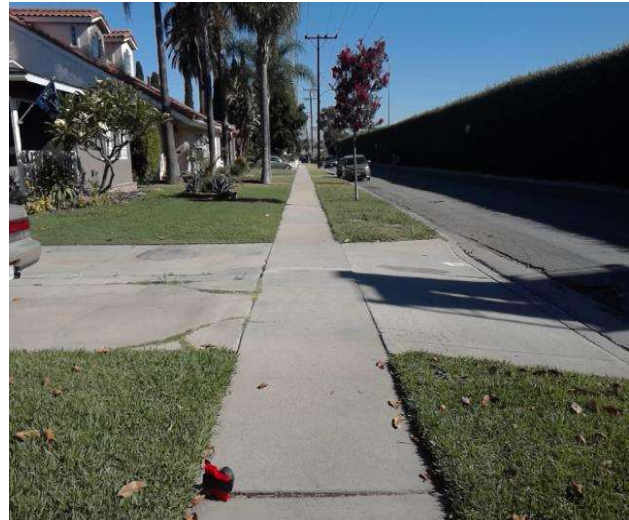
**Change in Level West of Tweedy Lane @ 33.968756057560, -118.122481405735**

Sidewalks , Change in Level : Change in Level Non Beveled

There is a change in elevation greater than recommended value.

**On-Site Finding** 1.00 inches

**Code Reference** ADA 206, 302

Ensure that the change in elevation is within the recommended value.

Recommendation Up to 0.25 inches

Remove tripping hazards \$198

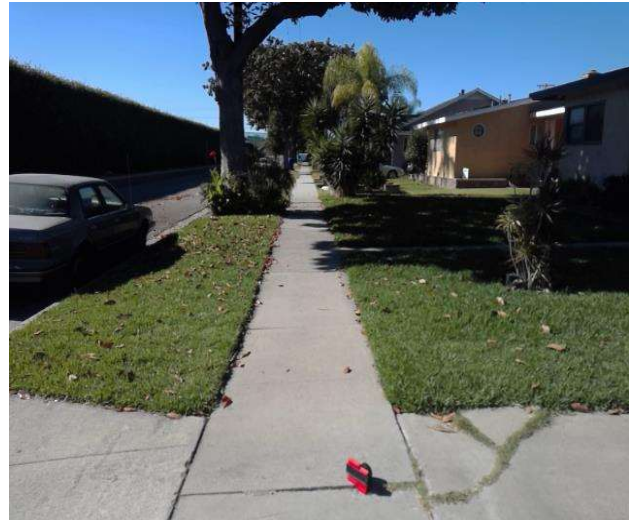
#### Change in Level West of Tweedy Lane @ 33.968784975660, -118.122488111258

Sidewalks , Change in Level : Change in Level Non Beveled

There is a change in elevation greater than recommended value.

**On-Site Finding** 0.62 inches

**Code Reference** ADA 206, 302

Ensure that the change in elevation is within the recommended value.

Recommendation Up to 0.25 inches

Remove tripping hazards \$198

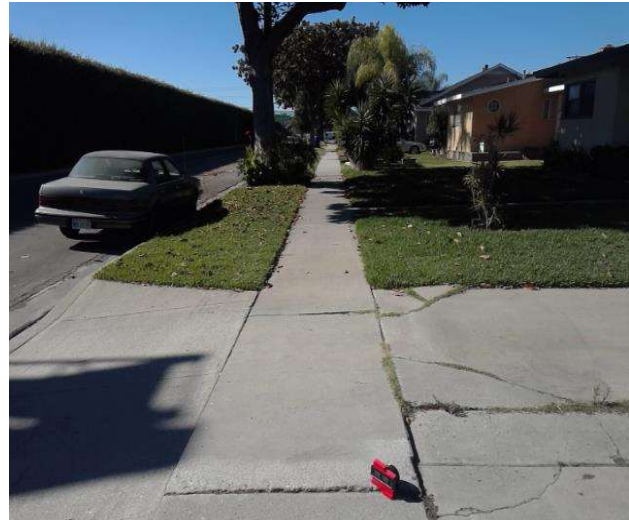
#### Change in Level West of Tweedy Lane @ 33.968806108112, -118.122497498989

Sidewalks , Change in Level : Change in Level Non Beveled

There is a change in elevation greater than recommended value.

**On-Site Finding** 0.62 inches

**Code Reference** ADA 206, 302

Ensure that the change in elevation is within the recommended value.

Recommendation Up to 0.25 inches

Remove tripping hazards \$198

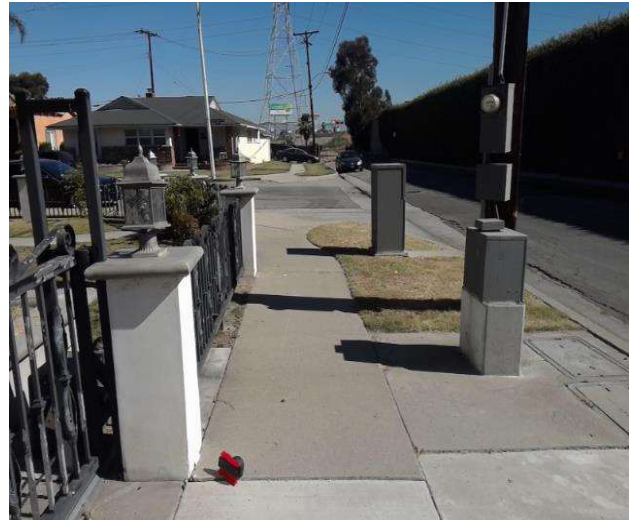
#### Change in Level West of Tweedy Lane @ 33.969646952974, -118.122764378786

Sidewalks , Change in Level : Change in Level Non Beveled

There is a change in elevation greater than recommended value.

**On-Site Finding** 0.50 inches

**Code Reference** ADA 206, 302

Ensure that the change in elevation is within the recommended value.

Recommendation Up to 0.25 inches

Remove tripping hazards \$198

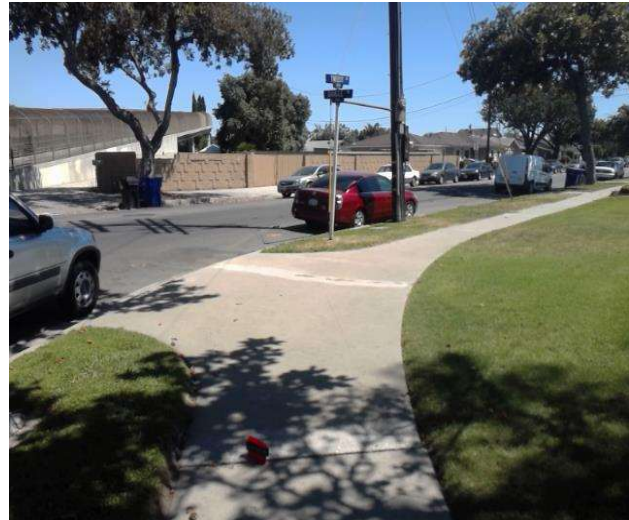
#### Change in Level West of Tweedy Lane @ 33.967723897395, -118.122150152922

Sidewalks , Change in Level : Change in Level Non Beveled

There is a change in elevation greater than recommended value.

**On-Site Finding** 0.37 inches

**Code Reference** ADA 206, 302

Ensure that the change in elevation is within the recommended value.

Recommendation Up to 0.25 inches

Remove tripping hazards \$198

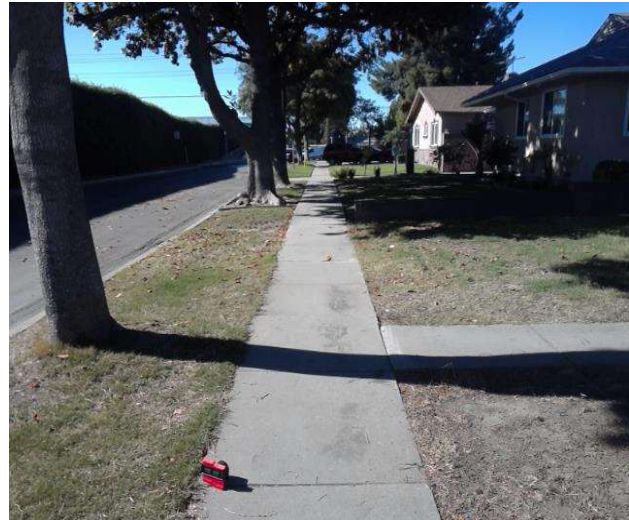
#### Change in Level West of Tweedy Lane @ 33.968235530077, -118.122321814299

Sidewalks , Change in Level : Change in Level Non Beveled

There is a change in elevation greater than recommended value.

**On-Site Finding** 0.37 inches

**Code Reference** ADA 206, 302

Ensure that the change in elevation is within the recommended value.

Recommendation Up to 0.25 inches

Remove tripping hazards \$198

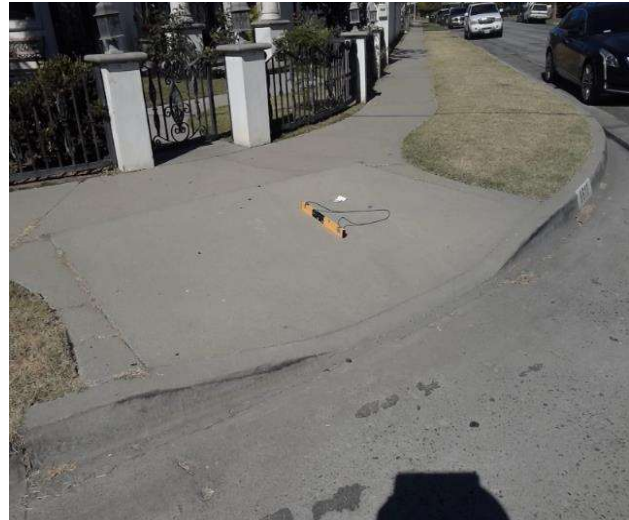
#### **Southeast Corner of Guatemala Avenue @ 33.969720359671, -118.122777789831**

Curb Ramp : No Detectable Warnings

The curb ramp does not provide a detectable warning surface which includes truncated domes.

**On-Site Finding** Not Found

**Code Reference** CA 11B-406.5.12

Provide compliant detectable warnings to surface.

Provide detectable warning to surface \$248

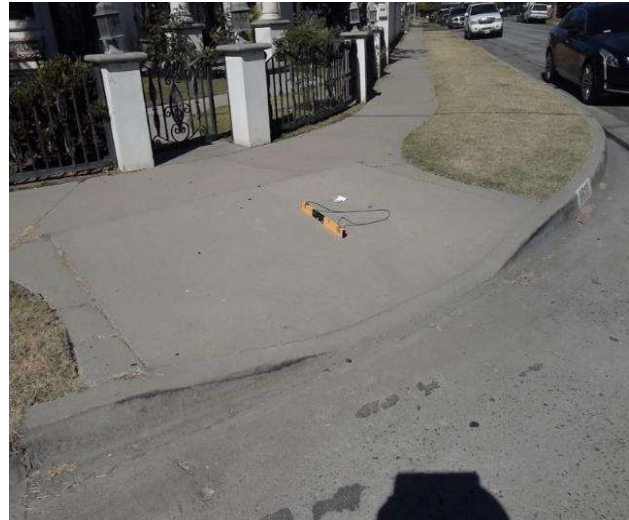
**Southeast Corner of Guatemala Avenue @ 33.969720359671, -  
118.122777789831**

Curb Ramp : Curb Ramp Width

The width of the curb ramp is less than required.

**On-Site Finding** 42.00 inches

**Code Reference** ADA 406, 406.1, 405.5, CA 11B-406.5.2

Provide a compliant curb ramp.

Recommendation At least 48.00 inches

Install curb ramp \$1,300

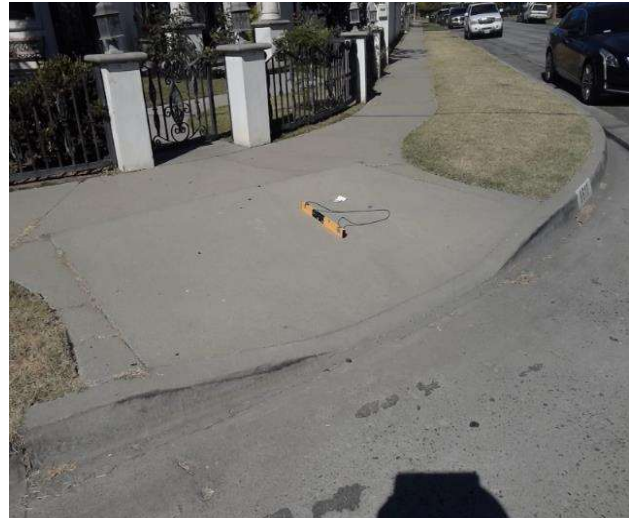
**Southeast Corner of Guatemala Avenue @ 33.969720359671, - 118.122777789831**

Curb Ramp : Curb Ramp Slope

The running slope is greater than allowed.

**On-Site Finding** 11.30 percent

**Code Reference** ADA 406, 406.1, 405.2, CA 11B-406

Provide a compliant curb ramp.

Recommendation Up to 8.33 percent

Install curb ramp \$1,300

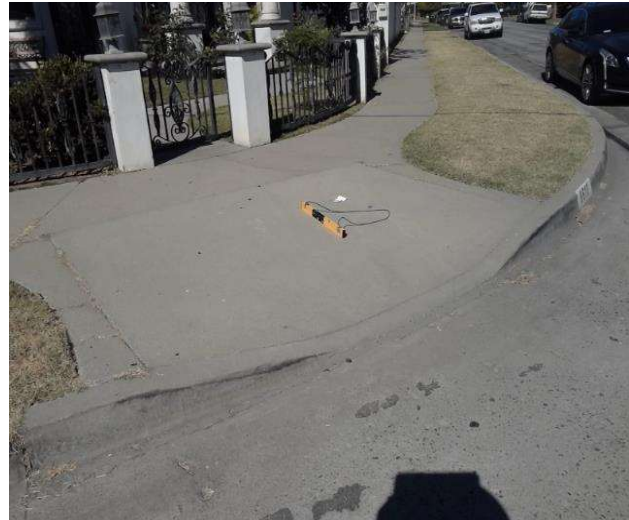
**Southeast Corner of Guatemala Avenue @ 33.969720359671, -  
118.122777789831**

Curb Ramp : Side Flare Slope

The slope of the curb ramp side flare is greater than allowed.

**On-Site Finding** 16.20 percent

**Code Reference** ADA 406, 406.3, CA 11B-406.2.2

Provide curb ramp side flares with a compliant slope.

Recommendation Up to 10.00 percent

Install flared sides \$1,300

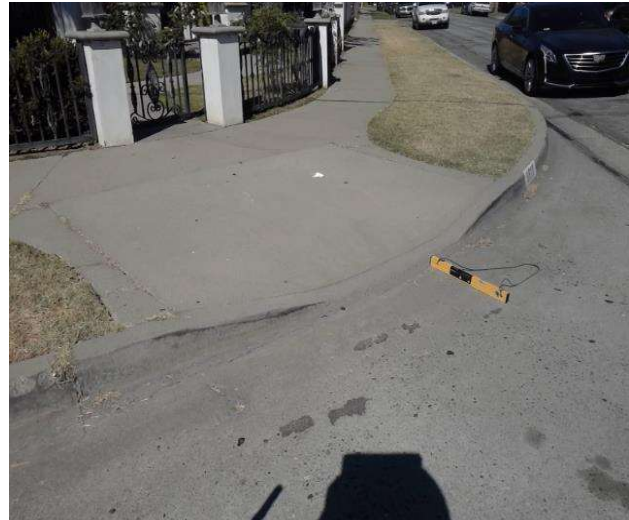
#### **Southeast Corner of Guatemala Avenue @ 33.969720359671, - 118.122777789831**

Curb Ramp : Bottom Landing Slope

The bottom landing of the curb ramp is on the street, and the slope of the bottom landing is not compliant.

**On-Site Finding** 5.60 percent

**Code Reference** ADA 406, 406.2, CA 11B-406.5.8

Ensure the bottom landing slope is compliant and provides a smooth transition.

Recommendation Up to 5.00 percent

Repave landing \$1,260

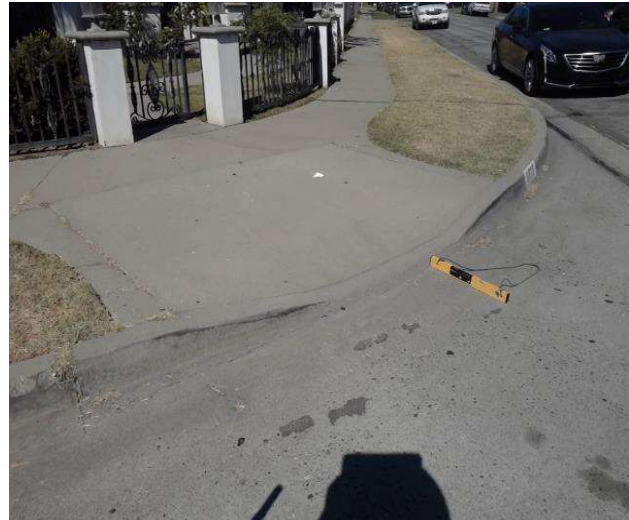
#### **Southeast Corner of Guatemala Avenue @ 33.969720359671, - 118.122777789831**

Curb Ramp , Landings and Transitions : Top Landing Slope

The slope at the top landing is greater than allowed.

**On-Site Finding** 2.60 percent

**Code Reference** ADA 402, 406.4, 403.3, 406.1, CA 11B-406.5.3

Provide a top landing surface that does not exceed the maximum slope and cross slope. Provide a sufficient maneuvering clearance that does not accumulate water.

Recommendation Up to 2.08 percent

Provide compliant landing \$1,260

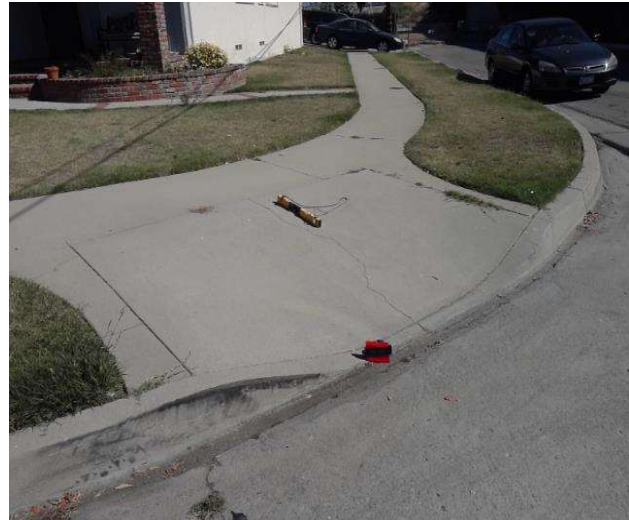
**Southwest Corner of Guatemala Avenue @ 33.969879407296, -118.122836798429**

Curb Ramp : No Detectable Warnings

The curb ramp does not provide a detectable warning surface which includes truncated domes.

**On-Site Finding** Not Found

**Code Reference** CA 11B-406.5.12

Provide compliant detectable warnings to surface.

Provide detectable warning to surface \$248

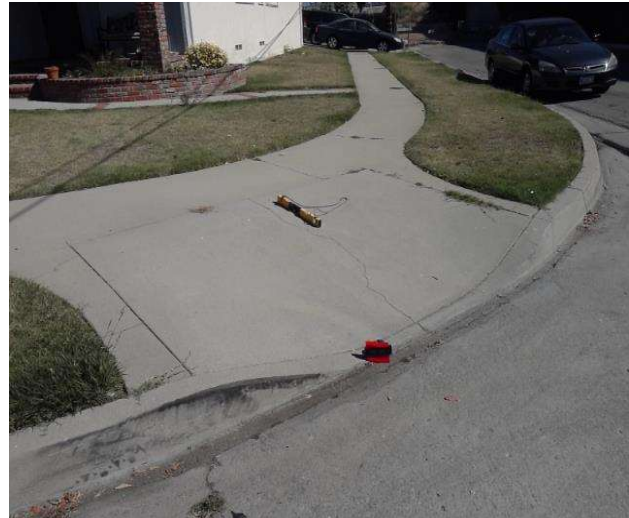
**Southwest Corner of Guatemala Avenue @ 33.969879407296, -  
118.122836798429**

Curb Ramp : Curb Ramp Slope

**Code Reference** ADA 406, 406.1, 405.2, CA 11B-406

Recommendation Up to 8.33 percent

Install curb ramp \$1,300

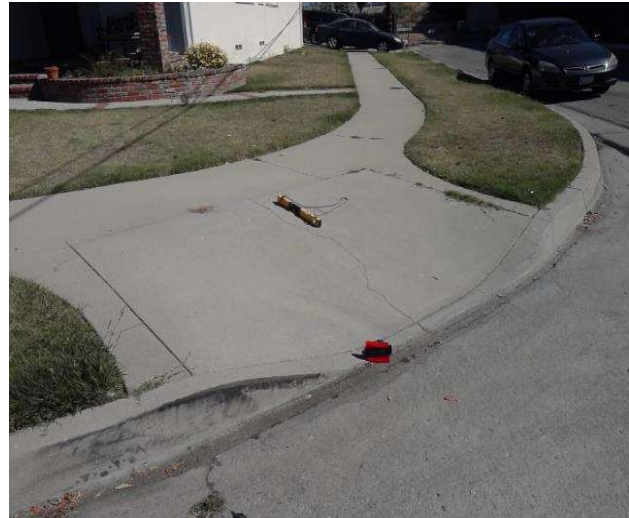
**Code Reference** ADA 406, 406.3,CA 11B-406.2.2

Recommendation Up to 10.00 percent

Install flared sides \$1,300

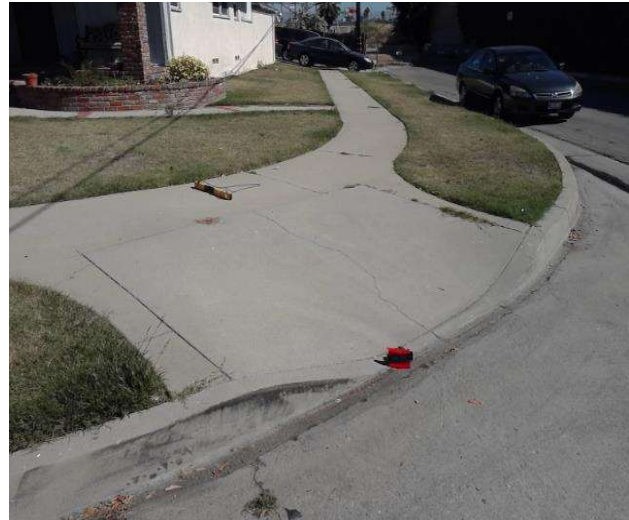
Curb Ramp , Landings and Transitions : Bottom Landing Change in Level - Curb Ramps

**Code Reference** ADA 302, 406.2

Patch lip at curb ramp \$255

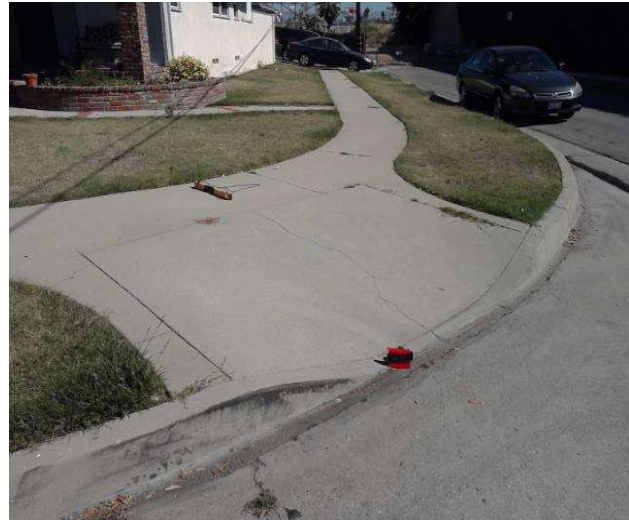
**Code Reference** ADA 402, 406.4, 403.3, 406.1, CA 11B-406.5.3

Recommendation Up to 2.08 percent

Provide compliant landing \$1,260

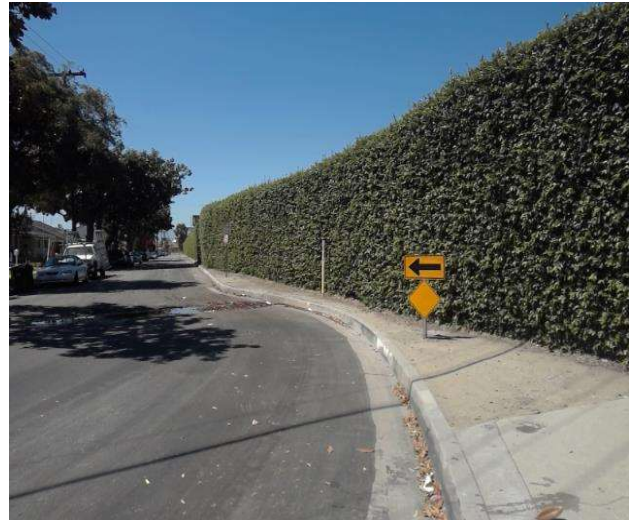
**On-Site Finding** Not Found

**Code Reference** ADA 206

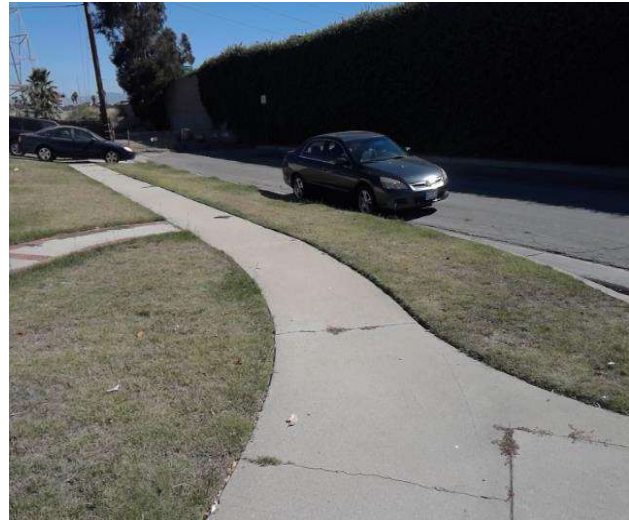
**Code Reference** ADA 206, 302, CA 11B-403.3

Repave the sidewalk surface with the recommended cross slope.

Recommendation Up to 2.08 percent

Repave surface \$1,092

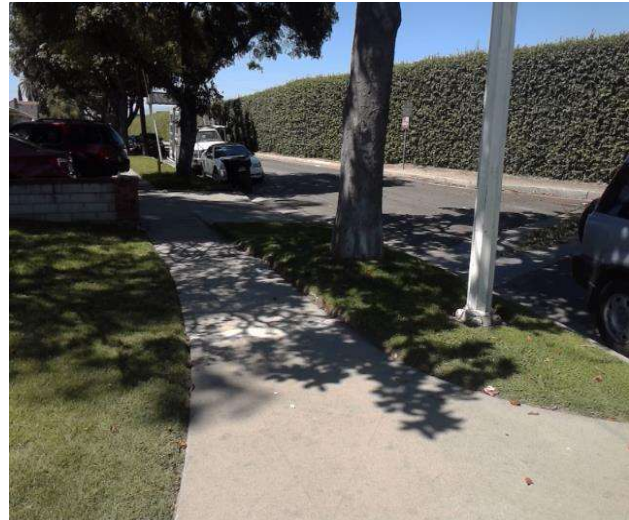
**Code Reference** ADA 206, 302,CA 11B-403.3

Repave the sidewalk surface with the recommended cross slope.

Recommendation Up to 2.08 percent

Repave surface \$1,092

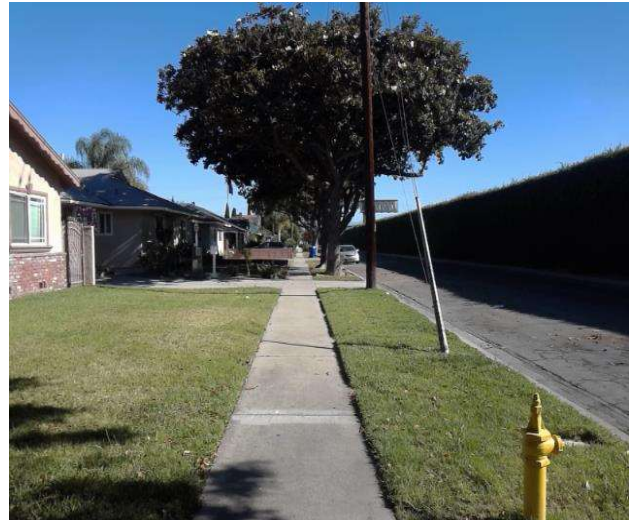
**Code Reference** ADA 206, 302,CA 11B-403.3

Repave the sidewalk surface with the recommended cross slope.

Recommendation Up to 2.08 percent

Repave surface \$1,092

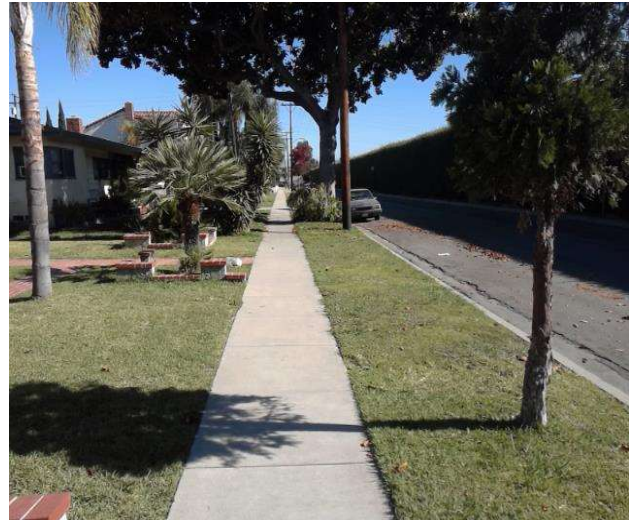
**Code Reference** ADA 206, 302,CA 11B-403.3

Repave the sidewalk surface with the recommended cross slope.

Recommendation Up to 2.08 percent

Repave surface \$1,092

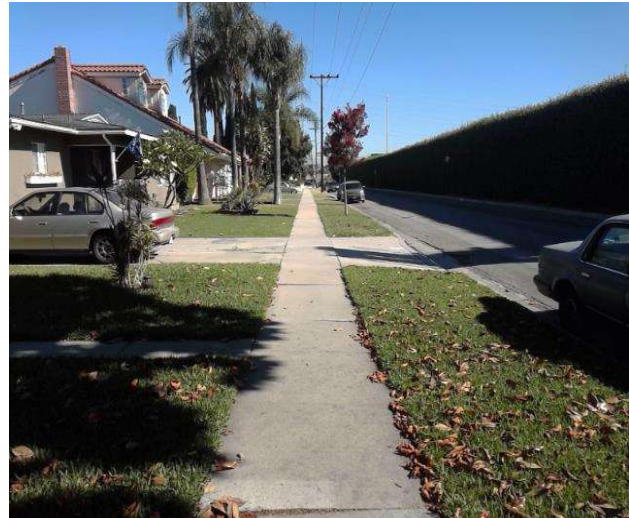
**Code Reference** ADA 206, 302, CA 11B-403.3

Repave the sidewalk surface with the recommended cross slope.

Recommendation Up to 2.08 percent

Repave surface \$1,092

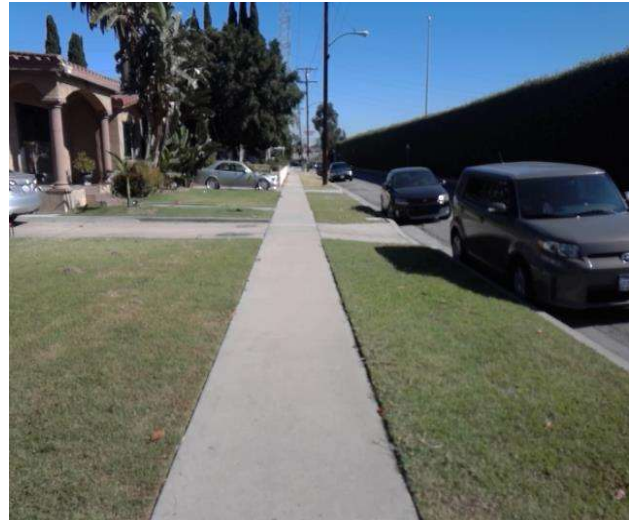
**Code Reference** ADA 206, 302, CA 11B-403.3

Repave the sidewalk surface with the recommended cross slope.

Recommendation Up to 2.08 percent

Repave surface \$1,092

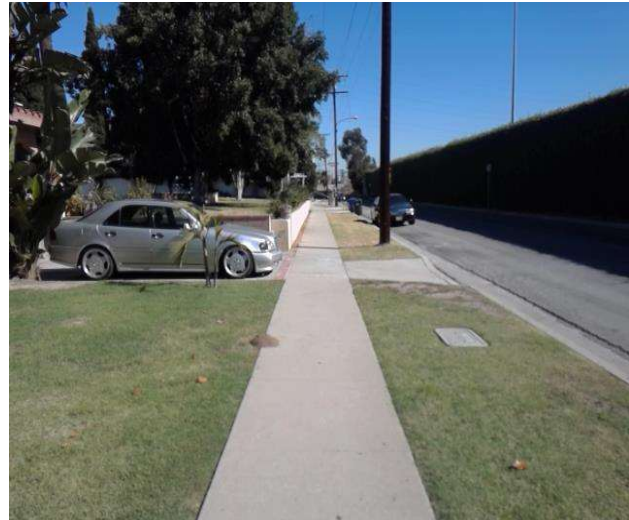
**Code Reference** ADA 206, 302, CA 11B-403.3

Repave the sidewalk surface with the recommended cross slope.

Recommendation Up to 2.08 percent

Repave surface \$1,092

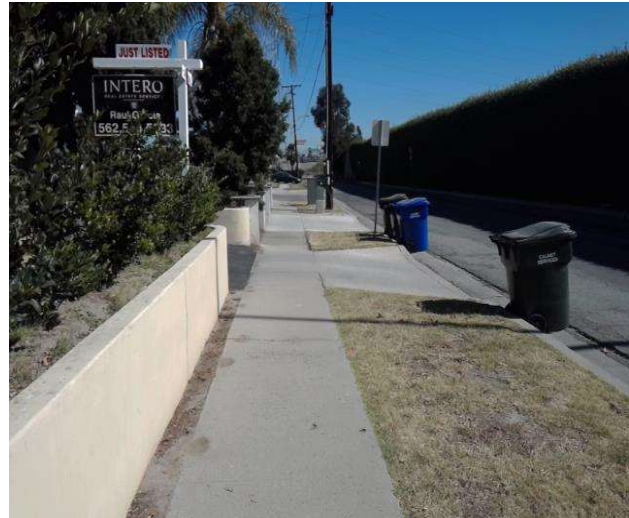
**Code Reference** ADA 206, 302, CA 11B-403.3

Repave the sidewalk surface with the recommended cross slope.

Recommendation Up to 2.08 percent

Repave surface \$1,092

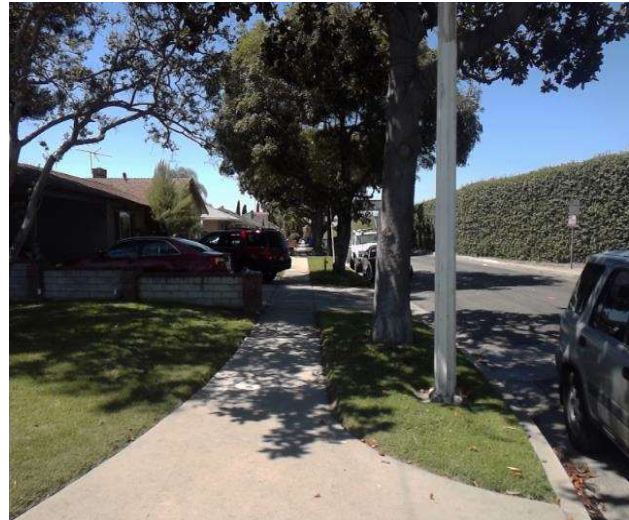
**On-Site Finding** Not Found

**Code Reference** ADA 206, 302

\$2,400
