Accessibility Survey

City of Downey Civic Center Drive - 3rd Street to Brookshire Avenue

3rd Street to Brookshire Avenue
Downey, CA 90242

Date of Inspection
8/12/2017

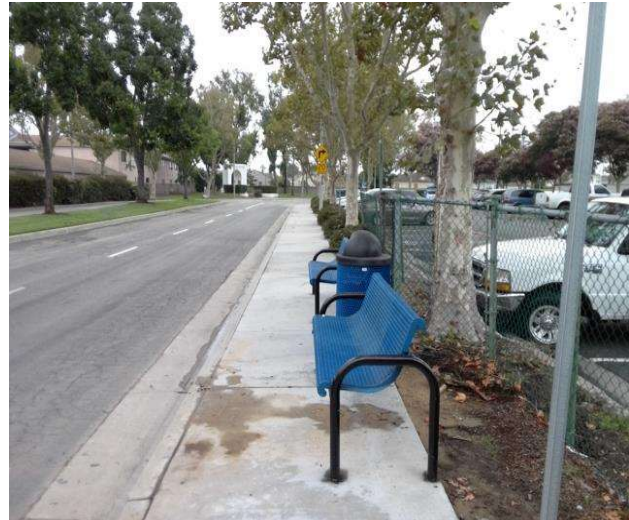
Bench North of 3rd Street @ 33.940990146234, -118.129583895206

Sidewalks , Hazards & Gratings : Sidewalk Width at Obstruction

Sidewalk width at the obstruction is not compliant.

On-Site Finding 37.00 inches

Code Reference ADA 206, 302, 403.5.1, CA 11B-403.5

Sidewalk width at the obstruction shall have the recommended value.

Recommendation At least 48.00 inches

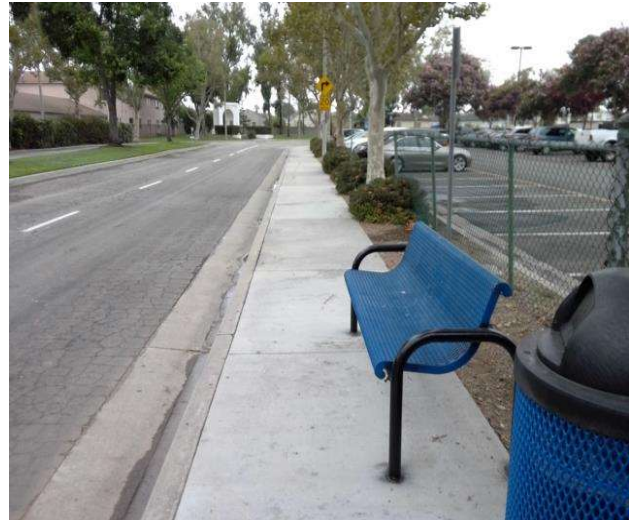
Bench North of 3rd Street @ 33.941031312343, -118.129561096430

Sidewalks , Hazards & Gratings : Sidewalk Width at Obstruction

Sidewalk width at the obstruction is not compliant.

On-Site Finding 38.00 inches

Code Reference ADA 206, 302, 403.5.1, CA 11B-403.5

Sidewalk width at the obstruction shall have the recommended value.

Recommendation At least 48.00 inches

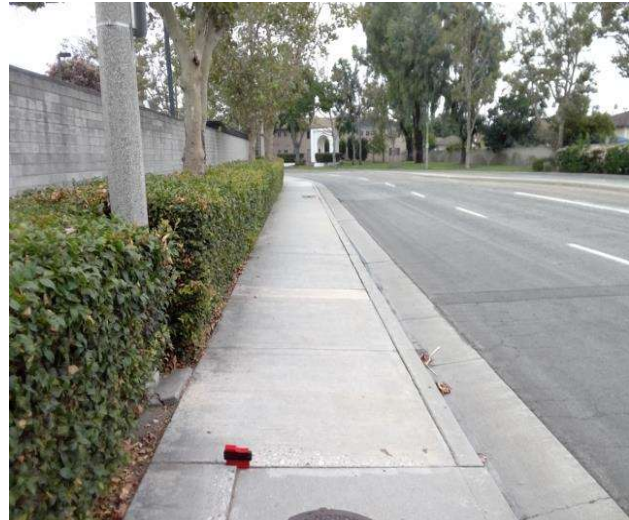
Change in Level North of 3rd Street @ 33.941347289381, -118.128366172314

Sidewalks , Change in Level : Change in Level Non Beveled

There is a change in elevation greater than recommended value.

On-Site Finding 0.62 inches

Code Reference ADA 206, 302

Ensure that the change in elevation is within the recommended value.

Recommendation Up to 0.25 inches

Remove tripping hazards \$198

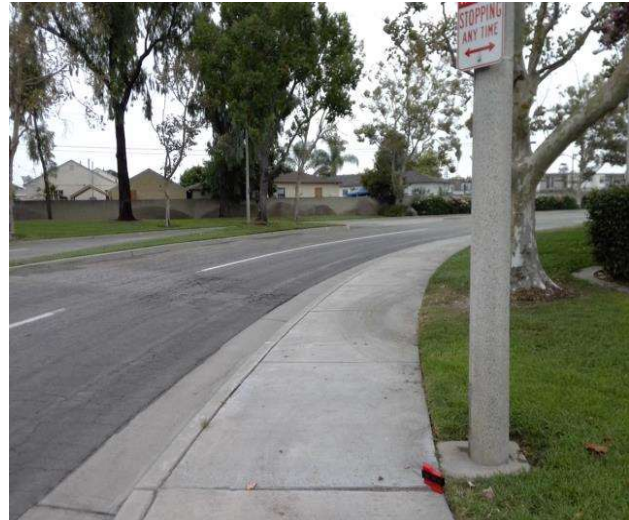
Change in Level North of 3rd Street @ 33.941503052278, -118.129117190838

Sidewalks , Change in Level : Change in Level Non Beveled

There is a change in elevation greater than recommended value.

On-Site Finding 0.75 inches

Code Reference ADA 206, 302

Ensure that the change in elevation is within the recommended value.

Recommendation Up to 0.25 inches

Remove tripping hazards \$198

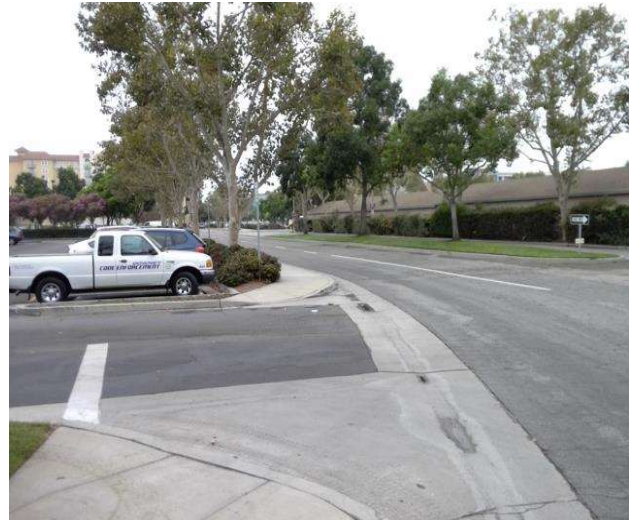
Crossing North of 3rd Street - 1st @ 33.941454098256, -118.129203021526

Sidewalks : Vehicular Traffic Slope

Slope at vehicular traffic is not compliant.

On-Site Finding 6.40 percent

Repave the surface to provide a compliant slope.

Recommendation Up to 5.00 percent

Repave surface \$1,092

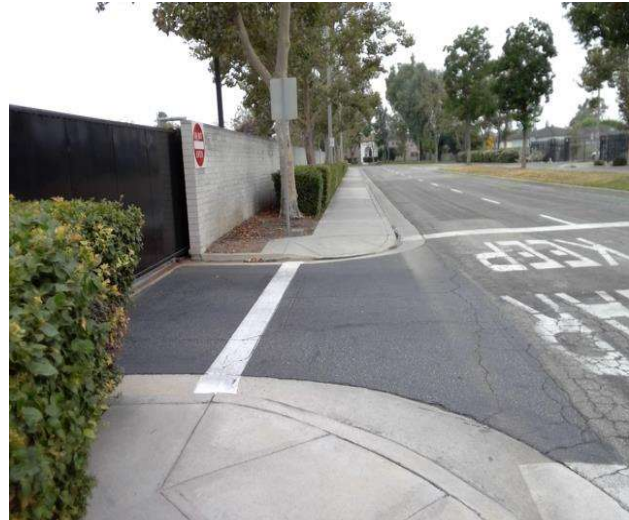
Driveway North of 3rd Street @ 33.941066915449, -118.127841800451

Sidewalks , Vehicular Traffic : Cross Walks and Detectable Warnings

There are no detectable warnings where the pedestrian route crosses vehicular traffic.

On-Site Finding Not Found

Code Reference ADA 705,CA 11B-705.1.2.5,CA 11B-247.1.2.5

Provide detectable warnings.

Install compliant detectable warnings \$190

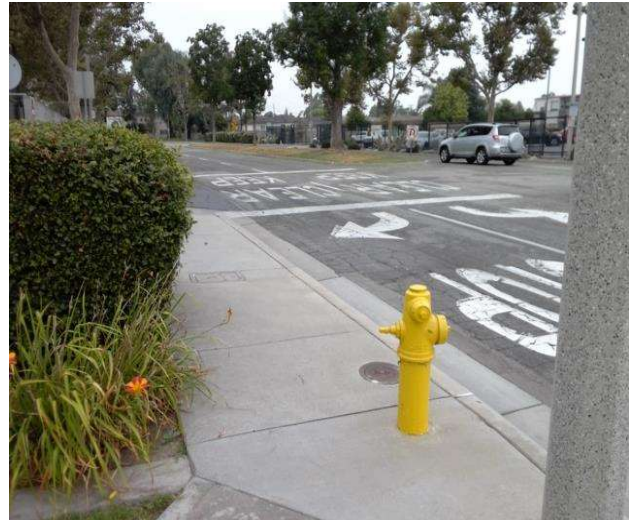
Hydrant North of 3rd Street @ 33.940997934419, -118.127727806568

Sidewalks , Hazards & Gratings : Sidewalk Width at Obstruction

Sidewalk width at the obstruction is not compliant.

On-Site Finding 40.00 inches

Code Reference ADA 206, 302, 403.5.1, CA 11B-403.5

Sidewalk width at the obstruction shall have the recommended value.

Recommendation At least 48.00 inches

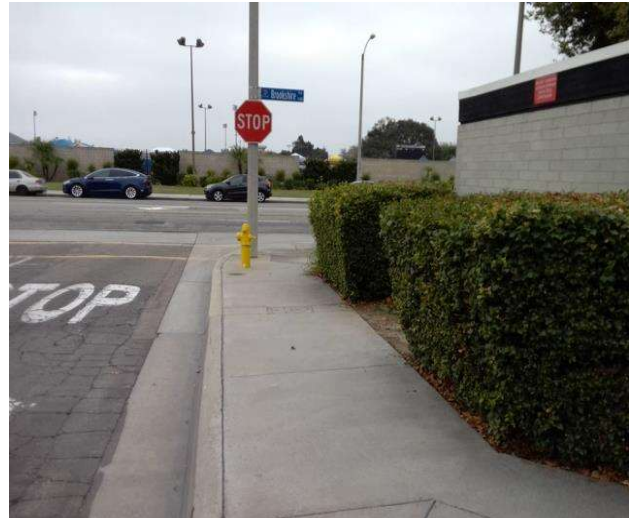
Sidewalk North of 3rd Street @ 33.941044663510, -118.127804249525

Sidewalks , Surface : Cross Slope

Sidewalk cross slope is not compliant.

On-Site Finding 3.20 percent for 24.00 feet

Code Reference ADA 206, 302,CA 11B-403.3

Repave the sidewalk surface with the recommended cross slope.

Recommendation Up to 2.08 percent

Repave surface \$1,092

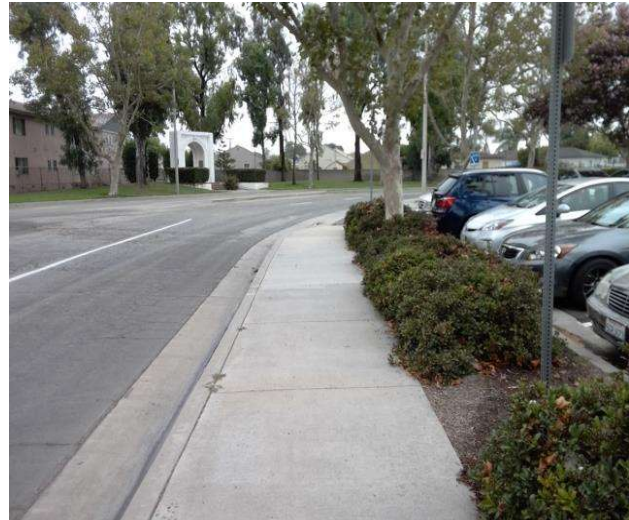
Sidewalk North of 3rd Street @ 33.941366203463, -118.129299581051

Sidewalks , Surface : Cross Slope

Sidewalk cross slope is not compliant.

On-Site Finding 3.10 percent for 49.00 feet

Code Reference ADA 206, 302,CA 11B-403.3

Repave the sidewalk surface with the recommended cross slope.

Recommendation Up to 2.08 percent

Repave surface \$1,092

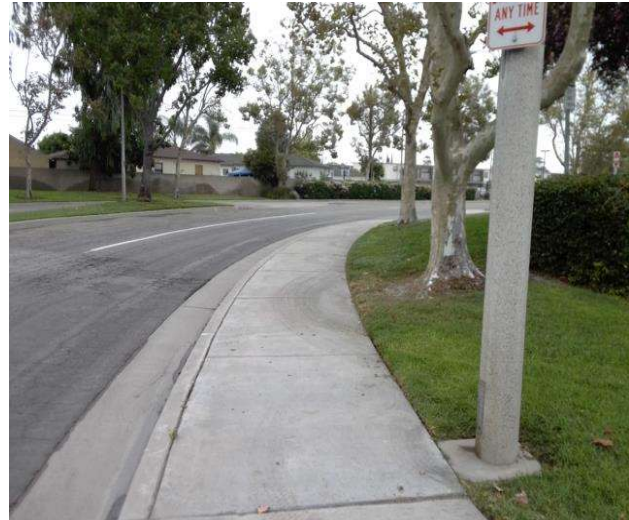
Sidewalk North of 3rd Street @ 33.941508615234, -118.12911826420

Sidewalks , Surface : Cross Slope

Sidewalk cross slope is not compliant.

On-Site Finding 5.30 percent for 77.00 feet

Code Reference ADA 206, 302, CA 11B-403.3

Repave the sidewalk surface with the recommended cross slope.

Recommendation Up to 2.08 percent

Repave surface \$1,092

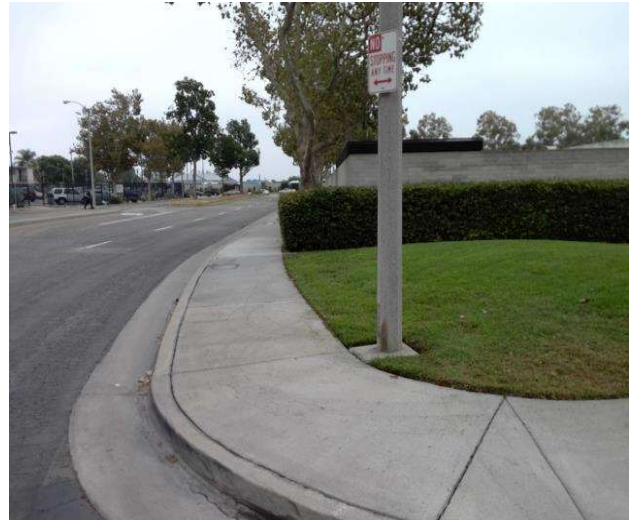
Sidewalk North of 3rd Street @ 33.941530867051, -118.128737658262

Sidewalks , Surface : Cross Slope

Sidewalk cross slope is not compliant.

On-Site Finding 4.50 percent for 301.00 feet

Code Reference ADA 206, 302,CA 11B-403.3

Repave the sidewalk surface with the recommended cross slope.

Recommendation Up to 2.08 percent

Repave surface \$1,092

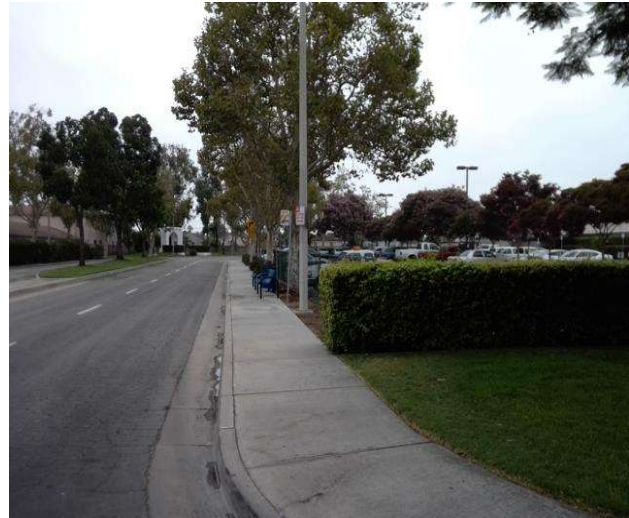
East Side @ 33.940853296594, -118.129683136940

Sidewalks : 60X60 Turn Area

There is no 60X60 turn area at every 200 feet.

On-Site Finding Not Found

Code Reference ADA 206, 302

Provide a 60X60 turn every 200 feet on the sidewalk.

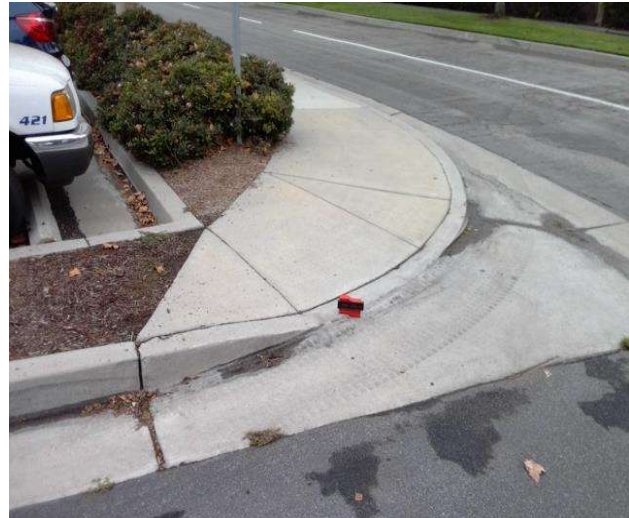
East Side North of 3rd Street - 1st @ 33.941422945681, - 118.129245936871

The transition from the bottom of the curb ramp to the walk, gutter, or street is abrupt.

On-Site Finding Not Beveled

Curb Ramp , Landings and Transitions : Bottom Landing Change in Level - Curb Ramps

Code Reference ADA 302, 406.2

Patch the transition area at the bottom of the curb ramp so that the transition is flush and free of abrupt changes.

Patch lip at curb ramp \$255

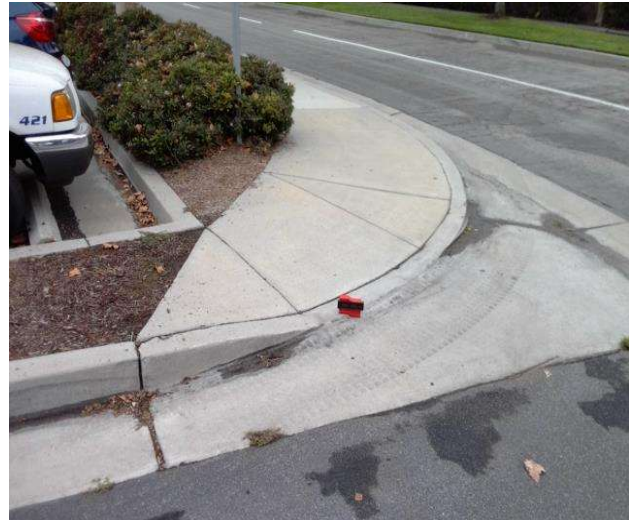
East Side North of 3rd Street - 1st @ 33.941422945681, - 118.129245936871

There is not enough top landing clear length.

On-Site Finding 0.00 inches

Curb Ramp , Landings and Transitions : Top Landing Clear Length - Landings

Code Reference ADA 406, 406.4,CA 11B-406.5.3

Provide a level top landing with enough clear length.

Recommendation At least 48.00 inches

Provide compliant landing \$240

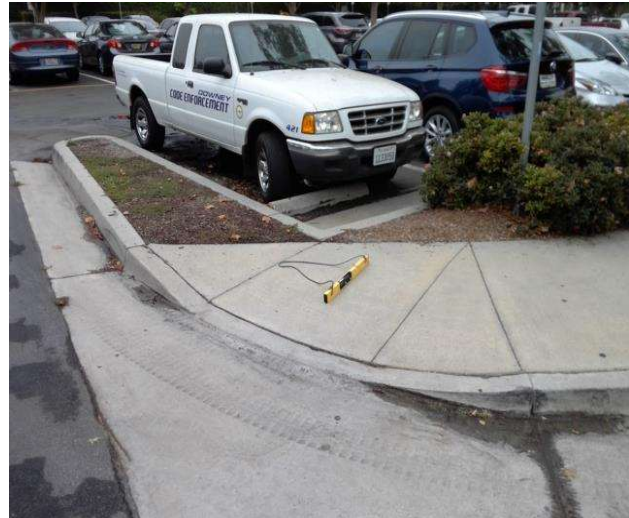
East Side North of 3rd Street - 1st @ 33.941422945681, - 118.129245936871

Curb Ramp : No Detectable Warnings

The curb ramp does not provide a detectable warning surface which includes truncated domes.

On-Site Finding Not Found

Code Reference CA 11B-406.5.12

Provide compliant detectable warnings to surface.

Provide detectable warning to surface \$248

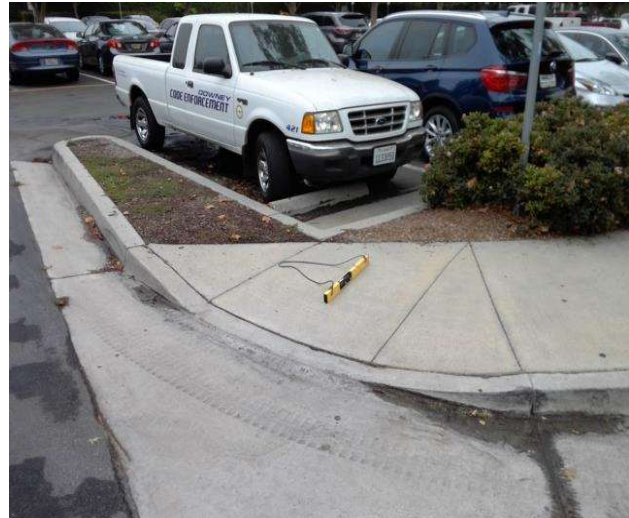
Curb Ramp : Curb Ramp Slope

Code Reference ADA 406, 406.1, 405.2, CA 11B-406

Recommendation Up to 8.33 percent

Install curb ramp \$1,300

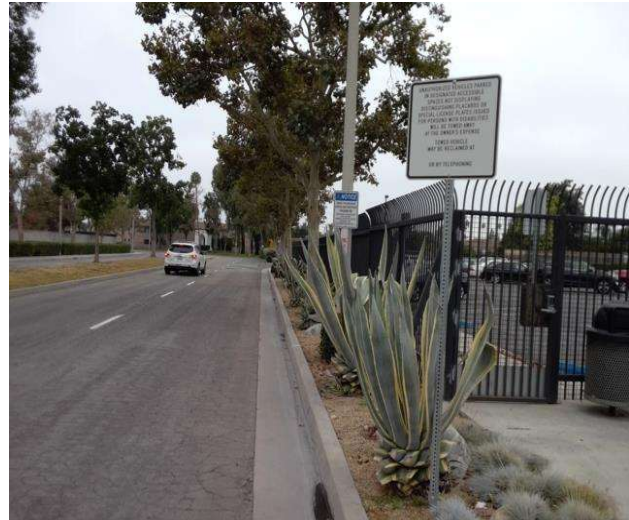
Sidewalks : Missing Sidewalk

Section of sidewalk is missing and consists of dirt, grass or gravel.

Code Reference ADA 206, 302,CA 11B-302,CA 11B-206

Provide a compliant sidewalk for the missing section.
