## Accessibility Survey

### City of Downey Cornuta Avenue - Foster Road to Angell Street

Date of Inspection  
12/10/2016

Prepared By  
**Disability Access Consultants**  
(800) 743-7067

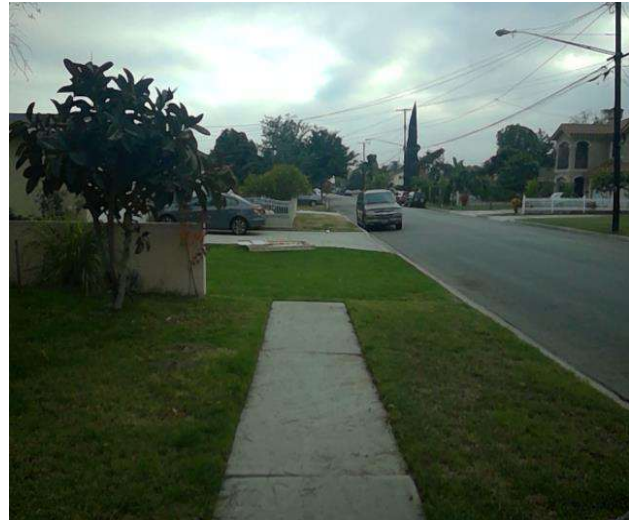
**Change In Level South Of Angell Street @ 33.912968098600, -118.118766546249**

Sidewalks , Change in Level : Change in Level Non Beveled

There is a change in elevation greater than recommended value.

**On-Site Finding** 1.00 inches

**Code Reference** ADA 206, 302

Ensure that the change in elevation is within the recommended value.

Recommendation Up to 0.25 inches

Remove tripping hazards \$198

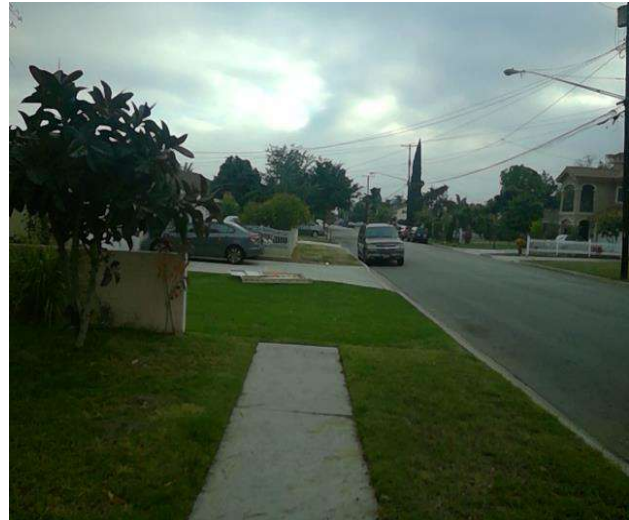
#### Sidewalk South Of Angell Street @ 33.912941387462, -118.118769228458

Sidewalks : Missing Sidewalk

Section of sidewalk is missing and consists of dirt, grass or gravel.

**On-Site Finding** 1272.00 feet

**Code Reference** ADA 206, 302,CA 11B-302,CA 11B-206

Provide a compliant sidewalk for the missing section.

\$1,260

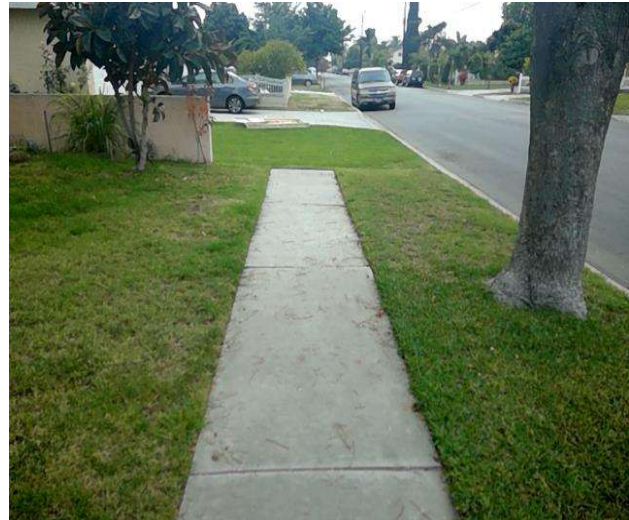
**Sidewalk South Of Angell Street @ 33.912968098600, -118.118766546249**

Sidewalks , Surface : Cross Slope

Sidewalk cross slope is not compliant.

**On-Site Finding** 3.30 percent for 12.00 feet

**Code Reference** ADA 206, 302,CA 11B-403.3

Repave the sidewalk surface with the recommended cross slope.

Recommendation Up to 2.08 percent

Repave surface \$1,092

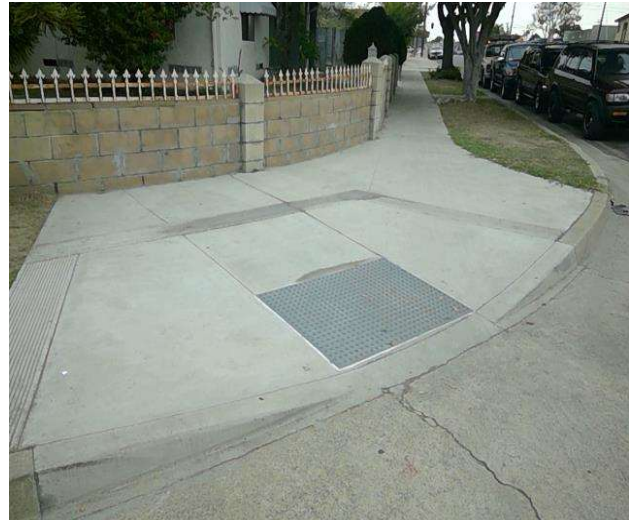
#### Northeast Corner Of Foster Road @ 33.909891810888, - 118.118533194065

Curb Ramp , Landings and Transitions : Top Landing Slope

The slope at the top landing is greater than allowed.

**On-Site Finding** 2.60 percent

**Code Reference** ADA 402, 406.4, 403.3, 406.1, CA 11B-406.5.3

Provide a top landing surface that does not exceed the maximum slope and cross slope. Provide a sufficient maneuvering clearance that does not accumulate water.

Recommendation Up to 2.08 percent

Provide compliant landing \$1,260

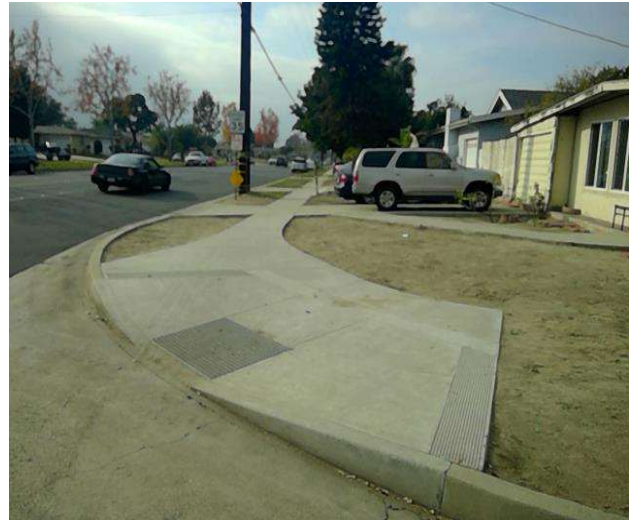
#### Northwest Corner Of Foster Road @ 33.909874002821, - 118.118522465229

Curb Ramp : Side Flare Slope

The slope of the curb ramp side flare is greater than allowed.

**On-Site Finding** 10.50 percent

**Code Reference** ADA 406, 406.3, CA 11B-406.2.2

Provide curb ramp side flares with a compliant slope.

Recommendation Up to 10.00 percent

Install flared sides \$1,300

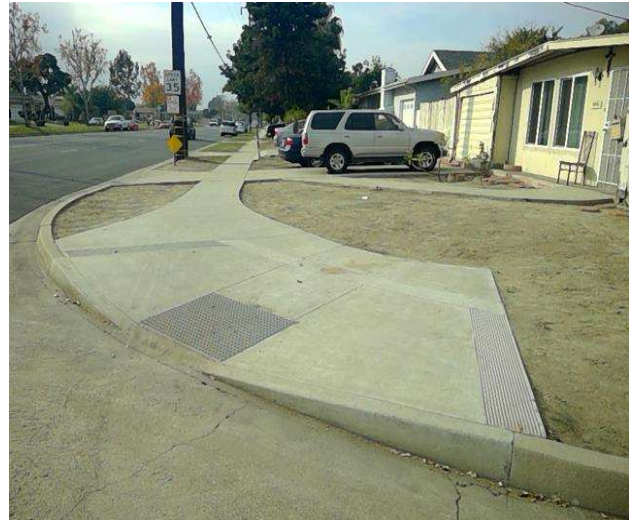
#### Northwest Corner Of Foster Road @ 33.909874002821, - 118.118522465229

Curb Ramp , Landings and Transitions : Top Landing Slope

The slope at the top landing is greater than allowed.

**On-Site Finding** 4.20 percent

**Code Reference** ADA 402, 406.4, 403.3, 406.1, CA 11B-406.5.3

Provide a top landing surface that does not exceed the maximum slope and cross slope. Provide a sufficient maneuvering clearance that does not accumulate water.

Recommendation Up to 2.08 percent

Provide compliant landing \$1,260

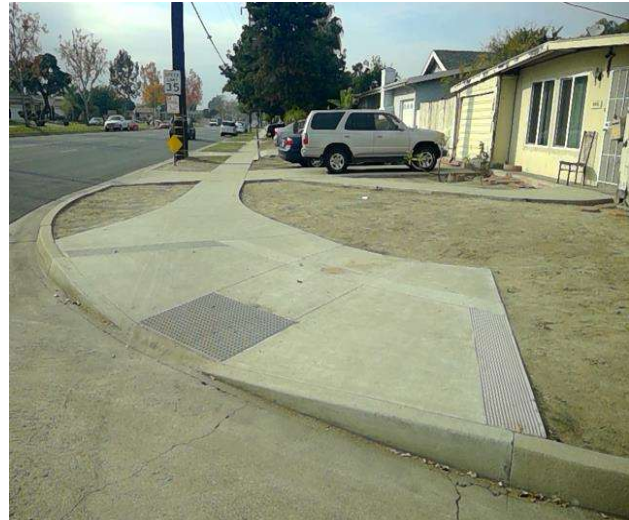
**Northwest Corner Of Foster Road @ 33.909874002821, - 118.118522465229**

There is not enough top landing clear length.

**On-Site Finding** 47.00 inches

Curb Ramp , Landings and Transitions : Top Landing Clear Length - Landings

**Code Reference** ADA 406, 406.4,CA 11B-406.5.3

Provide a level top landing with enough clear length.

Recommendation At least 48.00 inches

Provide compliant landing \$240

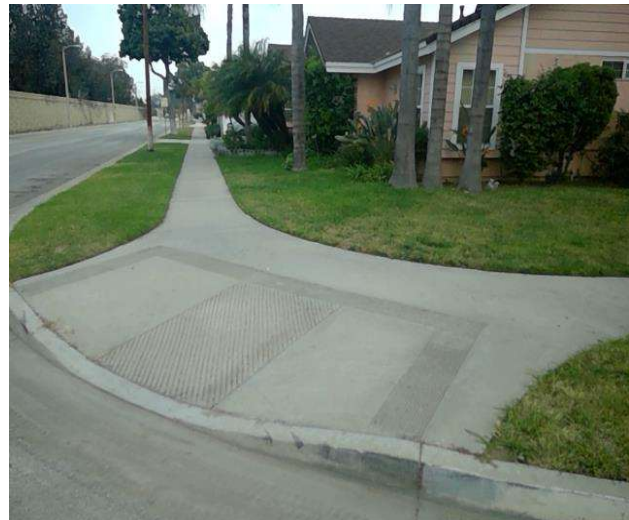
**Southeast Corner Of Angell Street @ 33.913008165290, - 118.118774592876**

Curb Ramp : No Detectable Warnings

The curb ramp does not provide a detectable warning surface which includes truncated domes.

**On-Site Finding** Not Found

**Code Reference** CA 11B-406.5.12

Provide compliant detectable warnings to surface.

Provide detectable warning to surface \$248

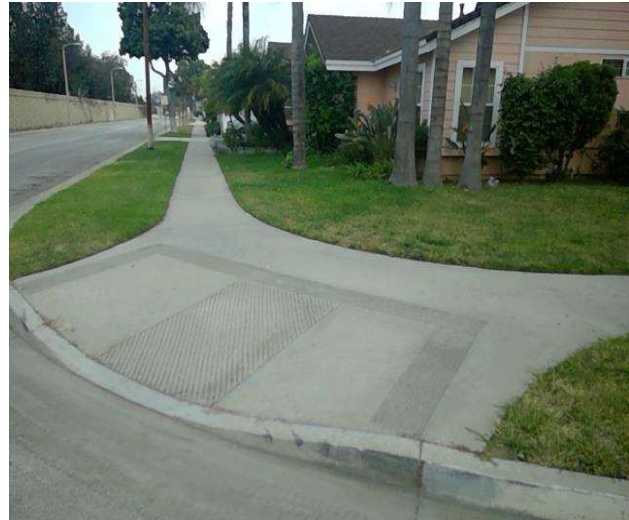
**Southeast Corner Of Angell Street @ 33.913008165290, - 118.118774592876**

Curb Ramp : Curb Ramp Slope

The running slope is greater than allowed.

**On-Site Finding** 10.30 percent

**Code Reference** ADA 406, 406.1, 405.2, CA 11B-406

Provide a compliant curb ramp.

Recommendation Up to 8.33 percent

Install curb ramp \$1,300

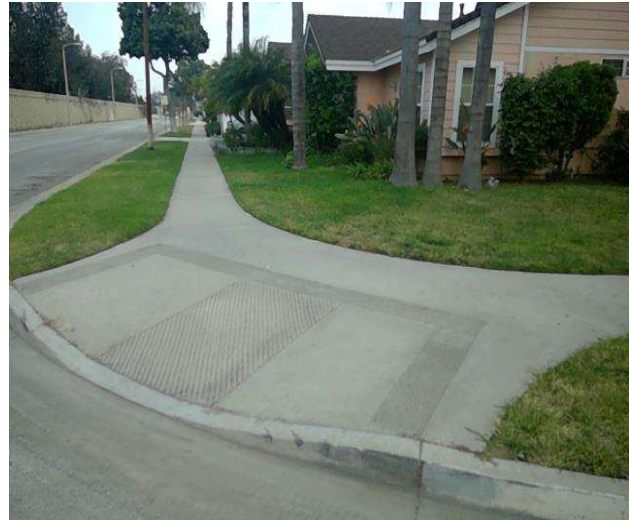
**Southeast Corner Of Angell Street @ 33.913008165290, - 118.118774592876**

Curb Ramp : Side Flare Slope

The slope of the curb ramp side flare is greater than allowed.

**On-Site Finding** 13.90 percent

**Code Reference** ADA 406, 406.3, CA 11B-406.2.2

Provide curb ramp side flares with a compliant slope.

Recommendation Up to 10.00 percent

Install flared sides \$1,300

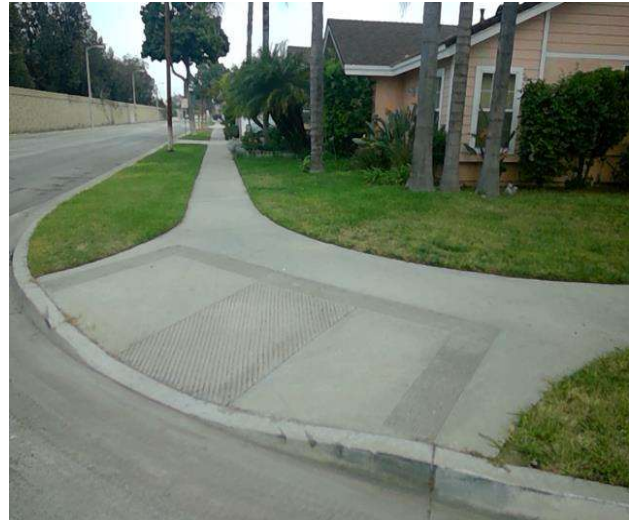
#### **Southeast Corner Of Angell Street @ 33.913008165290, - 118.118774592876**

Curb Ramp : Bottom Landing Slope

The bottom landing of the curb ramp is on the street, and the slope of the bottom landing is not compliant.

**On-Site Finding** 9.30 percent

**Code Reference** ADA 406, 406.2, CA 11B-406.5.8

Ensure the bottom landing slope is compliant and provides a smooth transition.

Recommendation Up to 5.00 percent

Repave landing \$1,260

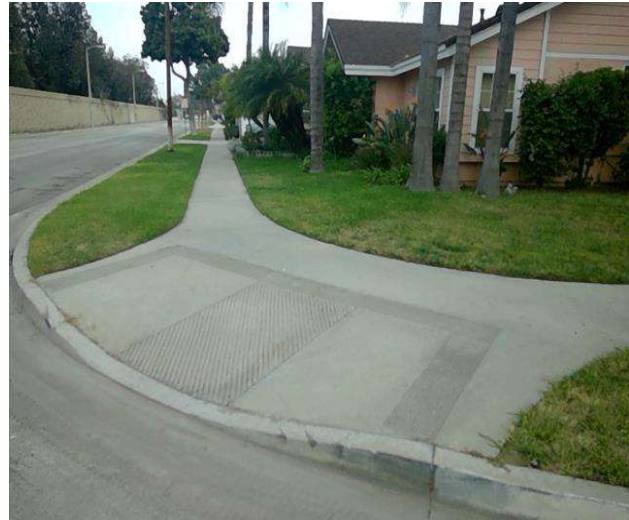
**Southeast Corner Of Angell Street @ 33.913008165290, - 118.118774592876**

The transition from the bottom of the curb ramp to the walk, gutter, or street is abrupt.

**On-Site Finding** 0.75 inches

Curb Ramp , Landings And Transitions : Bottom Landing Change in Level

**Code Reference** ADA 302, 303, 406.2, 303.1

Patch the transition area at the bottom of the curb ramp so that the transition is flush and free of abrupt changes.

Recommendation Up to 0.50 inches

Patch lip at curb ramp \$255

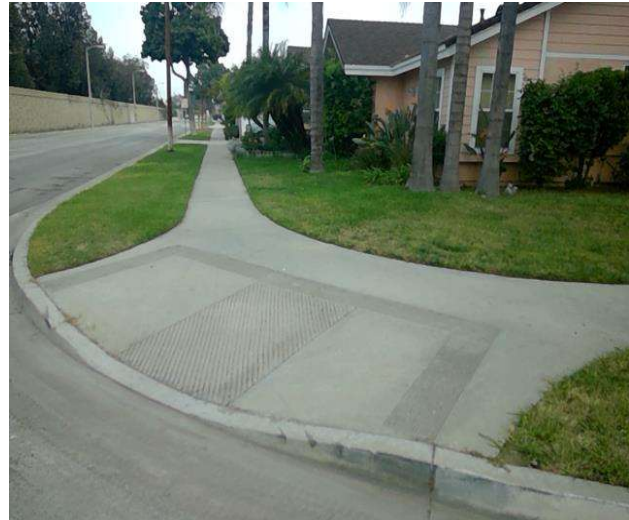
#### **Southeast Corner Of Angell Street @ 33.913008165290, - 118.118774592876**

Curb Ramp , Landings and Transitions : Top Landing Slope

The slope at the top landing is greater than allowed.

**On-Site Finding** 4.00 percent

**Code Reference** ADA 402, 406.4, 403.3, 406.1, CA 11B-406.5.3

Provide a top landing surface that does not exceed the maximum slope and cross slope. Provide a sufficient maneuvering clearance that does not accumulate water.

Recommendation Up to 2.08 percent

Provide compliant landing \$1,260

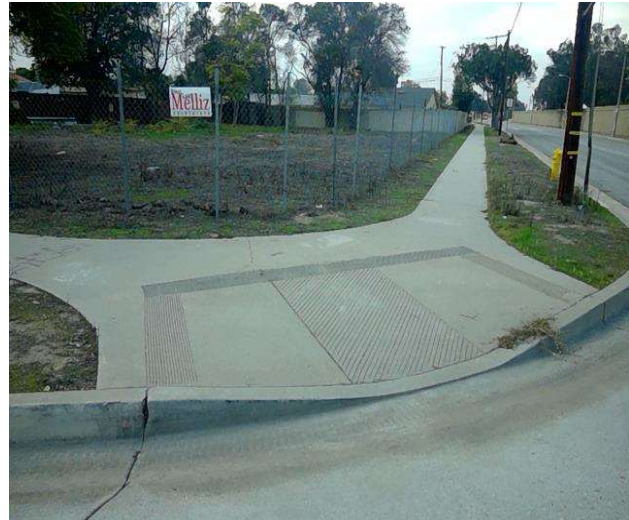
**On-Site Finding** Not Found

**Code Reference** CA 11B-406.5.12

Recommendation See Recommendation

Provide detectable warning to surface \$248

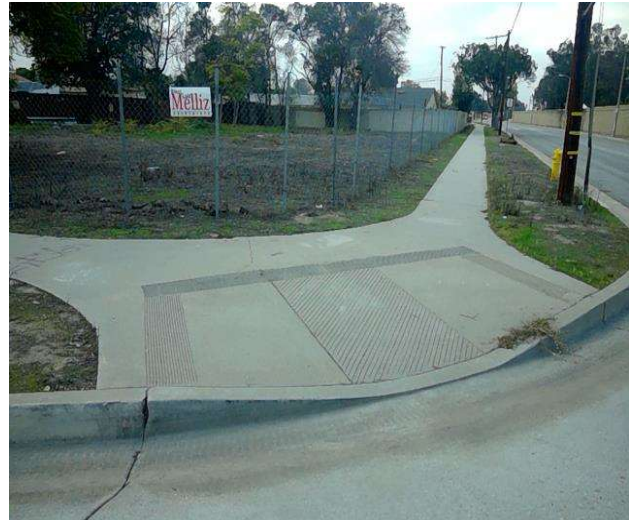
**Code Reference** ADA 406, 406.1, 405.2, CA 11B-406

Recommendation Up to 8.33 percent

Install curb ramp \$1,300

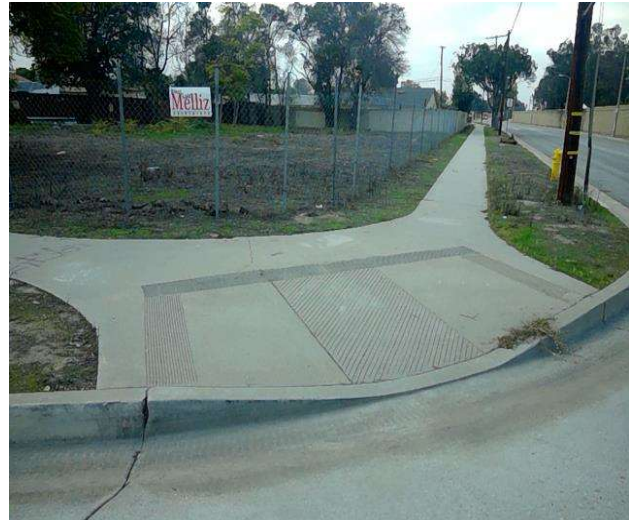
**Code Reference** ADA 406, 406.3, CA 11B-406.2.2

Recommendation Up to 10.00 percent

Install flared sides \$1,300

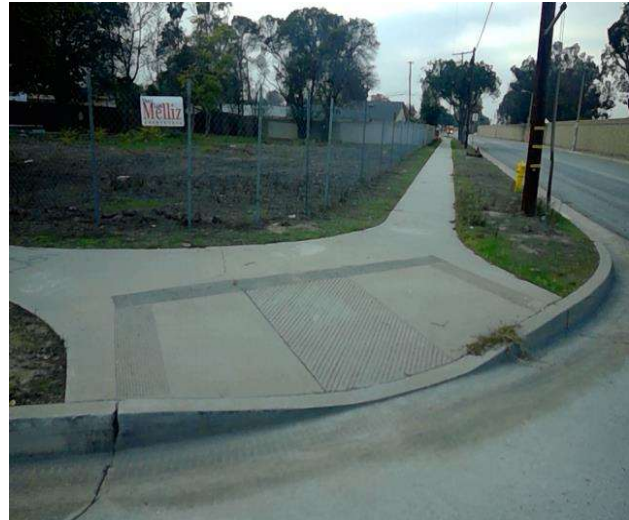
**Code Reference** ADA 406, 406.2, CA 11B-406.5.8

Recommendation Up to 5.00 percent

Repave landing \$1,260

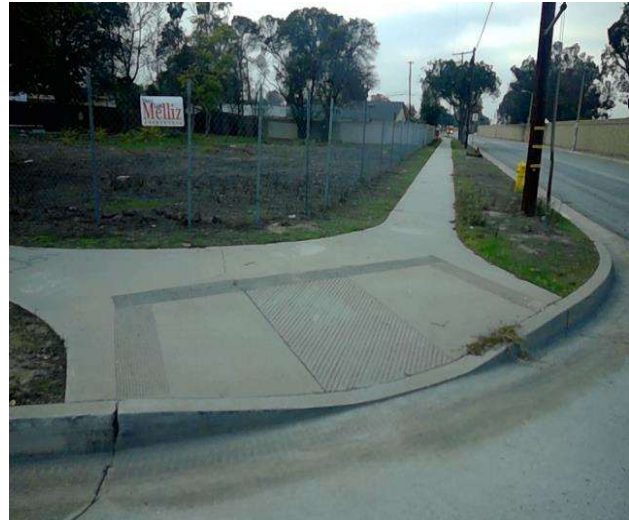
Curb Ramp , Landings And Transitions : Bottom Landing Change in Level

**Code Reference** ADA 302, 303, 406.2, 303.1

Recommendation Up to 0.50 inches

Patch lip at curb ramp \$255

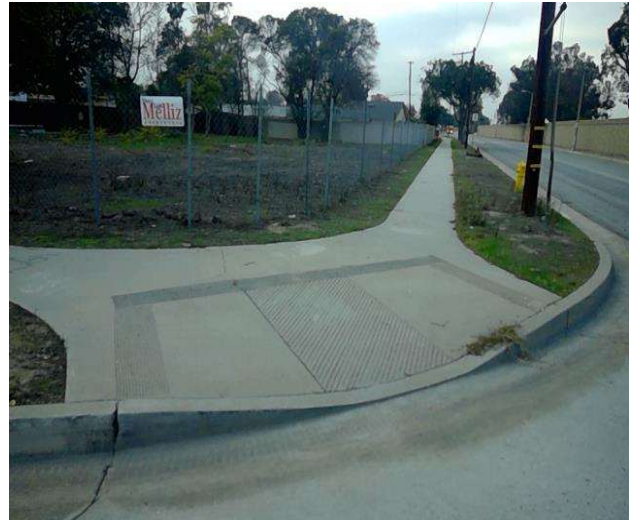
**Code Reference** ADA 402, 406.4, 403.3, 406.1, CA 11B-406.5.3

Recommendation Up to 2.08 percent

Provide compliant landing \$1,260

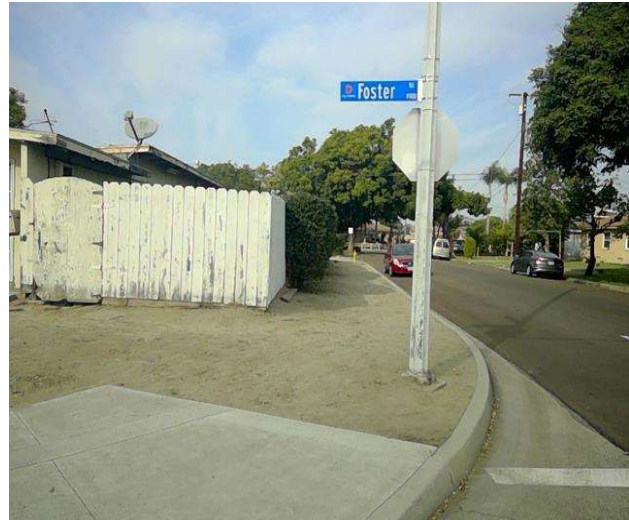
Sidewalks : Missing Sidewalk

Section of sidewalk is missing and consists of dirt, grass or gravel.

**Code Reference** ADA 206, 302,CA 11B-302,CA 11B-206

Provide a compliant sidewalk for the missing section.

\$1,260

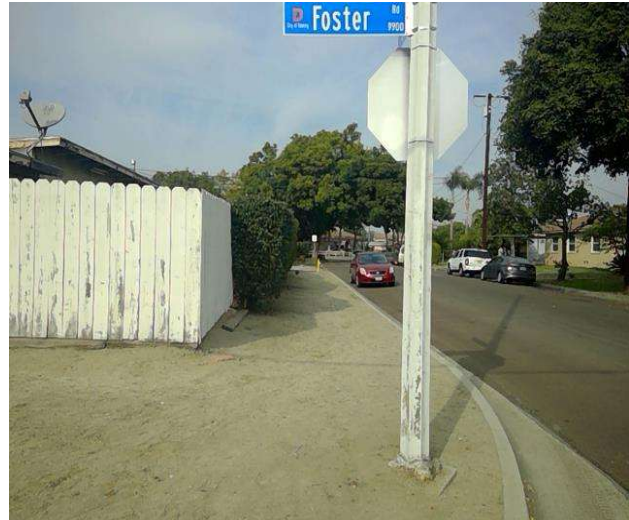
**On-Site Finding** Not Found

**Code Reference** ADA 206, 302

Recommendation See Recommendation

\$2,400

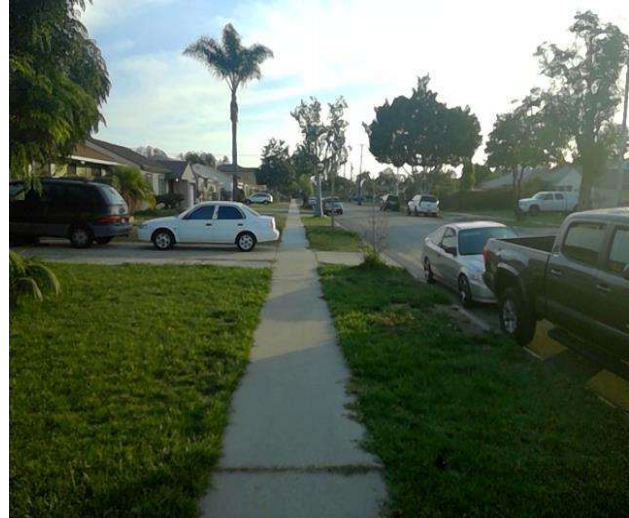
There is a change in elevation greater than recommended value.

**Code Reference** ADA 206, 302

Ensure that the change in elevation is within the recommended value.

Recommendation Up to 0.25 inches

Remove tripping hazards \$198

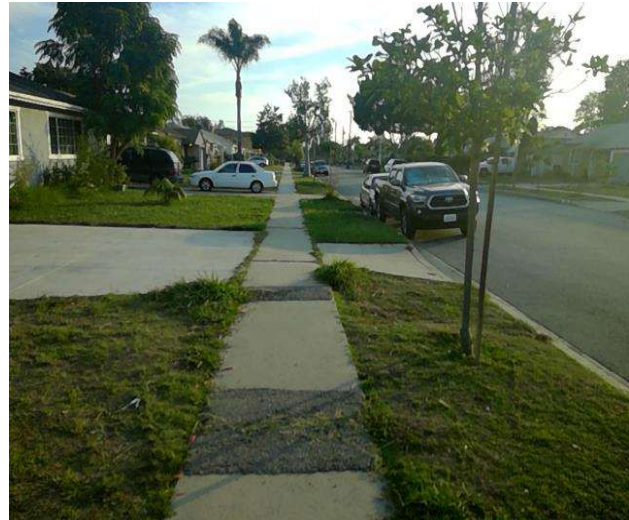
**Code Reference** ADA 206, 302, CA 11B-403.3

Repave the sidewalk surface with the recommended cross slope.

Recommendation Up to 2.08 percent

Repave surface \$1,092

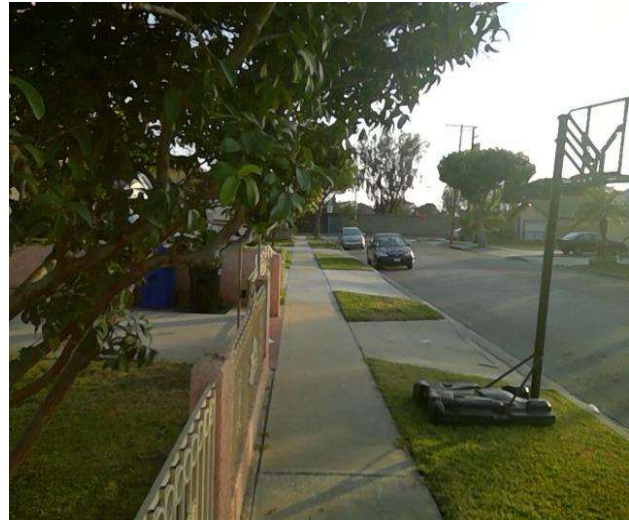
Sidewalks , Hazards & Gratings : Overhead Obstruction Height

**Code Reference** ADA 206, 307.4, CA 11B-307.4

Recommendation At least 80.00 inches

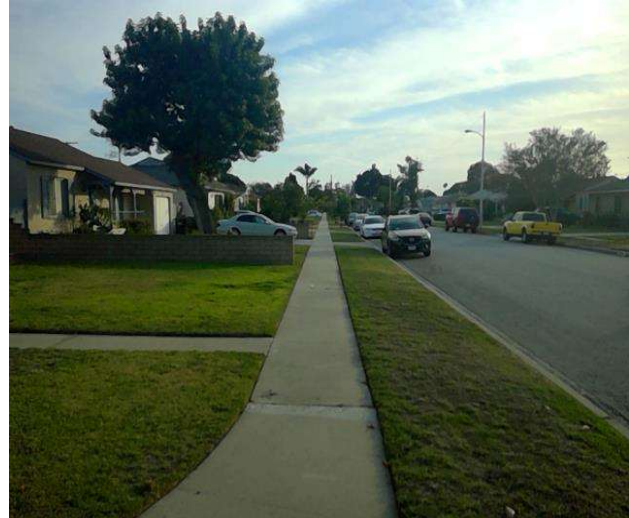
**On-Site Finding** Not Found

**Code Reference** ADA 206, 302

Recommendation See Recommendation

\$2,400

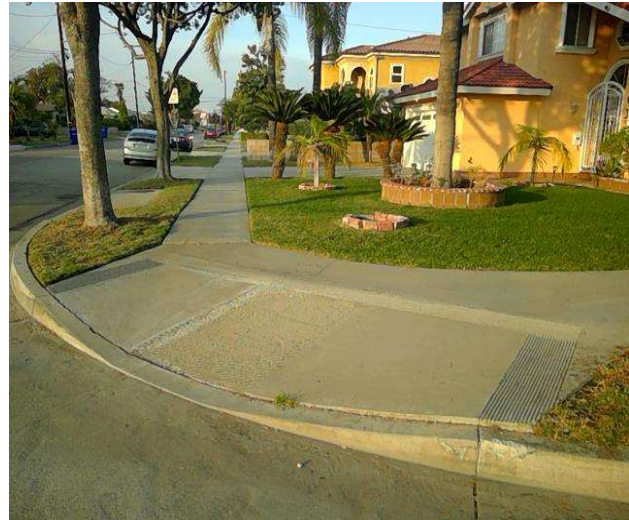
**On-Site Finding** Not Found

**Code Reference** CA 11B-406.5.12

Recommendation See Recommendation

Provide detectable warning to surface \$248

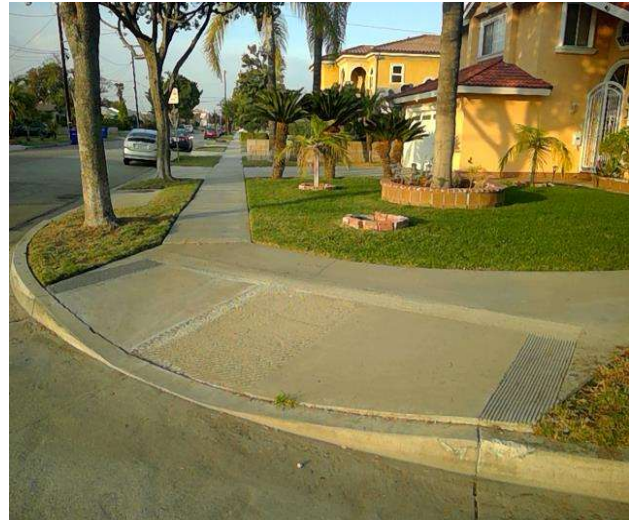
**Code Reference** ADA 406, 406.1, 405.2, CA 11B-406

Recommendation Up to 8.33 percent

Install curb ramp \$1,300

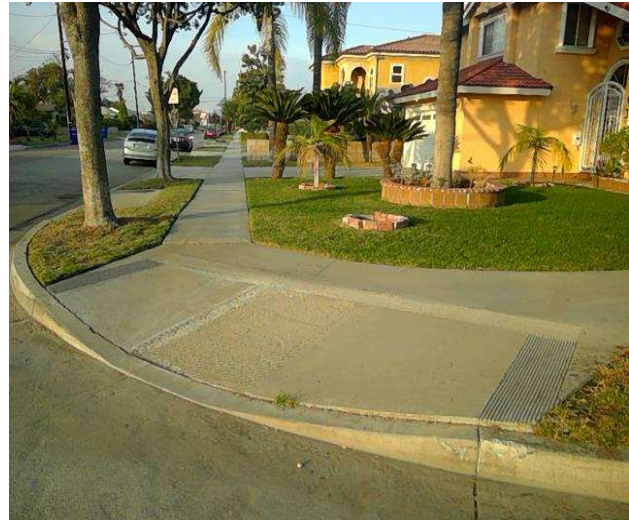
**Code Reference** ADA 406, 406.3, CA 11B-406.2.2

Recommendation Up to 10.00 percent

Install flared sides \$1,300

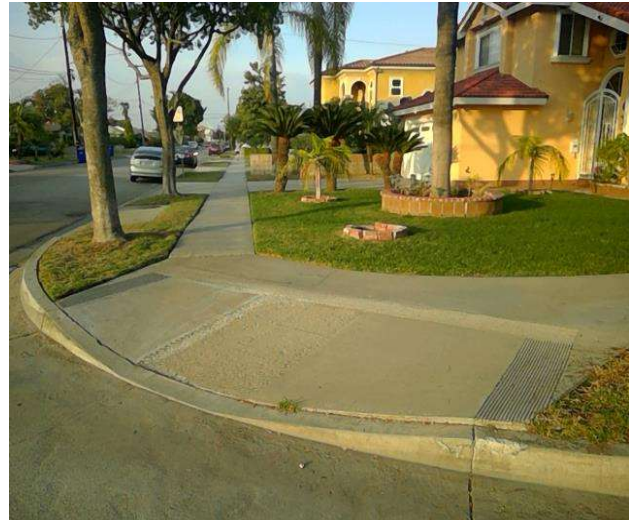
Curb Ramp , Landings And Transitions : Bottom Landing Change in Level

**Code Reference** ADA 302, 303, 406.2, 303.1

Recommendation Up to 0.50 inches

Patch lip at curb ramp \$255

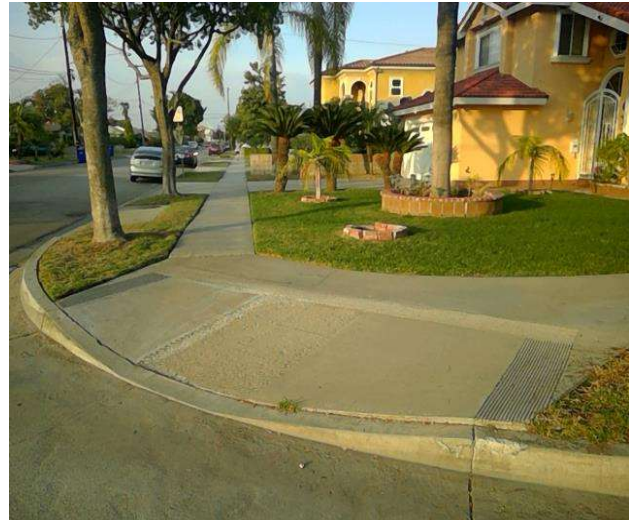
**Code Reference** ADA 402, 406.4, 403.3, 406.1, CA 11B-406.5.3

Recommendation Up to 2.08 percent

Provide compliant landing \$1,260

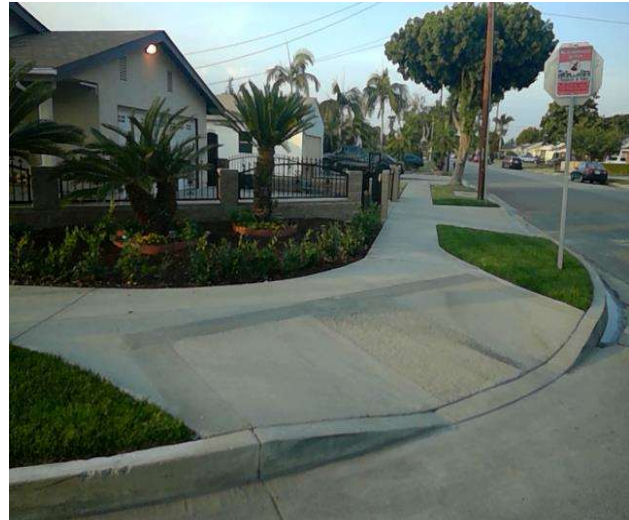
**On-Site Finding** Not Found

**Code Reference** CA 11B-406.5.12

Recommendation See Recommendation

Provide detectable warning to surface \$248

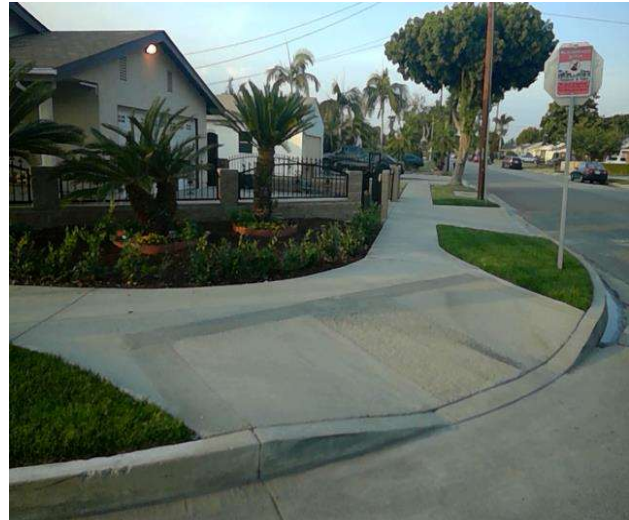
**Code Reference** ADA 406, 406.1, 405.2, CA 11B-406

Recommendation Up to 8.33 percent

Install curb ramp \$1,300

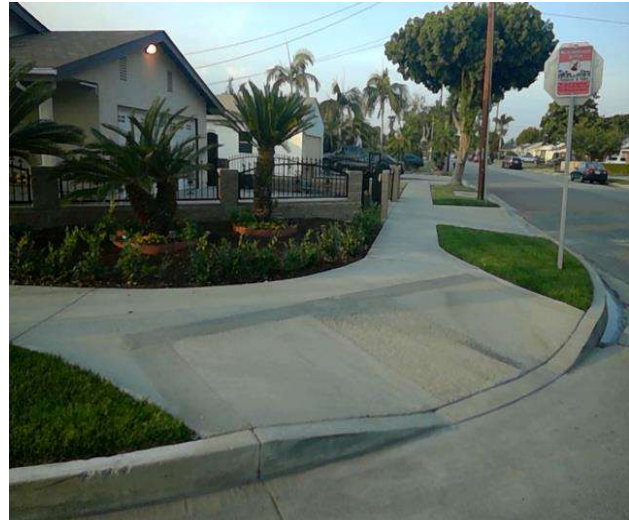
**Code Reference** ADA 406, 406.3,CA 11B-406.2.2

Recommendation Up to 10.00 percent

Install flared sides \$1,300

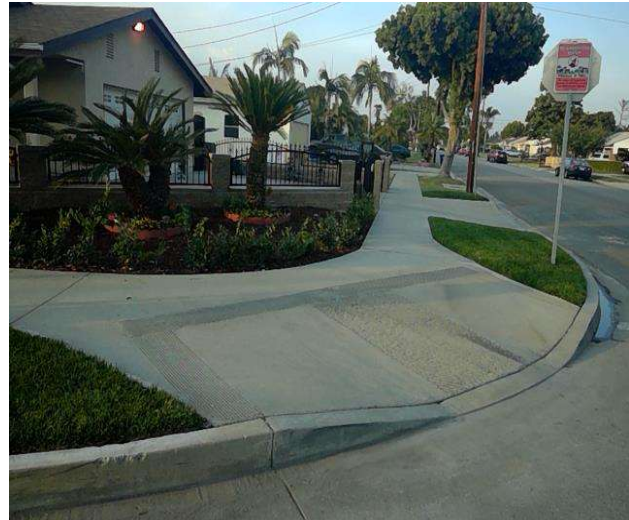
Curb Ramp , Landings and Transitions : Bottom Landing Change in Level - Curb Ramps

**Code Reference** ADA 302, 406.2

Recommendation See Recommendation

Patch lip at curb ramp \$255

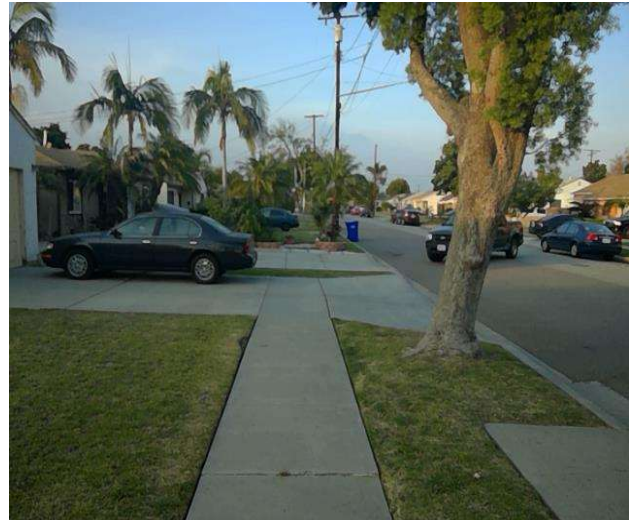
There is a change in elevation greater than recommended value.

**Code Reference** ADA 206, 302

Ensure that the change in elevation is within the recommended value.

Recommendation Up to 0.25 inches

Remove tripping hazards \$198

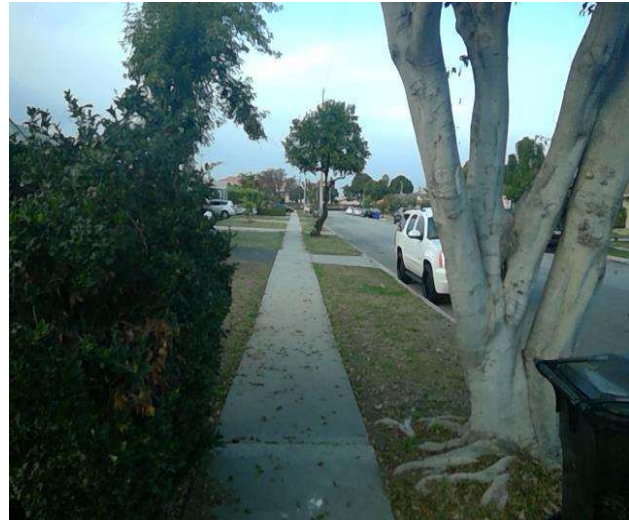
There is a change in elevation greater than recommended value.

**Code Reference** ADA 206, 302

Ensure that the change in elevation is within the recommended value.

Recommendation Up to 0.25 inches

Remove tripping hazards \$198

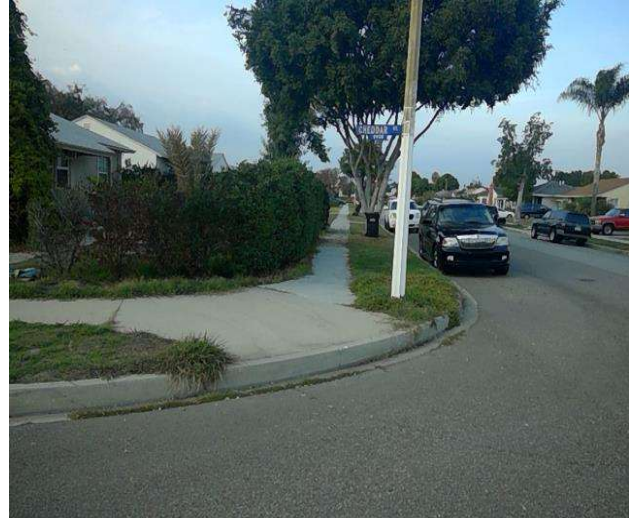
Sidewalks , Hazards & Gratings : Curb is on Path of Travel

**Code Reference** ADA 402, 303, 406, 403.4, 303.4

Recommendation See Recommendation

Install curb ramp \$2,500

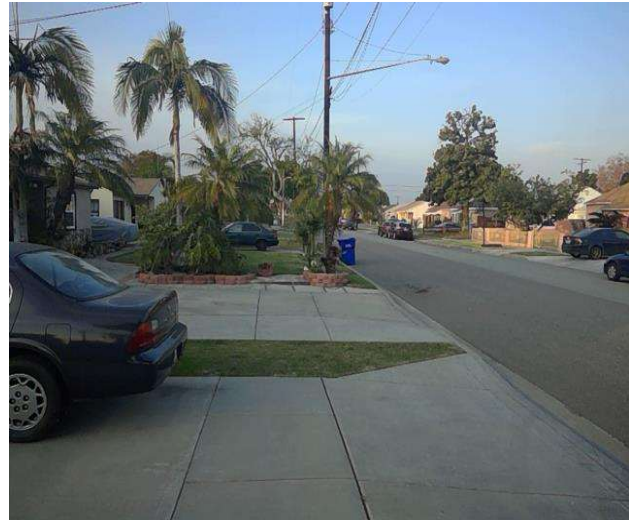
Sidewalks : Missing Sidewalk

Section of sidewalk is missing and consists of dirt, grass or gravel.

**Code Reference** ADA 206, 302,CA 11B-302,CA 11B-206

Provide a compliant sidewalk for the missing section.

\$1,260

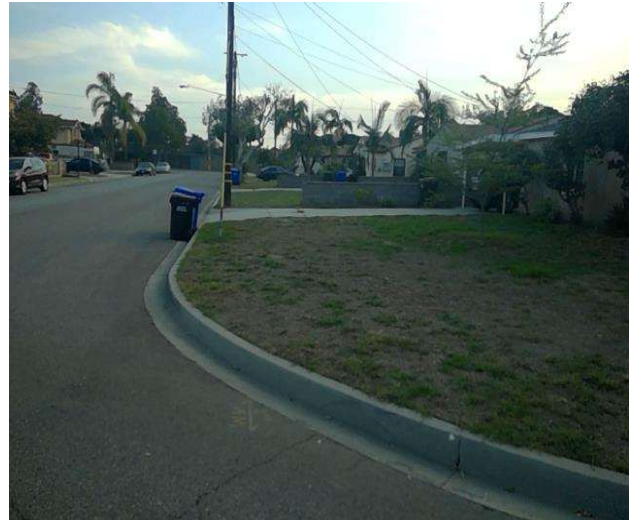
Sidewalks , Hazards & Gratings : Curb is on Path of Travel

**Code Reference** ADA 402, 303, 406, 403.4, 303.4

Recommendation See Recommendation

Install curb ramp \$2,500

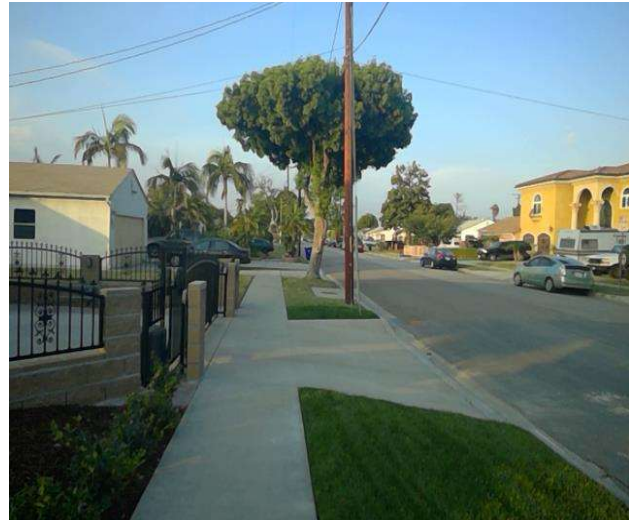
**On-Site Finding** Not Found

**Code Reference** ADA 206, 302

Recommendation See Recommendation

\$2,400

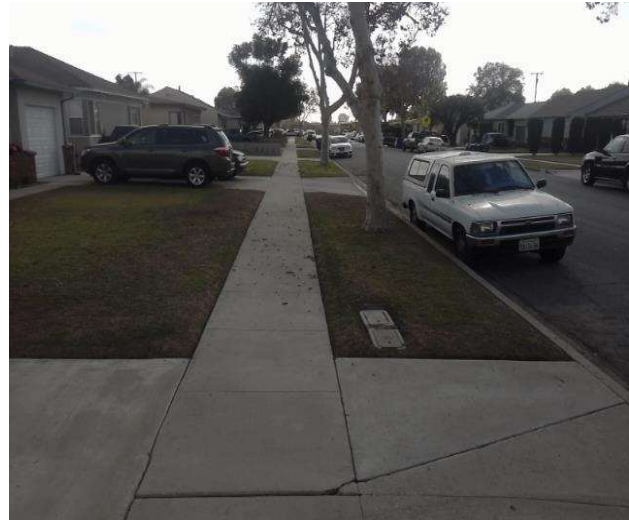
There is a change in elevation greater than recommended value.

**Code Reference** ADA 206, 302

Ensure that the change in elevation is within the recommended value.

Recommendation Up to 0.25 inches

Remove tripping hazards \$198

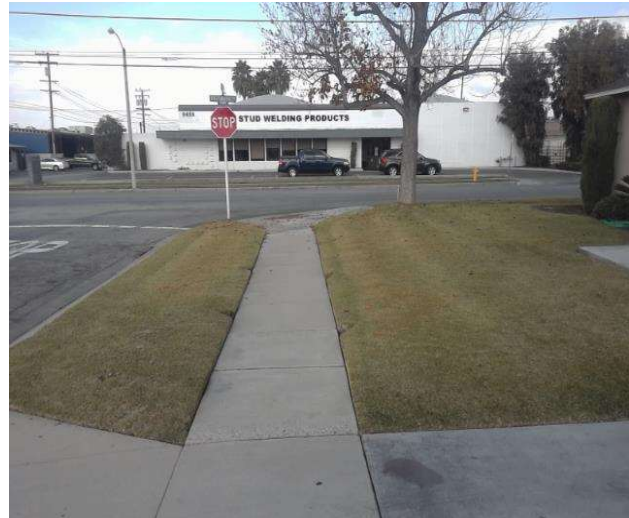
**Code Reference** ADA 206, 302, CA 11B-403.3

Repave the sidewalk surface with the recommended cross slope.

Recommendation Up to 2.08 percent

Repave surface \$1,092

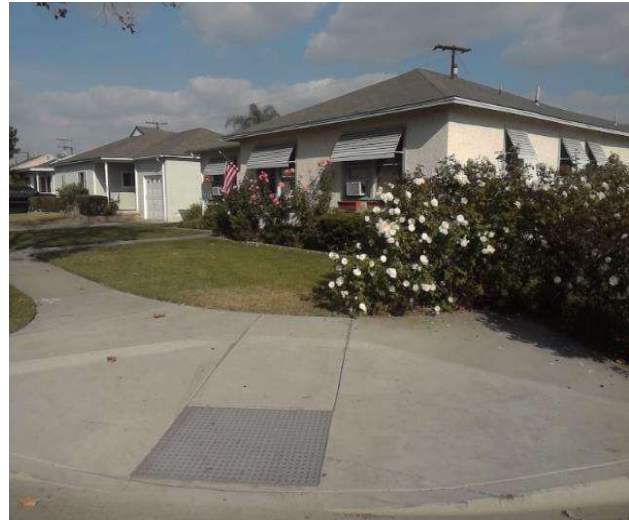
**Code Reference** ADA 402, 406.4, 403.3, 406.1, CA 11B-406.5.3

Recommendation Up to 2.08 percent

Provide compliant landing \$1,260

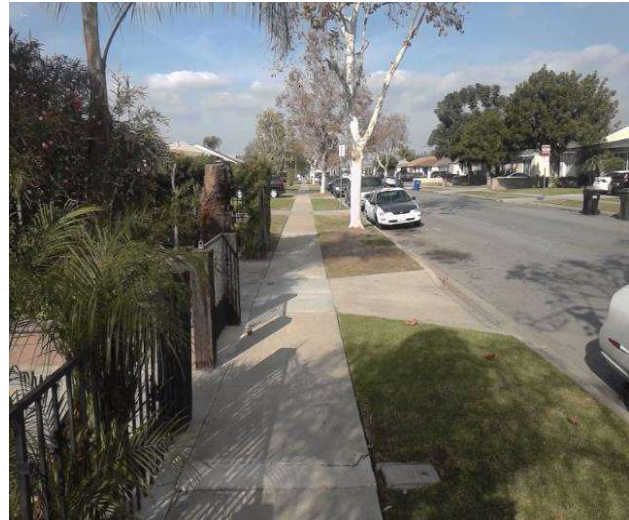
There is a change in elevation greater than recommended value.

**Code Reference** ADA 206, 302

Ensure that the change in elevation is within the recommended value.

Recommendation Up to 0.25 inches

Remove tripping hazards \$198
