Accessibility Survey

City of Downey Dinwiddie Street - Old River School Road To Rio Hondo Drive

Old River School Road To Rio Hondo Drive
Downey, CA 90241

Date of Inspection
2/10/2017

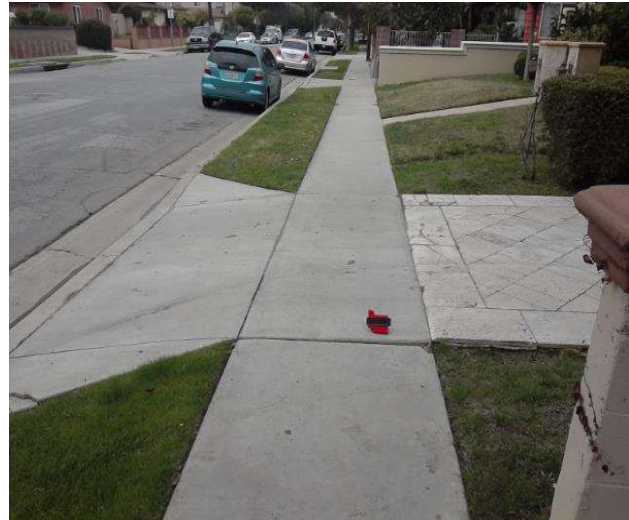
Change In Level East Of Rio Hondo Drive @ 33.951249904885, -118.154321908951

Sidewalks , Change in Level : Change in Level - Beveled

There is a change in elevation greater than recommended value.

On-Site Finding 0.87 inches

Code Reference ADA 206, 302

Ensure that the change in elevation not exceed a .5 beveled inch.

Recommendation Up to 0.50 inches

Remove tripping hazards \$198

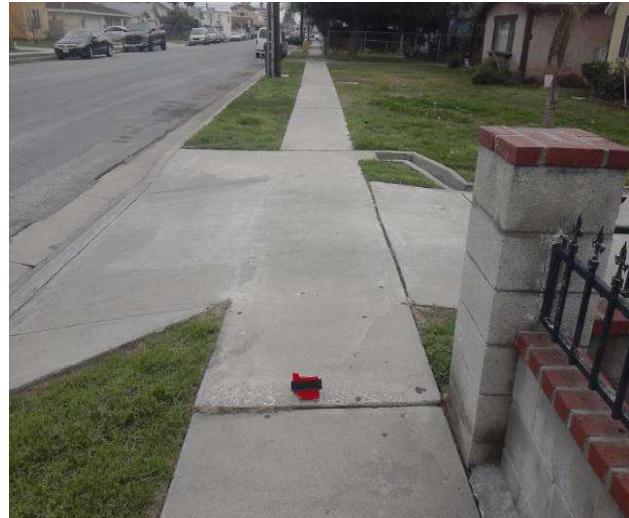
Change In Level West Of Old River School Road @ 33.948557700134, - 118.149611949921

Sidewalks , Change in Level : Change in Level - Beveled

There is a change in elevation greater than recommended value.

On-Site Finding 0.75 inches

Code Reference ADA 206, 302

Ensure that the change in elevation not exceed a .5 beveled inch.

Recommendation Up to 0.50 inches

Remove tripping hazards \$198

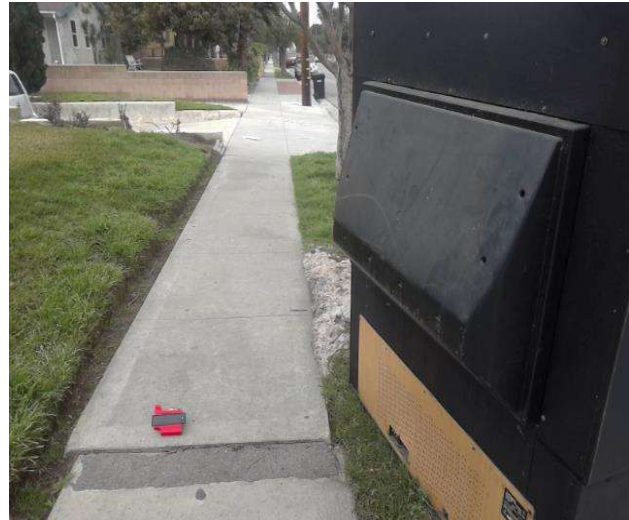
Change In Level West Of Ryerson Avenue @ 33.950604673489, -118.153463602066

Sidewalks , Change in Level : Change in Level - Beveled

There is a change in elevation greater than recommended value.

On-Site Finding 0.87 inches

Code Reference ADA 206, 302

Ensure that the change in elevation not exceed a .5 beveled inch.

Recommendation Up to 0.50 inches

Remove tripping hazards \$198

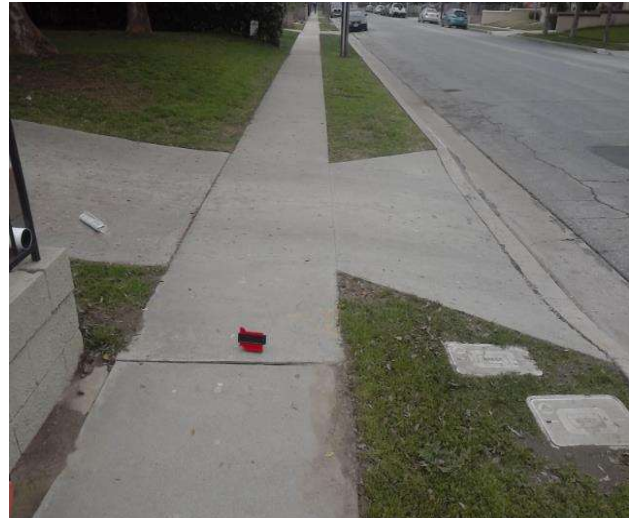
Change In Level West Of Ryerson Avenue @ 33.951521345596, -118.155094385147

Sidewalks , Change in Level : Change in Level Non Beveled

There is a change in elevation greater than recommended value.

On-Site Finding 0.75 inches

Code Reference ADA 206, 302

Ensure that the change in elevation is within the recommended value.

Recommendation Up to 0.25 inches

Remove tripping hazards \$198

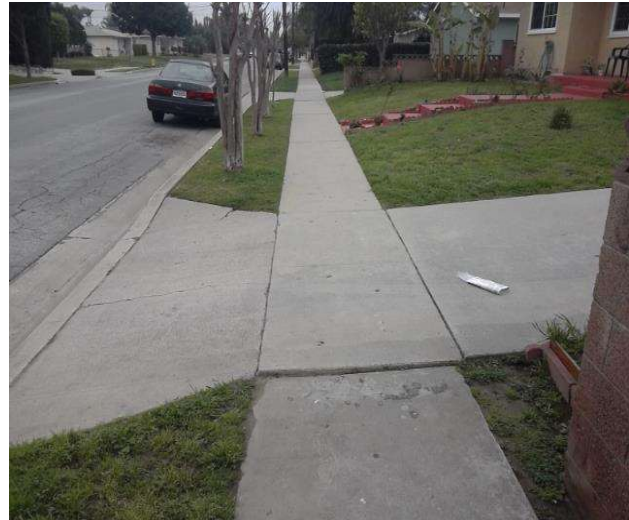
Change In Level West Of Ryerson Avenue @ 33.951596992853, -118.155217766762

Sidewalks , Change in Level : Change in Level Non Beveled

There is a change in elevation greater than recommended value.

On-Site Finding 1.25 inches

Code Reference ADA 206, 302

Ensure that the change in elevation is within the recommended value.

Recommendation Up to 0.25 inches

Remove tripping hazards \$198

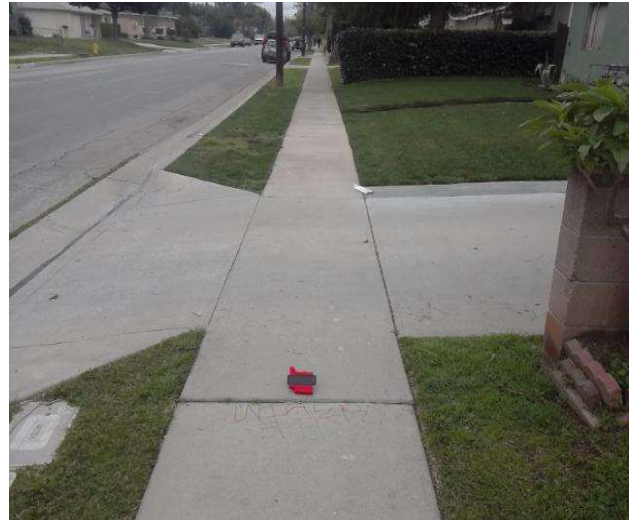
Change In Level West Of Ryerson Avenue @ 33.951596992853, -118.155207037926

Sidewalks , Change in Level : Change in Level - Beveled

There is a change in elevation greater than recommended value.

On-Site Finding 0.62 inches

Code Reference ADA 206, 302

Ensure that the change in elevation not exceed a .5 beveled inch.

Recommendation Up to 0.50 inches

Remove tripping hazards \$198

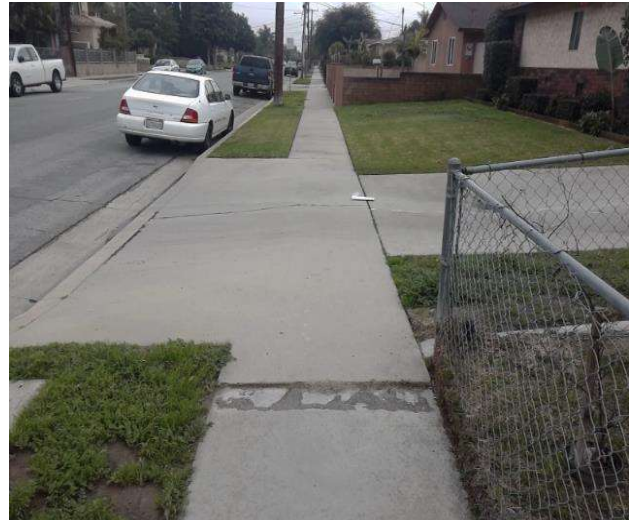
Change In Level West Of Ryerson Avenue @ 33.951908480850, -118.155834674835

Sidewalks , Change in Level : Change in Level - Beveled

There is a change in elevation greater than recommended value.

On-Site Finding 0.62 inches

Code Reference ADA 206, 302

Ensure that the change in elevation not exceed a .5 beveled inch.

Recommendation Up to 0.50 inches

Remove tripping hazards \$198

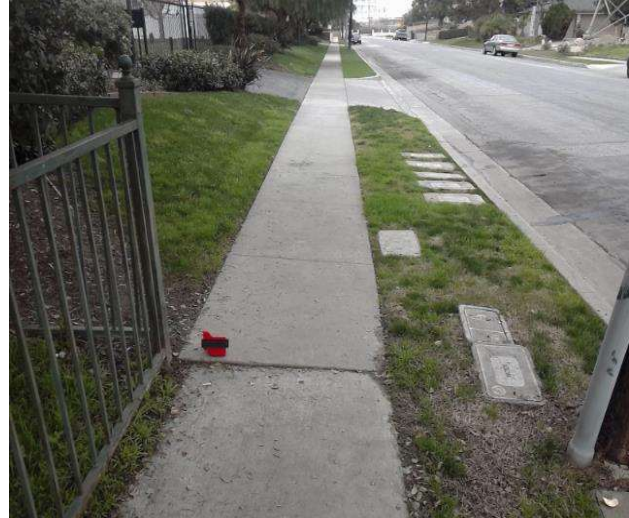
Change In Level West Of Ryerson Avenue @ 33.952001927027, -118.155958056450

Sidewalks , Change in Level : Change in Level - Beveled

There is a change in elevation greater than recommended value.

On-Site Finding 0.62 inches

Code Reference ADA 206, 302

Ensure that the change in elevation not exceed a .5 beveled inch.

Recommendation Up to 0.50 inches

Remove tripping hazards \$198

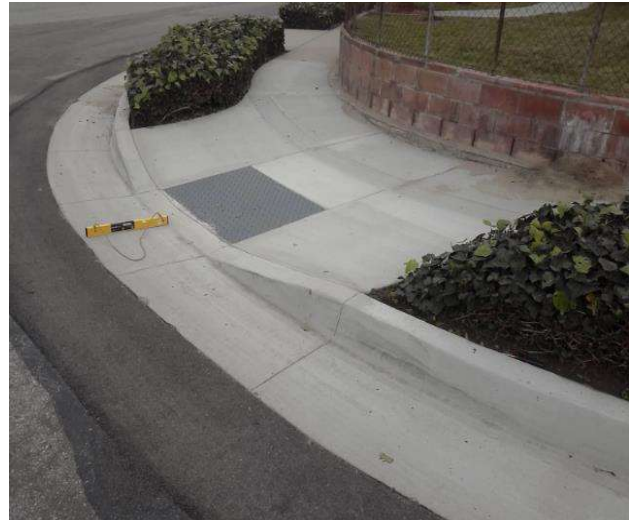
Northeast Corner Of Rio Hondo Drive @ 33.952513654271, - 118.156564235687

Curb Ramp : No Contrasting Finish

The surface of the curb ramp does not have a finish that contrasts with the adjacent sidewalk.

On-Site Finding Not Found

Provide the surface on the curb ramp that contrasts with the adjacent sidewalk.

Apply contrasting finish to surface \$155

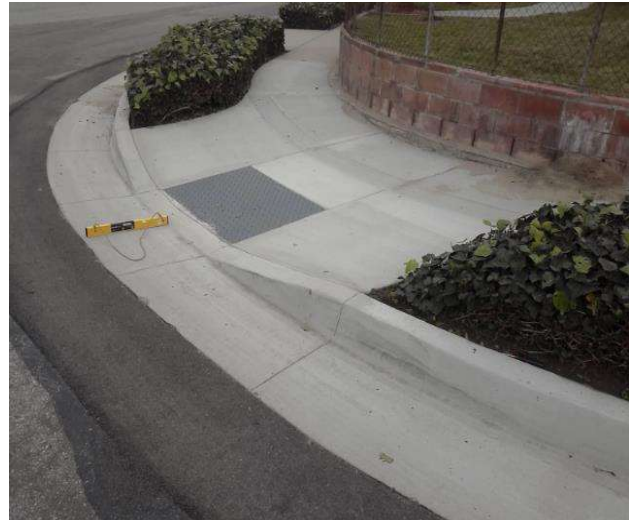
Northeast Corner Of Rio Hondo Drive @ 33.952513654271, - 118.156564235687

Curb Ramp : Side Flare Slope

The slope of the curb ramp side flare is greater than allowed.

On-Site Finding 15.90 percent

Code Reference ADA 406, 406.3, CA 11B-406.2.2

Provide curb ramp side flares with a compliant slope.

Recommendation Up to 10.00 percent

Install flared sides \$1,300

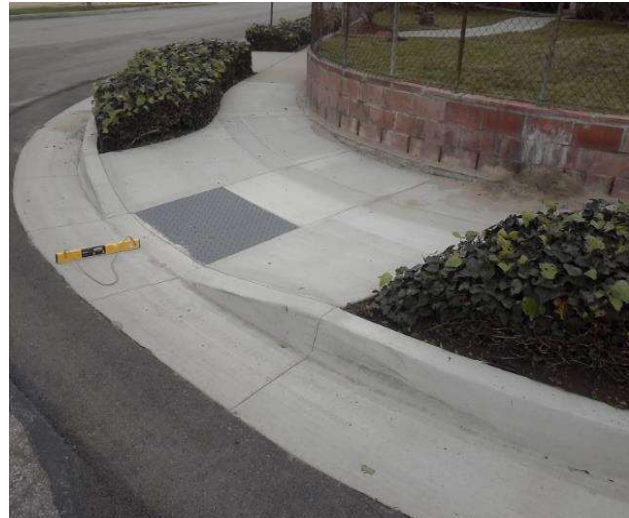
Northeast Corner Of Rio Hondo Drive @ 33.952513654271, - 118.156564235687

Curb Ramp : Bottom Landing Slope

The bottom landing of the curb ramp is on the street, and the slope of the bottom landing is not compliant.

On-Site Finding 9.00 percent

Code Reference ADA 406, 406.2, CA 11B-406.5.8

Ensure the bottom landing slope is compliant and provides a smooth transition.

Recommendation Up to 5.00 percent

Repave landing \$1,260

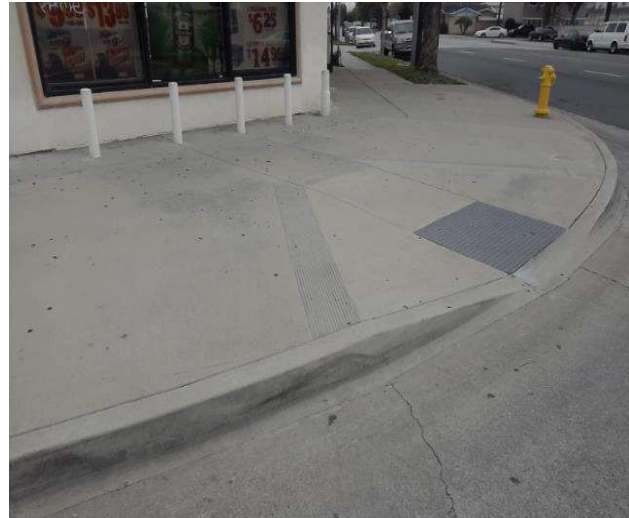
Northwest Corner Of Old River School Road @ 33.948166099621, - 118.148506879807

Curb Ramp : No Contrasting Finish

The surface of the curb ramp does not have a finish that contrasts with the adjacent sidewalk.

On-Site Finding Not Found

Provide the surface on the curb ramp that contrasts with the adjacent sidewalk.

Apply contrasting finish to surface \$155

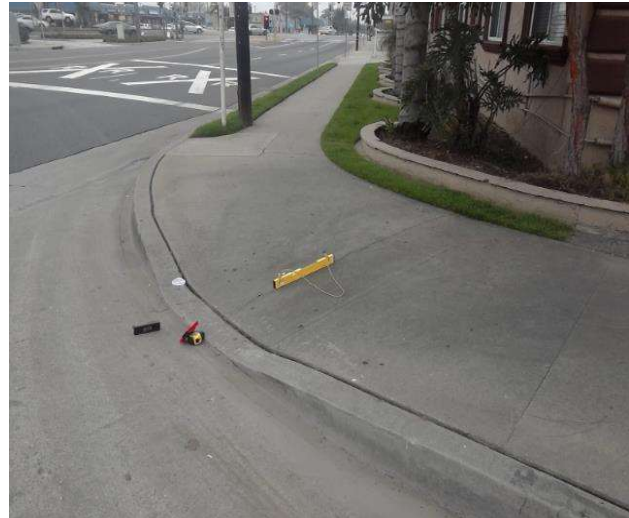
Southwest Corner Of Old River School Road @ 33.948023698988, - 118.148646354675

Curb Ramp : No Detectable Warnings

The curb ramp does not provide a detectable warning surface which includes truncated domes.

On-Site Finding Not Found

Code Reference CA 11B-406.5.12

Provide compliant detectable warnings to surface.

Provide detectable warning to surface \$248

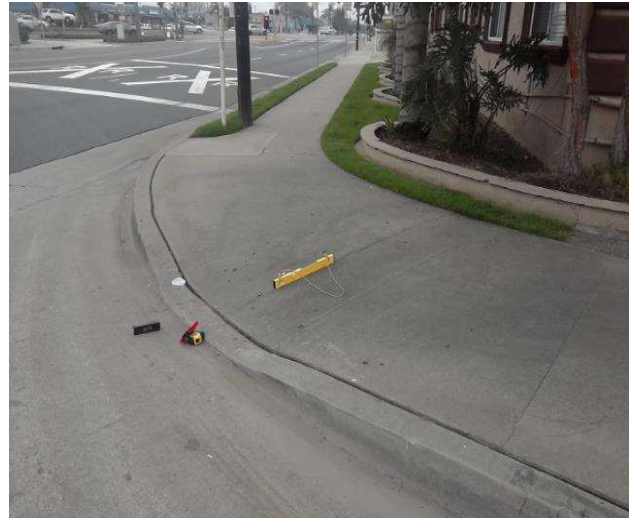
Southwest Corner Of Old River School Road @ 33.948023698988, - 118.148646354675

Curb Ramp : Curb Ramp Slope

The running slope is greater than allowed.

On-Site Finding 9.70 percent

Code Reference ADA 406, 406.1, 405.2, CA 11B-406

Provide a compliant curb ramp.

Recommendation Up to 8.33 percent

Install curb ramp \$1,300

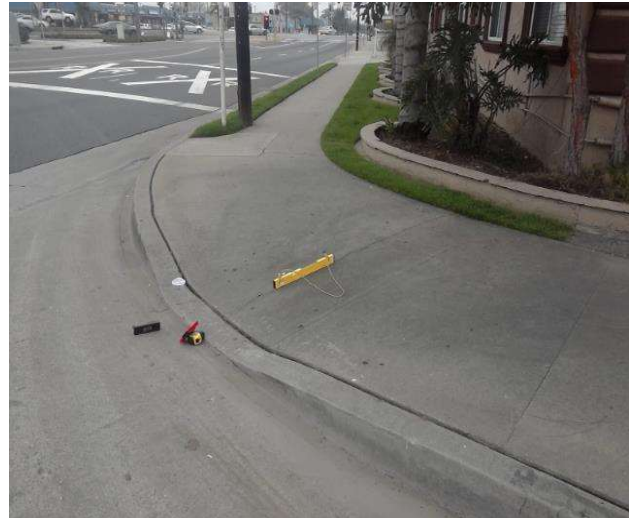
Southwest Corner Of Old River School Road @ 33.948023698988, - 118.148646354675

Curb Ramp : Side Flare Slope

The slope of the curb ramp side flare is greater than allowed.

On-Site Finding 10.80 percent

Code Reference ADA 406, 406.3,CA 11B-406.2.2

Provide curb ramp side flares with a compliant slope.

Recommendation Up to 10.00 percent

Install flared sides \$1,300

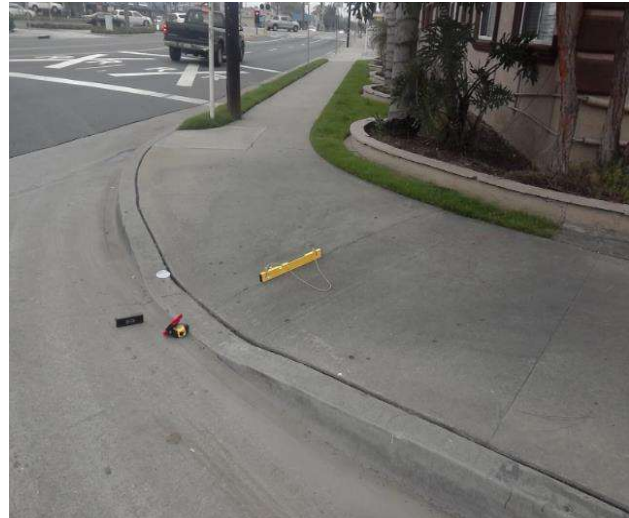
Southwest Corner Of Old River School Road @ 33.948023698988, - 118.148646354675

Curb Ramp : Bottom Landing Slope

The bottom landing of the curb ramp is on the street, and the slope of the bottom landing is not compliant.

On-Site Finding 7.90 percent

Code Reference ADA 406, 406.2, CA 11B-406.5.8

Ensure the bottom landing slope is compliant and provides a smooth transition.

Recommendation Up to 5.00 percent

Repave landing \$1,260

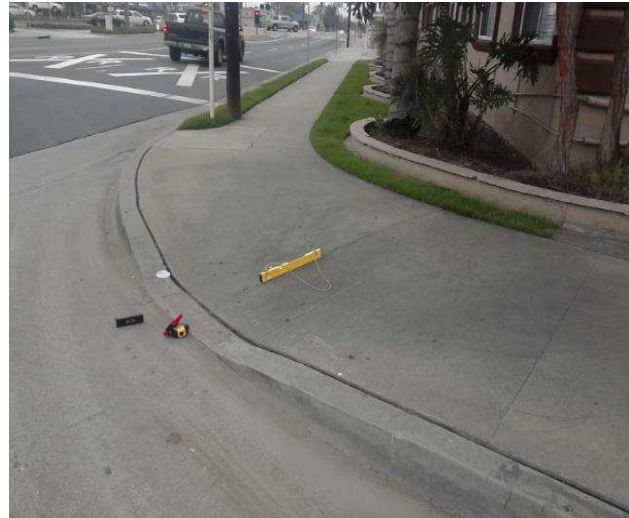
Curb Ramp , Landings And Transitions : Bottom Landing Change in Level

Code Reference ADA 302, 303, 406.2, 303.1

Recommendation Up to 0.50 inches

Patch lip at curb ramp \$255

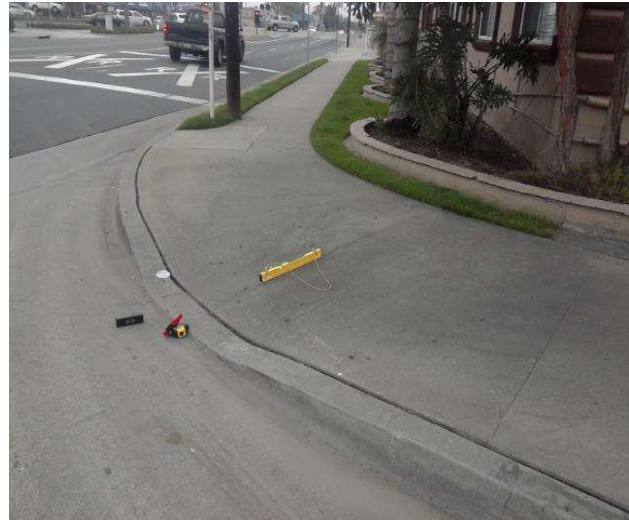
Curb Ramp , Landings and Transitions : Top Landing Clear Length - Landings

Code Reference ADA 406, 406.4,CA 11B-406.5.3

Recommendation At least 48.00 inches

Provide compliant landing \$240

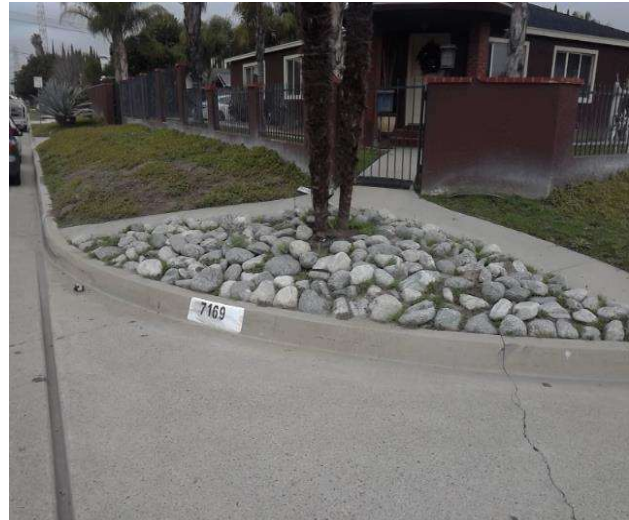
Sidewalks , Hazards & Gratings : Curb is on Path of Travel

Code Reference ADA 402, 303, 406, 403.4, 303.4

Install curb ramp \$2,500

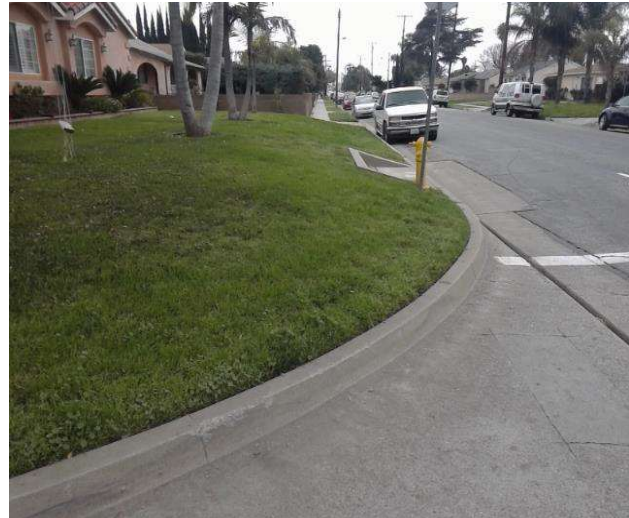
Sidewalks , Hazards & Gratings : Curb is on Path of Travel

Code Reference ADA 402, 303, 406, 403.4, 303.4

Install curb ramp \$2,500

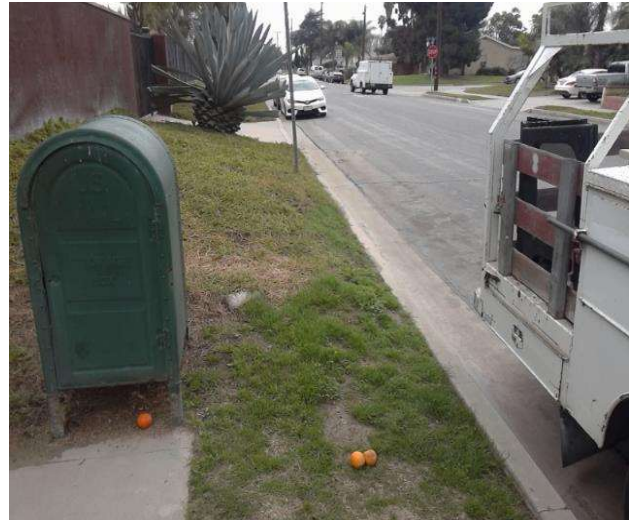
Sidewalks : Missing Sidewalk

Section of sidewalk is missing and consists of dirt, grass or gravel.

Code Reference ADA 206, 302,CA 11B-302,CA 11B-206

Provide a compliant sidewalk for the missing section.

\$1,260

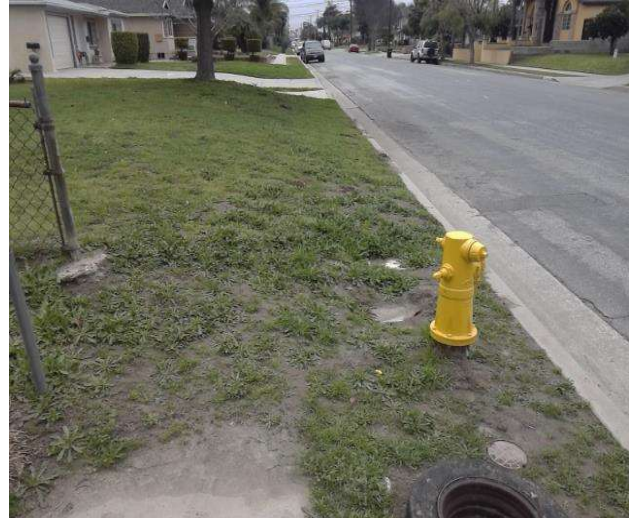
Sidewalks : Missing Sidewalk

Section of sidewalk is missing and consists of dirt, grass or gravel.

Code Reference ADA 206, 302,CA 11B-302,CA 11B-206

Provide a compliant sidewalk for the missing section.

\$1,260

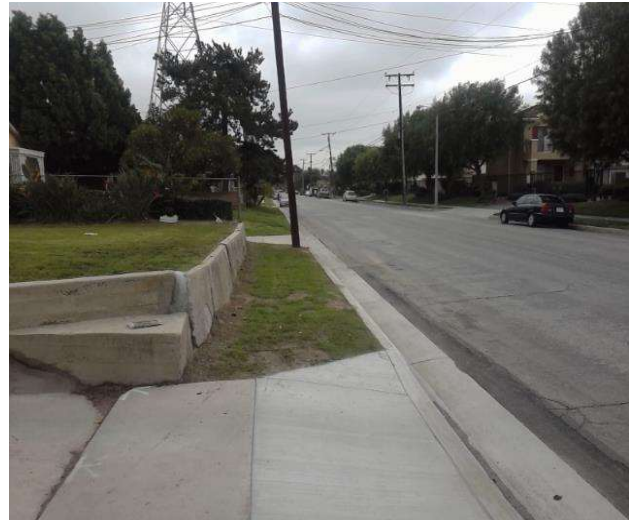
Sidewalks : Missing Sidewalk

Section of sidewalk is missing and consists of dirt, grass or gravel.

Code Reference ADA 206, 302,CA 11B-302,CA 11B-206

Provide a compliant sidewalk for the missing section.

\$1,260

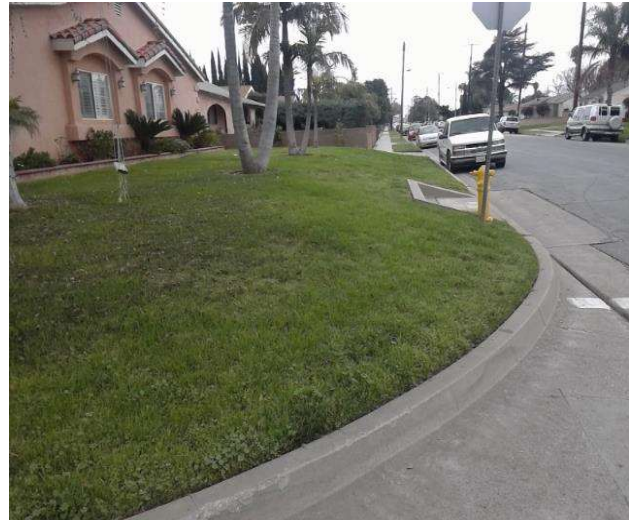
Sidewalks : Missing Sidewalk

Section of sidewalk is missing and consists of dirt, grass or gravel.

Code Reference ADA 206, 302,CA 11B-302,CA 11B-206

Provide a compliant sidewalk for the missing section.

\$1,260

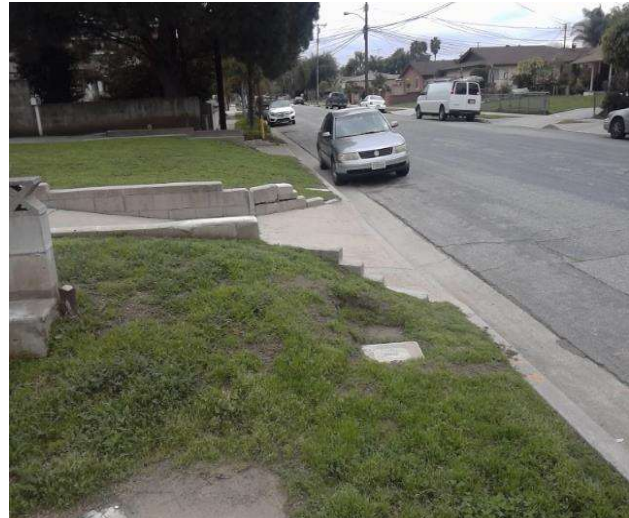
Sidewalks : Missing Sidewalk

Section of sidewalk is missing and consists of dirt, grass or gravel.

Code Reference ADA 206, 302,CA 11B-302,CA 11B-206

Provide a compliant sidewalk for the missing section.

\$1,260

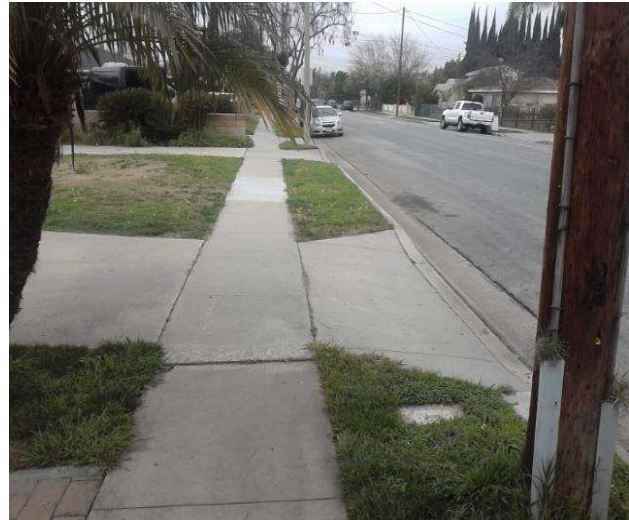
Sidewalks , Hazards & Gratings : Overhead Obstruction Height

Code Reference ADA 206, 307.4,CA 11B-307.4

Recommendation At least 80.00 inches

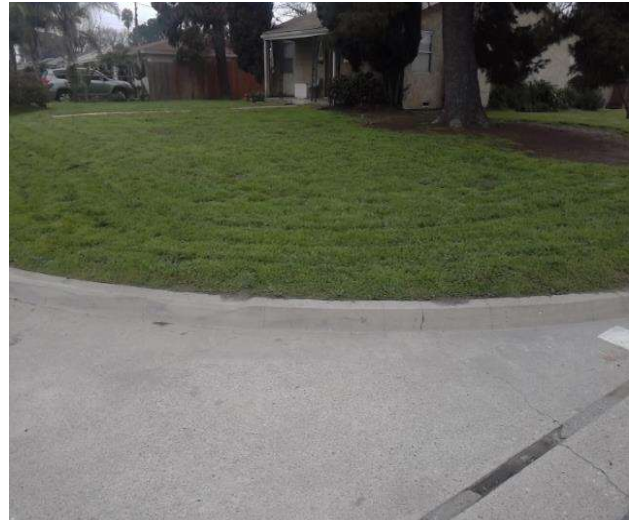
Sidewalks , Hazards & Gratings : Curb is on Path of Travel

Code Reference ADA 402, 303, 406, 403.4, 303.4

Install curb ramp \$2,500

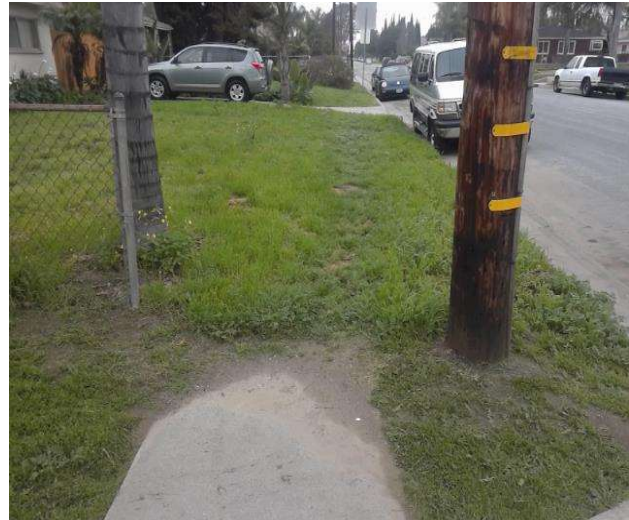
Sidewalks : Missing Sidewalk

Section of sidewalk is missing and consists of dirt, grass or gravel.

Code Reference ADA 206, 302,CA 11B-302,CA 11B-206

Provide a compliant sidewalk for the missing section.

\$1,260

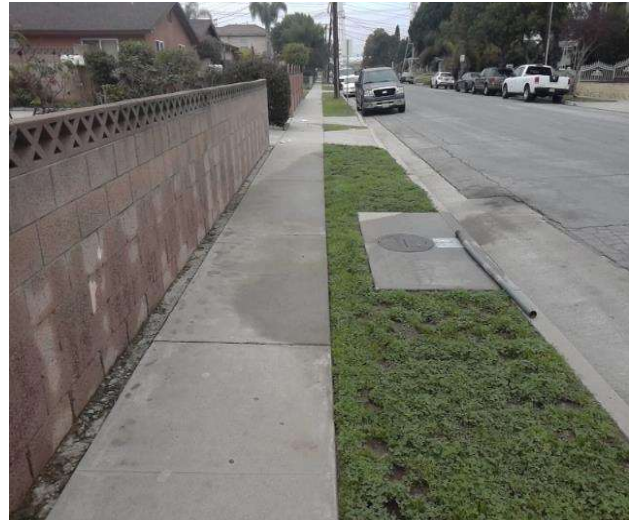
Code Reference ADA 206, 302, CA 11B-403.3

Repave the sidewalk surface with the recommended cross slope.

Recommendation Up to 2.08 percent

Repave surface \$1,092

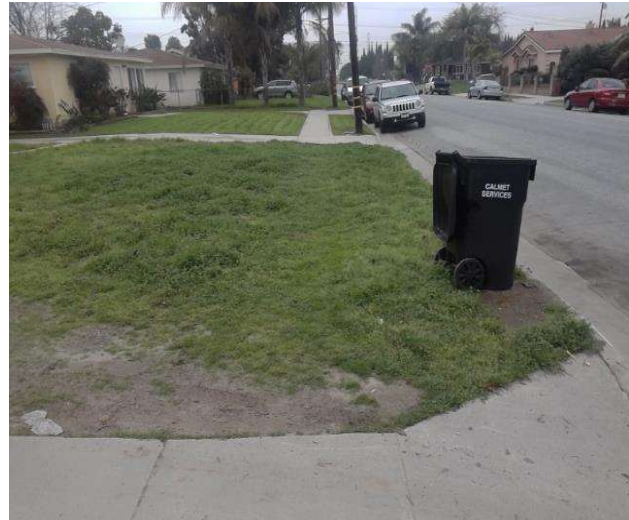
Sidewalks : Missing Sidewalk

Section of sidewalk is missing and consists of dirt, grass or gravel.

Code Reference ADA 206, 302, CA 11B-302, CA 11B-206

Provide a compliant sidewalk for the missing section.

\$1,260
