Accessibility Survey

City of Downey Laura Street & Old River School Road

Laura Street & Old River School Road Downey, CA 90242

Date of Inspection 4/18/2017

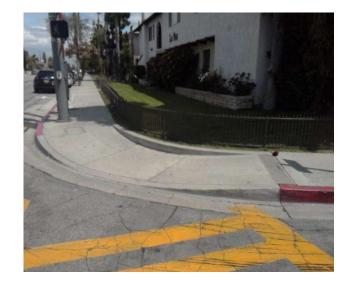
Northeast Corner @ 33.937808057040, -118.155577182770

Curb Ramp : Parallel Curb Ramp Left Side Slope

The running slope is greater than allowed.

On-Site Finding 13.60 percent

Provide a compliant curb ramp.

Recommendation Up to 8.33 percent

Install curb ramp \$1,300

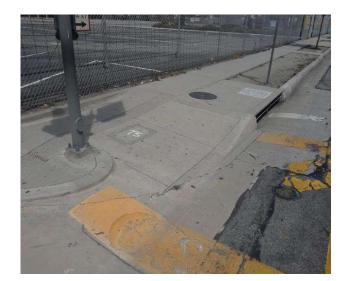
On-Site Finding Not Found

Recommendation See Recommendation

Provide detectable warning to \$248 surface

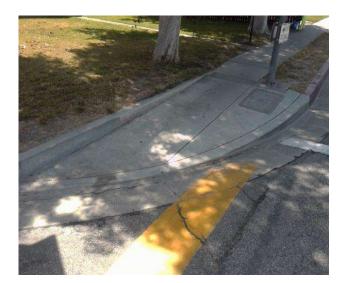
On-Site Finding Not Found

Recommendation See Recommendation

Provide detectable warning to \$248 surface

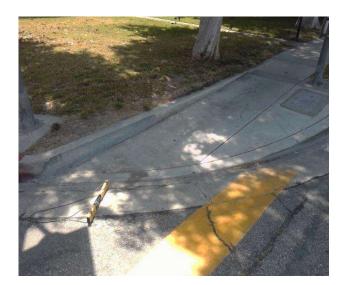
Curb Ramp , Landings And Transitions : Bottom Landing Change in

Recommendation Up to 0.50 inches

Patch lip at curb ramp \$255

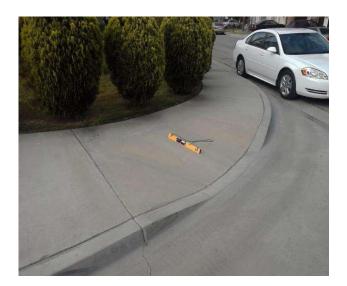
On-Site Finding Not Found

Recommendation See Recommendation

Provide detectable warning to \$248 surface

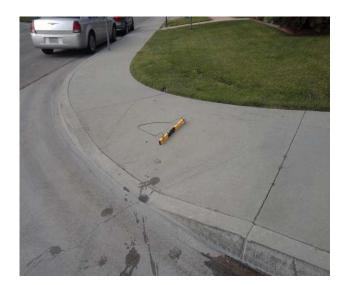
On-Site Finding Not Found

Recommendation See Recommendation

Provide detectable warning to \$248 surface

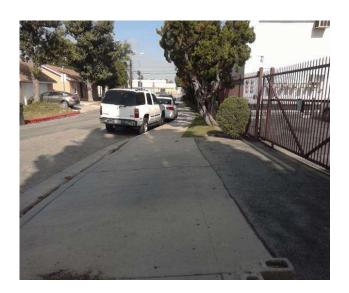
On-Site Finding Not Found

Install compliant detectable \$190

warnings

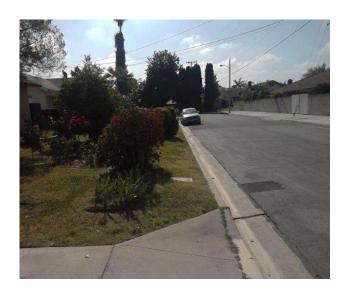
Sidewalks : Missing Sidewalk

\$1,260
