Accessibility Survey

City of Downey Brookmill Road - Old River School Road To End

Date of Inspection
4/19/2017

Prepared By
Disability Access Consultants
(800) 743-7067

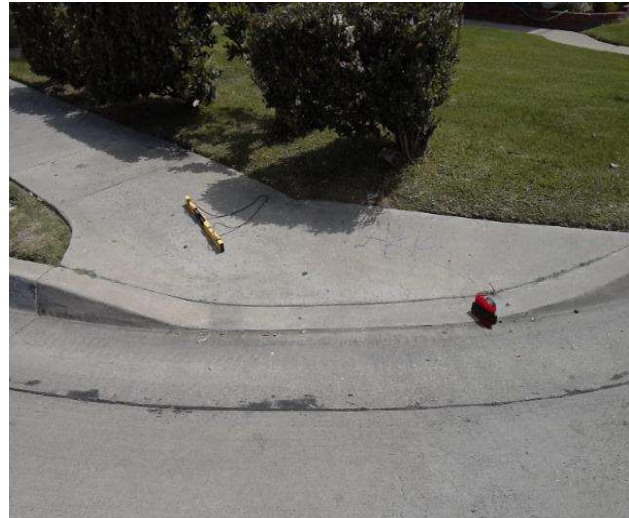
Northeast Corner Of Old River School Road @ 33.943433375958, - 118.151606172323

Curb Ramp : No Detectable Warnings

The curb ramp does not provide a detectable warning surface which includes truncated domes.

On-Site Finding Not Found

Code Reference CA 11B-406.5.12

Provide compliant detectable warnings to surface.

Provide detectable warning to surface \$248

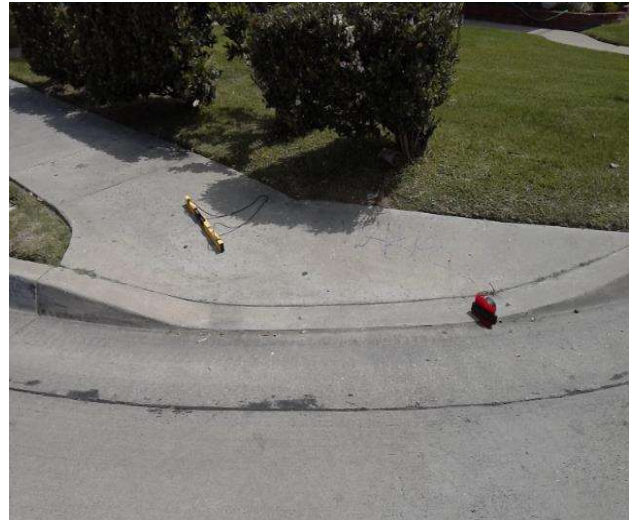
Northeast Corner Of Old River School Road @ 33.943433375958, - 118.151606172323

Curb Ramp : Curb Ramp Width

The width of the curb ramp is less than required.

On-Site Finding 44.00 inches

Code Reference ADA 406, 406.1, 405.5, CA 11B-406.5.2

Provide a compliant curb ramp.

Recommendation At least 48.00 inches

Install curb ramp \$1,300

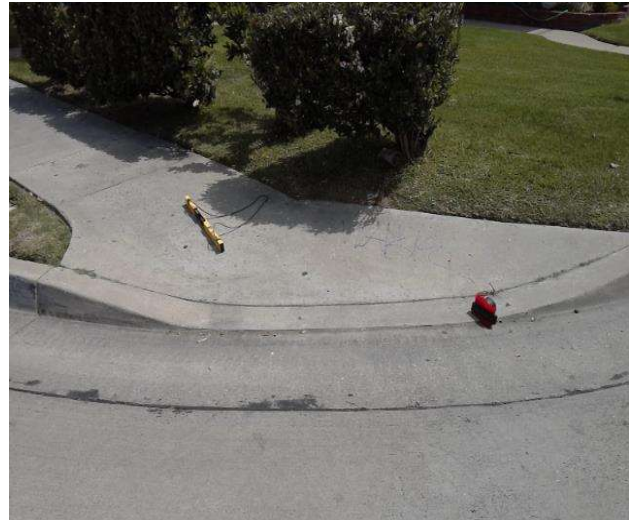
Northeast Corner Of Old River School Road @ 33.943433375958, - 118.151606172323

Curb Ramp : Curb Ramp Slope

The running slope is greater than allowed.

On-Site Finding 14.80 percent

Code Reference ADA 406, 406.1, 405.2, CA 11B-406

Provide a compliant curb ramp.

Recommendation Up to 8.33 percent

Install curb ramp \$1,300

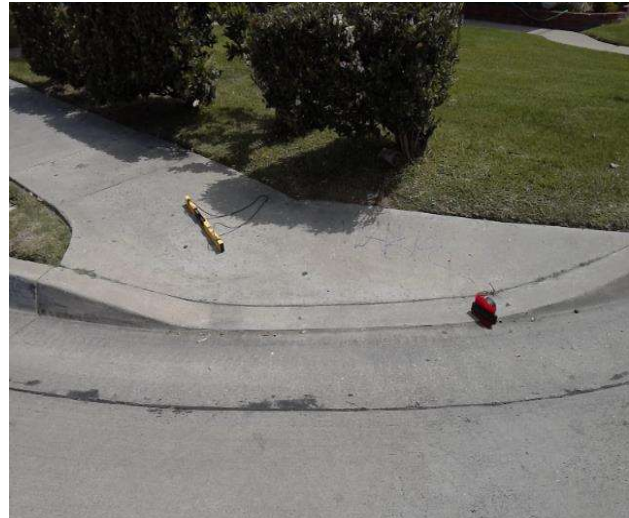
Northeast Corner Of Old River School Road @ 33.943433375958, - 118.151606172323

Curb Ramp : Curb Ramp - Cross Slope

The cross slope is greater than allowed.

On-Site Finding 10.90 percent

Code Reference ADA 402, 406.1, 405.3, CA 11B-406.5.7

Provide a compliant curb ramp.

Recommendation Up to 2.08 percent

Install curb ramp \$1,300

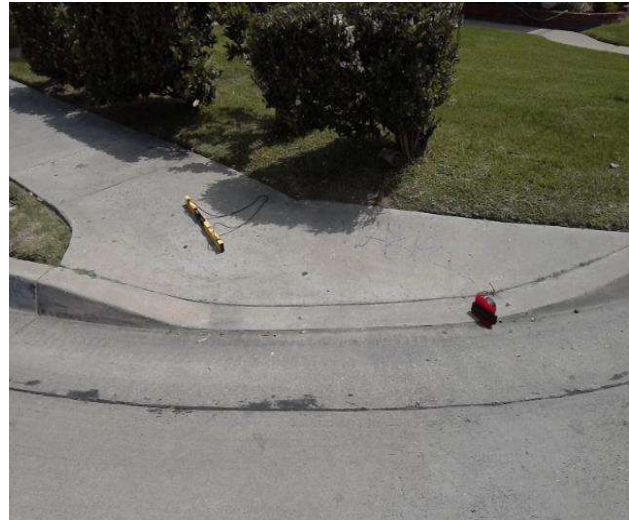
Northeast Corner Of Old River School Road @ 33.943433375958, - 118.151606172323

Curb Ramp : Side Flare Slope

The slope of the curb ramp side flare is greater than allowed.

On-Site Finding 17.90 percent

Code Reference ADA 406, 406.3,CA 11B-406.2.2

Provide curb ramp side flares with a compliant slope.

Recommendation Up to 10.00 percent

Install flared sides \$1,300

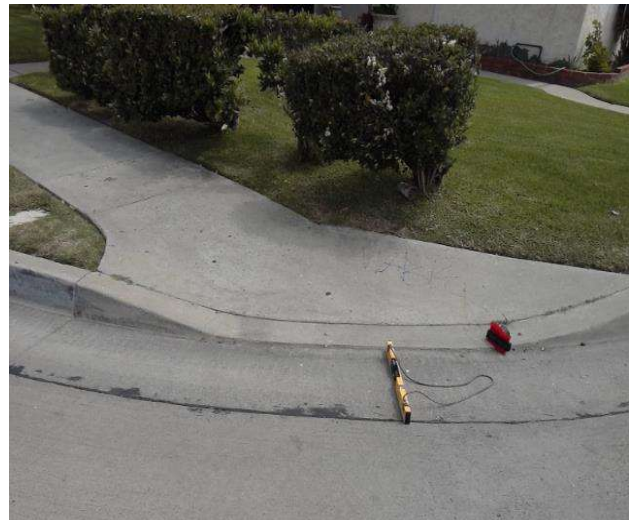
Northeast Corner Of Old River School Road @ 33.943433375958, - 118.151606172323

Curb Ramp : Bottom Landing Slope

The bottom landing of the curb ramp is on the street, and the slope of the bottom landing is not compliant.

On-Site Finding 9.70 percent

Code Reference ADA 406, 406.2, CA 11B-406.5.8

Ensure the bottom landing slope is compliant and provides a smooth transition.

Recommendation Up to 5.00 percent

Repave landing \$1,260

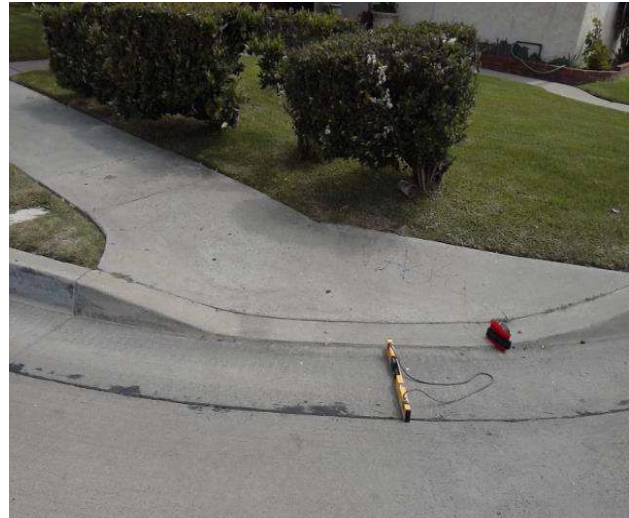
Northeast Corner Of Old River School Road @ 33.943433375958, - 118.151606172323

Curb Ramp , Landings and Transitions : Bottom Landing Change in Level - Curb Ramps

The transition from the bottom of the curb ramp to the walk, gutter, or street is abrupt.

On-Site Finding Not Beveled

Code Reference ADA 302, 406.2

Patch the transition area at the bottom of the curb ramp so that the transition is flush and free of abrupt changes.

Patch lip at curb ramp \$255

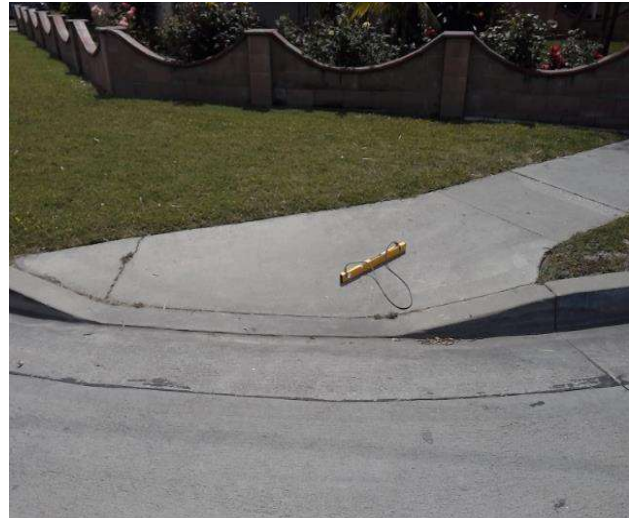
Southeast Corner Of Old River School Road @ 33.943294305110, - 118.151685297489

Curb Ramp : No Detectable Warnings

The curb ramp does not provide a detectable warning surface which includes truncated domes.

On-Site Finding Not Found

Code Reference CA 11B-406.5.12

Provide compliant detectable warnings to surface.

Provide detectable warning to surface \$248

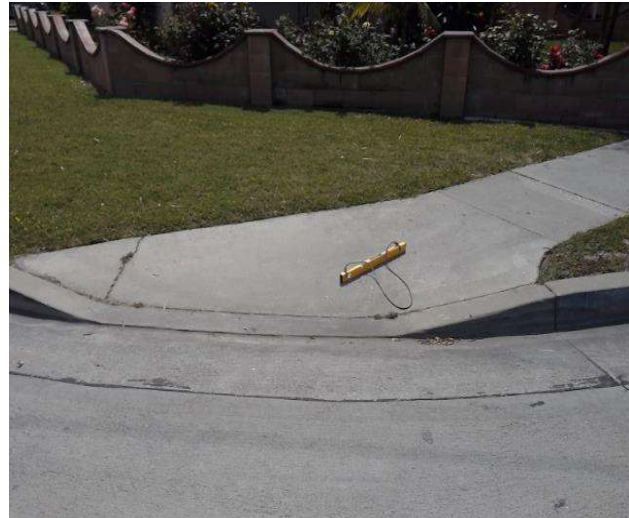
Southeast Corner Of Old River School Road @ 33.943294305110, - 118.151685297489

Curb Ramp : Curb Ramp Slope

The running slope is greater than allowed.

On-Site Finding 10.90 percent

Code Reference ADA 406, 406.1, 405.2, CA 11B-406

Provide a compliant curb ramp.

Recommendation Up to 8.33 percent

Install curb ramp \$1,300

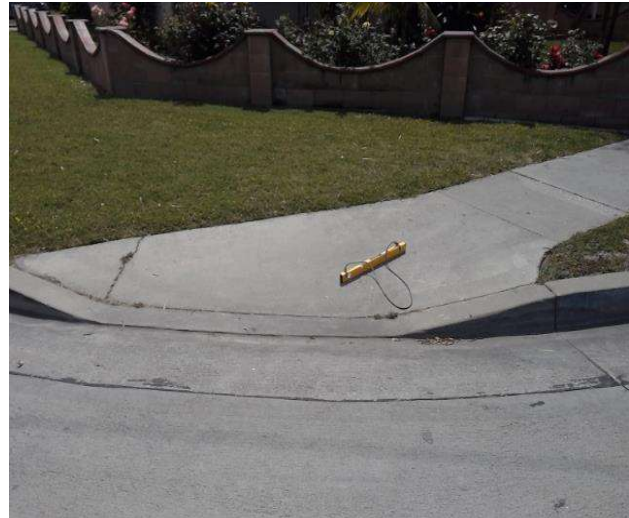
Southeast Corner Of Old River School Road @ 33.943294305110, - 118.151685297489

Curb Ramp : Curb Ramp - Cross Slope

The cross slope is greater than allowed.

On-Site Finding 15.20 percent

Code Reference ADA 402, 406.1, 405.3, CA 11B-406.5.7

Provide a compliant curb ramp.

Recommendation Up to 2.08 percent

Install curb ramp \$1,300

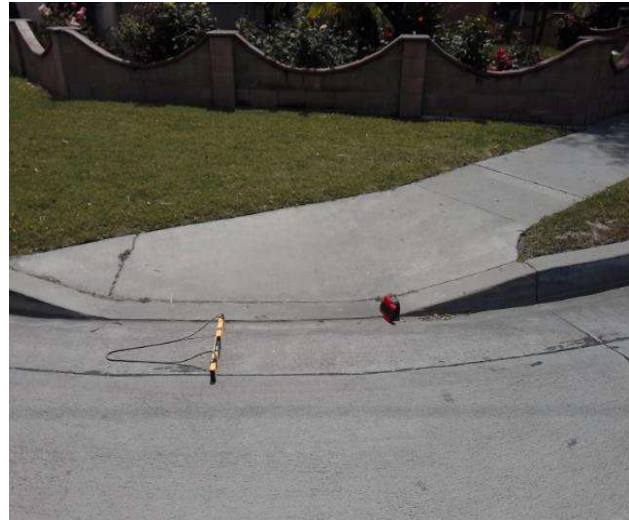
Southeast Corner Of Old River School Road @ 33.943294305110, - 118.151685297489

Curb Ramp : Bottom Landing Slope

The bottom landing of the curb ramp is on the street, and the slope of the bottom landing is not compliant.

On-Site Finding 9.30 percent

Code Reference ADA 406, 406.2, CA 11B-406.5.8

Ensure the bottom landing slope is compliant and provides a smooth transition.

Recommendation Up to 5.00 percent

Repave landing \$1,260

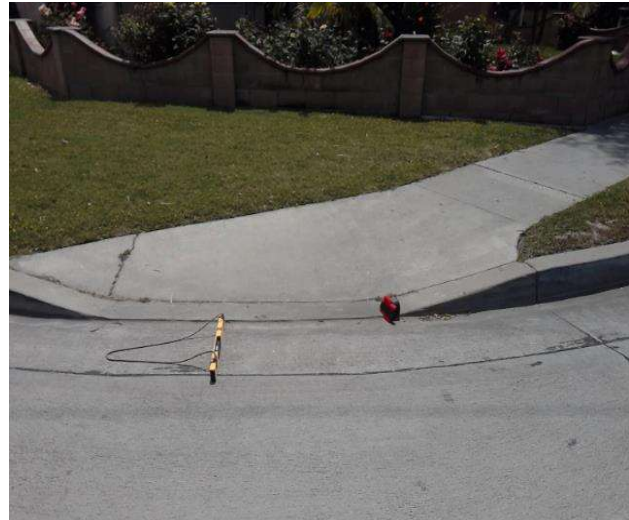
Southeast Corner Of Old River School Road @ 33.943294305110, - 118.151685297489

The transition from the bottom of the curb ramp to the walk, gutter, or street is abrupt.

On-Site Finding 0.62 inches

Curb Ramp , Landings And Transitions : Bottom Landing Change in Level

Code Reference ADA 302, 303, 406.2, 303.1

Patch the transition area at the bottom of the curb ramp so that the transition is flush and free of abrupt changes.

Recommendation Up to 0.50 inches

Patch lip at curb ramp \$255

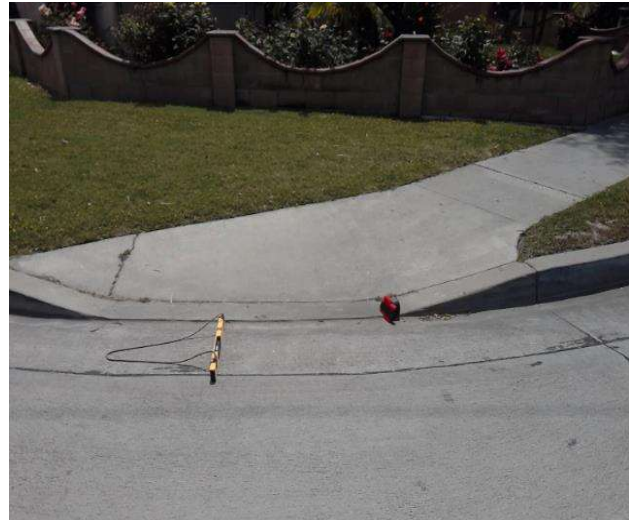
Southeast Corner Of Old River School Road @ 33.943294305110, - 118.151685297489

Curb Ramp , Landings and Transitions : Top Landing Slope

The slope at the top landing is greater than allowed.

On-Site Finding 4.70 percent

Code Reference ADA 402, 406.4, 403.3, 406.1, CA 11B-406.5.3

Provide a top landing surface that does not exceed the maximum slope and cross slope. Provide a sufficient maneuvering clearance that does not accumulate water.

Recommendation Up to 2.08 percent

Provide compliant landing \$1,260

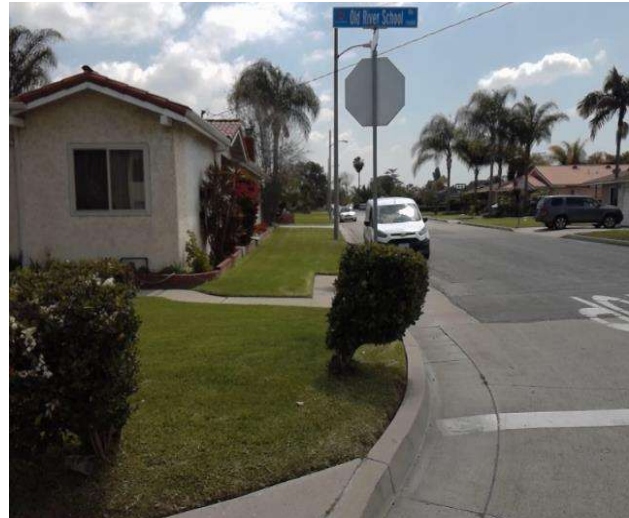
North Side @ 33.943410012072, -118.151595443487

Sidewalks : No Sidewalk

No sidewalk exists at the location.

No action necessary until a sidewalk is provided.

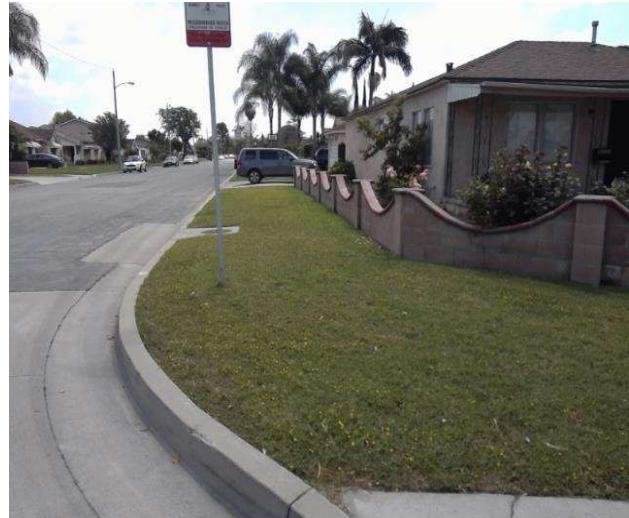
South Side @ 33.943299867949, -118.151683956385

Sidewalks : No Sidewalk

No sidewalk exists at the location.

No action necessary until a sidewalk is provided.

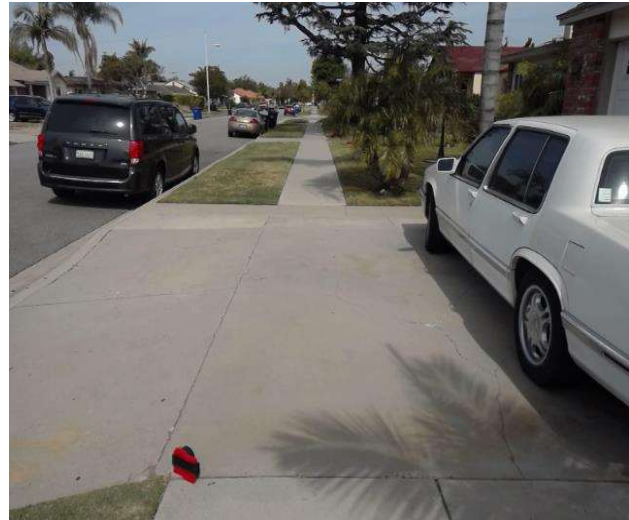
Change In Level East Of Samoline Avenue @ 33.938241985297, -118.141845613718

Sidewalks , Change in Level : Change in Level Non Beveled

There is a change in elevation greater than recommended value.

On-Site Finding 0.50 inches

Code Reference ADA 206, 302

Ensure that the change in elevation is within the recommended value.

Recommendation Up to 0.25 inches

Remove tripping hazards \$198

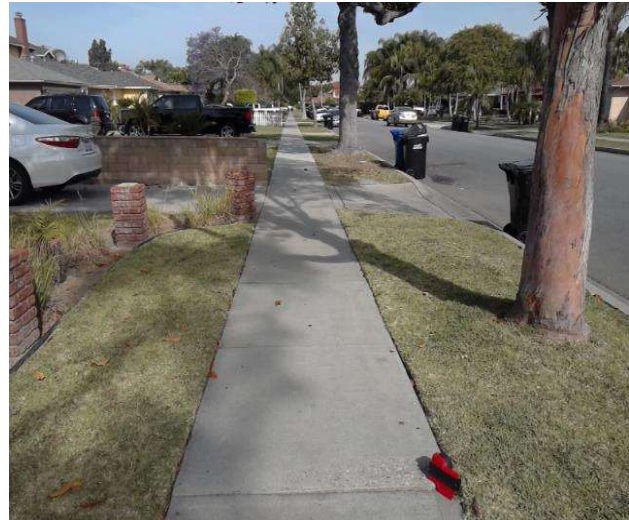
There is a change in elevation greater than recommended value.

Code Reference ADA 206, 302

Ensure that the change in elevation is within the recommended value.

Recommendation Up to 0.25 inches

Remove tripping hazards \$198

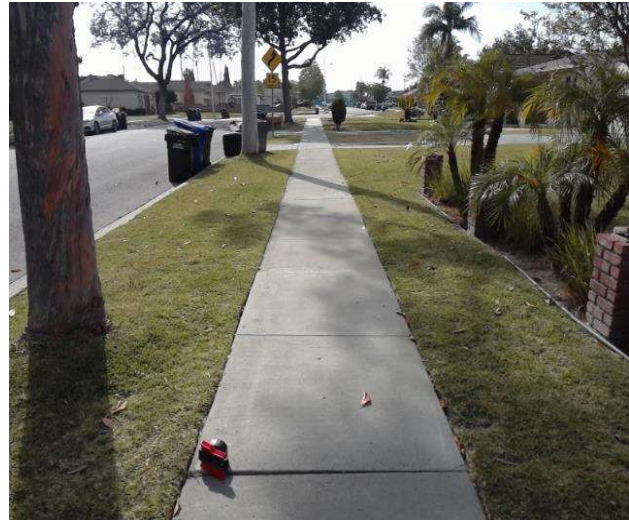
There is a change in elevation greater than recommended value.

Code Reference ADA 206, 302

Ensure that the change in elevation is within the recommended value.

Recommendation Up to 0.25 inches

Remove tripping hazards \$198

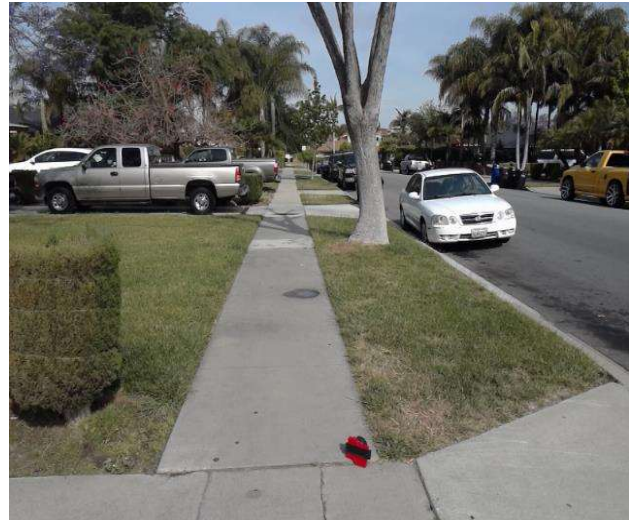
There is a change in elevation greater than recommended value.

Code Reference ADA 206, 302

Ensure that the change in elevation is within the recommended value.

Recommendation Up to 0.25 inches

Remove tripping hazards \$198

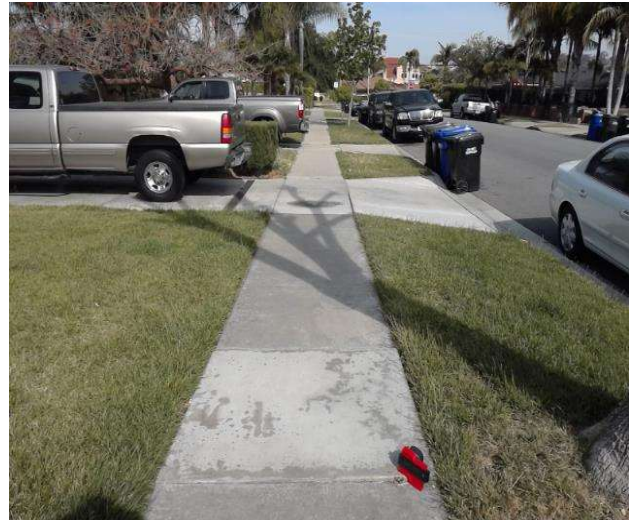
There is a change in elevation greater than recommended value.

Code Reference ADA 206, 302

Ensure that the change in elevation is within the recommended value.

Recommendation Up to 0.25 inches

Remove tripping hazards \$198

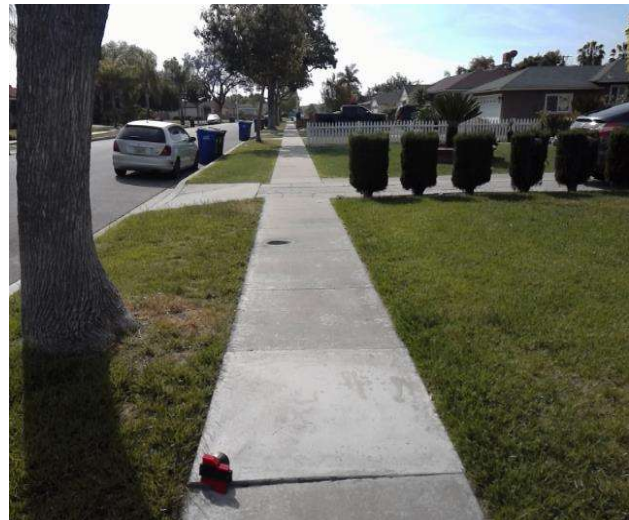
There is a change in elevation greater than recommended value.

Code Reference ADA 206, 302

Ensure that the change in elevation is within the recommended value.

Recommendation Up to 0.25 inches

Remove tripping hazards \$198

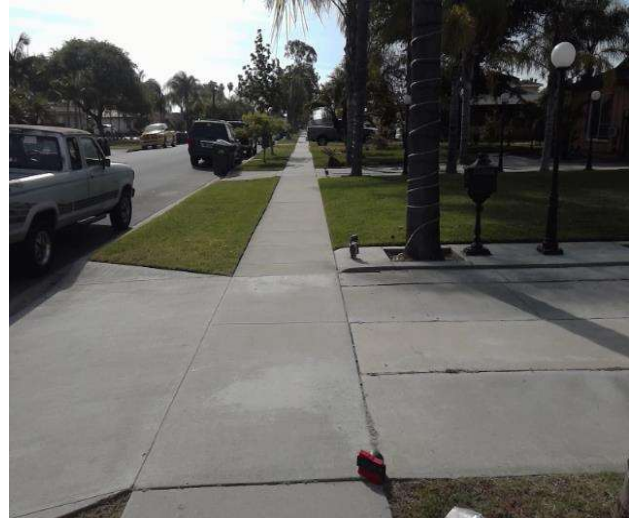
There is a change in elevation greater than recommended value.

Code Reference ADA 206, 302

Ensure that the change in elevation is within the recommended value.

Recommendation Up to 0.25 inches

Remove tripping hazards \$198

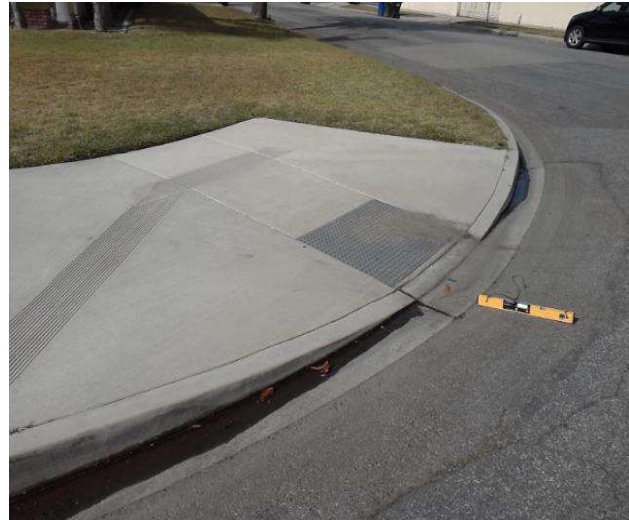
Curb Ramp , Landings and Transitions : Top Landing Clear Length - Landings

Code Reference ADA 406, 406.4,CA 11B-406.5.3

Recommendation At least 48.00 inches

Provide compliant landing \$240

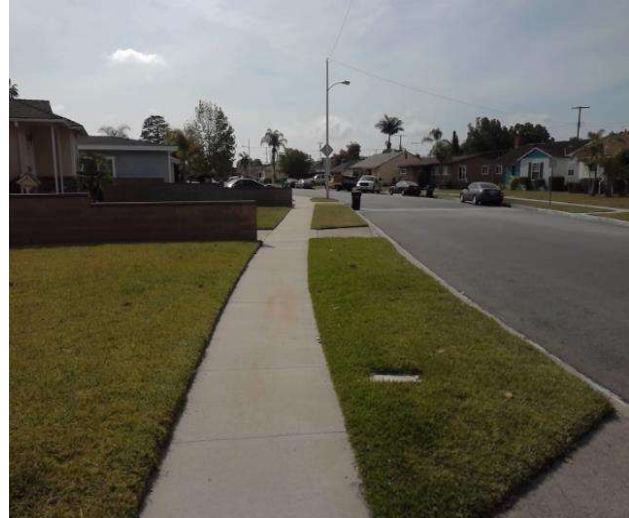
Code Reference ADA 206, 302, CA 11B-403.3

Repave the sidewalk surface with the recommended cross slope.

Recommendation Up to 2.08 percent

Repave surface \$1,092

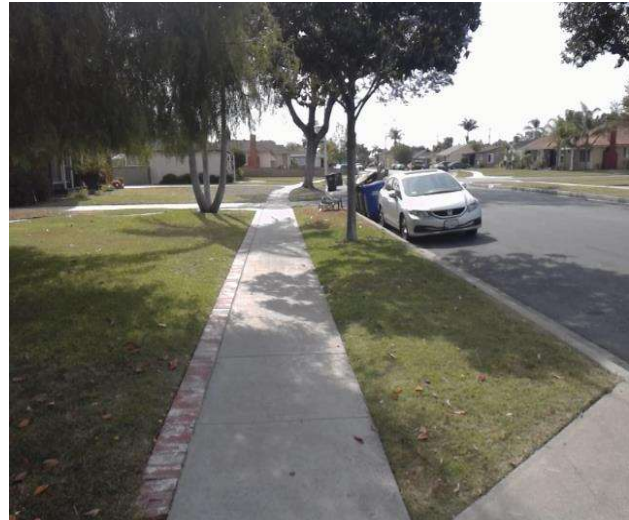
Code Reference ADA 206, 302, CA 11B-403.3

Repave the sidewalk surface with the recommended cross slope.

Recommendation Up to 2.08 percent

Repave surface \$1,092

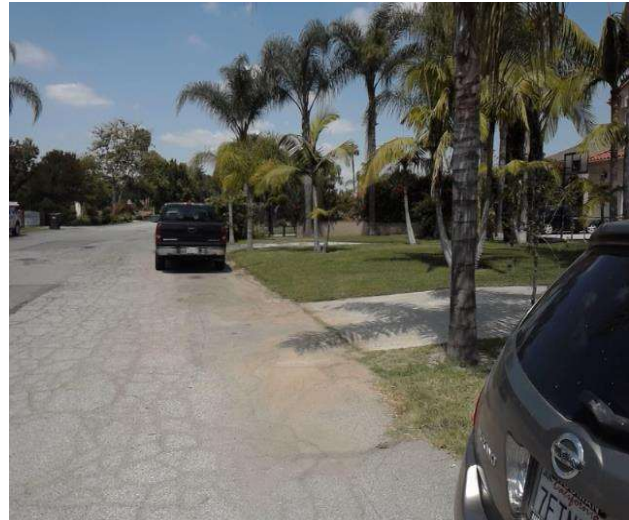
Sidewalks : Missing Sidewalk

Section of sidewalk is missing and consists of dirt, grass or gravel.

ADA 206, 302,CA 11B-302,CA 11B-206

Provide a compliant sidewalk for the missing section.

\$1,260
