Accessibility Survey

City of Downey Deming Avenue - Fontana Street to Cul-De-Sac

Date of Inspection
8/8/2017

Prepared By
Disability Access Consultants
(800) 743-7067

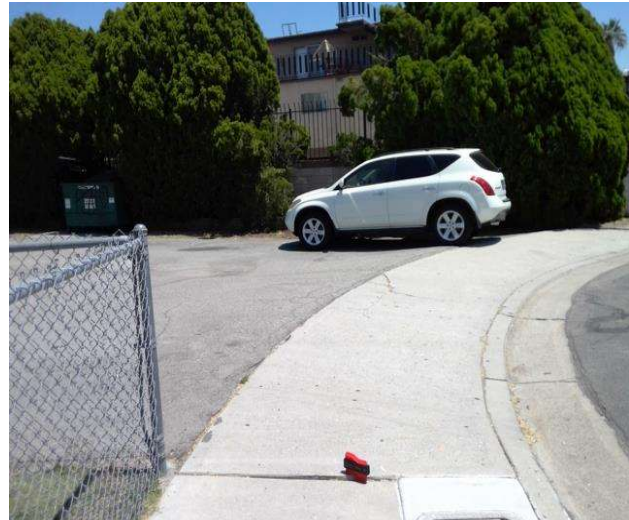
Change in Level North of Fontana Street @ 33.929674274630, -118.129396140575

Sidewalks , Change in Level : Change in Level Non Beveled

There is a change in elevation greater than recommended value.

On-Site Finding 0.75 inches

Ensure that the change in elevation is within the recommended value.

Recommendation Up to 0.25 inches

Remove tripping hazards \$198

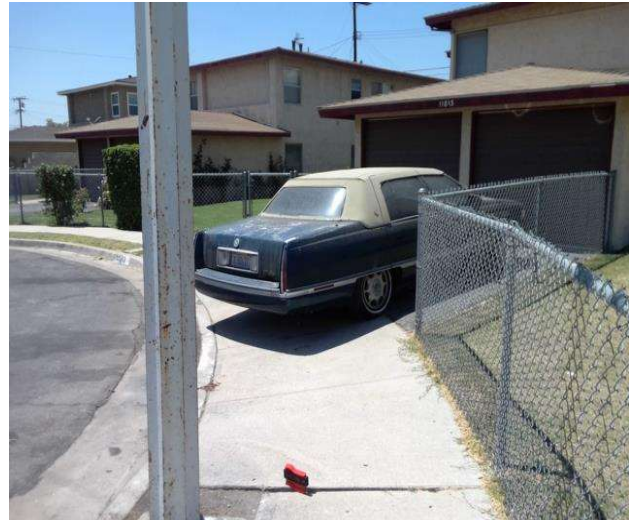
Change in Level North of Fontana Street @ 33.929677612867, -118.129437714815

Sidewalks , Change in Level : Change in Level Non Beveled

There is a change in elevation greater than recommended value.

On-Site Finding 0.75 inches

Ensure that the change in elevation is within the recommended value.

Recommendation Up to 0.25 inches

Remove tripping hazards \$198

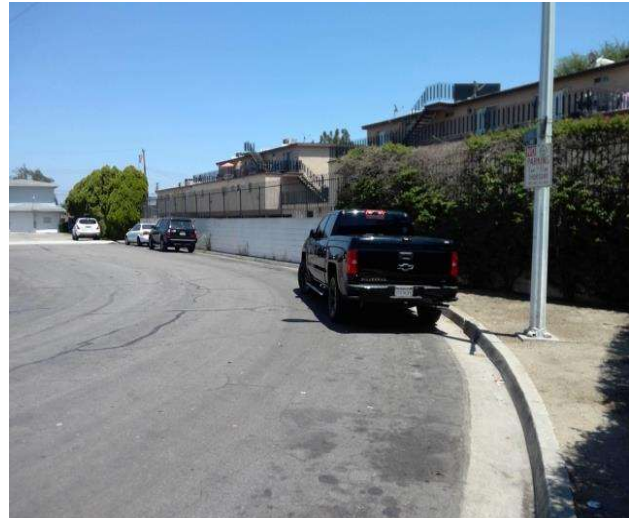
East Side @ 33.929283704, -118.129713982344

Sidewalks : No Sidewalk

No sidewalk exists at the location.

On-Site Finding Not Found

No action necessary until a sidewalk is provided.

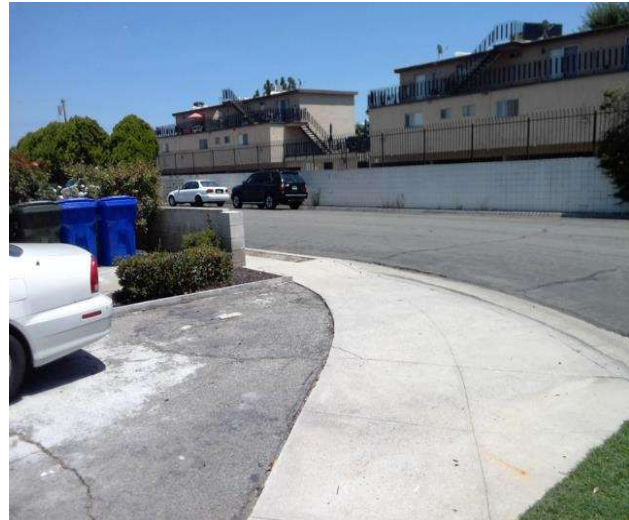
Driveway North of Fontana Street @ 33.929410553497, -118.129612058401

Sidewalks : Vehicular Traffic Cross Slope

Cross slope at vehicular traffic is not compliant.

On-Site Finding 11.80 percent

Repave the surface to provide a compliant cross slope.

Recommendation Up to 2.08 percent

Repave surface \$1,092

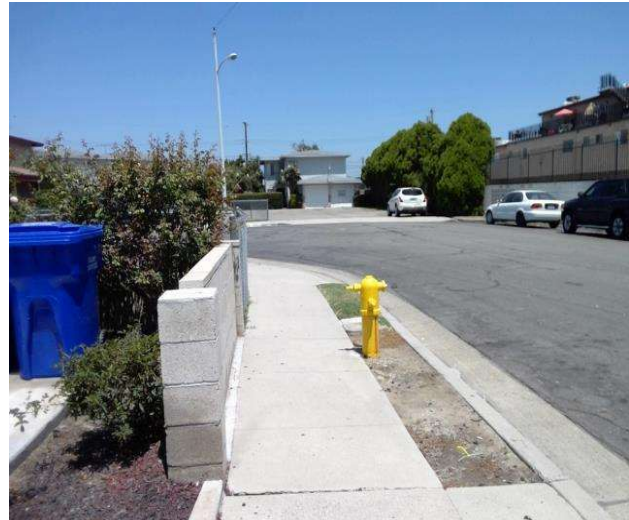
Sidewalk North of Fontana Street @ 33.929429470230, -118.129583895206

Sidewalks : Width

Sidewalk does not have enough width.

On-Site Finding 47.00 inches for 22.00 feet

Widen the sidewalk to the recommended value.

Recommendation At least 48.00 inches

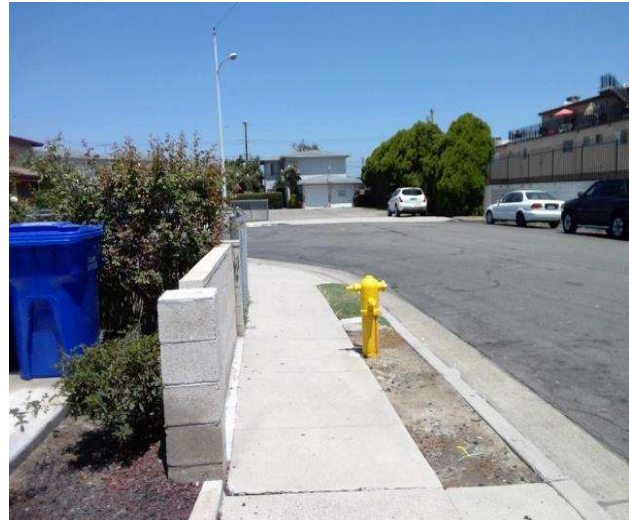
Sidewalk North of Fontana Street @ 33.929429470230, -118.129583895206

Sidewalks , Surface : Cross Slope

Sidewalk cross slope is not compliant.

On-Site Finding 4.30 percent for 118.00 feet

Repave the sidewalk surface with the recommended cross slope.

Recommendation Up to 2.08 percent

Repave surface \$1,092

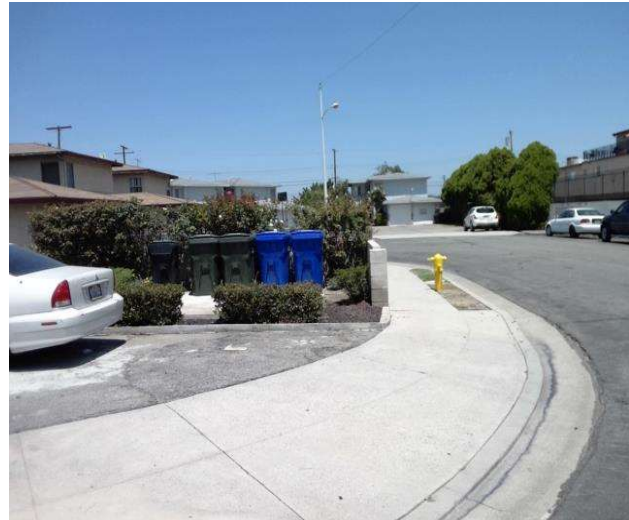
West Side @ 33.929410553497, -118.129681795835

Sidewalks : 60X60 Turn Area

There is no 60X60 turn area at every 200 feet.

On-Site Finding Not Found

Provide a 60X60 turn every 200 feet on the sidewalk.

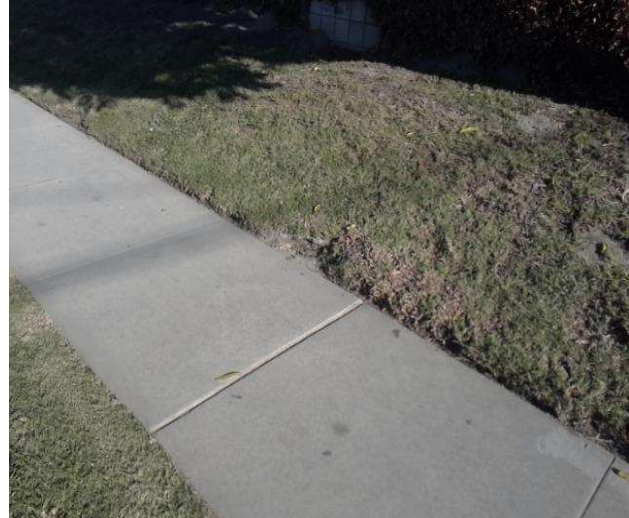
Change In Level South Of Gardendale Street @ 33.910668684184, - 118.143646717072

Sidewalks , Change in Level : Change in Level Non Beveled

There is a change in elevation greater than recommended value.

On-Site Finding 0.50 inches

Ensure that the change in elevation is within the recommended value.

Recommendation Up to 0.25 inches

Remove tripping hazards \$198

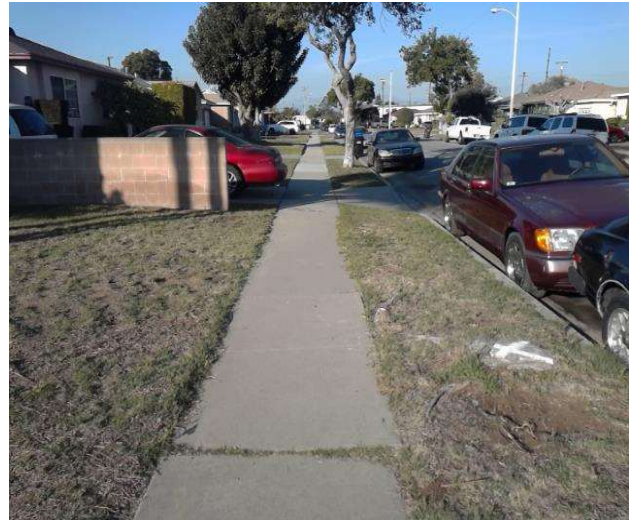
Change In Level North Of Castana Avenue @ 33.908855597807, -118.144142925739

Sidewalks , Change in Level : Change in Level Non Beveled

There is a change in elevation greater than recommended value.

On-Site Finding 1.00 inches

Ensure that the change in elevation is within the recommended value.

Recommendation Up to 0.25 inches

Remove tripping hazards \$198

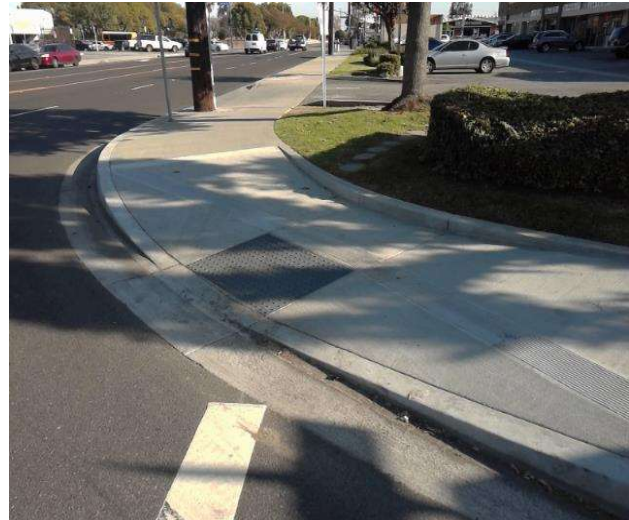
Southeast Corner Of Gardendale Street @ 33.910832294133, - 118.143534064293

There is not enough top landing clear length.

On-Site Finding 45.50 inches

Curb Ramp , Landings and Transitions : Top Landing Clear Length - Landings

Provide a level top landing with enough clear length.

Recommendation At least 48.00 inches

Provide compliant landing \$240

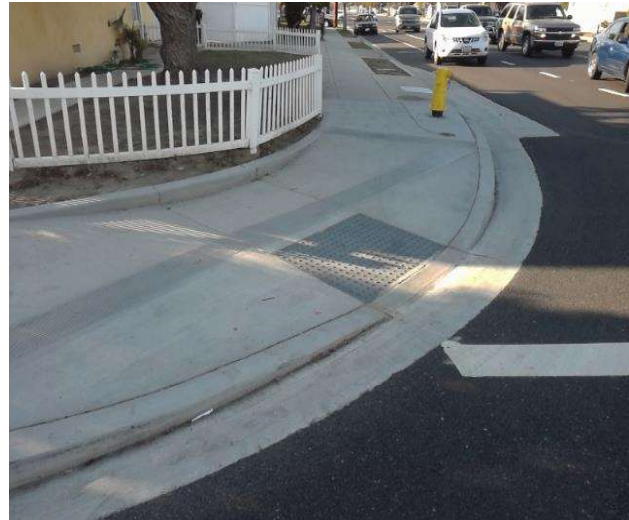
Southwest Corner Of Gardendale Street @ 33.910926898381, - 118.143672198057

Curb Ramp , Landings and Transitions : Top Landing Clear Length - Landings

There is not enough top landing clear length.

On-Site Finding 46.50 inches

Provide a level top landing with enough clear length.

Recommendation At least 48.00 inches

Provide compliant landing \$240

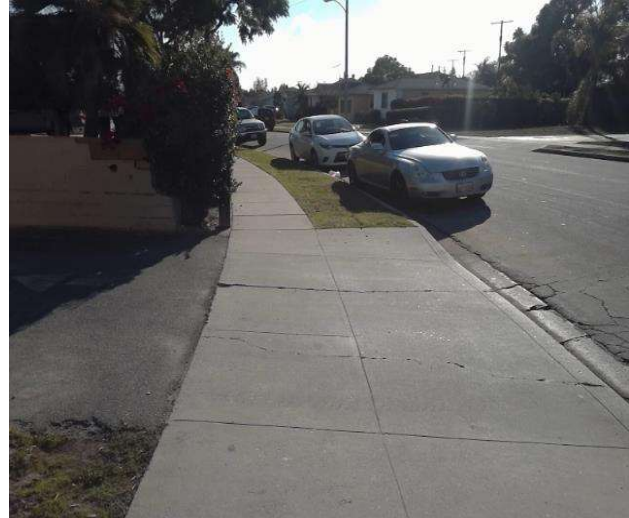
Driveway South Of Gardendale Street @ 33.910282474419, -118.143906891346

Sidewalks , Vehicular Traffic : Cross Walks and Detectable Warnings

There are no detectable warnings where the pedestrian route crosses vehicular traffic.

On-Site Finding Not Found

Provide detectable warnings.

Install compliant detectable warnings \$190

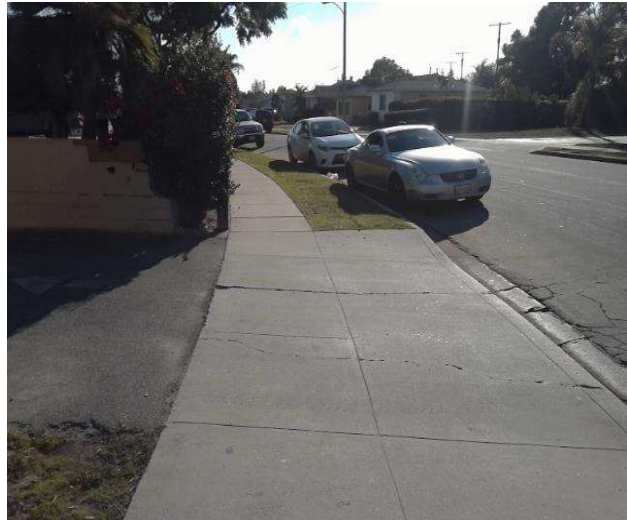
Driveway South Of Gardendale Street @ 33.910282474419, -118.143906891346

Sidewalks : Vehicular Traffic Cross Slope

Cross slope at vehicular traffic is not compliant.

On-Site Finding 8.70 percent

Repave the surface to provide a compliant cross slope.

Recommendation Up to 2.08 percent

Repave surface \$1,092

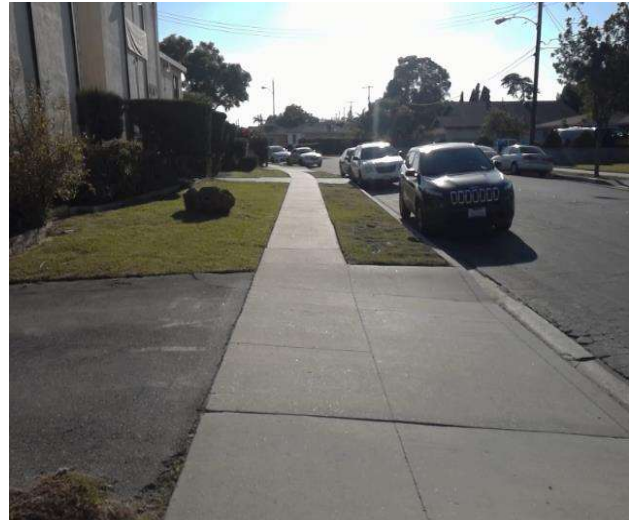
Driveway South Of Gardendale Street @ 33.910539576791, -118.143747299910

Sidewalks , Vehicular Traffic : Cross Walks and Detectable Warnings

There are no detectable warnings where the pedestrian route crosses vehicular traffic.

On-Site Finding Not Found

Provide detectable warnings.

Install compliant detectable warnings \$190

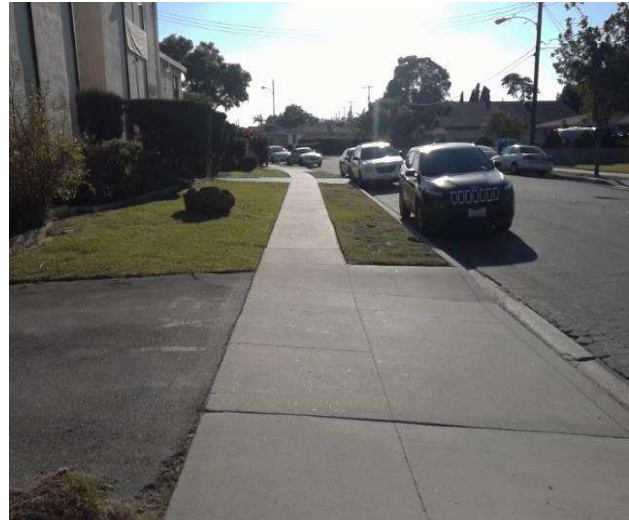
Driveway South Of Gardendale Street @ 33.910539576791, -118.143747299910

Sidewalks : Vehicular Traffic Cross Slope

Cross slope at vehicular traffic is not compliant.

On-Site Finding 10.00 percent

Repave the surface to provide a compliant cross slope.

Recommendation Up to 2.08 percent

Repave surface \$1,092

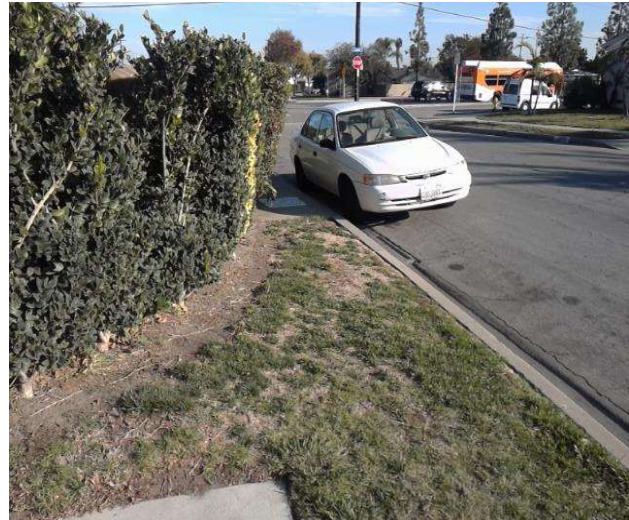
Sidewalk South Of Gardendale Street @ 33.908035299893, -118.143516629934

Sidewalks : Missing Sidewalk

Section of sidewalk is missing and consists of dirt, grass or gravel.

On-Site Finding 81.00 feet

Provide a compliant sidewalk for the missing section.

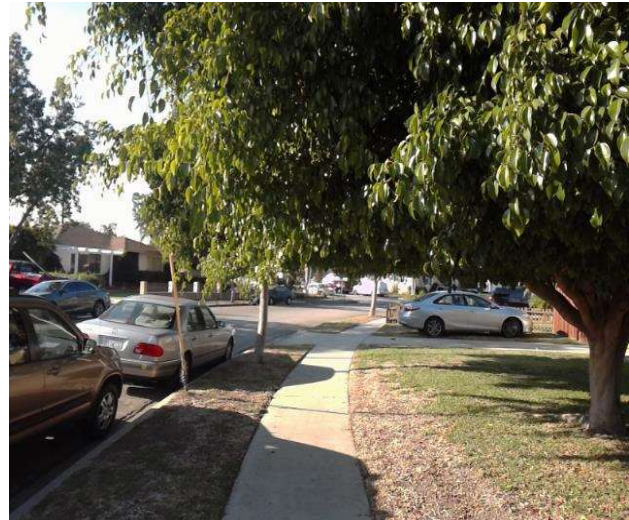
Tree South Of Gardendale Street @ 33.908158845945, -118.143784850836

Sidewalks , Hazards & Gratings : Overhead Obstruction Height

Overhead obstruction height is not compliant.

On-Site Finding 75.00 inches

Provide a compliant vertical clearance height.

Recommendation At least 80.00 inches

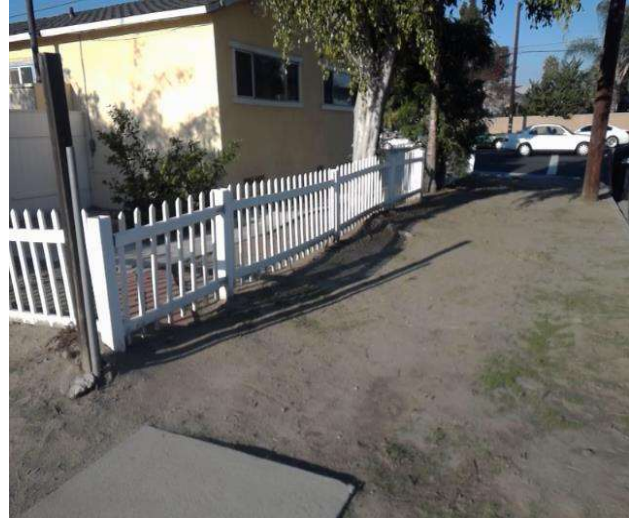
Sidewalk North Of Castana Avenue @ 33.910774418540, -118.143748641014

Sidewalks : Missing Sidewalk

Section of sidewalk is missing and consists of dirt, grass or gravel.

On-Site Finding 50.00 feet

Provide a compliant sidewalk for the missing section.

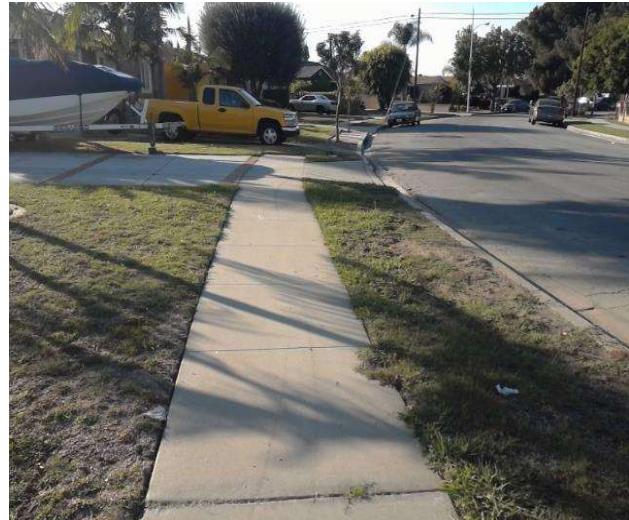
Sidewalk North Of Gardendale Street @ 33.907883927909, -118.143332898617

Sidewalks , Surface : Cross Slope

Sidewalk cross slope is not compliant.

On-Site Finding 3.20 percent for 42.00 feet

Repave the sidewalk surface with the recommended cross slope.

Recommendation Up to 2.08 percent

Repave surface \$1,092

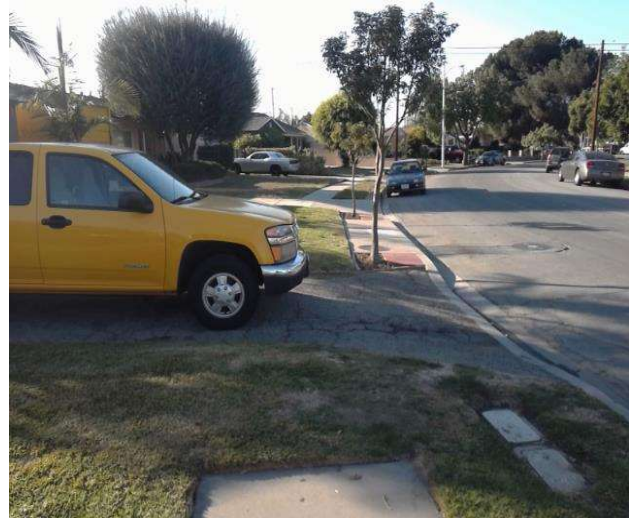
Sidewalk North Of Gardendale Street @ 33.907900623362, -118.143467009068

Sidewalks : Missing Sidewalk

Section of sidewalk is missing and consists of dirt, grass or gravel.

On-Site Finding 40.00 feet

Provide a compliant sidewalk for the missing section.

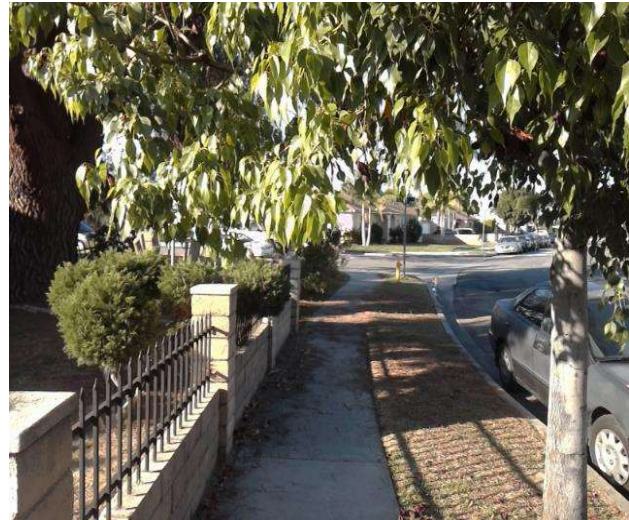
Tree North Of Lakewood Boulevard @ 33.908276826693, -118.144102692604

Sidewalks , Hazards & Gratings : Overhead Obstruction Height

Overhead obstruction height is not compliant.

On-Site Finding 66.00 inches

Provide a compliant vertical clearance height.

Recommendation At least 80.00 inches

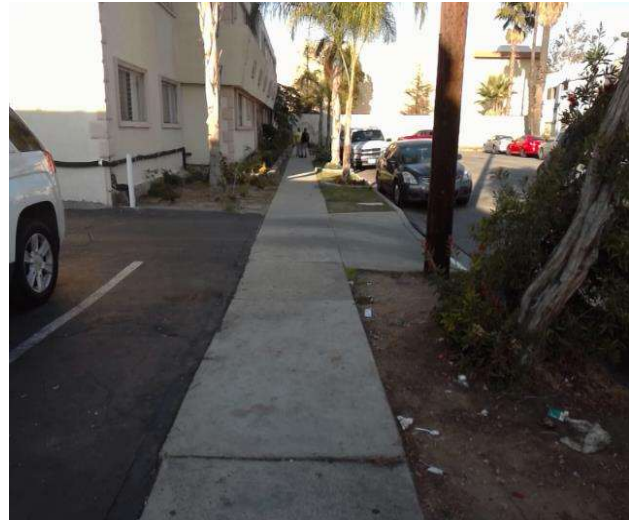
Change In Level North Of Rosecrans Avenue @ 33.904406750391, - 118.145017325878

Sidewalks , Change in Level : Change in Level Non Beveled

There is a change in elevation greater than recommended value.

On-Site Finding 1.00 inches

Ensure that the change in elevation is within the recommended value.

Recommendation Up to 0.25 inches

Remove tripping hazards \$198

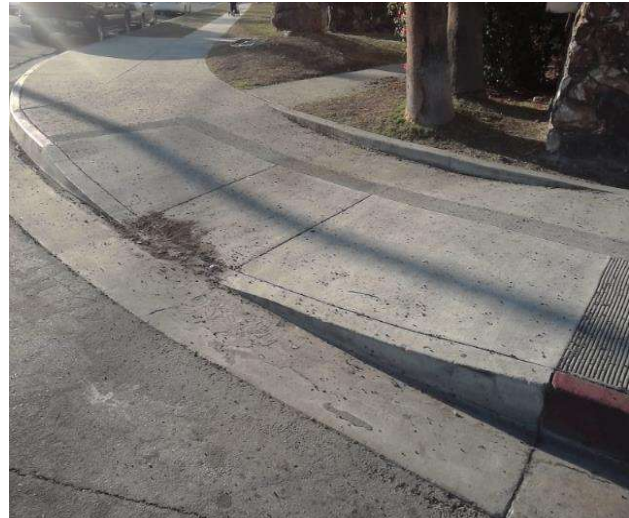
Northwest Corner Of Rosecrans Avenue @ 33.904046113106, - 118.145250678062

Curb Ramp : No Detectable Warnings

The curb ramp does not provide a detectable warning surface which includes truncated domes.

On-Site Finding Not Found

Provide compliant detectable warnings to surface.

Provide detectable warning to surface \$248

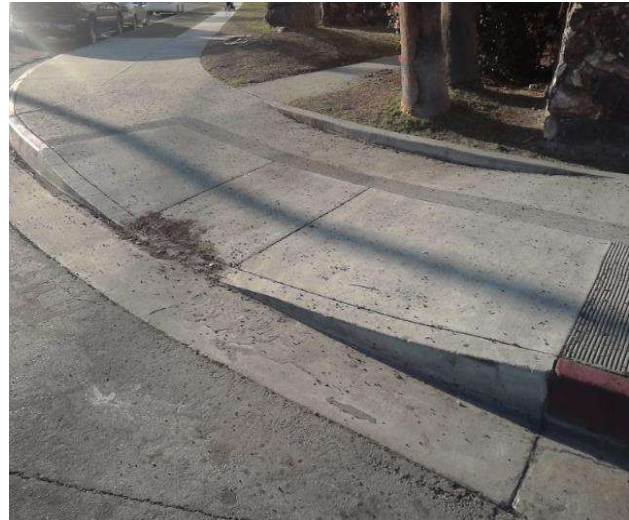
Northwest Corner Of Rosecrans Avenue @ 33.904046113106, - 118.145250678062

Bottom Landing

Recommendation Up to 5.00 percent

Repave landing \$1,260

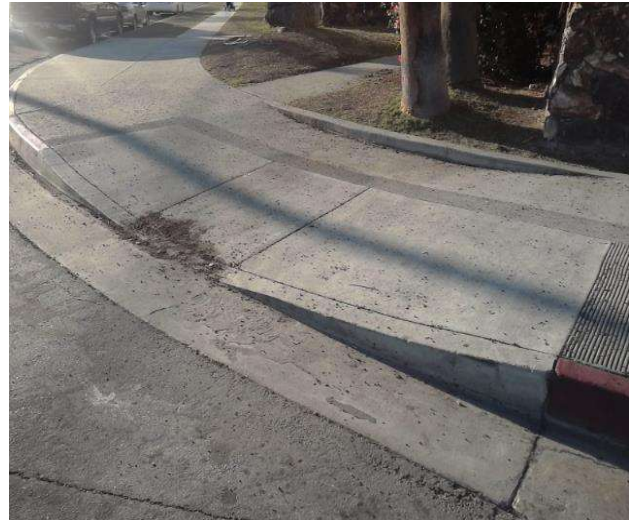
Curb Ramp , Landings and Transitions : Top Landing Clear Length - Landings

Recommendation At least 48.00 inches

Provide compliant landing \$240

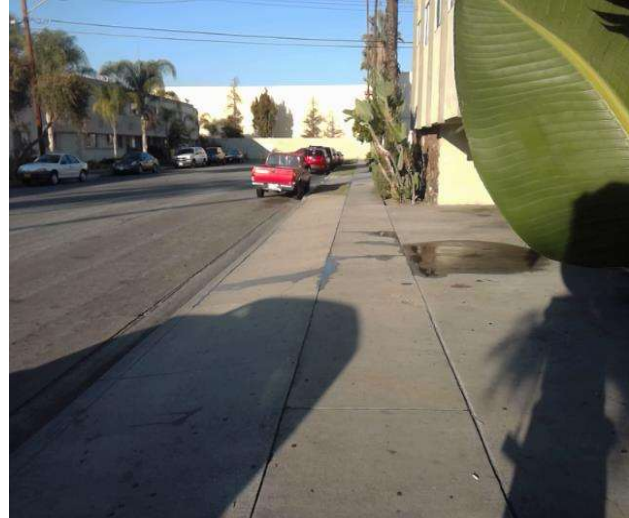
On-Site Finding Not Found

Install compliant detectable warnings \$190

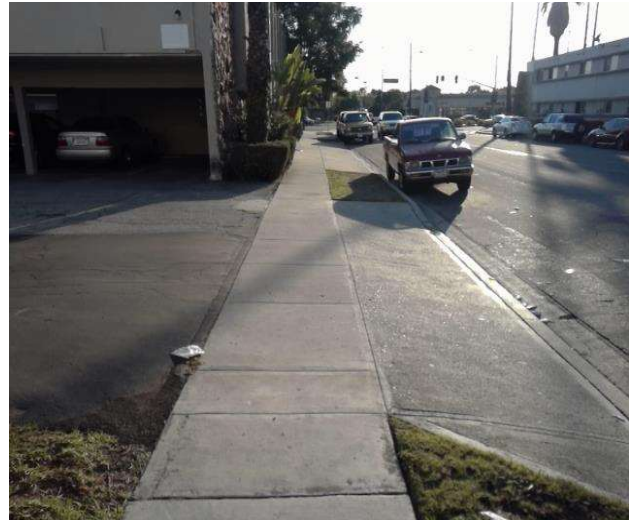
On-Site Finding Not Found

Install compliant detectable warnings \$190

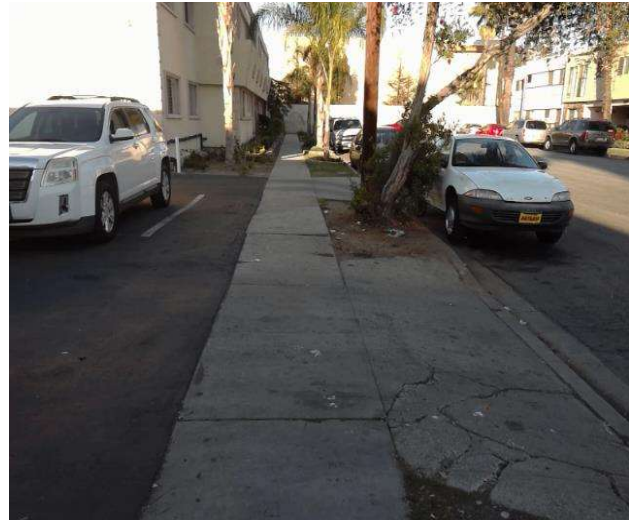
On-Site Finding Not Found

Install compliant detectable warnings \$190

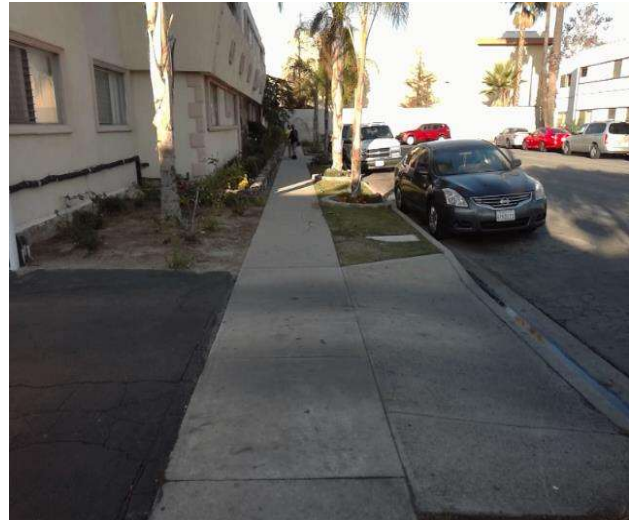
On-Site Finding Not Found

Install compliant detectable warnings \$190
