Accessibility Survey

City of Downey Gainford Street - Brookshire Avenue to Bellder Drive

Date of Inspection
7/13/2017

Disability Access Consultants

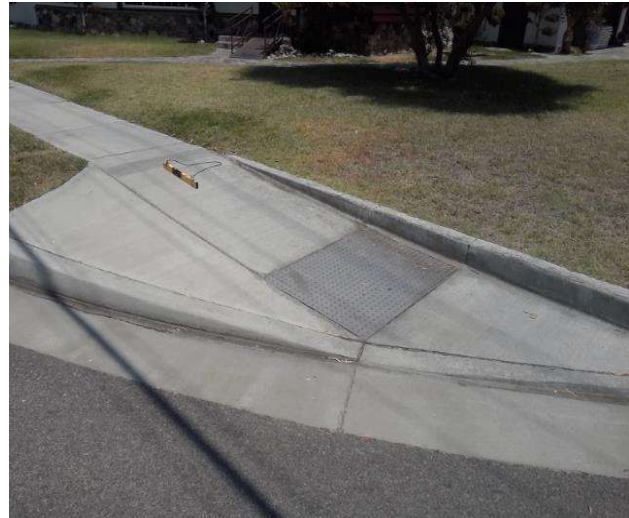
Northeast Corner of Brookshire Avenue @ 33.952376823157, - 118.119828701019

Curb Ramp : Curb Ramp Slope

The running slope is greater than allowed.

On-Site Finding 10.00 percent

Code Reference ADA 406, 406.1, 405.2, CA 11B-406

Provide a compliant curb ramp.

Recommendation Up to 8.33 percent

Install curb ramp \$1,300

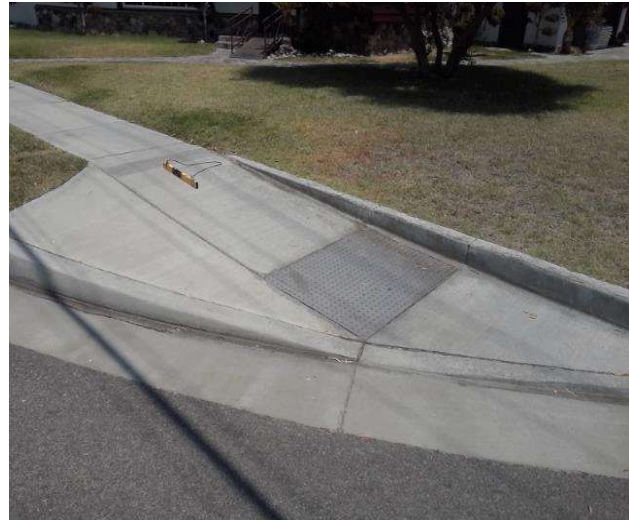
Northeast Corner of Brookshire Avenue @ 33.952376823157, - 118.119828701019

Curb Ramp : Curb Ramp - Cross Slope

The cross slope is greater than allowed.

On-Site Finding 2.50 percent

Code Reference ADA 402, 406.1, 405.3, CA 11B-406.5.7

Provide a compliant curb ramp.

Recommendation Up to 2.08 percent

Install curb ramp \$1,300

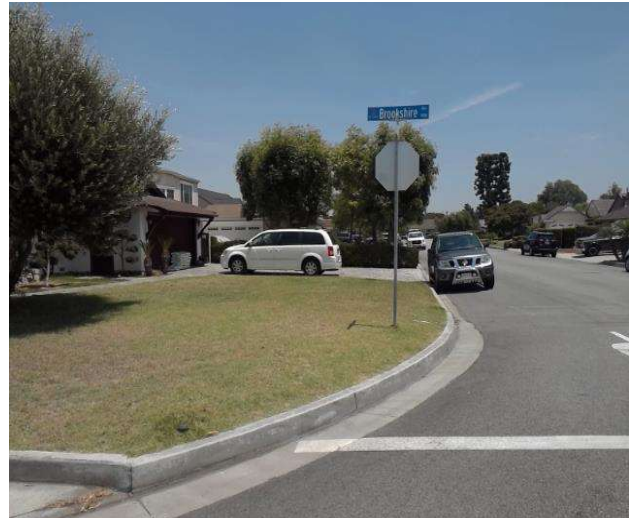
North Side @ 33.952352349276, -118.119824677706

Sidewalks : No Sidewalk

No sidewalk exists at the location.

No action necessary until a sidewalk is provided.

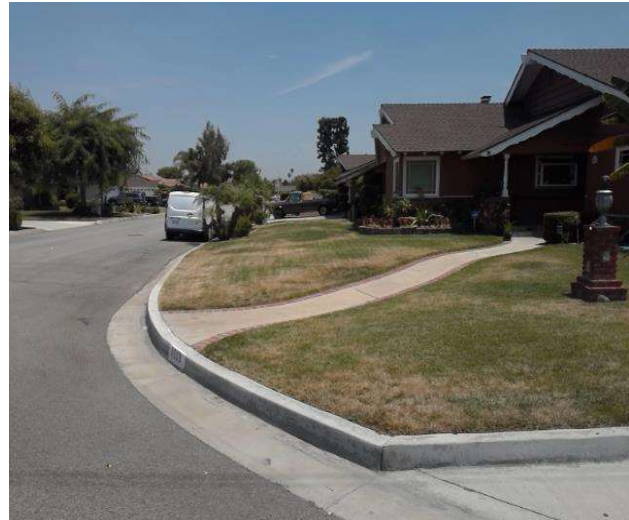
South Side @ 33.952207730745, -118.119945377111

Sidewalks : No Sidewalk

No sidewalk exists at the location.

No action necessary until a sidewalk is provided.

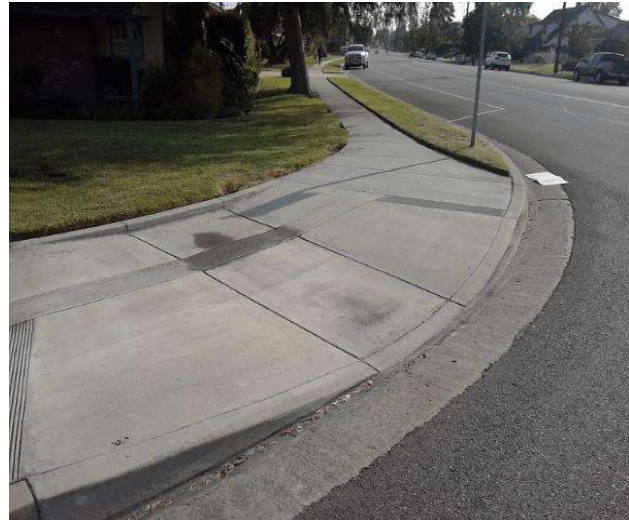
Northwest Corner of Brookshire Avenue @ 33.952449132310, - 118.120080828667

Curb Ramp : No Detectable Warnings

The curb ramp does not provide a detectable warning surface which includes truncated domes.

Code Reference CA 11B-406.5.12

Provide compliant detectable warnings to surface.

Provide detectable warning to surface \$248

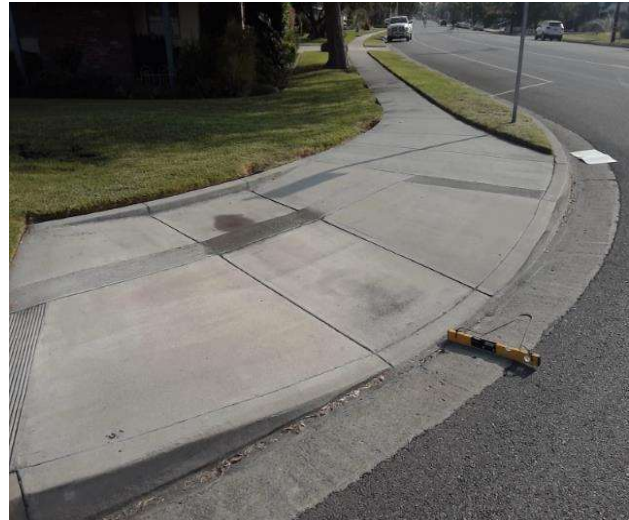
Northwest Corner of Brookshire Avenue @ 33.952449132310, - 118.120080828667

Curb Ramp : Bottom Landing Slope

The bottom landing of the curb ramp is on the street, and the slope of the bottom landing is not compliant.

On-Site Finding 13.20 percent

Code Reference ADA 406, 406.2, CA 11B-406.5.8

Ensure the bottom landing slope is compliant and provides a smooth transition.

Recommendation Up to 5.00 percent

Repave landing \$1,260

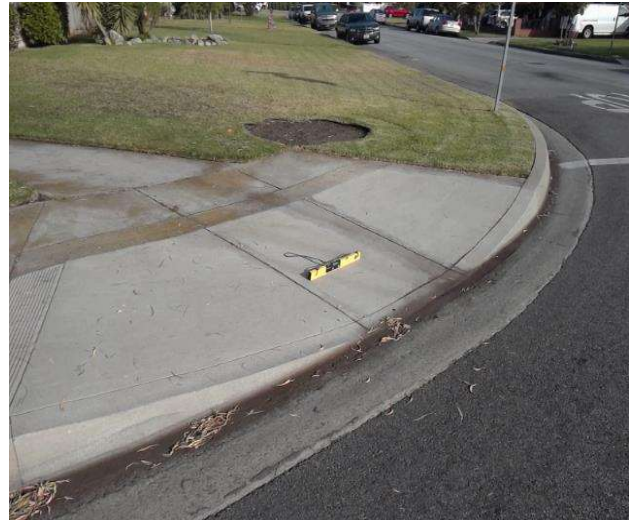
**Southwest Corner of Brookshire Avenue @ 33.952364143, -
118.120188117027**

Curb Ramp : No Detectable Warnings

The curb ramp does not provide a detectable warning surface which includes truncated domes.

Code Reference CA 11B-406.5.12

Provide compliant detectable warnings to surface.

Provide detectable warning to surface \$248

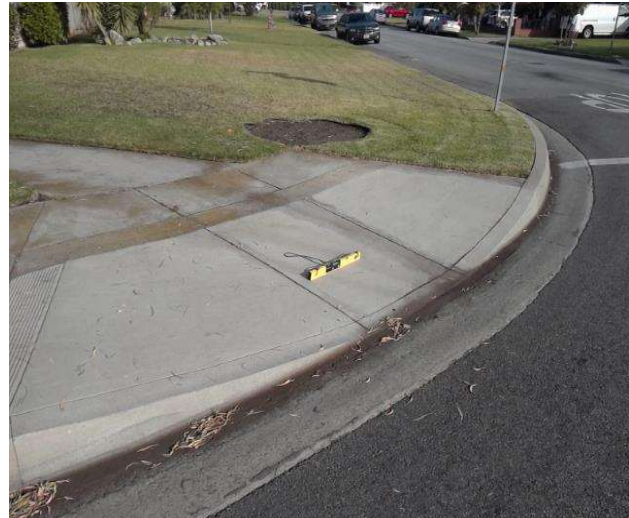
Southwest Corner of Brookshire Avenue @ 33.952364143, - 118.120188117027

Curb Ramp : Curb Ramp - Cross Slope

The cross slope is greater than allowed.

On-Site Finding 3.10 percent

Code Reference ADA 402, 406.1, 405.3, CA 11B-406.5.7

Provide a compliant curb ramp.

Recommendation Up to 2.08 percent

Install curb ramp \$1,300

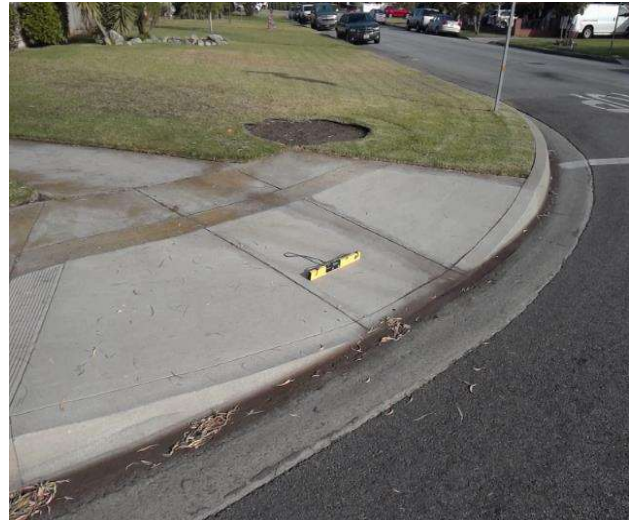
Southwest Corner of Brookshire Avenue @ 33.952364143, - 118.120188117027

Curb Ramp : Side Flare Slope

The slope of the curb ramp side flare is greater than allowed.

On-Site Finding 12.10 percent

Code Reference ADA 406, 406.3,CA 11B-406.2.2

Provide curb ramp side flares with a compliant slope.

Recommendation Up to 10.00 percent

Install flared sides \$1,300

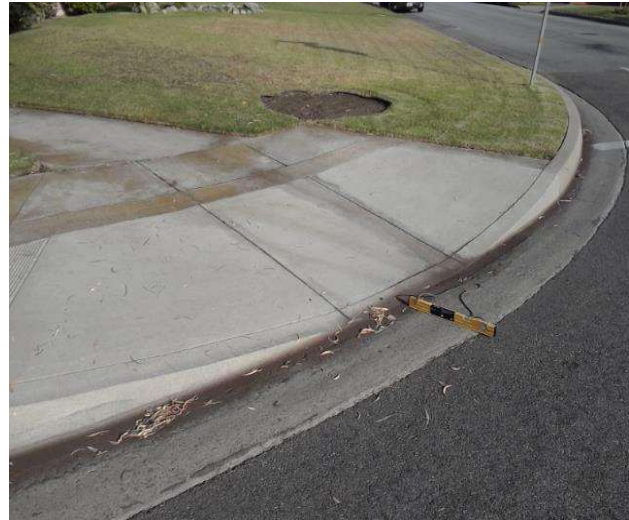
Southwest Corner of Brookshire Avenue @ 33.952364143, - 118.120188117027

Curb Ramp : Bottom Landing Slope

The bottom landing of the curb ramp is on the street, and the slope of the bottom landing is not compliant.

On-Site Finding 11.50 percent

Code Reference ADA 406, 406.2, CA 11B-406.5.8

Ensure the bottom landing slope is compliant and provides a smooth transition.

Recommendation Up to 5.00 percent

Repave landing \$1,260

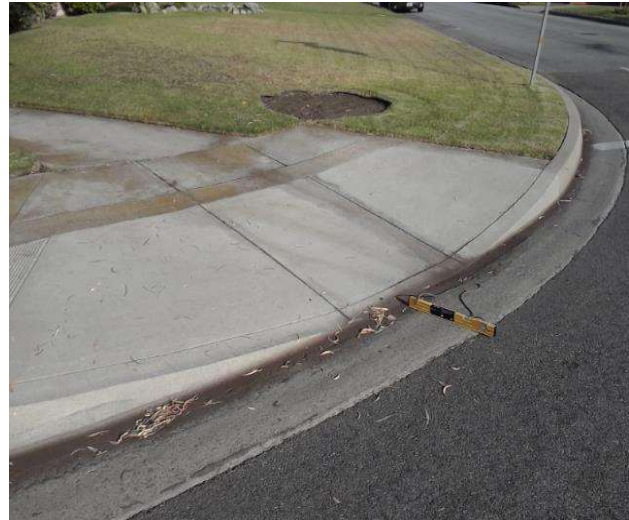
Southwest Corner of Brookshire Avenue @ 33.952364143, - 118.120188117027

Curb Ramp , Landings and Transitions : Top Landing Slope

The slope at the top landing is greater than allowed.

On-Site Finding 5.00 percent

Code Reference ADA 402, 406.4, 403.3, 406.1, CA 11B-406.5.3

Provide a top landing surface that does not exceed the maximum slope and cross slope. Provide a sufficient maneuvering clearance that does not accumulate water.

Recommendation Up to 2.08 percent

Provide compliant landing \$1,260

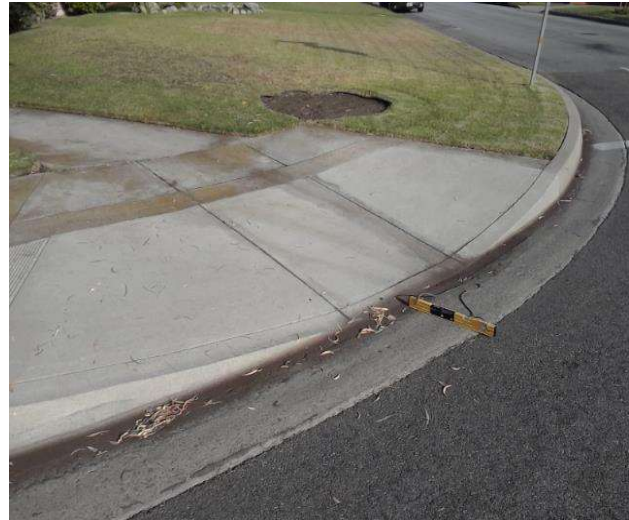
**Southwest Corner of Brookshire Avenue @ 33.952364143, -
118.120188117027**

Curb Ramp , Landings and Transitions : Top Landing Clear Length - Landings

There is not enough top landing clear length.

On-Site Finding 47.00 inches

Code Reference ADA 406, 406.4,CA 11B-406.5.3

Provide a level top landing with enough clear length.

Recommendation At least 48.00 inches

Provide compliant landing \$240

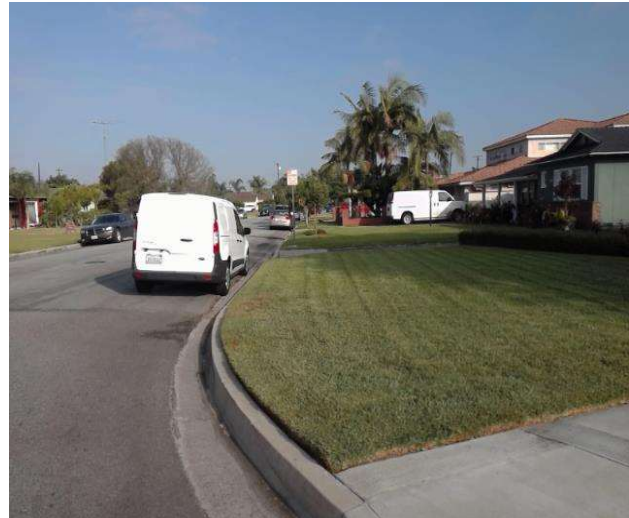
North Side @ 33.952438007829, -118.120121061802

Sidewalks : No Sidewalk

No sidewalk exists at the location.

No action necessary until a sidewalk is provided.

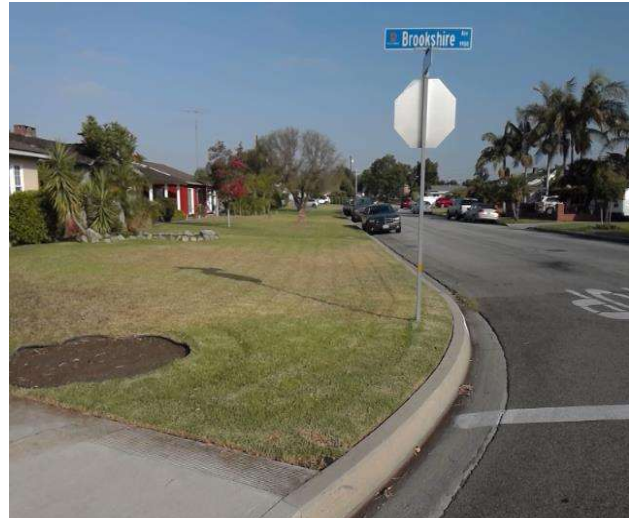
South Side @ 33.952317863341, -118.120198845863

Sidewalks : No Sidewalk

No sidewalk exists at the location.

No action necessary until a sidewalk is provided.

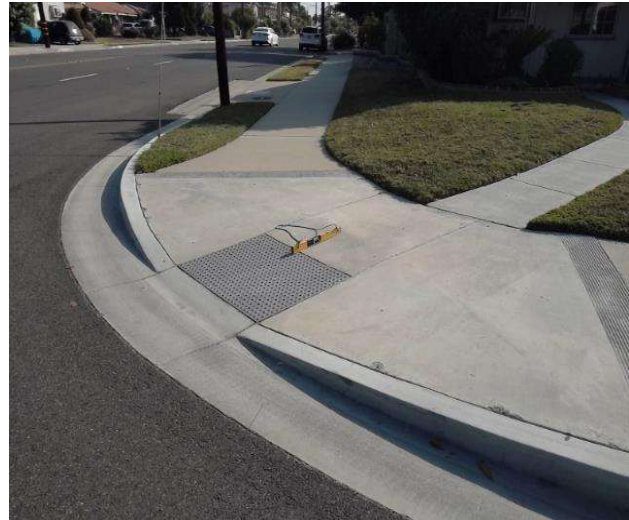
Northeast Corner of Downey Avenue @ 33.954277977216, - 118.123530149460

Curb Ramp : Curb Ramp Slope

The running slope is greater than allowed.

On-Site Finding 8.70 percent

Code Reference ADA 406, 406.1, 405.2, CA 11B-406

Provide a compliant curb ramp.

Recommendation Up to 8.33 percent

Install curb ramp \$1,300

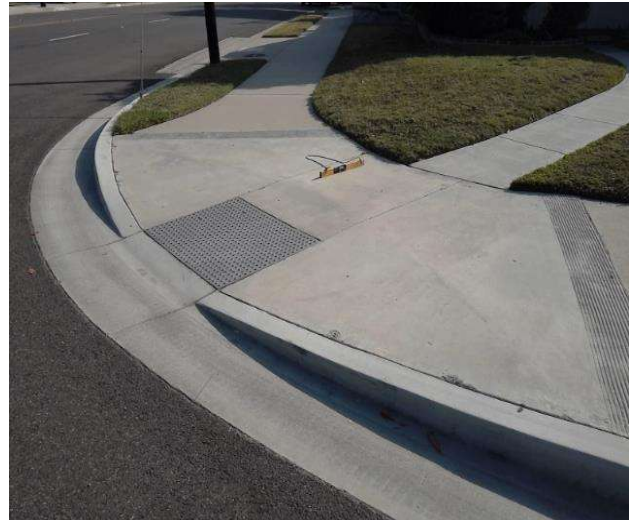
Northeast Corner of Downey Avenue @ 33.954277977216, - 118.123530149460

Curb Ramp , Landings and Transitions : Top Landing Slope

The slope at the top landing is greater than allowed.

On-Site Finding 3.70 percent

Code Reference ADA 402, 406.4, 403.3, 406.1, CA 11B-406.5.3

Provide a top landing surface that does not exceed the maximum slope and cross slope. Provide a sufficient maneuvering clearance that does not accumulate water.

Recommendation Up to 2.08 percent

Provide compliant landing \$1,260

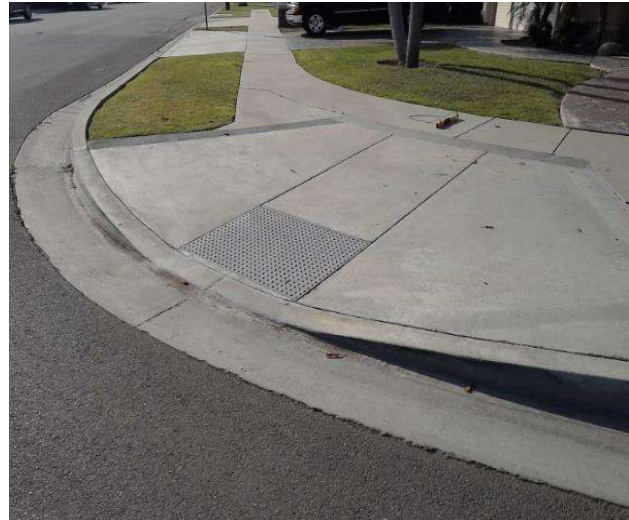
Southeast Corner of Downey Avenue @ 33.954150048346, - 118.123642802238

Curb Ramp , Landings and Transitions : Top Landing Slope

The slope at the top landing is greater than allowed.

On-Site Finding 3.00 percent

Code Reference ADA 402, 406.4, 403.3, 406.1, CA 11B-406.5.3

Provide a top landing surface that does not exceed the maximum slope and cross slope. Provide a sufficient maneuvering clearance that does not accumulate water.

Recommendation Up to 2.08 percent

Provide compliant landing \$1,260

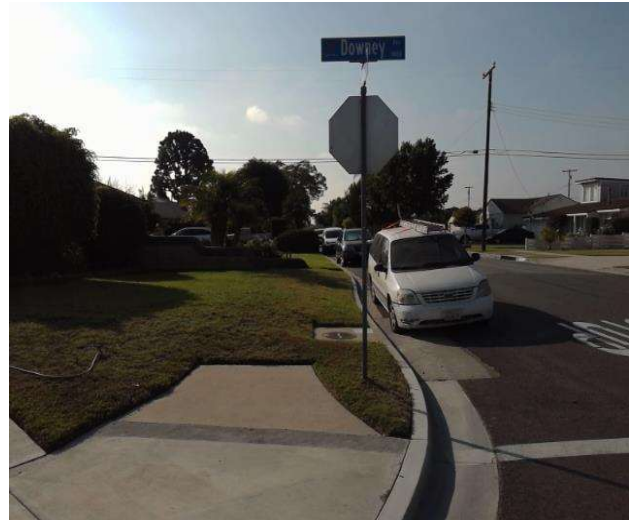
North Side @ 33.954246829335, -118.123485893011

Sidewalks : No Sidewalk

No sidewalk exists at the location.

No action necessary until a sidewalk is provided.

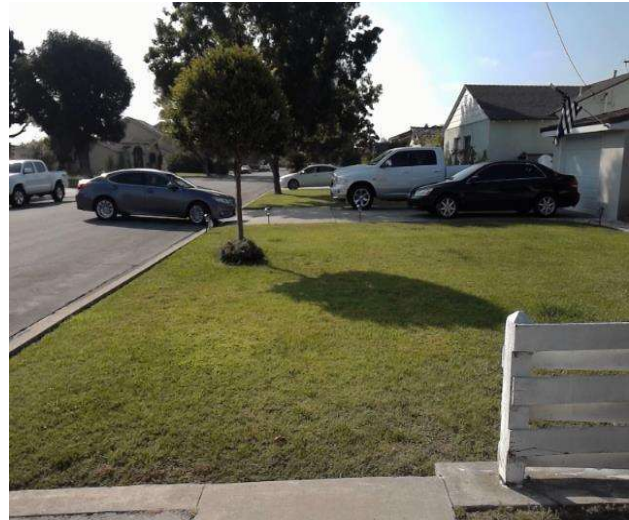
Sidewalk East of Downey Avenue @ 33.953982071886, -118.123314231634

Sidewalks : Missing Sidewalk

Section of sidewalk is missing and consists of dirt, grass or gravel.

On-Site Finding 570.00 feet

Code Reference ADA 206, 302,CA 11B-302,CA 11B-206

Provide a compliant sidewalk for the missing section.

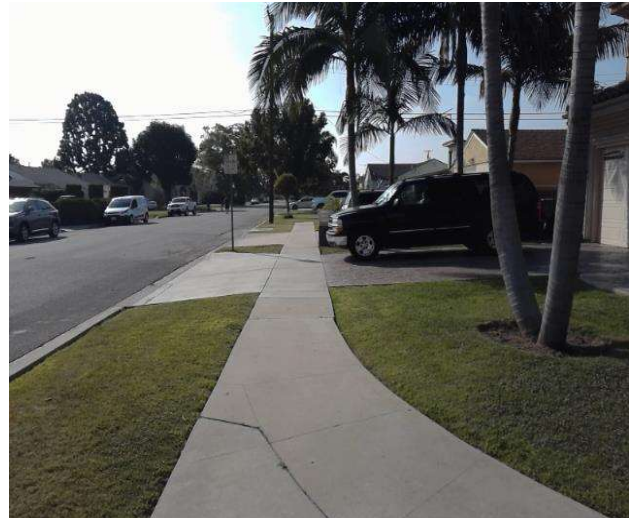
South Side @ 33.954150048346, -118.123642802238

Sidewalks : 60X60 Turn Area

There is no 60X60 turn area at every 200 feet.

Code Reference ADA 206, 302

Provide a 60X60 turn every 200 feet on the sidewalk.

\$2,400

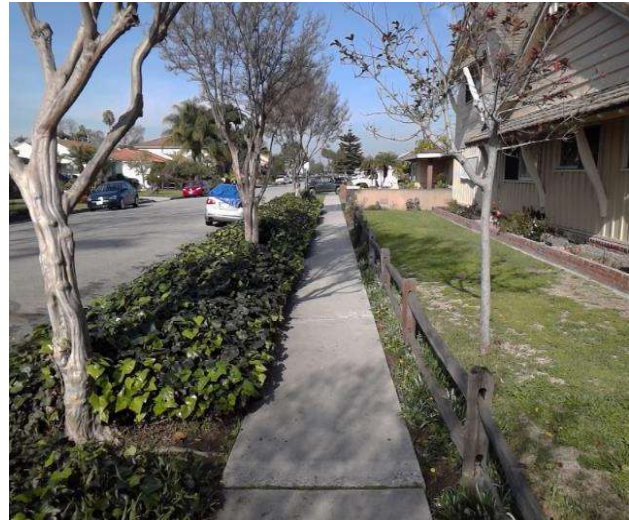
Bush West Of Tweedy Lane @ 33.957337088555, -118.129806518555

Sidewalks , Hazards & Gratings : Sidewalk Width at Obstruction

Sidewalk width at the obstruction is not compliant.

On-Site Finding 39.00 inches

Code Reference ADA 206, 302, 403.5.1, CA 11B-403.5

Sidewalk width at the obstruction shall have the recommended value.

Recommendation At least 48.00 inches

\$1,260

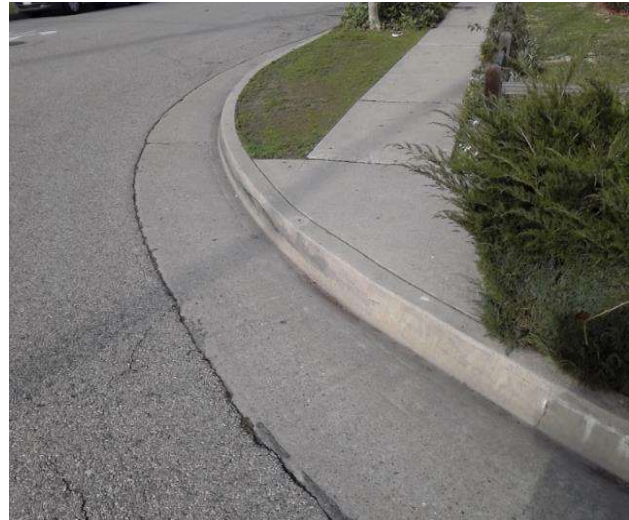
Northwest Corner Of Tweedy Lane @ 33.957265895941, -118.129672408104

Sidewalks , Hazards & Gratings : Curb is on Path of Travel

There is a curb on the designated path of travel.

Code Reference ADA 402, 303, 406, 403.4, 303.4

Provide a compliant curb ramp.

Install curb ramp \$2,500

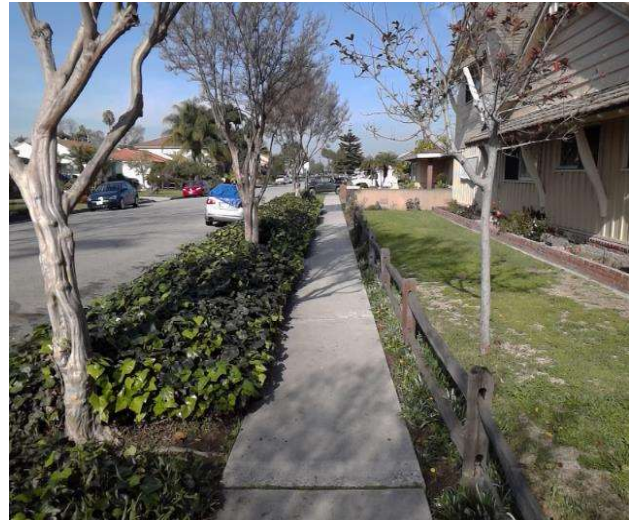
Code Reference ADA 206, 302,CA 11B-403.3

Repave the sidewalk surface with the recommended cross slope.

Recommendation Up to 2.08 percent

Repave surface \$1,092

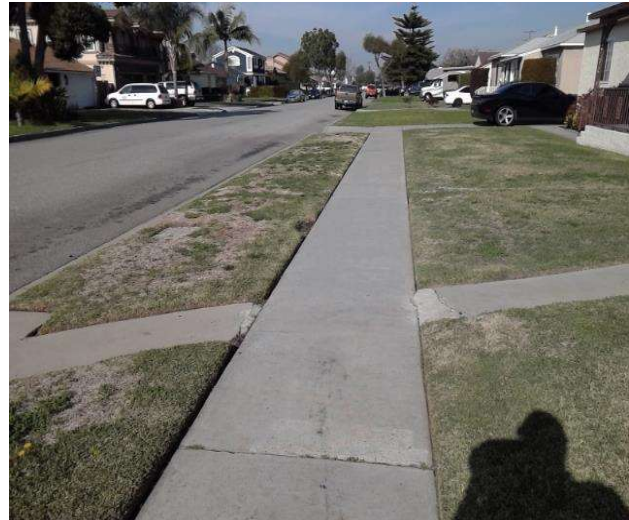
Code Reference ADA 206, 302, CA 11B-403.3

Repave the sidewalk surface with the recommended cross slope.

Recommendation Up to 2.08 percent

Repave surface \$1,092

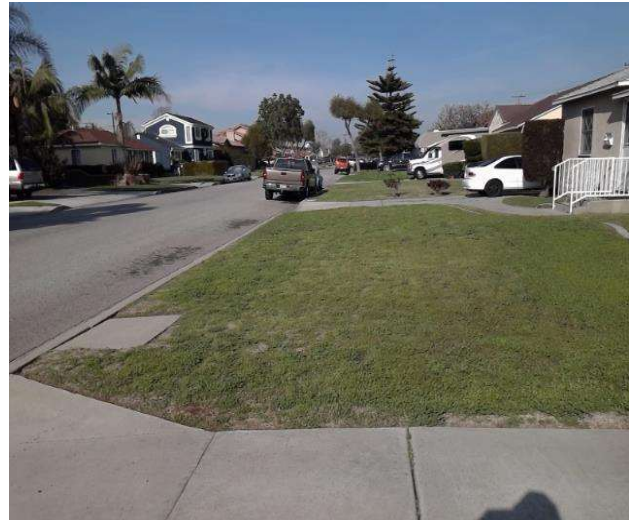
Sidewalks : Missing Sidewalk

Section of sidewalk is missing and consists of dirt, grass or gravel.

Code Reference ADA 206, 302,CA 11B-302,CA 11B-206

Provide a compliant sidewalk for the missing section.

\$1,260

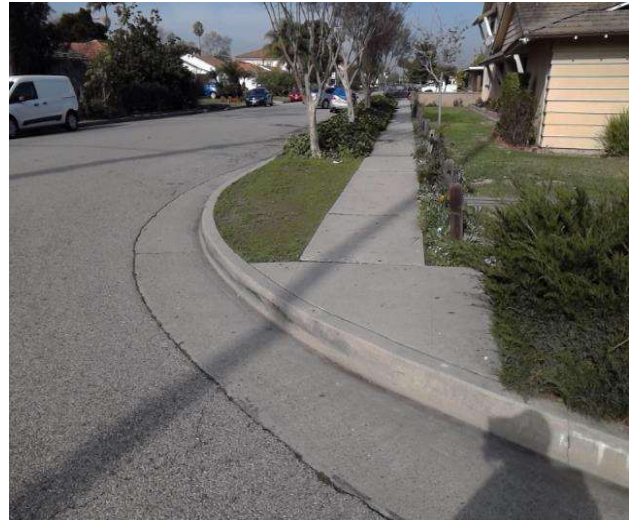
On-Site Finding Not Found

Code Reference ADA 206, 302

\$2,400

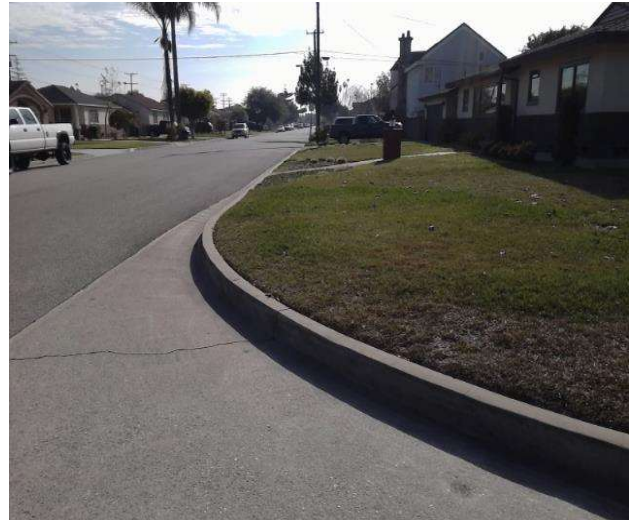
Sidewalks : Missing Sidewalk

Section of sidewalk is missing and consists of dirt, grass or gravel.

Code Reference ADA 206, 302,CA 11B-302,CA 11B-206

Provide a compliant sidewalk for the missing section.

\$1,260

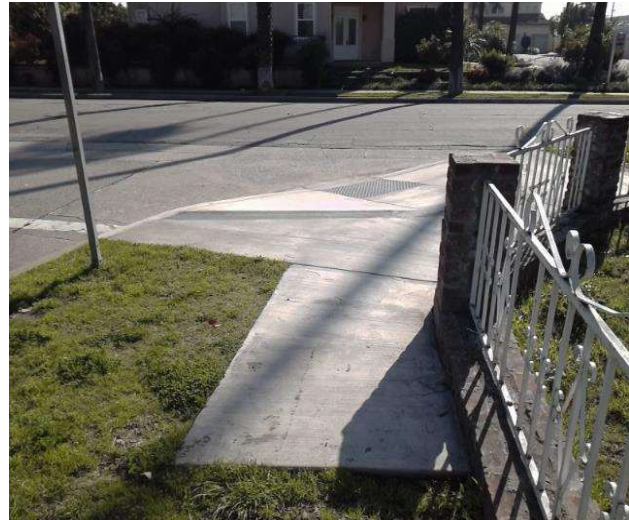
Code Reference ADA 206, 302,CA 11B-403.5.1

Widen the sidewalk to the recommended value.

Recommendation At least 48.00 inches

\$1,260

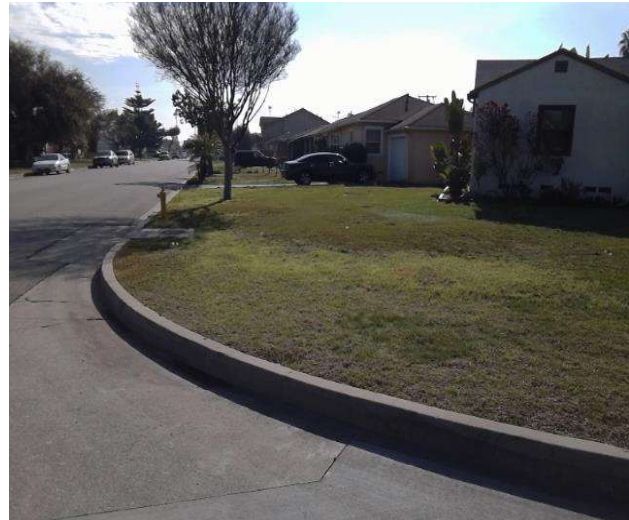
Sidewalks : Missing Sidewalk

Section of sidewalk is missing and consists of dirt, grass or gravel.

Code Reference ADA 206, 302,CA 11B-302,CA 11B-206

Provide a compliant sidewalk for the missing section.

\$1,260

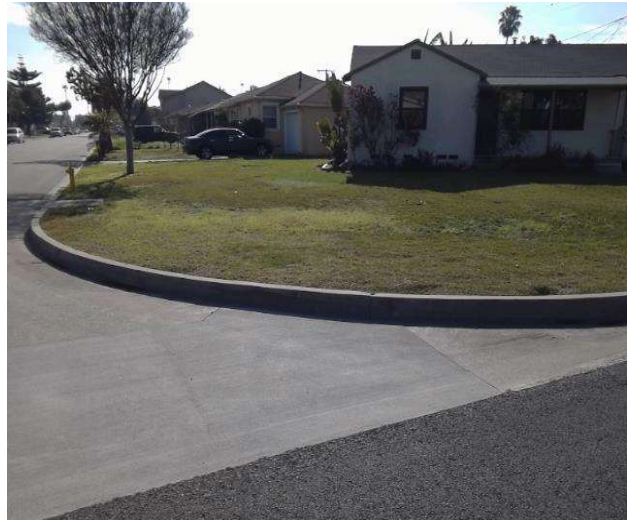
Sidewalks , Hazards & Gratings : Curb is on Path of Travel

Code Reference ADA 402, 303, 406, 403.4, 303.4

Install curb ramp \$2,500
