Accessibility Survey

City of Downey Lexington Road - Brookshire Avenue to Downey Avenue

Brookshire Avenue to Downey Avenue
Downey, CA 90242

Date of Inspection
7/14/2017

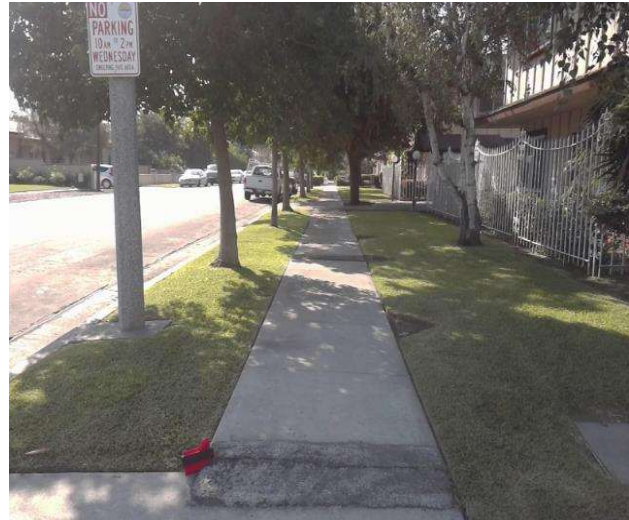
Change in Level West of Brookshire Avenue @ 33.950436690030, - 118.125940114260

Sidewalks , Change in Level : Change in Level Non Beveled

There is a change in elevation greater than recommended value.

On-Site Finding 1.50 inches

Notes : Surface is Rough And Uneven.

Ensure that the change in elevation is within the recommended value.

Recommendation Up to 0.25 inches

Remove tripping hazards \$198

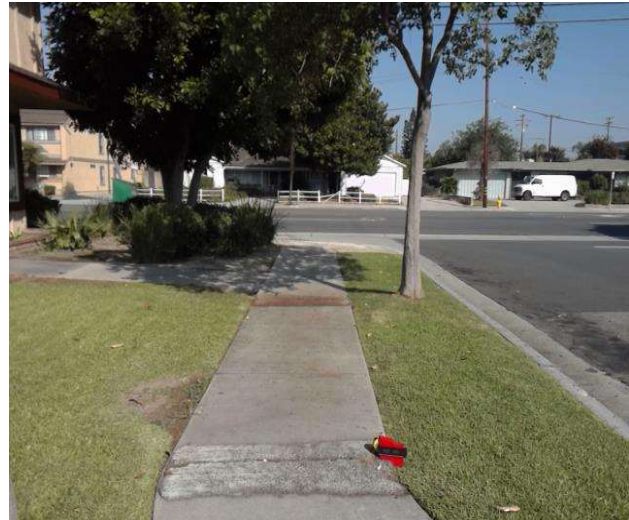
Change in Level West of Brookshire Avenue @ 33.950506775885, - 118.126078248024

Sidewalks , Change in Level : Change in Level Non Beveled

There is a change in elevation greater than recommended value.

On-Site Finding 1.50 inches

Notes : Surface is Rough And Uneven.

Ensure that the change in elevation is within the recommended value.

Recommendation Up to 0.25 inches

Remove tripping hazards \$198

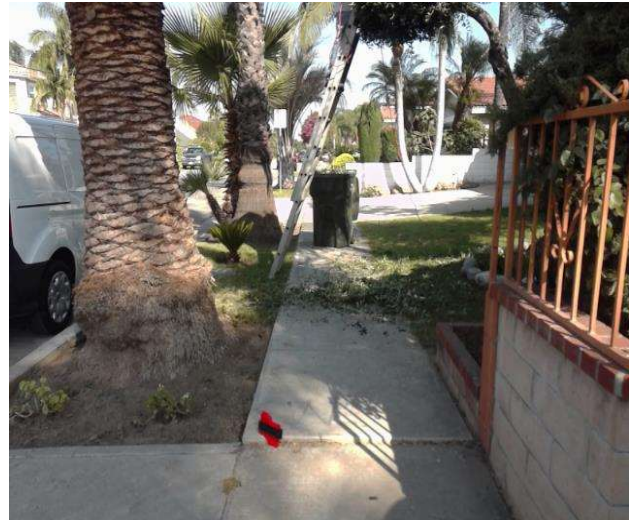
Change in Level East of Downey Avenue @ 33.949054985689, -118.122871667147

Sidewalks , Change in Level : Change in Level Non Beveled

There is a change in elevation greater than recommended value.

On-Site Finding 1.25 inches

Ensure that the change in elevation is within the recommended value.

Recommendation Up to 0.25 inches

Remove tripping hazards \$198

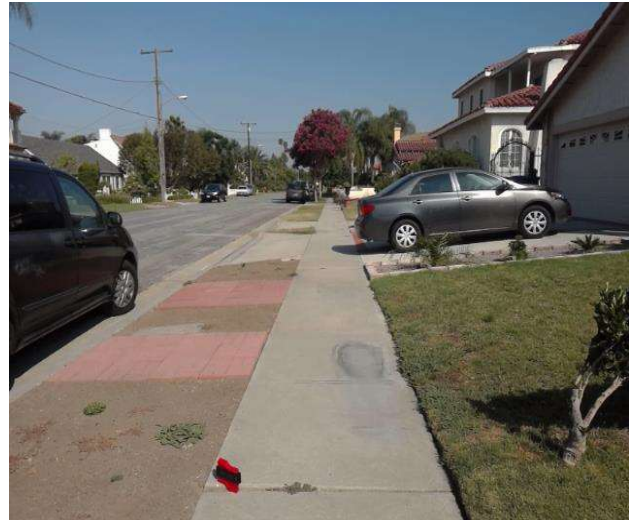
Change in Level East of Downey Avenue @ 33.949271921430, -118.123284727335

Sidewalks , Change in Level : Change in Level Non Beveled

There is a change in elevation greater than recommended value.

On-Site Finding 0.75 inches

Ensure that the change in elevation is within the recommended value.

Recommendation Up to 0.25 inches

Remove tripping hazards \$198

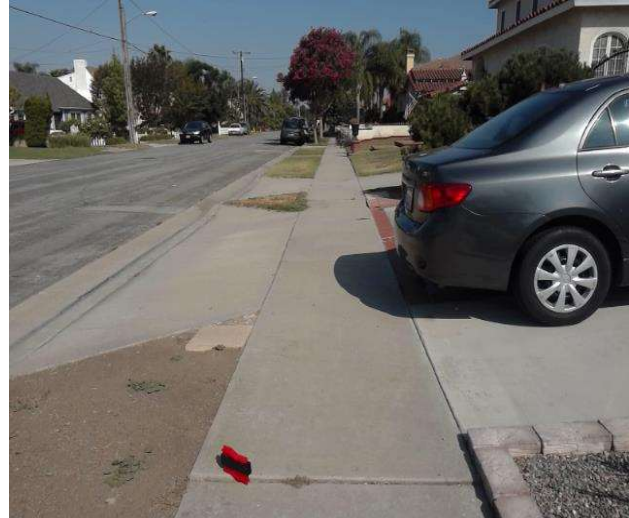
Change in Level East of Downey Avenue @ 33.949284158814, -118.123319596052

Sidewalks , Change in Level : Change in Level Non Beveled

There is a change in elevation greater than recommended value.

On-Site Finding 0.75 inches

Ensure that the change in elevation is within the recommended value.

Recommendation Up to 0.25 inches

Remove tripping hazards \$198

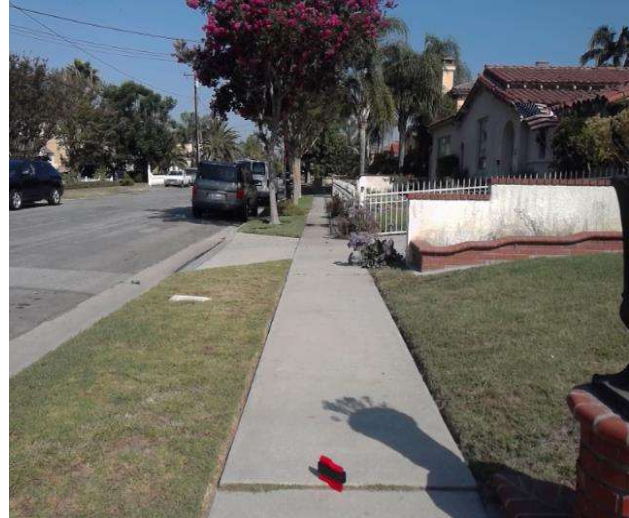
Change in Level East of Downey Avenue @ 33.949416544950, -118.123573064804

Sidewalks , Change in Level : Change in Level Non Beveled

There is a change in elevation greater than recommended value.

On-Site Finding 0.50 inches

Ensure that the change in elevation is within the recommended value.

Recommendation Up to 0.25 inches

Remove tripping hazards \$198

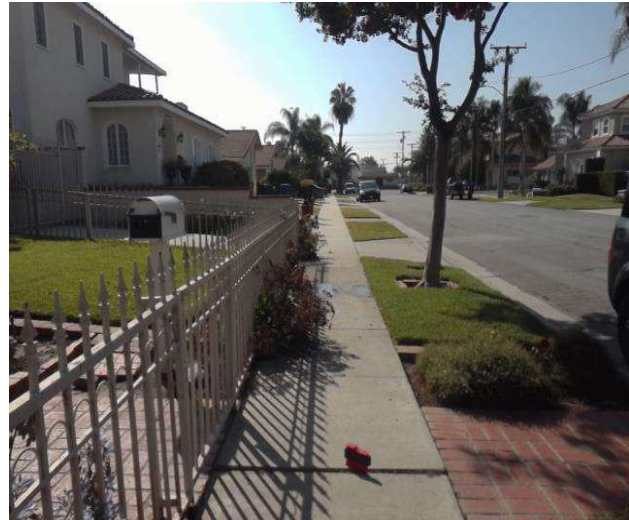
Change in Level East of Downey Avenue @ 33.949492194078, -118.123716562986

Sidewalks , Change in Level : Change in Level Non Beveled

There is a change in elevation greater than recommended value.

On-Site Finding 0.50 inches

Ensure that the change in elevation is within the recommended value.

Recommendation Up to 0.25 inches

Remove tripping hazards \$198

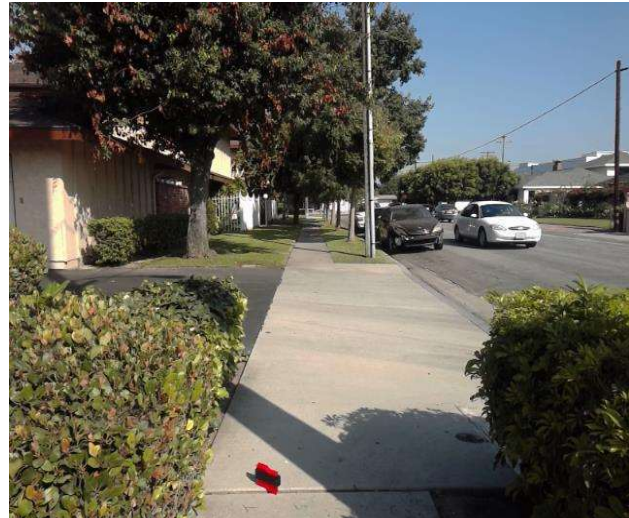
Change in Level West of Brookshire Avenue @ 33.950159683470, - 118.125414401293

Sidewalks , Change in Level : Change in Level Non Beveled

There is a change in elevation greater than recommended value.

On-Site Finding 0.50 inches

Ensure that the change in elevation is within the recommended value.

Recommendation Up to 0.25 inches

Remove tripping hazards \$198

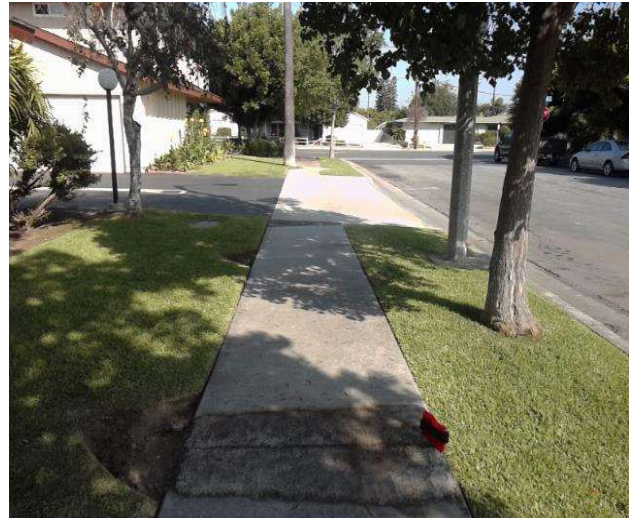
Change in Level West of Brookshire Avenue @ 33.950405540743, - 118.125881105661

Sidewalks , Change in Level : Change in Level Non Beveled

There is a change in elevation greater than recommended value.

On-Site Finding 1.00 inches

Notes : Surface is Rough And Uneven.

Ensure that the change in elevation is within the recommended value.

Recommendation Up to 0.25 inches

Remove tripping hazards \$198

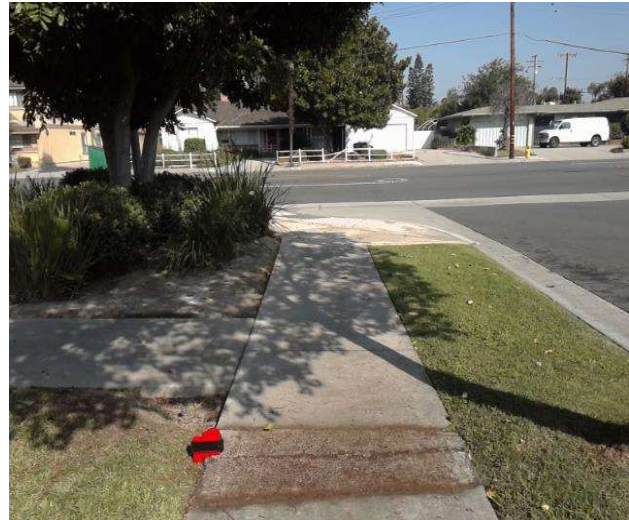
Change in Level West of Brookshire Avenue @ 33.950525687931, - 118.126118481159

Sidewalks , Change in Level : Change in Level Non Beveled

There is a change in elevation greater than recommended value.

On-Site Finding 1.25 inches

Notes : Surface is Rough And Uneven.

Ensure that the change in elevation is within the recommended value.

Recommendation Up to 0.25 inches

Remove tripping hazards \$198

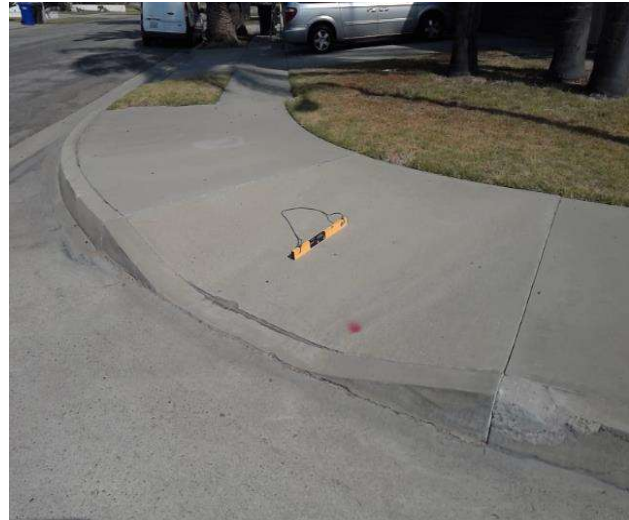
Northwest Corner of Brookshire Avenue @ 33.948979336172, - 118.122718781233

Curb Ramp : No Detectable Warnings

The curb ramp does not provide a detectable warning surface which includes truncated domes.

On-Site Finding Not Found

Provide compliant detectable warnings to surface.

Provide detectable warning to surface \$248

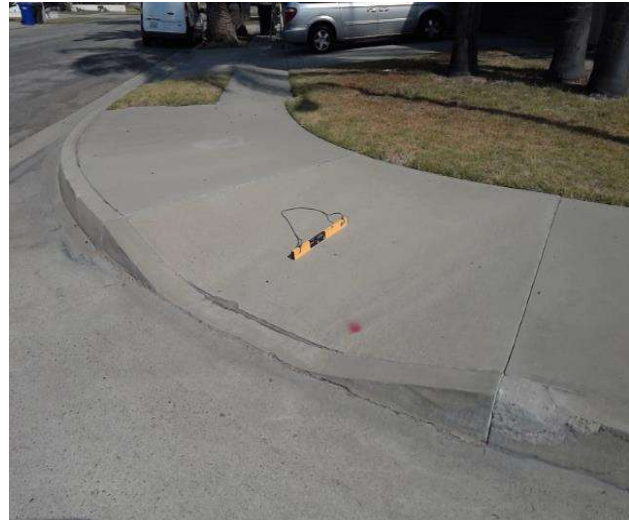
Northwest Corner of Brookshire Avenue @ 33.948979336172, - 118.122718781233

Curb Ramp : Curb Ramp Slope

The running slope is greater than allowed.

On-Site Finding 12.60 percent

Provide a compliant curb ramp.

Recommendation Up to 8.33 percent

Install curb ramp \$1,300

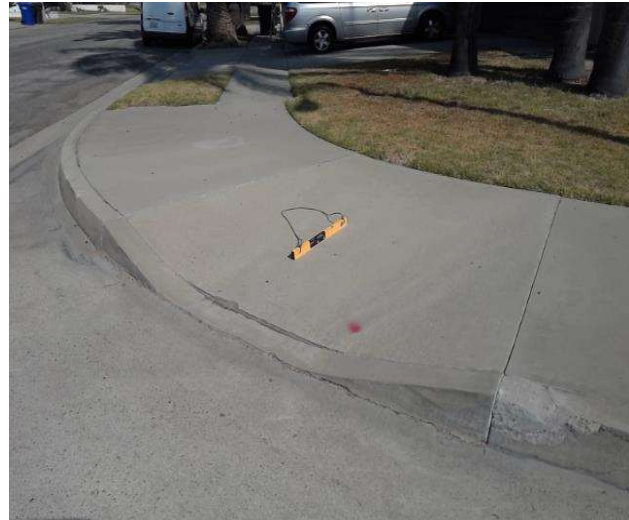
Northwest Corner of Brookshire Avenue @ 33.948979336172, - 118.122718781233

Curb Ramp : Side Flare Slope

The slope of the curb ramp side flare is greater than allowed.

On-Site Finding 19.30 percent

Provide curb ramp side flares with a compliant slope.

Recommendation Up to 10.00 percent

Install flared sides \$1,300

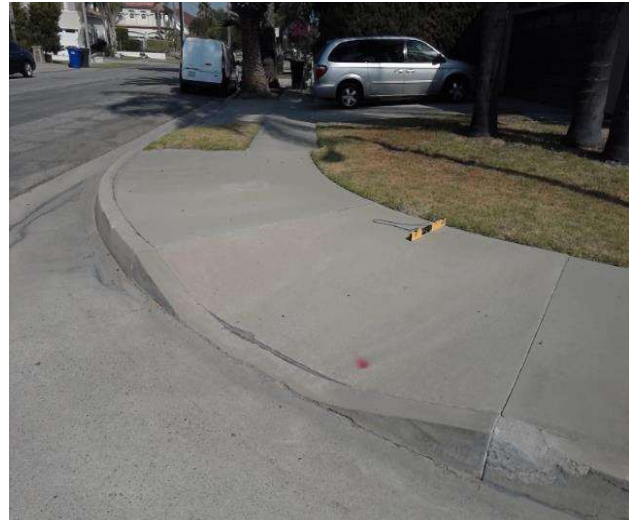
Northwest Corner of Brookshire Avenue @ 33.948979336172, - 118.122718781233

Curb Ramp , Landings and Transitions : Top Landing Slope

The slope at the top landing is greater than allowed.

On-Site Finding 3.90 percent

Provide a top landing surface that does not exceed the maximum slope and cross slope. Provide a sufficient maneuvering clearance that does not accumulate water.

Recommendation Up to 2.08 percent

Provide compliant landing \$1,260

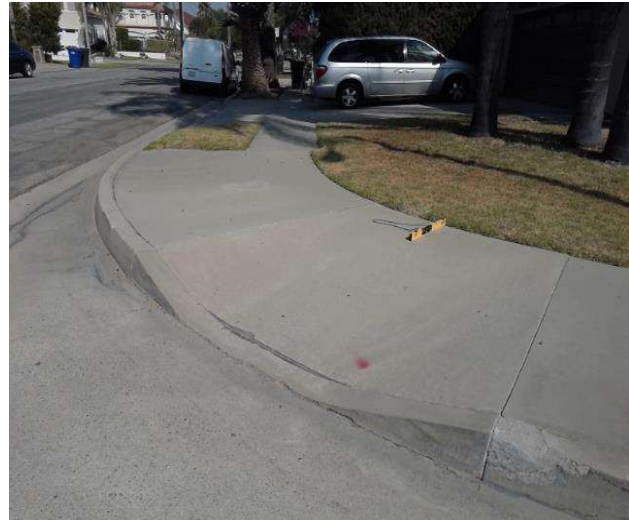
Northwest Corner of Brookshire Avenue @ 33.948979336172, - 118.122718781233

There is not enough top landing clear length.

On-Site Finding 24.00 inches

Curb Ramp , Landings and Transitions : Top Landing Clear Length - Landings

Provide a level top landing with enough clear length.

Recommendation At least 48.00 inches

Provide compliant landing \$240

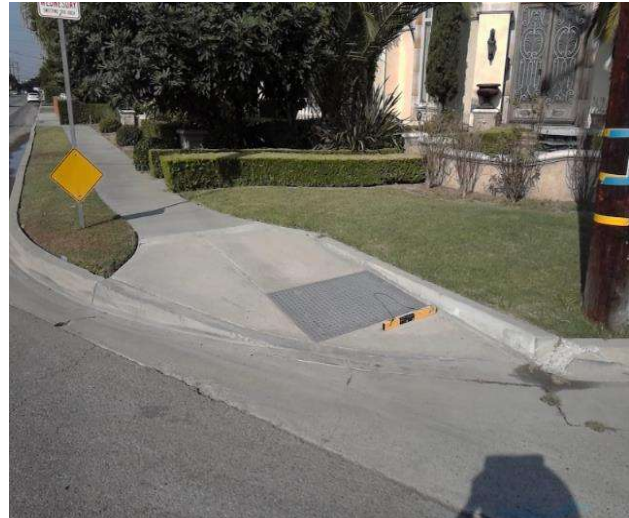
Southwest Corner of Brookshire Avenue @ 33.948832486918, - 118.122781813145

Curb Ramp : Curb Ramp - Cross Slope

The cross slope is greater than allowed.

On-Site Finding 3.80 percent

Provide a compliant curb ramp.

Recommendation Up to 2.08 percent

Install curb ramp \$1,300

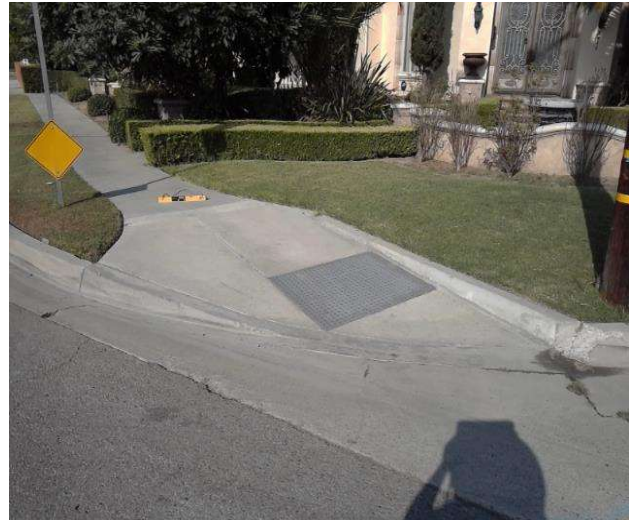
Southwest Corner of Brookshire Avenue @ 33.948832486918, - 118.122781813145

Curb Ramp , Landings and Transitions : Top Landing Slope

The slope at the top landing is greater than allowed.

On-Site Finding 2.70 percent

Provide a top landing surface that does not exceed the maximum slope and cross slope. Provide a sufficient maneuvering clearance that does not accumulate water.

Recommendation Up to 2.08 percent

Provide compliant landing \$1,260

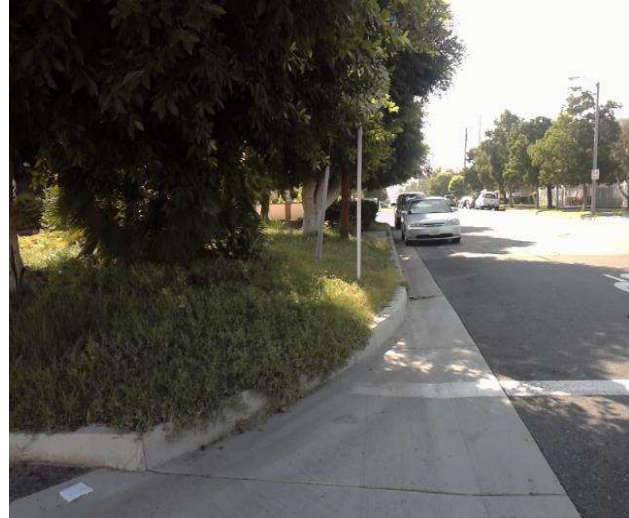
Sidewalk East of Downey Avenue @ 33.950712583219, -118.126123845577

Sidewalks : Missing Sidewalk

Section of sidewalk is missing and consists of dirt, grass or gravel.

On-Site Finding 790.00 feet

Provide a compliant sidewalk for the missing section.

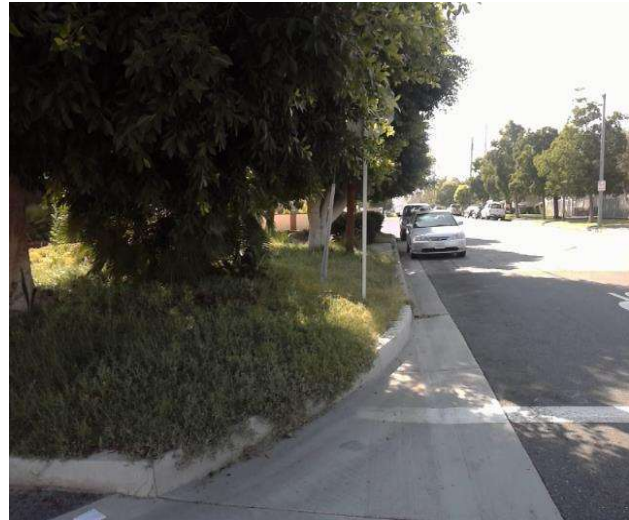
North Side @ 33.950712583219, -118.126123845577

Sidewalks : 60X60 Turn Area

There is no 60X60 turn area at every 200 feet.

On-Site Finding Not Found

Provide a 60X60 turn every 200 feet on the sidewalk.

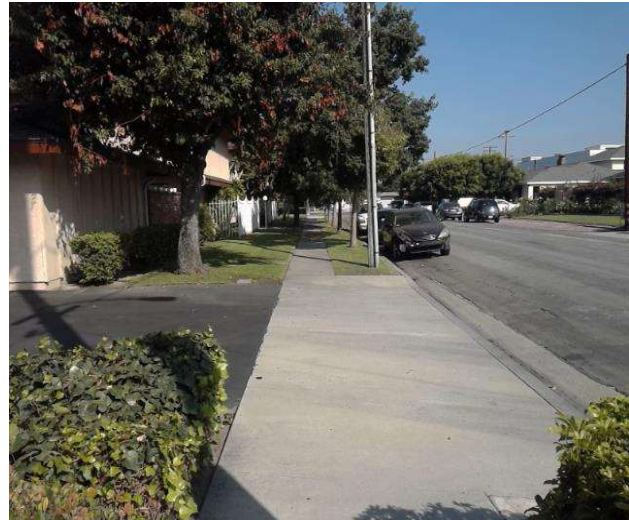
Driveway West of Brookshire Avenue @ 33.950191945324, -118.125461339951

Sidewalks , Vehicular Traffic : Cross Walks and Detectable Warnings

There are no detectable warnings where the pedestrian route crosses vehicular traffic.

On-Site Finding Not Found

Provide detectable warnings.

Install compliant detectable warnings \$190

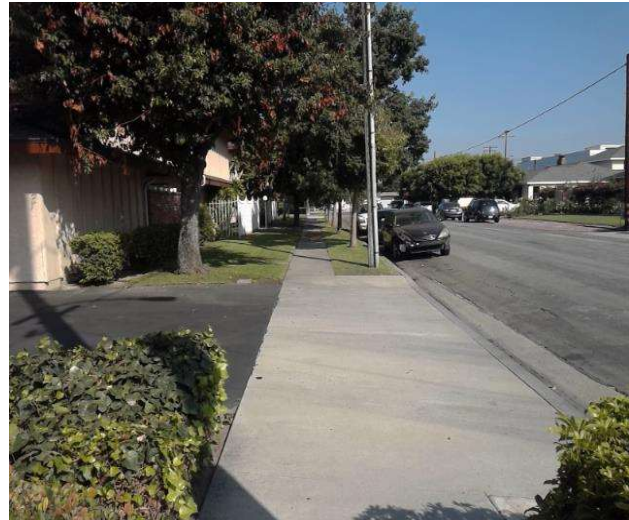
Driveway West of Brookshire Avenue @ 33.950191945324, -118.125461339951

Sidewalks : Vehicular Traffic Cross Slope

Cross slope at vehicular traffic is not compliant.

On-Site Finding 7.00 percent

Repave the surface to provide a compliant cross slope.

Recommendation Up to 2.08 percent

Repave surface \$1,092

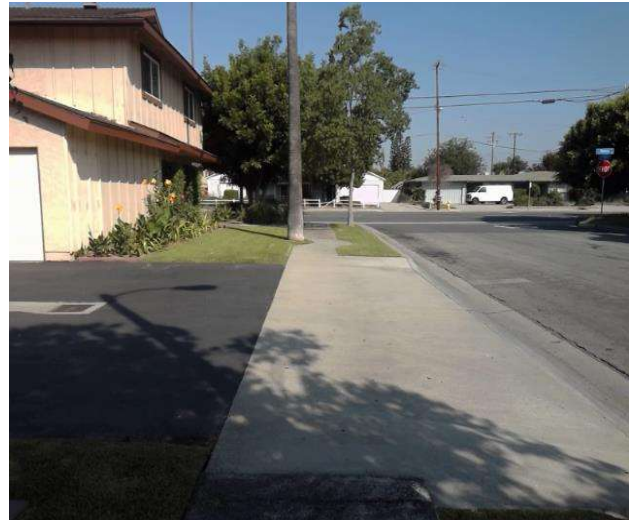
Driveway West of Brookshire Avenue @ 33.950461164462, -118.125999122858

Sidewalks , Vehicular Traffic : Cross Walks and Detectable Warnings

There are no detectable warnings where the pedestrian route crosses vehicular traffic.

On-Site Finding Not Found

Provide detectable warnings.

Install compliant detectable warnings \$190

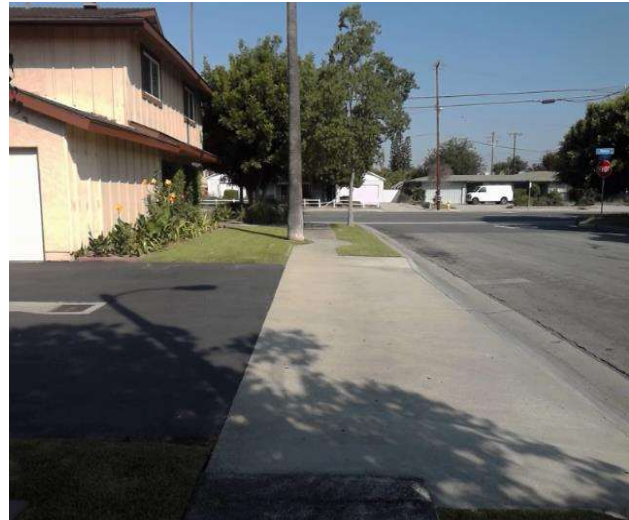
Driveway West of Brookshire Avenue @ 33.950461164462, -118.125999122858

Sidewalks : Vehicular Traffic Cross Slope

Cross slope at vehicular traffic is not compliant.

On-Site Finding 7.00 percent

Repave the surface to provide a compliant cross slope.

Recommendation Up to 2.08 percent

Repave surface \$1,092

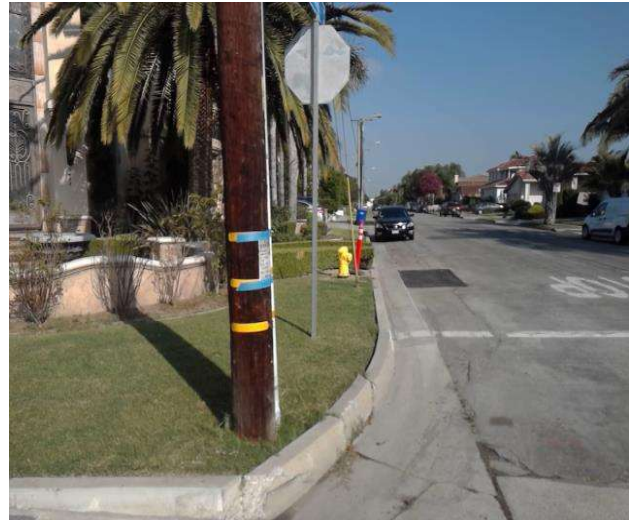
Sidewalks : Missing Sidewalk

Section of sidewalk is missing and consists of dirt, grass or gravel.

Provide a compliant sidewalk for the missing section.

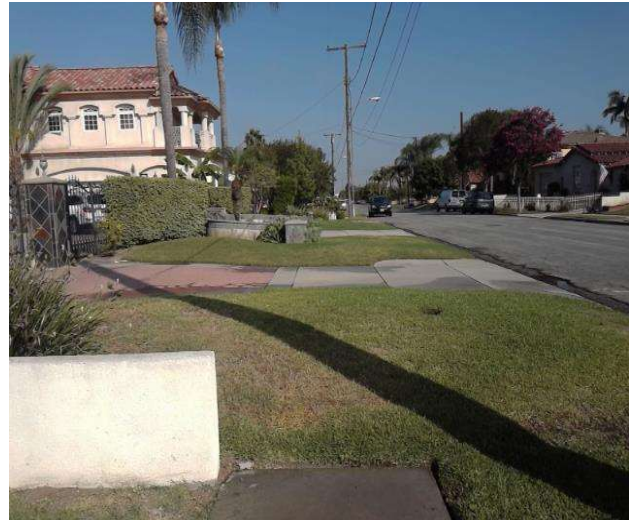
Sidewalks : Missing Sidewalk

Section of sidewalk is missing and consists of dirt, grass or gravel.

Provide a compliant sidewalk for the missing section.

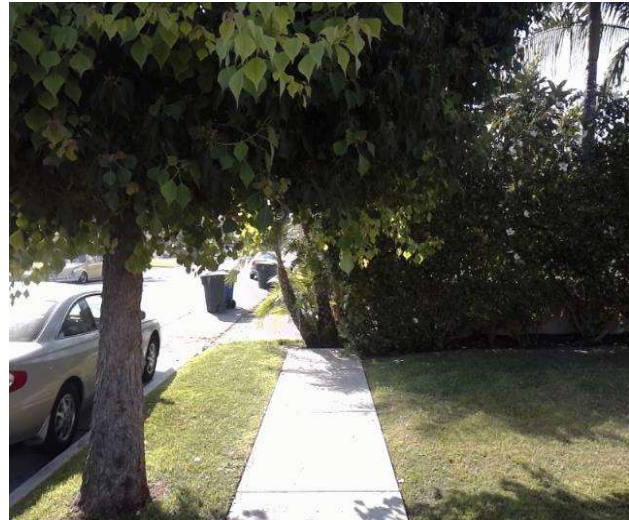
Sidewalks , Hazards & Gratings : Overhead Obstruction Height

Recommendation At least 80.00 inches

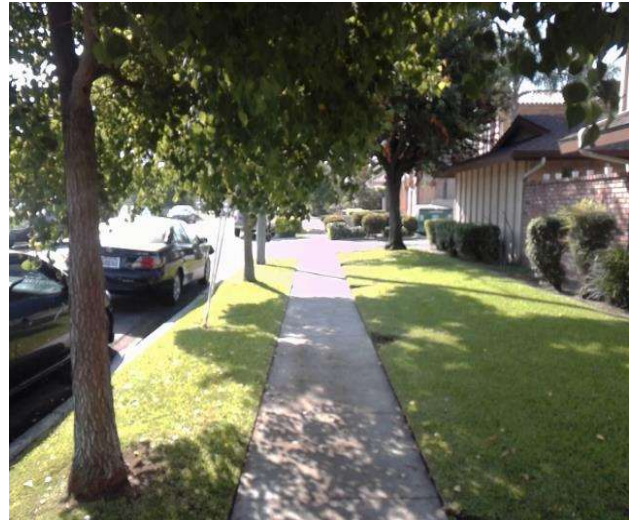
Sidewalks , Hazards & Gratings : Overhead Obstruction Height

Recommendation At least 80.00 inches
