Accessibility Survey

City of Downey Corey Street - Pomeroy Road To Cul-de-sac

Date of Inspection
4/17/2017

Prepared By
Disability Access Consultants
(800) 743-7067

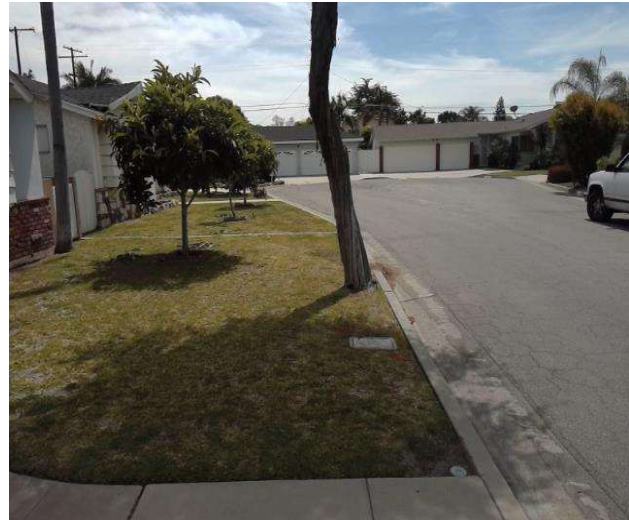
Sidewalk East Of Pomeroy Road @ 33.935063131417, -118.155853450298

Section of sidewalk is missing and consists of dirt, grass or gravel.

On-Site Finding 147.00 feet

Provide a compliant sidewalk for the missing section.

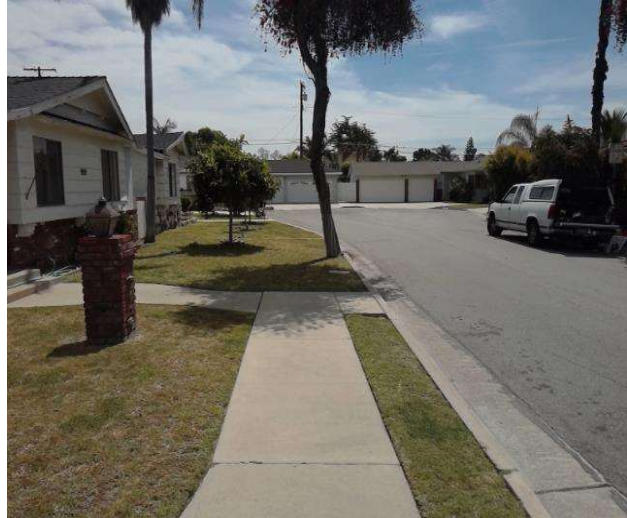
Sidewalk East Of Pomeroy Road @ 33.935110976439, -118.155931234360

Sidewalk cross slope is not compliant.

On-Site Finding 3.80 percent for 28.00 feet

Repave the sidewalk surface with the recommended cross slope.

Recommendation Up to 2.08 percent

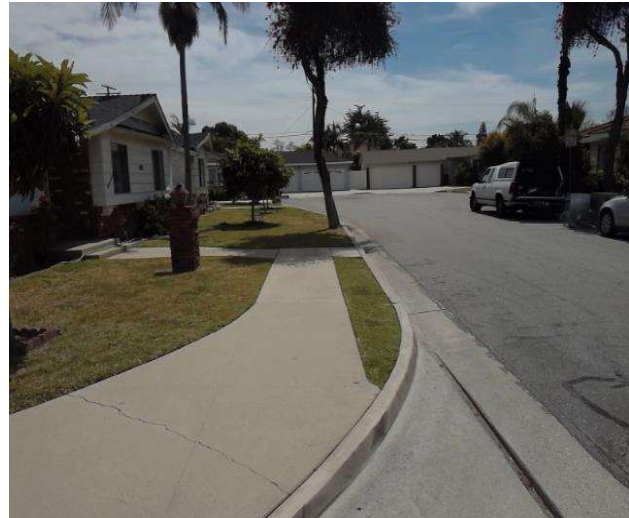
North Side @ 33.935110976439, -118.155931234360

There is no 60X60 turn area at every 200 feet.

On-Site Finding Not Found

Provide a 60X60 turn every 200 feet on the sidewalk.

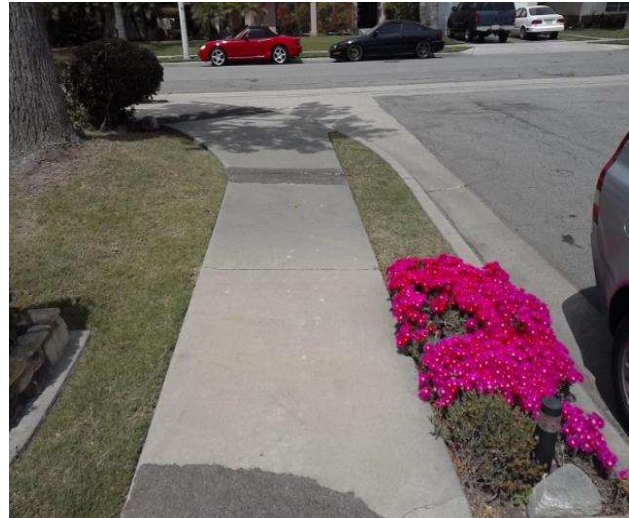
Sidewalk West Of Cul-de-sac @ 33.934976342702, -118.155908435583

Sidewalk cross slope is not compliant.

On-Site Finding 6.80 percent for 34.00 feet

Repave the sidewalk surface with the recommended cross slope.

Recommendation Up to 2.08 percent

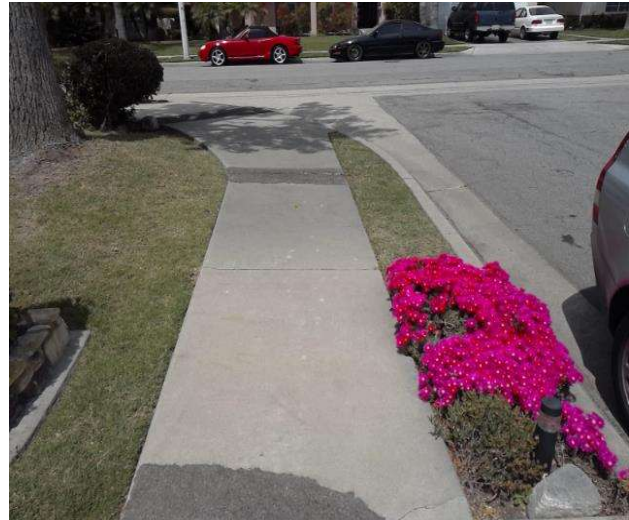
Sidewalk West Of Cul-de-sac @ 33.934976342702, -118.155908435583

Sidewalk running slope is not compliant.

On-Site Finding 13.80 percent for 4.00 feet

Repave the sidewalk surface with the recommended running slope.

Recommendation Up to 5.00 percent

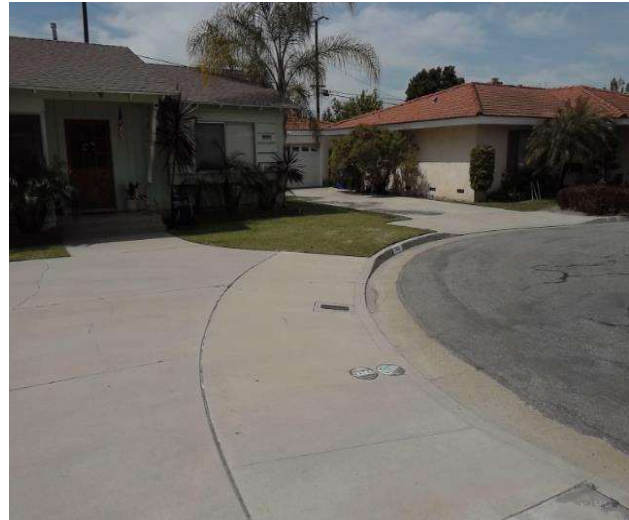
Sidewalk West Of Pomeroy Road To Cul-de-sac @ 33.934829469291, - 118.155504763126

Section of sidewalk is missing and consists of dirt, grass or gravel.

On-Site Finding 152.00 feet

Provide a compliant sidewalk for the missing section.

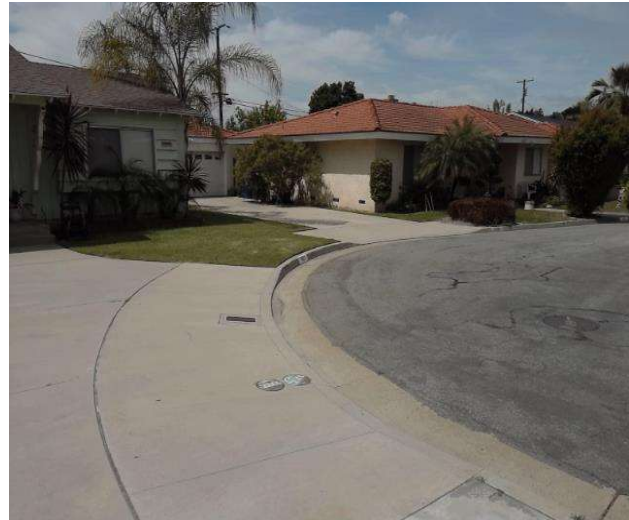
South Side @ 33.934829469291, -118.155504763126

There is no 60X60 turn area at every 200 feet.

On-Site Finding Not Found

Provide a 60X60 turn every 200 feet on the sidewalk.

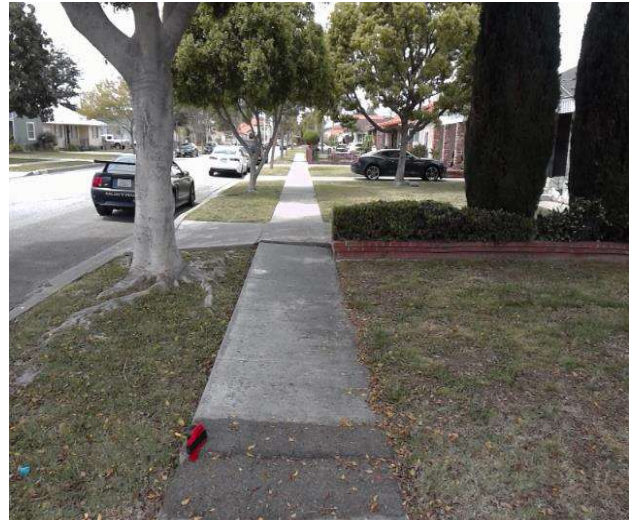
Change In Level East Of Julius Avenue @ 33.934154070877, -118.153236955404

There is a change in elevation greater than recommended value.

On-Site Finding 1.25 inches

Ensure that the change in elevation is within the recommended value.

Recommendation Up to 0.25 inches

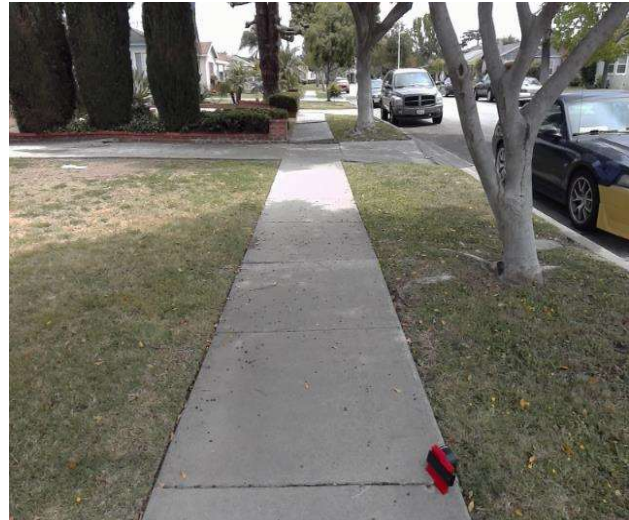
Change In Level East Of Julius Avenue @ 33.934183737, -118.153295964003

There is a change in elevation greater than recommended value.

On-Site Finding 0.62 inches

Ensure that the change in elevation is within the recommended value.

Recommendation Up to 0.25 inches

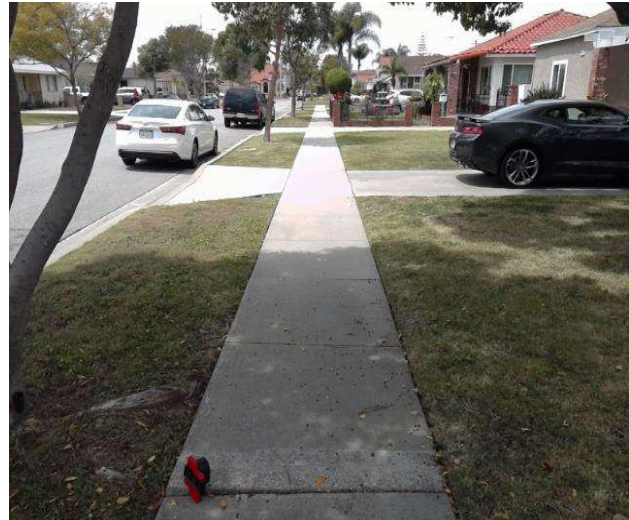
Change In Level East Of Julius Avenue @ 33.934209705215, -118.153352290392

There is a change in elevation greater than recommended value.

On-Site Finding 1.00 inches

Ensure that the change in elevation is within the recommended value.

Recommendation Up to 0.25 inches

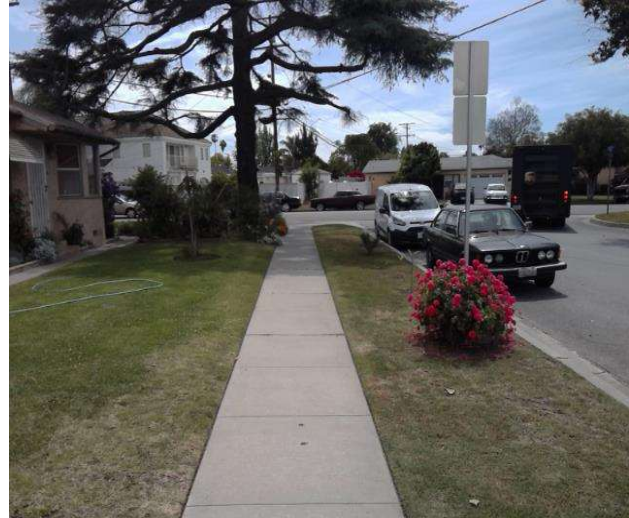
Sidewalk East Of Julius Avenue @ 33.933206056158, -118.151944130659

Sidewalk cross slope is not compliant.

On-Site Finding 3.00 percent for 80.00 feet

Repave the sidewalk surface with the recommended cross slope.

Recommendation Up to 2.08 percent

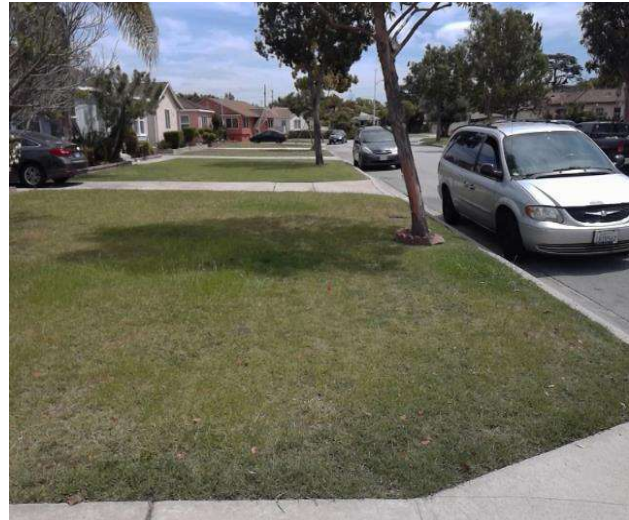
Sidewalk East Of Julius Avenue @ 33.933892588998, -118.152716606855

Section of sidewalk is missing and consists of dirt, grass or gravel.

On-Site Finding 345.00 feet

Provide a compliant sidewalk for the missing section.

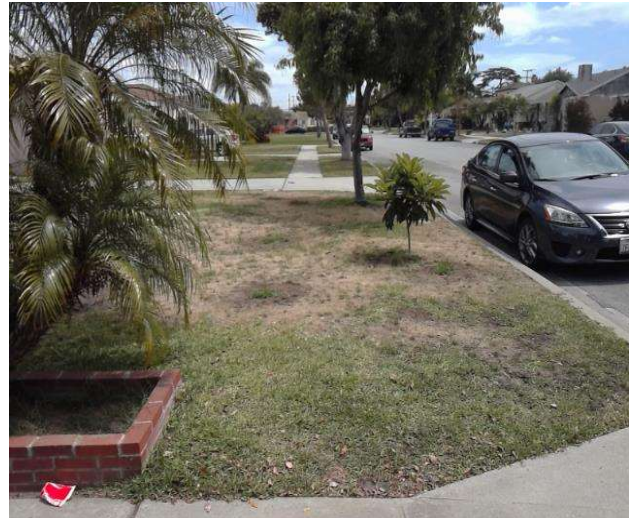
Sidewalk East Of Julius Avenue @ 33.934107338004, -118.153147101402

Section of sidewalk is missing and consists of dirt, grass or gravel.

On-Site Finding 40.00 feet

Provide a compliant sidewalk for the missing section.

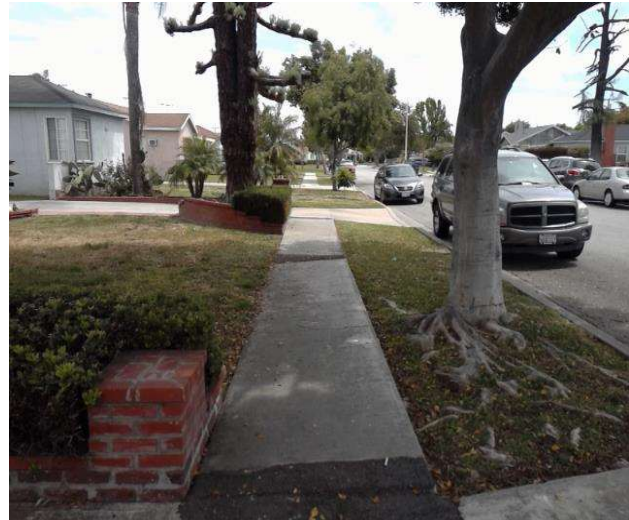
Sidewalk East Of Julius Avenue @ 33.934177437303, -118.153287917376

Sidewalk does not have enough width.

On-Site Finding 47.00 inches for 39.00 feet

Notes : Surface is rough and uneven.

Widen the sidewalk to the recommended value.

Recommendation At least 48.00 inches

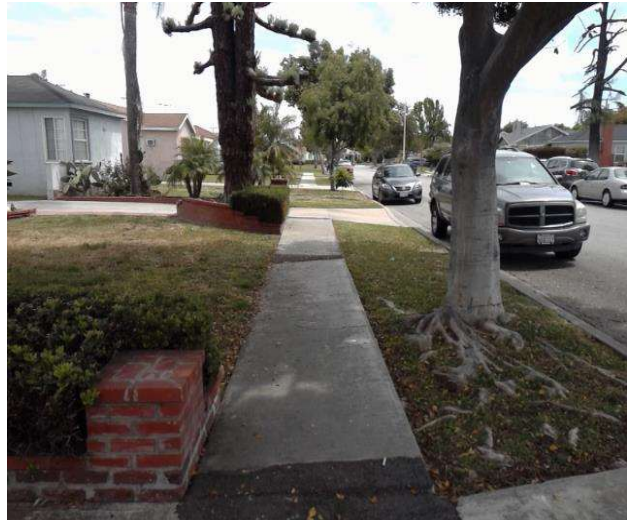
Sidewalk East Of Julius Avenue @ 33.934177437303, -118.153287917376

Sidewalk cross slope is not compliant.

On-Site Finding 6.60 percent for 39.00 feet

Notes : Surface is rough and uneven.

Repave the sidewalk surface with the recommended cross slope.

Recommendation Up to 2.08 percent

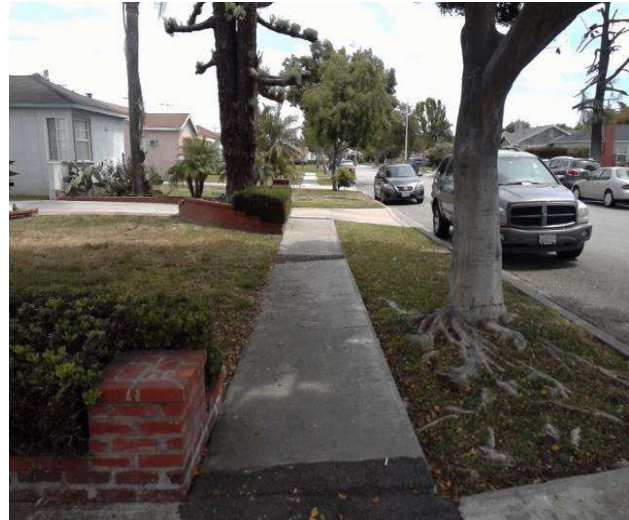
Sidewalk East Of Julius Avenue @ 33.934177437303, -118.153287917376

Sidewalk running slope is not compliant.

On-Site Finding 25.60 percent for 2.00 feet

Notes : Surface is rough and uneven.

Repave the sidewalk surface with the recommended running slope.

Recommendation Up to 5.00 percent

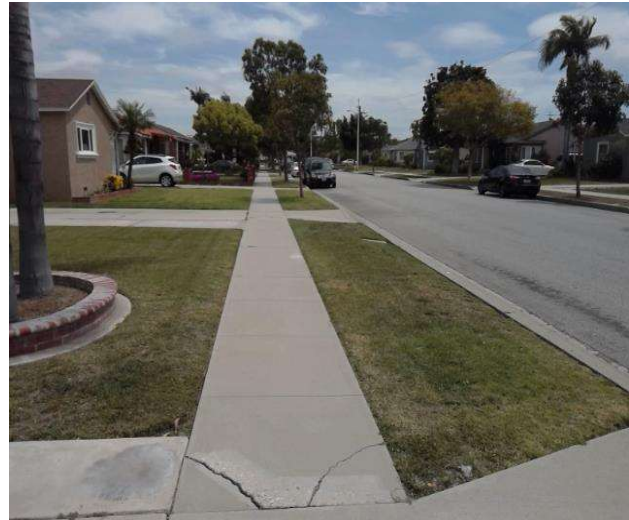
Sidewalk East Of Julius Avenue @ 33.934537947074, -118.153985291719

Sidewalk cross slope is not compliant.

On-Site Finding 3.80 percent for 44.00 feet

Repave the sidewalk surface with the recommended cross slope.

Recommendation Up to 2.08 percent

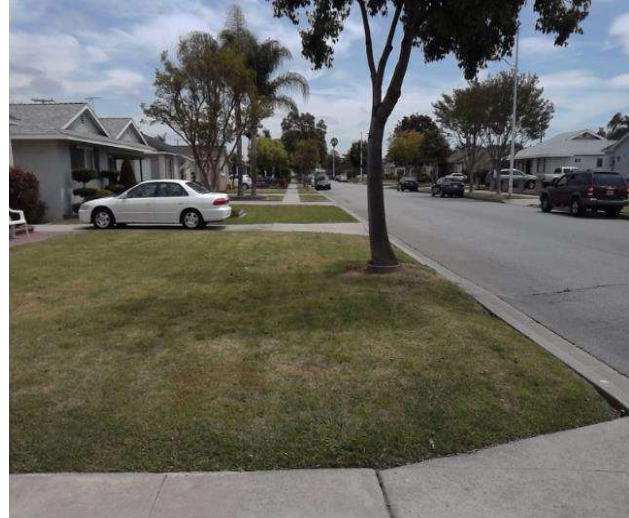
Sidewalk East Of Julius Avenue @ 33.934677032226, -118.154272288084

Section of sidewalk is missing and consists of dirt, grass or gravel.

On-Site Finding 90.00 feet

Provide a compliant sidewalk for the missing section.

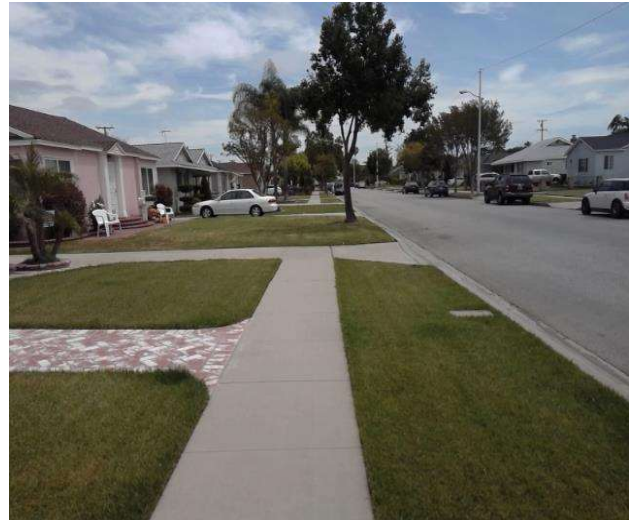
Sidewalk East Of Julius Avenue @ 33.934750469095, -118.154410421848

Sidewalk cross slope is not compliant.

On-Site Finding 3.10 percent for 40.00 feet

Repave the sidewalk surface with the recommended cross slope.

Recommendation Up to 2.08 percent

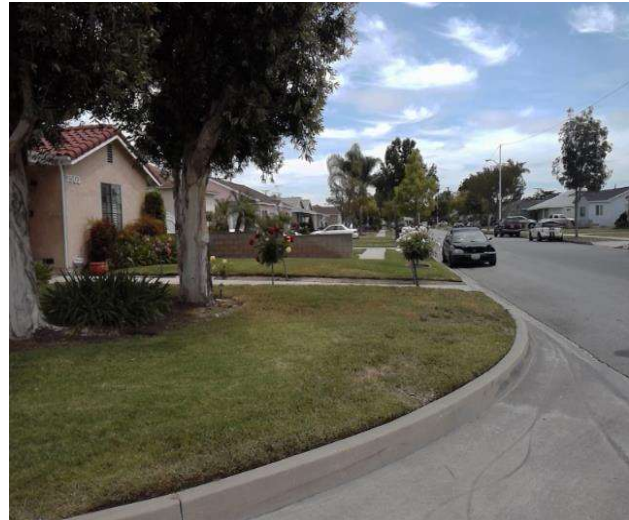
Sidewalk East Of Julius Avenue @ 33.934831694648, -118.154555261135

Section of sidewalk is missing and consists of dirt, grass or gravel.

On-Site Finding 53.00 feet

Provide a compliant sidewalk for the missing section.

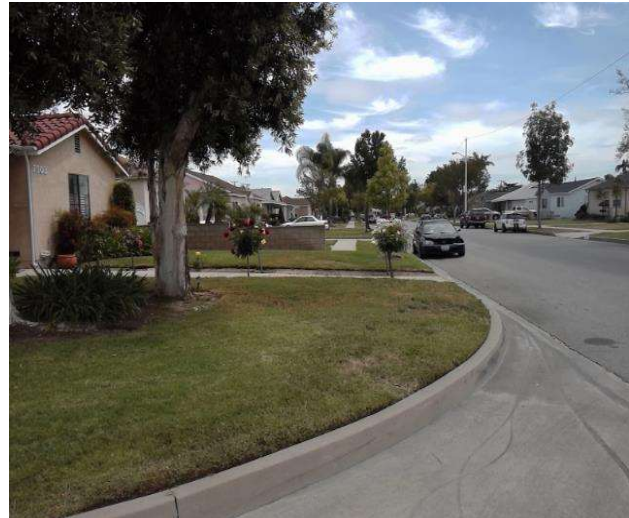
North Side @ 33.934831694648, -118.154555261135

There is no 60X60 turn area at every 200 feet.

On-Site Finding Not Found

Provide a 60X60 turn every 200 feet on the sidewalk.

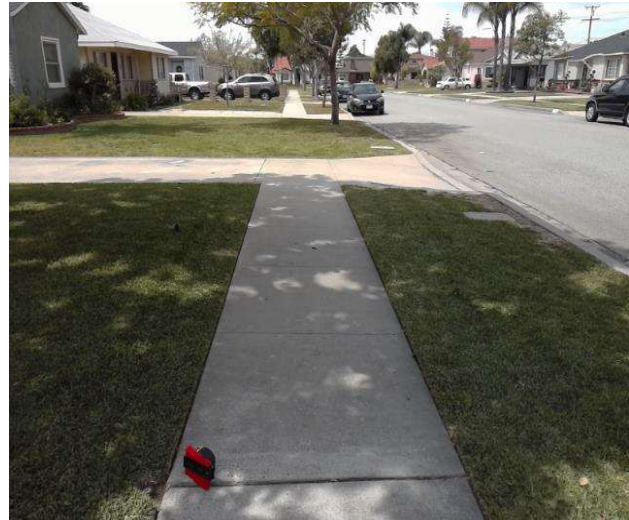
Change In Level West Of Rundell Street @ 33.934144056692, -118.153578937054

There is a change in elevation greater than recommended value.

On-Site Finding 0.62 inches

Ensure that the change in elevation is within the recommended value.

Recommendation Up to 0.25 inches

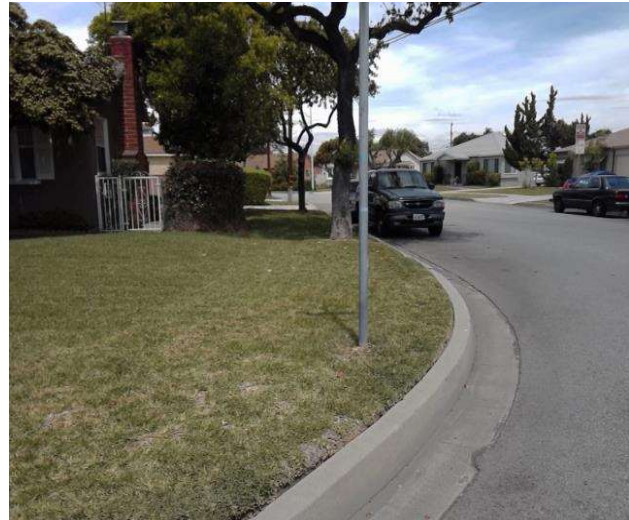
Sidewalk West Of Rundell Street @ 33.932895612424, -118.152196258307

Section of sidewalk is missing and consists of dirt, grass or gravel.

On-Site Finding 344.00 feet

Provide a compliant sidewalk for the missing section.

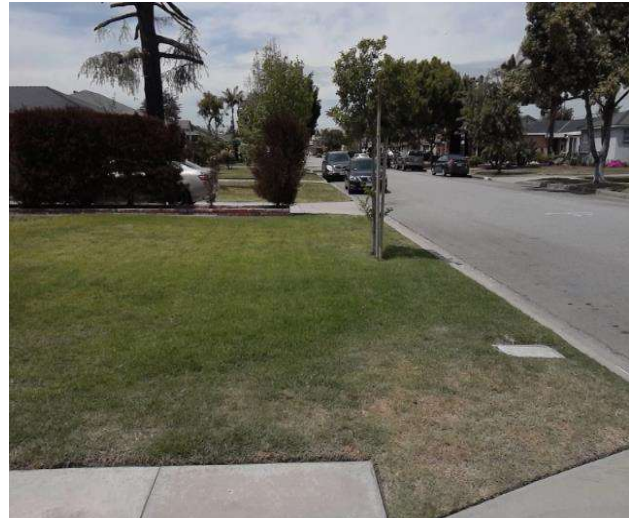
Sidewalk West Of Rundell Street @ 33.933783545253, -118.152850717306

Section of sidewalk is missing and consists of dirt, grass or gravel.

On-Site Finding 191.00 feet

Provide a compliant sidewalk for the missing section.

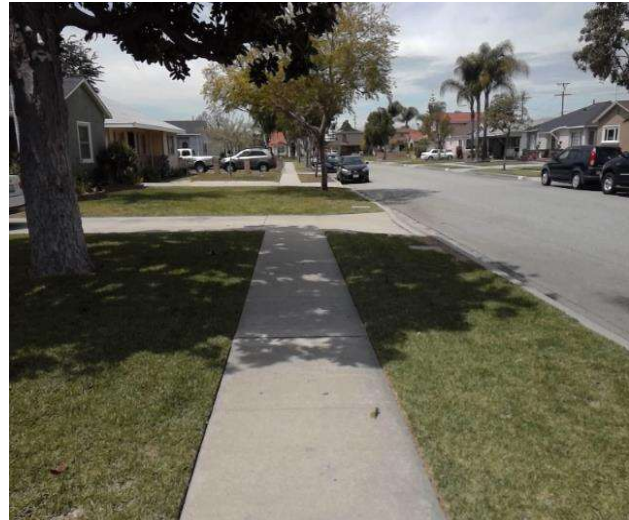
Sidewalk West Of Rundell Street @ 33.934144056692, -118.153578937054

Sidewalk cross slope is not compliant.

On-Site Finding 4.60 percent for 28.00 feet

Repave the sidewalk surface with the recommended cross slope.

Recommendation Up to 2.08 percent

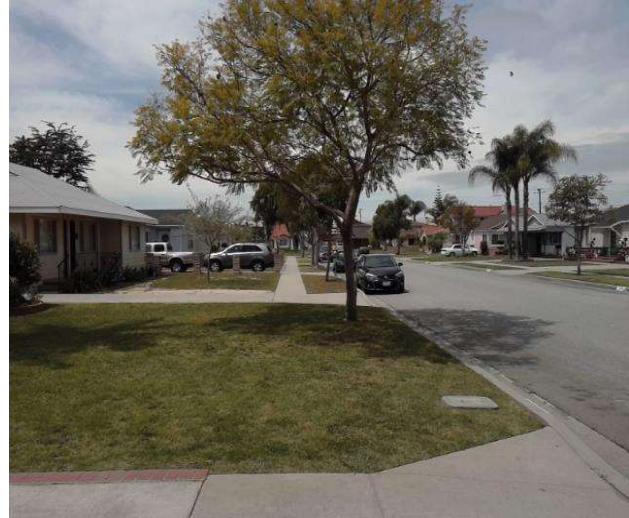
Sidewalk West Of Rundell Street @ 33.934204141783, -118.153700977564

Section of sidewalk is missing and consists of dirt, grass or gravel.

On-Site Finding 40.00 feet

Provide a compliant sidewalk for the missing section.

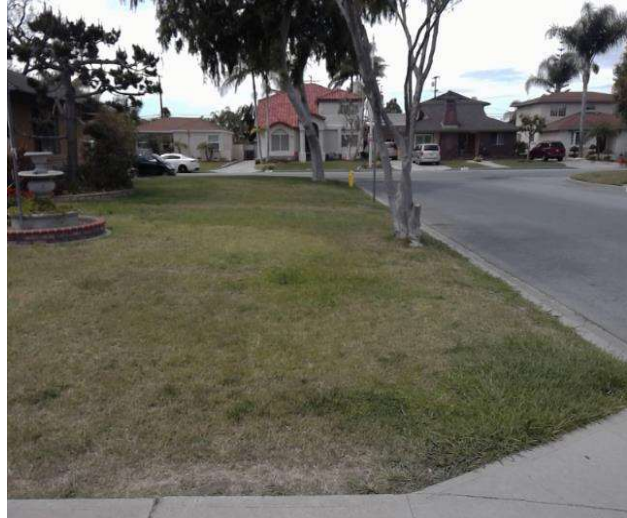
Sidewalk West Of Rundell Street @ 33.934562426077, -118.154401034117

Section of sidewalk is missing and consists of dirt, grass or gravel.

On-Site Finding 94.00 feet

Provide a compliant sidewalk for the missing section.

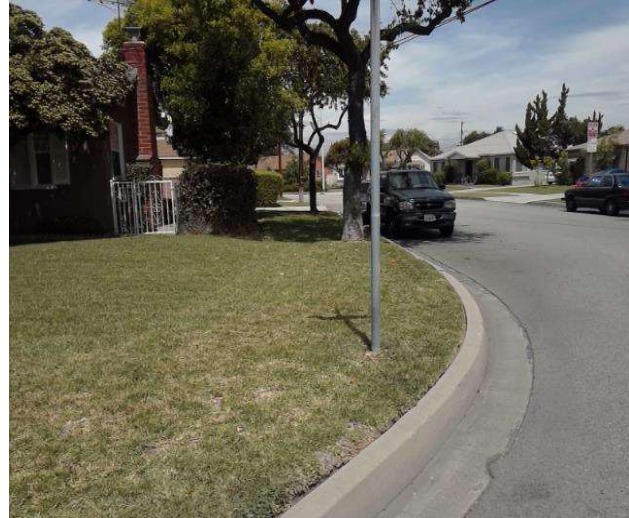
South Side @ 33.932895612424, -118.152196258307

There is no 60X60 turn area at every 200 feet.

On-Site Finding Not Found

Provide a 60X60 turn every 200 feet on the sidewalk.
