Accessibility Survey

City of Downey Gaybrook Avenue - Pico Vista Road to Cul-De-Sac

Date of Inspection
6/9/2017

Prepared By
Disability Access Consultants
(800) 743-7067

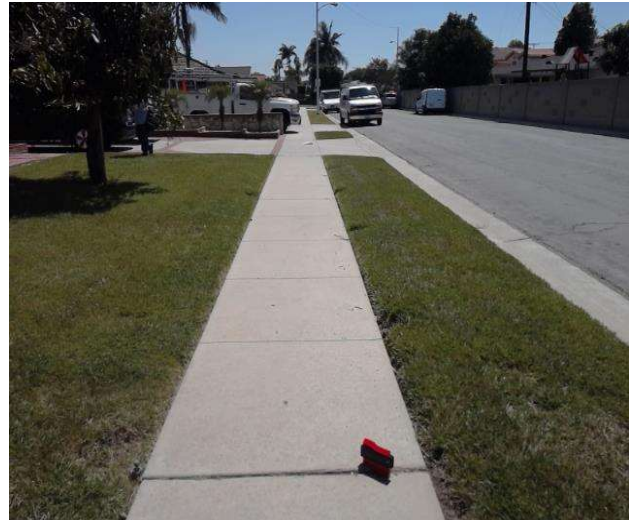
Change in Level South of Cul-De-Sac @ 33.935880943806, -118.104540109634

Sidewalks , Change in Level : Change in Level Non Beveled

There is a change in elevation greater than recommended value.

On-Site Finding 0.50 inches

Code Reference ADA 206, 302

Ensure that the change in elevation is within the recommended value.

Recommendation Up to 0.25 inches

Remove tripping hazards \$198

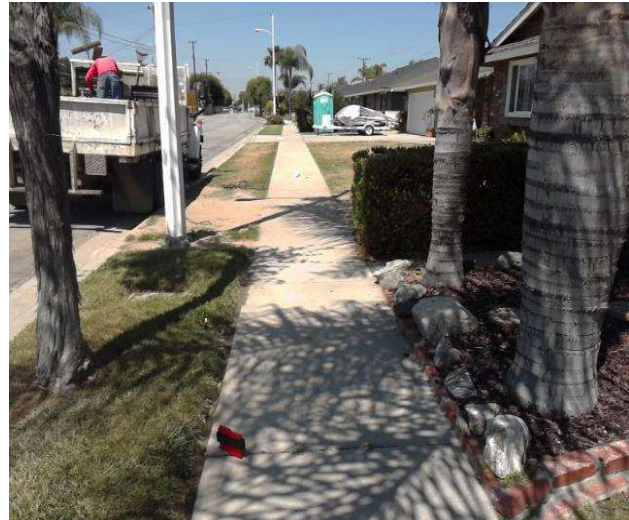
Change in Level South of Cul-De-Sac @ 33.935880943806, -118.104540109634

Sidewalks , Change in Level : Change in Level Non Beveled

There is a change in elevation greater than recommended value.

On-Site Finding 0.50 inches

Code Reference ADA 206, 302

Ensure that the change in elevation is within the recommended value.

Recommendation Up to 0.25 inches

Remove tripping hazards \$198

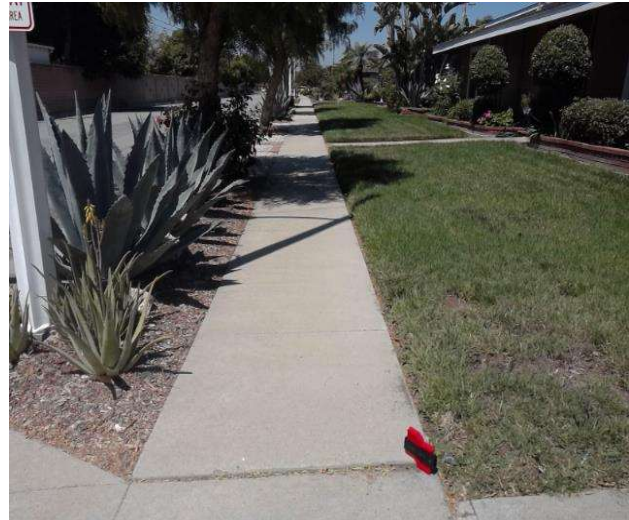
Change in Level South of Cul-De-Sac @ 33.936642002973, -118.103845417500

Sidewalks , Change in Level : Change in Level Non Beveled

There is a change in elevation greater than recommended value.

On-Site Finding 0.75 inches

Code Reference ADA 206, 302

Ensure that the change in elevation is within the recommended value.

Recommendation Up to 0.25 inches

Remove tripping hazards \$198

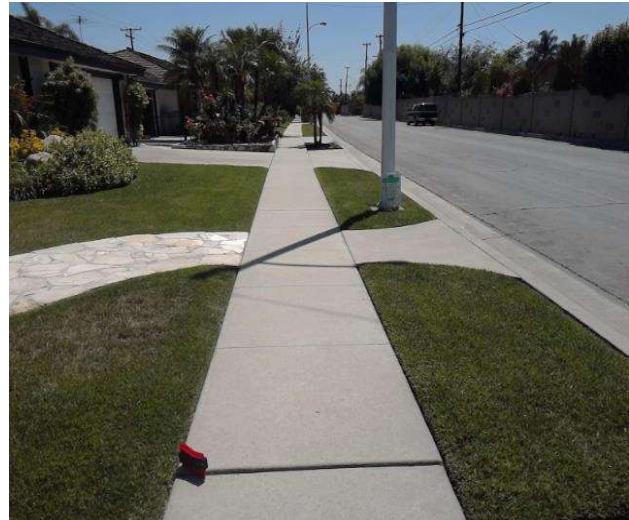
Change in Level South of Cul-De-Sac @ 33.937373013927, -118.103219121695

Sidewalks , Change in Level : Change in Level Non Beveled

There is a change in elevation greater than recommended value.

On-Site Finding 0.75 inches

Code Reference ADA 206, 302

Ensure that the change in elevation is within the recommended value.

Recommendation Up to 0.25 inches

Remove tripping hazards \$198

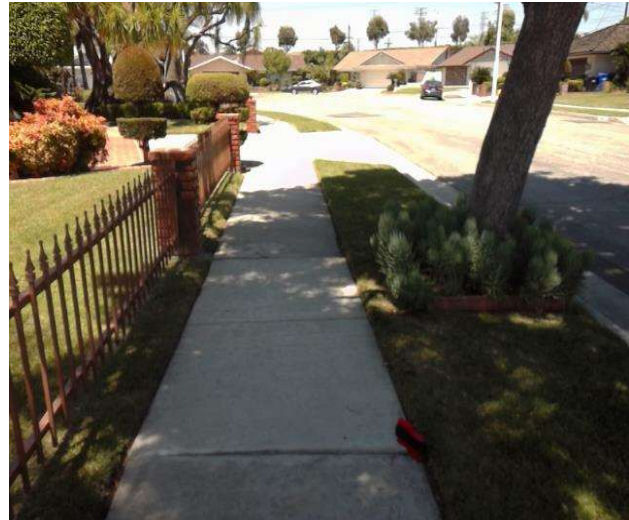
Change in Level North of Via Amorita @ 33.938758245778, -118.102287054062

Sidewalks , Change in Level : Change in Level Non Beveled

There is a change in elevation greater than recommended value.

On-Site Finding 0.87 inches

Code Reference ADA 206, 302

Ensure that the change in elevation is within the recommended value.

Recommendation Up to 0.25 inches

Remove tripping hazards \$198

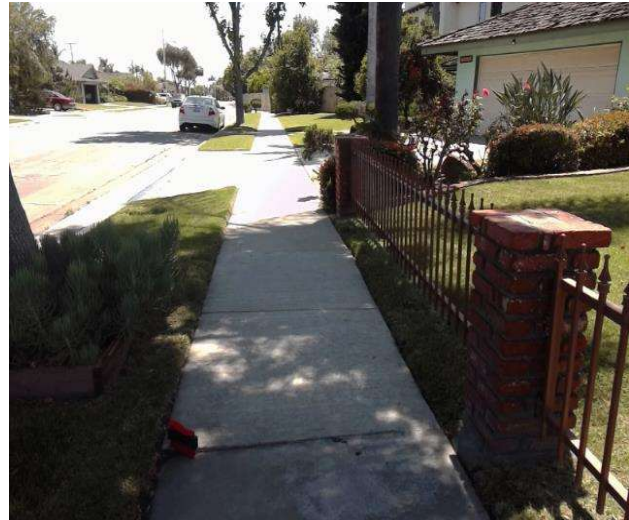
Change in Level North of Via Amorita @ 33.938758245778, -118.102287054062

Sidewalks , Change in Level : Change in Level Non Beveled

There is a change in elevation greater than recommended value.

On-Site Finding 0.75 inches

Code Reference ADA 206, 302

Ensure that the change in elevation is within the recommended value.

Recommendation Up to 0.25 inches

Remove tripping hazards \$198

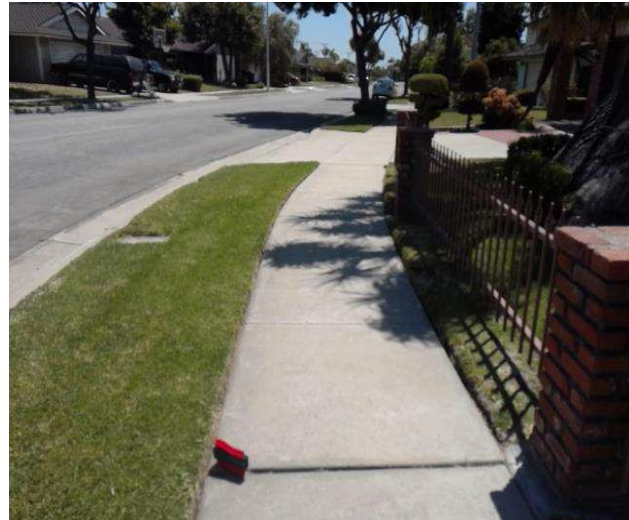
Change in Level North of Via Amorita @ 33.938891760911, -118.102187812328

Sidewalks , Change in Level : Change in Level Non Beveled

There is a change in elevation greater than recommended value.

On-Site Finding 0.75 inches

Code Reference ADA 206, 302

Ensure that the change in elevation is within the recommended value.

Recommendation Up to 0.25 inches

Remove tripping hazards \$198

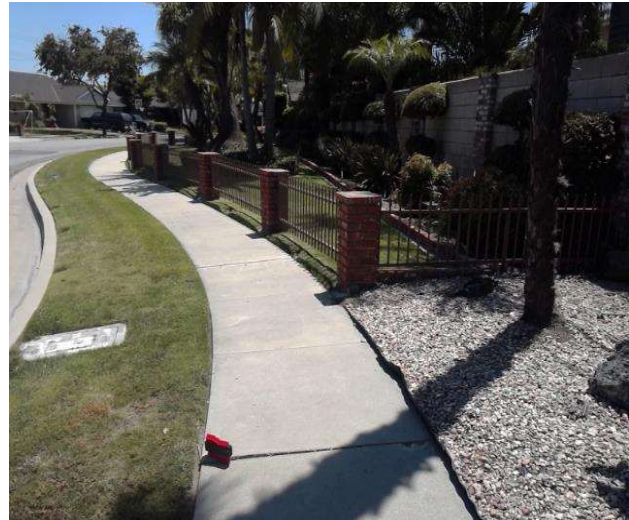
Change in Level North of Via Amorita @ 33.939153227438, -118.102171719074

Sidewalks , Change in Level : Change in Level Non Beveled

There is a change in elevation greater than recommended value.

On-Site Finding 0.75 inches

Code Reference ADA 206, 302

Ensure that the change in elevation is within the recommended value.

Recommendation Up to 0.25 inches

Remove tripping hazards \$198

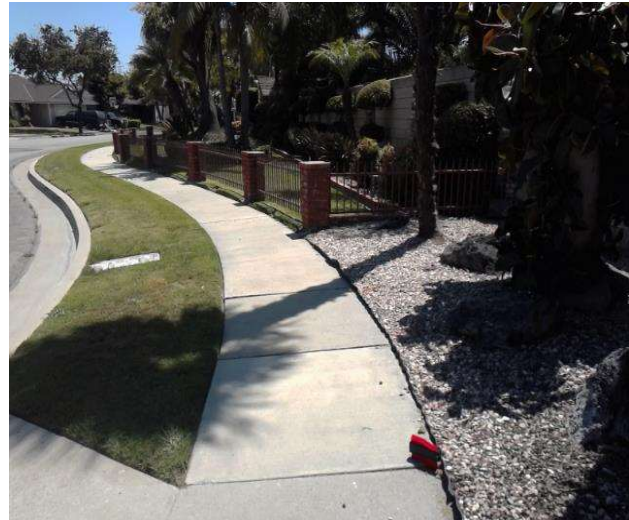
Change in Level North of Via Amorita @ 33.939172142007, -118.102160990238

Sidewalks , Change in Level : Change in Level Non Beveled

There is a change in elevation greater than recommended value.

On-Site Finding 0.62 inches

Code Reference ADA 206, 302

Ensure that the change in elevation is within the recommended value.

Recommendation Up to 0.25 inches

Remove tripping hazards \$198

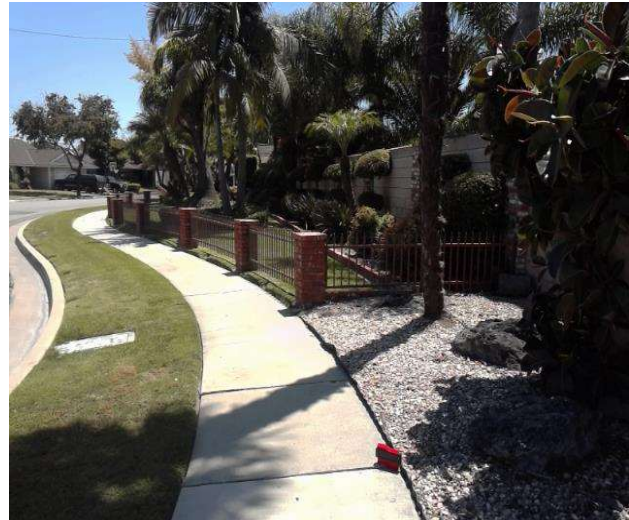
Change in Level North of Via Amorita @ 33.939172142007, -118.102160990238

Sidewalks , Change in Level : Change in Level Non Beveled

There is a change in elevation greater than recommended value.

On-Site Finding 0.50 inches

Code Reference ADA 206, 302

Ensure that the change in elevation is within the recommended value.

Recommendation Up to 0.25 inches

Remove tripping hazards \$198

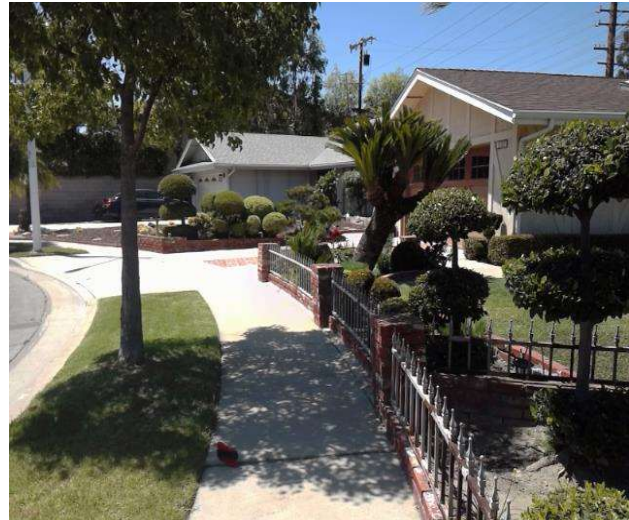
Change in Level North of Via Amorita @ 33.939238899275, -118.101861923933

Sidewalks , Change in Level : Change in Level Non Beveled

There is a change in elevation greater than recommended value.

On-Site Finding 0.87 inches

Code Reference ADA 206, 302

Ensure that the change in elevation is within the recommended value.

Recommendation Up to 0.25 inches

Remove tripping hazards \$198

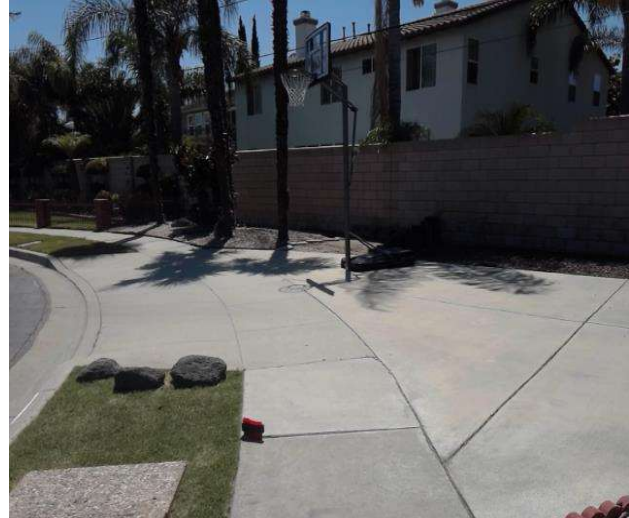
Change in Level North of Via Amorita @ 33.939246687619, -118.102080523968

Sidewalks , Change in Level : Change in Level Non Beveled

There is a change in elevation greater than recommended value.

On-Site Finding 0.50 inches

Code Reference ADA 206, 302

Ensure that the change in elevation is within the recommended value.

Recommendation Up to 0.25 inches

Remove tripping hazards \$198

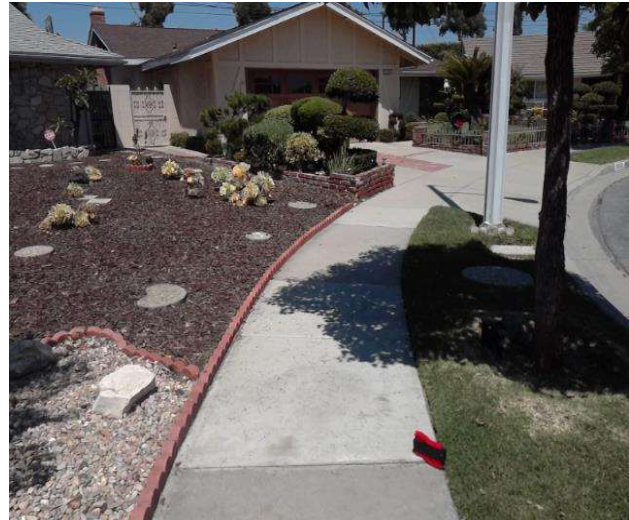
Change in Level North of Via Amorita @ 33.939261151686, -118.102048337460

Sidewalks , Change in Level : Change in Level Non Beveled

There is a change in elevation greater than recommended value.

On-Site Finding 0.75 inches

Code Reference ADA 206, 302

Ensure that the change in elevation is within the recommended value.

Recommendation Up to 0.25 inches

Remove tripping hazards \$198

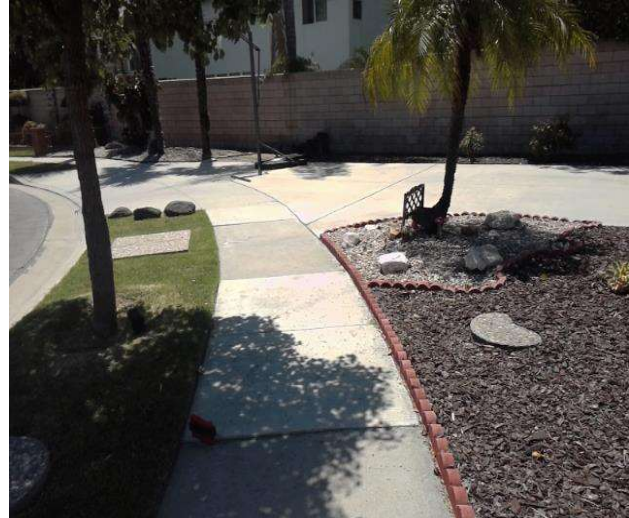
Change in Level North of Via Amorita @ 33.939274503129, -118.102016150951

Sidewalks , Change in Level : Change in Level Non Beveled

There is a change in elevation greater than recommended value.

On-Site Finding 0.75 inches

Code Reference ADA 206, 302

Ensure that the change in elevation is within the recommended value.

Recommendation Up to 0.25 inches

Remove tripping hazards \$198

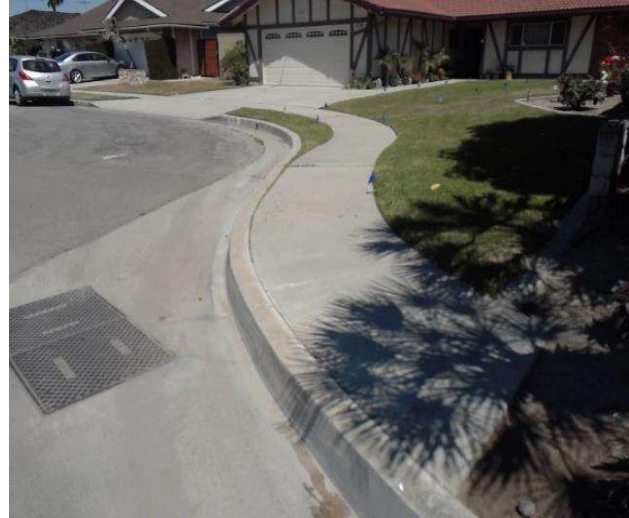
Curb South of Cul-De-Sac @ 33.935300130917, -118.105250895023

Sidewalks , Hazards & Gratings : Curb is on Path of Travel

There is a curb on the designated path of travel.

On-Site Finding Not Compliant

Code Reference ADA 402, 303, 406, 403.4, 303.4

Provide a compliant curb ramp.

Install curb ramp \$2,500

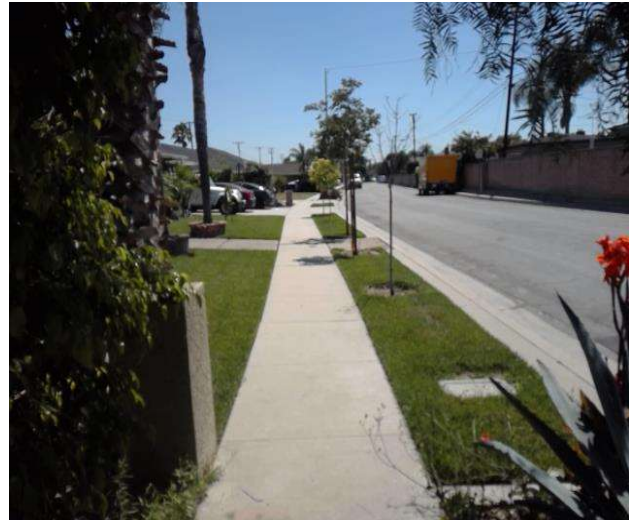
Sidewalk South of Cul-De-Sac @ 33.936611961293, -118.103868216276

Sidewalks , Surface : Cross Slope

Sidewalk cross slope is not compliant.

On-Site Finding 3.40 percent for 97.00 feet

Code Reference ADA 206, 302,CA 11B-403.3

Repave the sidewalk surface with the recommended cross slope.

Recommendation Up to 2.08 percent

Repave surface \$1,092

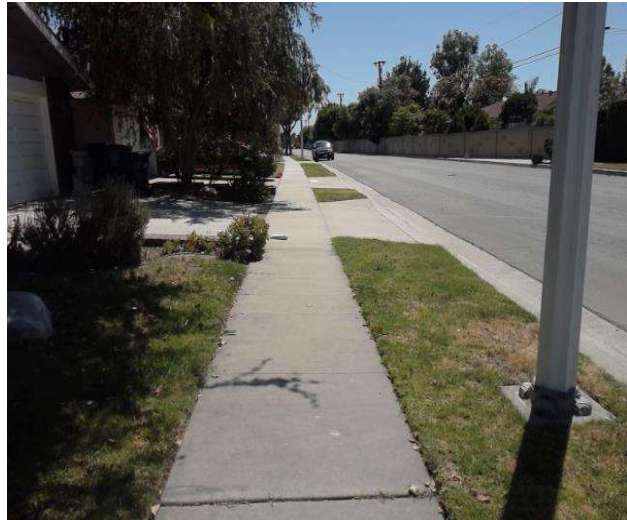
Sidewalk South of Cul-De-Sac @ 33.938504566450, -118.102315217257

Sidewalks , Surface : Cross Slope

Sidewalk cross slope is not compliant.

On-Site Finding 4.40 percent for 93.00 feet

Code Reference ADA 206, 302,CA 11B-403.3

Repave the sidewalk surface with the recommended cross slope.

Recommendation Up to 2.08 percent

Repave surface \$1,092

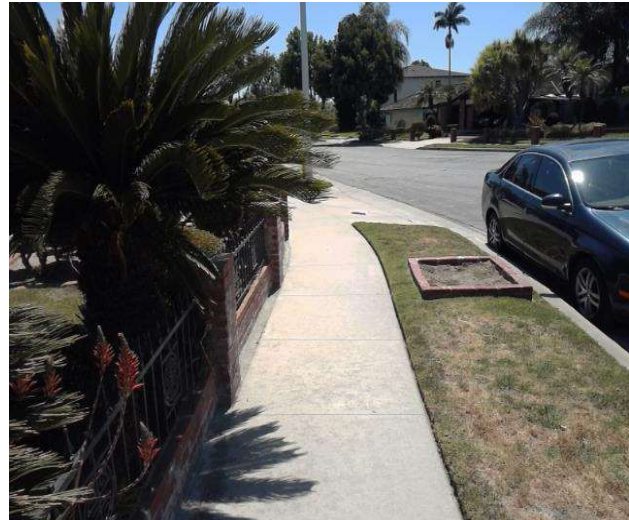
Tree South of Cul-De-Sac @ 33.938988559251, -118.101867288351

Sidewalks , Hazards & Gratings : Protruding Object Height

The leading edge of the protruding object is more than 4 inches from the edge of sidewalk.

On-Site Finding 35.00 inches

Code Reference ADA 307.2,CA 11B-307.2

Install side extensions, modify, relocate, or lower the protruding object so that the leading edge protrudes less than 4 inches from the edge of sidewalk.

Recommendation Up to 4.00 inches

Install wing walls or relocate object \$640

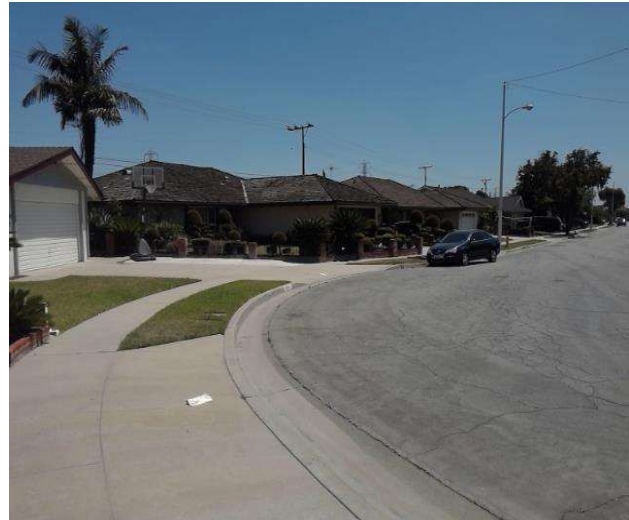
East Side @ 33.939194394435, -118.101816326380

Sidewalks : 60X60 Turn Area

There is no 60X60 turn area at every 200 feet.

On-Site Finding Not Found

Code Reference ADA 206, 302

Provide a 60X60 turn every 200 feet on the sidewalk.

\$2,400

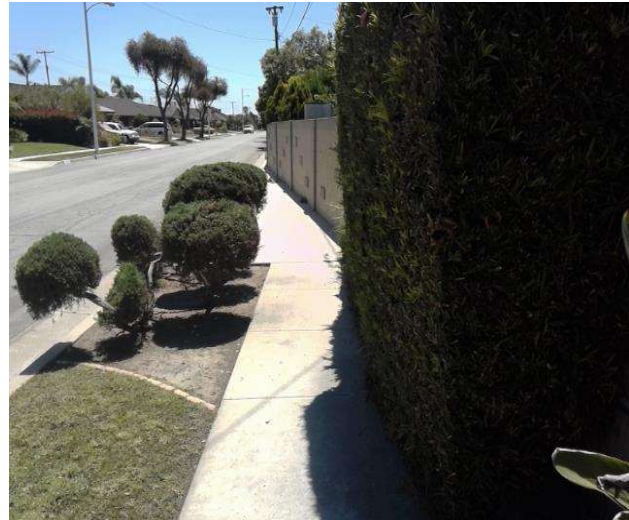
Bush North of Via Amorita @ 33.938416668612, -118.102602213621

Sidewalks , Hazards & Gratings : Sidewalk Width at Obstruction

Sidewalk width at the obstruction is not compliant.

On-Site Finding 40.00 inches

Code Reference ADA 206, 302, 403.5.1, CA 11B-403.5

Sidewalk width at the obstruction shall have the recommended value.

Recommendation At least 48.00 inches

\$1,260

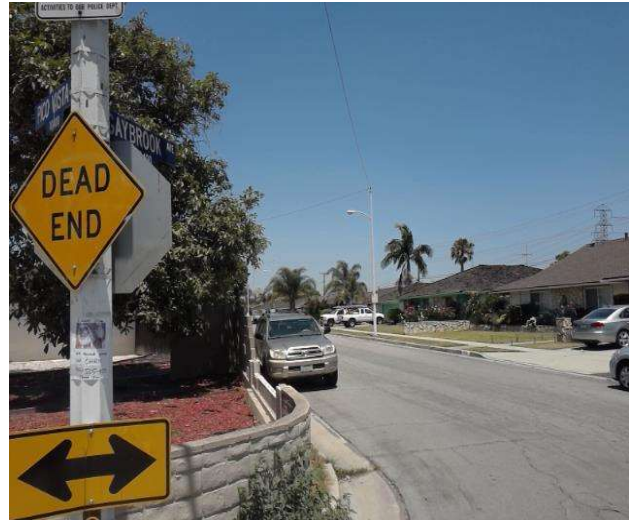
Sidewalk North of Pico Vista Road @ 33.935426975450, -118.105169087648

Sidewalks : Missing Sidewalk

Section of sidewalk is missing and consists of dirt, grass or gravel.

On-Site Finding 543.00 feet

Code Reference ADA 206, 302,CA 11B-302,CA 11B-206

Provide a compliant sidewalk for the missing section.

\$1,260

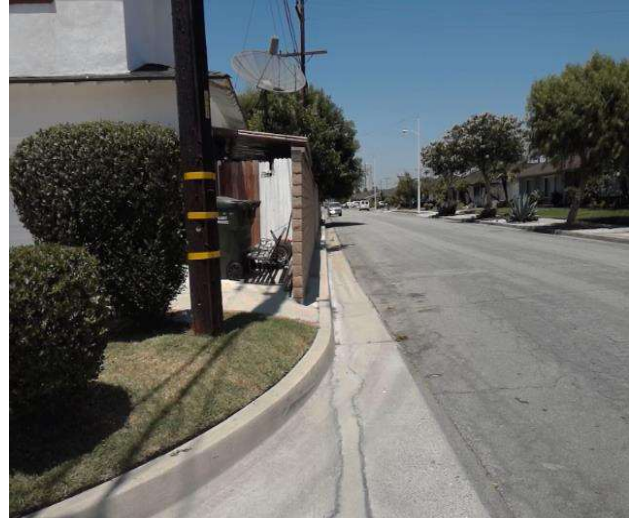
Sidewalk North of Via Amorita @ 33.936684283839, -118.103983551264

Sidewalks : Missing Sidewalk

Section of sidewalk is missing and consists of dirt, grass or gravel.

On-Site Finding 710.00 feet

Code Reference ADA 206, 302,CA 11B-302,CA 11B-206

Provide a compliant sidewalk for the missing section.

\$1,260

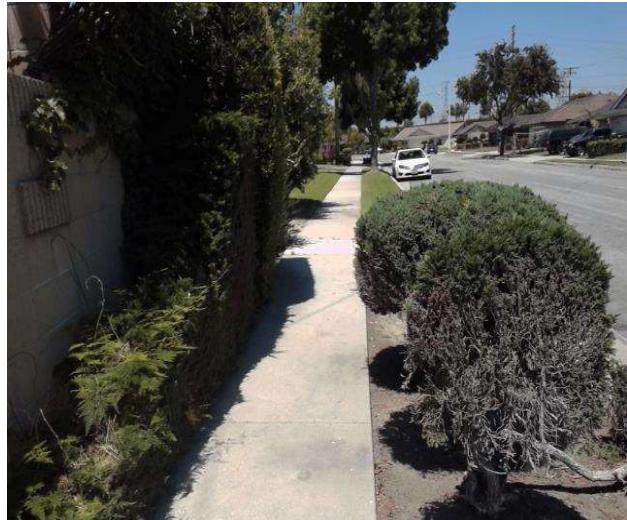
Sidewalk North of Via Amorita @ 33.938416668612, -118.102602213621

Sidewalks , Surface : Cross Slope

Sidewalk cross slope is not compliant.

On-Site Finding 4.20 percent for 40.00 feet

Code Reference ADA 206, 302, CA 11B-403.3

Repave the sidewalk surface with the recommended cross slope.

Recommendation Up to 2.08 percent

Repave surface \$1,092

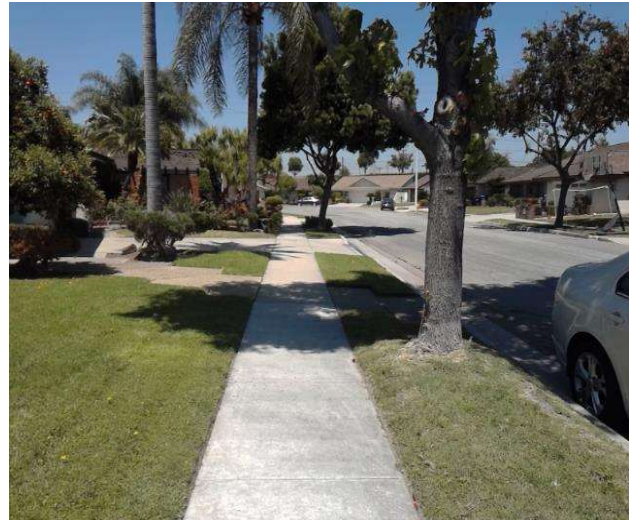
Sidewalk North of Via Amorita @ 33.938581337906, -118.102450668812

Sidewalks , Surface : Cross Slope

Sidewalk cross slope is not compliant.

On-Site Finding 3.80 percent for 76.00 feet

Code Reference ADA 206, 302, CA 11B-403.3

Repave the sidewalk surface with the recommended cross slope.

Recommendation Up to 2.08 percent

Repave surface \$1,092

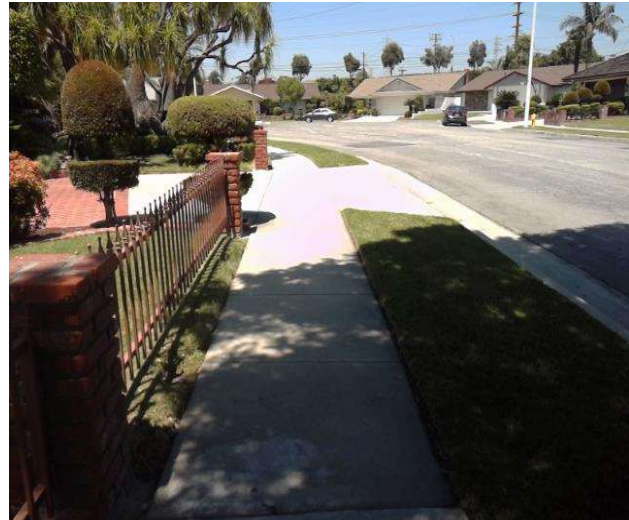
Sidewalk North of Via Amorita @ 33.938758245778, -118.102287054062

Sidewalks , Surface : Cross Slope

Sidewalk cross slope is not compliant.

On-Site Finding 3.40 percent for 92.00 feet

Code Reference ADA 206, 302,CA 11B-403.3

Repave the sidewalk surface with the recommended cross slope.

Recommendation Up to 2.08 percent

Repave surface \$1,092
