## Accessibility Survey

## City of Downey Golondrinas Street - Rives Avenue to Erickson Avenue

Rives Avenue to Erickson Avenue  
Downey, CA 90242

Date of Inspection  
7/6/2017

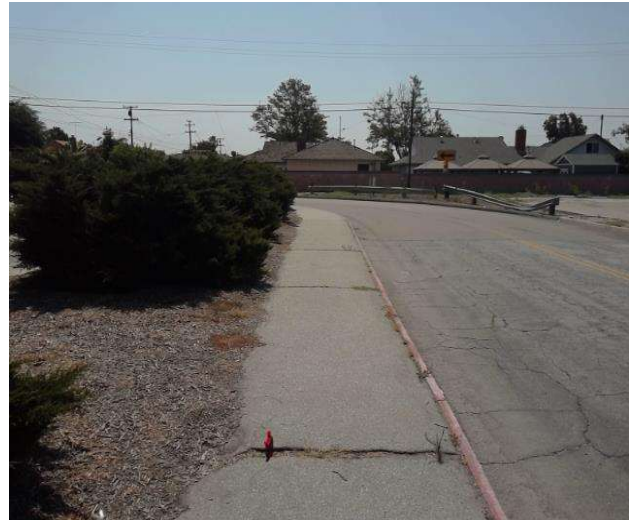
**Change in Level East of Dahlia Street @ 33.923803226134, -118.158634901047**

Sidewalks , Change in Level : Change in Level Non Beveled

There is a change in elevation greater than recommended value.

**On-Site Finding** 1.00 inches

Ensure that the change in elevation is within the recommended value.

Recommendation Up to 0.25 inches

Remove tripping hazards \$198

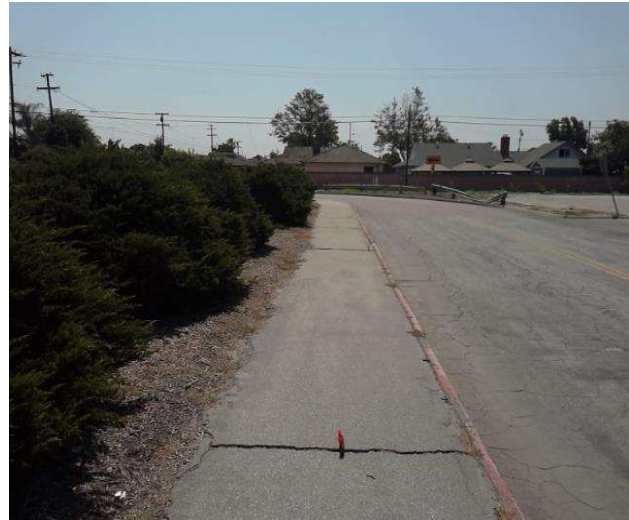
**Change in Level East of Dahlia Street @ 33.923825482579, -118.158693909645**

Sidewalks , Change in Level : Change in Level Non Beveled

There is a change in elevation greater than recommended value.

**On-Site Finding** 1.00 inches

Ensure that the change in elevation is within the recommended value.

Recommendation Up to 0.25 inches

Remove tripping hazards \$198

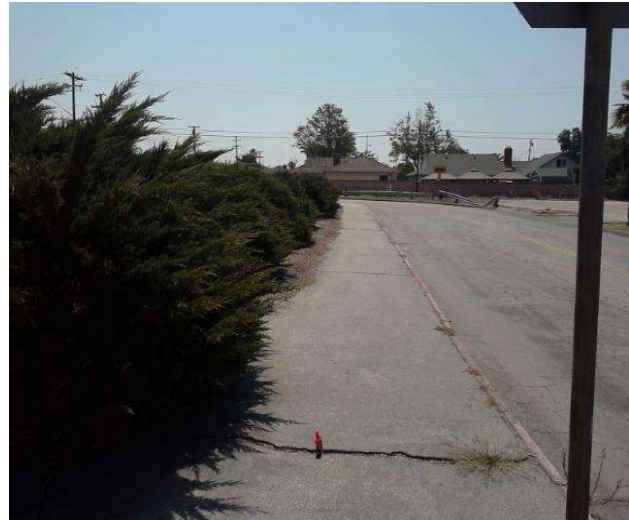
**Change in Level East of Dahlia Street @ 33.923865544164, -118.158774375916**

Sidewalks , Change in Level : Change in Level Non Beveled

There is a change in elevation greater than recommended value.

**On-Site Finding** 1.00 inches

Ensure that the change in elevation is within the recommended value.

Recommendation Up to 0.25 inches

Remove tripping hazards \$198

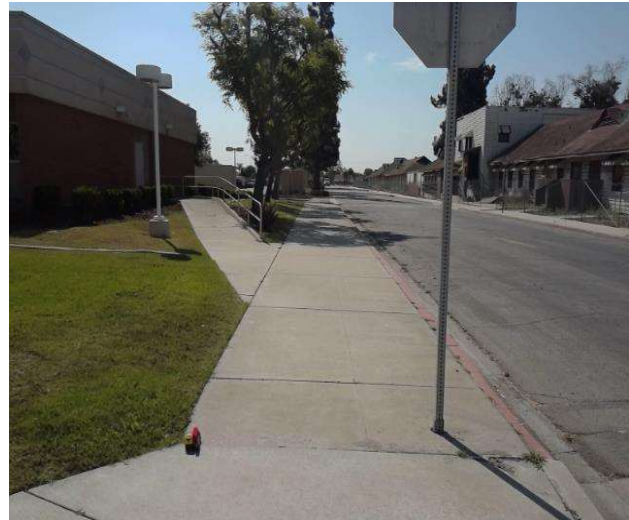
**Change in Level East of Erickson Avenue @ 33.924853723974, -118.160732388496**

Sidewalks , Change in Level : Change in Level Non Beveled

There is a change in elevation greater than recommended value.

**On-Site Finding** 0.50 inches

Ensure that the change in elevation is within the recommended value.

Recommendation Up to 0.25 inches

Remove tripping hazards \$198

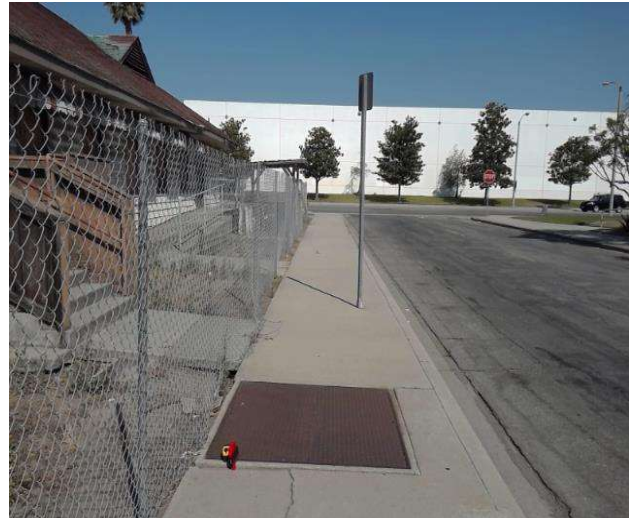
**Change in Level West of Dahlia Street @ 33.924604454473, -118.160507082939**

Sidewalks , Change in Level : Change in Level Non Beveled

There is a change in elevation greater than recommended value.

**On-Site Finding** 0.75 inches

Ensure that the change in elevation is within the recommended value.

Recommendation Up to 0.25 inches

Remove tripping hazards \$198

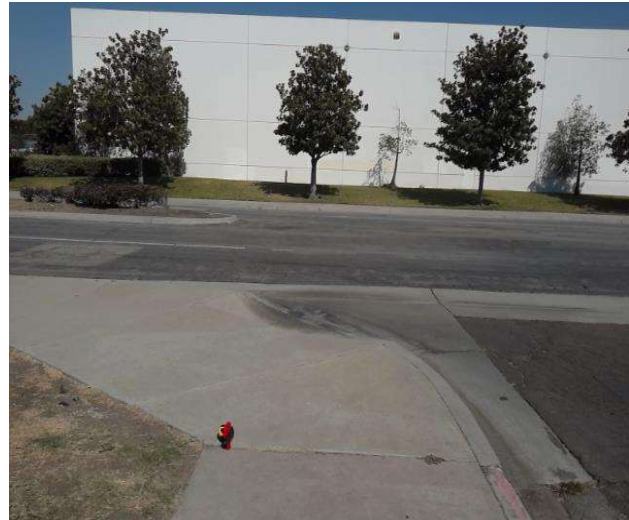
**Change in Level West of Dahlia Street @ 33.924715735590, -118.160716295242**

Sidewalks , Change in Level : Change in Level Non Beveled

There is a change in elevation greater than recommended value.

**On-Site Finding** 0.87 inches

Ensure that the change in elevation is within the recommended value.

Recommendation Up to 0.25 inches

Remove tripping hazards \$198

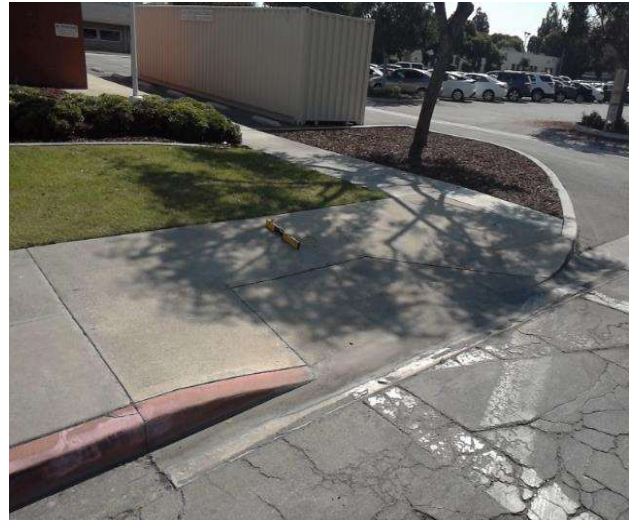
**North Side East of Erickson Avenue @ 33.924684576892, - 118.160389065742**

Curb Ramp : No Detectable Warnings

The curb ramp does not provide a detectable warning surface which includes truncated domes.

**On-Site Finding** Not Found

Provide compliant detectable warnings to surface.

Provide detectable warning to surface \$248

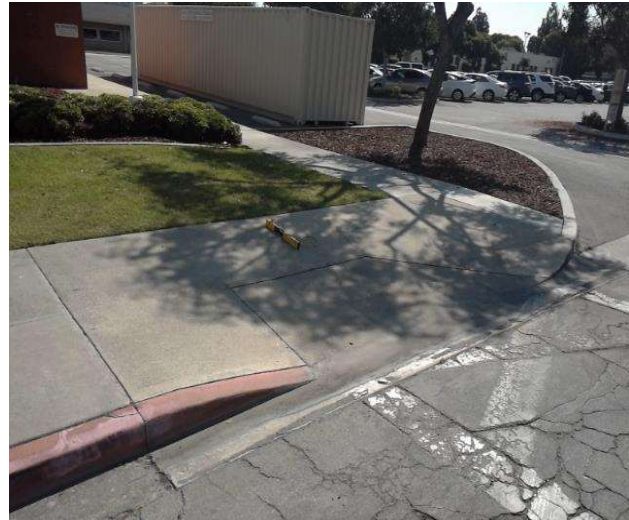
**North Side East of Erickson Avenue @ 33.924684576892, - 118.160389065742**

Curb Ramp : Curb Ramp Slope

The running slope is greater than allowed.

**On-Site Finding** 10.30 percent

Provide a compliant curb ramp.

Recommendation Up to 8.33 percent

Install curb ramp \$1,300

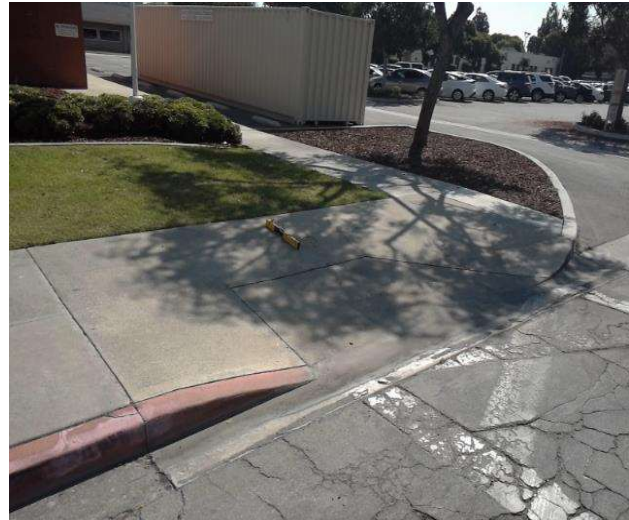
**North Side East of Erickson Avenue @ 33.924684576892, - 118.160389065742**

Curb Ramp : Side Flare Slope

The slope of the curb ramp side flare is greater than allowed.

**On-Site Finding** 15.80 percent

Provide curb ramp side flares with a compliant slope.

Recommendation Up to 10.00 percent

Install flared sides \$1,300

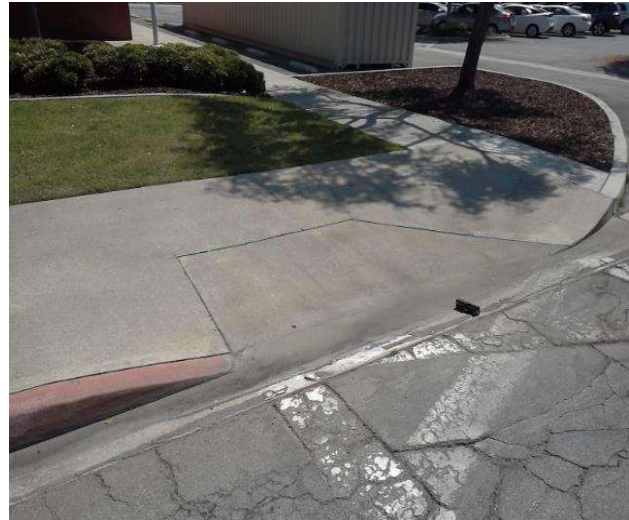
#### North Side East of Erickson Avenue @ 33.924684576892, - 118.160389065742

Curb Ramp : Bottom Landing Slope

The bottom landing of the curb ramp is on the street, and the slope of the bottom landing is not compliant.

**On-Site Finding** 13.50 percent

Ensure the bottom landing slope is compliant and provides a smooth transition.

Recommendation Up to 5.00 percent

Repave landing \$1,260

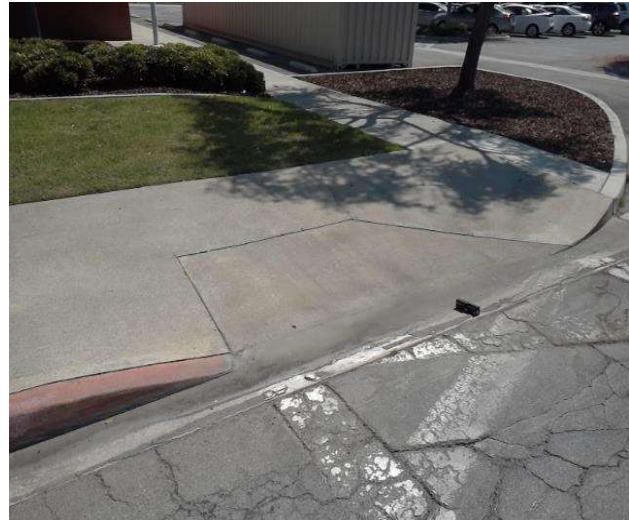
**North Side East of Erickson Avenue @ 33.924684576892, - 118.160389065742**

Curb Ramp , Landings and Transitions : Top Landing Clear Length - Landings

There is not enough top landing clear length.

**On-Site Finding** 0.00 inches

Provide a level top landing with enough clear length.

Recommendation At least 48.00 inches

Provide compliant landing \$240

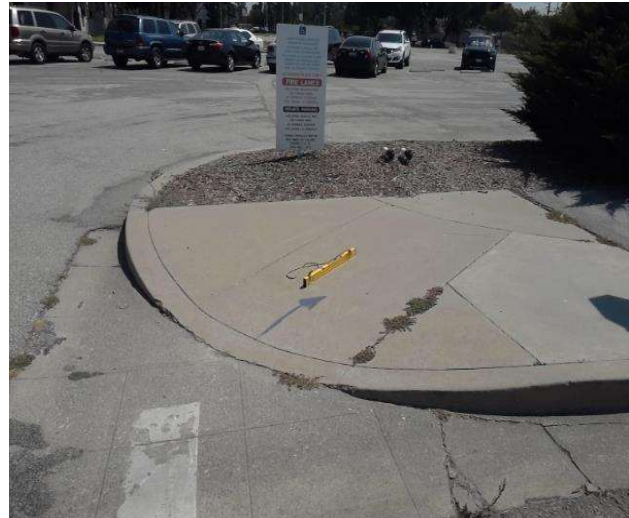
**Northeast Corner of Dahlia Street @ 33.923901154446, - 118.158838748932**

Curb Ramp : No Detectable Warnings

The curb ramp does not provide a detectable warning surface which includes truncated domes.

**On-Site Finding** Not Found

Provide compliant detectable warnings to surface.

Provide detectable warning to surface \$248

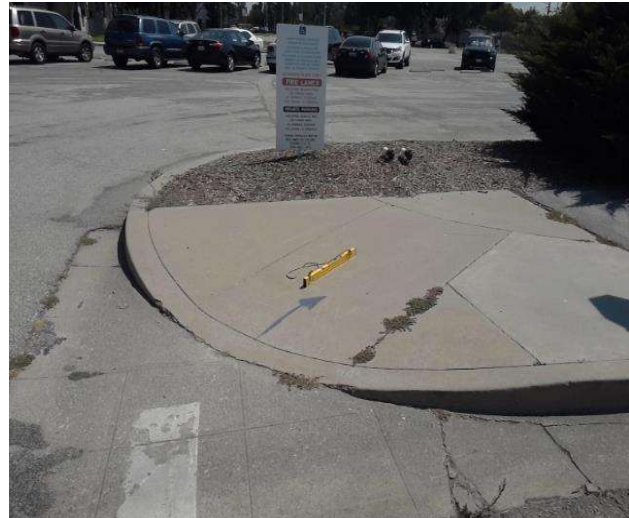
**Northeast Corner of Dahlia Street @ 33.923901154446, - 118.158838748932**

Curb Ramp : Curb Ramp Slope

The running slope is greater than allowed.

**On-Site Finding** 10.00 percent

Provide a compliant curb ramp.

Recommendation Up to 8.33 percent

Install curb ramp \$1,300

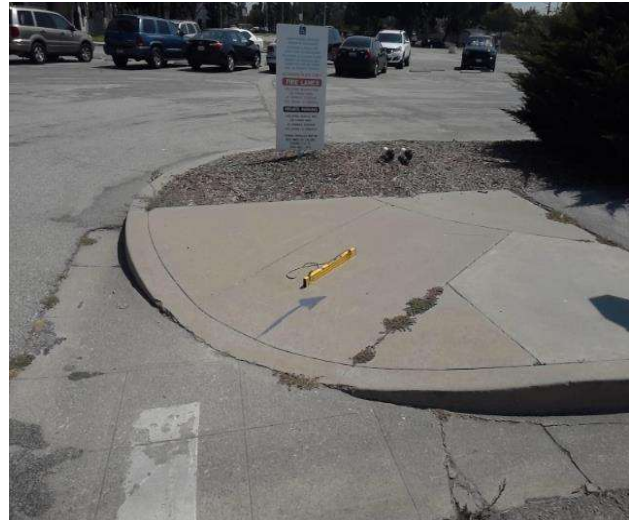
#### Northeast Corner of Dahlia Street @ 33.923901154446, - 118.158838748932

Curb Ramp : Side Flare Slope

The slope of the curb ramp side flare is greater than allowed.

**On-Site Finding** 13.50 percent

Provide curb ramp side flares with a compliant slope.

Recommendation Up to 10.00 percent

Install flared sides \$1,300

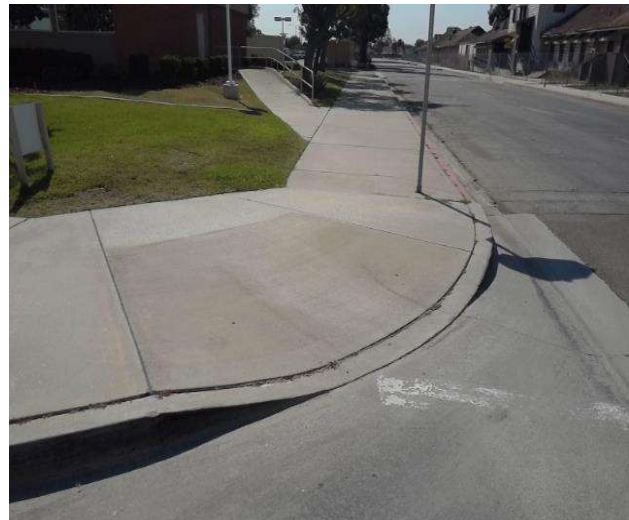
**On-Site Finding** Not Found

Provide detectable warning to surface \$248

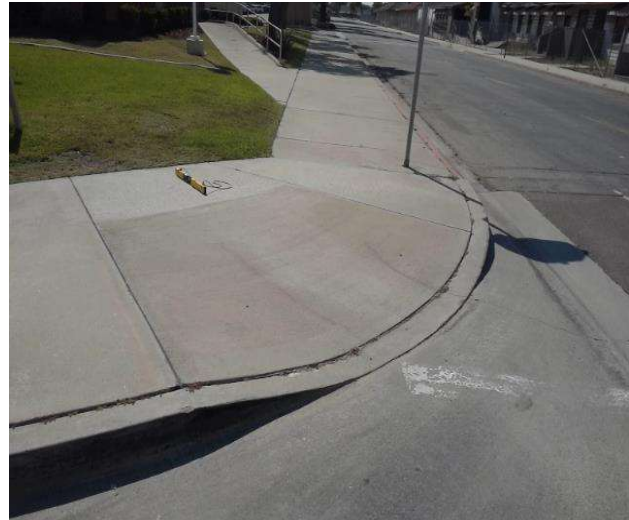
Curb Ramp , Landings and Transitions : Bottom Landing Change in Level - Curb Ramps

Patch lip at curb ramp \$255

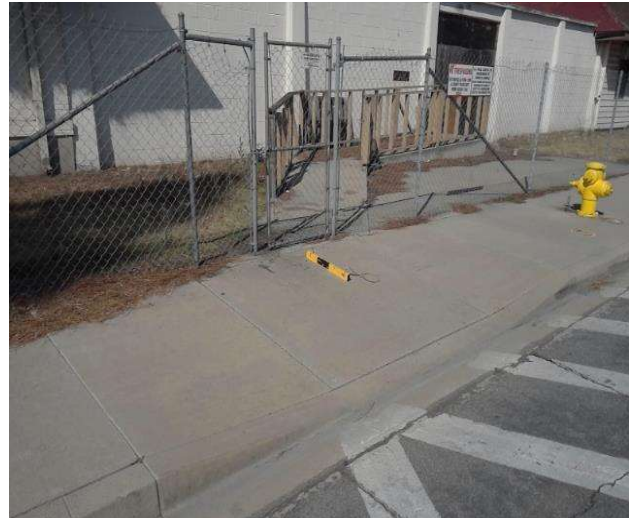
**On-Site Finding** Not Found

Provide detectable warning to surface \$248

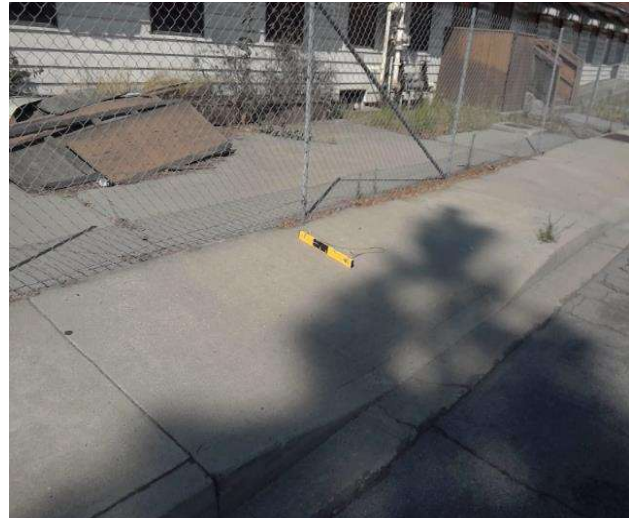
**On-Site Finding** Not Found

Provide detectable warning to surface \$248

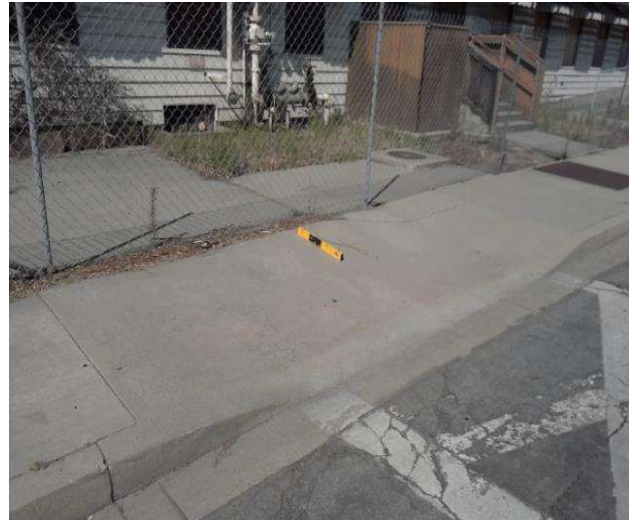
**On-Site Finding** Not Found

Provide detectable warning to surface \$248

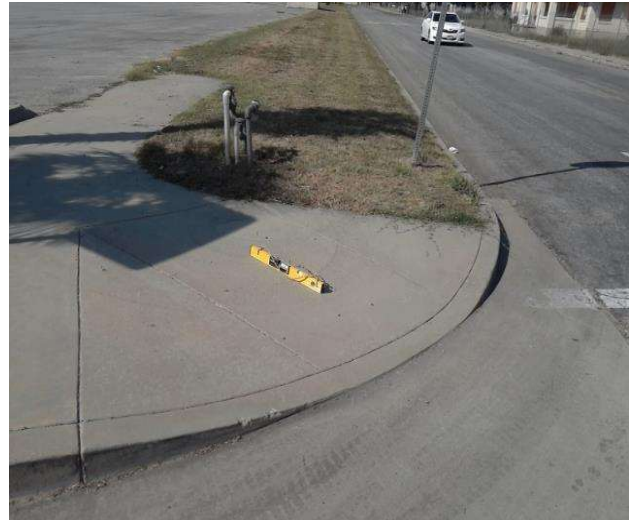
**On-Site Finding** Not Found

Provide detectable warning to surface \$248

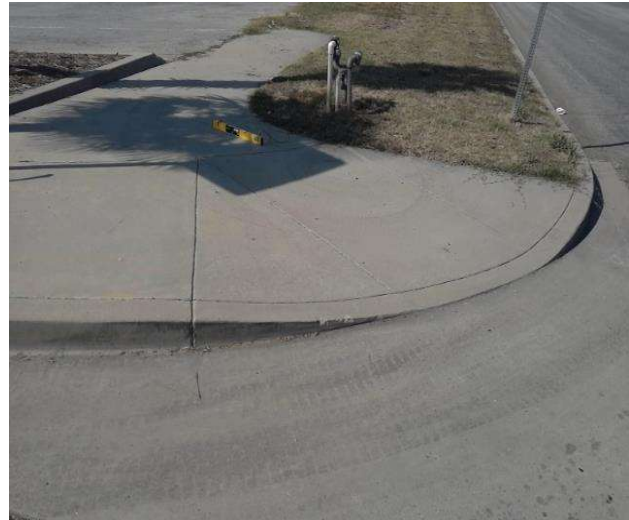
Curb Ramp , Landings and Transitions : Bottom Landing Change in Level - Curb Ramps

Patch lip at curb ramp \$255

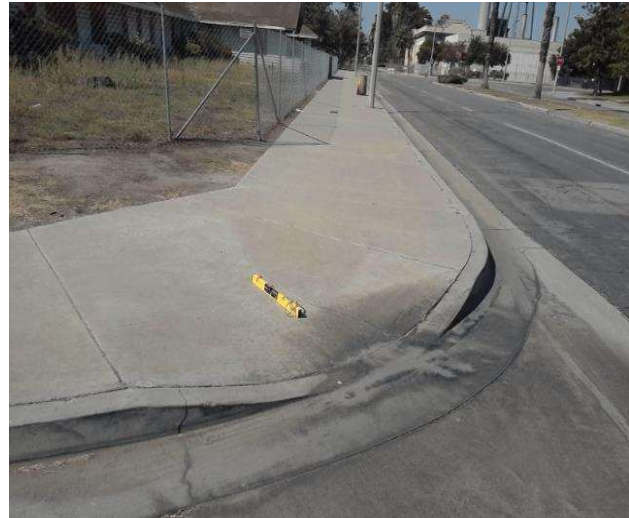
**On-Site Finding** Not Found

Provide detectable warning to surface \$248

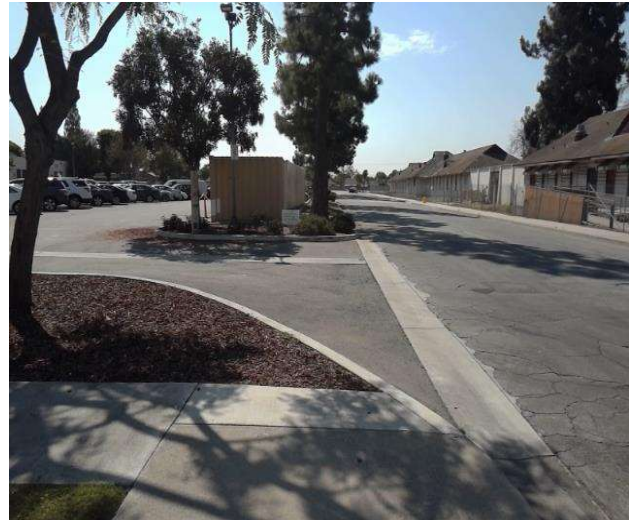
Sidewalks : Missing Sidewalk

Section of sidewalk is missing and consists of dirt, grass or gravel.

Provide a compliant sidewalk for the missing section.

\$1,260

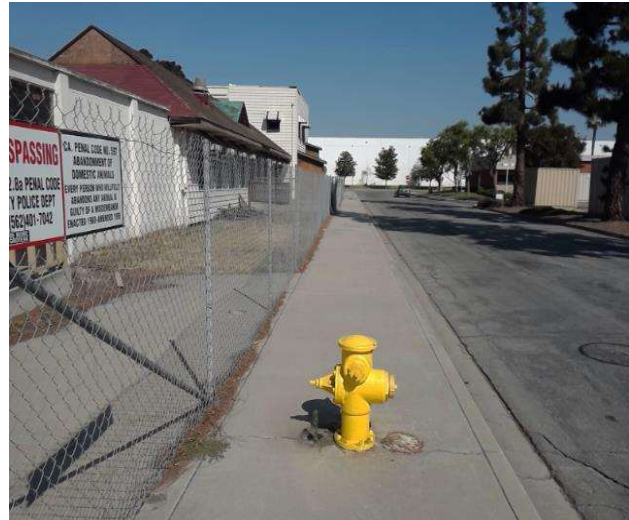
Sidewalks , Hazards & Gratings : Sidewalk Width at Obstruction

Sidewalk width at the obstruction shall have the recommended value.

Recommendation At least 48.00 inches

\$1,260
