Accessibility Survey

City of Downey

Newville Avenue - Ardine Street To La Villa Street

Date of Inspection
5/4/2017

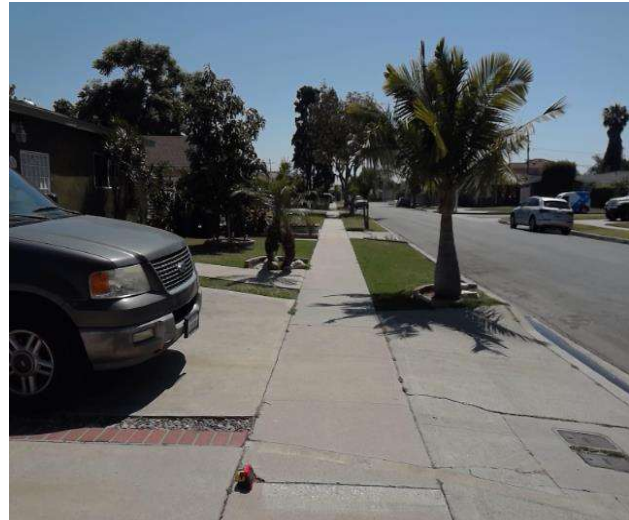
Change In Level South Of La Villa Street @ 33.932367076582, -118.110400736332

Sidewalks , Change in Level : Change in Level Non Beveled

There is a change in elevation greater than recommended value.

On-Site Finding 0.62 inches

Ensure that the change in elevation is within the recommended value.

Recommendation Up to 0.25 inches

Remove tripping hazards \$198

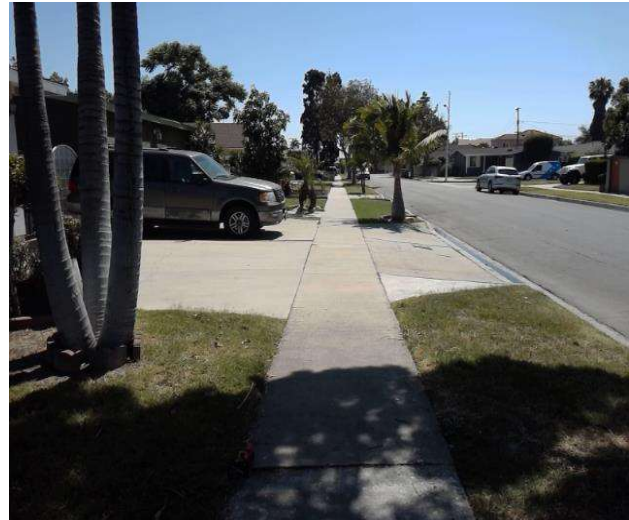
Change In Level South Of La Villa Street @ 33.932469445886, -118.110328316689

Sidewalks , Change in Level : Change in Level Non Beveled

There is a change in elevation greater than recommended value.

On-Site Finding 0.50 inches

Ensure that the change in elevation is within the recommended value.

Recommendation Up to 0.25 inches

Remove tripping hazards \$198

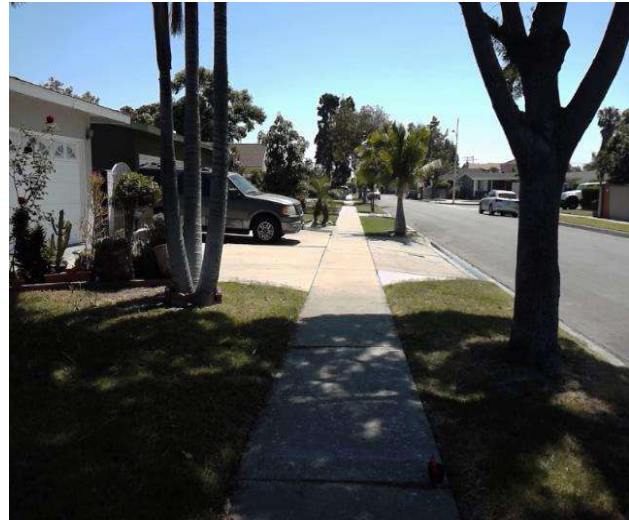
Change In Level South Of La Villa Street @ 33.932491, -118.110312223434

Sidewalks , Change in Level : Change in Level Non Beveled

There is a change in elevation greater than recommended value.

On-Site Finding 0.62 inches

Ensure that the change in elevation is within the recommended value.

Recommendation Up to 0.25 inches

Remove tripping hazards \$198

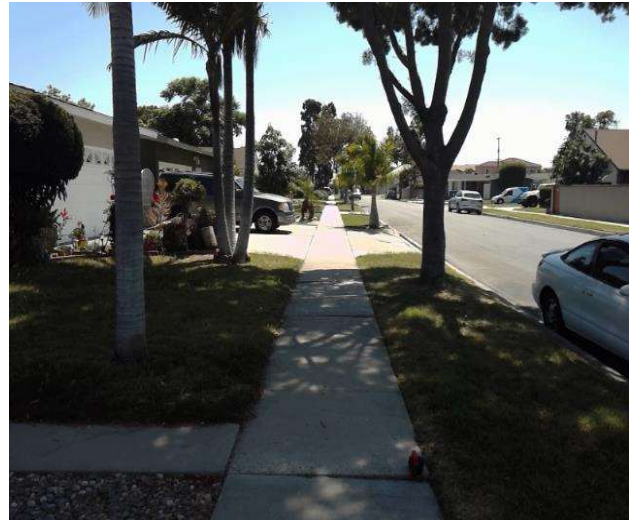
Change In Level South Of La Villa Street @ 33.932502827154, -118.110290765762

Sidewalks , Change in Level : Change in Level Non Beveled

There is a change in elevation greater than recommended value.

On-Site Finding 0.62 inches

Ensure that the change in elevation is within the recommended value.

Recommendation Up to 0.25 inches

Remove tripping hazards \$198

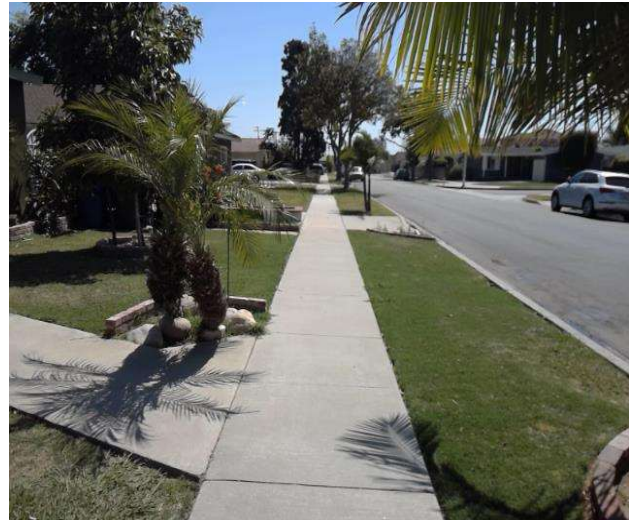
Sidewalk South Of La Villa Street @ 33.932295863081, -118.110449016094

Sidewalks , Surface : Cross Slope

Sidewalk cross slope is not compliant.

On-Site Finding 3.10 percent for 20.00 feet

Repave the sidewalk surface with the recommended cross slope.

Recommendation Up to 2.08 percent

Repave surface \$1,092

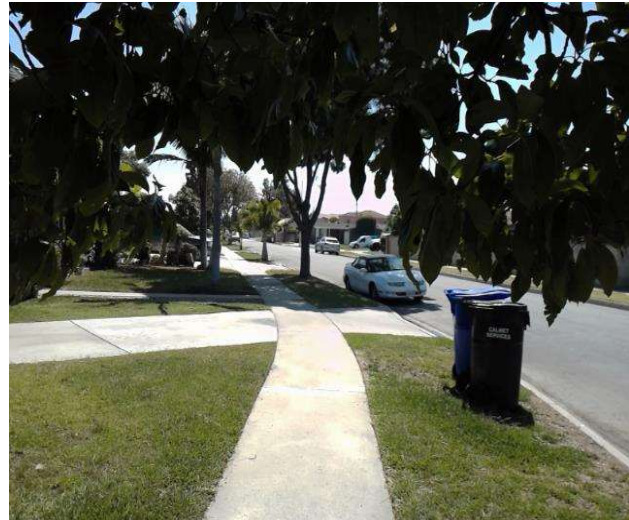
Tree South Of La Villa Street @ 33.932585167559, -118.110218346119

Sidewalks , Hazards & Gratings : Overhead Obstruction Height

Overhead obstruction height is not compliant.

On-Site Finding 68.00 inches

Provide a compliant vertical clearance height.

Recommendation At least 80.00 inches

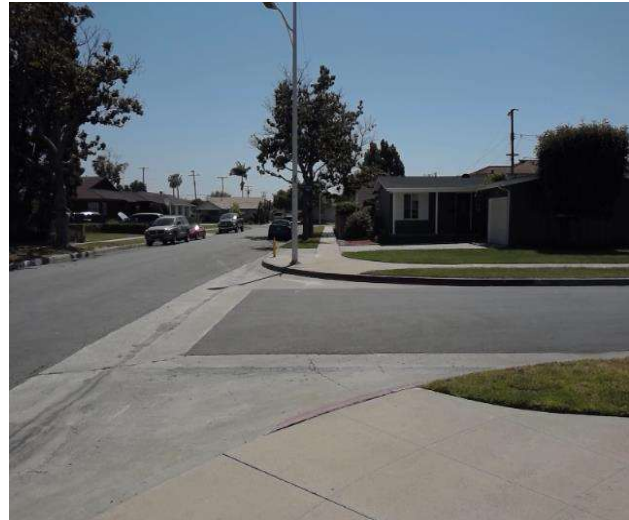
Northwest Corner Of Fostoria Street @ 33.932142308767, -118.110757470131

Sidewalks , Hazards & Gratings : Curb is on Path of Travel

There is a curb on the designated path of travel.

On-Site Finding Not Compliant

Provide a compliant curb ramp.

Install curb ramp \$2,500

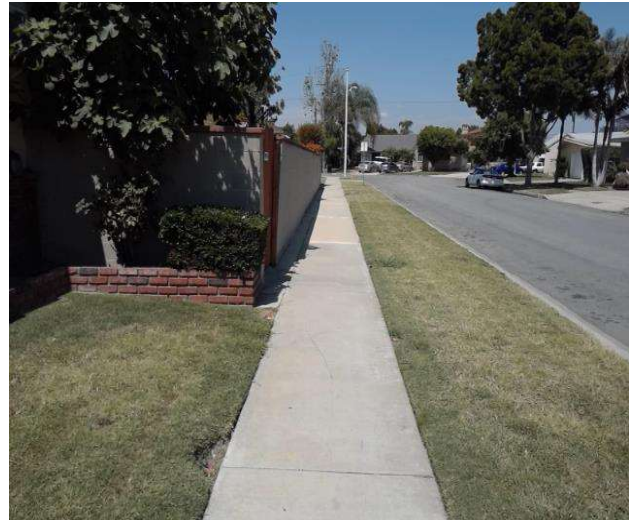
Sidewalk North Of Fostoria Street @ 33.932255805461, -118.110674321651

Sidewalks , Surface : Cross Slope

Sidewalk cross slope is not compliant.

On-Site Finding 4.10 percent for 10.00 feet

Repave the sidewalk surface with the recommended cross slope.

Recommendation Up to 2.08 percent

Repave surface \$1,092

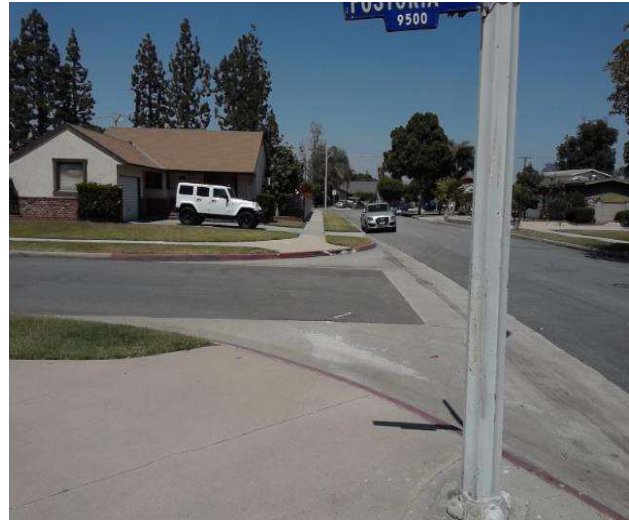
Southwest Corner Of Fostoria Street @ 33.932046615359, -118.110824525356

Sidewalks , Hazards & Gratings : Curb is on Path of Travel

There is a curb on the designated path of travel.

On-Site Finding Not Compliant

Provide a compliant curb ramp.

Install curb ramp \$2,500

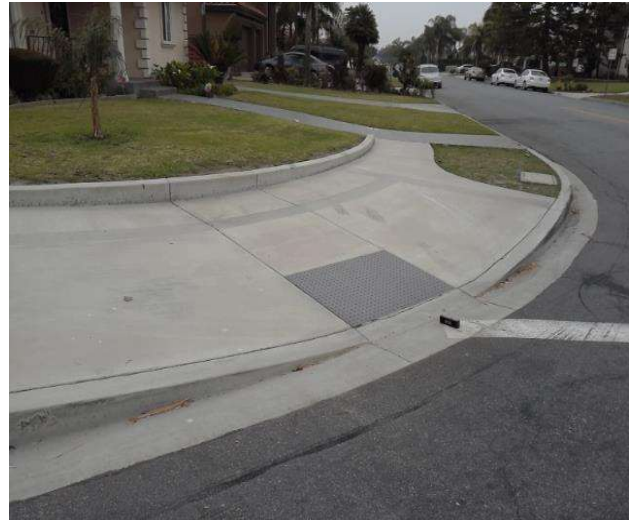
Southeast Corner Of Florence Avenue @ 33.940763175979, - 118.104234337807

Curb Ramp : Bottom Landing Slope

The bottom landing of the curb ramp is on the street, and the slope of the bottom landing is not compliant.

On-Site Finding 12.60 percent

Ensure the bottom landing slope is compliant and provides a smooth transition.

Recommendation Up to 5.00 percent

Repave landing \$1,260

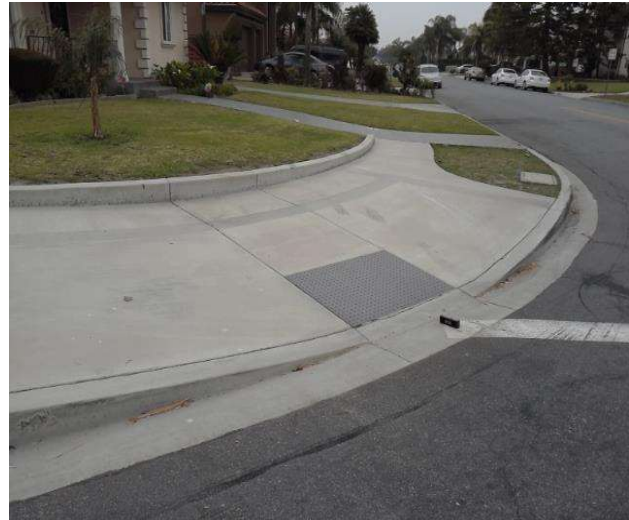
Southeast Corner Of Florence Avenue @ 33.940763175979, - 118.104234337807

Curb Ramp , Landings and Transitions : Top Landing Clear Length - Landings

There is not enough top landing clear length.

On-Site Finding 46.00 inches

Provide a level top landing with enough clear length.

Recommendation At least 48.00 inches

Provide compliant landing \$240

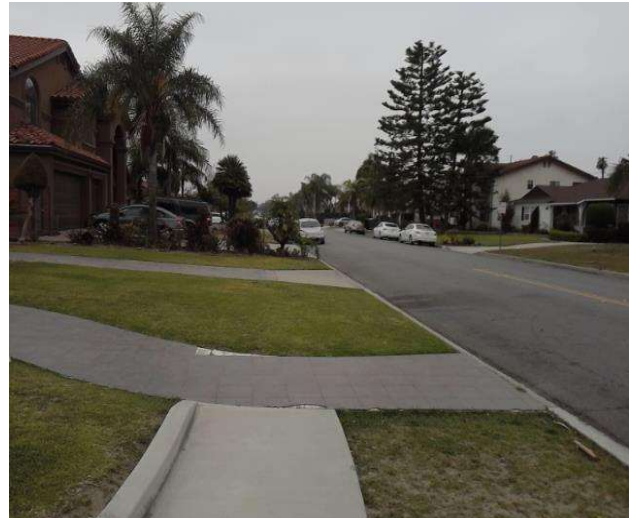
East Side @ 33.940714221531, -118.104277253151

Sidewalks : No Sidewalk

No sidewalk exists at the location.

No action necessary until a sidewalk is provided.

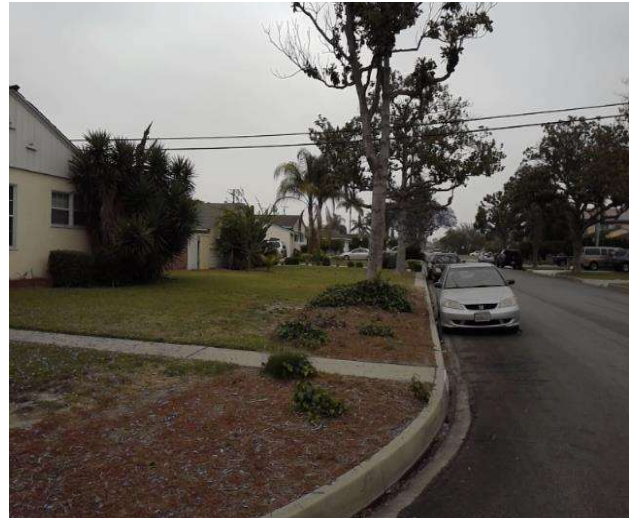
West Side @ 33.936980249309, -118.107171356678

Sidewalks : No Sidewalk

No sidewalk exists at the location.

No action necessary until a sidewalk is provided.

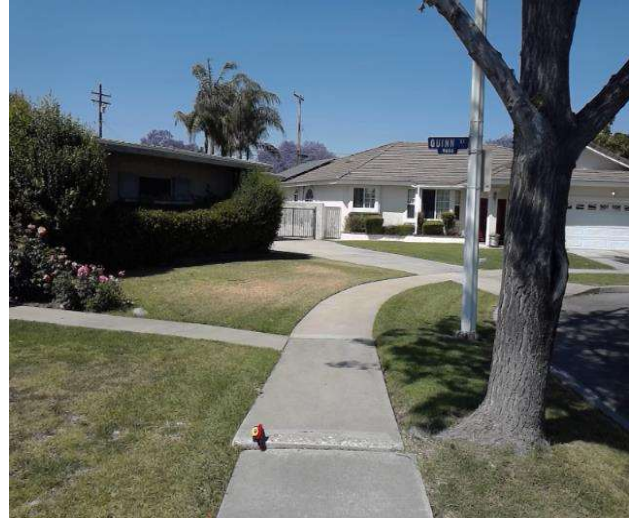
Change In Level North Of Mueller Street @ 33.936141306918, -118.107536137104

Sidewalks , Change in Level : Change in Level Non Beveled

There is a change in elevation greater than recommended value.

On-Site Finding 1.50 inches

Ensure that the change in elevation is within the recommended value.

Recommendation Up to 0.25 inches

Remove tripping hazards \$198

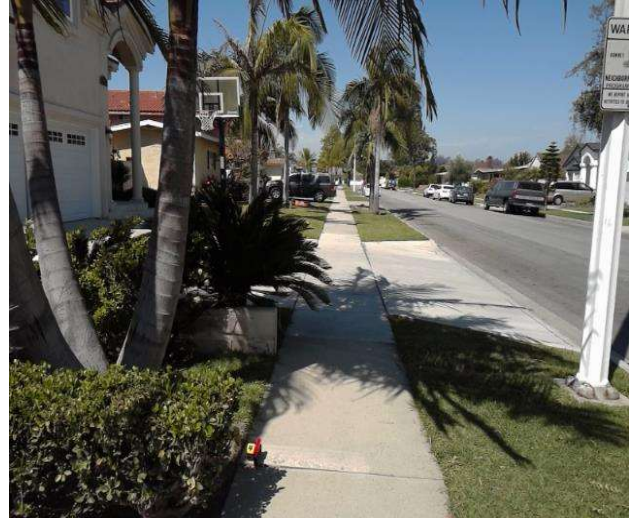
Change In Level North Of Mueller Street @ 33.934952976495, -118.108351528645

Sidewalks , Change in Level : Change in Level Non Beveled

There is a change in elevation greater than recommended value.

On-Site Finding 0.50 inches

Ensure that the change in elevation is within the recommended value.

Recommendation Up to 0.25 inches

Remove tripping hazards \$198

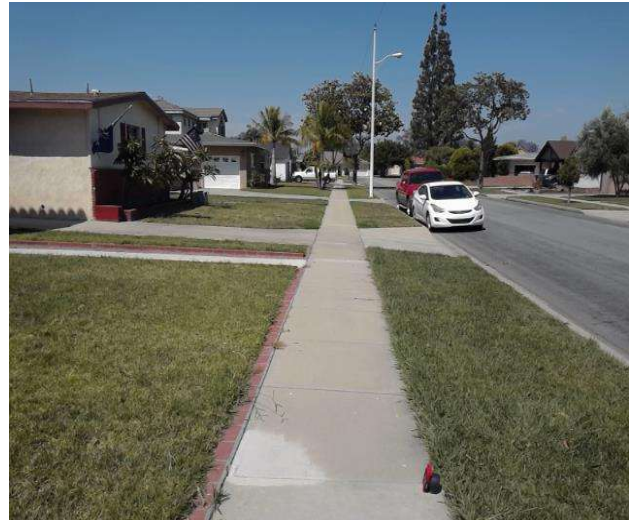
Change In Level North Of Mueller Street @ 33.935315708326, -118.108088672161

Sidewalks , Change in Level : Change in Level Non Beveled

There is a change in elevation greater than recommended value.

On-Site Finding 0.50 inches

Ensure that the change in elevation is within the recommended value.

Recommendation Up to 0.25 inches

Remove tripping hazards \$198

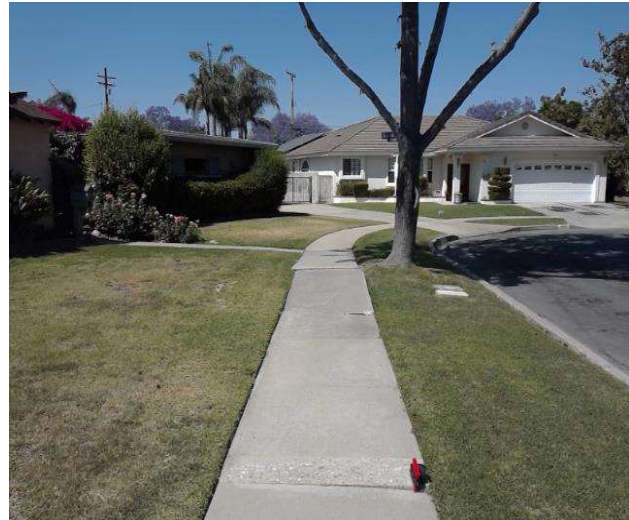
Change In Level North Of Mueller Street @ 33.936107927076, -118.107544183731

Sidewalks , Change in Level : Change in Level Non Beveled

There is a change in elevation greater than recommended value.

On-Site Finding 0.62 inches

Ensure that the change in elevation is within the recommended value.

Recommendation Up to 0.25 inches

Remove tripping hazards \$198

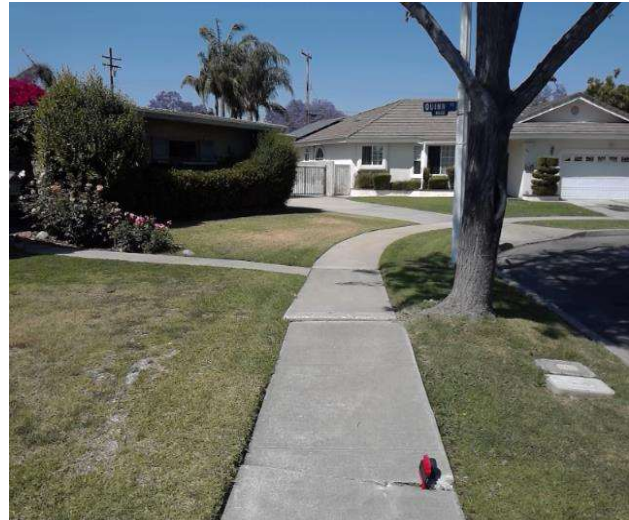
Change In Level North Of Mueller Street @ 33.936127954983, -118.107536137104

Sidewalks , Change in Level : Change in Level Non Beveled

There is a change in elevation greater than recommended value.

On-Site Finding 0.62 inches

Ensure that the change in elevation is within the recommended value.

Recommendation Up to 0.25 inches

Remove tripping hazards \$198

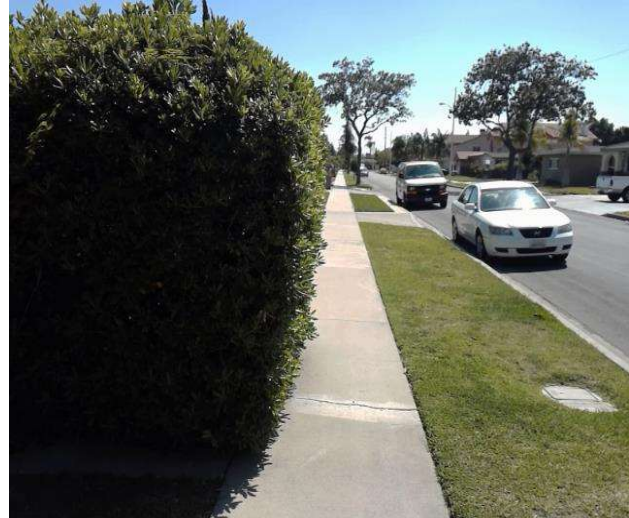
Bush South Of Quinn Street @ 33.934996370875, -118.108206689358

Sidewalks , Hazards & Gratings : Sidewalk Width at Obstruction

Sidewalk width at the obstruction is not compliant.

On-Site Finding 39.00 inches

Sidewalk width at the obstruction shall have the recommended value.

Recommendation At least 48.00 inches

\$1,260

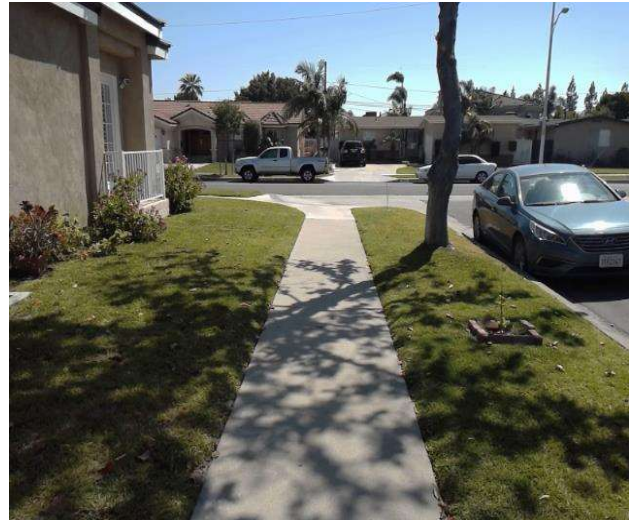
Sidewalk South Of Quinn Street @ 33.934996370875, -118.108413219452

Sidewalks , Surface : Cross Slope

Sidewalk cross slope is not compliant.

On-Site Finding 3.80 percent for 25.00 feet

Repave the sidewalk surface with the recommended cross slope.

Recommendation Up to 2.08 percent

Repave surface \$1,092

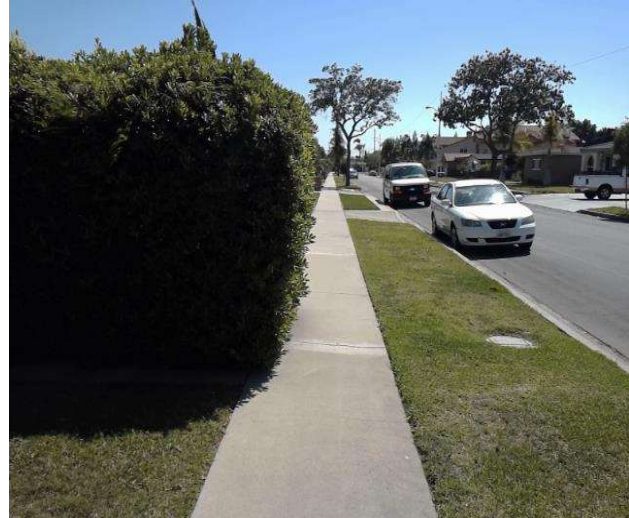
Sidewalk South Of Quinn Street @ 33.935184412934, -118.108413219452

Sidewalks , Surface : Cross Slope

Sidewalk cross slope is not compliant.

On-Site Finding 4.40 percent for 15.00 feet

Repave the sidewalk surface with the recommended cross slope.

Recommendation Up to 2.08 percent

Repave surface \$1,092

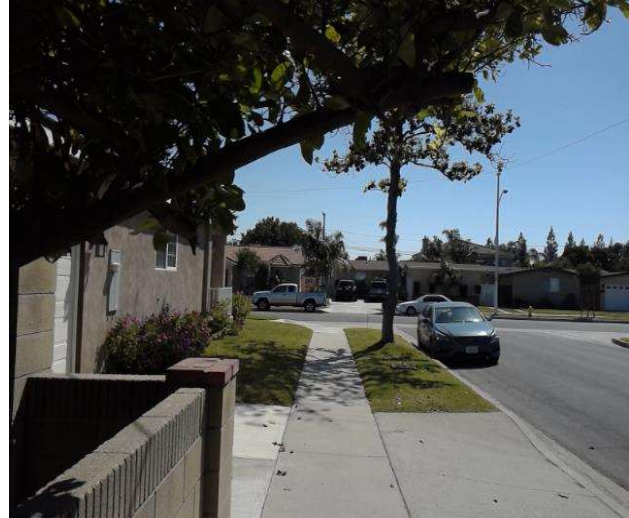
Tree South Of Quinn Street @ 33.934697060469, -118.108343482018

Sidewalks , Hazards & Gratings : Overhead Obstruction Height

Overhead obstruction height is not compliant.

On-Site Finding 76.50 inches

Provide a compliant vertical clearance height.

Recommendation At least 80.00 inches

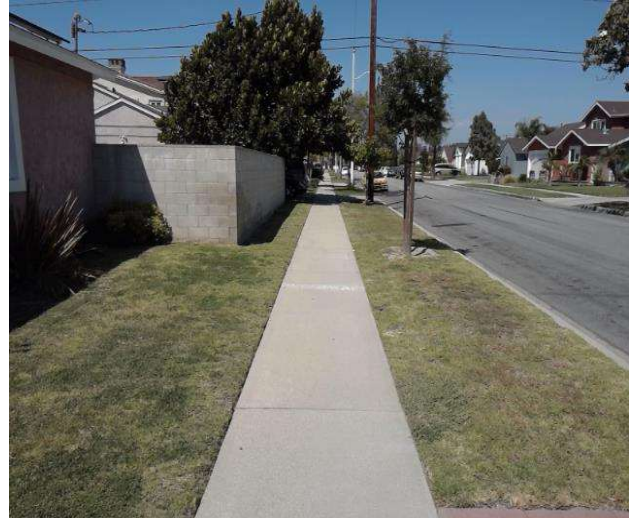
Sidewalk North Of Mueller Street @ 33.934659229339, -118.108560740948

Sidewalks , Surface : Cross Slope

Sidewalk cross slope is not compliant.

On-Site Finding 4.10 percent for 45.00 feet

Repave the sidewalk surface with the recommended cross slope.

Recommendation Up to 2.08 percent

Repave surface \$1,092

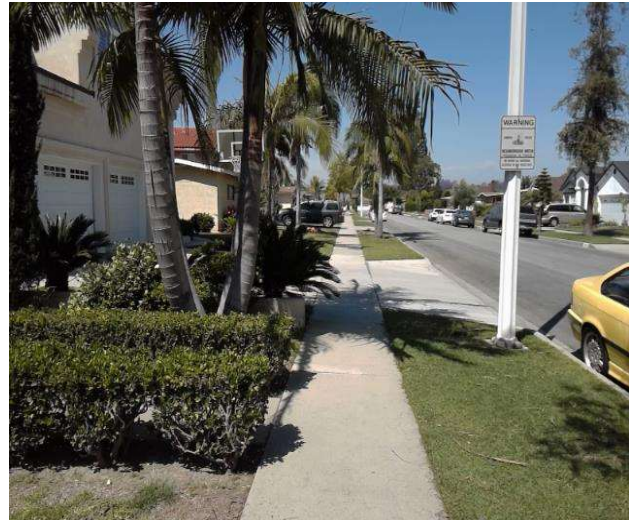
Sidewalk North Of Mueller Street @ 33.934941849727, -118.108367621899

Sidewalks , Surface : Cross Slope

Sidewalk cross slope is not compliant.

On-Site Finding 4.80 percent for 15.00 feet

Repave the sidewalk surface with the recommended cross slope.

Recommendation Up to 2.08 percent

Repave surface \$1,092

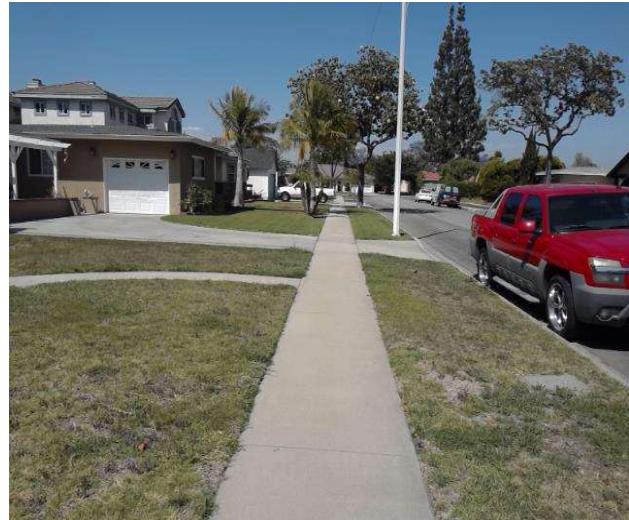
Sidewalk North Of Mueller Street @ 33.935420299426, -118.108013570309

Sidewalks , Surface : Cross Slope

Sidewalk cross slope is not compliant.

On-Site Finding 4.10 percent for 75.00 feet

Repave the sidewalk surface with the recommended cross slope.

Recommendation Up to 2.08 percent

Repave surface \$1,092
