Accessibility Survey

City of Downey Pico Vista Road - End to Cul-De-Sac

Date of Inspection
6/9/2017

Prepared By
Disability Access Consultants
(800) 743-7067

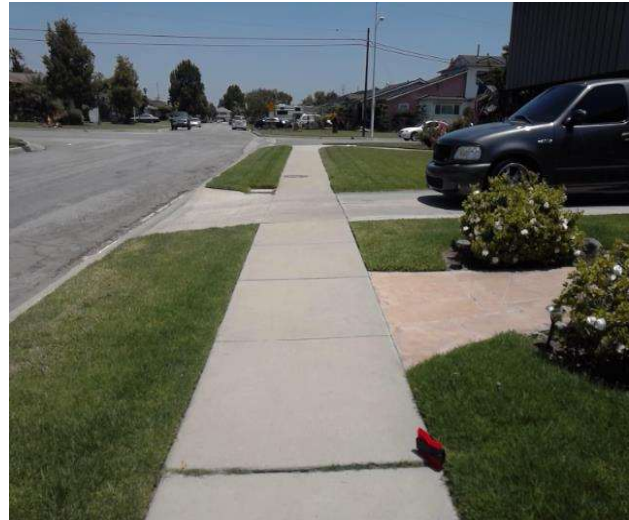
Change in Level South of Via Amorita @ 33.936558553835, -118.104589730501

Sidewalks , Change in Level : Change in Level Non Beveled

There is a change in elevation greater than recommended value.

On-Site Finding 0.62 inches

Code Reference ADA 206, 302

Ensure that the change in elevation is within the recommended value.

Recommendation Up to 0.25 inches

Remove tripping hazards \$198

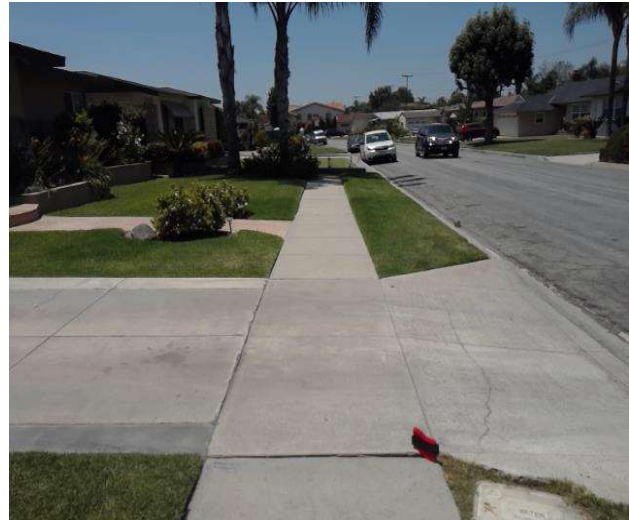
Change in Level South of Via Amorita @ 33.936614186603, -118.104536086321

Sidewalks , Change in Level : Change in Level Non Beveled

There is a change in elevation greater than recommended value.

On-Site Finding 1.00 inches

Code Reference ADA 206, 302

Ensure that the change in elevation is within the recommended value.

Recommendation Up to 0.25 inches

Remove tripping hazards \$198

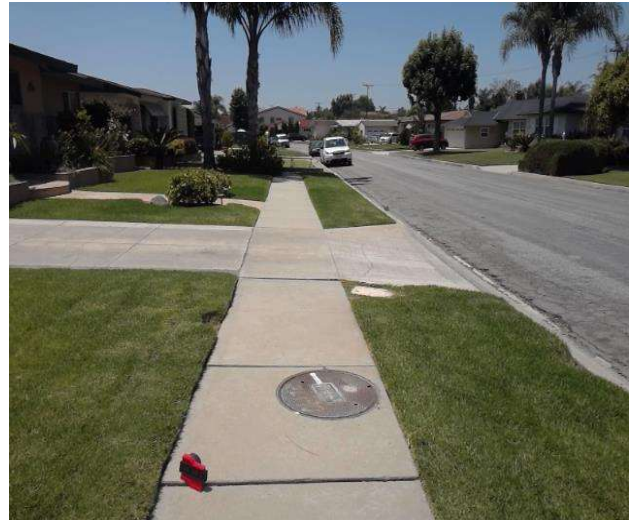
Change in Level South of Via Amorita @ 33.936642002973, -118.104507923126

Sidewalks , Change in Level : Change in Level Non Beveled

There is a change in elevation greater than recommended value.

On-Site Finding 0.75 inches

Code Reference ADA 206, 302

Ensure that the change in elevation is within the recommended value.

Recommendation Up to 0.25 inches

Remove tripping hazards \$198

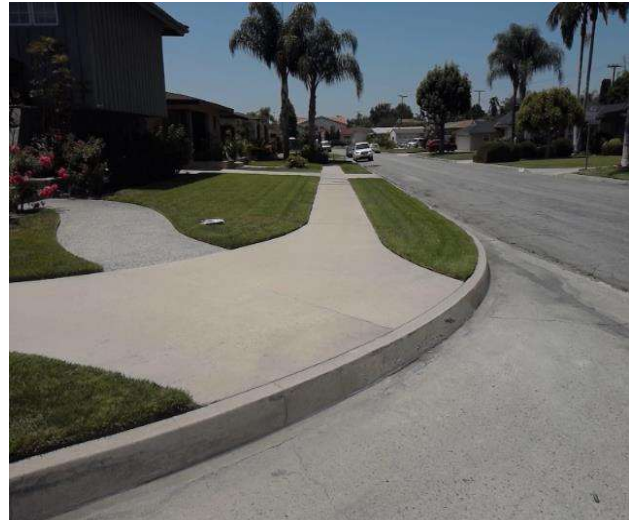
Curb Southeast Corner of Via Amorita @ 33.936746592444, -118.104407340288

Sidewalks , Hazards & Gratings : Curb is on Path of Travel

There is a curb on the designated path of travel.

On-Site Finding Not Compliant

Code Reference ADA 402, 303, 406, 403.4, 303.4

Provide a compliant curb ramp.

Install curb ramp \$2,500

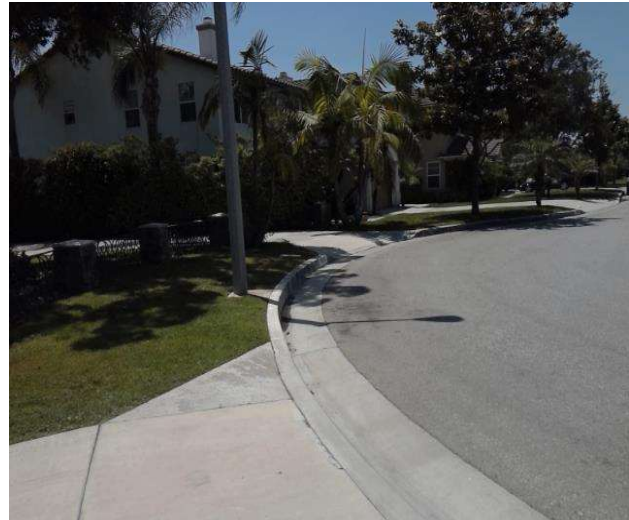
Sidewalk South of Cul-De-Sac @ 33.939469211447, -118.102478832006

Sidewalks : Missing Sidewalk

Section of sidewalk is missing and consists of dirt, grass or gravel.

On-Site Finding 1100.00 feet

Code Reference ADA 206, 302,CA 11B-302,CA 11B-206

Provide a compliant sidewalk for the missing section.

\$1,260

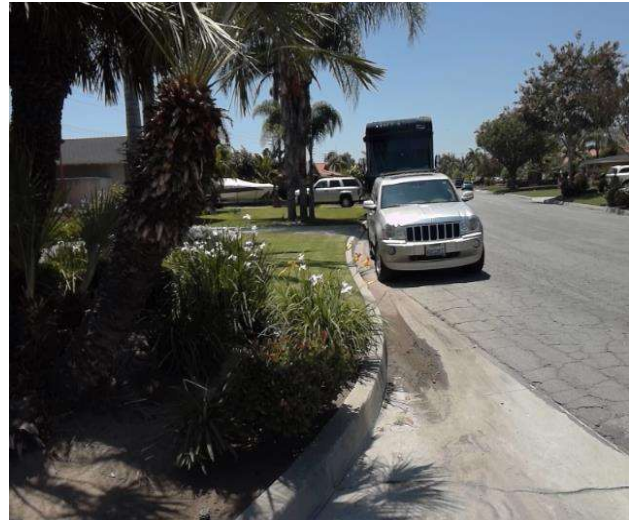
Sidewalk South of Gaybrook Avenue @ 33.935292342212, -118.105261623859

Sidewalks : Missing Sidewalk

Section of sidewalk is missing and consists of dirt, grass or gravel.

On-Site Finding 1482.00 feet

Code Reference ADA 206, 302,CA 11B-302,CA 11B-206

Provide a compliant sidewalk for the missing section.

\$1,260

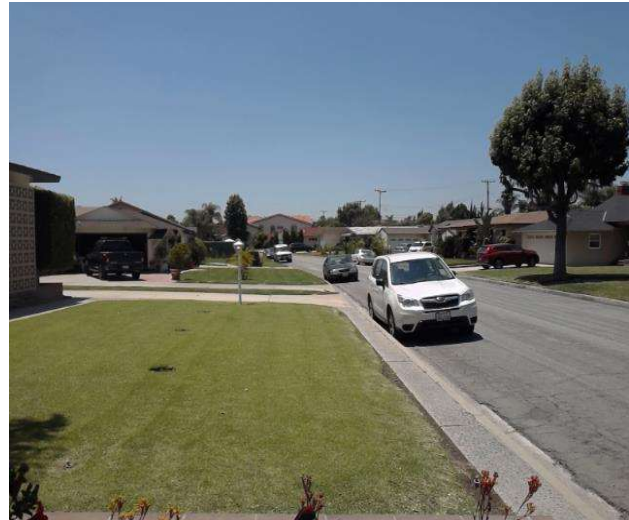
Sidewalk South of Via Amorita @ 33.936480667899, -118.104664832354

Sidewalks : Missing Sidewalk

Section of sidewalk is missing and consists of dirt, grass or gravel.

On-Site Finding 440.00 feet

Code Reference ADA 206, 302,CA 11B-302,CA 11B-206

Provide a compliant sidewalk for the missing section.

\$1,260

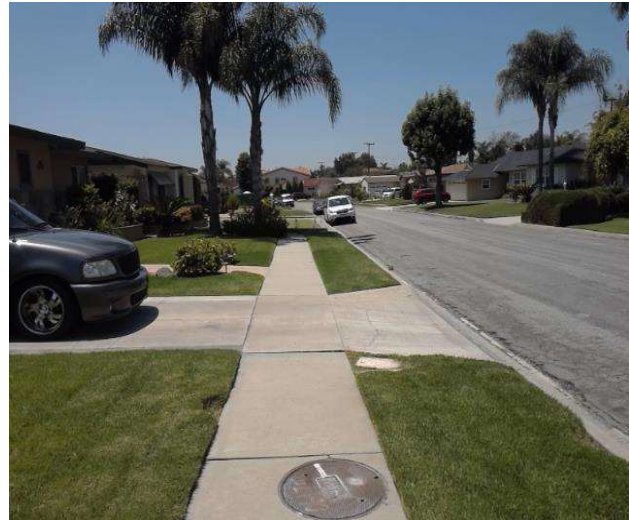
Sidewalk South of Via Amorita @ 33.936628651117, -118.104526698589

Sidewalks , Surface : Cross Slope

Sidewalk cross slope is not compliant.

On-Site Finding 4.30 percent for 68.50 feet

Code Reference ADA 206, 302, CA 11B-403.3

Repave the sidewalk surface with the recommended cross slope.

Recommendation Up to 2.08 percent

Repave surface \$1,092

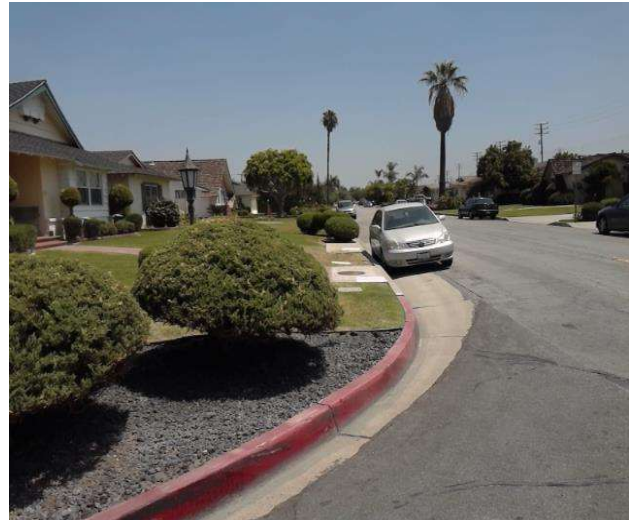
Sidewalk North of Cecilia Street @ 33.932360400319, -118.107679635286

Sidewalks : Missing Sidewalk

Section of sidewalk is missing and consists of dirt, grass or gravel.

On-Site Finding 1615.00 feet

Code Reference ADA 206, 302,CA 11B-302,CA 11B-206

Provide a compliant sidewalk for the missing section.

\$1,260

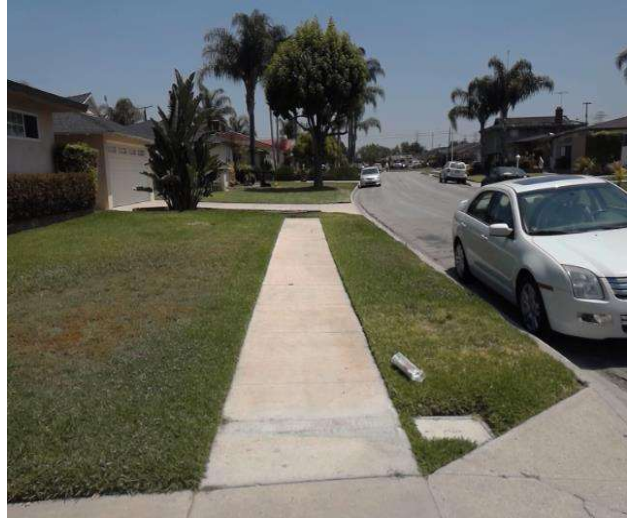
Sidewalk North of Cecilia Street @ 33.936170236104, -118.105130195618

Sidewalks , Surface : Cross Slope

Sidewalk cross slope is not compliant.

On-Site Finding 3.50 percent for 48.00 feet

Code Reference ADA 206, 302, CA 11B-403.3

Repave the sidewalk surface with the recommended cross slope.

Recommendation Up to 2.08 percent

Repave surface \$1,092

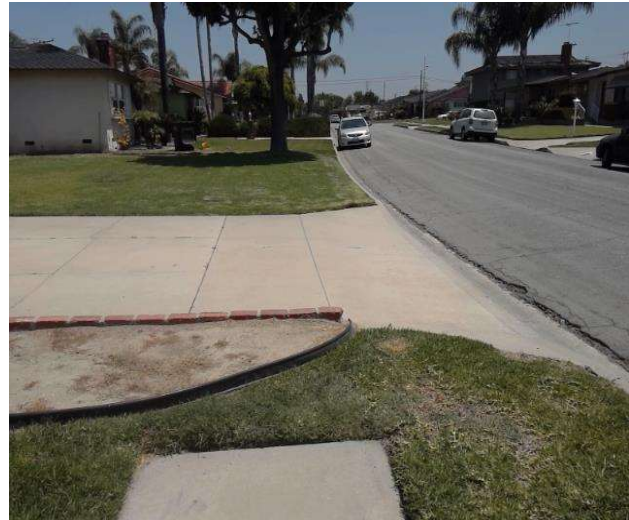
Sidewalk North of Cecilia Street @ 33.936328233790, -118.105008155108

Sidewalks : Missing Sidewalk

Section of sidewalk is missing and consists of dirt, grass or gravel.

On-Site Finding 247.00 feet

Code Reference ADA 206, 302,CA 11B-302,CA 11B-206

Provide a compliant sidewalk for the missing section.

\$1,260

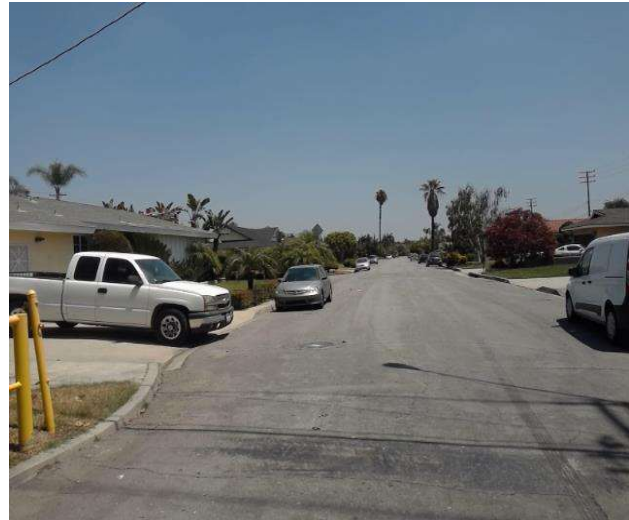
Sidewalk North of End @ 33.931993205038, -118.107876777649

Sidewalks : Missing Sidewalk

Section of sidewalk is missing and consists of dirt, grass or gravel.

On-Site Finding 112.00 feet

Code Reference ADA 206, 302,CA 11B-302,CA 11B-206

Provide a compliant sidewalk for the missing section.

\$1,260

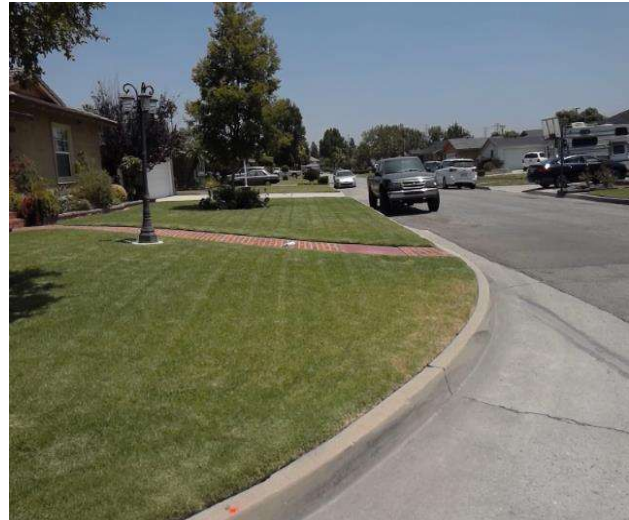
Sidewalk North of Via Amorita @ 33.936936855940, -118.104436844587

Sidewalks : Missing Sidewalk

Section of sidewalk is missing and consists of dirt, grass or gravel.

On-Site Finding 1135.00 feet

Code Reference ADA 206, 302,CA 11B-302,CA 11B-206

Provide a compliant sidewalk for the missing section.

\$1,260

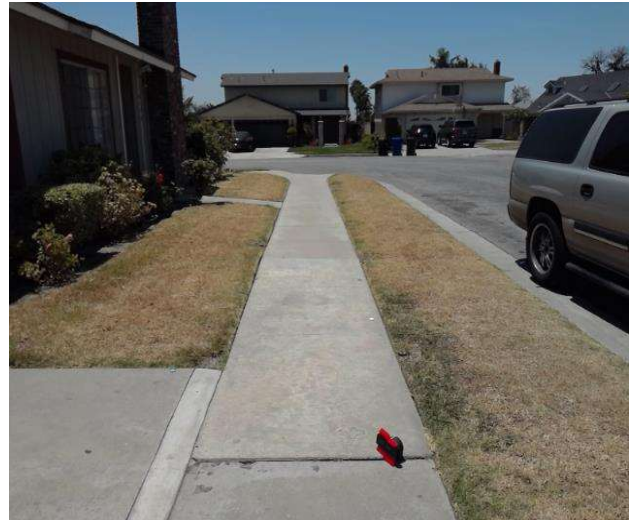
Change in Level East of Telegraph Road @ 33.950966226167, -118.095739781857

Sidewalks , Change in Level : Change in Level Non Beveled

There is a change in elevation greater than recommended value.

On-Site Finding 0.50 inches

Code Reference ADA 206, 302

Ensure that the change in elevation is within the recommended value.

Recommendation Up to 0.25 inches

Remove tripping hazards \$198

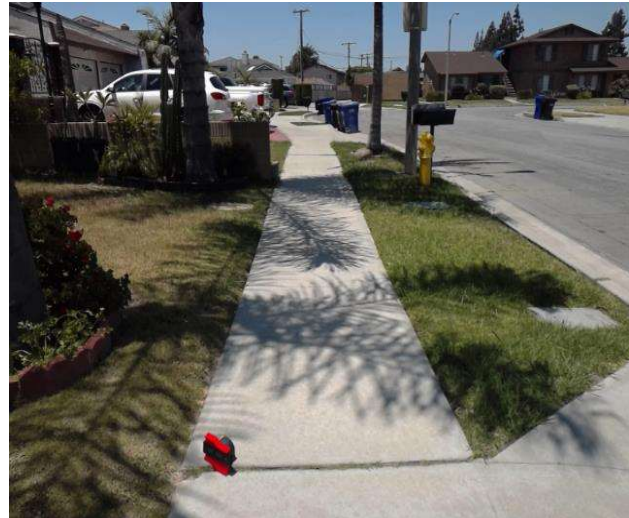
Change in Level West of Cul-De-Sac @ 33.950535700189, -118.095580190420

Sidewalks , Change in Level : Change in Level Non Beveled

There is a change in elevation greater than recommended value.

On-Site Finding 0.62 inches

Code Reference ADA 206, 302

Ensure that the change in elevation is within the recommended value.

Recommendation Up to 0.25 inches

Remove tripping hazards \$198

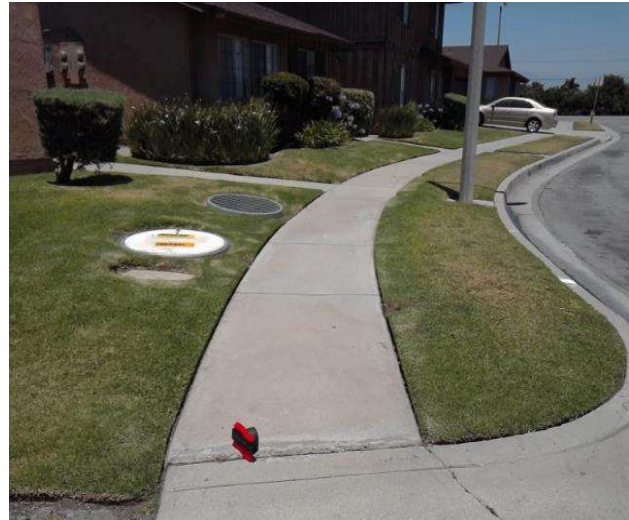
Change in Level West of Cul-De-Sac @ 33.950804918239, -118.096044212580

Sidewalks , Change in Level : Change in Level Non Beveled

There is a change in elevation greater than recommended value.

On-Site Finding 0.62 inches

Code Reference ADA 206, 302

Ensure that the change in elevation is within the recommended value.

Recommendation Up to 0.25 inches

Remove tripping hazards \$198

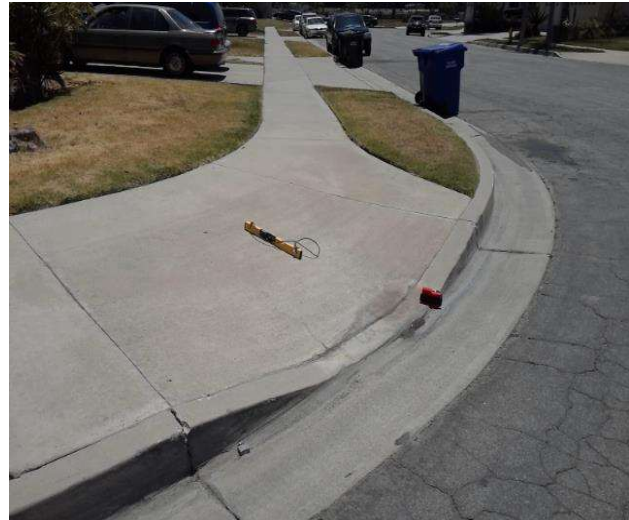
North Side East of Telegraph Road @ 33.950816042934, - 118.095839023590

Curb Ramp : No Detectable Warnings

The curb ramp does not provide a detectable warning surface which includes truncated domes.

On-Site Finding Not Found

Code Reference CA 11B-406.5.12

Provide compliant detectable warnings to surface.

Provide detectable warning to surface \$248

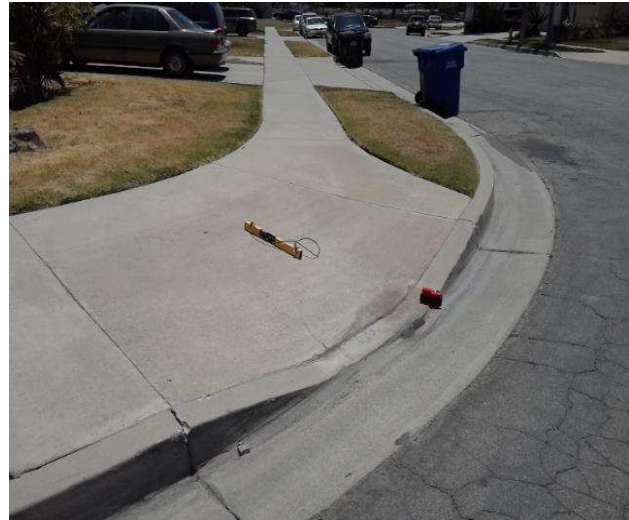
North Side East of Telegraph Road @ 33.950816042934, - 118.095839023590

Curb Ramp : Curb Ramp Width

The width of the curb ramp is less than required.

On-Site Finding 42.00 inches

Code Reference ADA 406, 406.1, 405.5, CA 11B-406.5.2

Provide a compliant curb ramp.

Recommendation At least 48.00 inches

Install curb ramp \$1,300

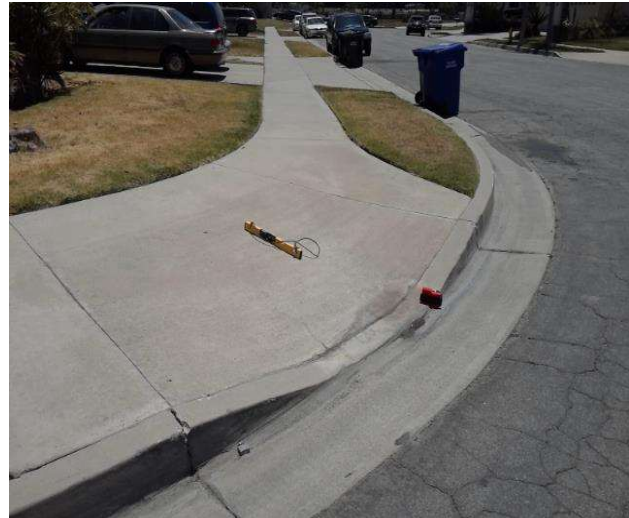
North Side East of Telegraph Road @ 33.950816042934, - 118.095839023590

Code Reference ADA 406, 406.1, 405.2, CA 11B-406

Recommendation Up to 8.33 percent

Install curb ramp \$1,300

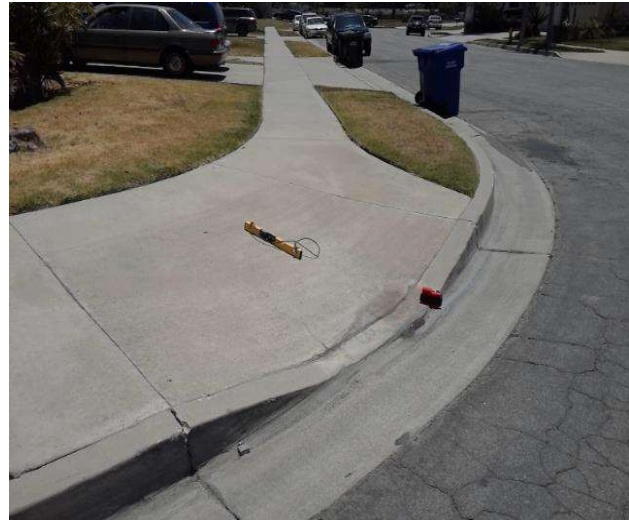
Code Reference ADA 402, 406.1, 405.3, CA 11B-406.5.7

Recommendation Up to 2.08 percent

Install curb ramp \$1,300

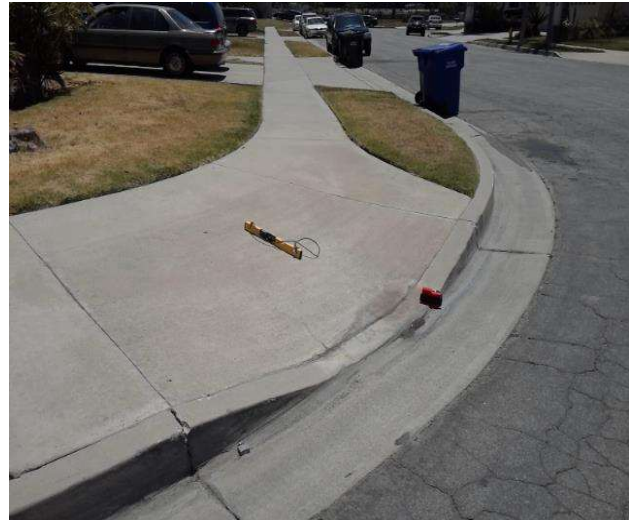
Code Reference ADA 406, 406.3, CA 11B-406.2.2

Recommendation Up to 10.00 percent

Install flared sides \$1,300

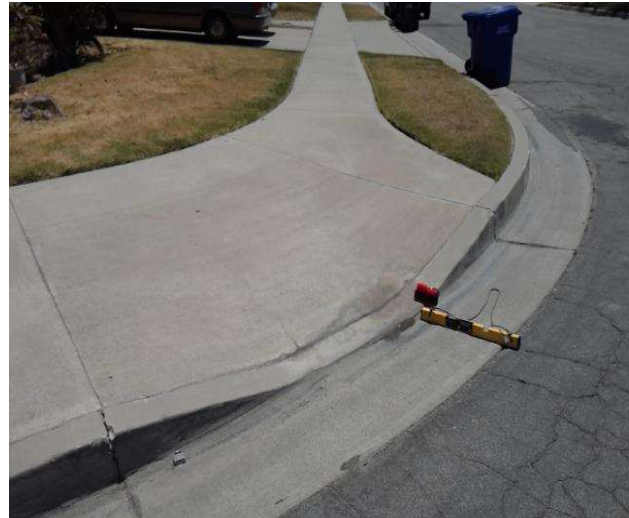
Code Reference ADA 406, 406.2, CA 11B-406.5.8

Recommendation Up to 5.00 percent

Repave landing \$1,260

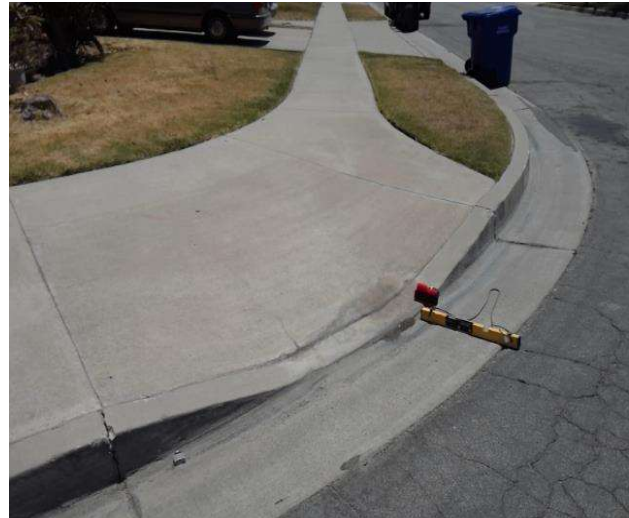
Curb Ramp , Landings And Transitions : Bottom Landing Change in Level

Code Reference ADA 302, 303, 406.2, 303.1

Recommendation Up to 0.50 inches

Patch lip at curb ramp \$255

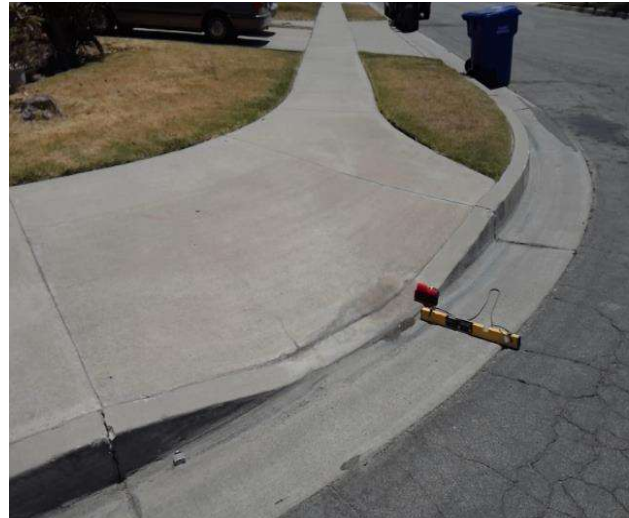
Code Reference ADA 402, 406.4, 403.3, 406.1, CA 11B-406.5.3

Recommendation Up to 2.08 percent

Provide compliant landing \$1,260

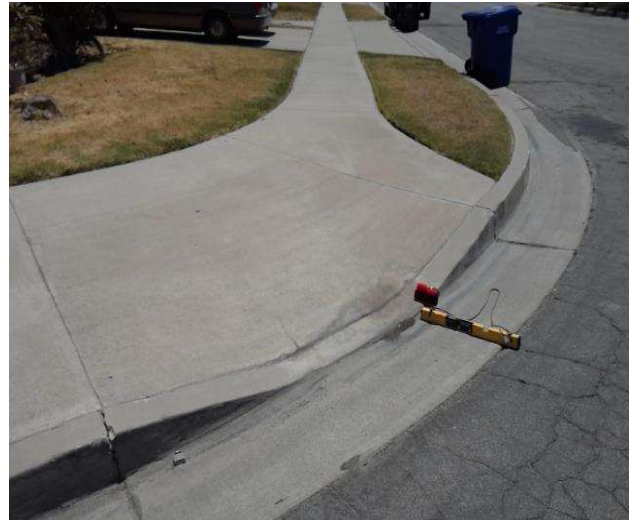
Code Reference ADA 406, 406.4,CA 11B-406.5.3

Recommendation At least 48.00 inches

Provide compliant landing \$240

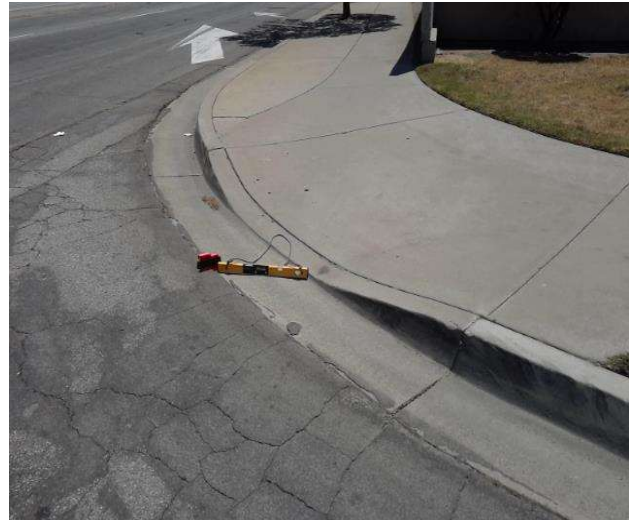
Curb Ramp , Landings And Transitions : Bottom Landing Change in Level

Code Reference ADA 302, 303, 406.2, 303.1

Recommendation Up to 0.50 inches

Patch lip at curb ramp \$255

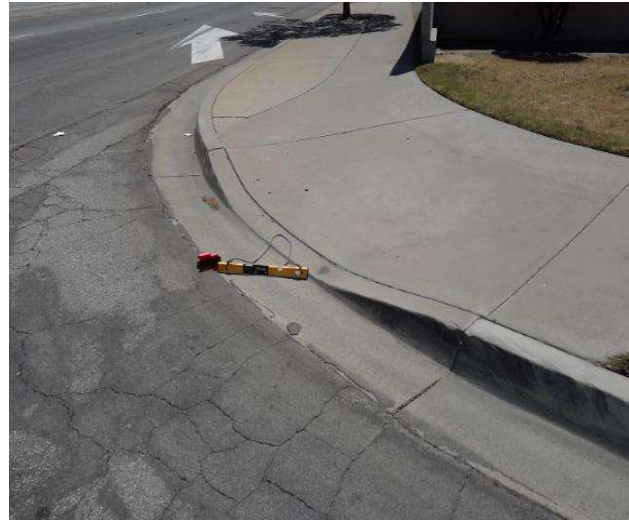
The overlayment causes a noncompliant change in level.

Code Reference ADA 303.2, 303.3,CA 11B-303.3,CA 11B-303.2

Ensure the change in elevation is within the recommended height.

Recommendation Up to 0.50 inches

Provide smooth surface \$150

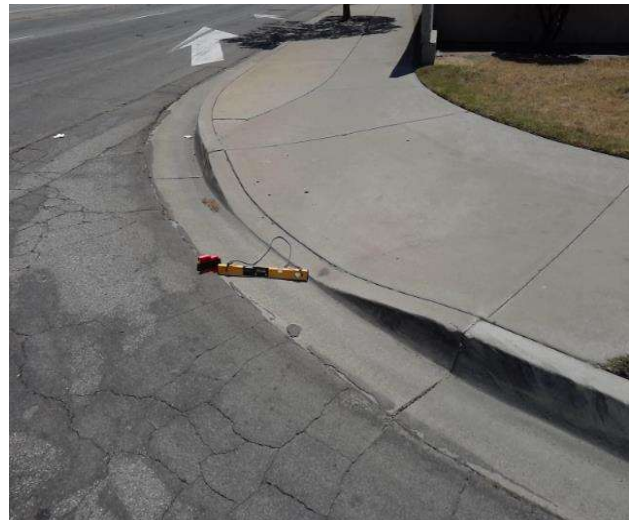
Code Reference ADA 402, 406.4, 403.3, 406.1, CA 11B-406.5.3

Recommendation Up to 2.08 percent

Provide compliant landing \$1,260

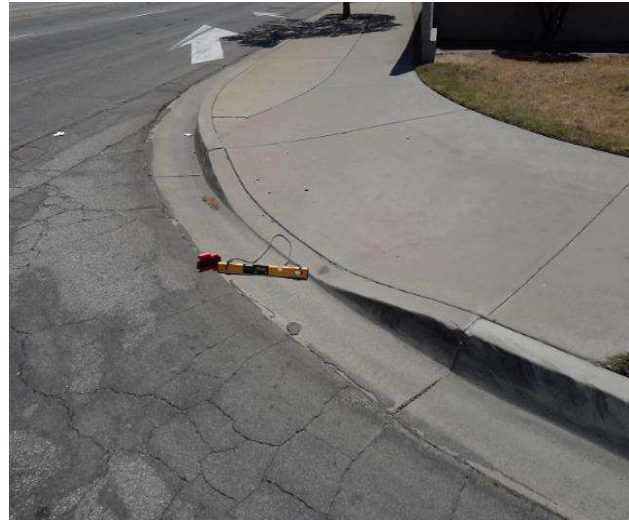
Curb Ramp , Landings and Transitions : Top Landing Clear Length - Landings

Code Reference ADA 406, 406.4,CA 11B-406.5.3

Recommendation At least 48.00 inches

Provide compliant landing \$240

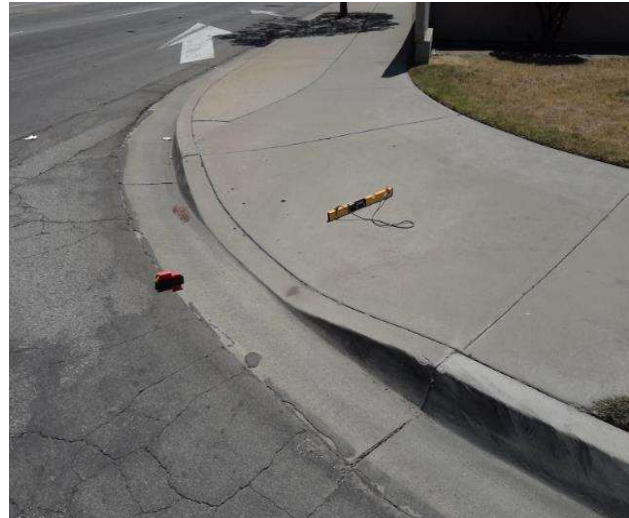
On-Site Finding Not Found

Code Reference CA 11B-406.5.12

Recommendation See Recommendation

Provide detectable warning to surface \$248

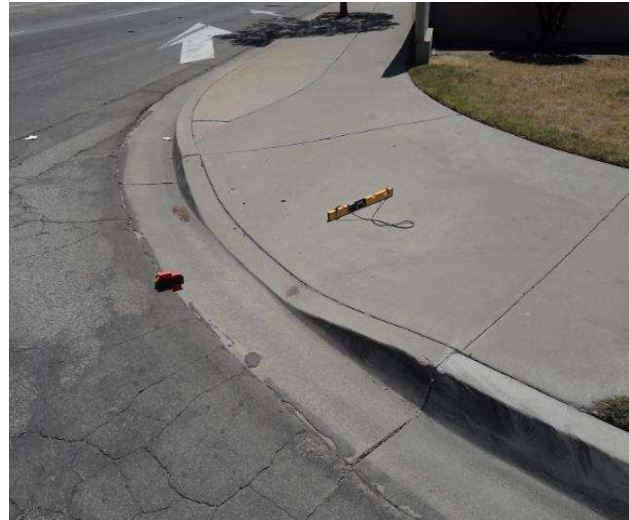
Code Reference ADA 406, 406.1, 405.2, CA 11B-406

Recommendation Up to 8.33 percent

Install curb ramp \$1,300

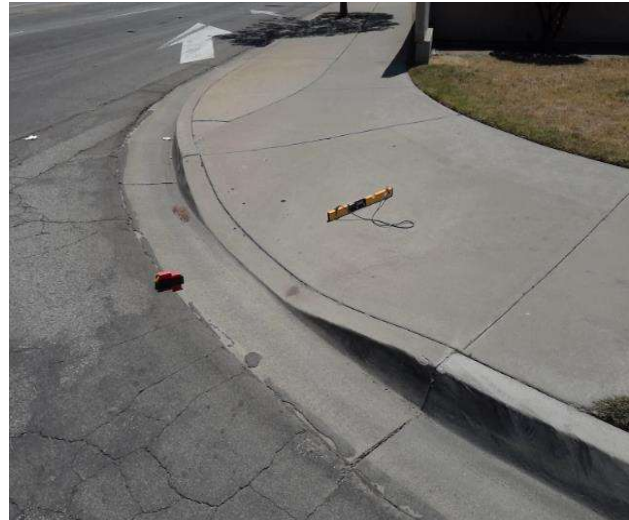
Code Reference ADA 406, 406.3, CA 11B-406.2.2

Recommendation Up to 10.00 percent

Install flared sides \$1,300

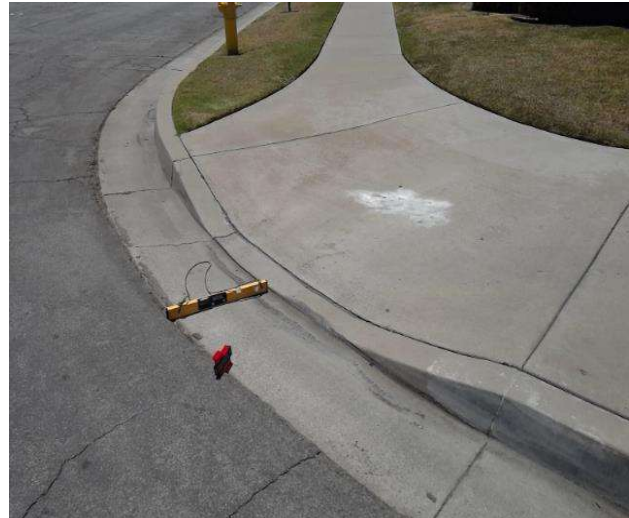
Code Reference ADA 406, 406.2, CA 11B-406.5.8

Recommendation Up to 5.00 percent

Repave landing \$1,260

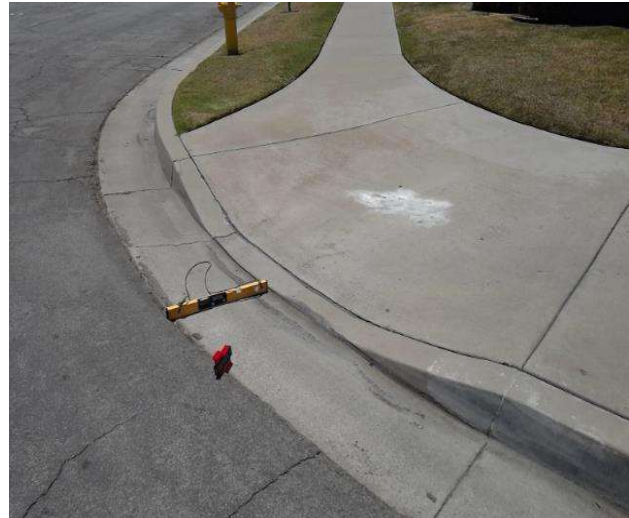
Code Reference ADA 302, 303, 406.2, 303.1

Recommendation Up to 0.50 inches

Patch lip at curb ramp \$255

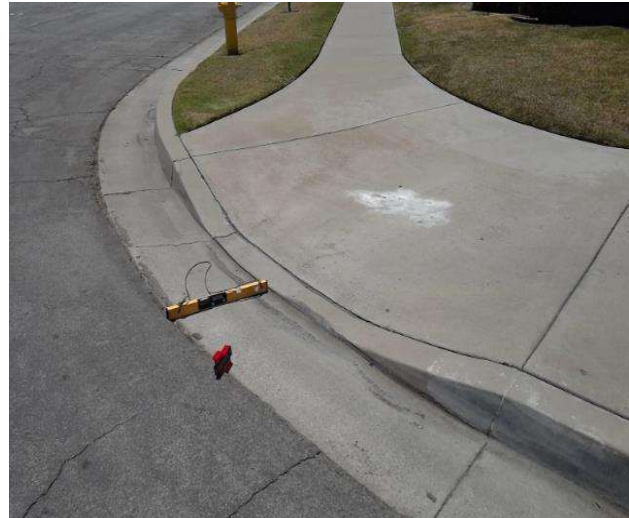
The overlayment causes a noncompliant change in level.

Code Reference ADA 303.2, 303.3,CA 11B-303.3,CA 11B-303.2

Ensure the change in elevation is within the recommended height.

Recommendation Up to 0.50 inches

Provide smooth surface \$150

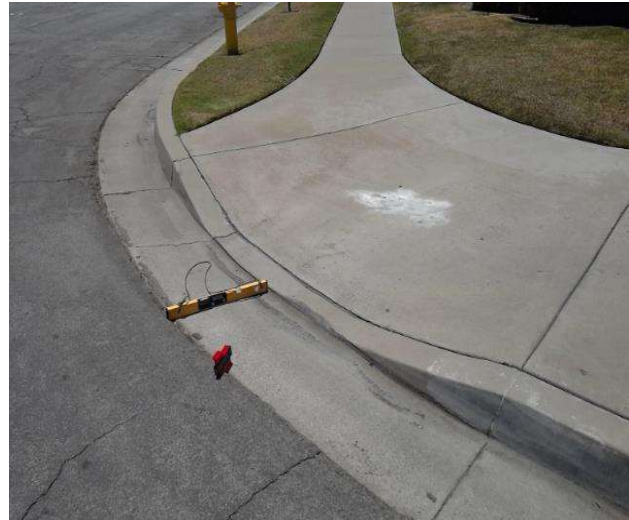
Code Reference ADA 402, 406.4, 403.3, 406.1, CA 11B-406.5.3

Recommendation Up to 2.08 percent

Provide compliant landing \$1,260

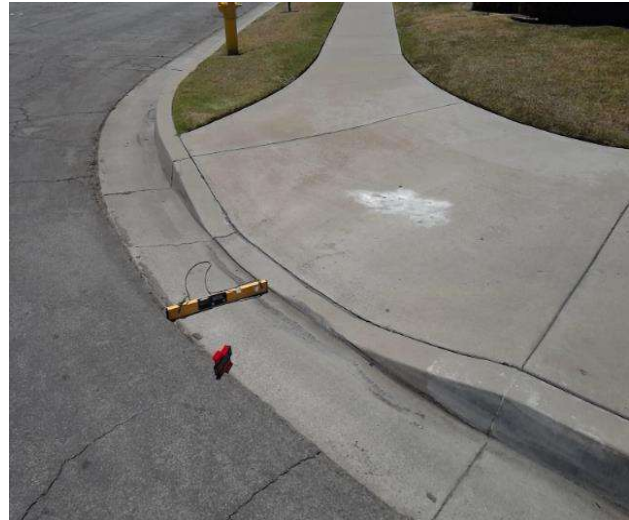
Code Reference ADA 406, 406.4,CA 11B-406.5.3

Recommendation At least 48.00 inches

Provide compliant landing \$240

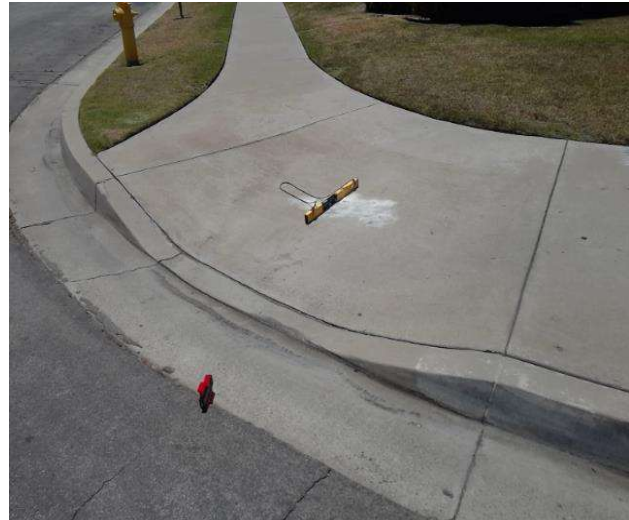
On-Site Finding Not Found

Code Reference CA 11B-406.5.12

Recommendation See Recommendation

Provide detectable warning to surface \$248

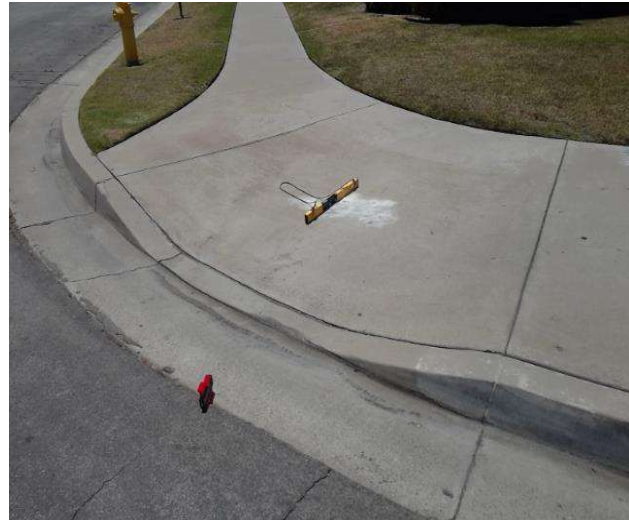
Code Reference ADA 406, 406.1, 405.2, CA 11B-406

Recommendation Up to 8.33 percent

Install curb ramp \$1,300

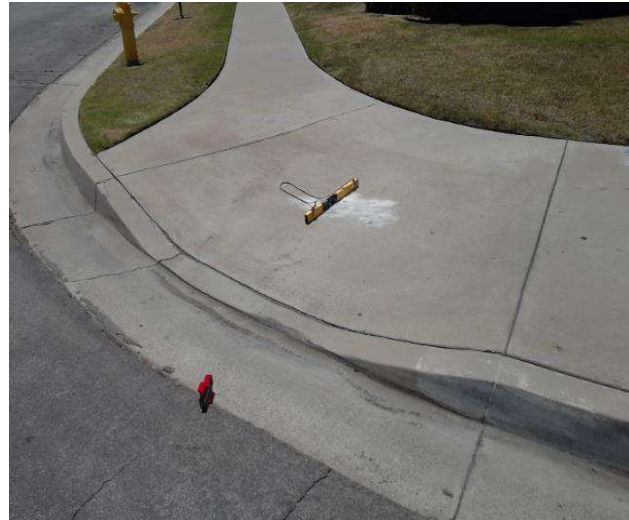
Code Reference ADA 402, 406.1, 405.3, CA 11B-406.5.7

Recommendation Up to 2.08 percent

Install curb ramp \$1,300

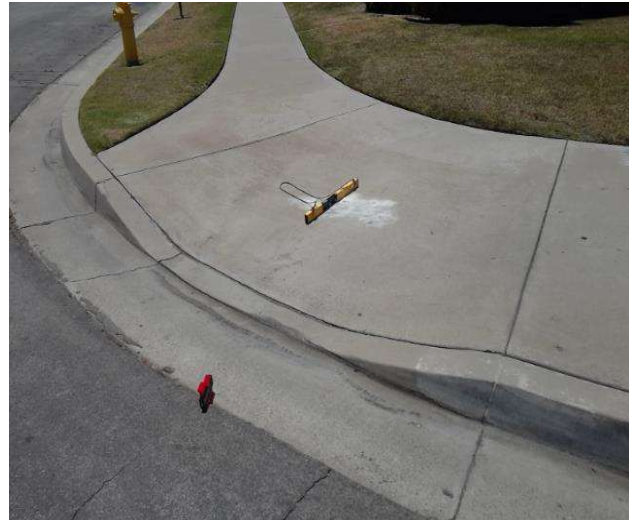
Code Reference ADA 406, 406.3, CA 11B-406.2.2

Recommendation Up to 10.00 percent

Install flared sides \$1,300

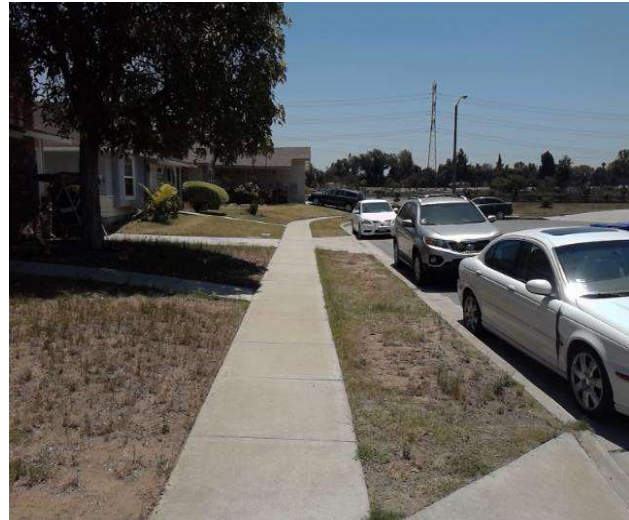
Code Reference ADA 206, 302, CA 11B-403.3

Repave the sidewalk surface with the recommended cross slope.

Recommendation Up to 2.08 percent

Repave surface \$1,092

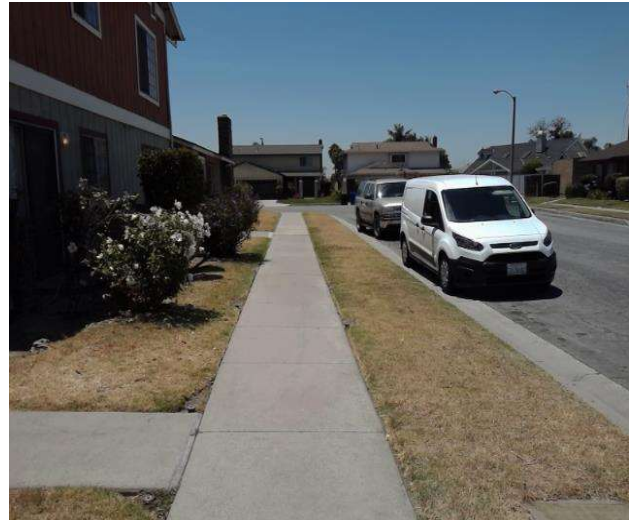
Code Reference ADA 206, 302,CA 11B-403.3

Repave the sidewalk surface with the recommended cross slope.

Recommendation Up to 2.08 percent

Repave surface \$1,092

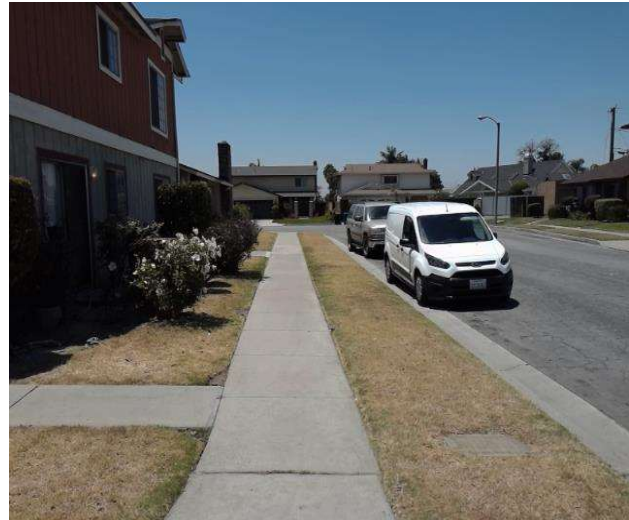
On-Site Finding Not Found

Code Reference ADA 206, 302

Recommendation See Recommendation

\$2,400

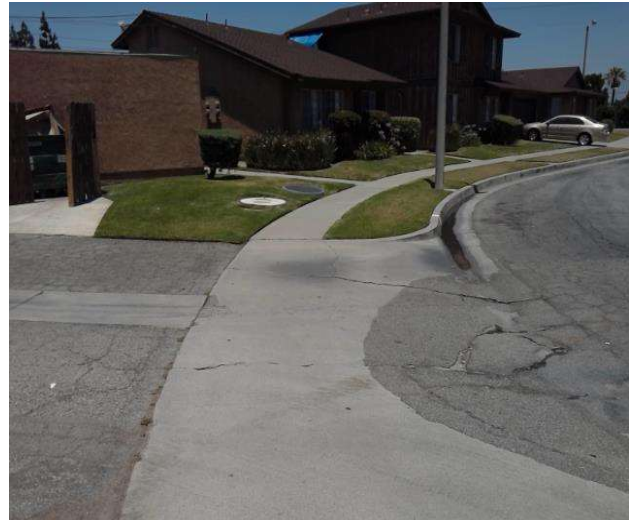
On-Site Finding Not Found

Code Reference ADA 705,CA 11B-705.1.2.5,CA 11B-247.1.2.5

Recommendation See Recommendation

Install compliant detectable warnings \$190

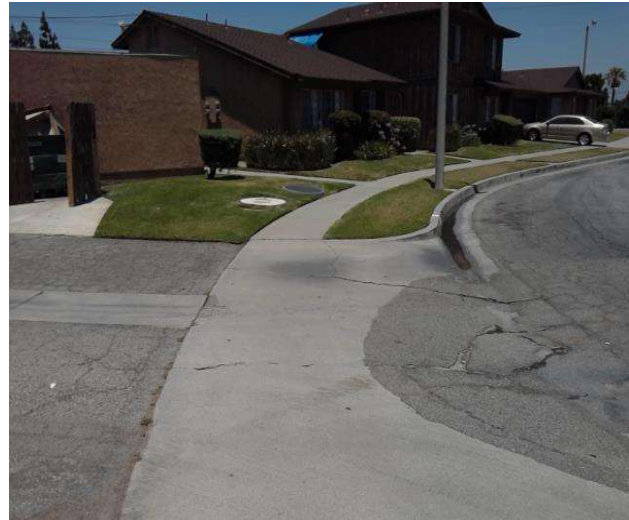
Code Reference ADA 206, 302,CA 11B-403.3

Recommendation Up to 2.08 percent

Repave surface \$1,092

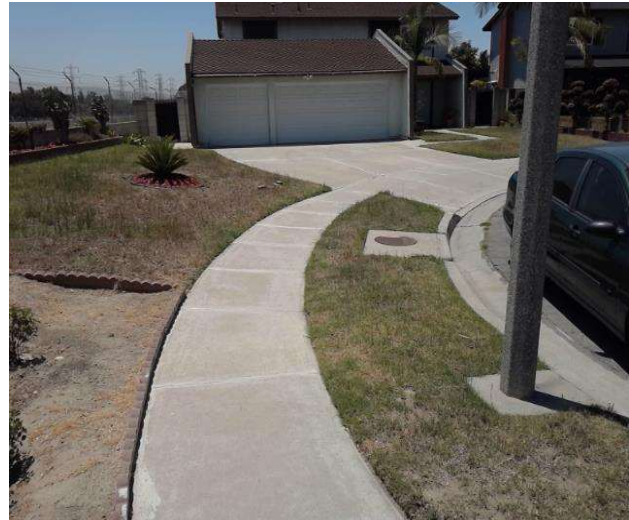
Code Reference ADA 206, 302,CA 11B-403.3

Repave the sidewalk surface with the recommended cross slope.

Recommendation Up to 2.08 percent

Repave surface \$1,092

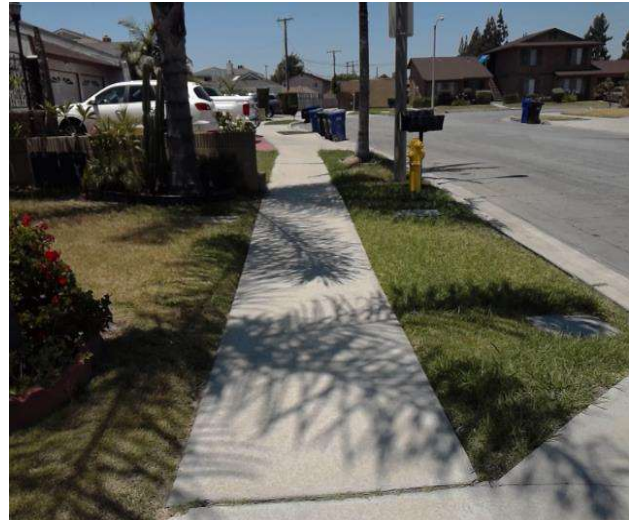
Code Reference ADA 206, 302, CA 11B-403.3

Repave the sidewalk surface with the recommended cross slope.

Recommendation Up to 2.08 percent

Repave surface \$1,092

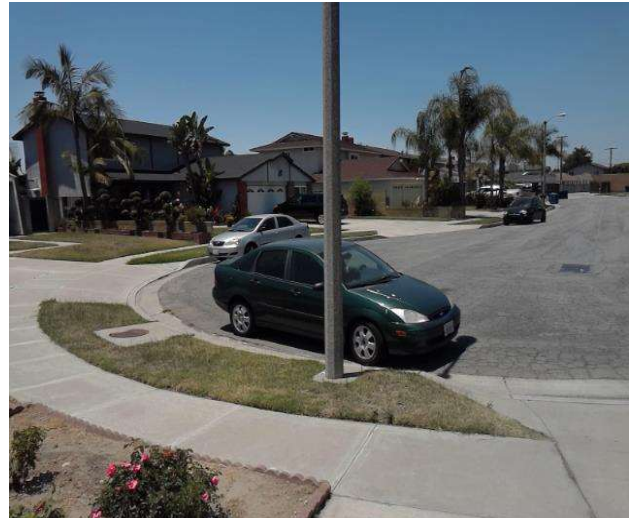
On-Site Finding Not Found

Code Reference ADA 206, 302

Recommendation See Recommendation

\$2,400
