Accessibility Survey

City of Downey Pruess Avenue - Brookmill Road To Phlox Street

Date of Inspection
4/26/2017

Prepared By
Disability Access Consultants
(800) 743-7067

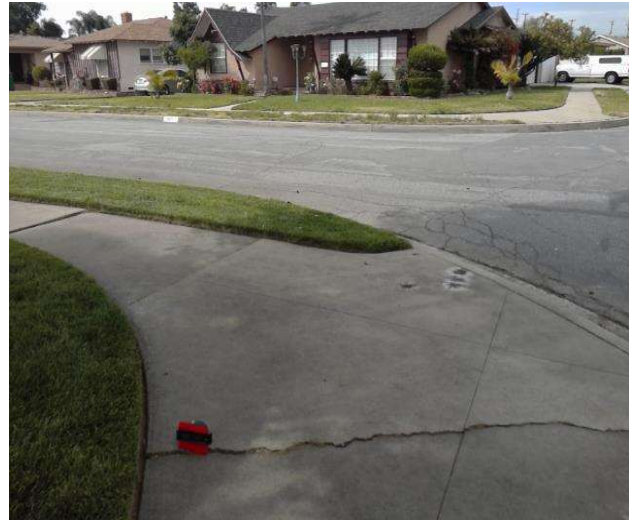
Change In Level North Of Adwen Street @ 33.940849958795, -118.142144680023

Sidewalks , Change in Level : Change in Level Non Beveled

There is a change in elevation greater than recommended value.

On-Site Finding 0.50 inches

Code Reference ADA 206, 302

Ensure that the change in elevation is within the recommended value.

Recommendation Up to 0.25 inches

Remove tripping hazards \$198

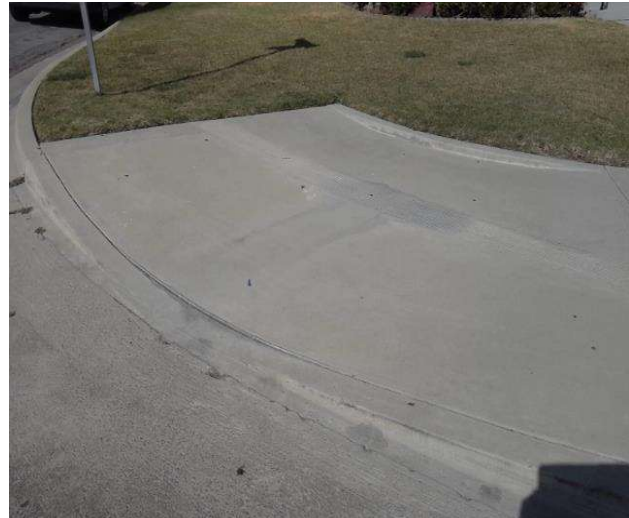
Northeast Corner Of Brookmill Road @ 33.938870621029, - 118.143078088760

Curb Ramp : No Detectable Warnings

The curb ramp does not provide a detectable warning surface which includes truncated domes.

On-Site Finding Not Found

Code Reference CA 11B-406.5.12

Provide compliant detectable warnings to surface.

Provide detectable warning to surface \$248

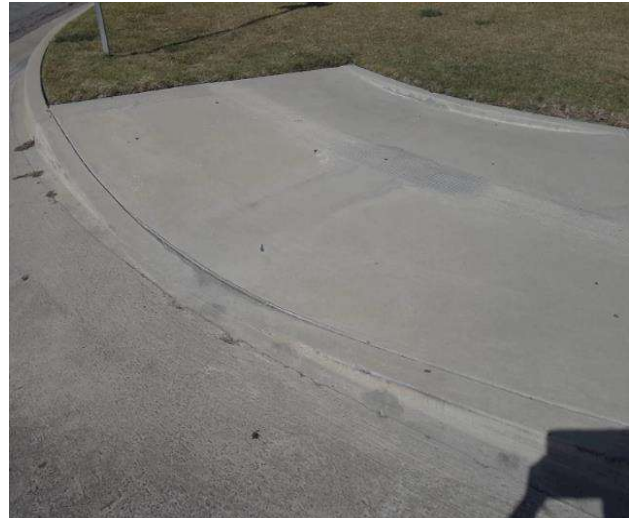
Northeast Corner Of Brookmill Road @ 33.938870621029, - 118.143078088760

Curb Ramp , Landings and Transitions : Top Landing Slope

The slope at the top landing is greater than allowed.

On-Site Finding 3.20 percent

Code Reference ADA 402, 406.4, 403.3, 406.1, CA 11B-406.5.3

Provide a top landing surface that does not exceed the maximum slope and cross slope. Provide a sufficient maneuvering clearance that does not accumulate water.

Recommendation Up to 2.08 percent

Provide compliant landing \$1,260

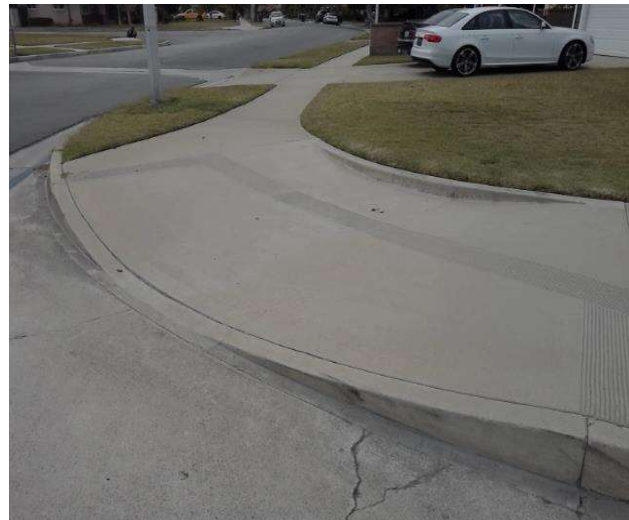
Northwest Corner Of Brookmill Road @ 33.938945166905, - 118.143218904734

Curb Ramp : No Detectable Warnings

The curb ramp does not provide a detectable warning surface which includes truncated domes.

On-Site Finding Not Found

Code Reference CA 11B-406.5.12

Provide compliant detectable warnings to surface.

Provide detectable warning to surface \$248

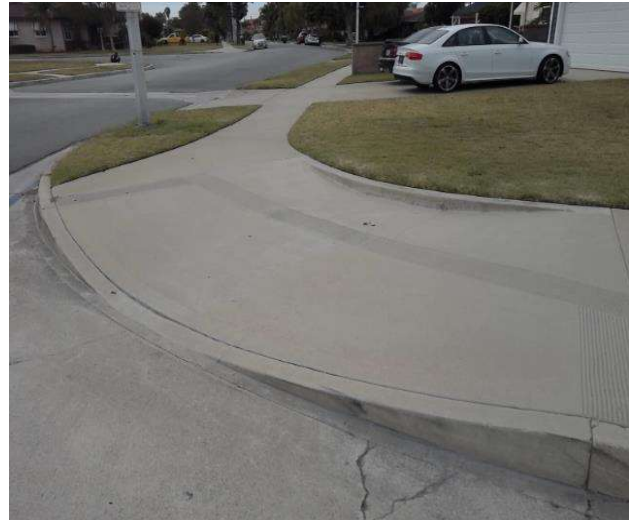
Northwest Corner Of Brookmill Road @ 33.938945166905, - 118.143218904734

Curb Ramp , Landings and Transitions : Top Landing Slope

The slope at the top landing is greater than allowed.

On-Site Finding 2.60 percent

Code Reference ADA 402, 406.4, 403.3, 406.1,CA 11B-406.5.3

Provide a top landing surface that does not exceed the maximum slope and cross slope. Provide a sufficient maneuvering clearance that does not accumulate water.

Recommendation Up to 2.08 percent

Provide compliant landing \$1,260

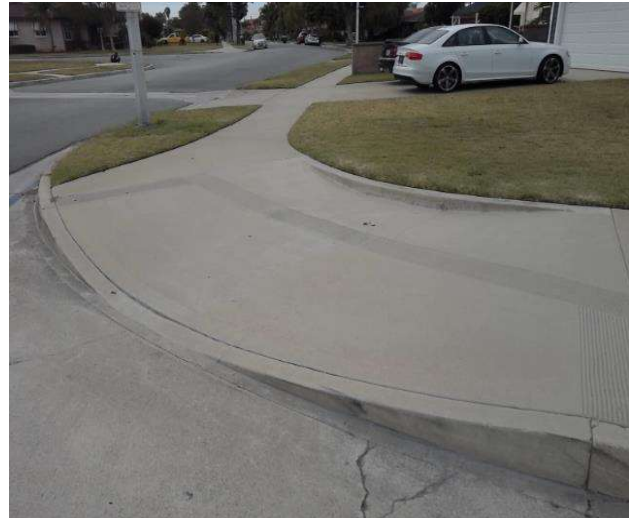
Northwest Corner Of Brookmill Road @ 33.938945166905, - 118.143218904734

Curb Ramp , Landings and Transitions : Top Landing Clear Length - Landings

There is not enough top landing clear length.

On-Site Finding 45.00 inches

Code Reference ADA 406, 406.4,CA 11B-406.5.3

Provide a level top landing with enough clear length.

Recommendation At least 48.00 inches

Provide compliant landing \$240

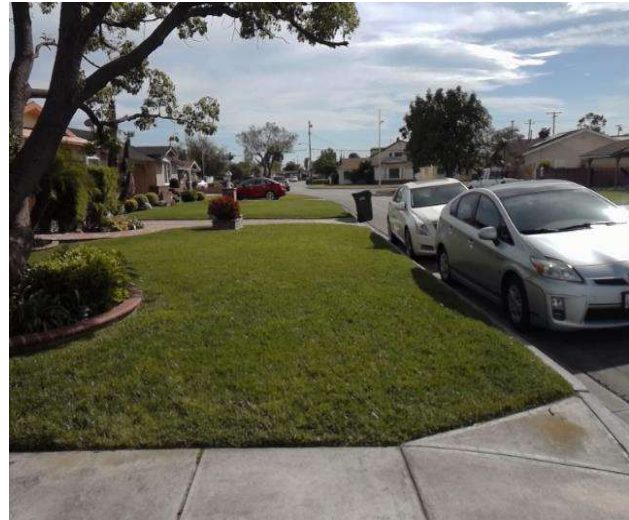
Sidewalk South Of Phlox Street @ 33.940441633749, -118.142127245665

Sidewalks : Missing Sidewalk

Section of sidewalk is missing and consists of dirt, grass or gravel.

On-Site Finding 640.00 feet

Code Reference ADA 206, 302,CA 11B-302,CA 11B-206

Provide a compliant sidewalk for the missing section.

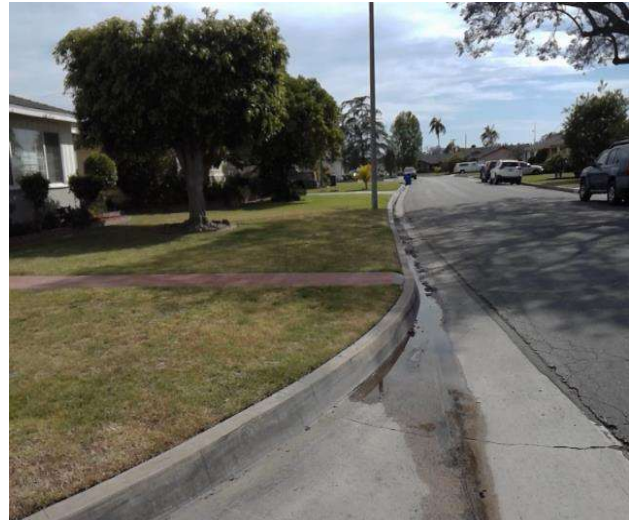
Sidewalk South Of Phlox Street @ 33.941833491195, -118.141305148602

Sidewalks : Missing Sidewalk

Section of sidewalk is missing and consists of dirt, grass or gravel.

On-Site Finding 500.00 feet

Code Reference ADA 206, 302,CA 11B-302,CA 11B-206

Provide a compliant sidewalk for the missing section.

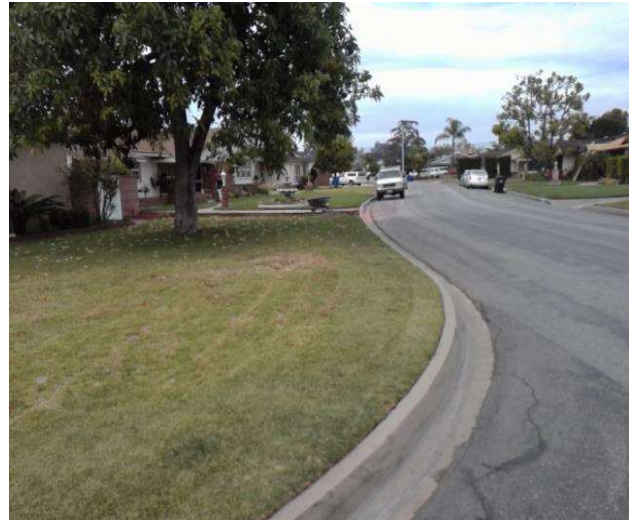
Sidewalk North Of Adwen Street @ 33.940033306743, -118.142532259226

Sidewalks : Missing Sidewalk

Section of sidewalk is missing and consists of dirt, grass or gravel.

On-Site Finding 183.00 feet

Code Reference ADA 206, 302,CA 11B-302,CA 11B-206

Provide a compliant sidewalk for the missing section.

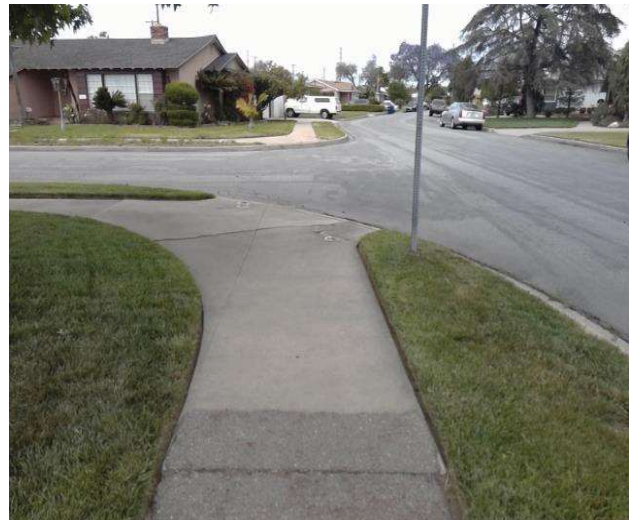
Sidewalk North Of Adwen Street @ 33.940813242999, -118.142144680023

Sidewalks , Surface : Cross Slope

Sidewalk cross slope is not compliant.

On-Site Finding 4.00 percent for 19.00 feet

Code Reference ADA 206, 302,CA 11B-403.3

Notes : Surface is rough and uneven for 3 feet.

Repave the sidewalk surface with the recommended cross slope.

Recommendation Up to 2.08 percent

Repave surface \$1,092

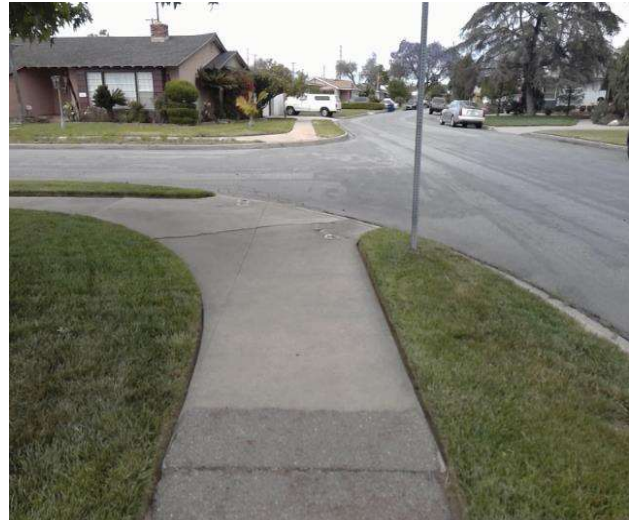
Sidewalk North Of Adwen Street @ 33.940813242999, -118.142144680023

Sidewalks , Surface : Running Slope

Sidewalk running slope is not compliant.

On-Site Finding 18.60 percent for 1.00 feet

Code Reference ADA 206, 302

Notes : Surface is rough and uneven for 3 feet.

Repave the sidewalk surface with the recommended running slope.

Recommendation Up to 5.00 percent

Repave surface \$1,184

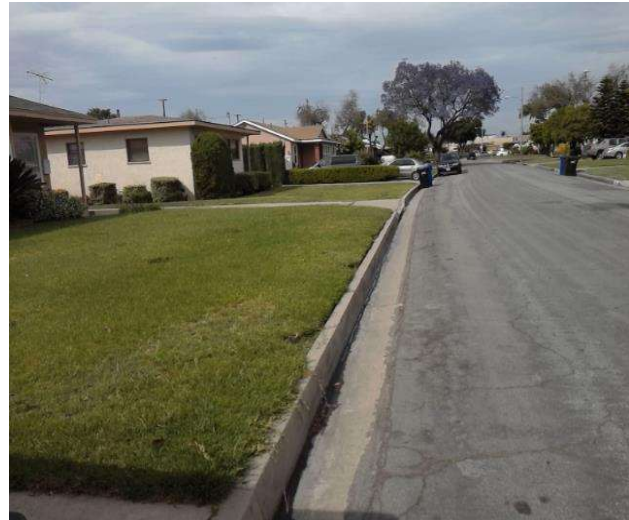
Sidewalk North Of Adwen Street @ 33.941244930751, -118.141982406378

Sidewalks : Missing Sidewalk

Section of sidewalk is missing and consists of dirt, grass or gravel.

On-Site Finding 300.00 feet

Code Reference ADA 206, 302,CA 11B-302,CA 11B-206

Provide a compliant sidewalk for the missing section.

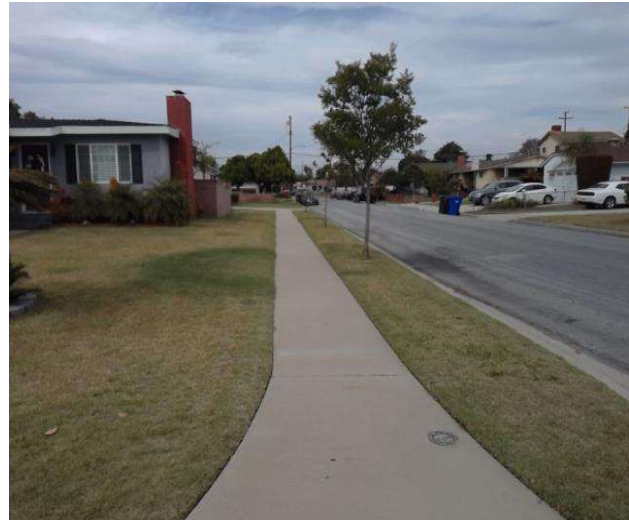
Sidewalk North Of Brookmill Road @ 33.938945166905, -118.143218904734

Sidewalks , Surface : Cross Slope

Sidewalk cross slope is not compliant.

On-Site Finding 3.40 percent for 87.00 feet

Code Reference ADA 206, 302,CA 11B-403.3

Repave the sidewalk surface with the recommended cross slope.

Recommendation Up to 2.08 percent

Repave surface \$1,092

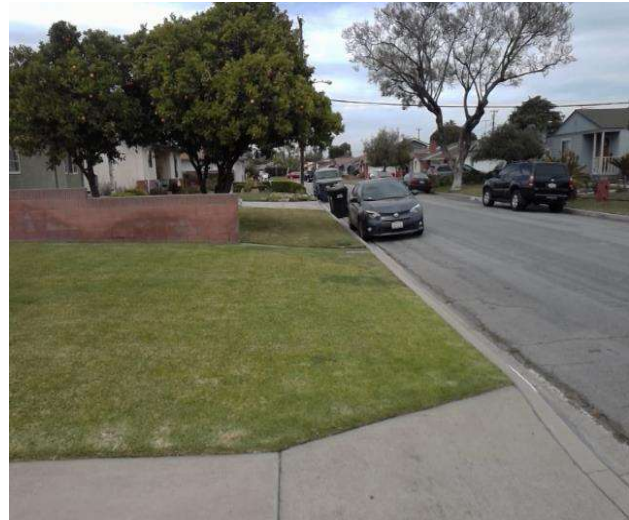
Sidewalk North Of Brookmill Road @ 33.939305656490, -118.142941296101

Sidewalks : Missing Sidewalk

Section of sidewalk is missing and consists of dirt, grass or gravel.

On-Site Finding 245.00 feet

Code Reference ADA 206, 302,CA 11B-302,CA 11B-206

Provide a compliant sidewalk for the missing section.

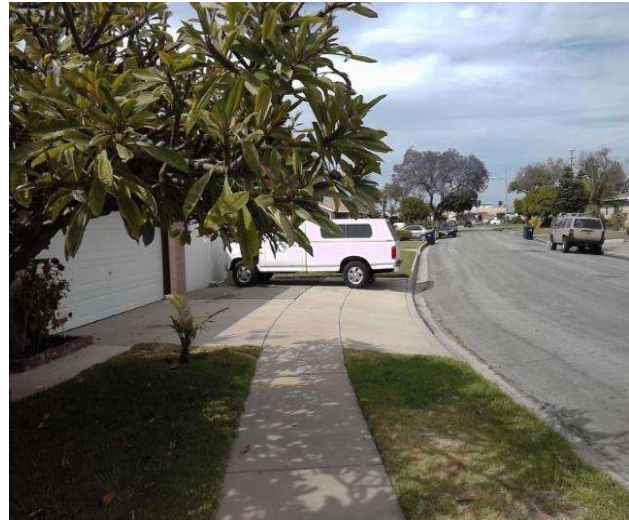
Tree North Of Adwen Street @ 33.941135896422, -118.142037391663

Sidewalks , Hazards & Gratings : Overhead Obstruction Height

Overhead obstruction height is not compliant.

On-Site Finding 68.00 inches

Code Reference ADA 206, 307.4, CA 11B-307.4

Provide a compliant vertical clearance height.

Recommendation At least 80.00 inches

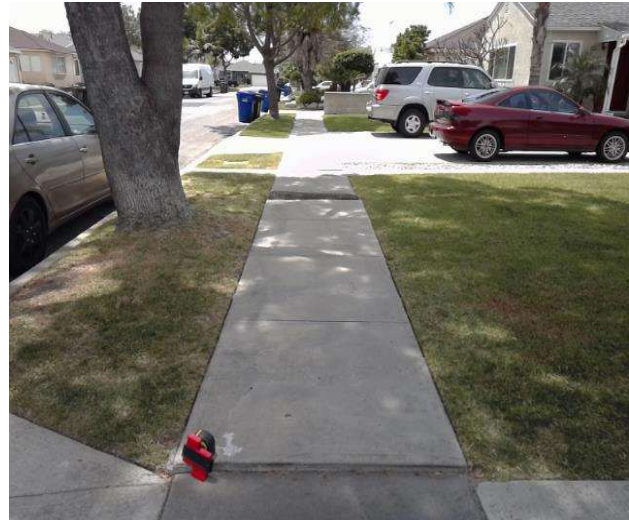
Change In Level North Of De Palma Street @ 33.937694567747, -118.144441992044

Sidewalks , Change in Level : Change in Level Non Beveled

There is a change in elevation greater than recommended value.

On-Site Finding 1.50 inches

Code Reference ADA 206, 302

Ensure that the change in elevation is within the recommended value.

Recommendation Up to 0.25 inches

Remove tripping hazards \$198

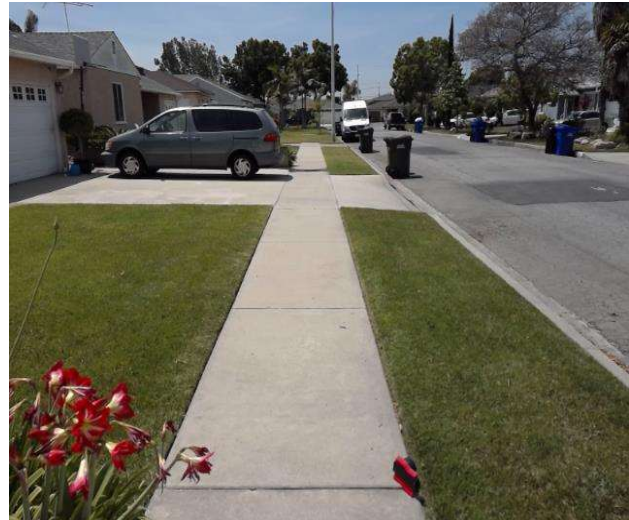
Change In Level South Of Cleeta Street @ 33.937567726592, -118.144352138042

Sidewalks , Change in Level : Change in Level Non Beveled

There is a change in elevation greater than recommended value.

On-Site Finding 0.50 inches

Code Reference ADA 206, 302

Ensure that the change in elevation is within the recommended value.

Recommendation Up to 0.25 inches

Remove tripping hazards \$198

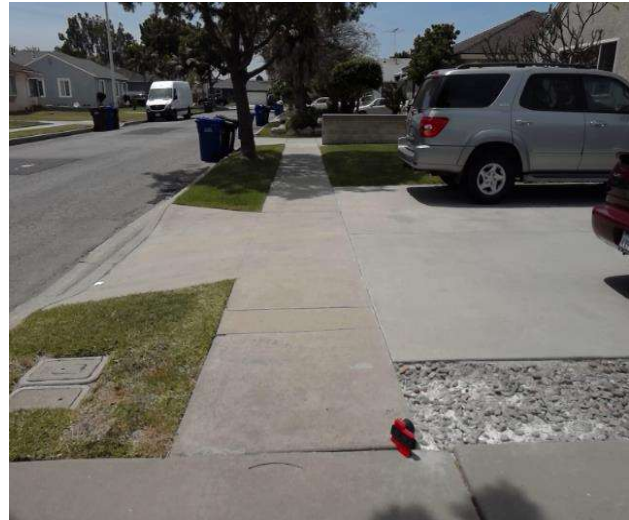
Change In Level North Of De Palma Street @ 33.937654512666, -118.144466131926

Sidewalks , Change in Level : Change in Level Non Beveled

There is a change in elevation greater than recommended value.

On-Site Finding 0.75 inches

Code Reference ADA 206, 302

Ensure that the change in elevation is within the recommended value.

Recommendation Up to 0.25 inches

Remove tripping hazards \$198

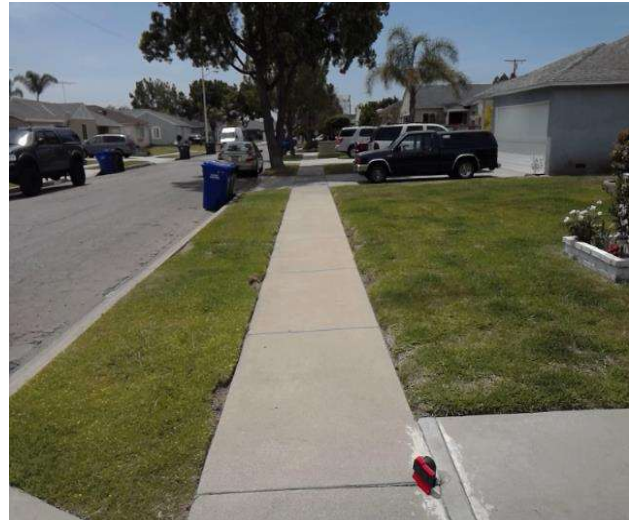
Change In Level North Of De Palma Street @ 33.937853675243, -118.144319951534

Sidewalks , Change in Level : Change in Level Non Beveled

There is a change in elevation greater than recommended value.

On-Site Finding 0.37 inches

Code Reference ADA 206, 302

Ensure that the change in elevation is within the recommended value.

Recommendation Up to 0.25 inches

Remove tripping hazards \$198

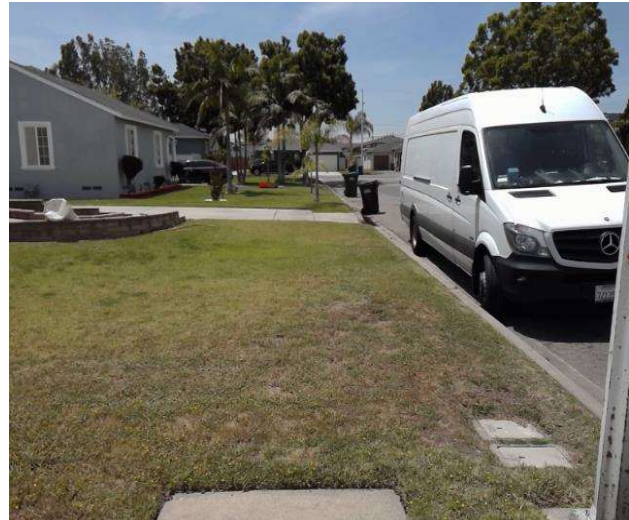
Sidewalk South Of Cleta Street @ 33.937314043717, -118.144534528255

Sidewalks : Missing Sidewalk

Section of sidewalk is missing and consists of dirt, grass or gravel.

On-Site Finding 172.00 feet

Code Reference ADA 206, 302,CA 11B-302,CA 11B-206

Provide a compliant sidewalk for the missing section.

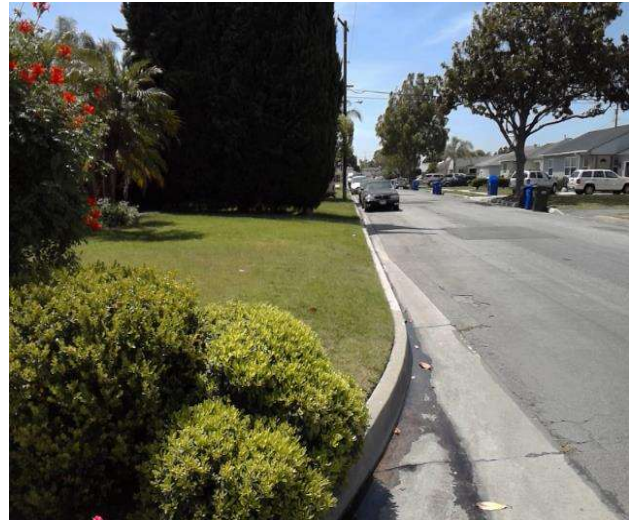
Sidewalk South Of Cleeta Street @ 33.938235309495, -118.143865317106

Sidewalks : Missing Sidewalk

Section of sidewalk is missing and consists of dirt, grass or gravel.

On-Site Finding 256.00 feet

Code Reference ADA 206, 302,CA 11B-302,CA 11B-206

Provide a compliant sidewalk for the missing section.

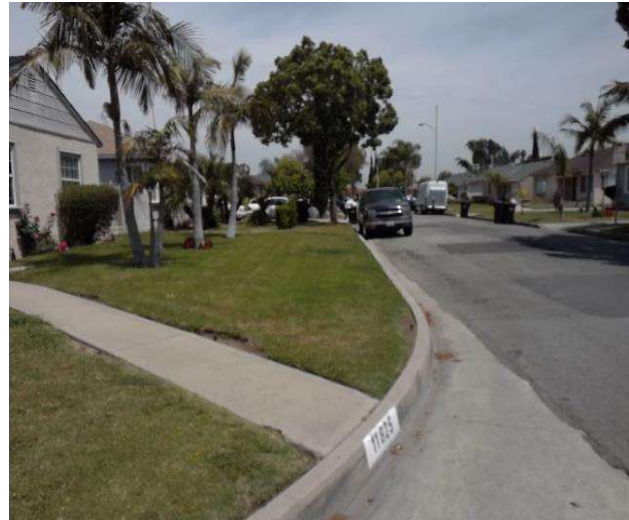
Sidewalk North Of De Palma Street @ 33.936982474609, -118.144974410534

Sidewalks : Missing Sidewalk

Section of sidewalk is missing and consists of dirt, grass or gravel.

On-Site Finding 215.00 feet

Code Reference ADA 206, 302,CA 11B-302,CA 11B-206

Provide a compliant sidewalk for the missing section.

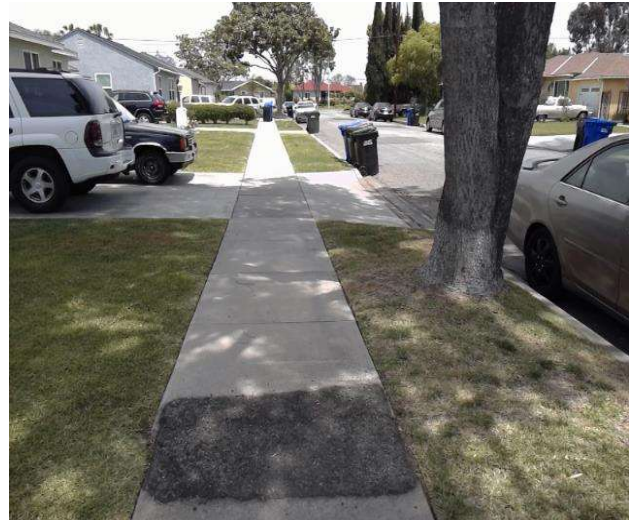
Sidewalk North Of De Palma Street @ 33.937680103414, -118.144452720881

Sidewalks , Surface : Running Slope

Sidewalk running slope is not compliant.

On-Site Finding 13.30 percent for 2.50 feet

Code Reference ADA 206, 302

Notes : Surface is rough and uneven.

Repave the sidewalk surface with the recommended running slope.

Recommendation Up to 5.00 percent

Repave surface \$1,184

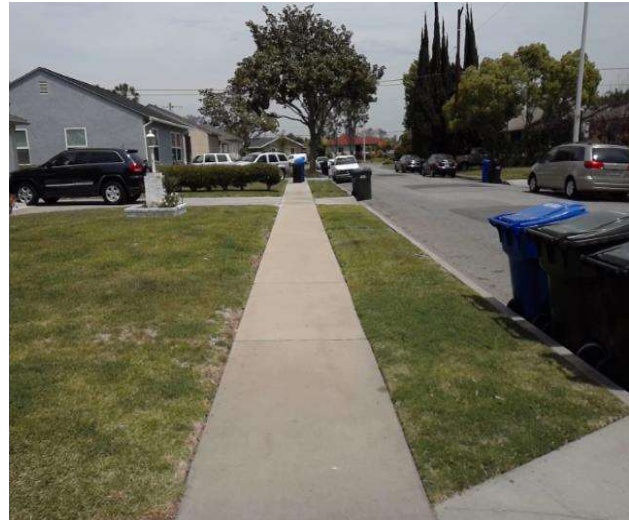
Sidewalk North Of De Palma Street @ 33.937733510168, -118.144411146641

Sidewalks , Surface : Cross Slope

Sidewalk cross slope is not compliant.

On-Site Finding 4.40 percent for 50.00 feet

Code Reference ADA 206, 302, CA 11B-403.3

Repave the sidewalk surface with the recommended cross slope.

Recommendation Up to 2.08 percent

Repave surface \$1,092

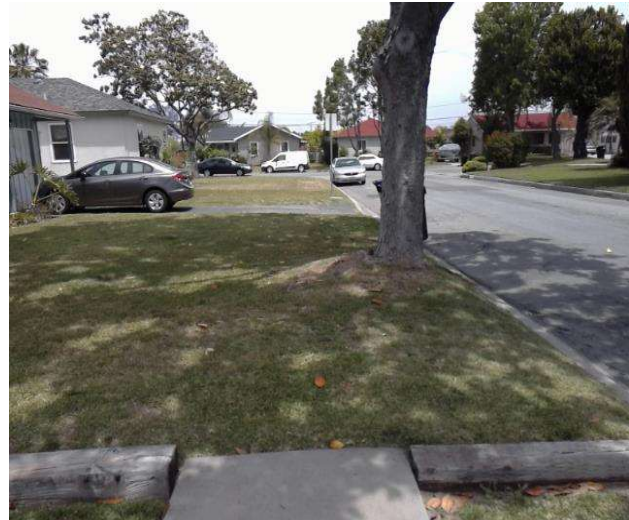
Sidewalk North Of De Palma Street @ 33.938017232989, -118.144197911024

Sidewalks : Missing Sidewalk

Section of sidewalk is missing and consists of dirt, grass or gravel.

On-Site Finding 115.00 feet

Code Reference ADA 206, 302,CA 11B-302,CA 11B-206

Provide a compliant sidewalk for the missing section.
