Accessibility Survey

City of Downey Rundell Street - Rives Avenue To Old River School Road

Date of Inspection 4/17/2017

Disability Access Consultants

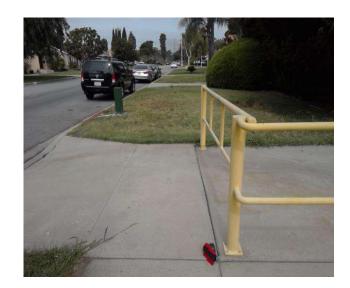
Change In Level East Of Pomering Road @ 33.934248649231, -118.155782371759

Sidewalks , Change in Level : Change in Level Non Beveled

There is a change in elevation greater than recommended value.

On-Site Finding 0.50 inches

Recommendation Up to 0.25 inches

Ensure that the change in elevation is within the recommended value.

Remove tripping hazards \$198

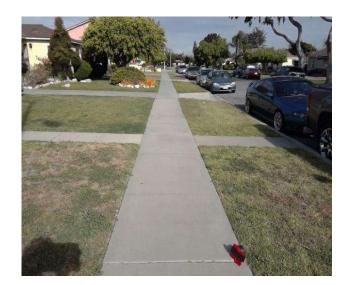
Change In Level West Of Richeon Avenue @ 33.933239437137, -118.153605759144

Sidewalks , Change in Level : Change in Level Non Beveled

There is a change in elevation greater than recommended value.

On-Site Finding 0.50 inches

Recommendation Up to 0.25 inches

Ensure that the change in elevation is within the recommended value.

Remove tripping hazards \$198

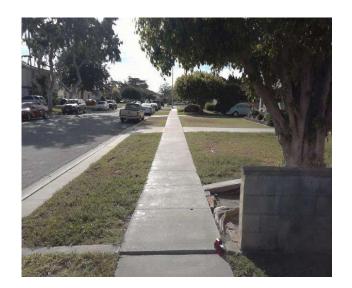
Change In Level West Of Richeon Avenue @ 33.933504259108, -118.154131472111

Sidewalks , Change in Level : Change in Level Non Beveled

There is a change in elevation greater than recommended value.

On-Site Finding 1.12 inches

Recommendation Up to 0.25 inches

Ensure that the change in elevation is within the recommended value.

Remove tripping hazards \$198

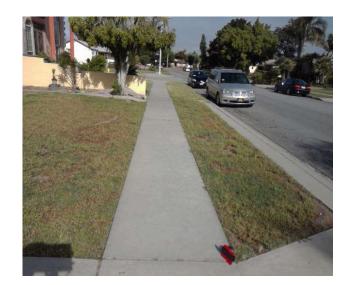
Change In Level West Of Richeon Avenue @ 33.933449737005, -118.154016137123

Sidewalks , Change in Level : Change in Level Non Beveled

There is a change in elevation greater than recommended value.

On-Site Finding 0.37 inches

Recommendation Up to 0.25 inches

Ensure that the change in elevation is within the recommended value.

Remove tripping hazards \$198

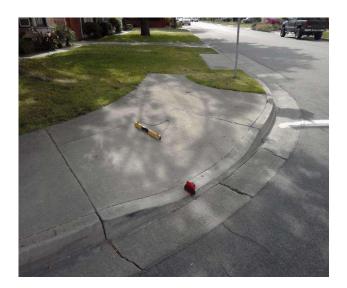
Curb Ramp : No Detectable Warnings

The curb ramp does not provide a detectable warning surface which includes truncated domes.

On-Site Finding Not Found

Code Reference CA 11B-406.5.12

Provide compliant detectable warnings to surface.

Provide detectable warning to \$248 surface

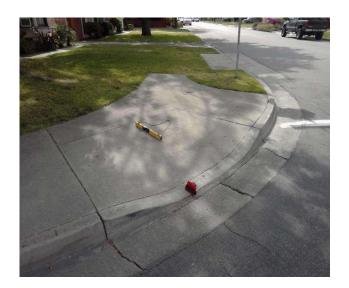
Curb Ramp : Curb Ramp Slope

The running slope is greater than allowed.

On-Site Finding 14.10 percent

Recommendation Up to 8.33 percent

Code Reference ADA 406, 406.1, 405.2,CA 11B-406

Provide a compliant curb ramp.

Install curb ramp \$1,300

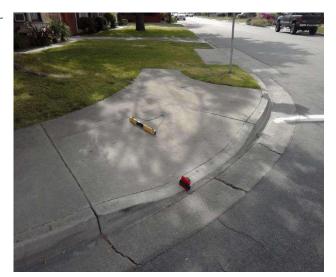
Curb Ramp : Side Flare Slope

The slope of the curb ramp side flare is greater than allowed.

On-Site Finding 17.50 percent

Recommendation Up to 10.00 percent

Code Reference ADA 406, 406.3,CA 11B-406.2.2

Provide curb ramp side flares with a compliant slope.

Install flared sides \$1,300

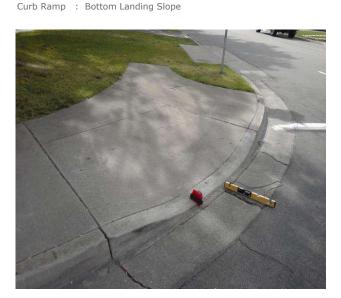
The bottom landing of the curb ramp is on the street, and the slope of the bottom landing is not compliant.

On-Site Finding 6.90 percent

Recommendation Up to 5.00 percent

Code Reference ADA 406, 406.2,CA 11B-406.5.8

Ensure the bottom landing slope is compliant and provides a smooth transition.

Repave landing \$1,260

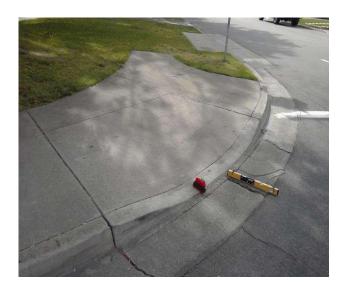
Curb Ramp , Landings and Transitions : Top Landing Slope

The slope at the top landing is greater than allowed.

On-Site Finding 4.80 percent

Recommendation Up to 2.08 percent

Code Reference ADA 402, 406.4, 403.3, 406.1,CA 11B-406.5.3

Provide a top landing surface that does not exceed the maximum slope and cross slope. Provide a sufficient maneuvering clearance that does not accumulate water.

Provide compliant landing \$1,260

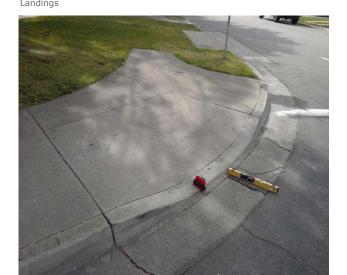
Curb Ramp , Landings and Transitions : Top Landing Clear Length -

There is not enough top landing clear length.

On-Site Finding 30.00 inches

Recommendation At least 48.00 inches

Code Reference ADA 406, 406.4,CA 11B-406.5.3

Provide a level top landing with enough clear length.

Provide compliant landing \$240

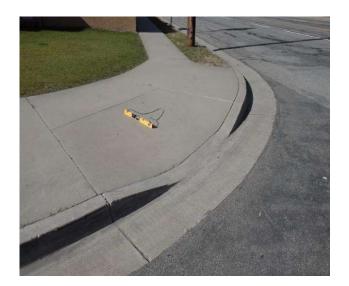
Curb Ramp : No Detectable Warnings

The curb ramp does not provide a detectable warning surface which includes truncated domes.

On-Site Finding Not Found

Code Reference CA 11B-406.5.12

Provide compliant detectable warnings to surface.

Provide detectable warning to \$248 surface

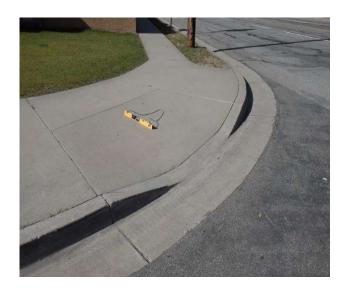
Curb Ramp : Curb Ramp Slope

The running slope is greater than allowed.

On-Site Finding 11.10 percent

Recommendation Up to 8.33 percent

Code Reference ADA 406, 406.1, 405.2,CA 11B-406

Provide a compliant curb ramp.

Install curb ramp \$1,300

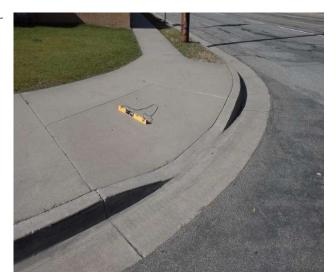
Curb Ramp : Side Flare Slope

The slope of the curb ramp side flare is greater than allowed.

On-Site Finding 17.30 percent

Recommendation Up to 10.00 percent

Code Reference ADA 406, 406.3,CA 11B-406.2.2

Provide curb ramp side flares with a compliant slope.

Install flared sides \$1,300

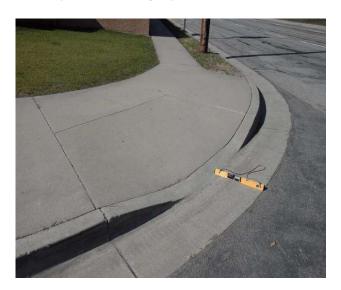
Curb Ramp : Bottom Landing Slope

The bottom landing of the curb ramp is on the street, and the slope of the bottom landing is not compliant.

On-Site Finding 8.60 percent

Recommendation Up to 5.00 percent

Code Reference ADA 406, 406.2,CA 11B-406.5.8

Ensure the bottom landing slope is compliant and provides a smooth transition.

Repave landing \$1,260

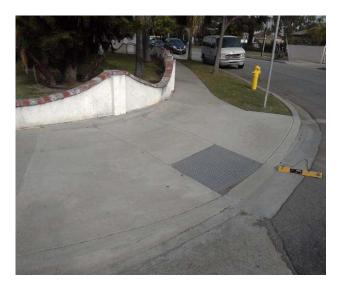
Curb Ramp : Bottom Landing Slope

The bottom landing of the curb ramp is on the street, and the slope of the bottom landing is not compliant.

On-Site Finding 8.00 percent

Recommendation Up to 5.00 percent

Code Reference ADA 406, 406.2,CA 11B-406.5.8

Ensure the bottom landing slope is compliant and provides a smooth transition.

Repave landing \$1,260

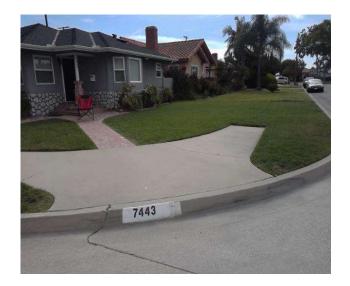
Curb Northeast Corner Of Pomering Road @ 33.934547961213, -118.156373798847

Sidewalks , Hazards & Gratings : Curb is on Path of Travel

There is a curb on the designated path of travel.

On-Site Finding Not Compliant

Code Reference ADA 402, 303, 406, 403.4, 303.4

Provide a compliant curb ramp.

Install curb ramp \$2,500

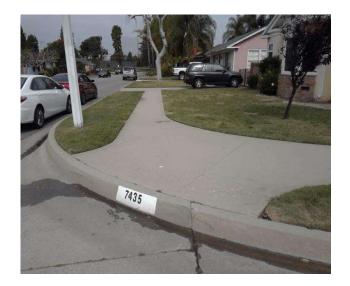
Curb Northwest Corner Of Pomering Road @ 33.934616947468, -118.156513273716

Sidewalks , Hazards & Gratings : Curb is on Path of Travel

There is a curb on the designated path of travel.

On-Site Finding Not Compliant

Code Reference ADA 402, 303, 406, 403.4, 303.4

Provide a compliant curb ramp.

Install curb ramp \$2,500

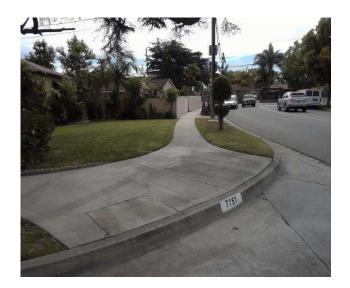
Northeast Corner Of Pomering Road @ 33.932884485387, -118.152028620243

Sidewalks , Hazards & Gratings : Curb is on Path of Travel

There is a curb on the designated path of travel.

On-Site Finding Not Compliant

Code Reference ADA 402, 303, 406, 403.4, 303.4

Provide a compliant curb ramp.

Install curb ramp \$2,500

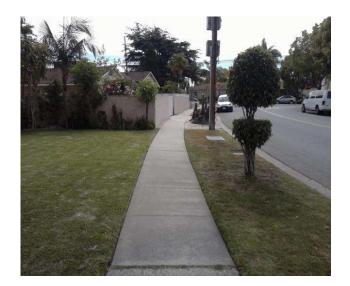
Sidewalk East Of Corey Street @ 33.932867794830, -118.152001798153

Sidewalks , Surface : Cross Slope

Sidewalk cross slope is not compliant.

On-Site Finding 4.00 percent for 34.00 feet

Up to 2.08 percent Recommendation

Code Reference ADA 206, 302,CA 11B-403.3

Repave the sidewalk surface with the recommended cross slope.

Repave surface \$1,092

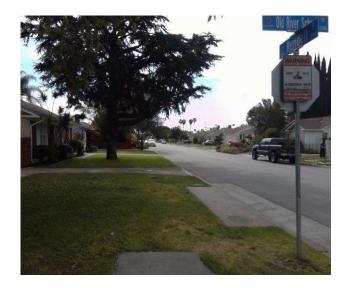
Sidewalks : Missing Sidewalk

Section of sidewalk is missing and consists of dirt, grass or gravel.

Code Reference ADA 206, 302,CA 11B-302,CA 11B-206

Provide a compliant sidewalk for the missing section.

\$1,260

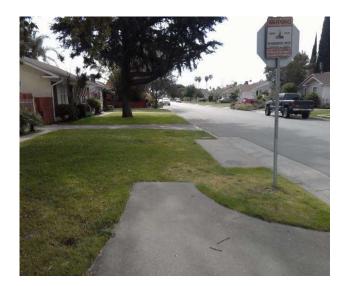
Recommendation Up to 2.08 percent

Code Reference ADA 206, 302,CA 11B-403.3

Repave the sidewalk surface with the recommended cross slope.

Repave surface \$1,092

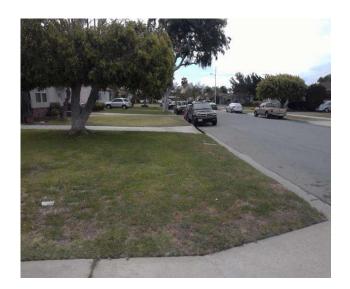
Sidewalks : Missing Sidewalk

Section of sidewalk is missing and consists of dirt, grass or gravel.

Code Reference ADA 206, 302,CA 11B-302,CA 11B-206

Provide a compliant sidewalk for the missing section.

\$1,260

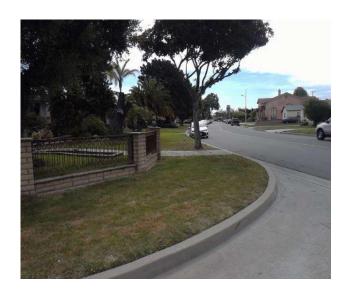
Sidewalks : Missing Sidewalk

Section of sidewalk is missing and consists of dirt, grass or gravel.

Code Reference ADA 206, 302,CA 11B-302,CA 11B-206

Provide a compliant sidewalk for the missing section.

\$1,260

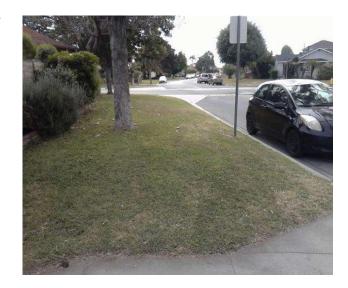
Sidewalks : Missing Sidewalk

Section of sidewalk is missing and consists of dirt, grass or gravel.

Code Reference ADA 206, 302,CA 11B-302,CA 11B-206

Provide a compliant sidewalk for the missing section.

\$1,260

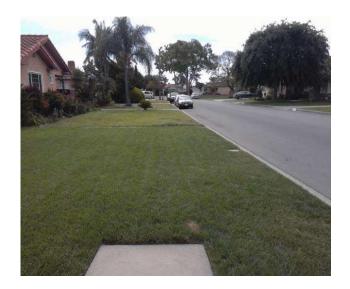
Sidewalks : Missing Sidewalk

Section of sidewalk is missing and consists of dirt, grass or gravel.

Code Reference ADA 206, 302,CA 11B-302,CA 11B-206

Provide a compliant sidewalk for the missing section.

\$1,260

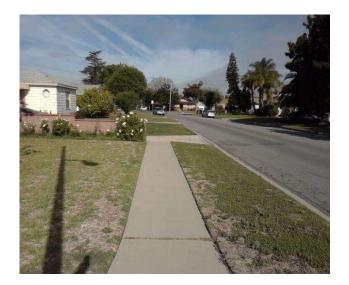
Recommendation Up to 2.08 percent

Code Reference ADA 206, 302,CA 11B-403.3

Repave the sidewalk surface with the recommended cross slope.

Repave surface \$1,092

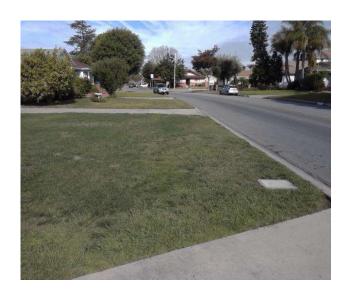
Sidewalks : Missing Sidewalk

Section of sidewalk is missing and consists of dirt, grass or gravel.

Code Reference ADA 206, 302,CA 11B-302,CA 11B-206

Provide a compliant sidewalk for the missing section.

\$1,260

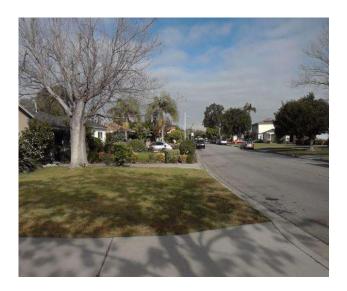
Sidewalks : Missing Sidewalk

Section of sidewalk is missing and consists of dirt, grass or gravel.

Code Reference ADA 206, 302, CA 11B-302, CA 11B-206

Provide a compliant sidewalk for the missing section.

\$1,260

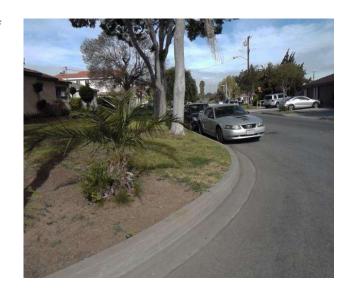
Sidewalks : Missing Sidewalk

Section of sidewalk is missing and consists of dirt, grass or gravel.

Code Reference ADA 206, 302,CA 11B-302,CA 11B-206

Provide a compliant sidewalk for the missing section.

\$1,260

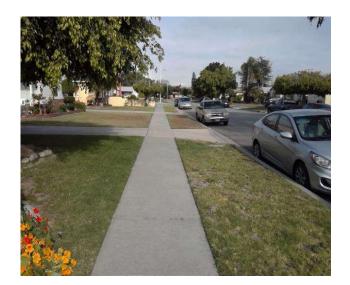
Recommendation Up to 2.08 percent

Code Reference ADA 206, 302,CA 11B-403.3

Repave the sidewalk surface with the recommended cross slope.

Repave surface \$1,092

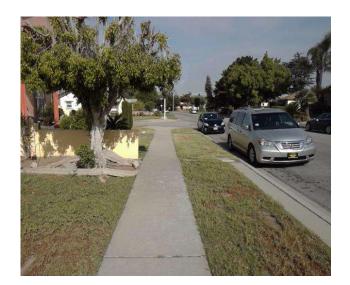
Recommendation Up to 2.08 percent

Code Reference ADA 206, 302,CA 11B-403.3

Repave the sidewalk surface with the recommended cross slope.

Repave surface \$1,092

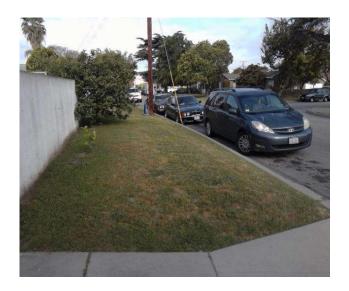
Sidewalks : Missing Sidewalk

Section of sidewalk is missing and consists of dirt, grass or gravel.

Code Reference ADA 206, 302,CA 11B-302,CA 11B-206

Provide a compliant sidewalk for the missing section.

\$1,260

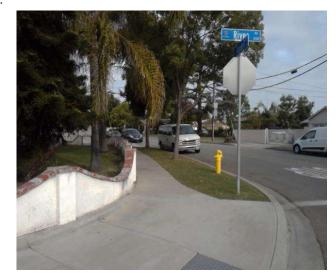
On-Site Finding Not Found

Code Reference ADA 206, 302

\$2,400
