Accessibility Survey

City of Downey Lemoran Avenue - Cedartree Road to Brookpark Road

Date of Inspection
6/20/2017

Disability Access Consultants

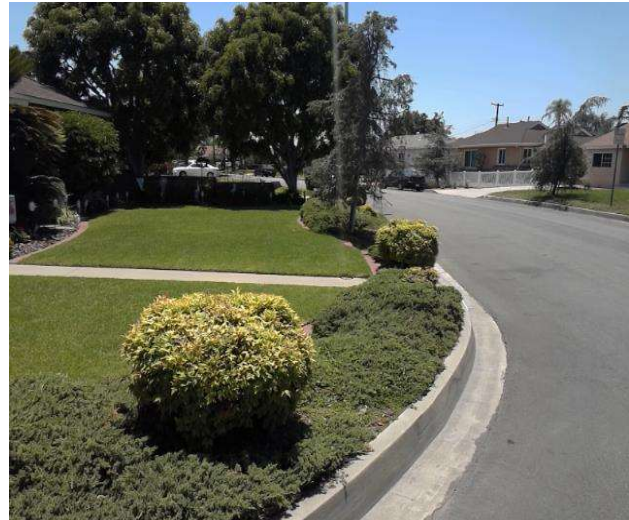
East Side @ 33.955610650876, -118.104333579540

Sidewalks : No Sidewalk

No sidewalk exists at the location.

No action necessary until a sidewalk is provided.

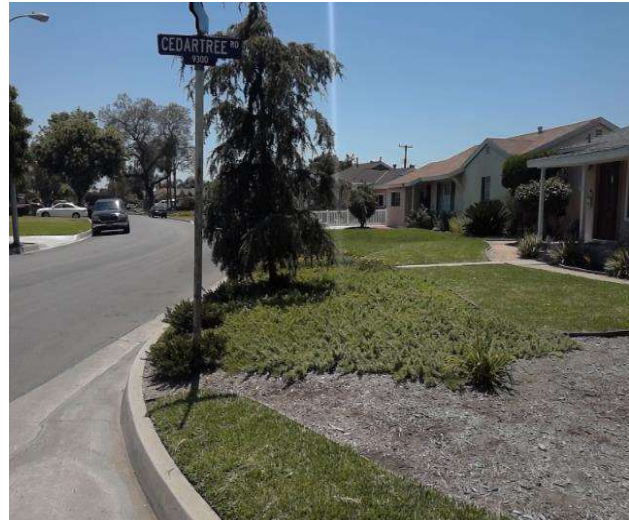
West Side @ 33.955712992231, -118.104454278946

Sidewalks : No Sidewalk

No sidewalk exists at the location.

No action necessary until a sidewalk is provided.

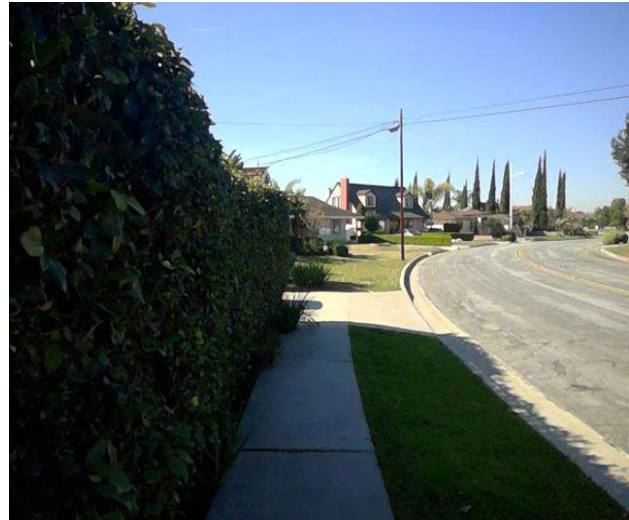
Change In Level South Of Gallatin Road @ 33.949494419051, -118.108643889427

Sidewalks , Change in Level : Change in Level Non Beveled

There is a change in elevation greater than recommended value.

On-Site Finding 0.62 inches

Ensure that the change in elevation is within the recommended value.

Recommendation Up to 0.25 inches

Remove tripping hazards \$198

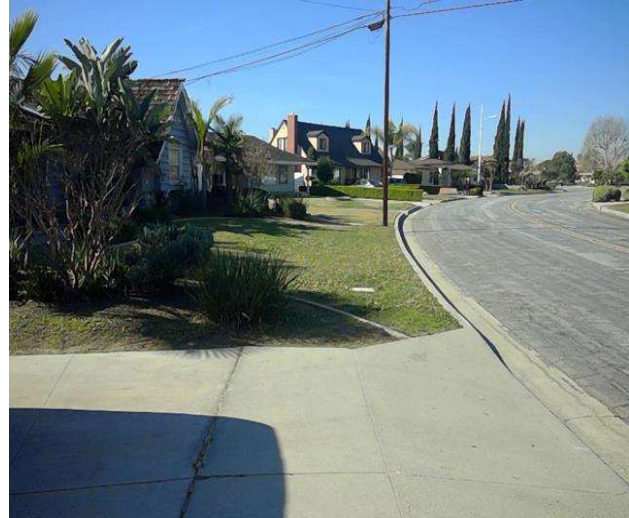
Sidewalk South Of Gallatin Road @ 33.949363145525, -118.108769953251

Sidewalks : Missing Sidewalk

Section of sidewalk is missing and consists of dirt, grass or gravel.

On-Site Finding 184.00 feet

Provide a compliant sidewalk for the missing section.

\$1,260

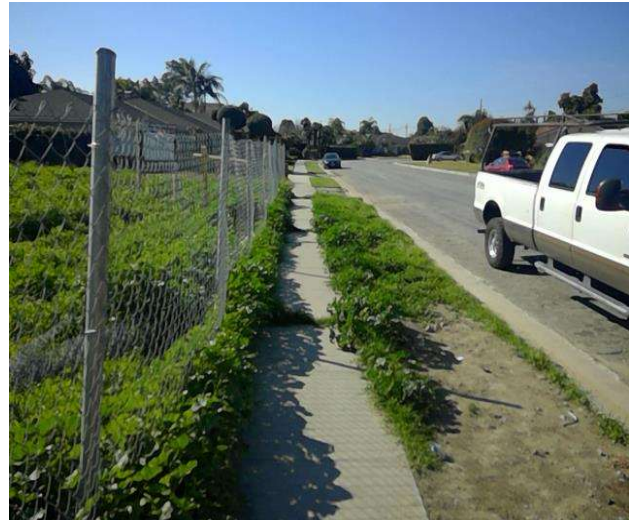
Sidewalk South Of Gallatin Road @ 33.950179708071, -118.108064532280

Sidewalks , Surface : Cross Slope

Sidewalk cross slope is not compliant.

On-Site Finding 4.10 percent for 100.00 feet

Repave the sidewalk surface with the recommended cross slope.

Recommendation Up to 2.08 percent

Repave surface \$1,092

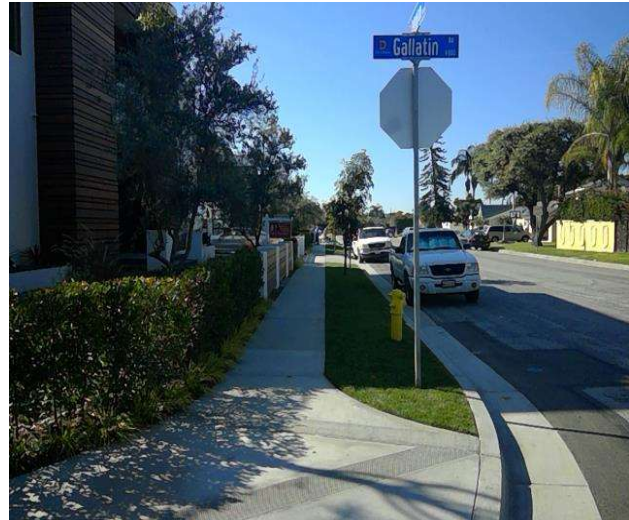
East Side @ 33.950537925135, -118.107777535915

Sidewalks : Turn Area

Turn area is not level.

Make sure that the turn area is level.

\$1,260

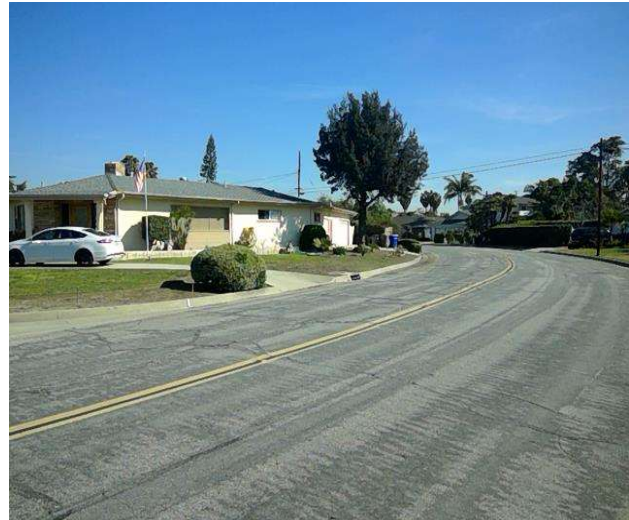
Sidewalk North Of Raviller Drive @ 33.949327545890, -118.109663128853

Sidewalks : Missing Sidewalk

Section of sidewalk is missing and consists of dirt, grass or gravel.

On-Site Finding 783.00 feet

Provide a compliant sidewalk for the missing section.

\$1,260

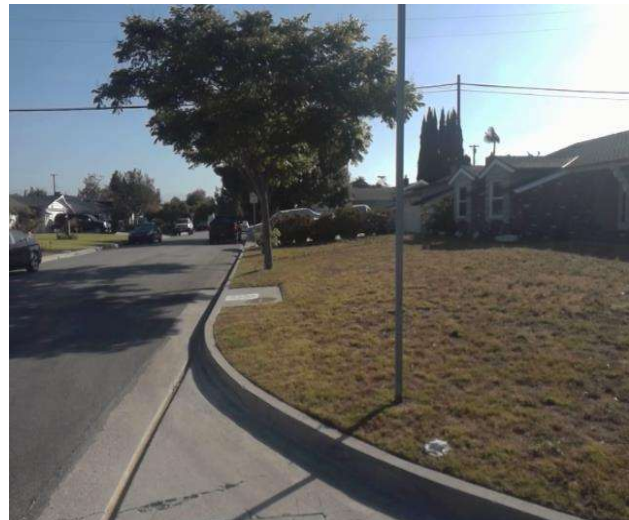
East Side @ 33.938635856723, -118.116231858730

Sidewalks : No Sidewalk

No sidewalk exists at the location.

No action necessary until a sidewalk is provided.

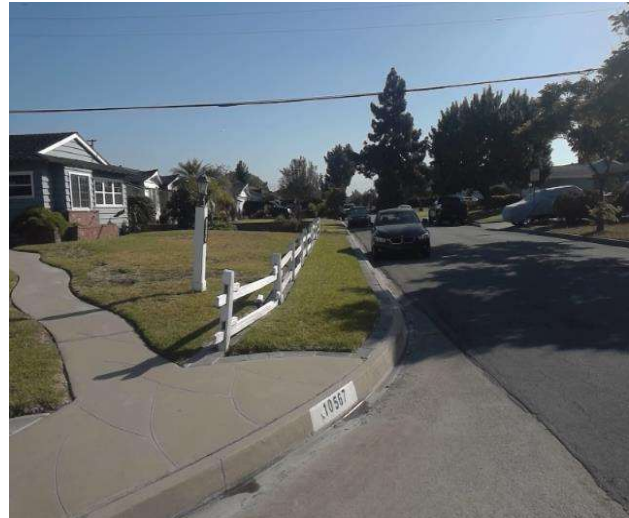
West Side @ 33.938715965943, -118.116355240345

Sidewalks : No Sidewalk

No sidewalk exists at the location.

No action necessary until a sidewalk is provided.

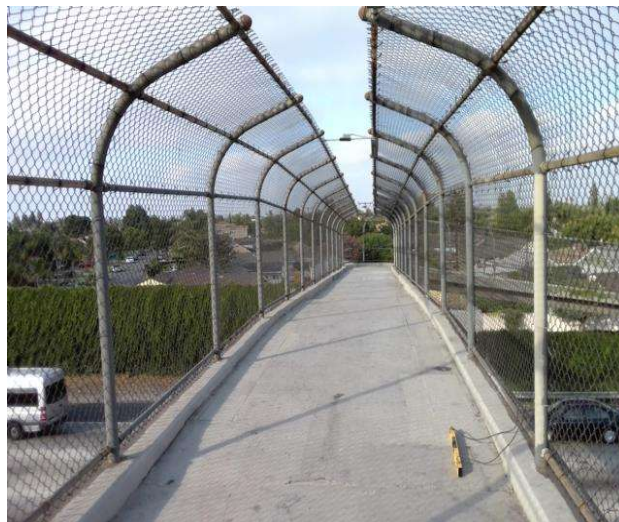
Path of Travel from North Ramp to South Ramp @ 33.953535987093, - 118.105362206697

Path Of Travel , Walking Surfaces : Walking Surface Slope

There are slopes greater than allowed maximum slope on the primary path of travel.

On-Site Finding 12.00 percent for 76.00 feet

Provide a compliant path of travel.

Recommendation Up to 5.00 percent

Install pathway \$3,600

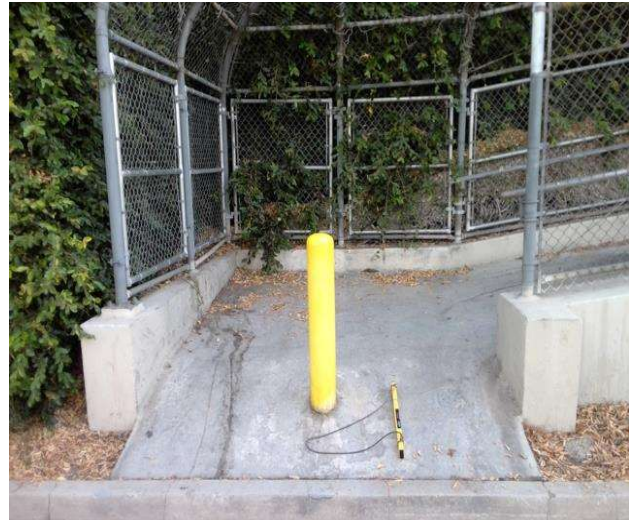
Curb to Ramp @ 33.953515963282, -118.106125295162

Path Of Travel , Walking Surfaces : Curb is on The Path of Travel

There is a curb on the designated path of travel.

On-Site Finding Curb Found

Provide a compliant curb ramp.

Install curb ramp \$2,500

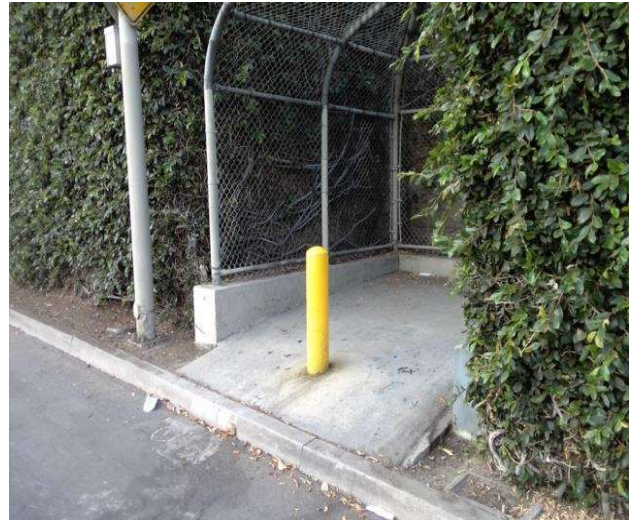
On-Site Finding Curb Found

Install curb ramp \$2,500

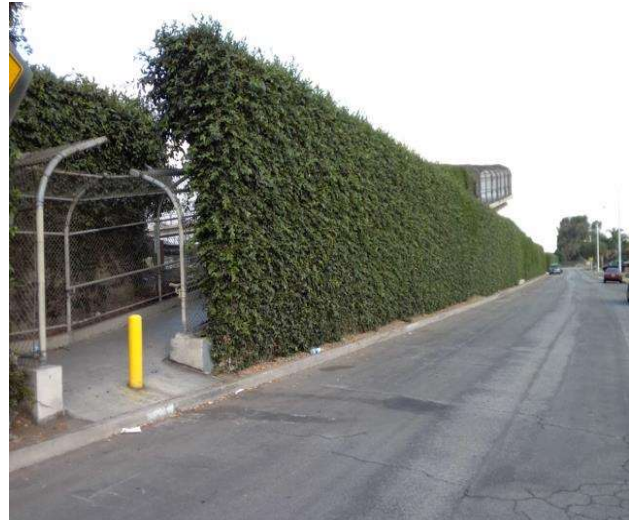
On-Site Finding None Found

Install Pathway \$1,840

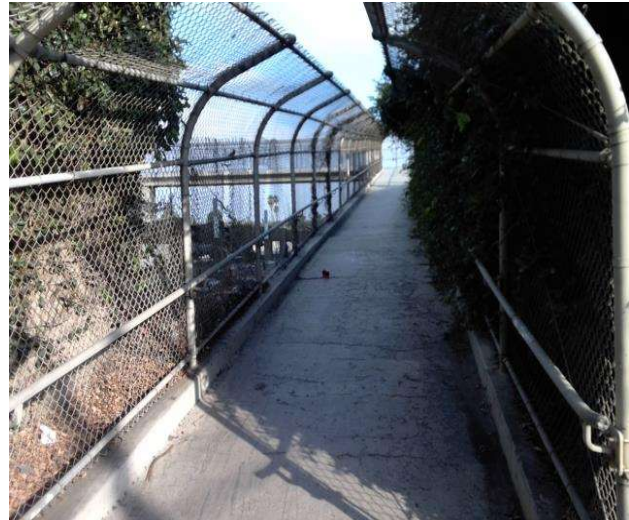
Notes : Bush Vines Interruptes Right Grip Surface

Recommendation Up to 8.33 percent

Correct ramp slope \$3,600

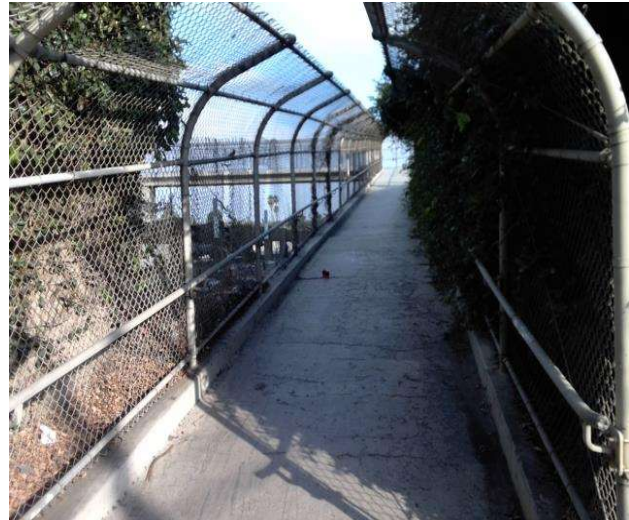
Notes : Bush Vines Interruptes Right Grip Surface

Modify or replace the landing to provide the minimum required length and width.

Recommendation At least 60.00 inches

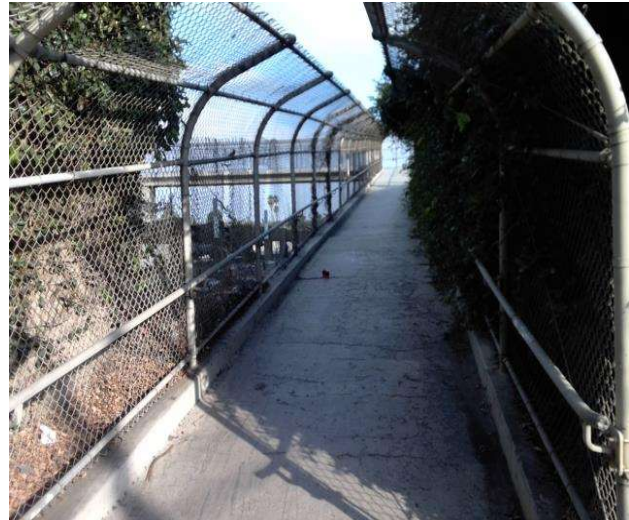
Notes : Bush Vines Interruptes Right Grip Surface

Replace the handrails on each side to provide a smooth and continuous gripping surface. The gripping surface shall be smooth and free from interruptions.

Attach pipe railing to wall \$2,320

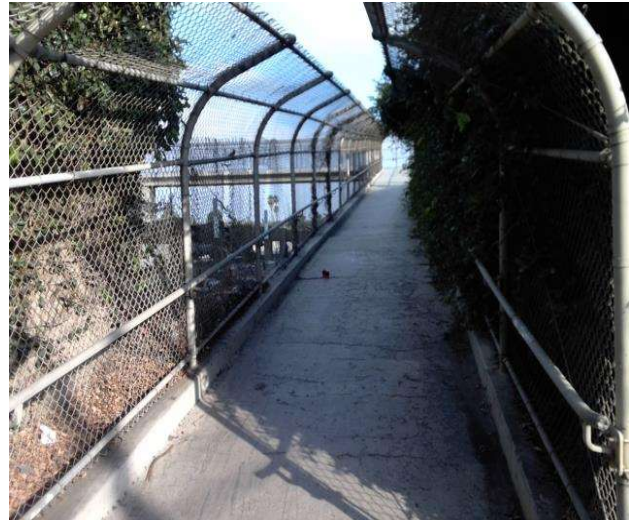
Notes : Bush Vines Interruptes Right Grip Surface

Modify or replace the handrails on the ramp to provide a gripping surface height within the required range above the ramp surface.

Recommendation 34.00 - 38.00 inches

Set hand-forged wrought iron railing in concrete \$3,918

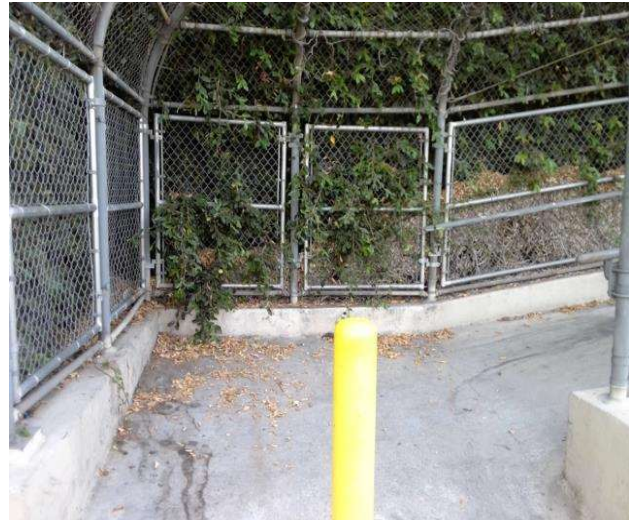
Notes : Bush Vines Interrupts Left Grip Surface

Replace the handrails on each side to provide a smooth and continuous gripping surface. The gripping surface shall be smooth and free from interruptions.

Attach pipe railing to wall \$2,320

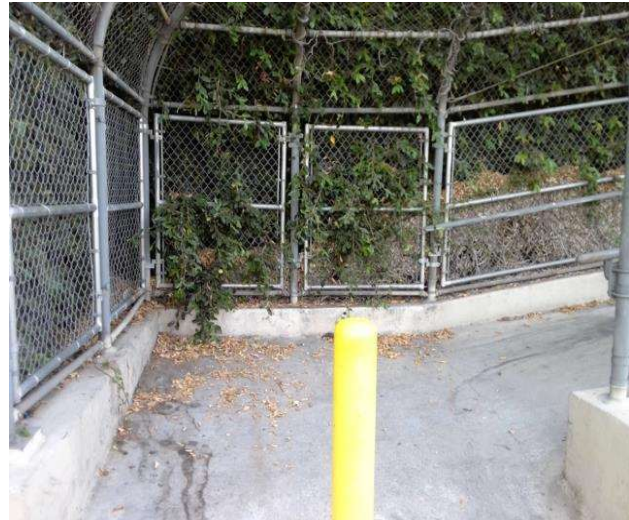
Notes : Bush Vines Interrupts Left Grip Surface

Modify or replace the handrails on the ramp to provide a gripping surface height within the required range above the ramp surface.

Recommendation 34.00 - 38.00 inches

Set hand-forged wrought iron railing in concrete \$3,918

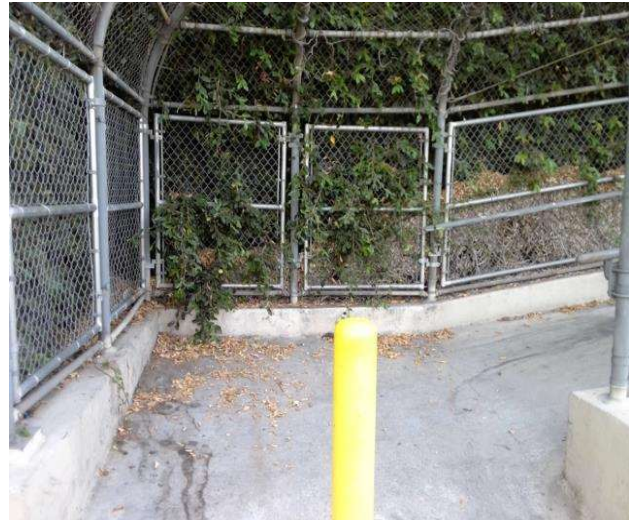
Notes : Bush Vines Interrupts Left Grip Surface

Modify or replace the handrails on the ramp to provide a gripping surface height within the required range above the ramp surface.

Recommendation 34.00 - 38.00 inches

Set hand-forged wrought iron railing in concrete \$3,918
